Public Works
Manly Hydraulics Laboratory

MHL
Report 2157

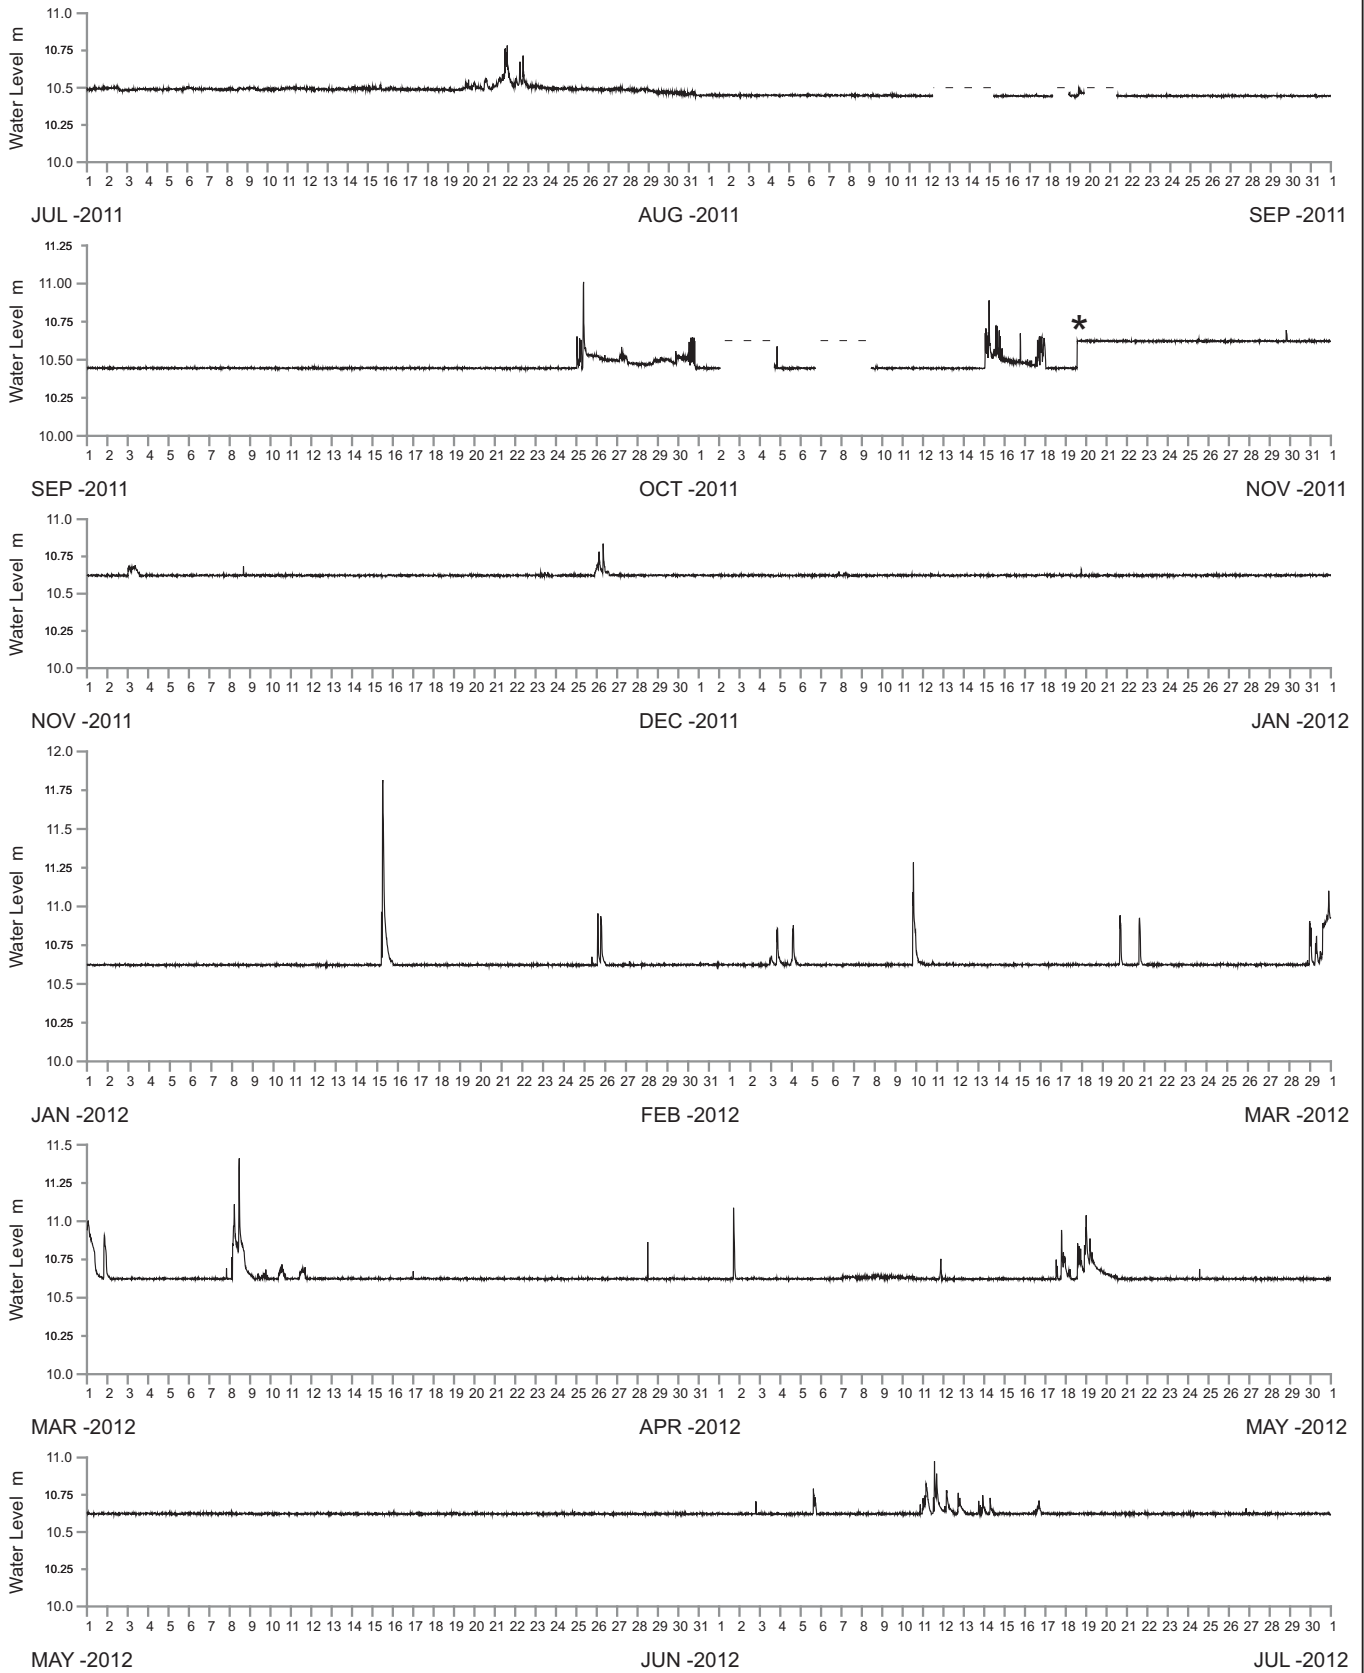
Figure
200

WATER LEVEL REFERENCED TO AUSTRALIAN HEIGHT DATUM

* ORIFICE RAISED TO 10.640m (AHD)

HEWITTS CREEK AT HEWITTS CREEK UPSTREAM
2011-2012
