Public Works
Manly Hydraulics Laboratory

MHL
Report 2218

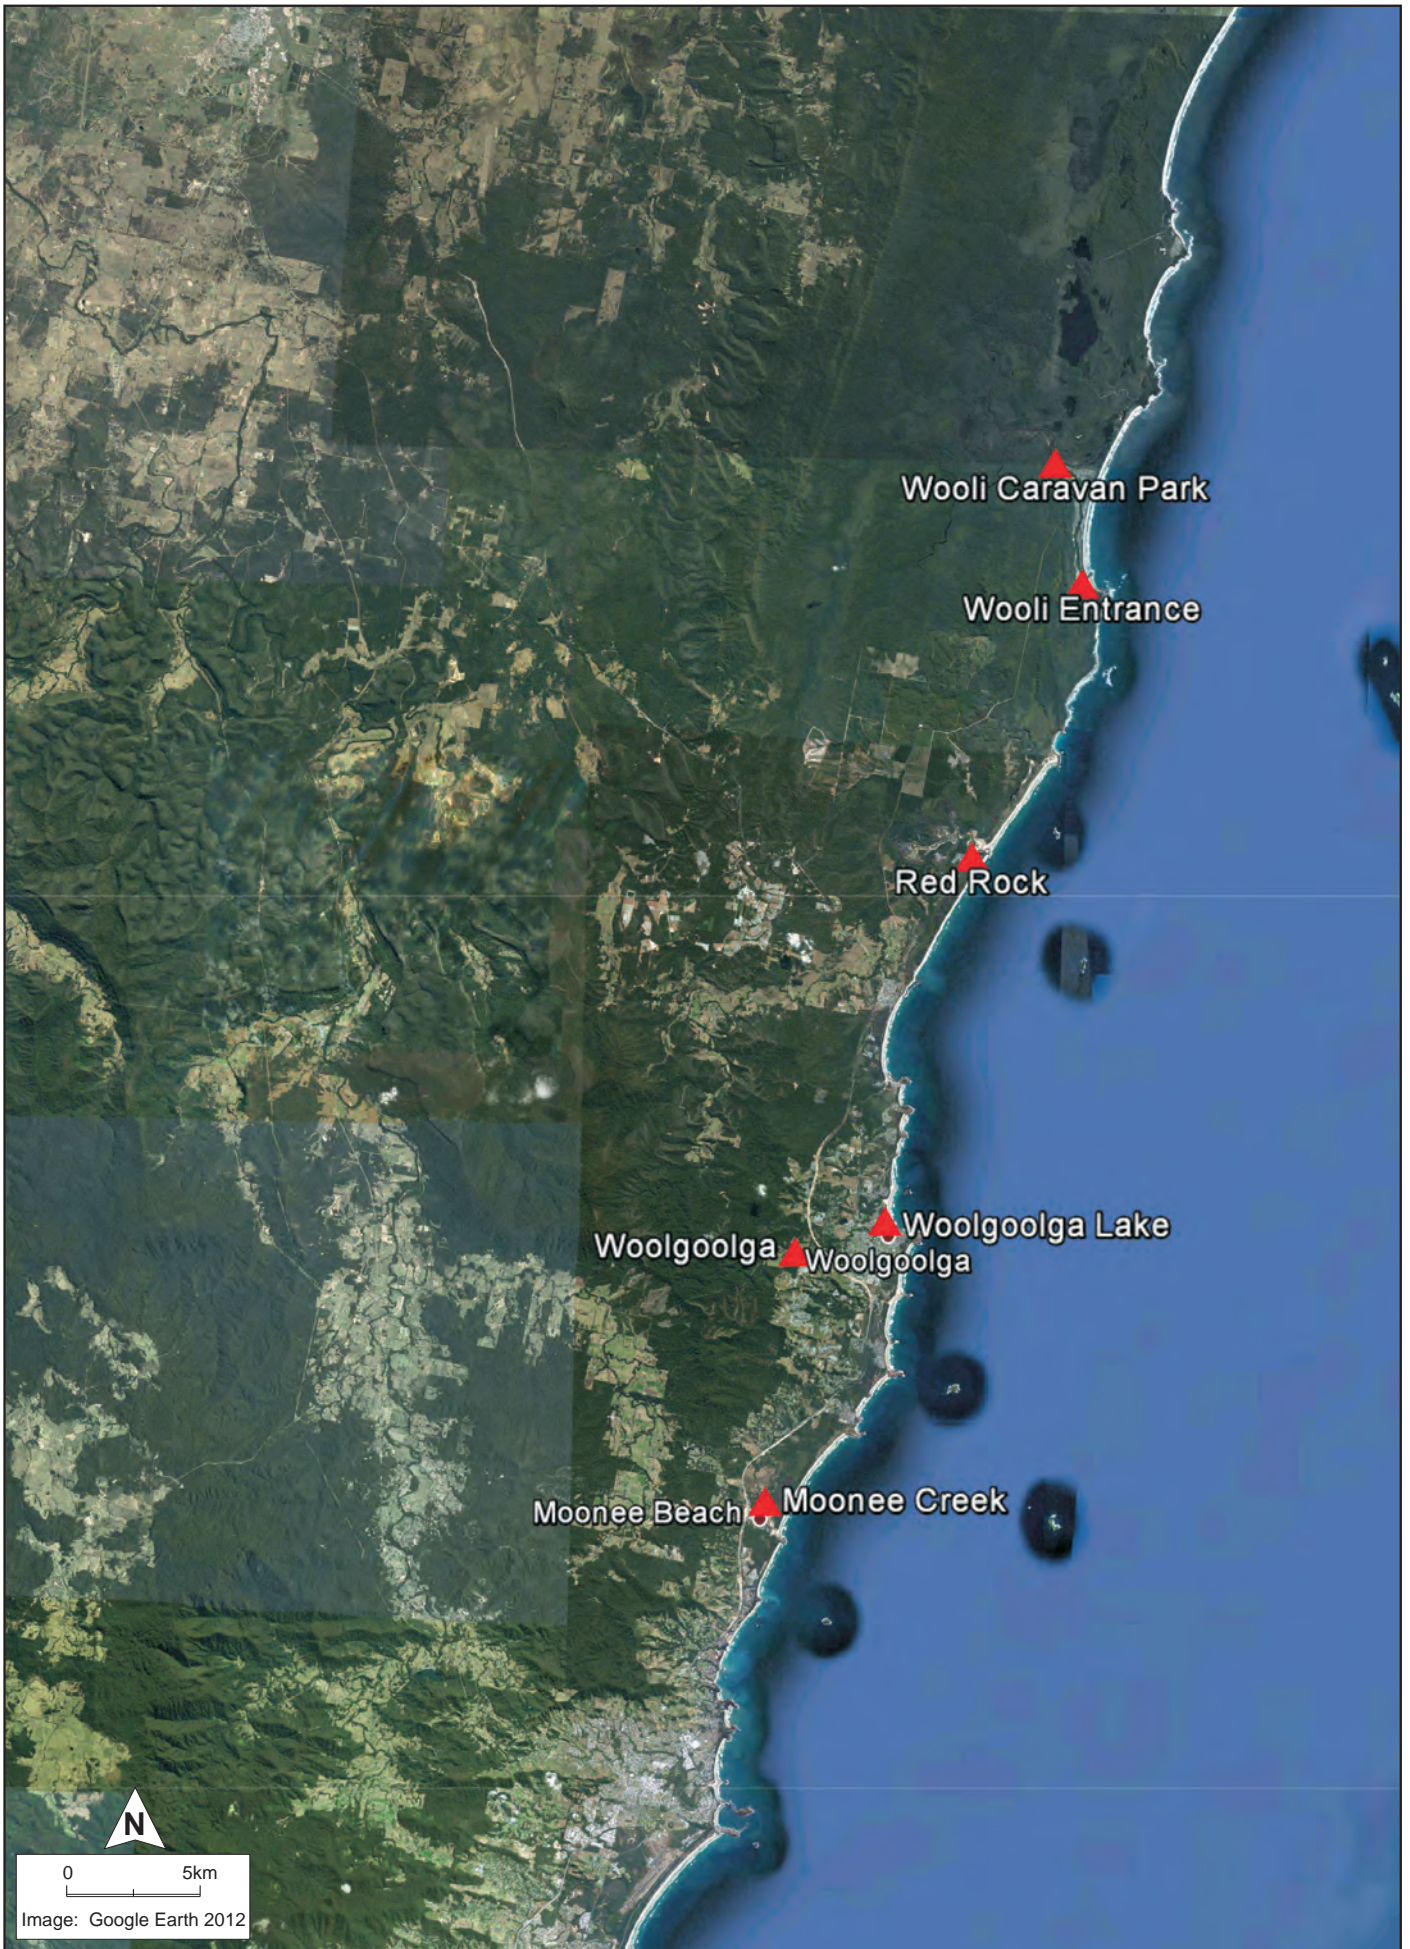
Figure
51

**STATION LOCATIONS
WOOLGOOLGA REGION**

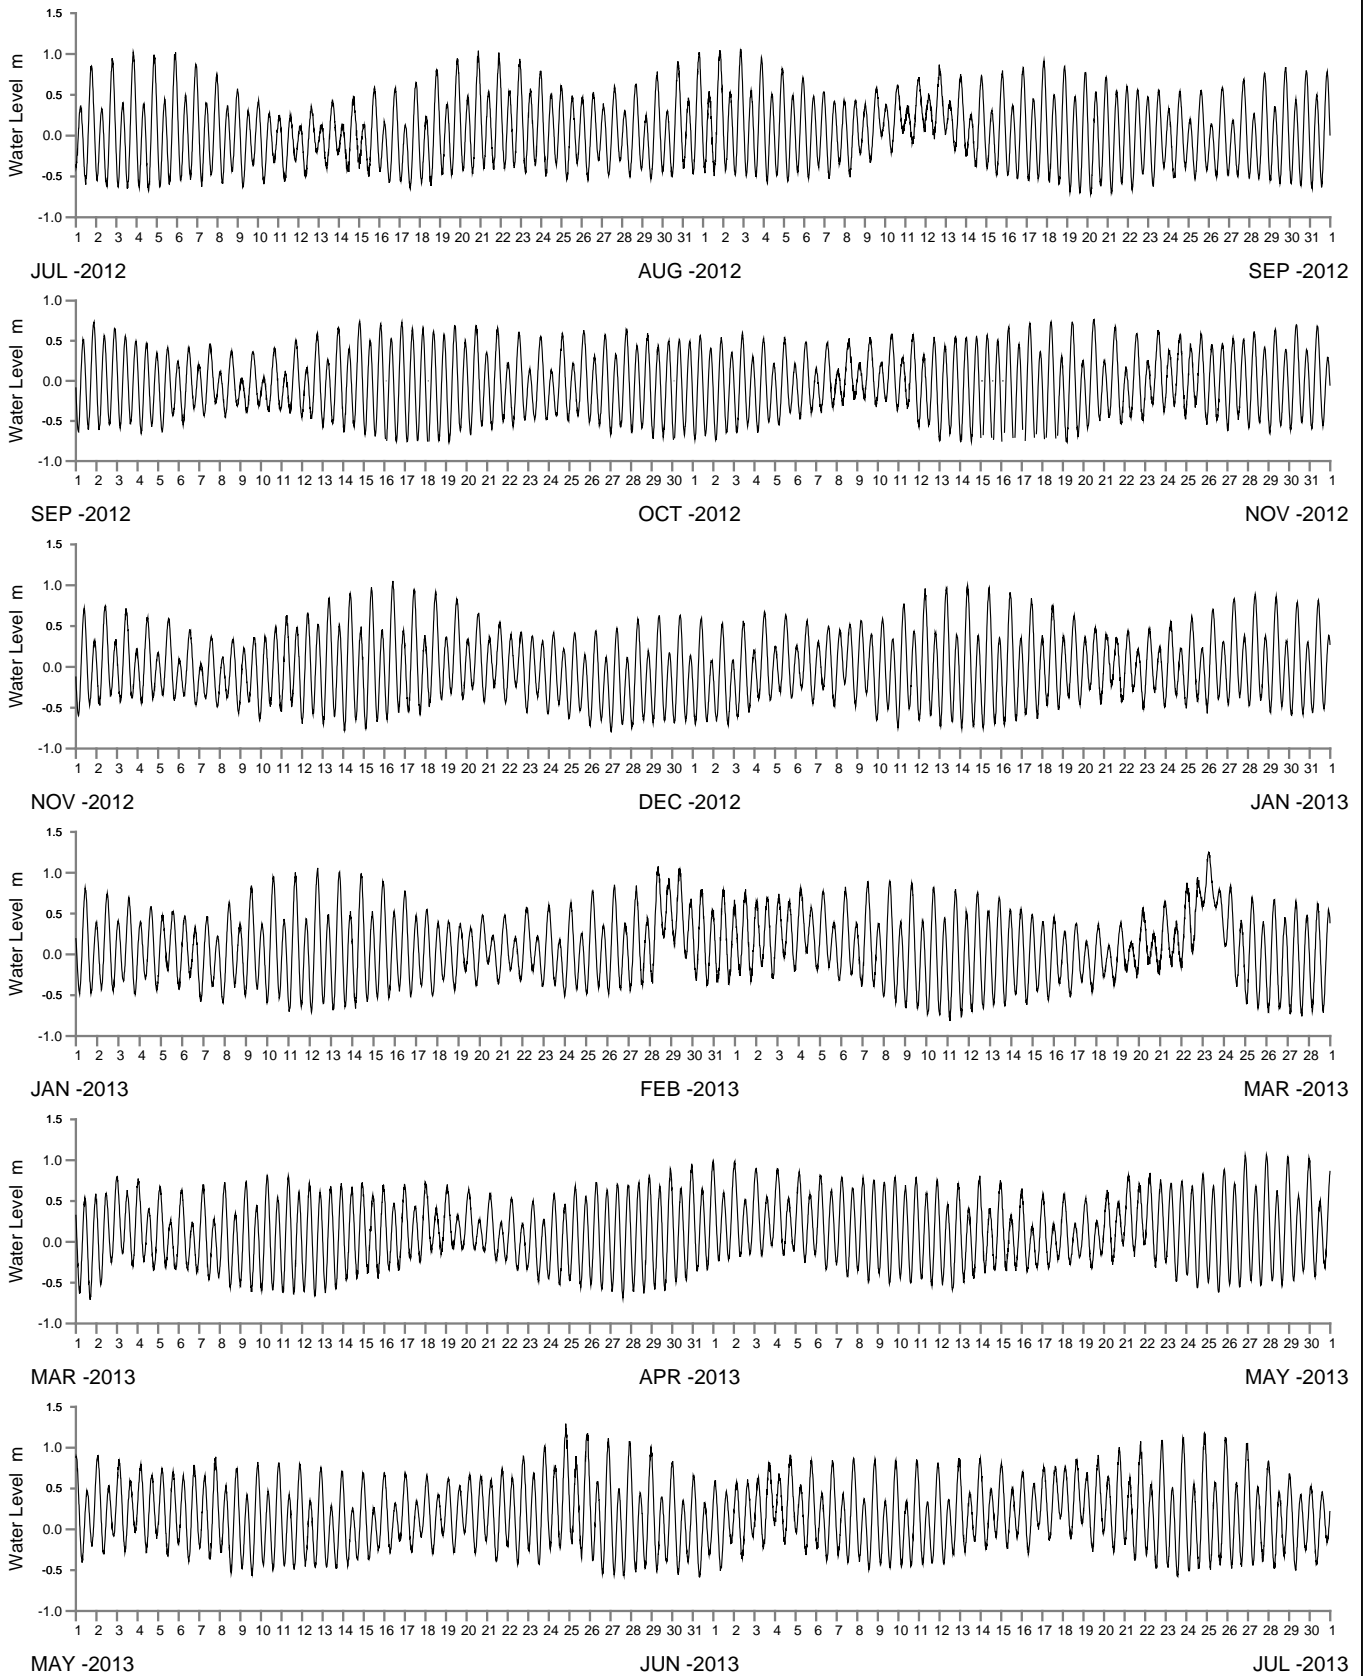
52

WATER LEVEL REFERENCED TO AUSTRALIAN HEIGHT DATUM

WOOLI RIVER AT WOOLI ENTRANCE
2012-2013

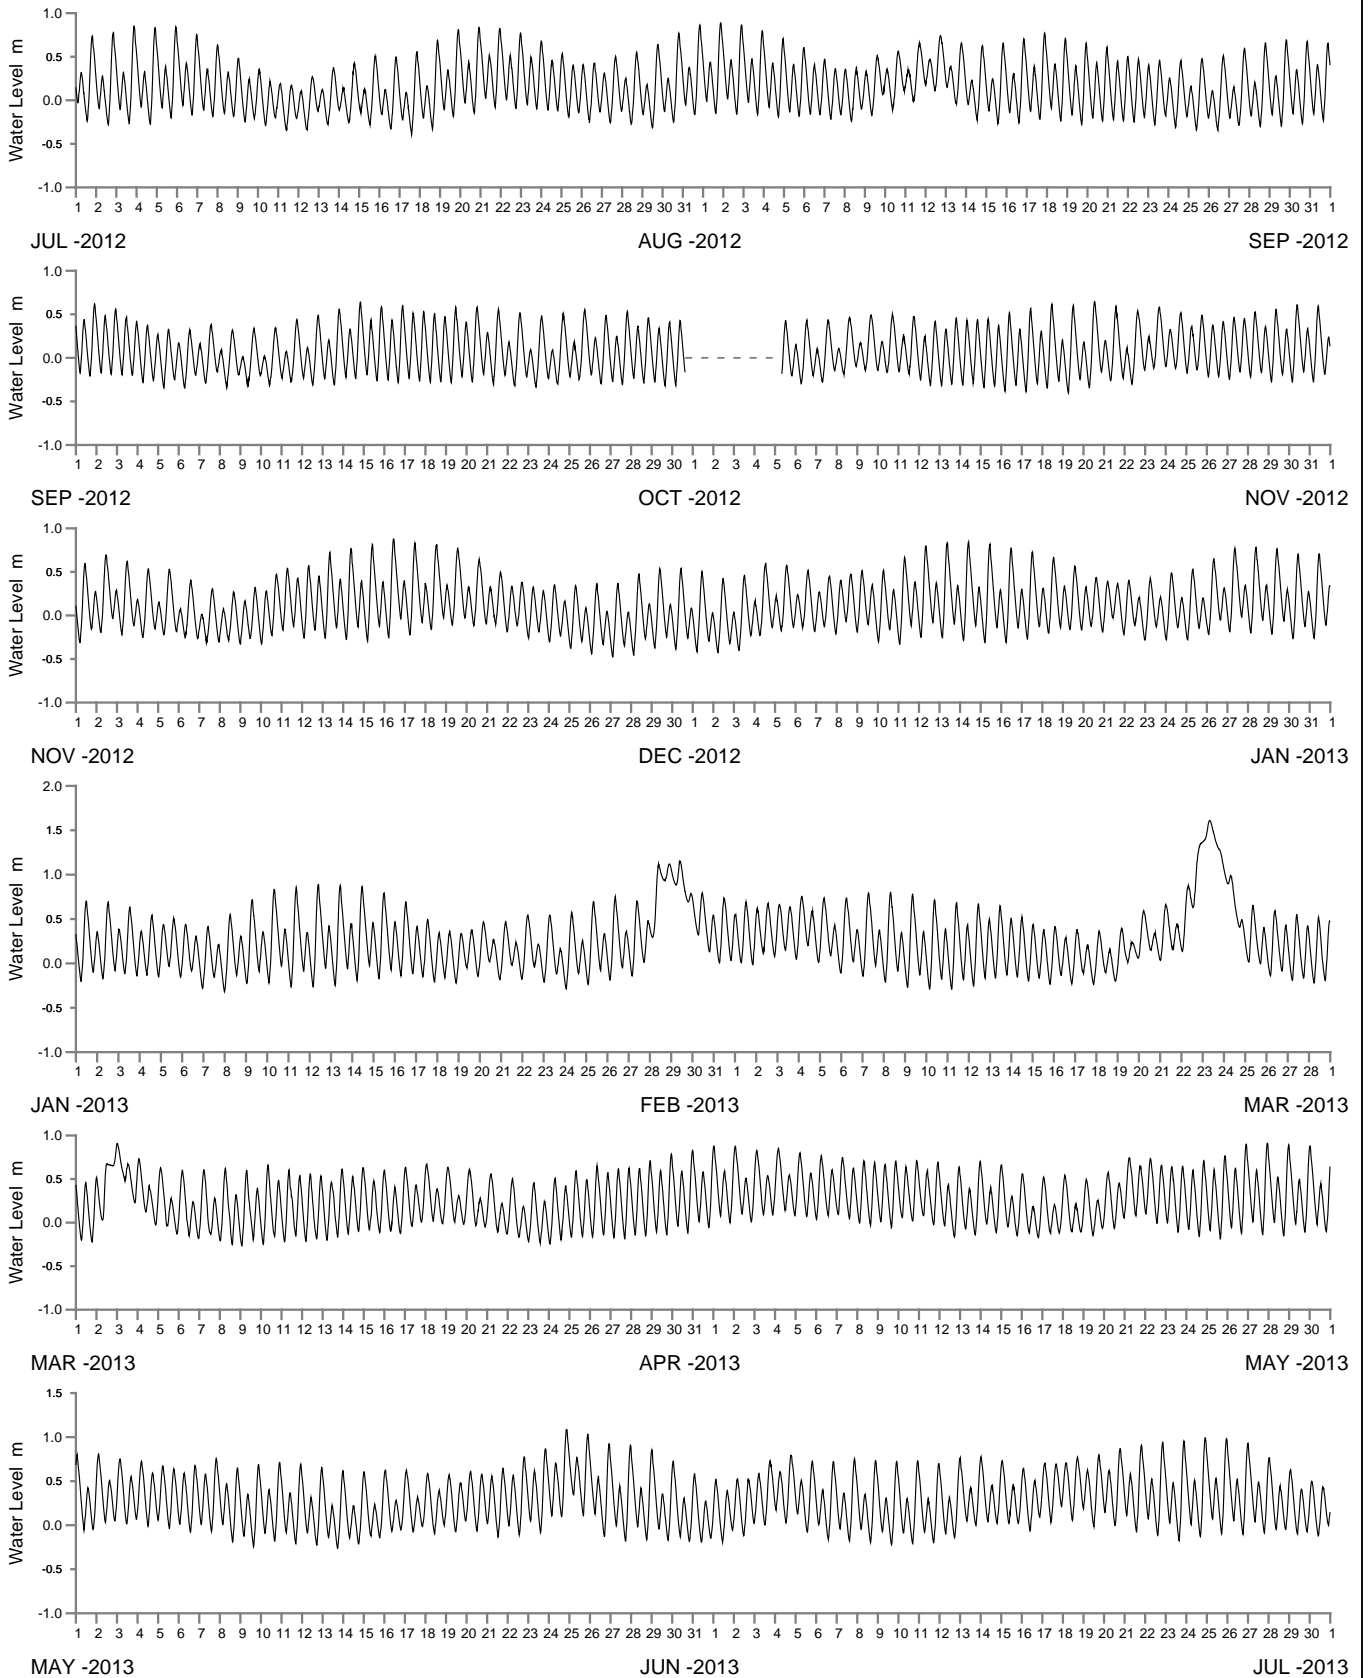
53

WATER LEVEL REFERENCED TO AUSTRALIAN HEIGHT DATUM

WOOLI RIVER AT WOOLI CARAVAN PARK
2012-2013

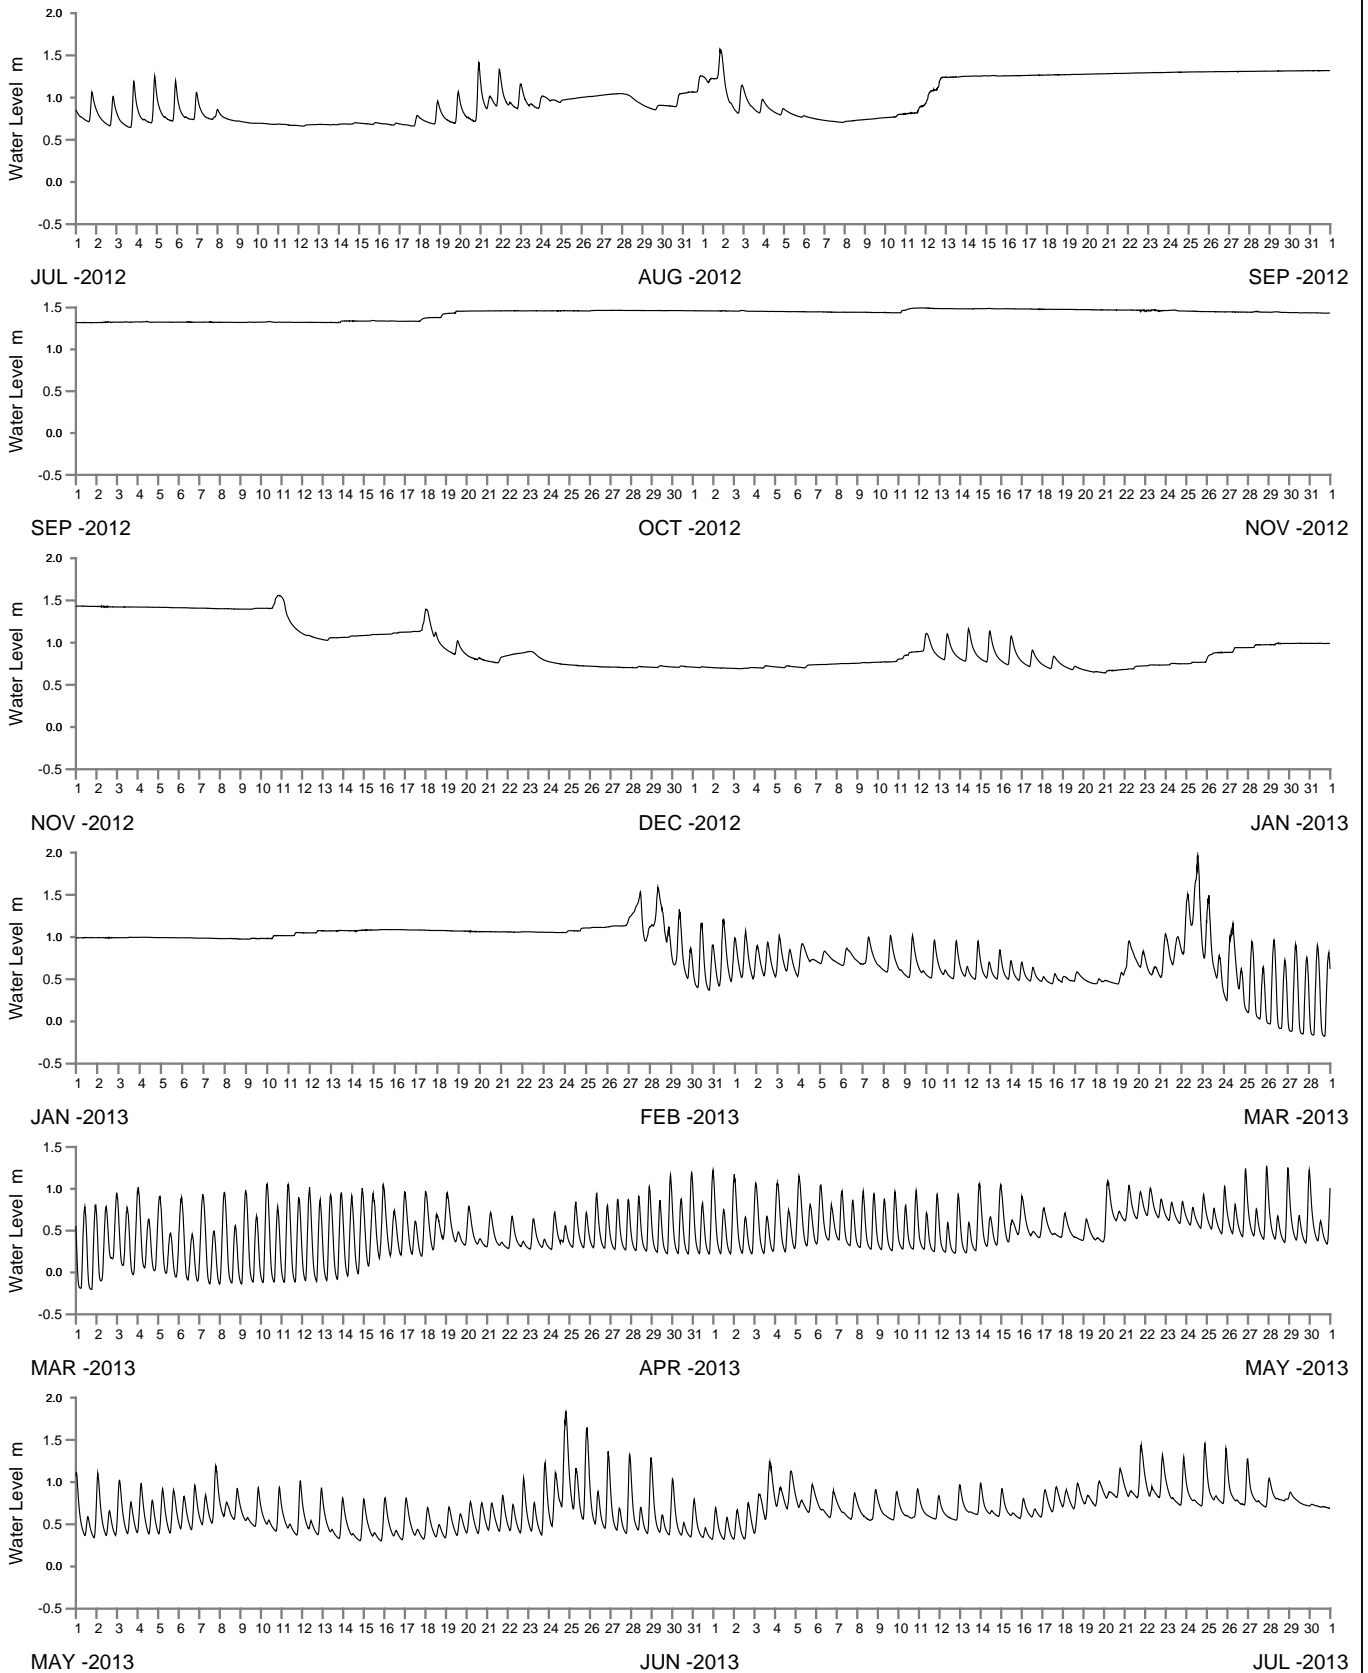
55

WATER LEVEL REFERENCED TO AUSTRALIAN HEIGHT DATUM

WOOLGOOLGA LAKE AT WOOLGOOLGA LAKE
2012-2013

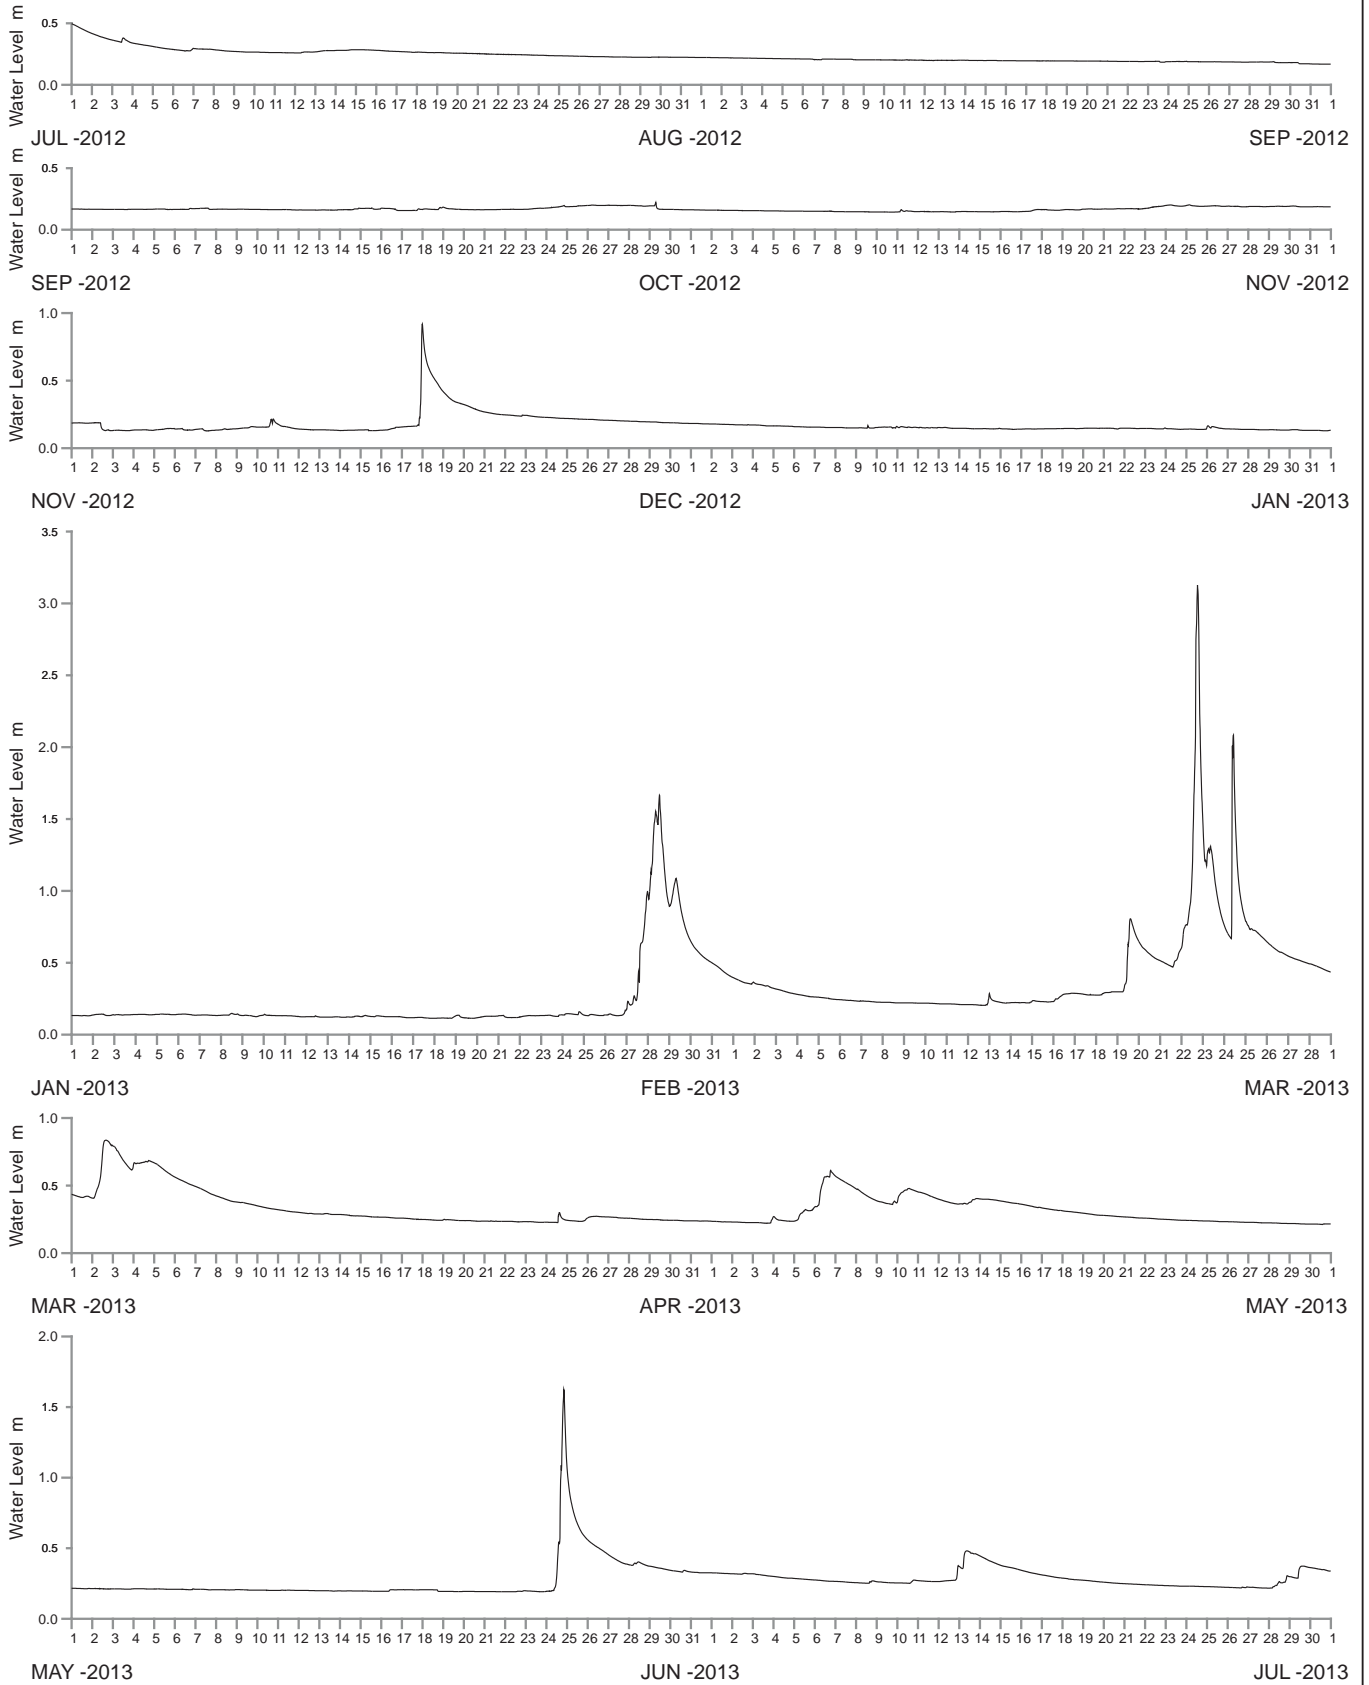
56

WATER LEVEL REFERENCED TO CTF OF CONTROL STRUCTURE

WOOLGOOLGA CREEK AT WOOLGOOLGA
2012-2013

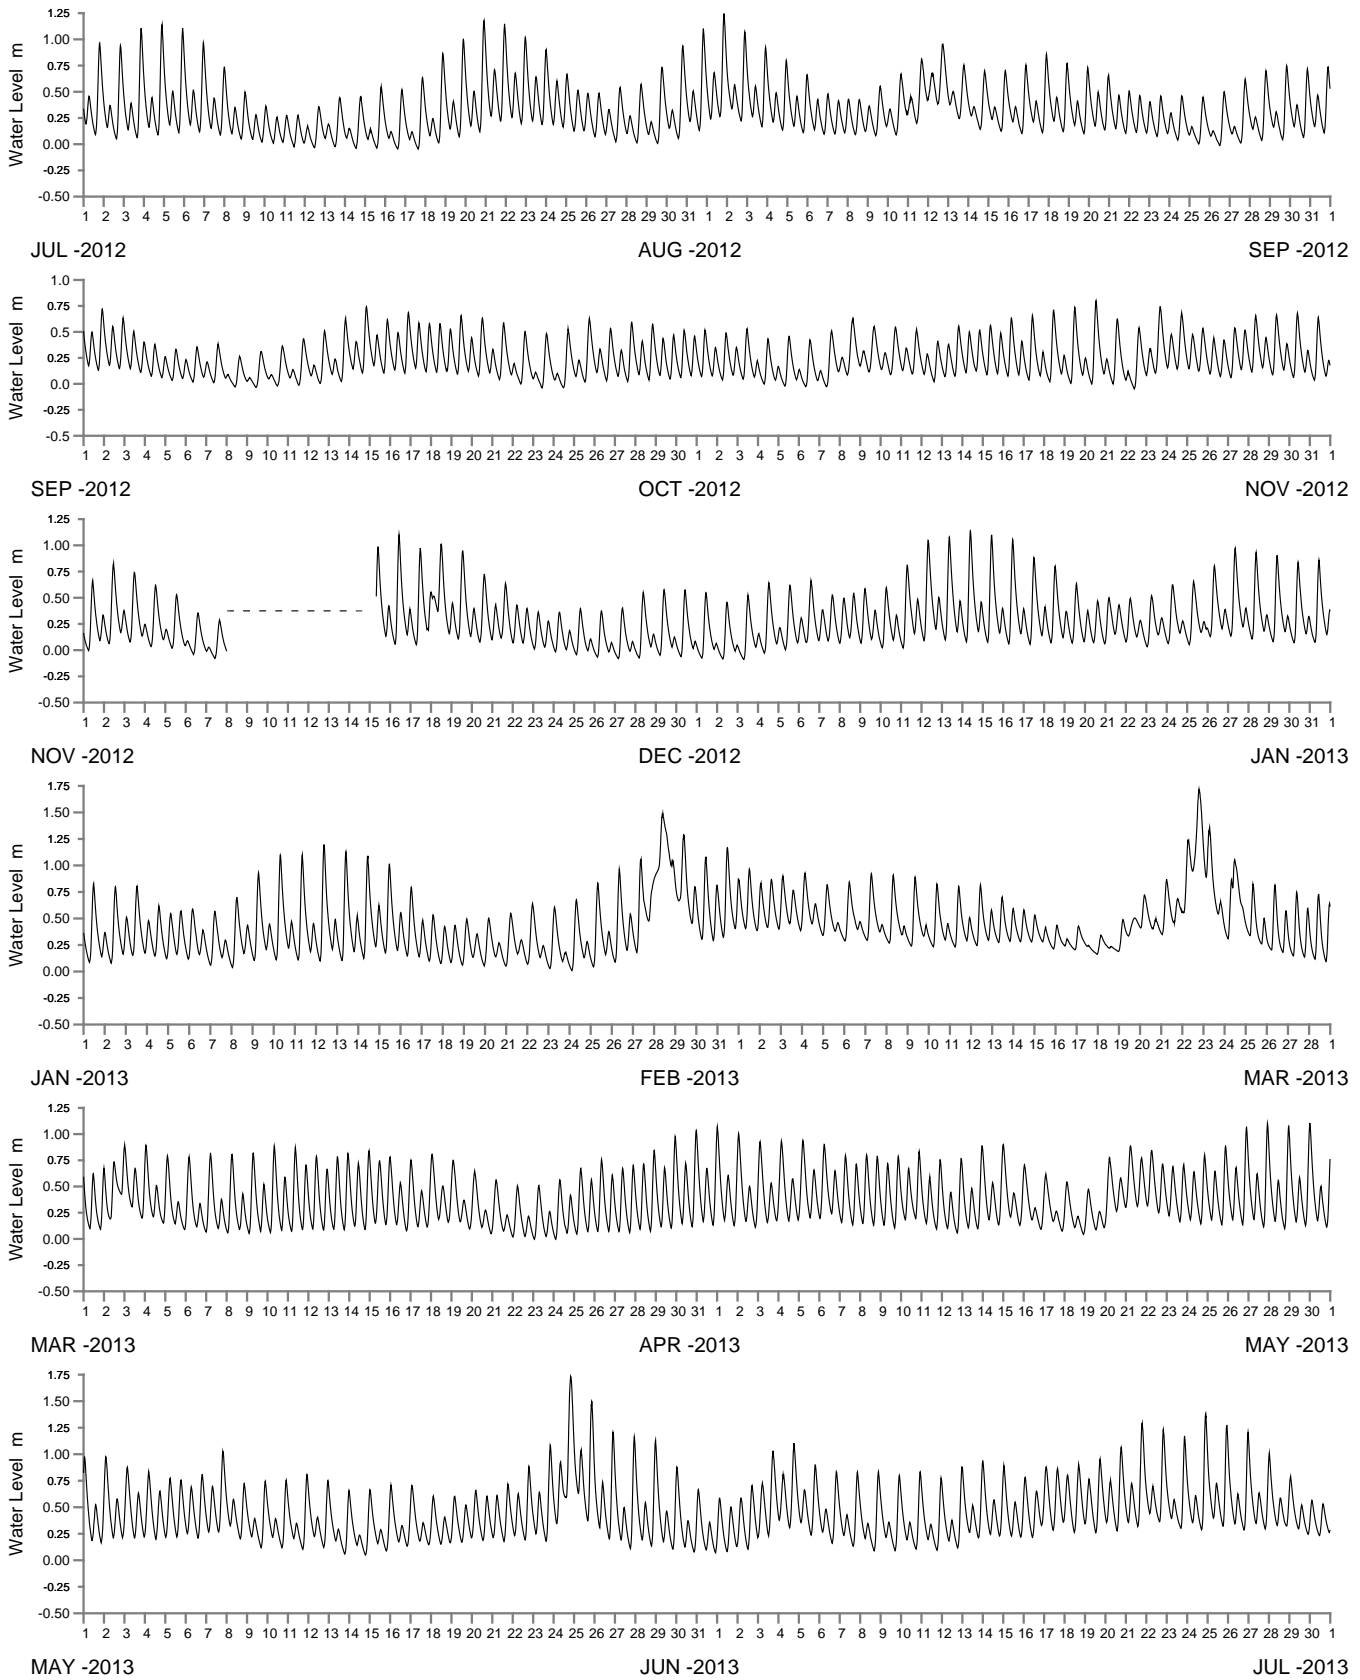
57

WATER LEVEL REFERENCED TO AUSTRALIAN HEIGHT DATUM

MOONEE CREEK AT MOONEE CREEK
2012-2013

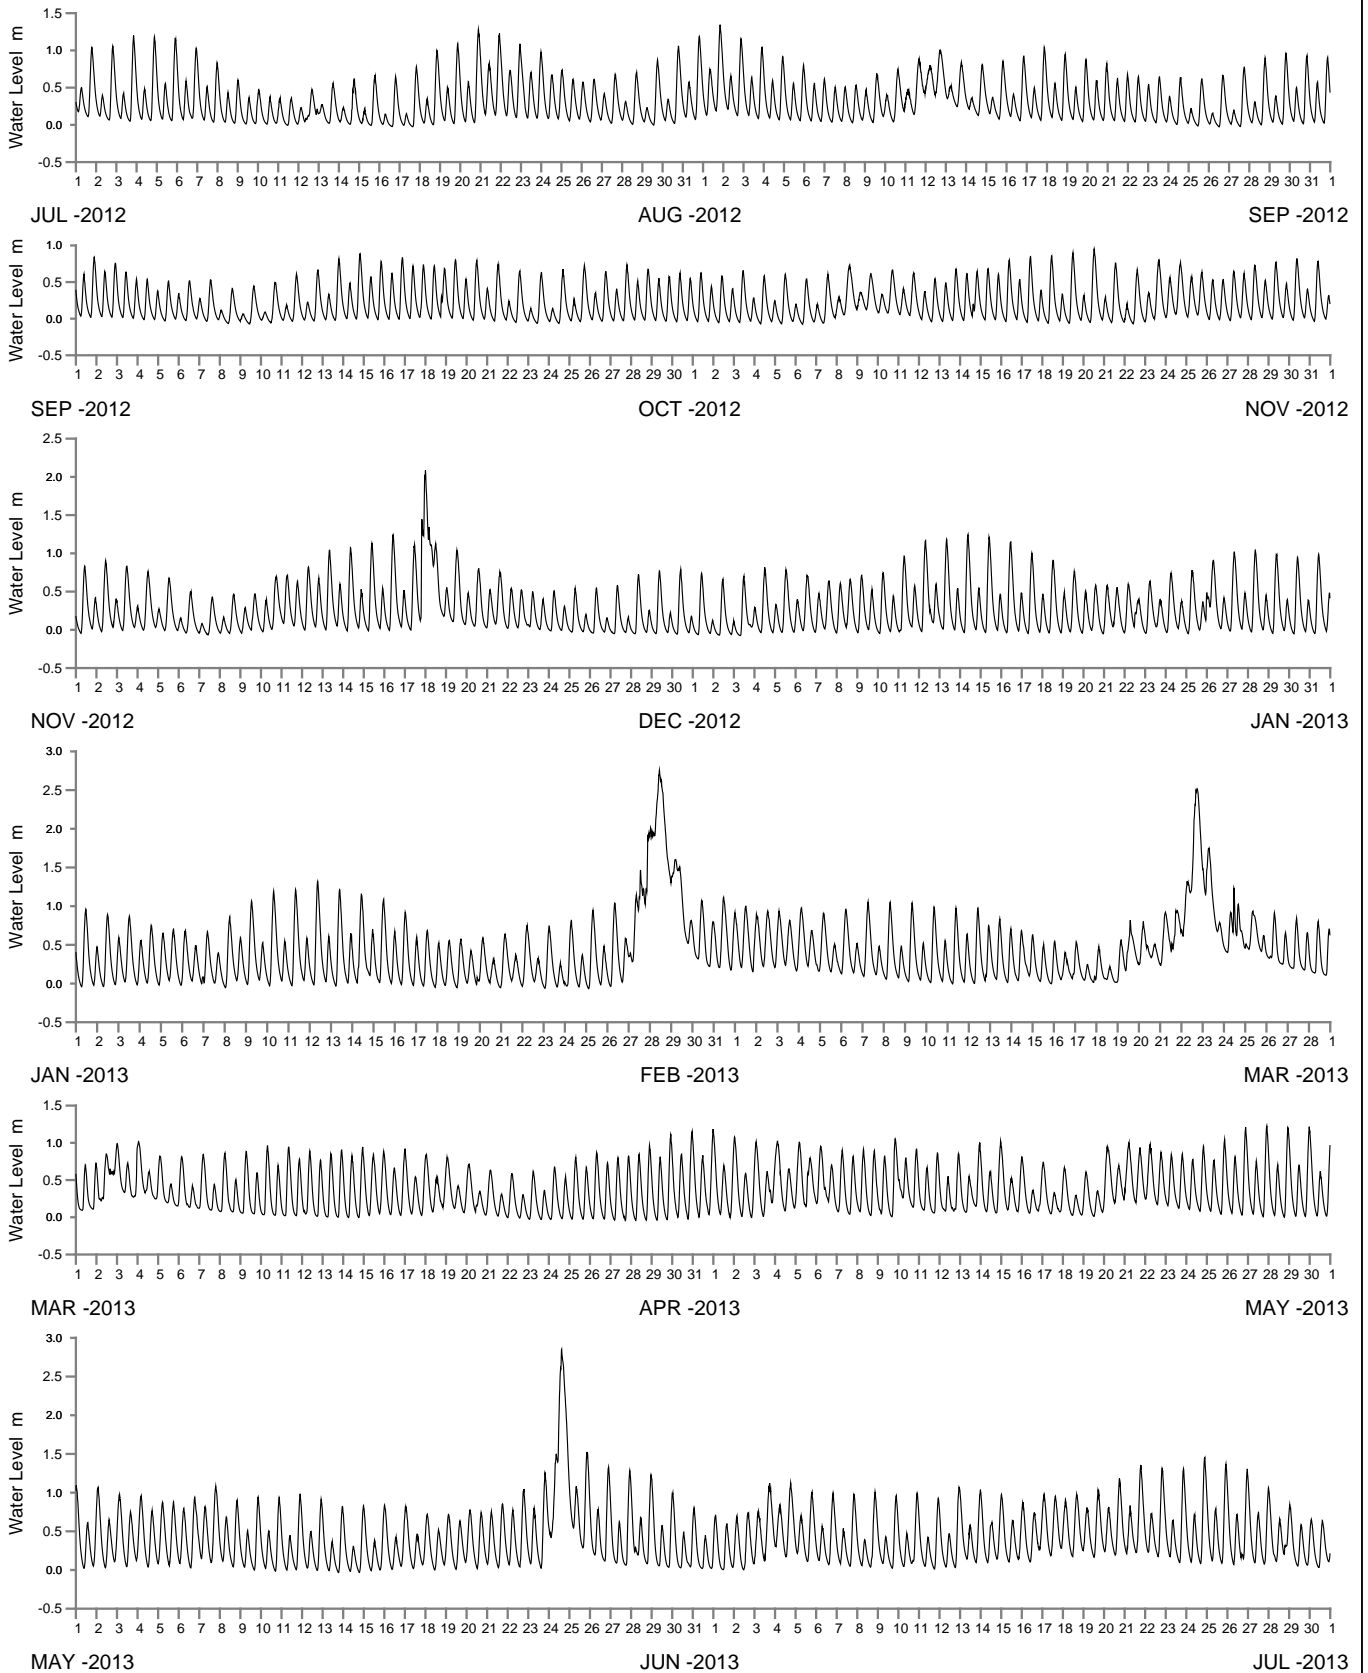
59

WATER LEVEL REFERENCED TO AUSTRALIAN HEIGHT DATUM

COFFS CREEK AT COFFS CREEK HIGHWAY BRIDGE
2012-2013

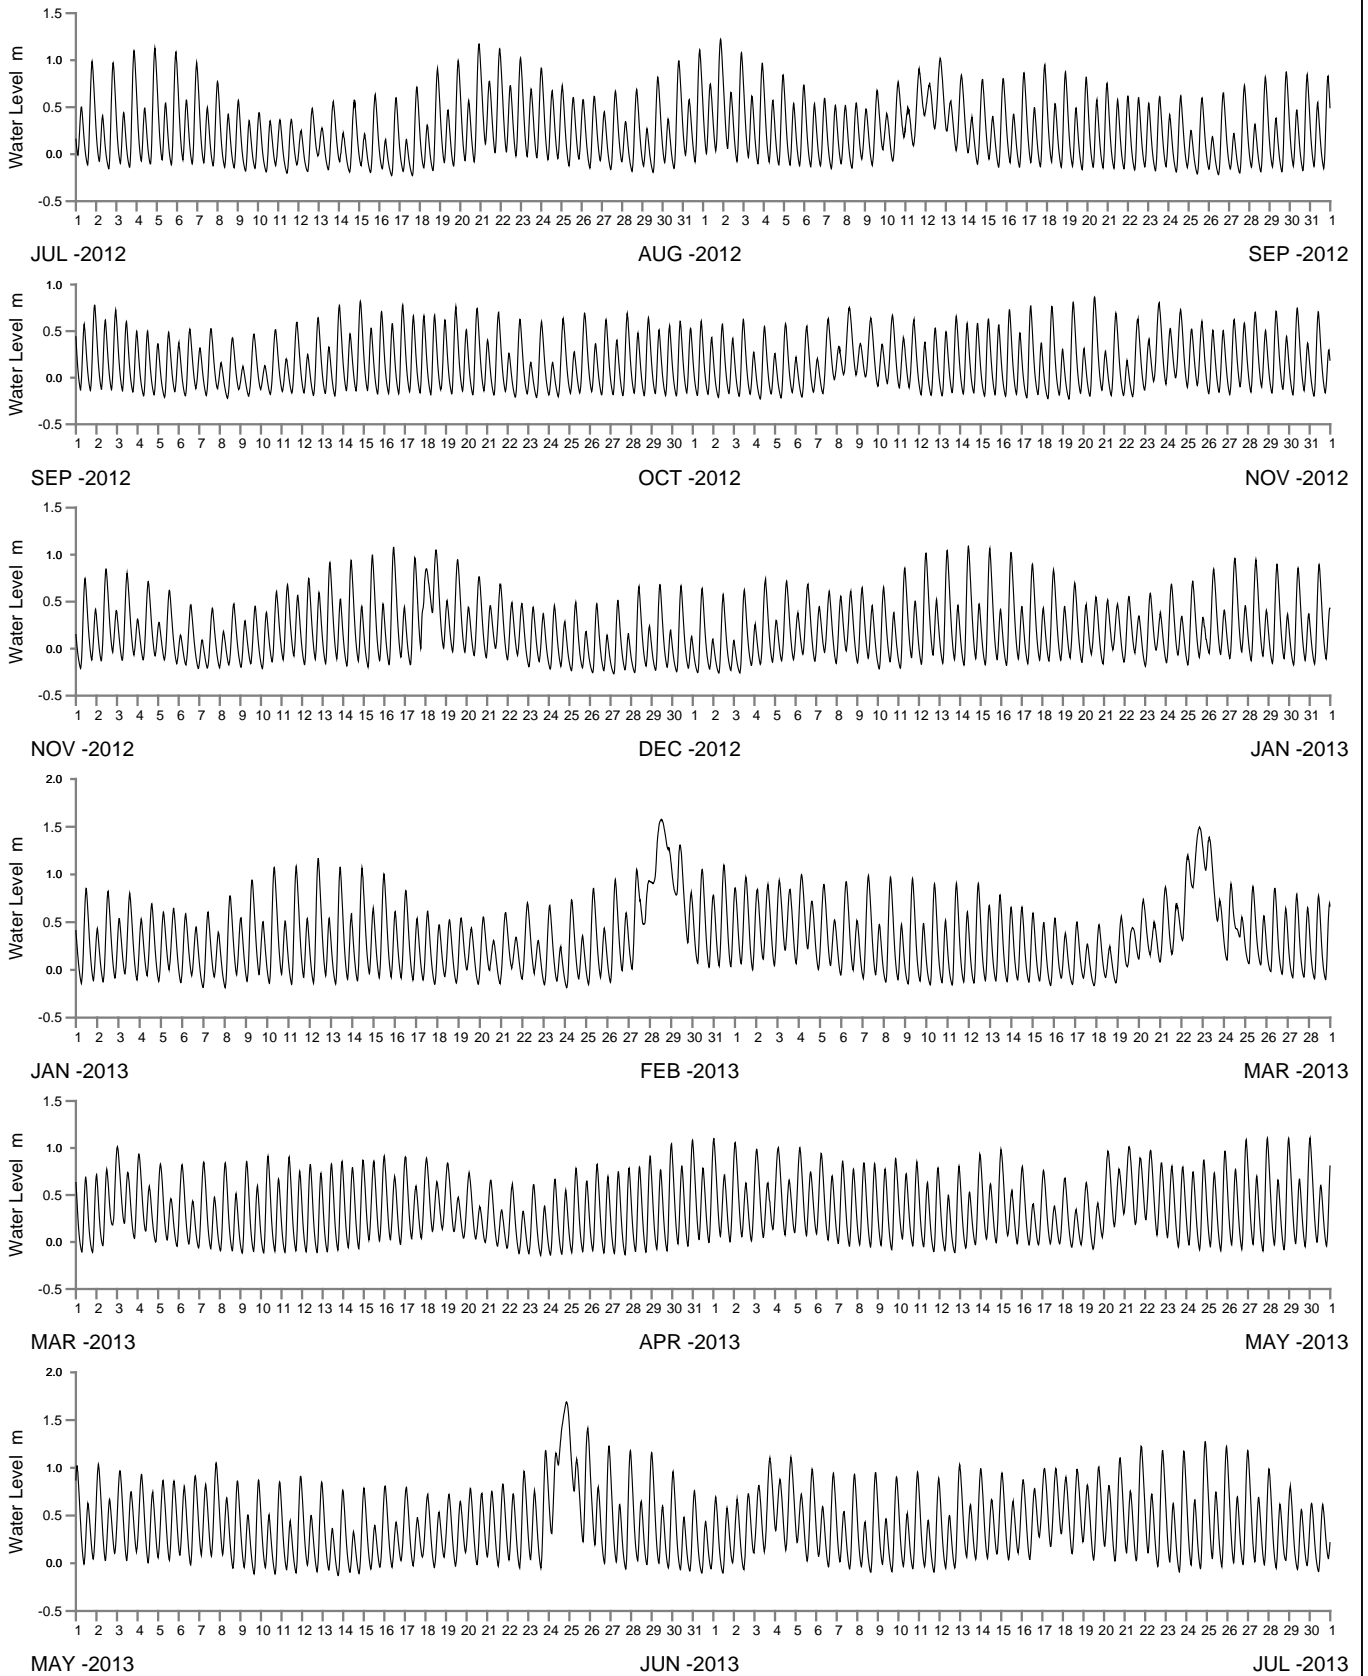
60

WATER LEVEL REFERENCED TO AUSTRALIAN HEIGHT DATUM

NEWPORTS CREEK AT NEWPORTS CREEK
2012-2013

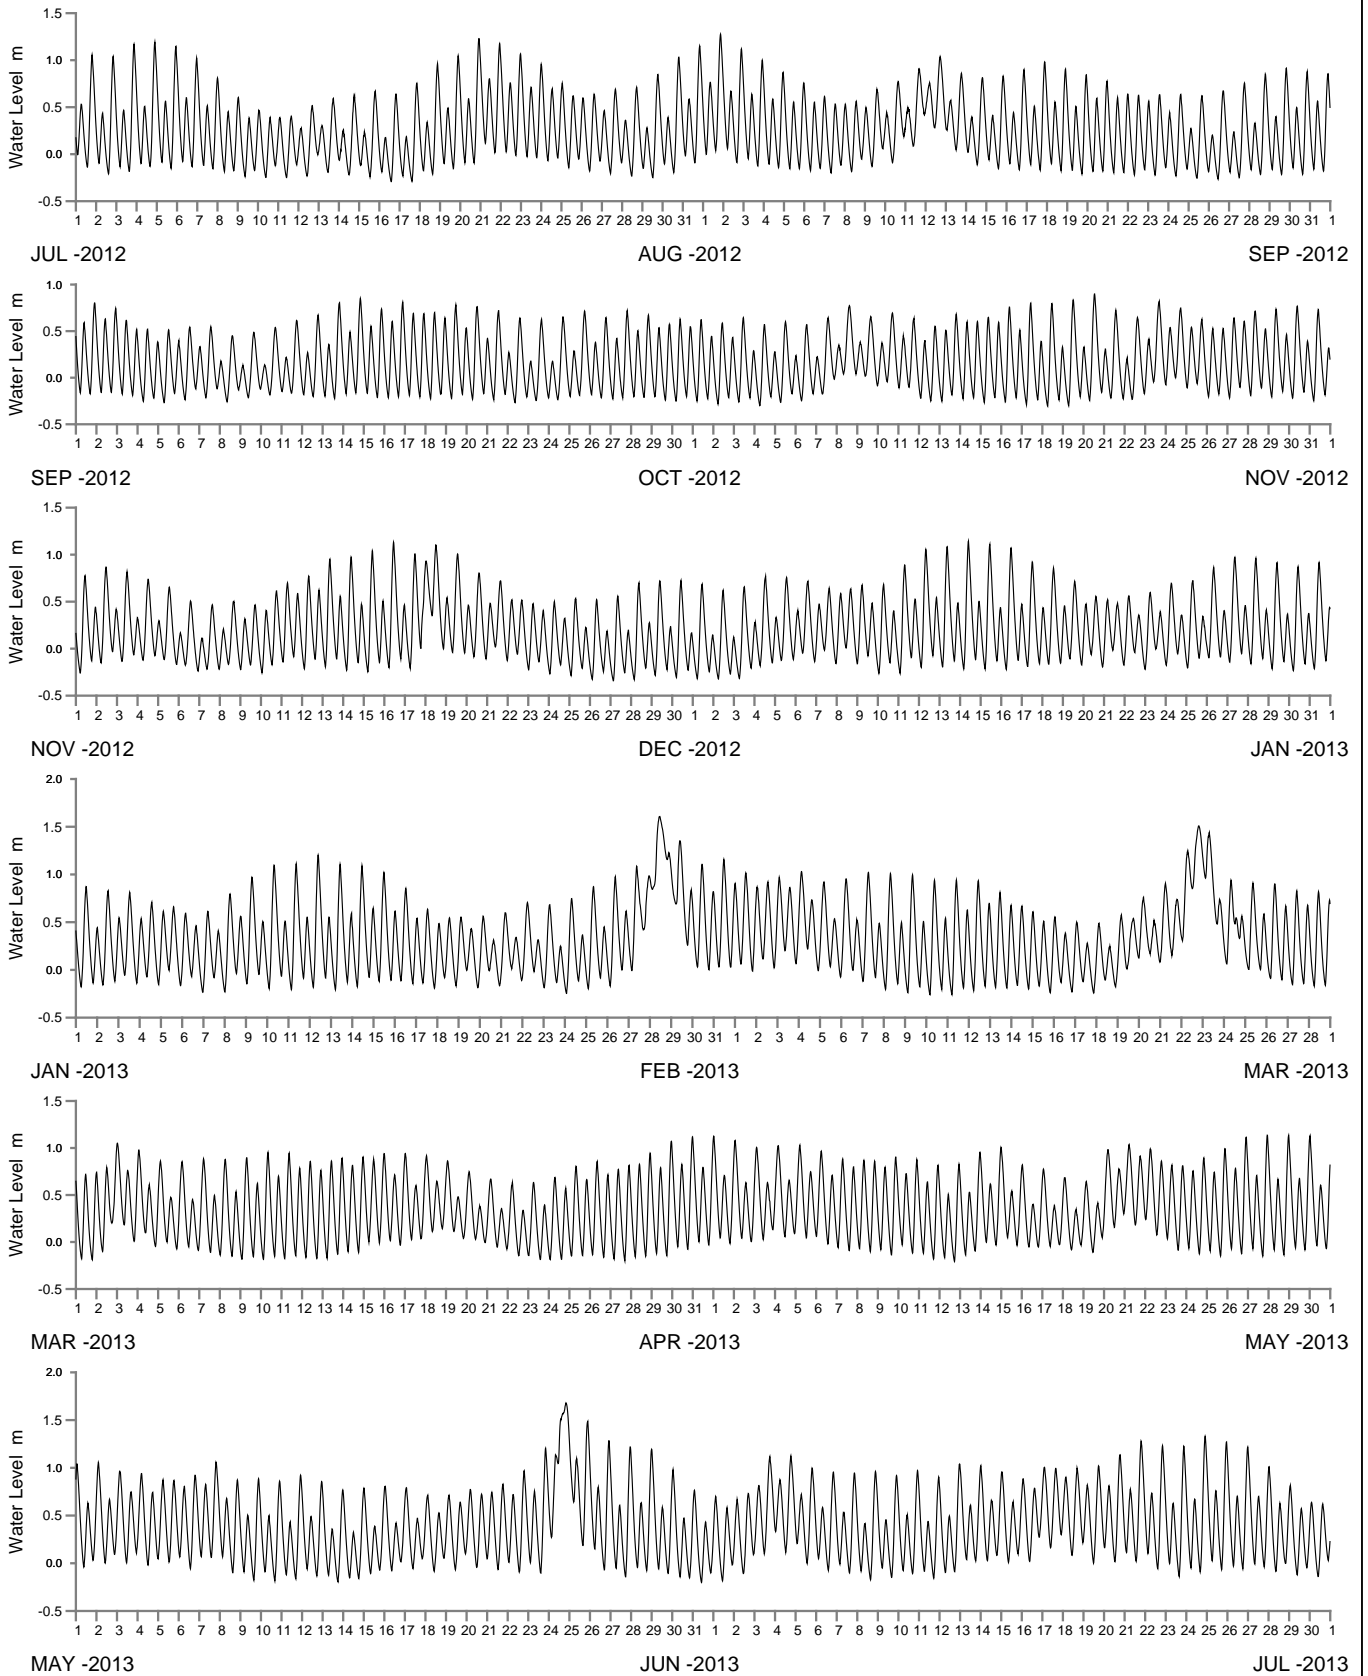
61

WATER LEVEL REFERENCED TO AUSTRALIAN HEIGHT DATUM

BOAMBEE CREEK AT BOAMBEE
2012-2013
