Public Works
Manly Hydraulics Laboratory

MHL
Report 2218

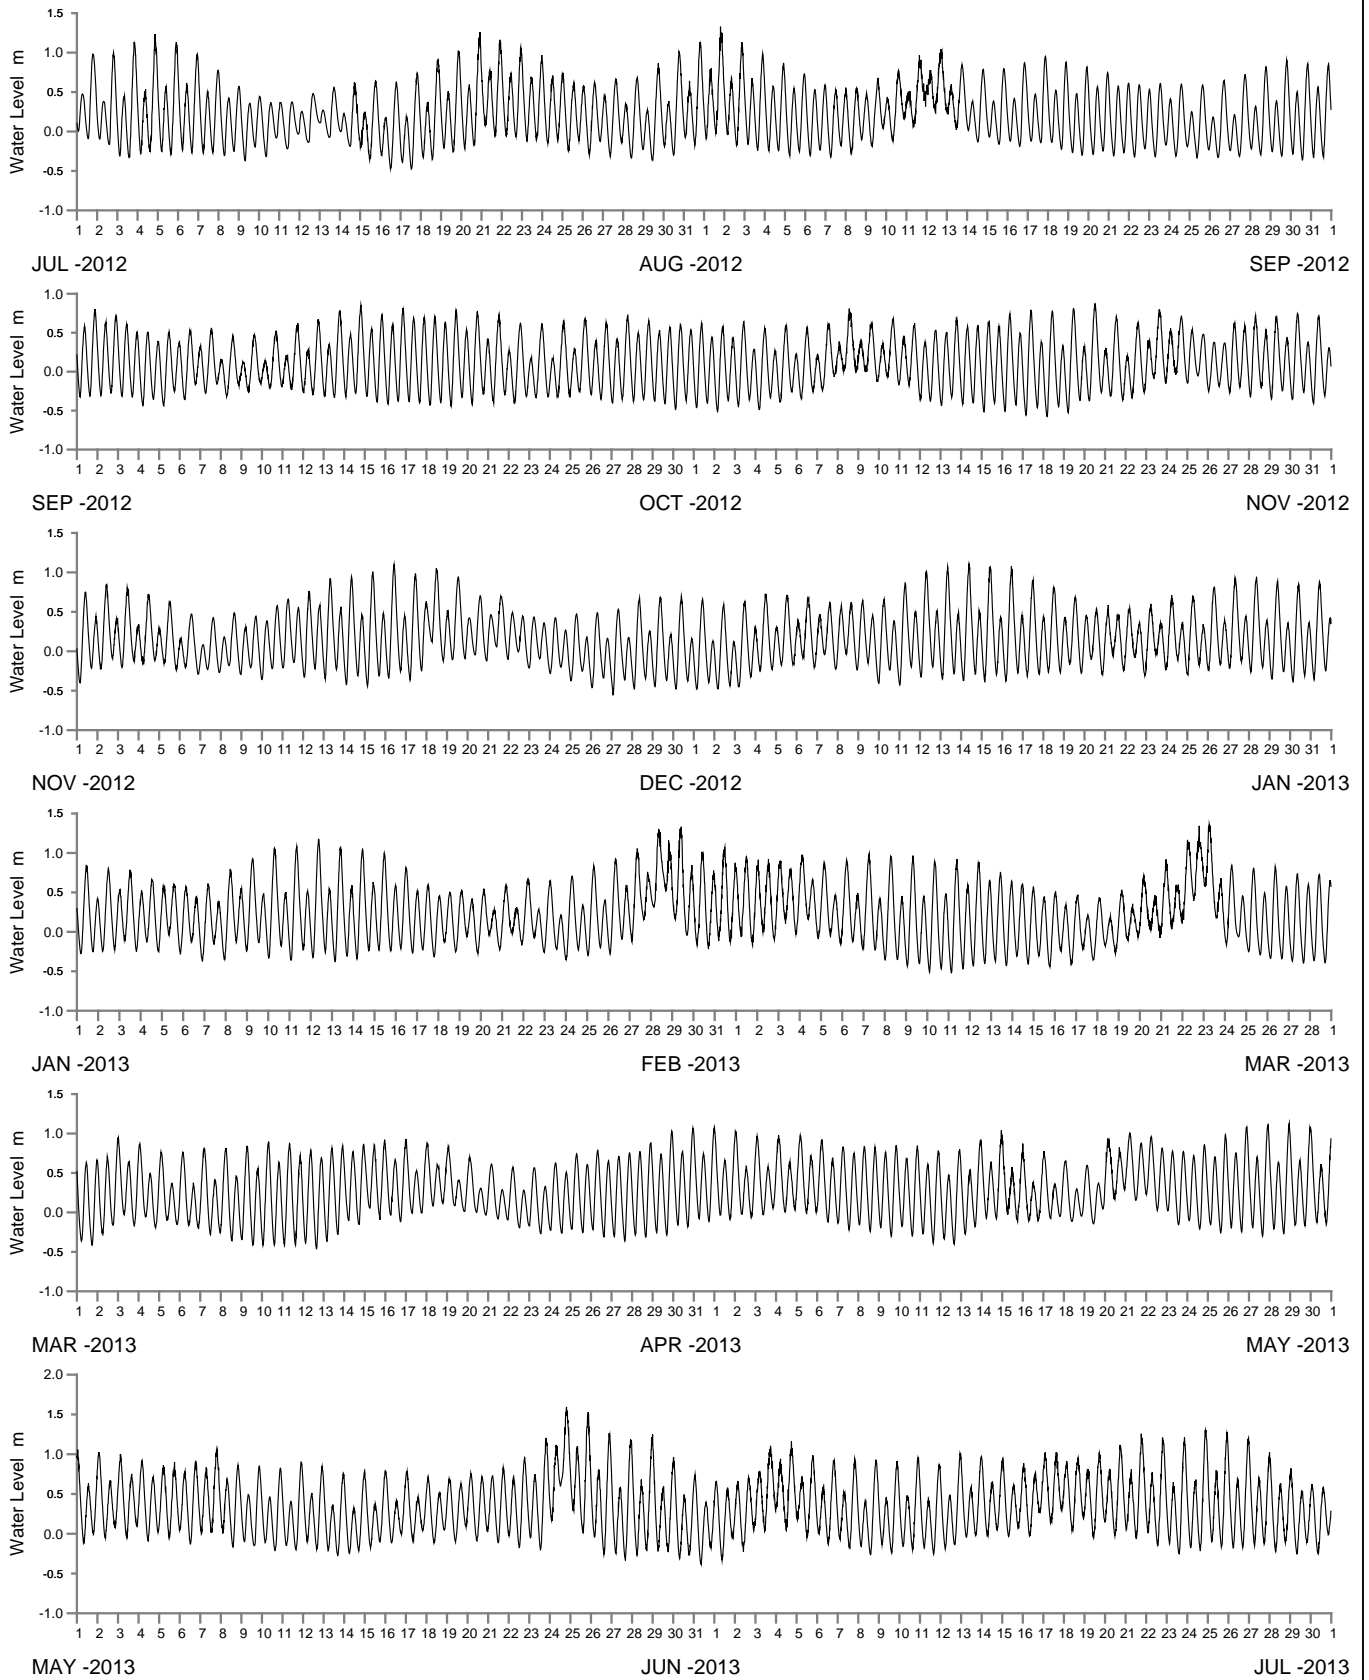
62

WATER LEVEL REFERENCED TO AUSTRALIAN HEIGHT DATUM

BOAMBEE CREEK AT BOAMBEE ENTRANCE
2012-2013

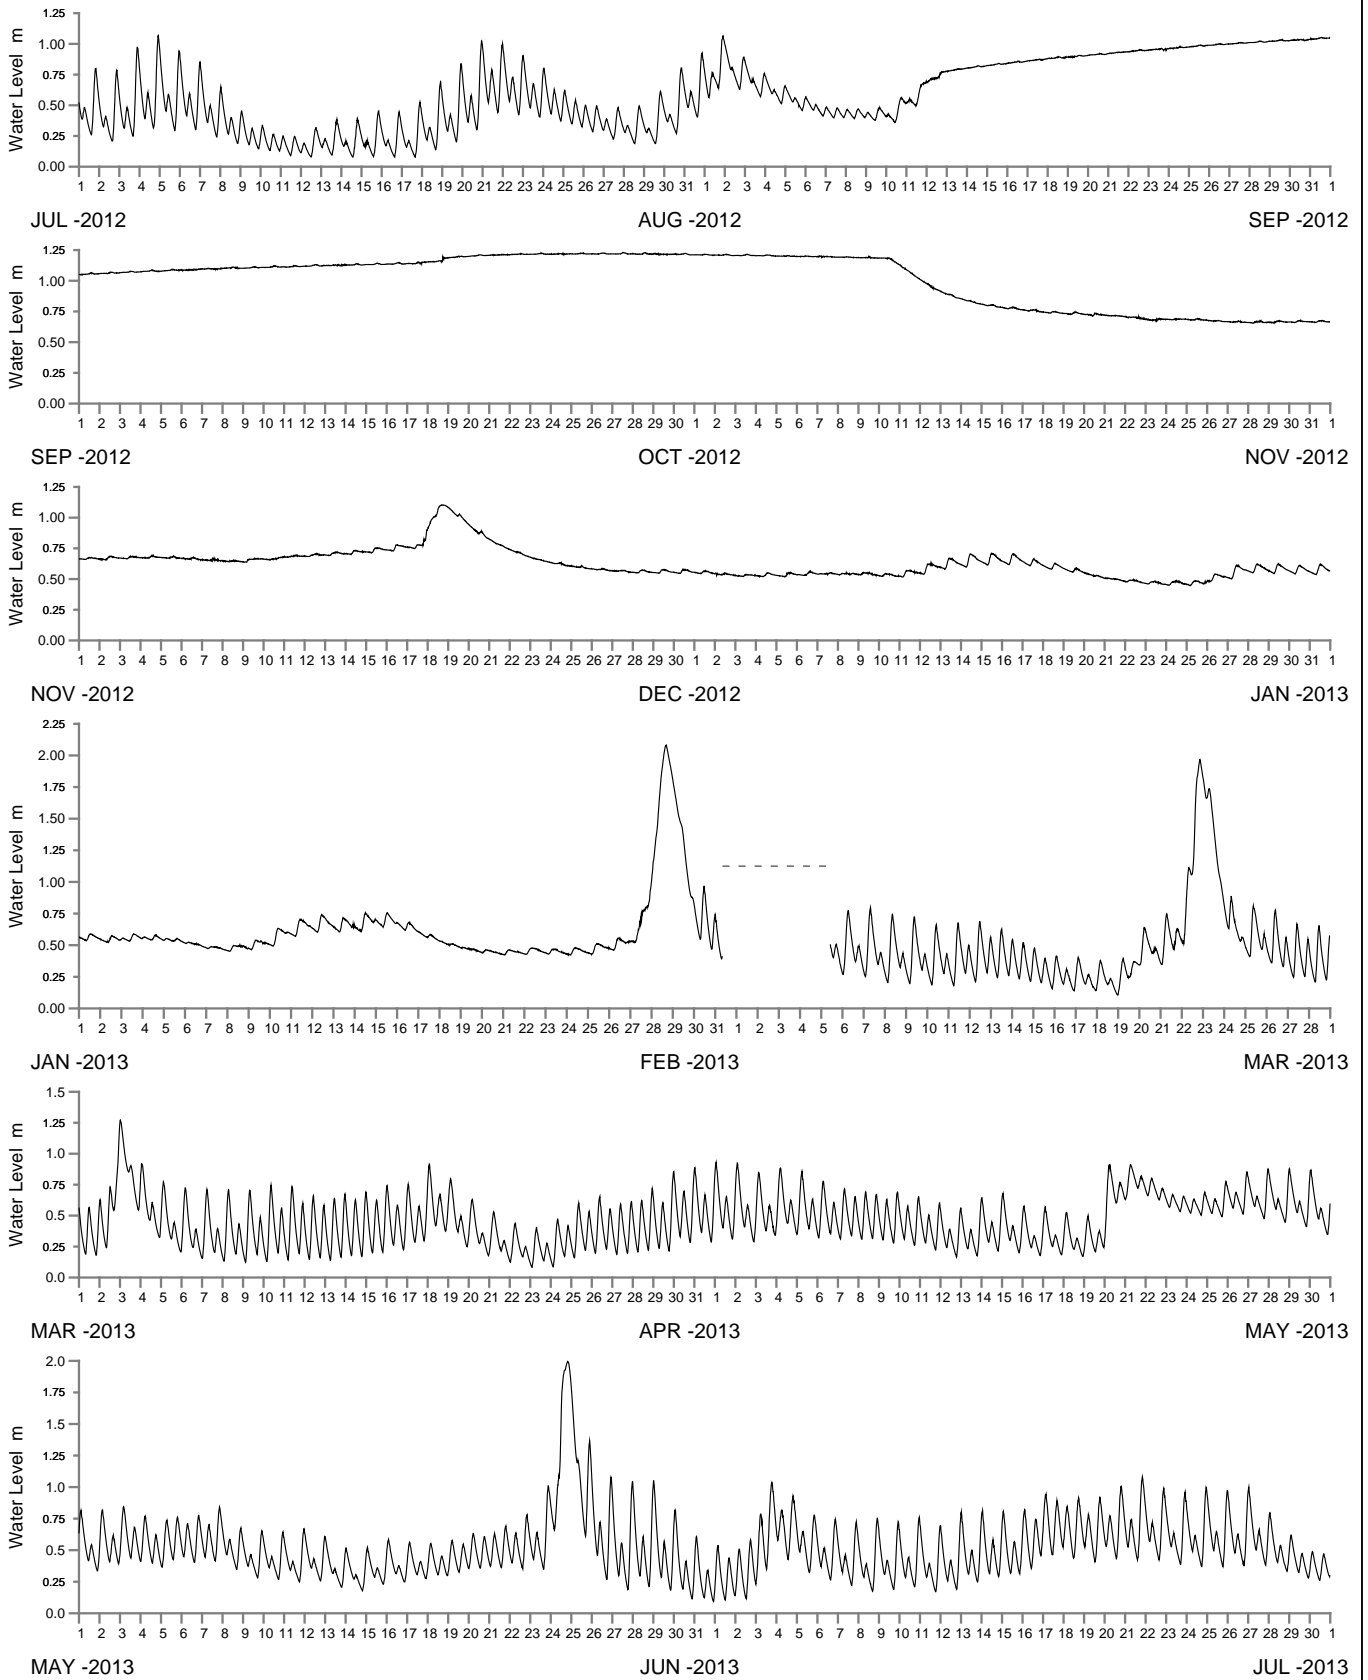
64

WATER LEVEL REFERENCED TO AUSTRALIAN HEIGHT DATUM

BONVILLE CREEK AT BONVILLE
2012-2013

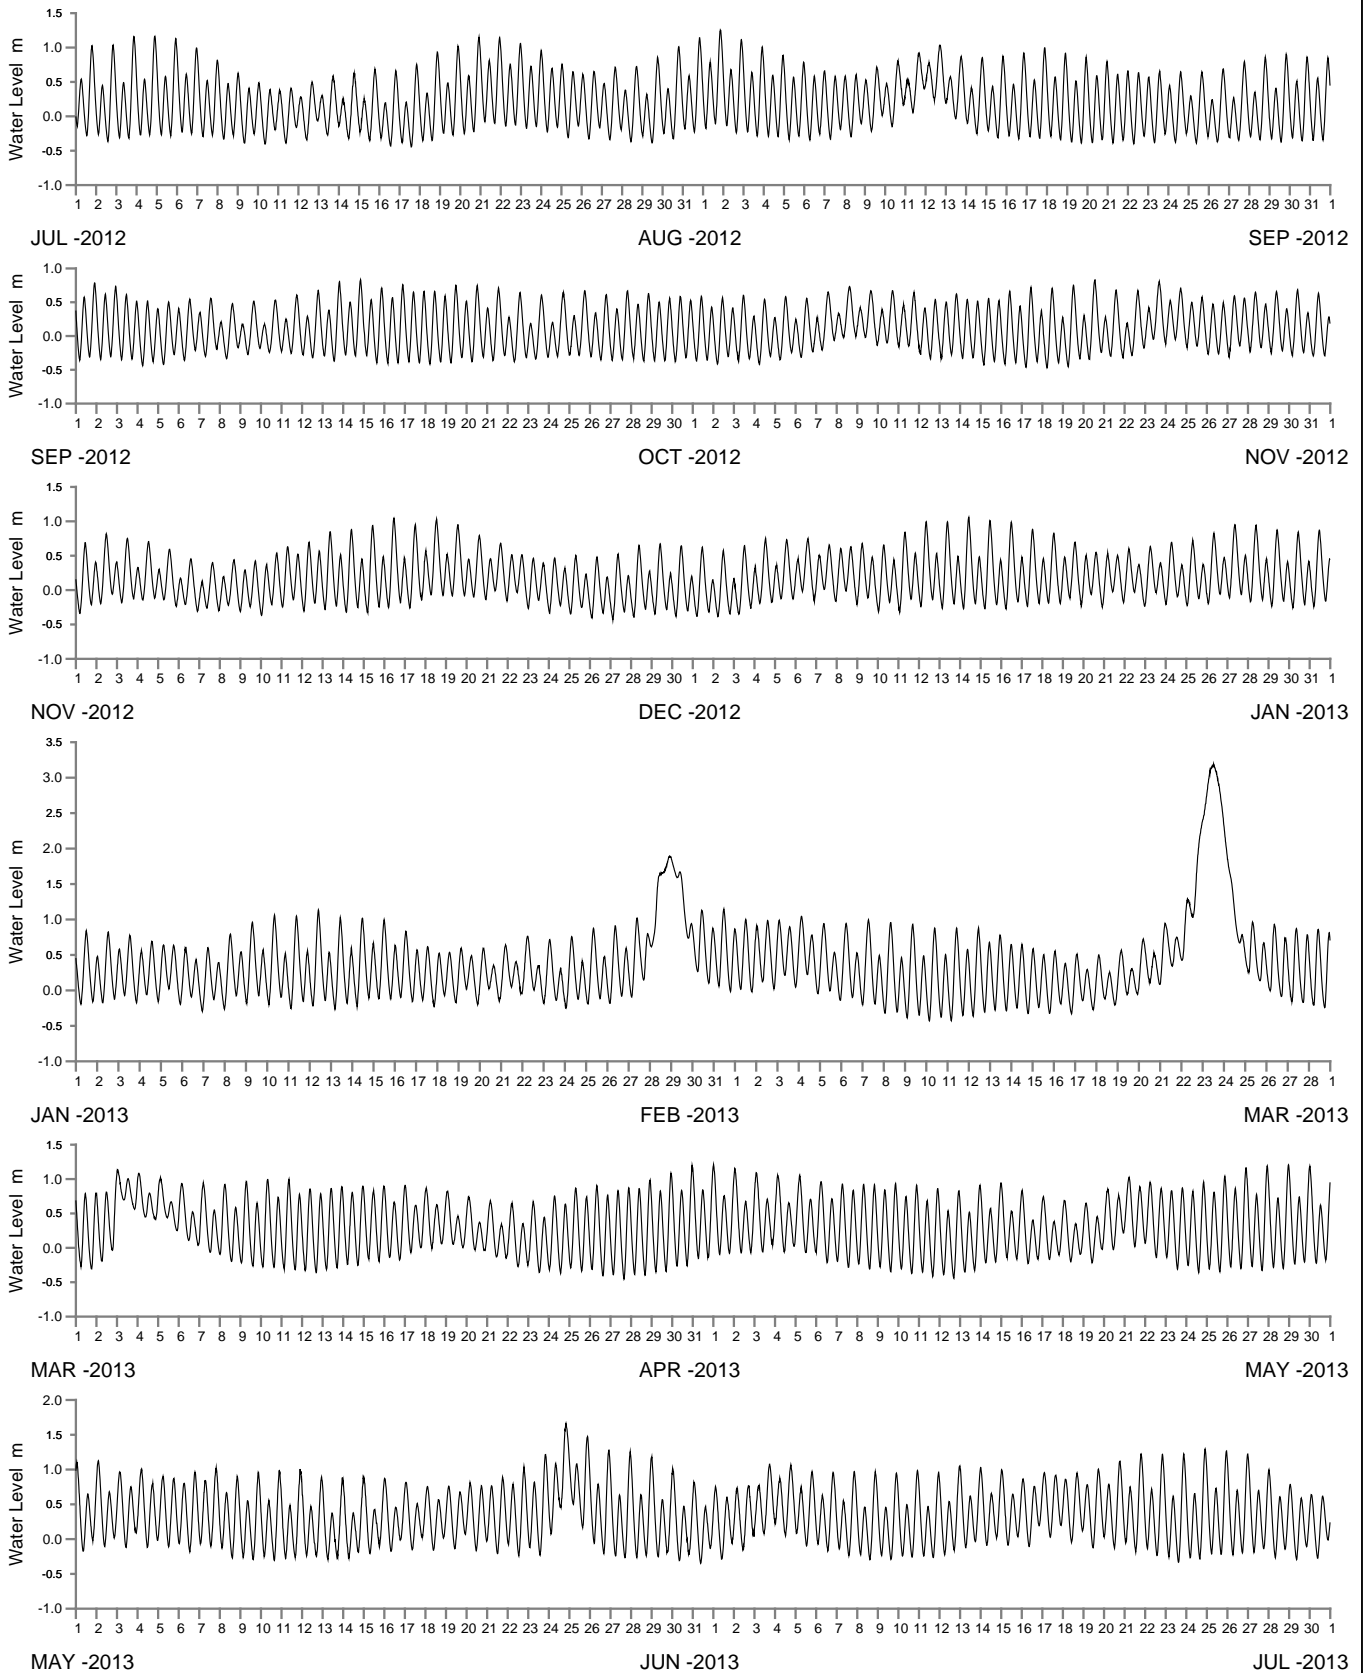
65

WATER LEVEL REFERENCED TO AUSTRALIAN HEIGHT DATUM

BELLINGER RIVER AT REPTON
2012-2013

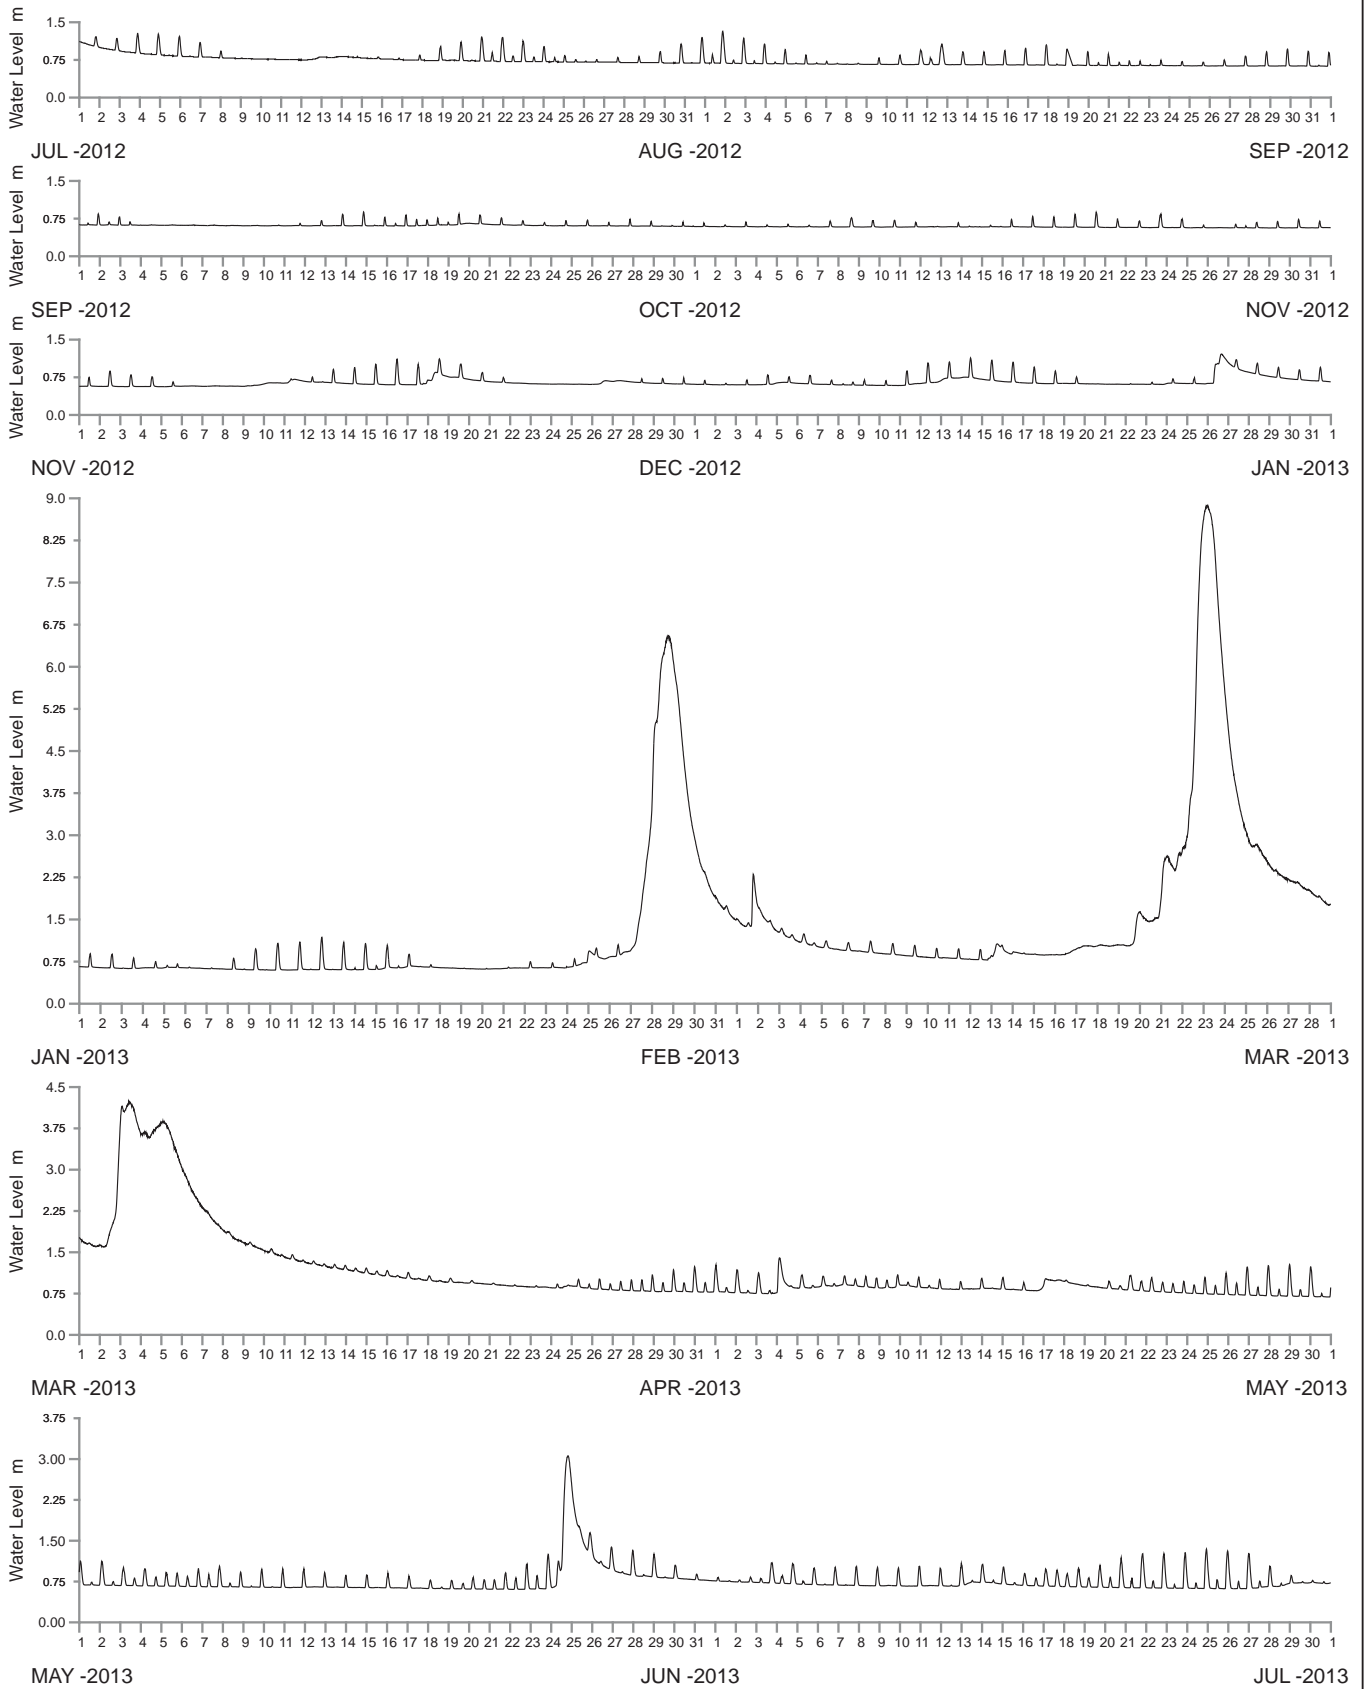
66

WATER LEVEL REFERENCED TO AUSTRALIAN HEIGHT DATUM

BELLINGER RIVER AT BELLINGEN BRIDGE
2012-2013

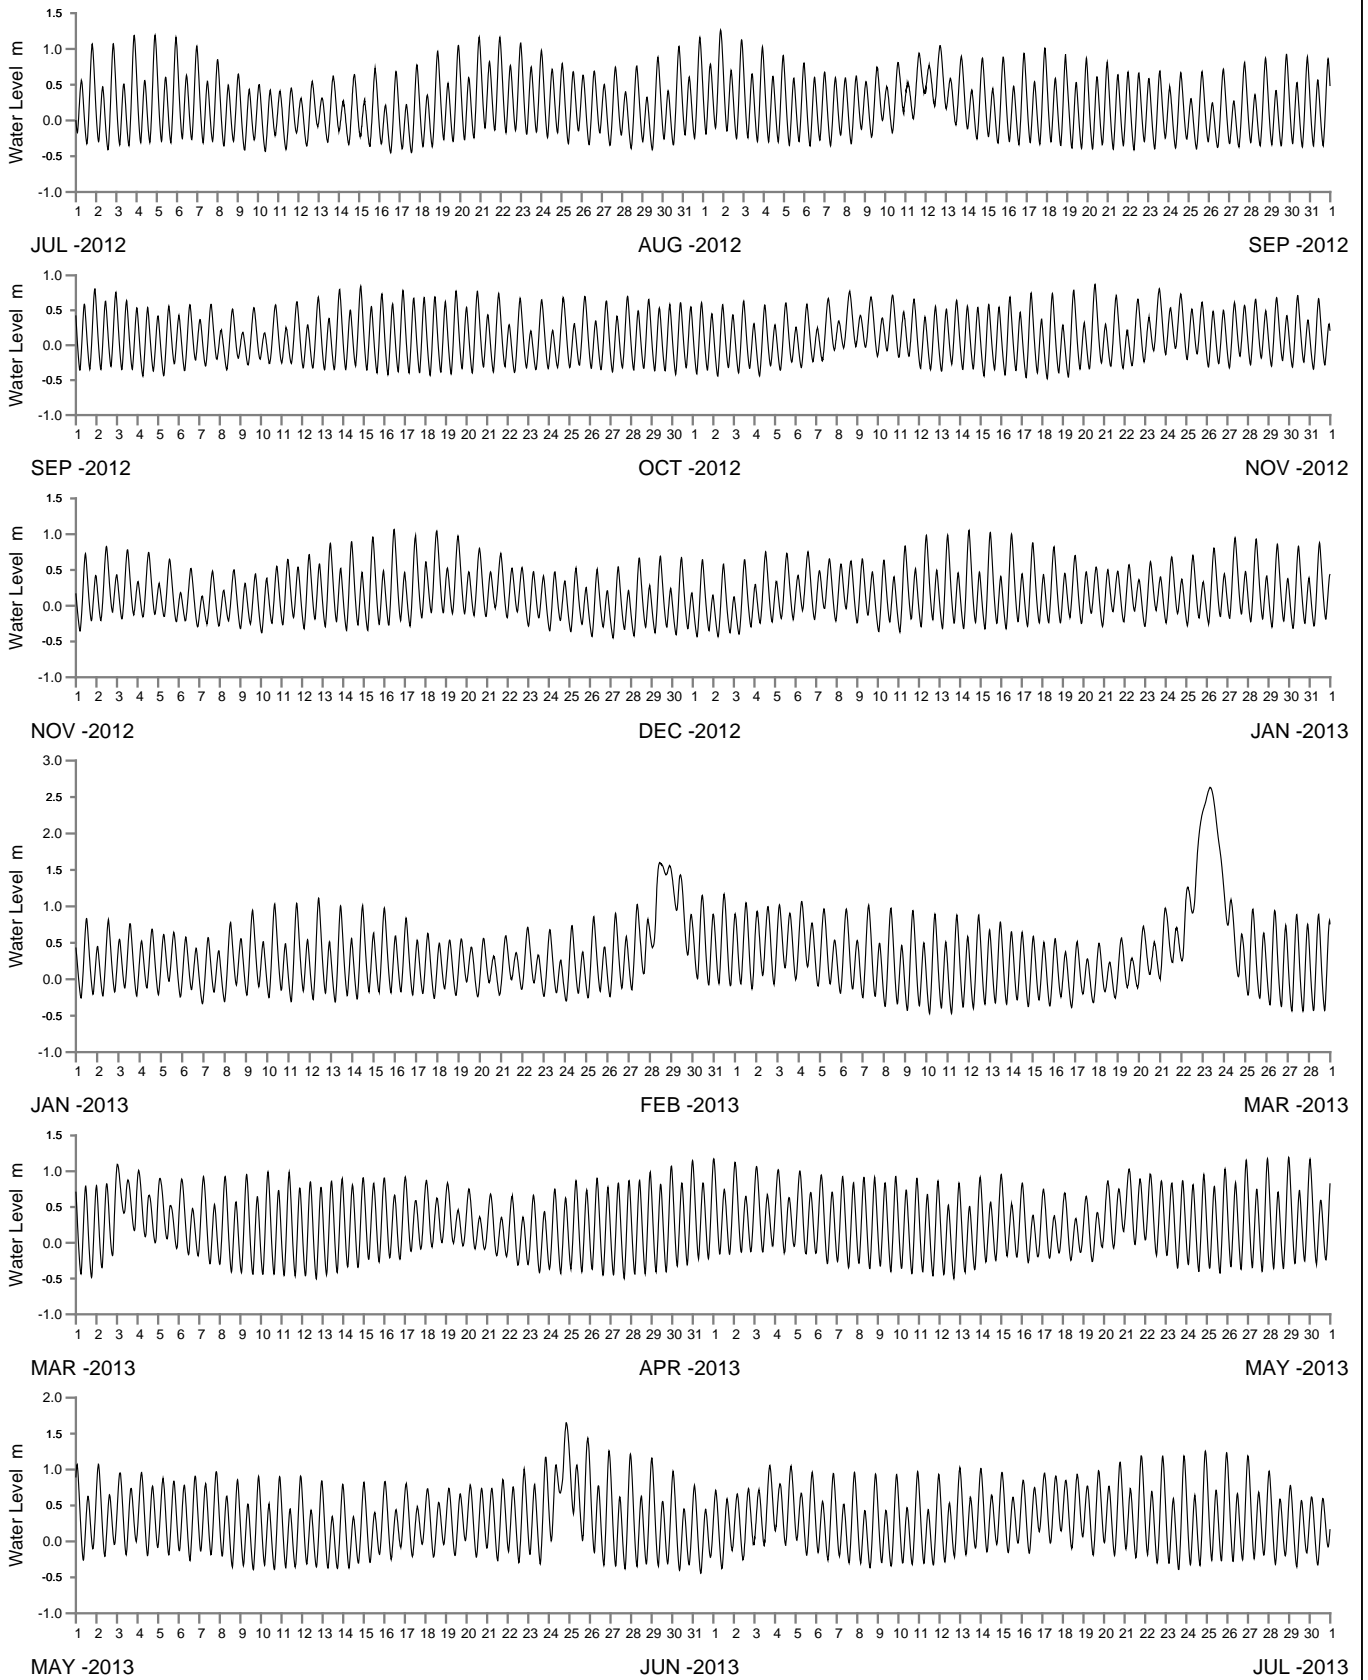
68

WATER LEVEL REFERENCED TO AUSTRALIAN HEIGHT DATUM

KALANG RIVER AT UPSTREAM NEWRY ISLAND
2012-2013

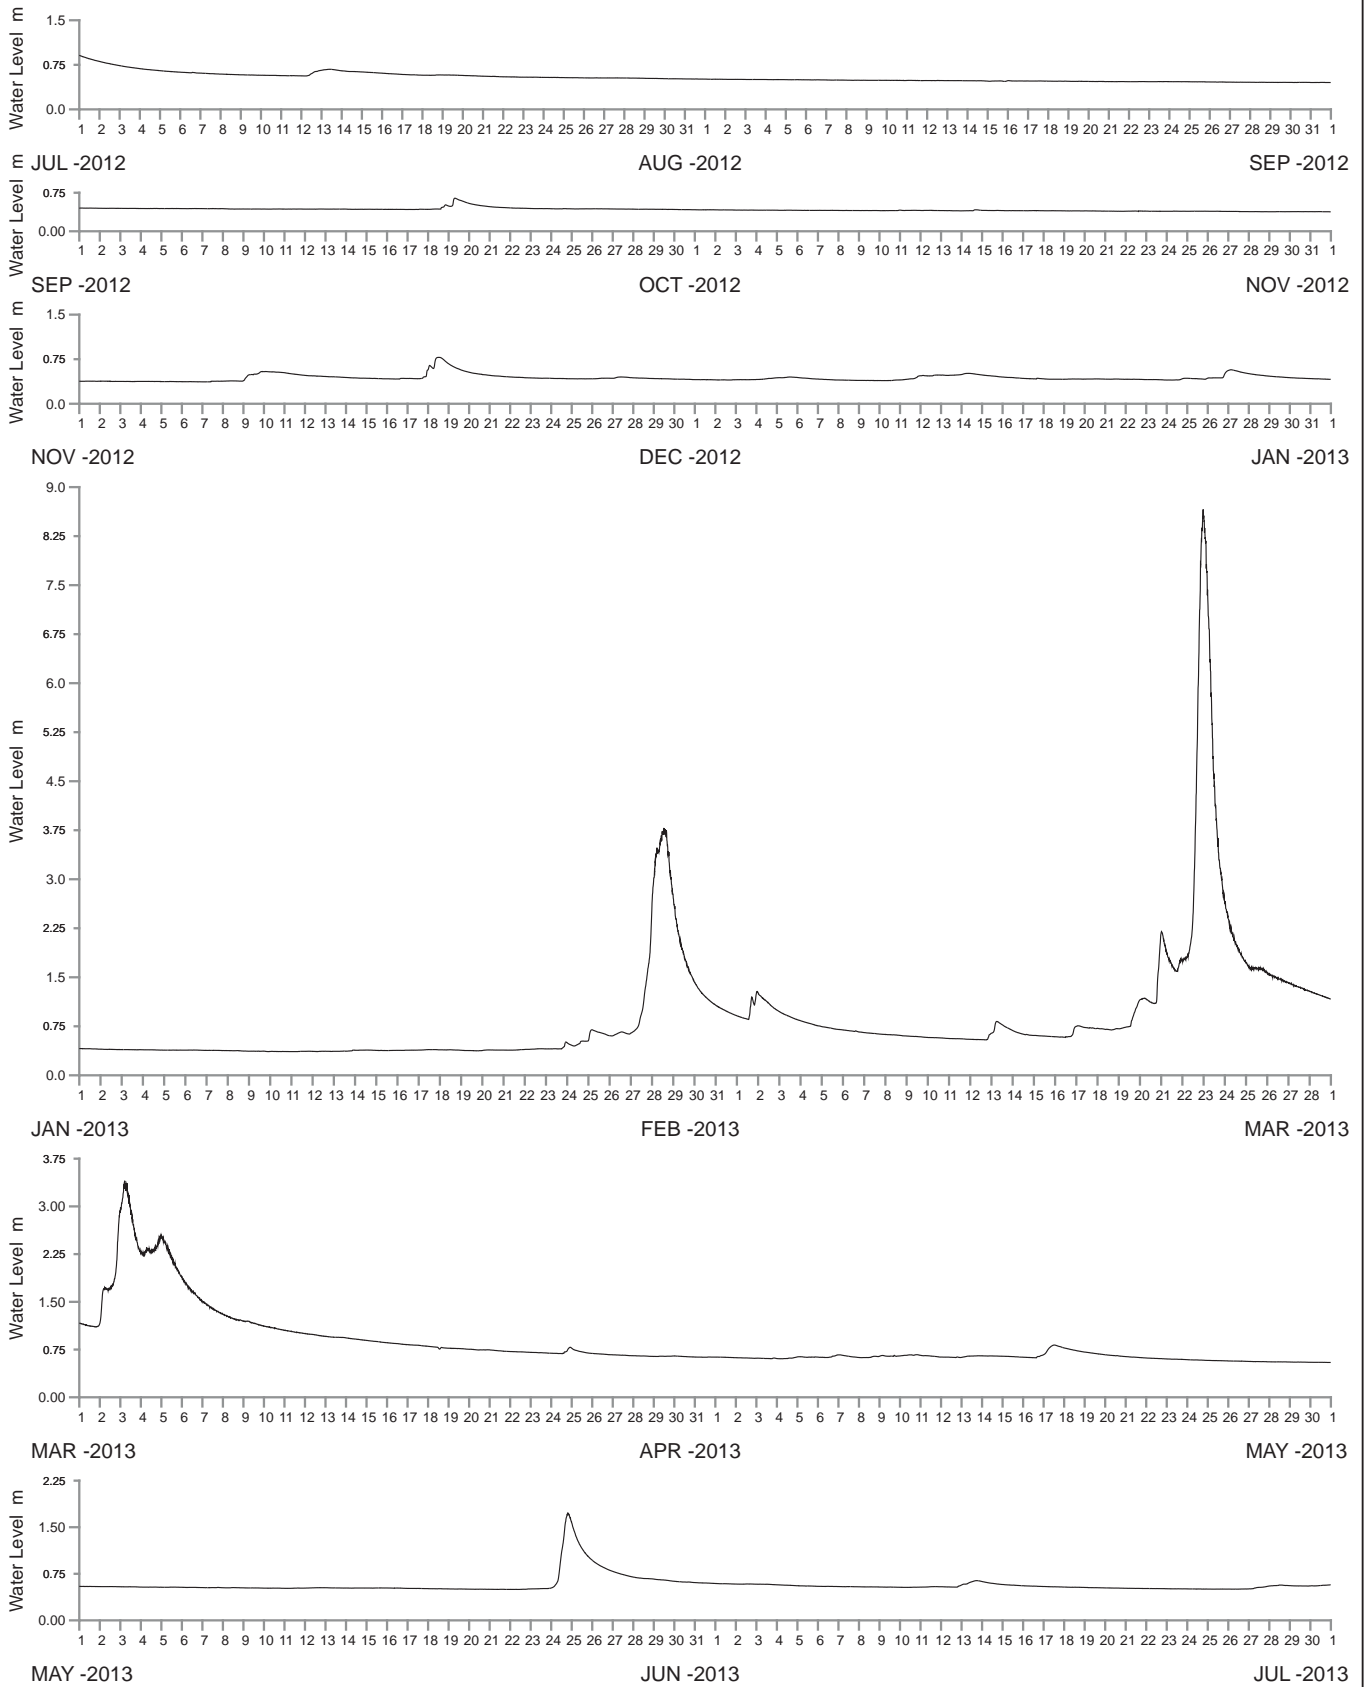
69

WATER LEVEL REFERENCED TO ASSUMED DATUM

KALANG RIVER AT KOOROOWI
2012-2013

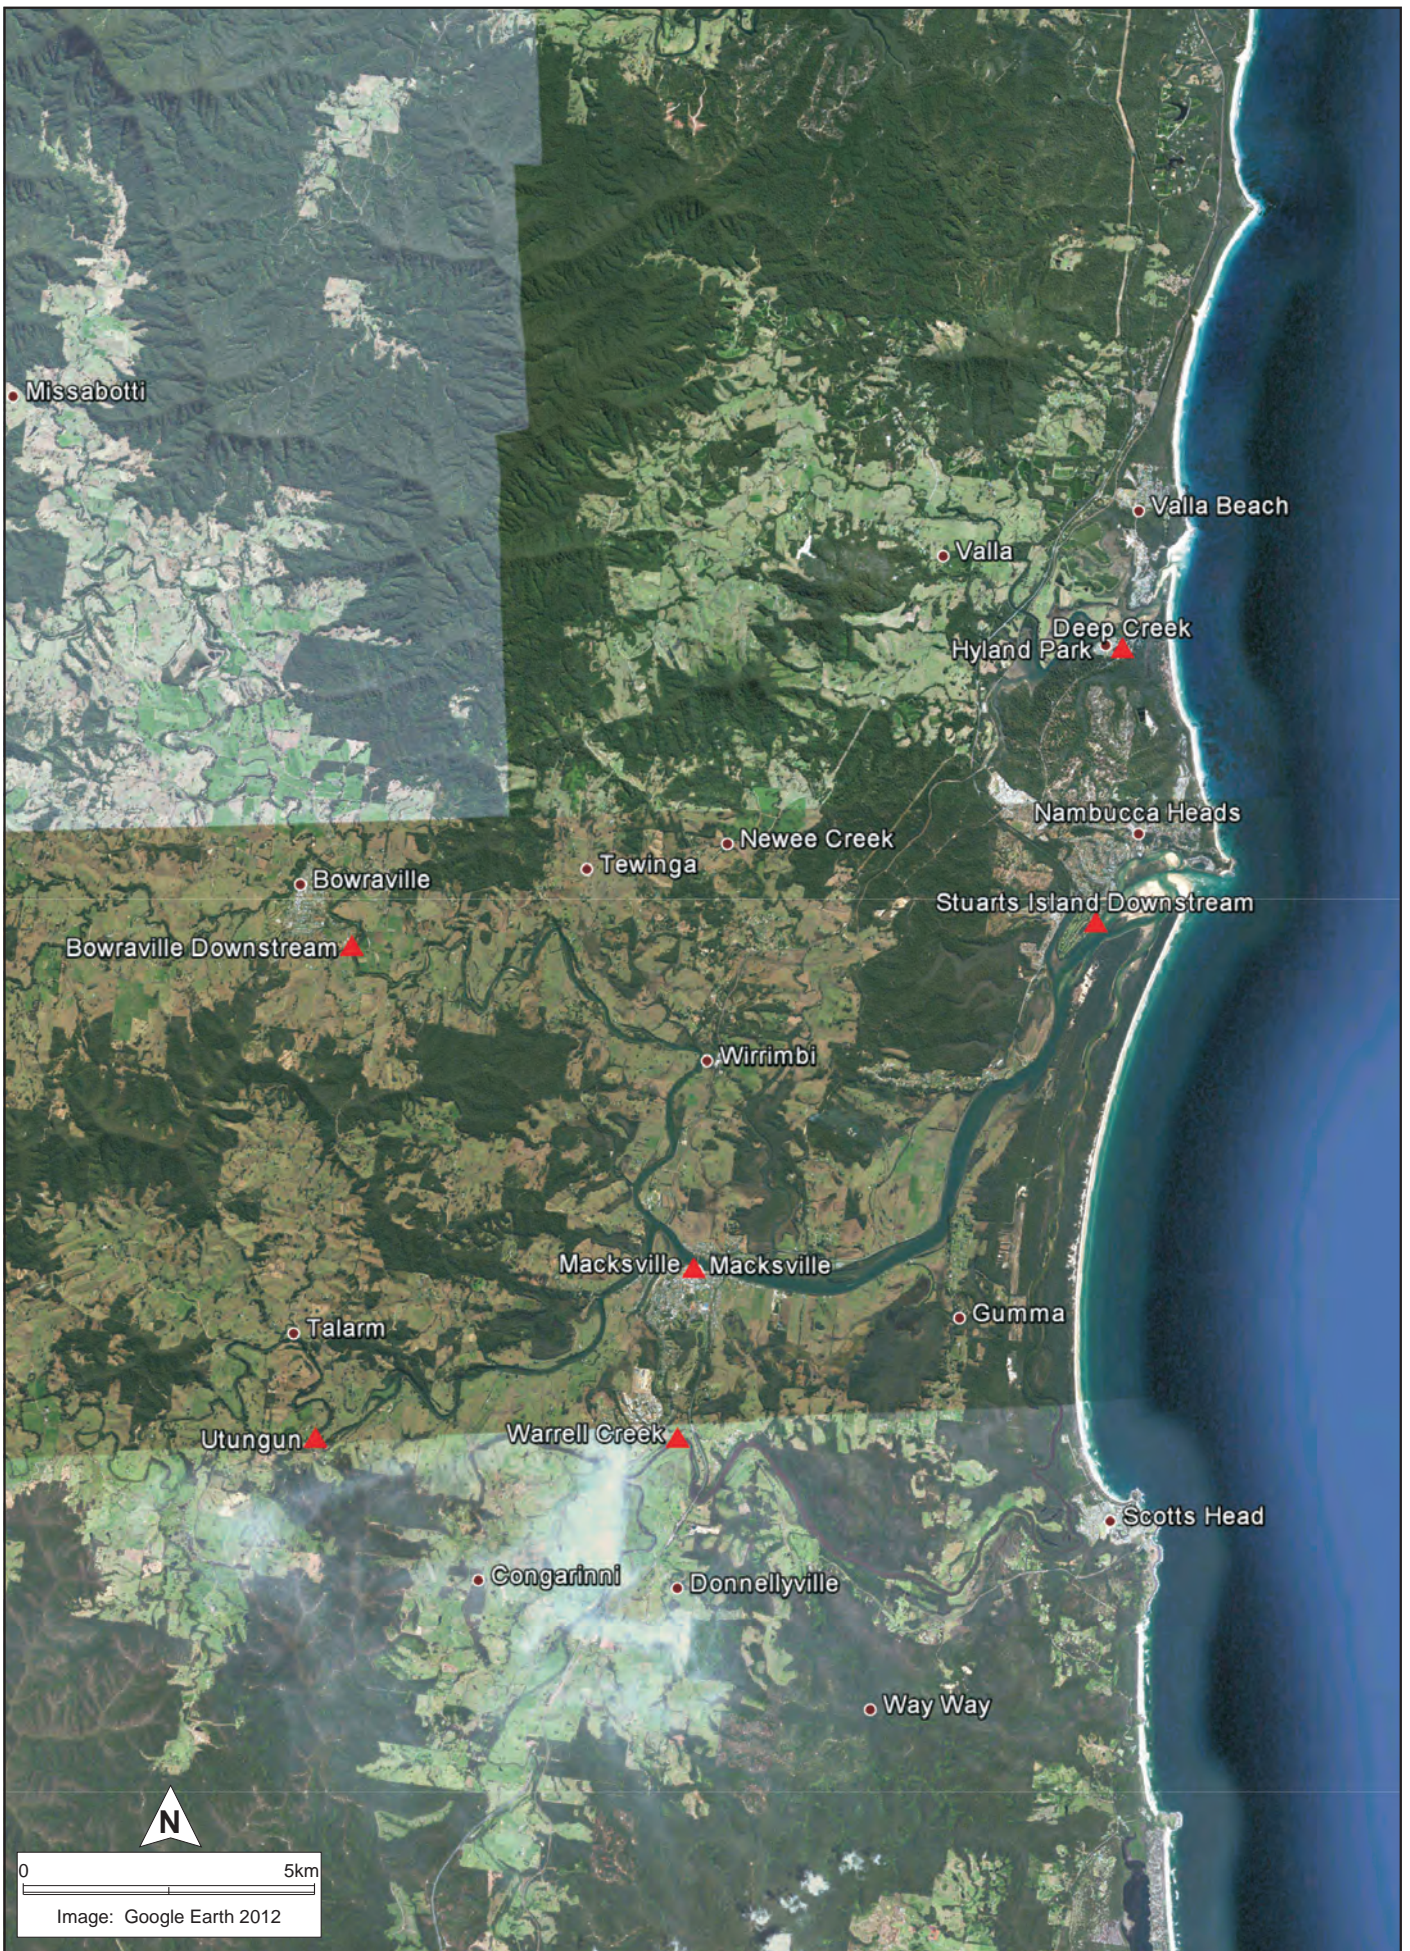
Figure
70

**STATION LOCATIONS
NAMBUCCA RIVER REGION**

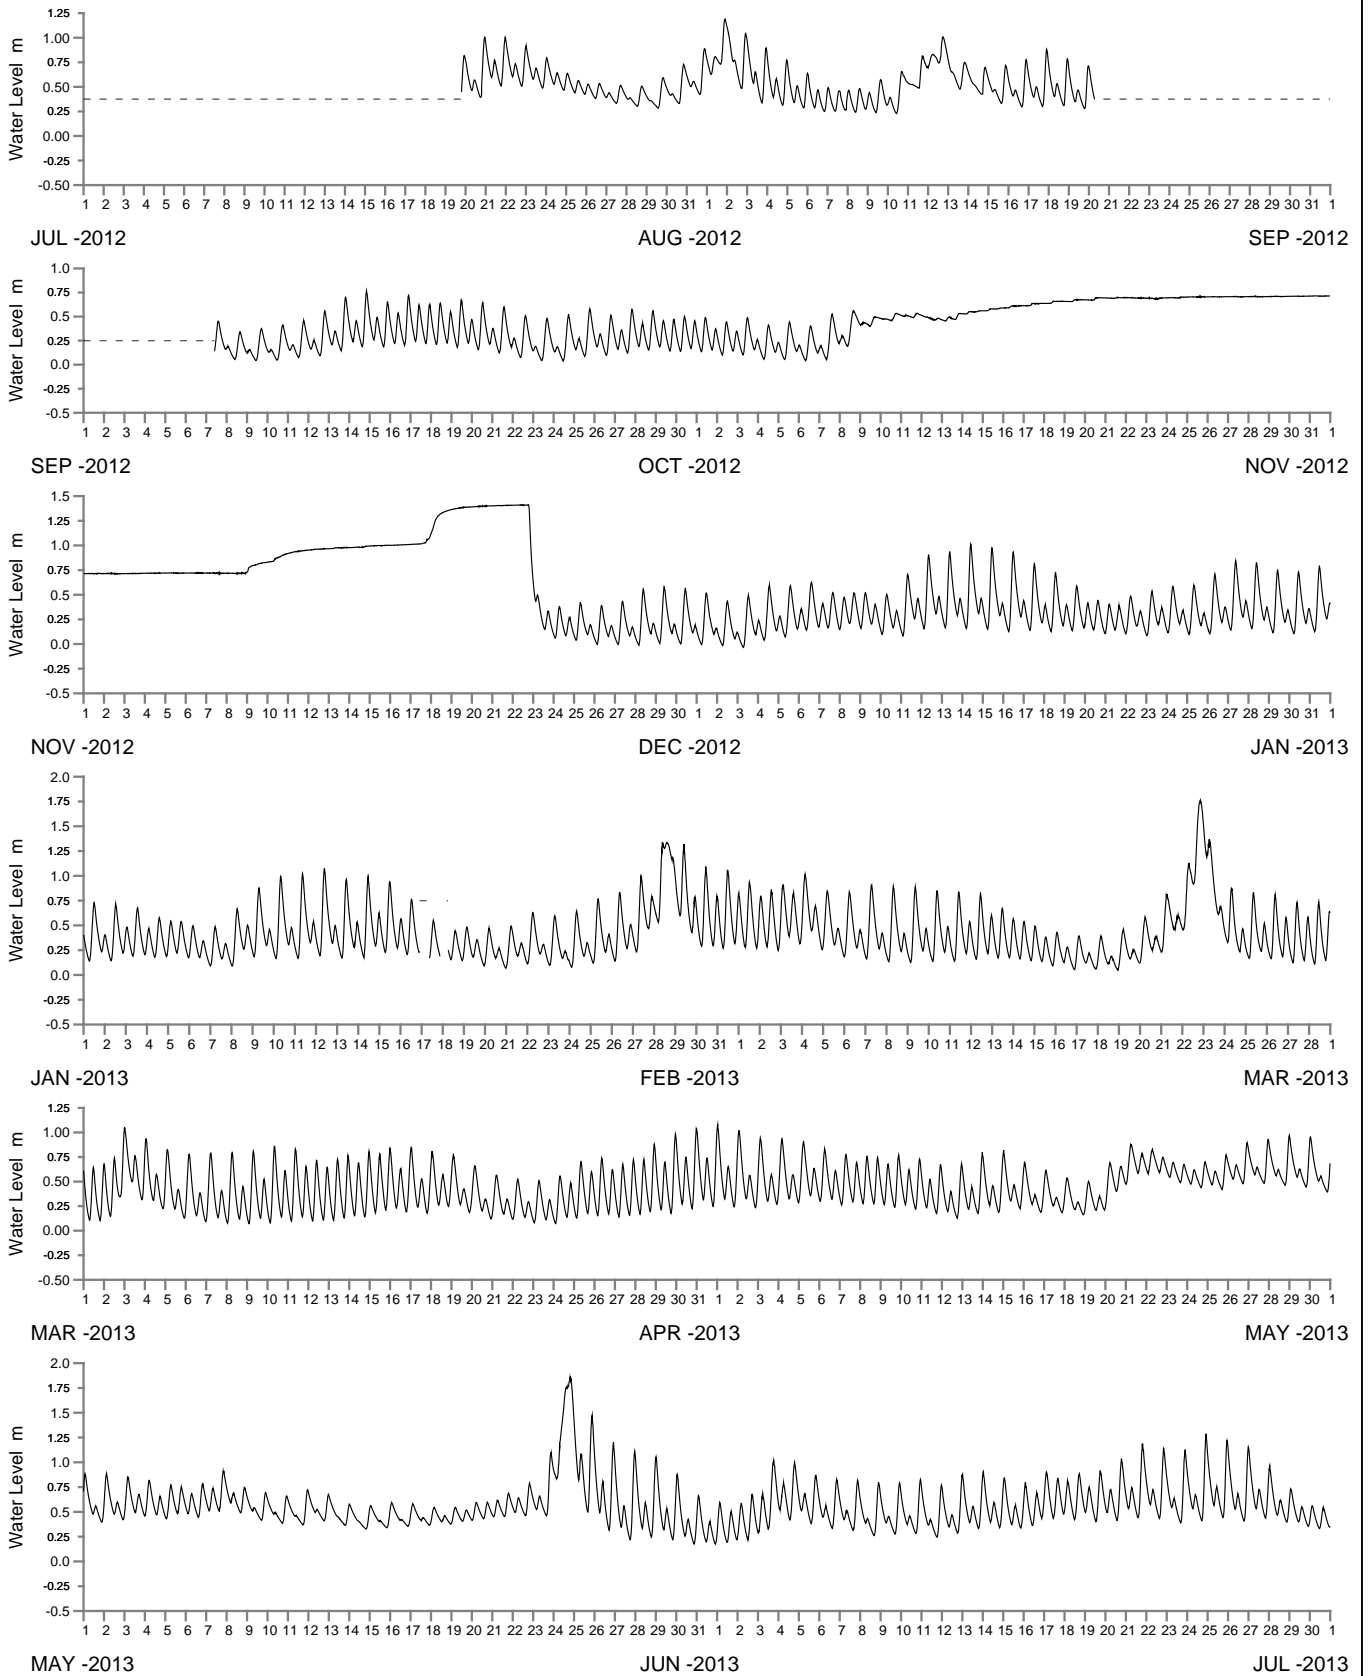
71

WATER LEVEL REFERENCED TO AUSTRALIAN HEIGHT DATUM

DEEP CREEK AT DEEP CREEK
2012-2013

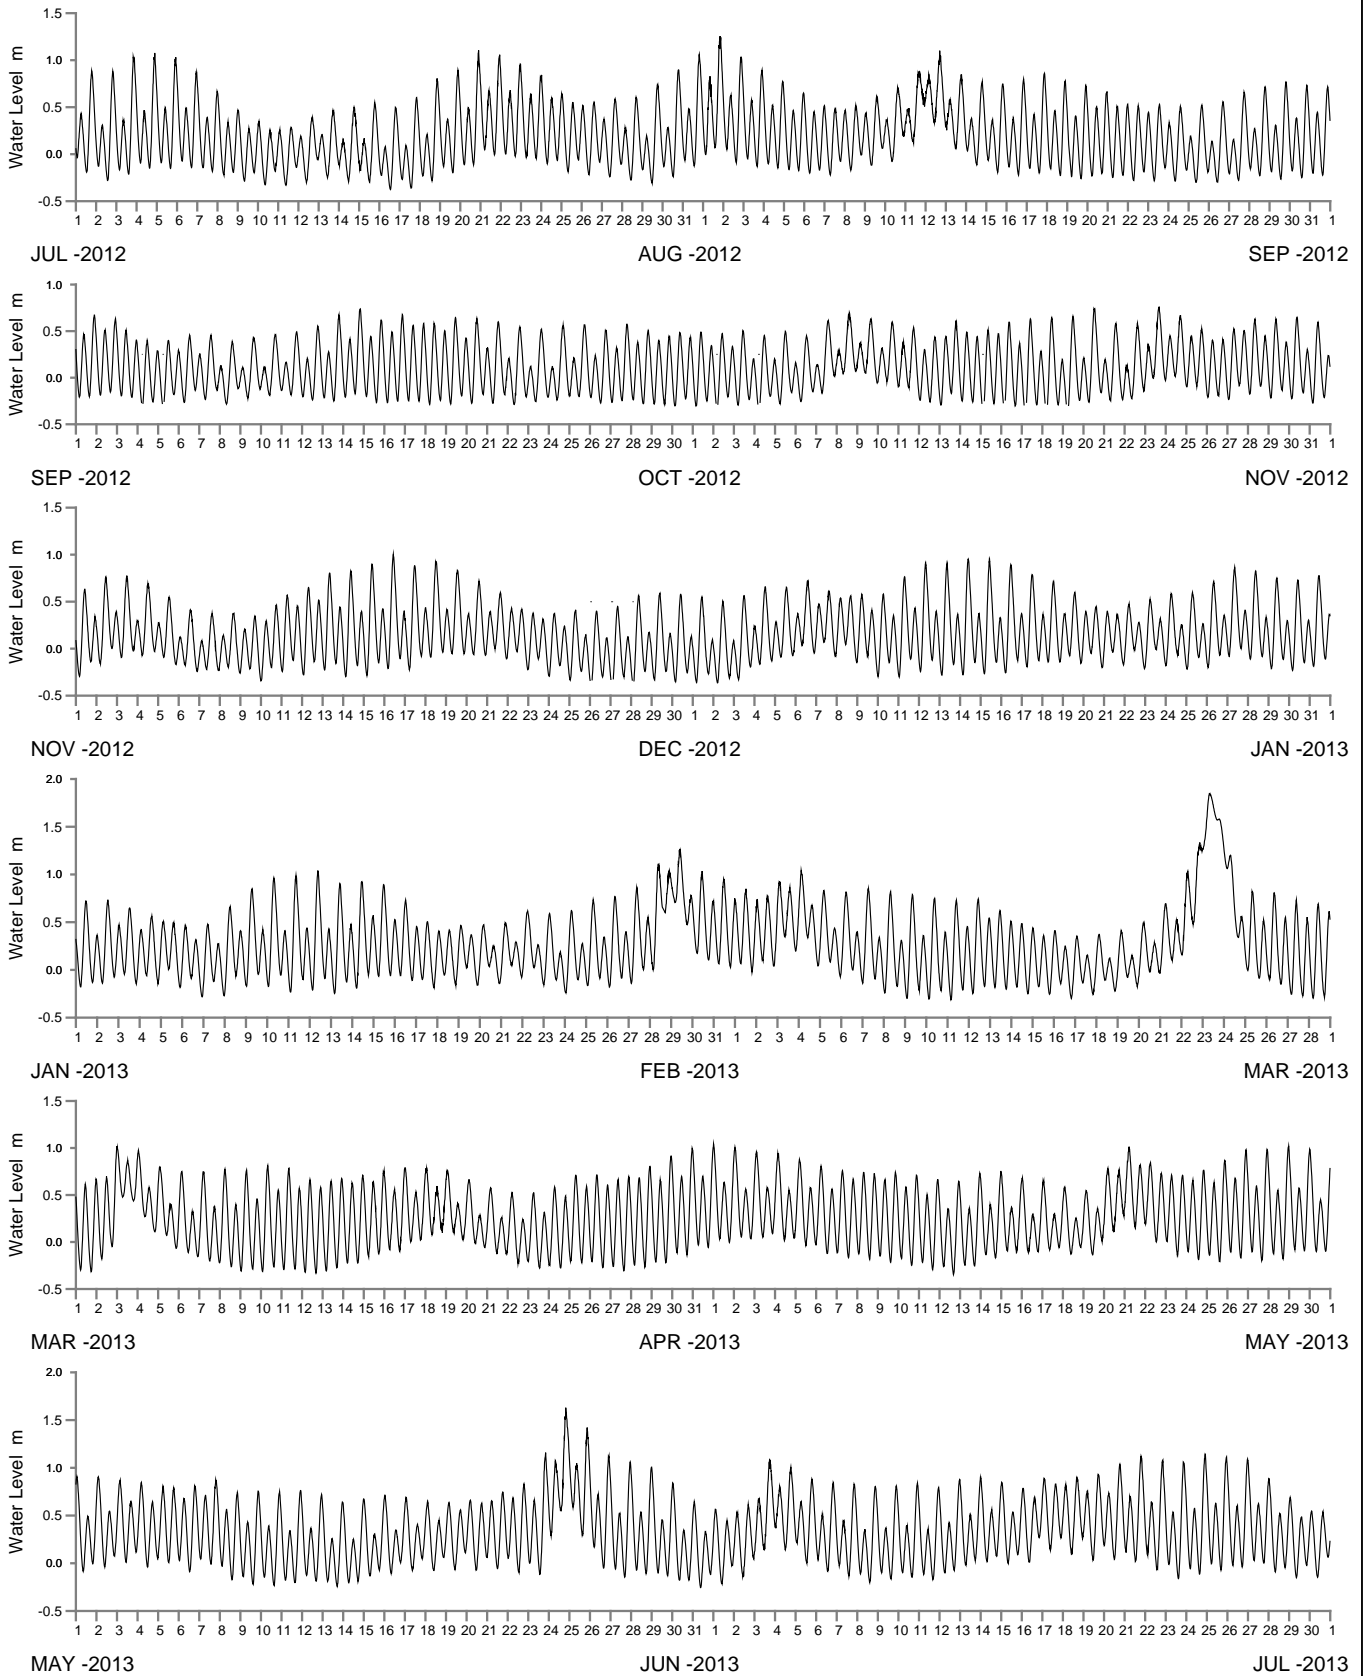
72

WATER LEVEL REFERENCED TO AUSTRALIAN HEIGHT DATUM

NAMBUCCA RIVER AT STUARTS ISLAND DOWNSTREAM
2012-2013
