Public Works
Manly Hydraulics Laboratory

MHL
Report 2218

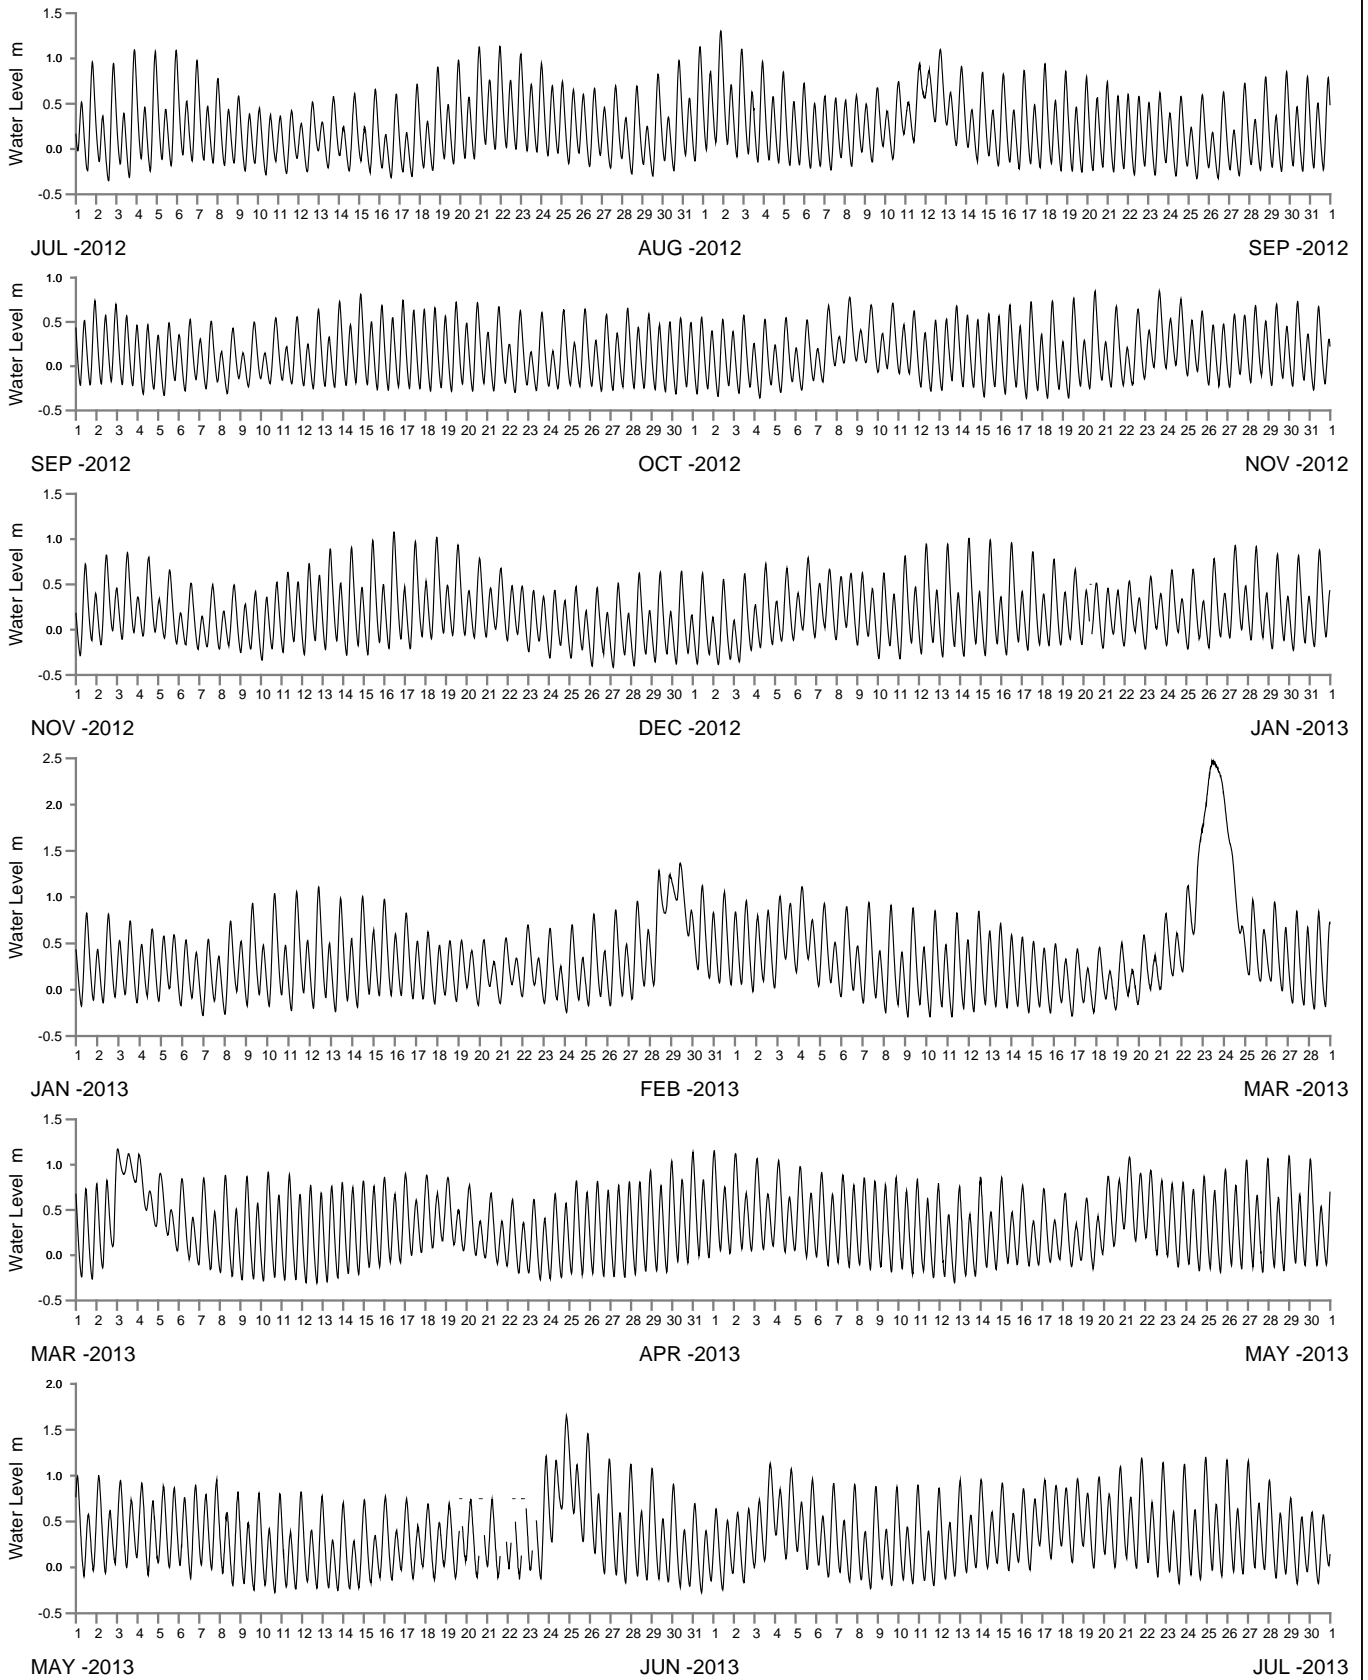
73

WATER LEVEL REFERENCED TO AUSTRALIAN HEIGHT DATUM

NAMBUCCA RIVER AT MACKSVILLE
2012-2013

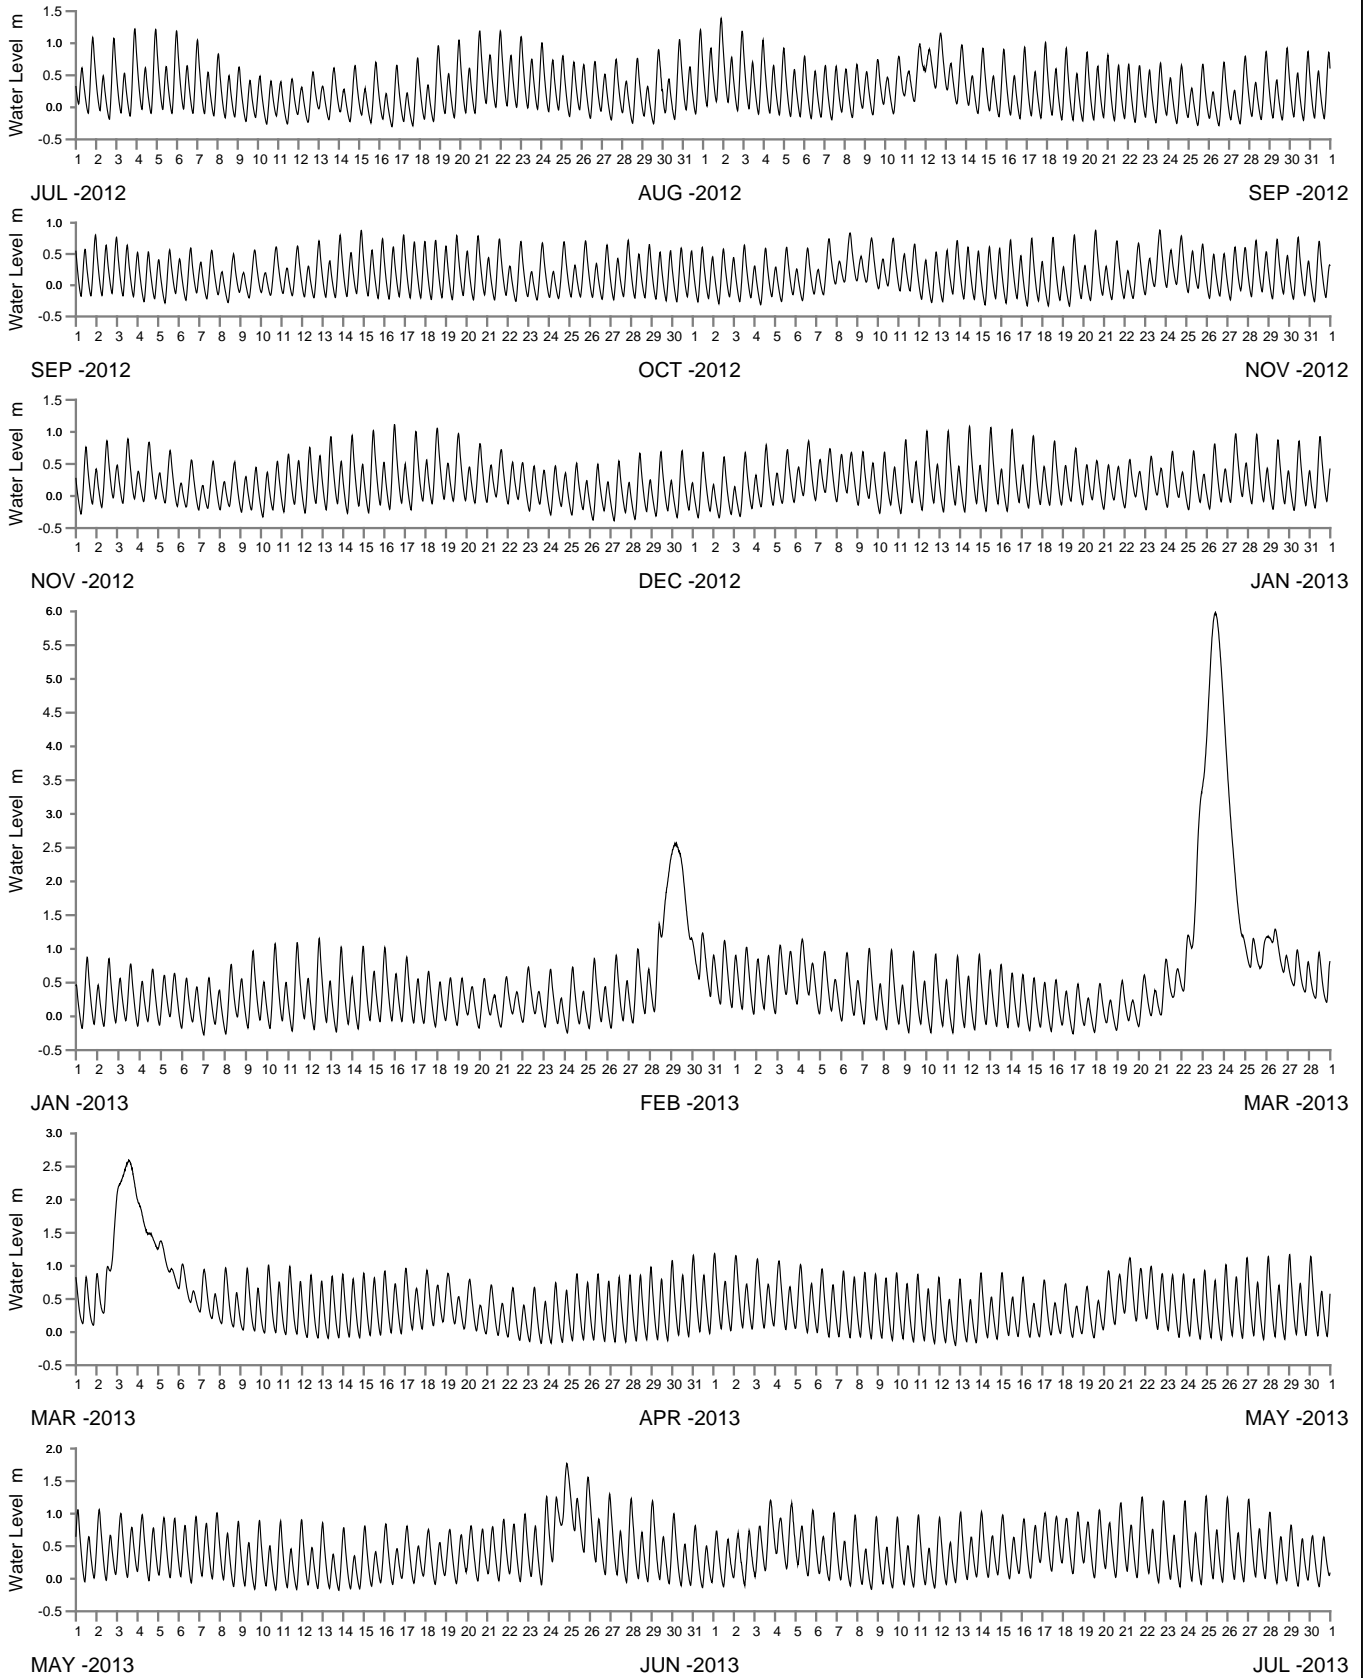
74

WATER LEVEL REFERENCED TO AUSTRALIAN HEIGHT DATUM

NAMBUCCA RIVER AT UTUNGUN
2012-2013

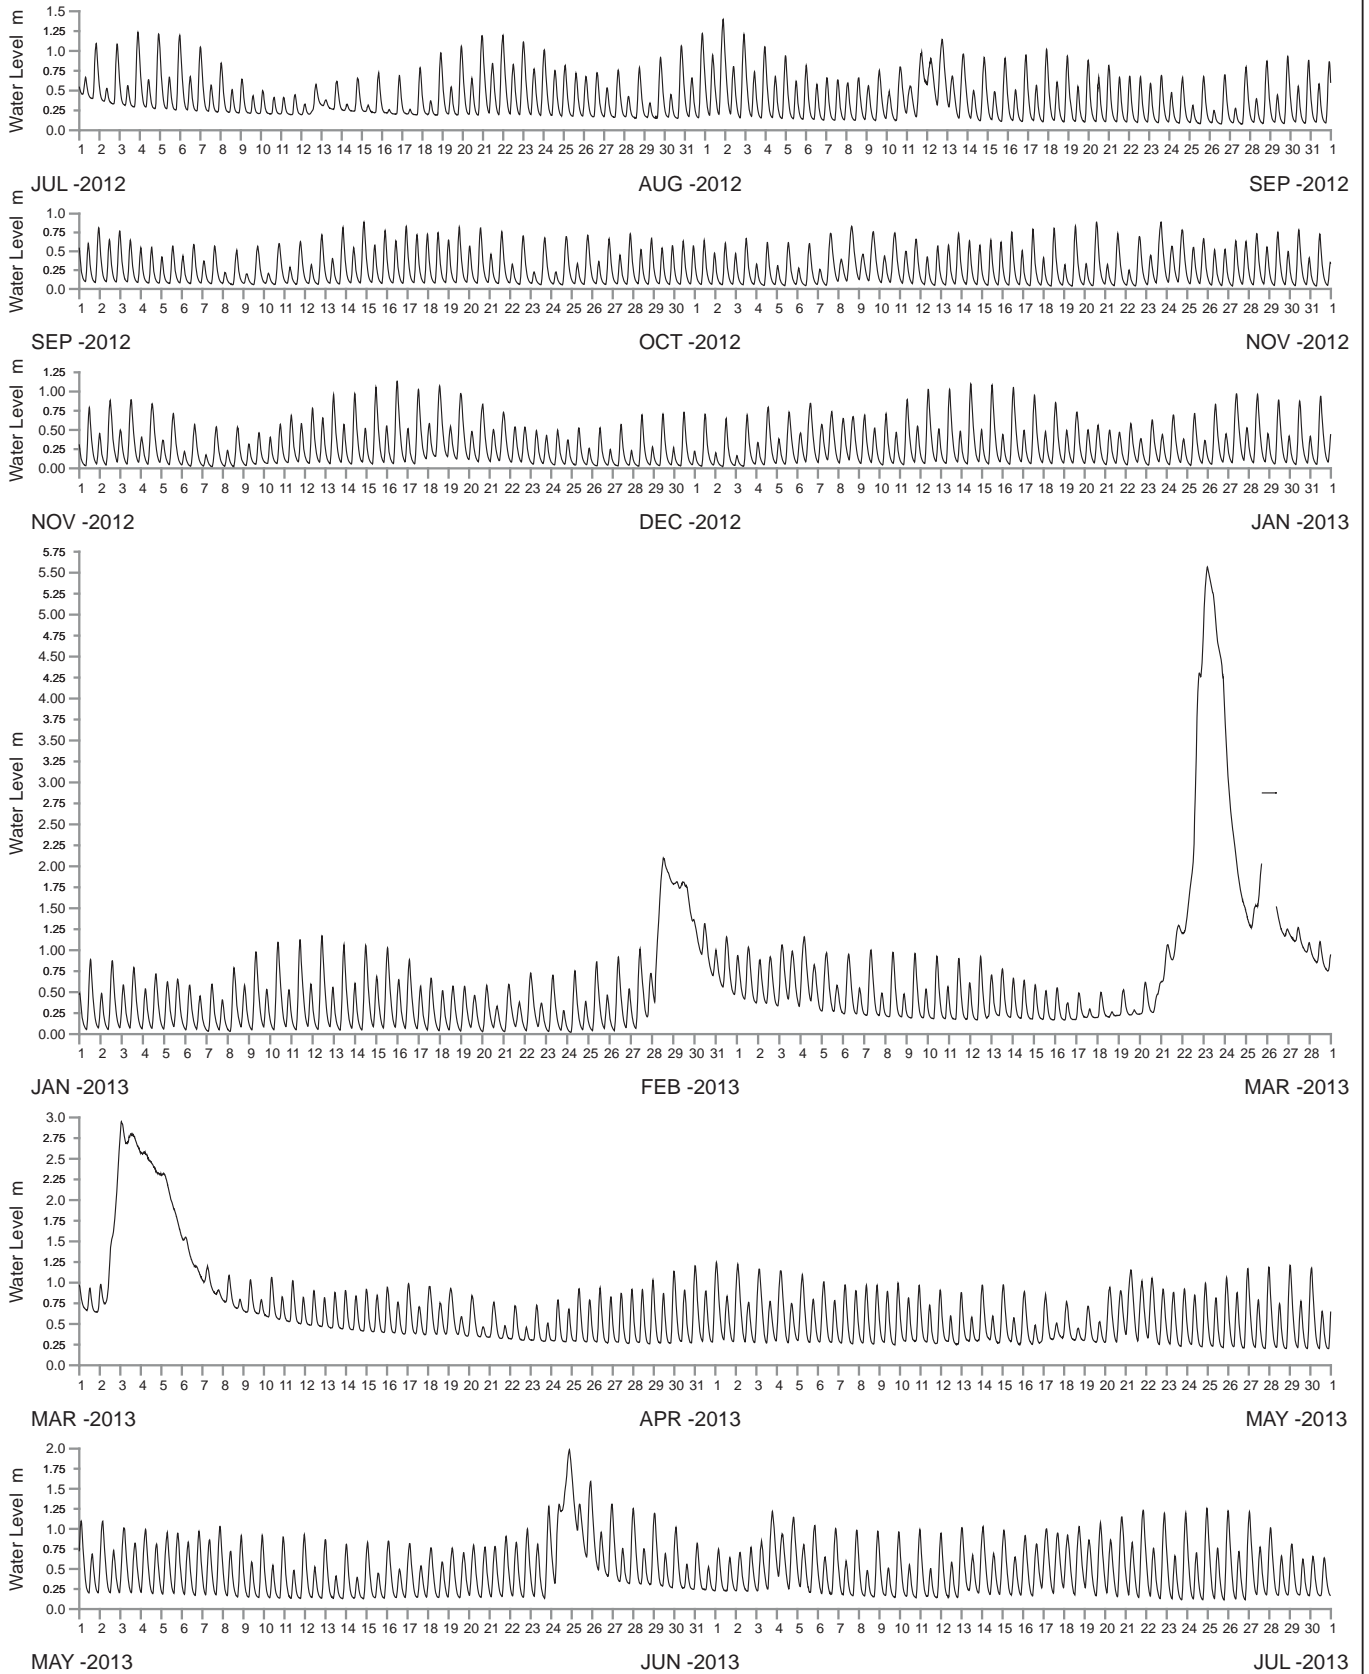
Figure
75

WATER LEVEL REFERENCED TO ASSUMED DATUM

NAMBUCCA RIVER AT BOWRAVILLE DOWNSTREAM
2012-2013

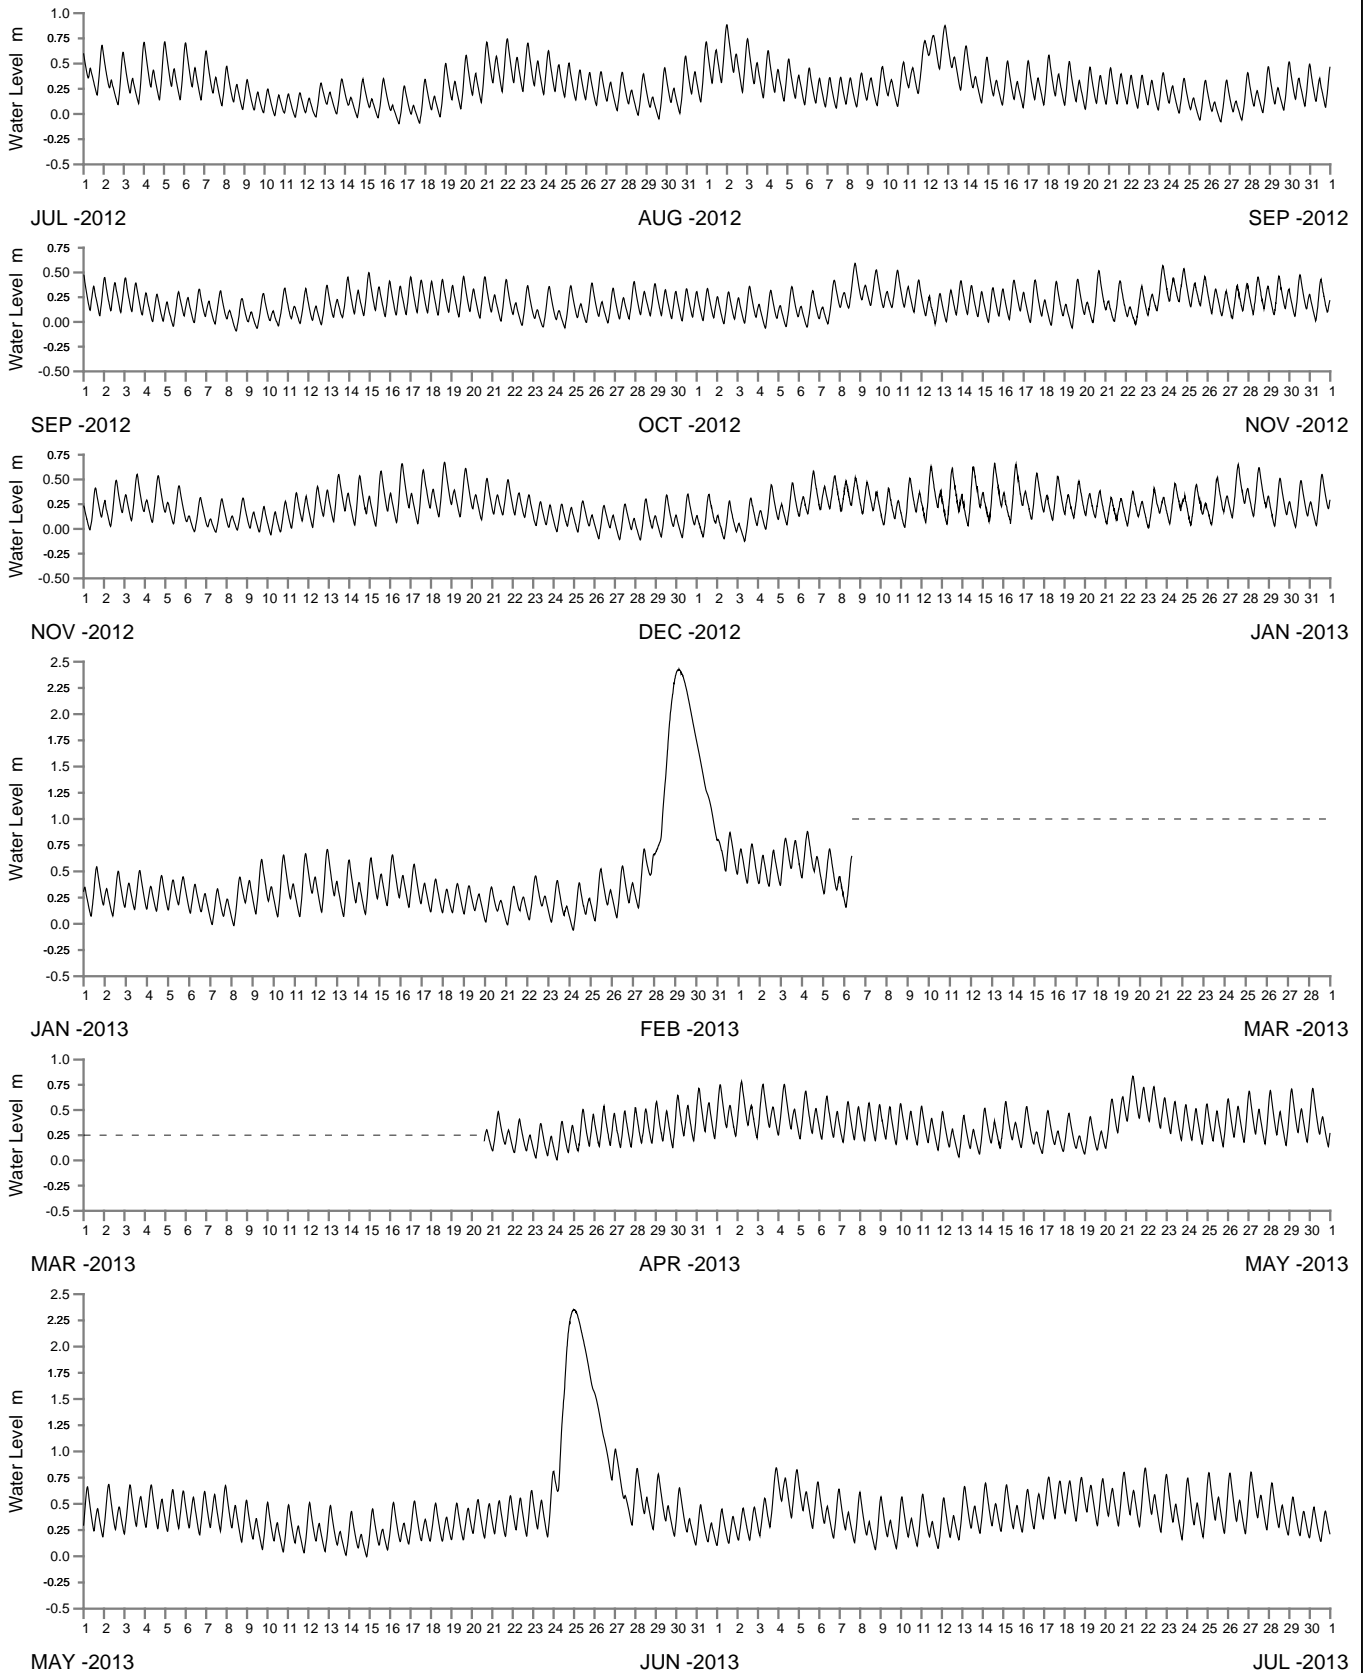
Figure
76

WATER LEVEL REFERENCED TO AUSTRALIAN HEIGHT DATUM

WARRELL CREEK AT WARRELL CREEK
2012-2013

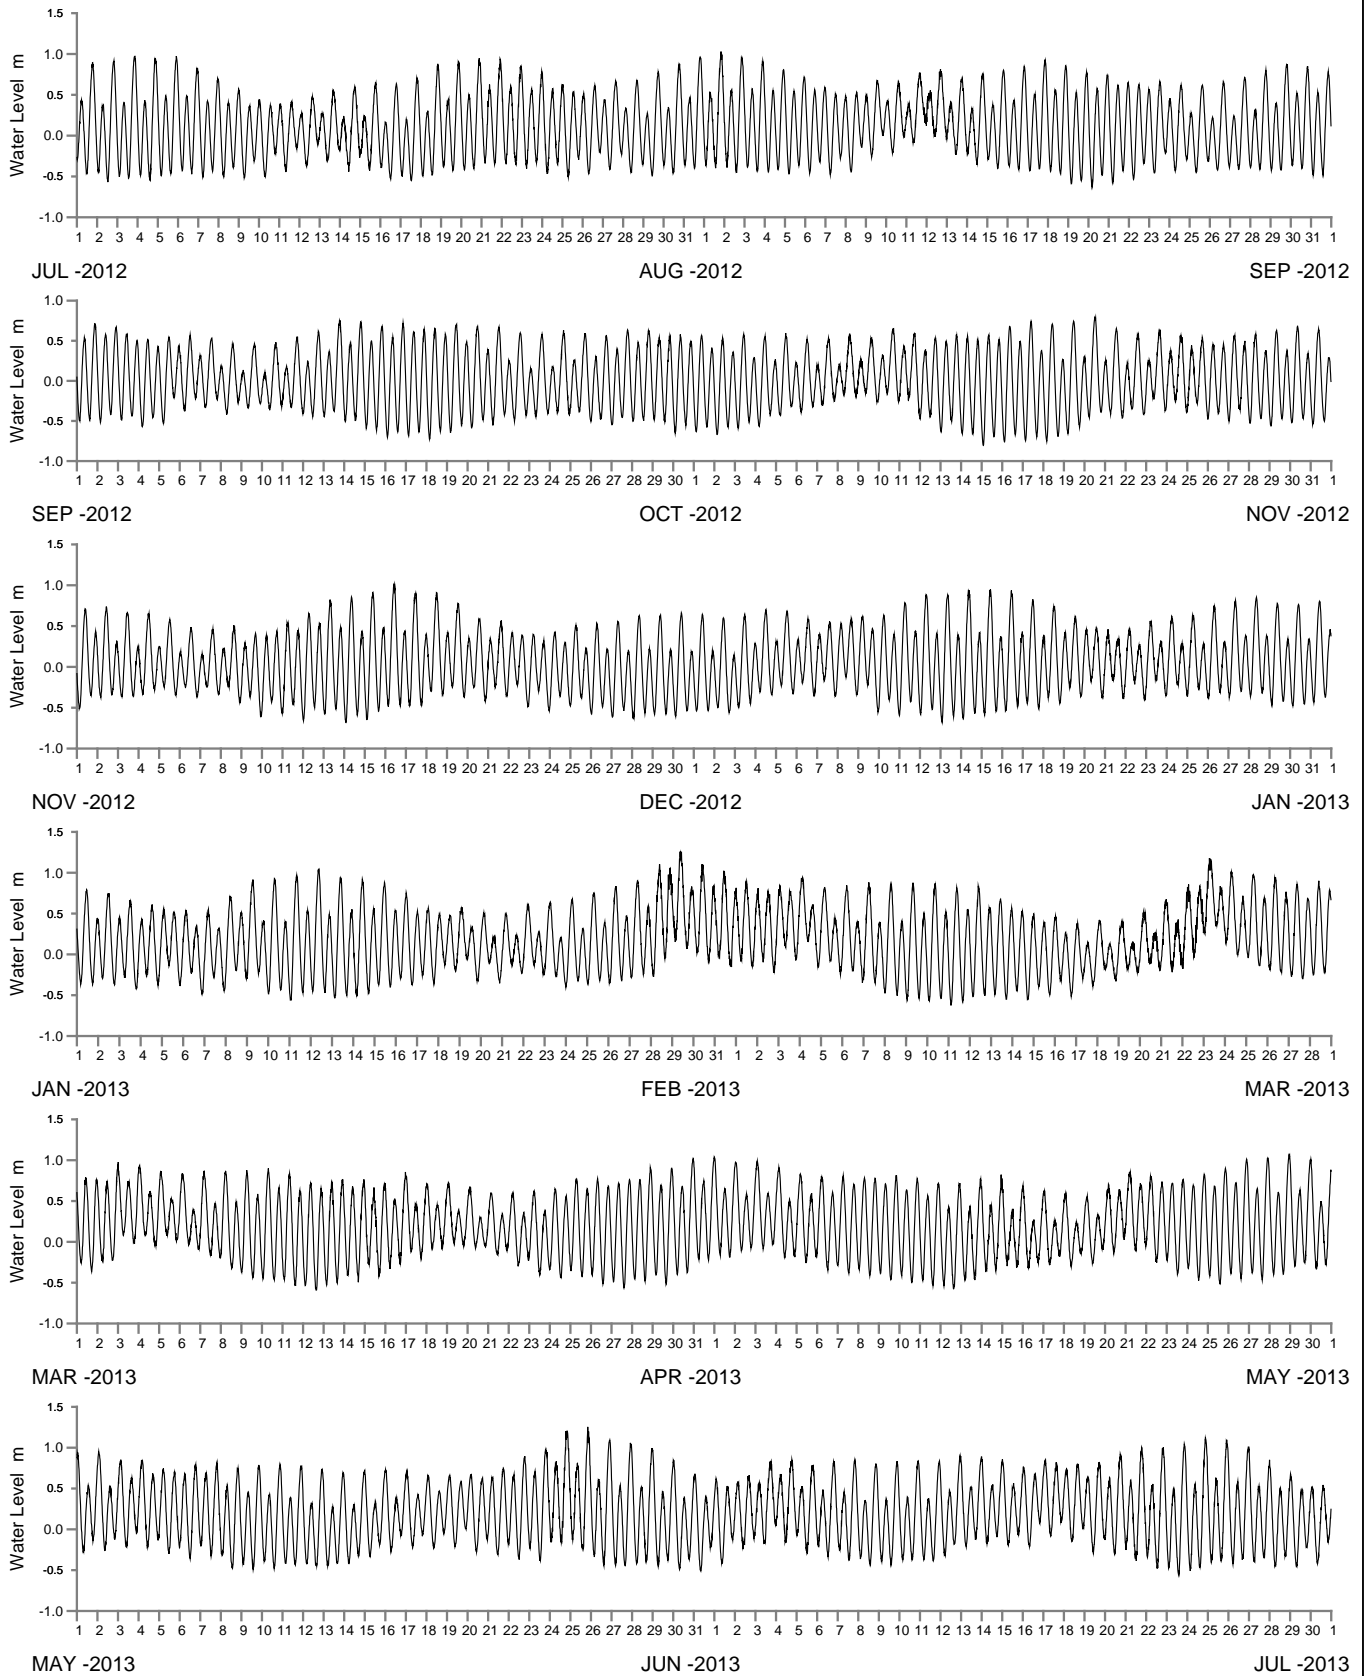
Figure
79

WATER LEVEL REFERENCED TO AUSTRALIAN HEIGHT DATUM

MACLEAY RIVER AT SOUTH WEST ROCKS
2012-2013

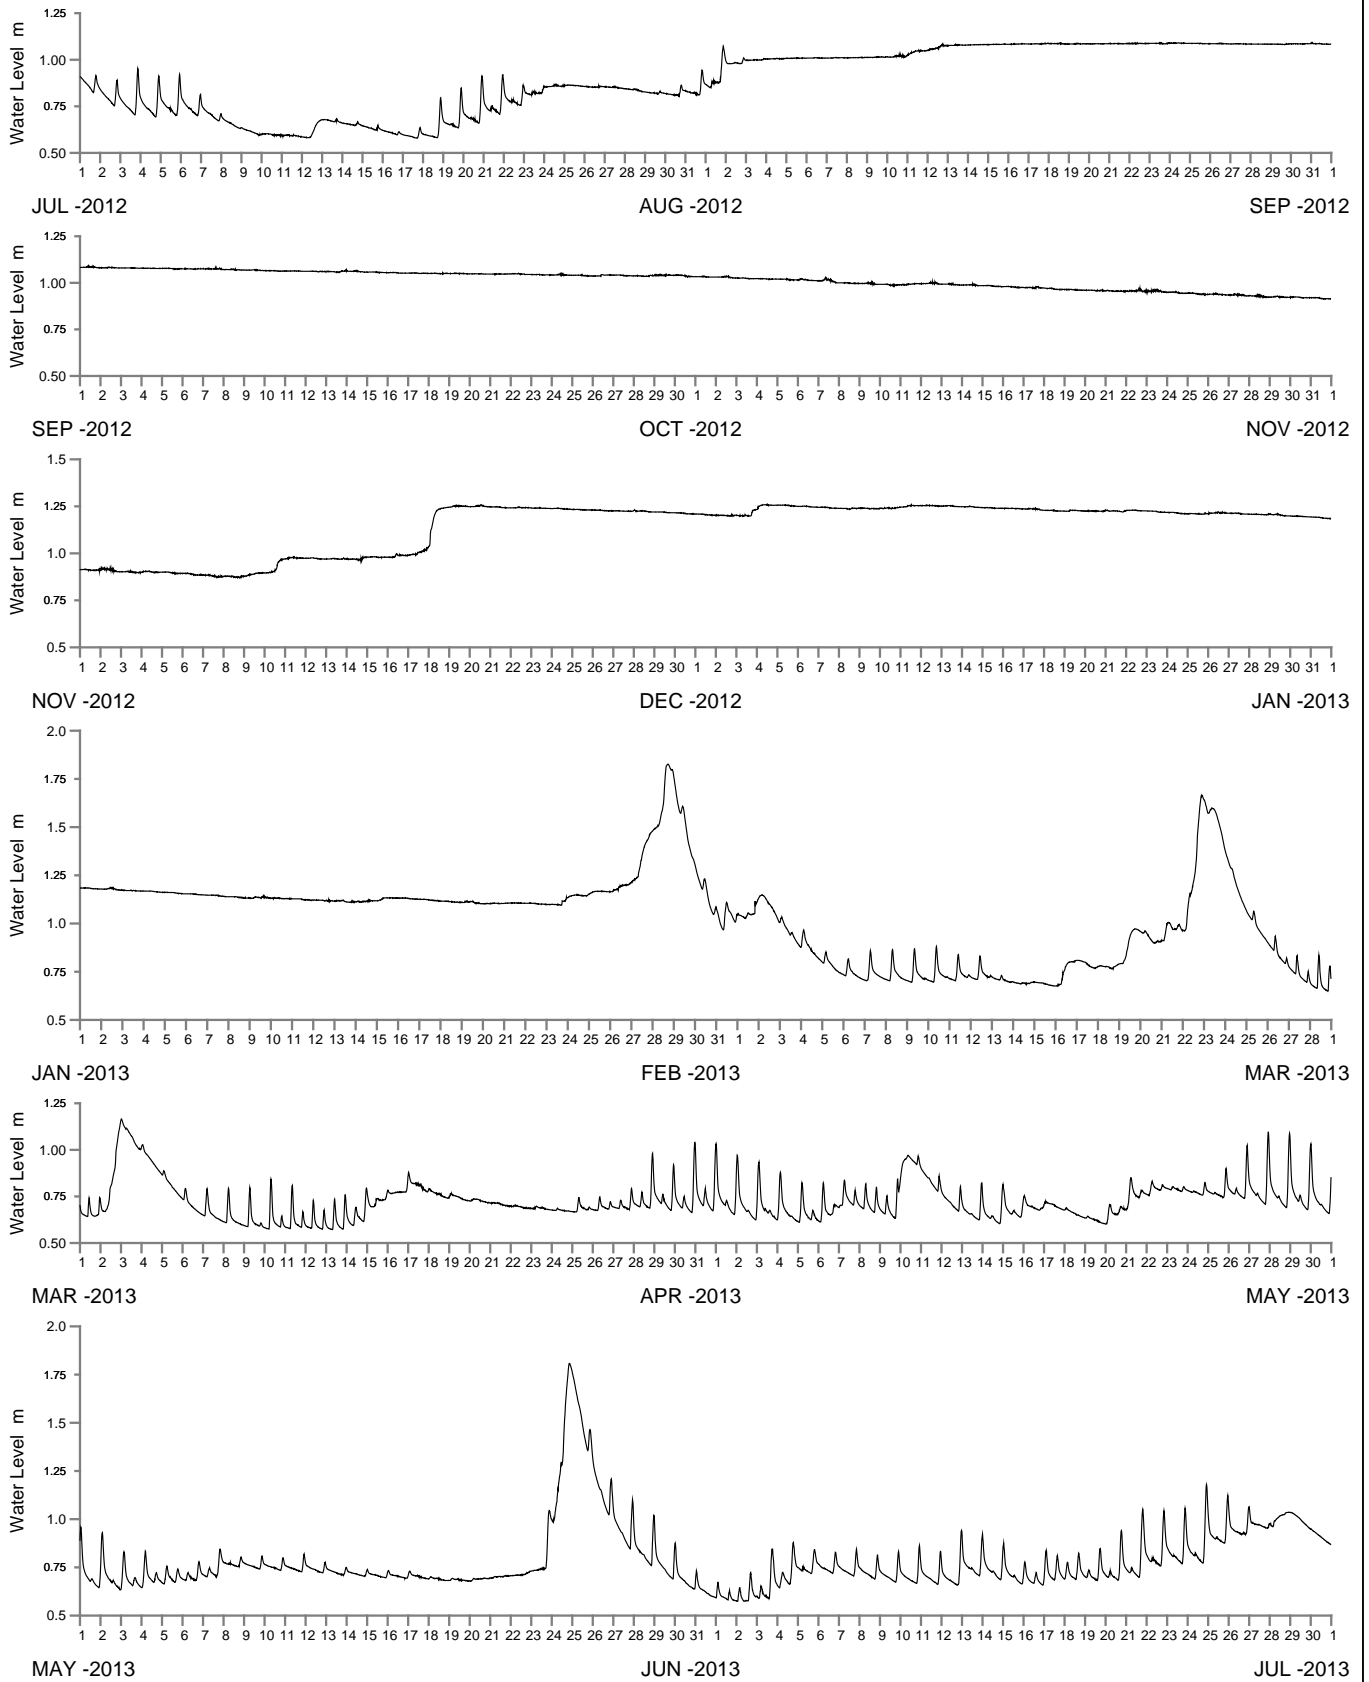
Figure
80

WATER LEVEL REFERENCED TO AUSTRALIAN HEIGHT DATUM

SALTWATER LAGOON AT SALTWATER LAGOON
2012-2013

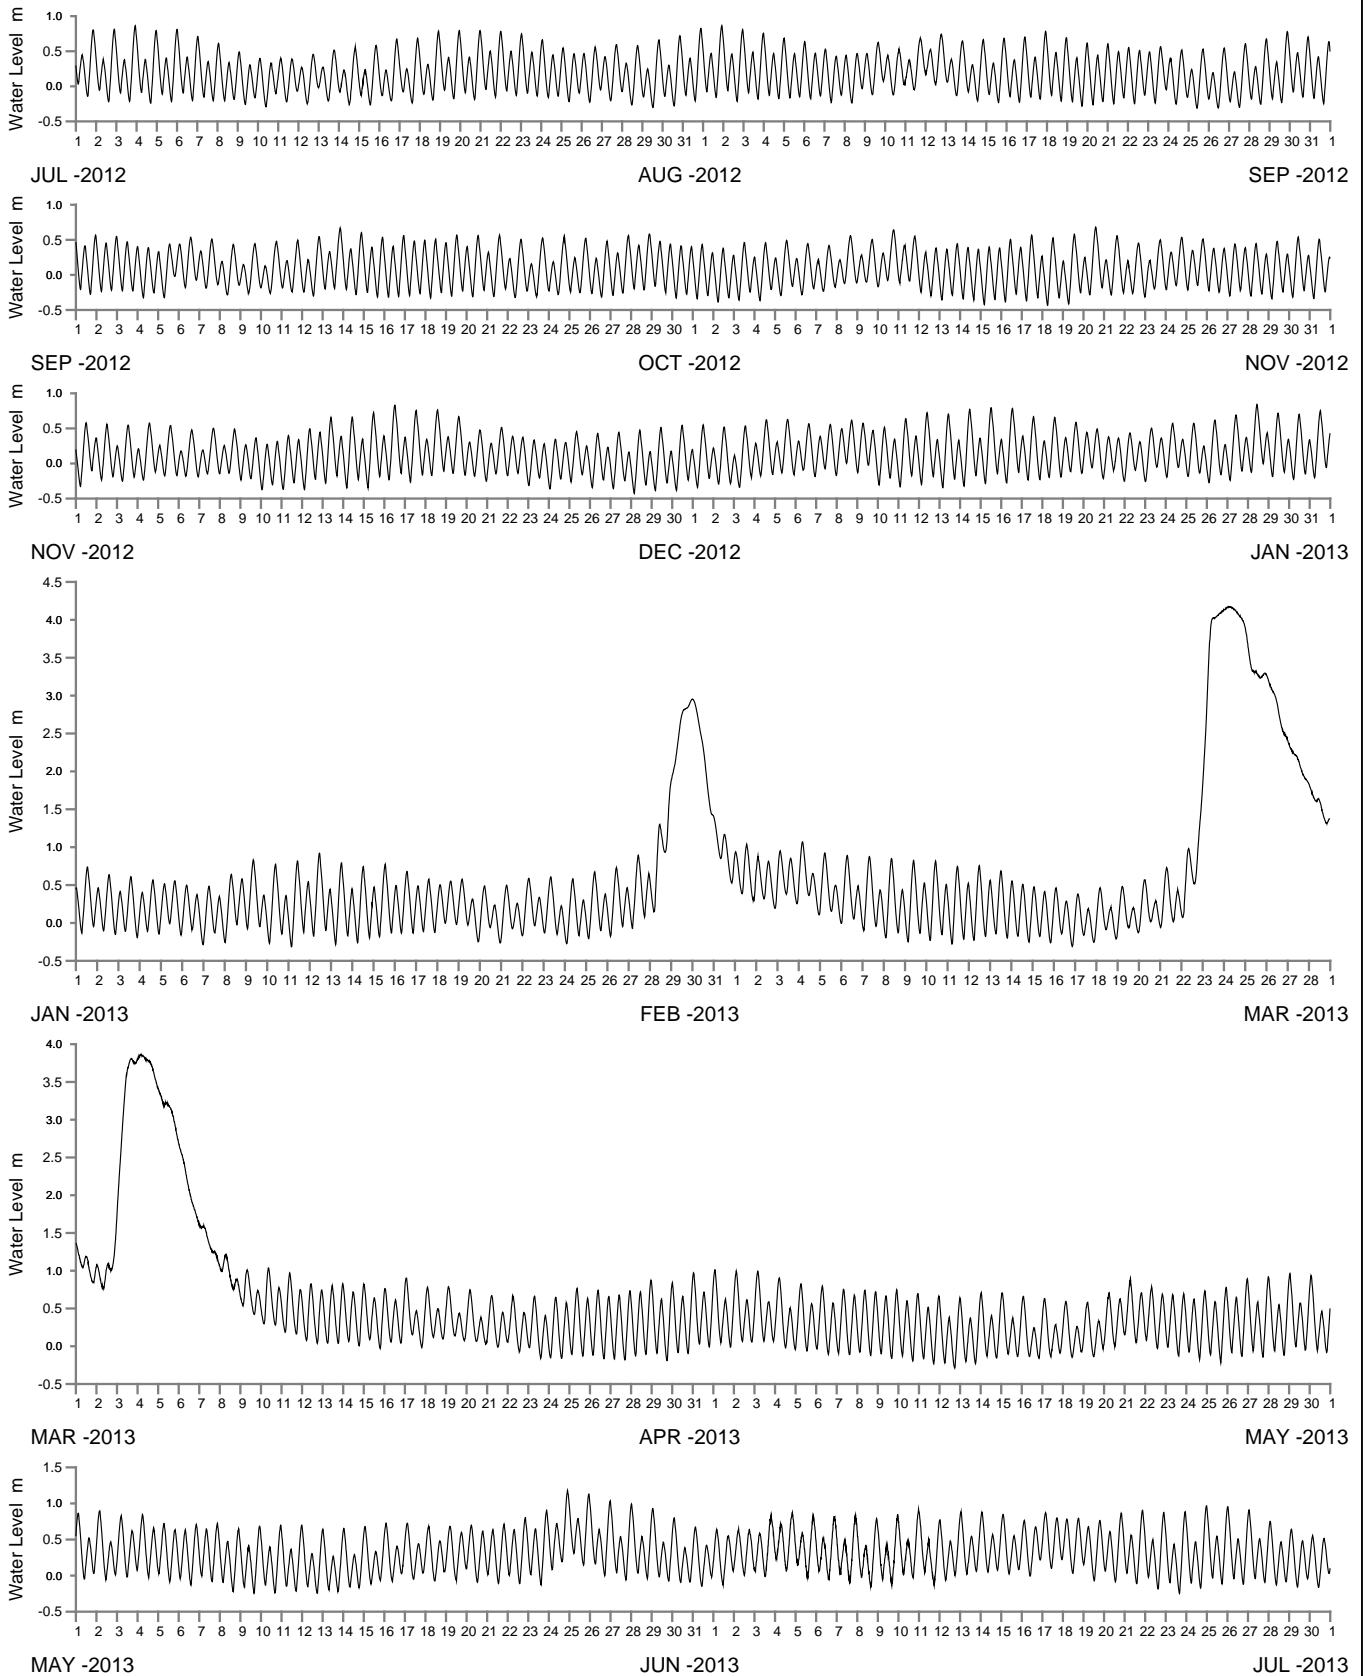
81

WATER LEVEL REFERENCED TO AUSTRALIAN HEIGHT DATUM

MACLEAY RIVER AT SMITHTOWN
2012-2013

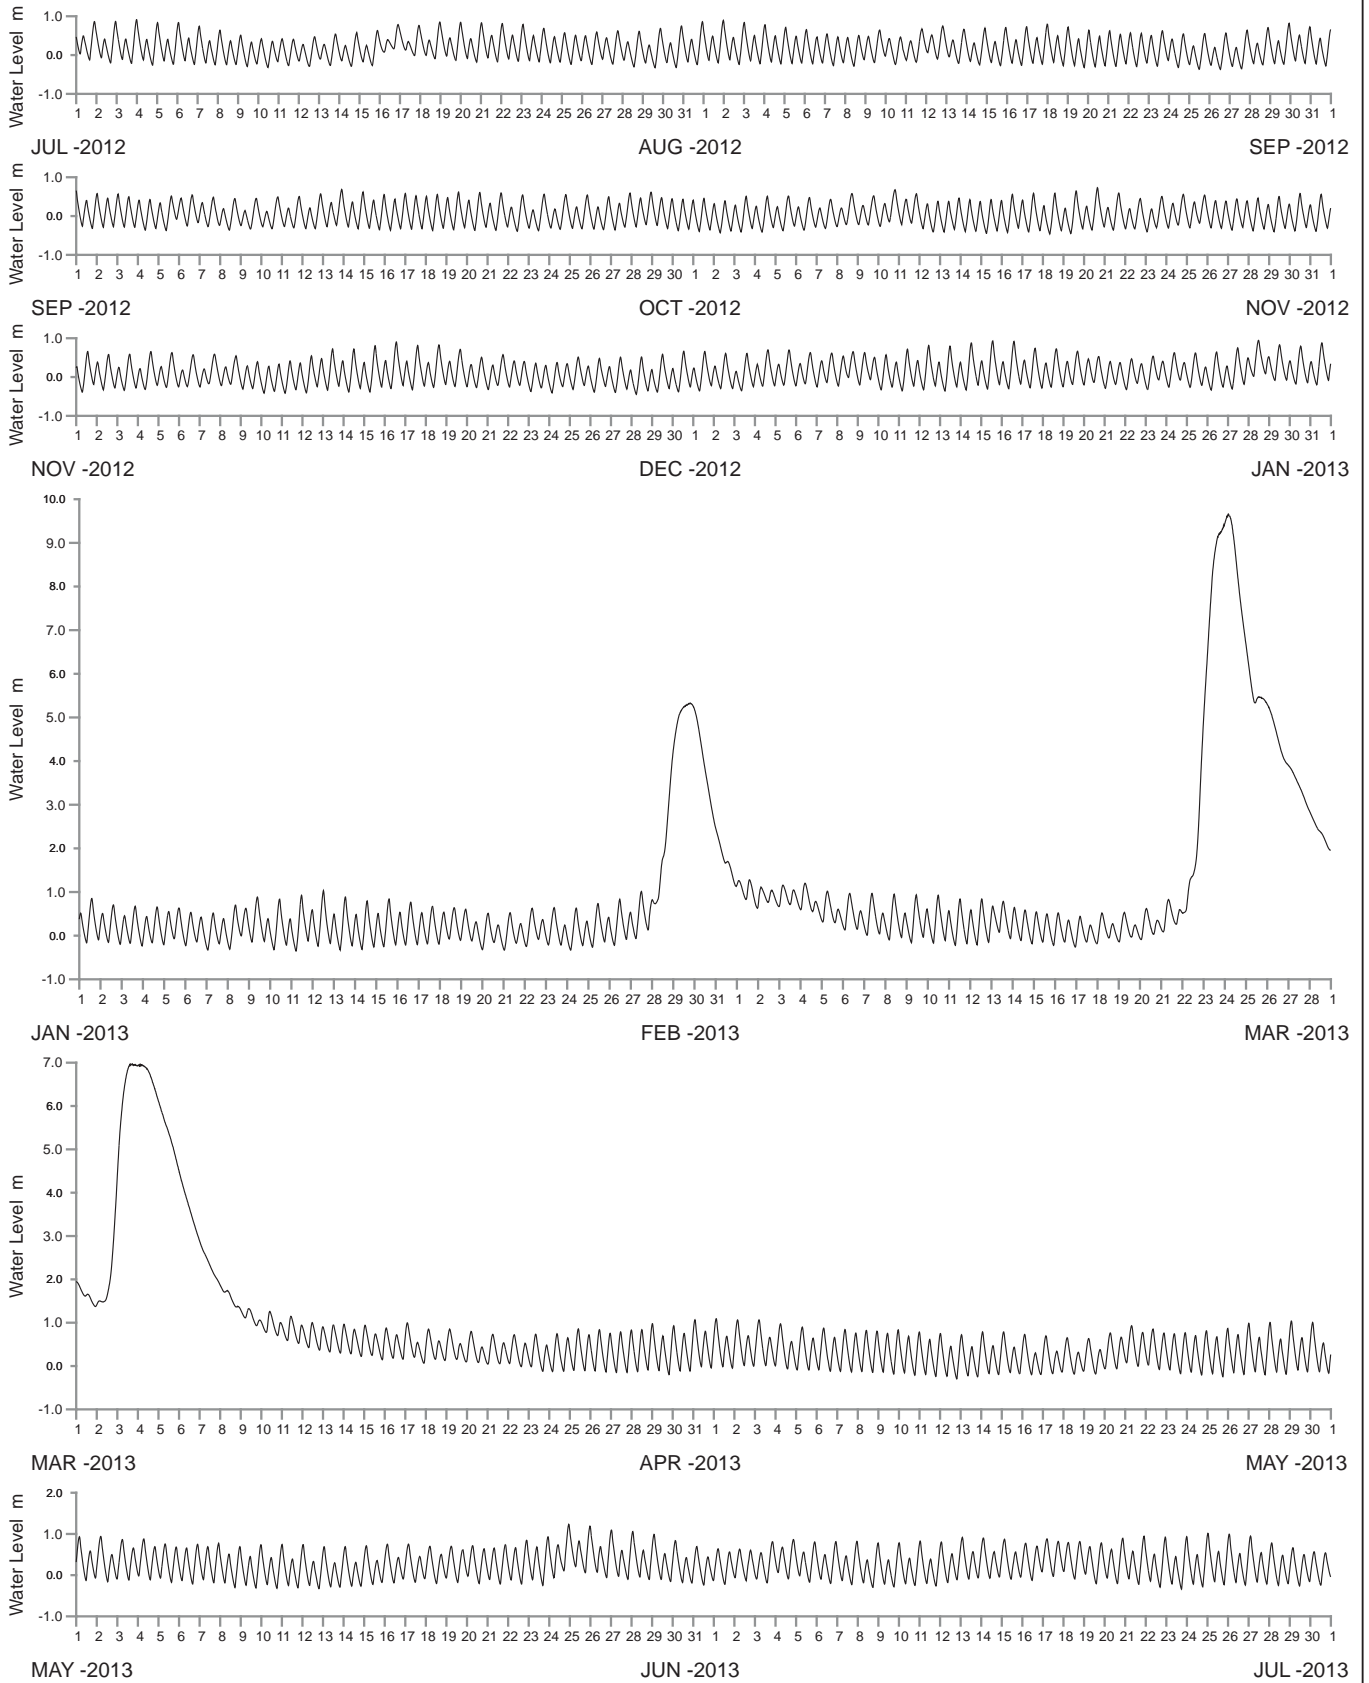
83

WATER LEVEL REFERENCED TO AUSTRALIAN HEIGHT DATUM

MACLEAY RIVER AT ALDAVILLA DOWNSTREAM
2012-2013

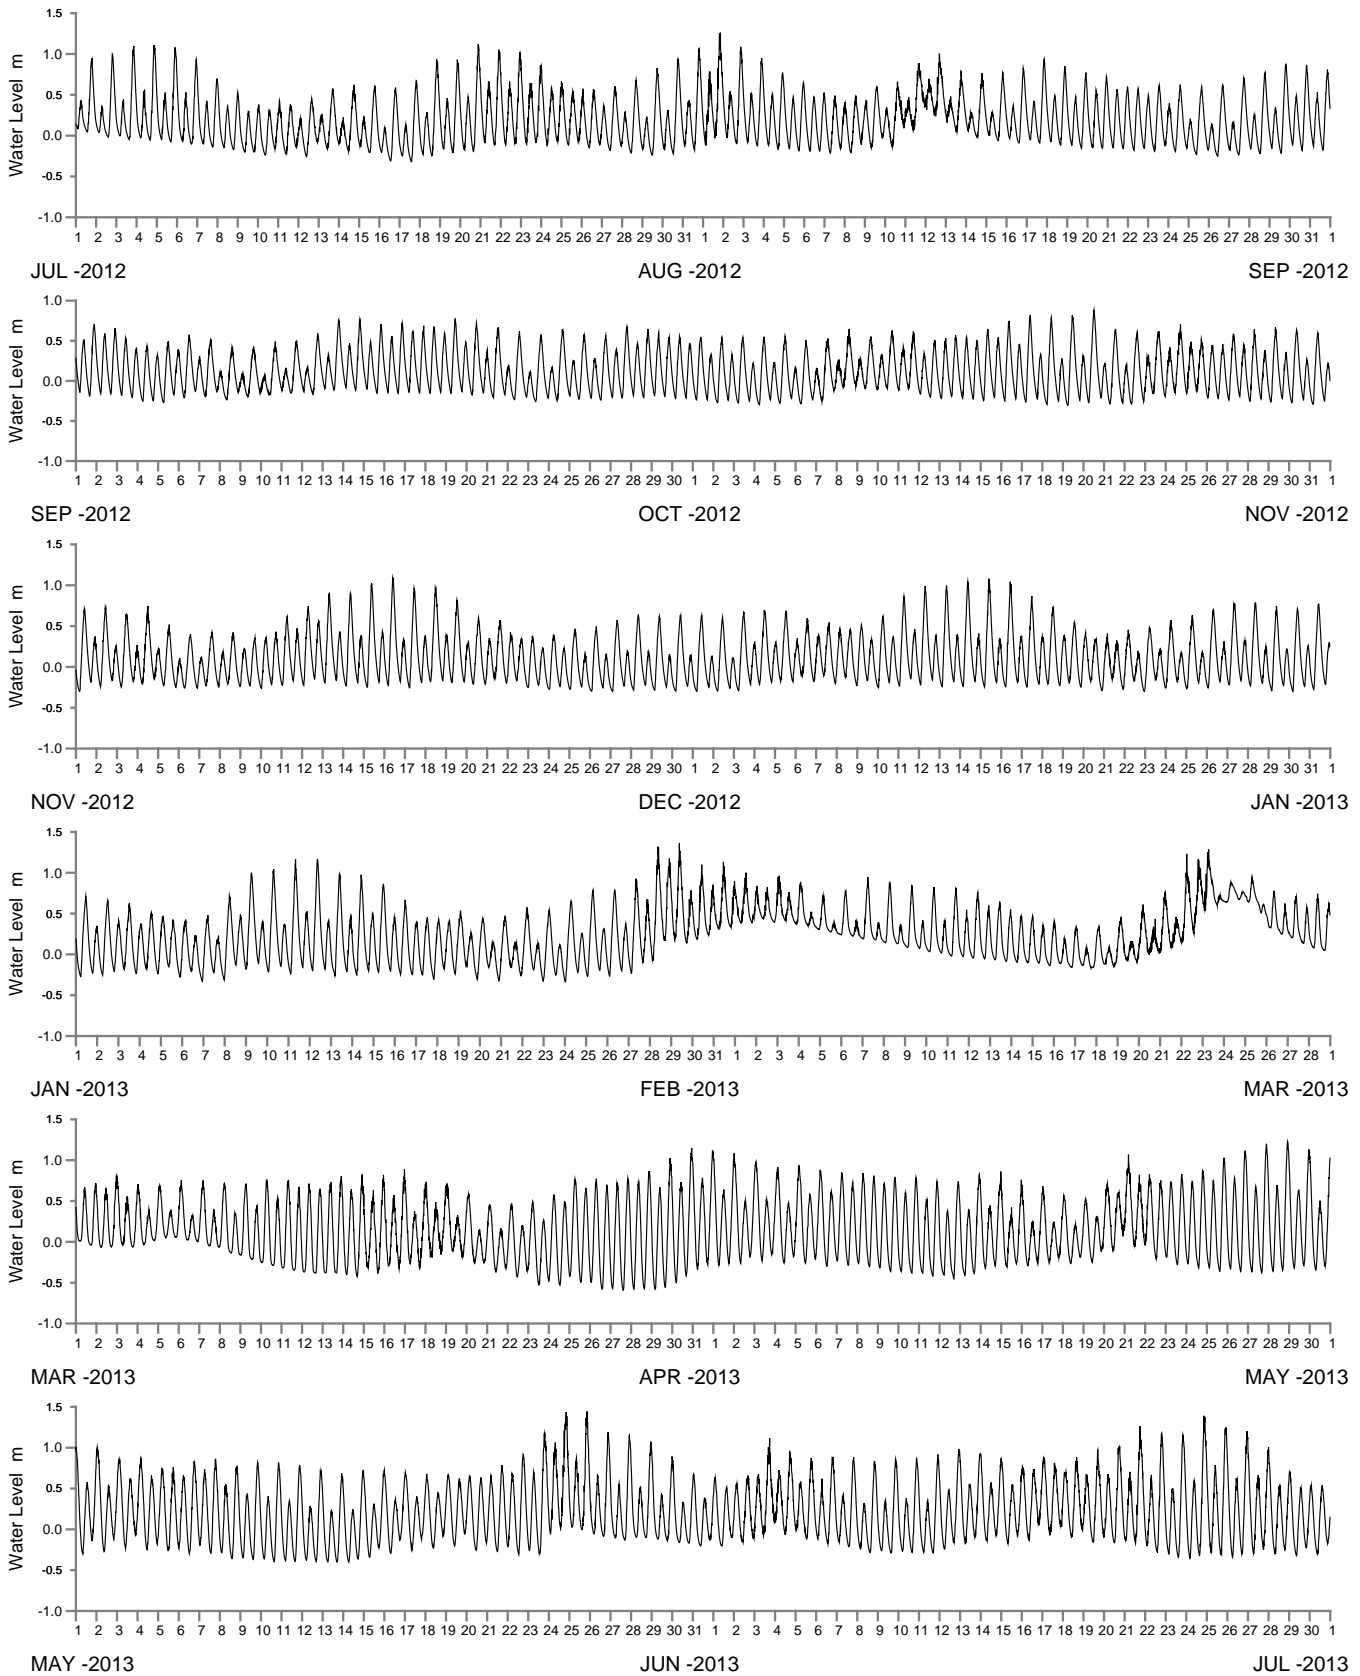
84

WATER LEVEL REFERENCED TO AUSTRALIAN HEIGHT DATUM

KILLICK CREEK AT CRESCENT HEAD
2012-2013

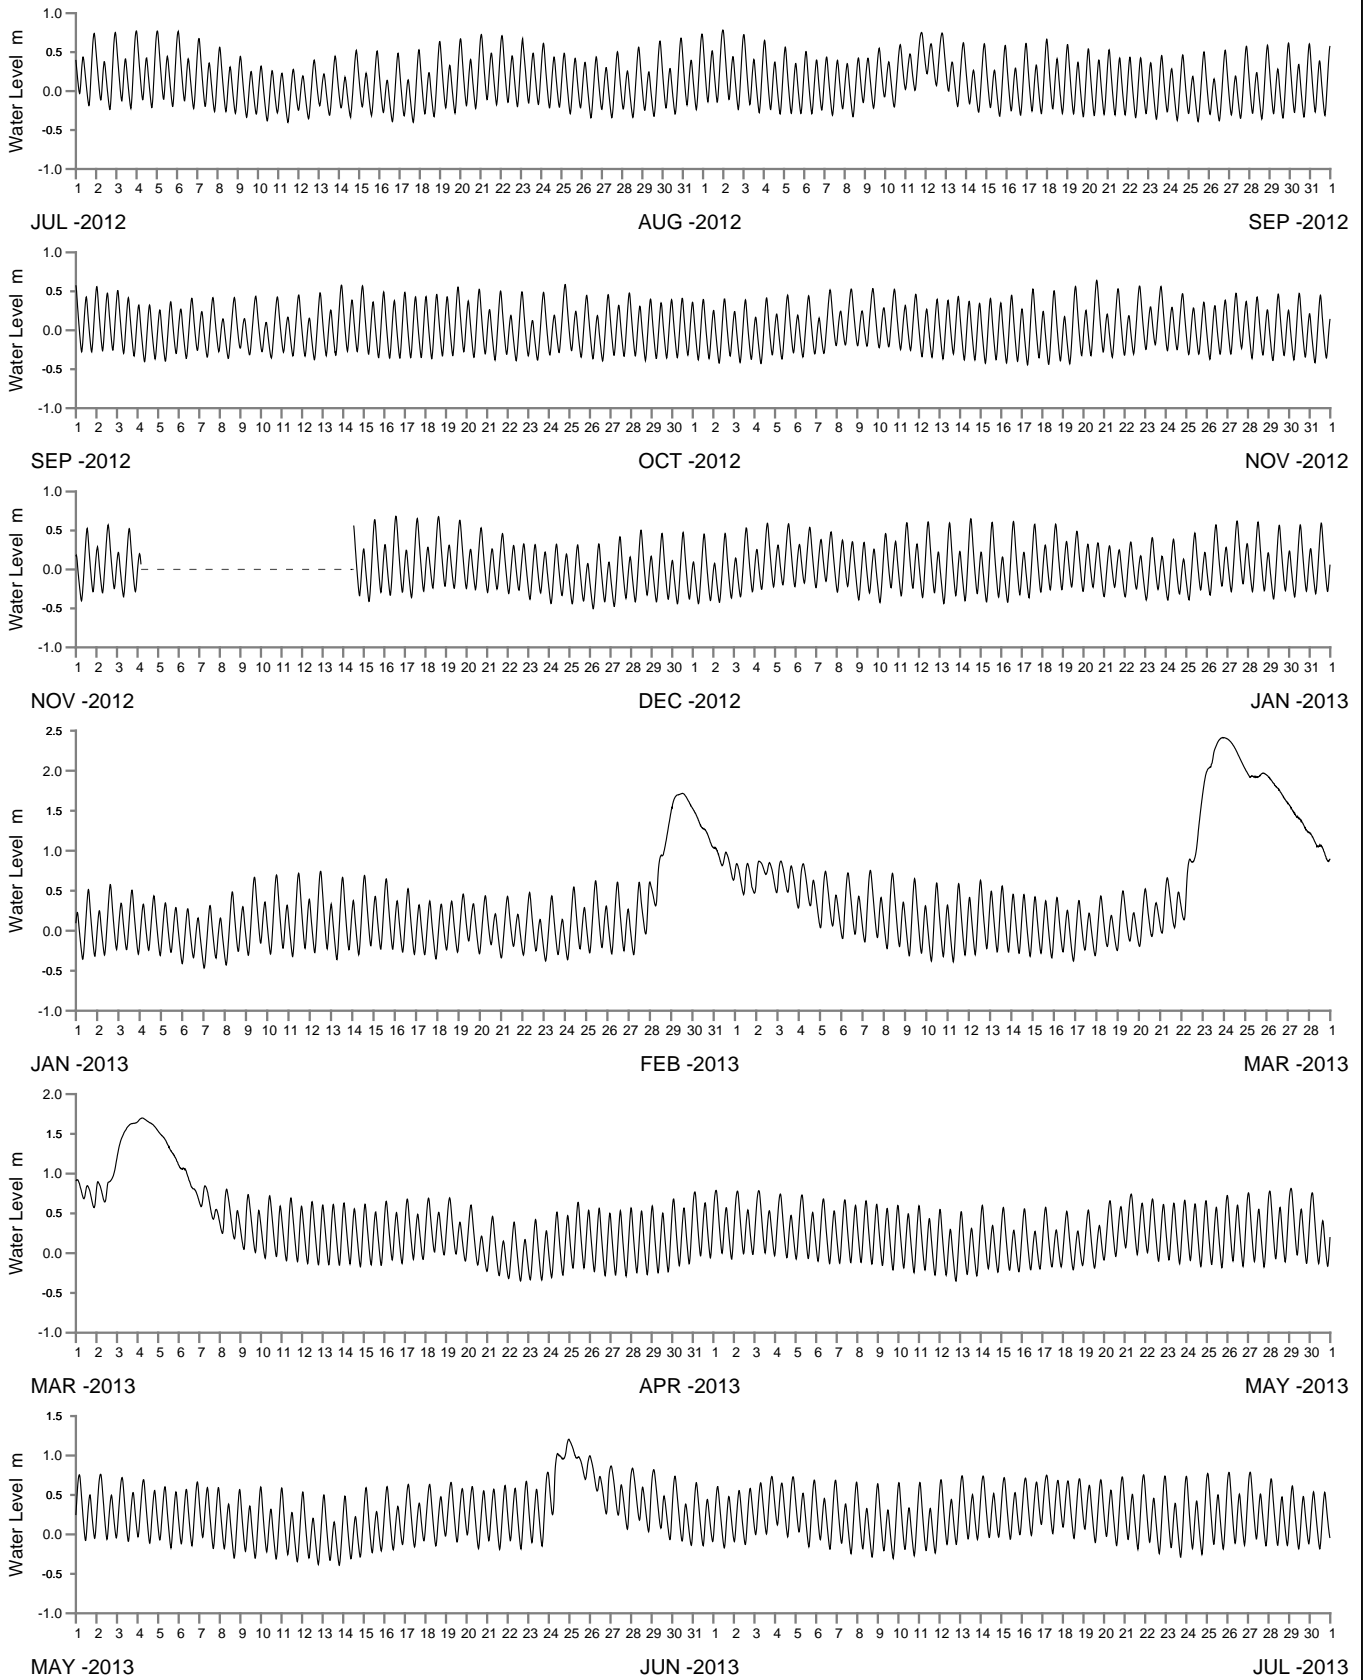
86

WATER LEVEL REFERENCED TO AUSTRALIAN HEIGHT DATUM

MARIA RIVER AT GREEN VALLEY
2012-2013
