Public Works
Manly Hydraulics Laboratory

MHL
Report 2218

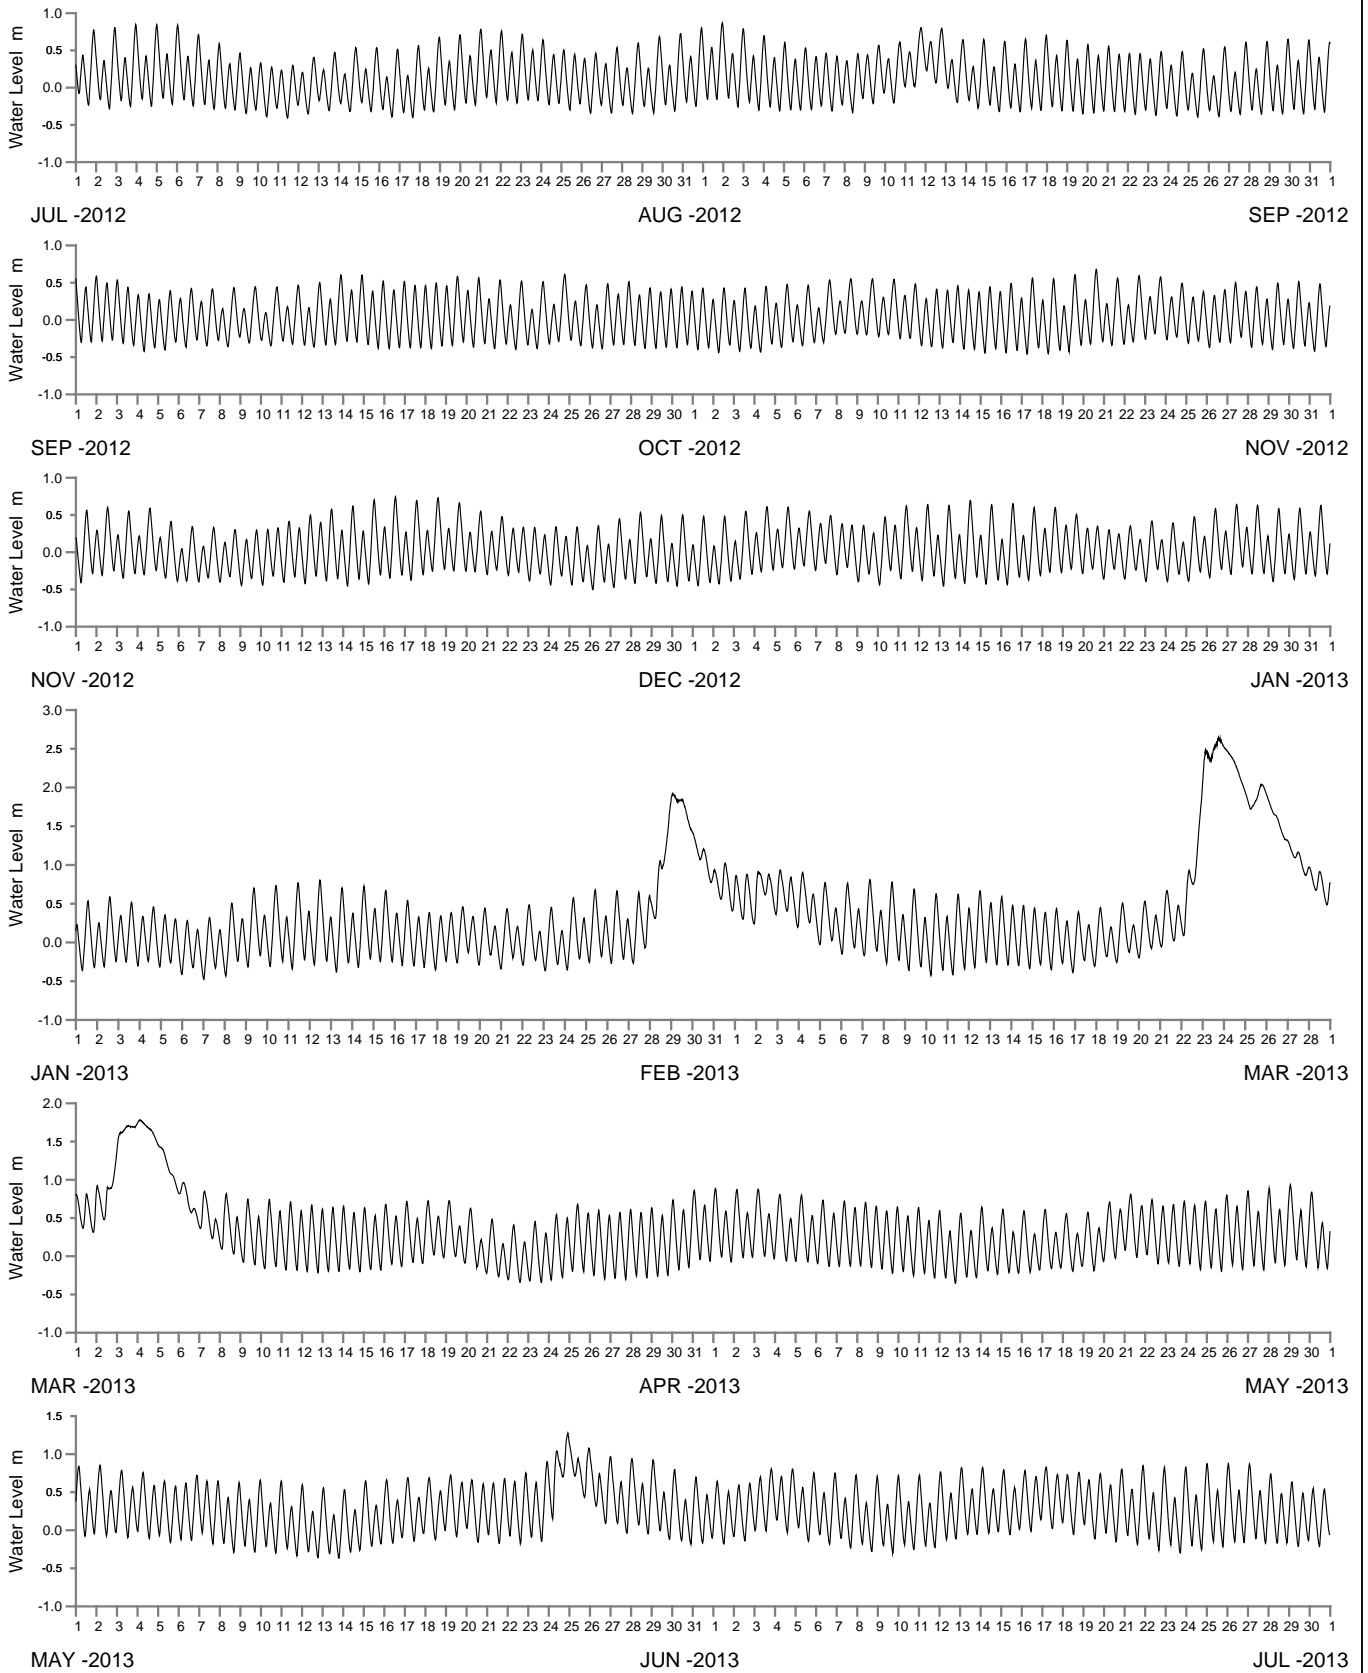
Figure
87

WATER LEVEL REFERENCED TO AUSTRALIAN HEIGHT DATUM

WILSONS RIVER AT TELEGRAPH POINT
2012-2013

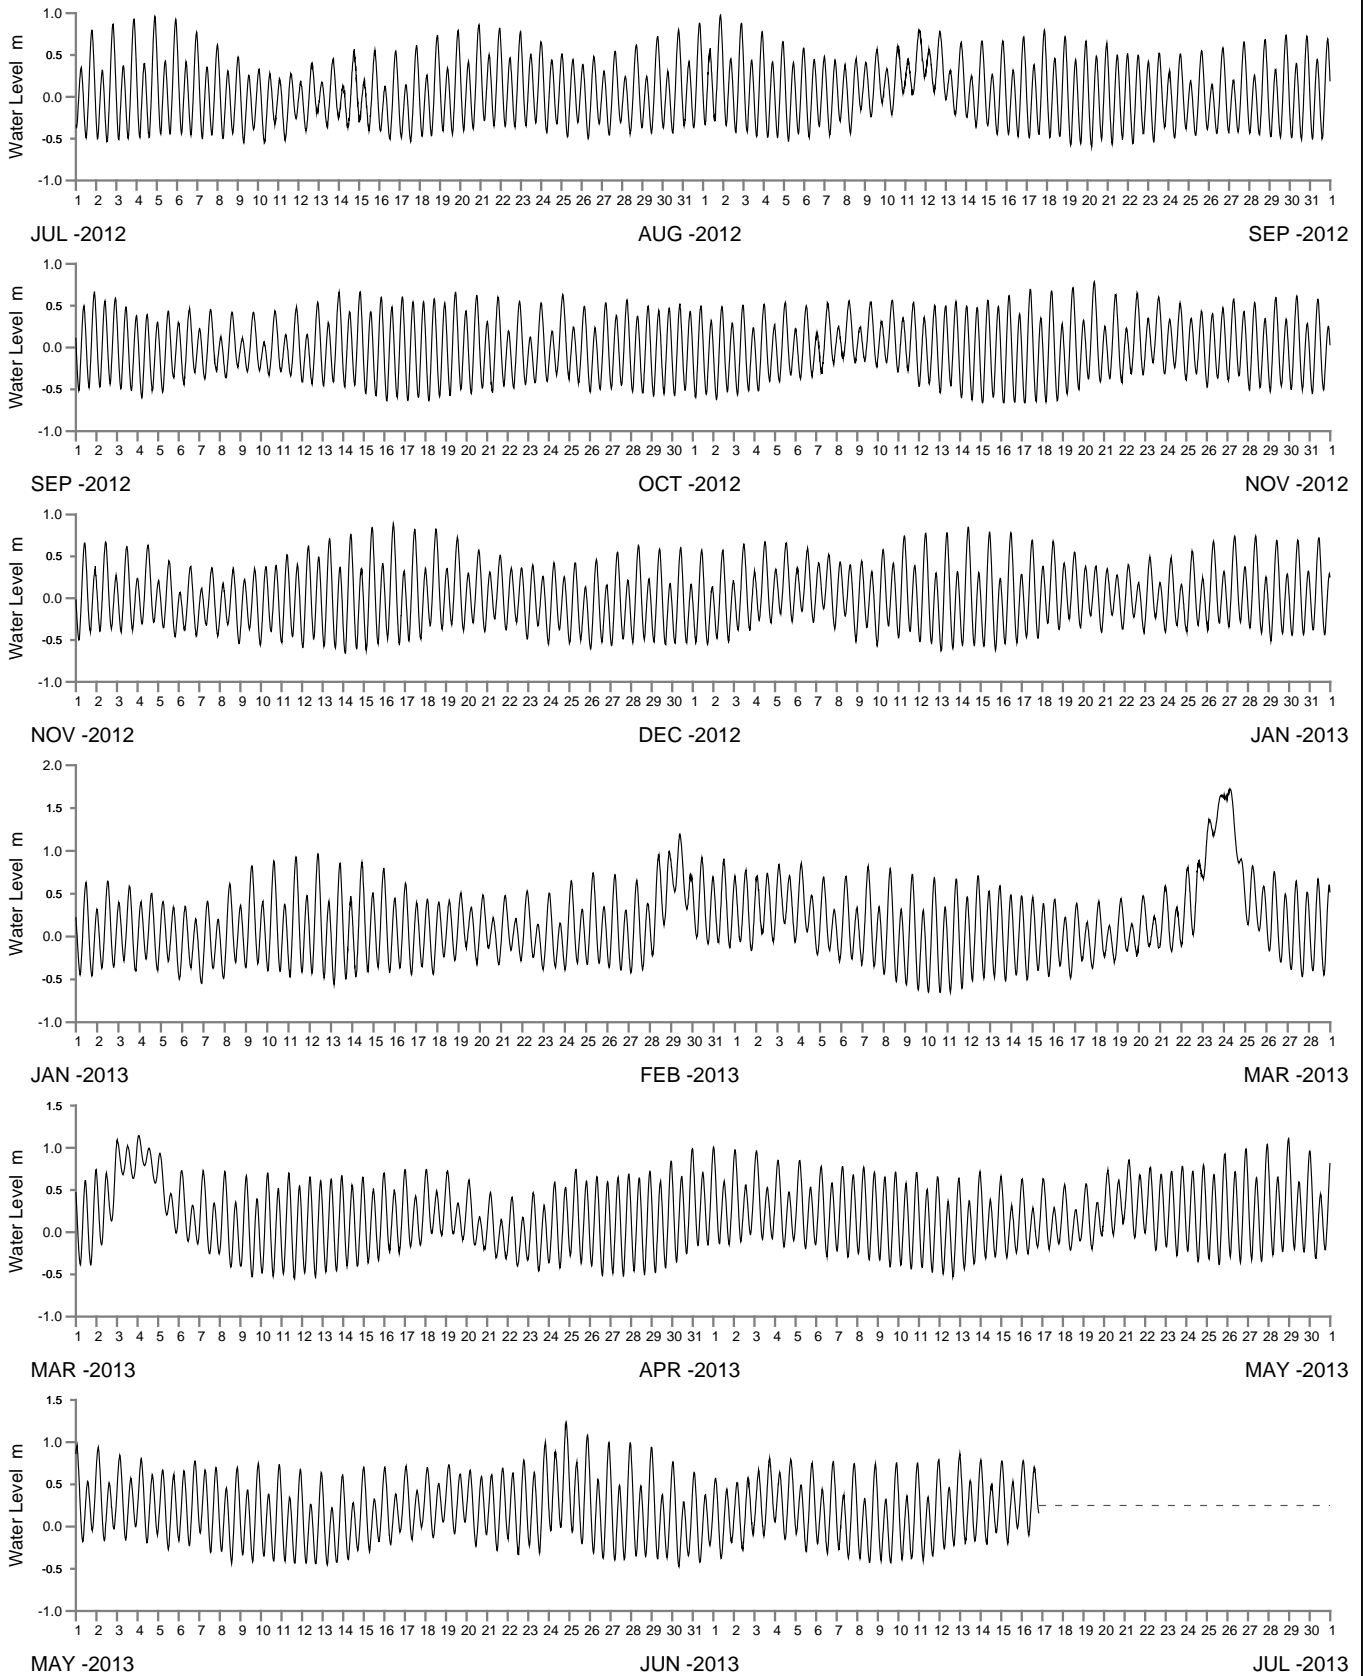
88

WATER LEVEL REFERENCED TO AUSTRALIAN HEIGHT DATUM

HASTINGS RIVER AT SETTLEMENT POINT
2012-2013

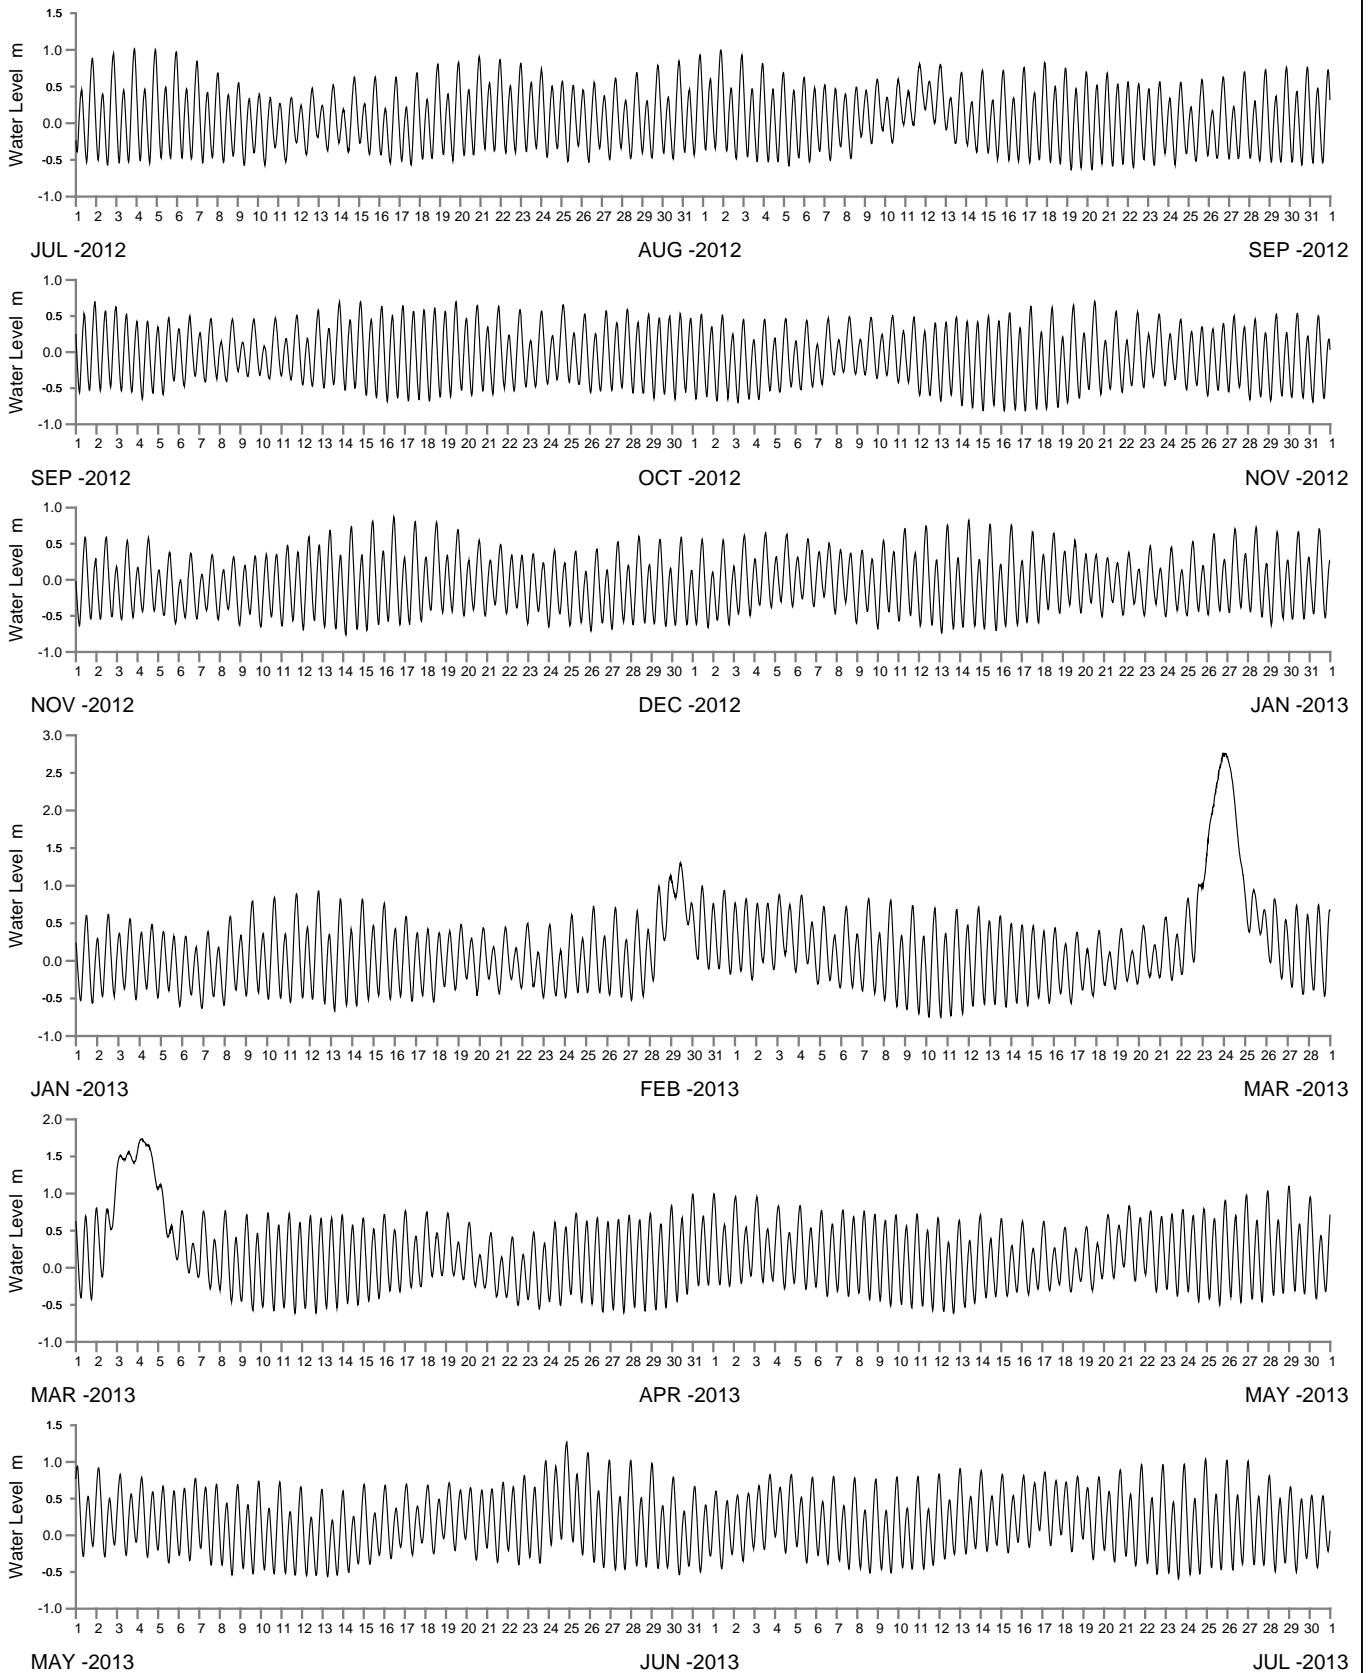
Figure
89

WATER LEVEL REFERENCED TO AUSTRALIAN HEIGHT DATUM

HASTINGS RIVER AT DENNIS BRIDGE DOWNSTREAM
2012-2013

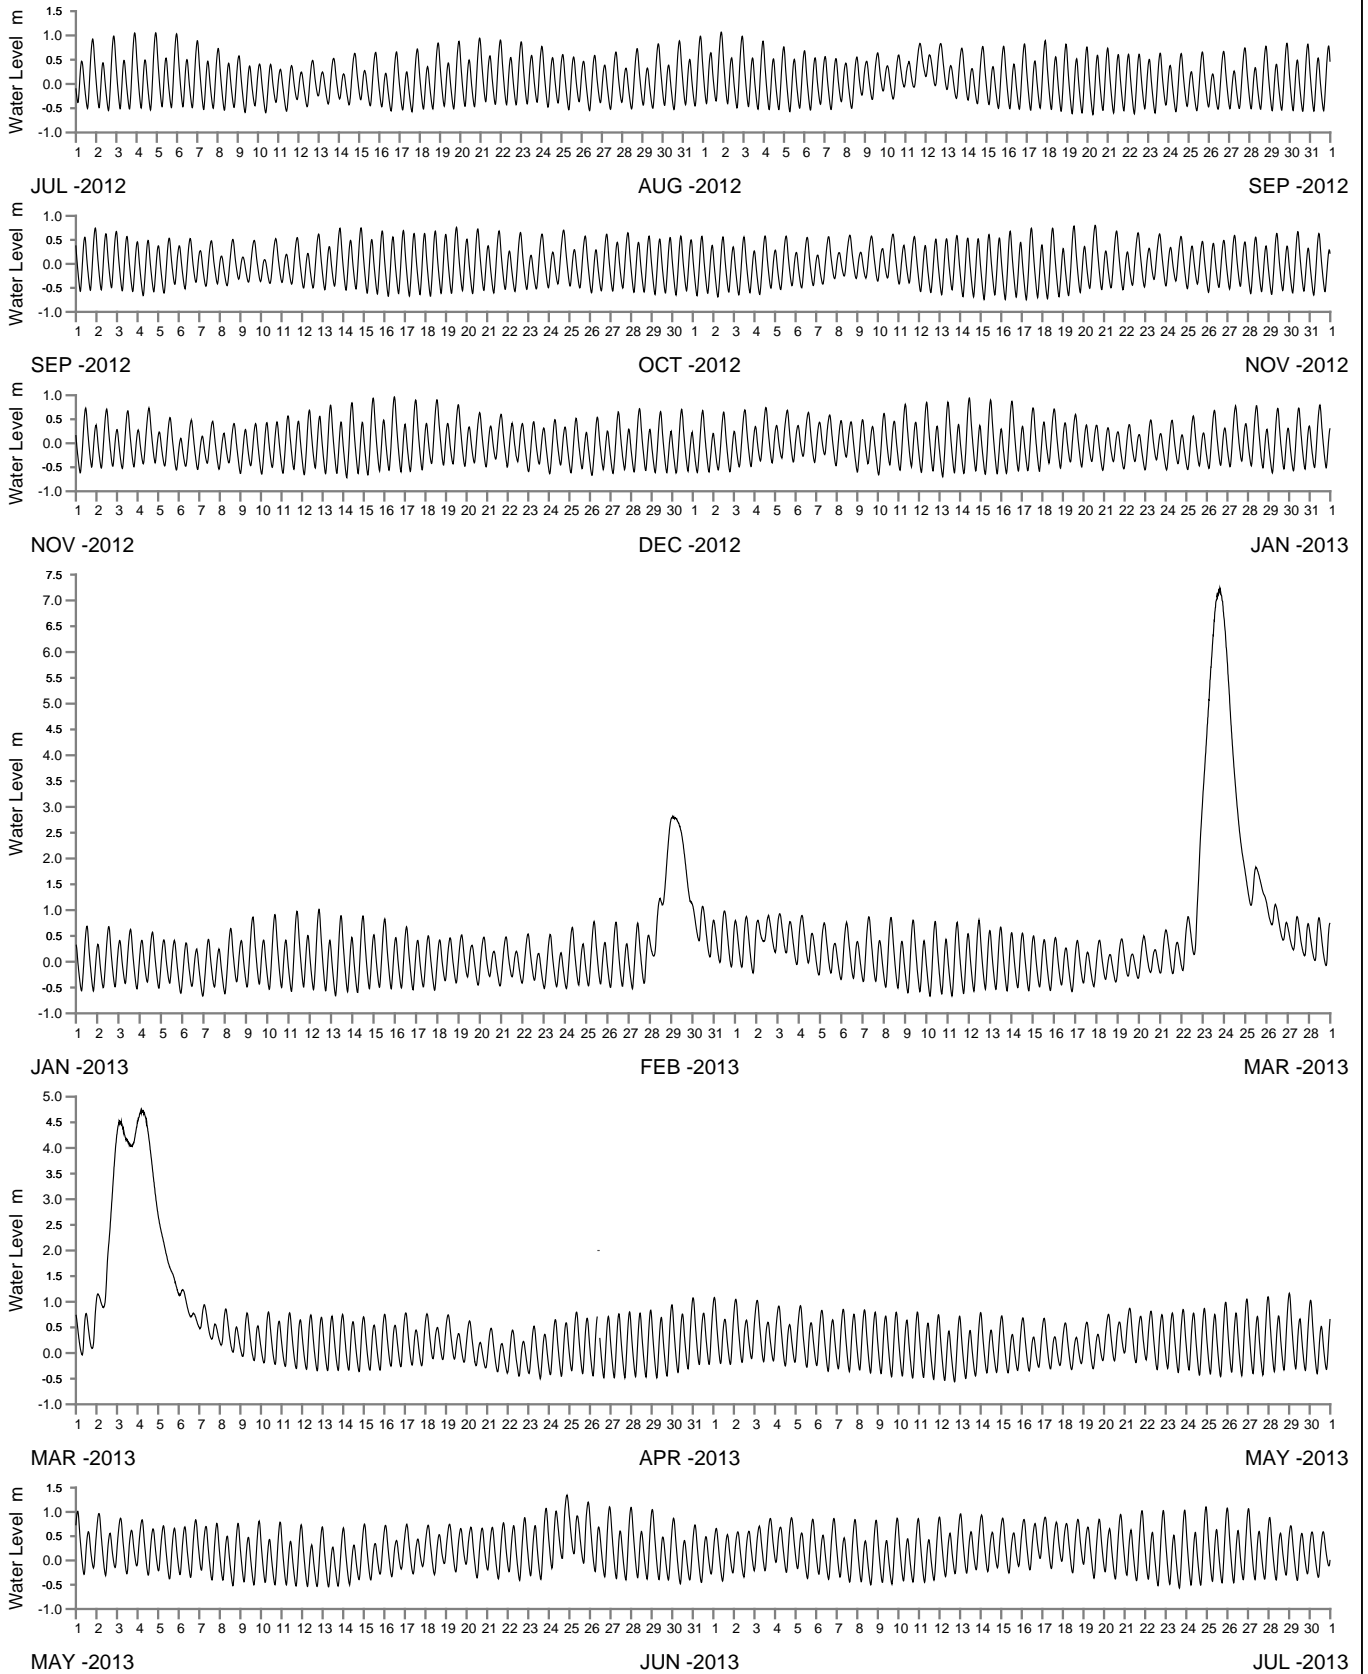
Figure
90

WATER LEVEL REFERENCED TO AUSTRALIAN HEIGHT DATUM

HASTINGS RIVER AT WAUCHOPE RAILWAY BRIDGE
2012-2013

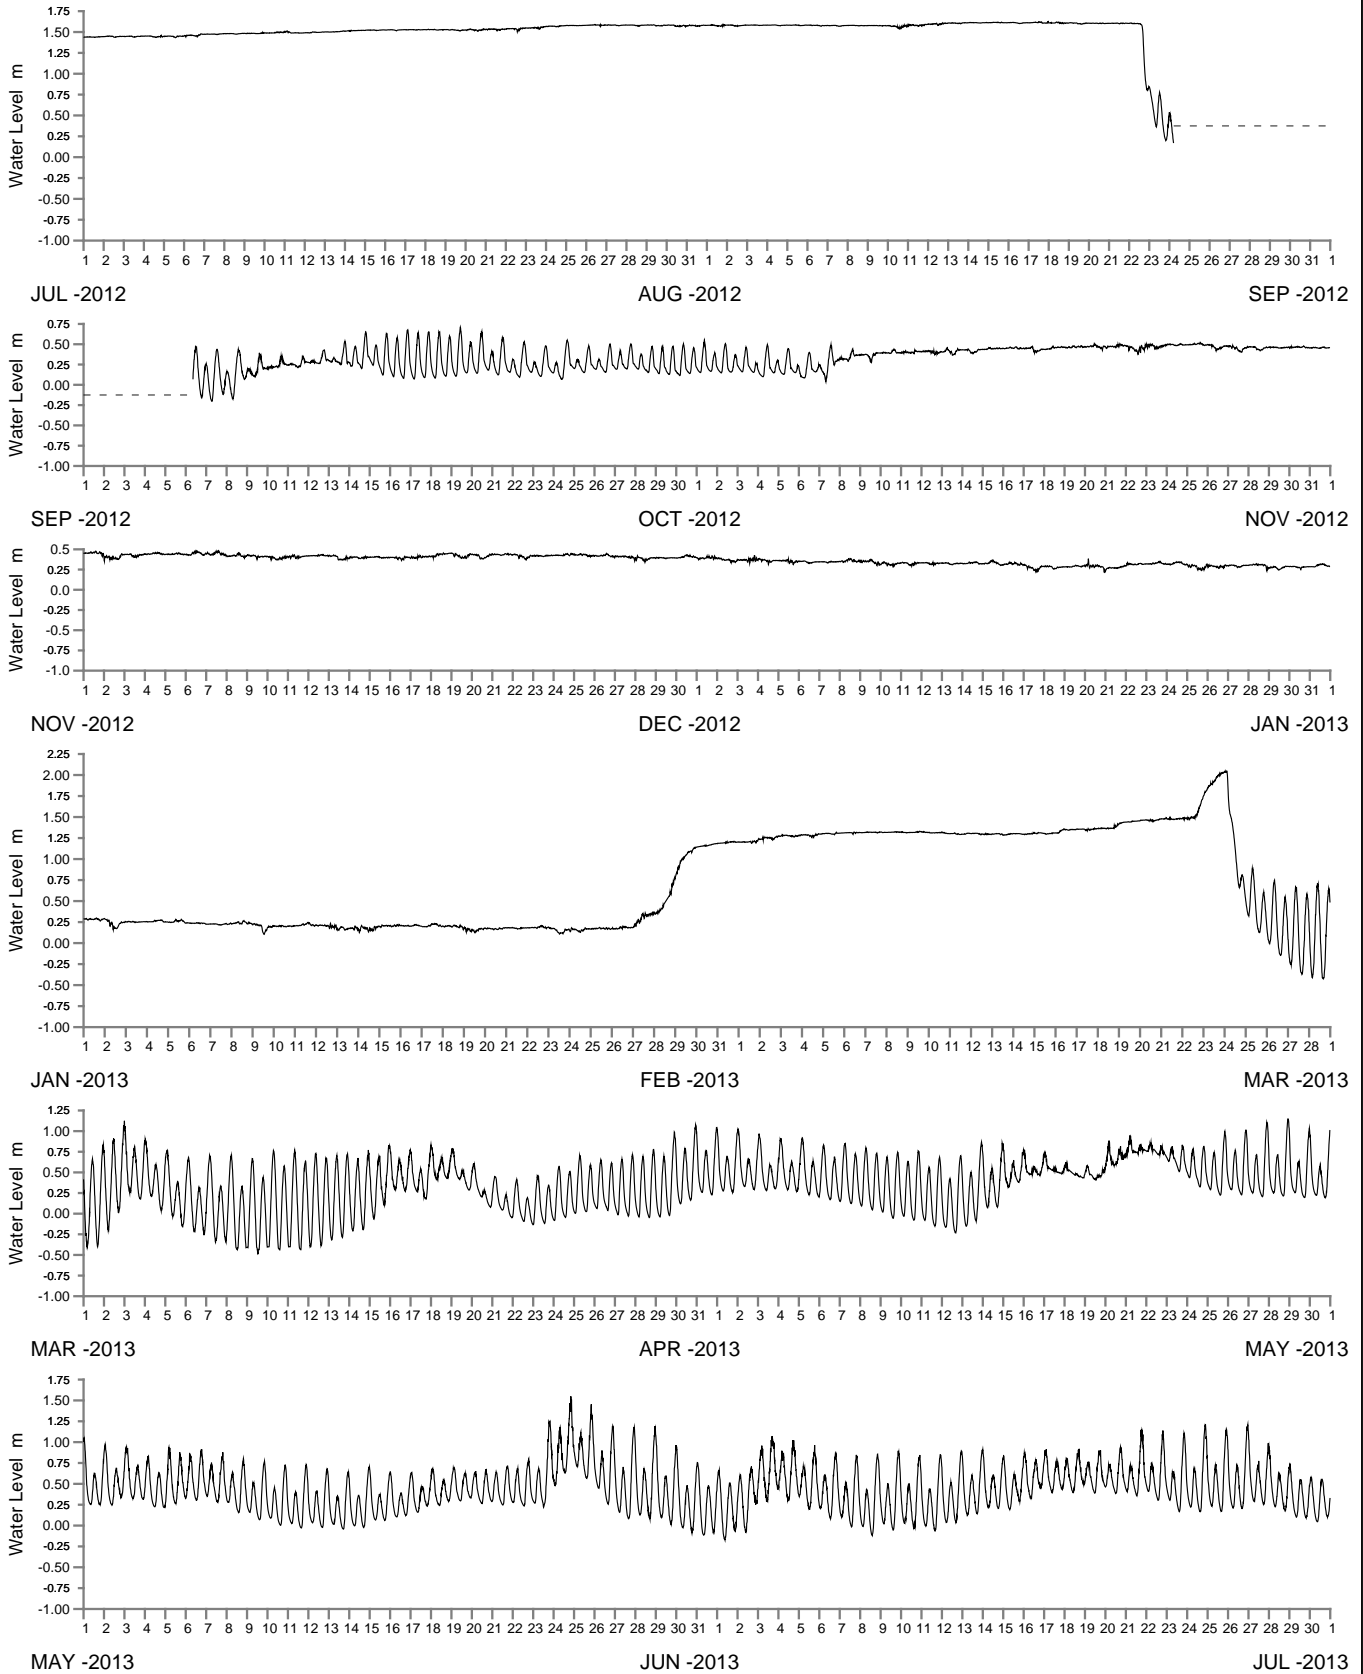
Figure
92

WATER LEVEL REFERENCED TO AUSTRALIAN HEIGHT DATUM

LAKE CATHIE AT LAKE CATHIE
2012-2013

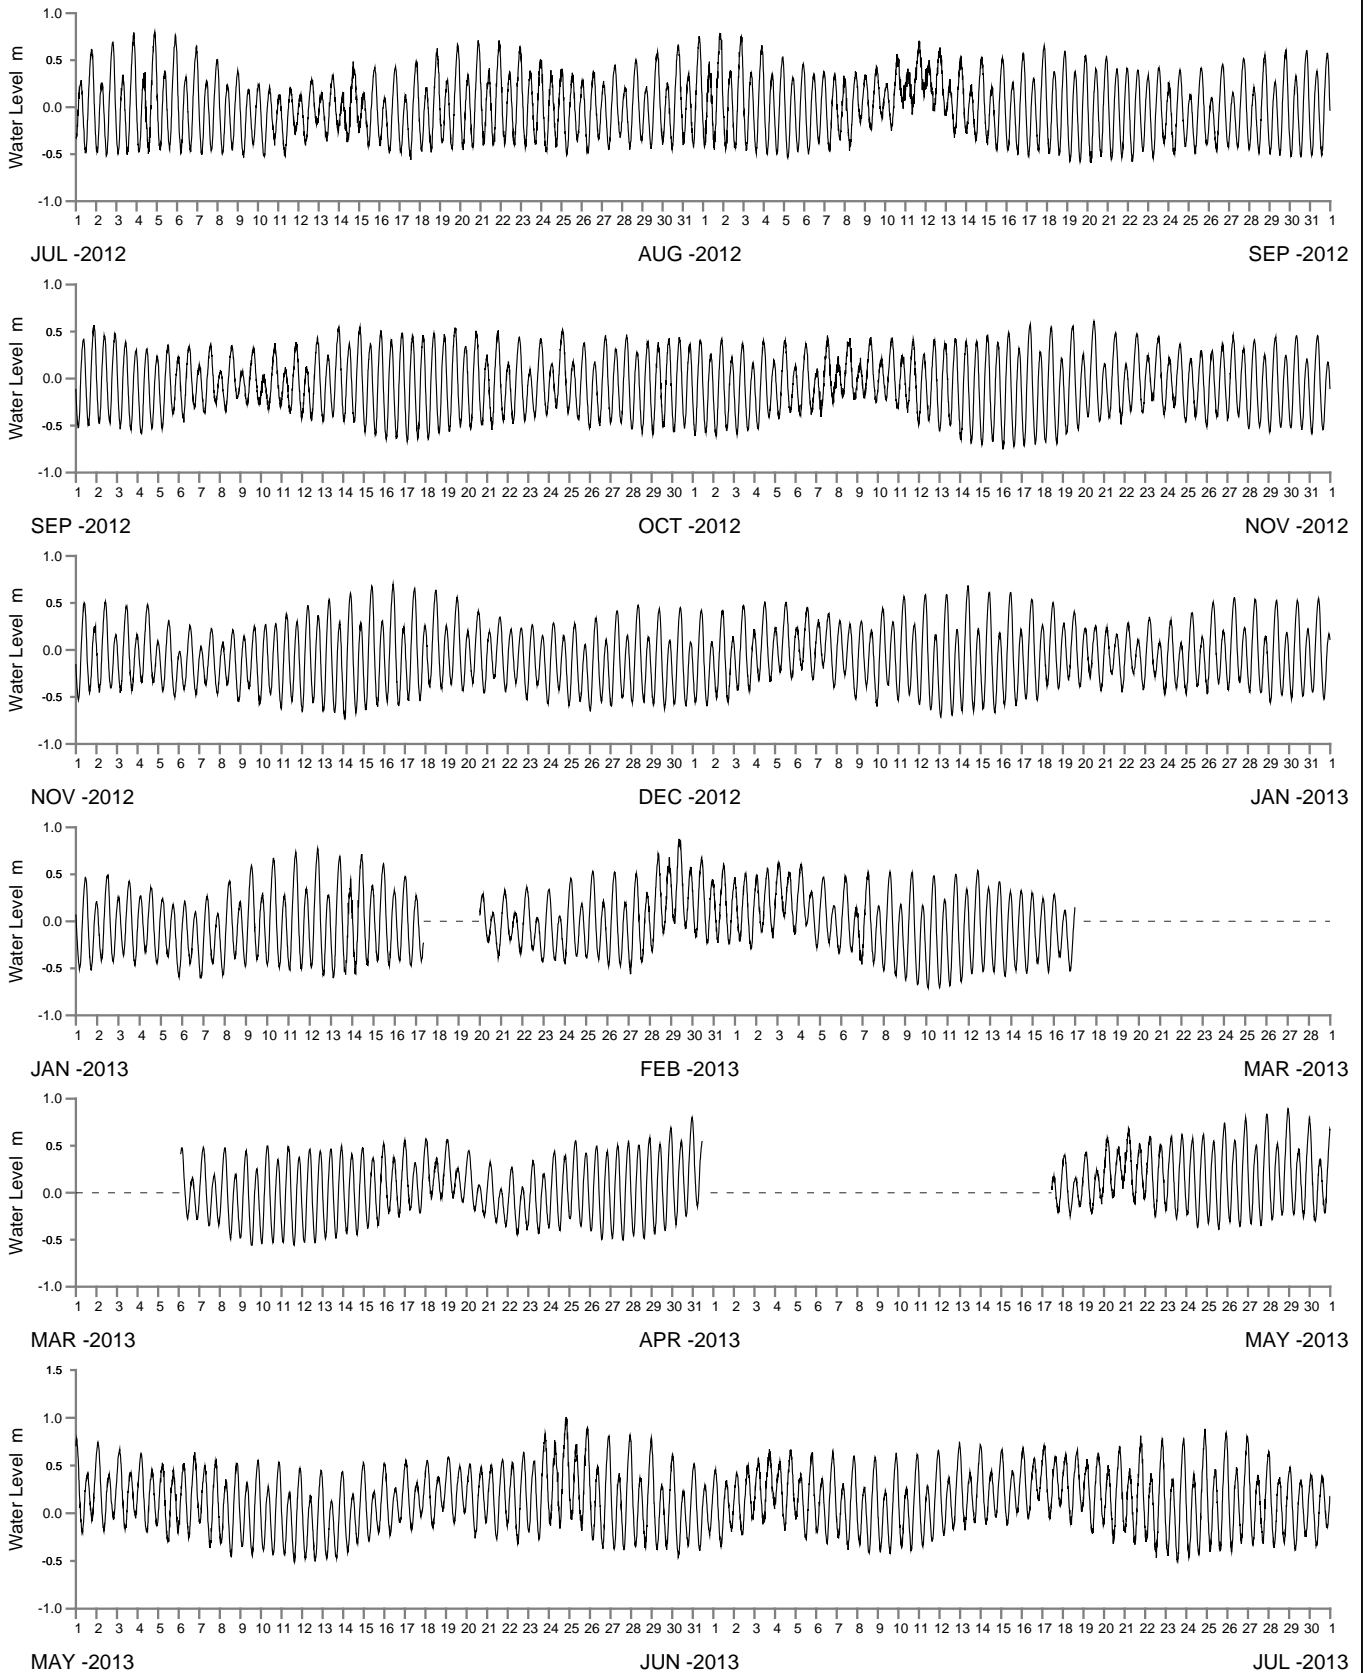
Figure
93

WATER LEVEL REFERENCED TO AUSTRALIAN HEIGHT DATUM

CAMDEN HAVEN AT NORTH HAVEN
2012-2013

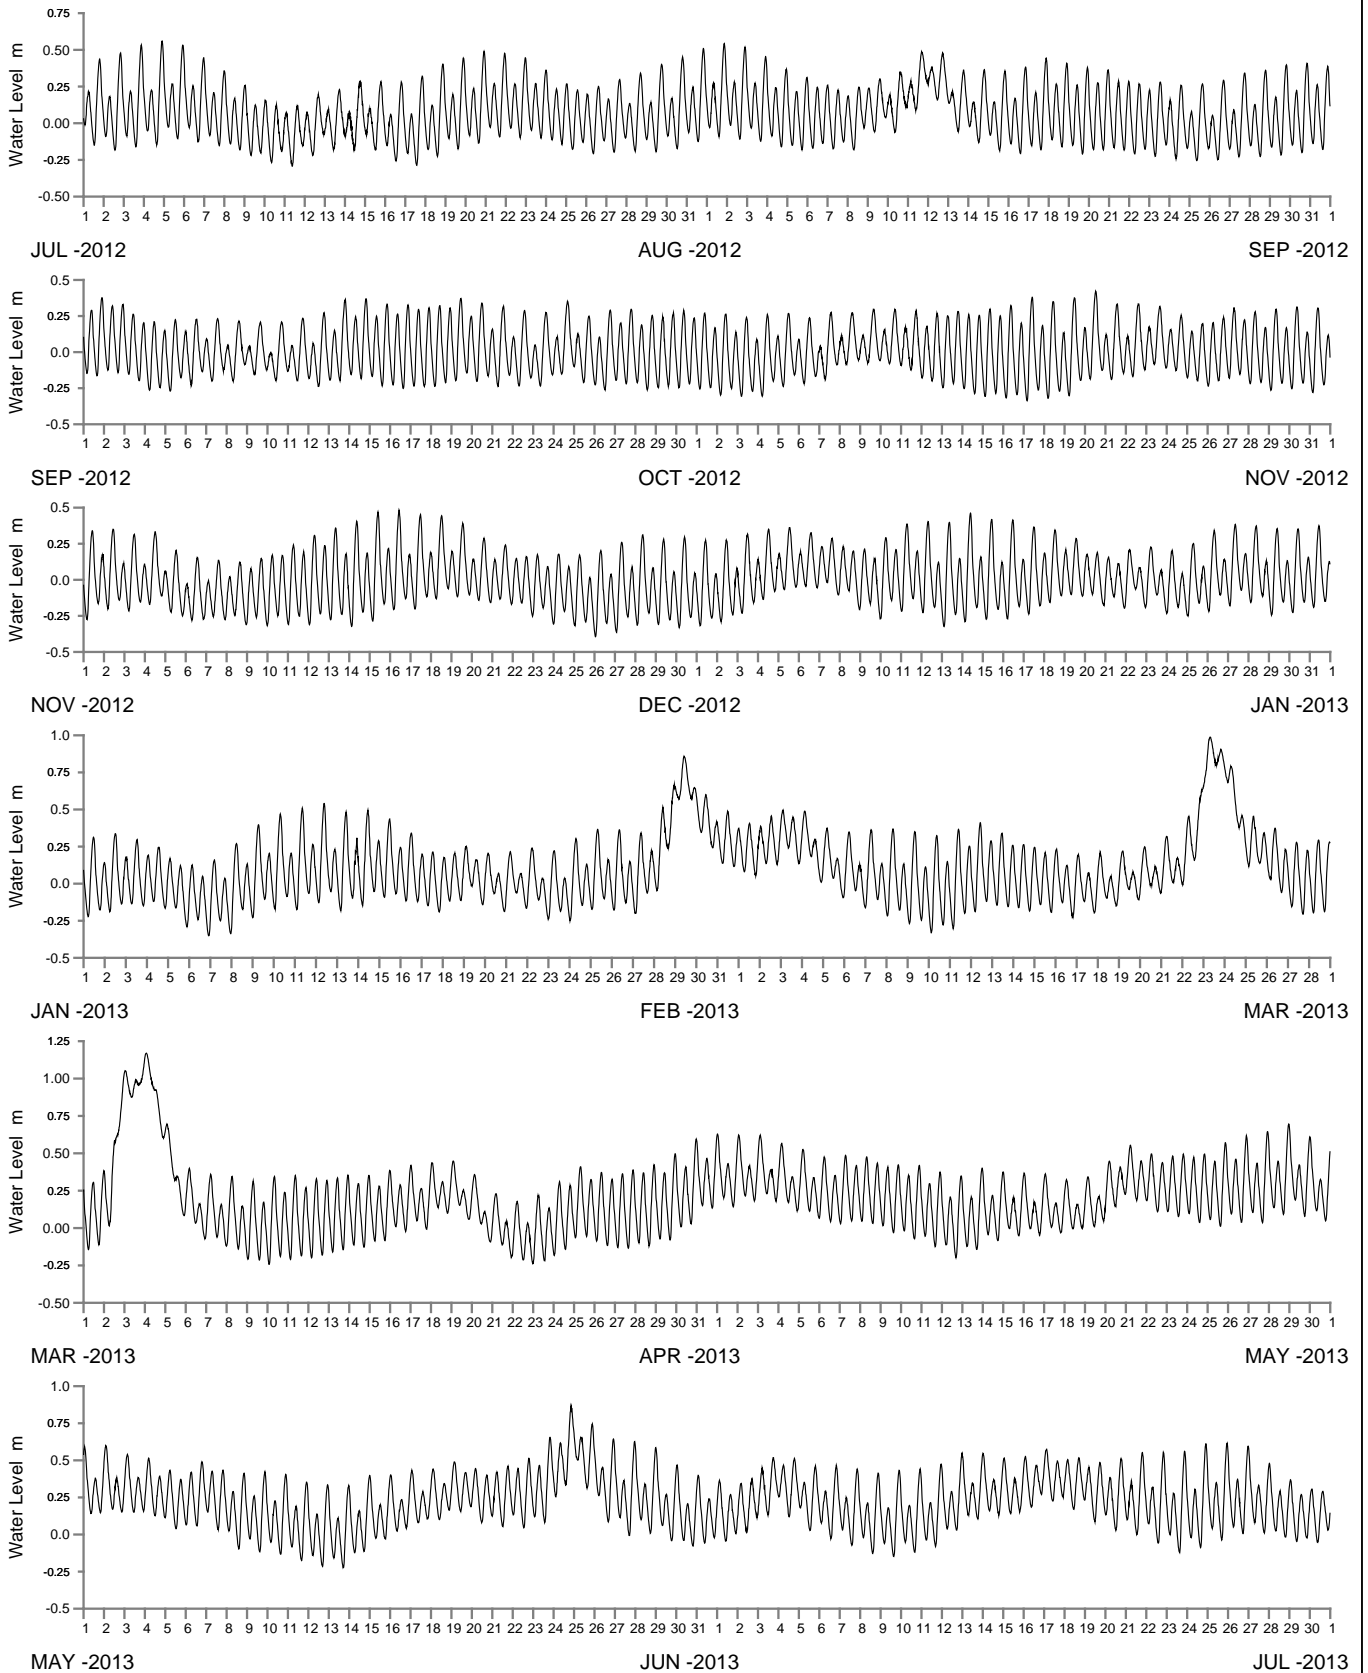
Figure
94

WATER LEVEL REFERENCED TO AUSTRALIAN HEIGHT DATUM

STRINGRAY CREEK AT WEST HAVEN
2012-2013

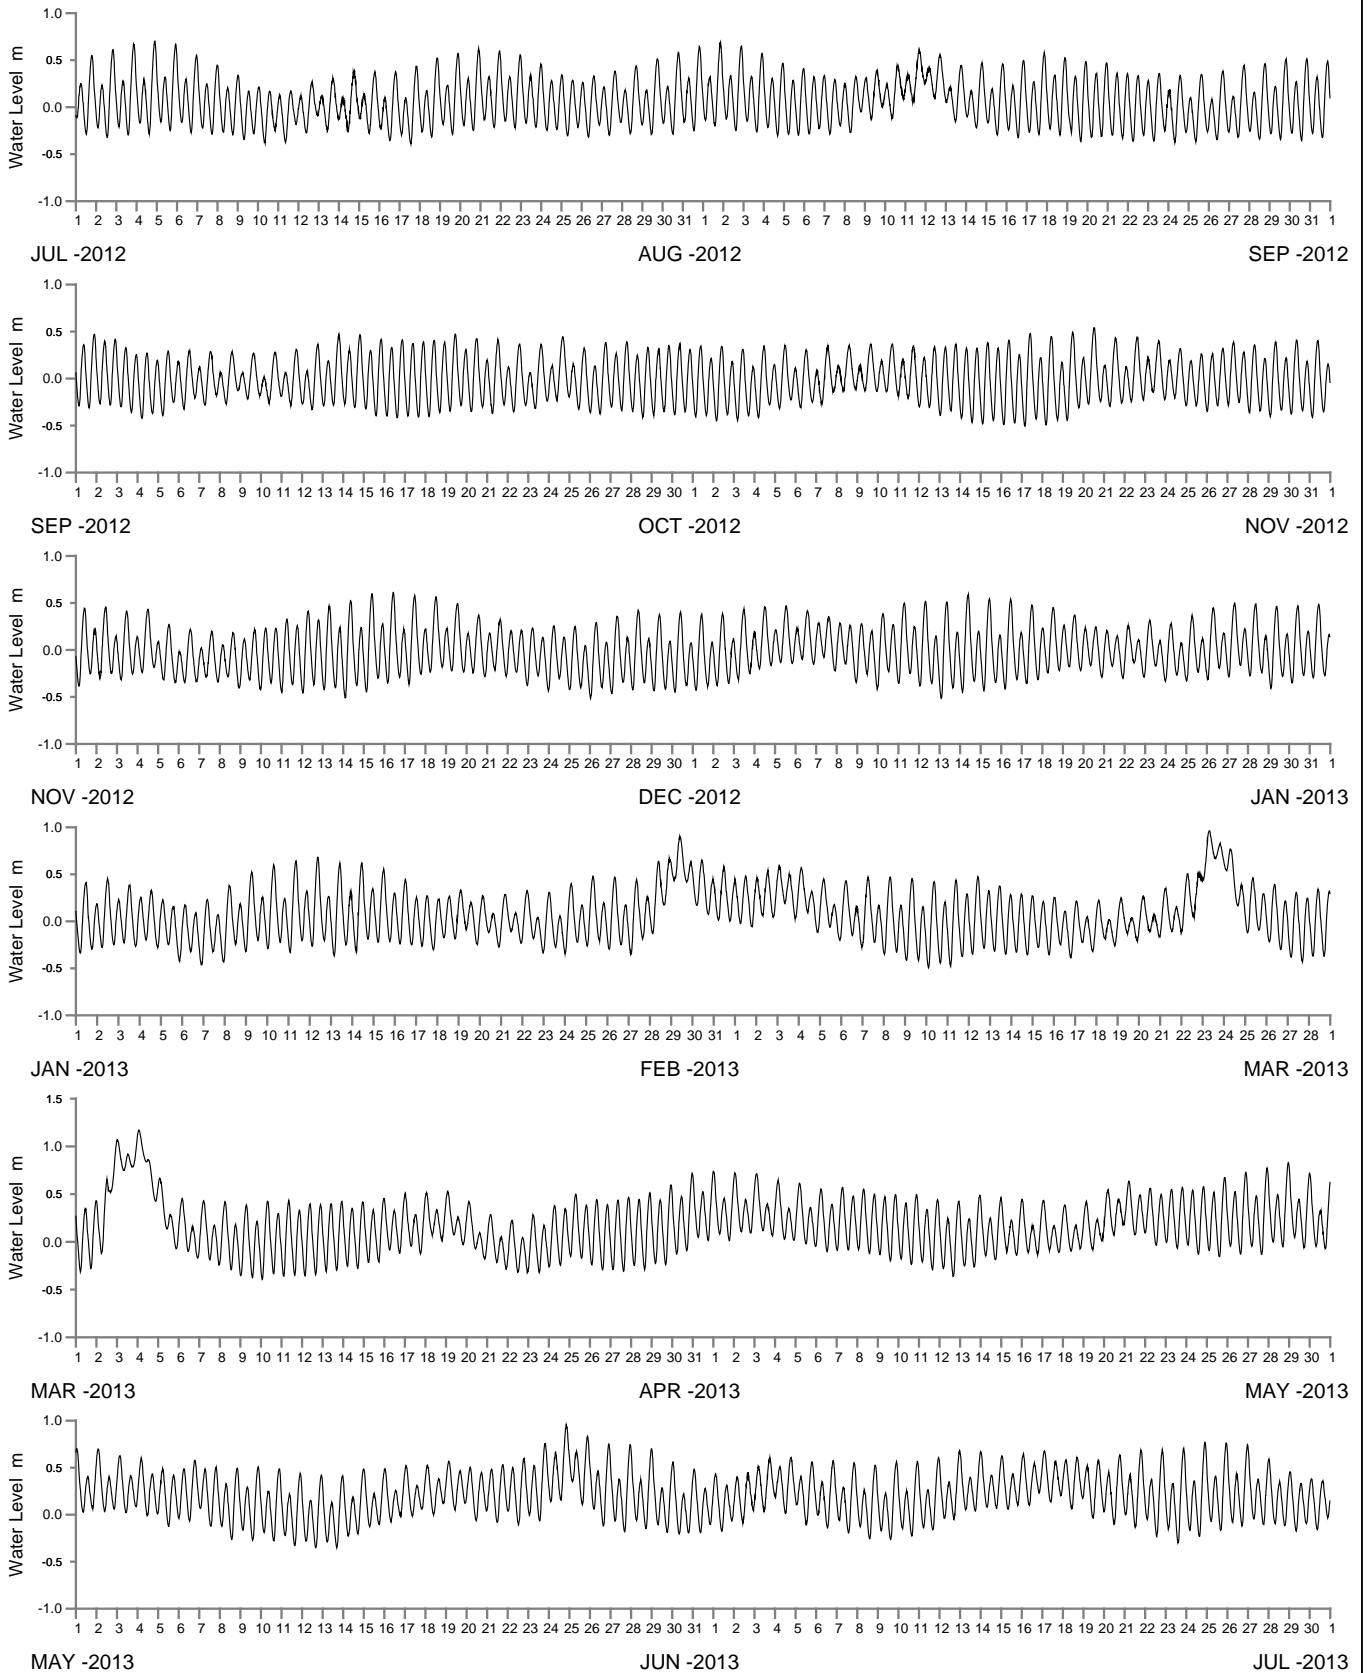
Figure
95

WATER LEVEL REFERENCED TO AUSTRALIAN HEIGHT DATUM

CAMDEN HAVEN AT LAURIETON
2012-2013

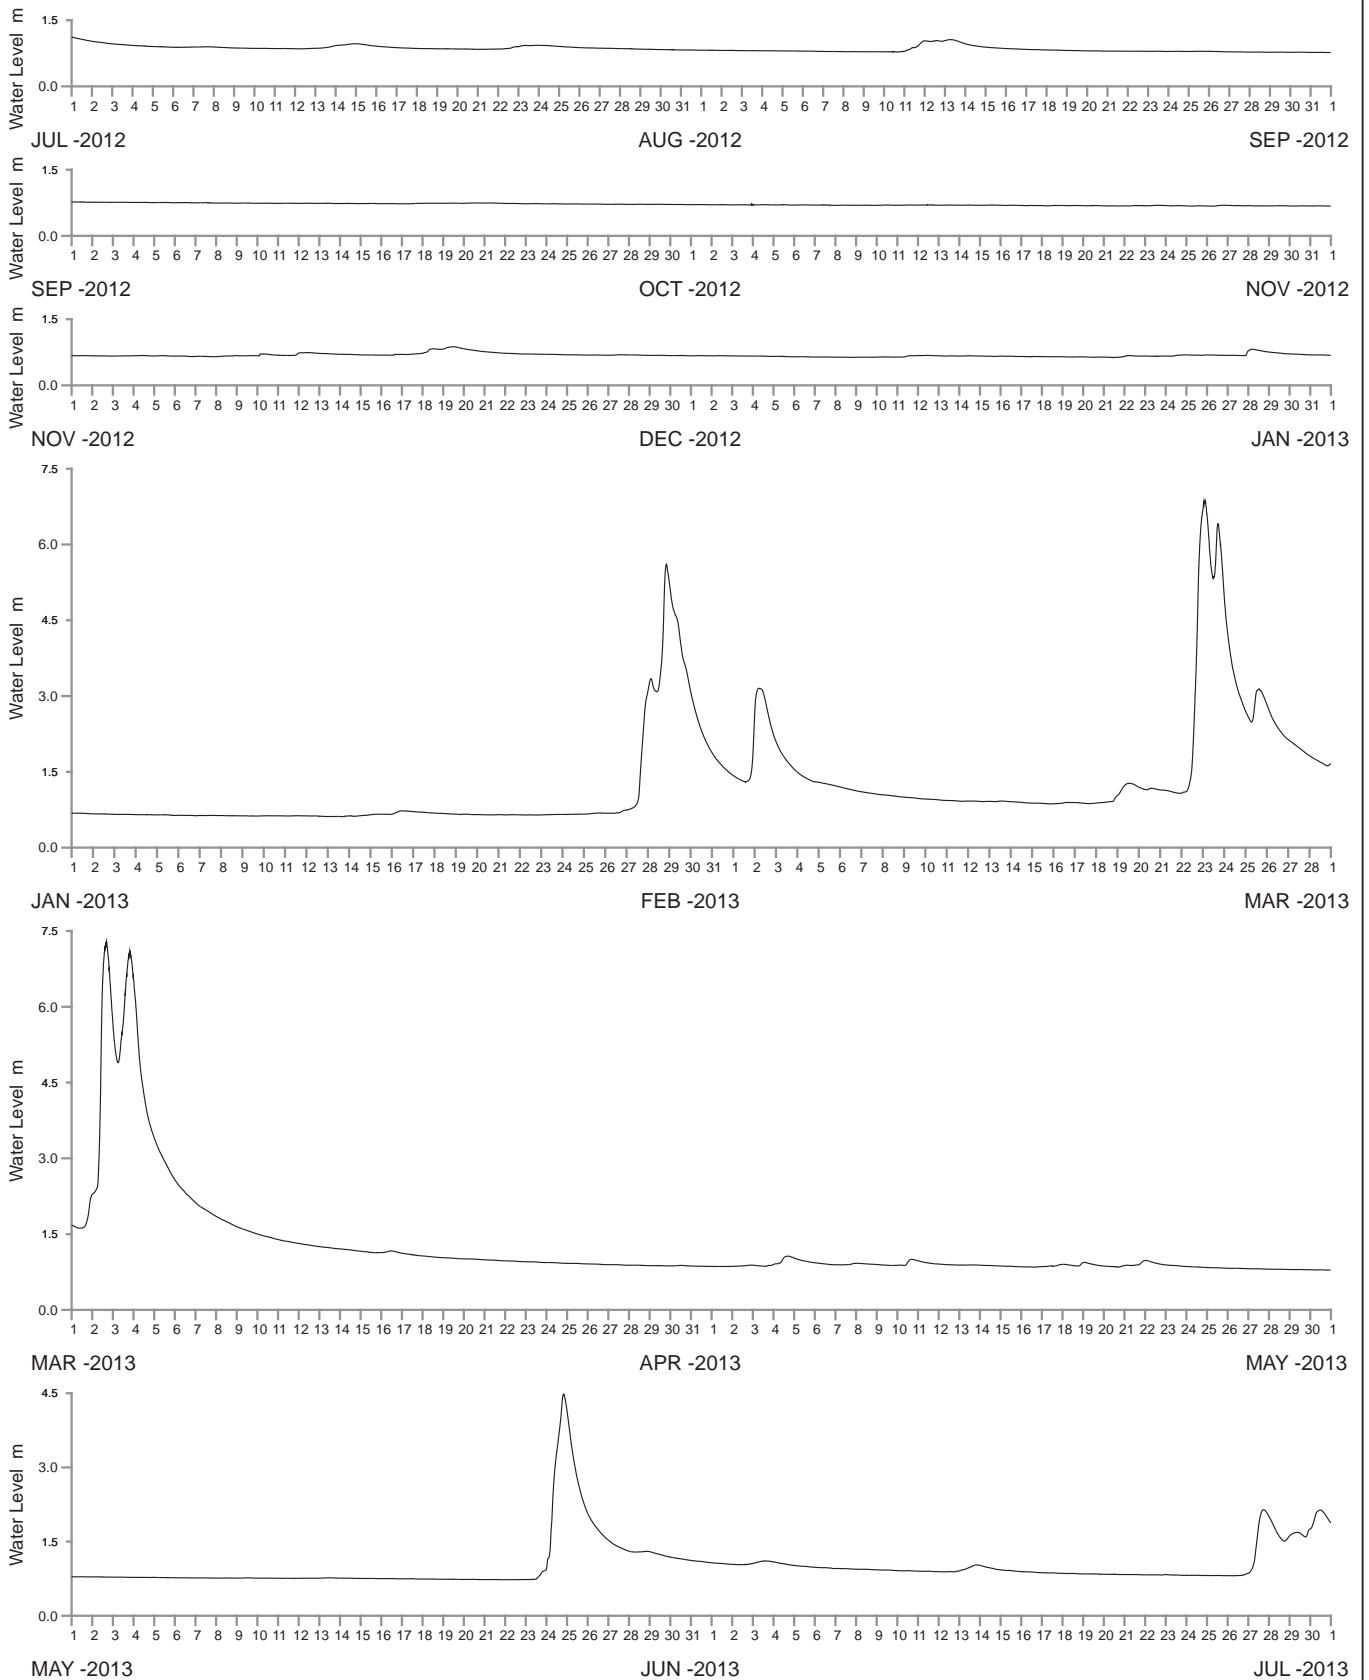
96

WATER LEVEL REFERENCED TO LOCAL WATER RESOURCES DATUM

CAMDEN HAVEN AT LOGANS CROSSING
2012-2013

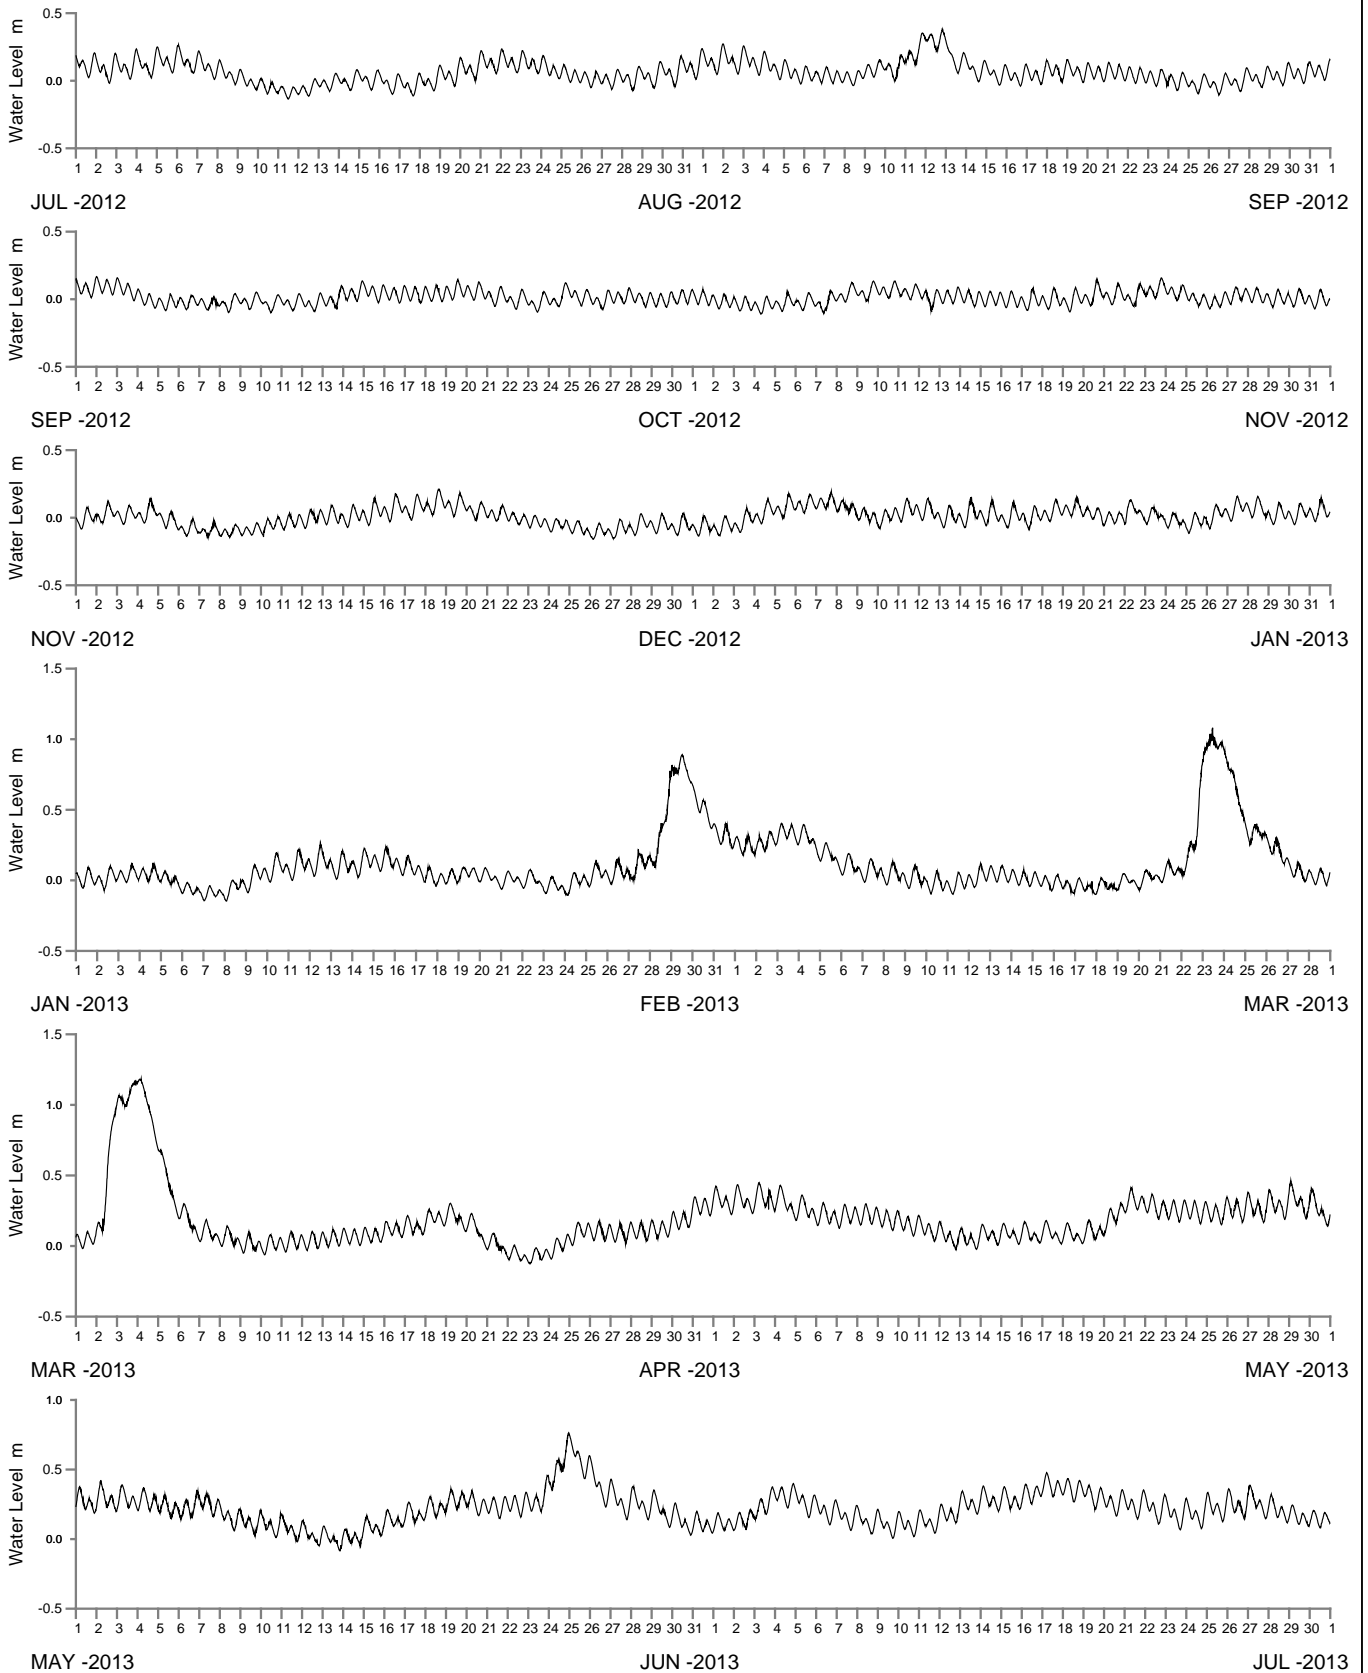
Figure
97

WATER LEVEL REFERENCED TO AUSTRALIAN HEIGHT DATUM

QUEENS LAKE AT LAKE WOOD
2012-2013
