Public Works
Manly Hydraulics Laboratory

MHL
Report 2218

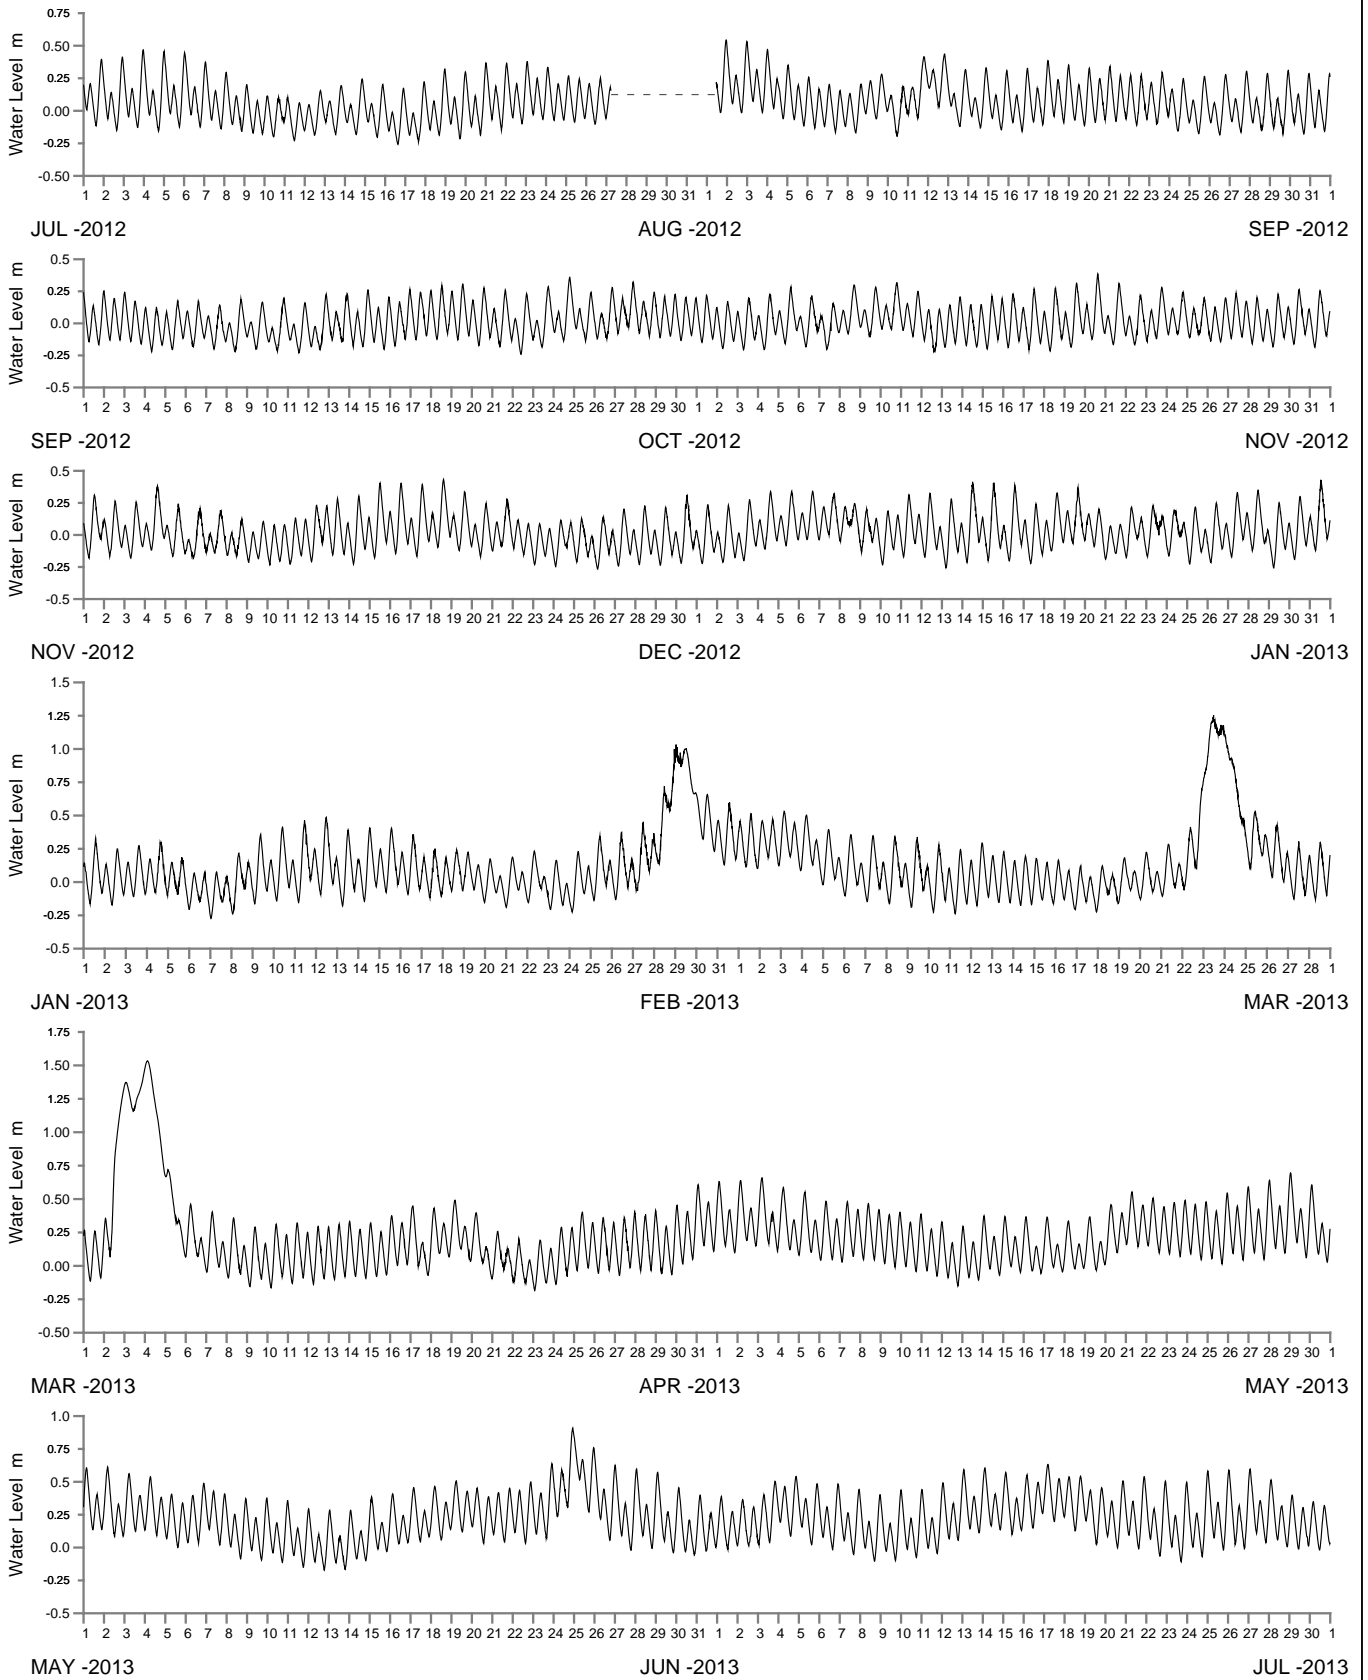
Figure
98

WATER LEVEL REFERENCED TO AUSTRALIAN HEIGHT DATUM

WATSON TAYLORS LAKE AT WATSON TAYLORS LAKE
2012-2013
