Public Works
Manly Hydraulics Laboratory

**STATION LOCATIONS
WOLLONGONG REGION**

MHL
Report 2218
**Figure
198**
DRAWING 2218-198.cdr

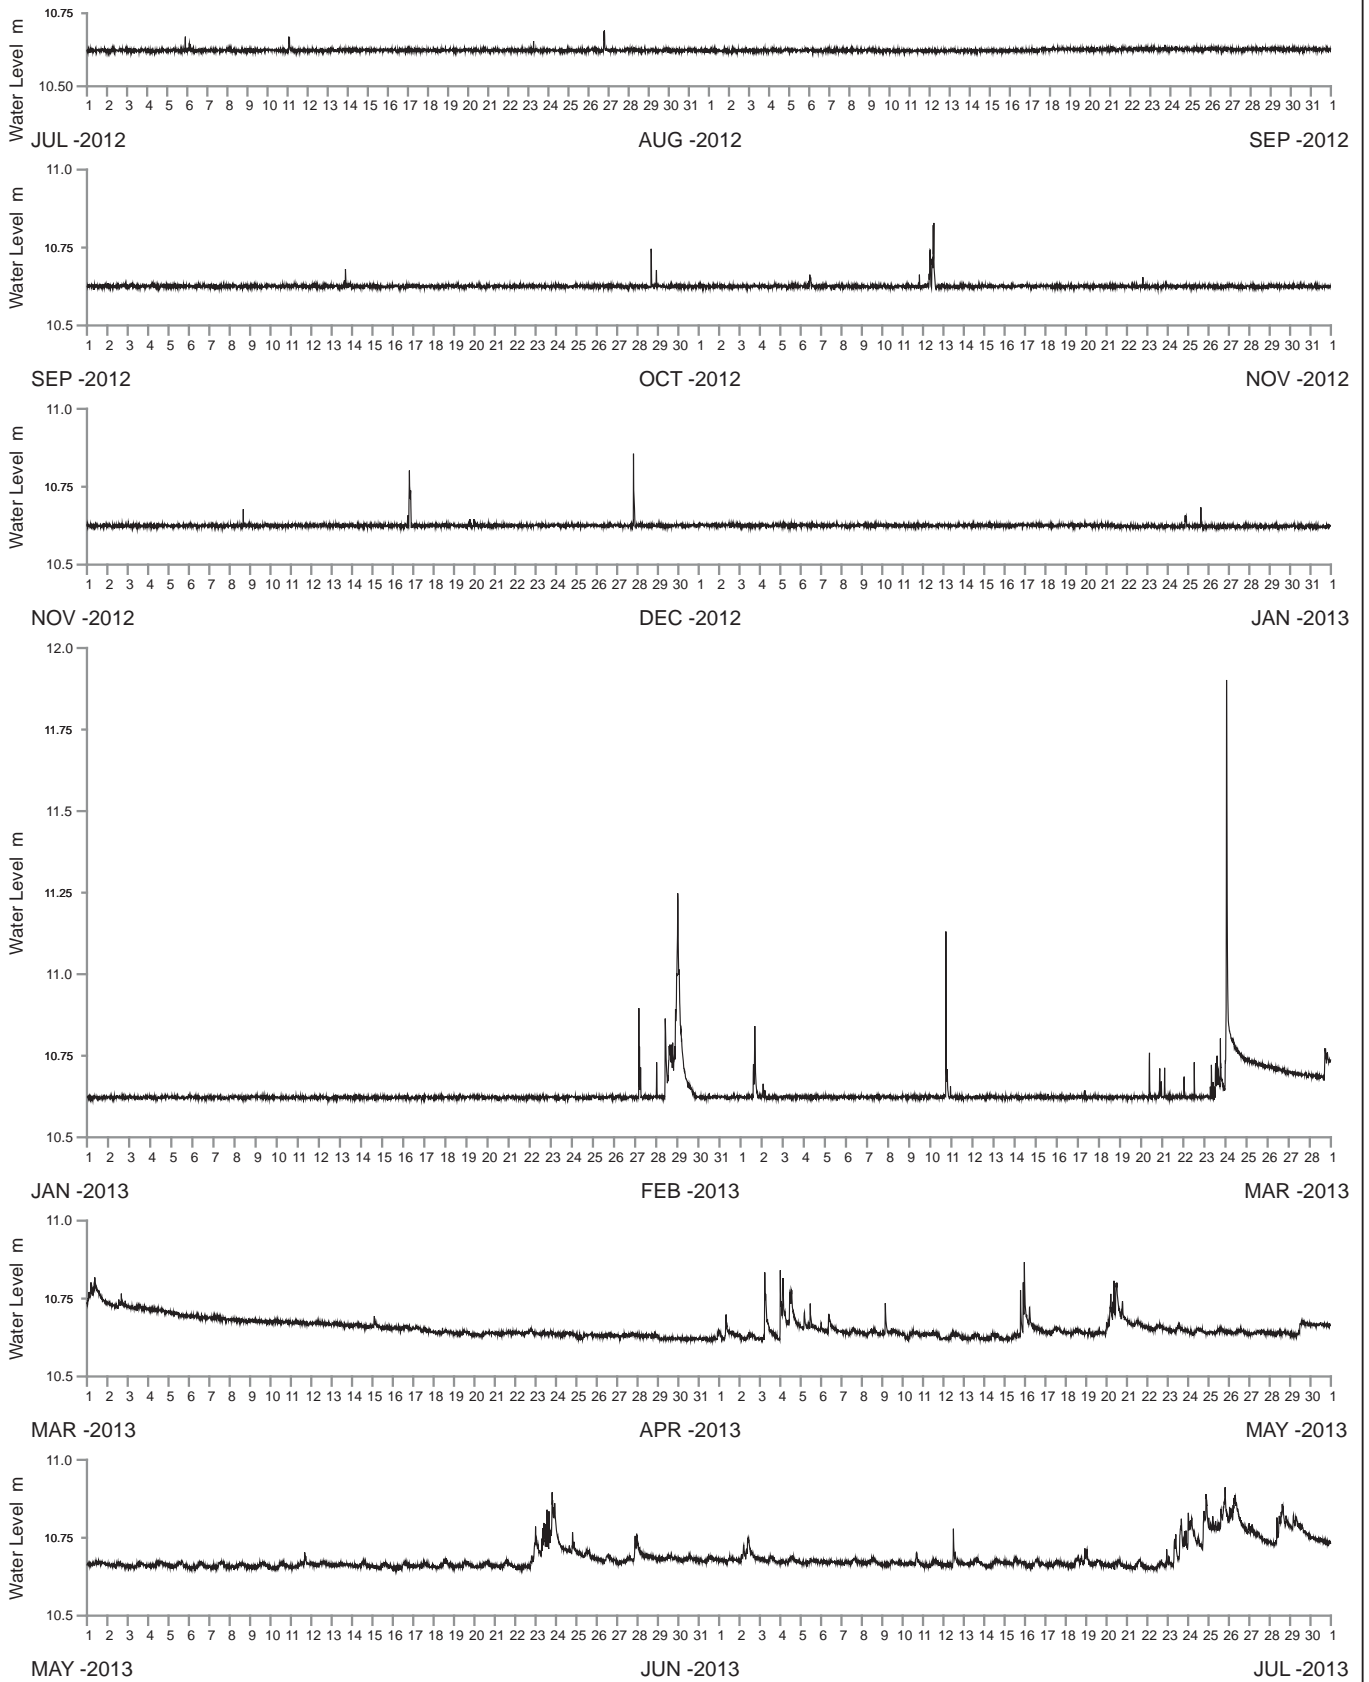
Figure
199

WATER LEVEL REFERENCED TO AUSTRALIAN HEIGHT DATUM

----- DATA LOSS

HEWITTS CREEK AT HEWITTS CREEK UPSTREAM
2012-2013

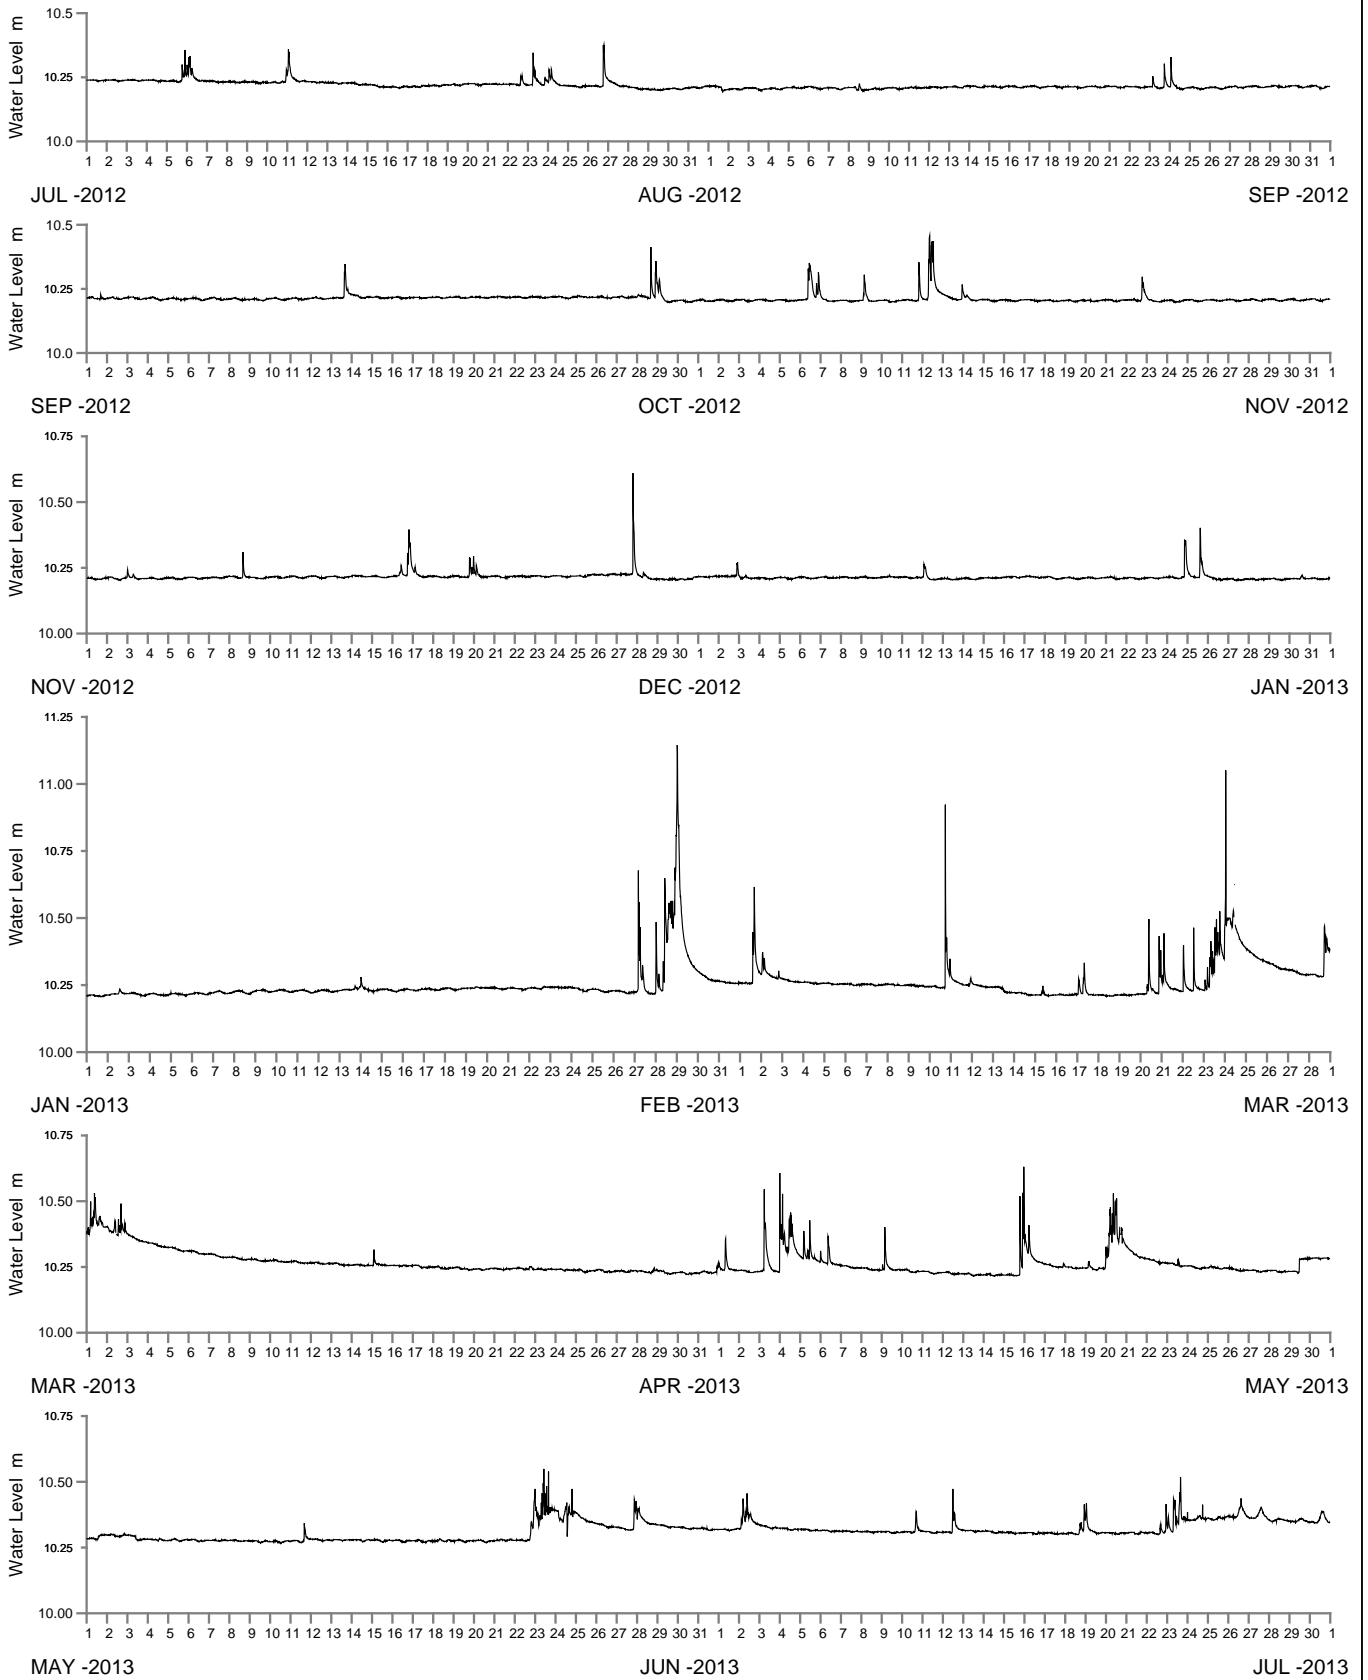
Figure
200

WATER LEVEL REFERENCED TO AUSTRALIAN HEIGHT DATUM

HEWITTS CREEK AT HEWITTS CREEK DOWNSTREAM
2012-2013

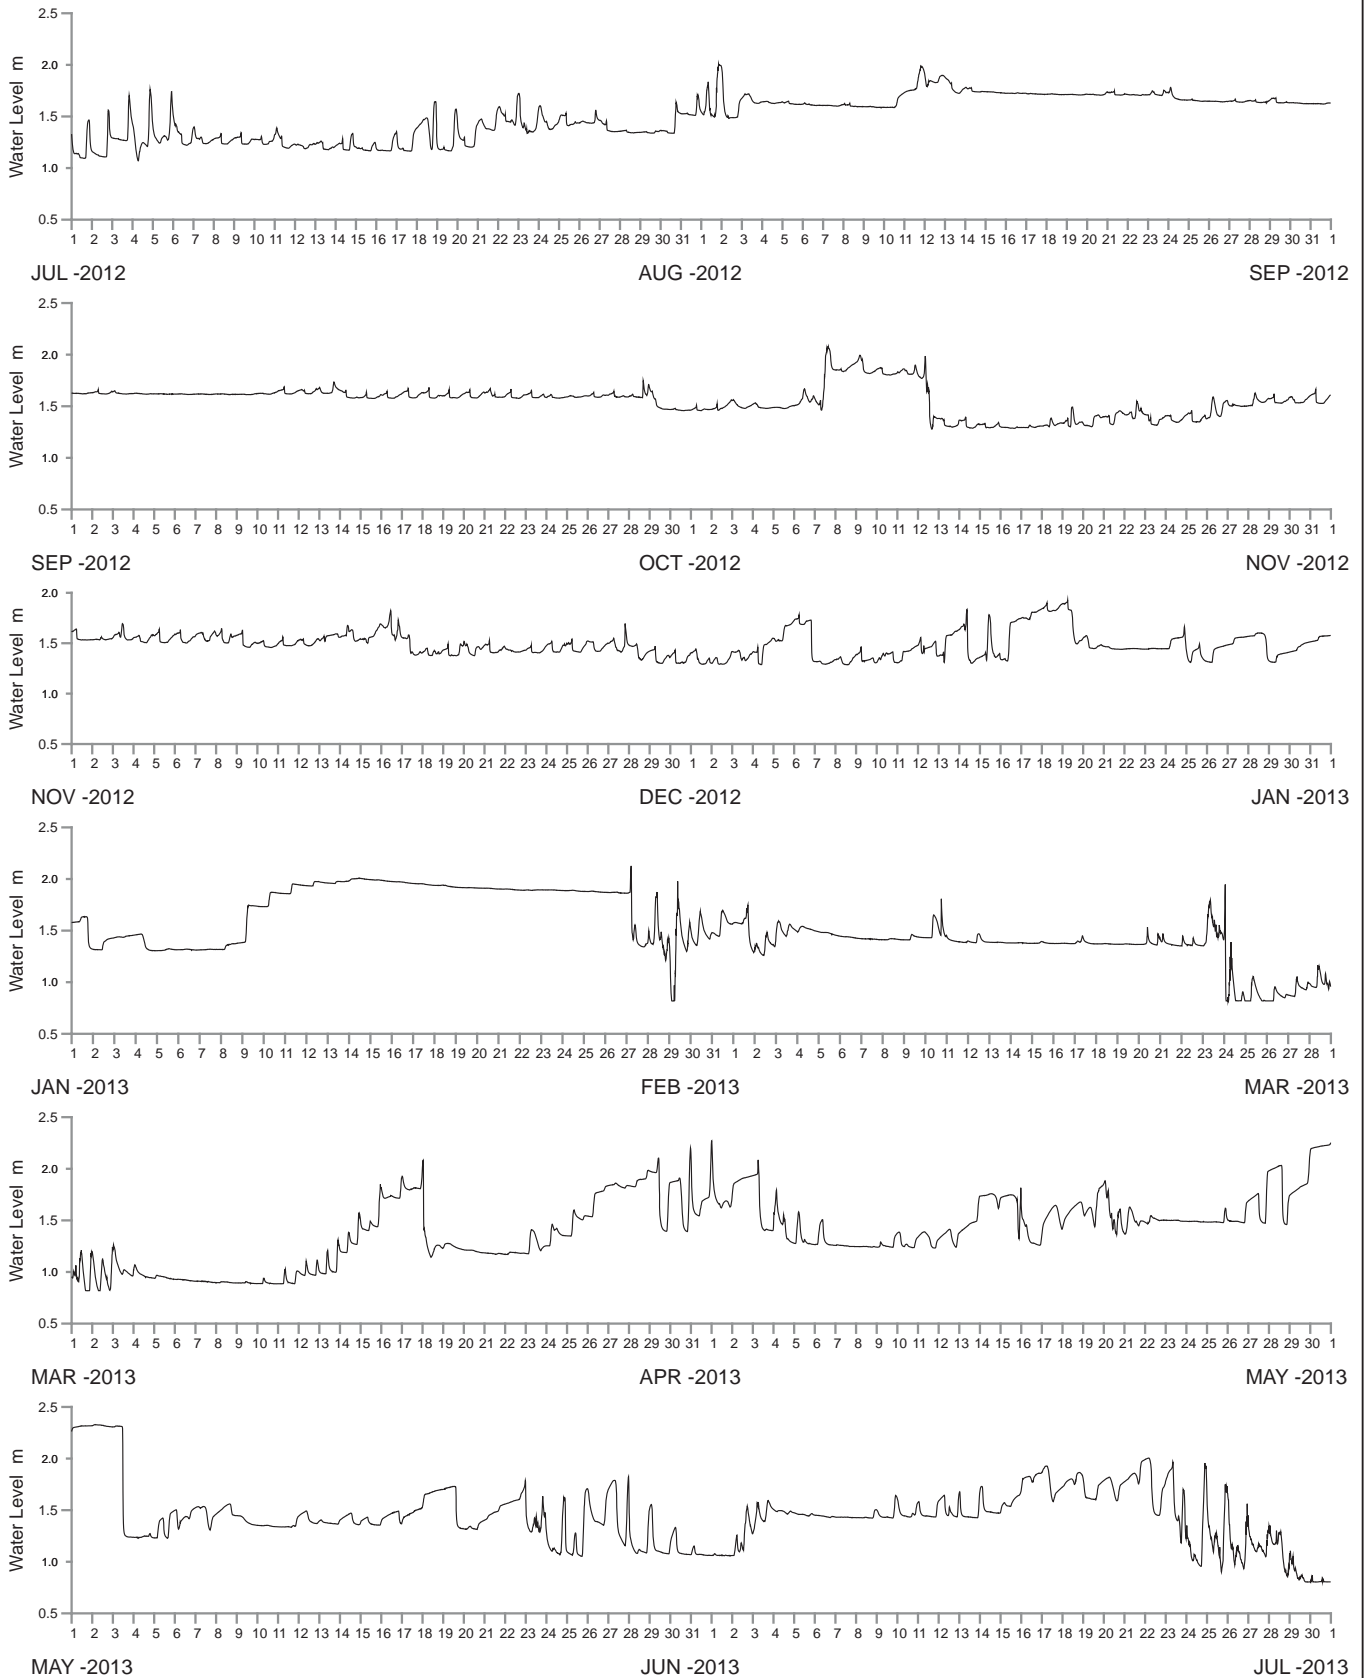
Figure
201

WATER LEVEL REFERENCED TO AUSTRALIAN HEIGHT DATUM

REDUCED LEVEL OF REGISTERED SURVEY MARK TO BE CONFIRMED

HEWITTS CREEK AT HEWITTS CREEK ENTRANCE
2012-2013

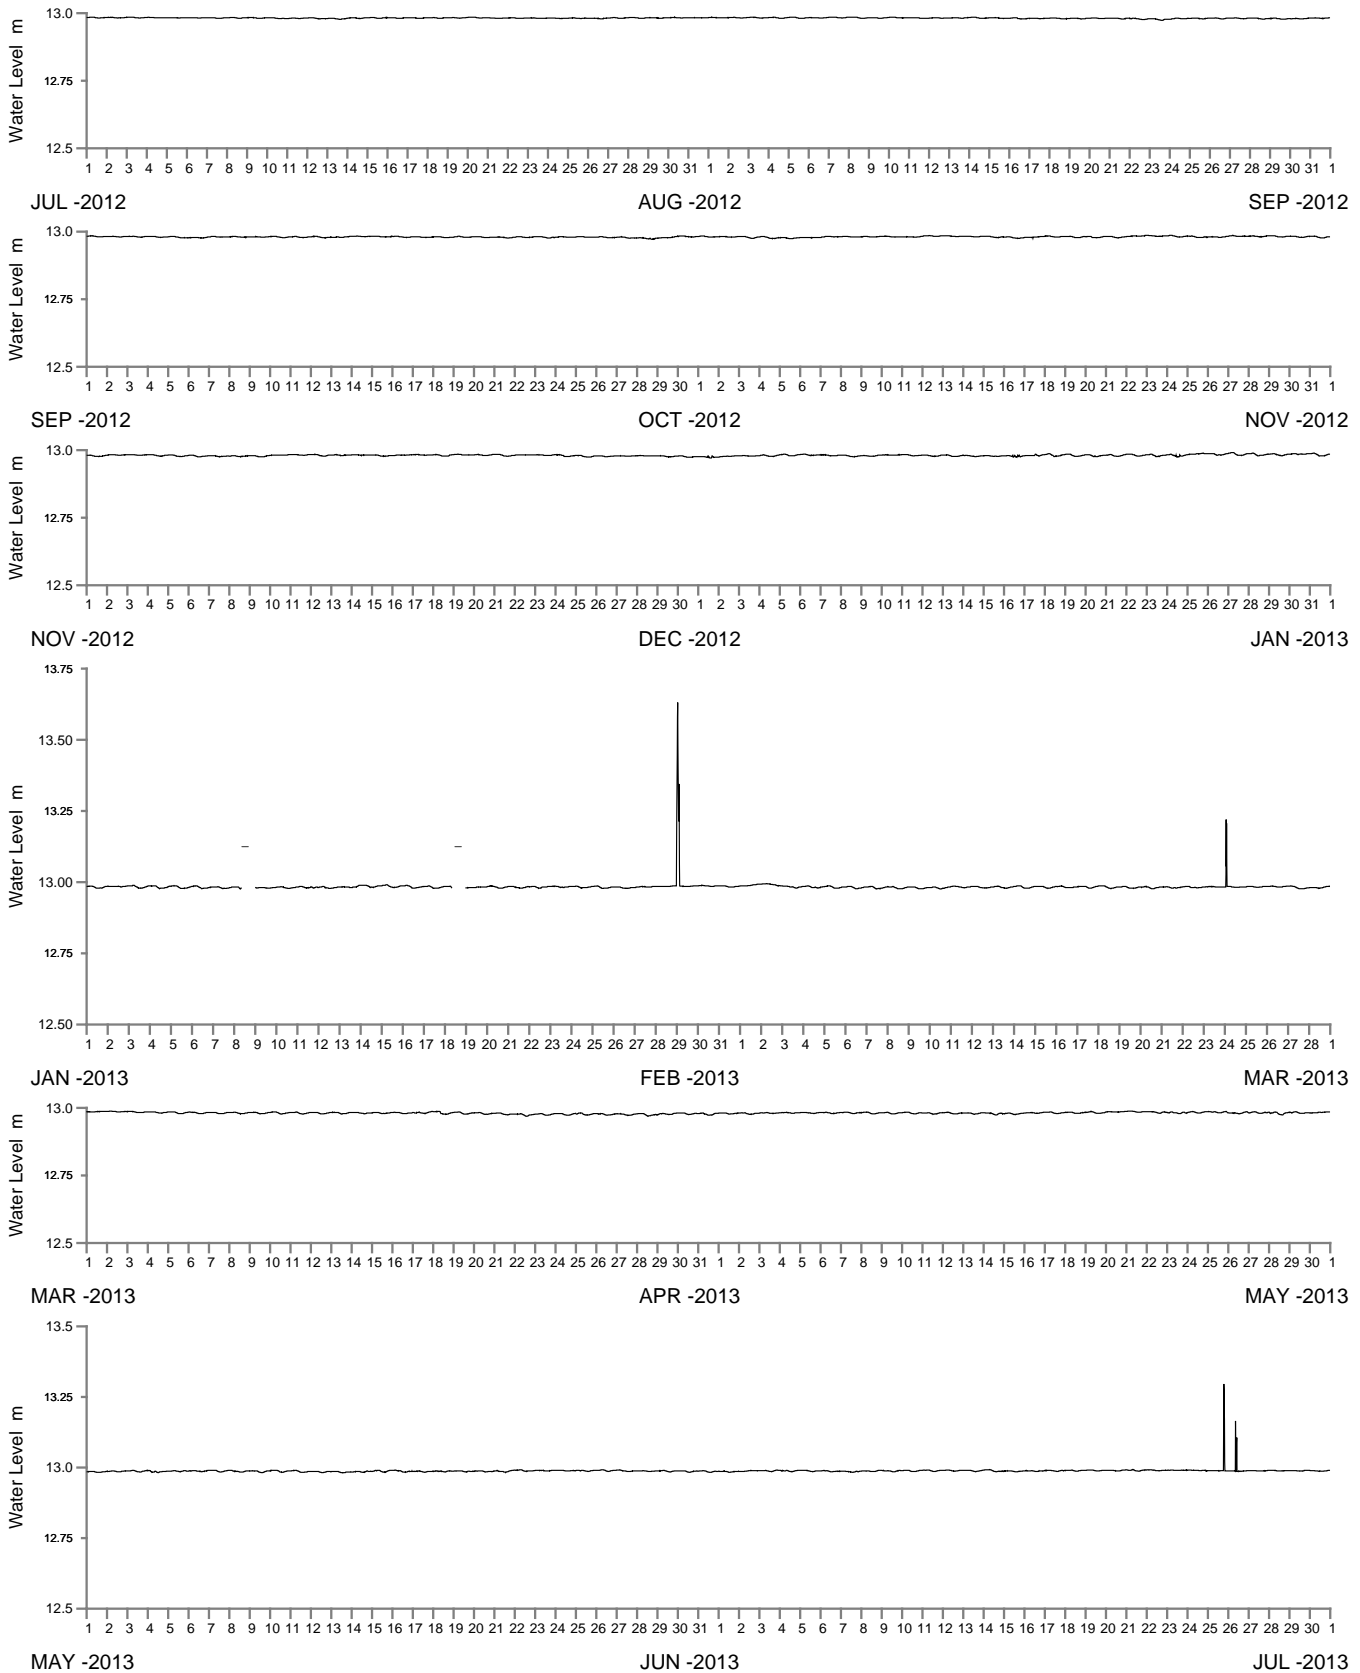
Figure
202

WATER LEVEL REFERENCED TO AUSTRALIAN HEIGHT DATUM

CABBAGE TREE CREEK AT BALGOWNIE ROAD
2012-2013

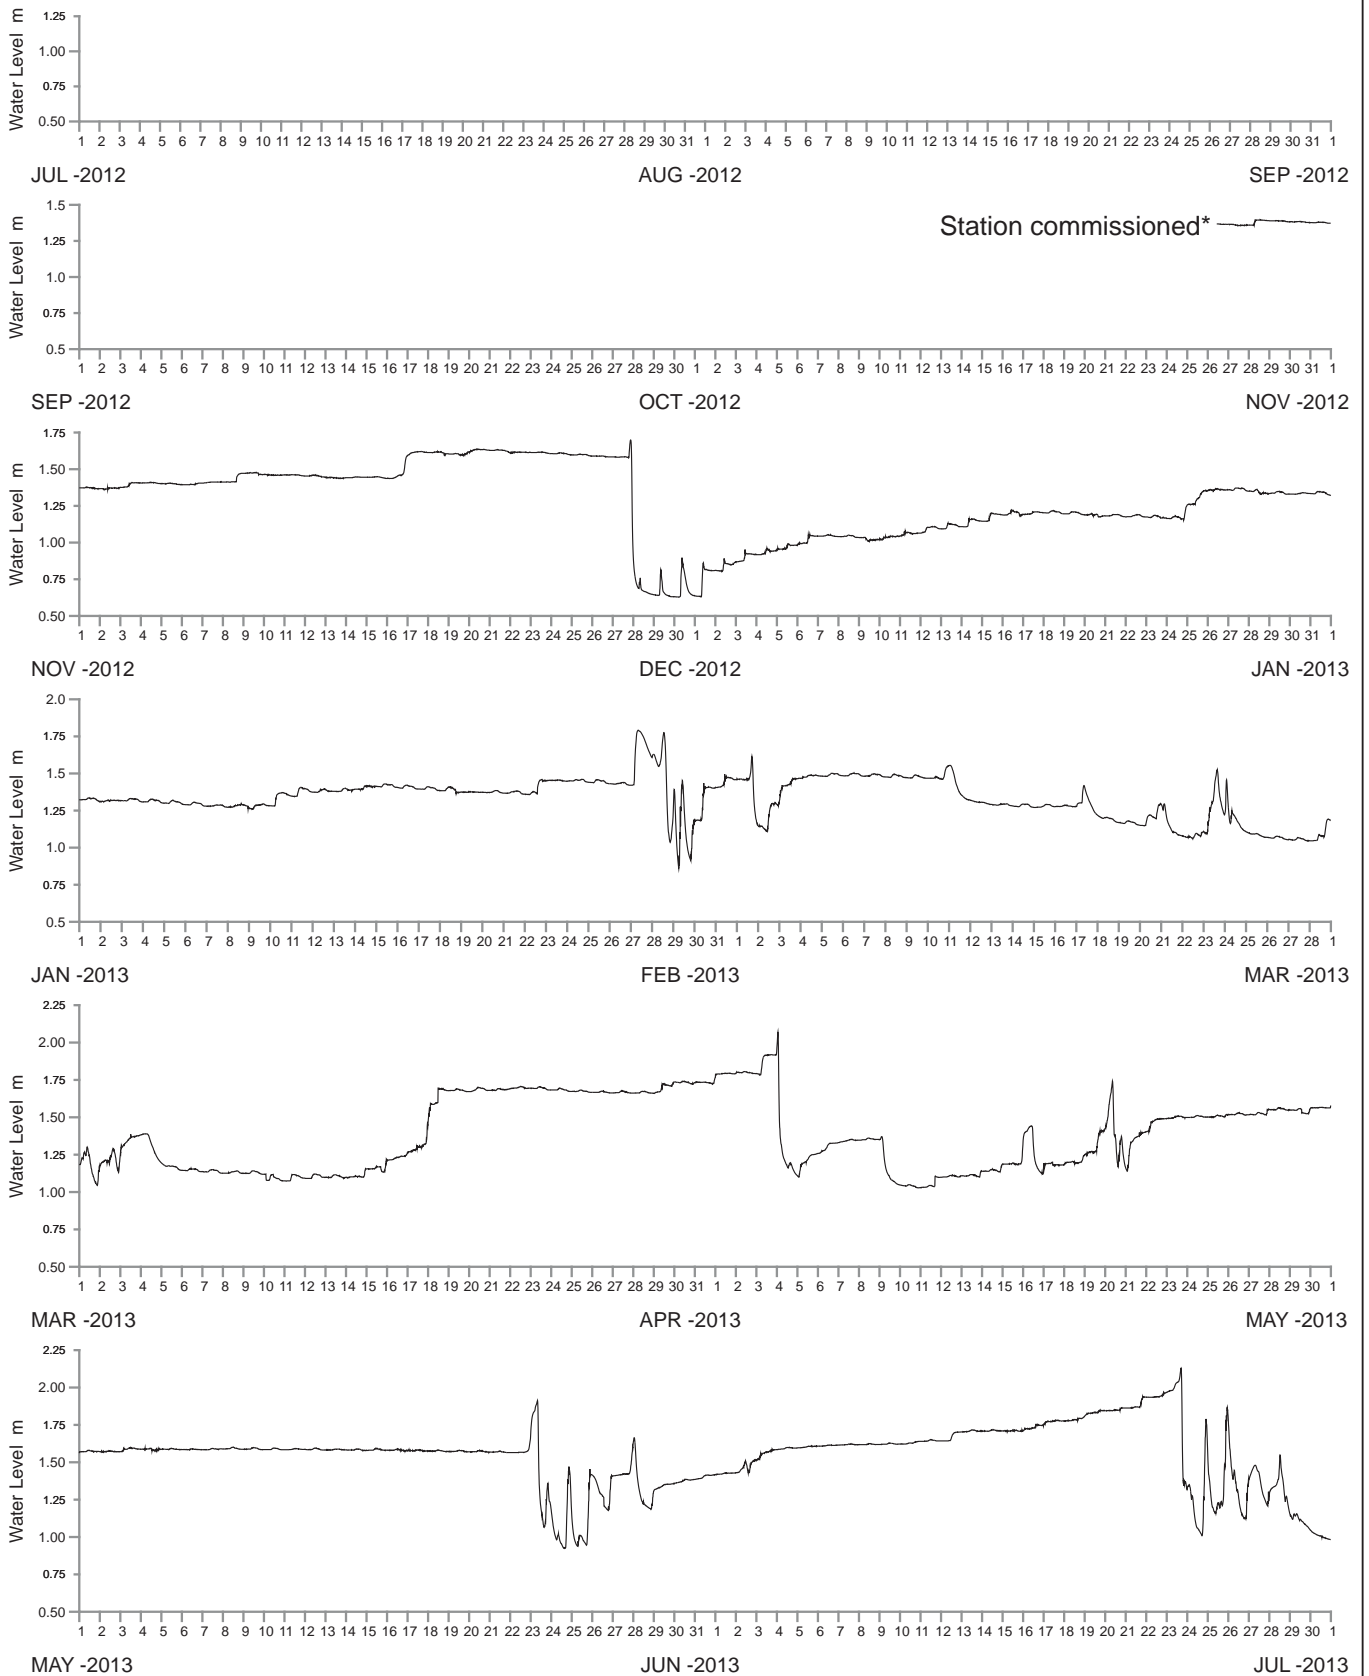
Figure
203

WATER LEVEL REFERENCED TO AUSTRALIAN HEIGHT DATUM

BELLAMBI LAGOON AT BELLAMBI
2012-2013

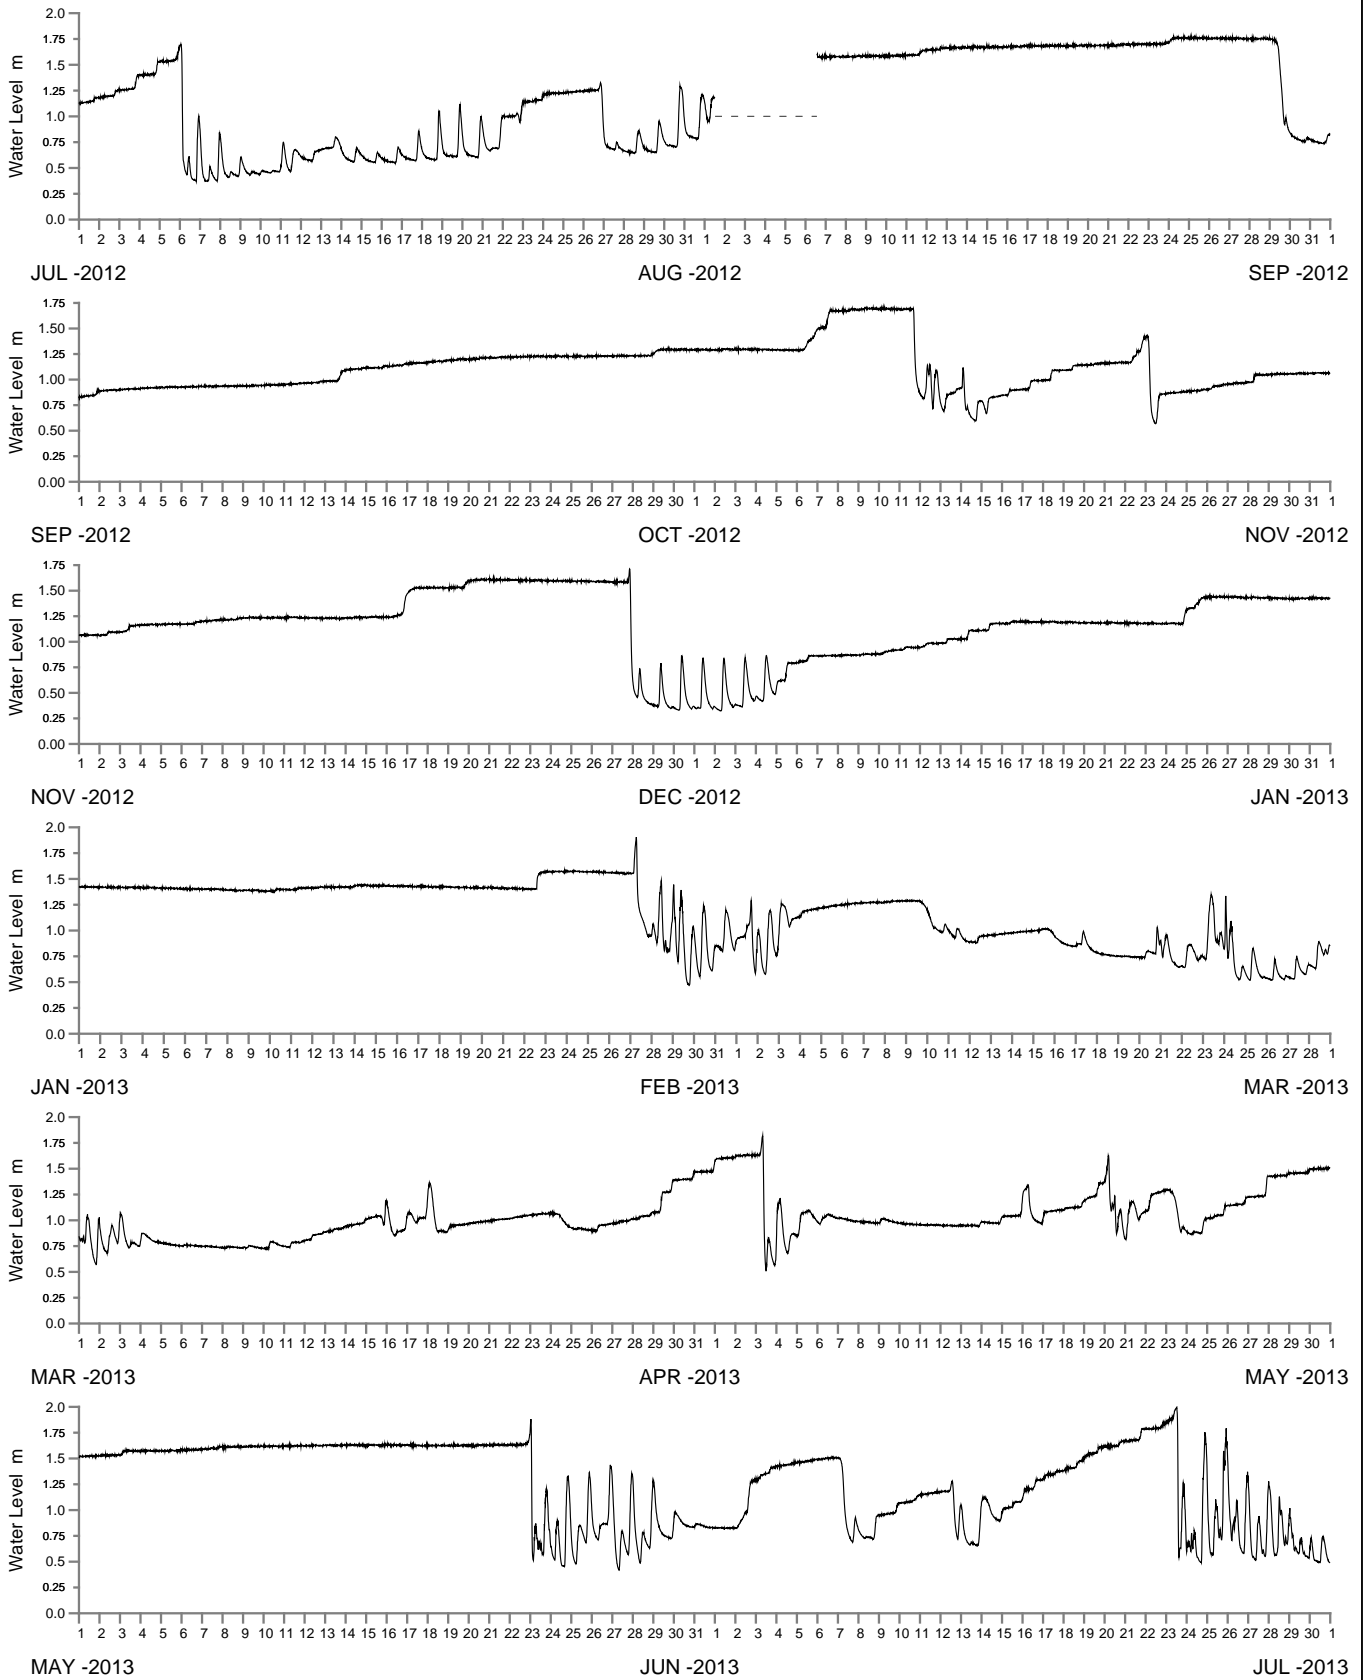
Figure
204

WATER LEVEL REFERENCED TO AUSTRALIAN HEIGHT DATUM

TOWRADGI CREEK AT TOWRADGI CREEK UPSTREAM
2012-2013

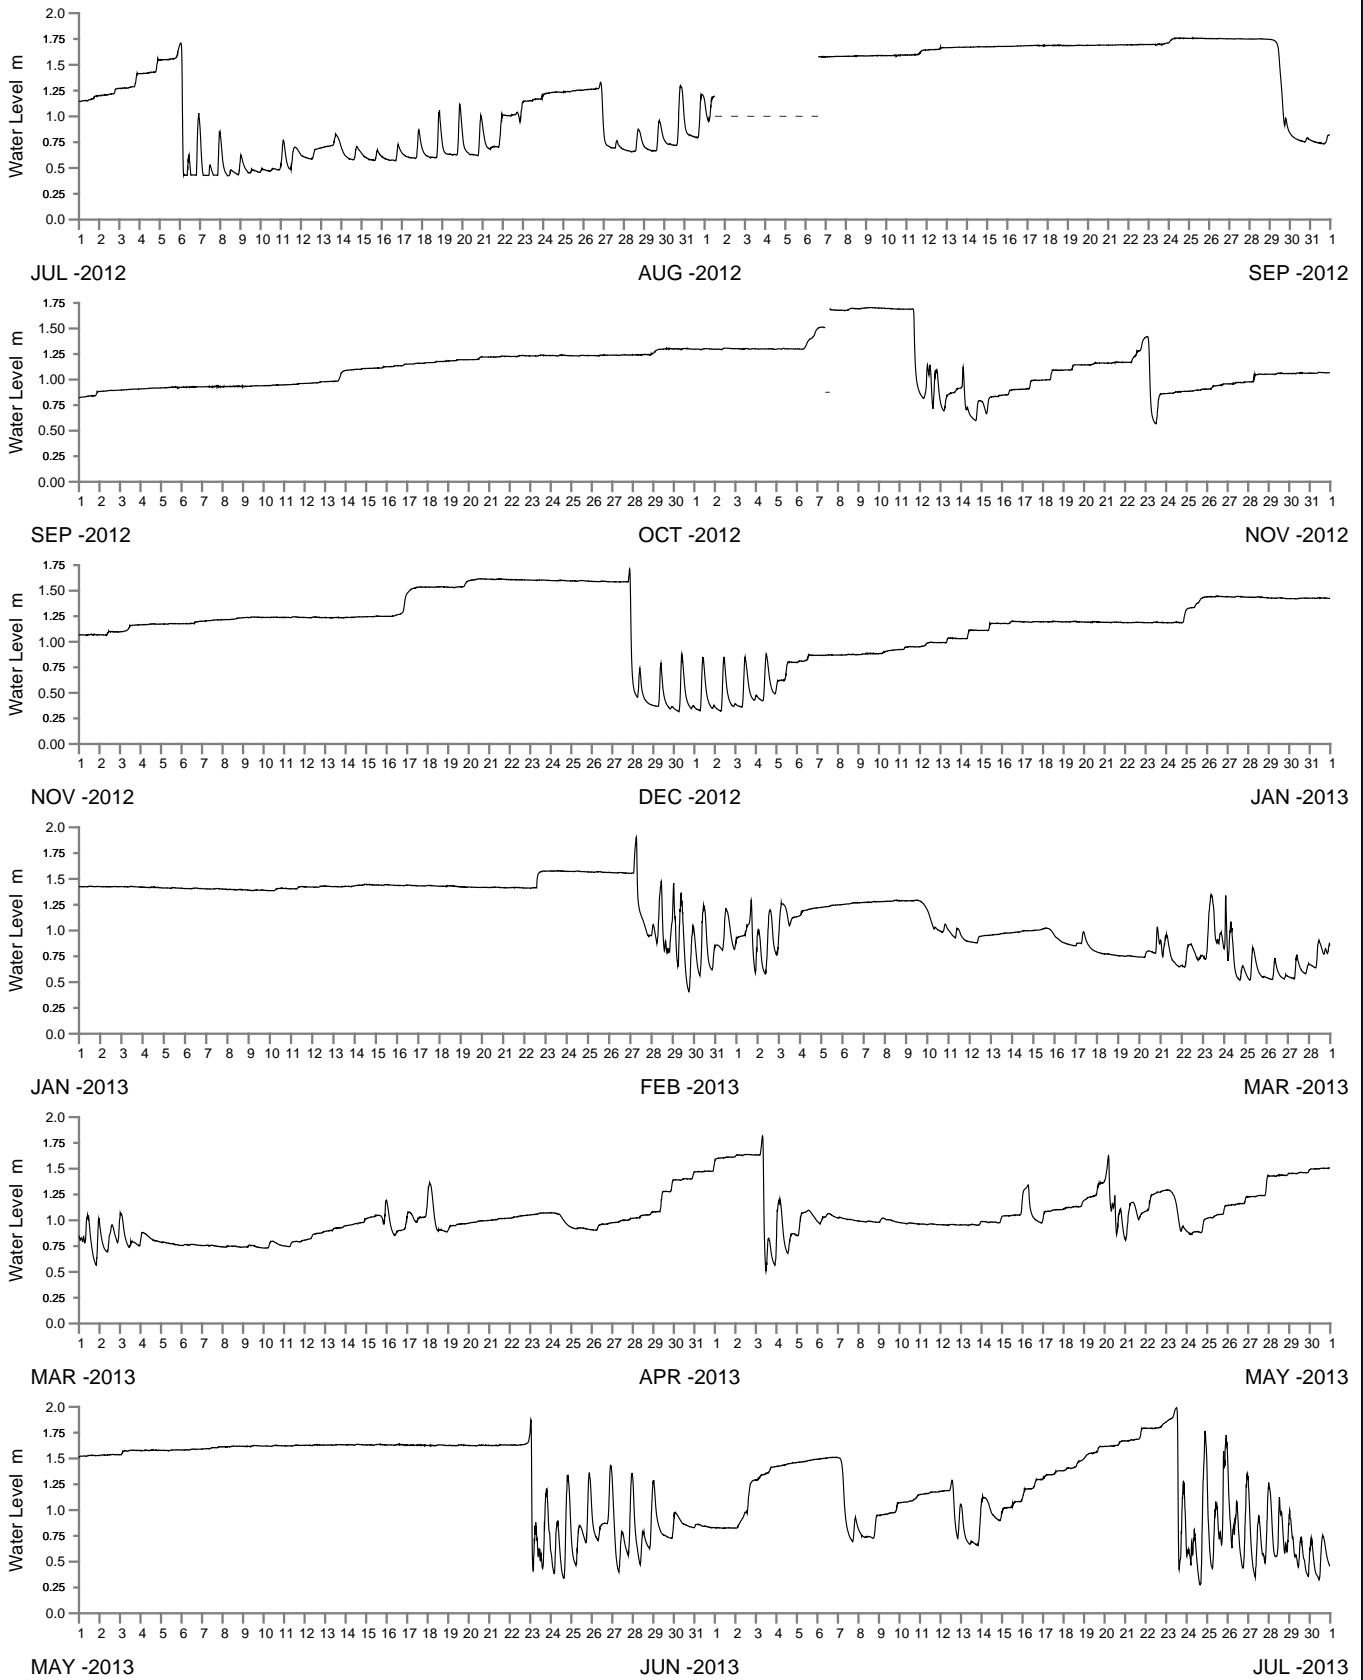
Figure
205

WATER LEVEL REFERENCED TO AUSTRALIAN HEIGHT DATUM

TOWRADGI CREEK AT TOWRADGI CREEK DOWNSTREAM
2012-2013

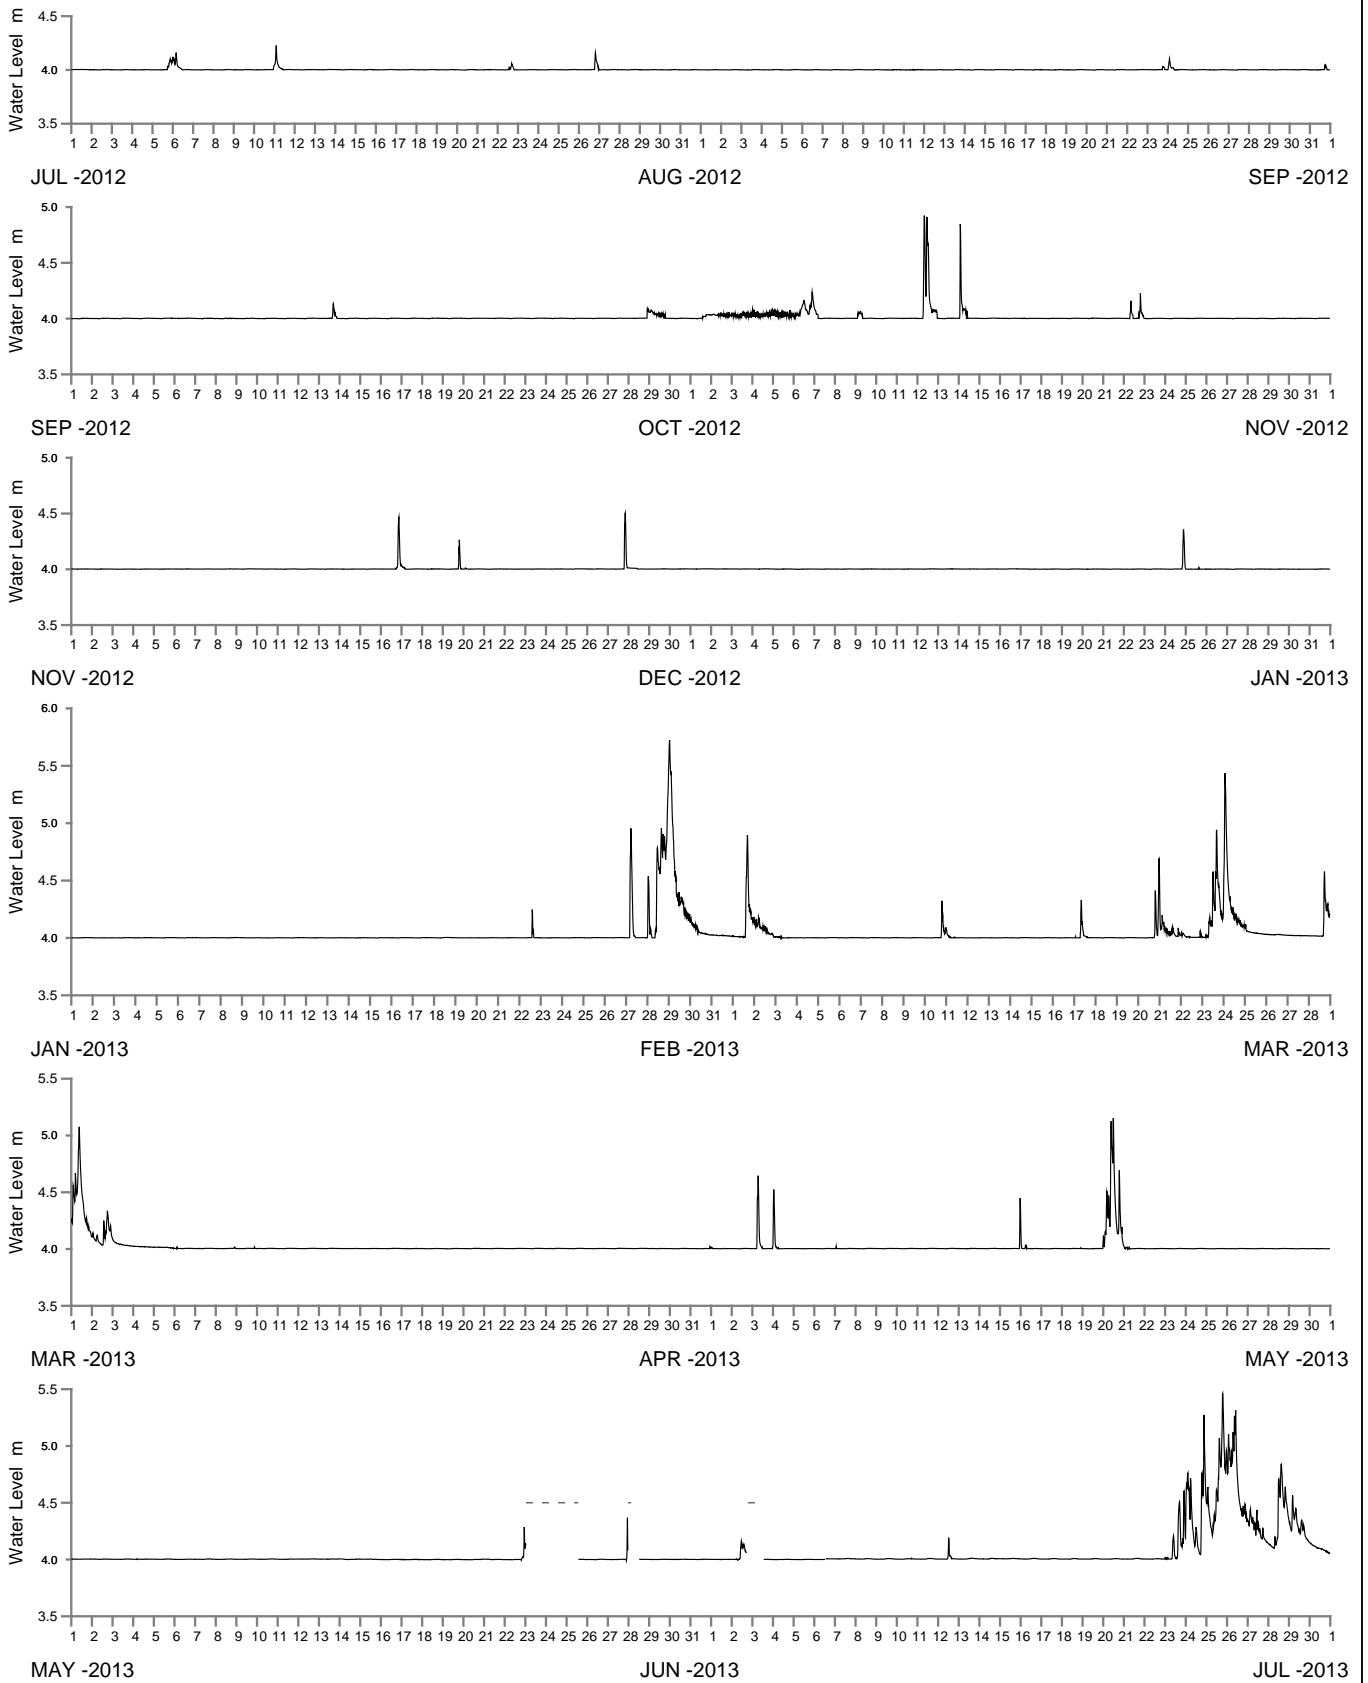
Figure
206

WATER LEVEL REFERENCED TO AUSTRALIAN HEIGHT DATUM

CABBAGE TREE CREEK AT CABBAGE TREE CREEK
2012-2013

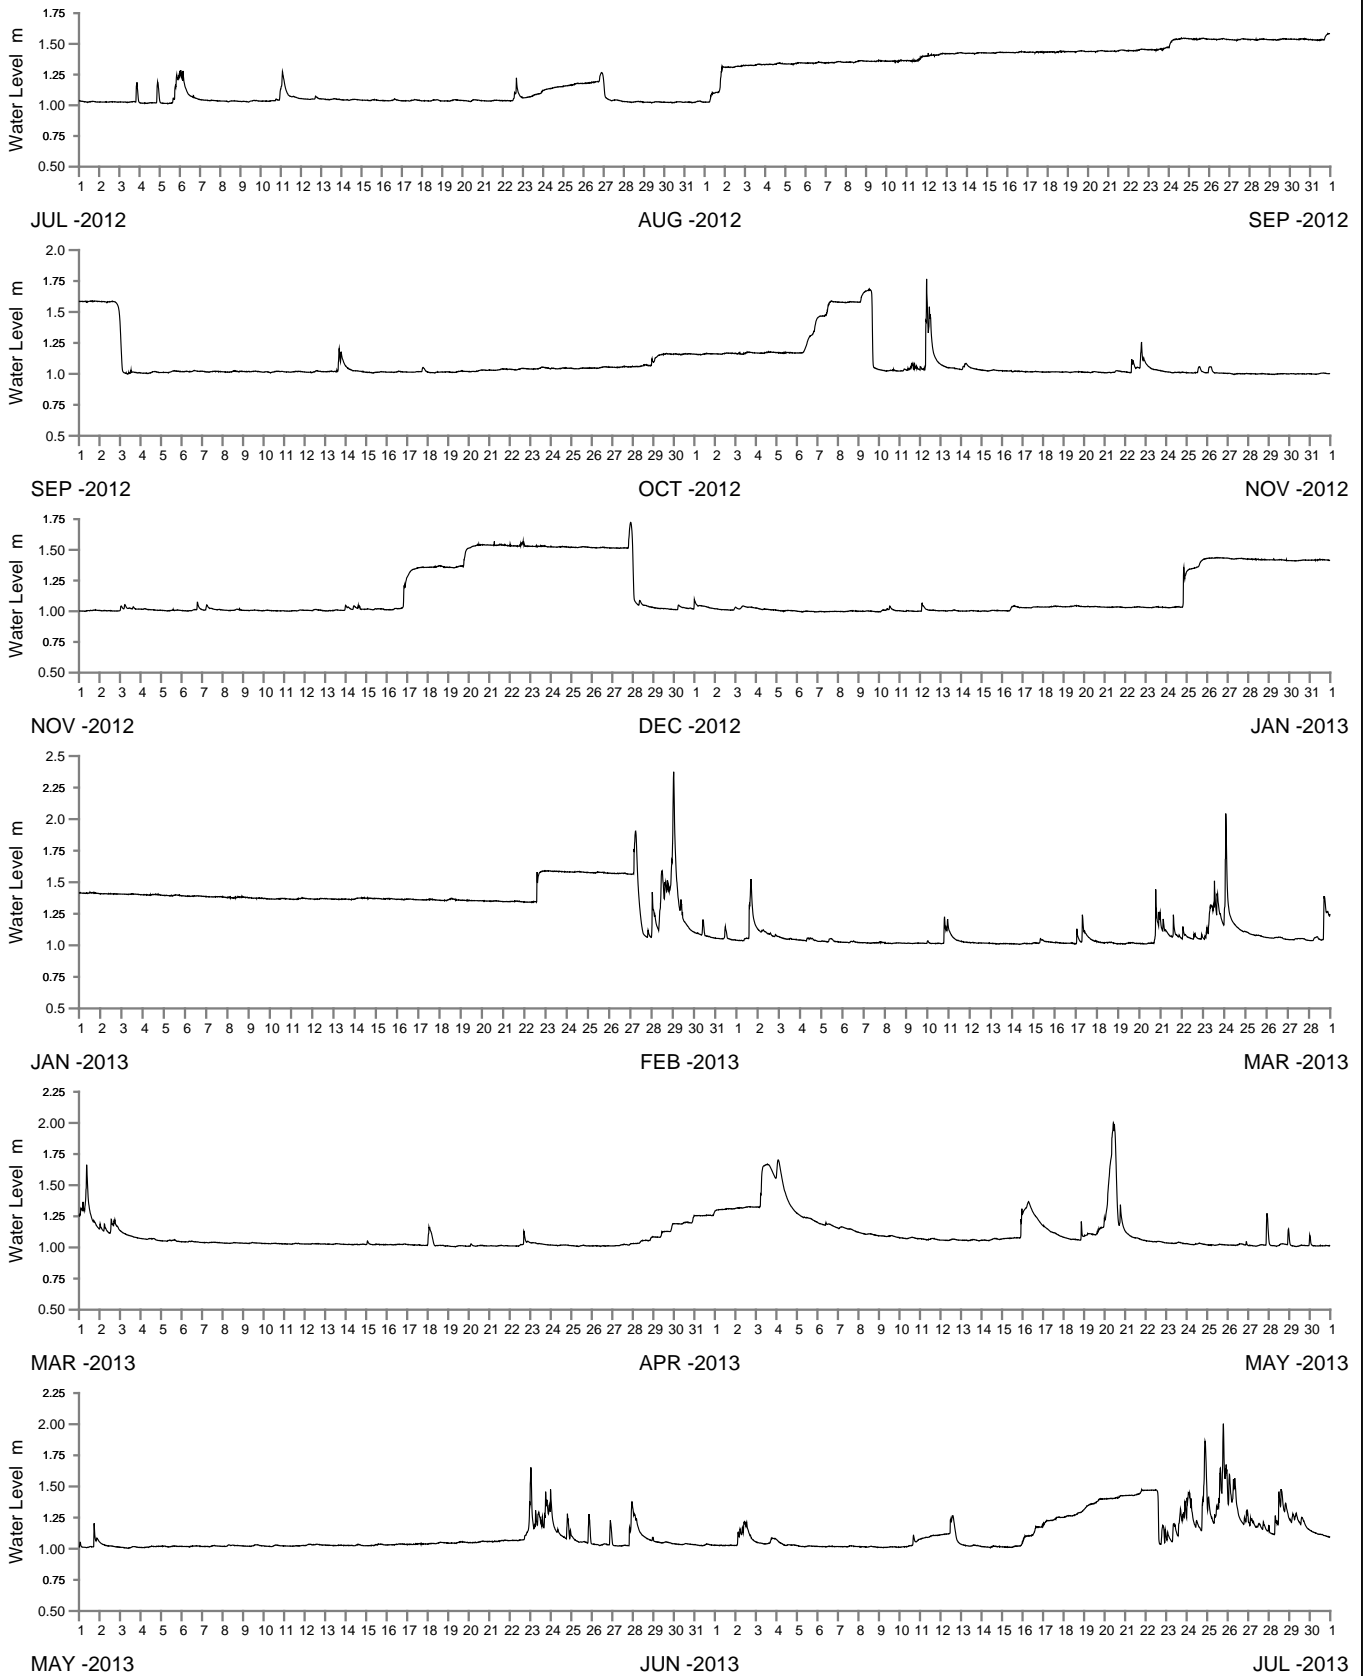
Figure
208

WATER LEVEL REFERENCED TO AUSTRALIAN HEIGHT DATUM

FAIRY CREEK AT FAIRY CREEK UPSTREAM
2012-2013

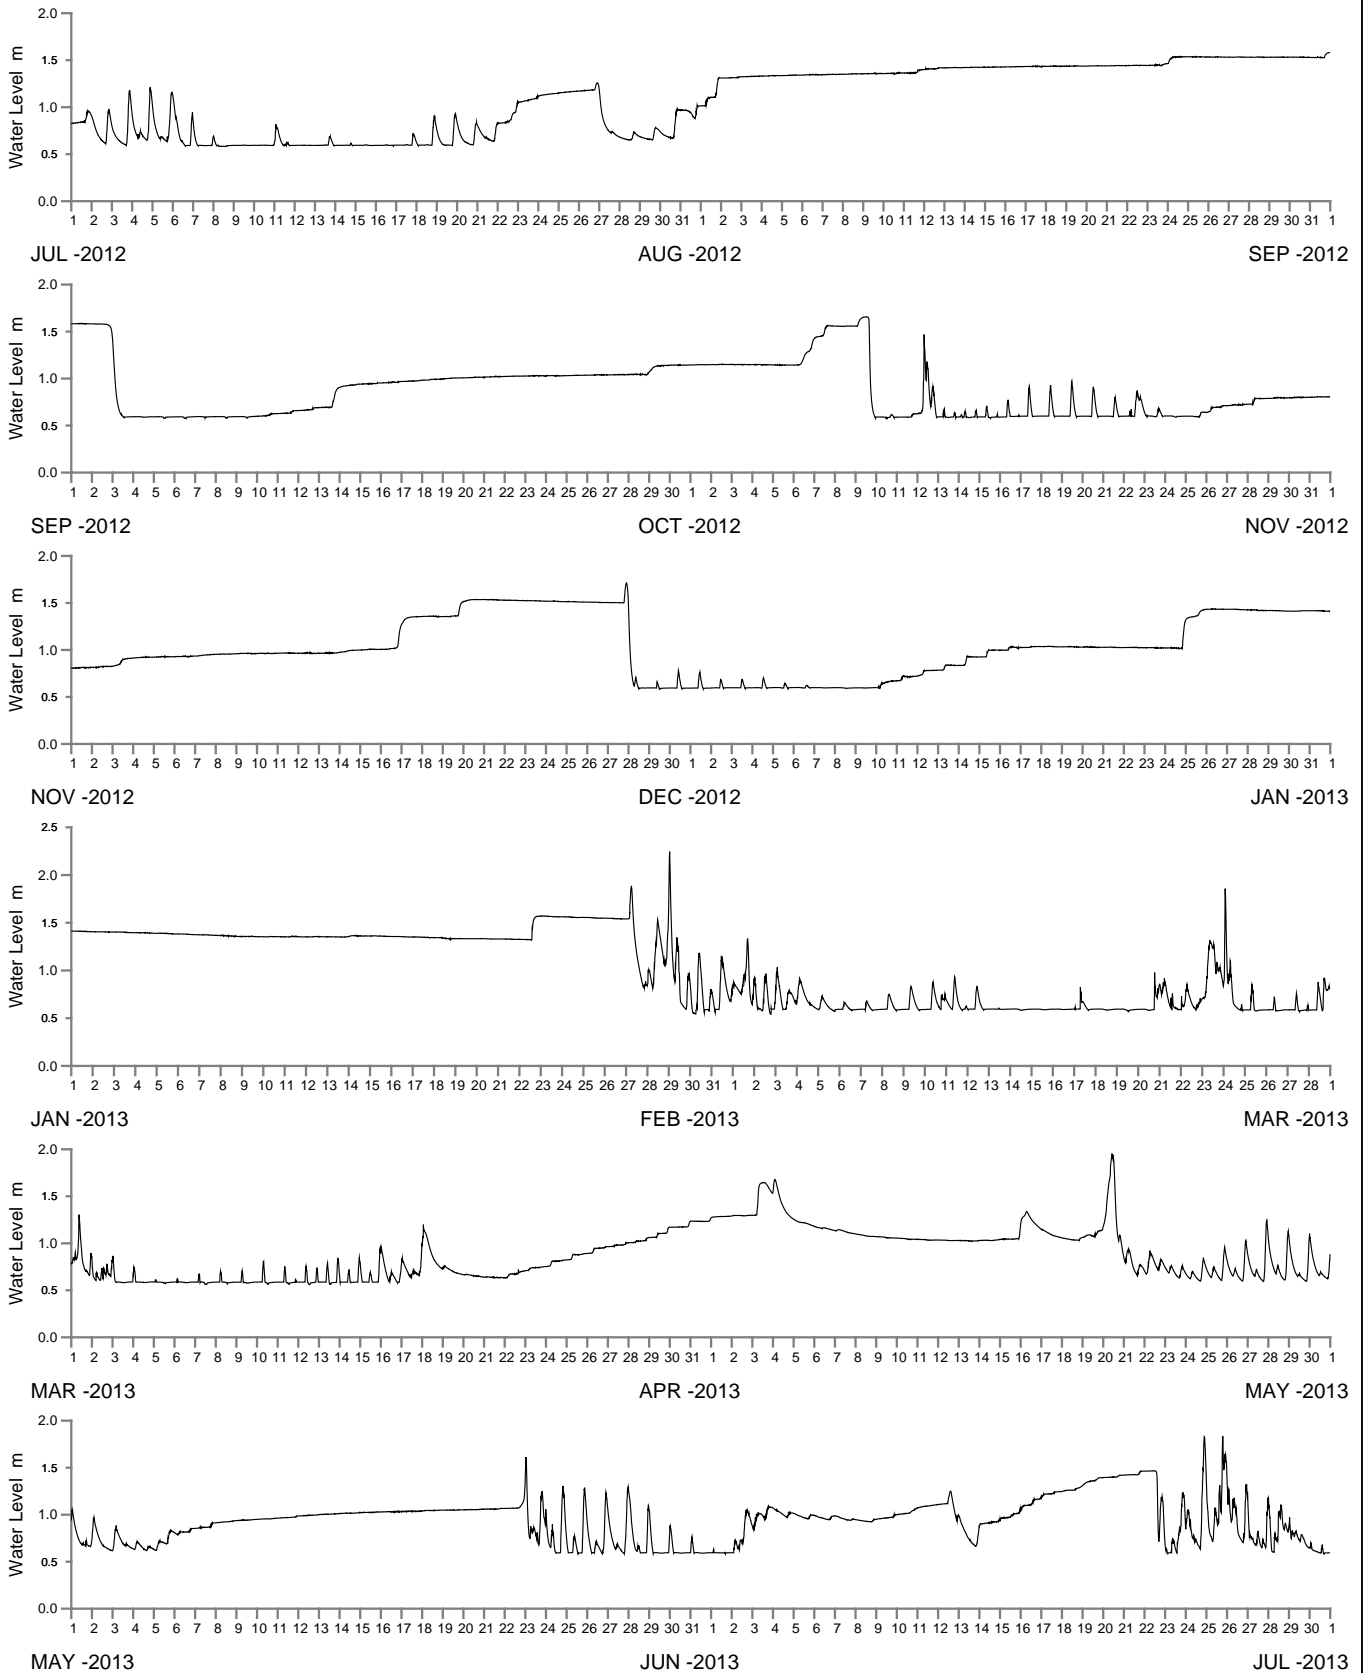
Figure
209

WATER LEVEL REFERENCED TO AUSTRALIAN HEIGHT DATUM

FAIRY CREEK AT FAIRY CREEK DOWNSTREAM
2012-2013
