Public Works
Manly Hydraulics Laboratory

**STATION LOCATIONS
WOLLONGONG REGION**

MHL
Report 2218
**Figure
198**
DRAWING 2218-198.cdr

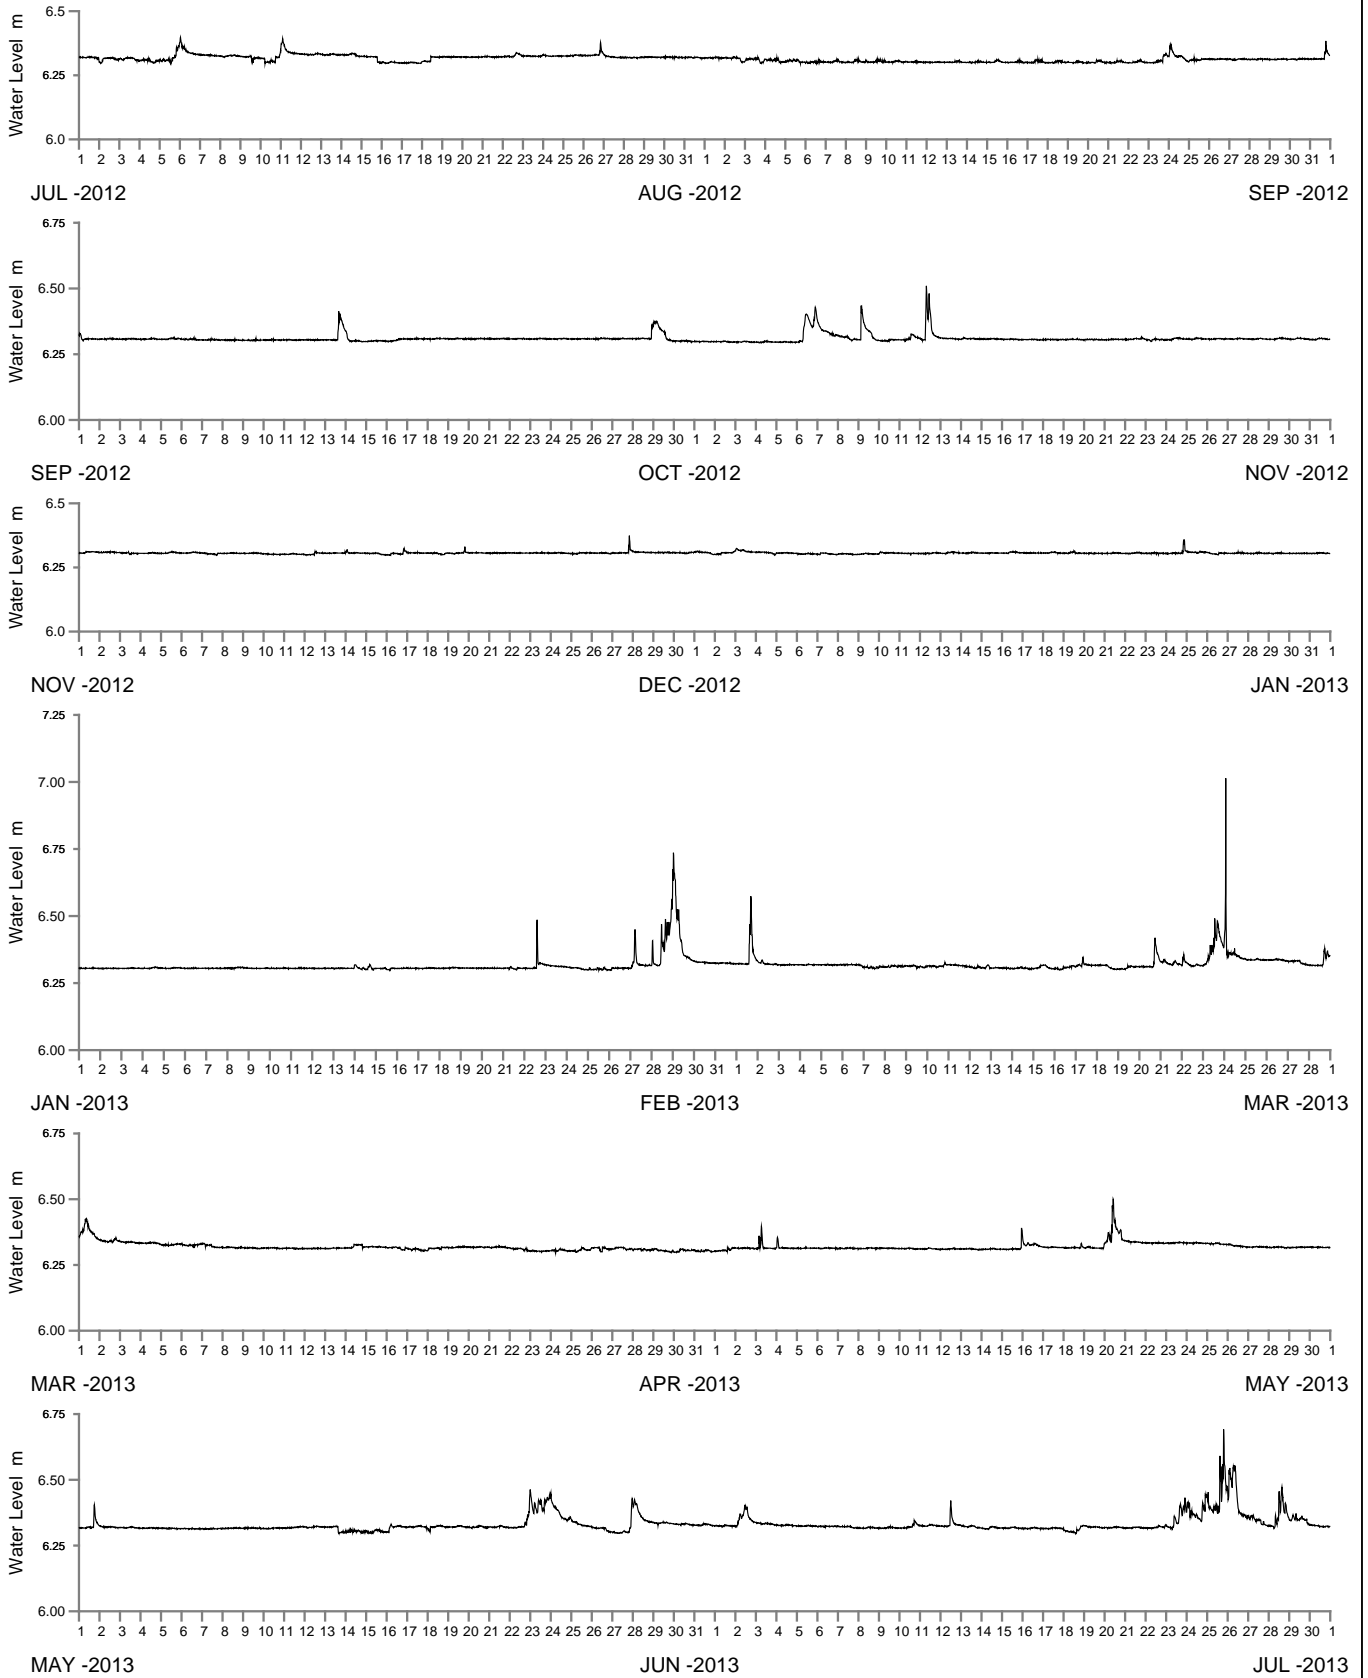
Figure
210

WATER LEVEL REFERENCED TO AUSTRALIAN HEIGHT DATUM

BYARONG CREEK AT F6 FREEWAY
2012-2013

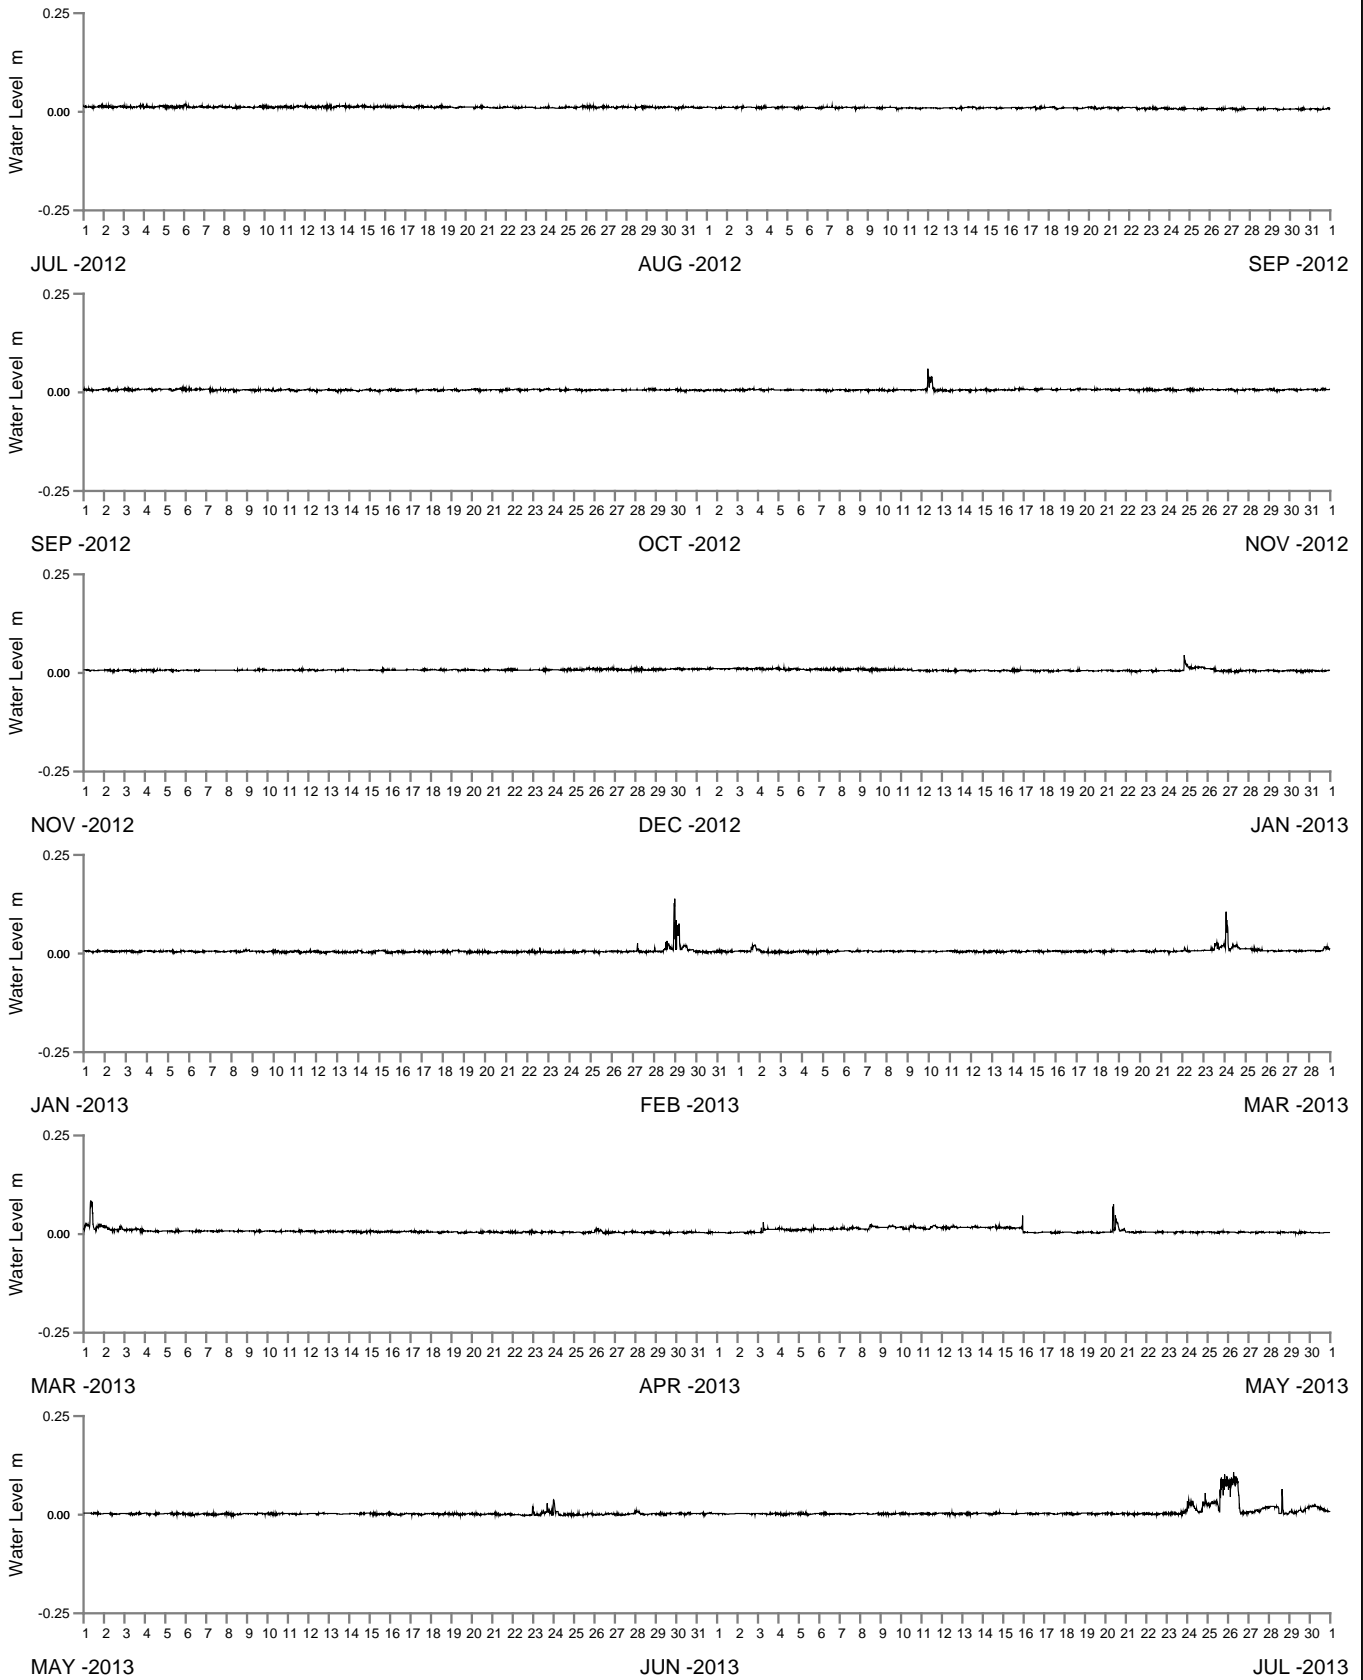
Figure
211

WATER LEVEL REFERENCED TO CULVERT BED

BYARONG CREEK AT KOLOONA AVENUE UPSTREAM
2012-2013

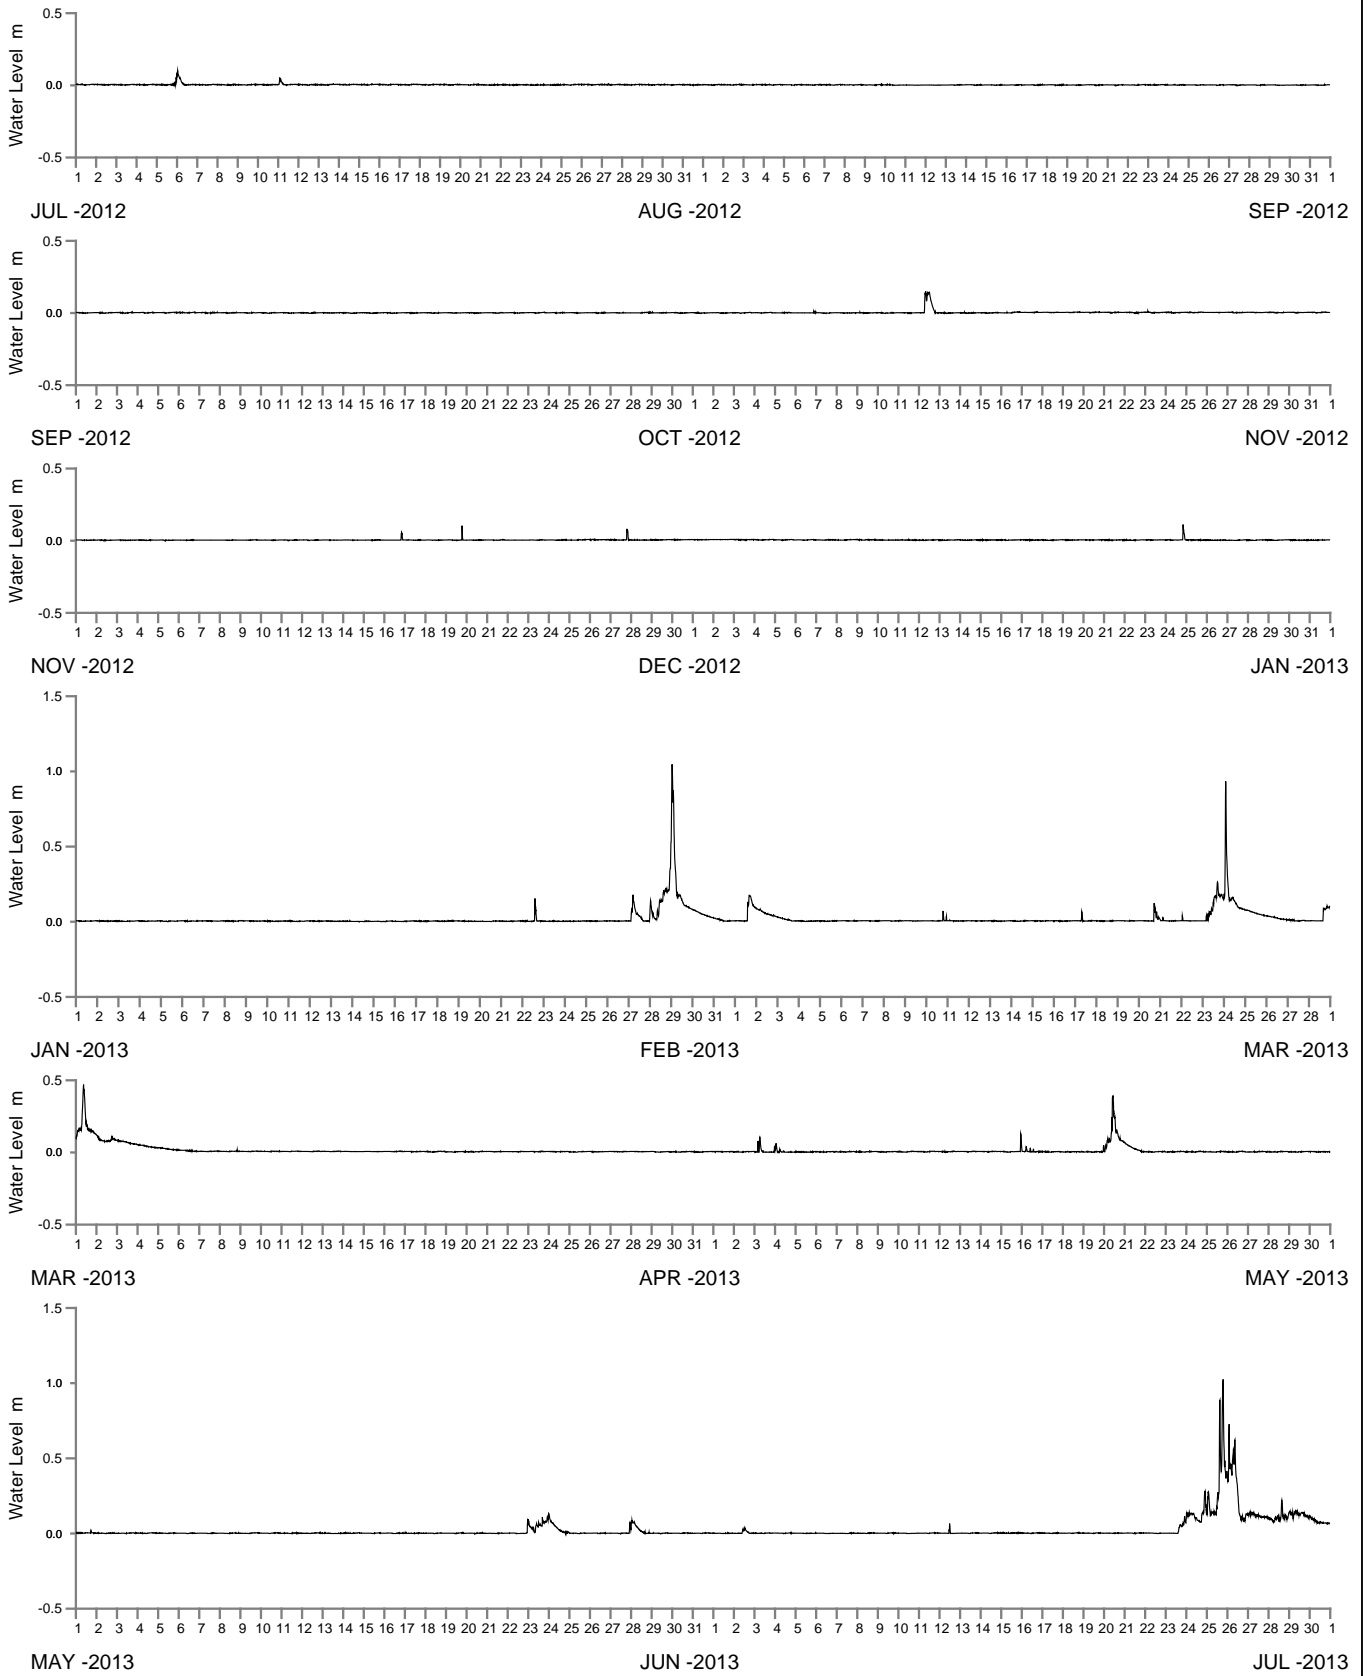
Figure
212

WATER LEVEL REFERENCED TO CULVERT BED

BYARONG CREEK AT KOLOONA AVENUE DOWNSTREAM
2012-2013

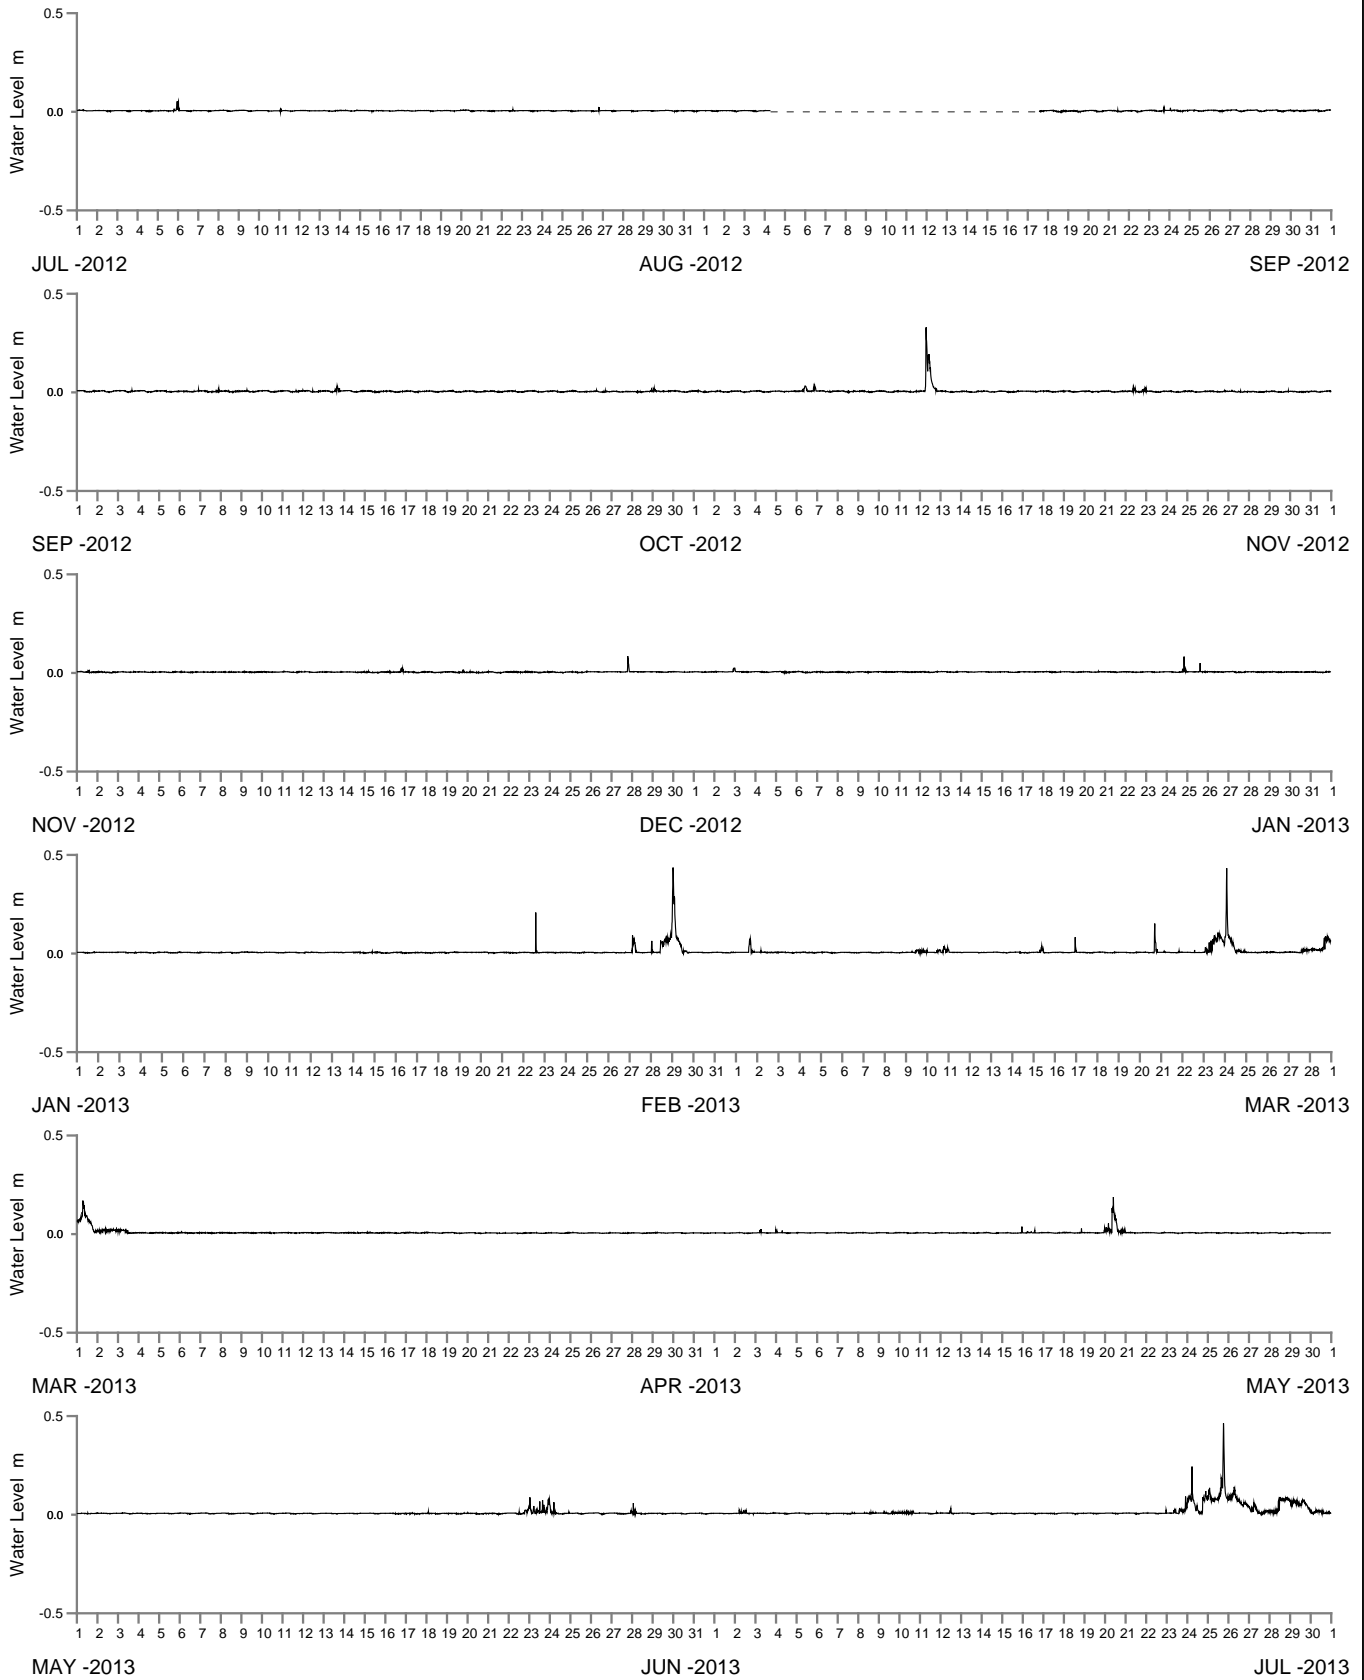
Figure
213

WATER LEVEL REFERENCED TO CULVERT BED

AMERICAN CREEK AT BLACKMANS PARADE UPSTREAM
2012-2013

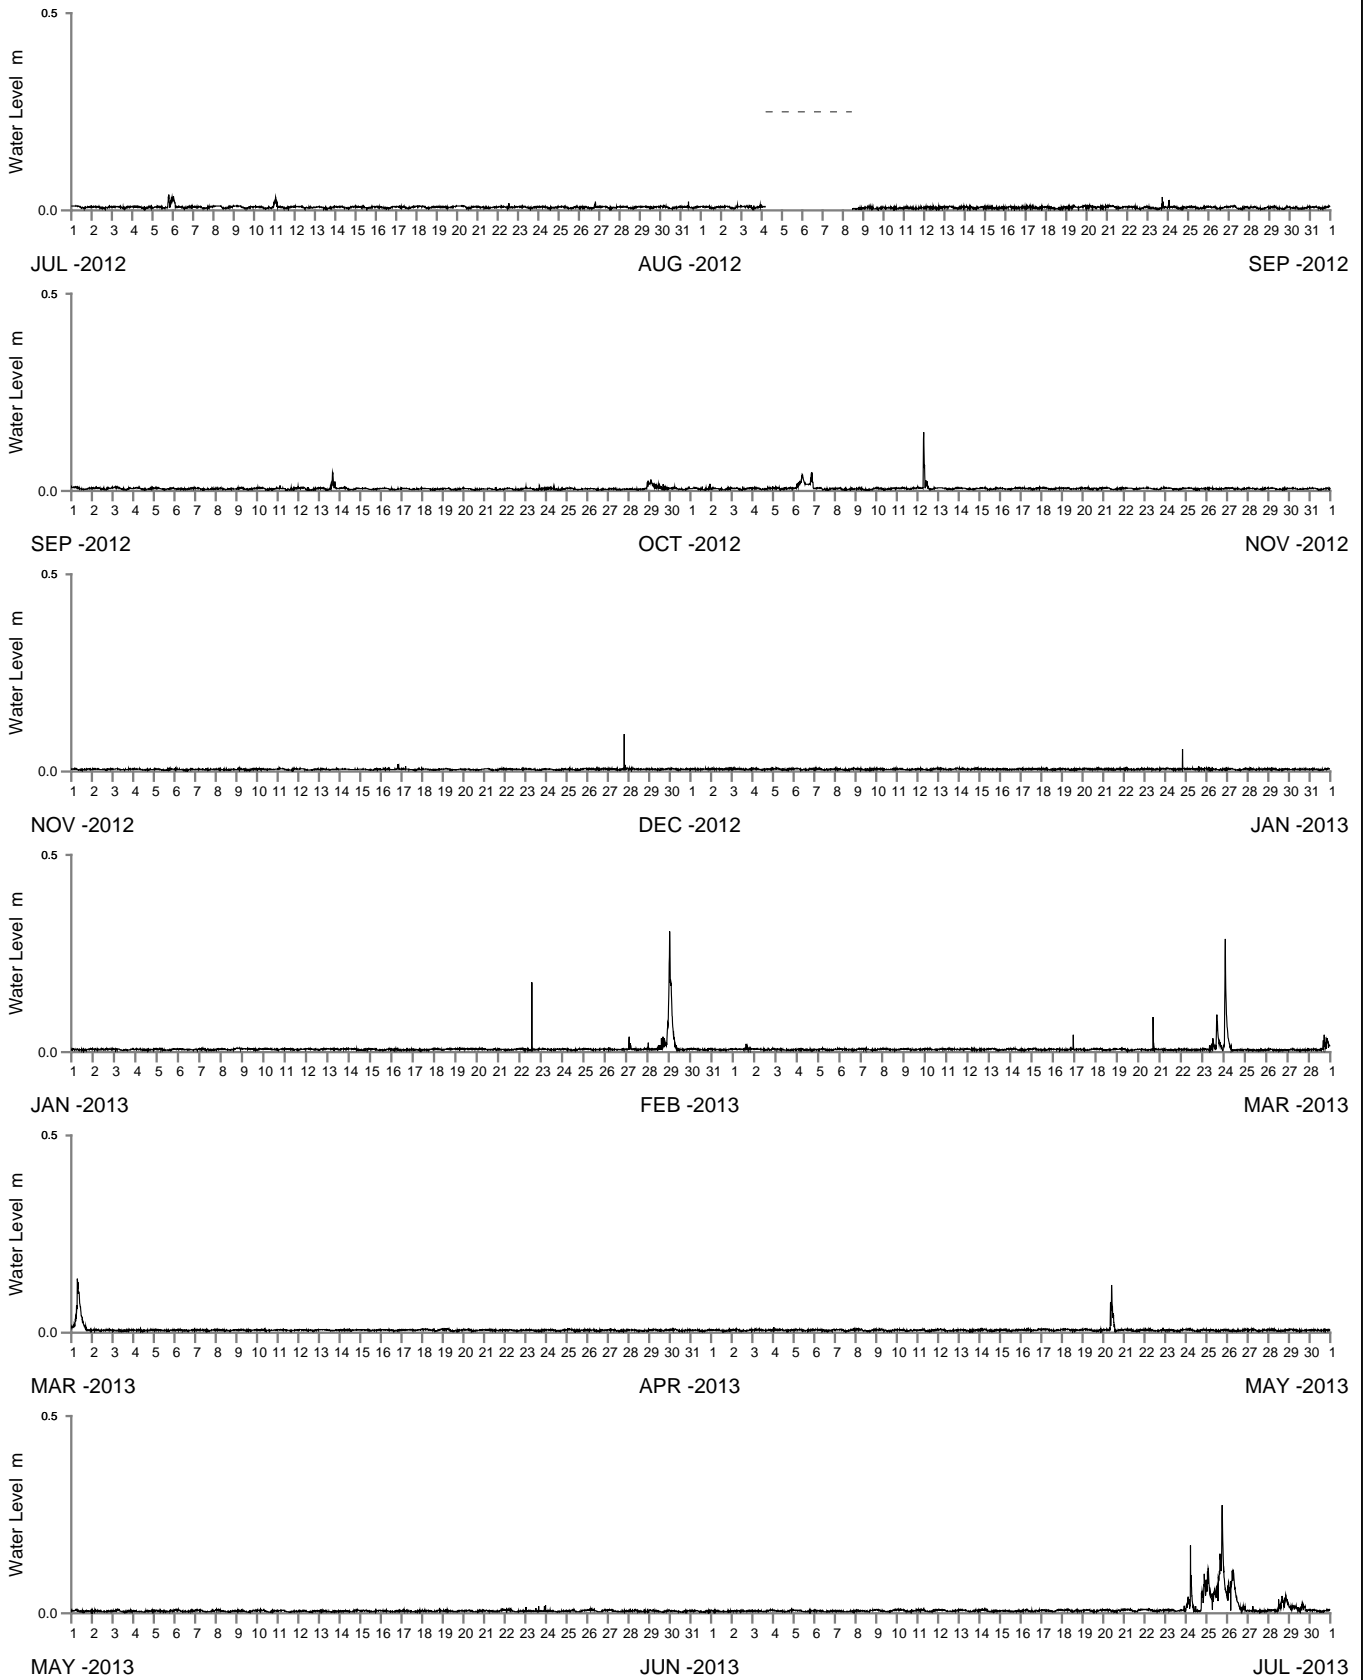
Figure
214

WATER LEVEL REFERENCED TO CULVERT BED

AMERICAN CREEK AT BLACKMANS PARADE DOWNSTREAM
2012-2013

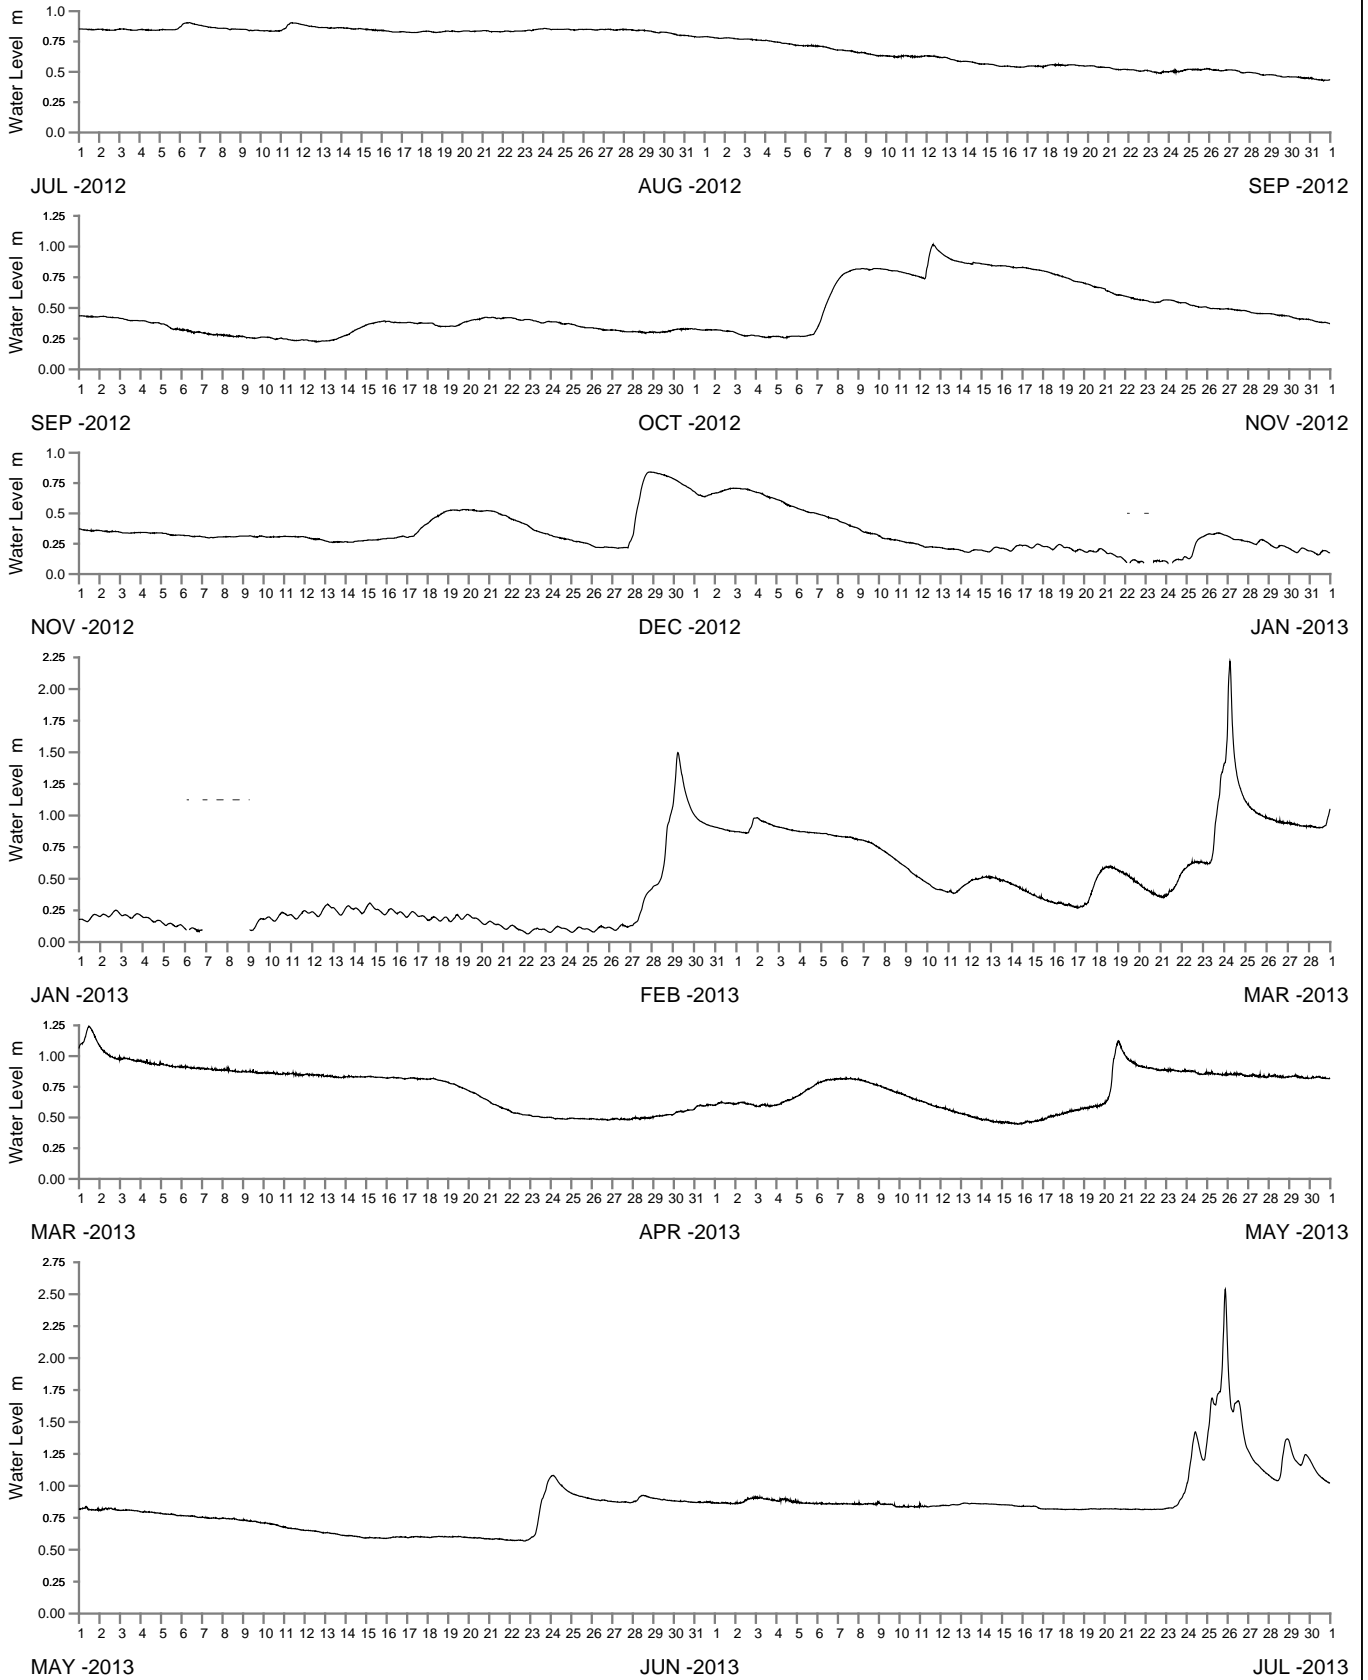
Figure
216

WATER LEVEL REFERENCED TO AUSTRALIAN HEIGHT DATUM

MULLET CREEK AT MULLET CREEK
2012-2013

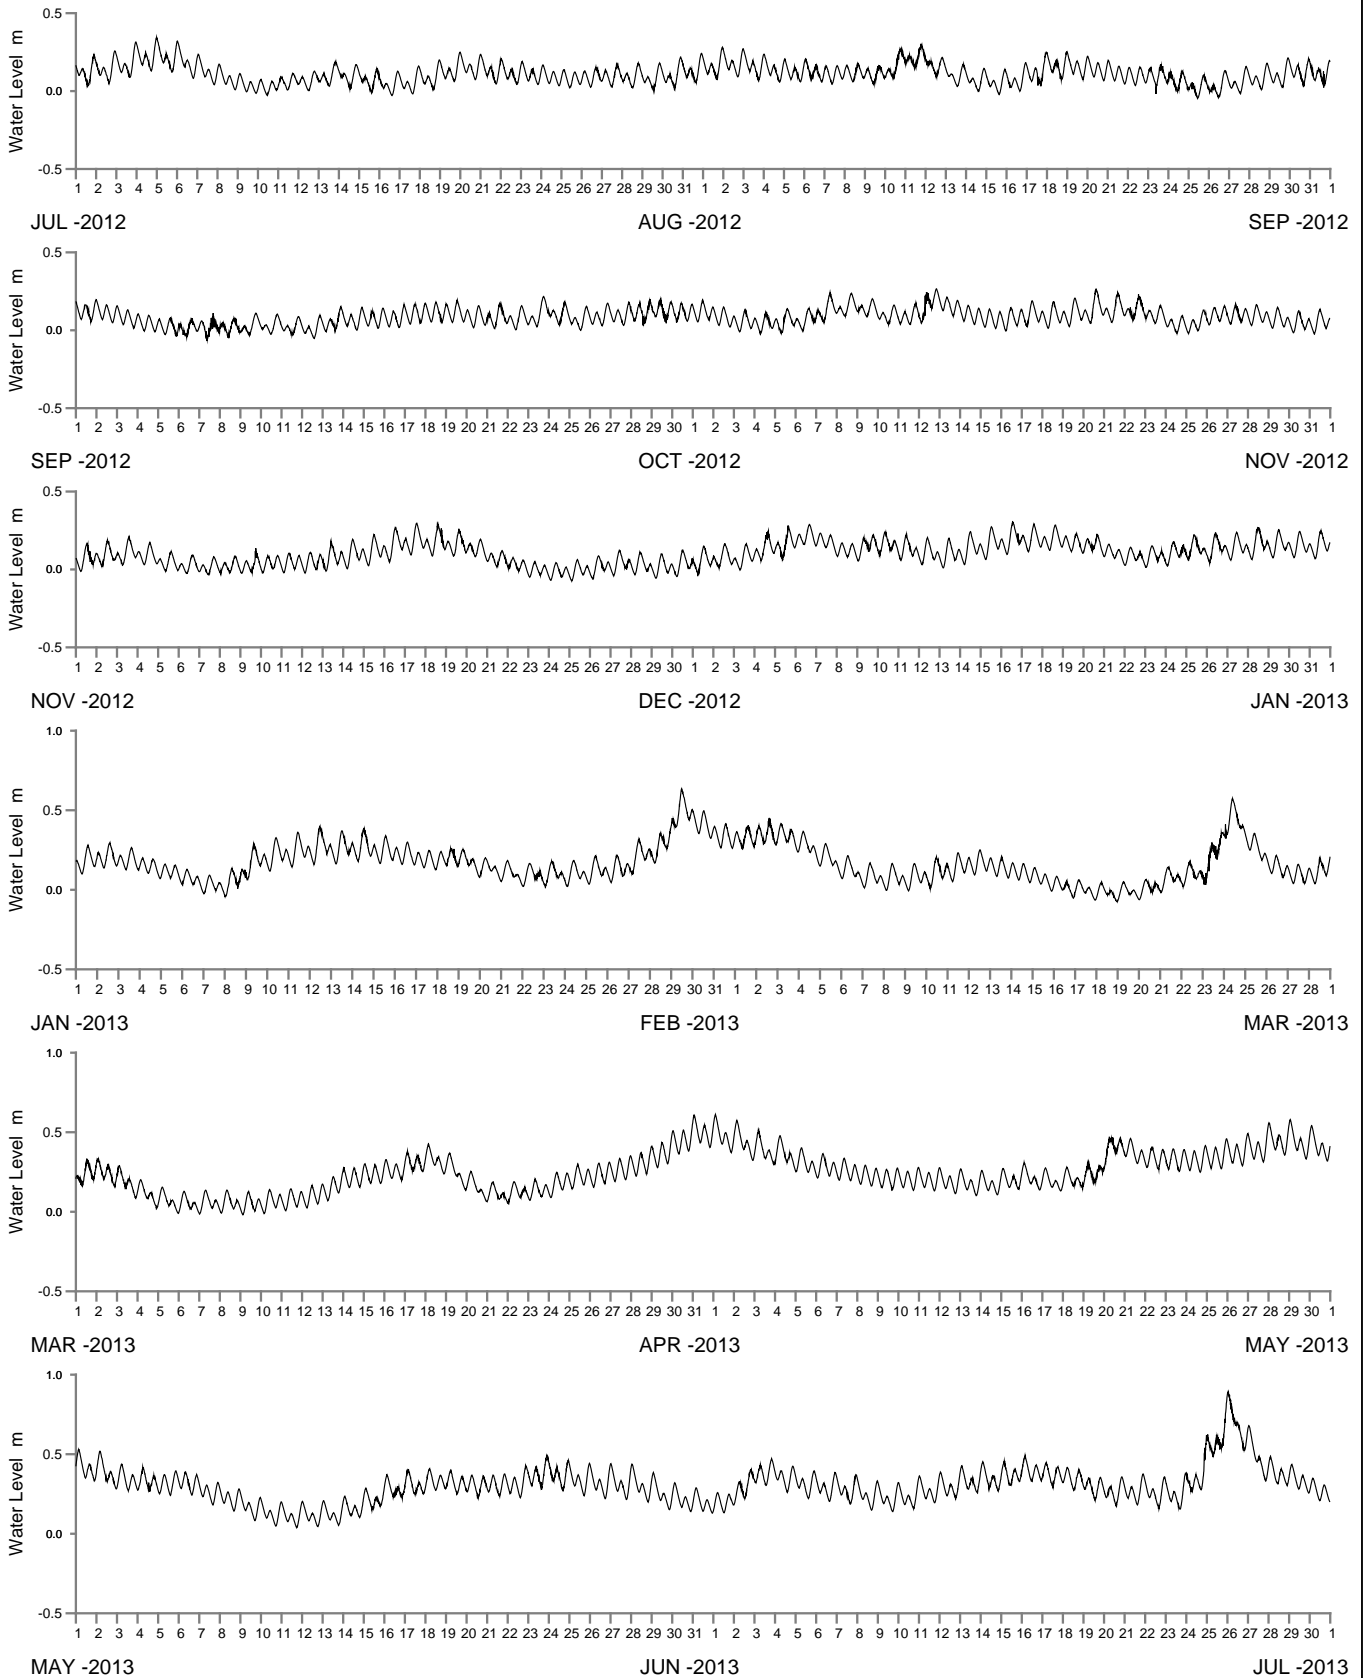
Figure
217

WATER LEVEL REFERENCED TO AUSTRALIAN HEIGHT DATUM

LAKE ILLAWARRA AT KOONAWARRA BAY
2012-2013

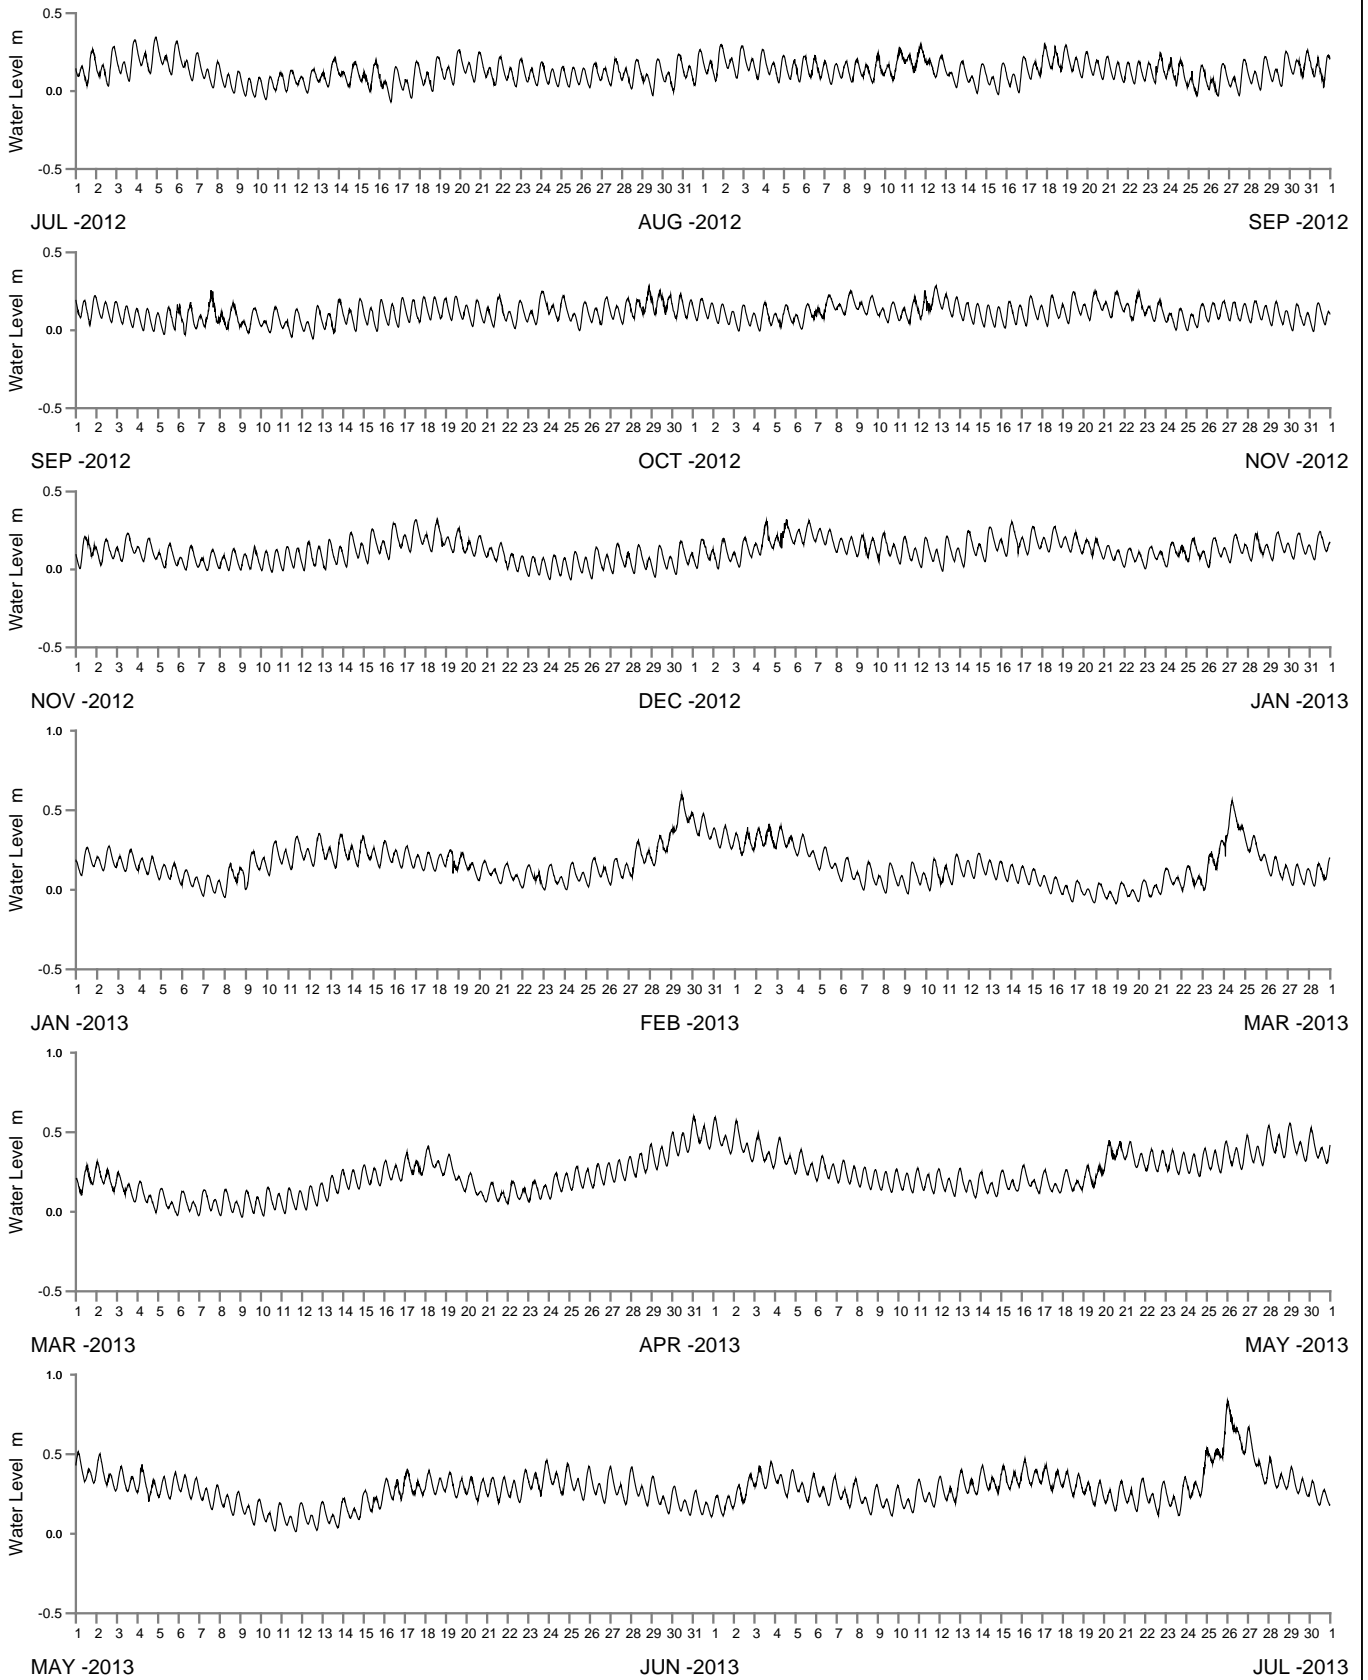
Figure
218

WATER LEVEL REFERENCED TO AUSTRALIAN HEIGHT DATUM

LAKE ILLAWARRA AT CUDGEREE BAY
2012-2013

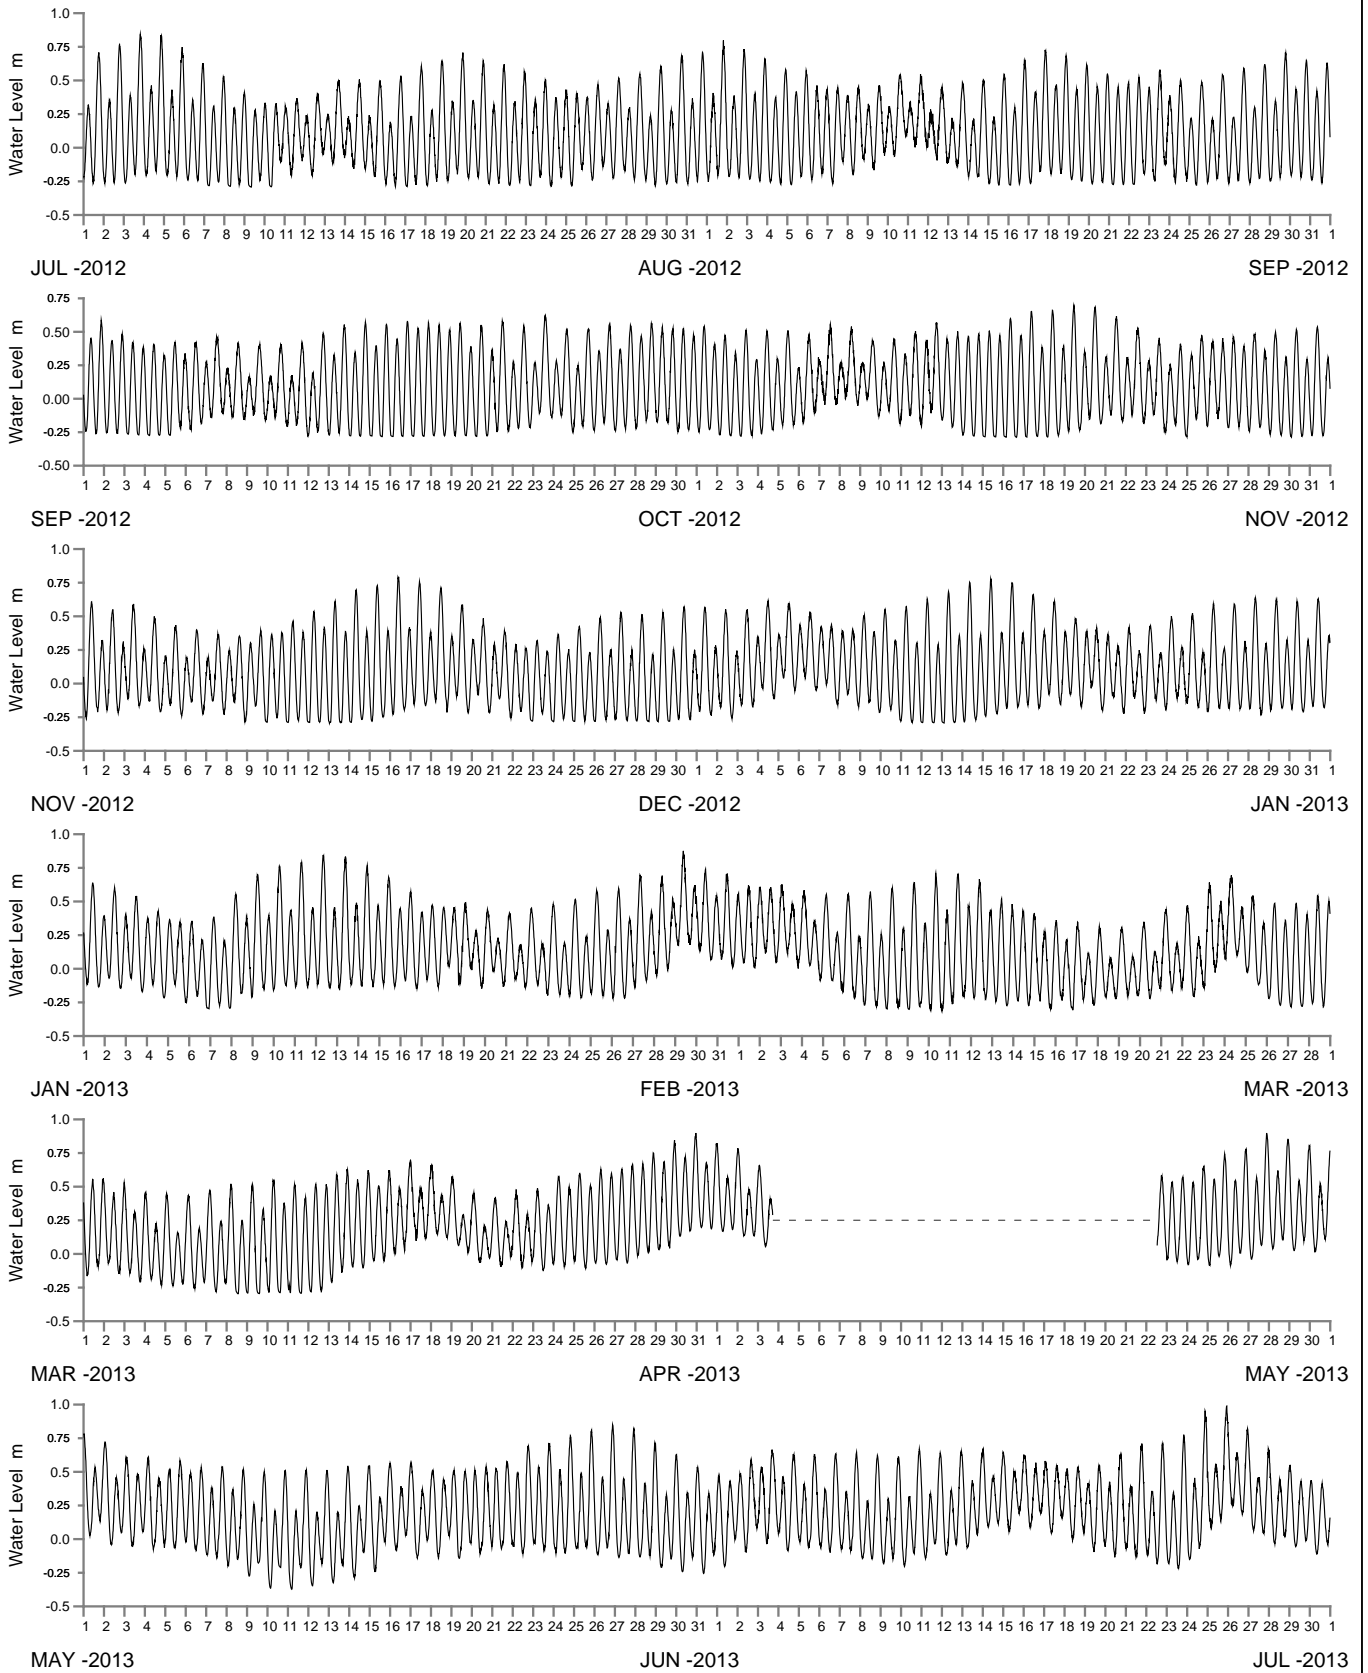
Figure
219

WATER LEVEL REFERENCED TO AUSTRALIAN HEIGHT DATUM

LAKE ILLAWARRA AT LAKE ILLAWARRA ENTRANCE
2012-2013

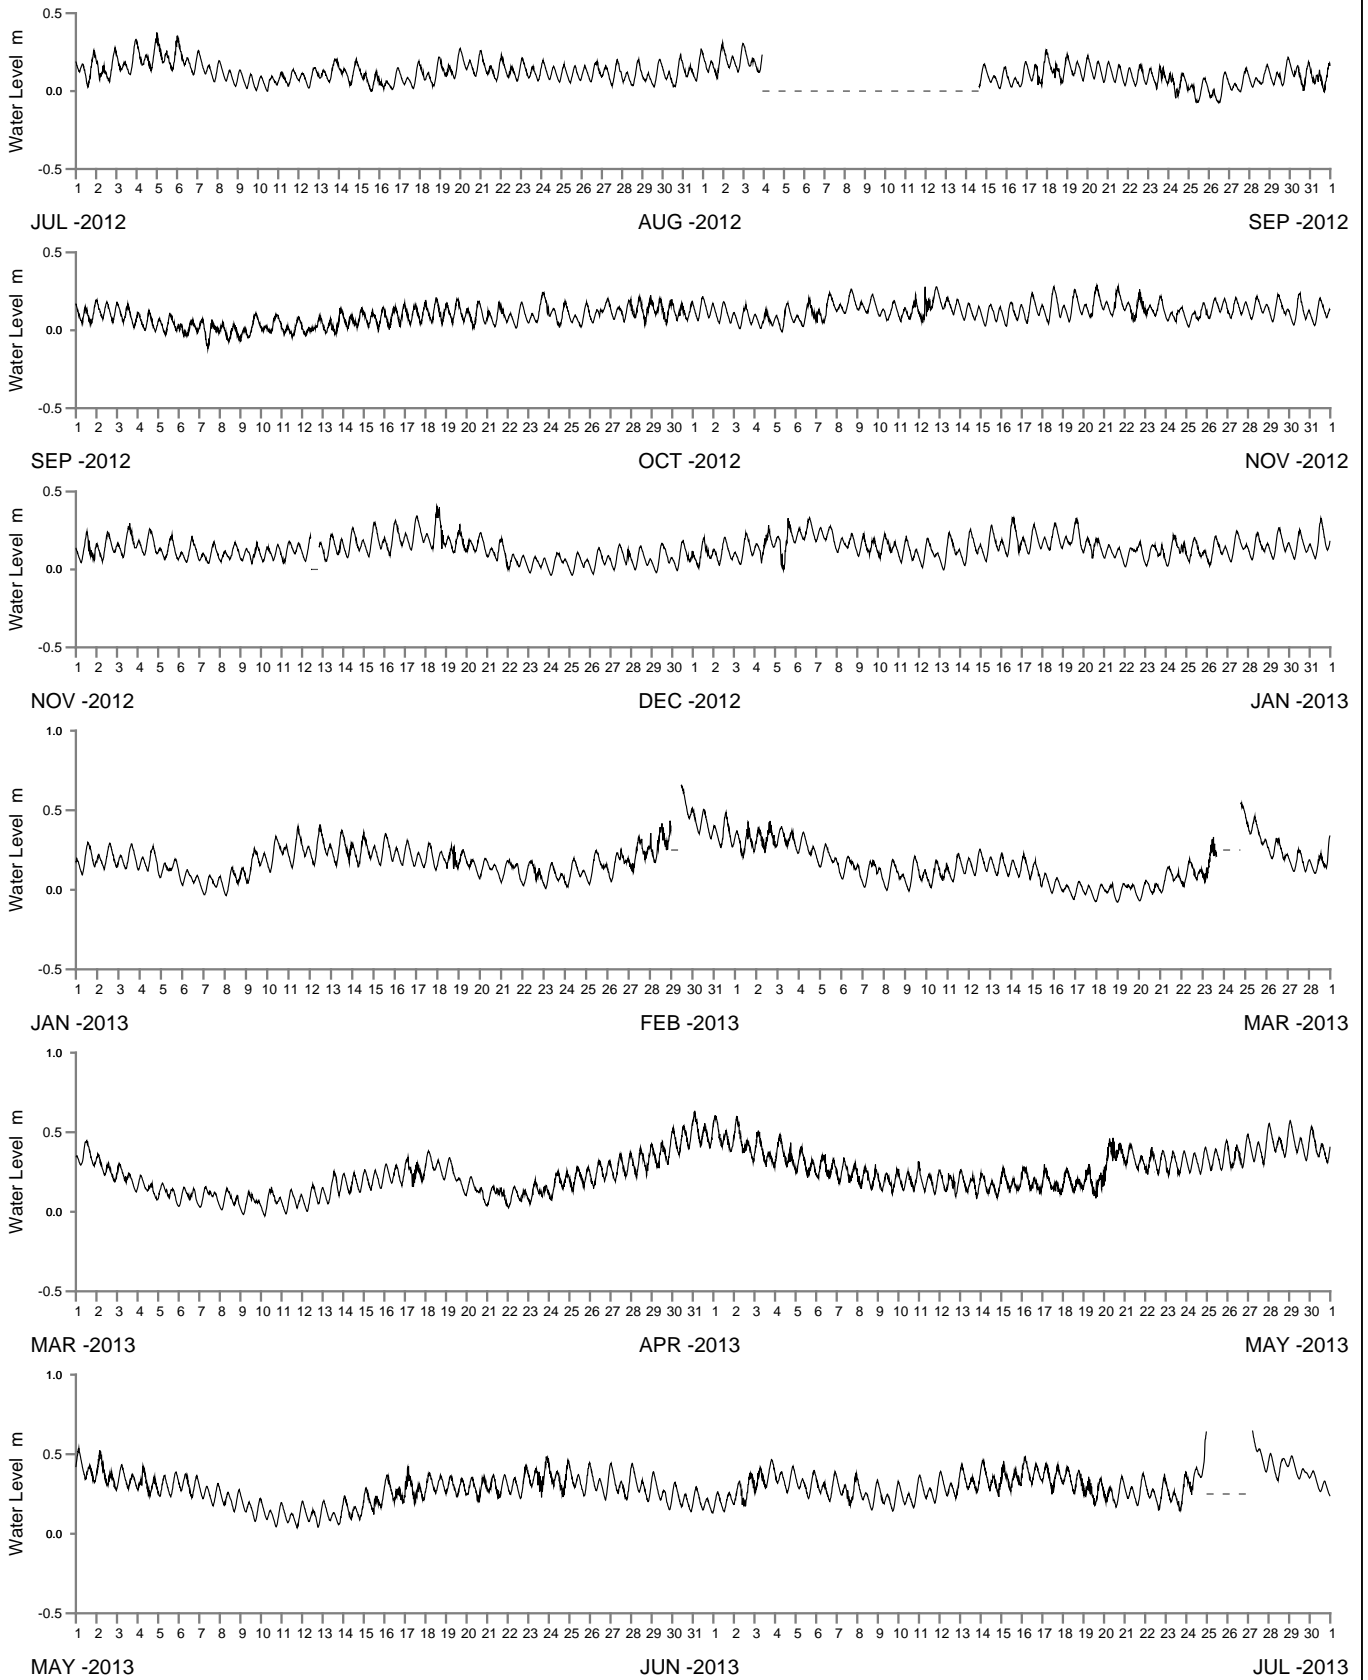
Figure
220

WATER LEVEL REFERENCED TO AUSTRALIAN HEIGHT DATUM

MACQUARIE RIVULET AT PRINCES HIGHWAY
2012-2013
