Public Works
Manly Hydraulics Laboratory

**STATION LOCATIONS
WOLLONGONG REGION**

MHL
Report 2218
**Figure
198**
DRAWING 2218-198.cdr

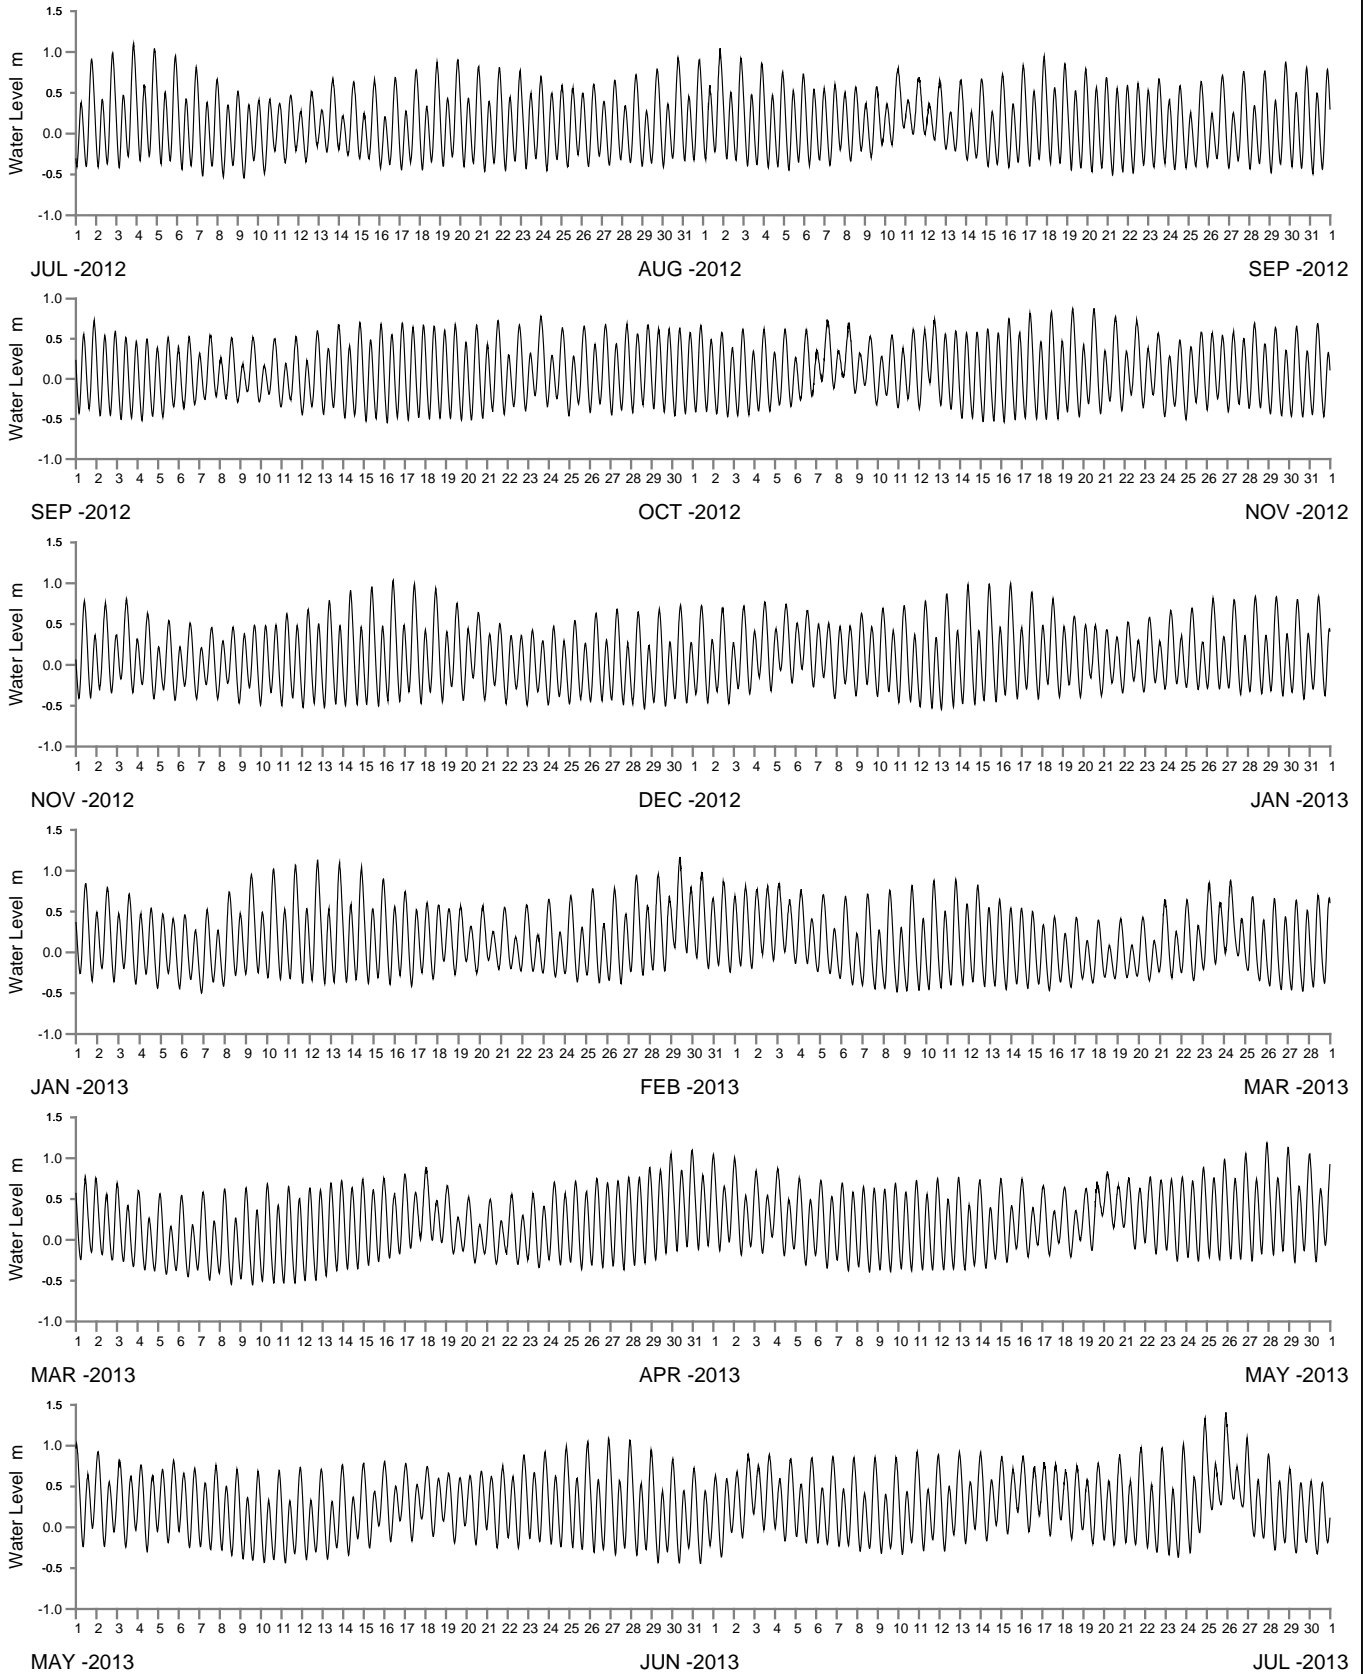
Figure
223

WATER LEVEL REFERENCED TO AUSTRALIAN HEIGHT DATUM

MINNAMURRA RIVER AT MINNAMURRA
2012-2013

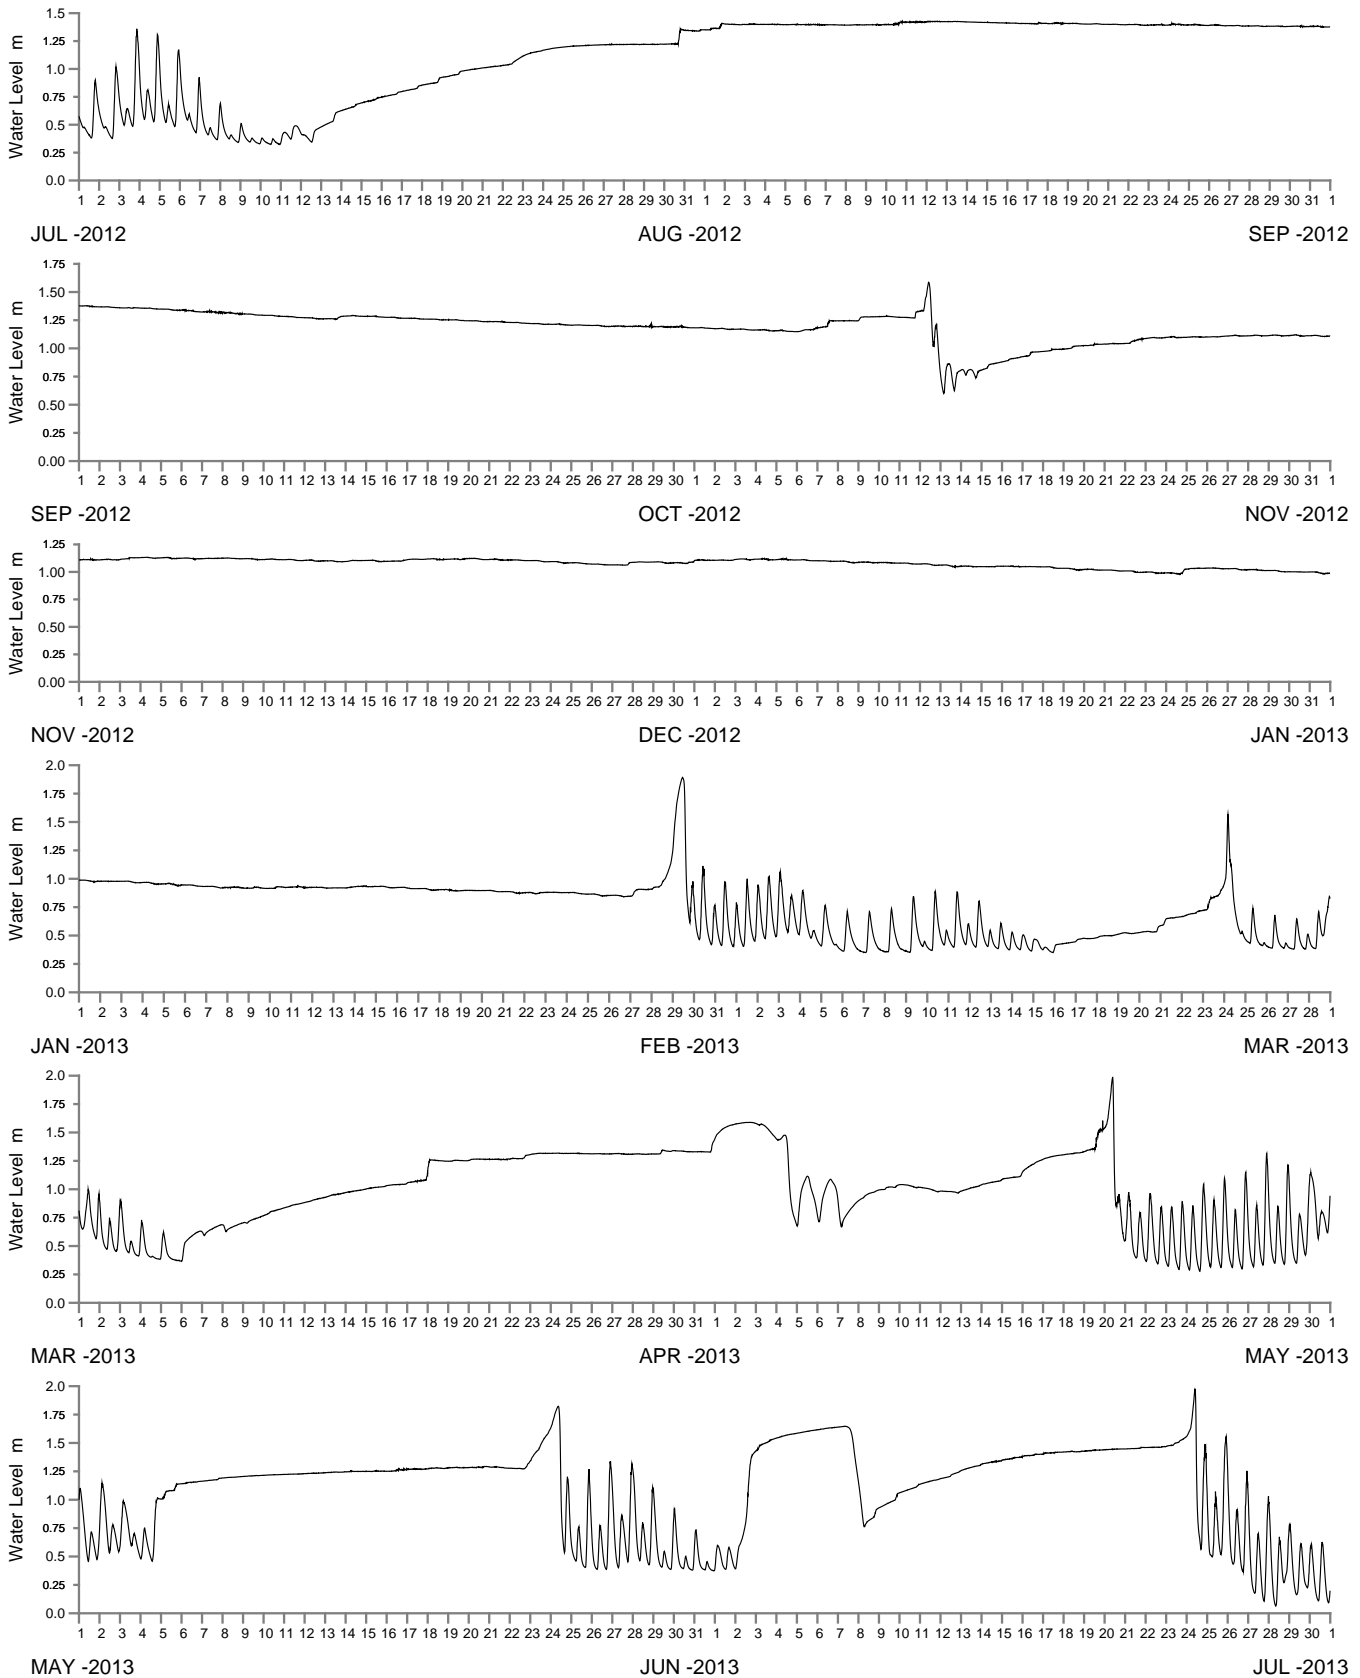
Figure
224

WATER LEVEL REFERENCED TO AUSTRALIAN HEIGHT DATUM

WERRI LAGOON AT WERRI LAGOON
2012-2013

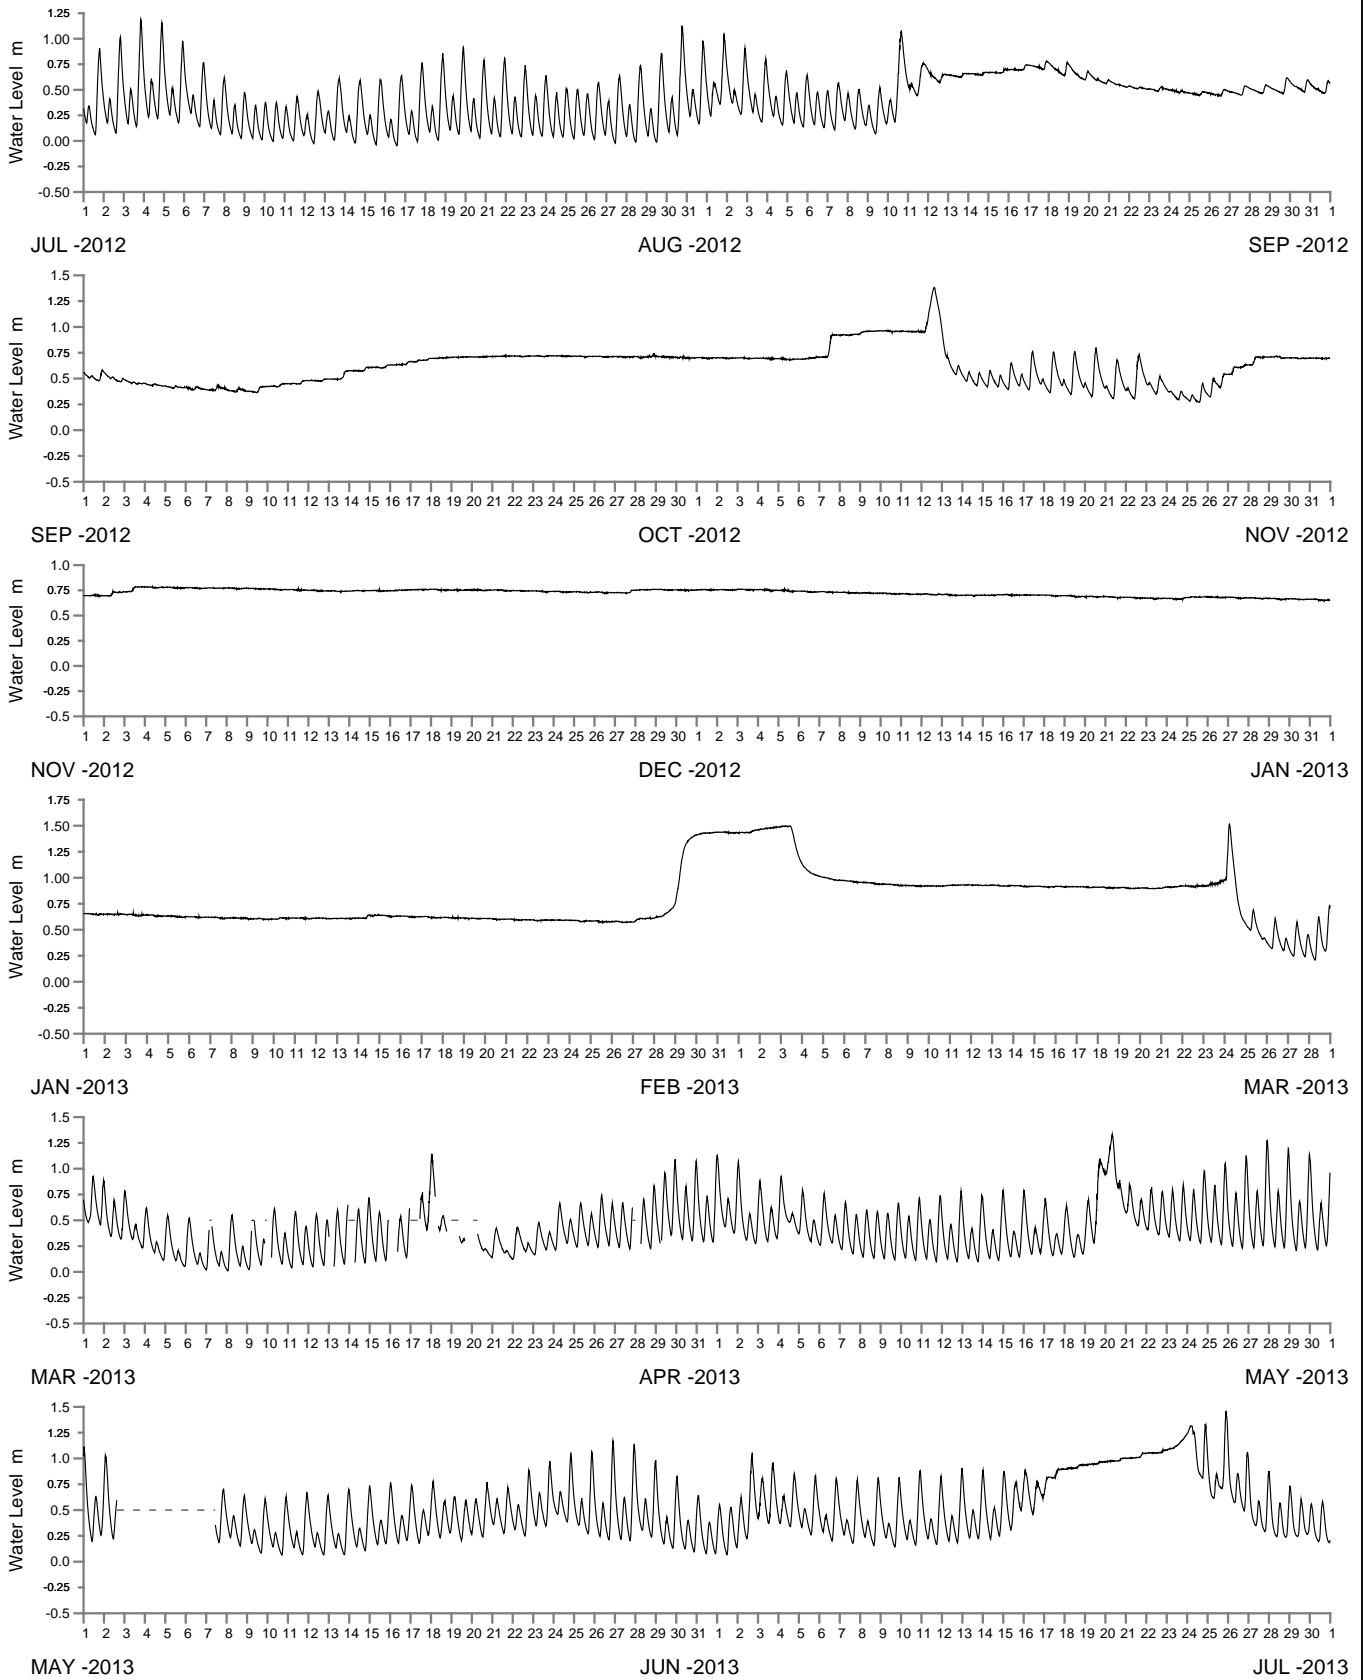
Figure
225

WATER LEVEL REFERENCED TO AUSTRALIAN HEIGHT DATUM

CROOKED CREEK AT GERROA
2012-2013

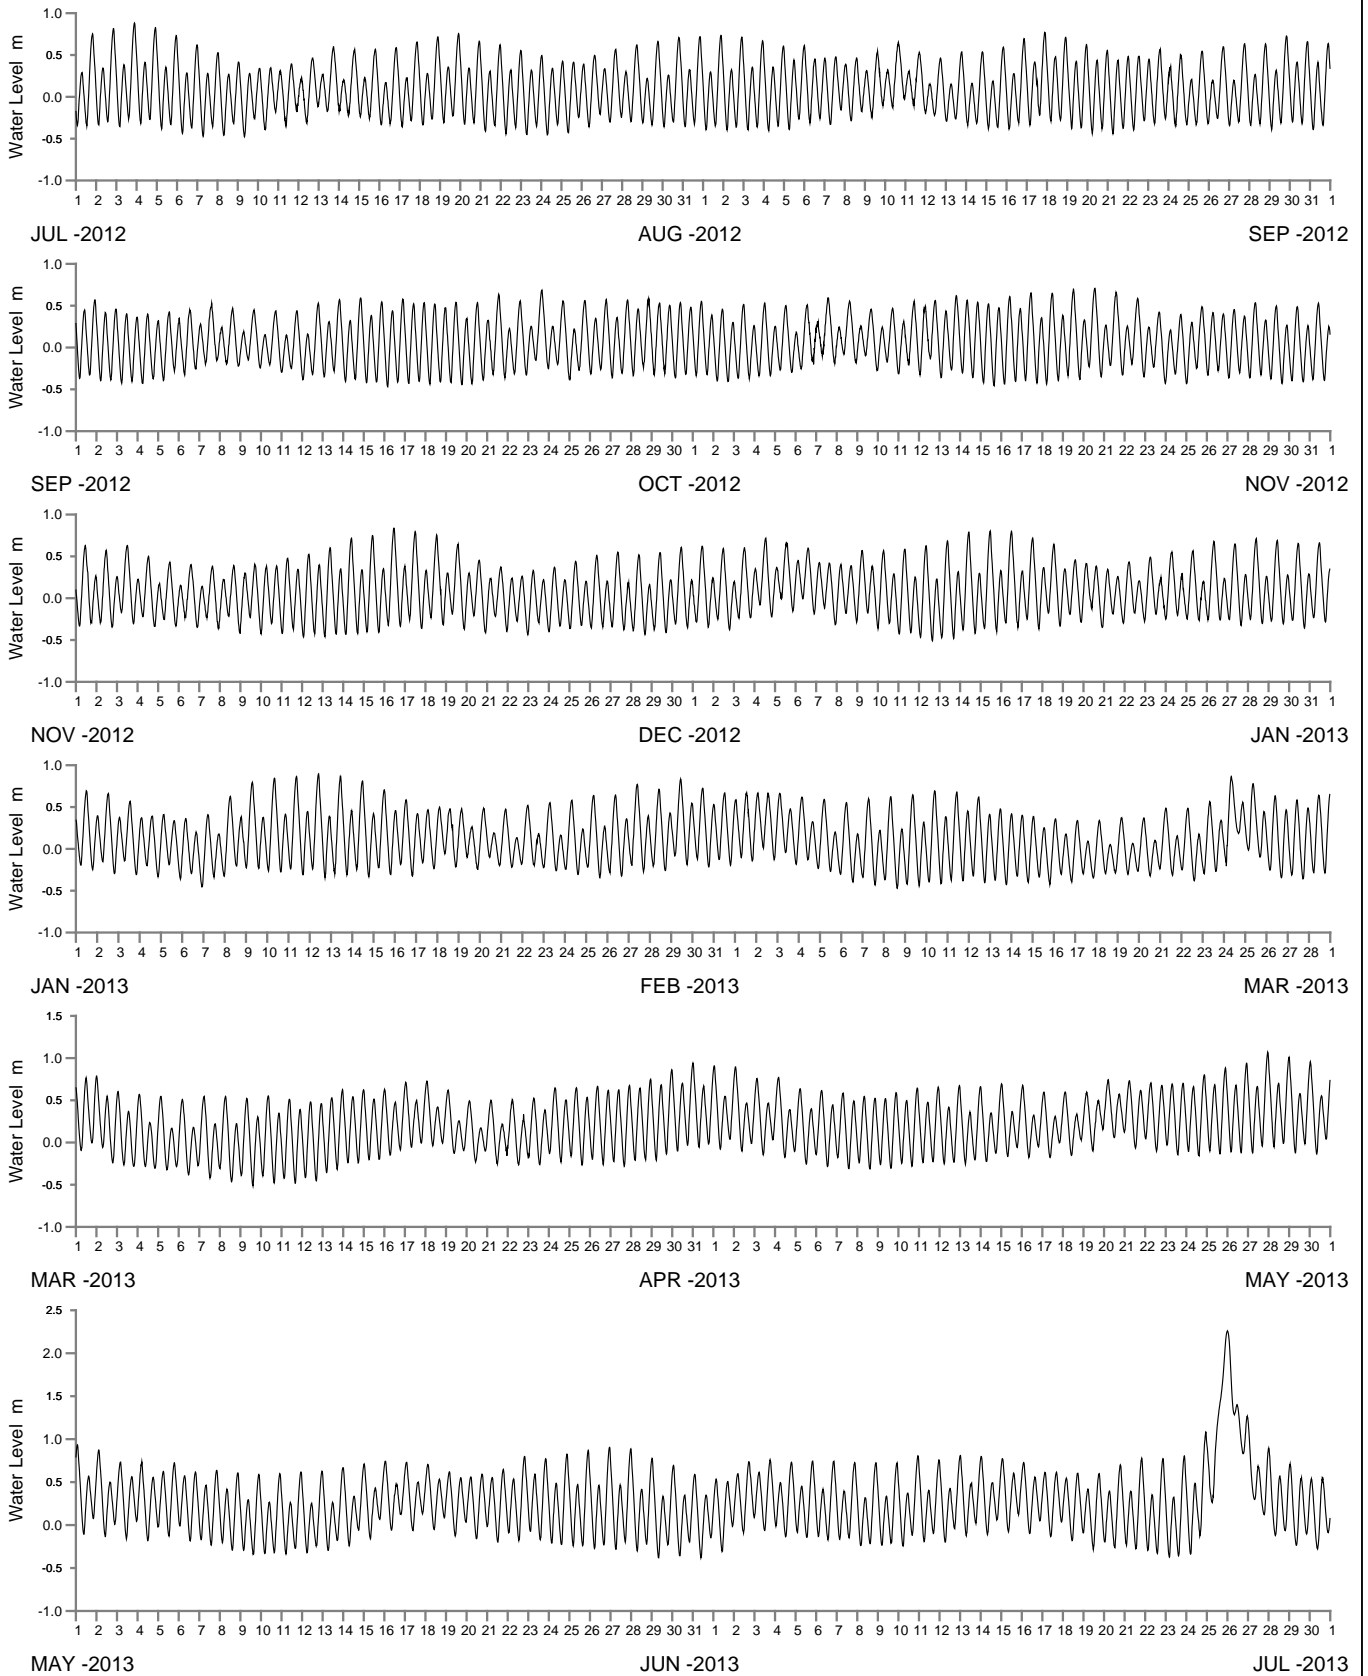
Figure
227

WATER LEVEL REFERENCED TO AUSTRALIAN HEIGHT DATUM

SHOALHAVEN RIVER AT SHOALHAVEN HEADS
2012-2013

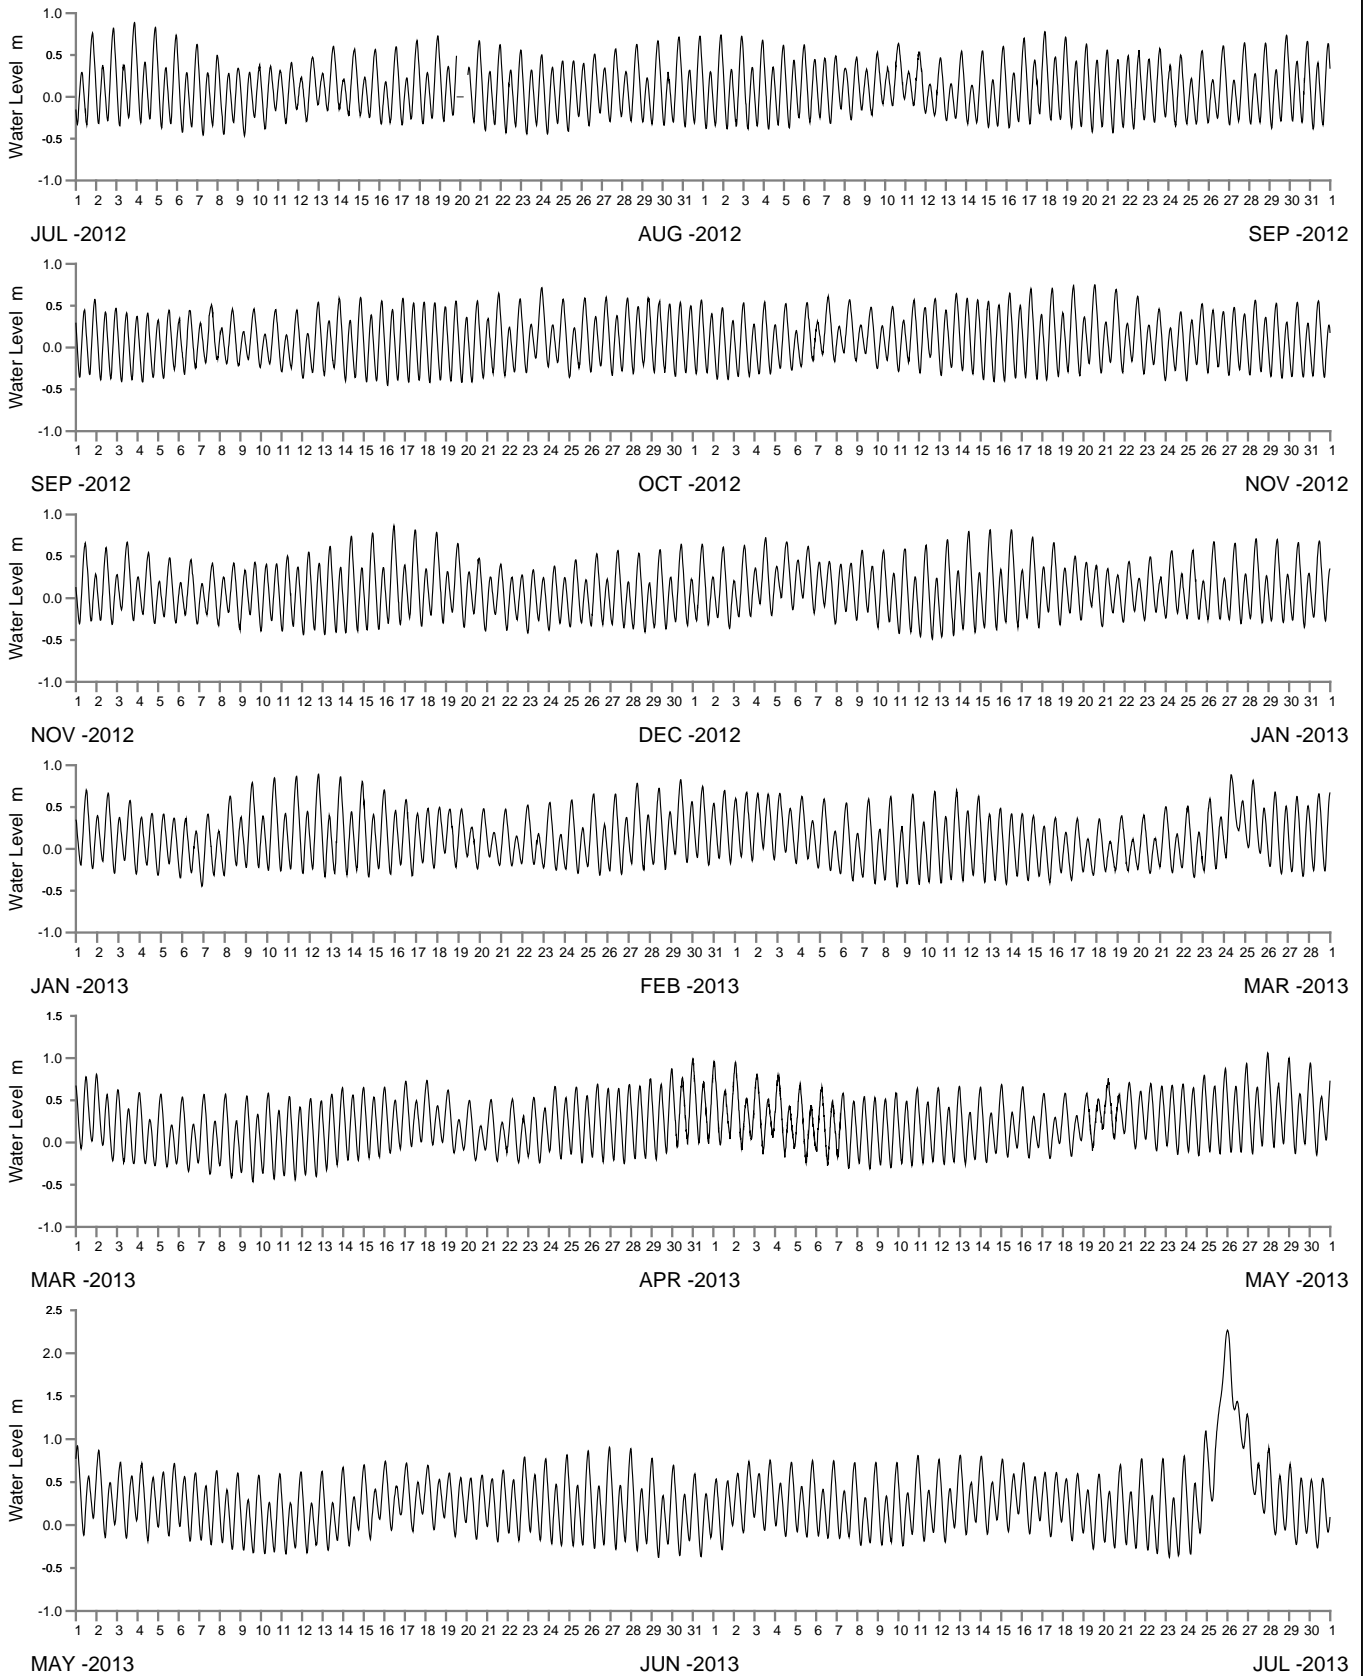
Figure
228

WATER LEVEL REFERENCED TO AUSTRALIAN HEIGHT DATUM

SHOALHAVEN RIVER AT HAY STREET
2012-2013

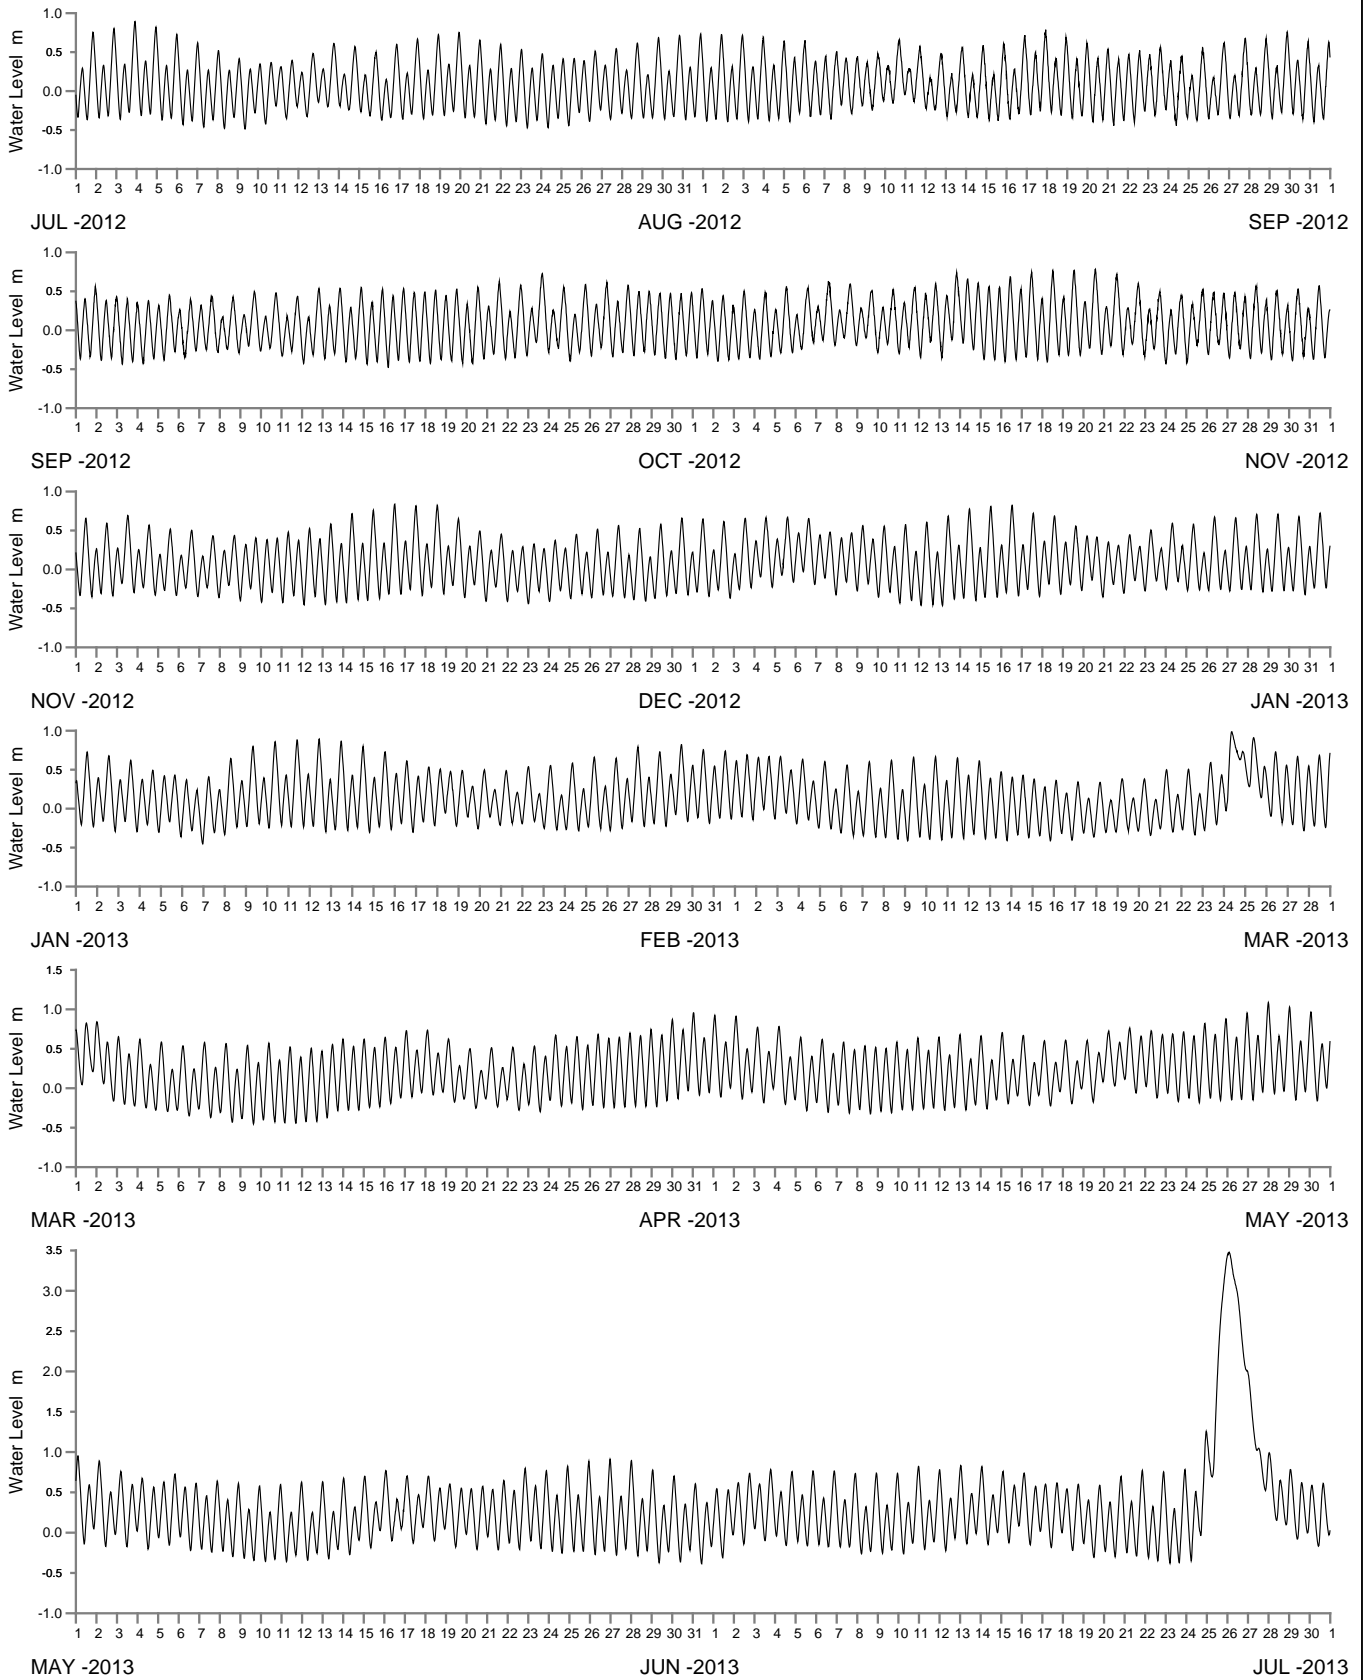
Figure
229

WATER LEVEL REFERENCED TO AUSTRALIAN HEIGHT DATUM

SHOALHAVEN RIVER AT TERARA
2012-2013

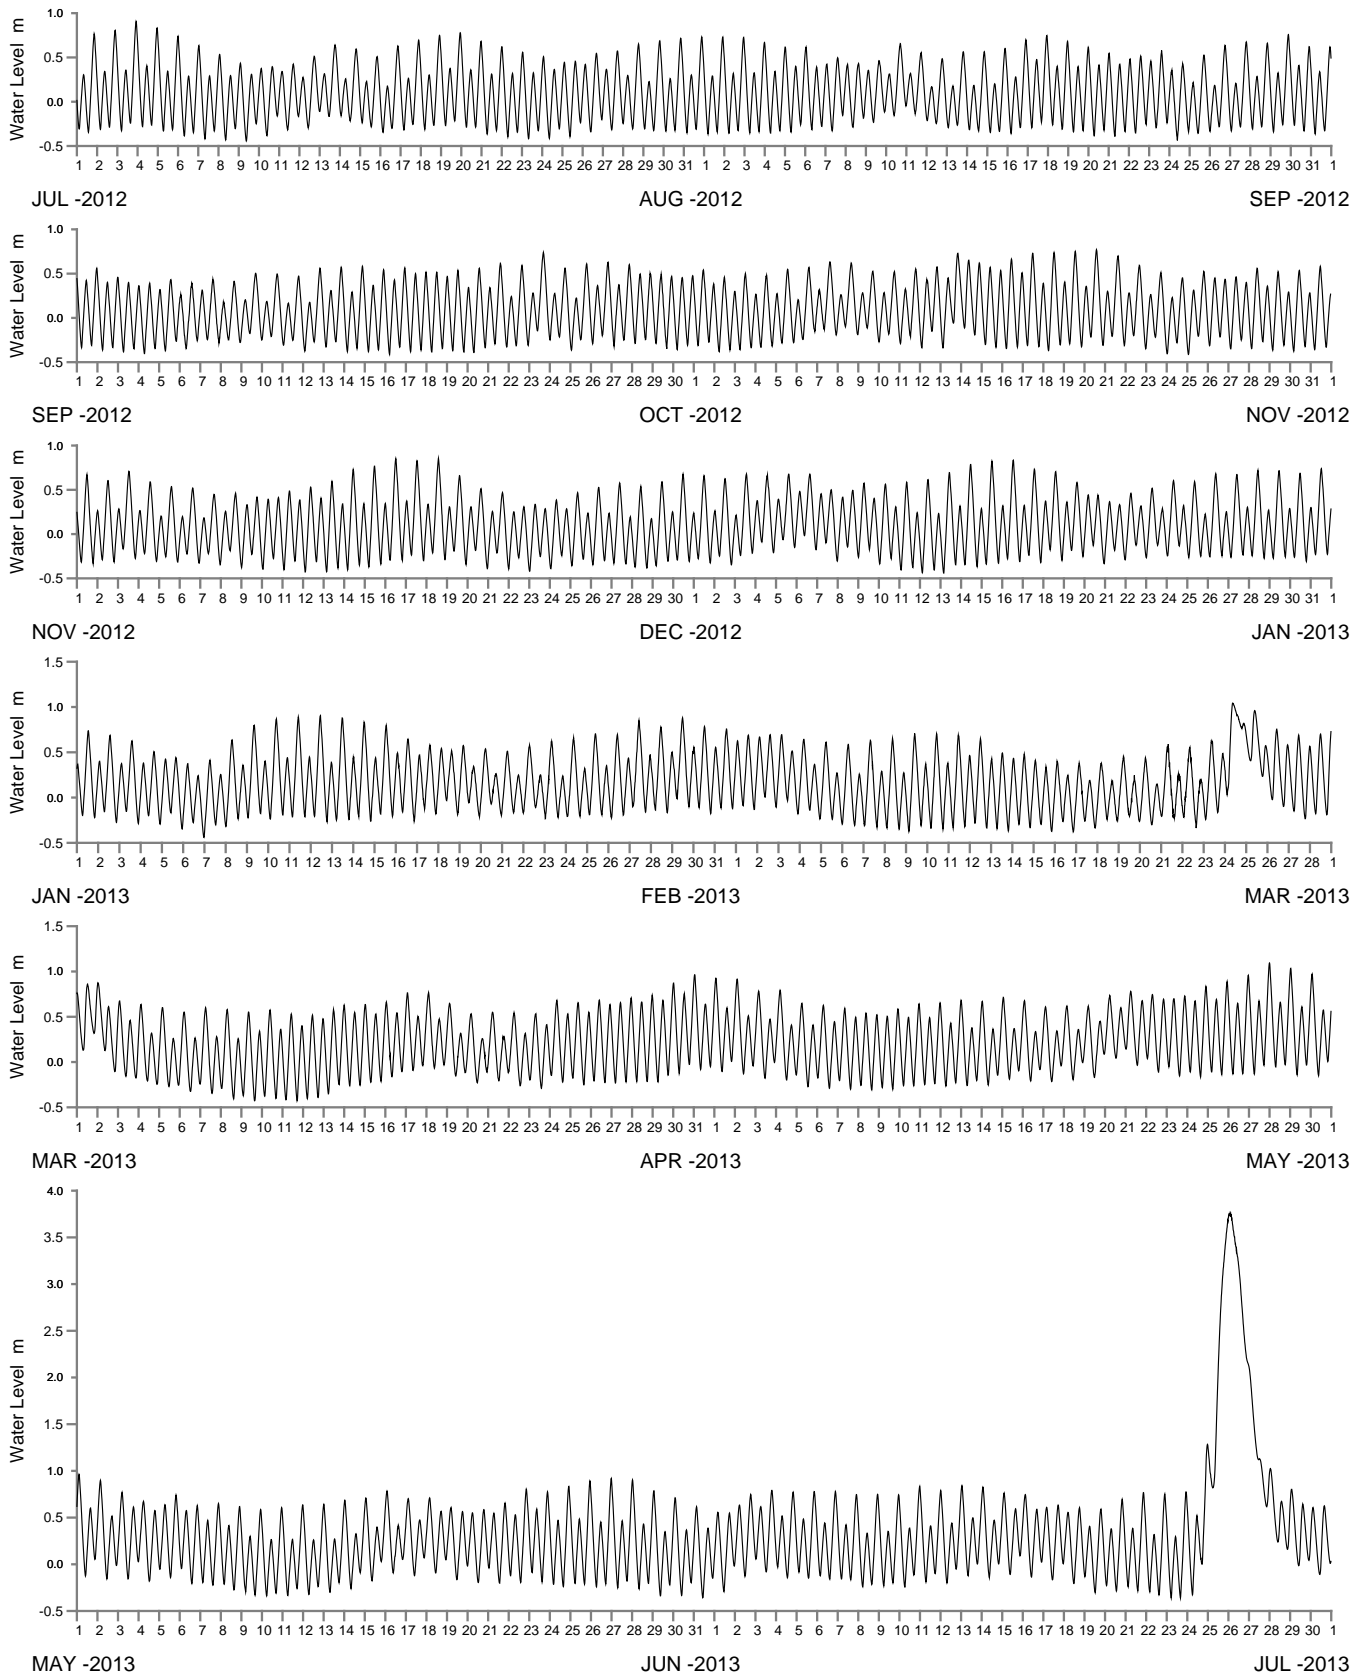
Figure
230

WATER LEVEL REFERENCED TO AUSTRALIAN HEIGHT DATUM

SHOALHAVEN RIVER AT NOWRA BRIDGE
2012-2013

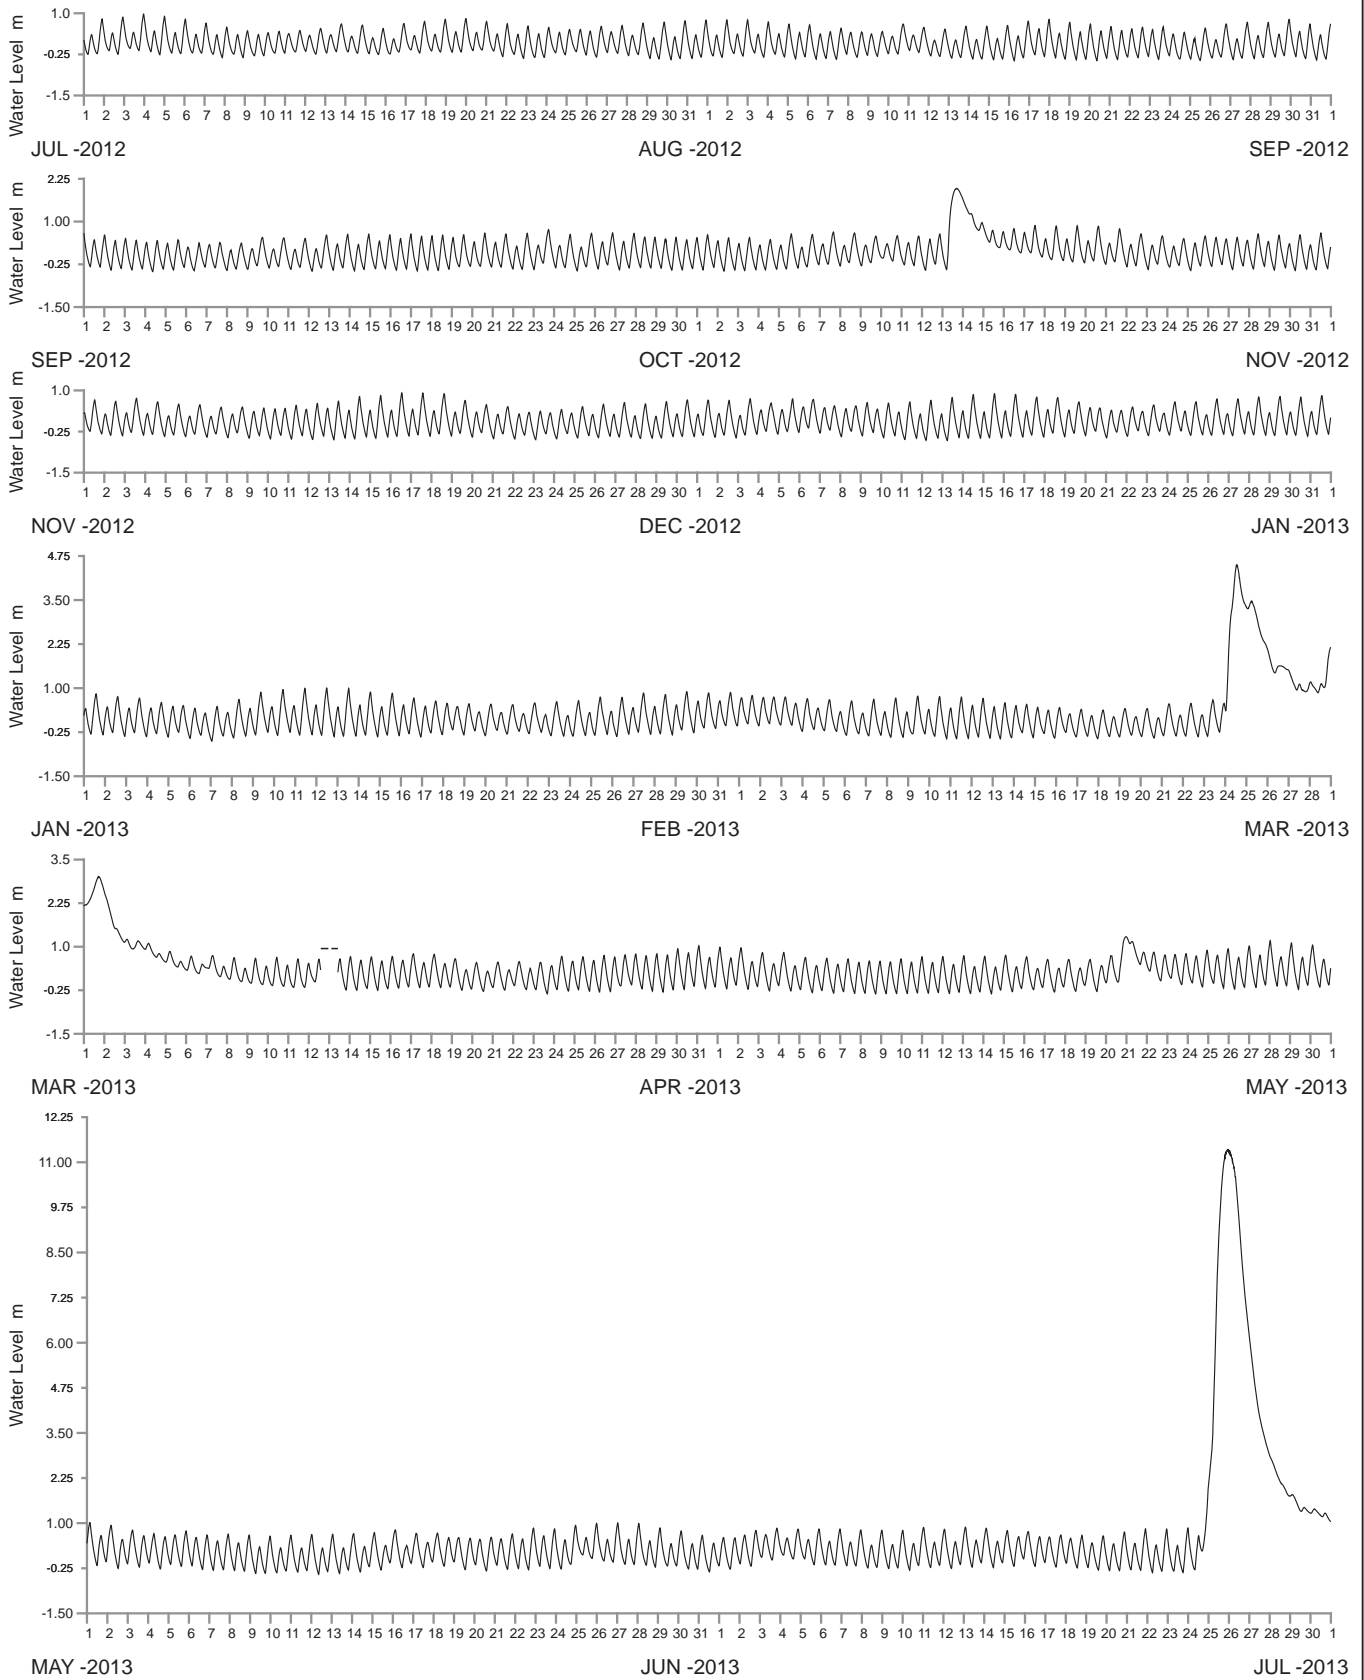
Figure
231

WATER LEVEL REFERENCED TO AUSTRALIAN HEIGHT DATUM

SHOALHAVEN RIVER AT GRADYS CARAVAN PARK
2012-2013

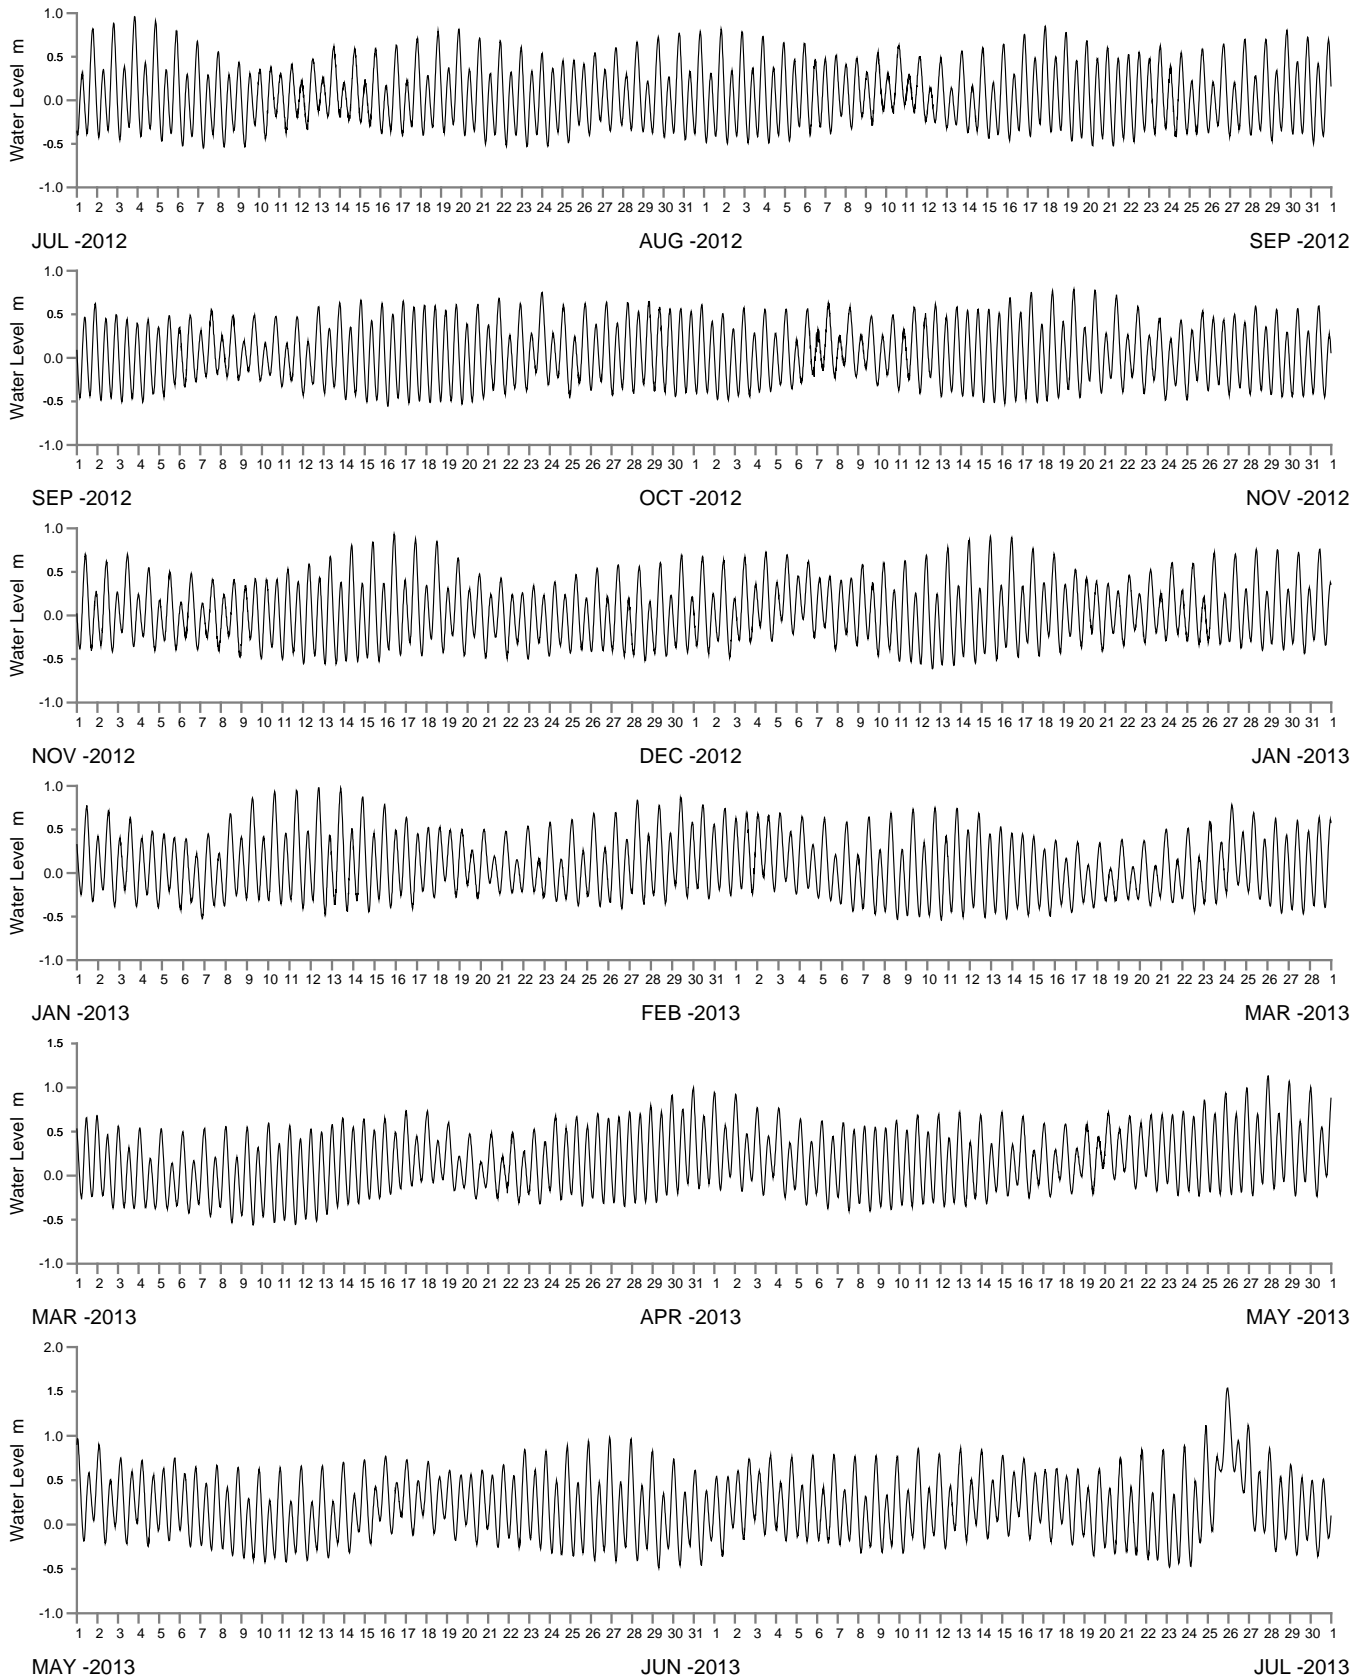
Figure
232

WATER LEVEL REFERENCED TO AUSTRALIAN HEIGHT DATUM

SHOALHAVEN RIVER AT GREENWELL POINT
2012-2013

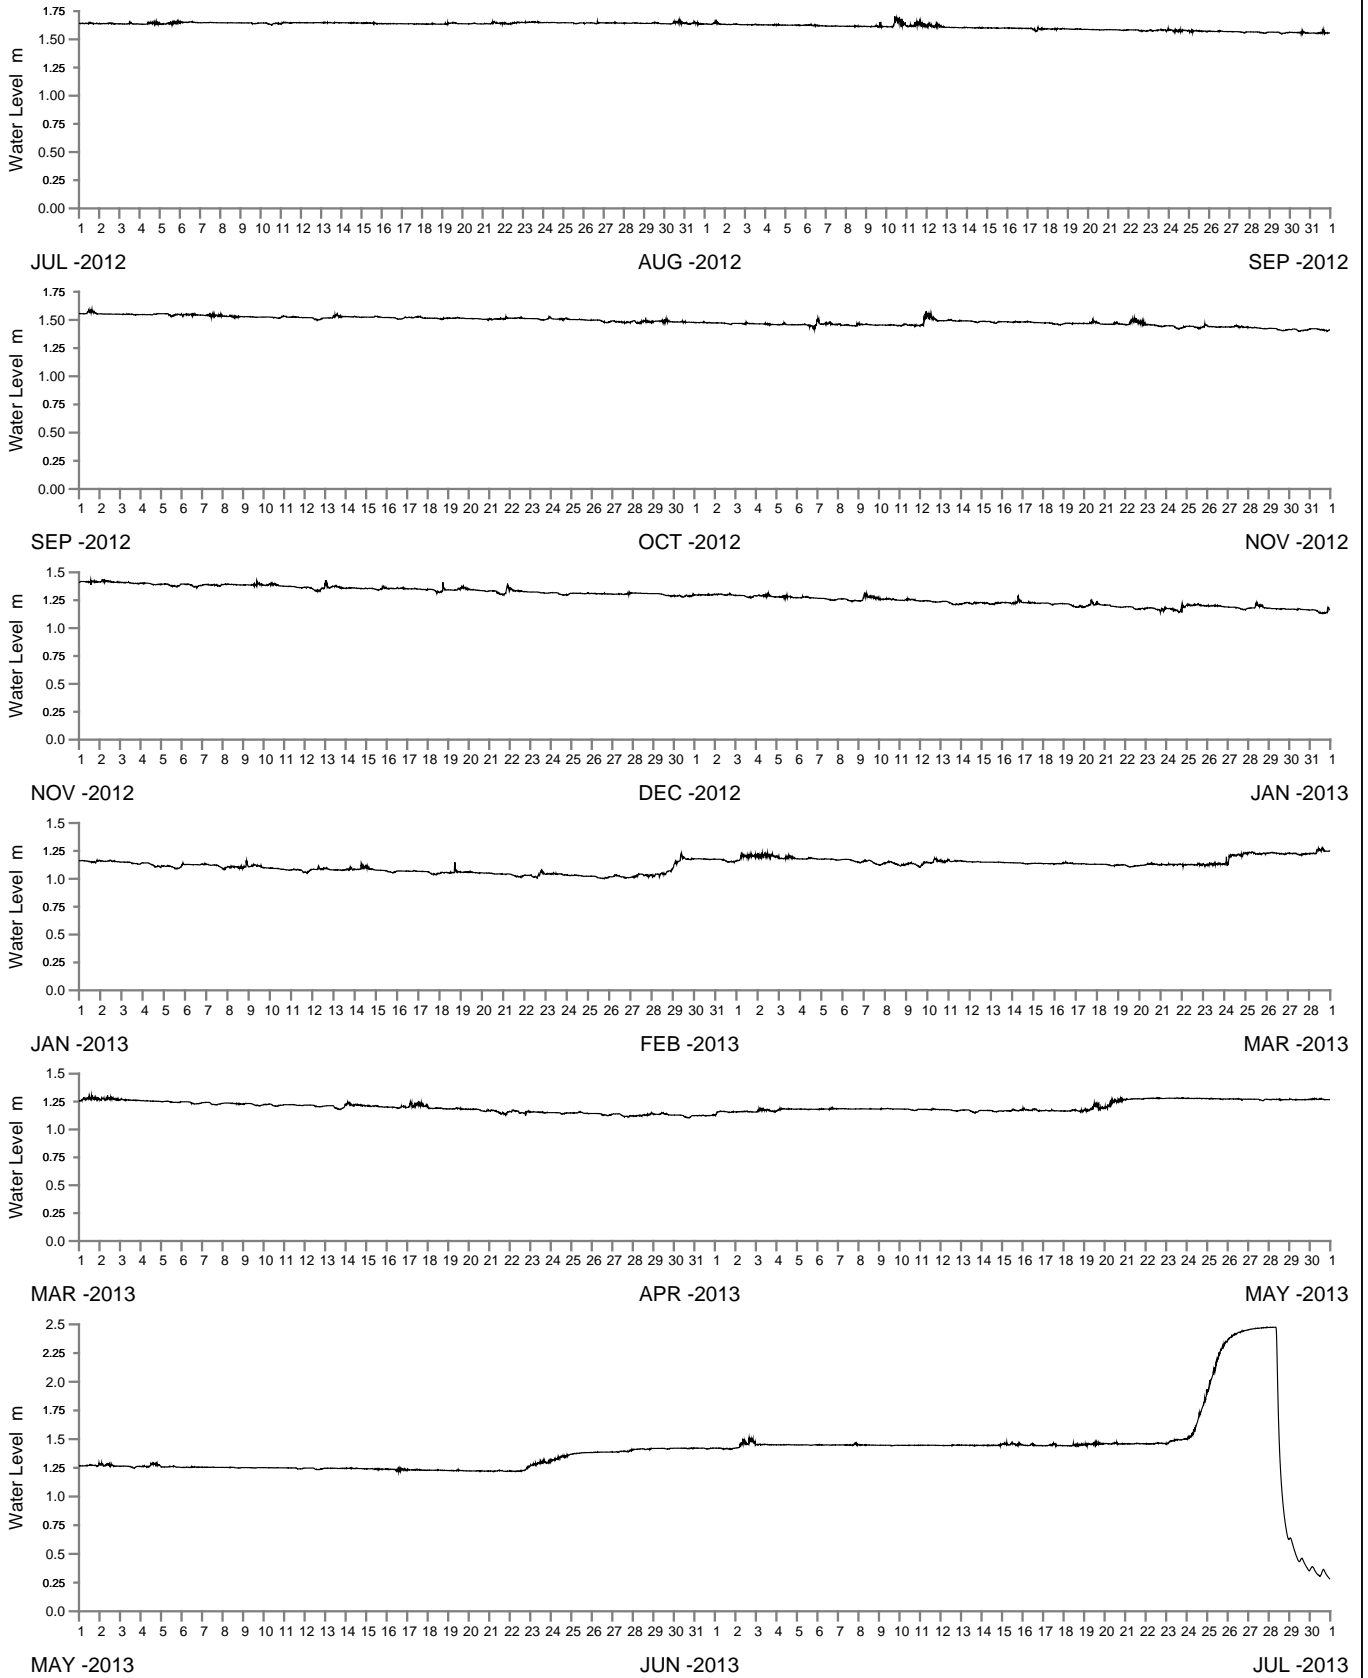
Figure
233

WATER LEVEL REFERENCED TO AUSTRALIAN HEIGHT DATUM

WOLLUMBOOLA LAKE AT WOLLUMBOOLA
2012-2013
