Public Works
Manly Hydraulics Laboratory

**STATION LOCATIONS
WOLLONGONG REGION**

MHL
Report 2218
**Figure
198**
DRAWING 2218-198.cdr

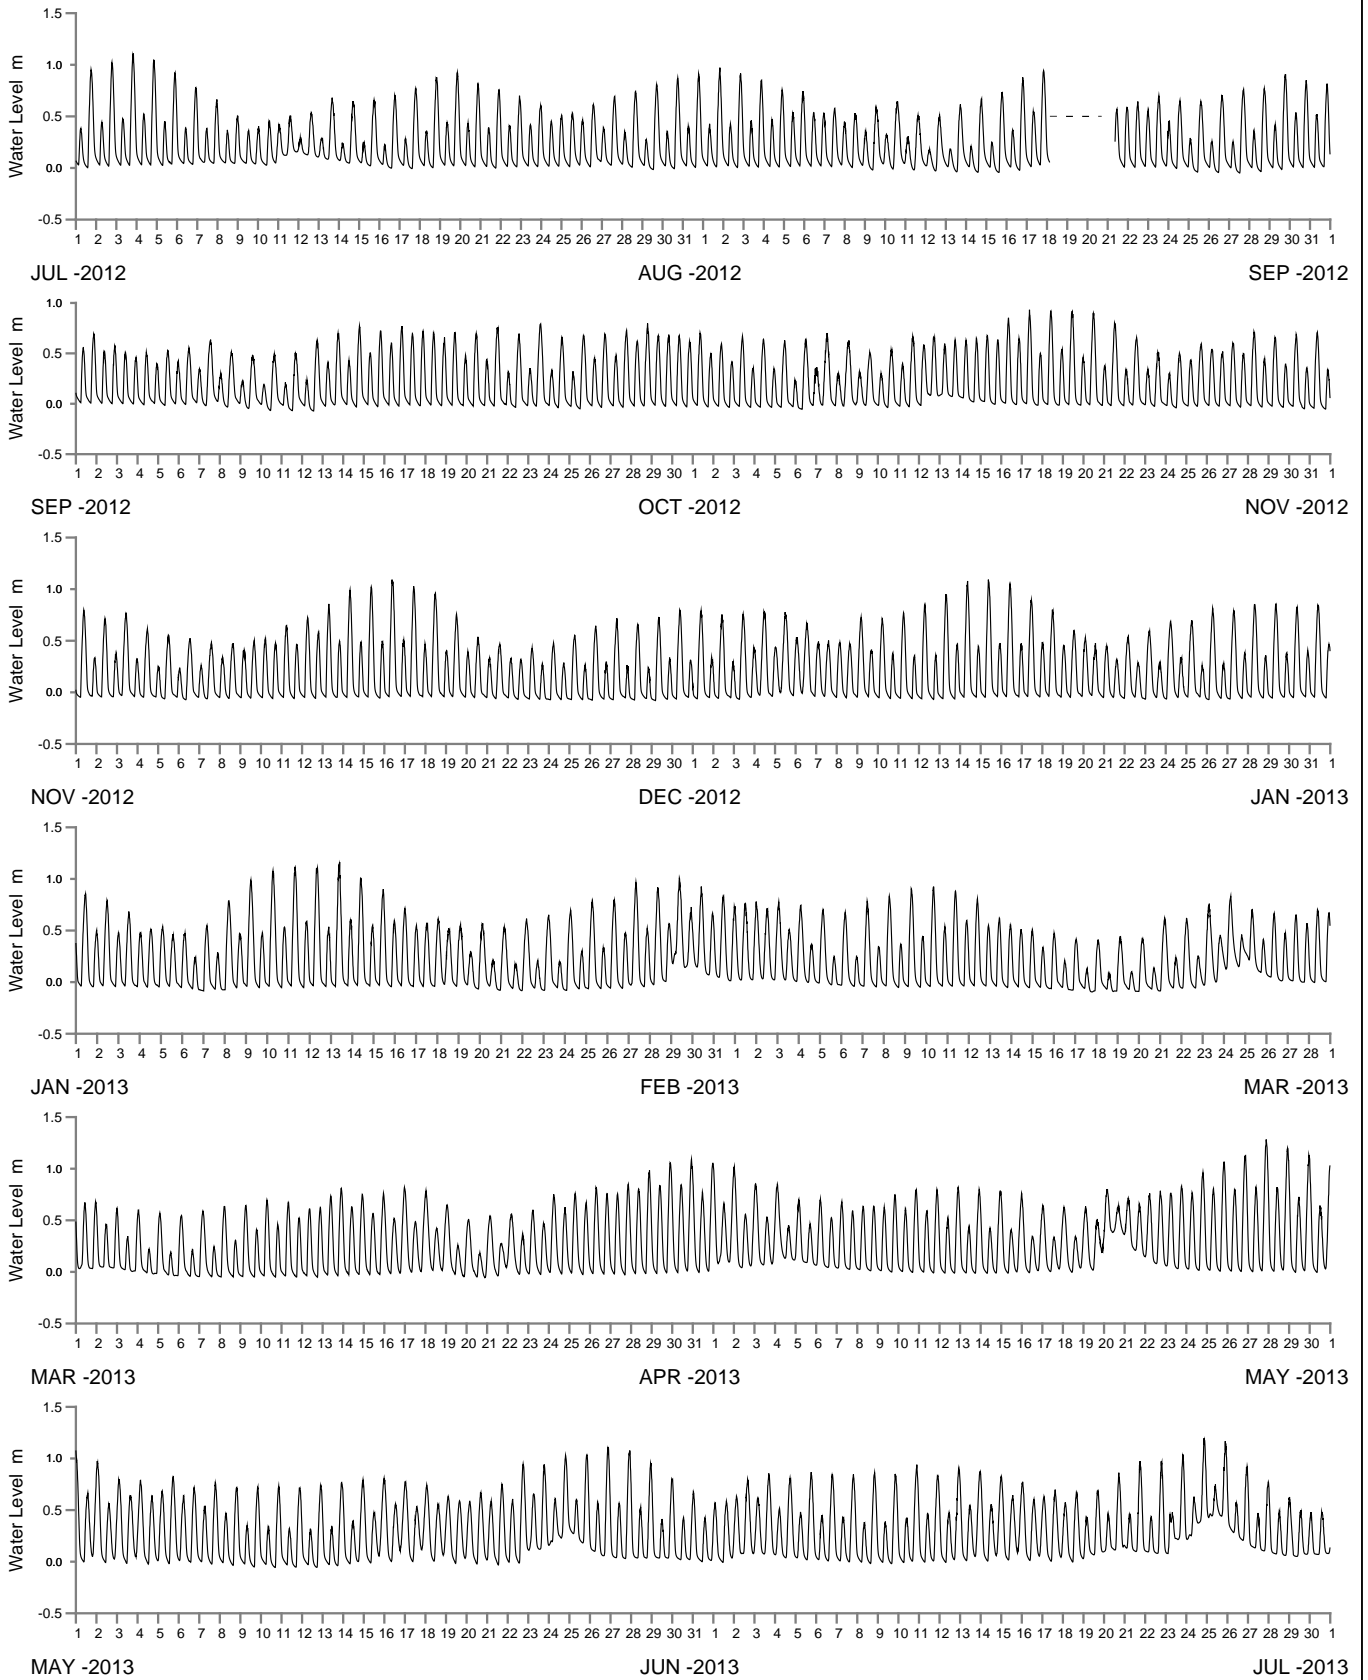
Figure
235

WATER LEVEL REFERENCED TO AUSTRALIAN HEIGHT DATUM

CURRARONG CREEK AT CURRARONG CREEK
2012-2013

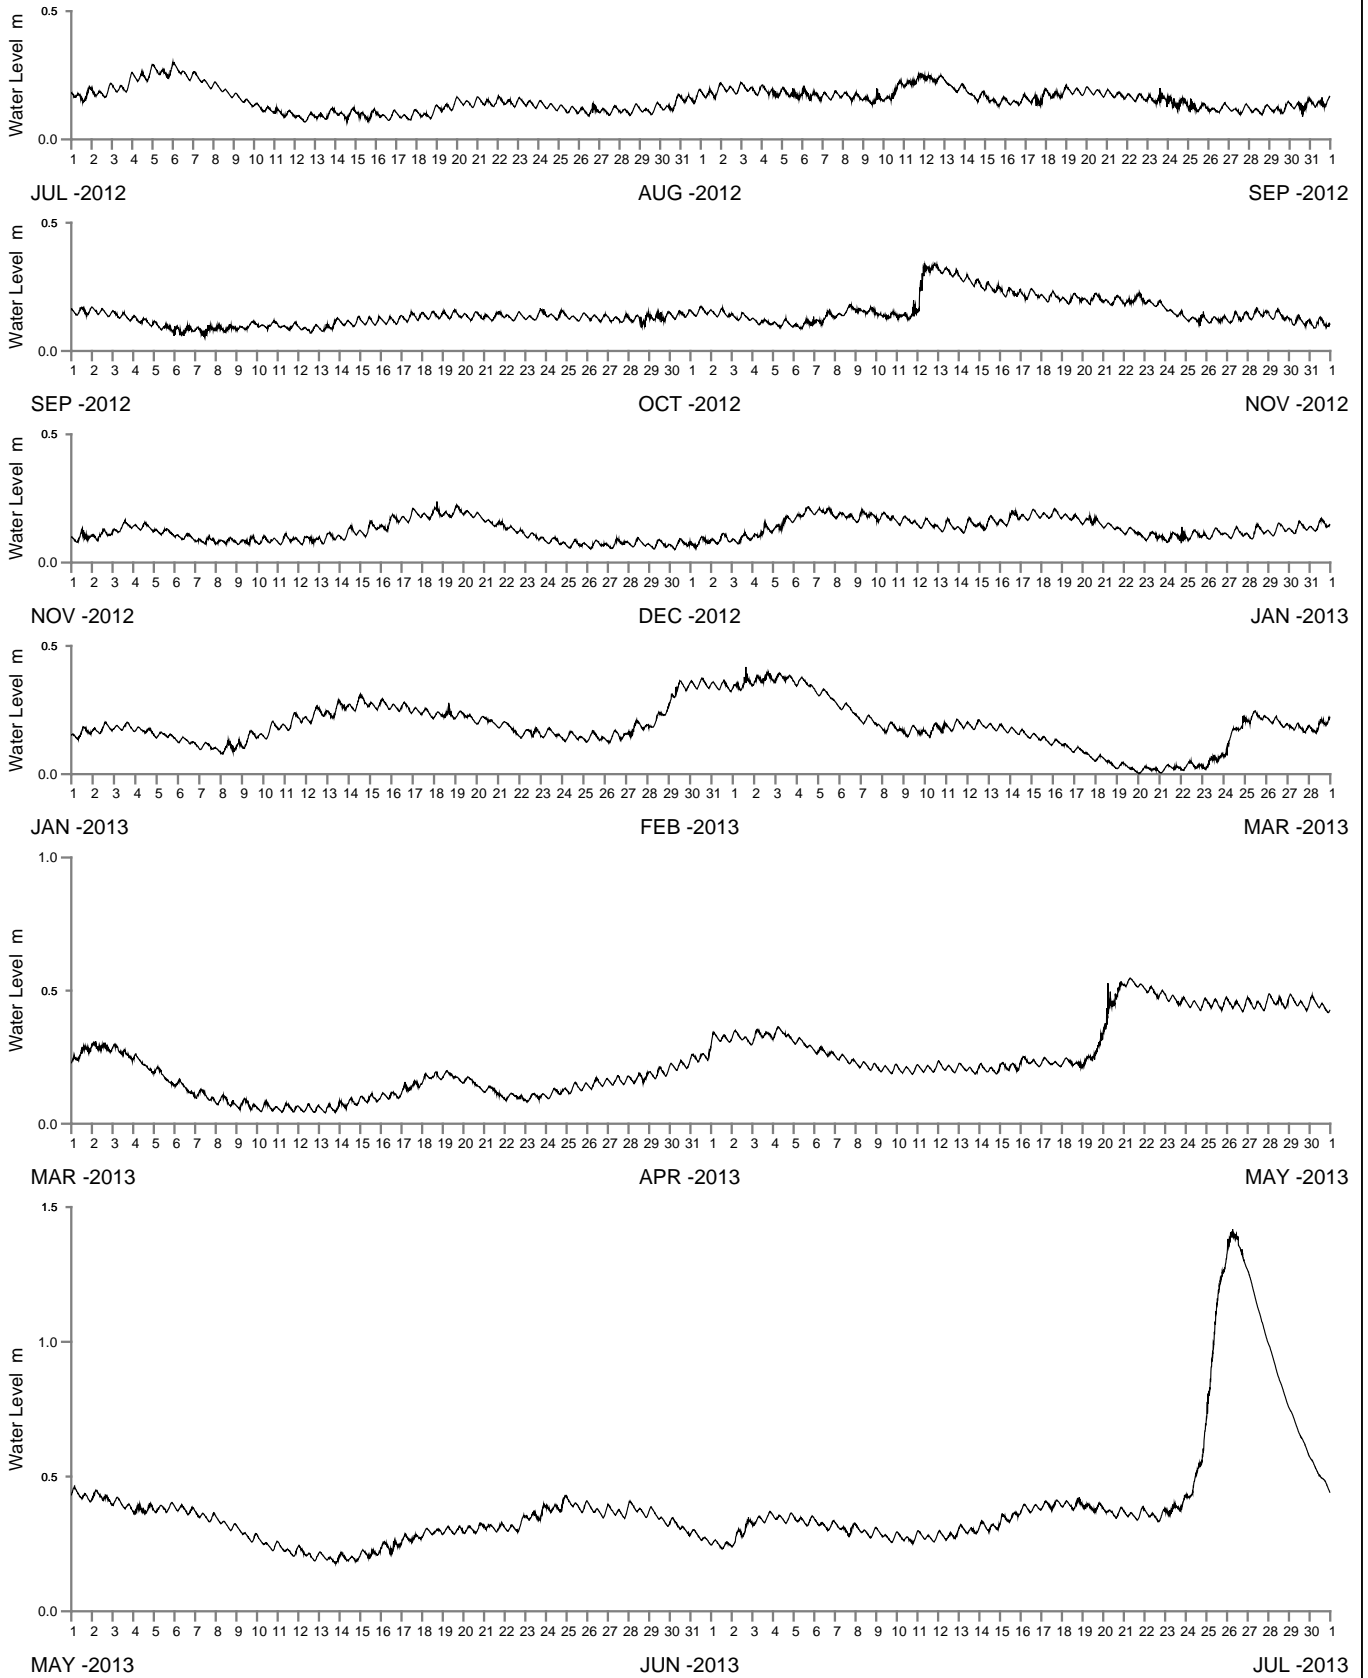
Figure
236

WATER LEVEL REFERENCED TO AUSTRALIAN HEIGHT DATUM

ST GEORGES BASIN AT ISLAND POINT
2012-2013

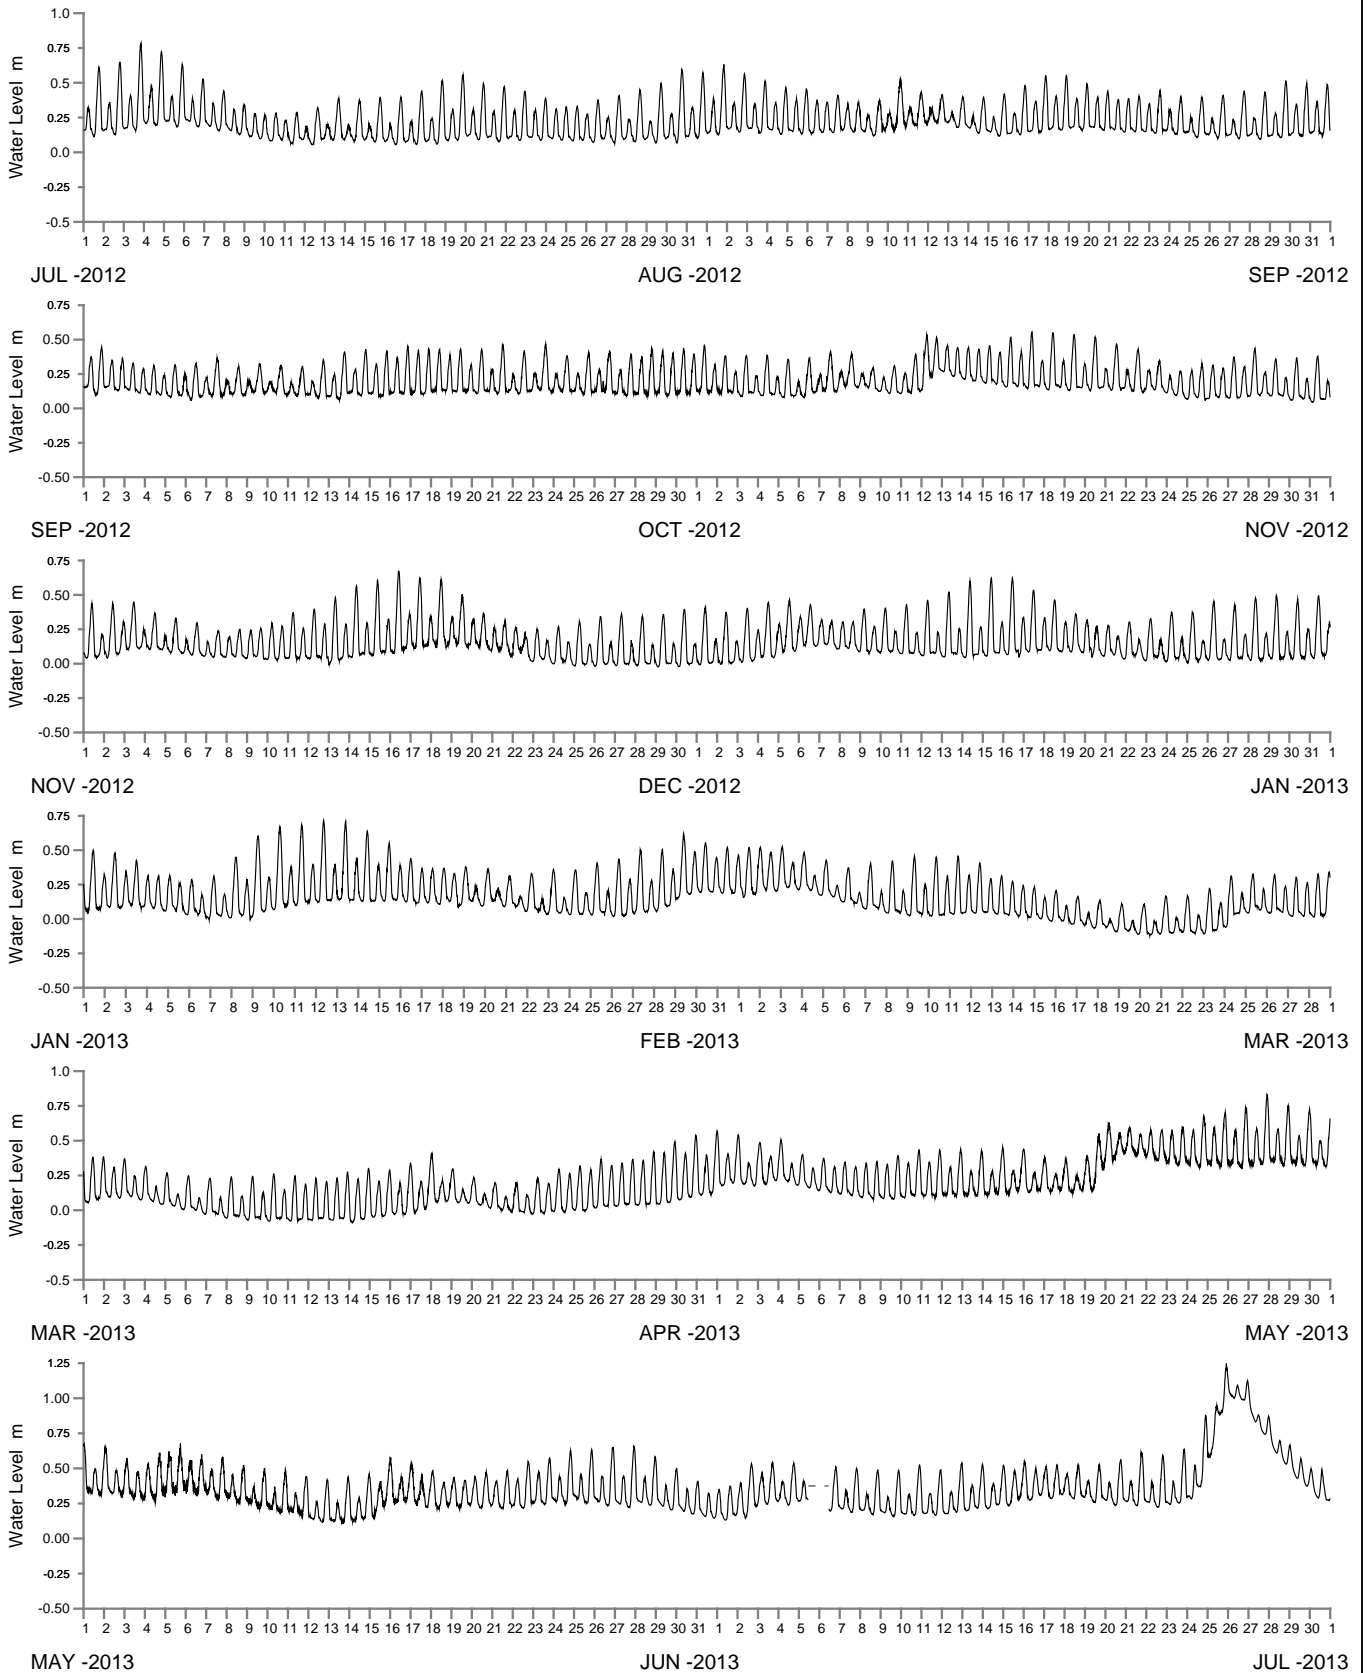
Figure
237

WATER LEVEL REFERENCED TO AUSTRALIAN HEIGHT DATUM

SUSSEX INLET AT SUSSEX INLET
2012-2013

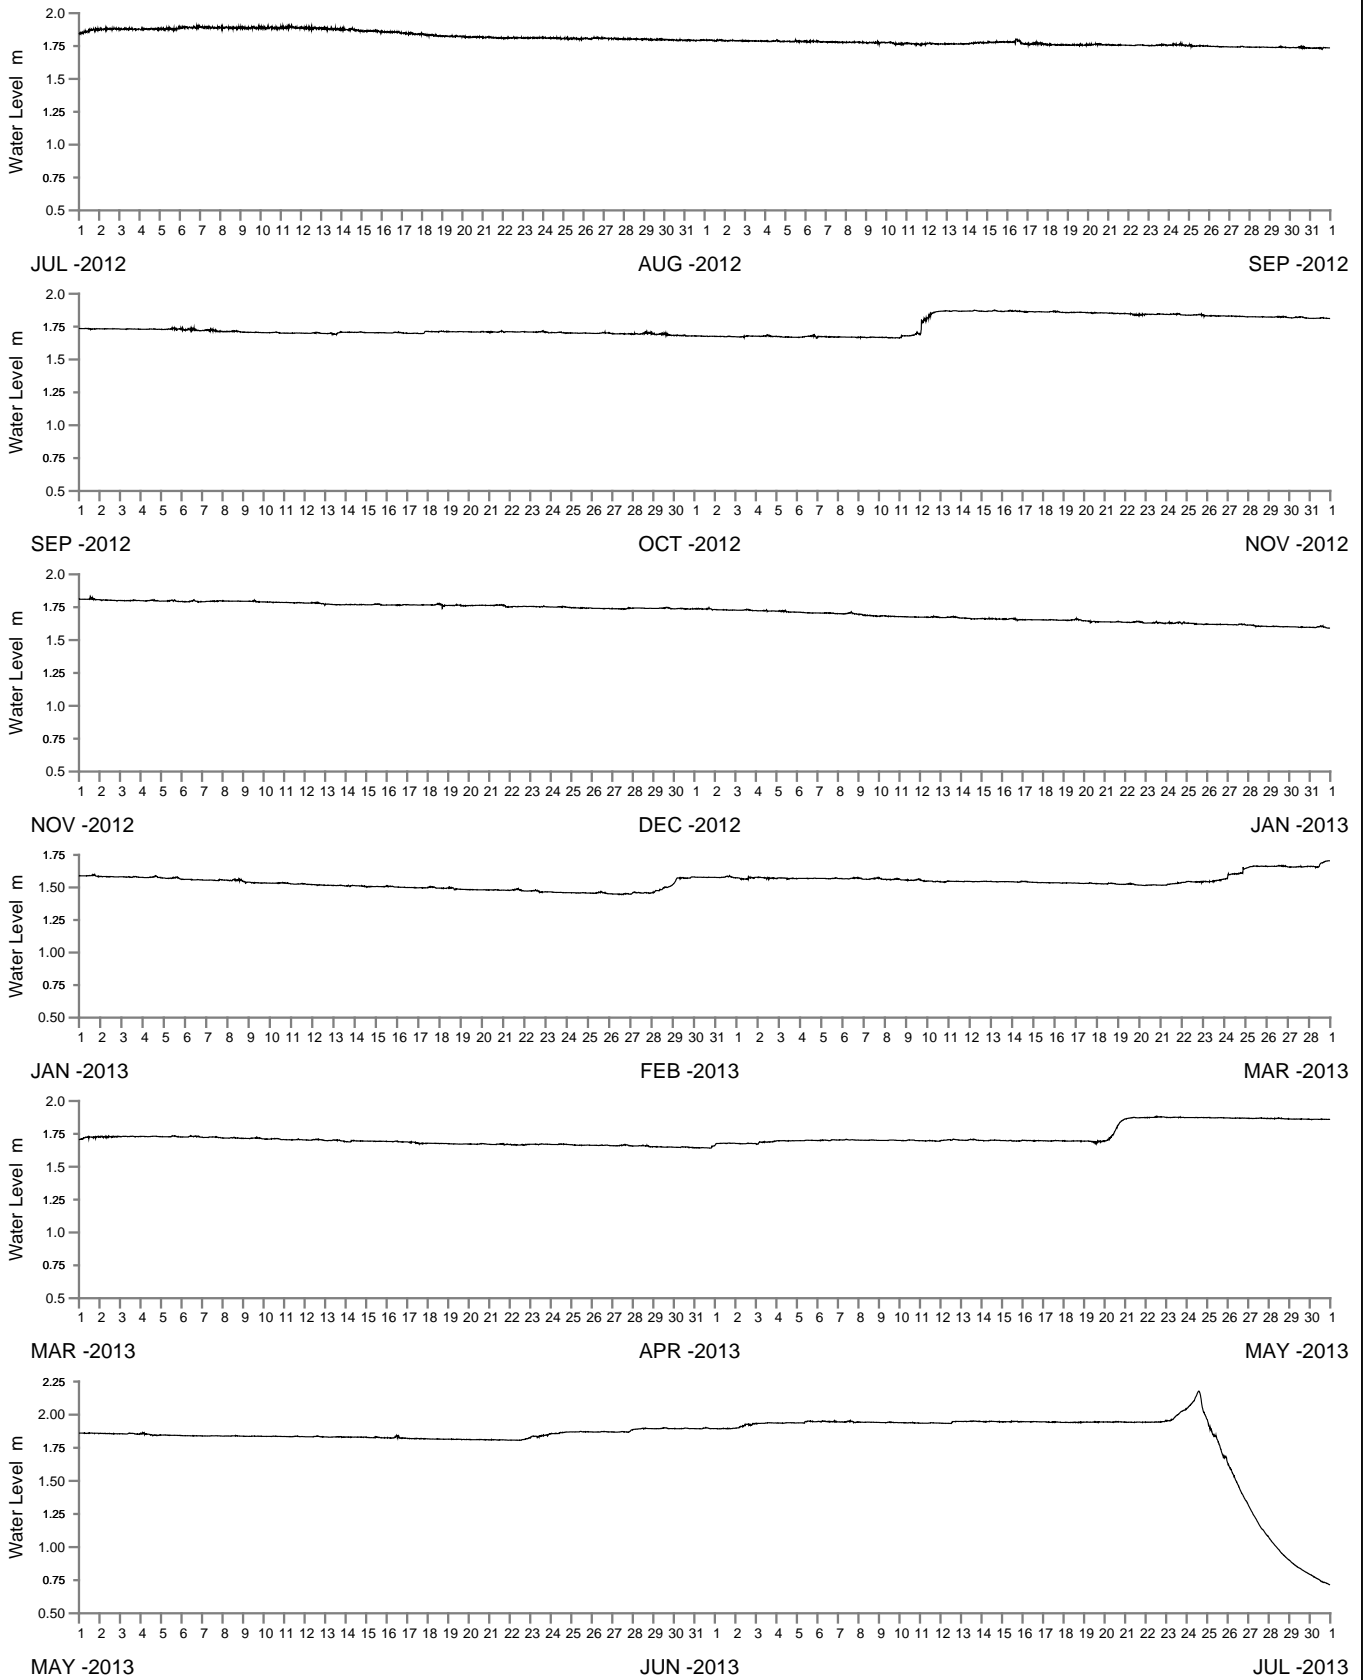
Figure
238

WATER LEVEL REFERENCED TO AUSTRALIAN HEIGHT DATUM

SWAN LAKE AT SWAN LAKE
2012-2013

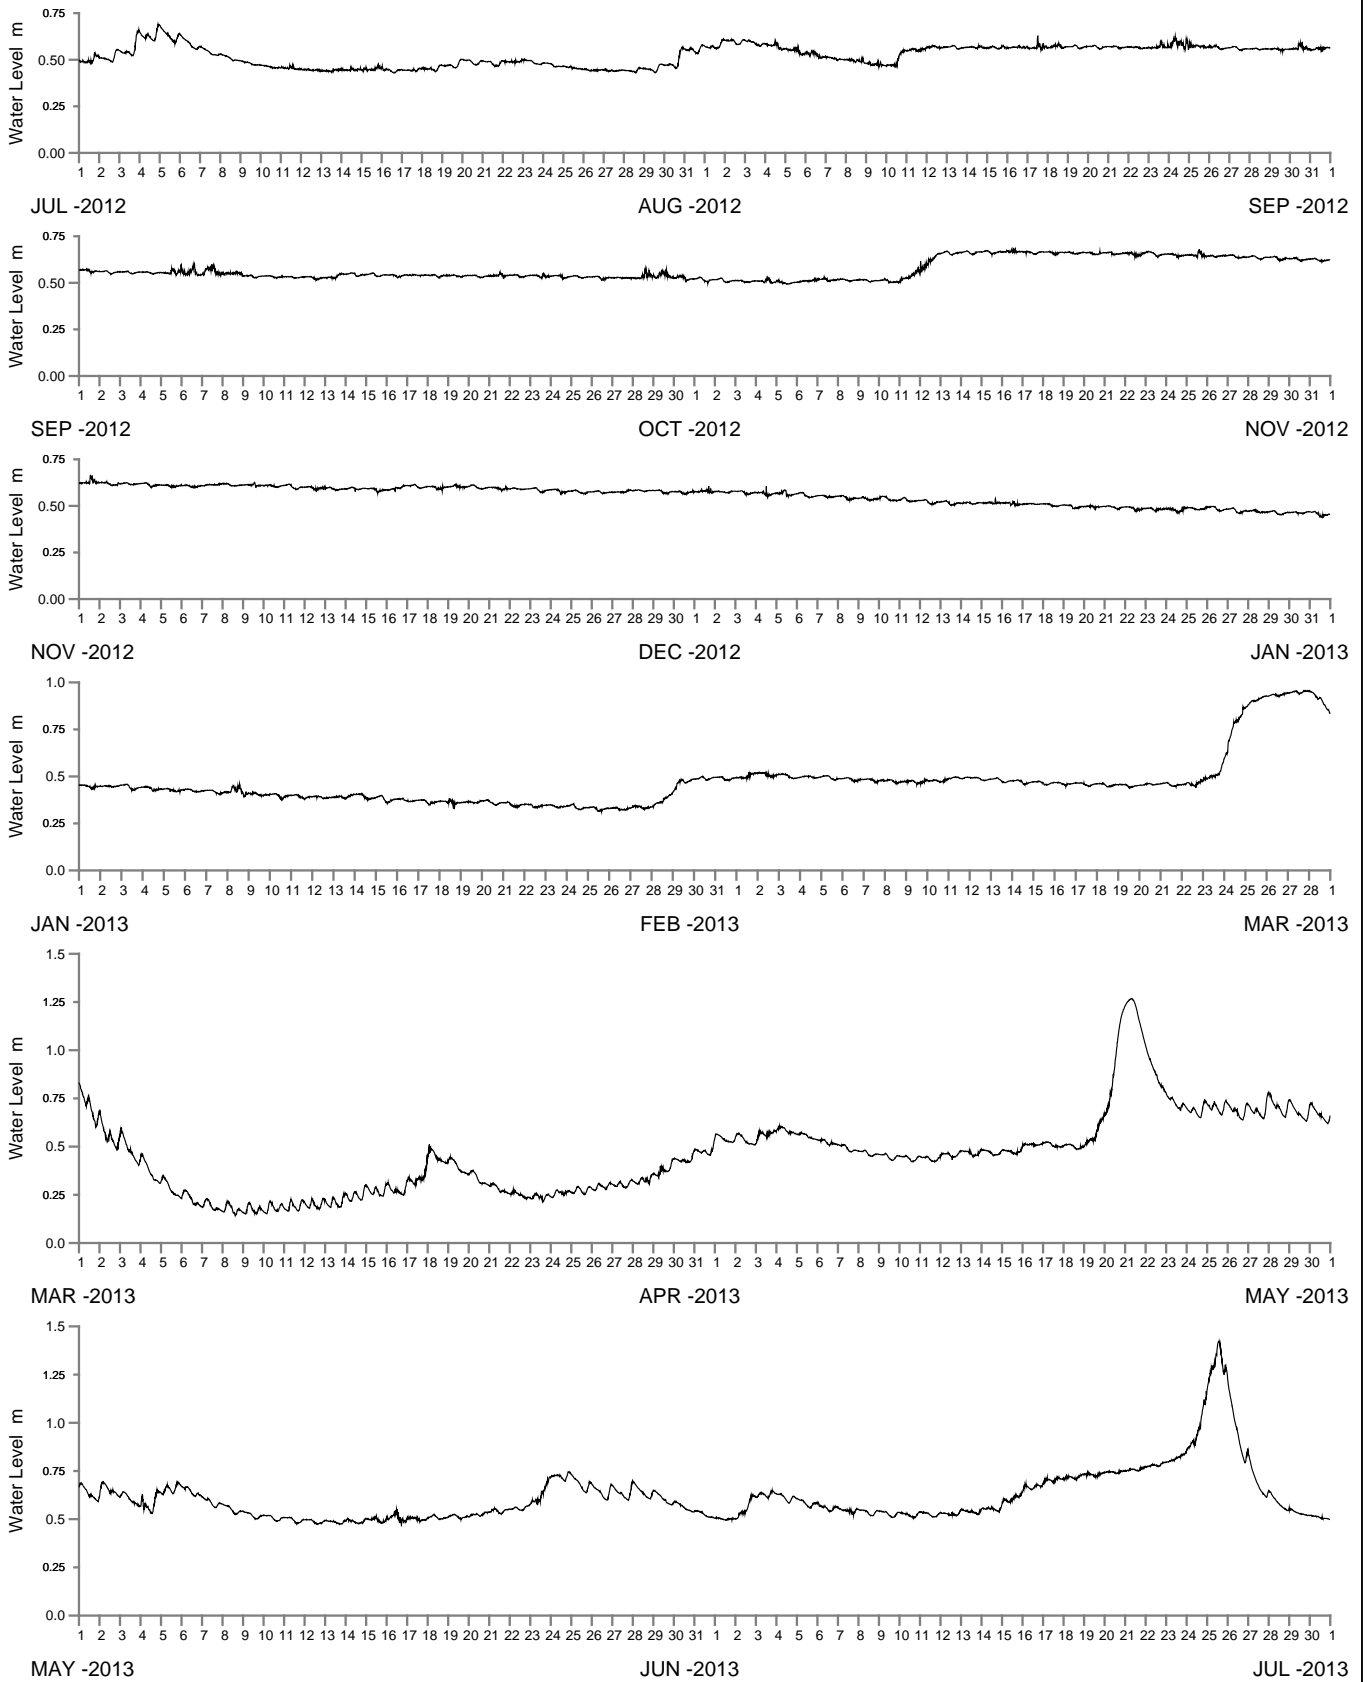
Figure
240

WATER LEVEL REFERENCED TO AUSTRALIAN HEIGHT DATUM

LAKE CONJOLA AT LAKE CONJOLA
2012-2013

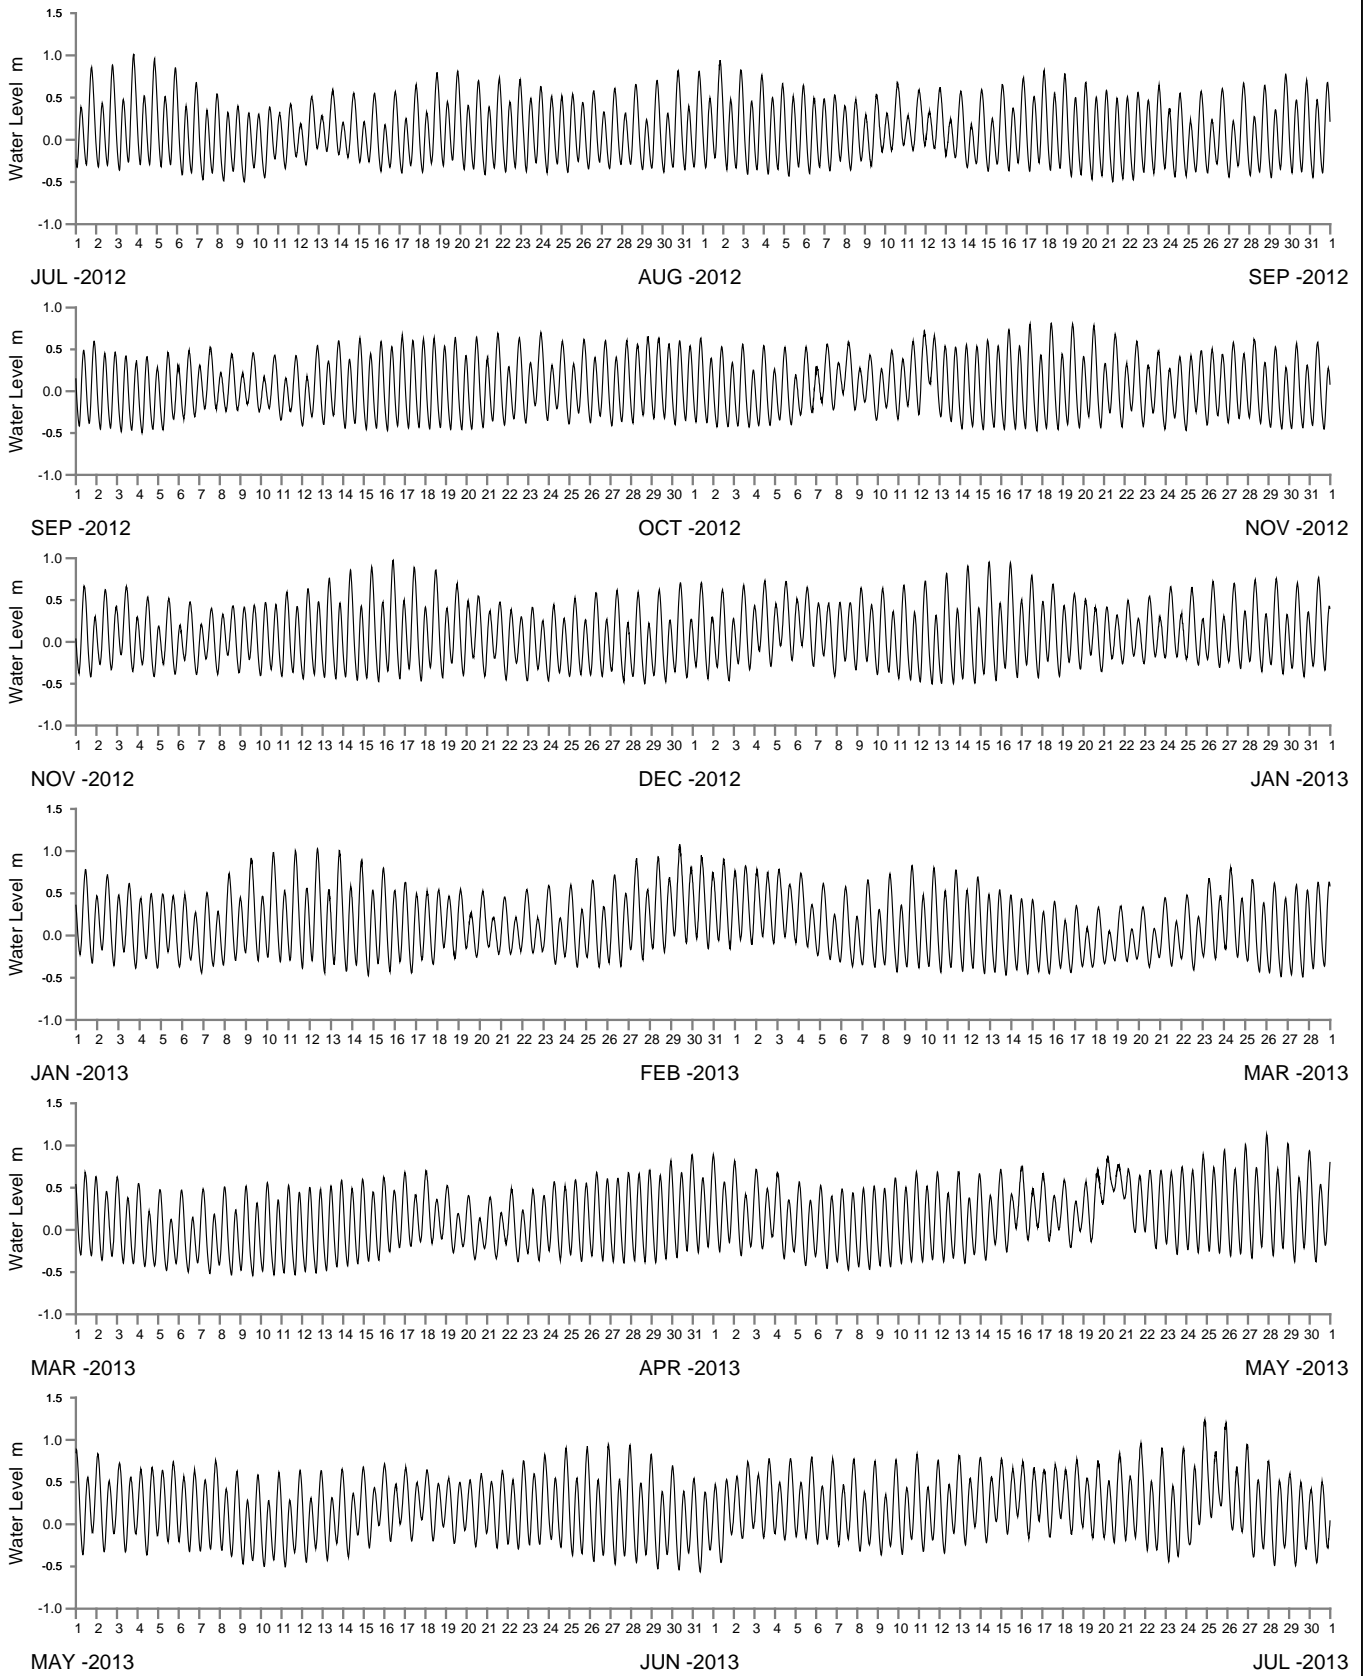
Figure
241

WATER LEVEL REFERENCED TO AUSTRALIAN HEIGHT DATUM

NARRAWALLEE INLET AT NARRAWALLEE
2012-2013

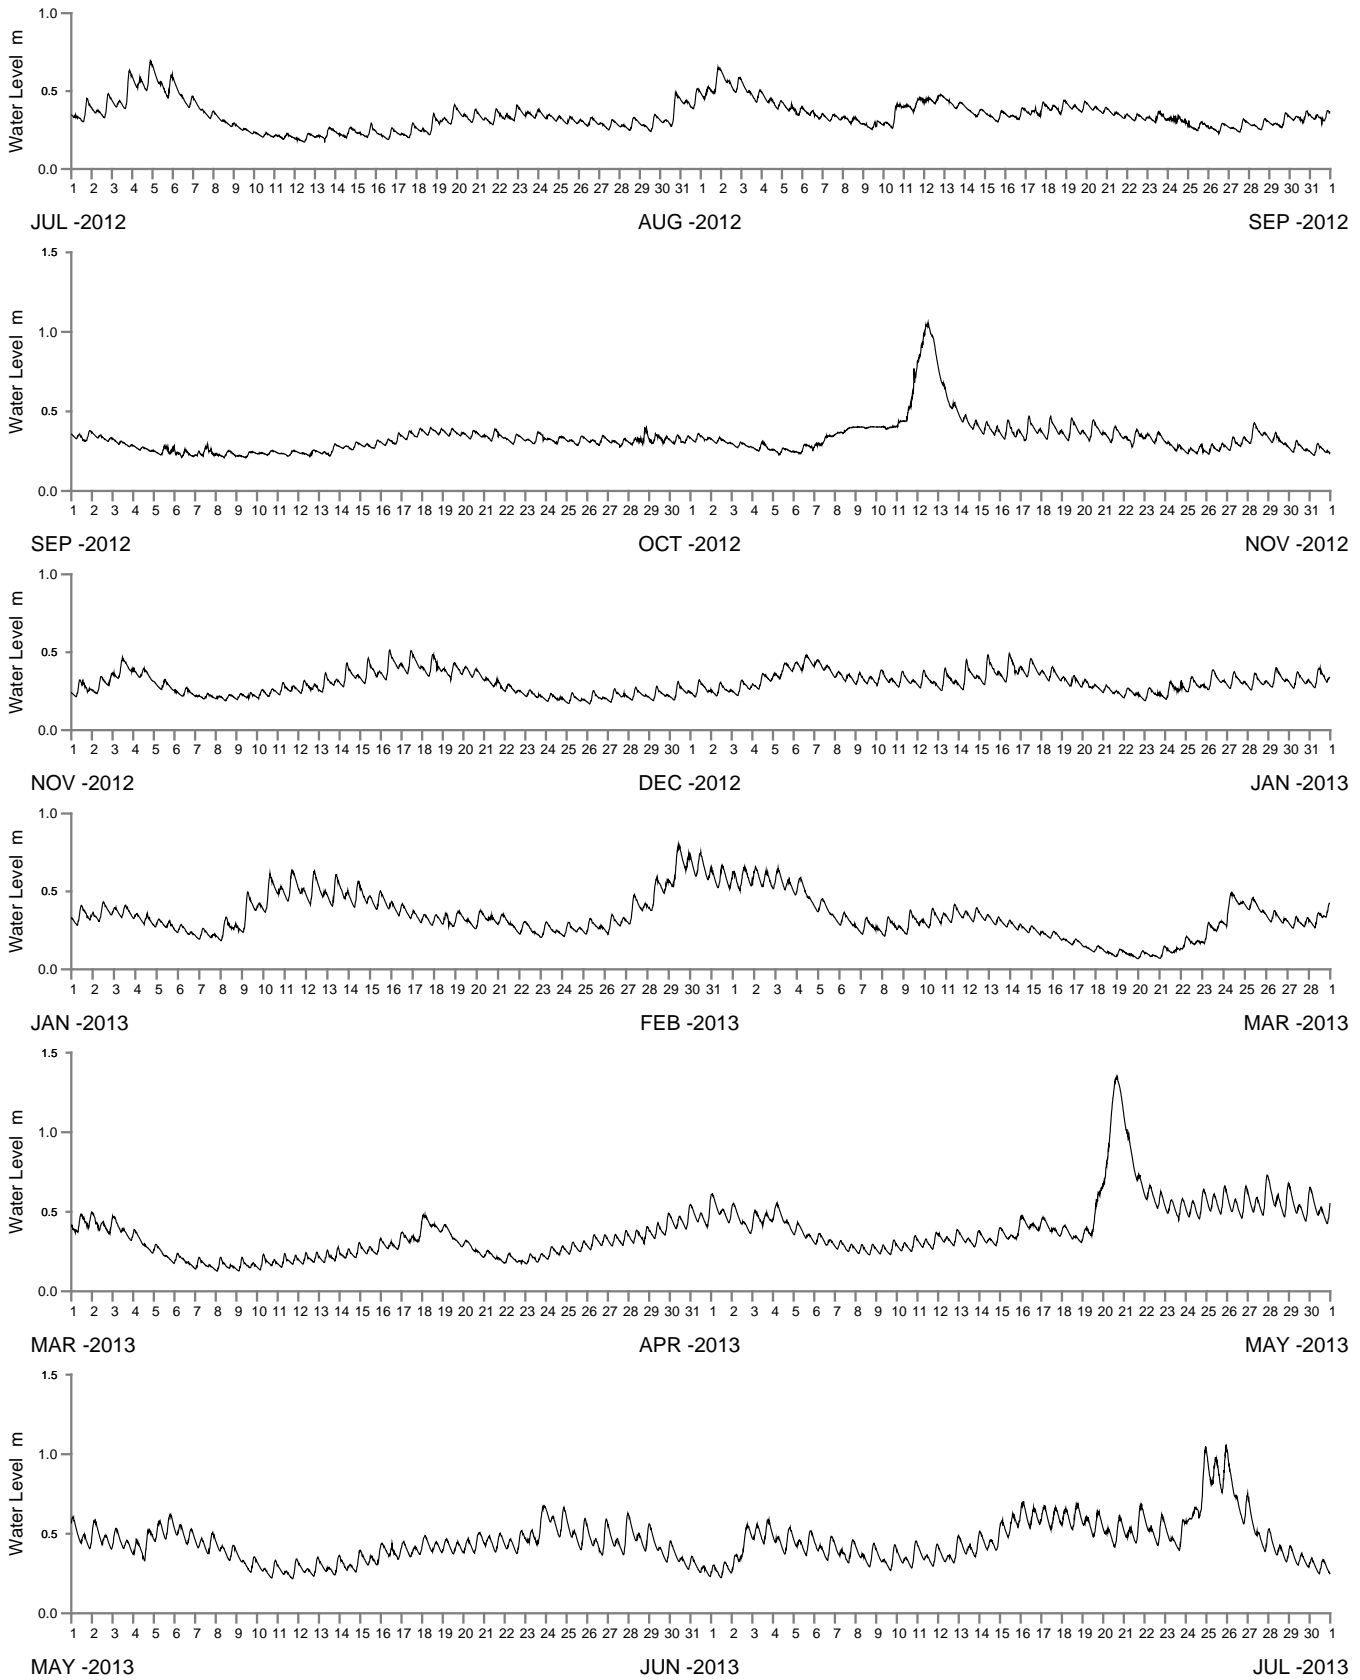
Figure
242

WATER LEVEL REFERENCED TO AUSTRALIAN HEIGHT DATUM

BURRILL LAKE AT BURRILL LAKE BRIDGE
2012-2013

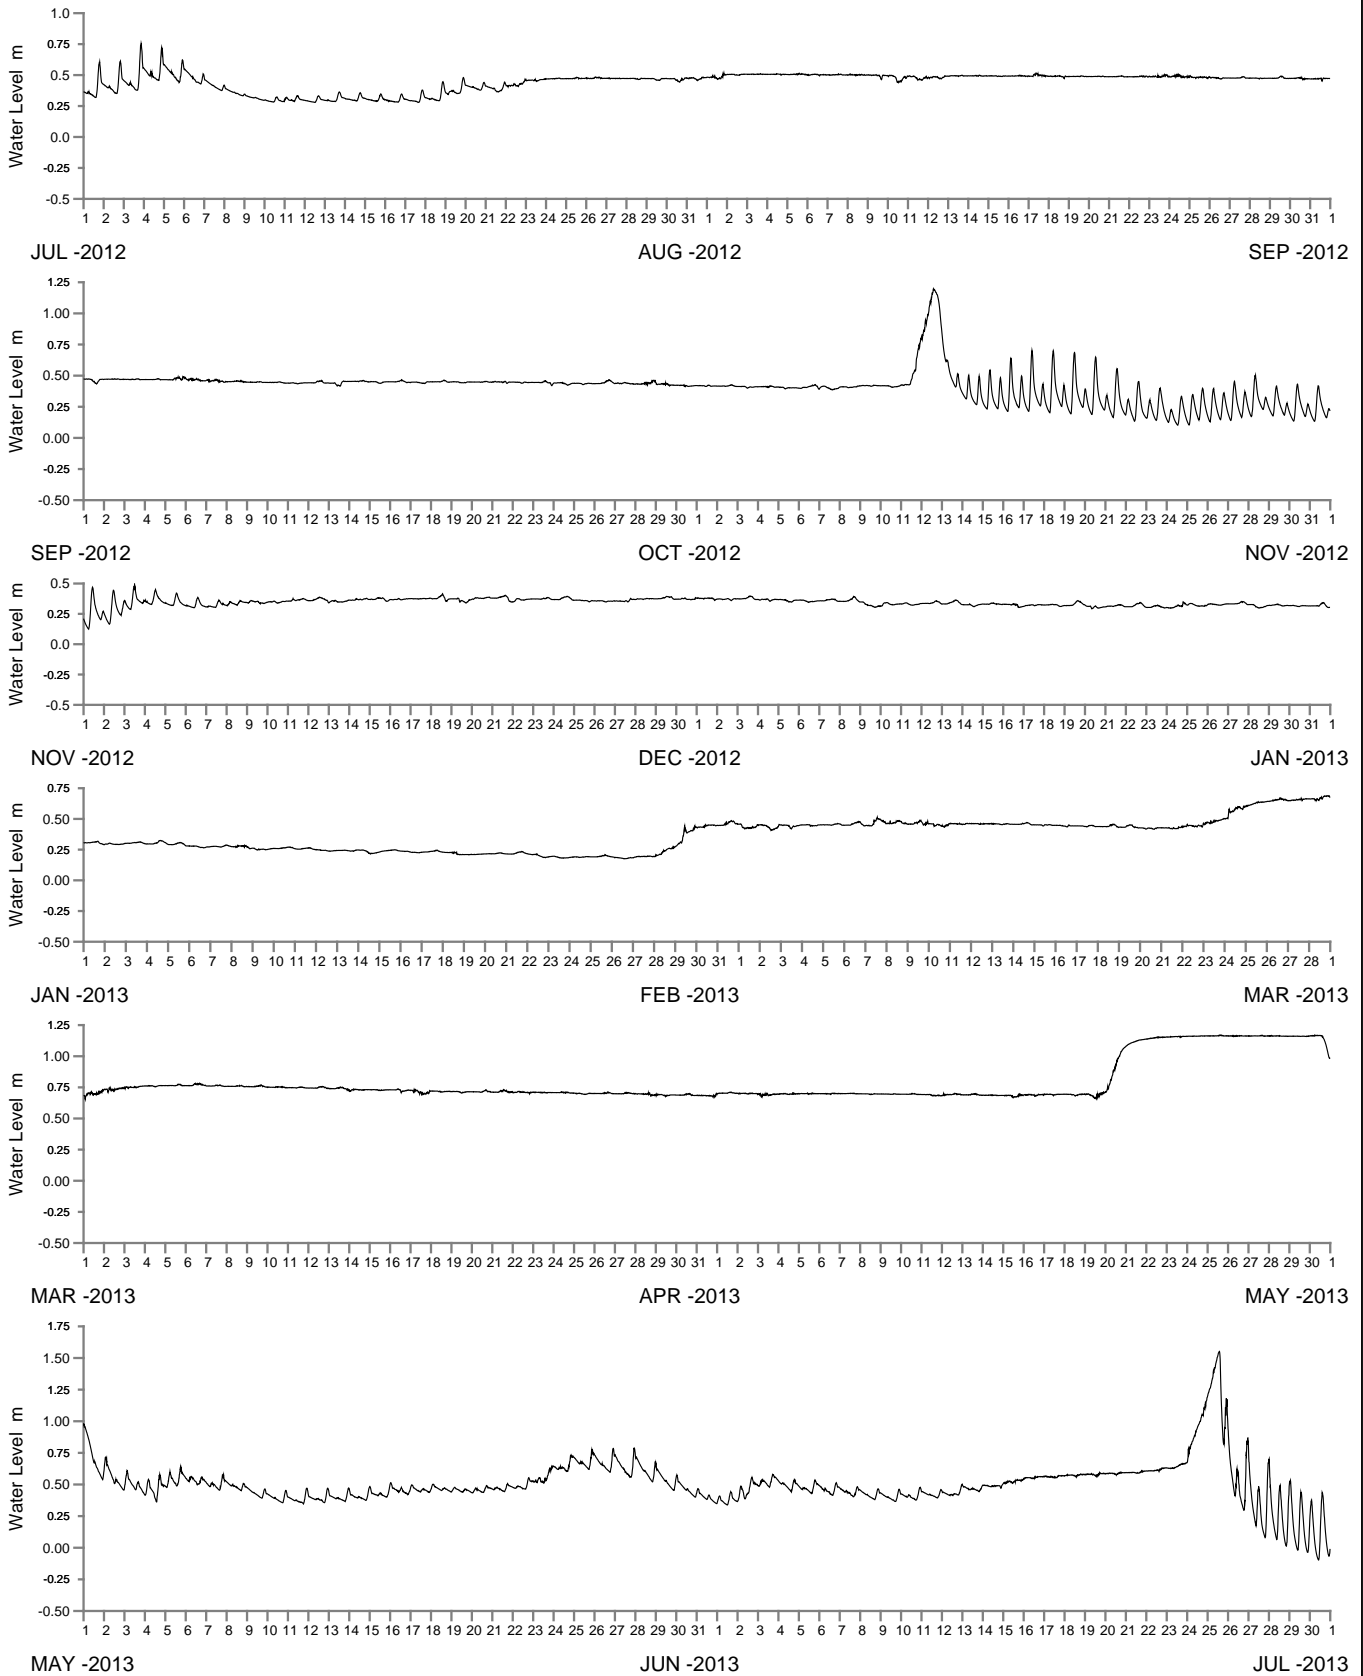
Figure
243

WATER LEVEL REFERENCED TO AUSTRALIAN HEIGHT DATUM

LAKE TABOURIE AT LAKE TABOURIE
2012-2013

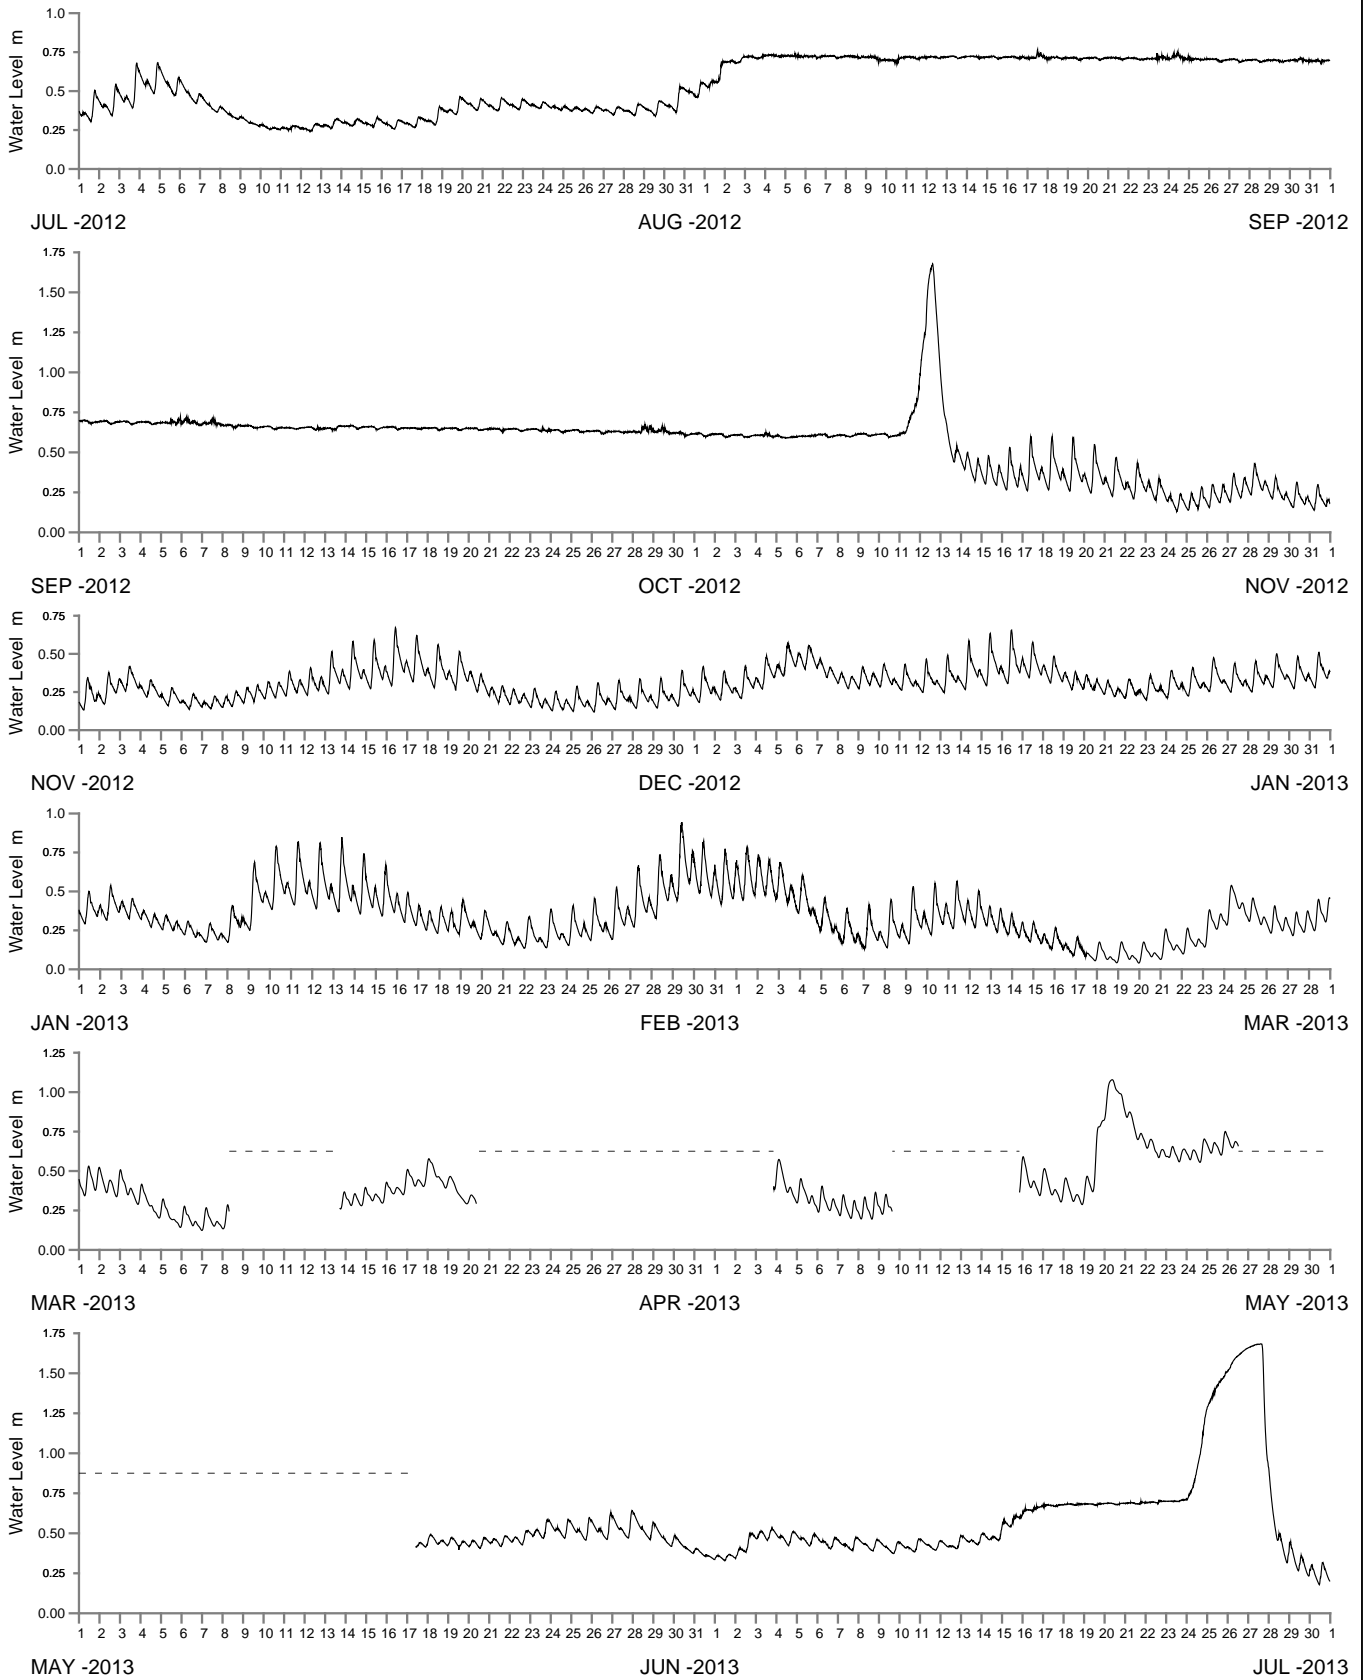
Figure
245

WATER LEVEL REFERENCED TO AUSTRALIAN HEIGHT DATUM

DURRAS LAKE AT DURRAS LAKE
2012-2013

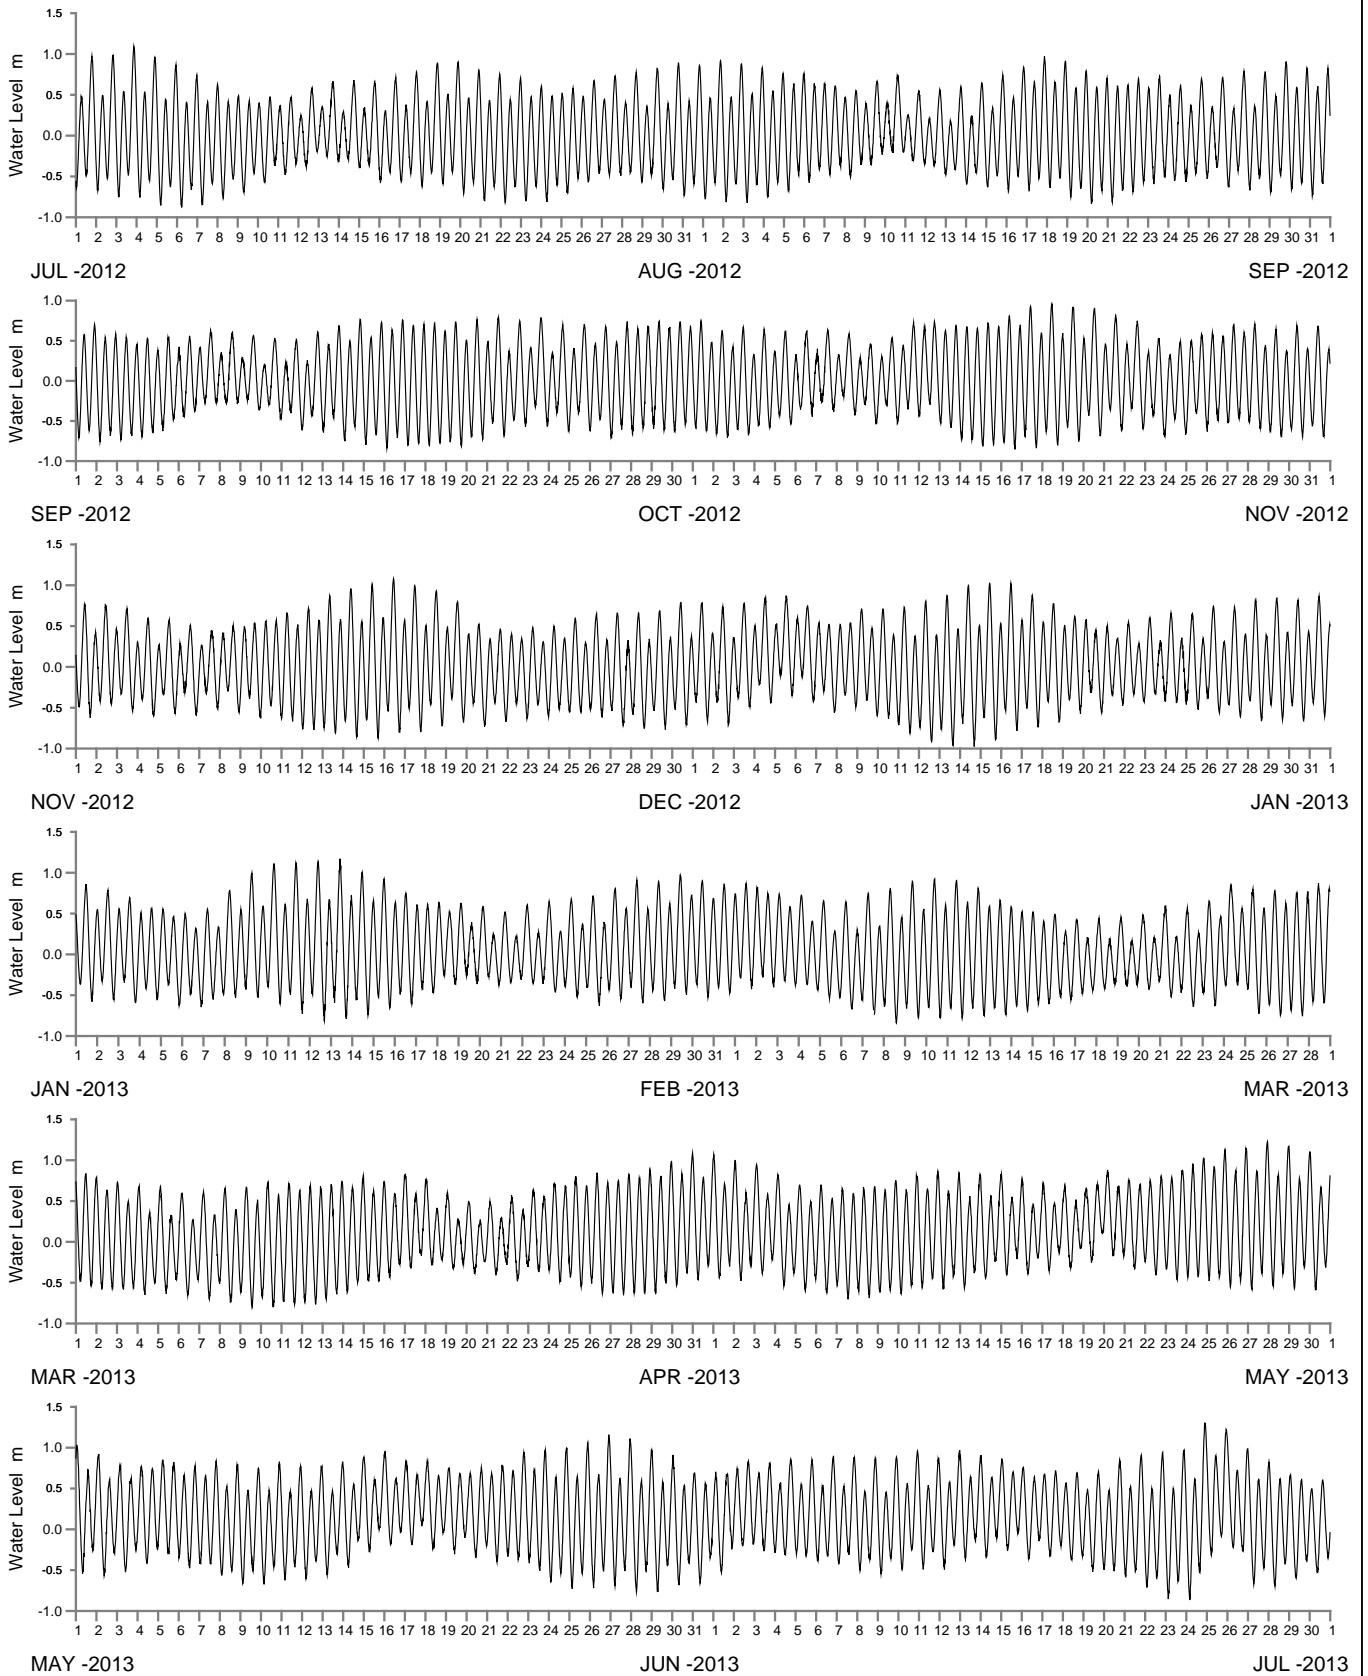
Figure
246

WATER LEVEL REFERENCED TO AUSTRALIAN HEIGHT DATUM

CLYDE RIVER AT NELLIGEN
2012-2013
