Public Works
Manly Hydraulics Laboratory

**STATION LOCATIONS
WOLLONGONG REGION**

MHL
Report 2218
**Figure
198**
DRAWING 2218-198.cdr

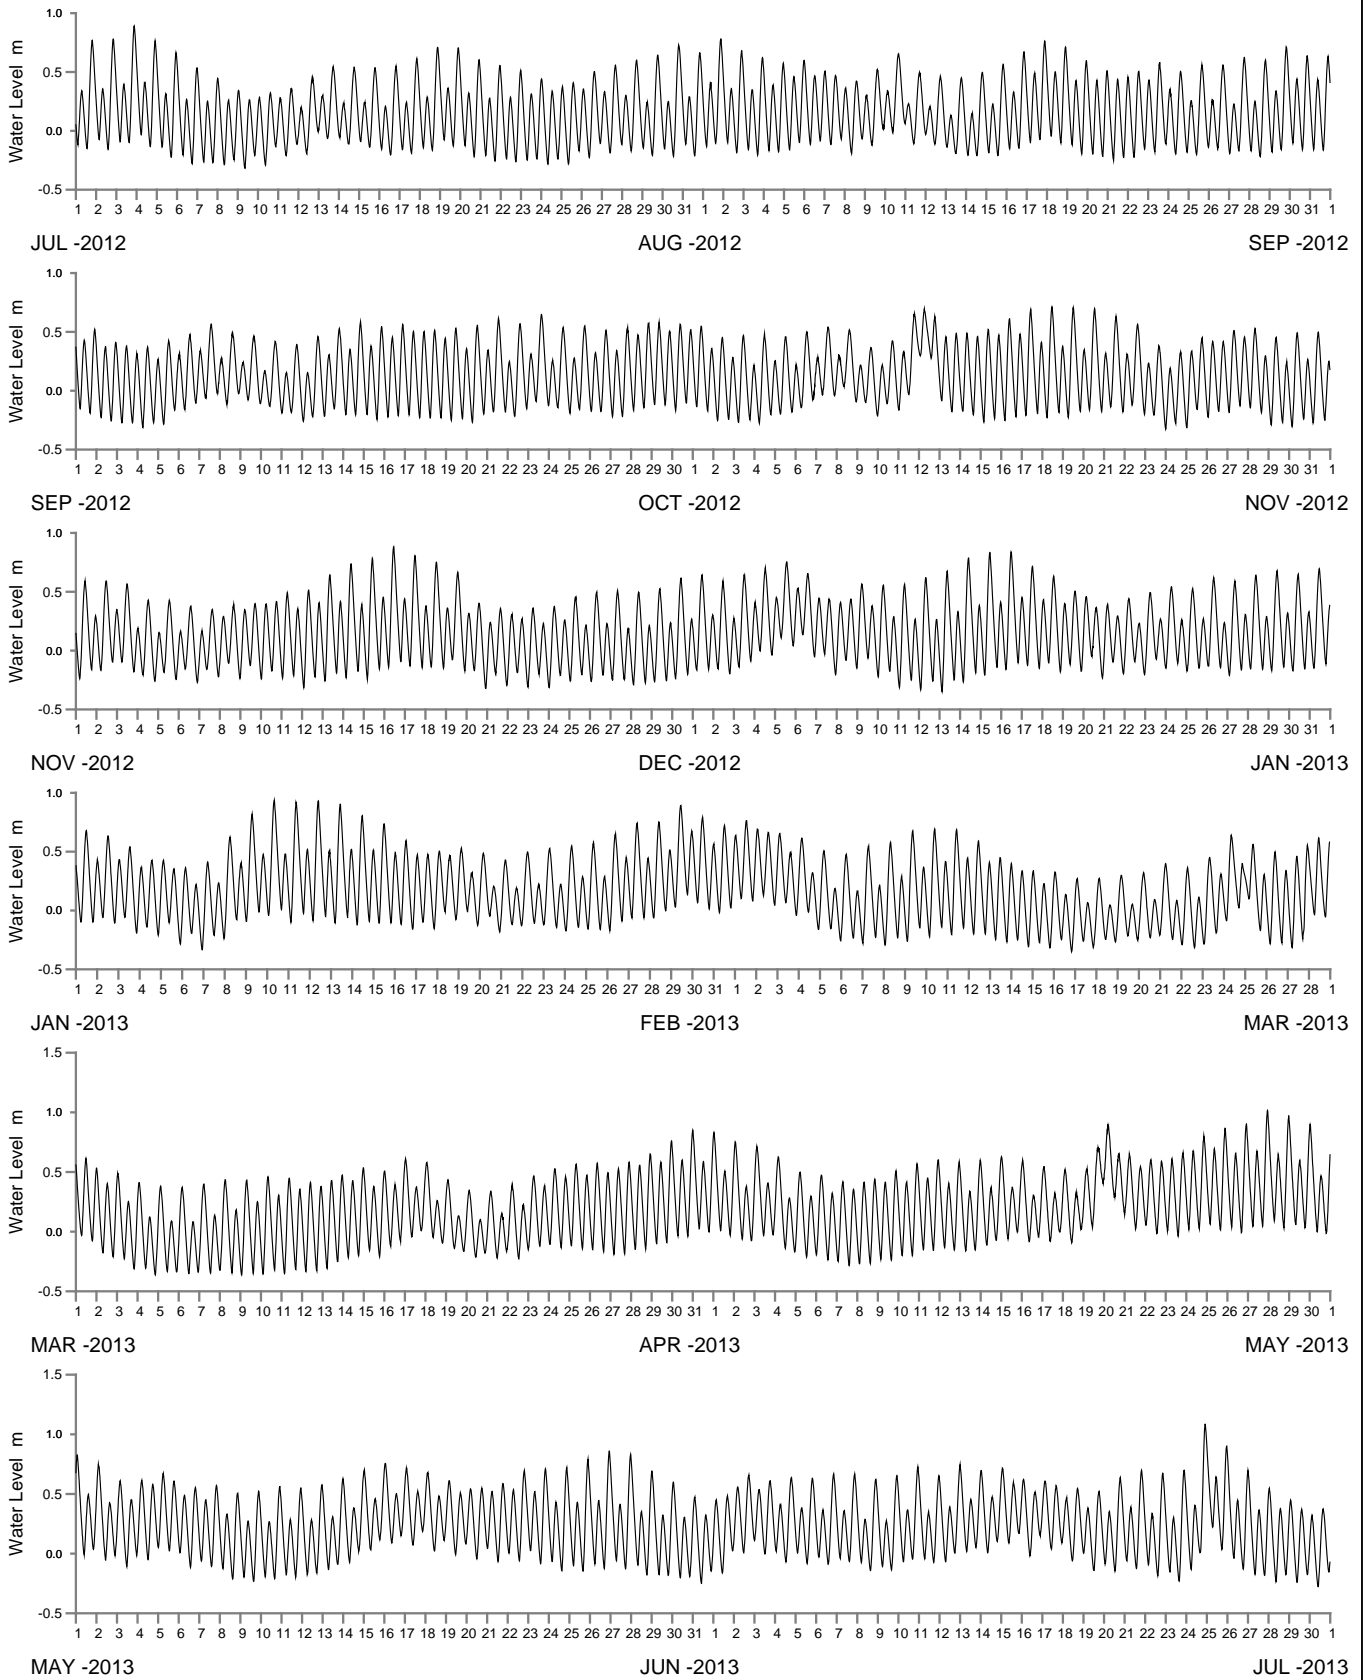
Figure
248

WATER LEVEL REFERENCED TO AUSTRALIAN HEIGHT DATUM

TOMAGA AT GEORGE BASS DRIVE
2012-2013

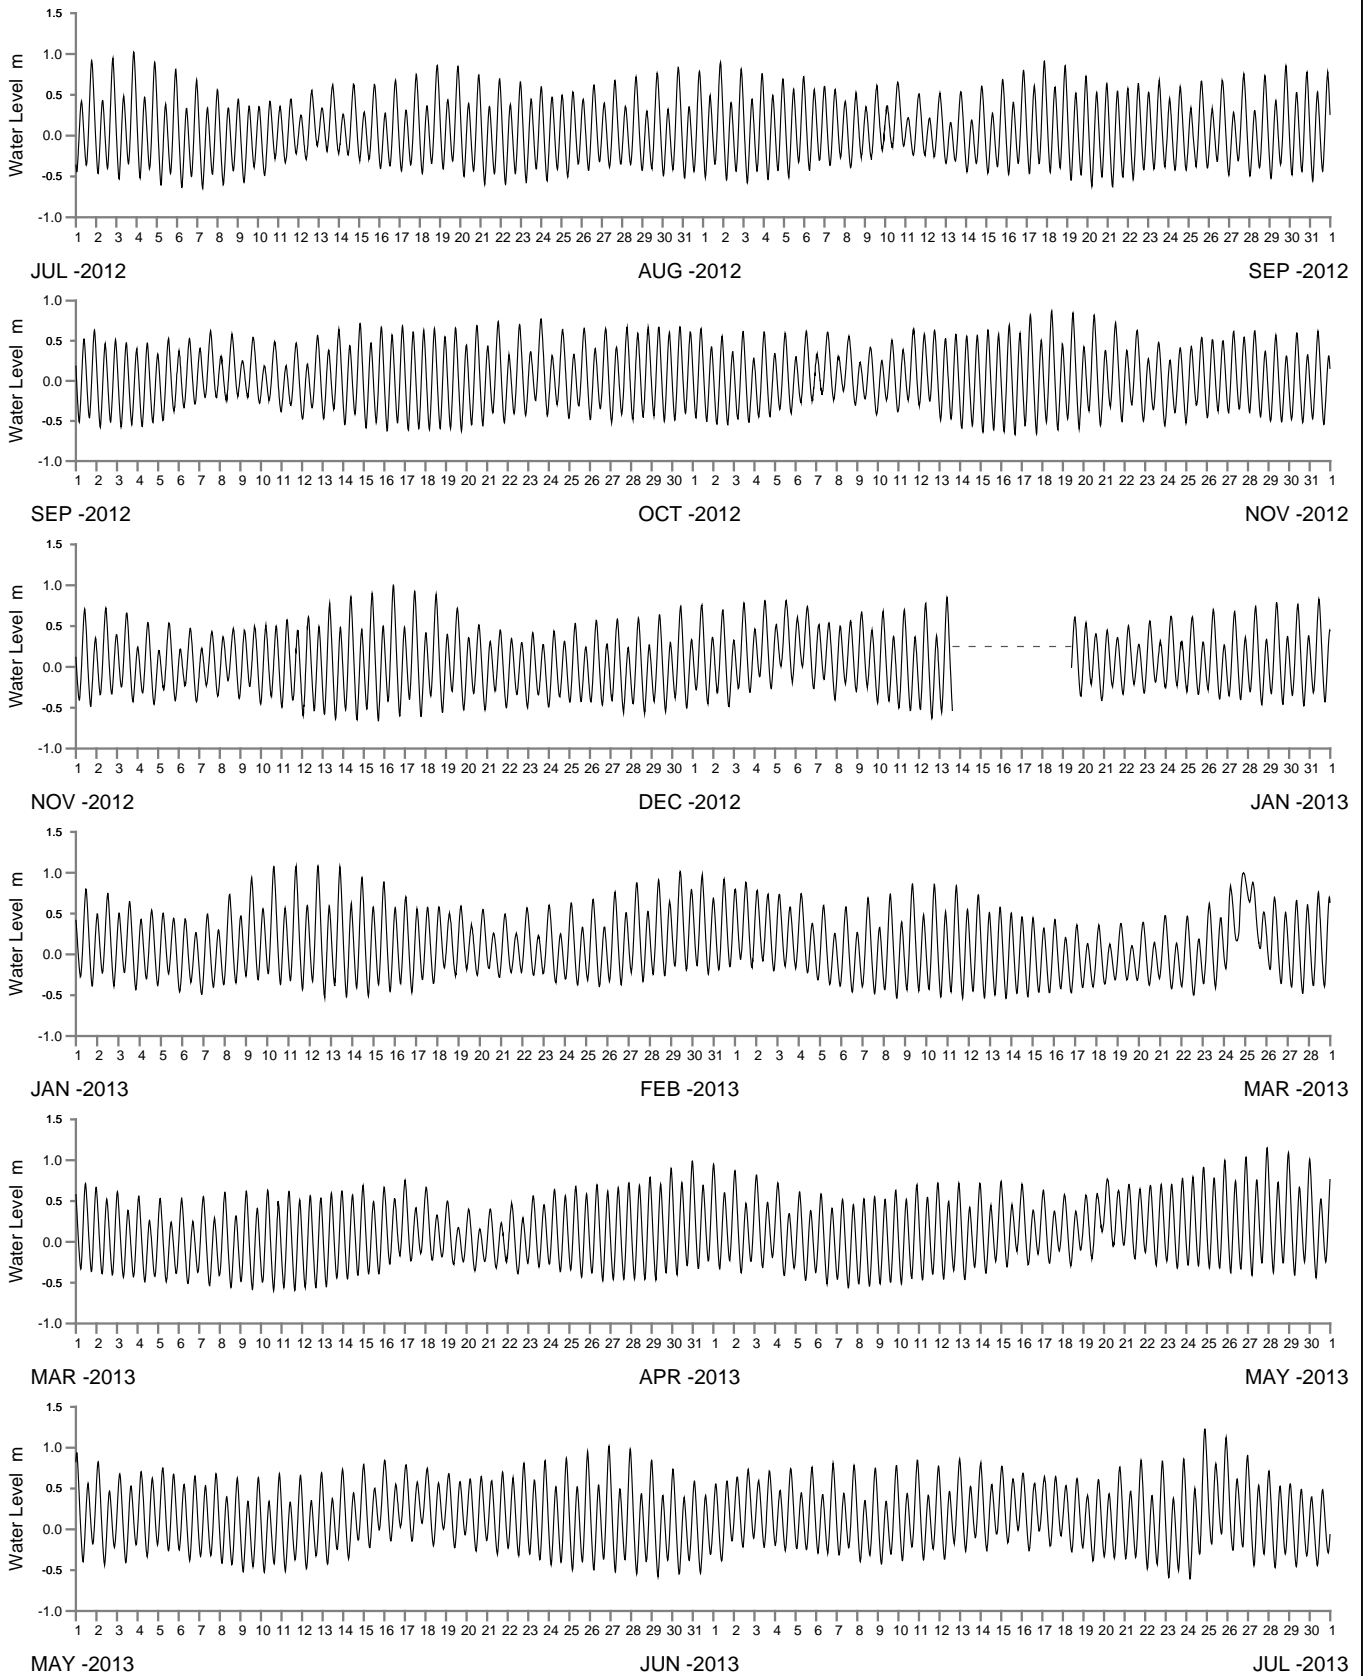
Figure
250

WATER LEVEL REFERENCED TO AUSTRALIAN HEIGHT DATUM

MORUYA RIVER AT MORUYA HOSPITAL
2012-2013

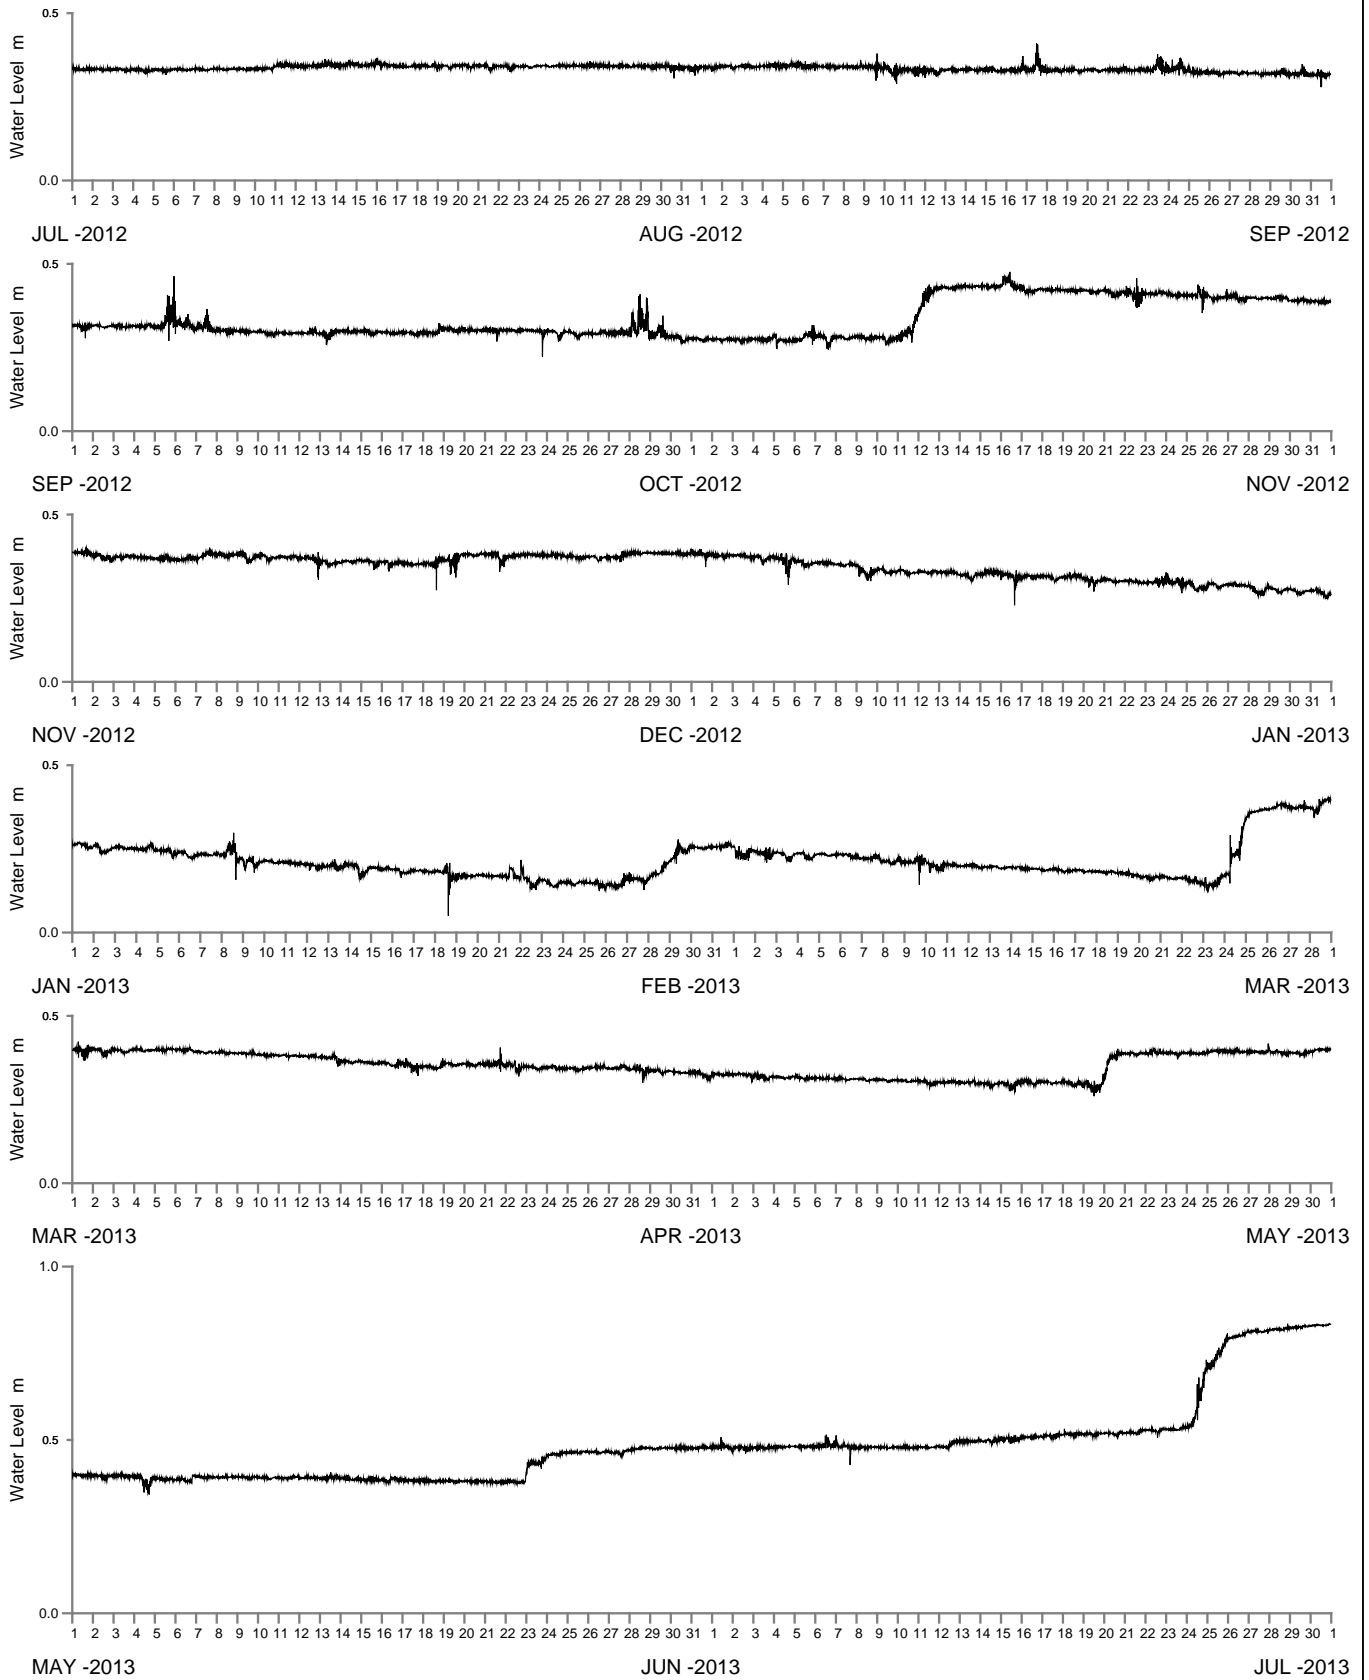
Figure
252

WATER LEVEL REFERENCED TO AUSTRALIAN HEIGHT DATUM

TUROSS RIVER AT COILA LAKE
2012-2013

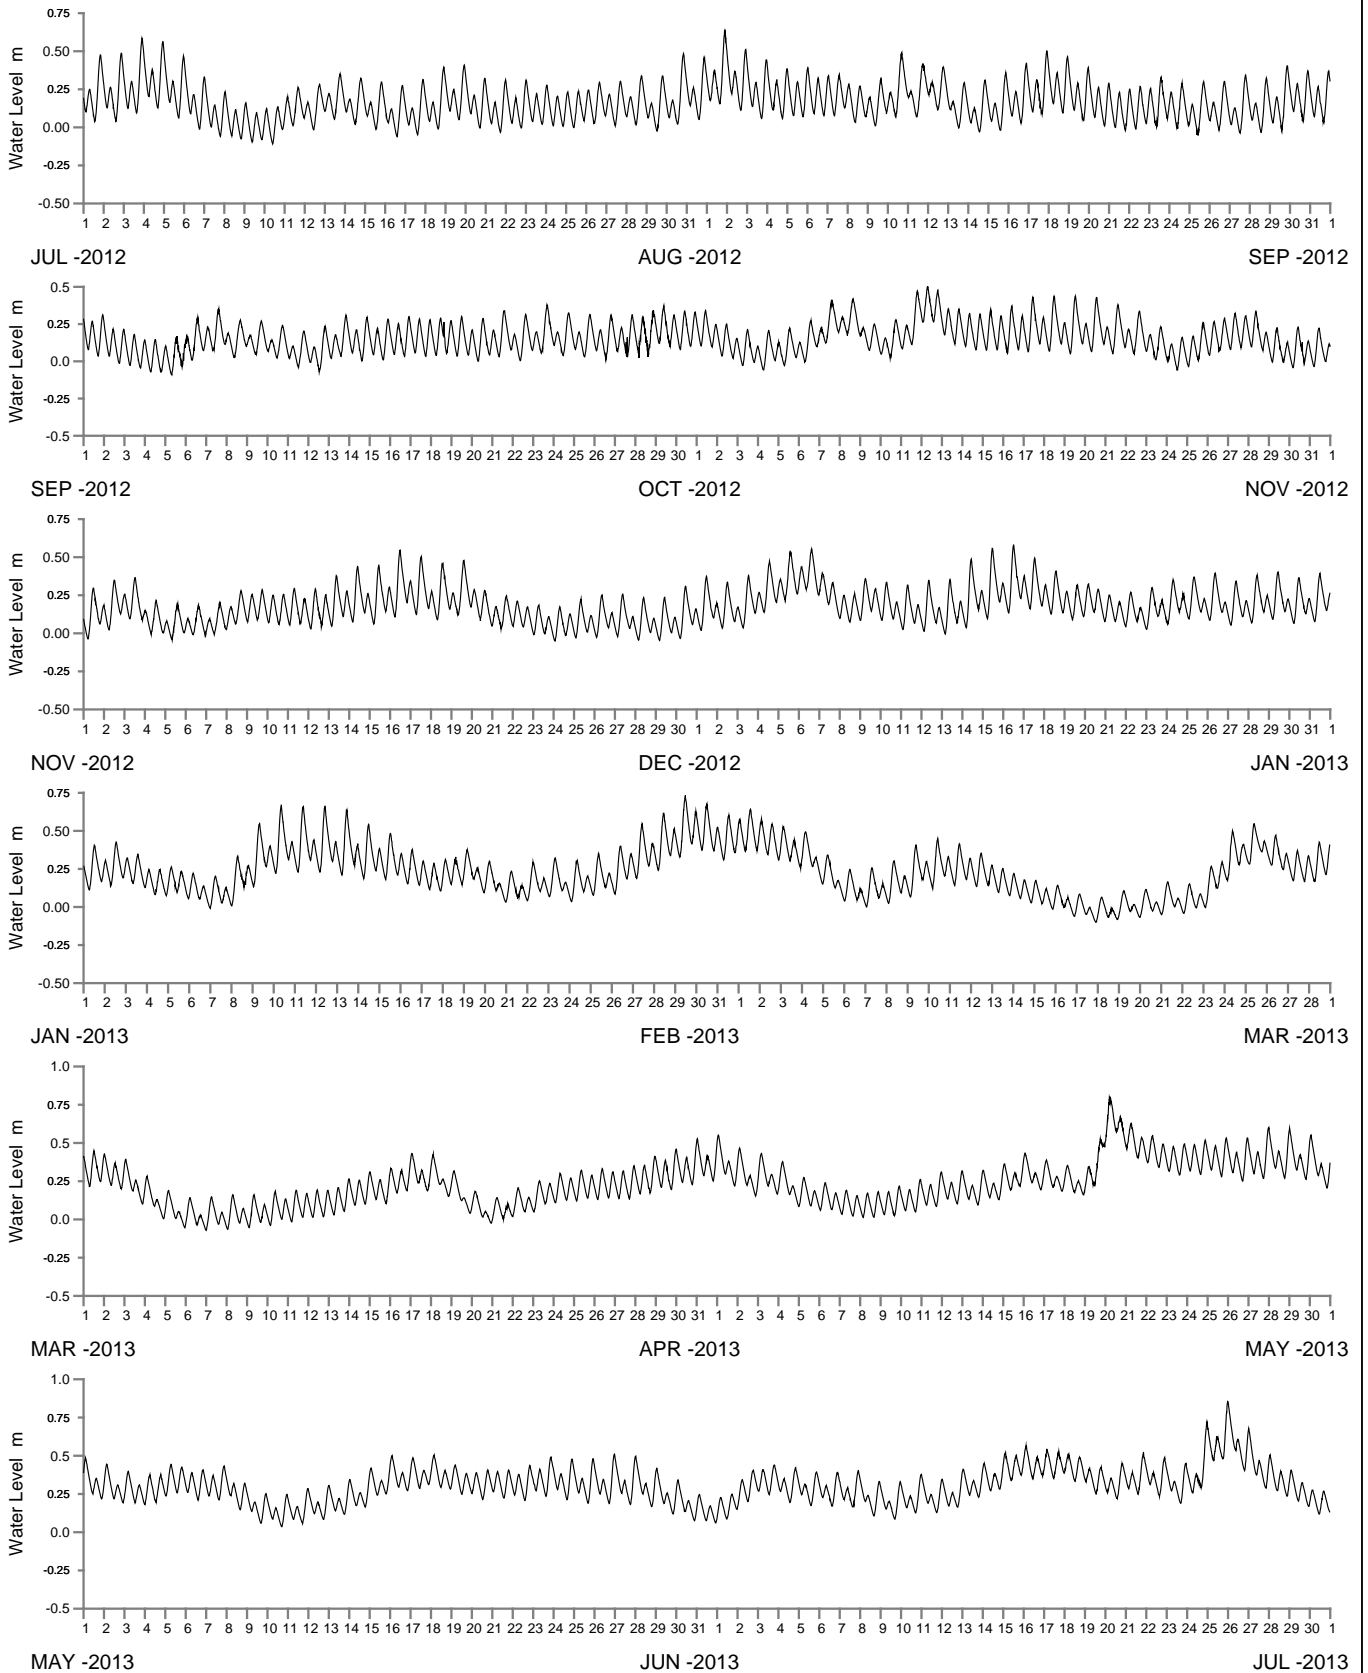
Figure
253

WATER LEVEL REFERENCED TO AUSTRALIAN HEIGHT DATUM

TUROSS RIVER AT TUROSS HEAD
2012-2013

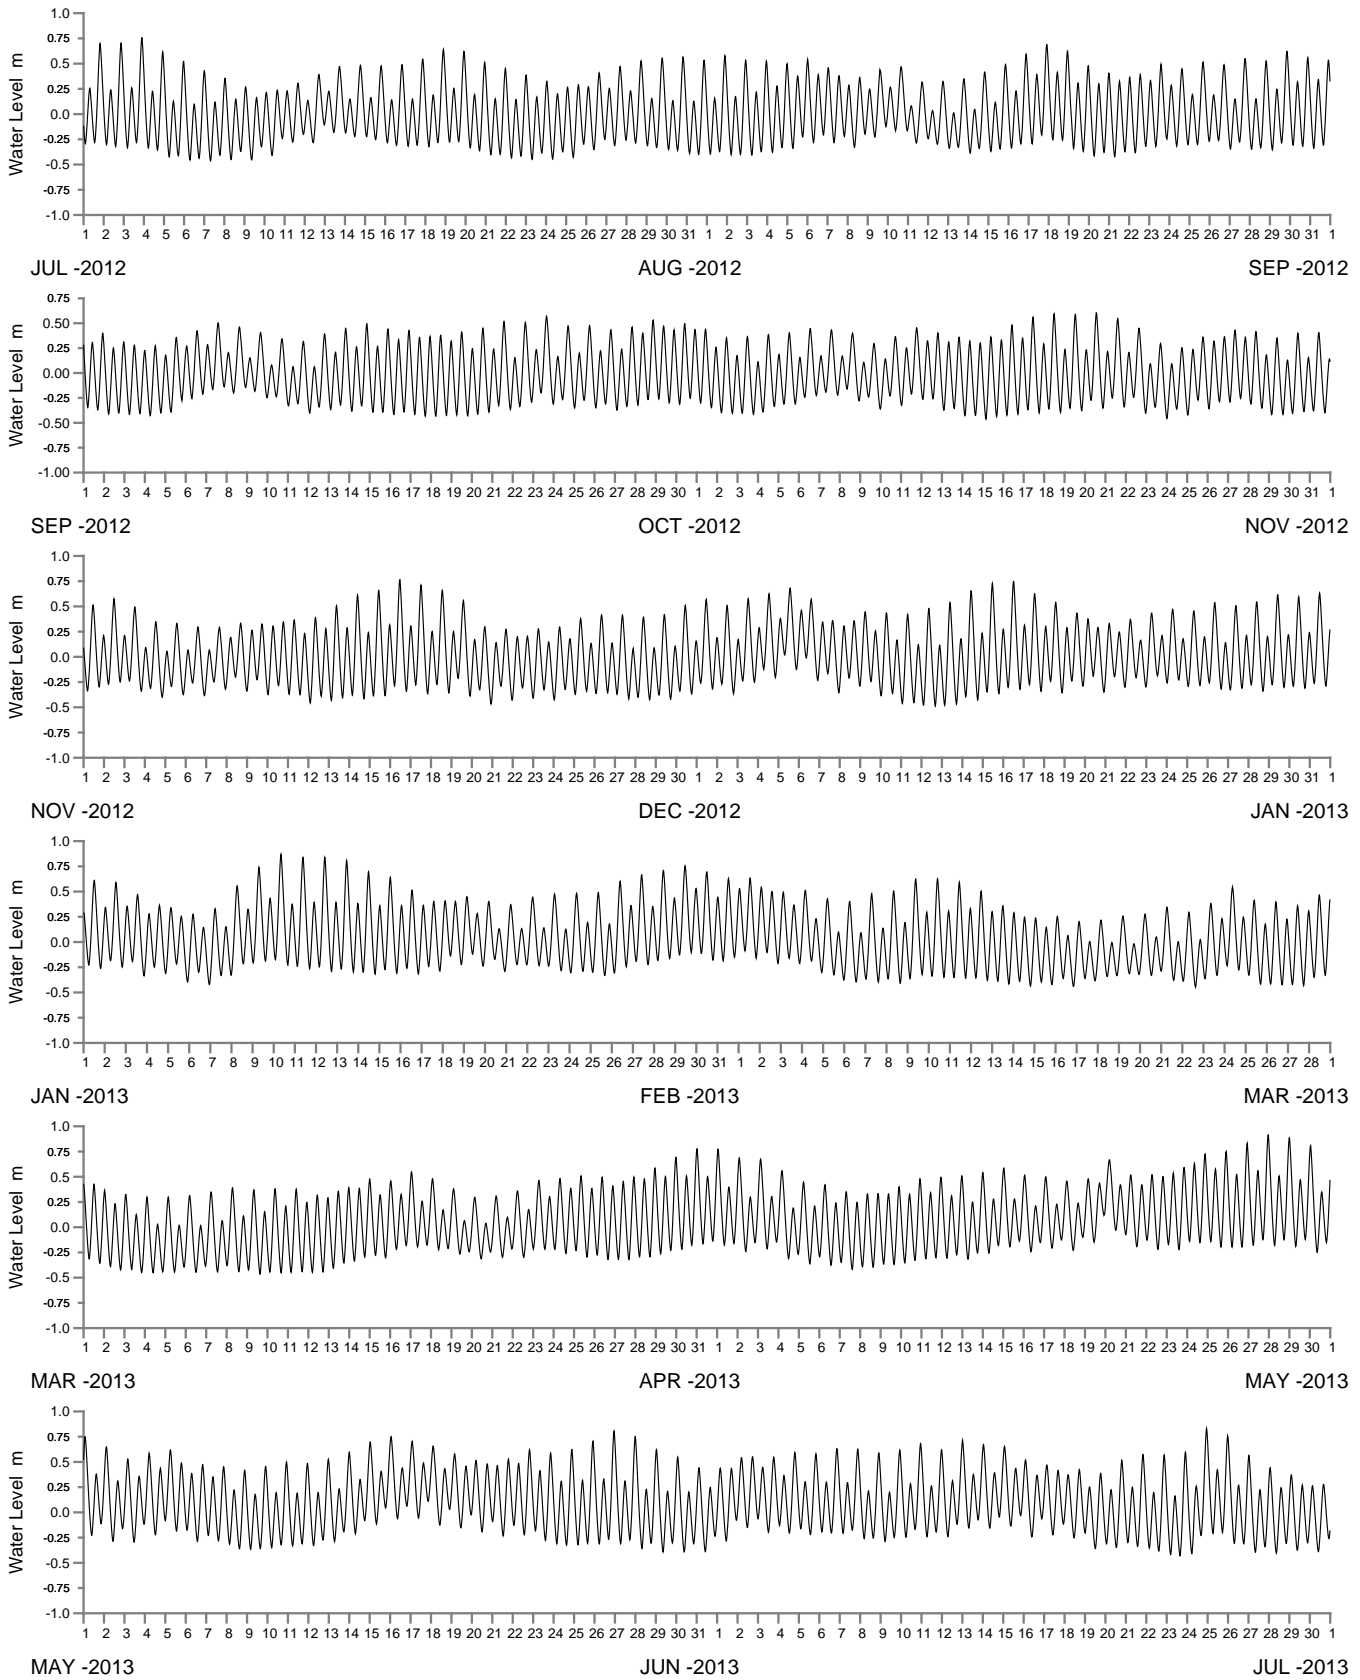
Figure
255

WATER LEVEL REFERENCED TO AUSTRALIAN HEIGHT DATUM

WAGONGA INLET AT BARLOWS BAY
2012-2013

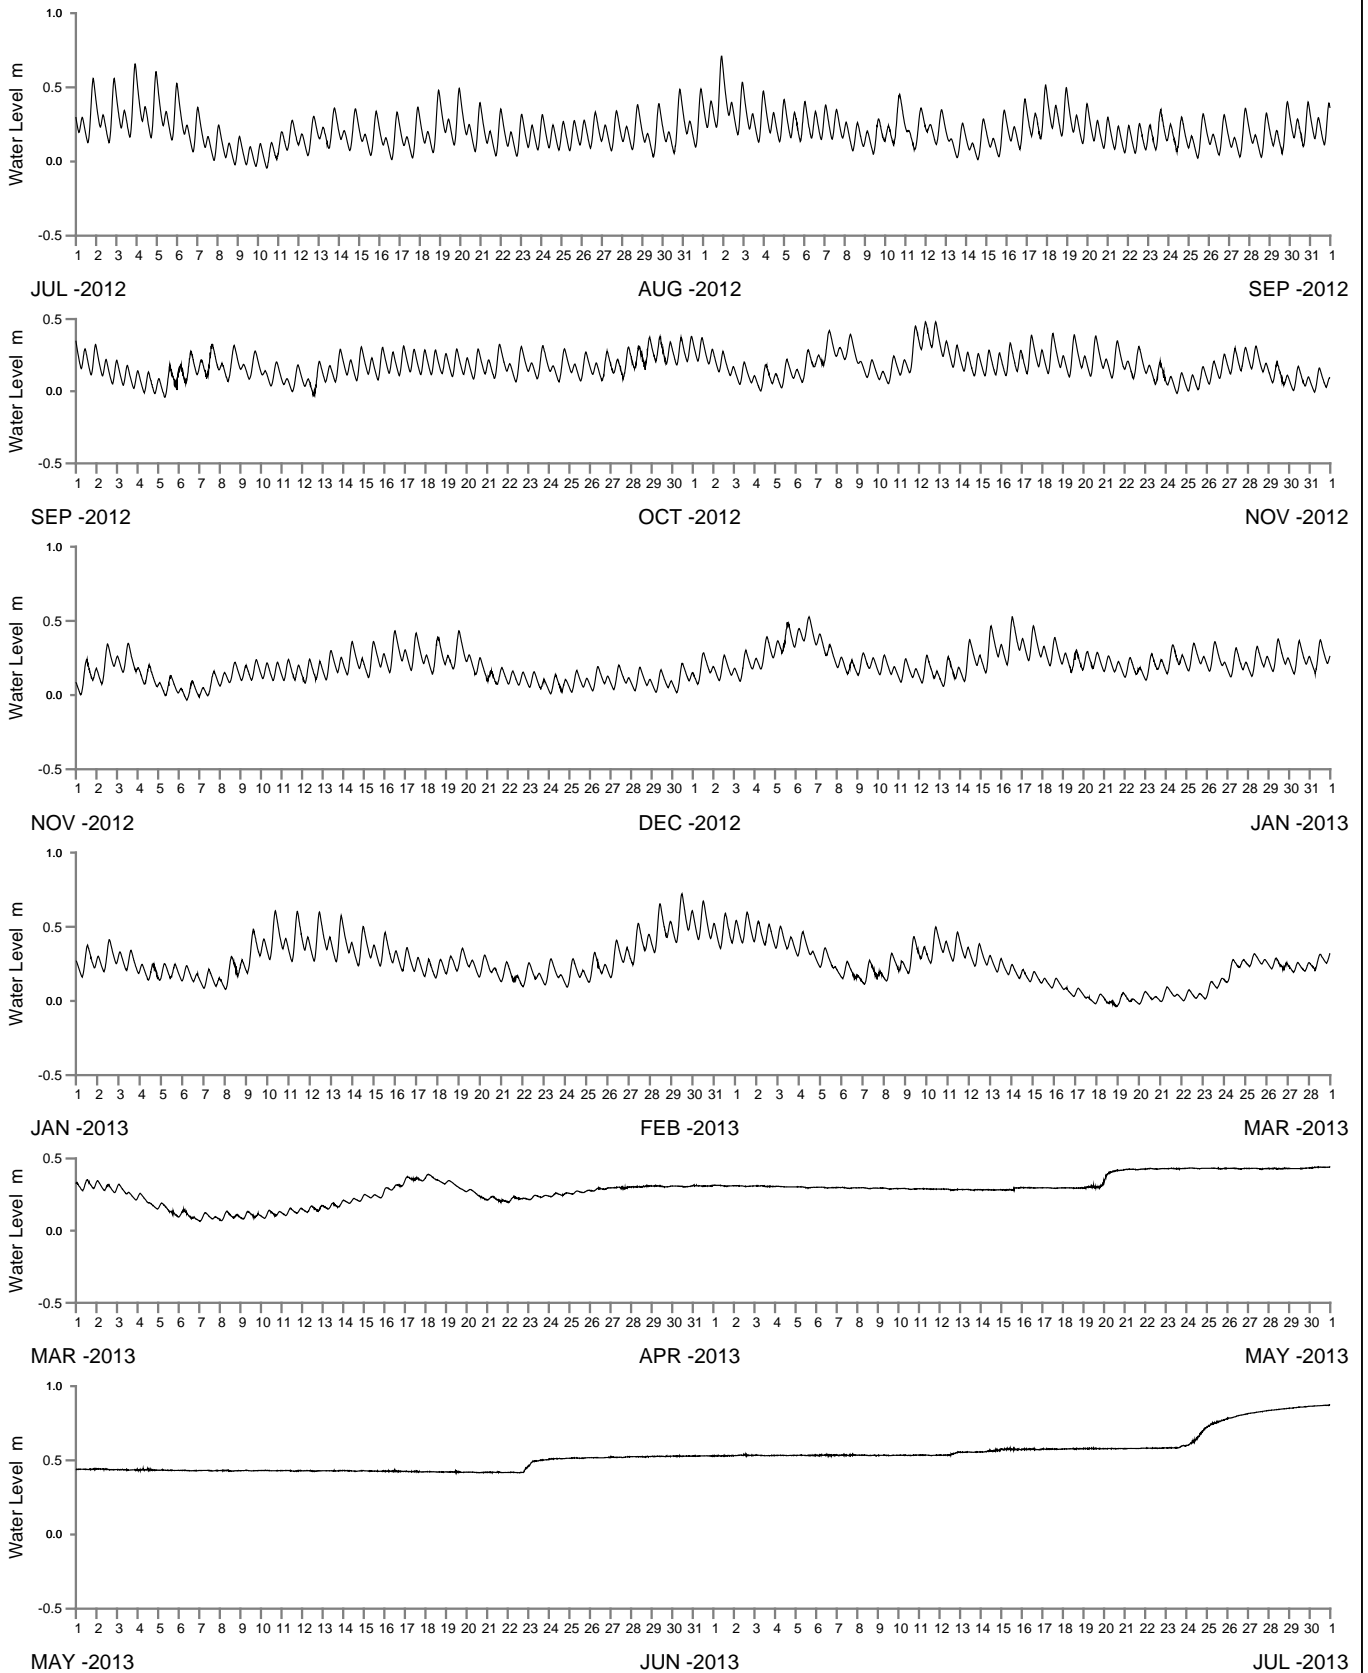
Figure
256

WATER LEVEL REFERENCED TO AUSTRALIAN HEIGHT DATUM

WALLAGA LAKE AT REGATTA POINT
2012-2013

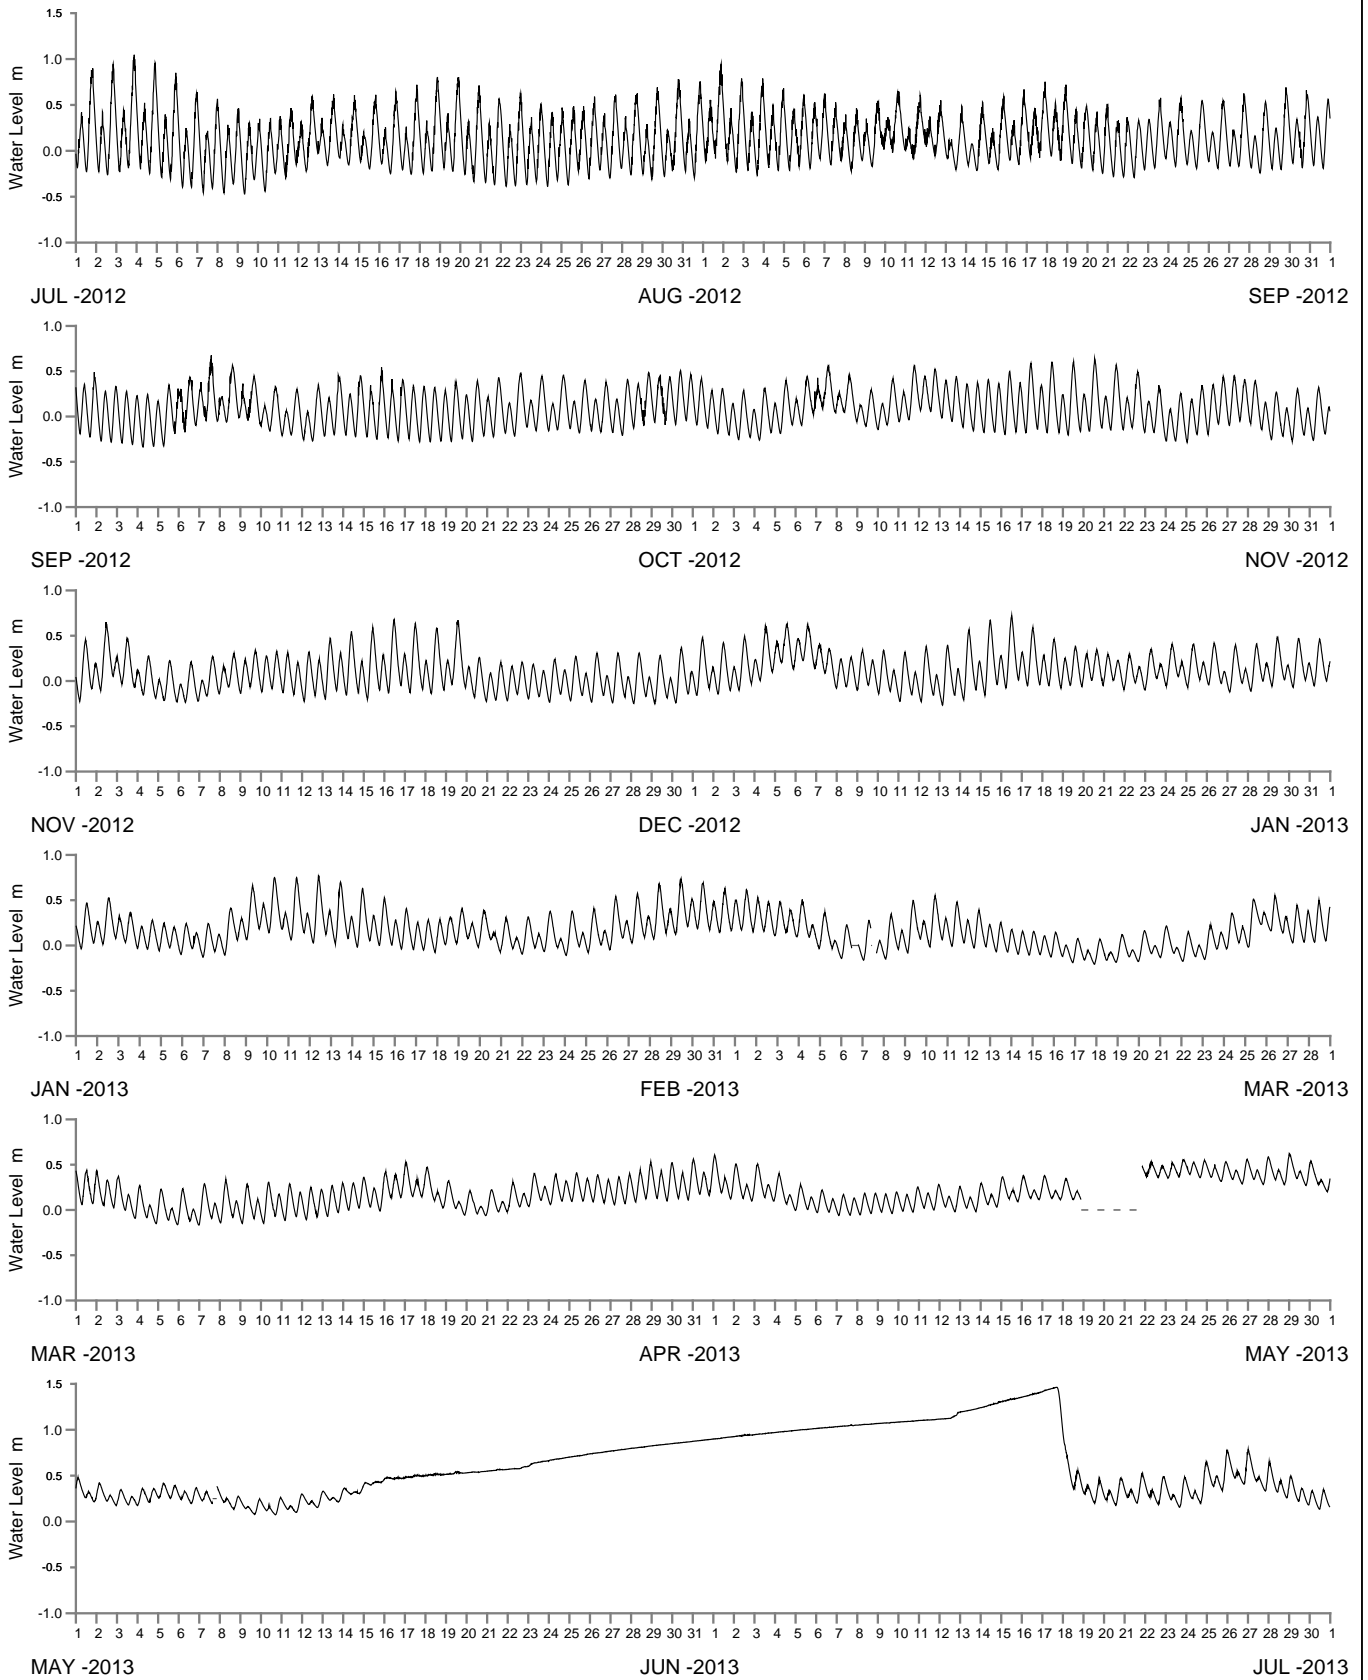
Figure
258

WATER LEVEL REFERENCED TO AUSTRALIAN HEIGHT DATUM

BEGA RIVER AT BEGA RIVER
2012-2013

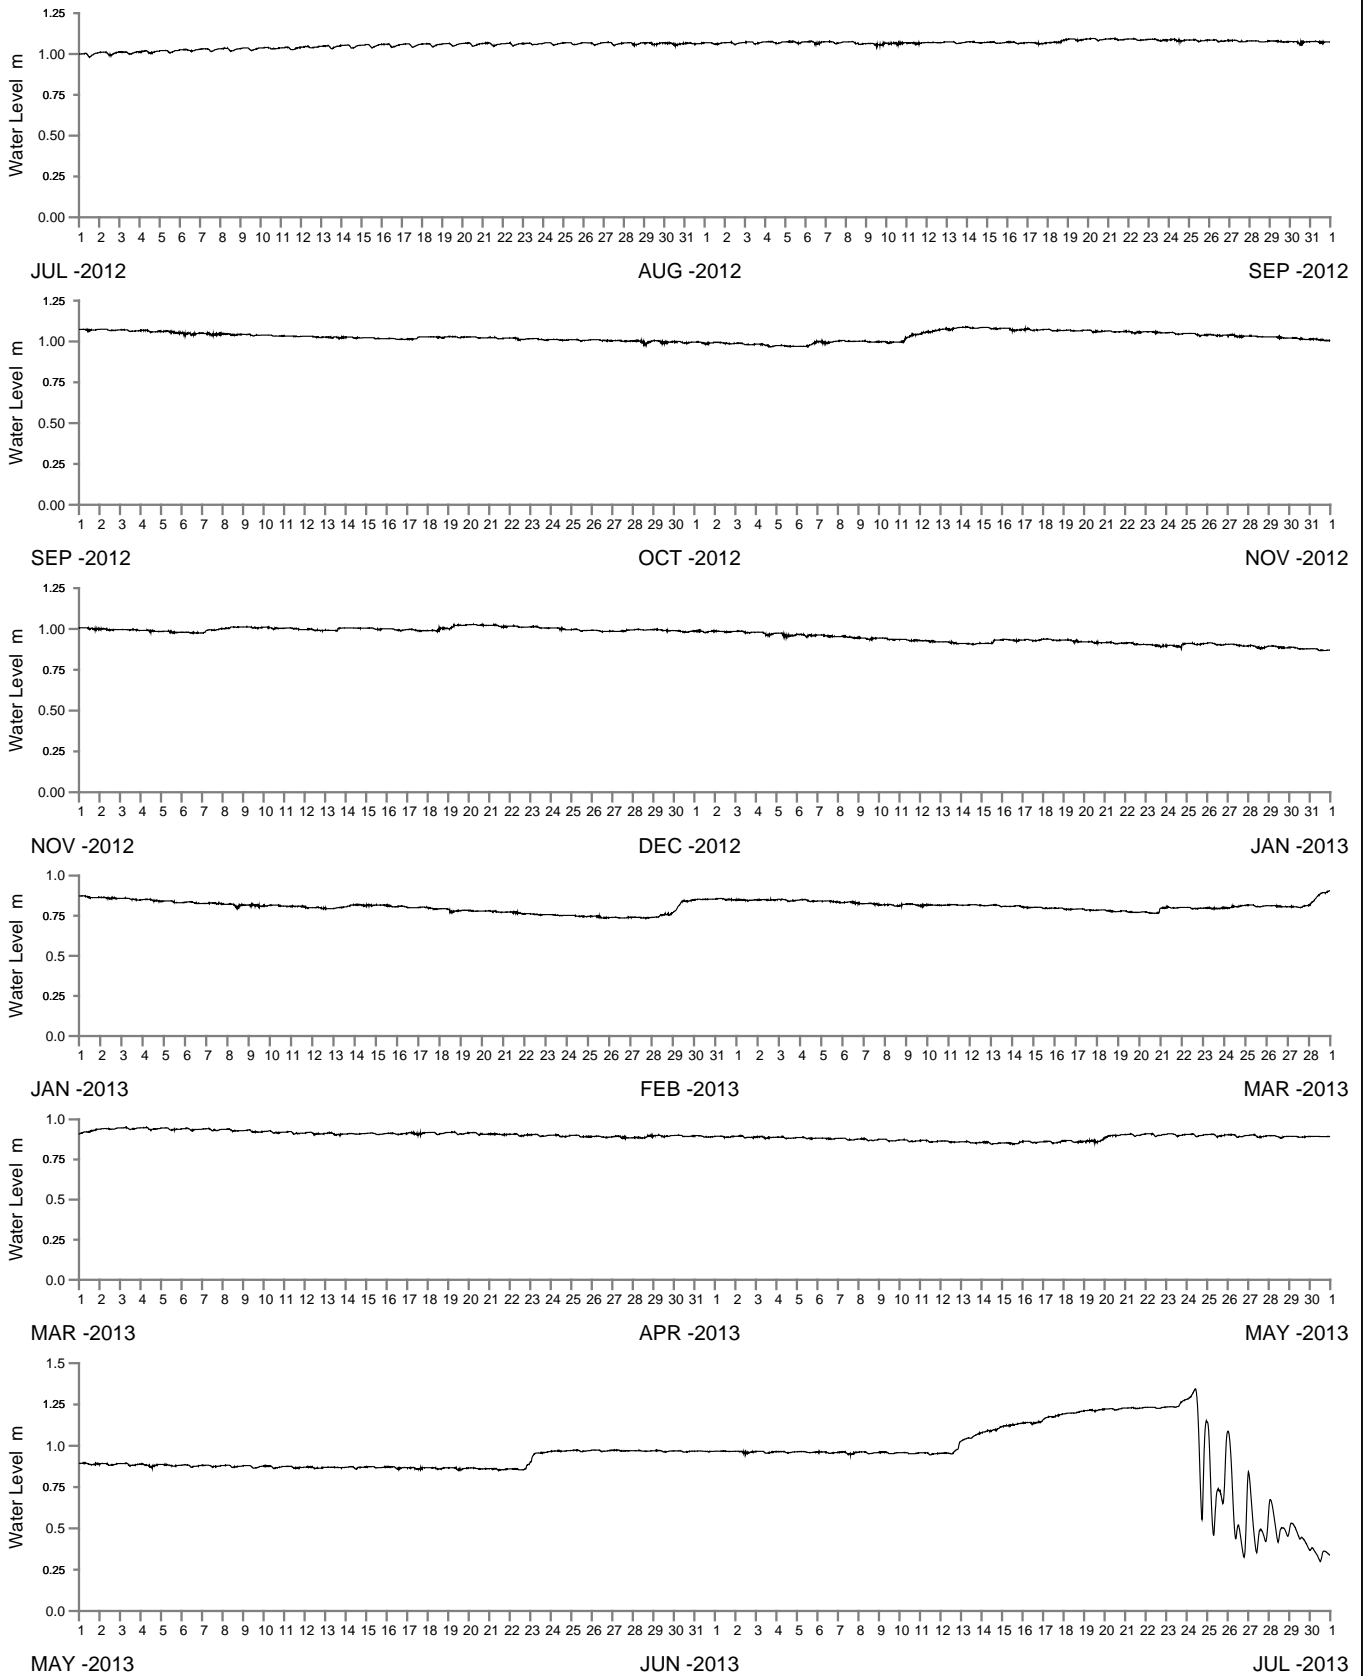
Figure
260

WATER LEVEL REFERENCED TO AUSTRALIAN HEIGHT DATUM

BACK LAGOON AT BACK LAGOON
2012-2013

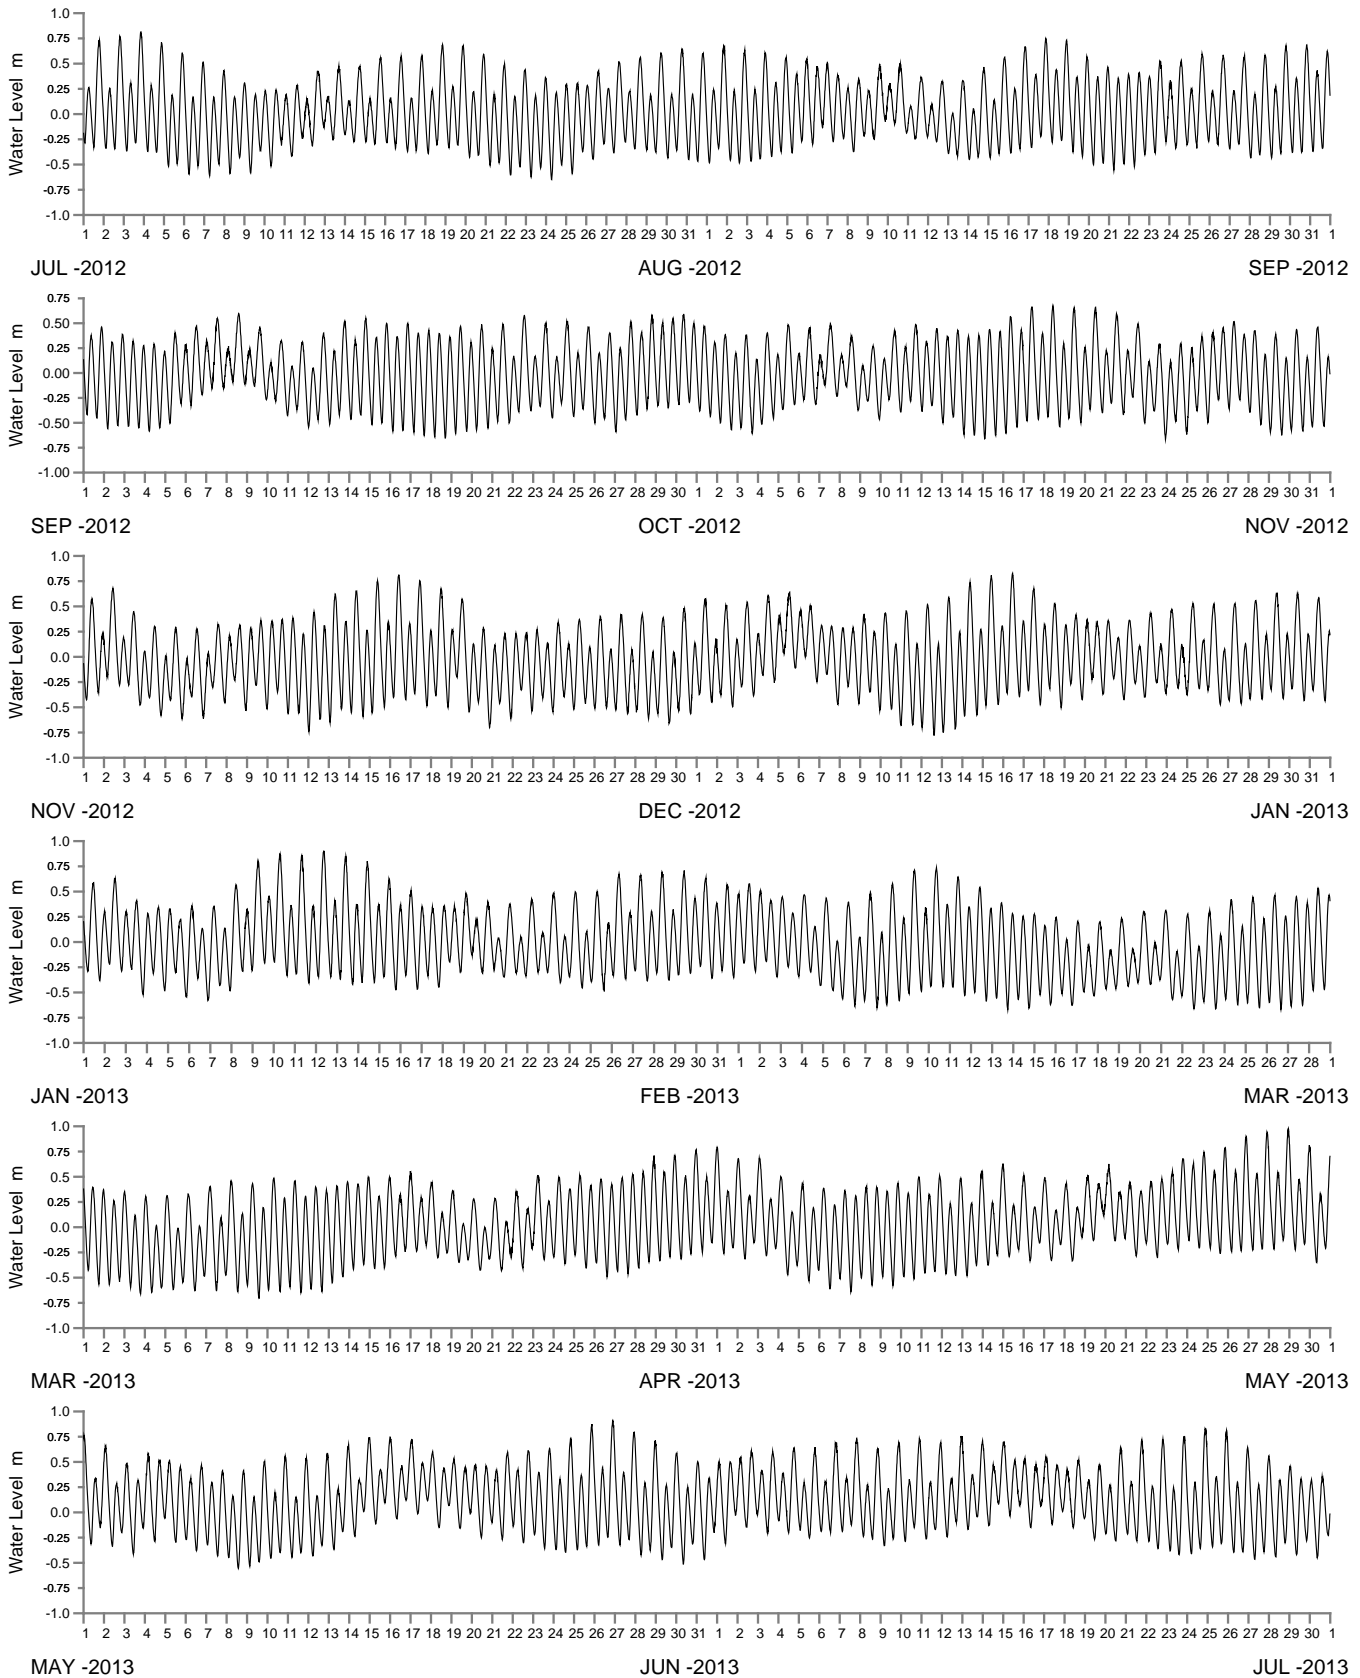
Figure
261

WATER LEVEL REFERENCED TO AUSTRALIAN HEIGHT DATUM

MERIMBULA LAKE AT MERIMBULA WHARF
2012-2013

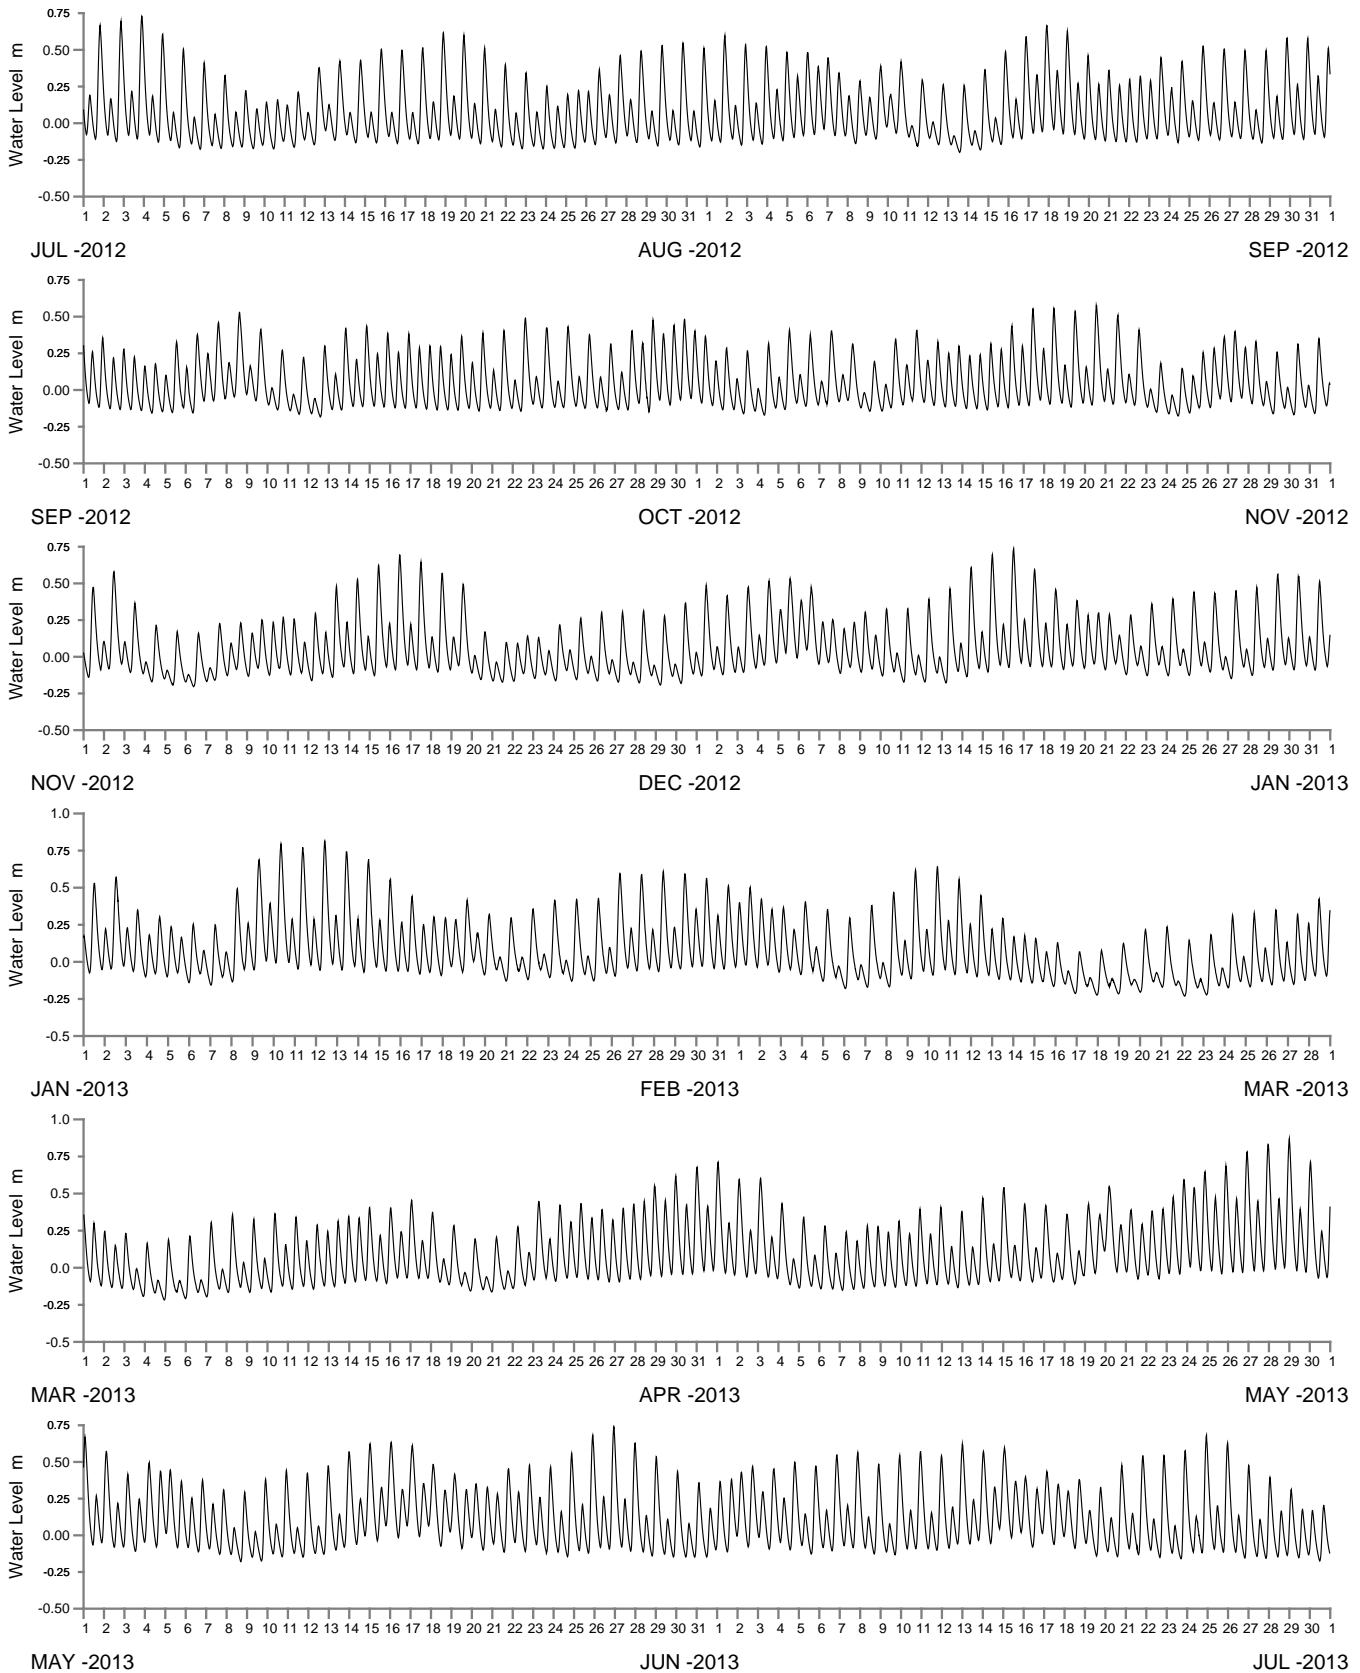
Figure
262

WATER LEVEL REFERENCED TO AUSTRALIAN HEIGHT DATUM

MERIMBULA LAKE AT MERIMBULA LAKE
2012-2013
