Public Works
Manly Hydraulics Laboratory

**STATION LOCATIONS
WOLLONGONG REGION**

MHL
Report 2218
**Figure
198**
DRAWING 2218-198.cdr

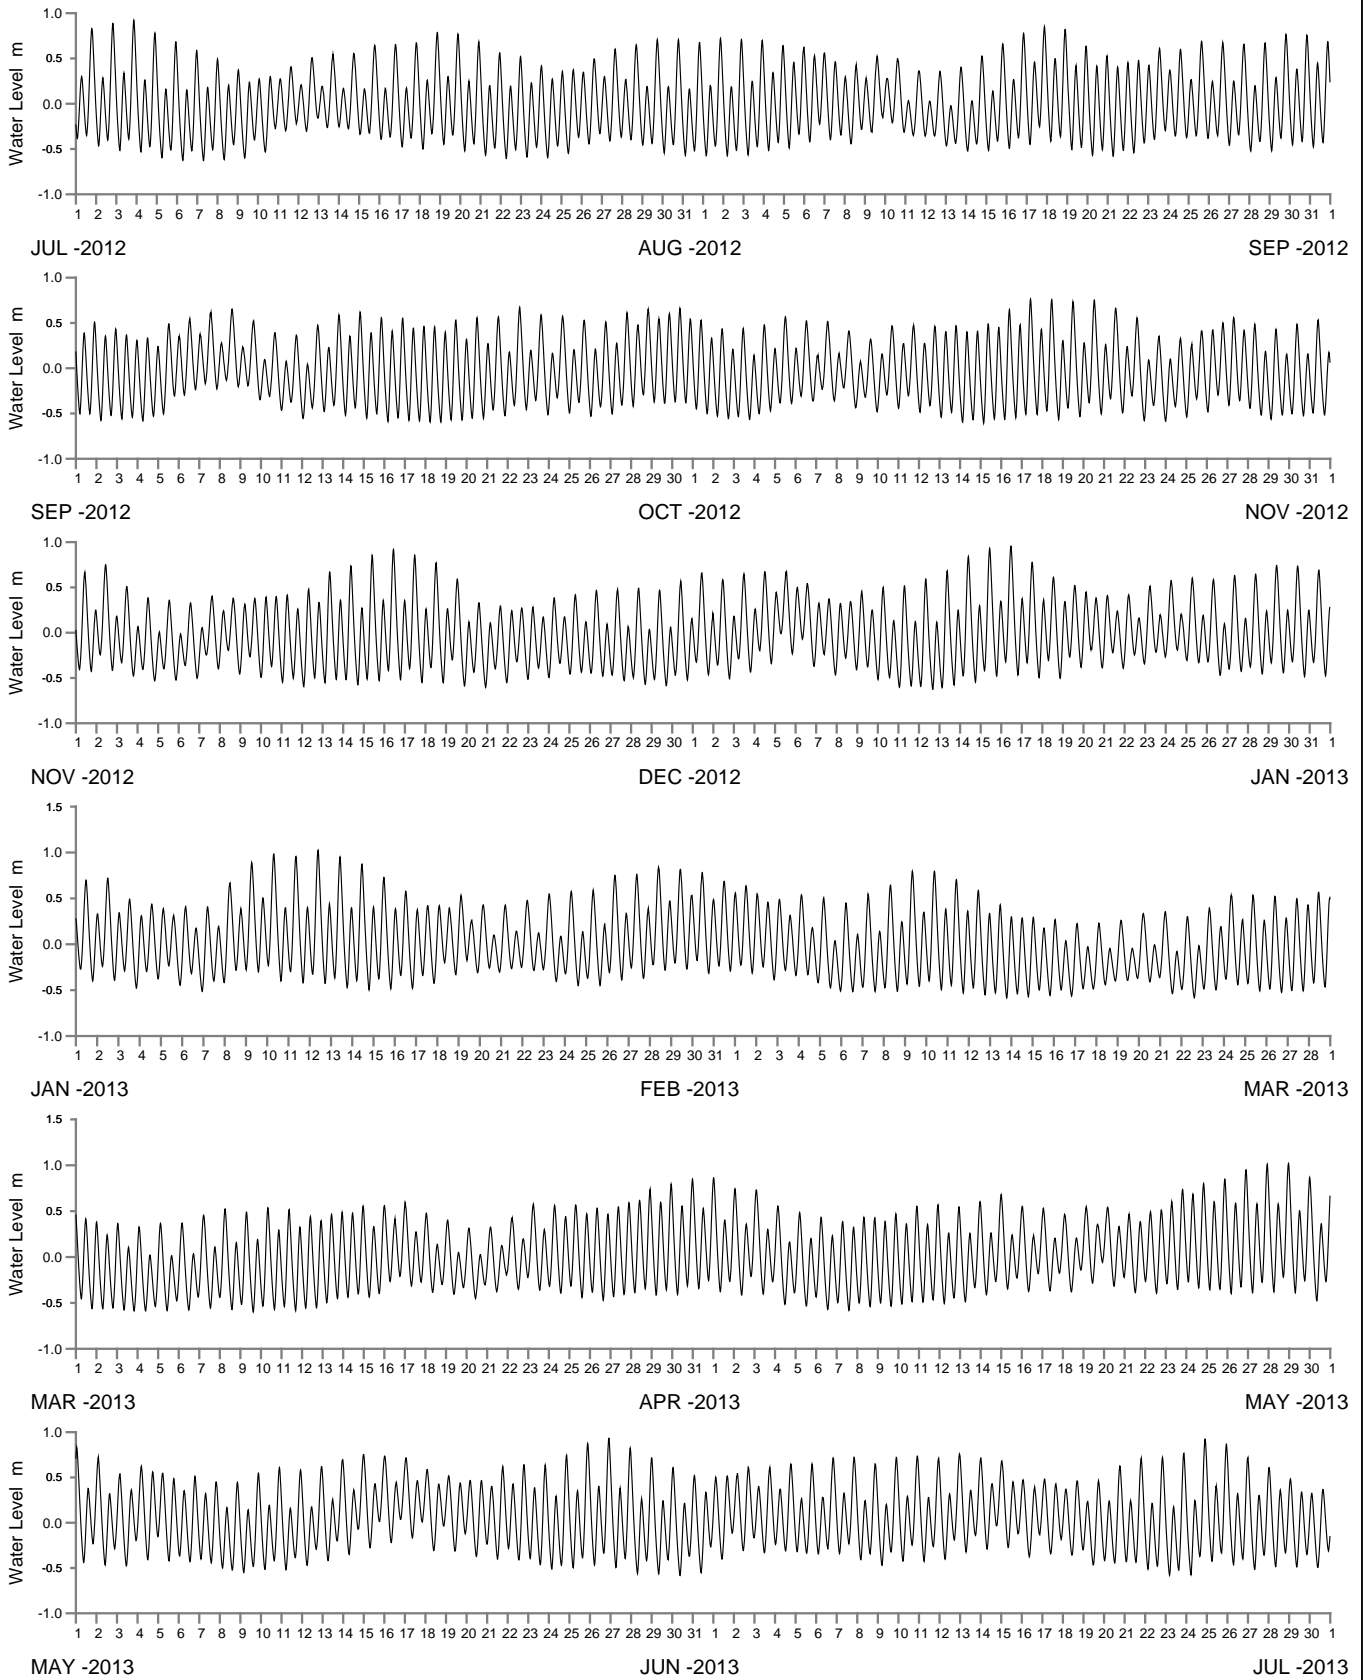
Figure
263

WATER LEVEL REFERENCED TO AUSTRALIAN HEIGHT DATUM

PAMBULA LAKE AT PAMBULA LAKE
2012-2013

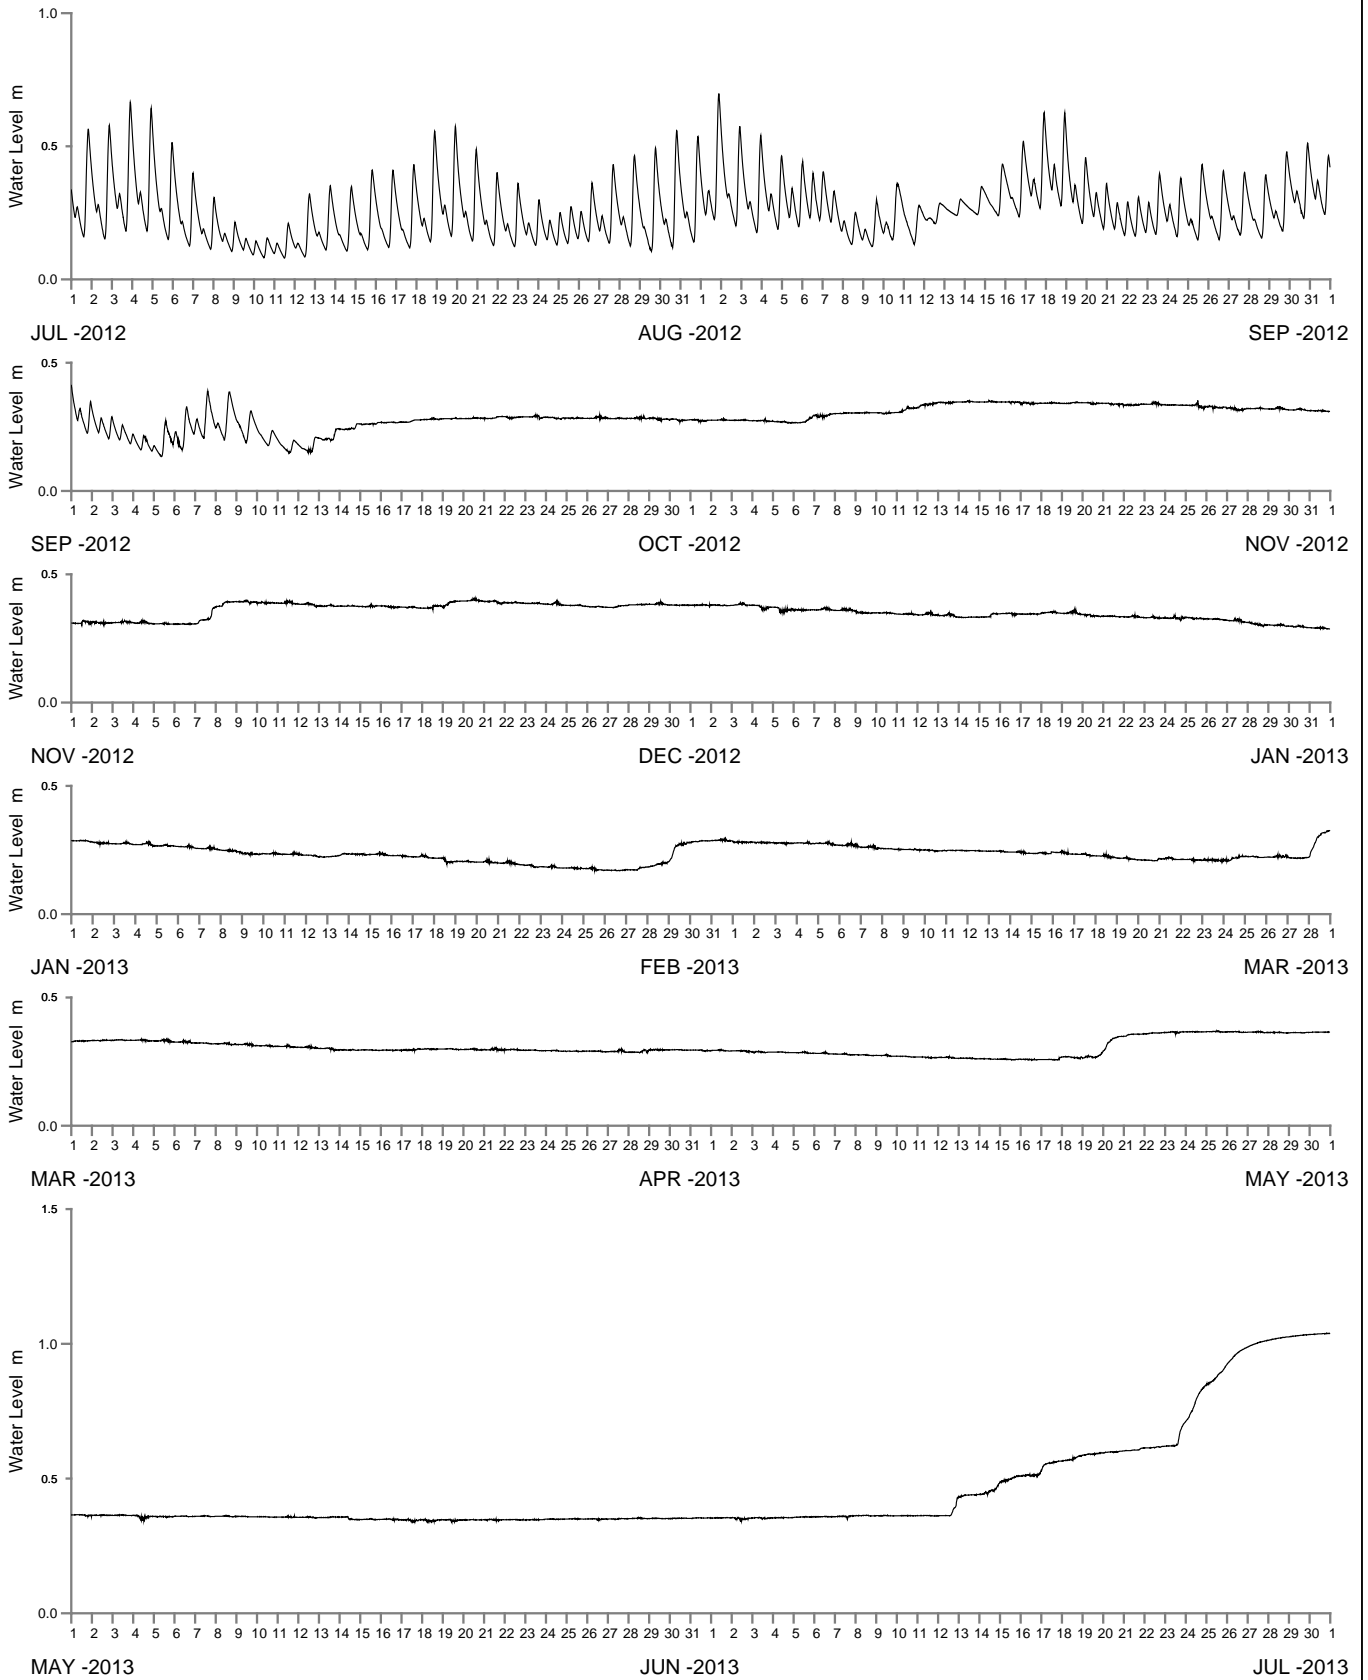
Figure
264

WATER LEVEL REFERENCED TO AUSTRALIAN HEIGHT DATUM

LAKE CURALO AT LAKE CURALO
2012-2013

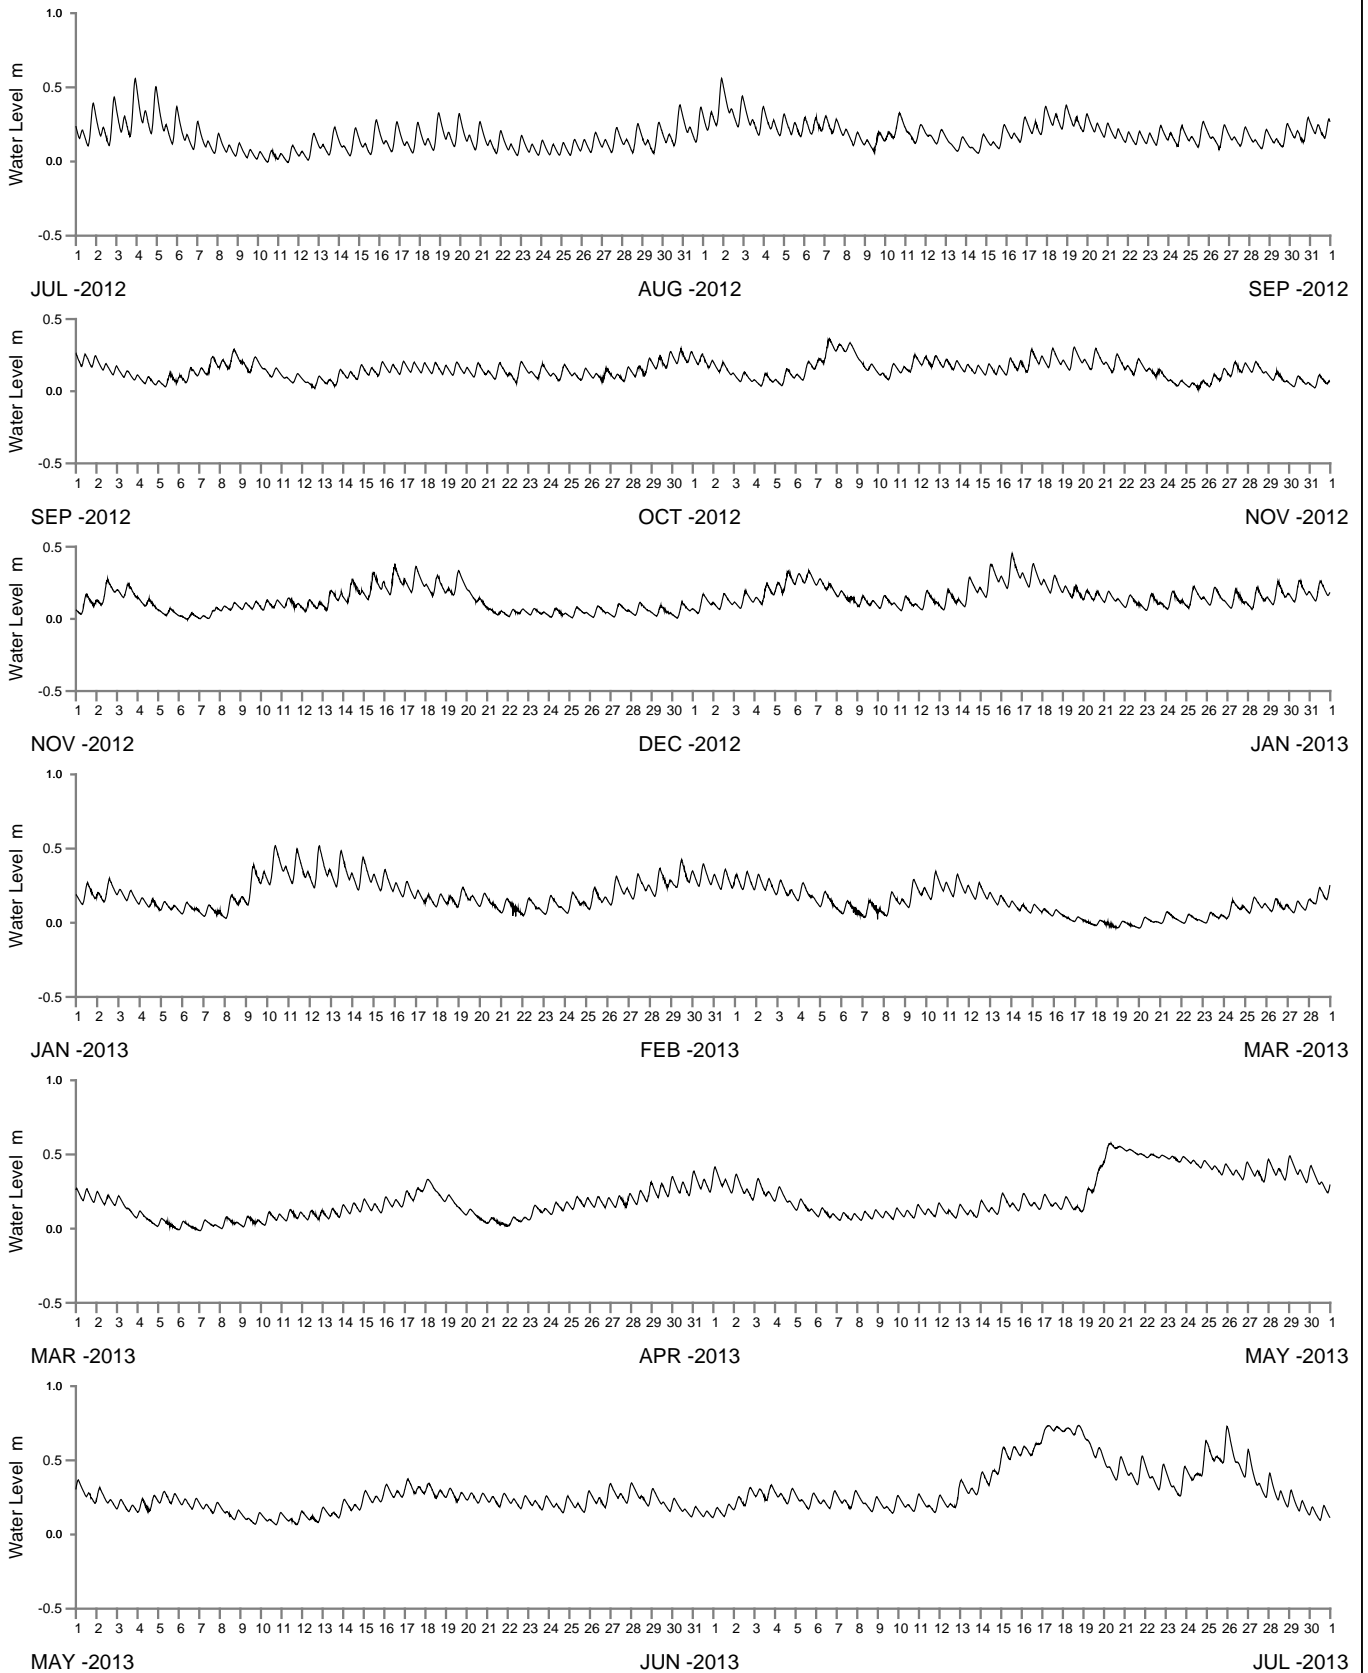
Figure
265

WATER LEVEL REFERENCED TO AUSTRALIAN HEIGHT DATUM

WONBOYN RIVER AT AGNEW WHARF
2012-2013
