Public Works
Manly Hydraulics Laboratory

MHL
Report 2218

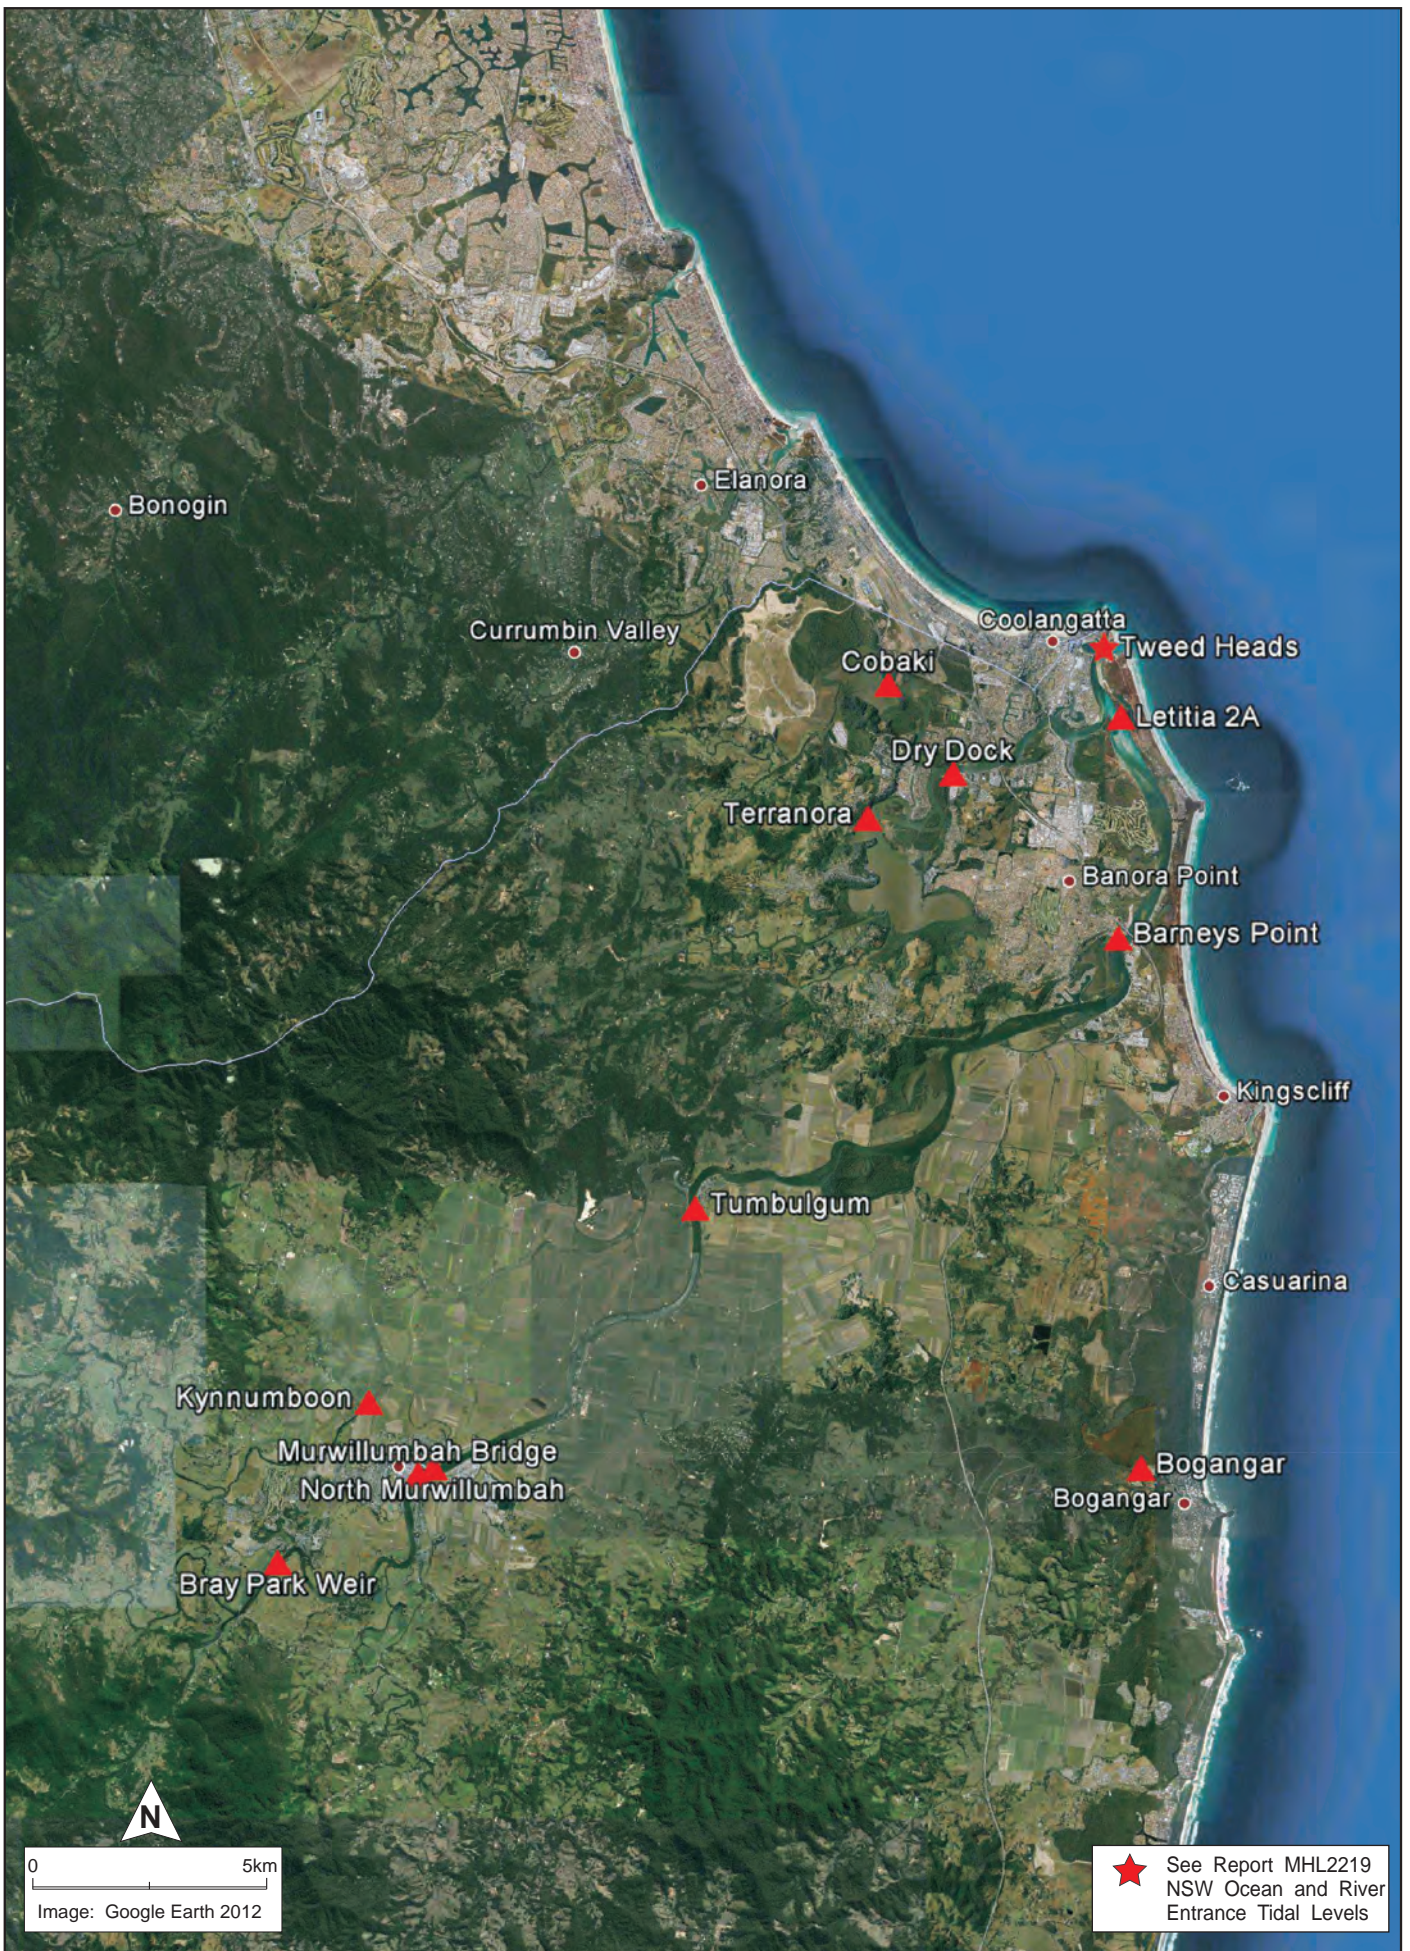
Figure
6

**STATION LOCATIONS
TWEED RIVER REGION**

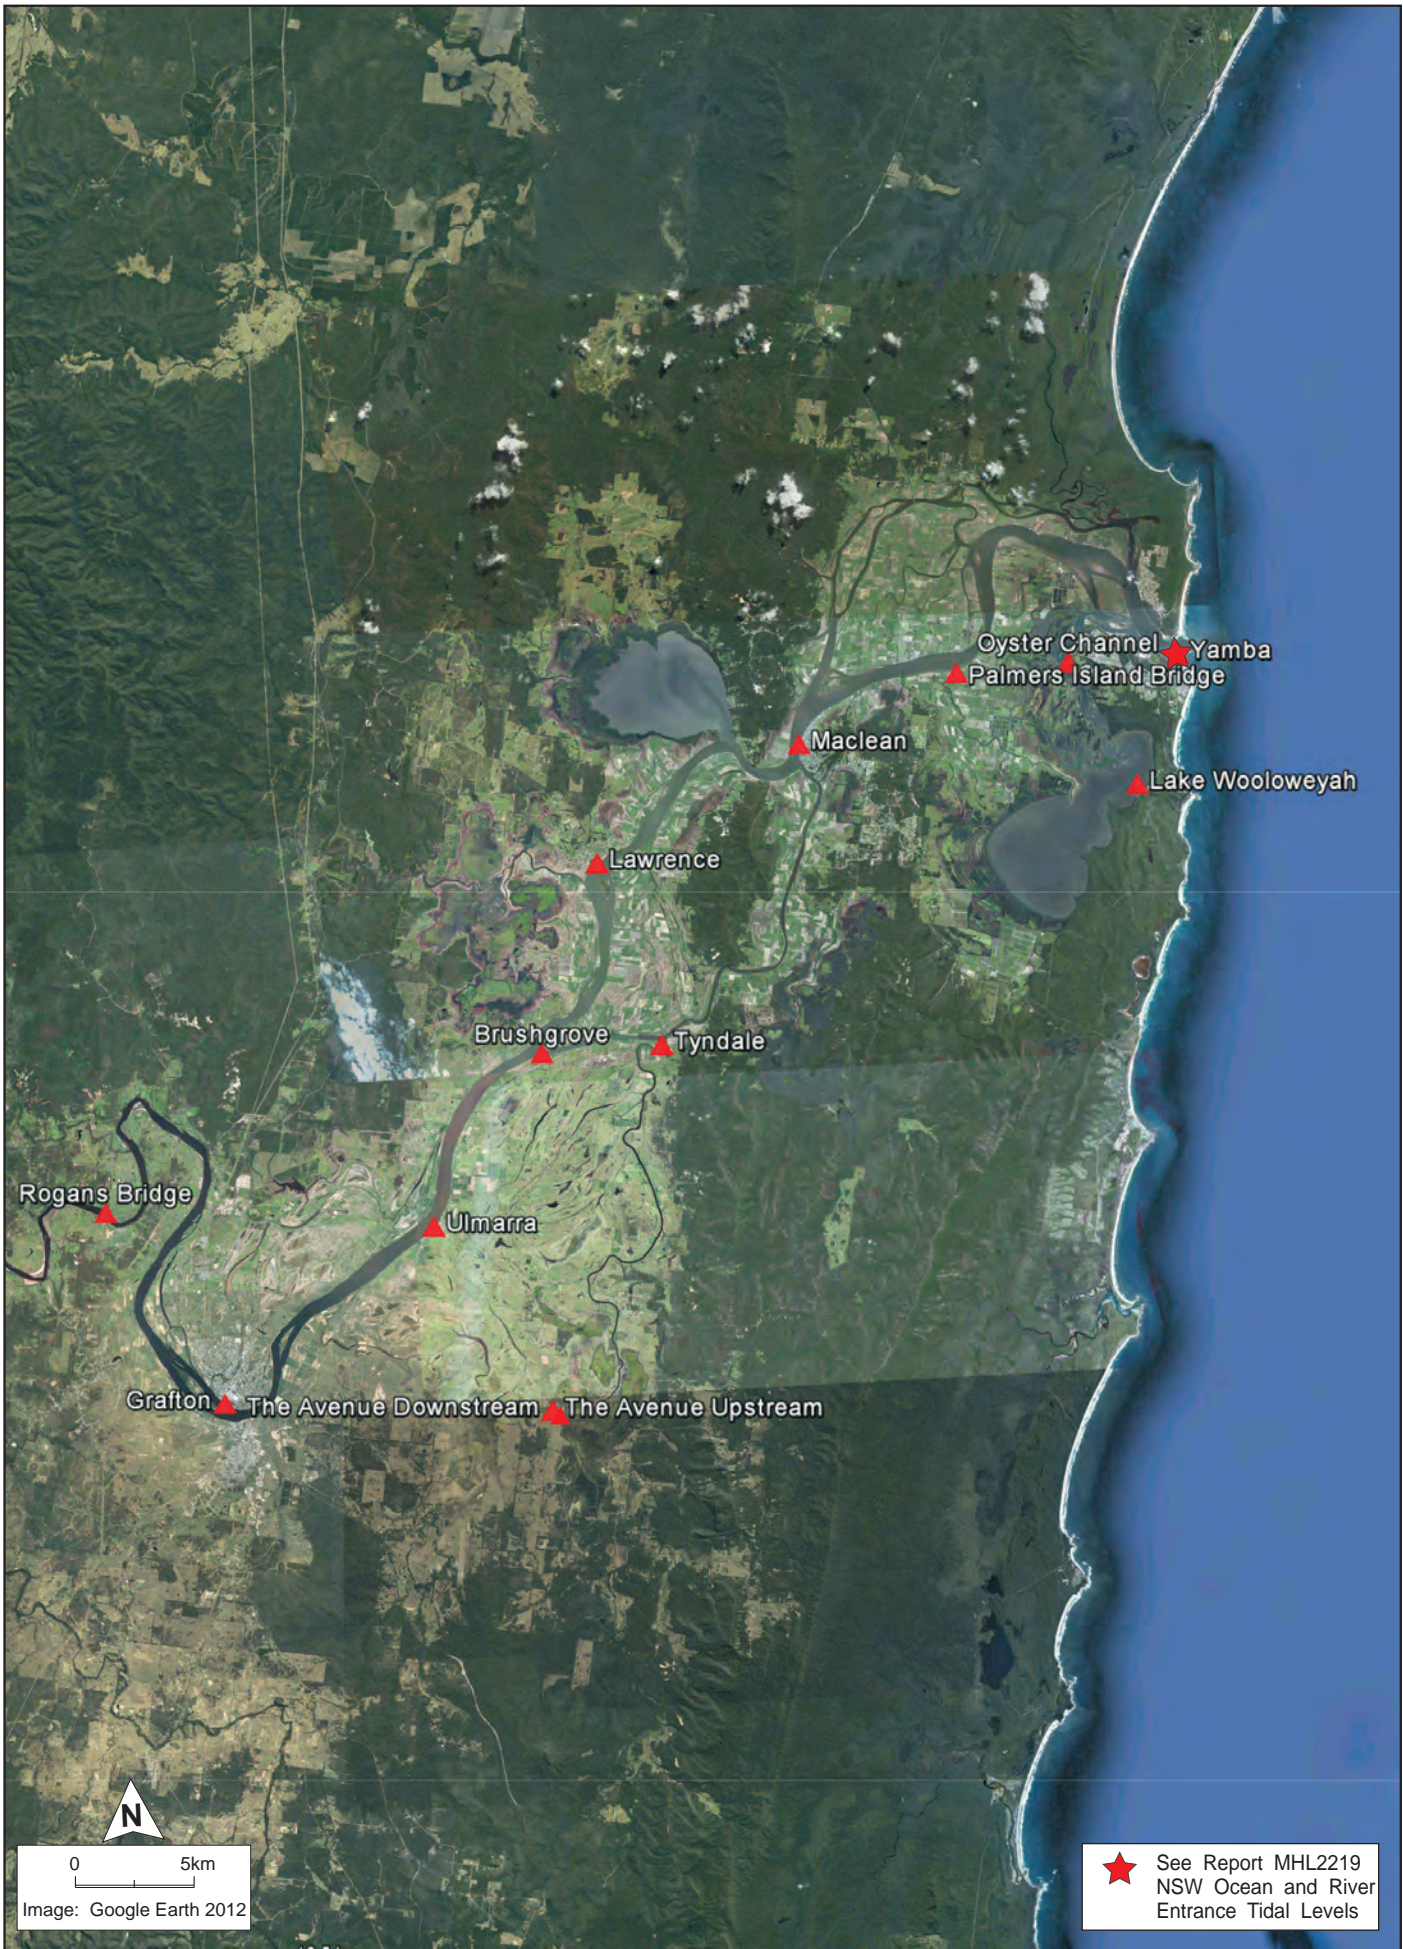
**Figure
 38**

**STATION LOCATIONS
 CLARENCE RIVER REGION**
