Public Works
Manly Hydraulics Laboratory

MHL
Report 2218

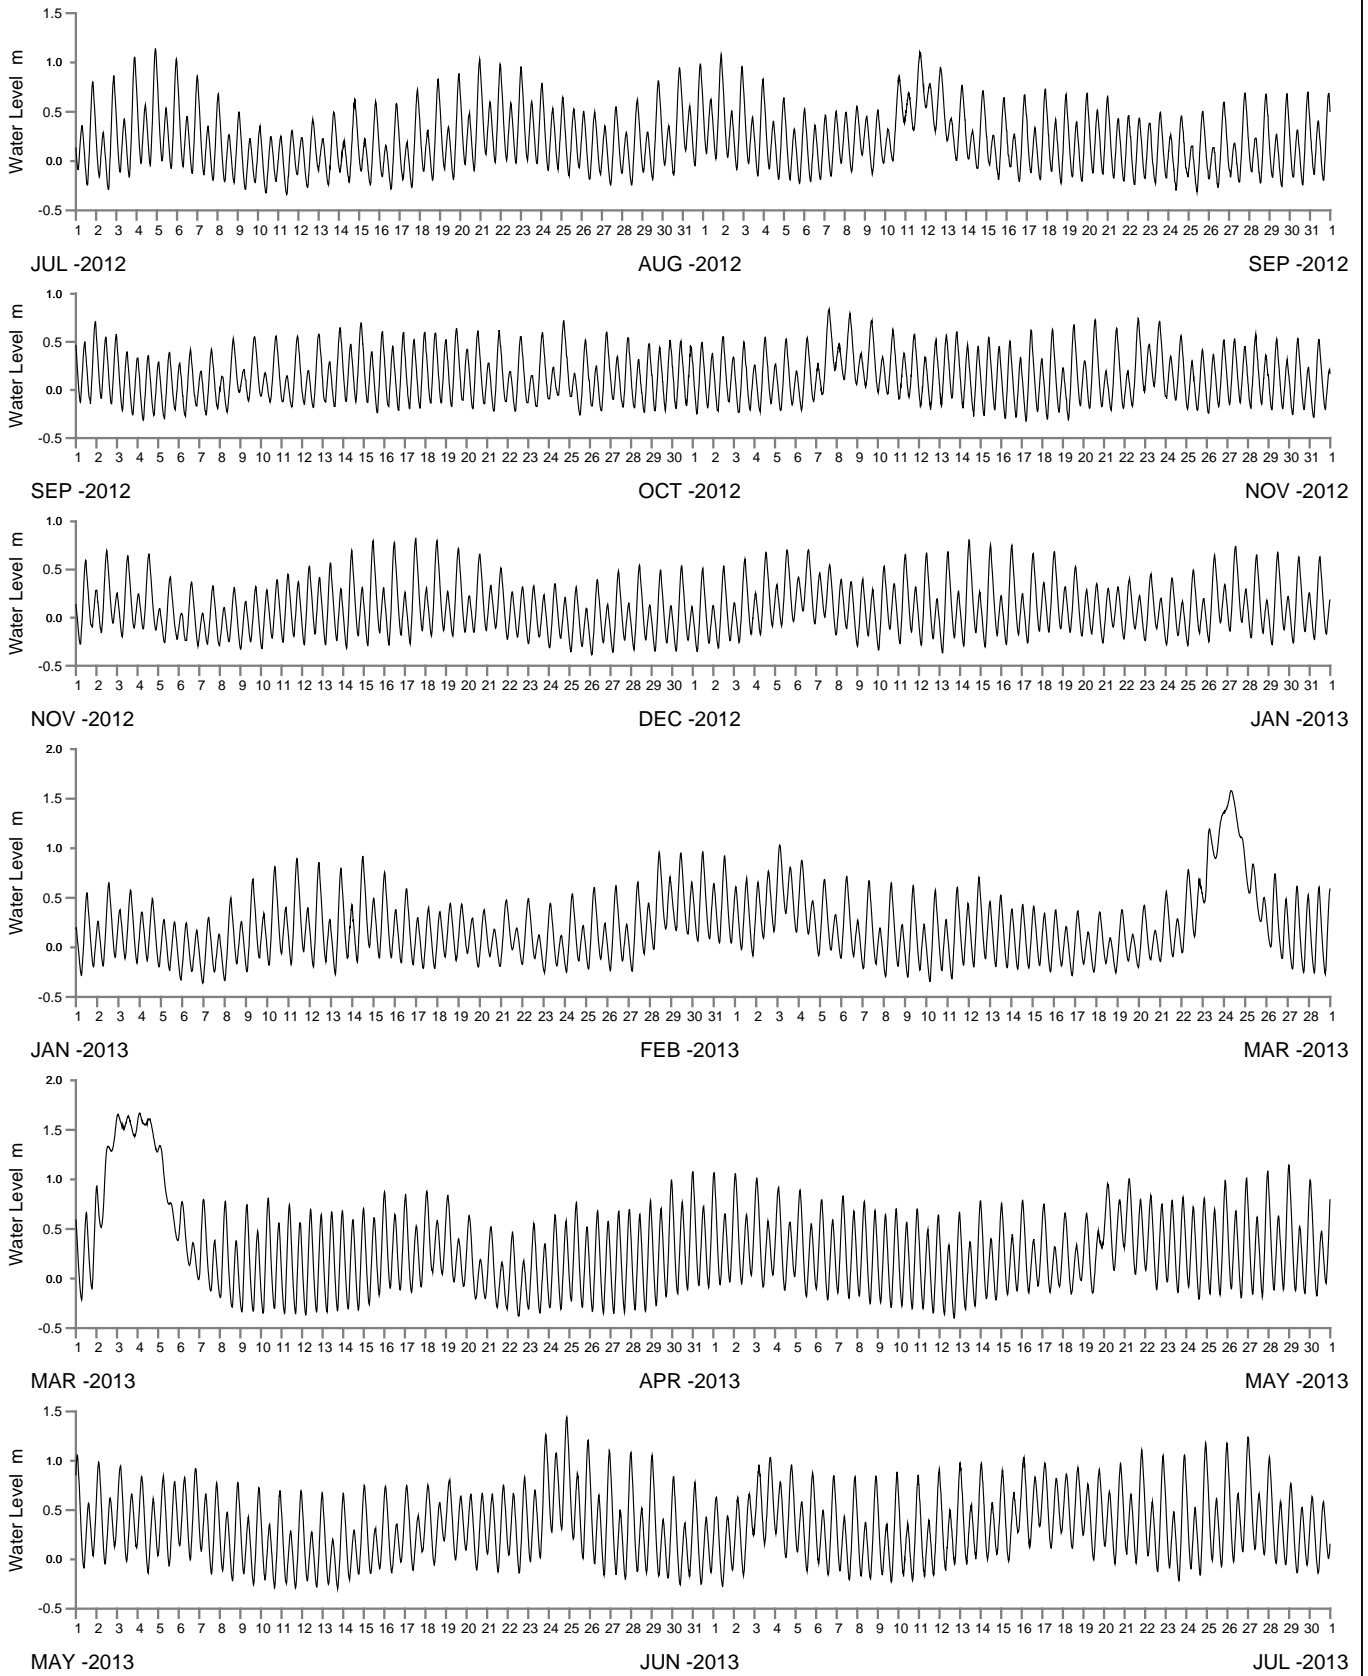
Figure

WATER LEVEL REFERENCED TO AUSTRALIAN HEIGHT DATUM

MANNING RIVER AT CROKI
2012-2013

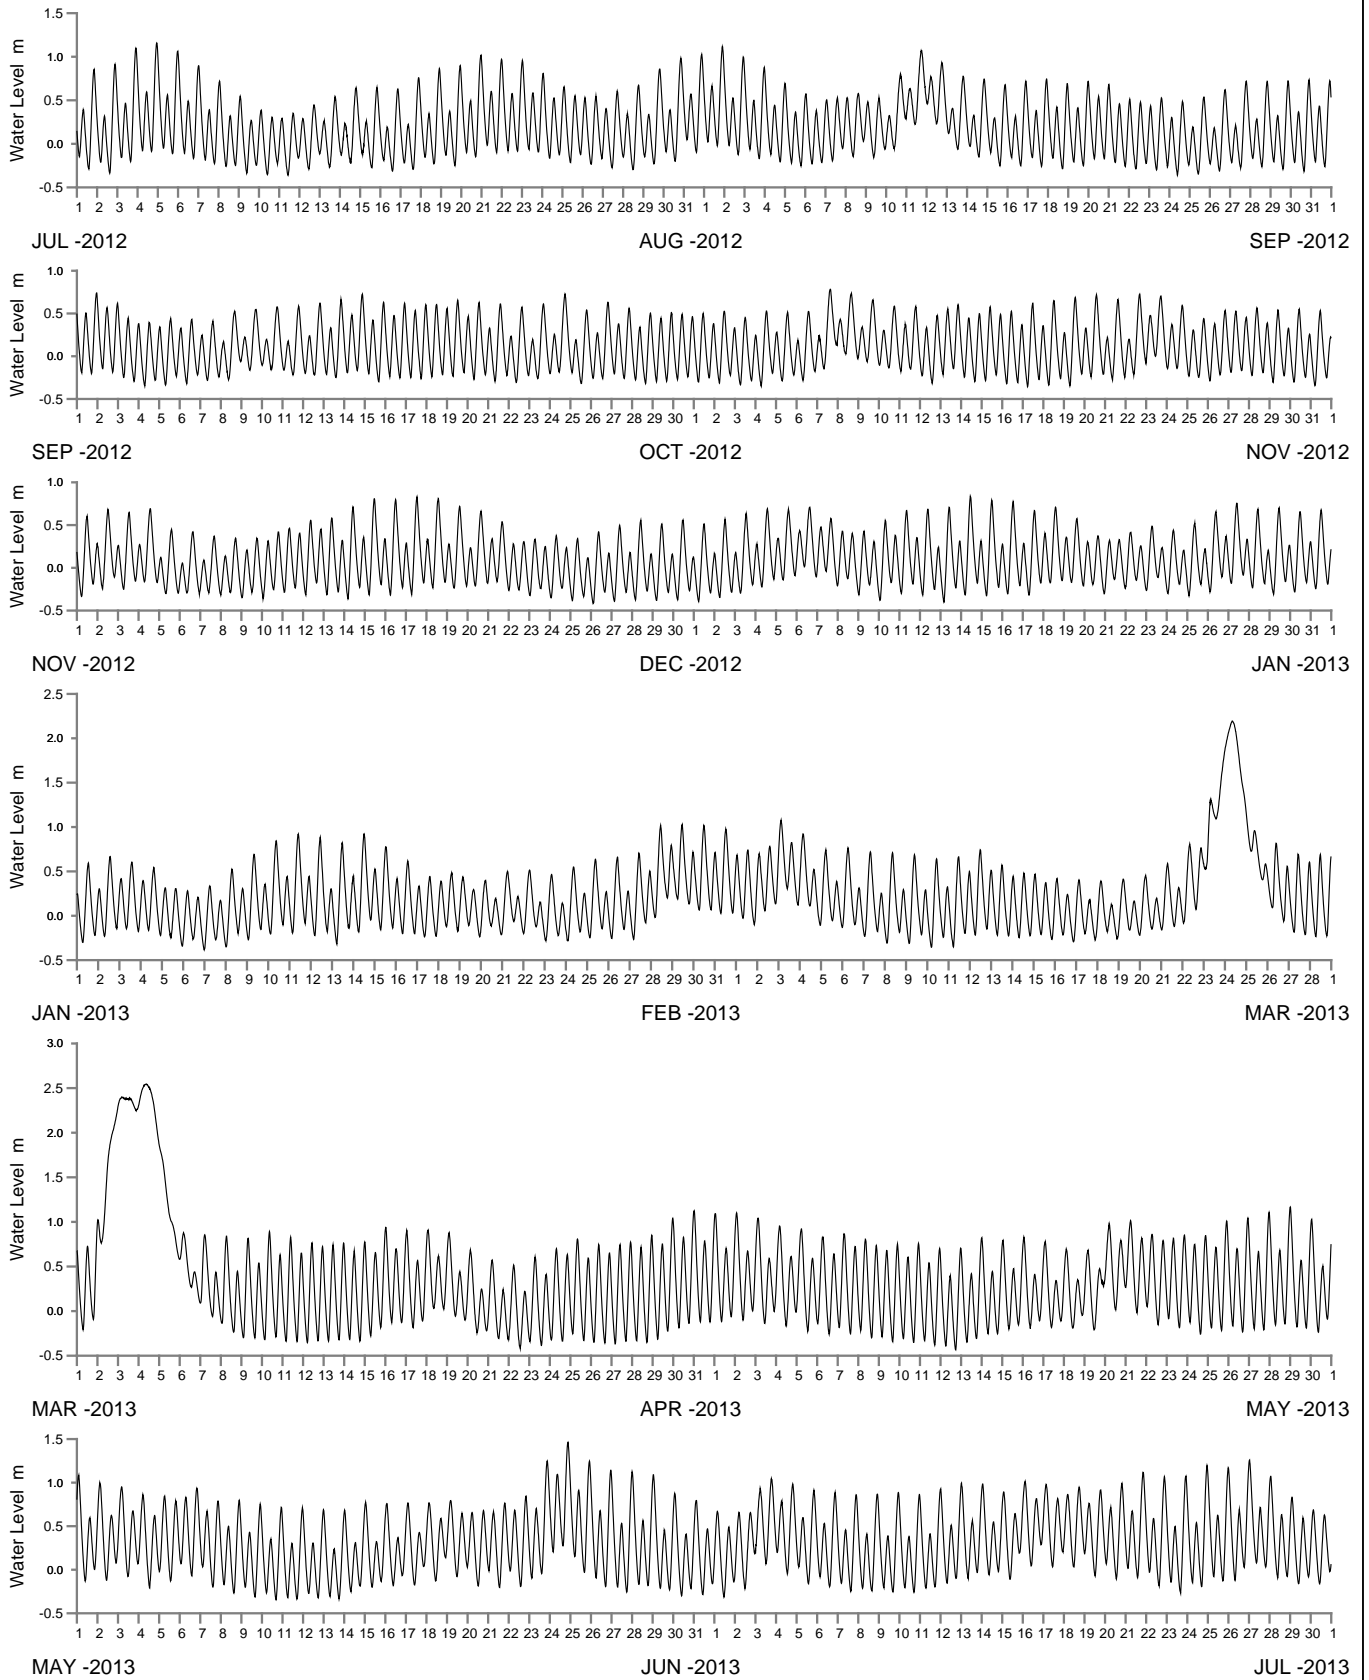
Figure
102

WATER LEVEL REFERENCED TO AUSTRALIAN HEIGHT DATUM

MANNING RIVER AT DUMARESQ ISLAND
2012-2013

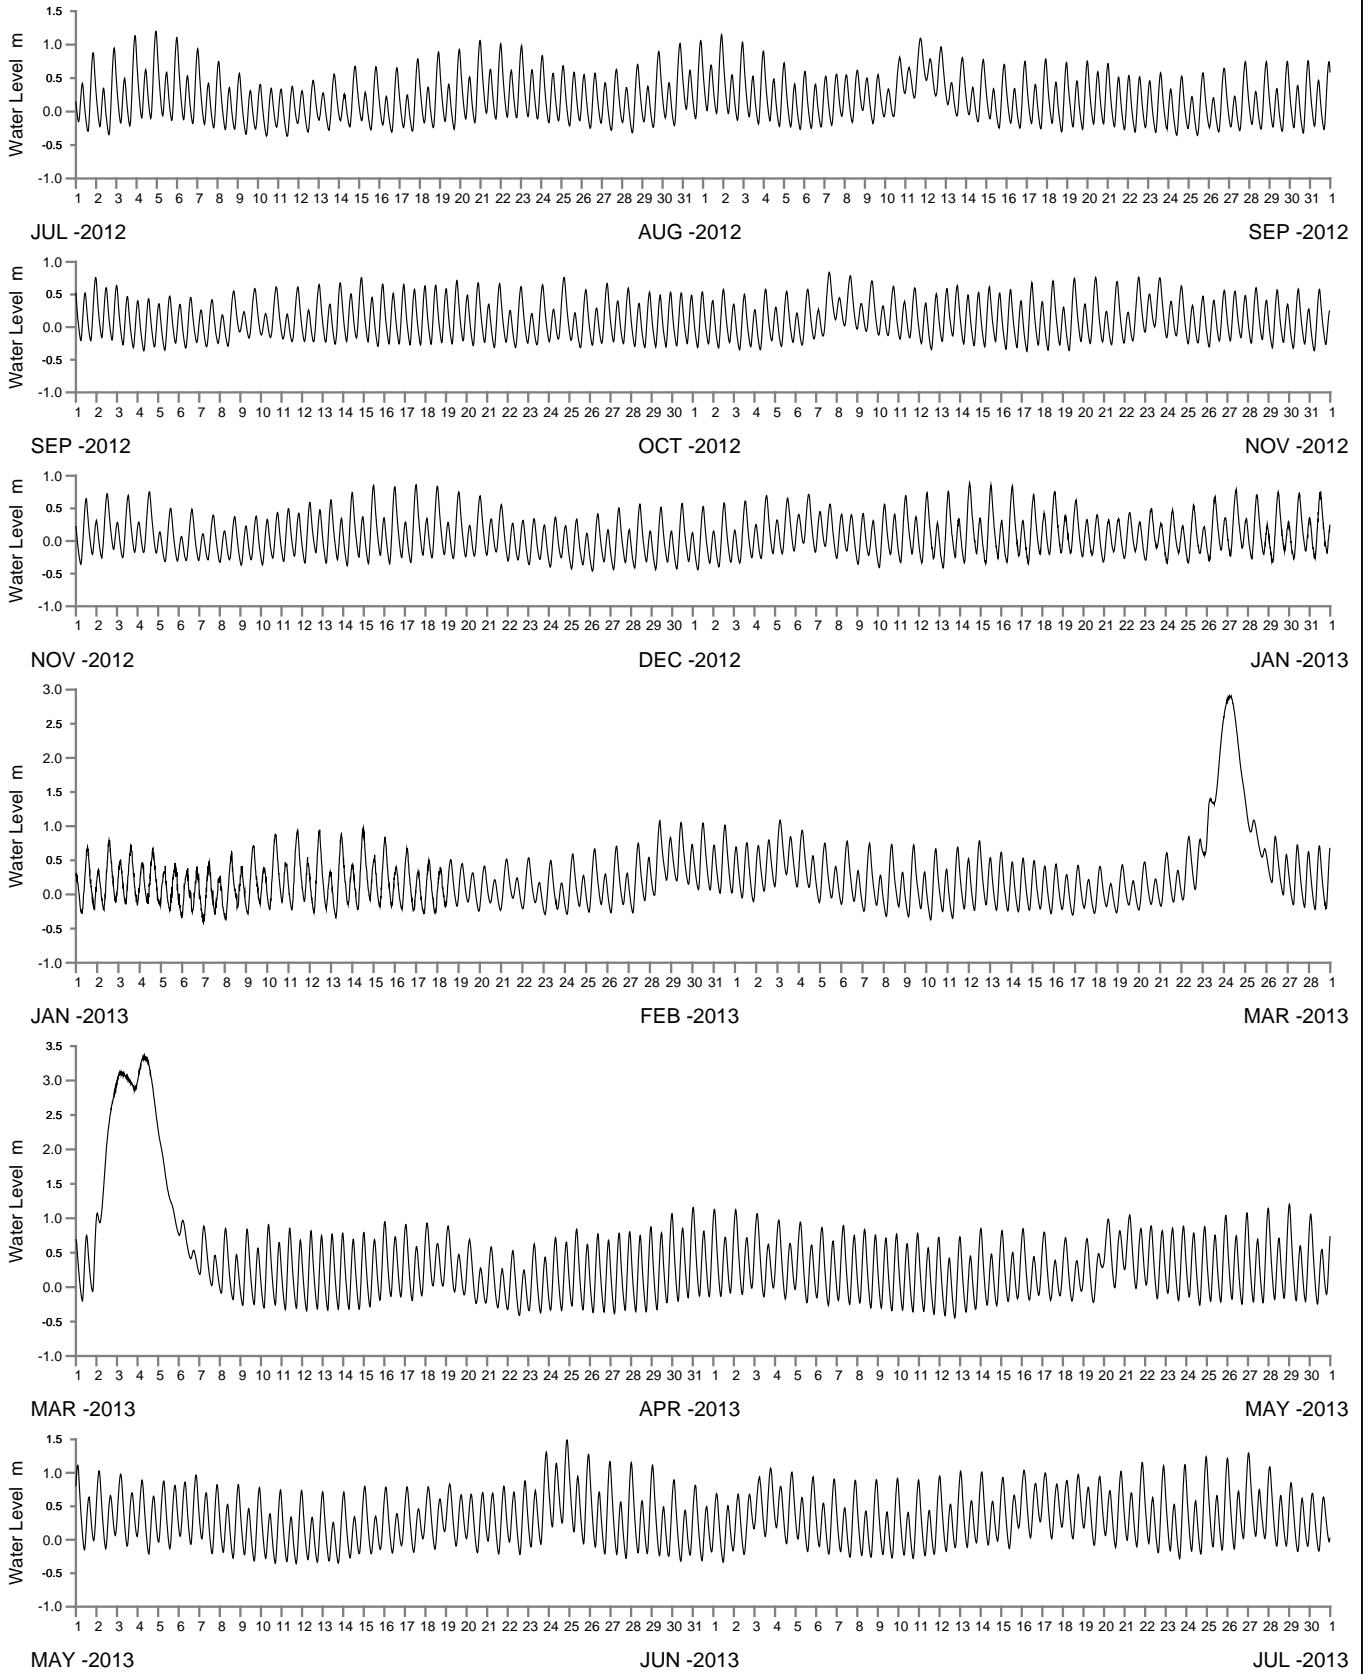
Figure
103

WATER LEVEL REFERENCED TO AUSTRALIAN HEIGHT DATUM

MANNING RIVER AT TAREE
2012-2013

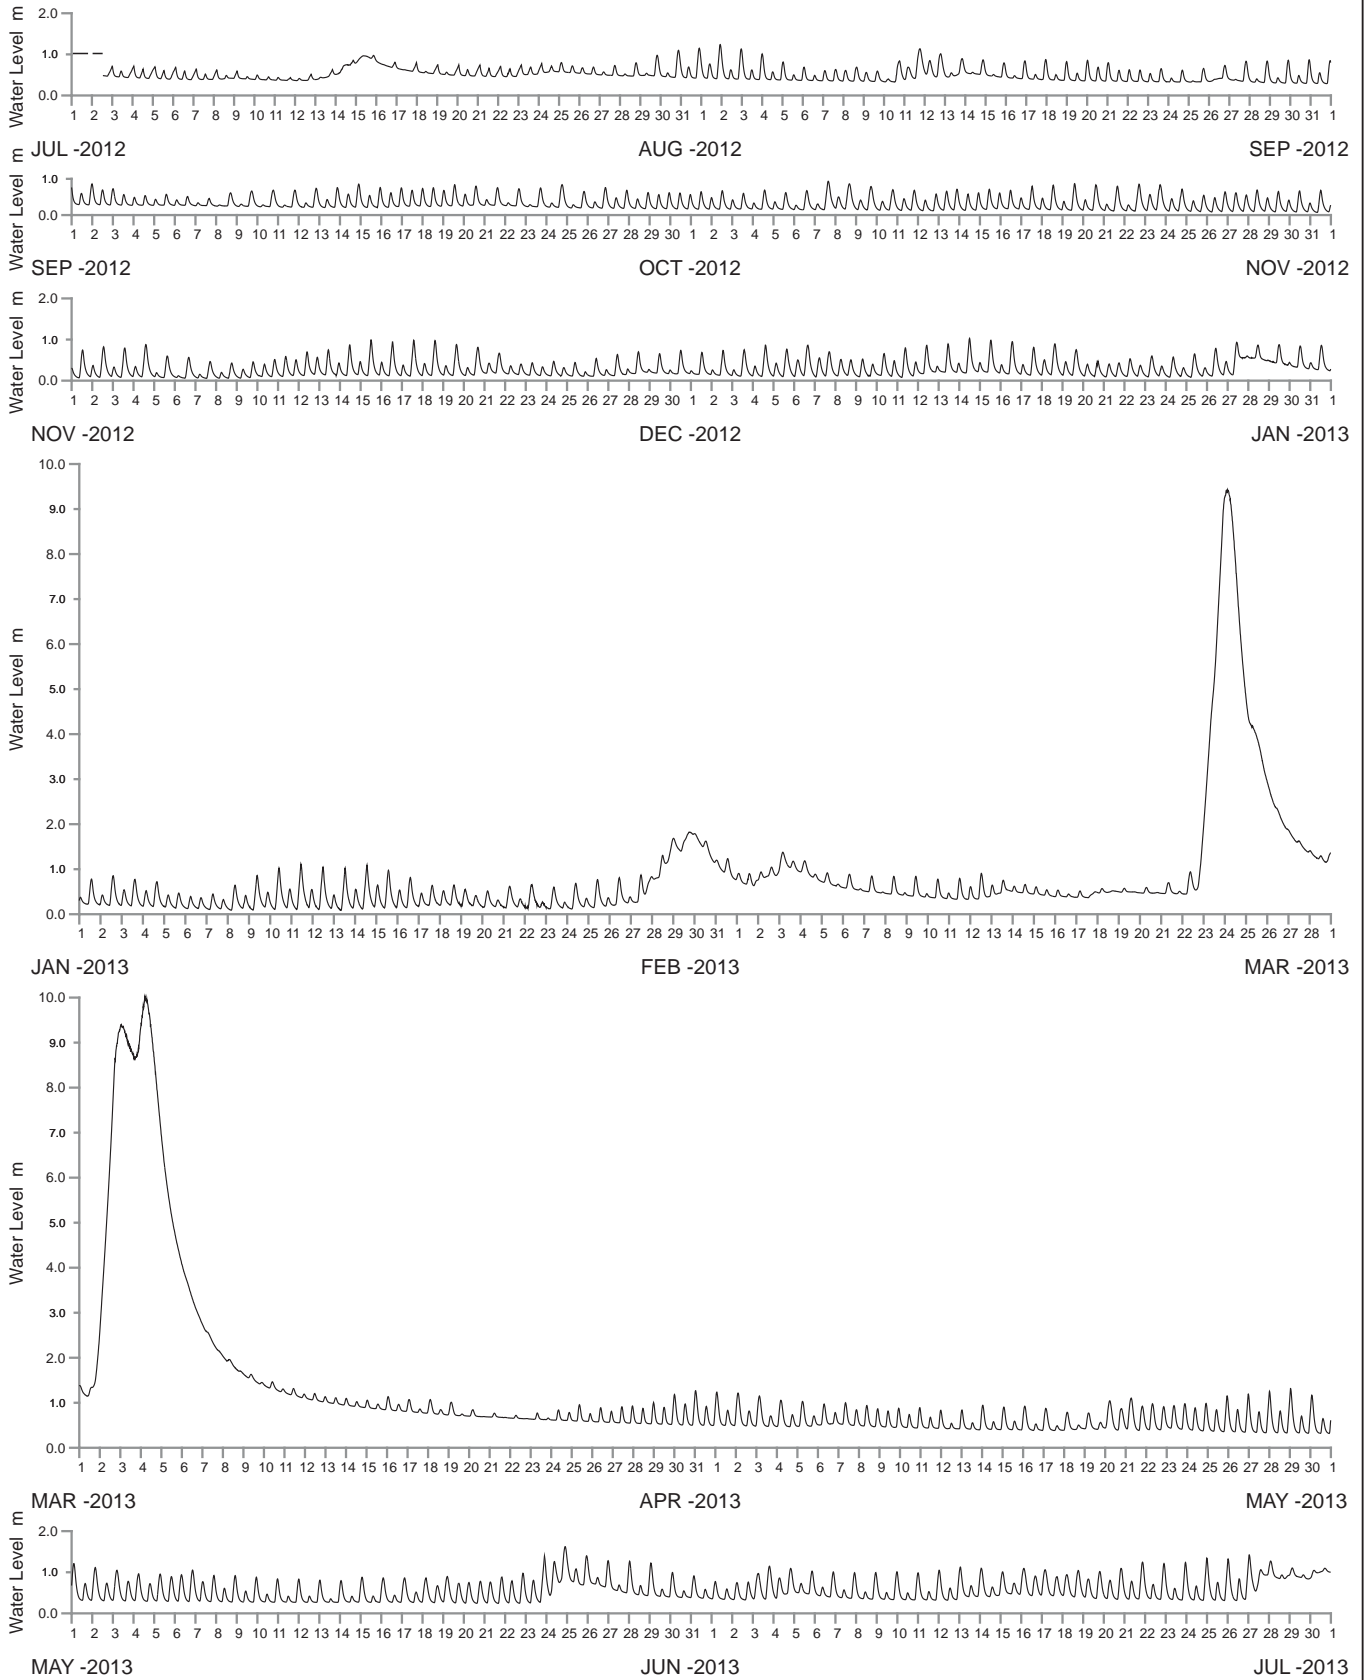
Figure

WATER LEVEL REFERENCED TO AUSTRALIAN HEIGHT DATUM

MANNING RIVER AT WINGHAM
2012-2013

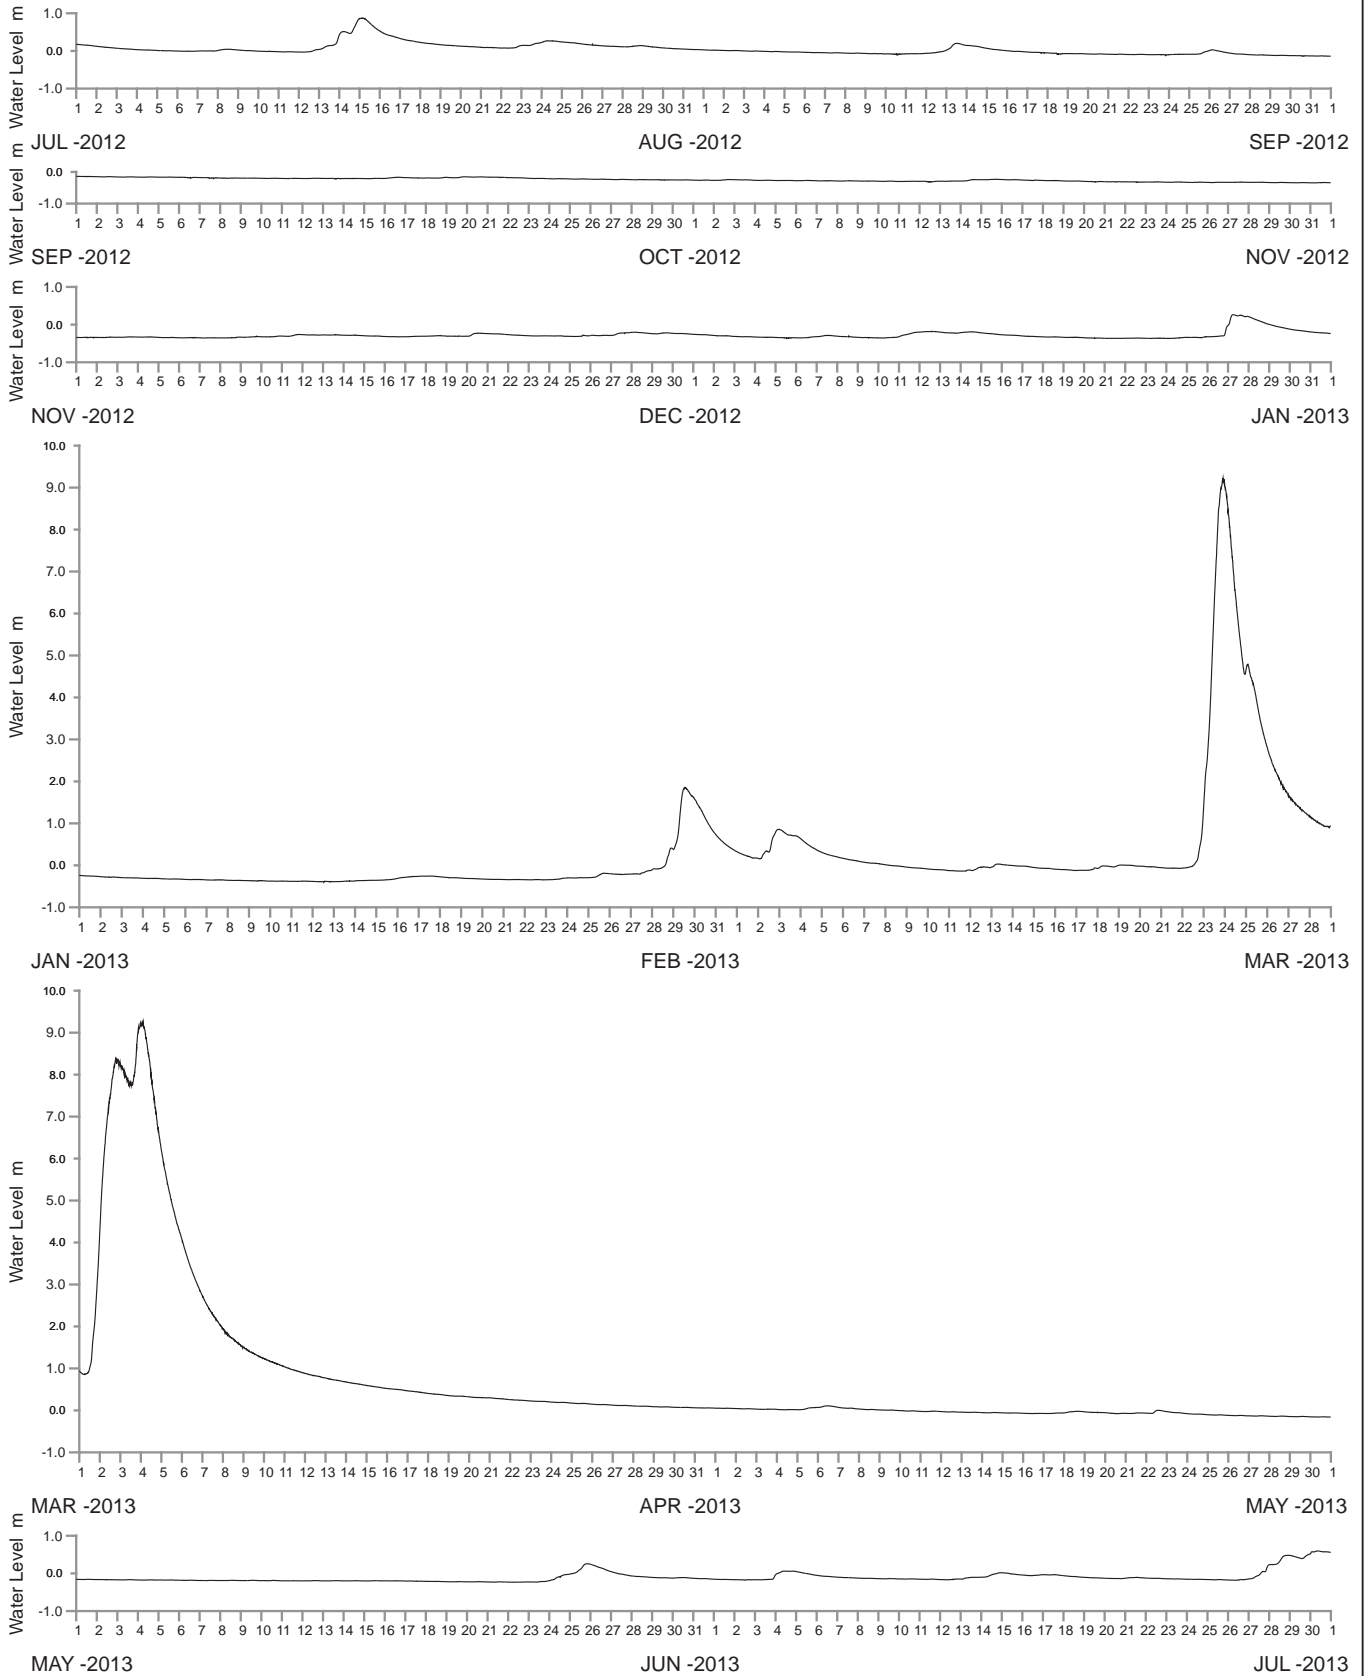
Figure
105

WATER LEVEL REFERENCED TO LOCAL WATER RESOURCES DATUM

MANNING RIVER AT MT GEORGE
2012-2013

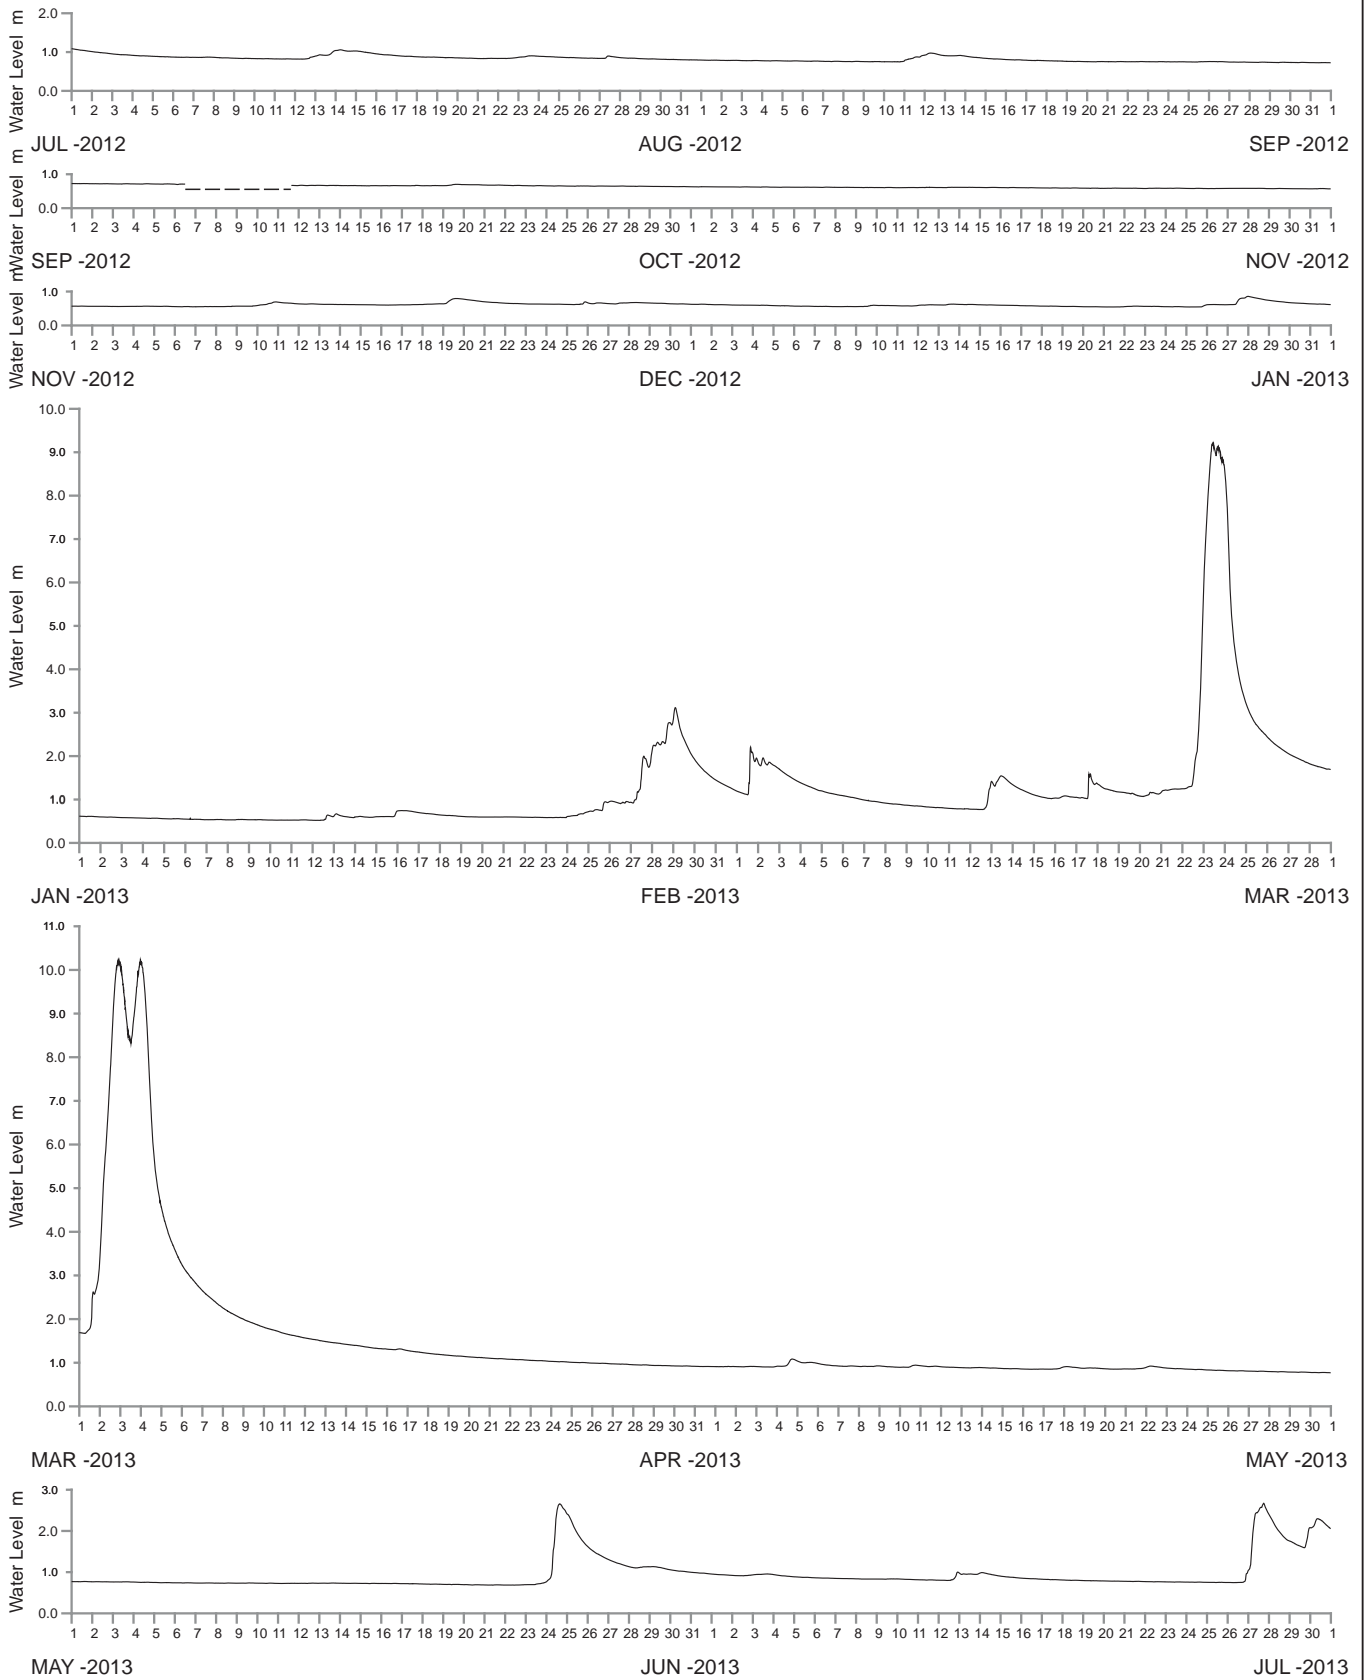
Figure
106

WATER LEVEL REFERENCED TO ASSUMED DATUM

DINGO CREEK AT DOWNSTREAM ASHLEA BRIDGE
2012-2013

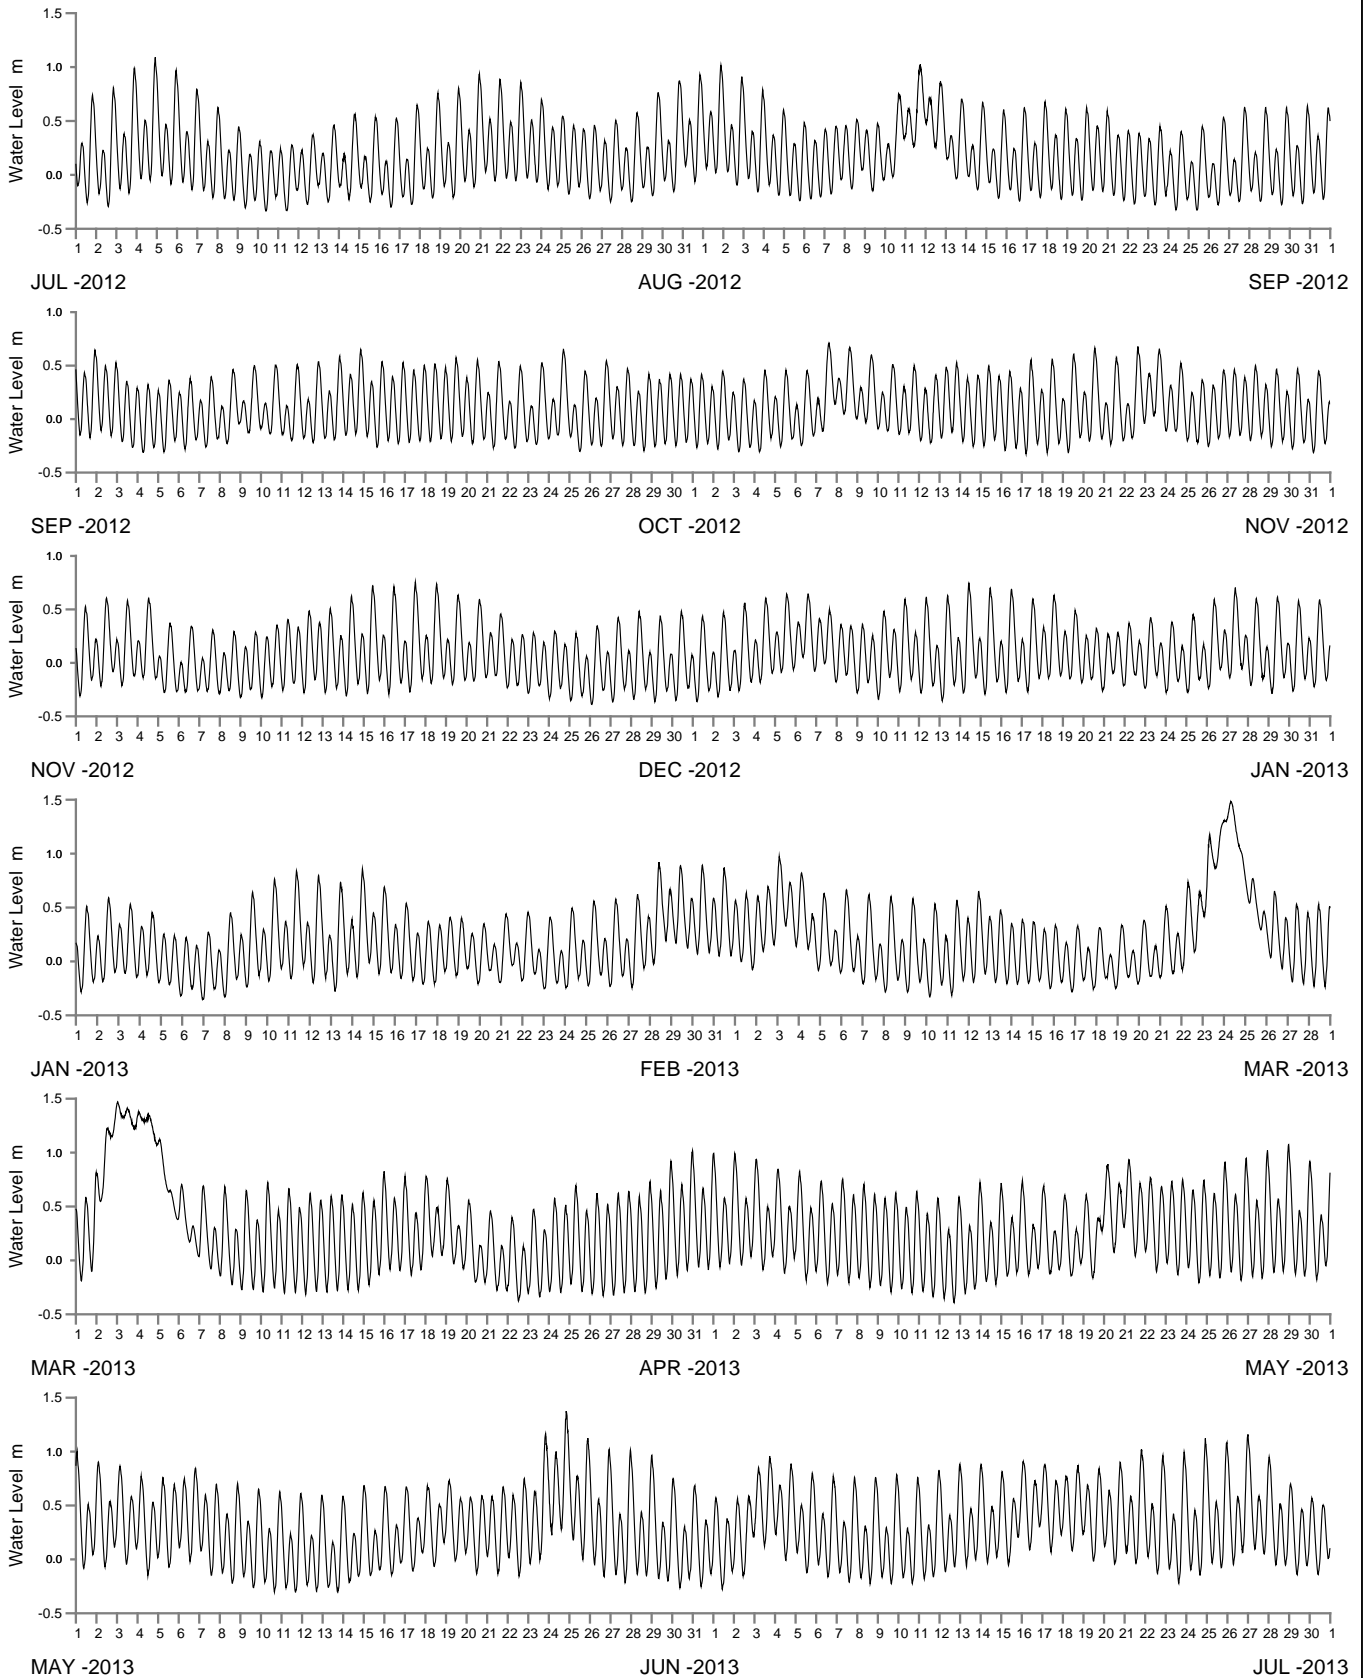
Figure
107

WATER LEVEL REFERENCED TO AUSTRALIAN HEIGHT DATUM

MANNING RIVER AT FARQUHAR INLET
2012-2013

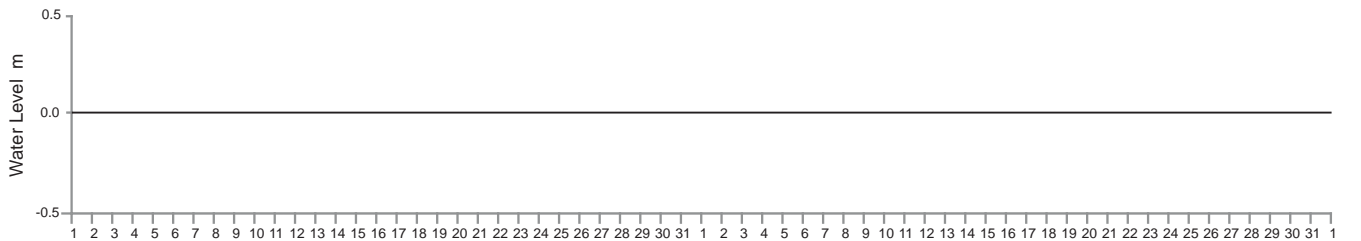
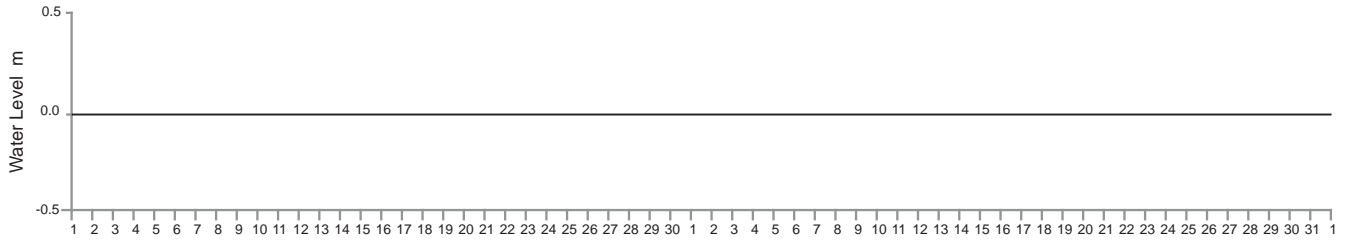
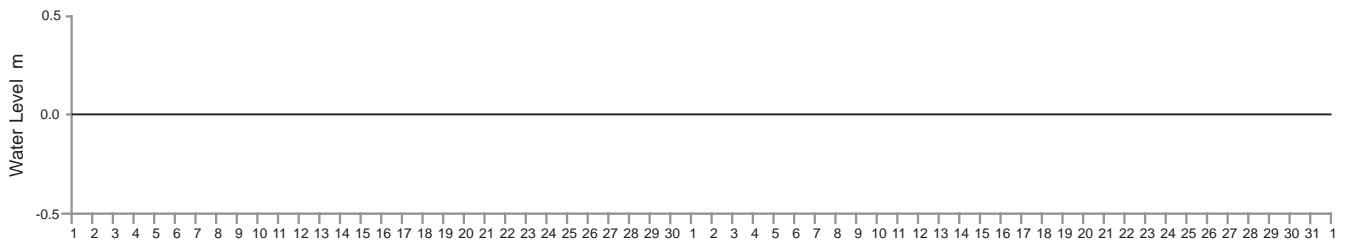
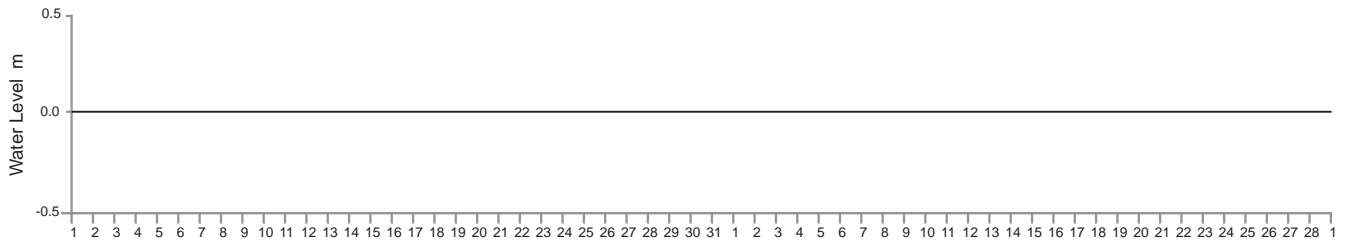
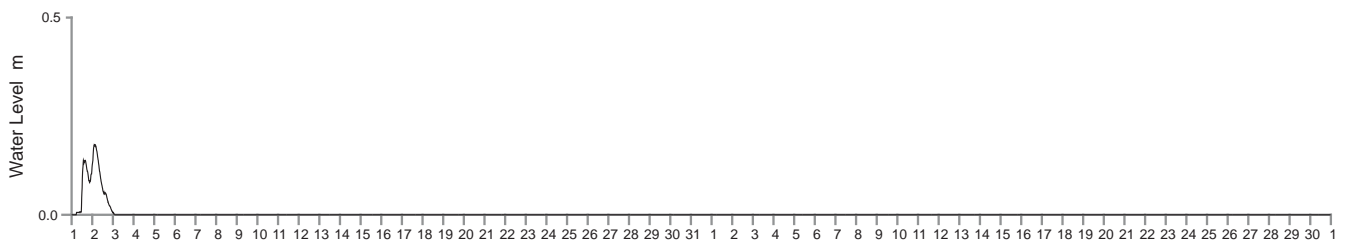
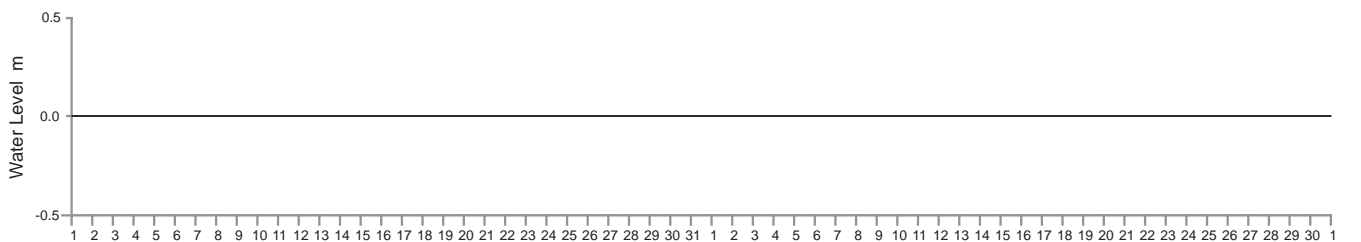
Figure

WATER LEVEL REFERENCED TO ASSUMED DATUM

WALLAMBA RIVER AT TUNCURRY WETLANDS
2012-2013

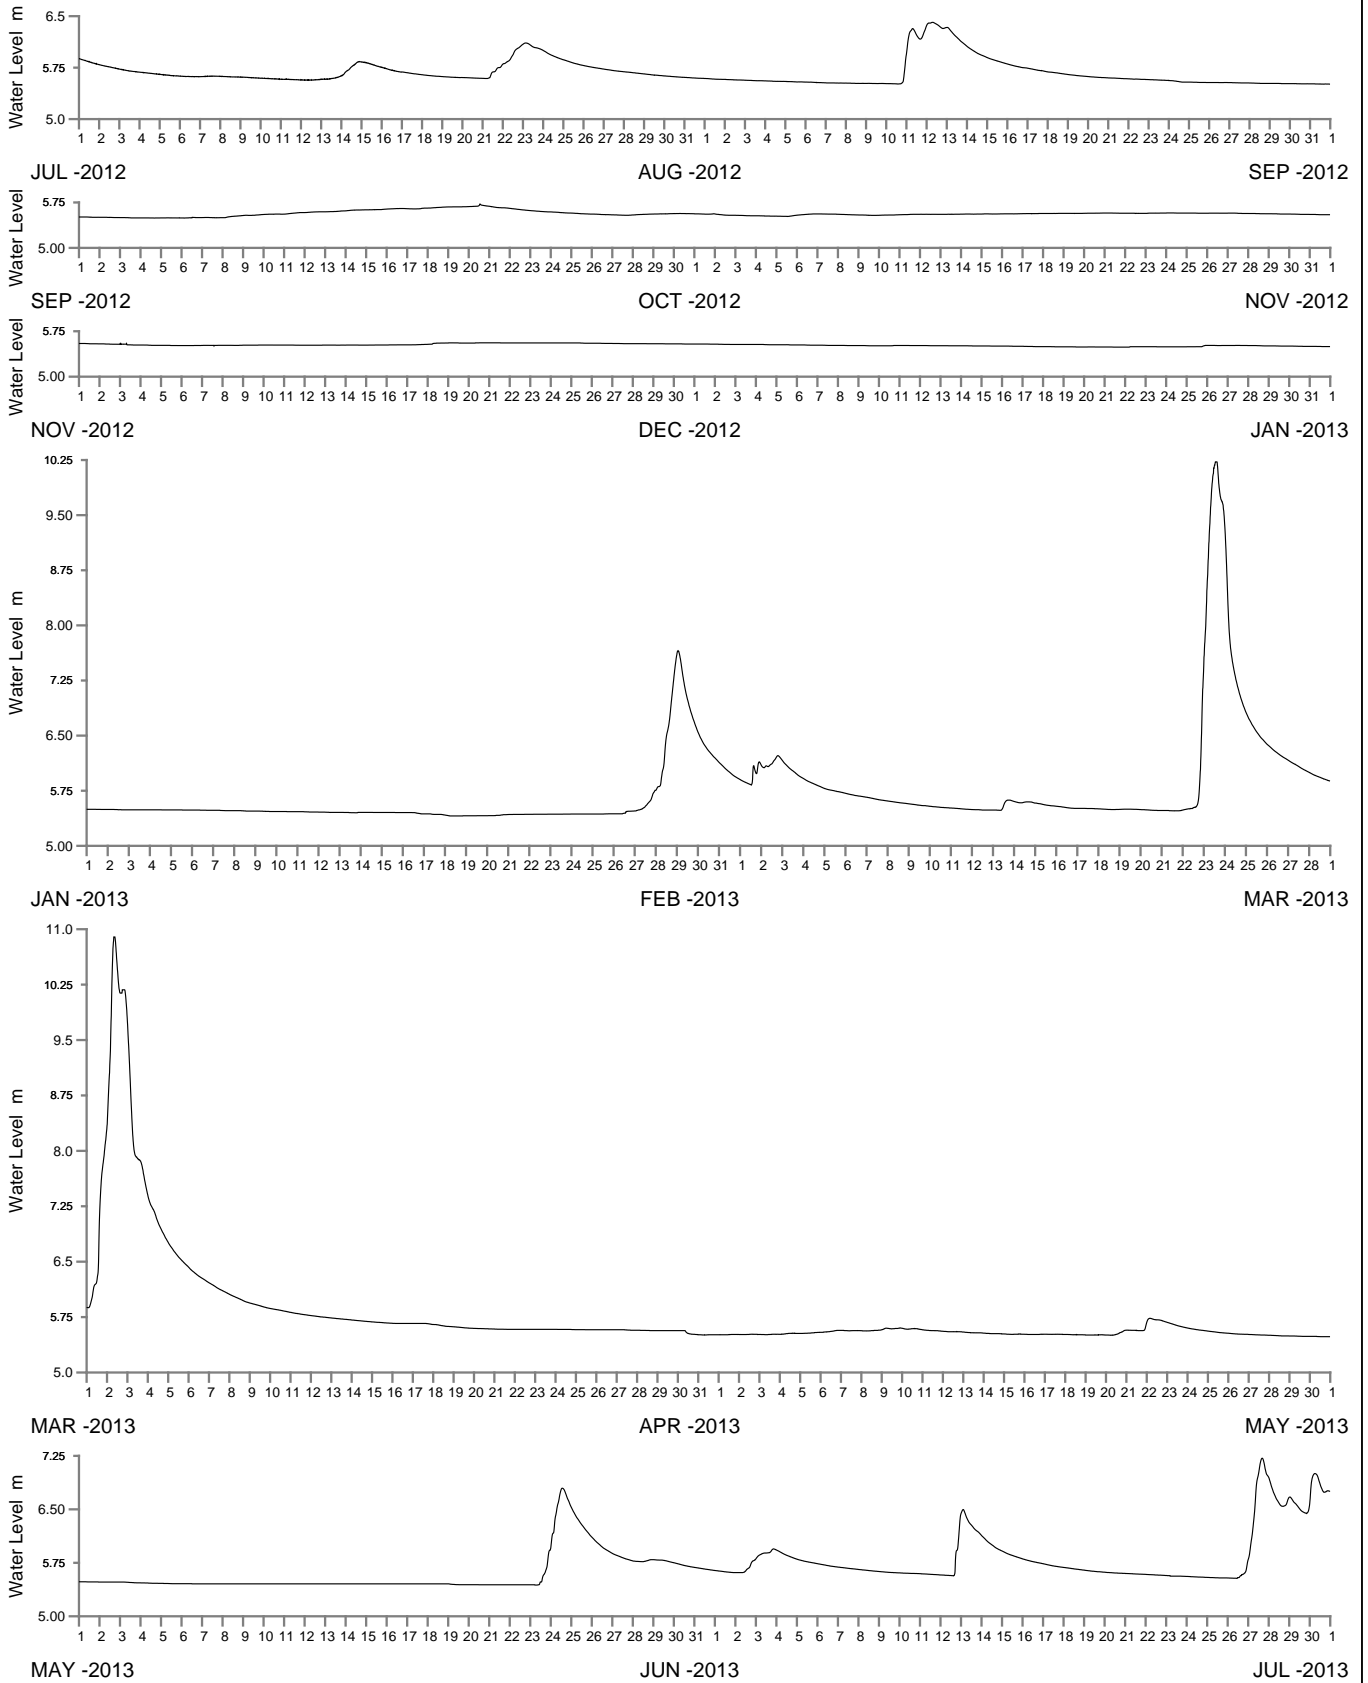
Figure
111

WATER LEVEL REFERENCED TO AUSTRALIAN HEIGHT DATUM

WALLAMBA RIVER AT NABIAC
2012-2013

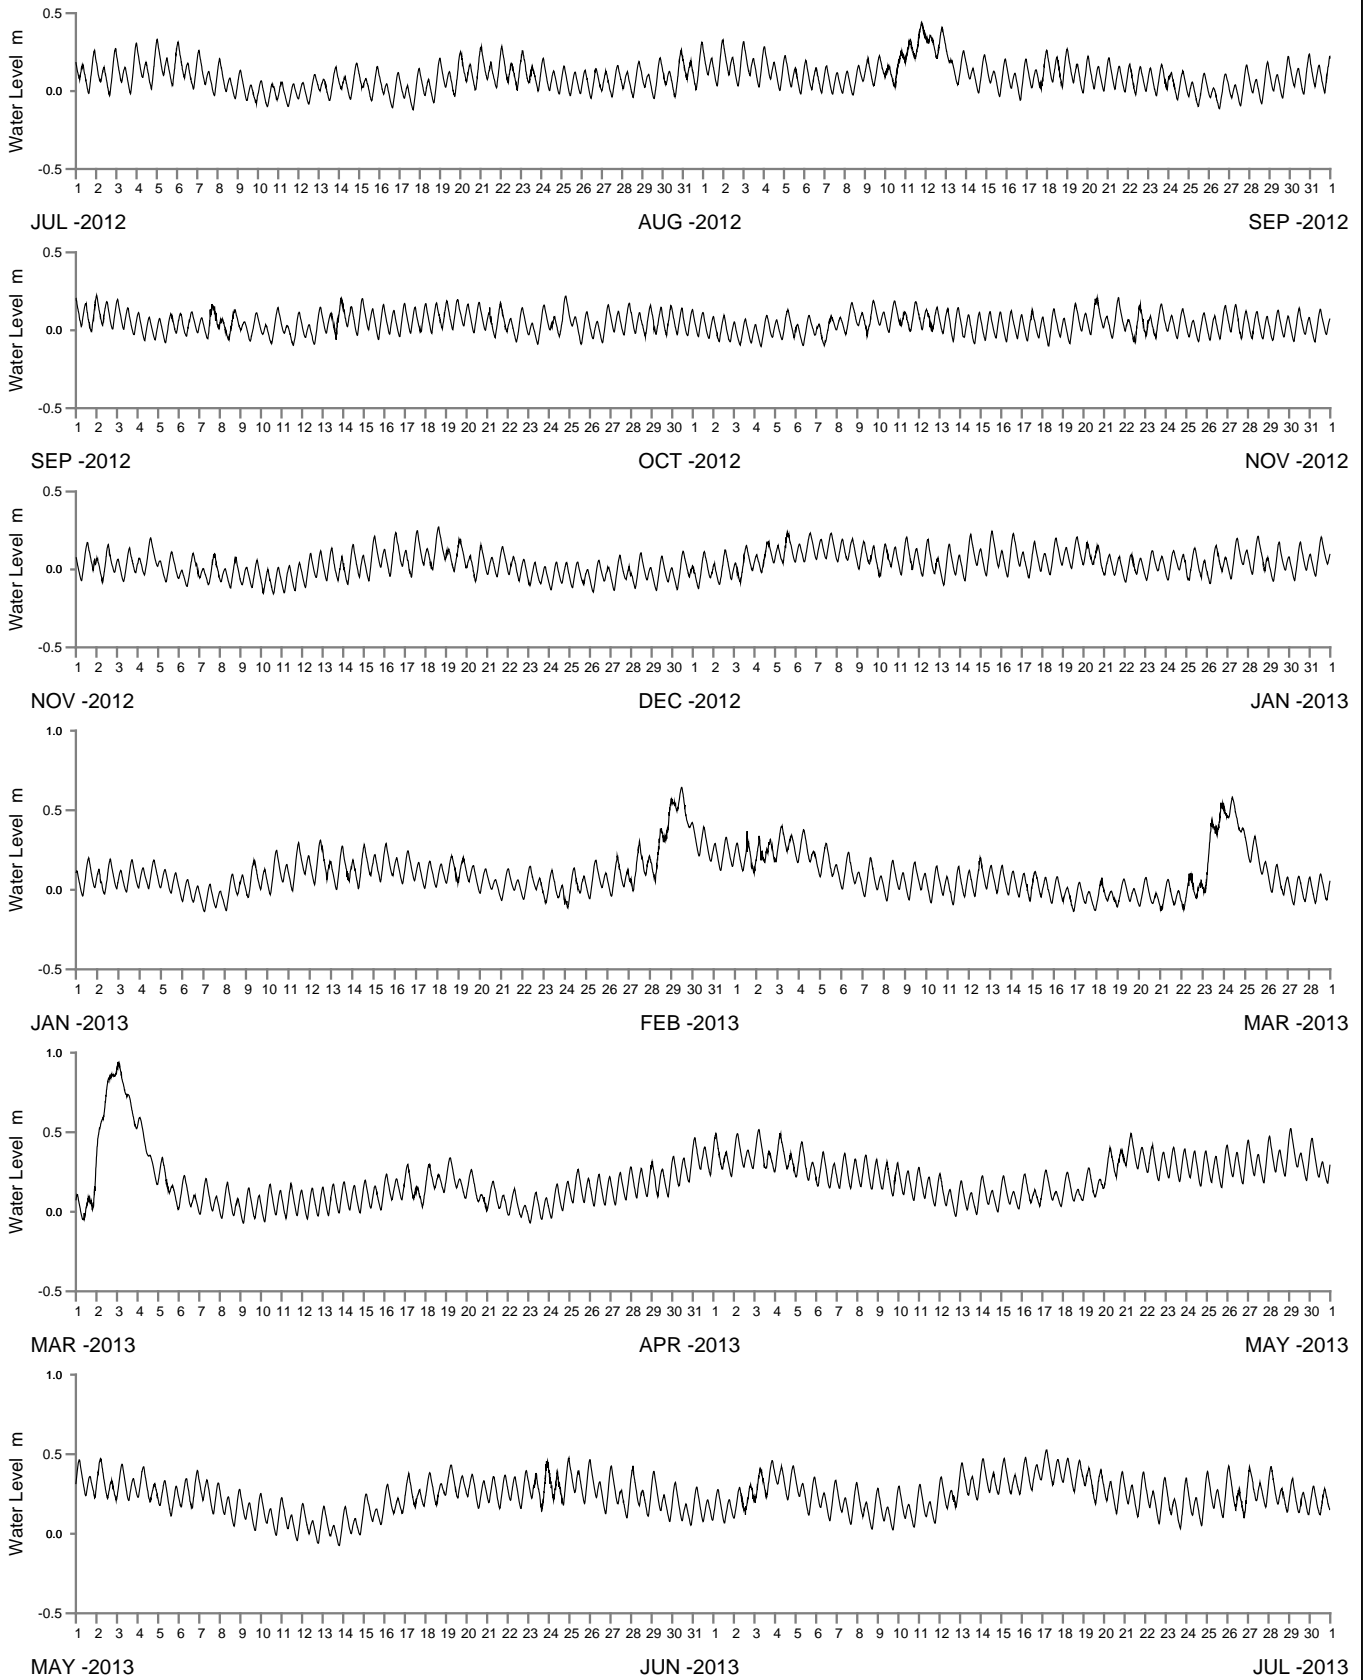
Figure
112

WATER LEVEL REFERENCED TO AUSTRALIAN HEIGHT DATUM

WALLIS LAKE AT TIONA
2012-2013
