Public Works
Manly Hydraulics Laboratory

MHL
Report 2218

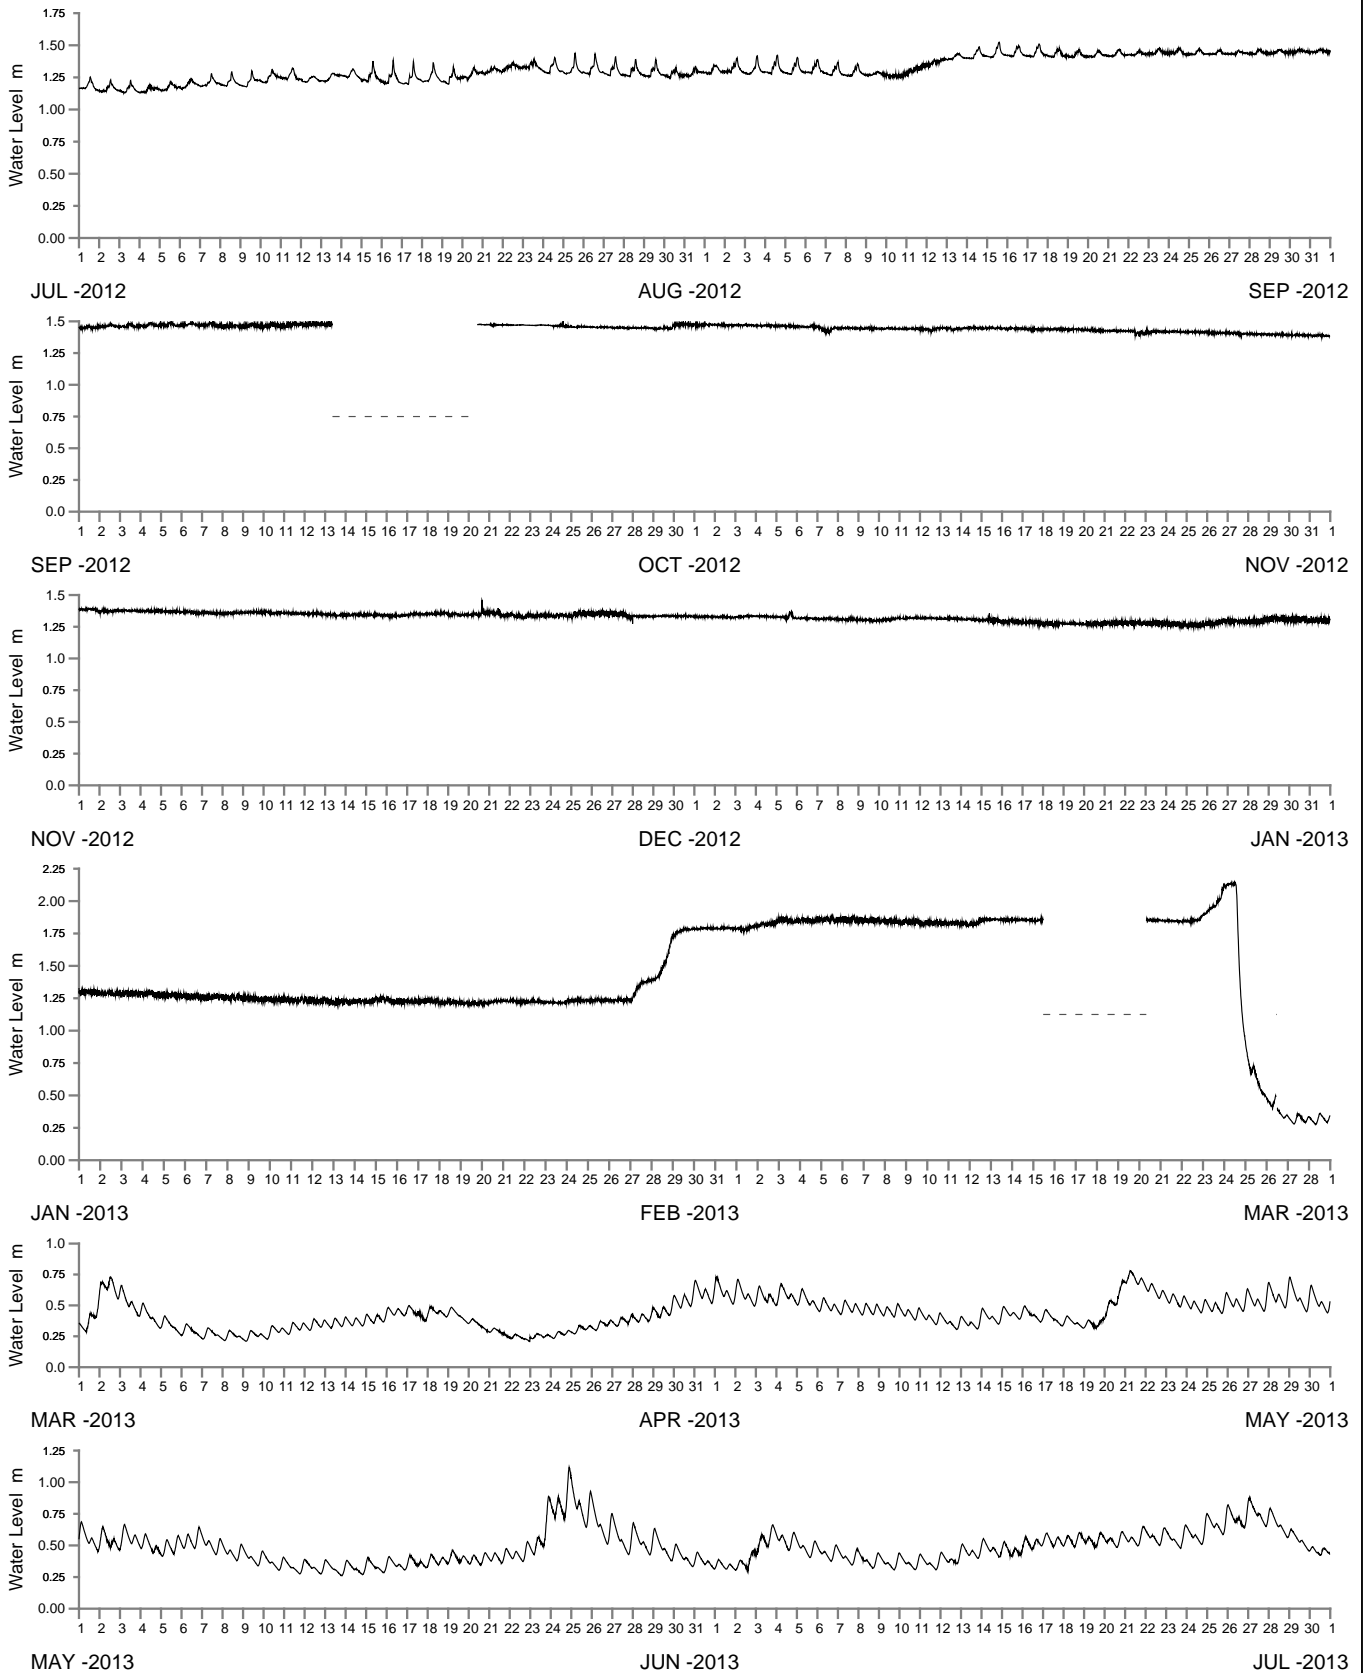
Figure
113

WATER LEVEL REFERENCED TO AUSTRALIAN HEIGHT DATUM

SMITHS LAKE AT TARBUCK BAY
2012-2013

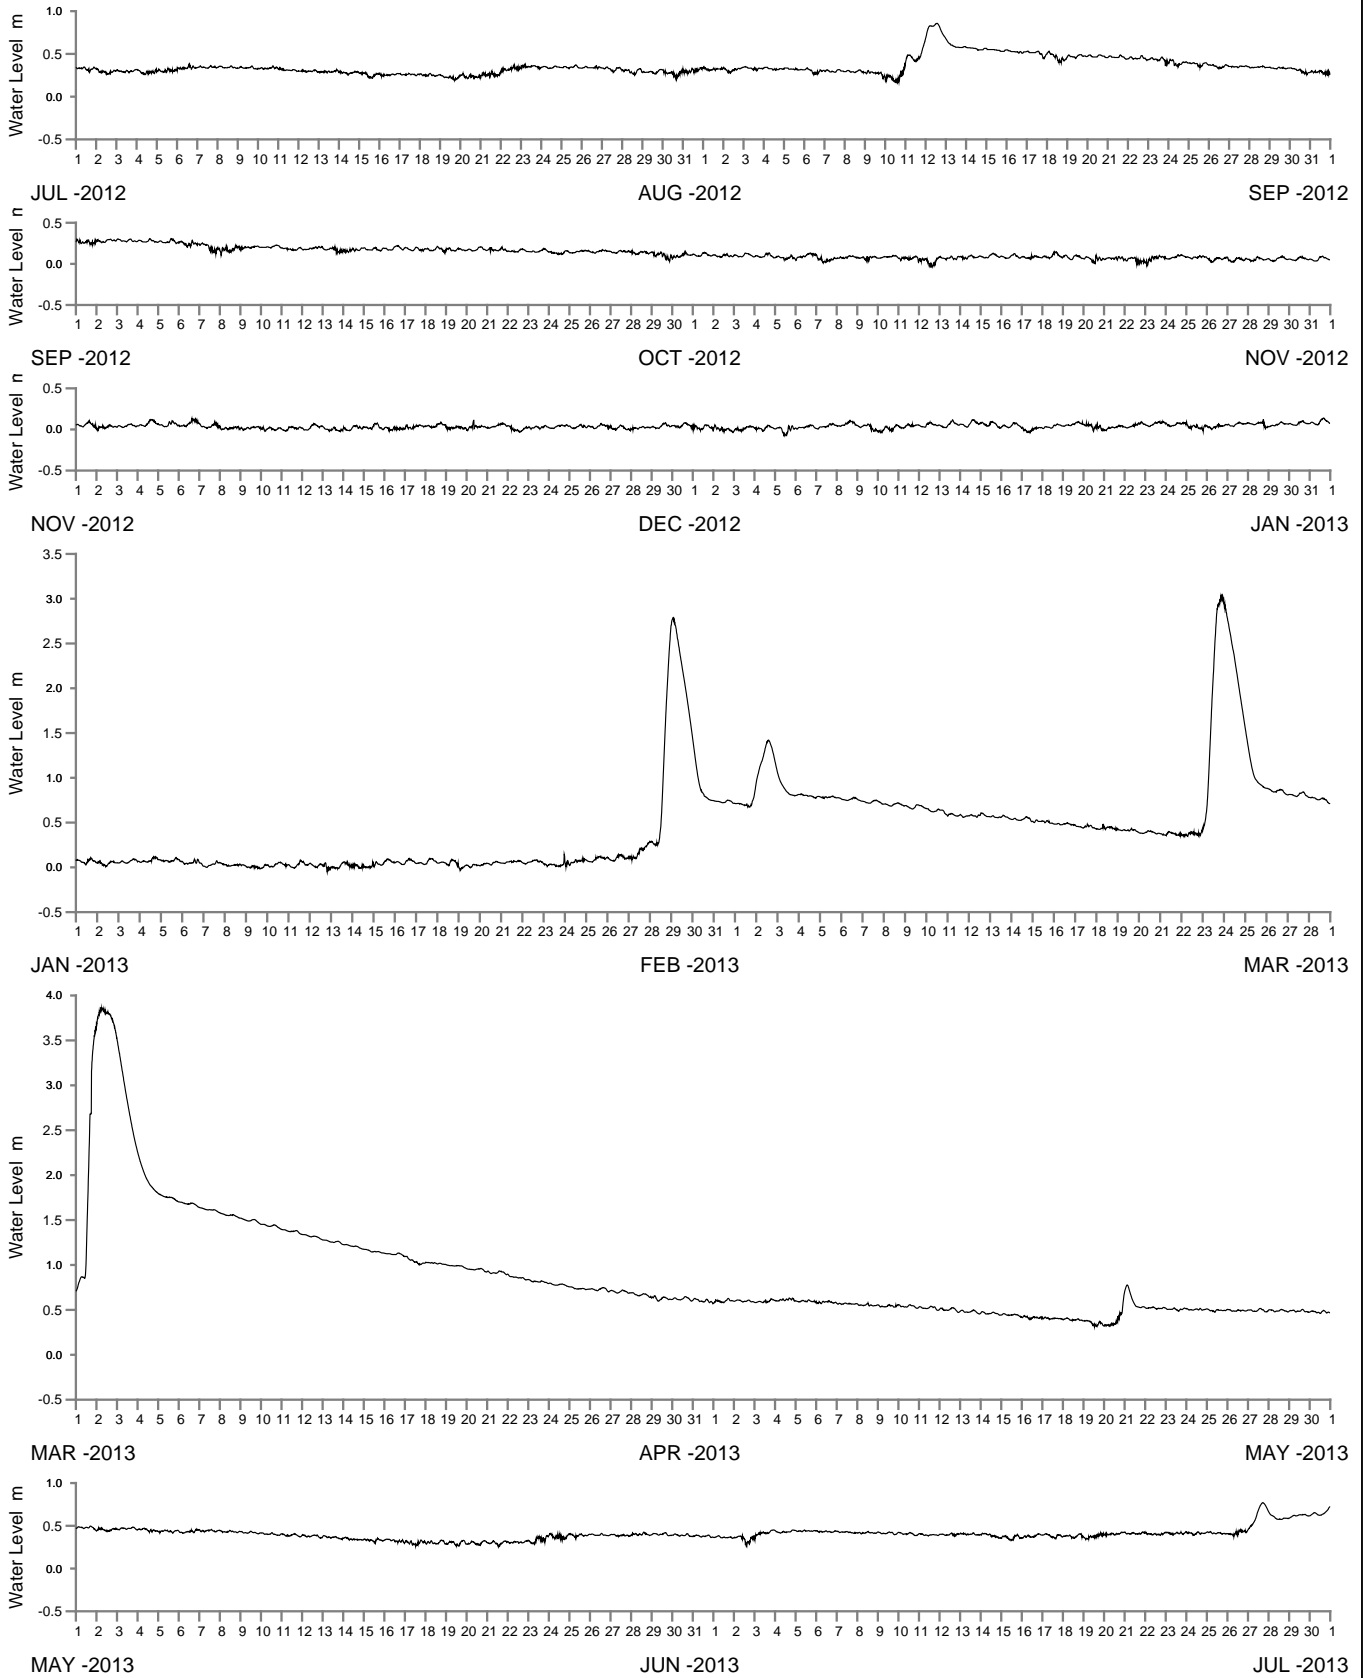
Figure

WATER LEVEL REFERENCED TO AUSTRALIAN HEIGHT DATUM

MYALL RIVER AT BULAHDELAH
2012-2013

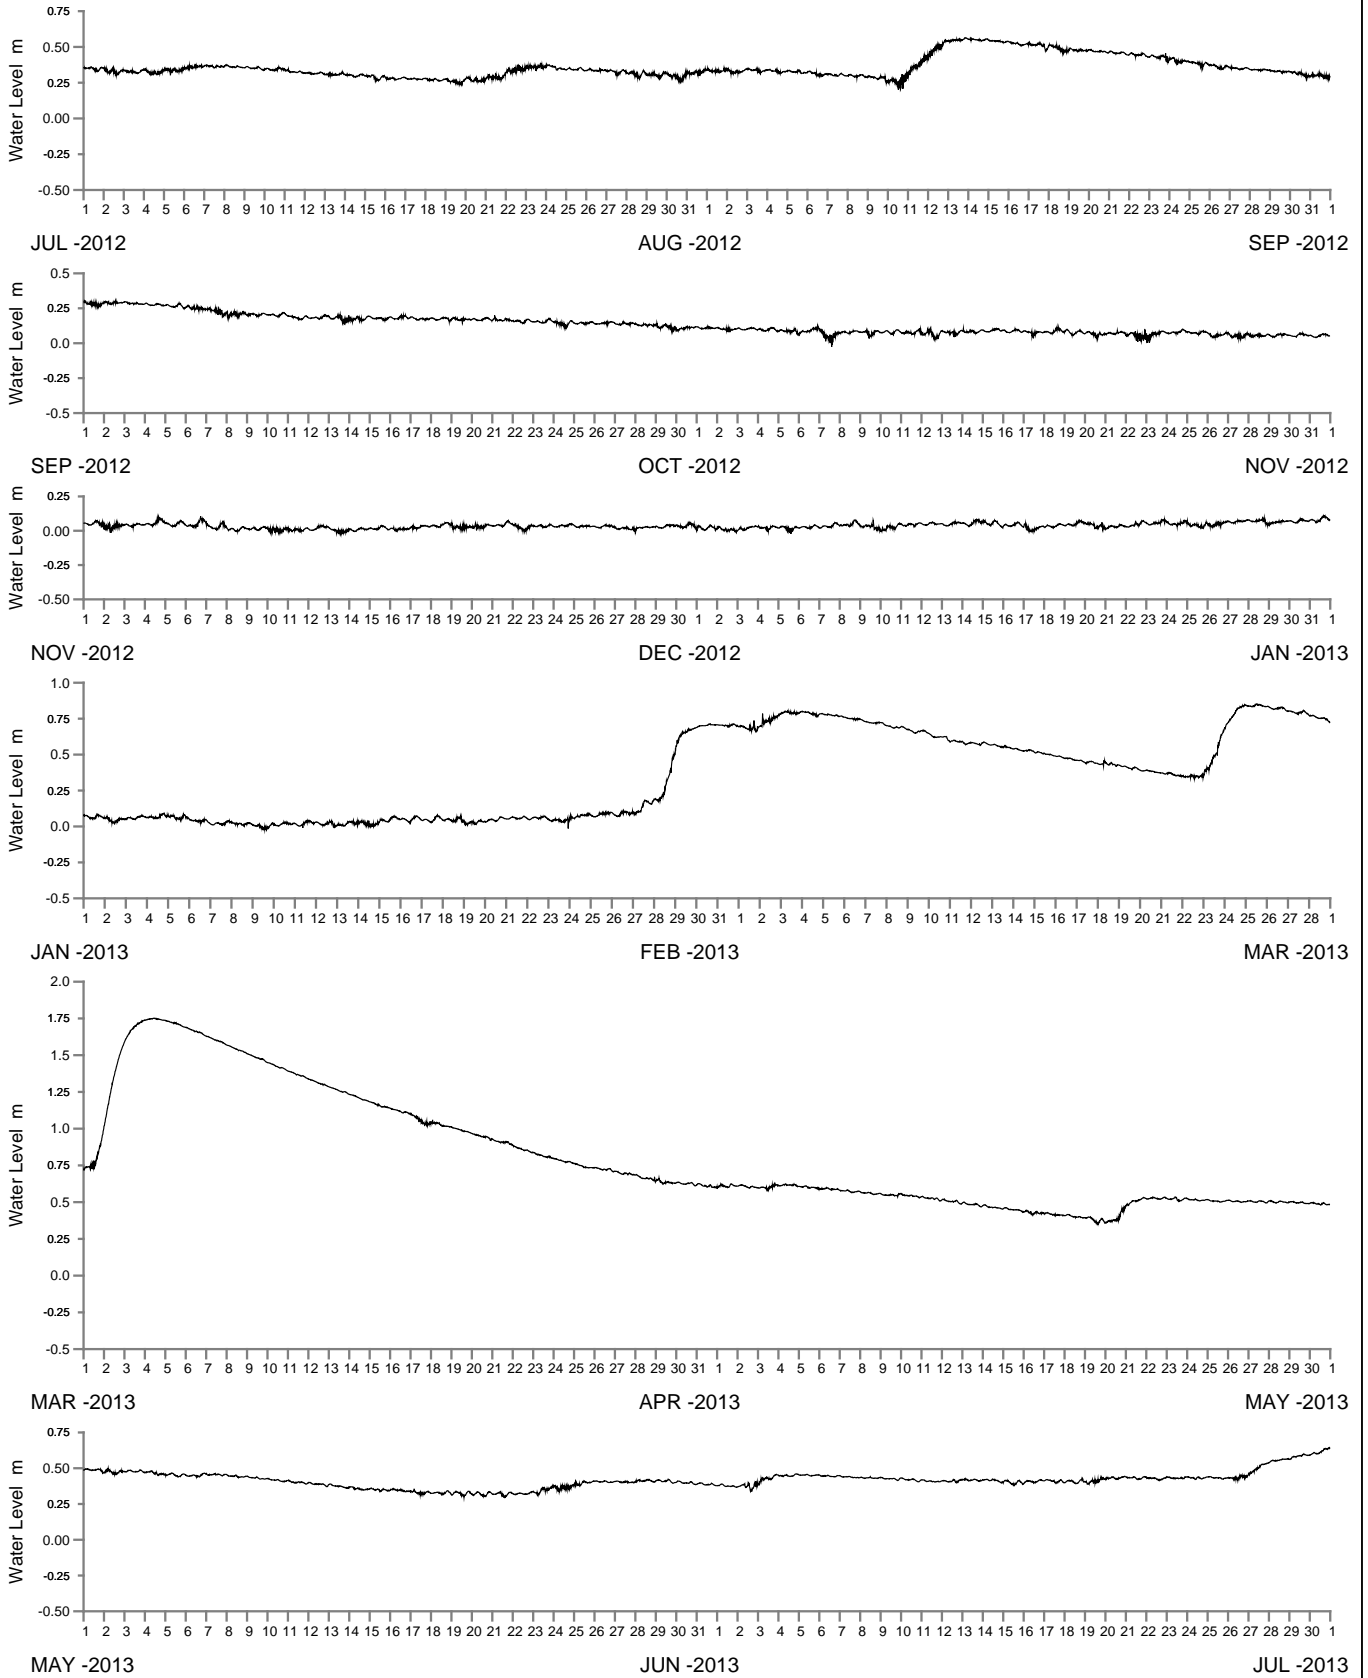
Figure
115

WATER LEVEL REFERENCED TO AUSTRALIAN HEIGHT DATUM

MYALL RIVER AT BOMBAH POINT
2012-2013

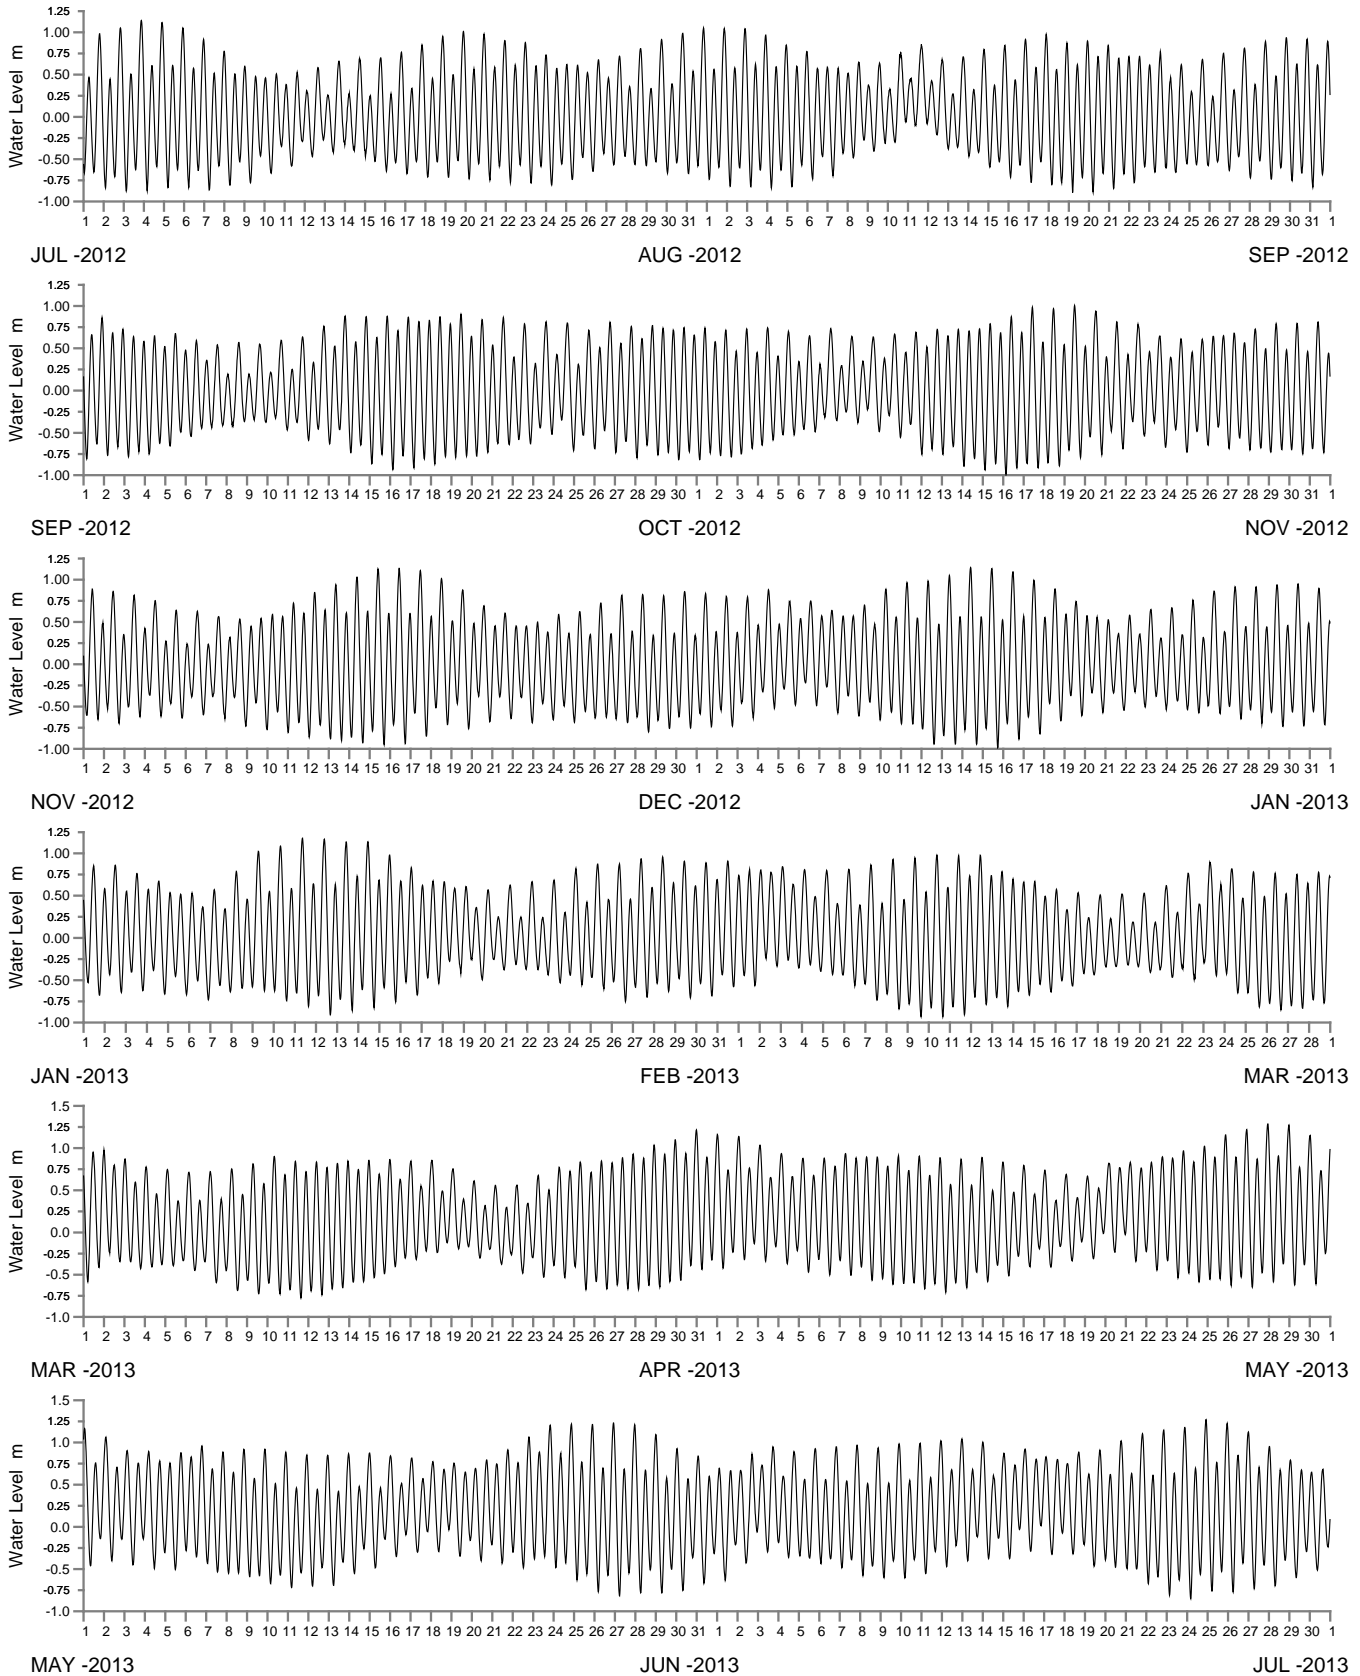
Figure
118

WATER LEVEL REFERENCED TO AUSTRALIAN HEIGHT DATUM

KARUAH RIVER AT KARUAH RIVER
2012-2013

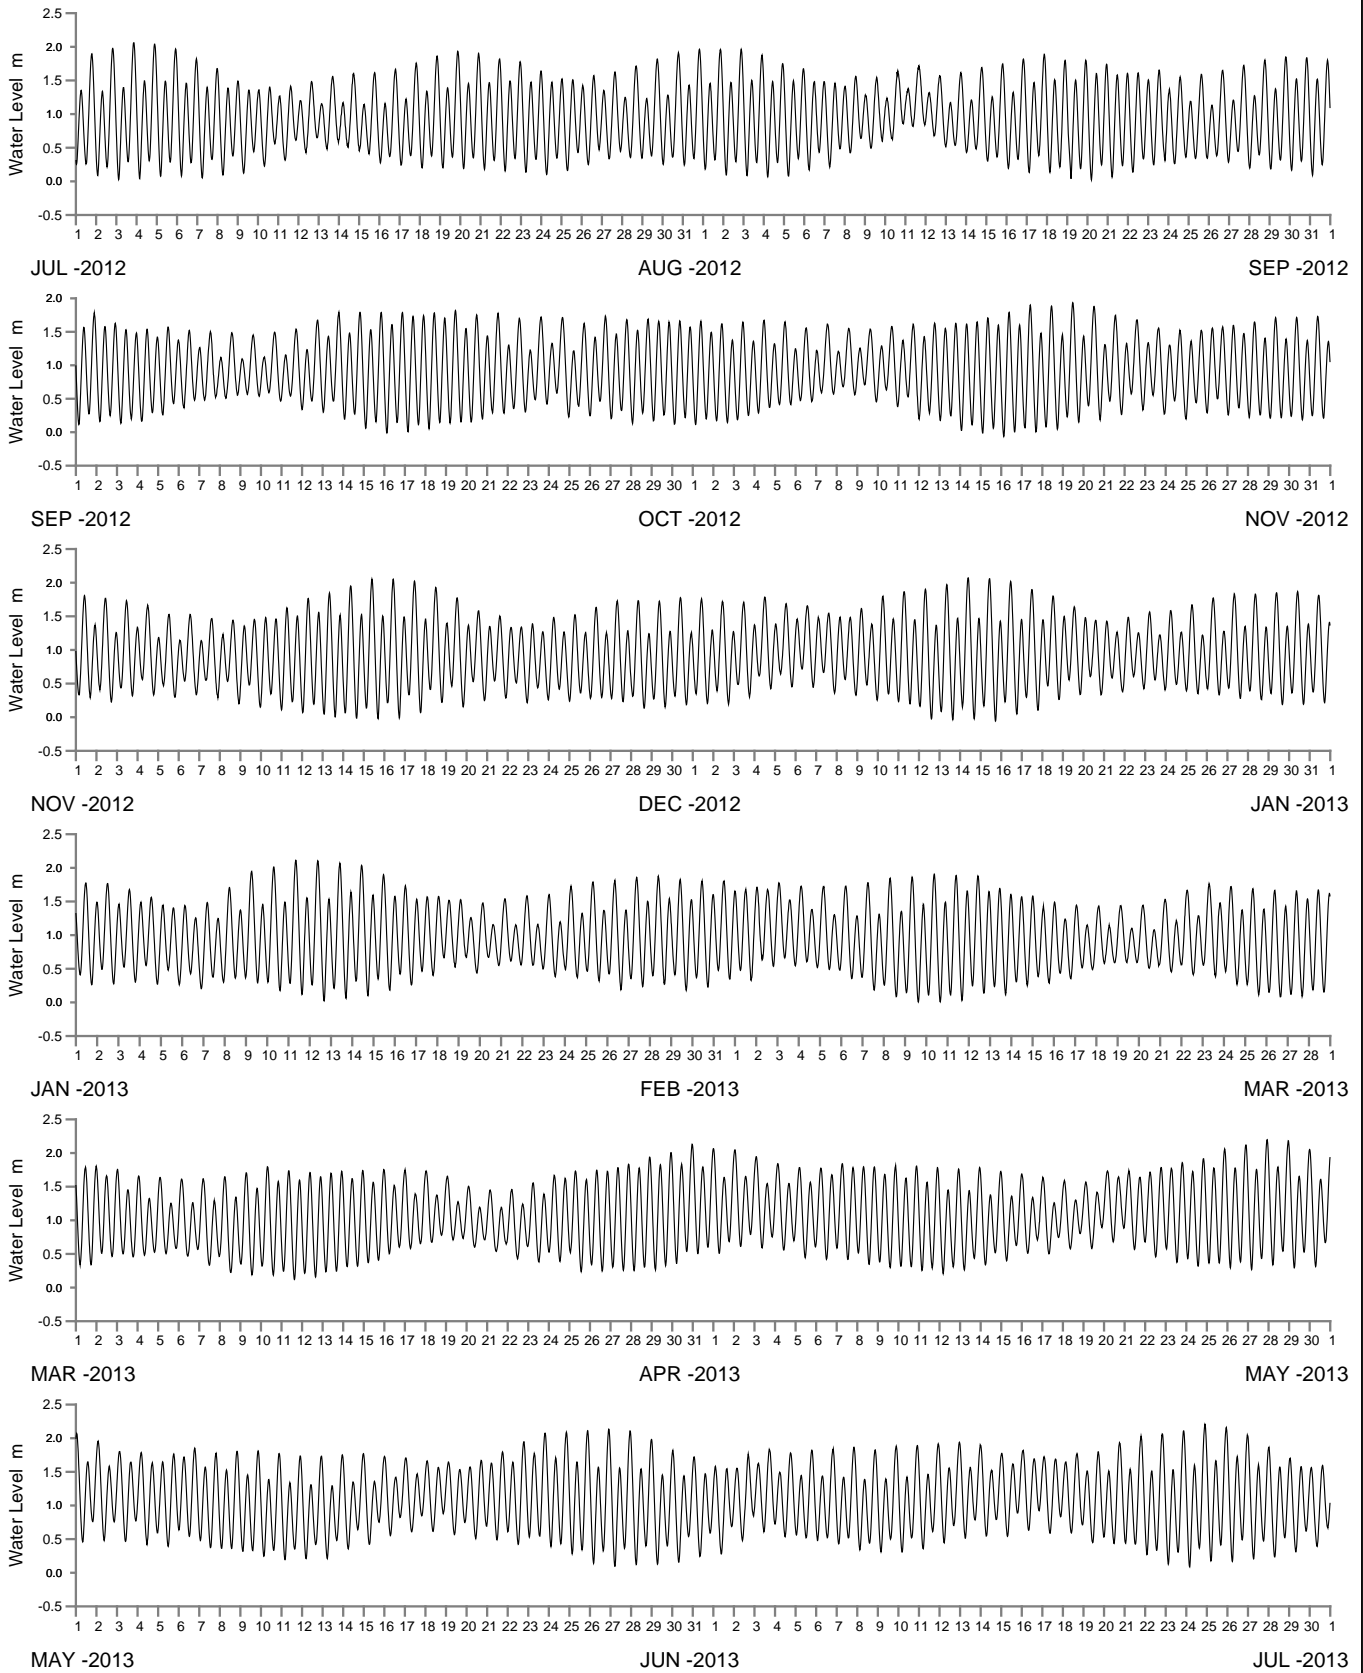
Figure
119

WATER LEVEL REFERENCED TO PORT STEPHENS HYDRO DATUM

KARUAH RIVER AT MALLABULLA POINT
2012-2013

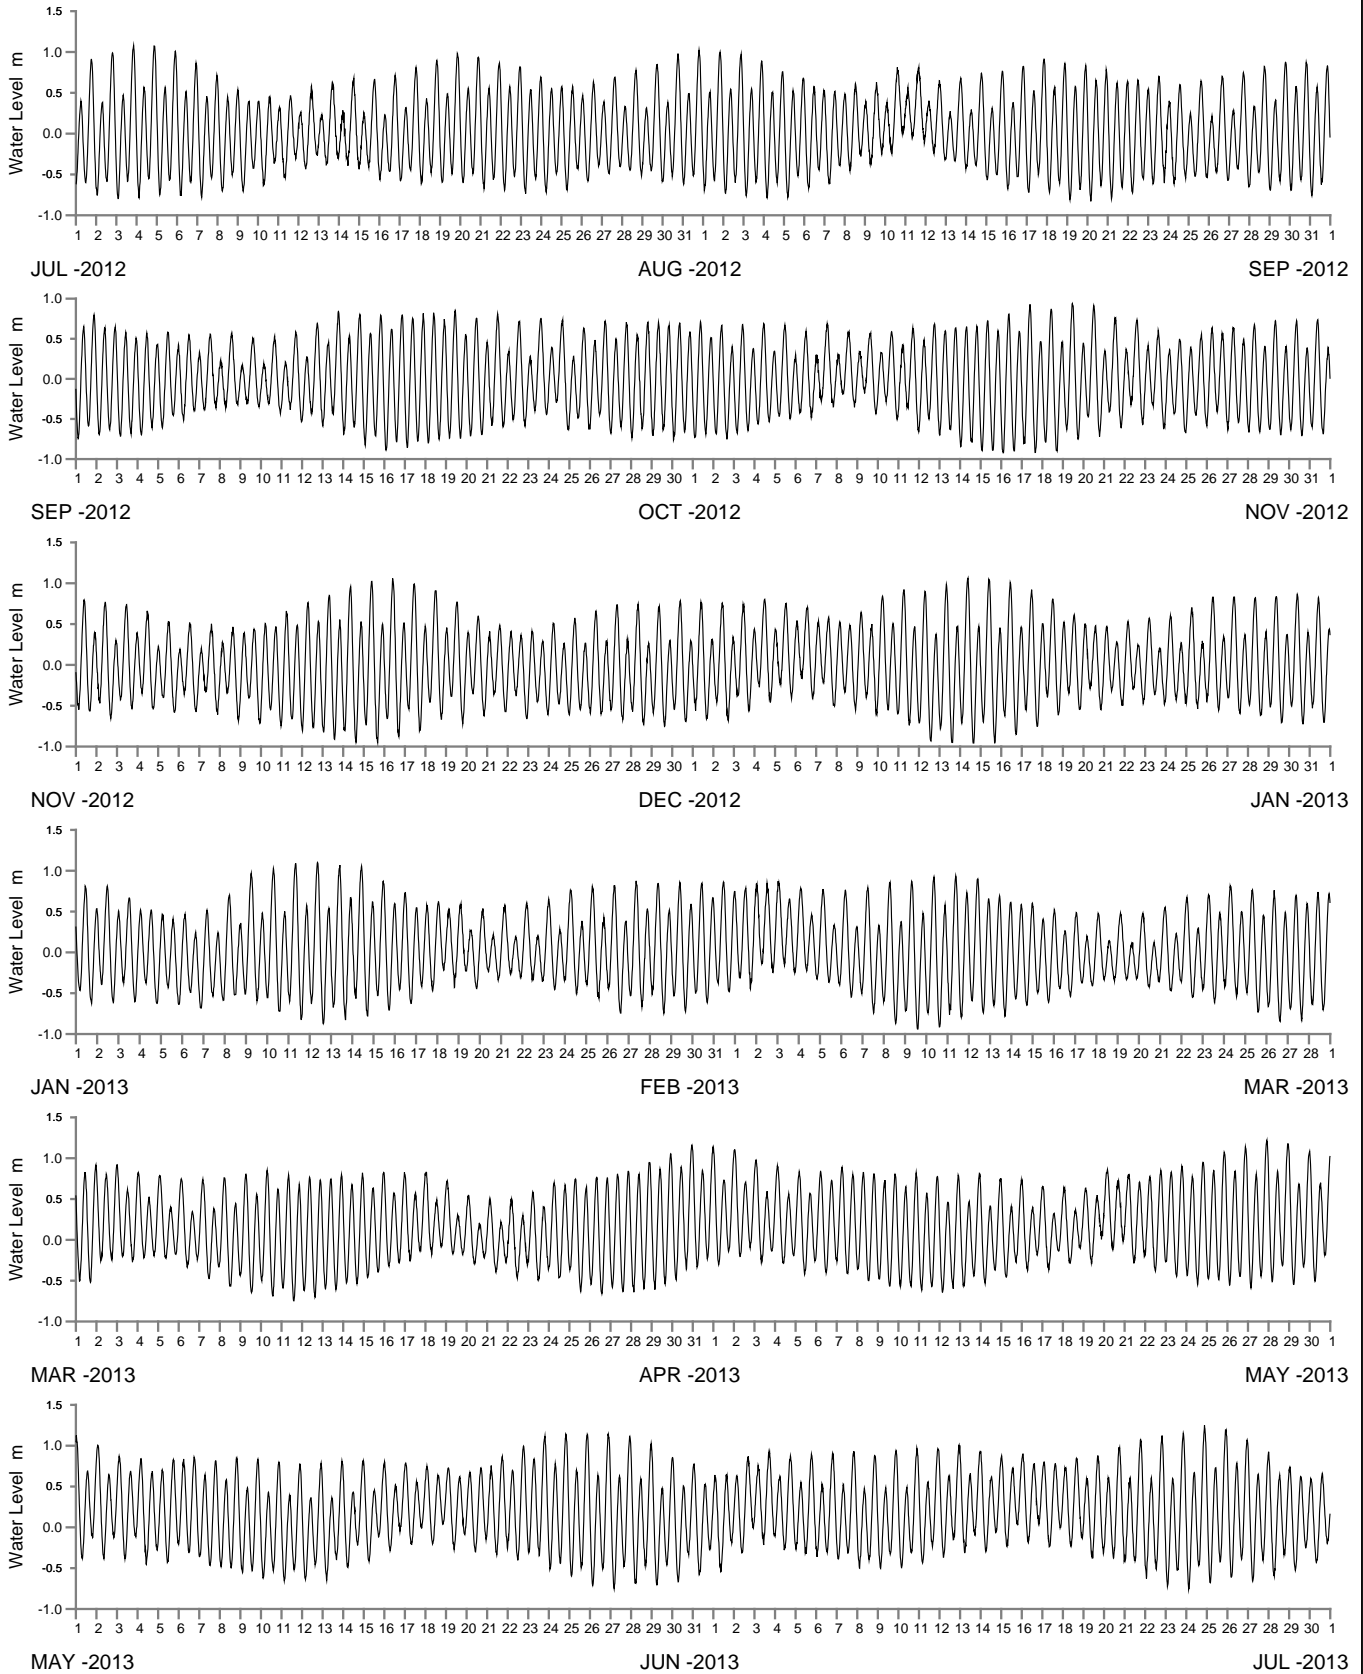
Figure
121

WATER LEVEL REFERENCED TO AUSTRALIAN HEIGHT DATUM

HUNTER RIVER AT STOCKTON BRIDGE
2012-2013

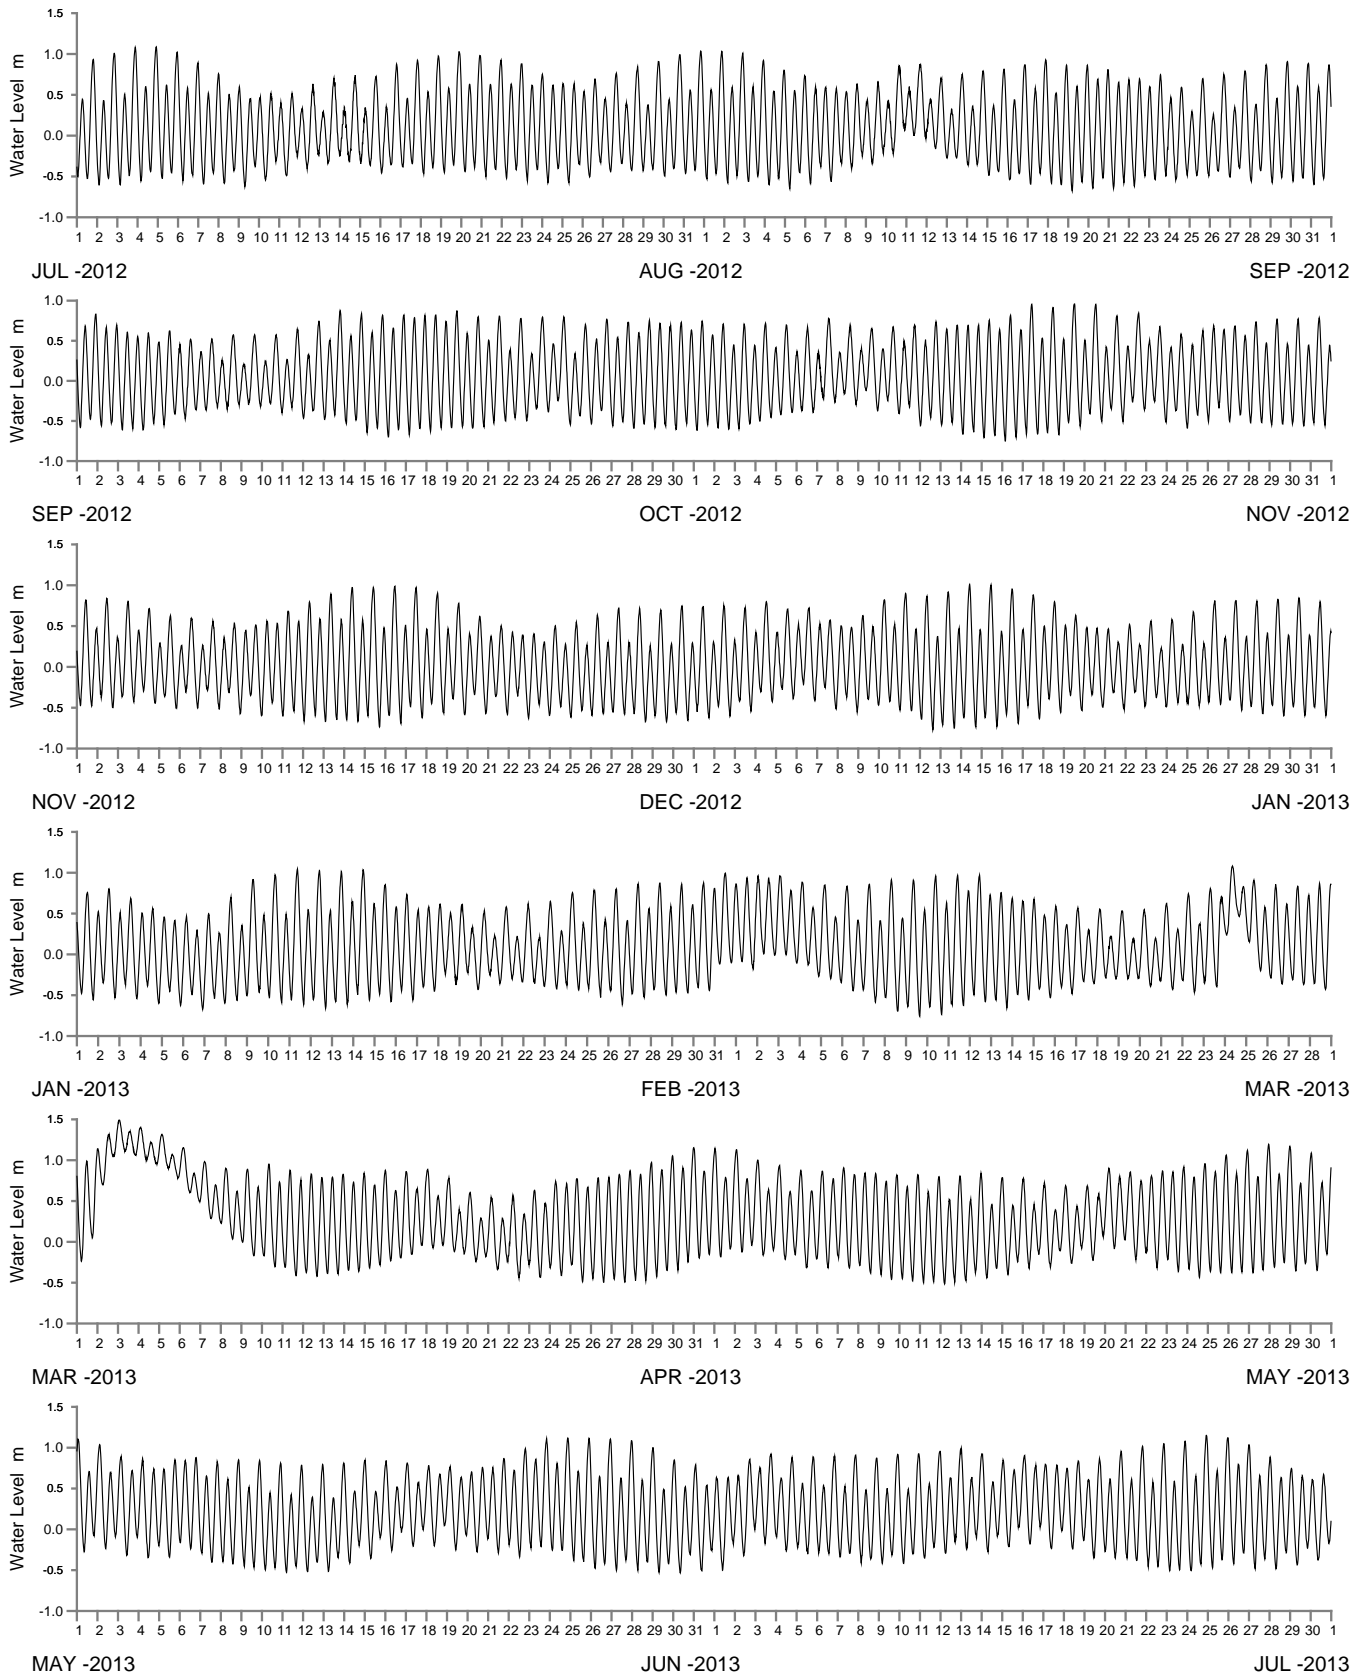
Figure
122

WATER LEVEL REFERENCED TO AUSTRALIAN HEIGHT DATUM

HUNTER RIVER AT HEXHAM BRIDGE
2012-2013

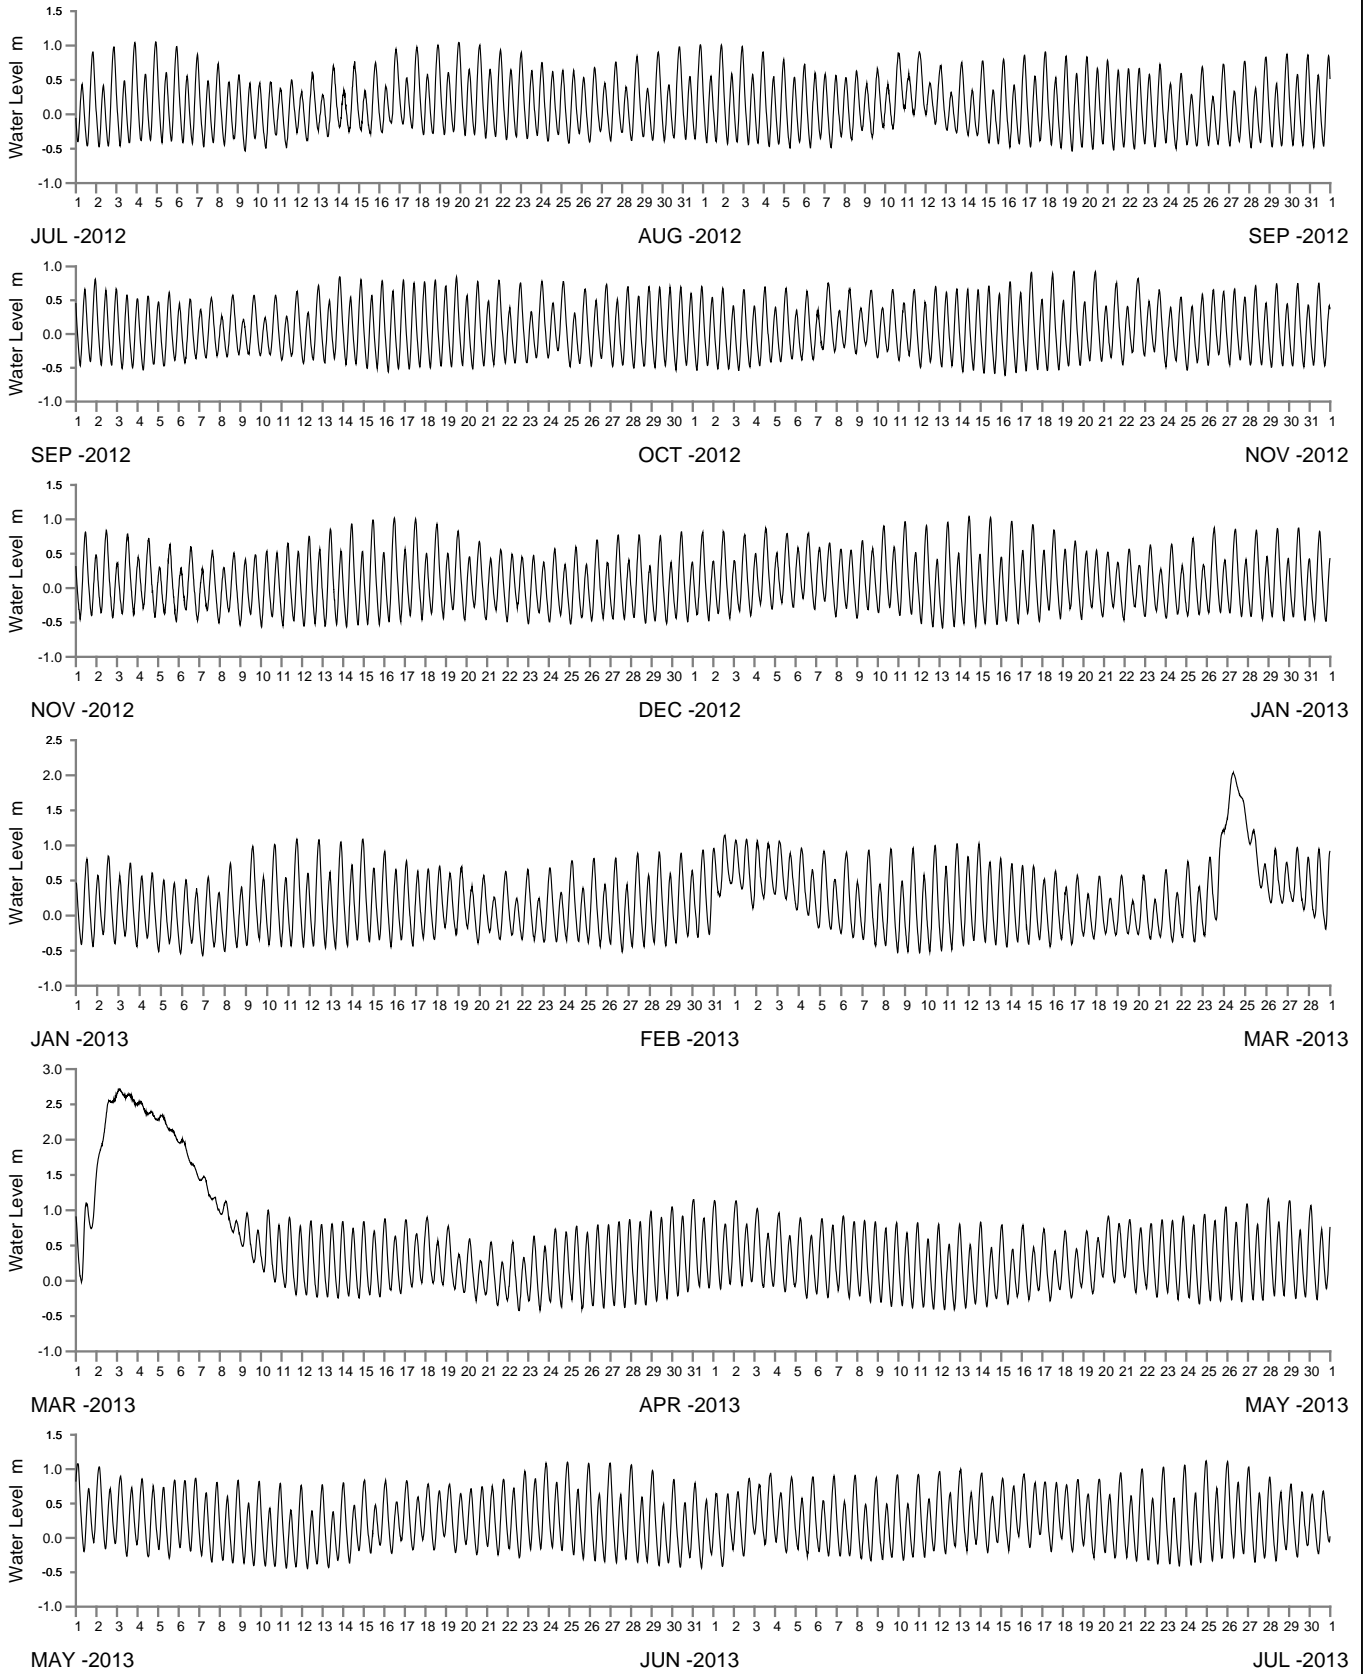
Figure
123

WATER LEVEL REFERENCED TO AUSTRALIAN HEIGHT DATUM

WILLIAMS RIVER AT RAYMOND TERRACE
2012-2013

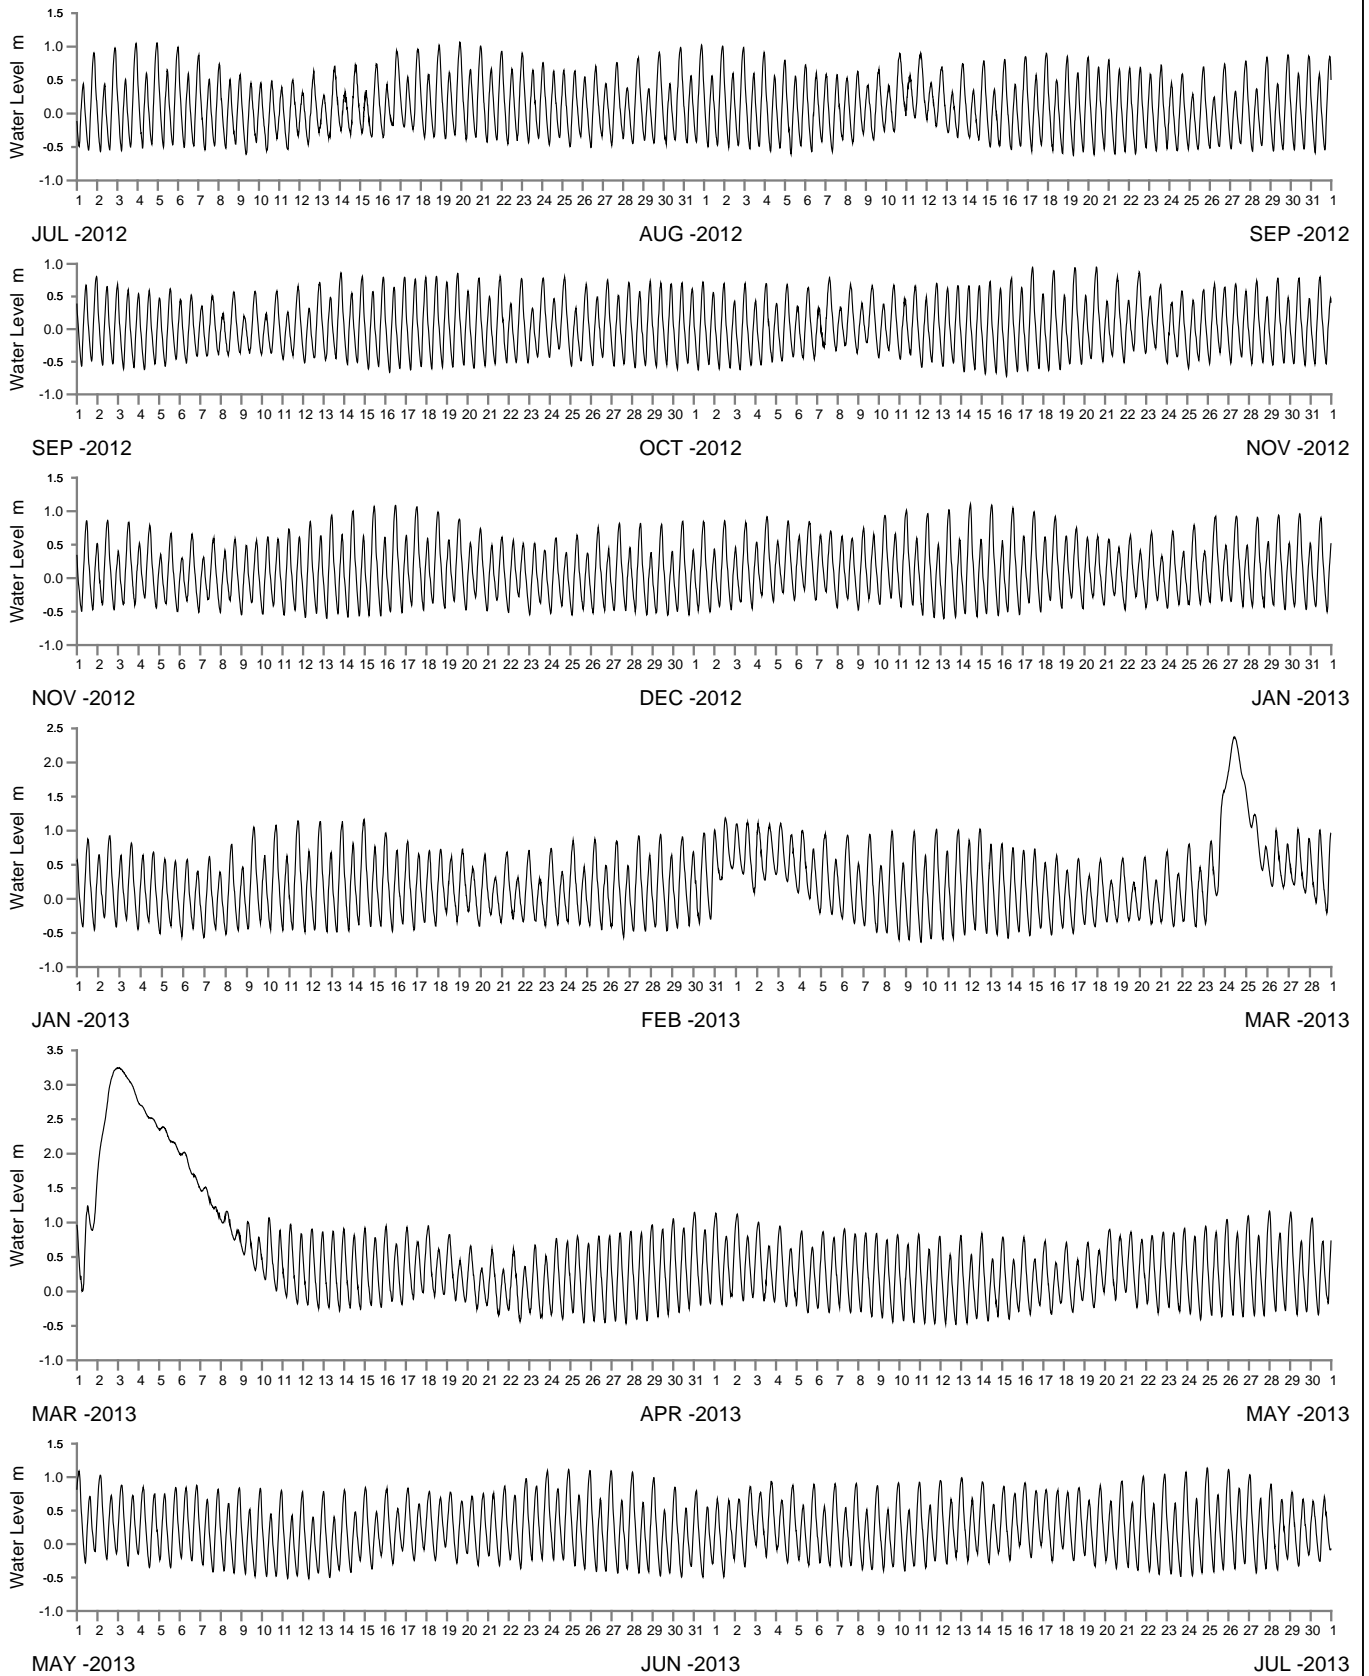
Figure

WATER LEVEL REFERENCED TO AUSTRALIAN HEIGHT DATUM

WILLIAMS RIVER AT SEAHAM
2012-2013

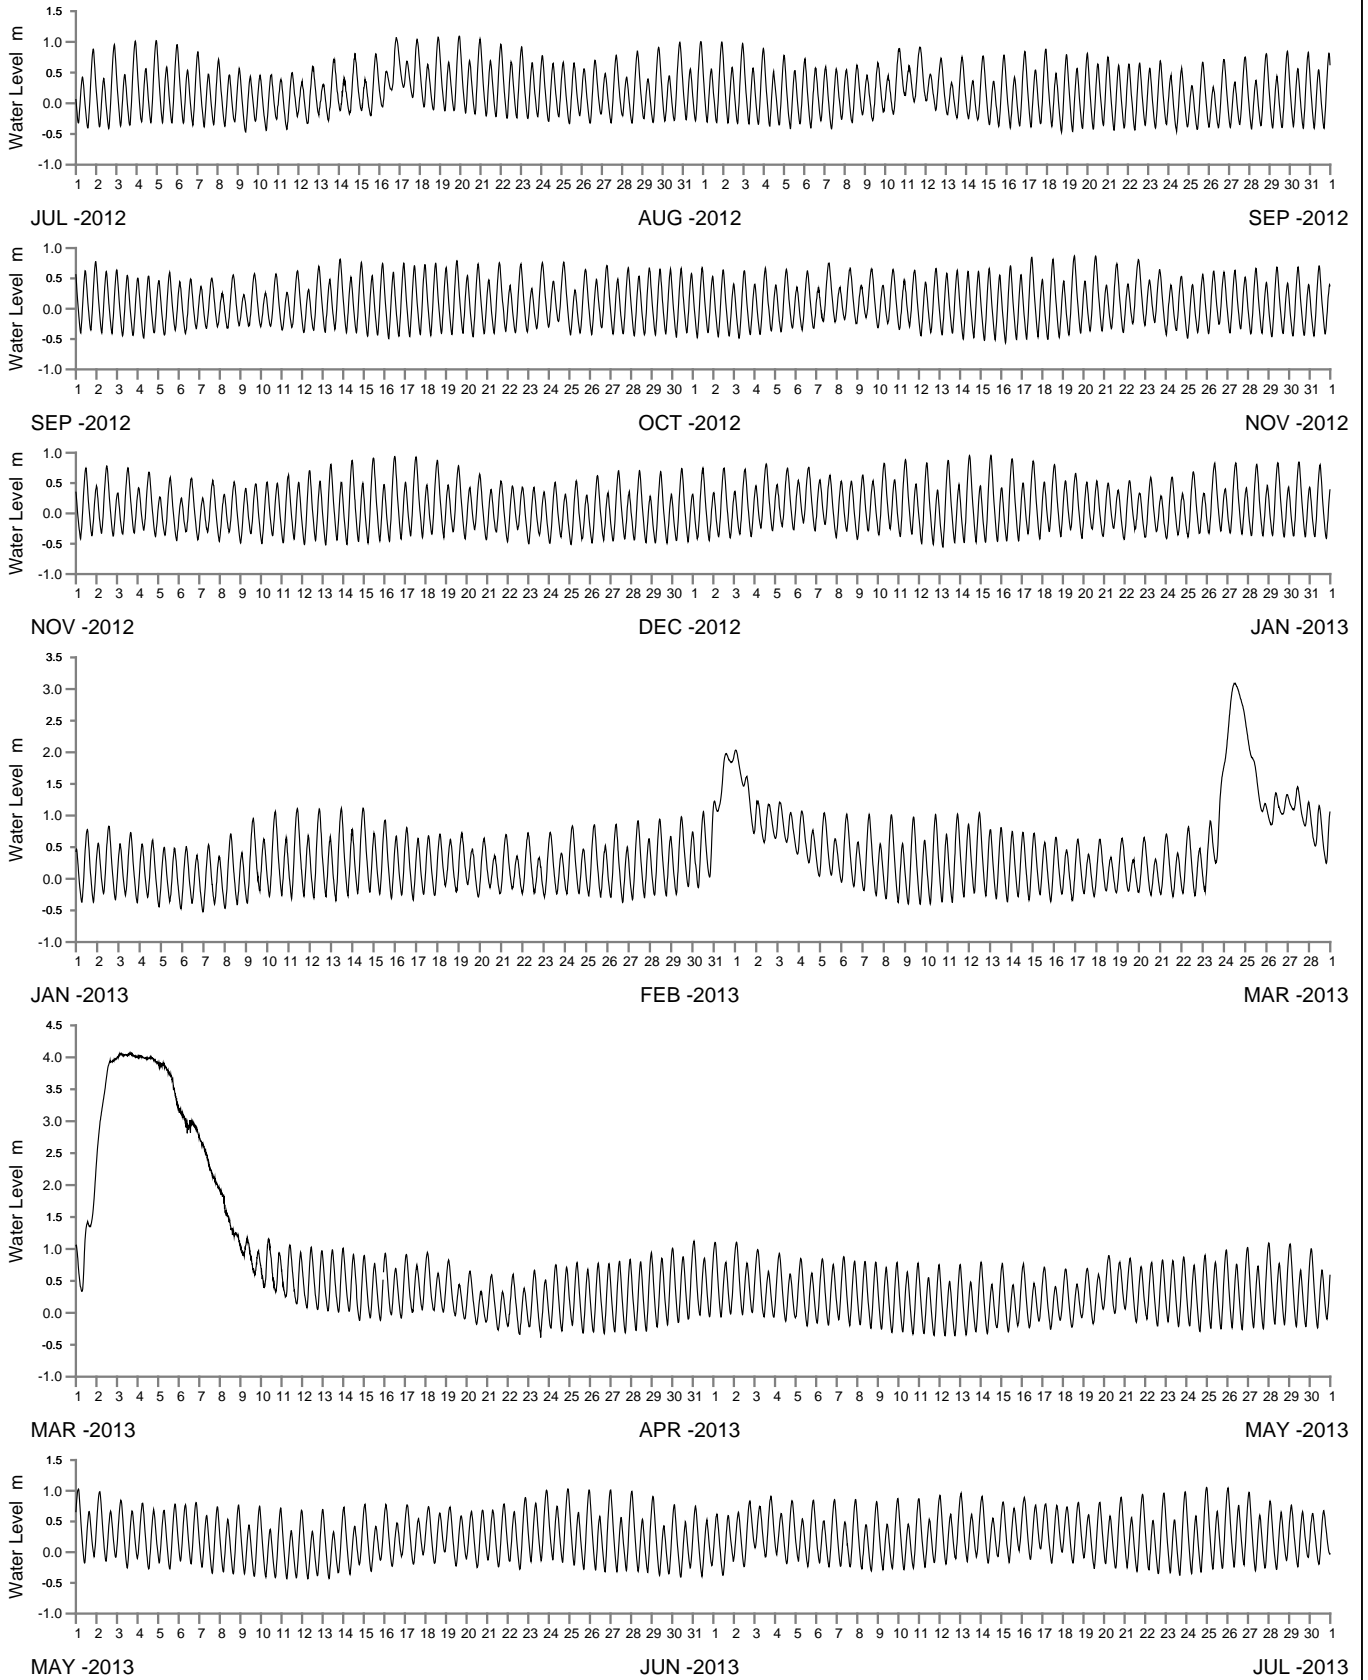
Figure
125

WATER LEVEL REFERENCED TO AUSTRALIAN HEIGHT DATUM

HUNTER RIVER AT GREEN ROCKS
2012-2013
