Public Works
Manly Hydraulics Laboratory

MHL
Report 2218

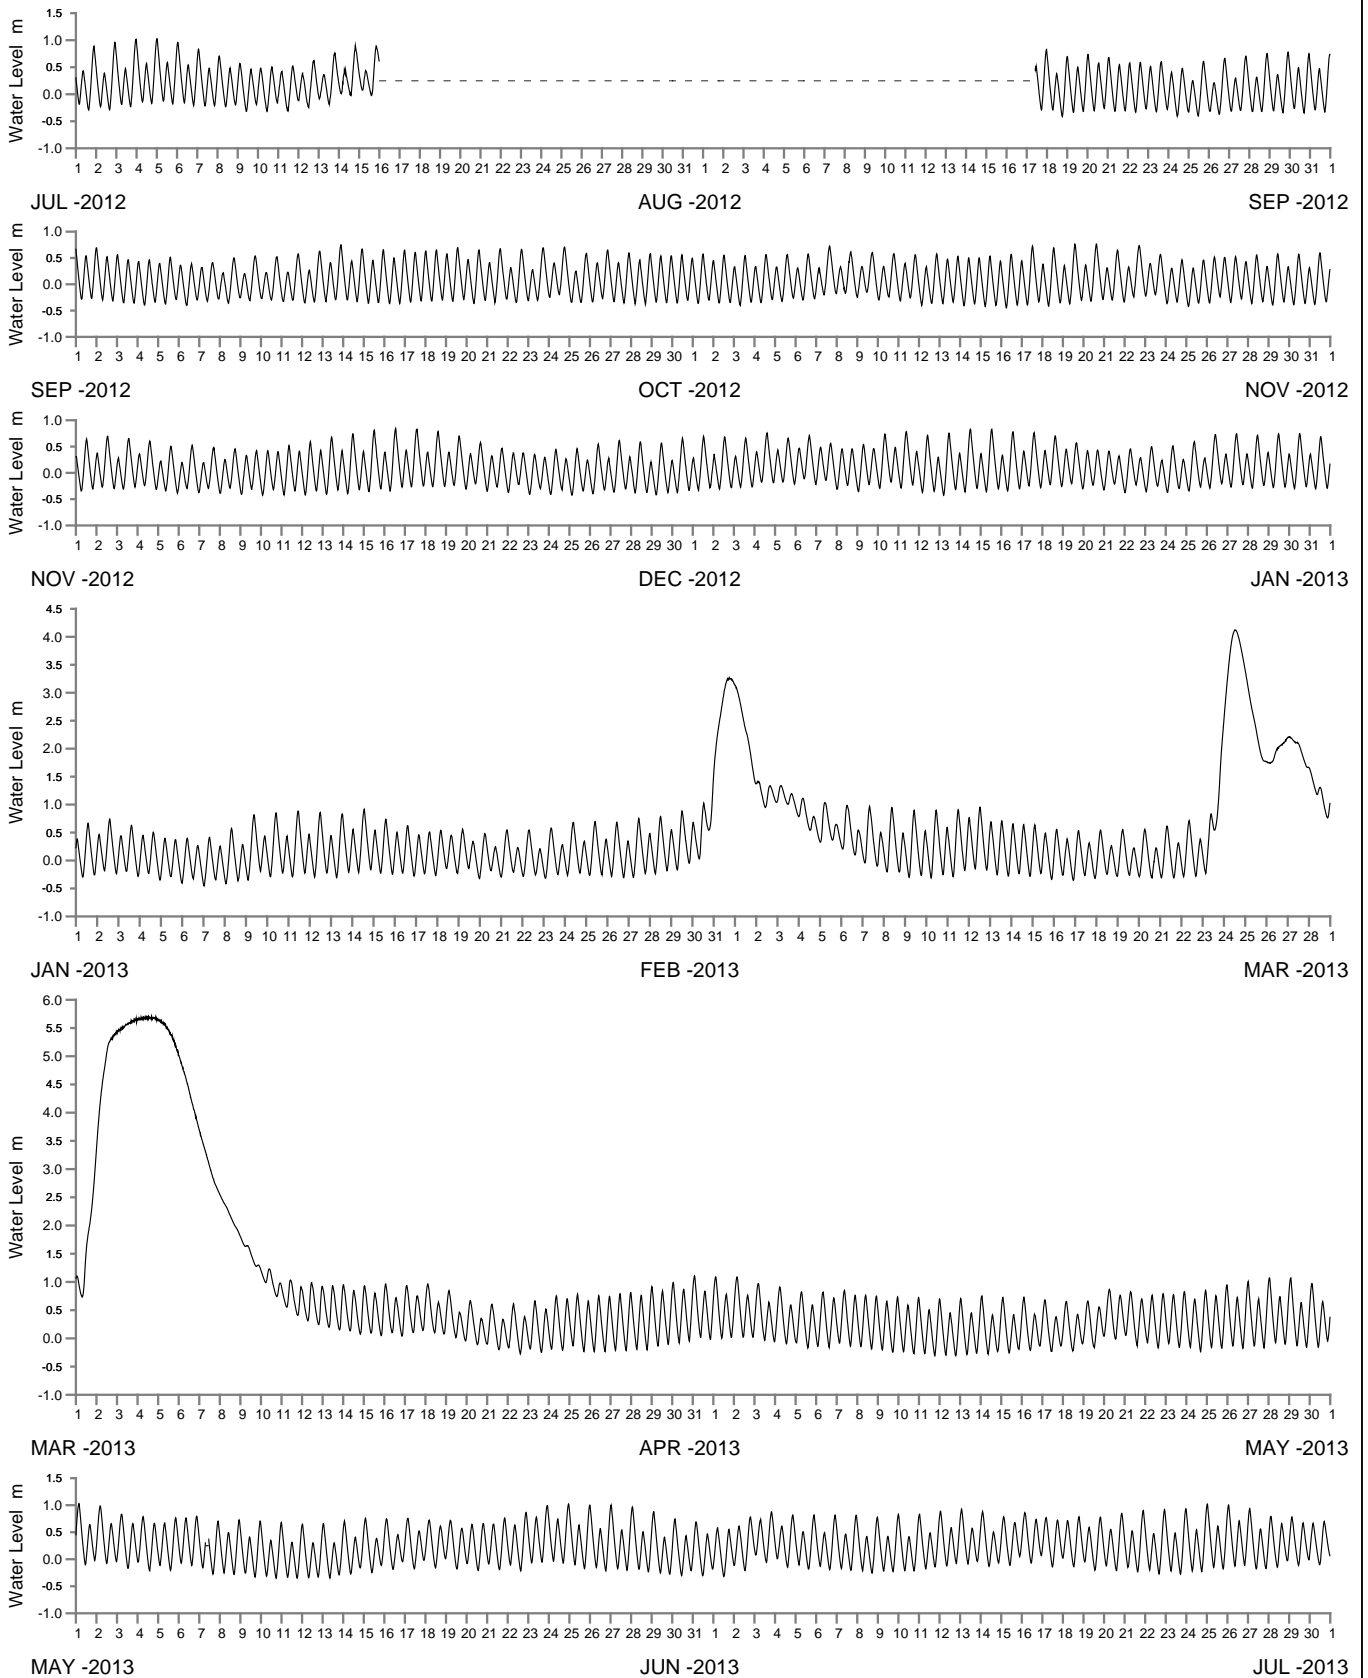
Figure
126

WATER LEVEL REFERENCED TO AUSTRALIAN HEIGHT DATUM

HUNTER RIVER AT MORPETH
2012-2013

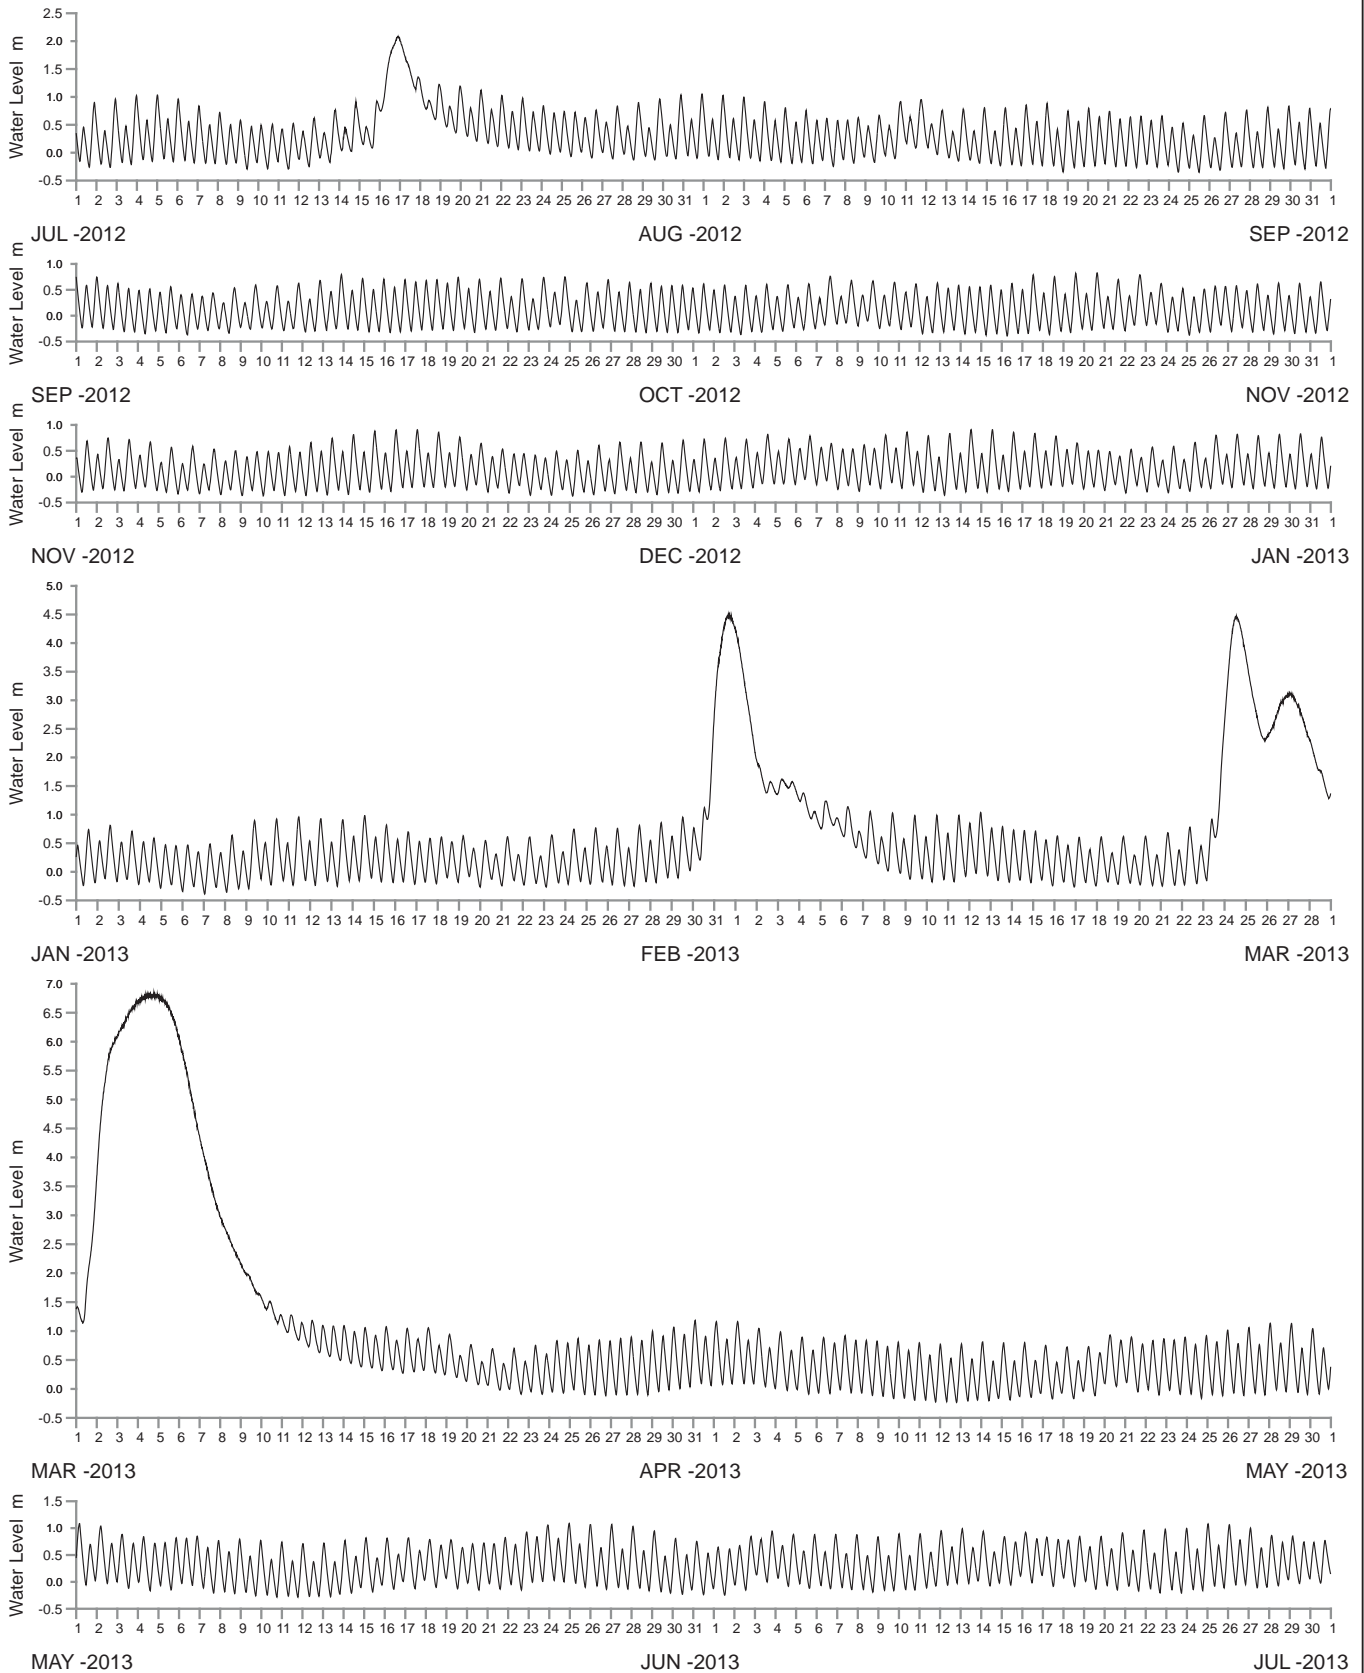
Figure
127

WATER LEVEL REFERENCED TO AUSTRALIAN HEIGHT DATUM

HUNTER RIVER AT MCKIMMS CORNER
2012-2013

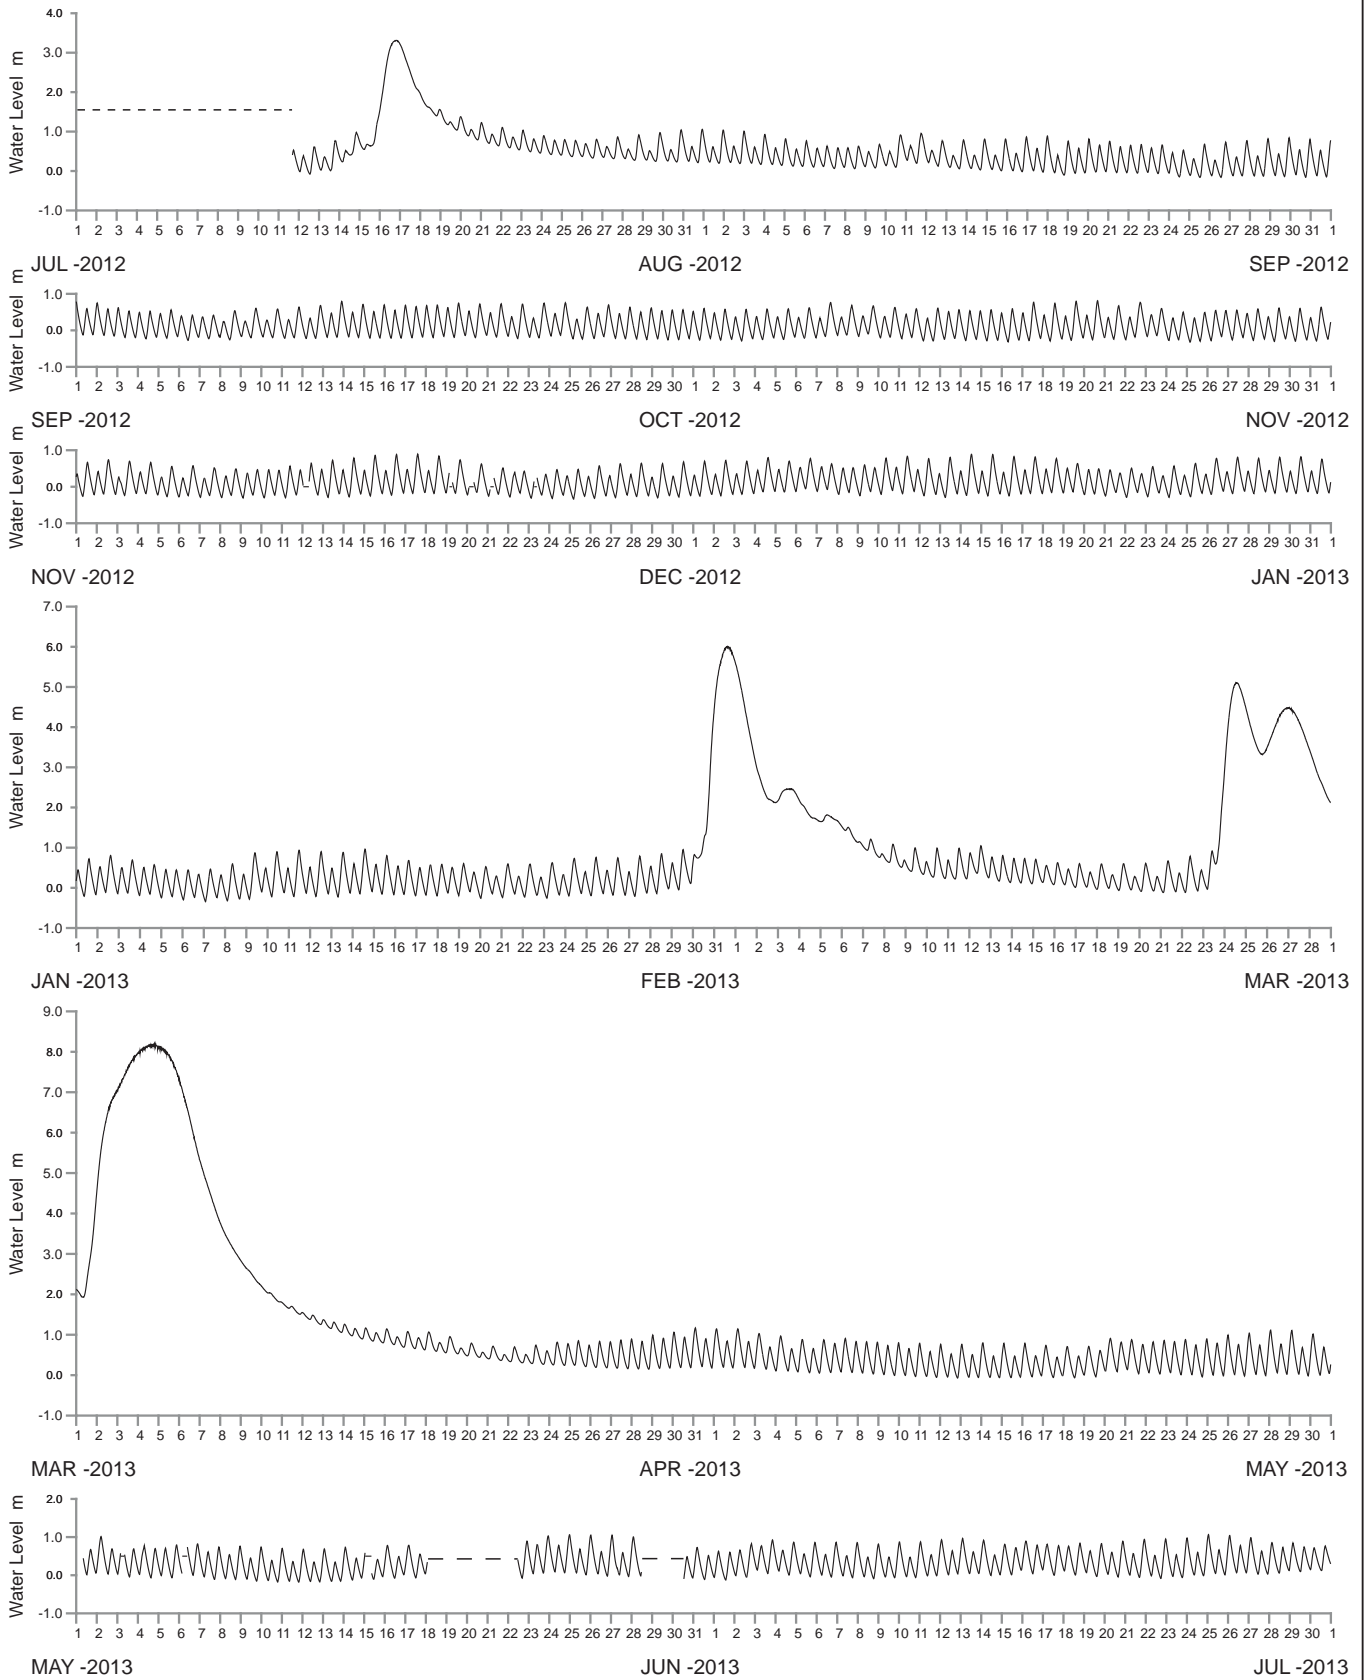
Figure
128

WATER LEVEL REFERENCED TO AUSTRALIAN HEIGHT DATUM

HUNTER RIVER AT BELMORE BRIDGE
2012-2013

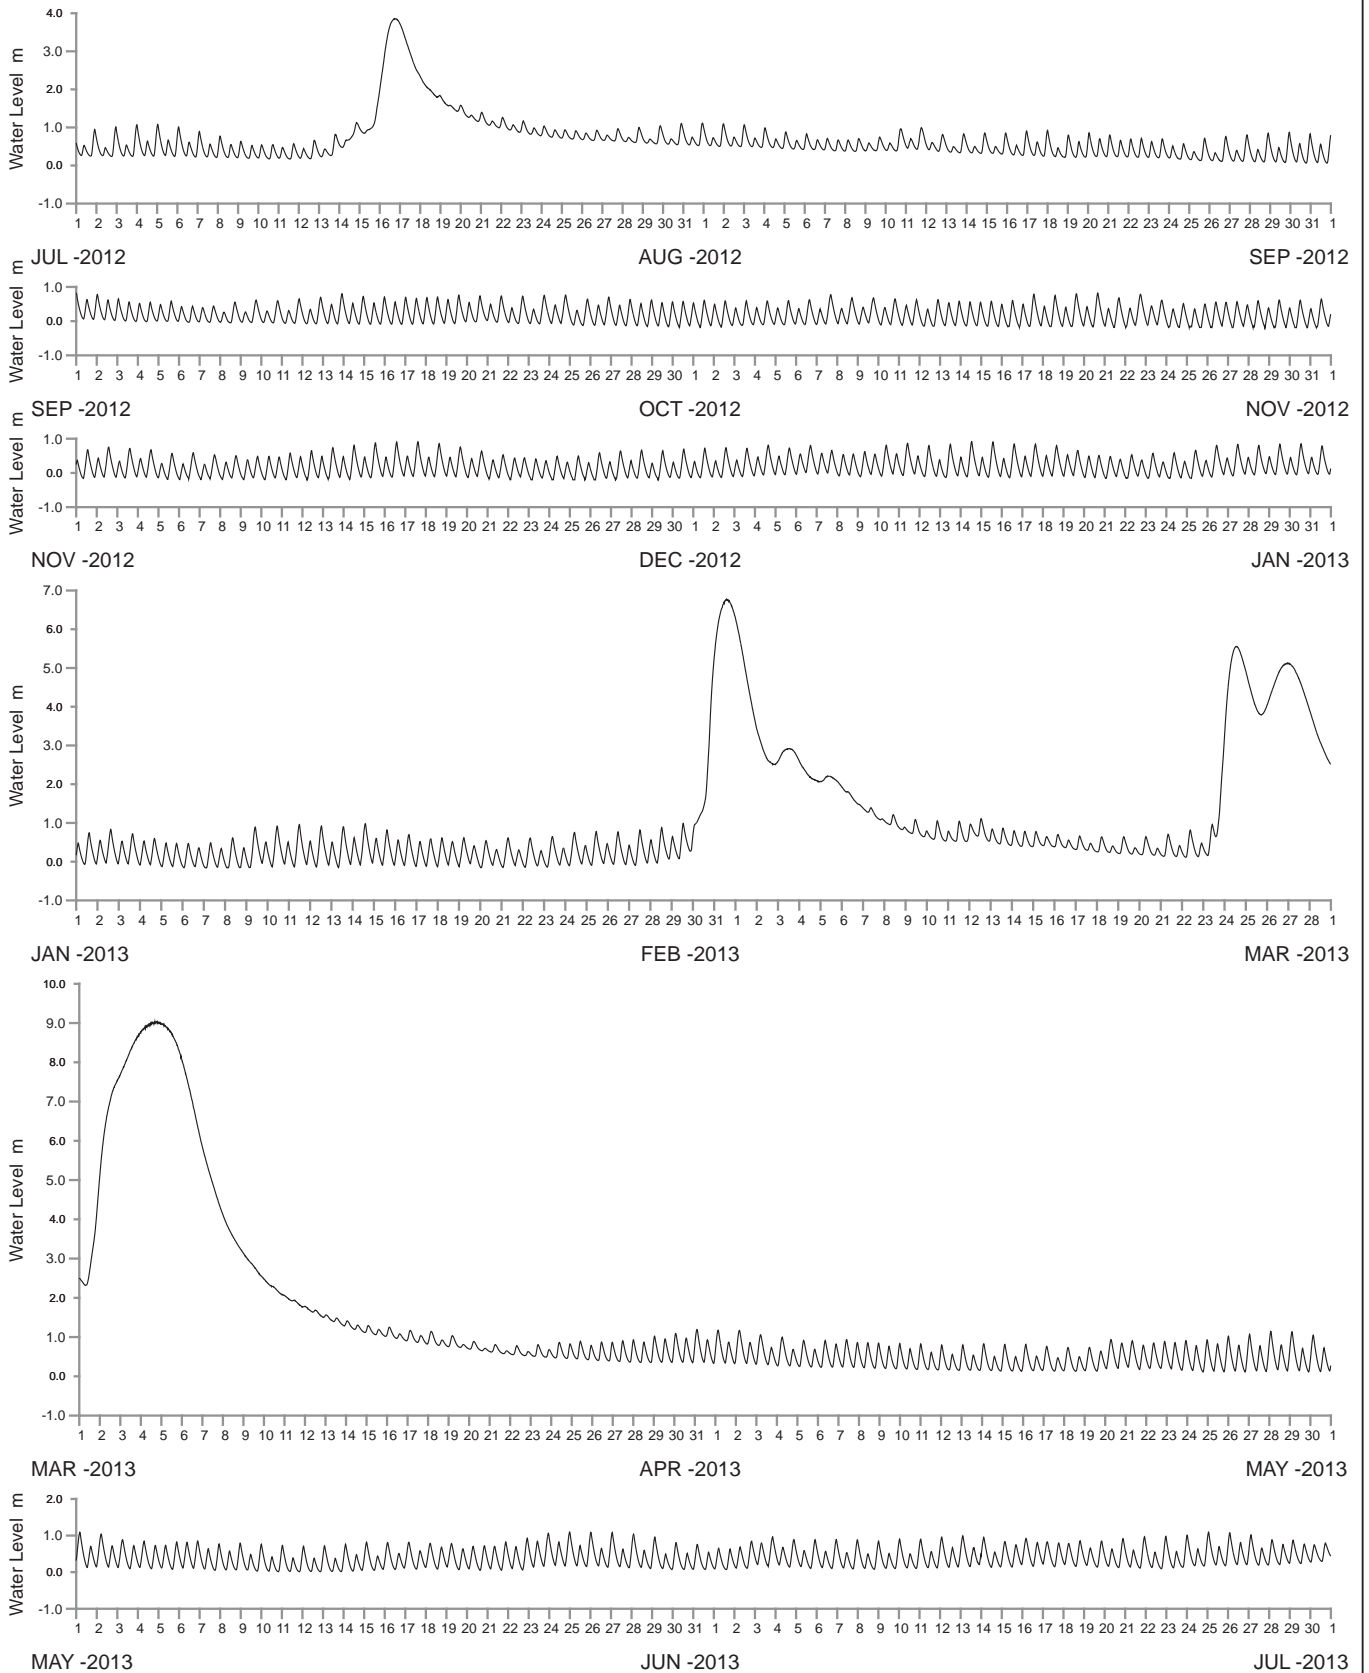
Figure
129

WATER LEVEL REFERENCED TO AUSTRALIAN HEIGHT DATUM

HUNTER RIVER AT BOLWARRA DOWNSTREAM
2012-2013

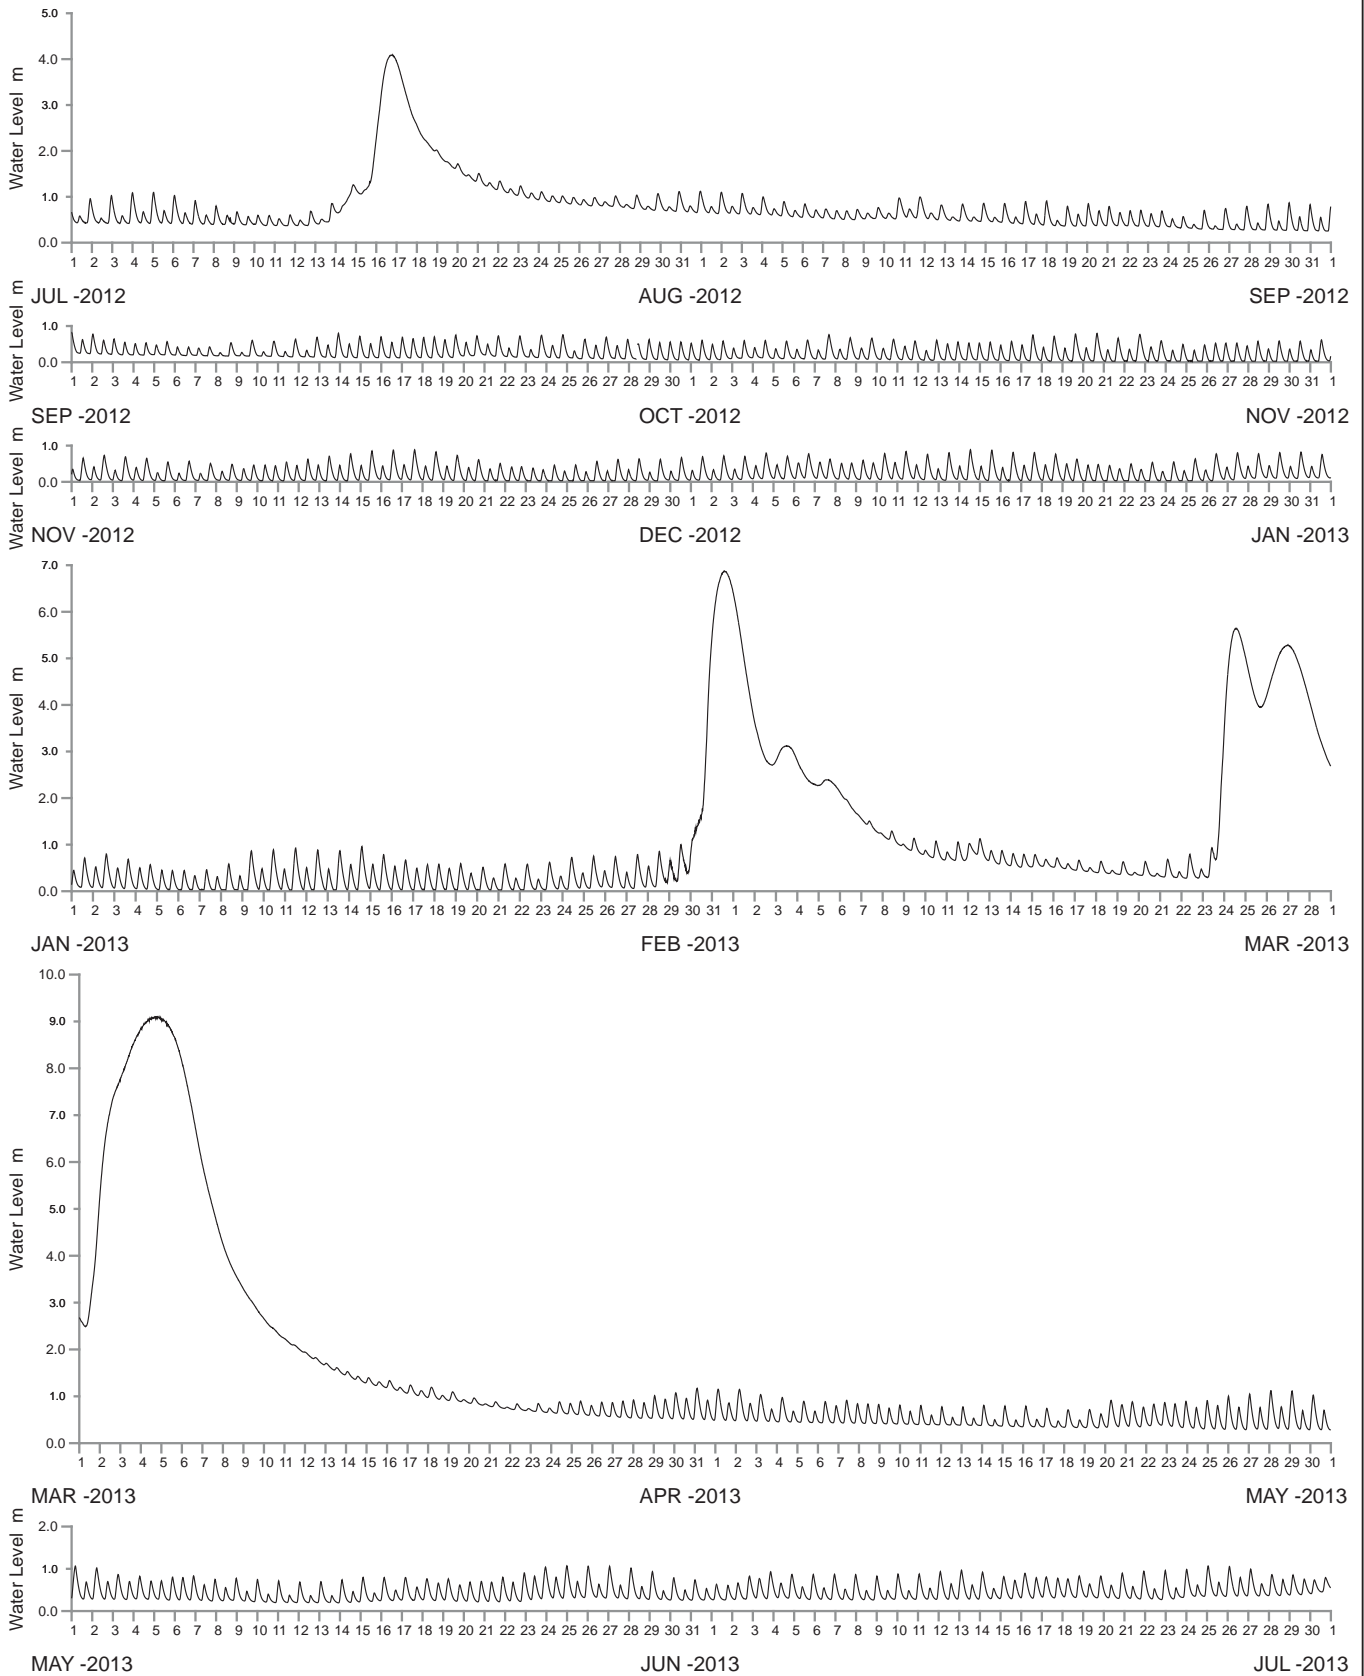
Figure
130

WATER LEVEL REFERENCED TO AUSTRALIAN HEIGHT DATUM

HUNTER RIVER AT BOLWARRA UPSTREAM
2012-2013

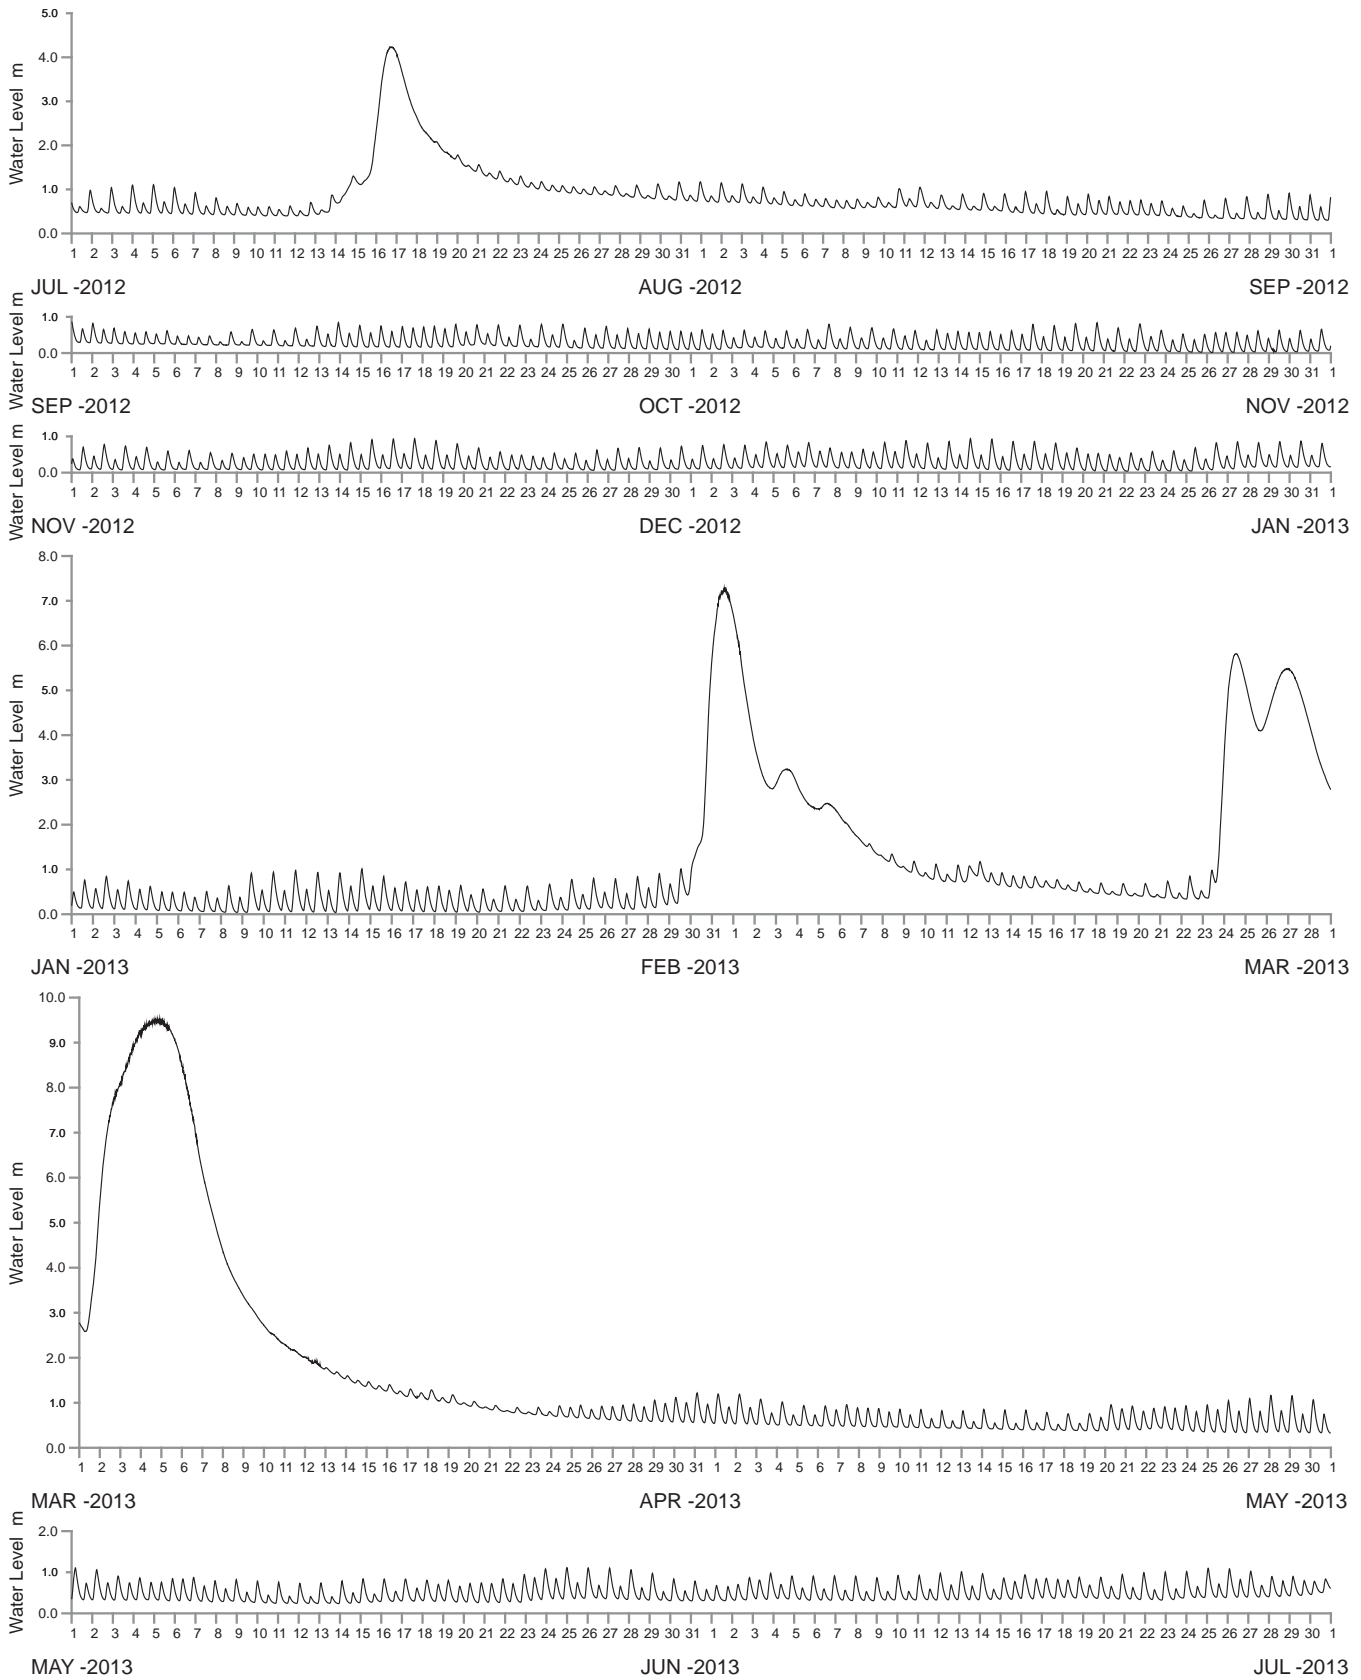
Figure

WATER LEVEL REFERENCED TO AUSTRALIAN HEIGHT DATUM

HUNTER RIVER OAKHAMPTON RAILWAY BRIDGE
2012-2013

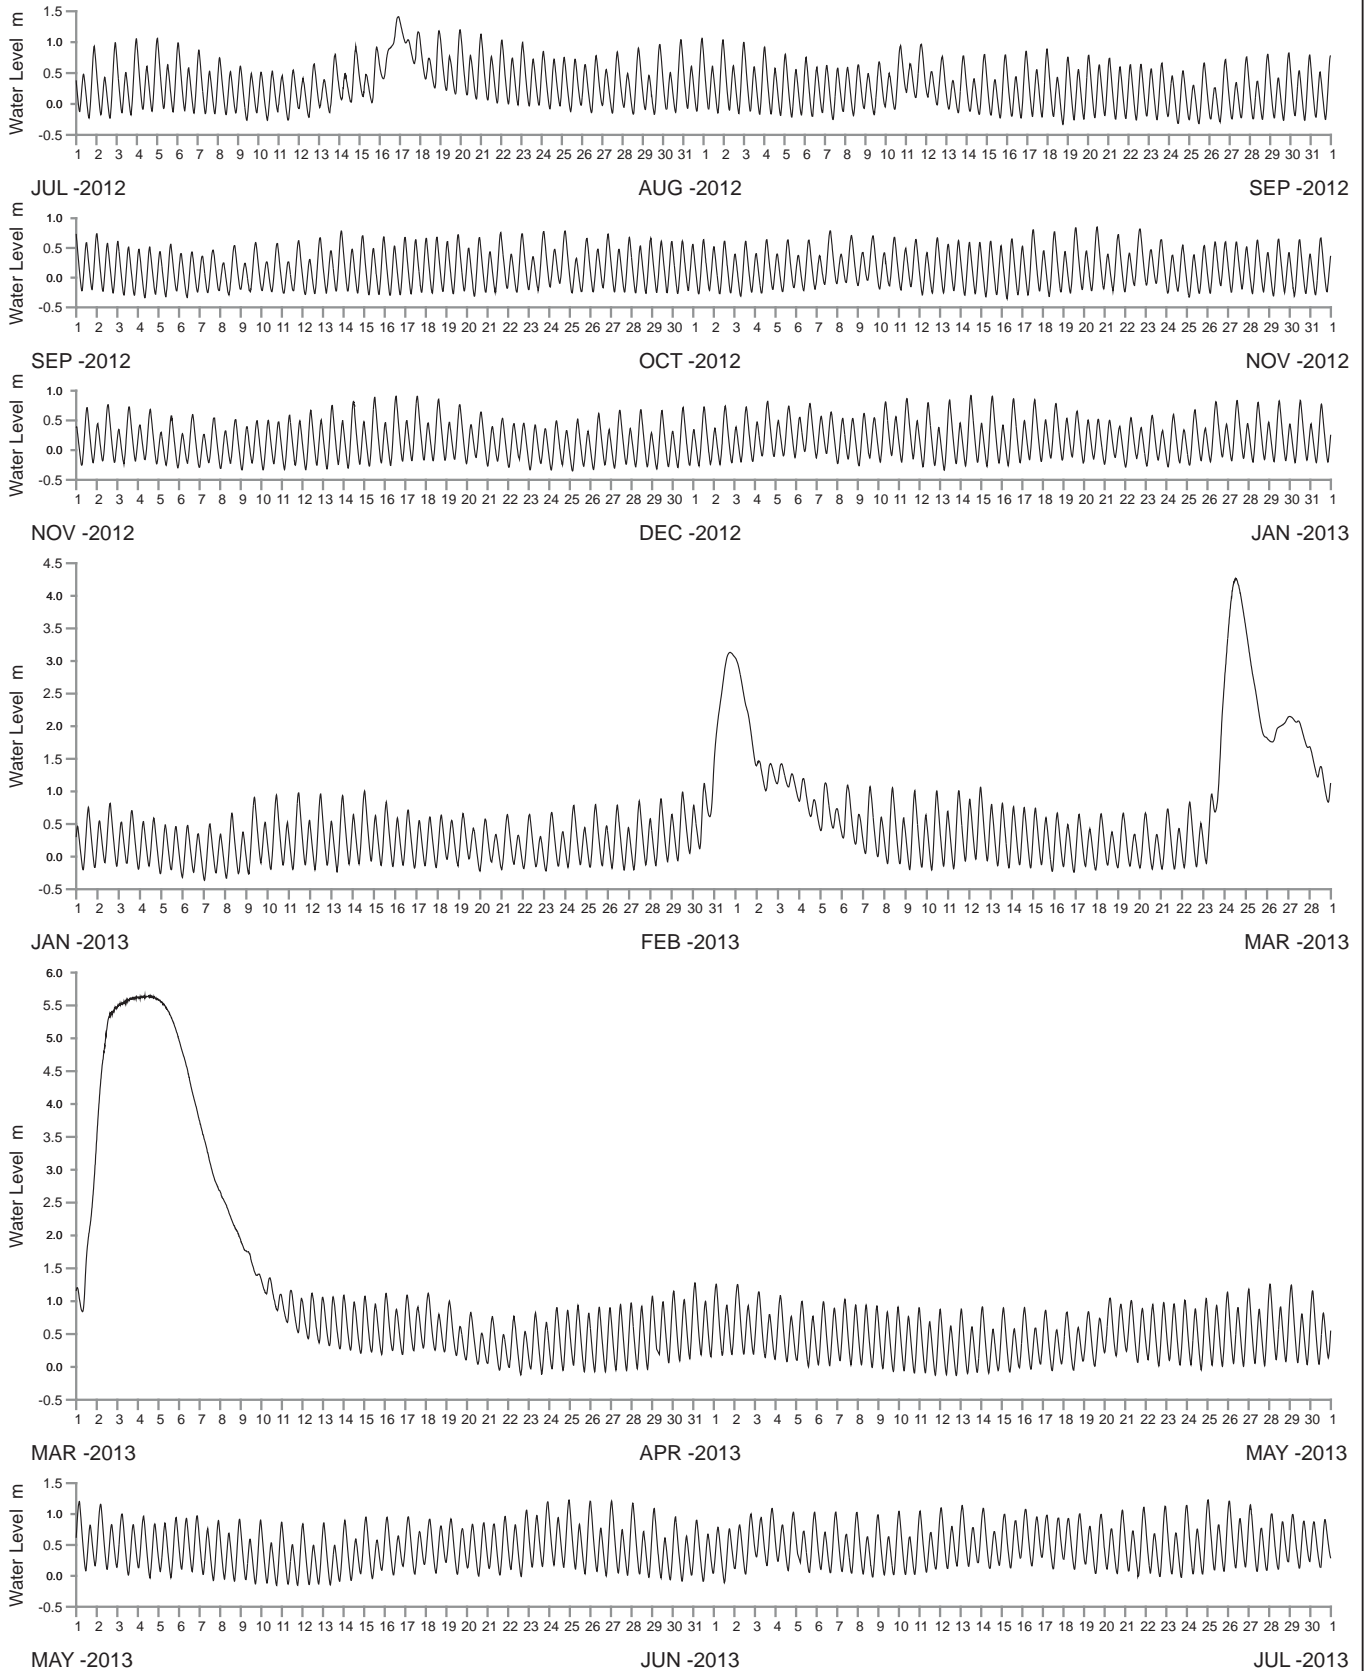
Figure

WATER LEVEL REFERENCED TO AUSTRALIAN HEIGHT DATUM

PATERSON RIVER AT HINTON BRIDGE
2012-2013

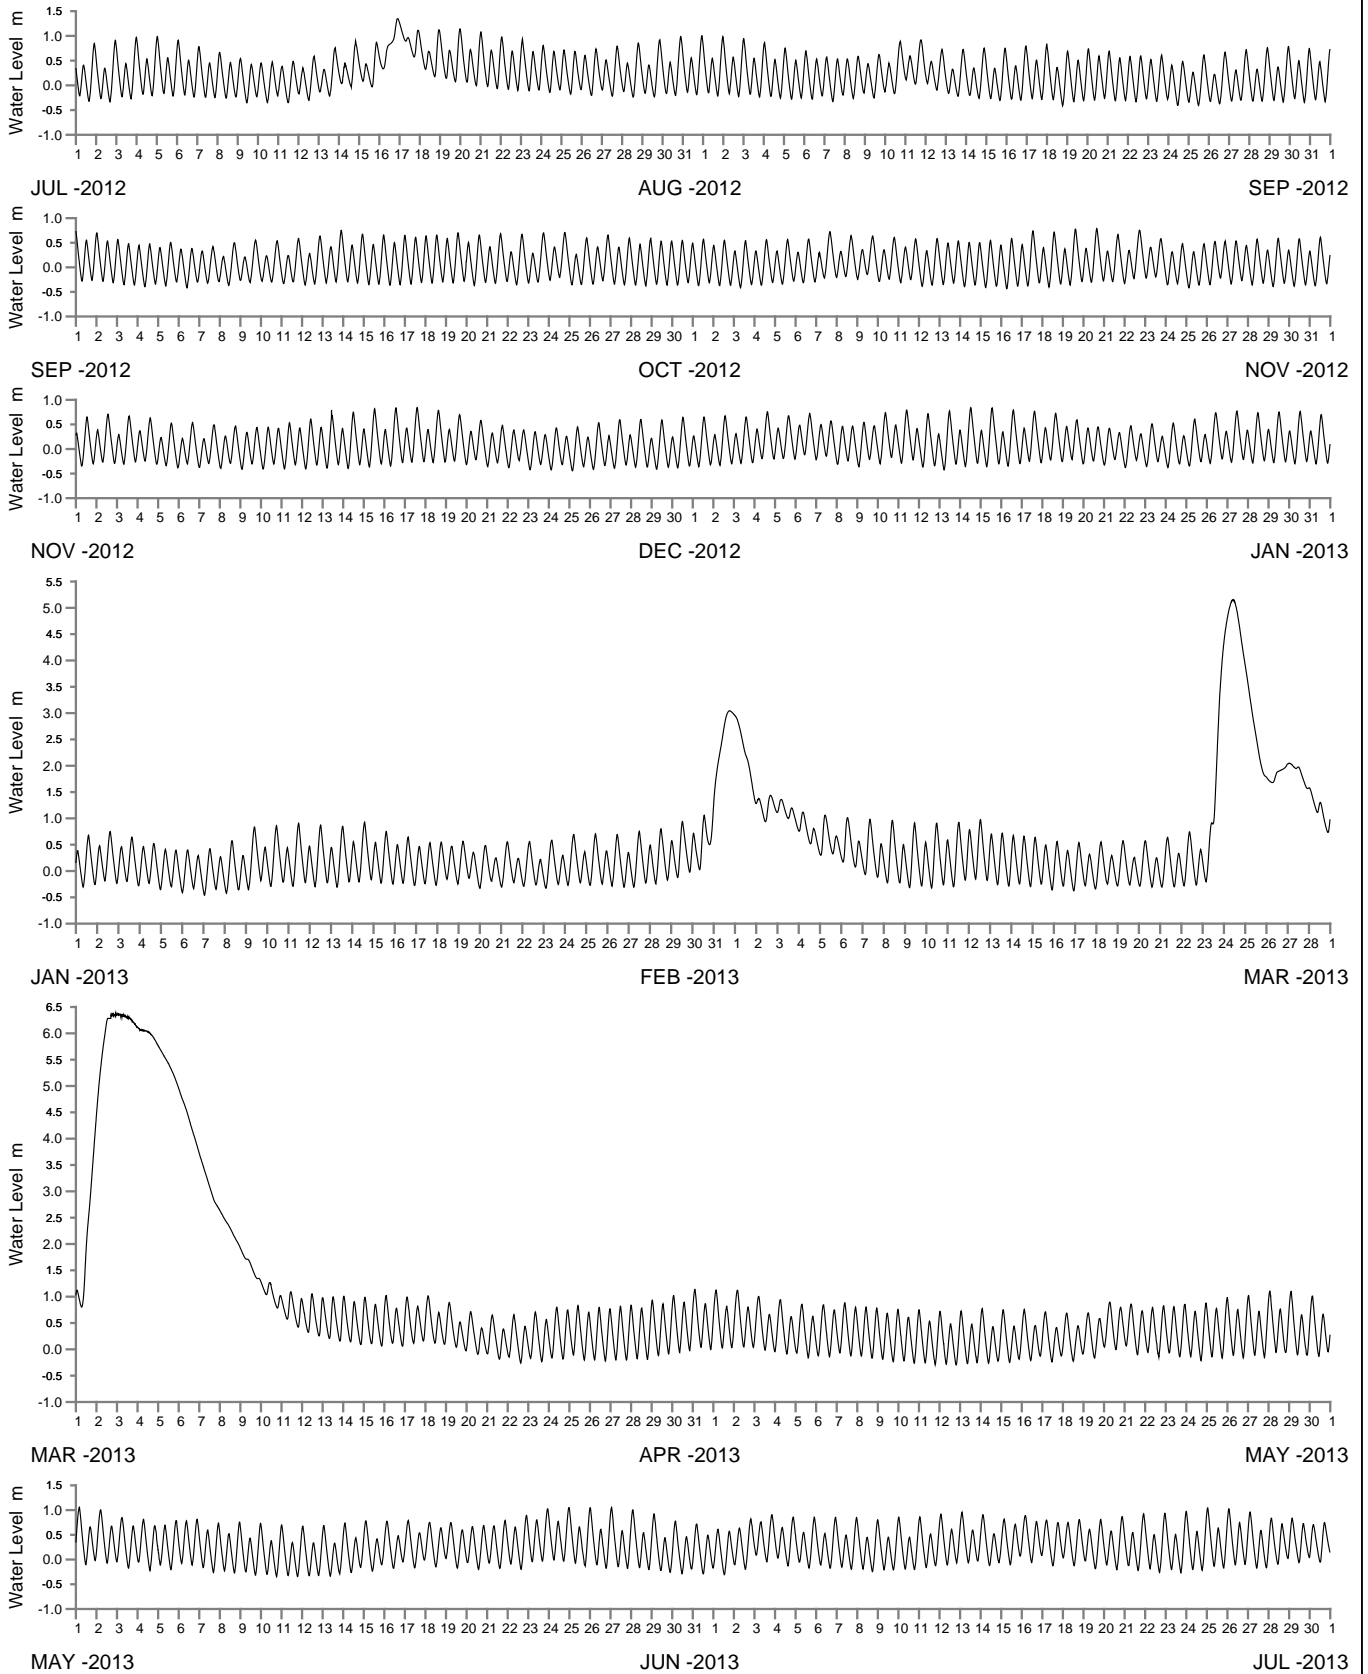
Figure

WATER LEVEL REFERENCED TO AUSTRALIAN HEIGHT DATUM

PATERSON RIVER AT DUNMORE
2012-2013

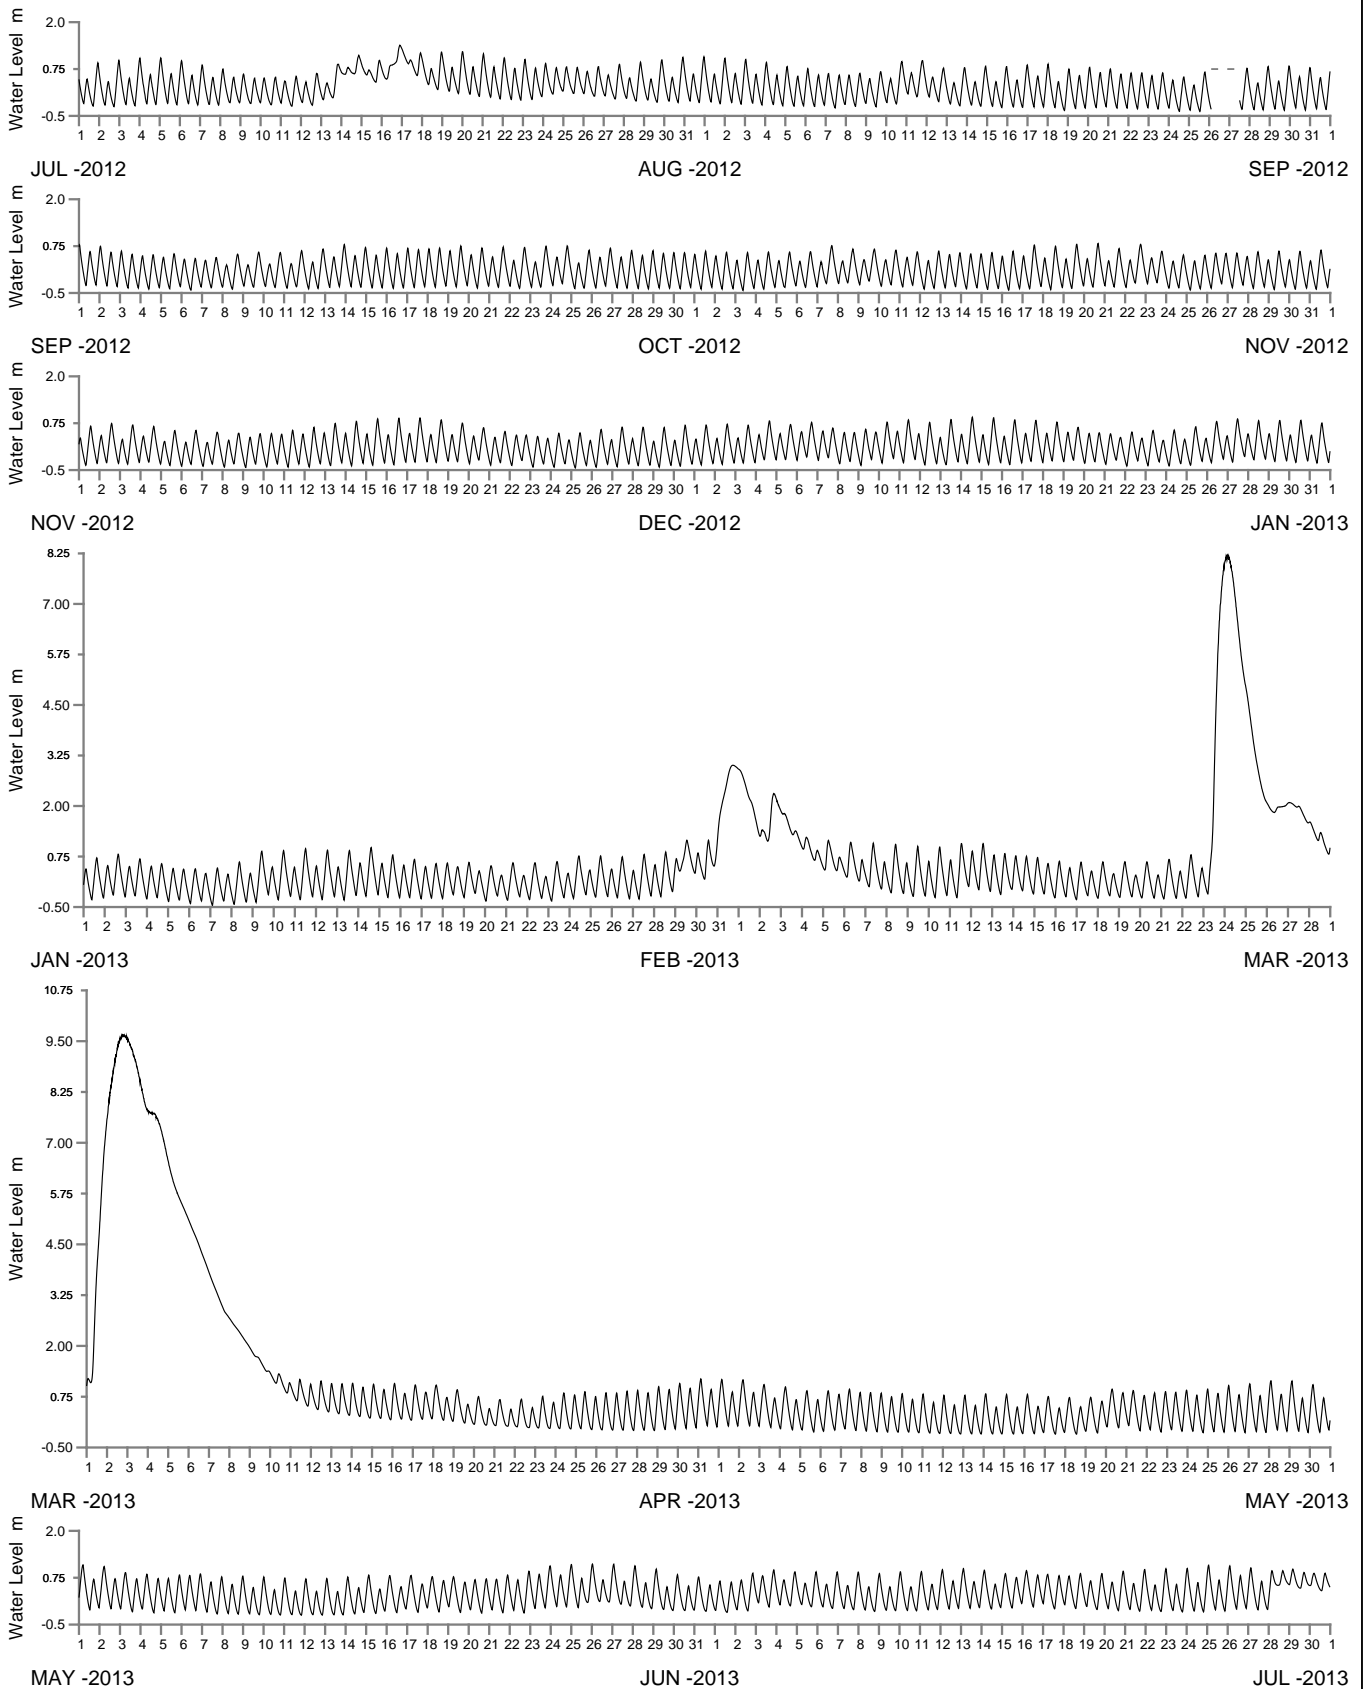
Figure
135

WATER LEVEL REFERENCED TO AUSTRALIAN HEIGHT DATUM

PATERSON RIVER AT PATERSON RAILWAY BRIDGE
2012-2013

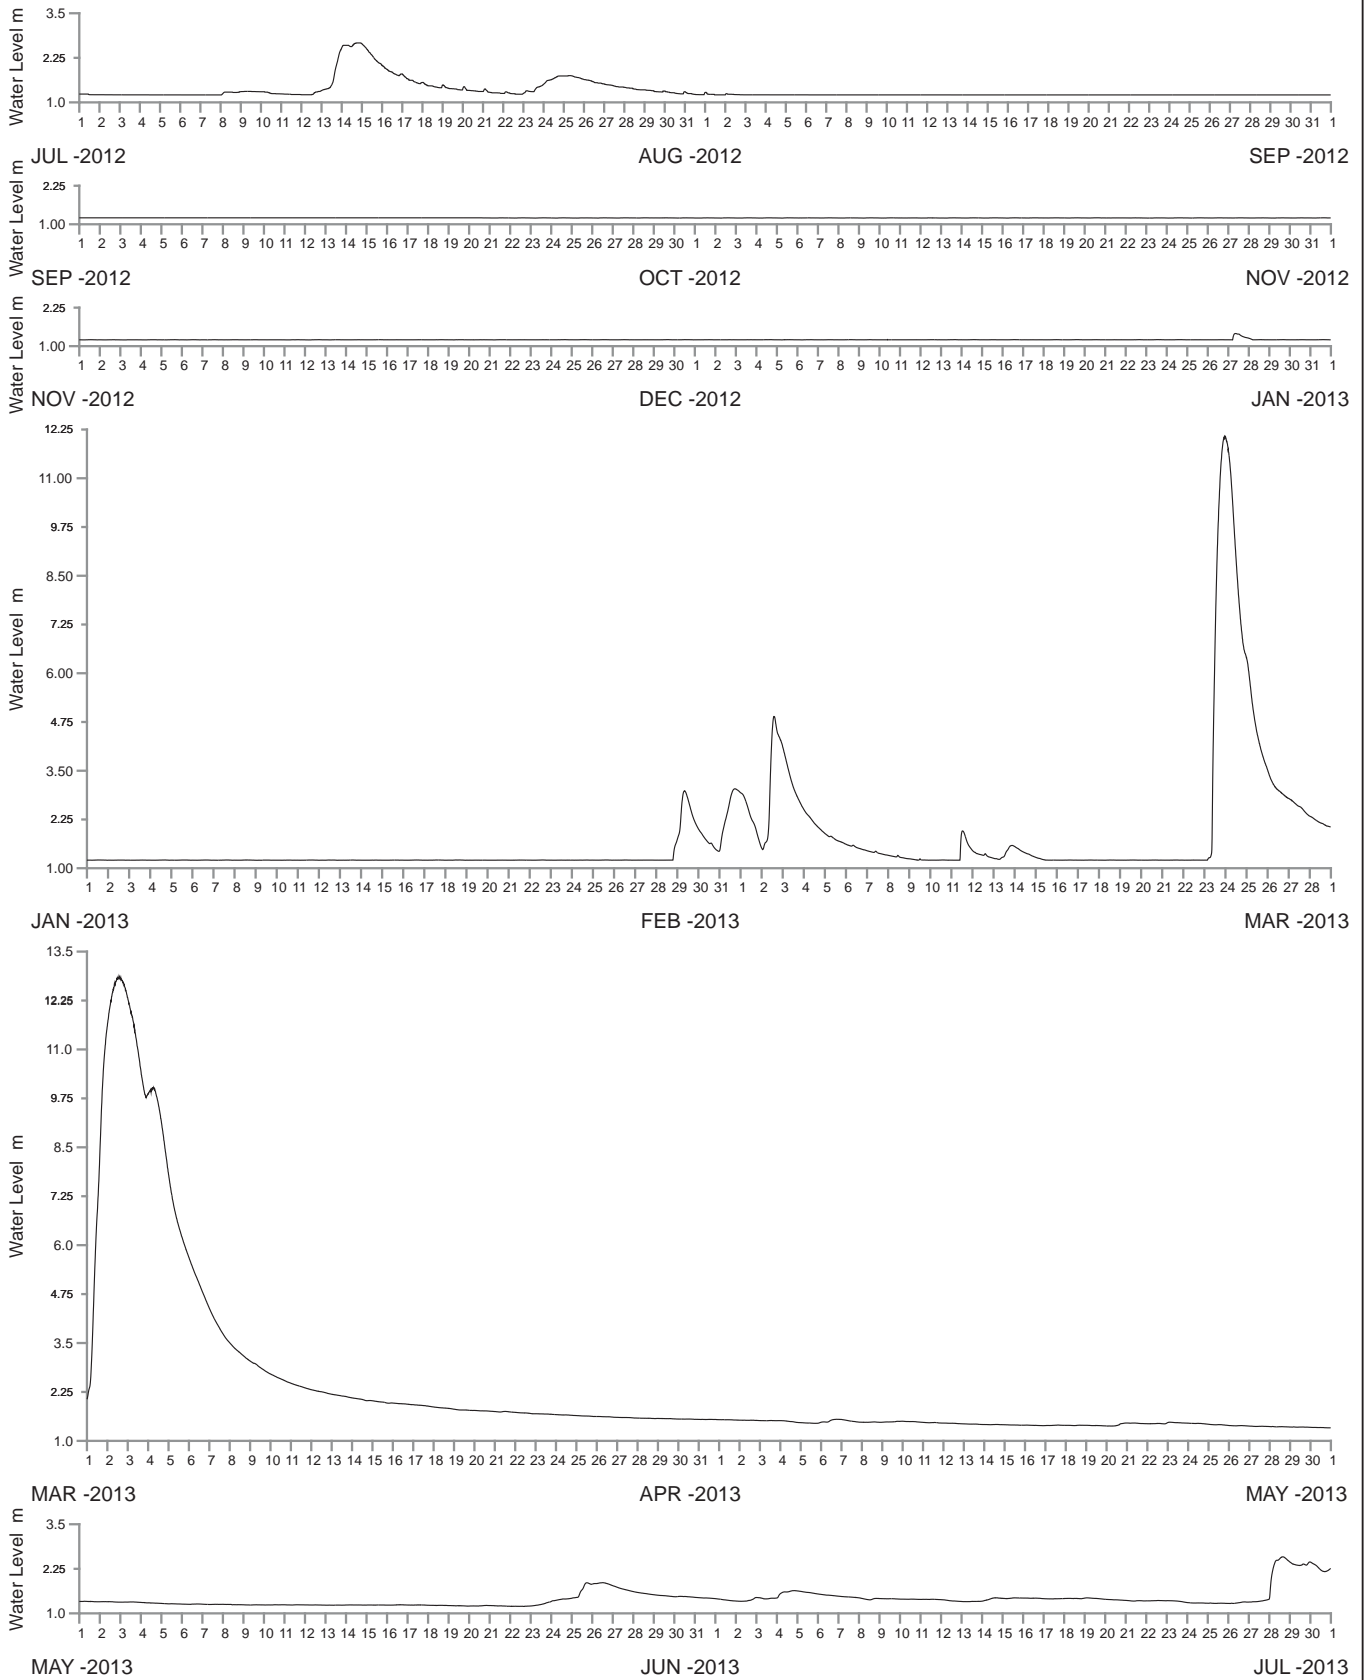
Figure

WATER LEVEL REFERENCED TO AUSTRALIAN HEIGHT DATUM

PATERSON RIVER AT GOSTWYCK
2012-2013
