Public Works
Manly Hydraulics Laboratory

MHL
Report 2218

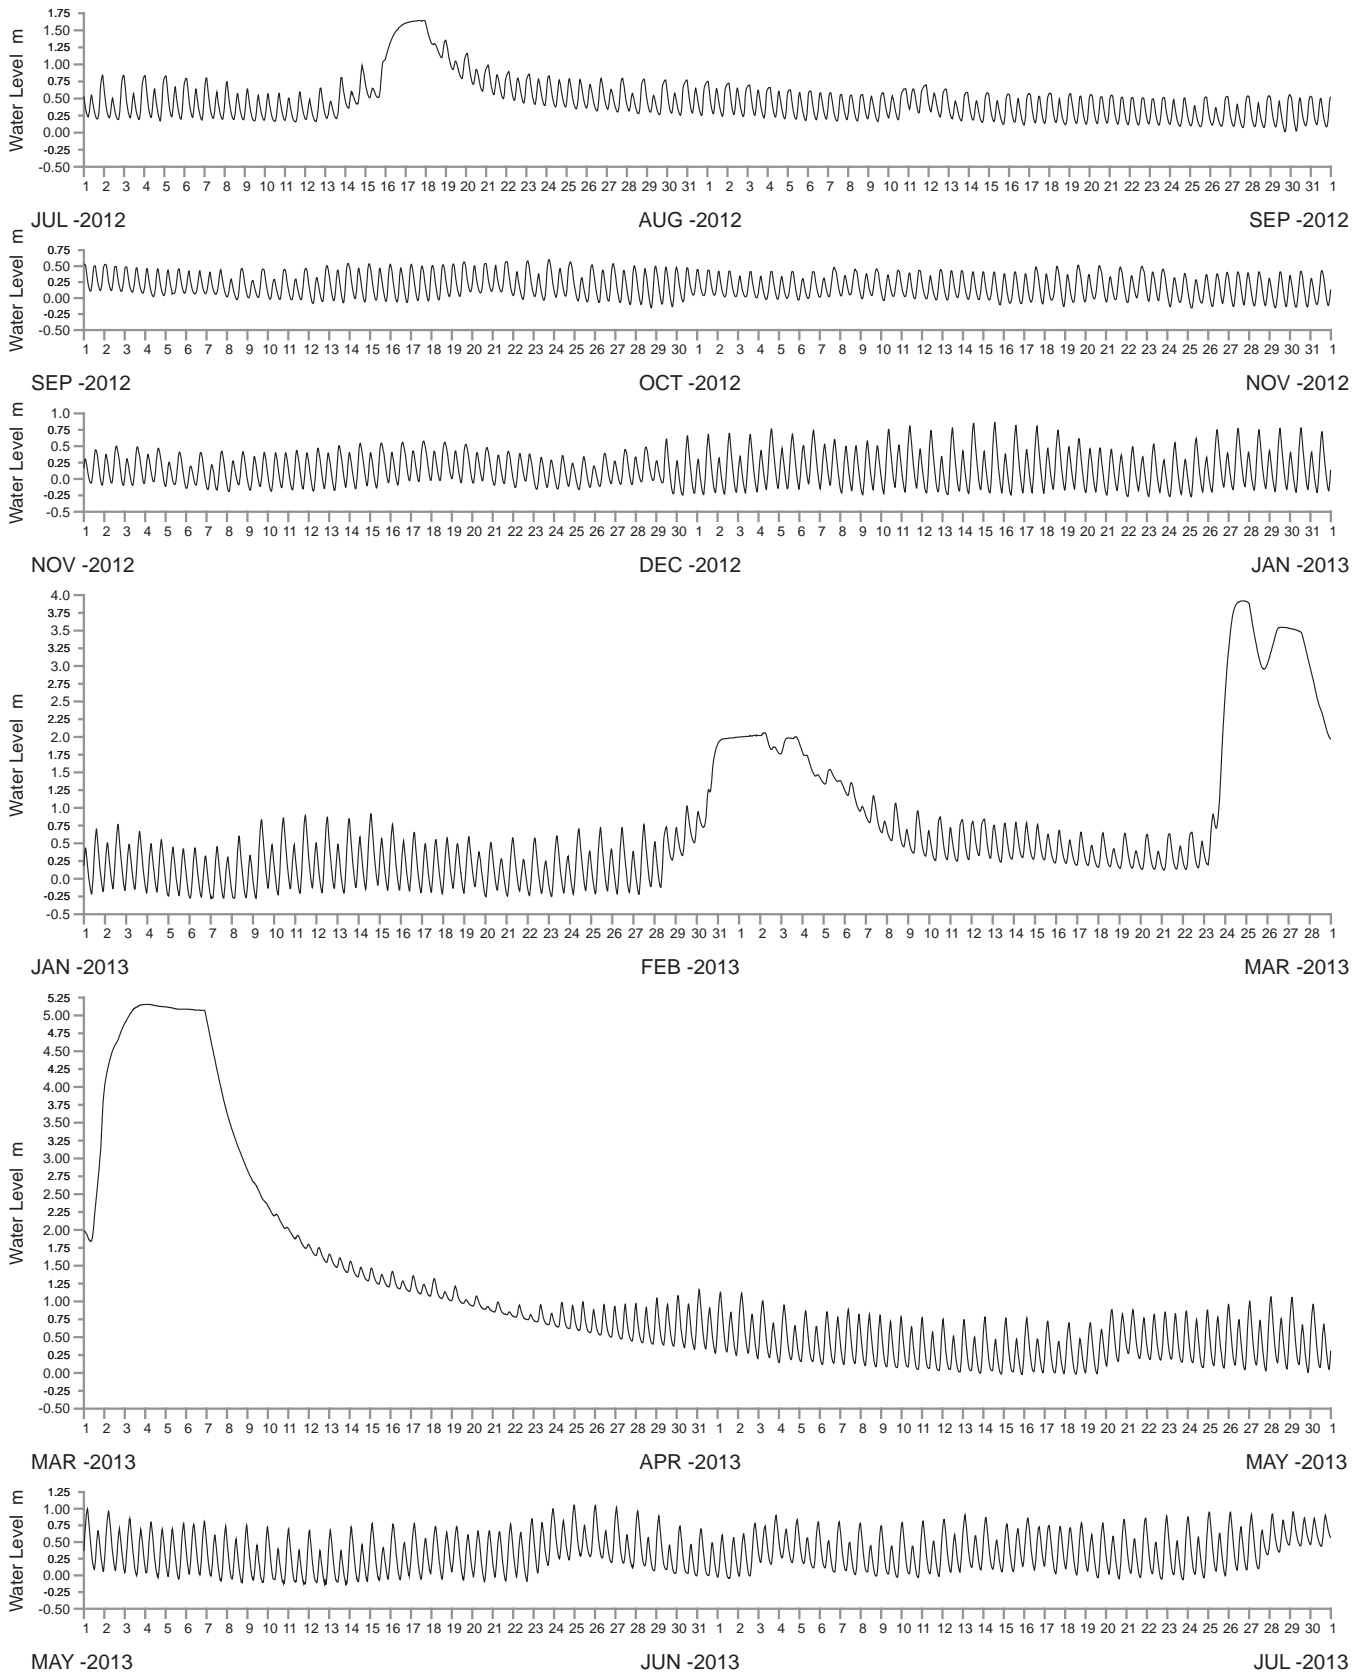
Figure
138

WATER LEVEL REFERENCED TO AUSTRALIAN HEIGHT DATUM

WALLIS CREEK AT WALLIS CREEK UPSTREAM
2012-2013

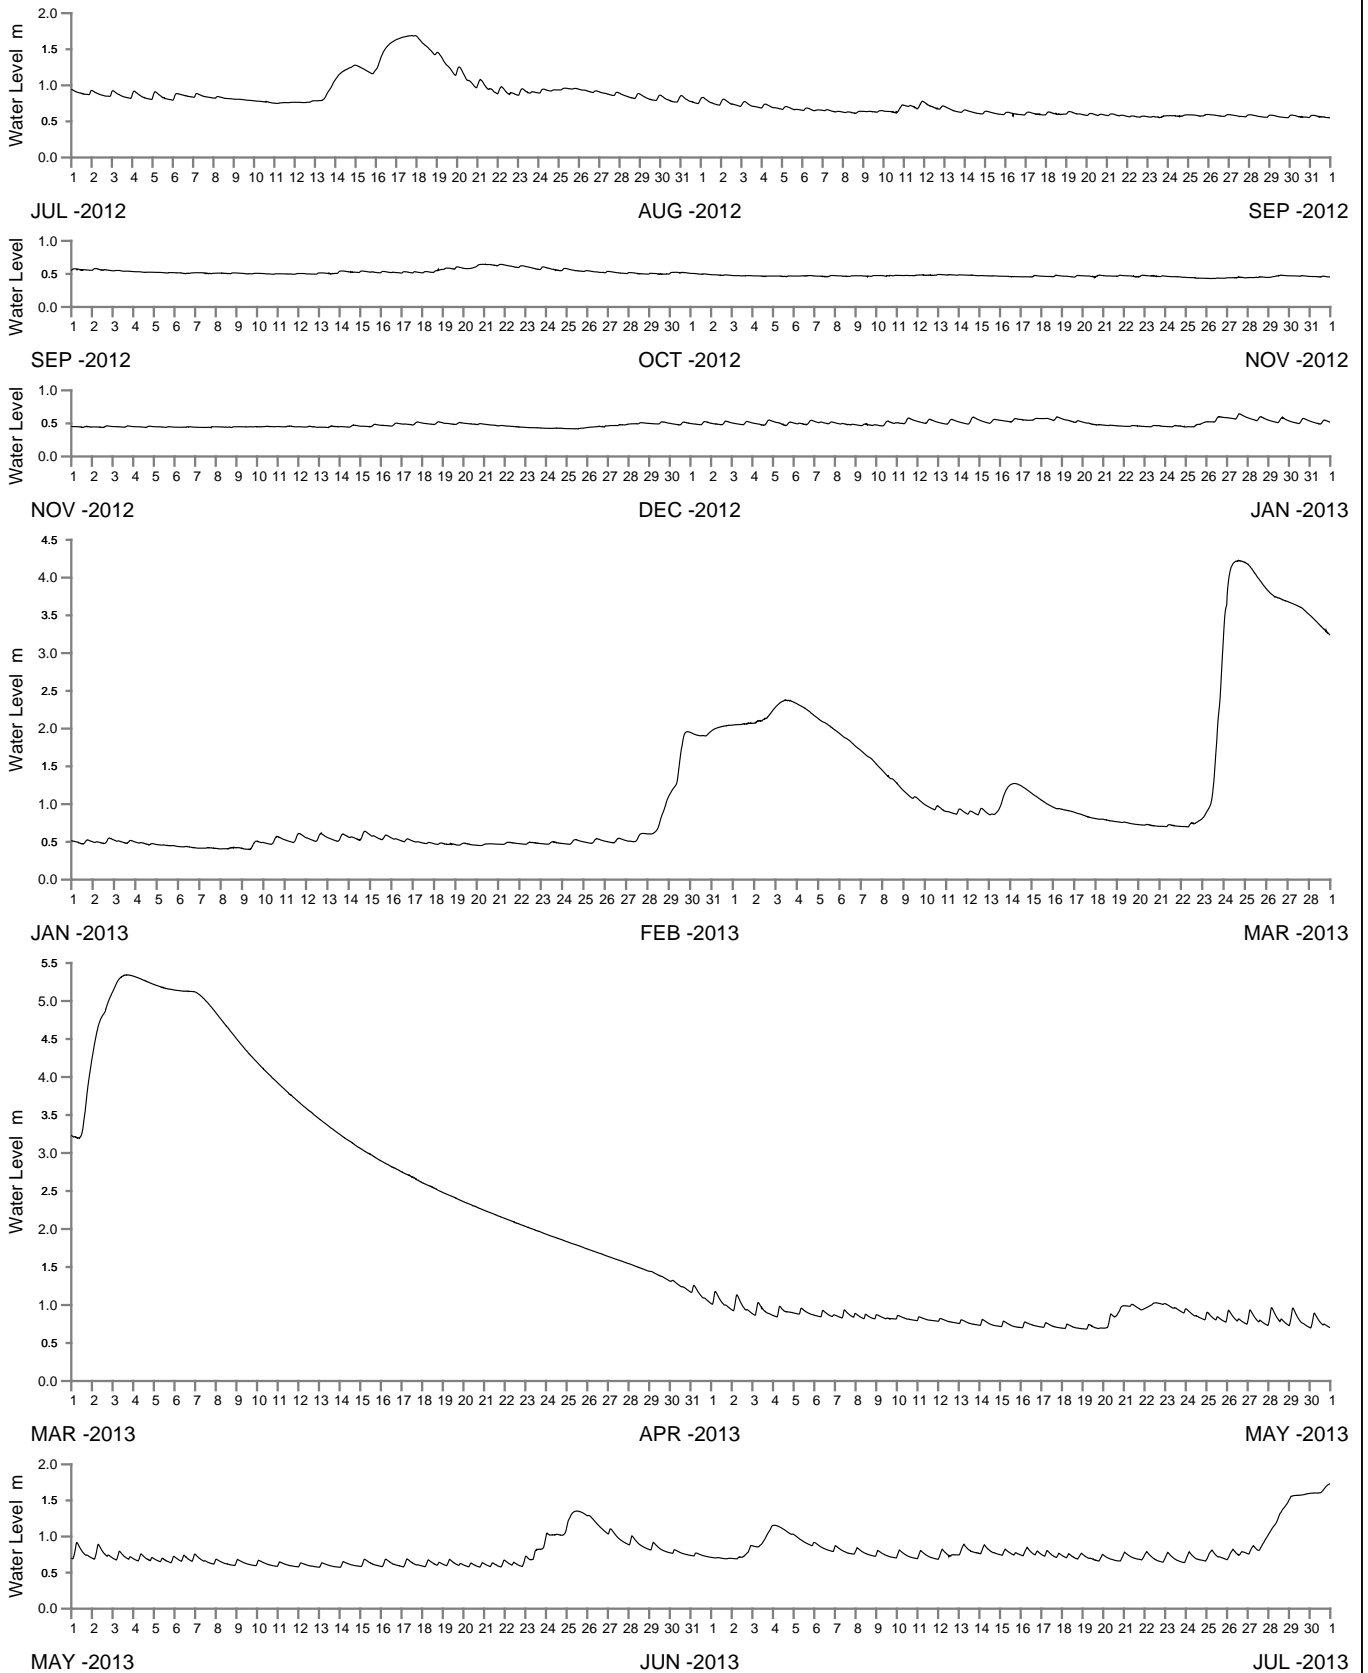
Figure
140

WATER LEVEL REFERENCED TO AUSTRALIAN HEIGHT DATUM

WALLIS CREEK AT LOUTH PARK
2012-2013

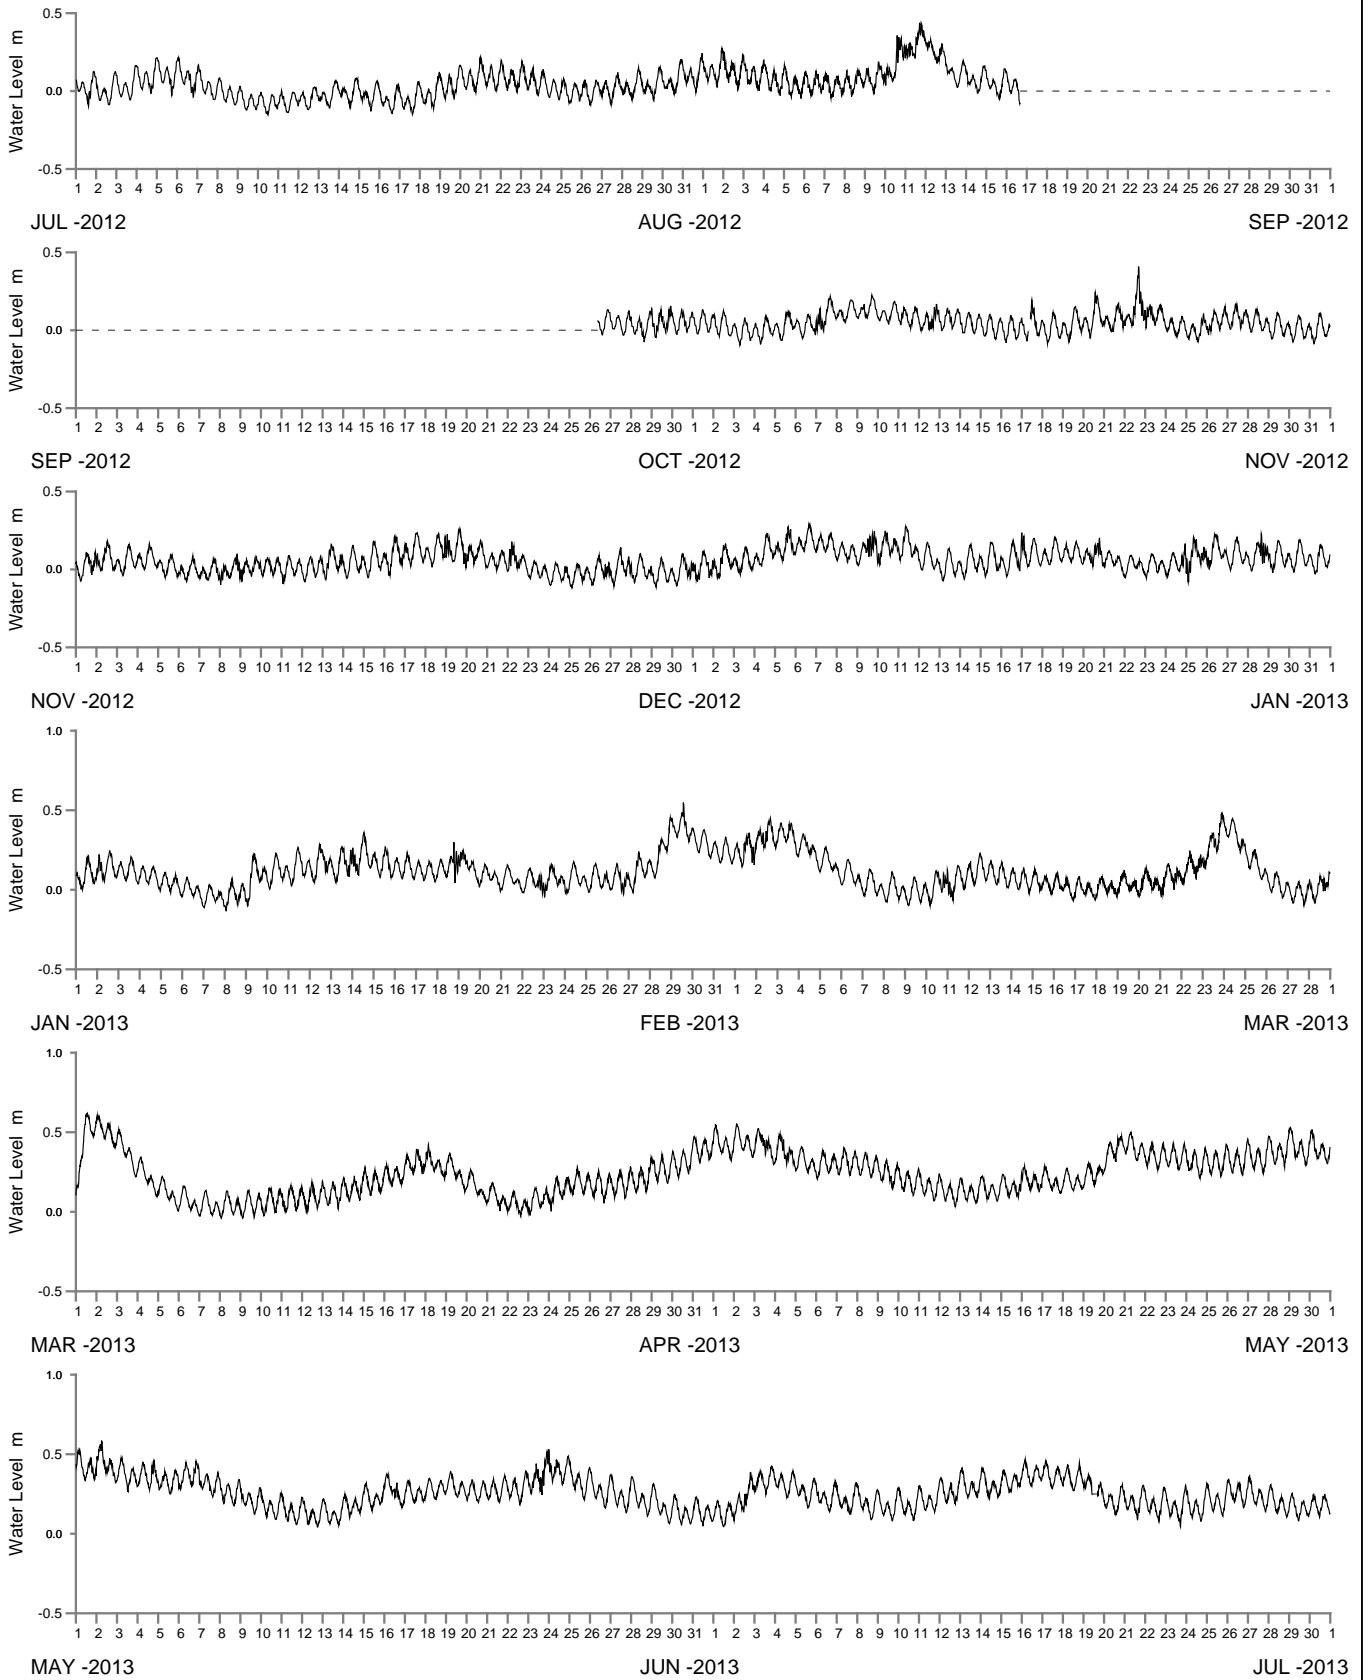
Figure
143

WATER LEVEL REFERENCED TO AUSTRALIAN HEIGHT DATUM

COCKLE CREEK AT COCKLE RAILWAY STATION
2012-2013

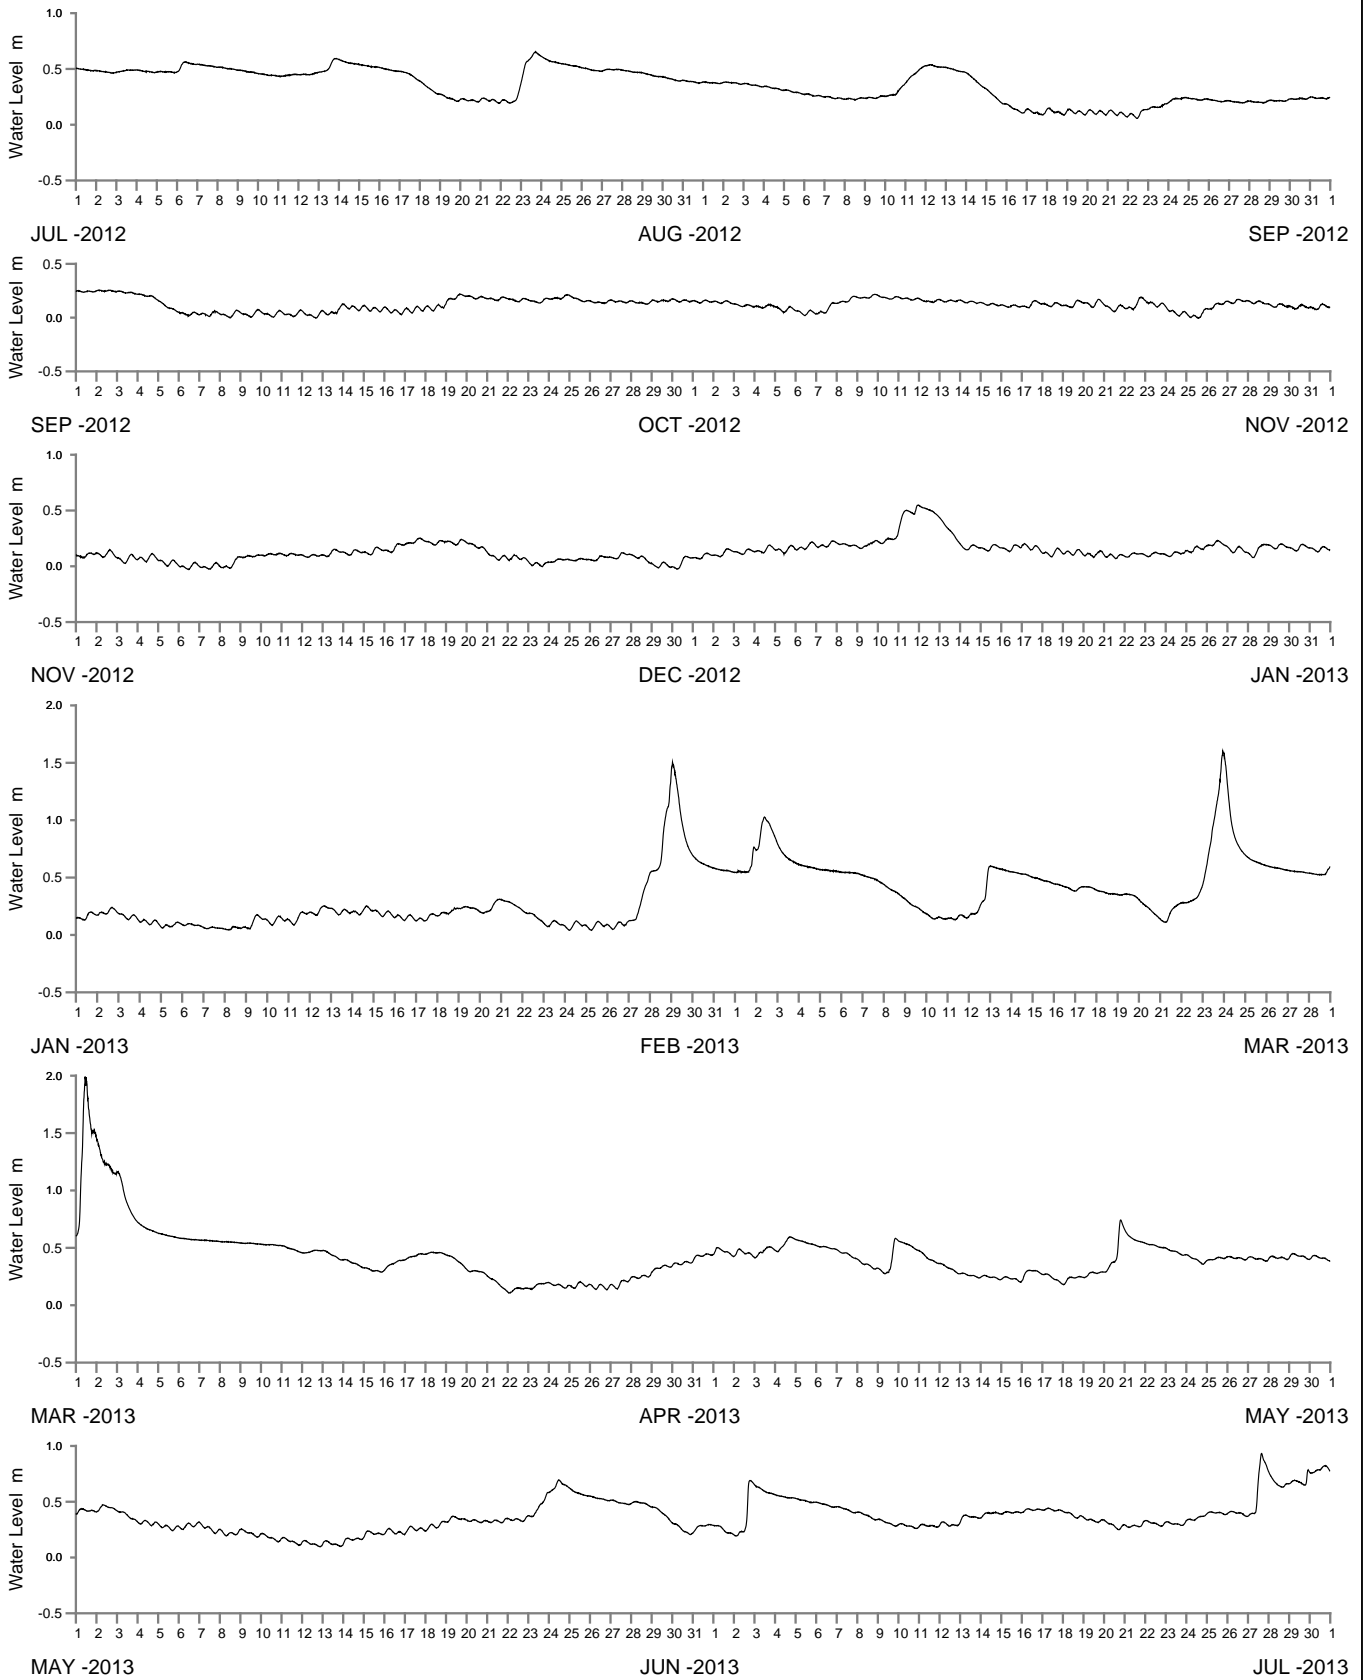
Figure
144

WATER LEVEL REFERENCED TO AUSTRALIAN HEIGHT DATUM

COCKLE CREEK AT BARNSLEY VALE
2012-2013

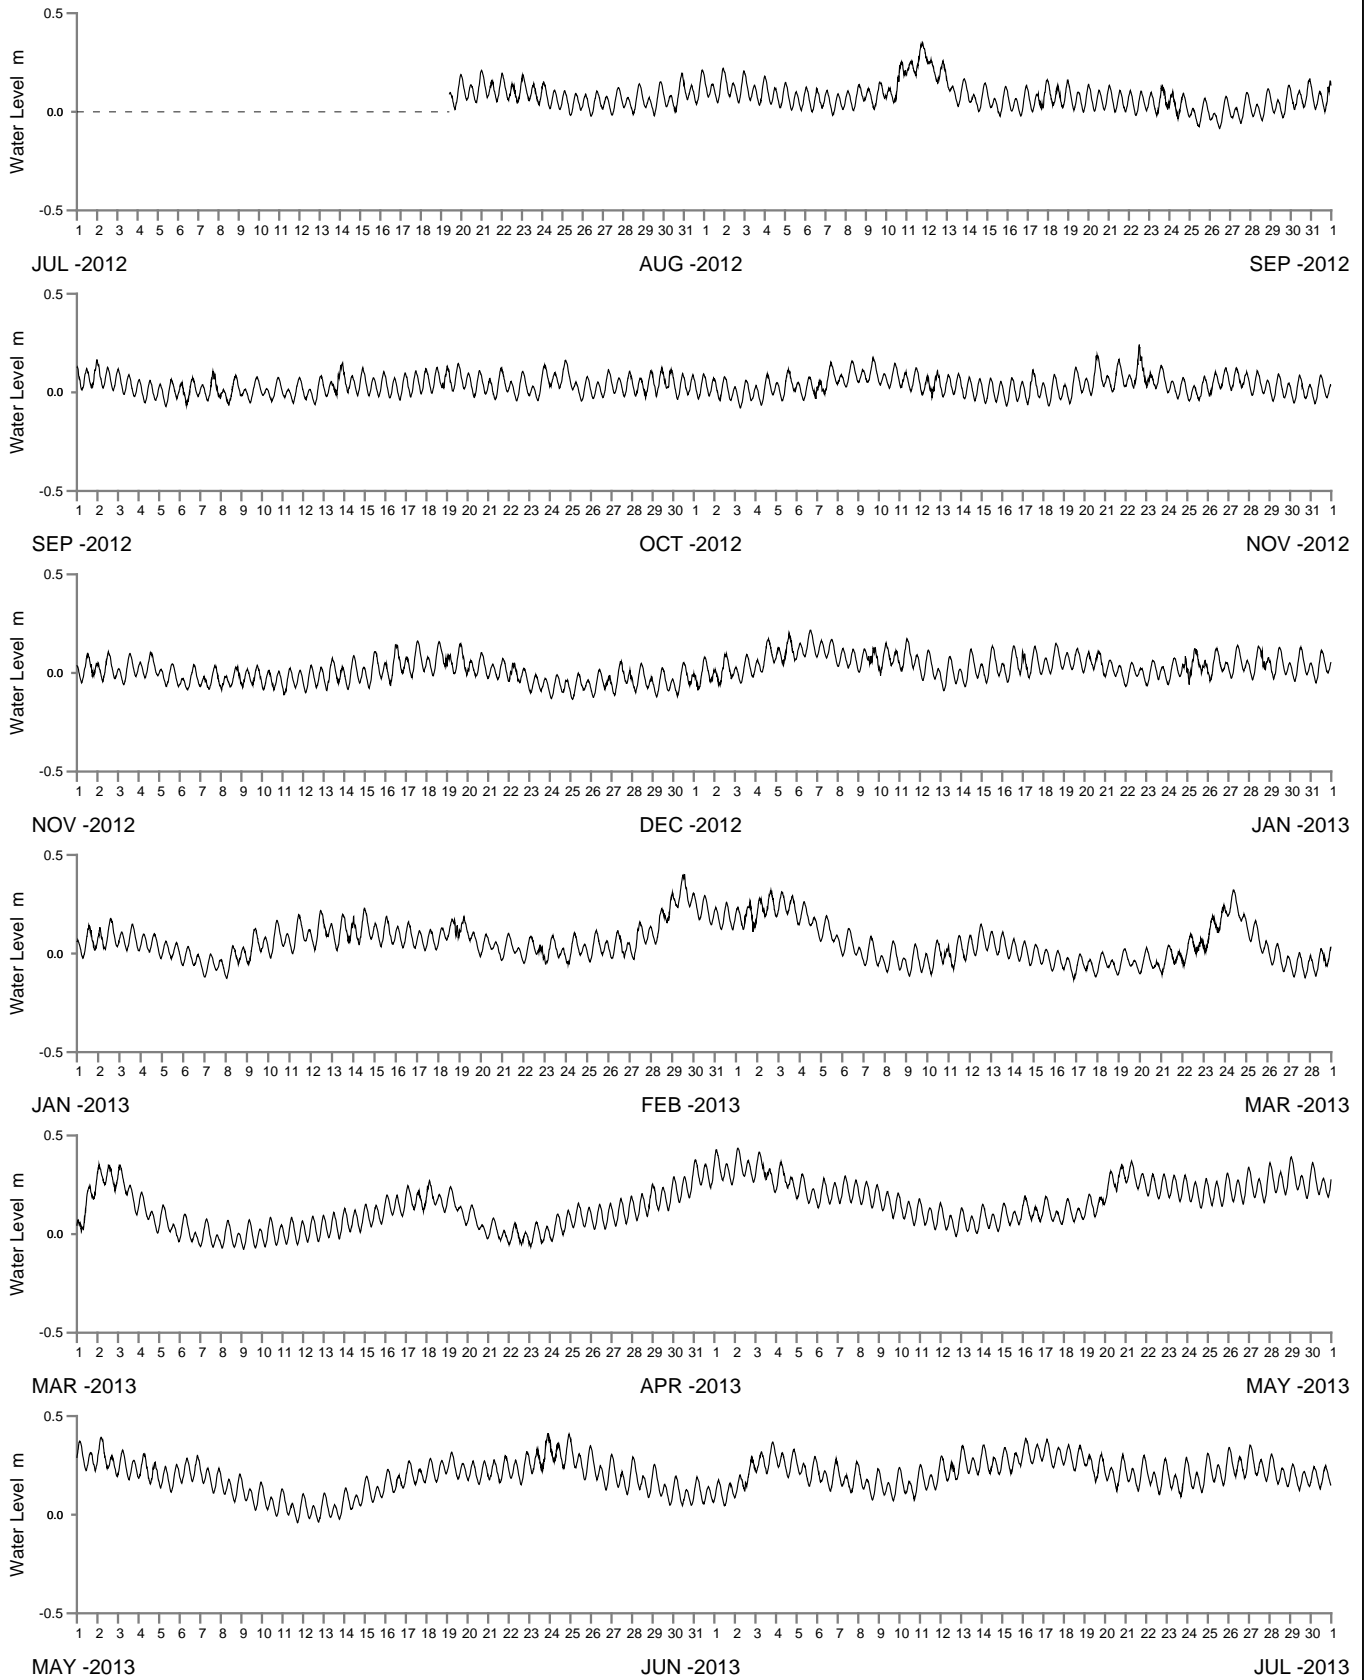
Figure

WATER LEVEL REFERENCED TO AUSTRALIAN HEIGHT DATUM

LAKE MACQUARIE AT BELMONT
2012-2013

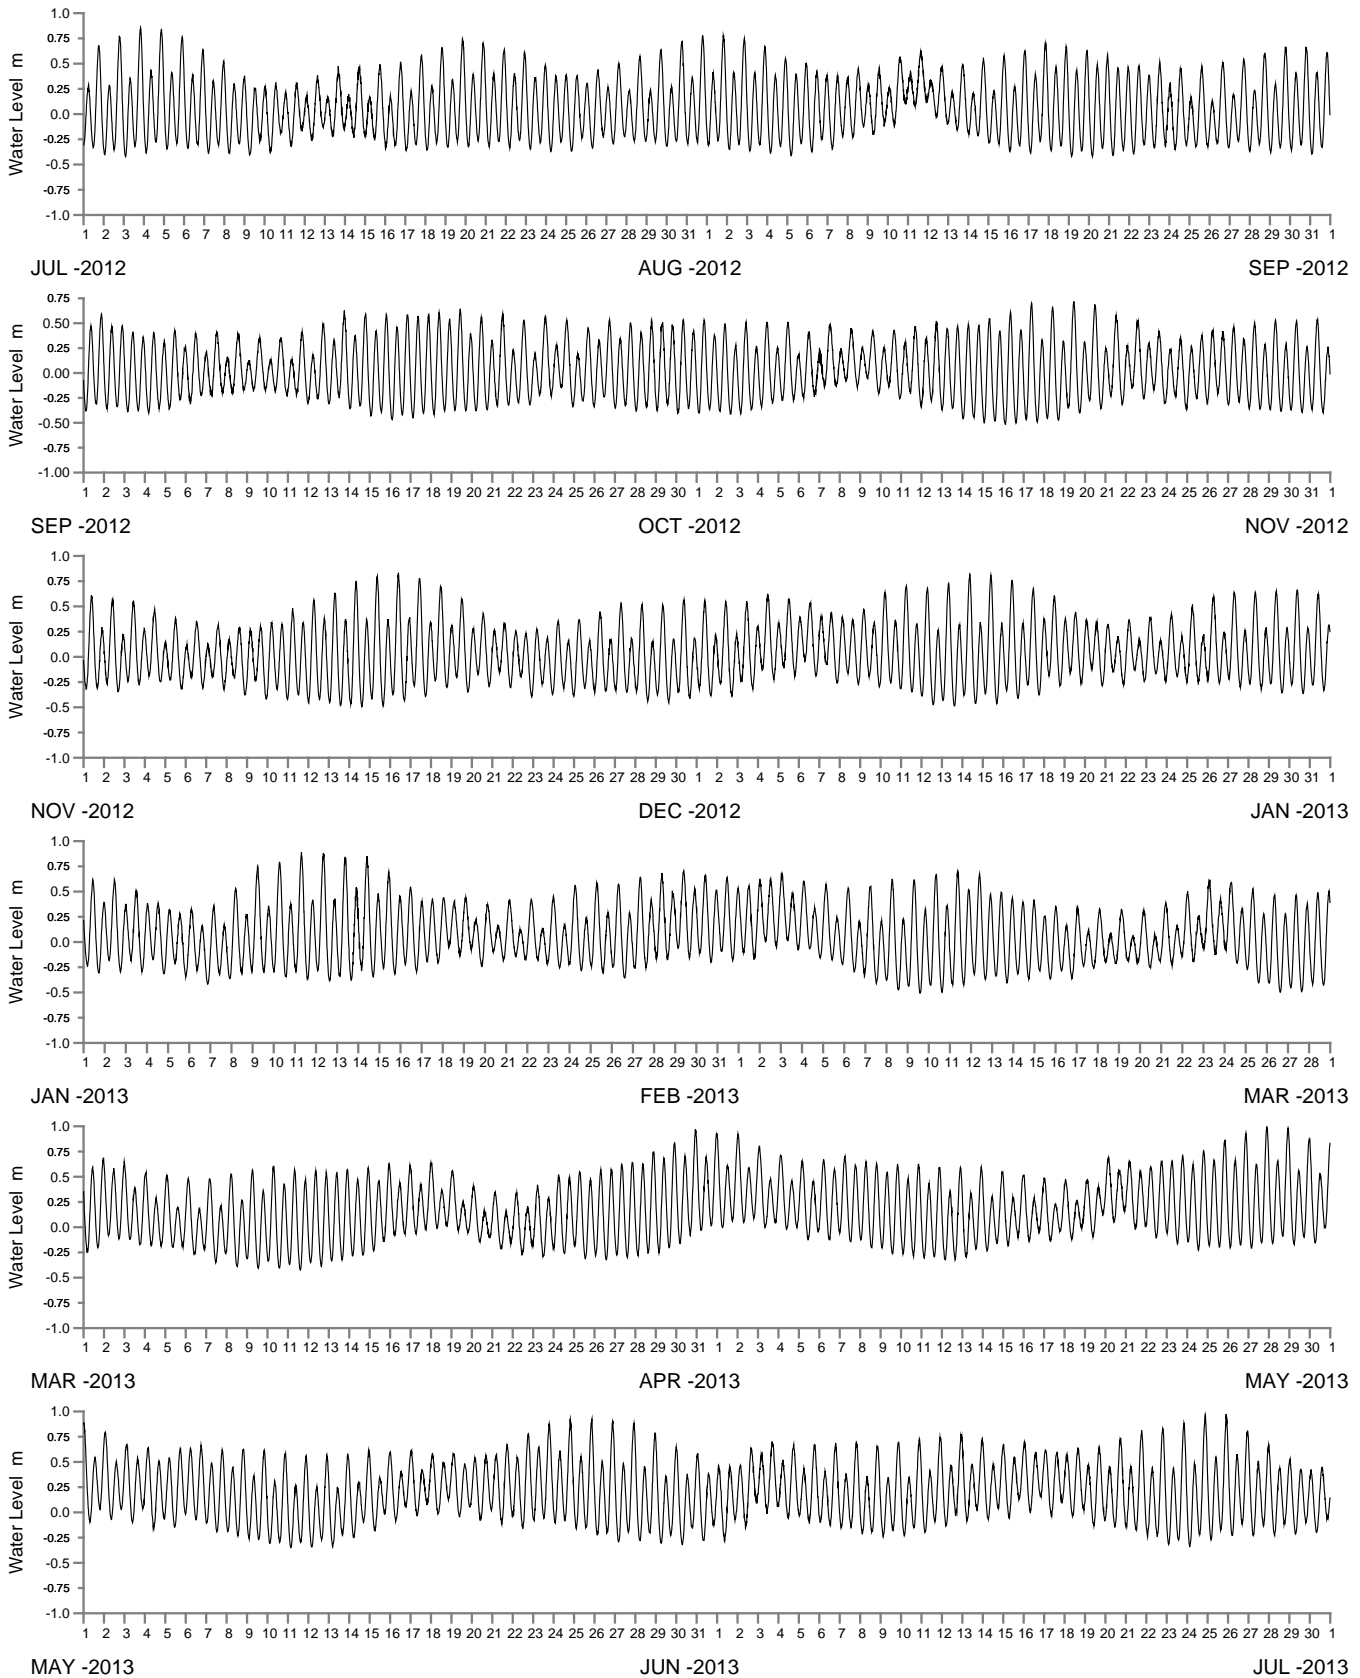
Figure
146

WATER LEVEL REFERENCED TO AUSTRALIAN HEIGHT DATUM

LAKE MACQUARIE AT SWANSEA CHANNEL
2012-2013

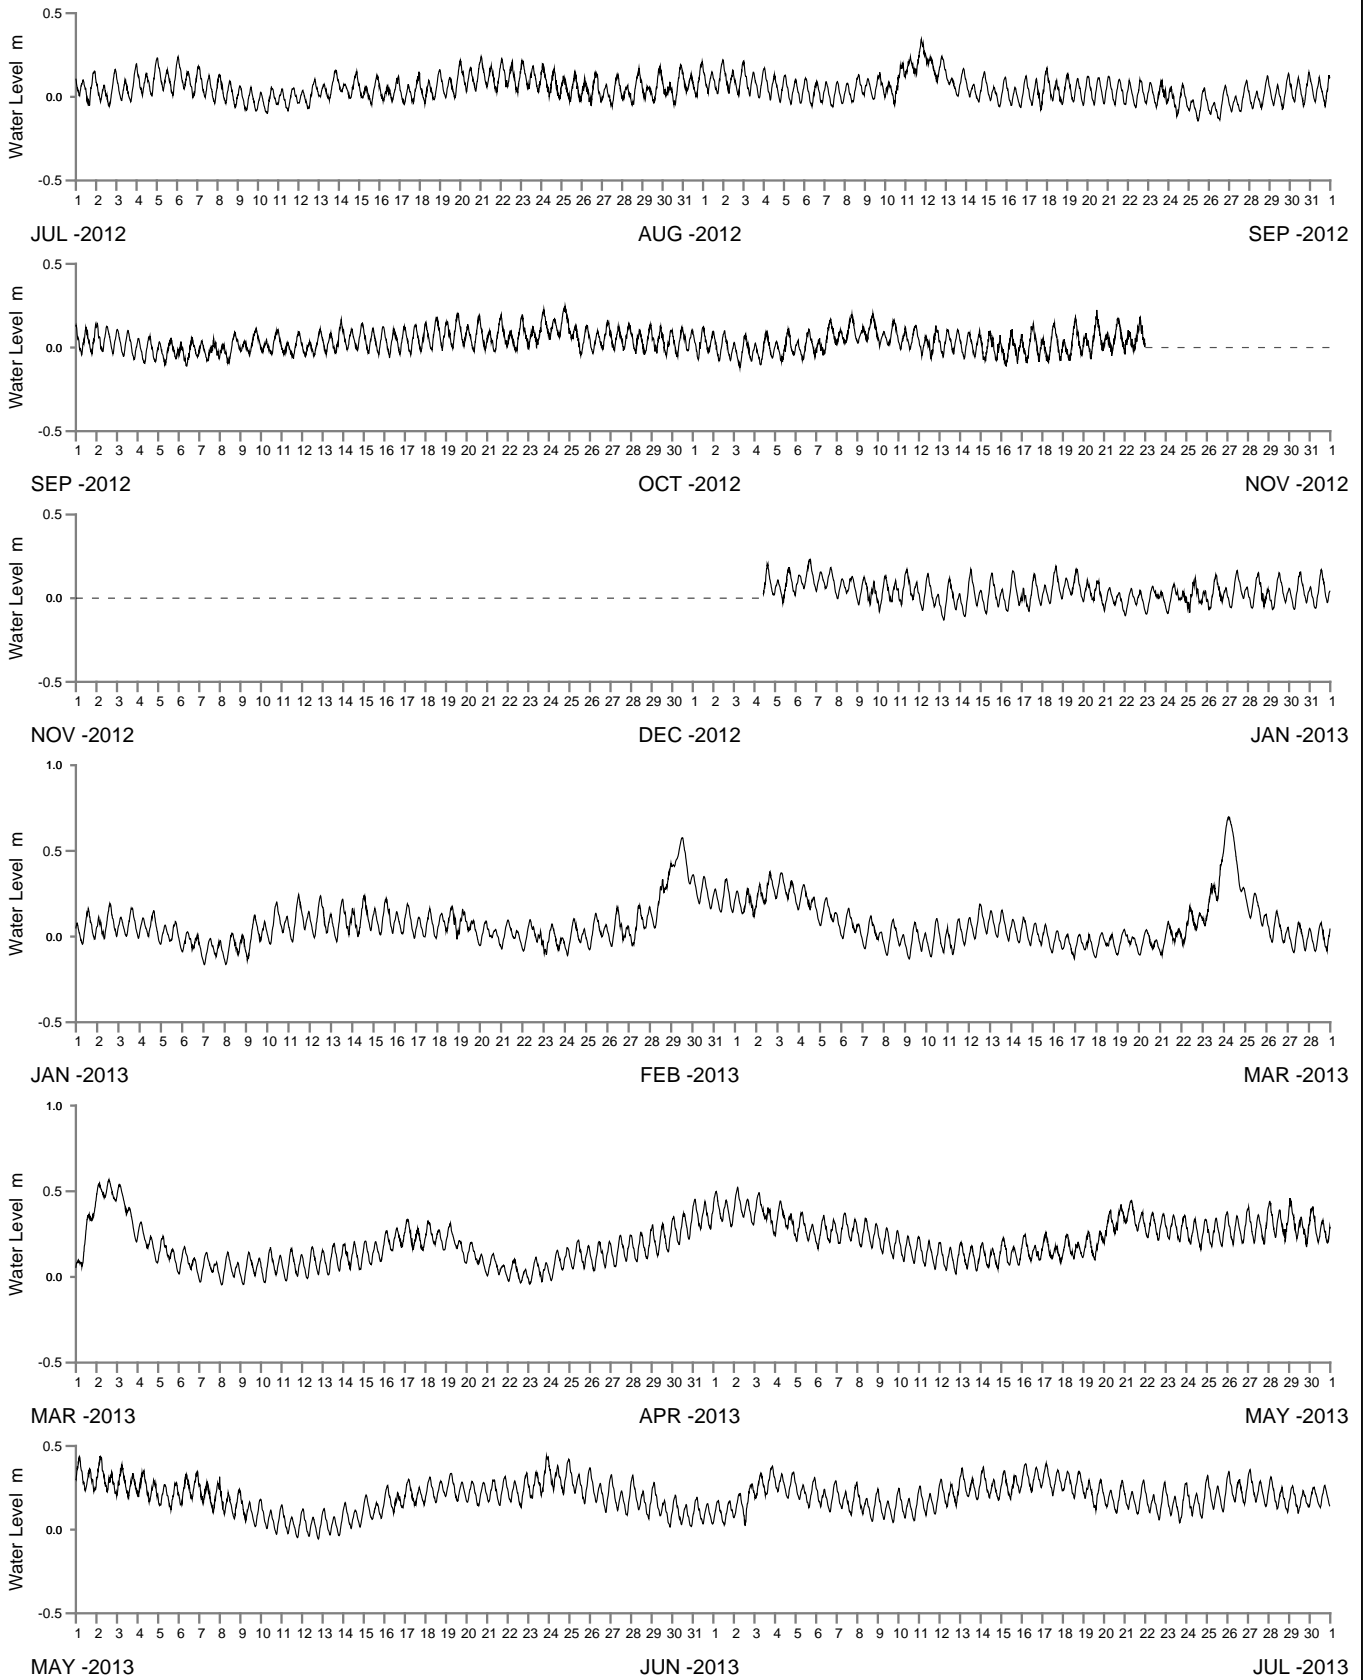
Figure
147

WATER LEVEL REFERENCED TO AUSTRALIAN HEIGHT DATUM

DORA CREEK AT KALANG ROAD
2012-2013

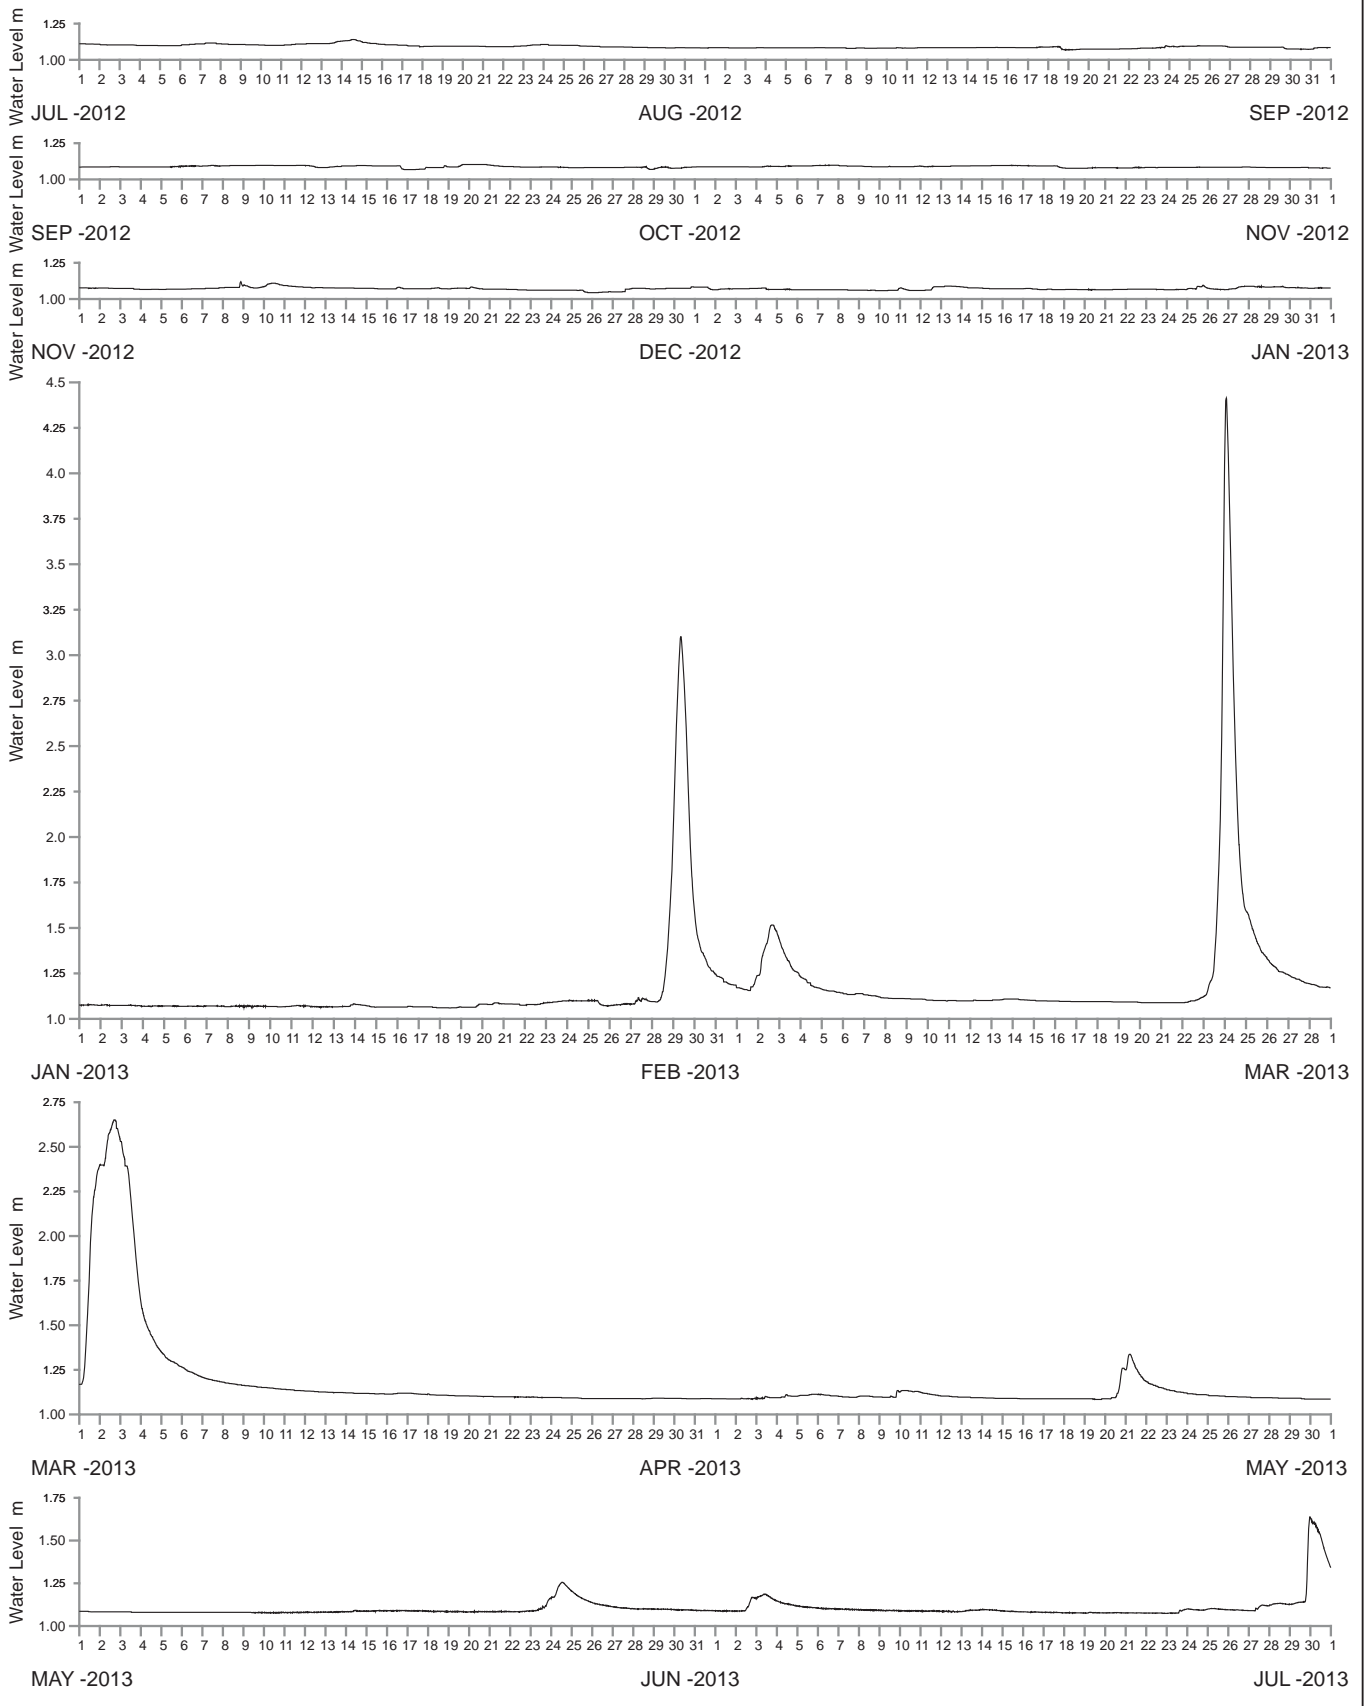
Figure

WATER LEVEL REFERENCED TO AUSTRALIAN HEIGHT DATUM

DORA CREEK AT COORANBONG
2012-2013

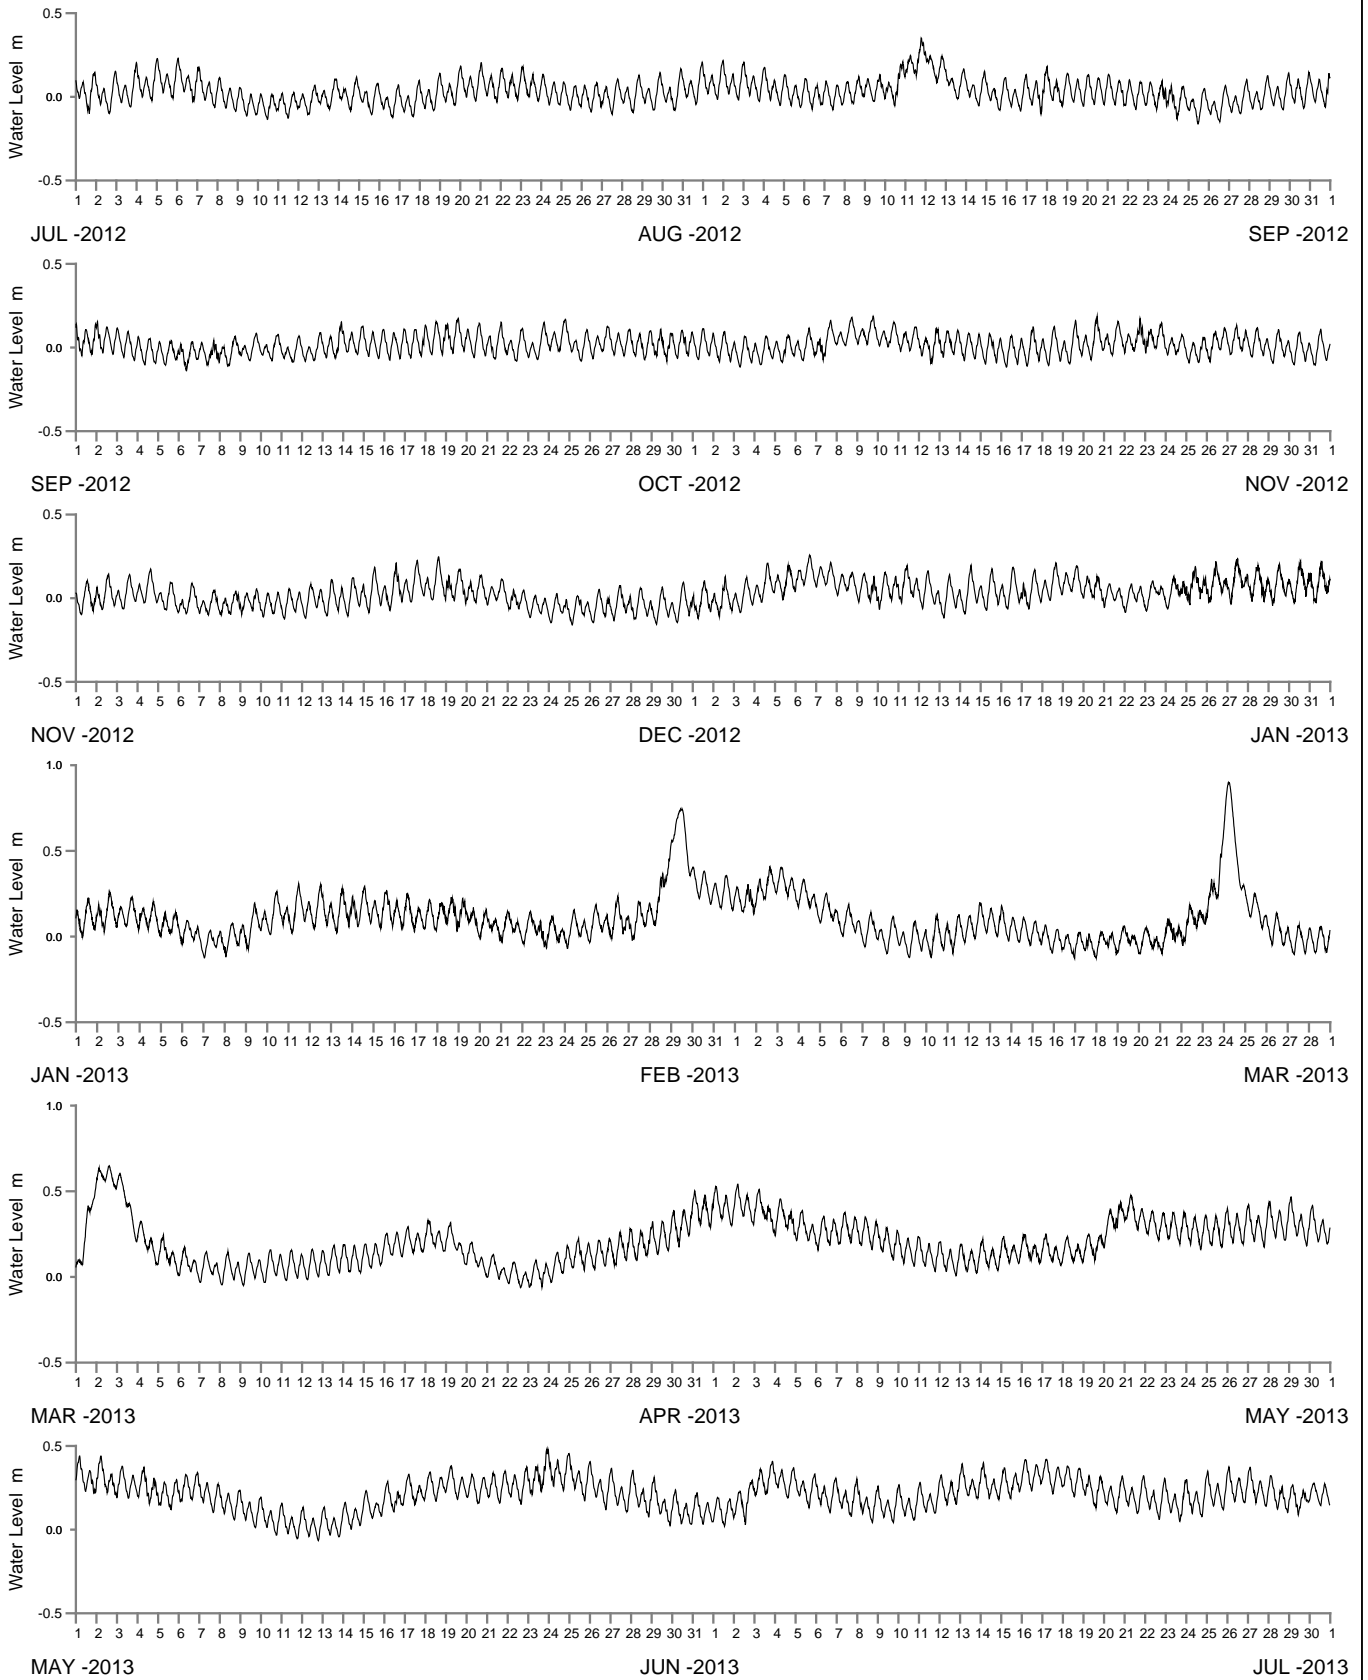
Figure
149

WATER LEVEL REFERENCED TO AUSTRALIAN HEIGHT DATUM

STOCKTON CREEK AT MORISSET
2012-2013
