Public Works
Manly Hydraulics Laboratory

MHL
Report 2291
Figure
100
DRAWING 2291-100.cdr

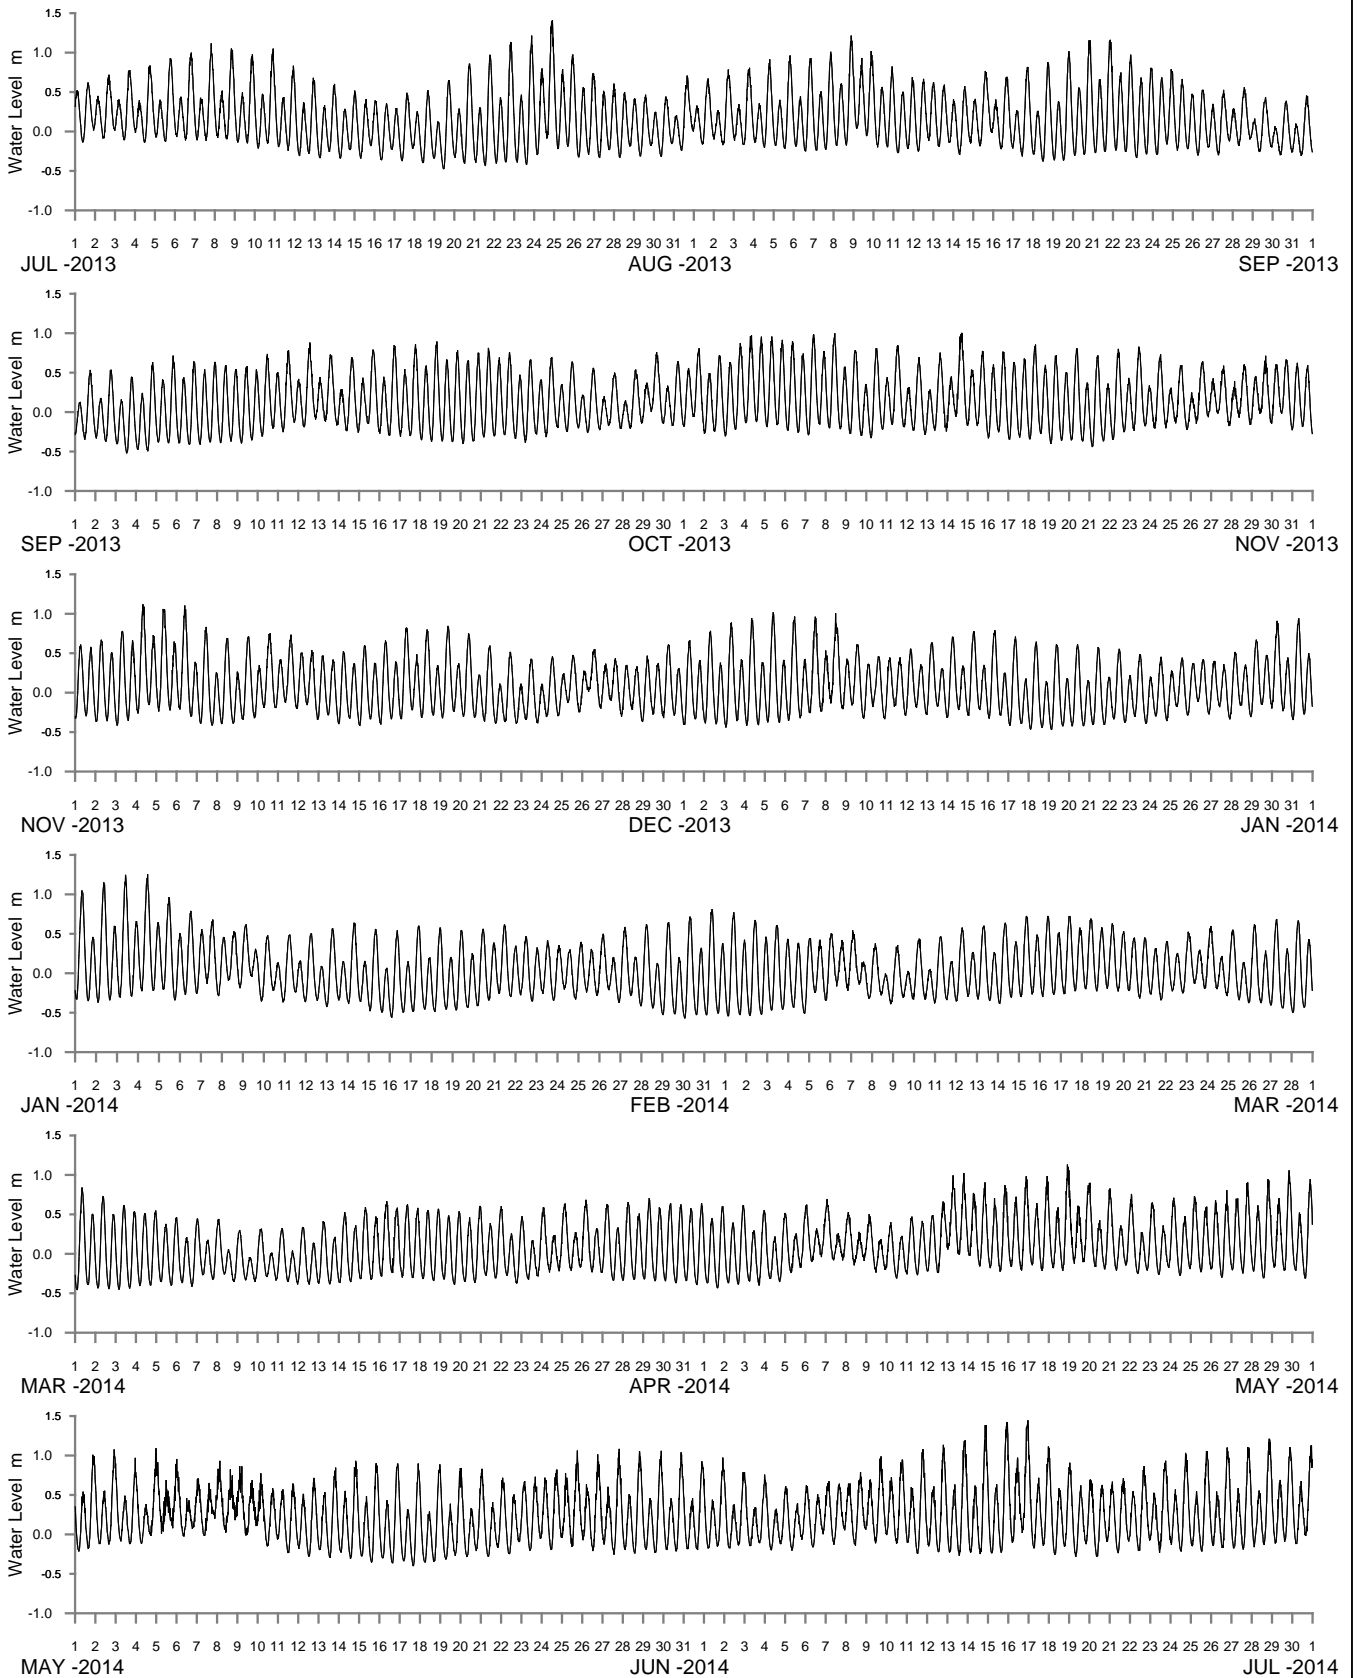
Figure
101

WATER LEVEL REFERENCED TO AUSTRALIAN HEIGHT DATUM

----- DATA LOSS

MANNING RIVER AT HARRINGTON
2013-2014

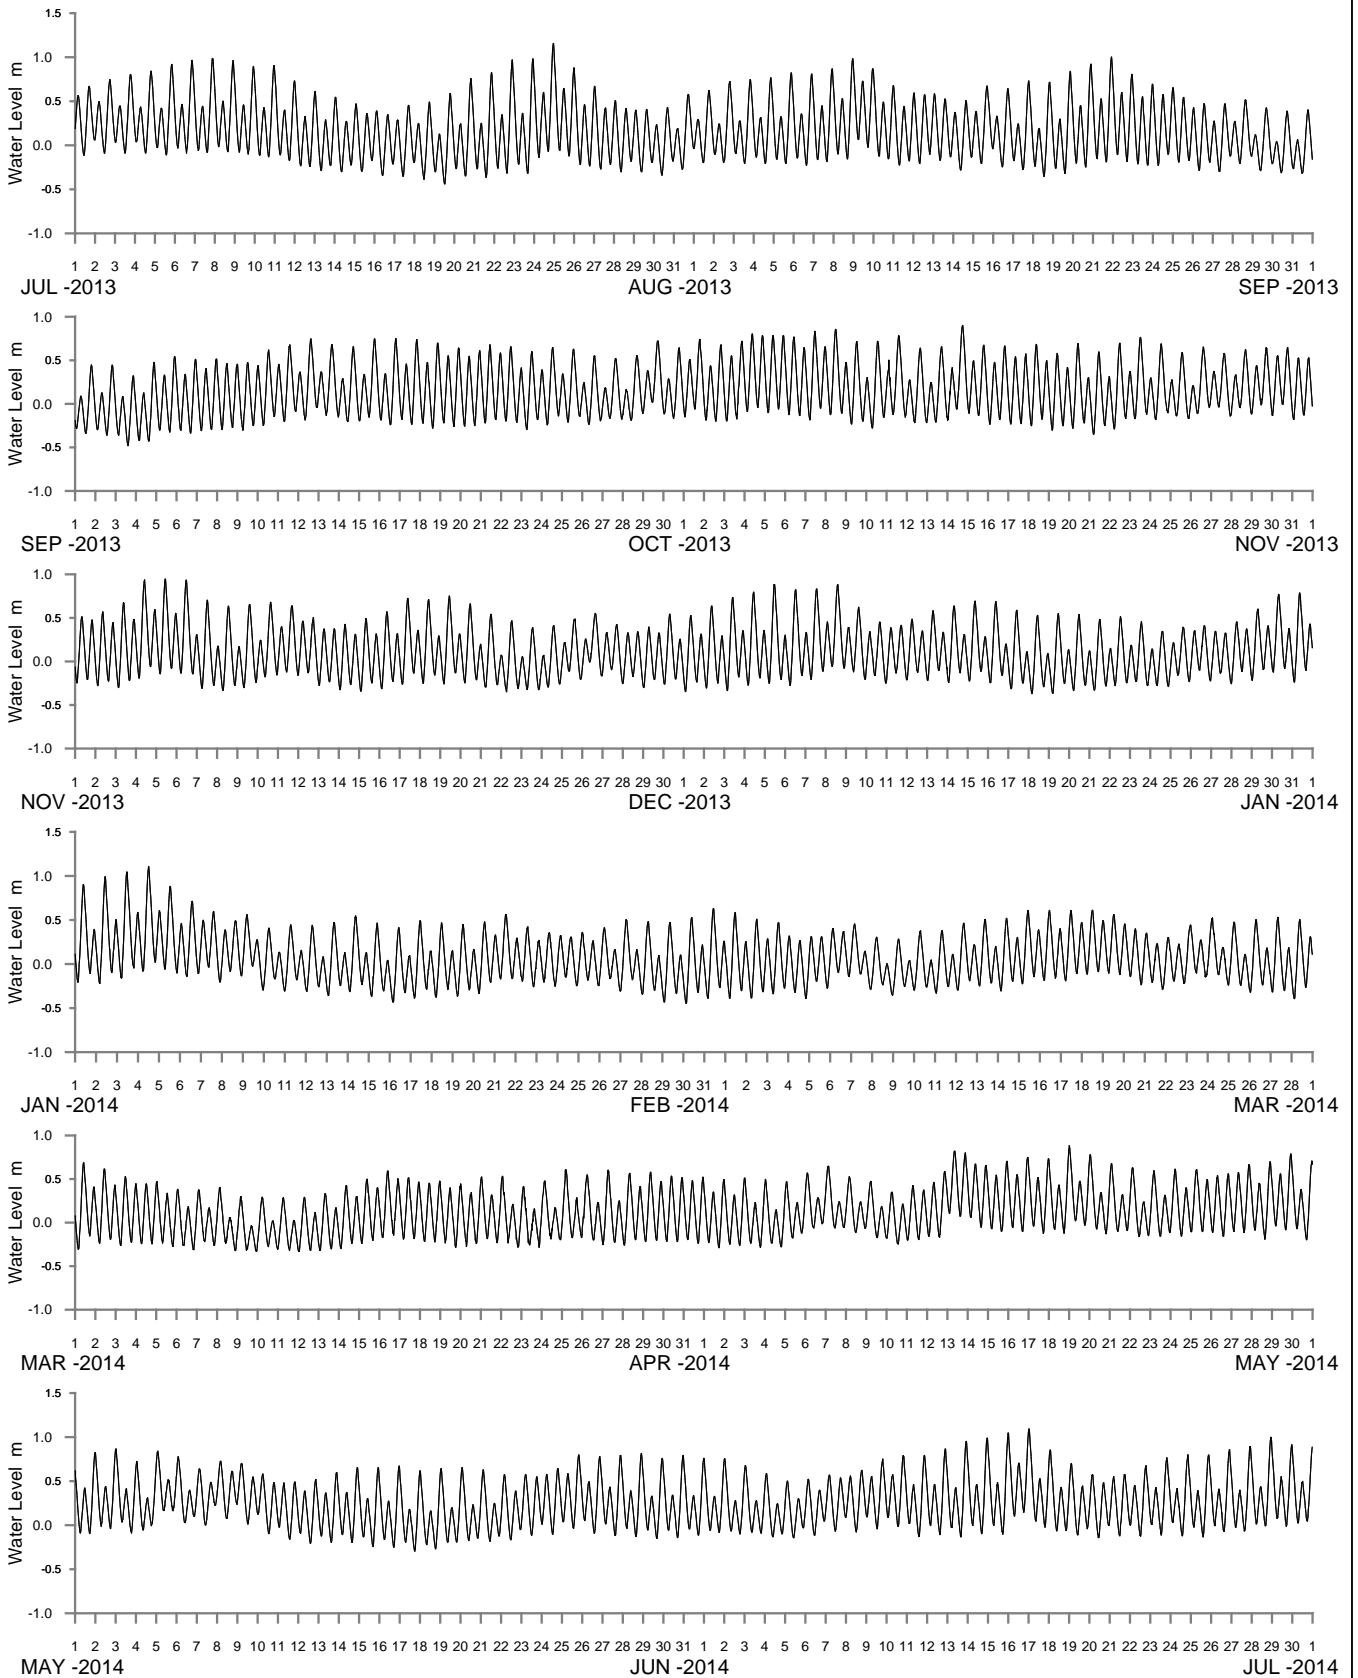
Figure
102

WATER LEVEL REFERENCED TO AUSTRALIAN HEIGHT DATUM

MANNING RIVER AT CROKI
2013-2014

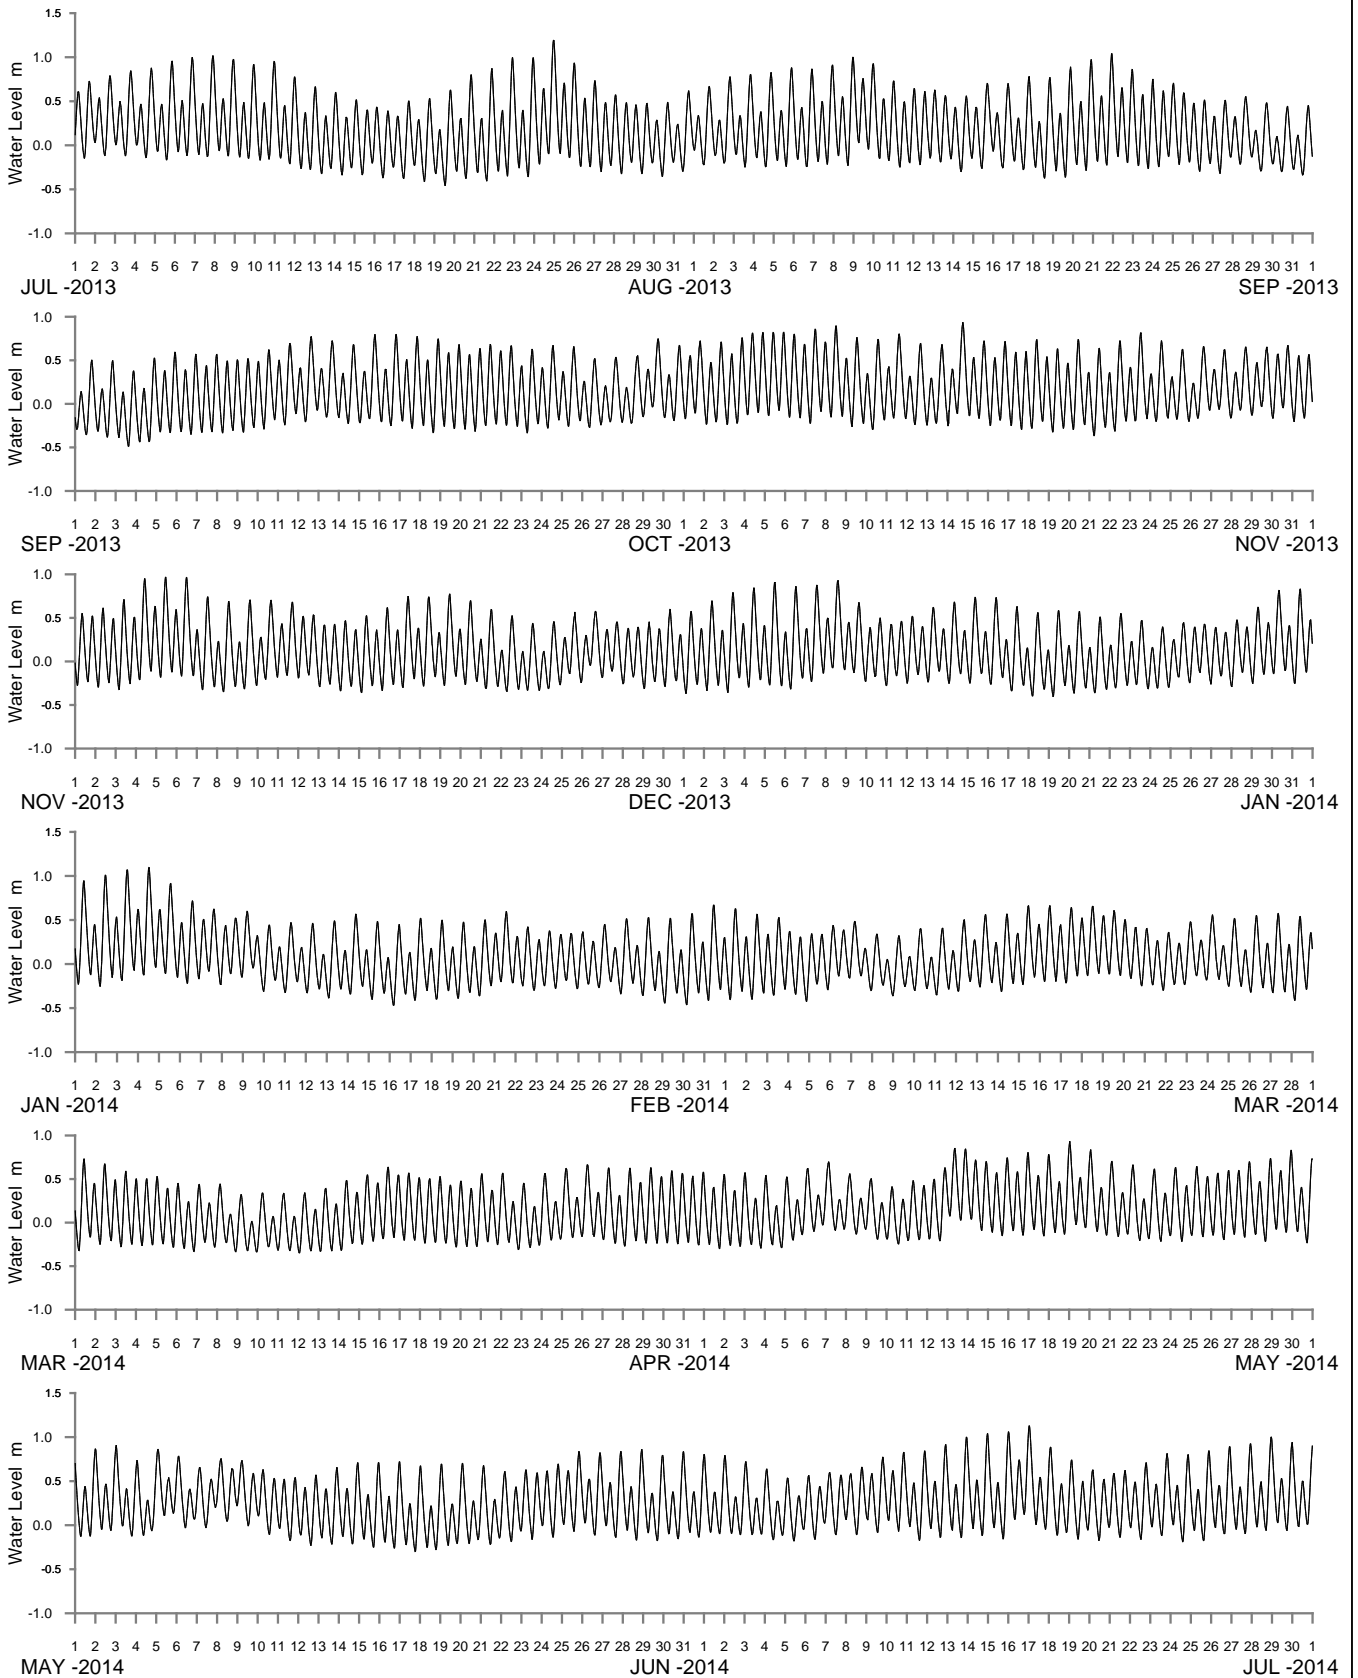
Figure
103

WATER LEVEL REFERENCED TO AUSTRALIAN HEIGHT DATUM

MANNING RIVER AT DUMARESQ ISLAND
2013-2014

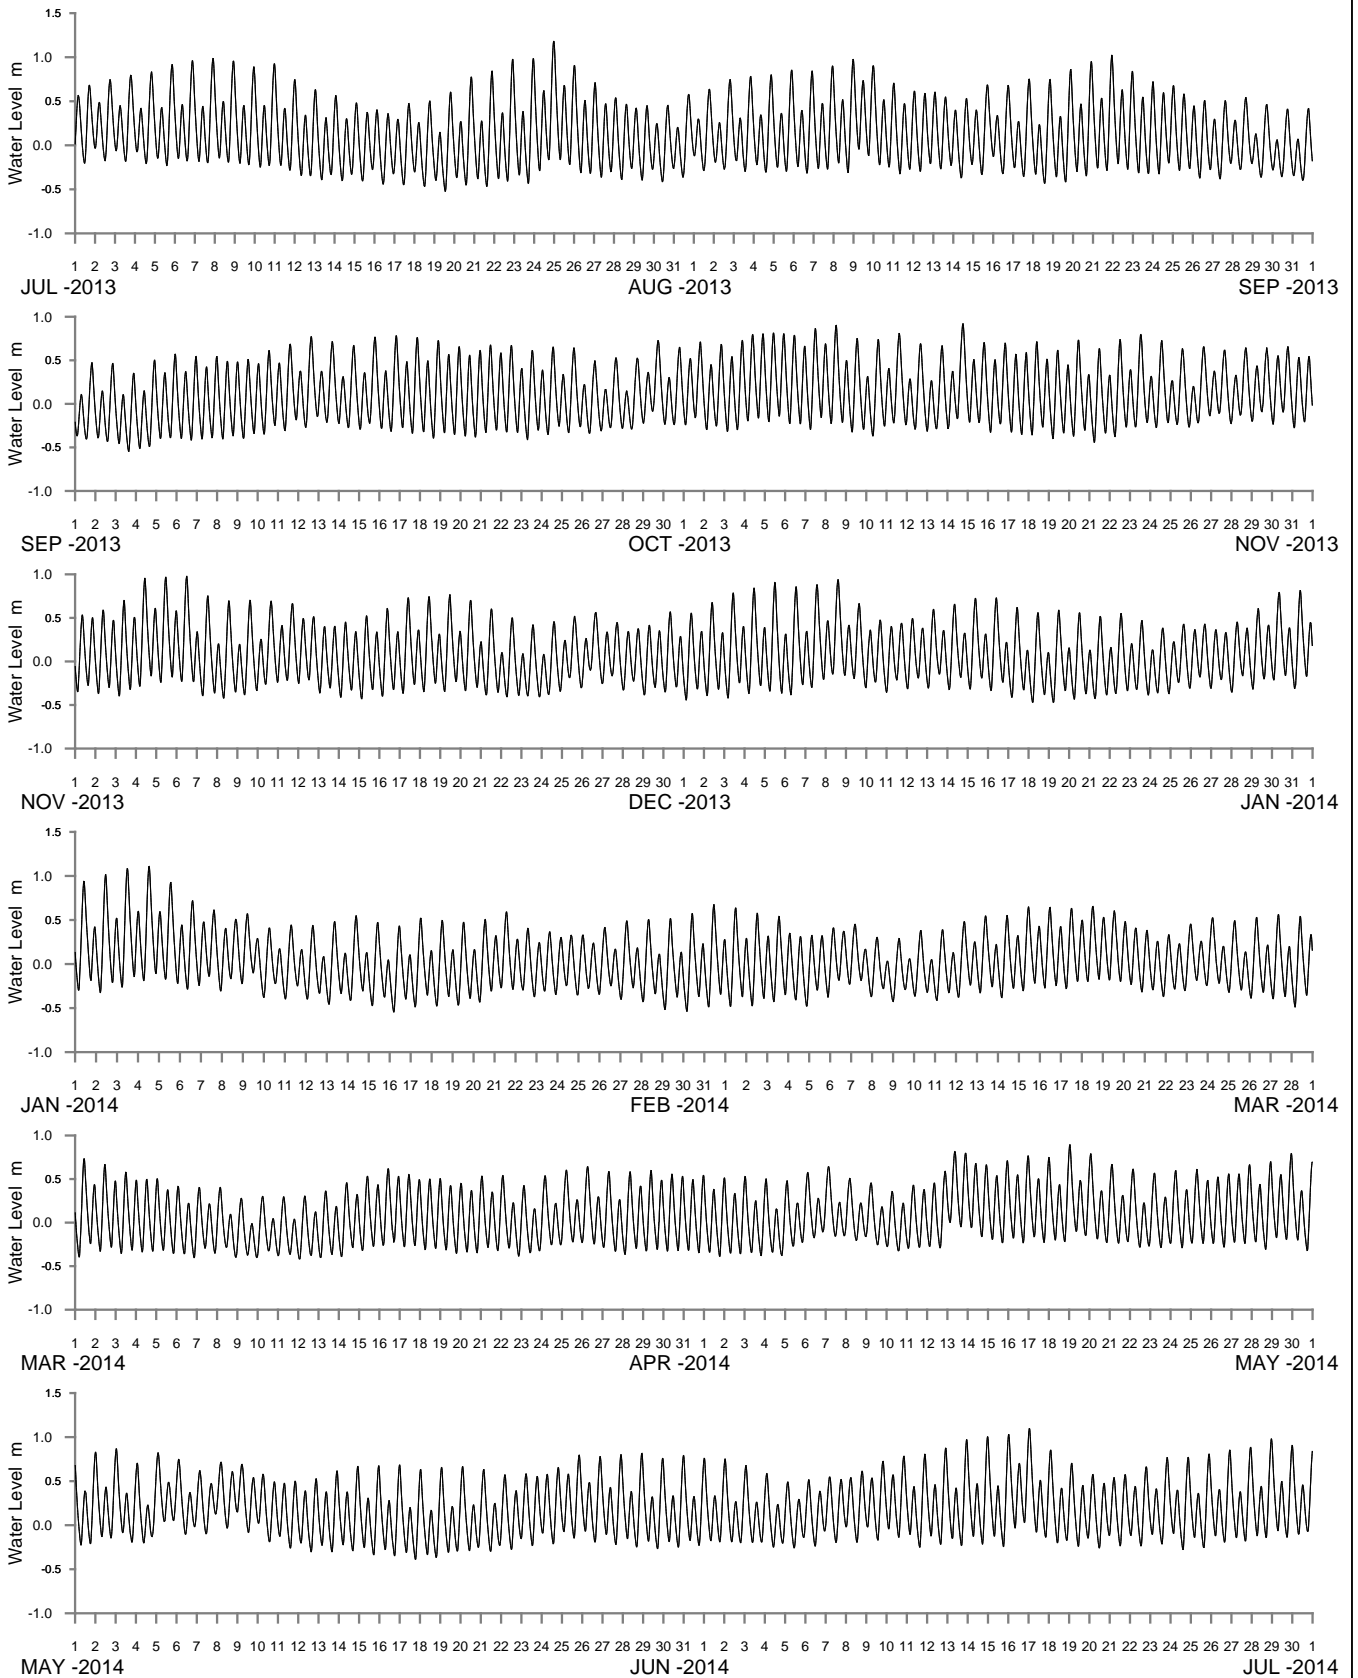
104

WATER LEVEL REFERENCED TO AUSTRALIAN HEIGHT DATUM

MANNING RIVER AT TAREE
2013-2014

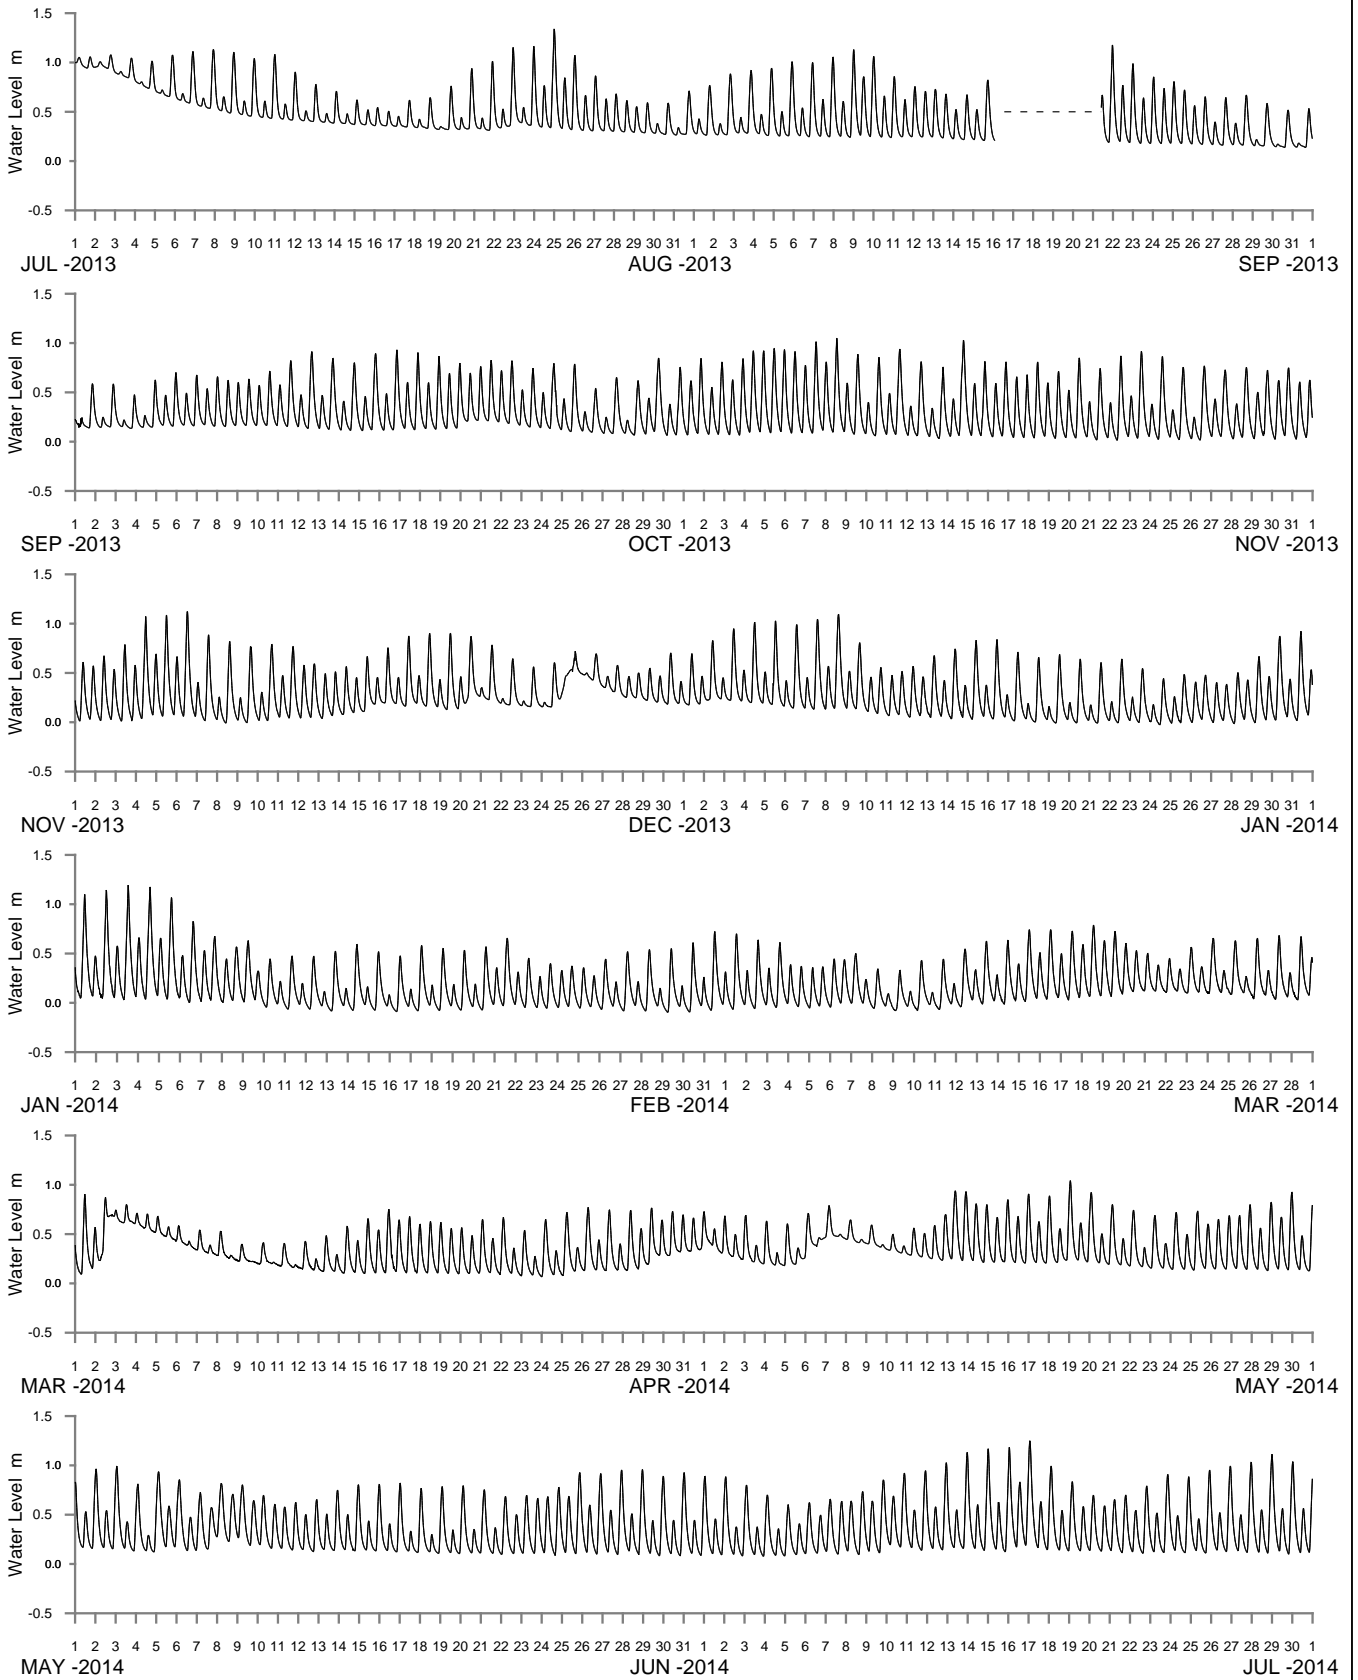
Figure
105

WATER LEVEL REFERENCED TO AUSTRALIAN HEIGHT DATUM

MANNING RIVER AT WINGHAM
2013-2014

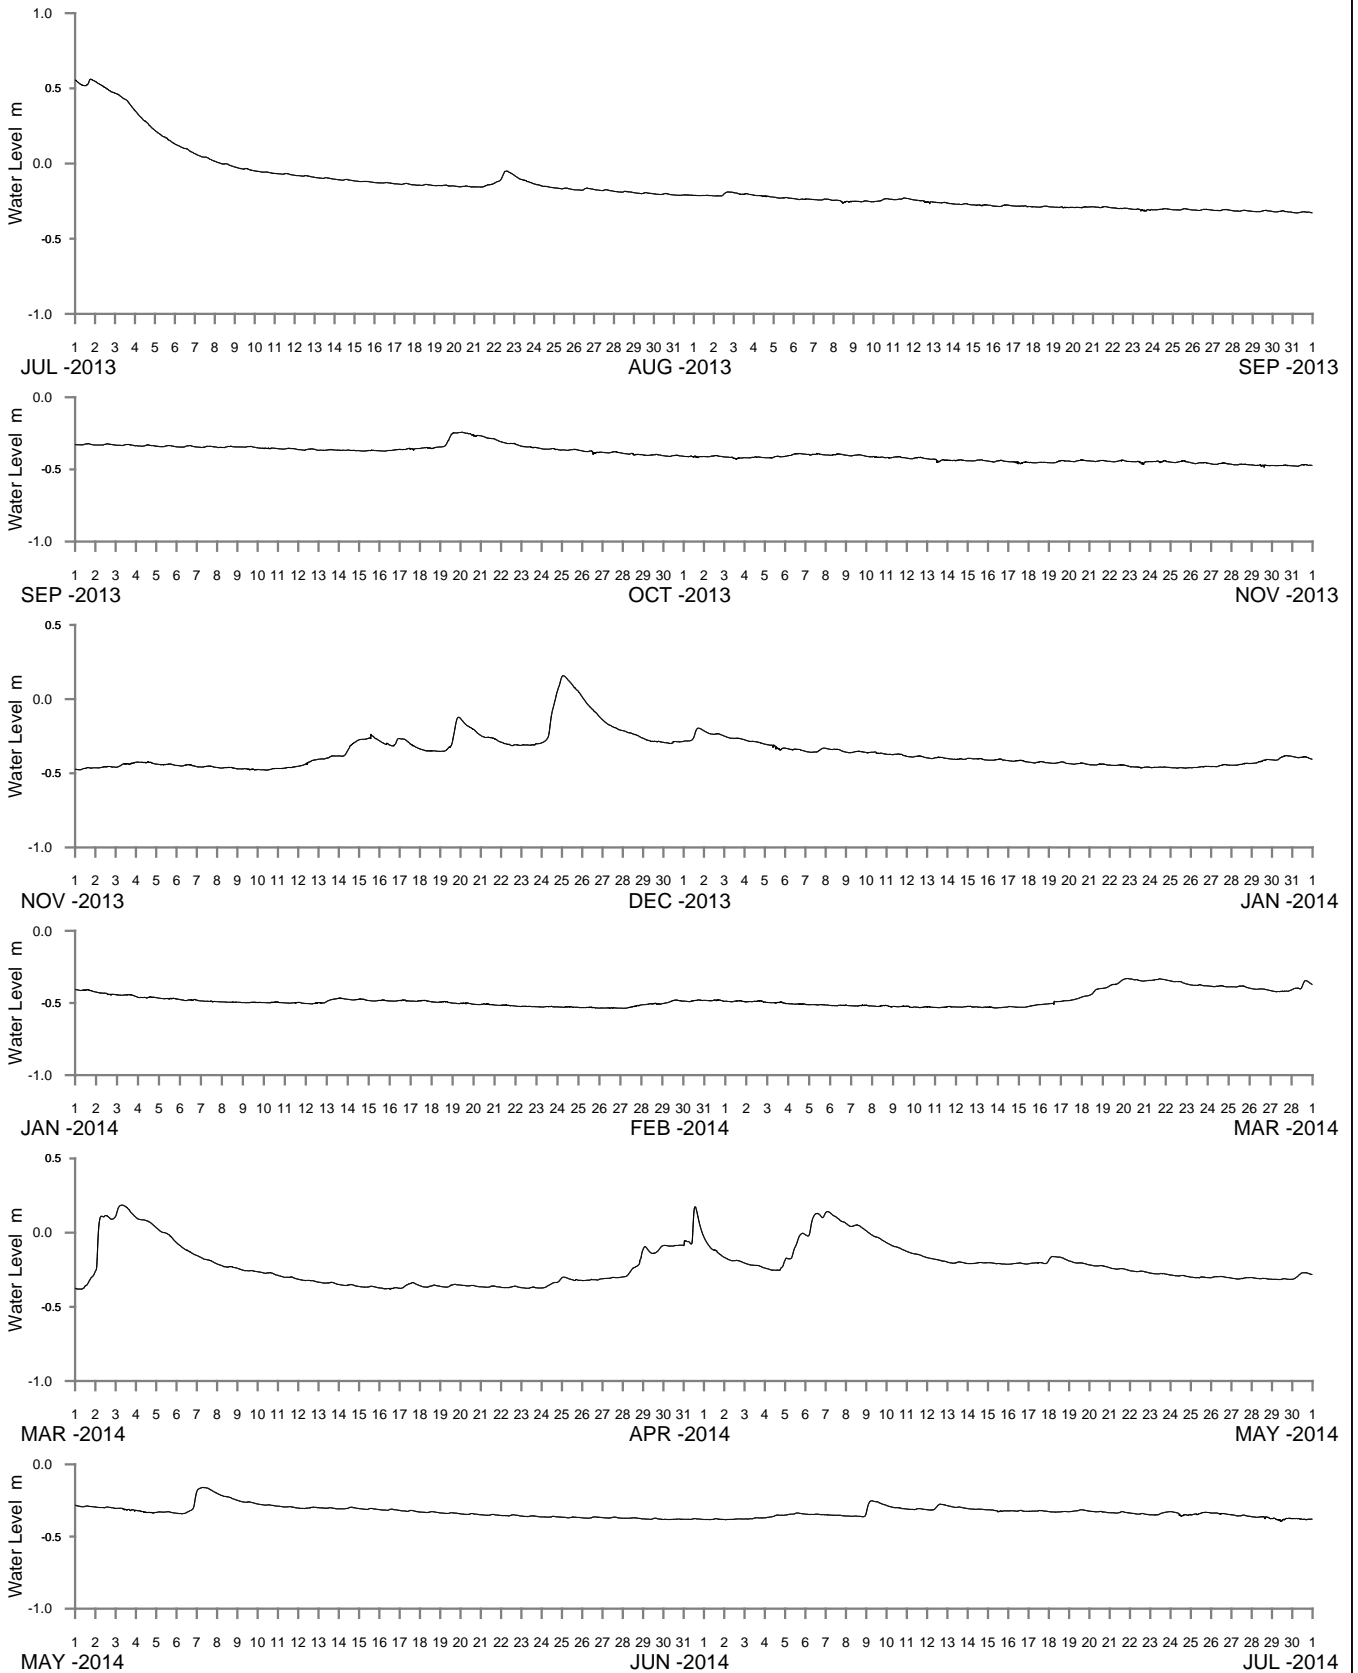
Figure
106

WATER LEVEL REFERENCED TO LOCAL WATER RESOURCES DATUM

MANNING RIVER AT MT GEORGE
2013-2014

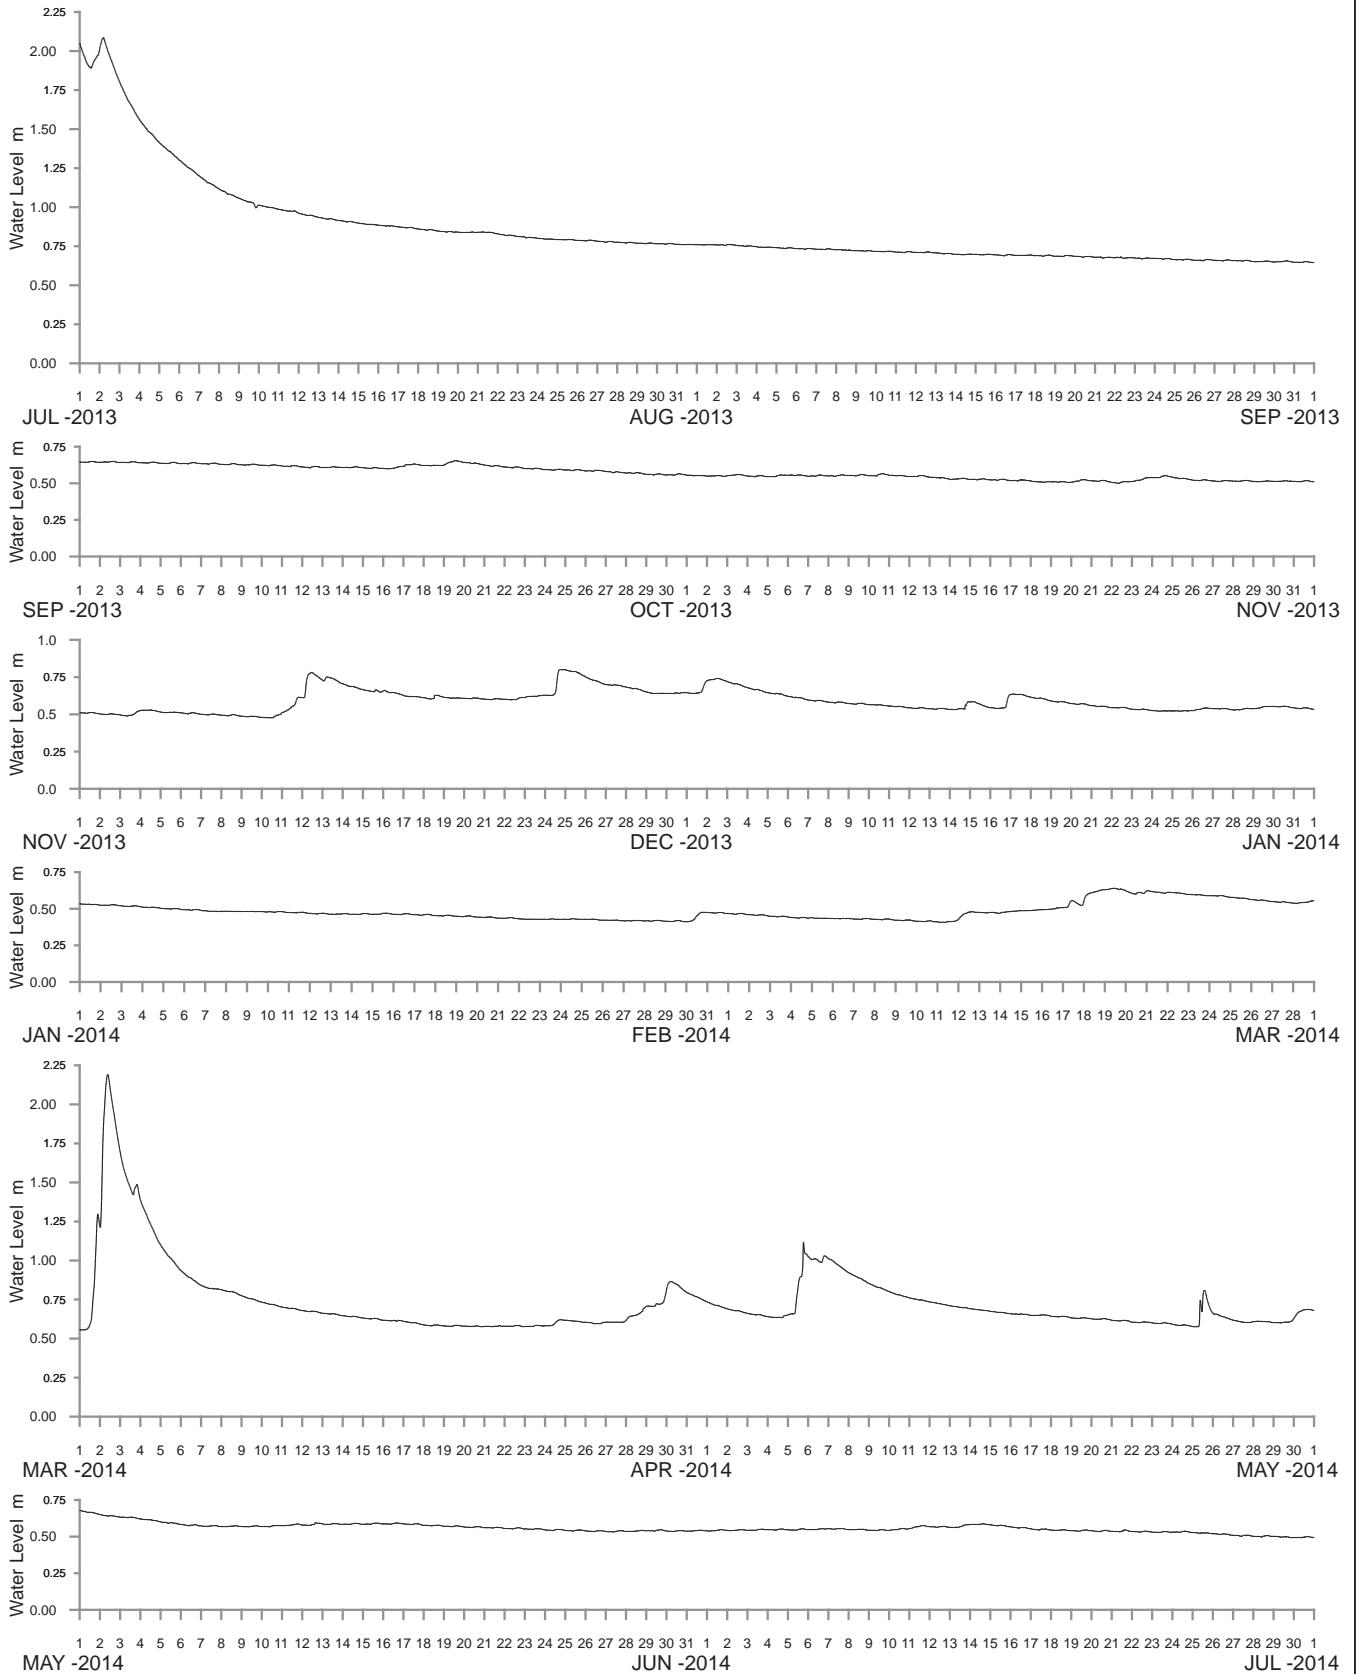
Figure
107

WATER LEVEL REFERENCED TO ASSUMED DATUM

DINGO CREEK AT DOWNSTREAM ASHLEA BRIDGE
2013-2014

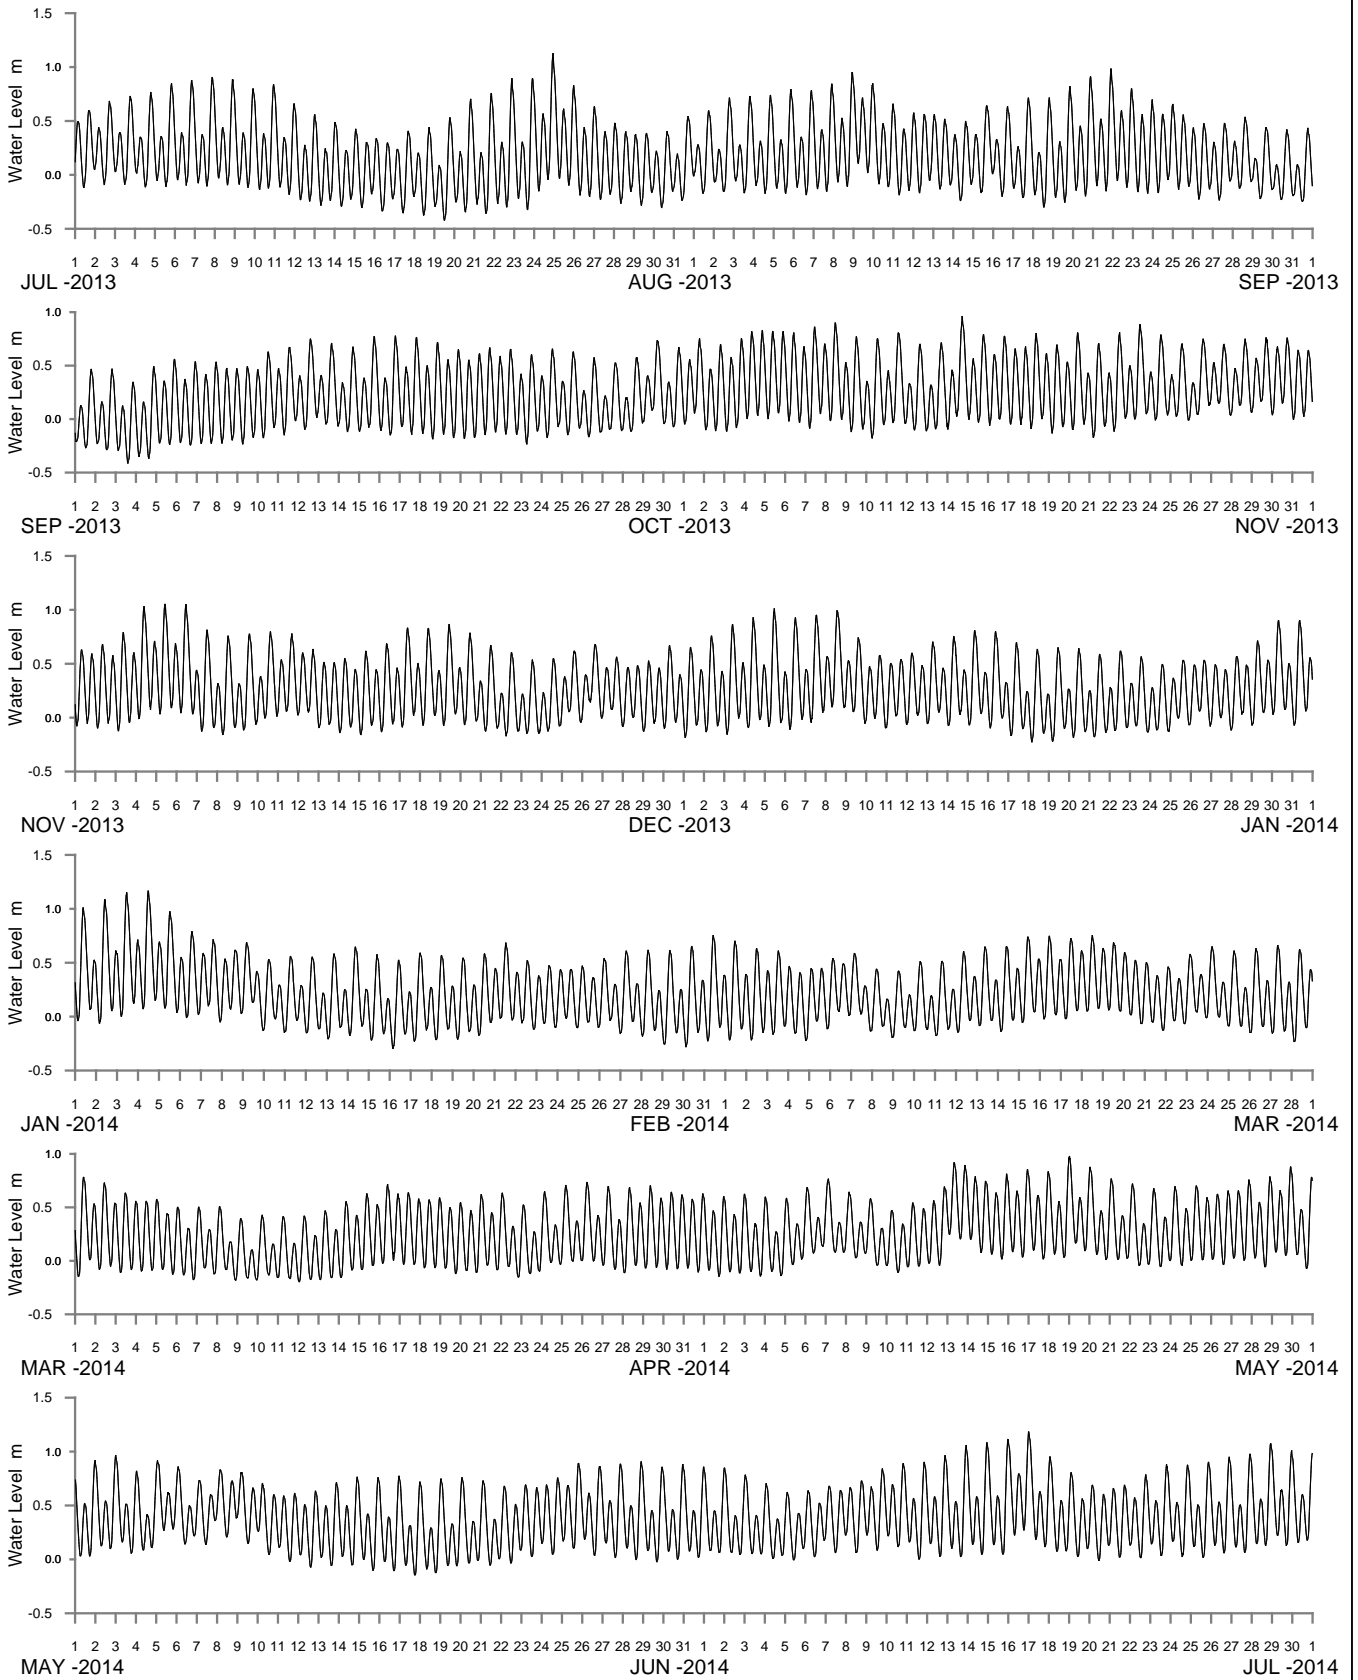
Figure
108

WATER LEVEL REFERENCED TO AUSTRALIAN HEIGHT DATUM

MANNING RIVER AT FARQUHAR INLET
2013-2014

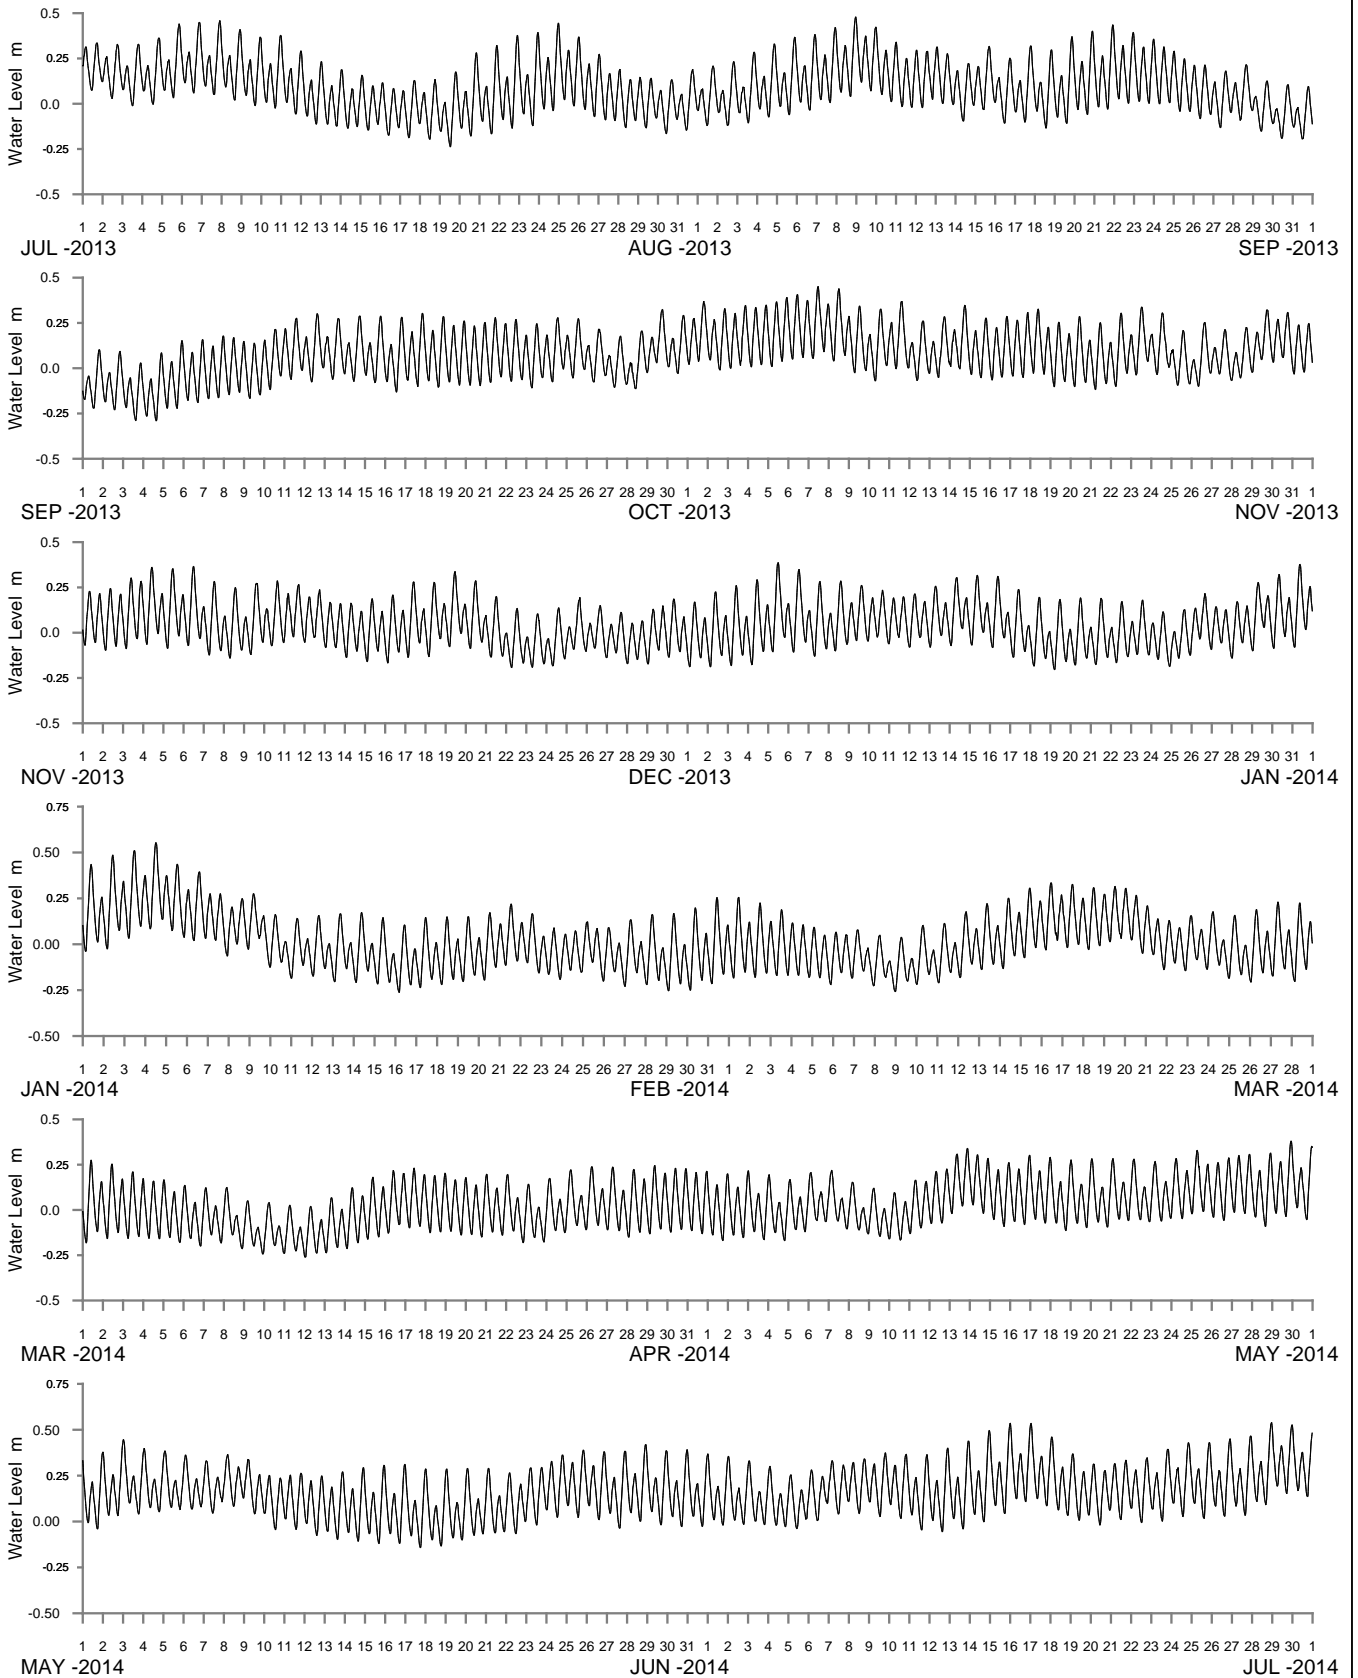
Figure
110

WATER LEVEL REFERENCED TO AUSTRALIAN HEIGHT DATUM

WALLAMBA RIVER AT TUNCURRY
2013-2014

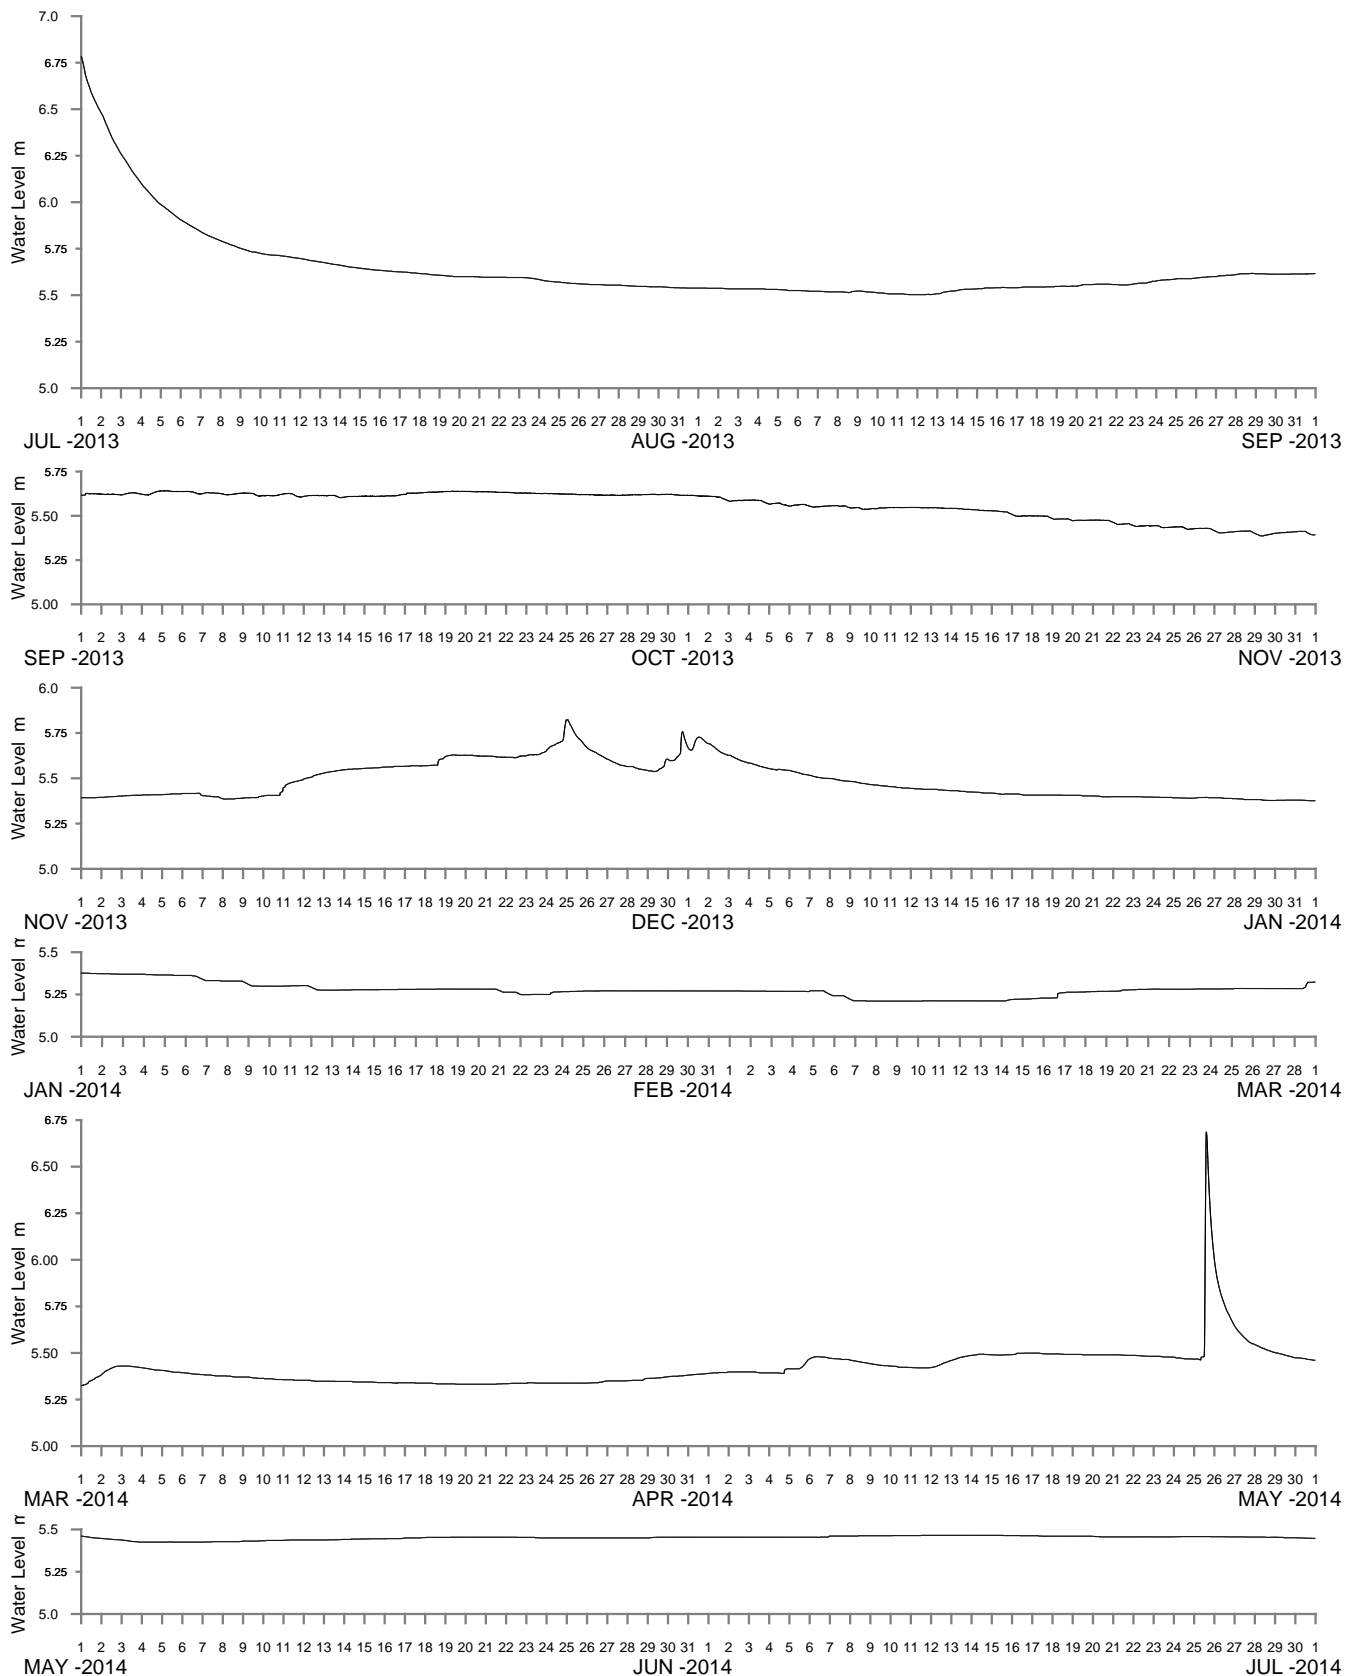
Figure
112

WATER LEVEL REFERENCED TO AUSTRALIAN HEIGHT DATUM

WALLAMBA RIVER AT NABIAC
2013-2014
