Public Works
Manly Hydraulics Laboratory

MHL
Report 2291
Figure
100
DRAWING 2291-100.cdr

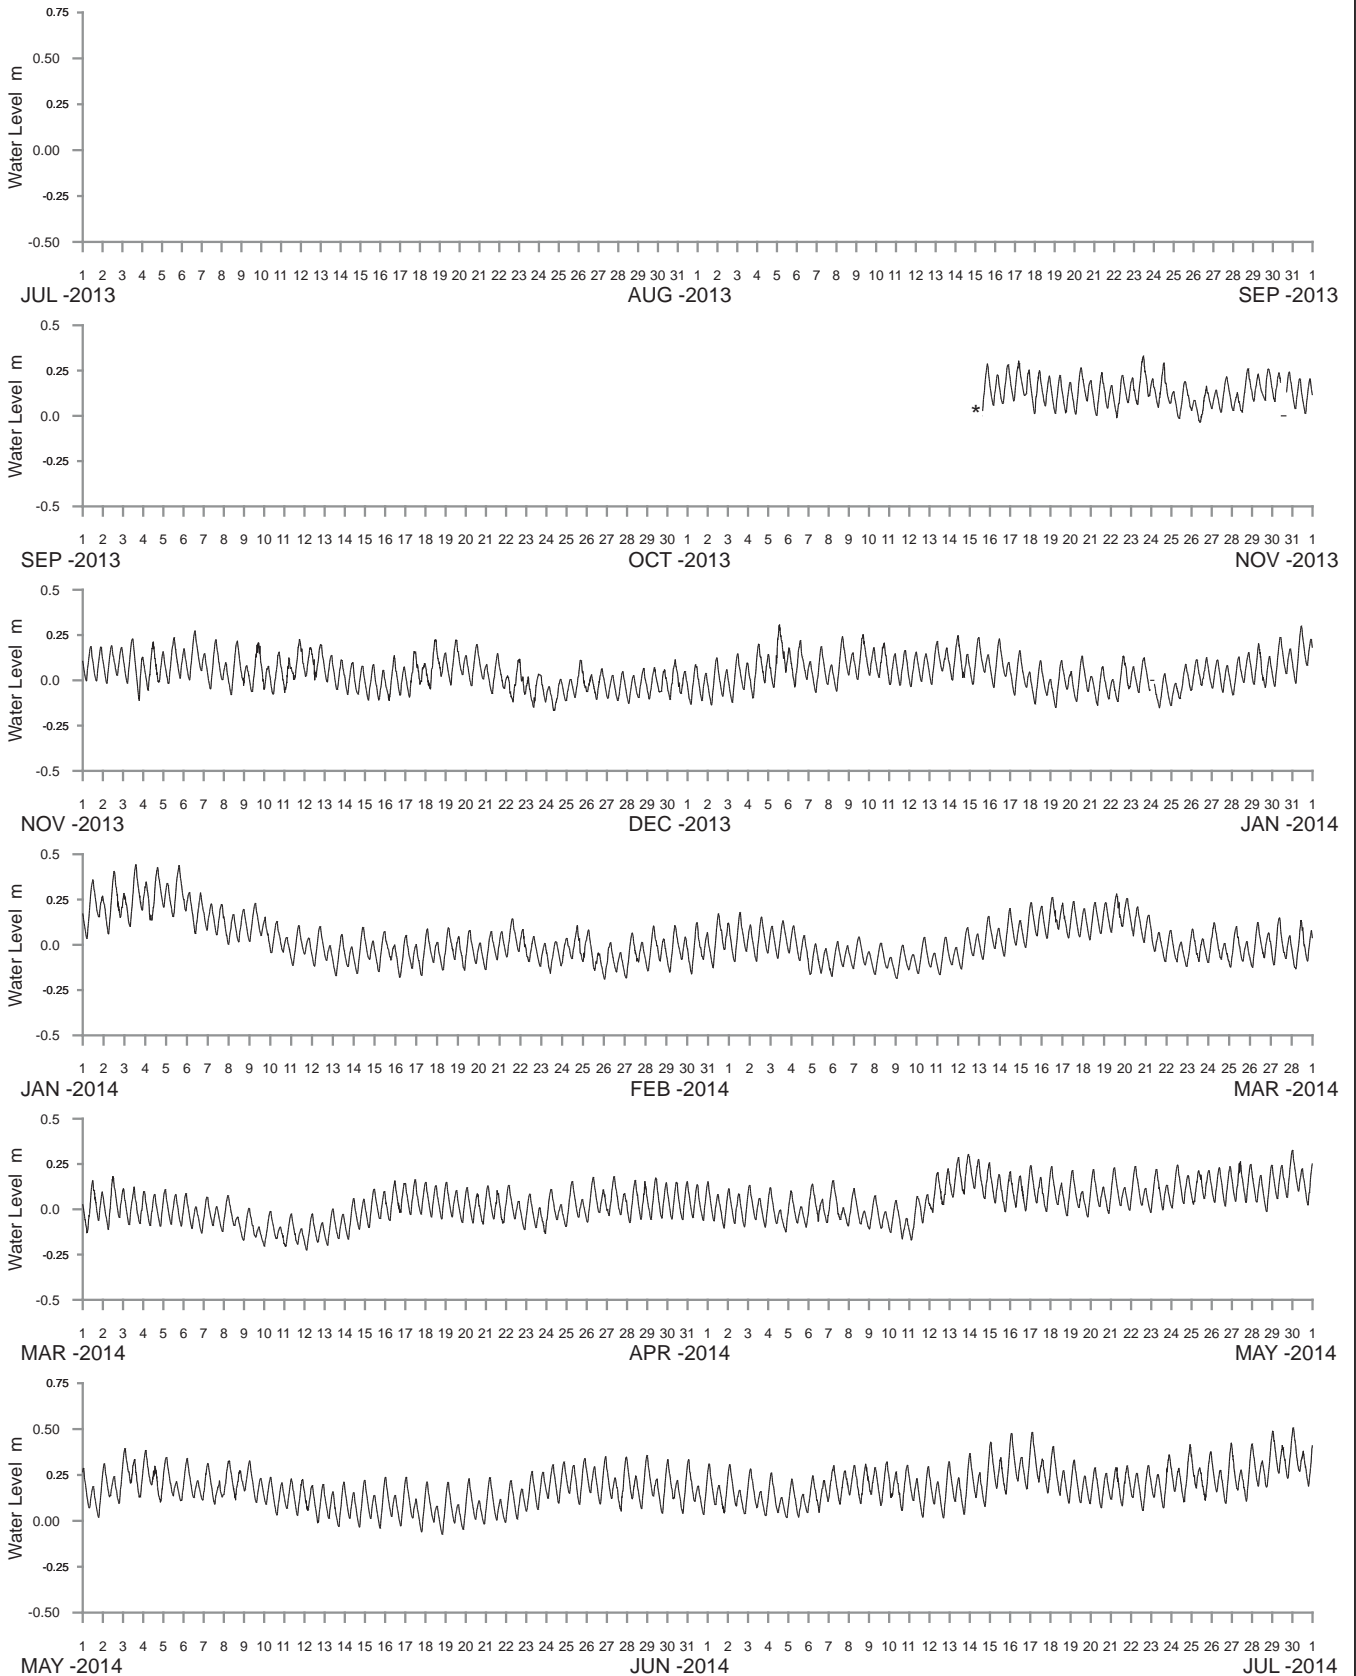
Figure
114

WATER LEVEL REFERENCED TO AUSTRALIAN HEIGHT DATUM

* STATION COMMISSIONED

WALLIS LAKE AT PACIFIC PALMS WHARF
2013-2014

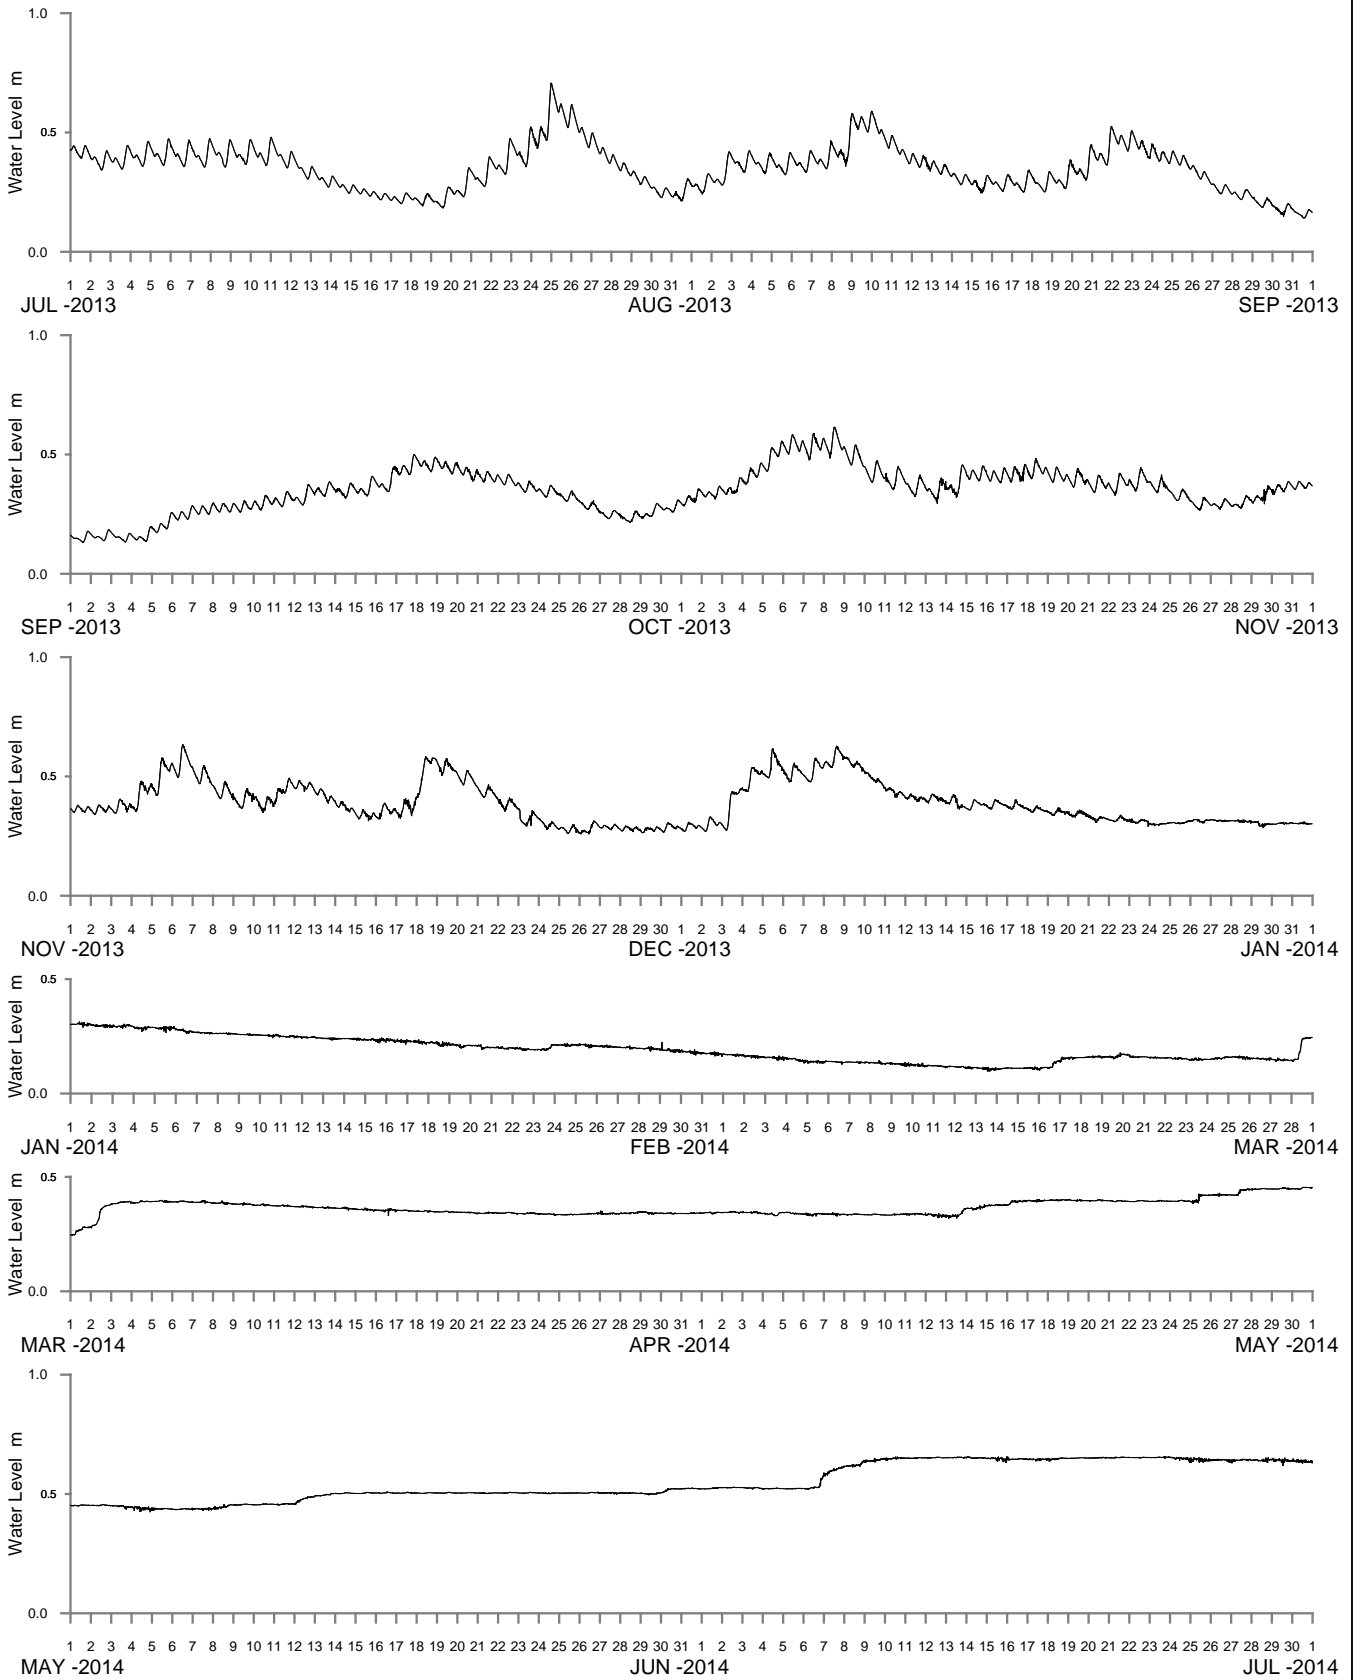
Figure
115

WATER LEVEL REFERENCED TO AUSTRALIAN HEIGHT DATUM

SMITHS LAKE AT TARBUCK BAY
2013-2014

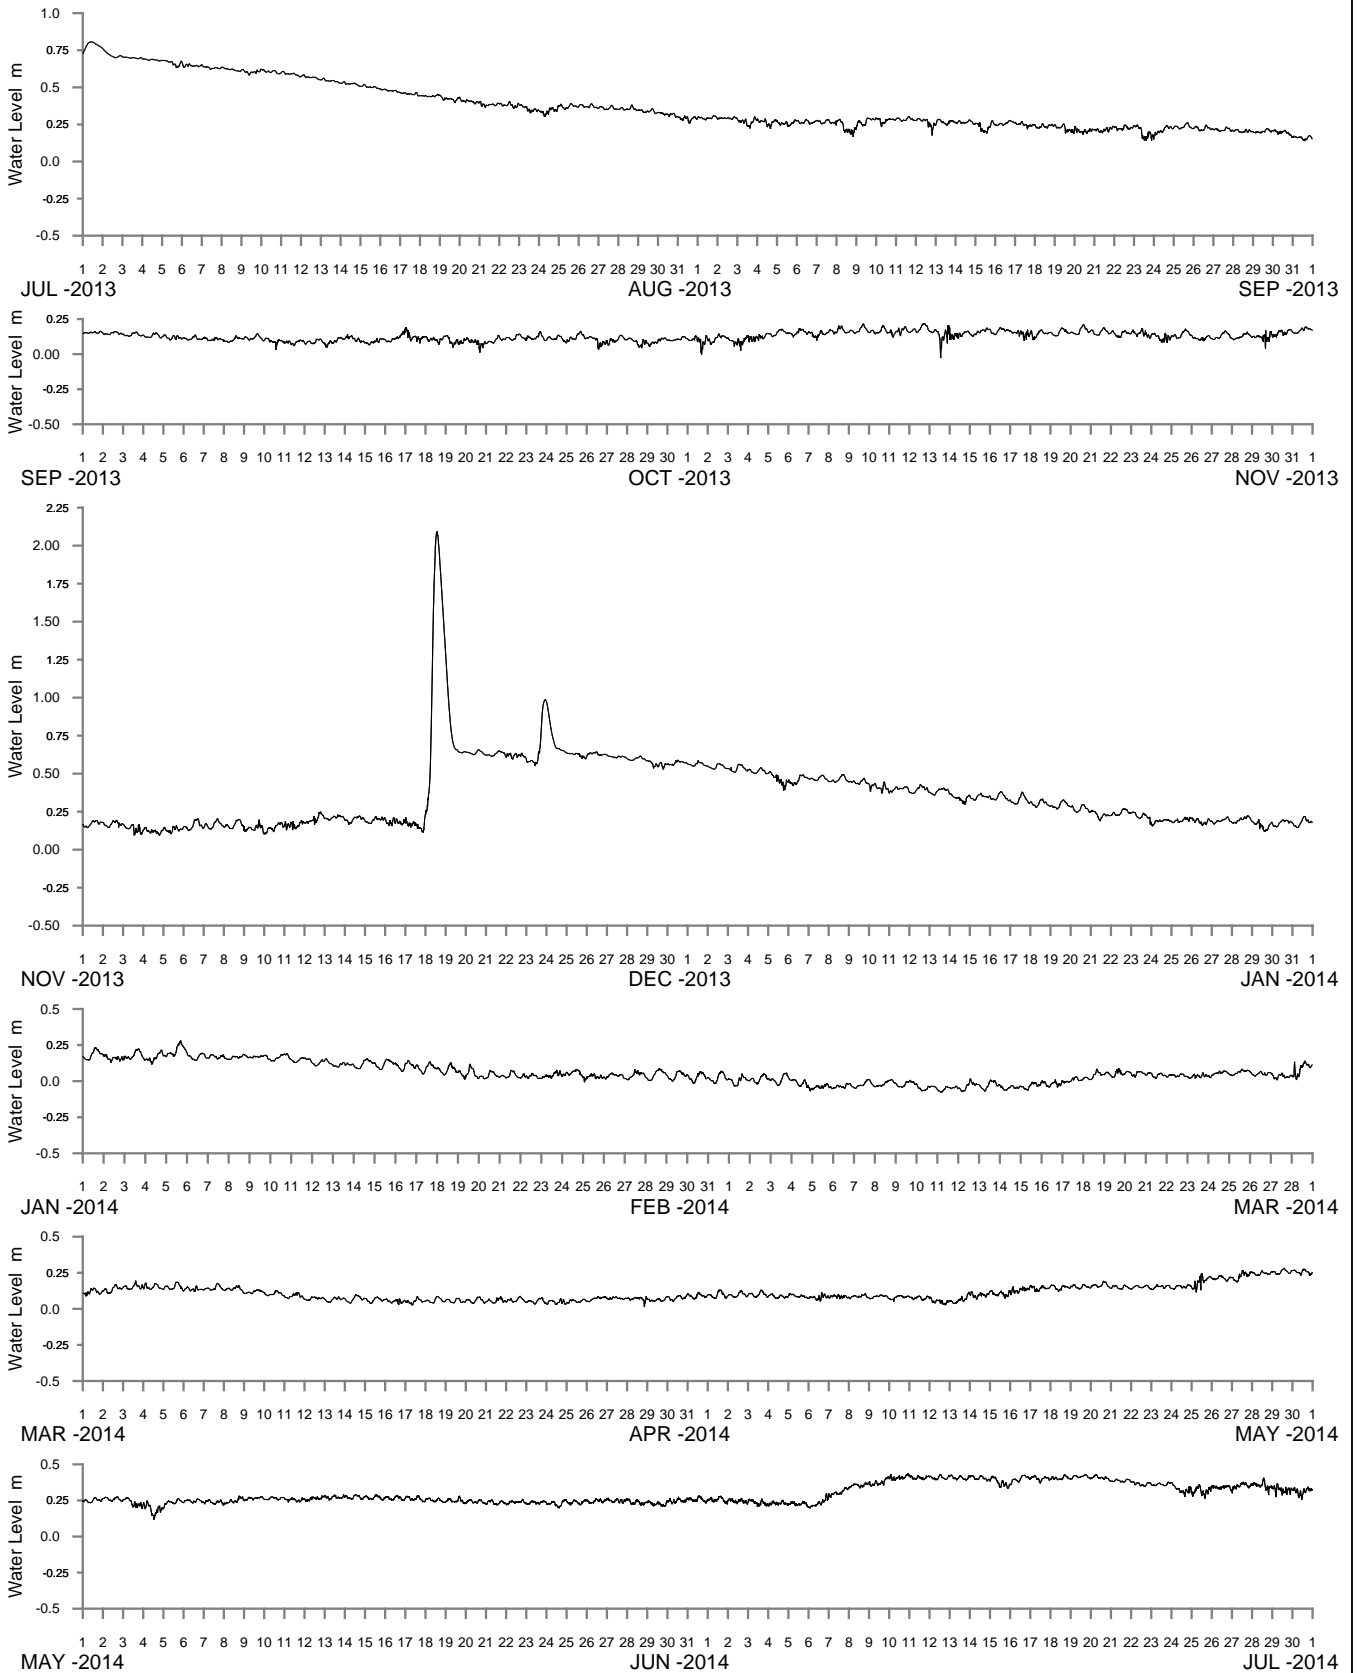
Figure
116

WATER LEVEL REFERENCED TO AUSTRALIAN HEIGHT DATUM

MYALL RIVER AT BULAHDELAH
2013-2014

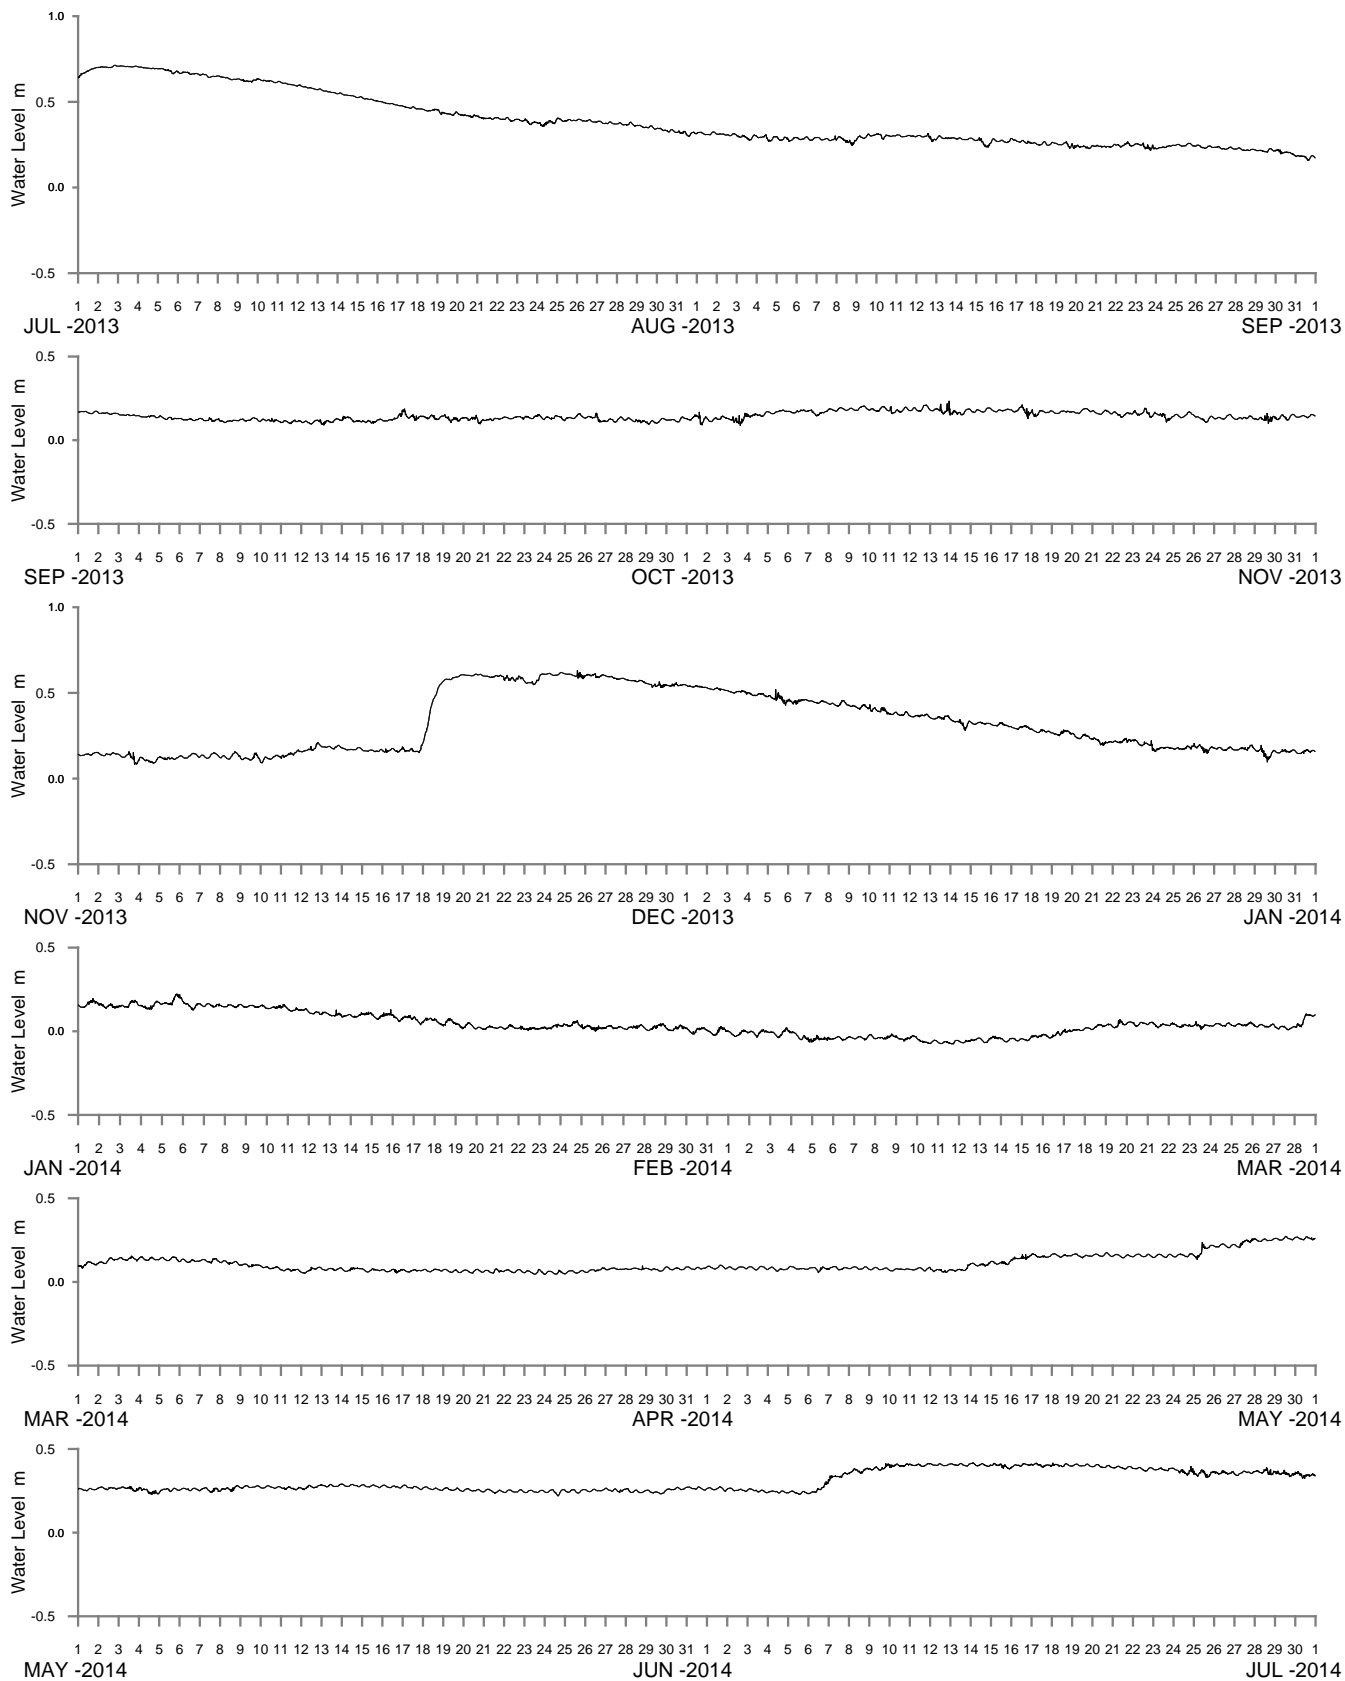
Figure
117

WATER LEVEL REFERENCED TO AUSTRALIAN HEIGHT DATUM

MYALL RIVER AT BOMBAH POINT
2013-2014

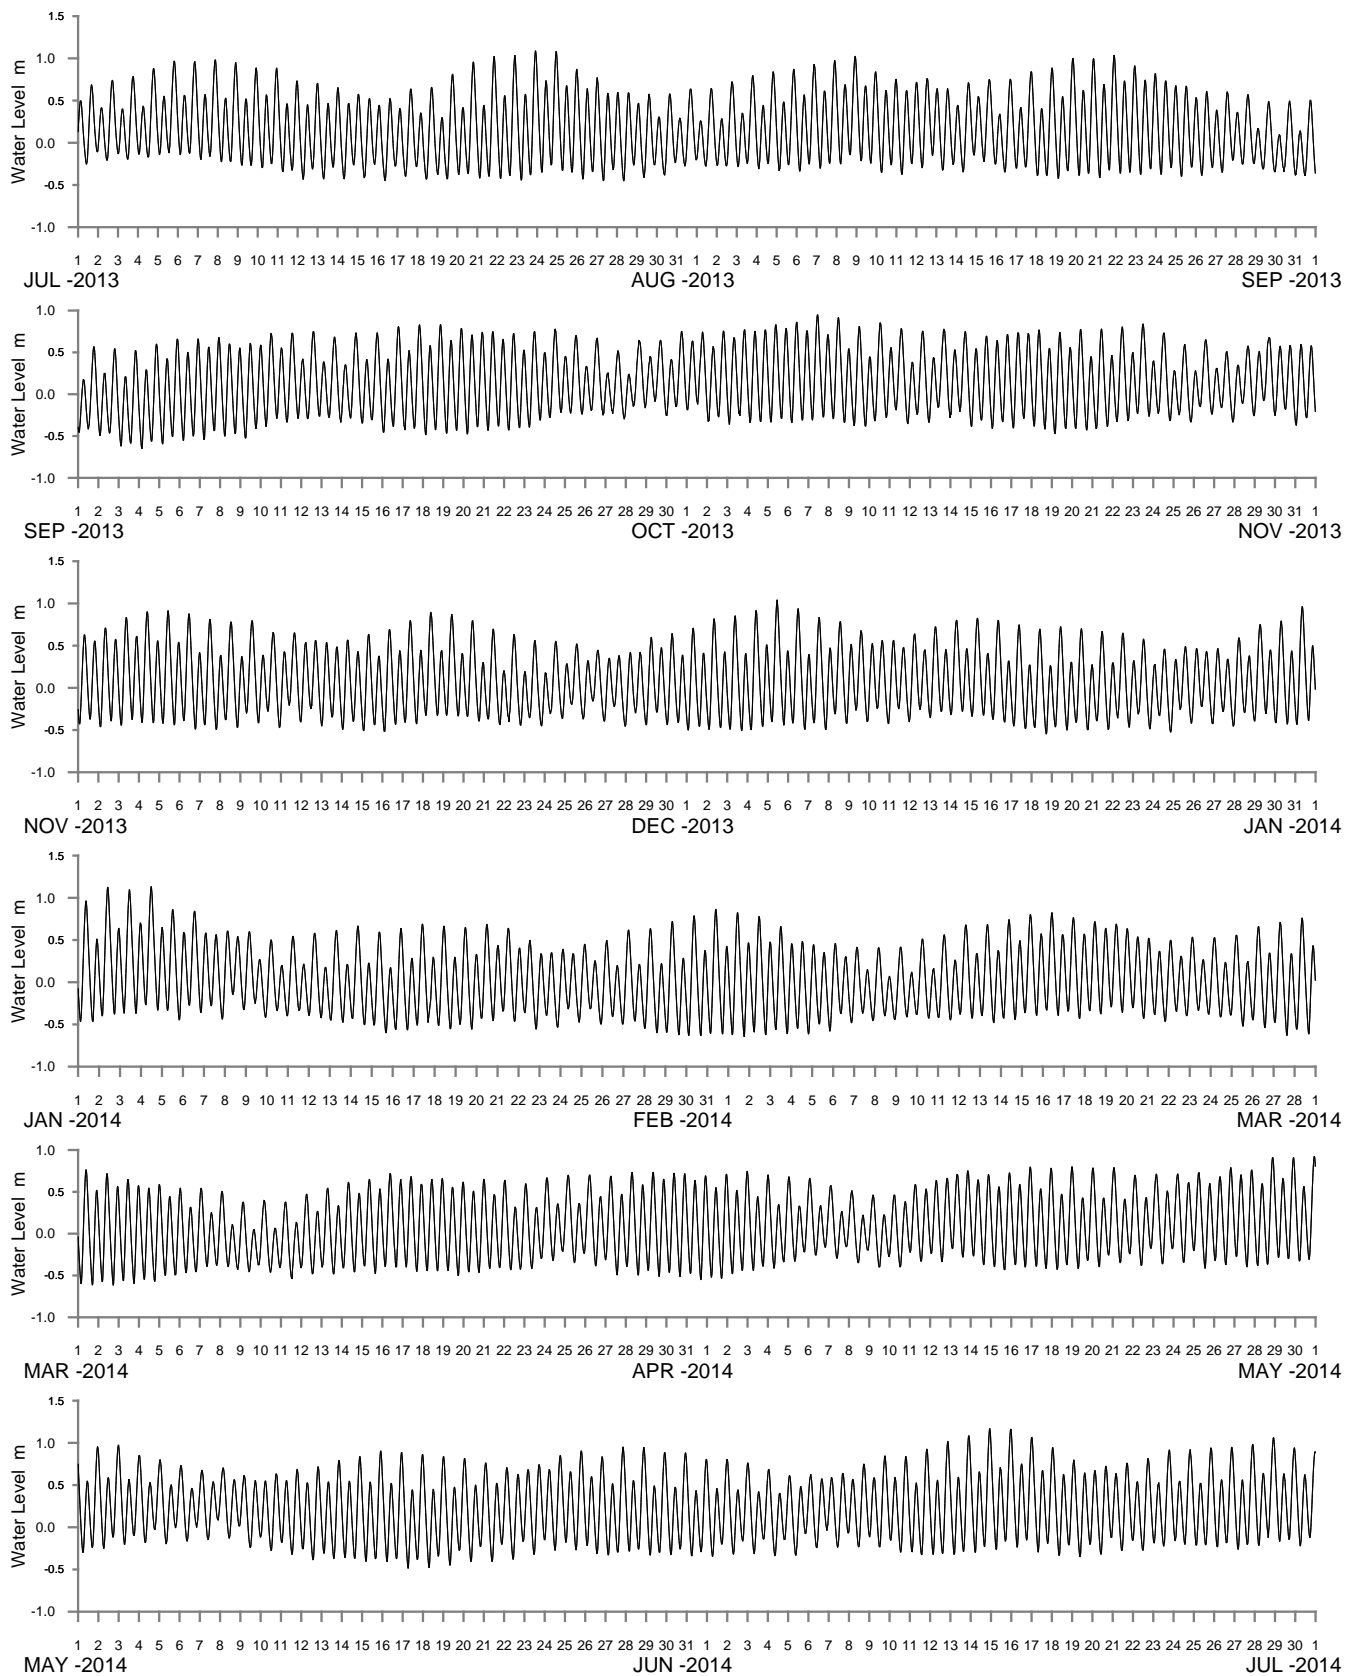
Figure
119

WATER LEVEL REFERENCED TO AUSTRALIAN HEIGHT DATUM

MYALL RIVER AT TEA GARDENS
2013-2014

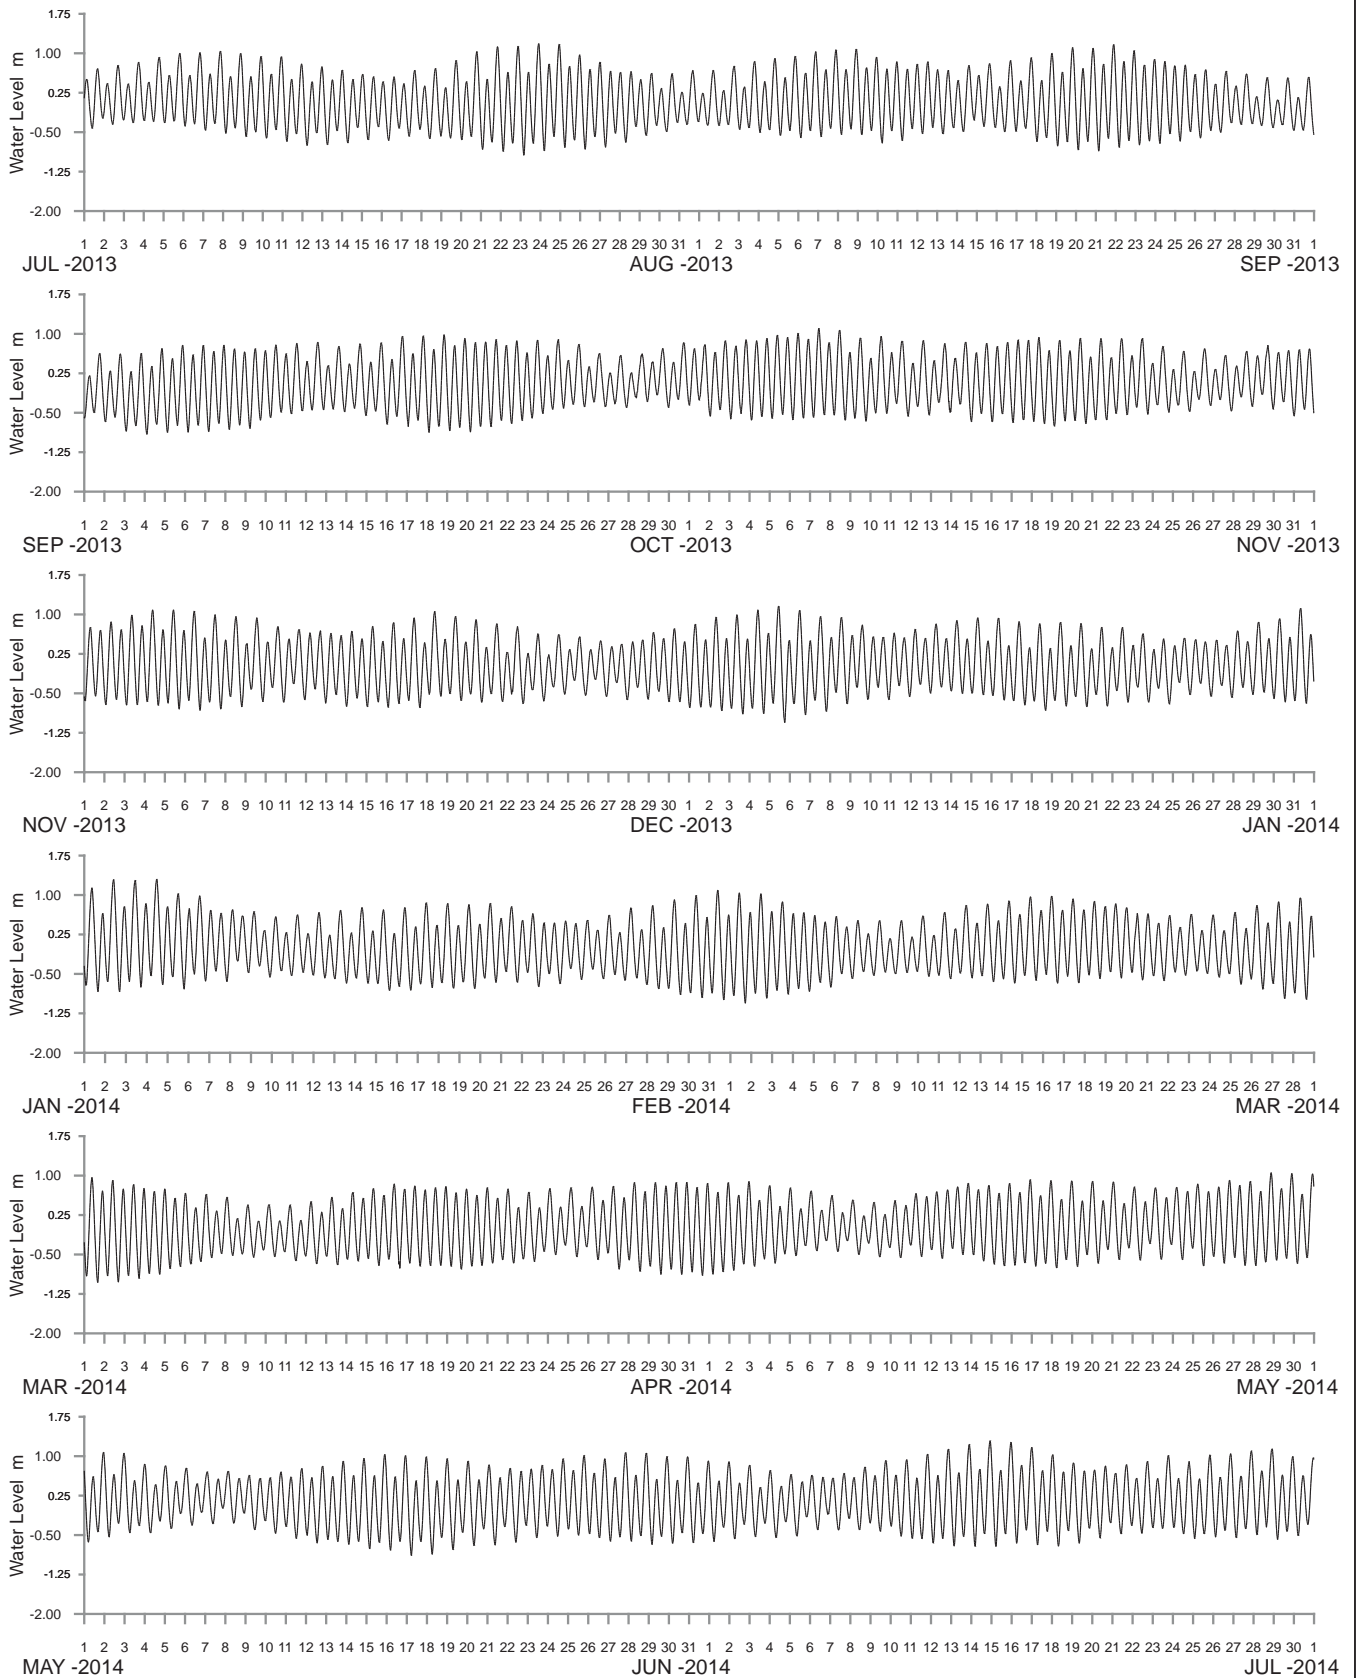
120

WATER LEVEL REFERENCED TO AUSTRALIAN HEIGHT DATUM

KARUAH RIVER AT KARUAH
2013-2014

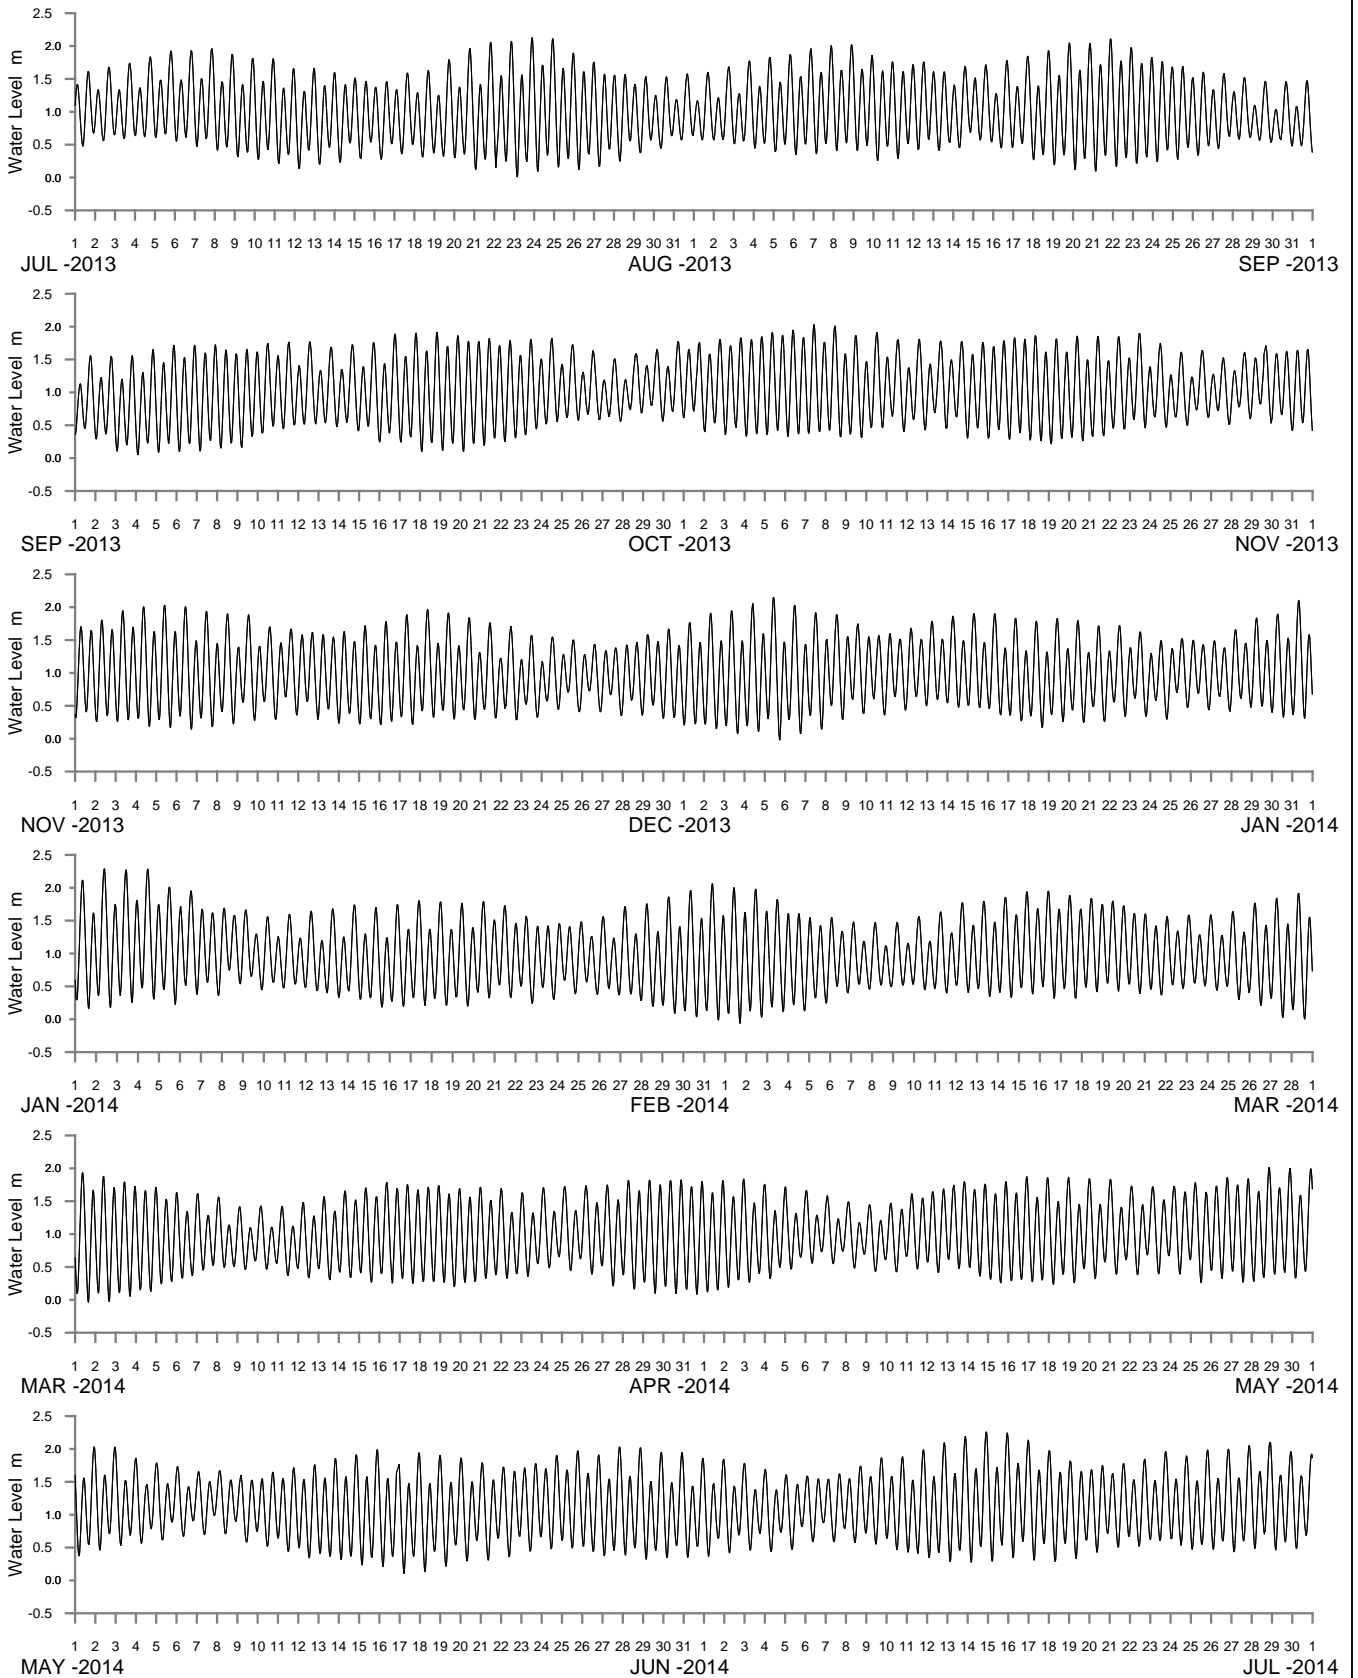
121

WATER LEVEL REFERENCED TO PORT STEPHENS HYDRO DATUM

KARUAH RIVER AT MALLABULLA POINT
2013-2014

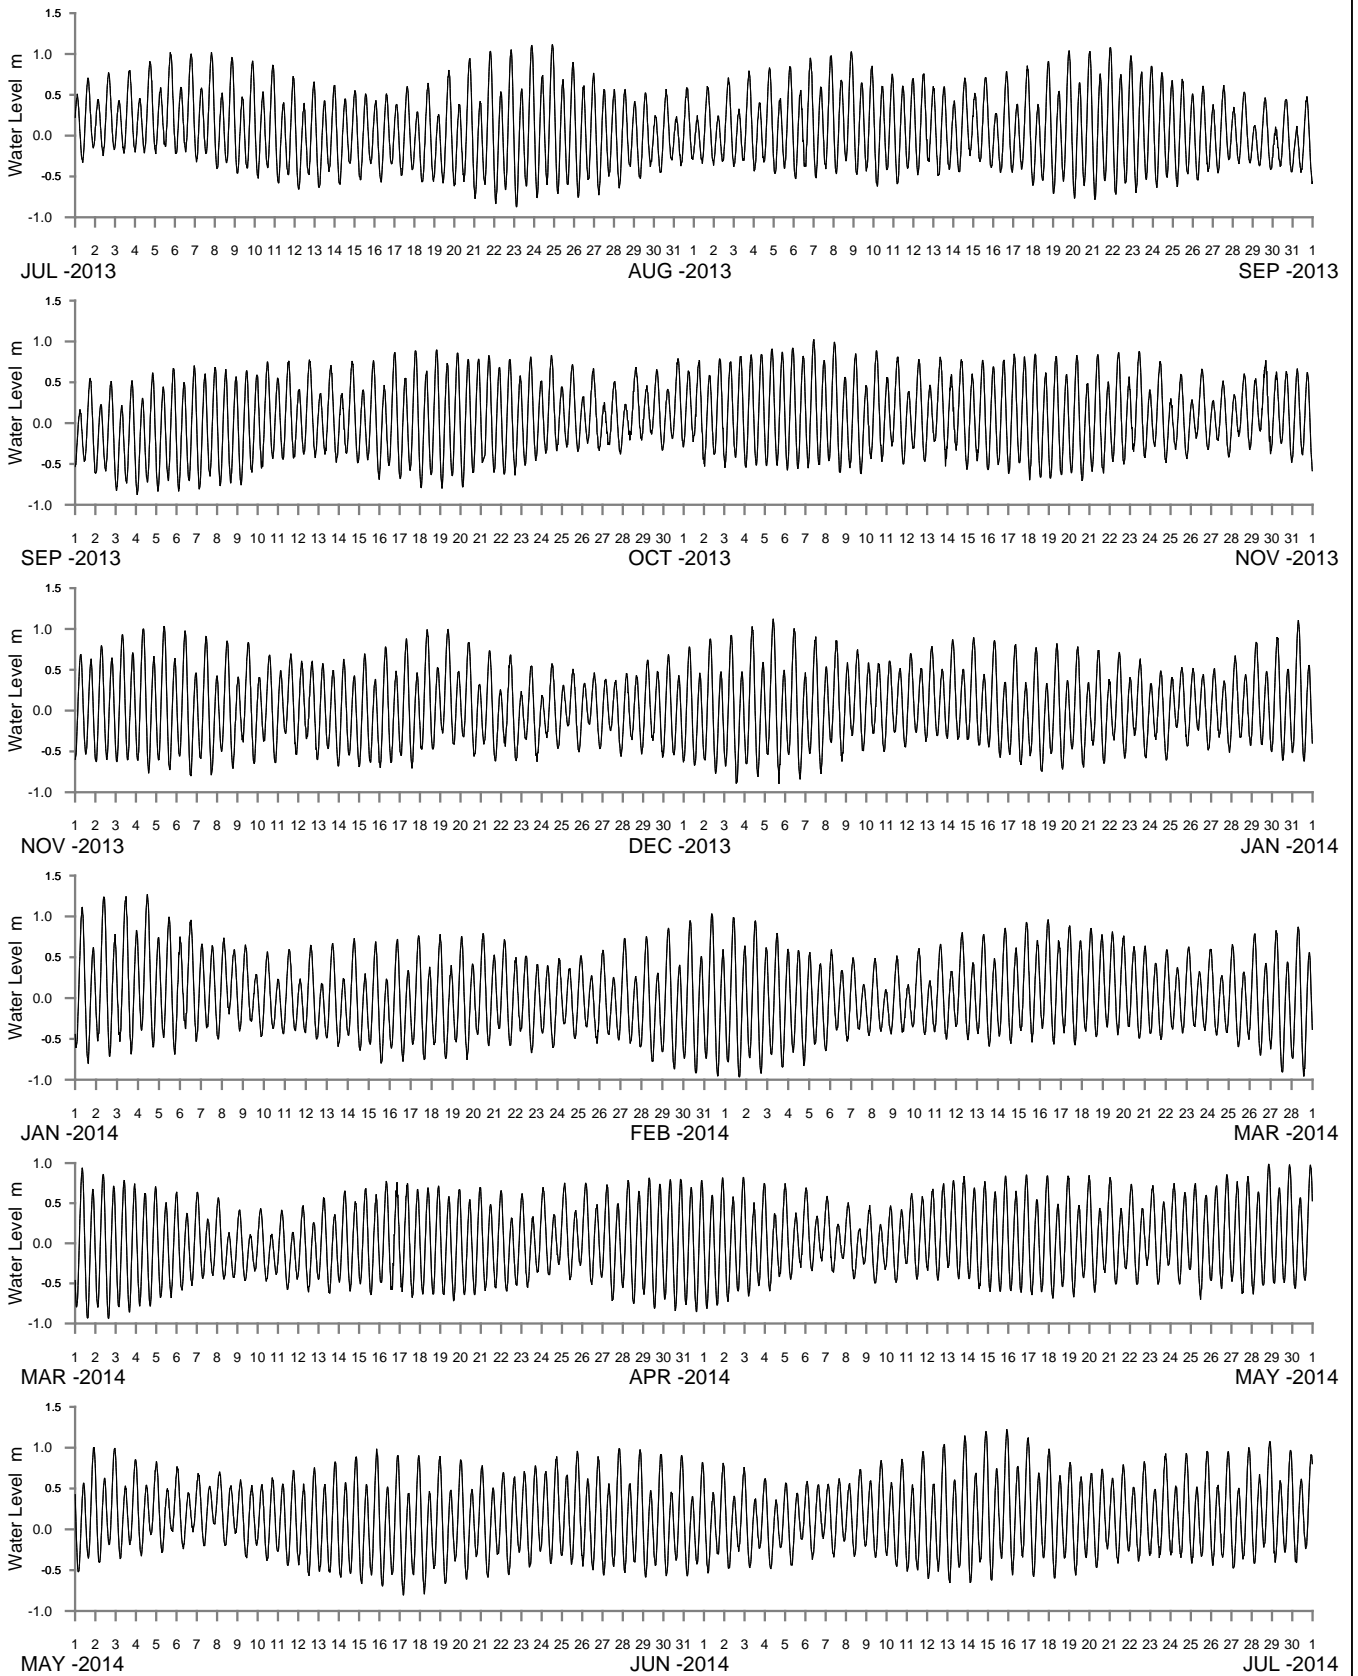
Figure
123

WATER LEVEL REFERENCED TO AUSTRALIAN HEIGHT DATUM

HUNTER RIVER AT STOCKTON BRIDGE
2013-2014

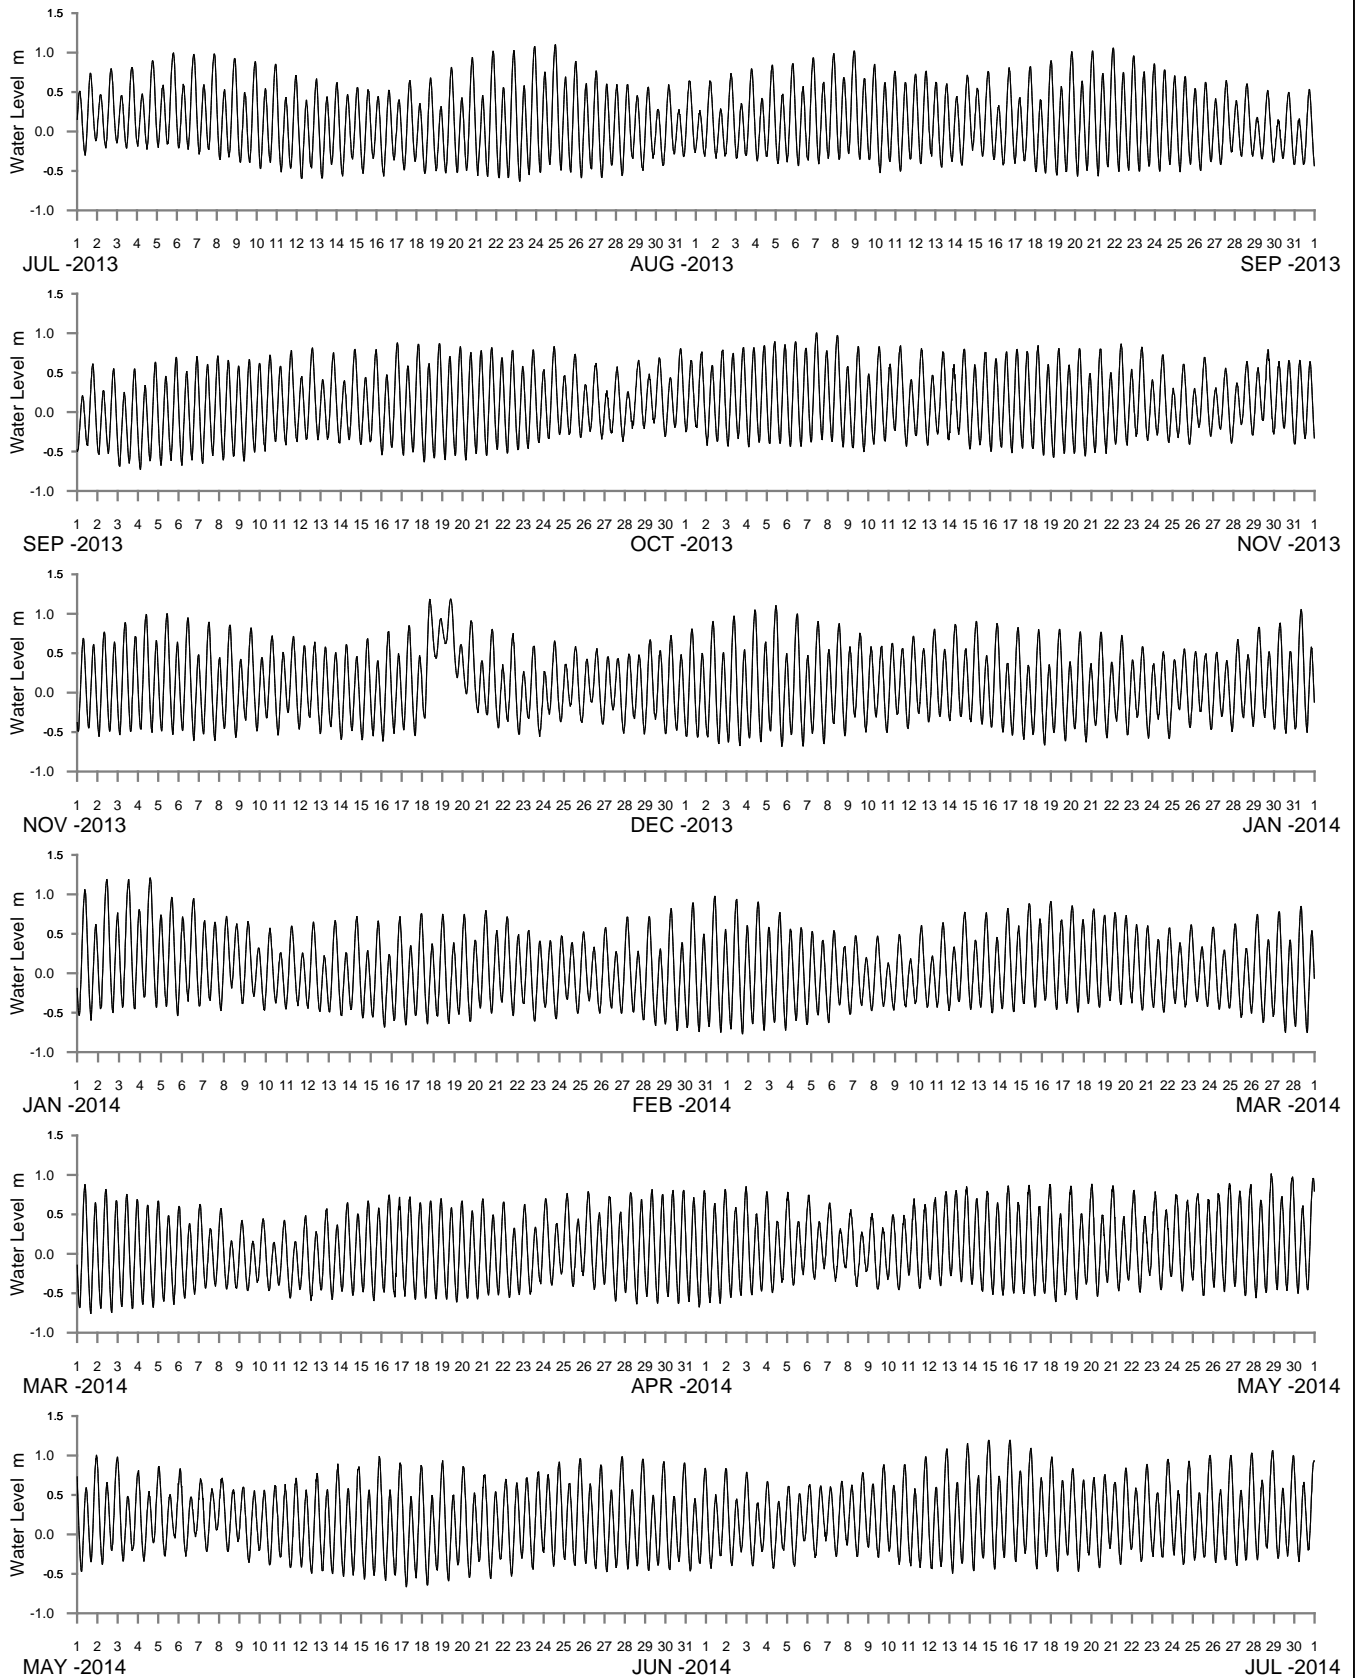
Figure
124

WATER LEVEL REFERENCED TO AUSTRALIAN HEIGHT DATUM

HUNTER RIVER AT HEXHAM BRIDGE
2013-2014

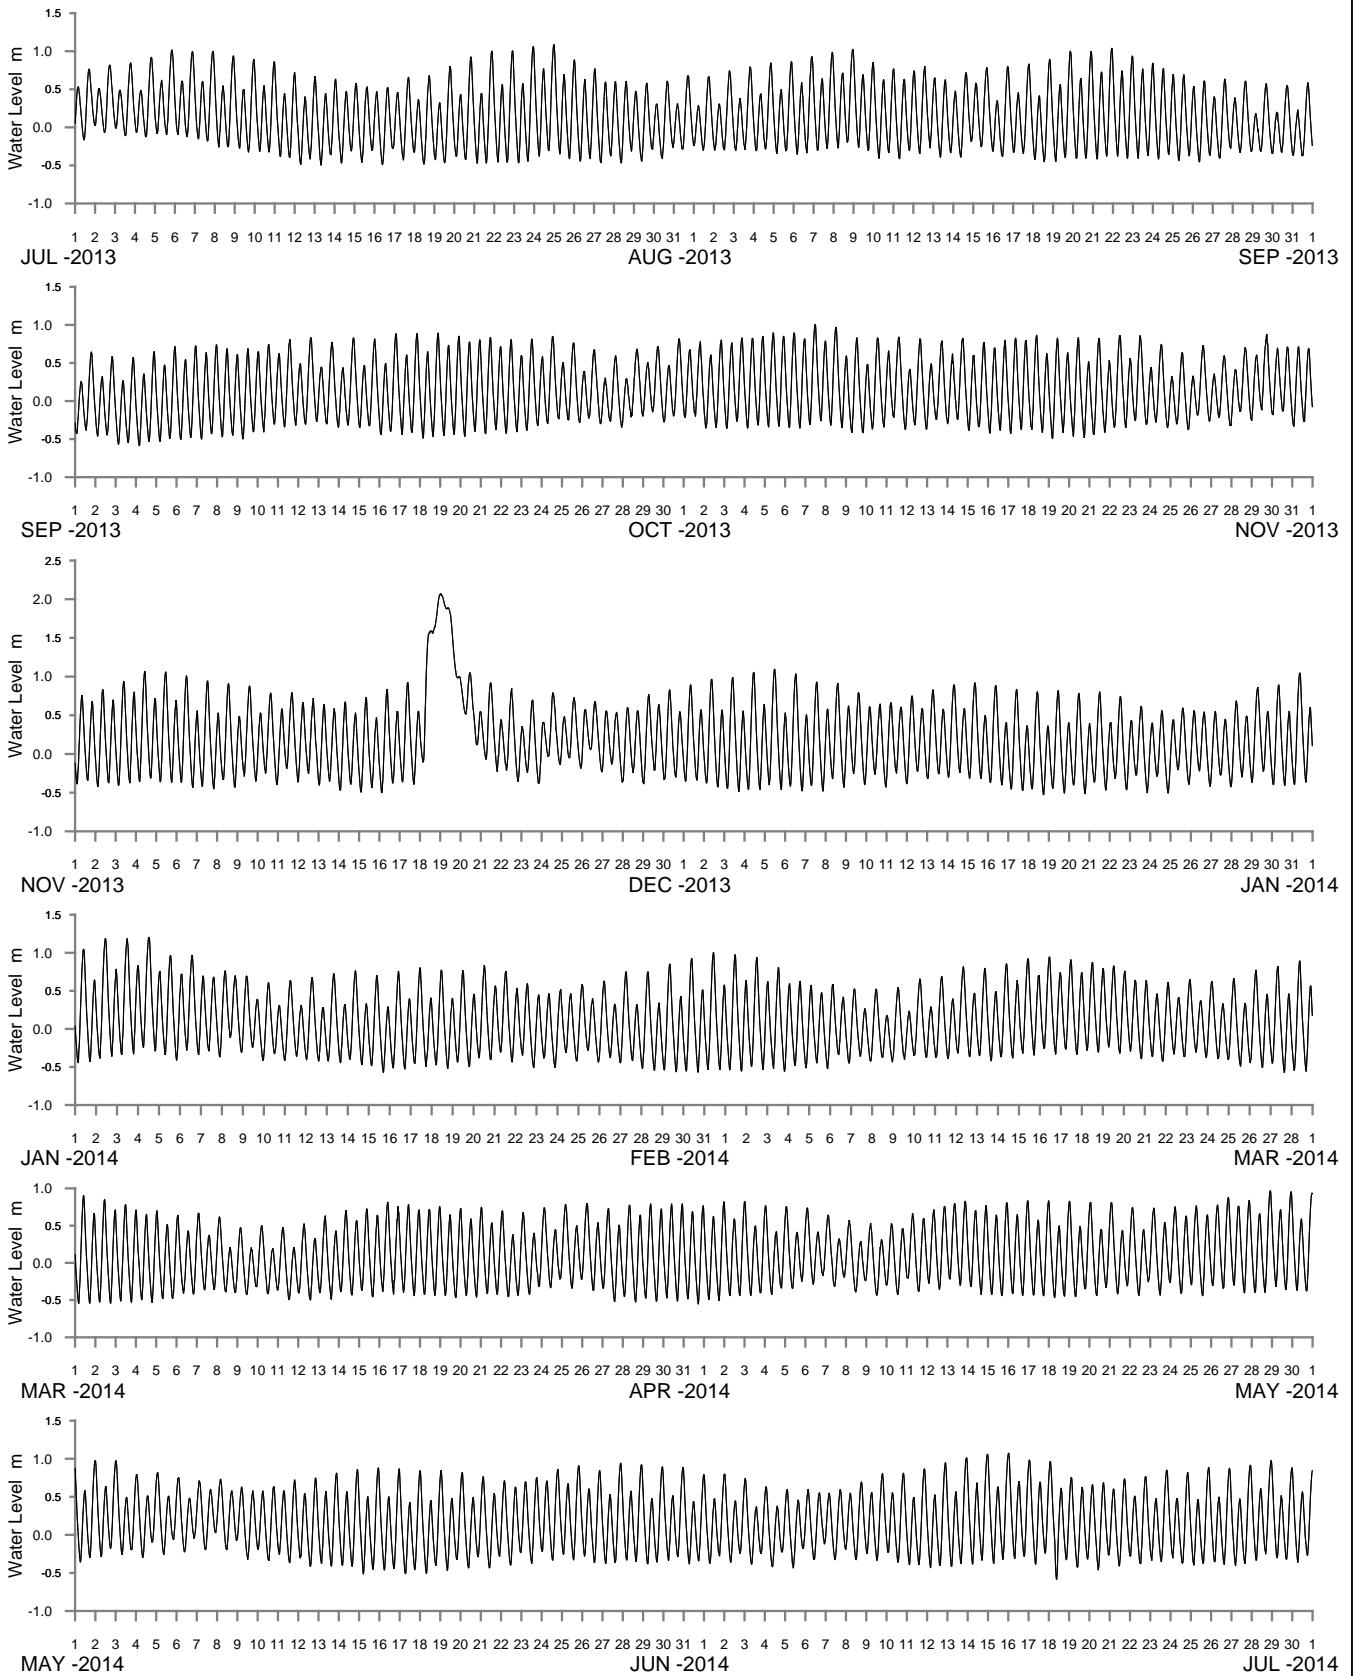
Figure
125

WATER LEVEL REFERENCED TO AUSTRALIAN HEIGHT DATUM

WILLIAMS RIVER AT RAYMOND TERRACE
2013-2014
