Public Works
Manly Hydraulics Laboratory

MHL
Report 2291
Figure
100
DRAWING 2291-100.cdr

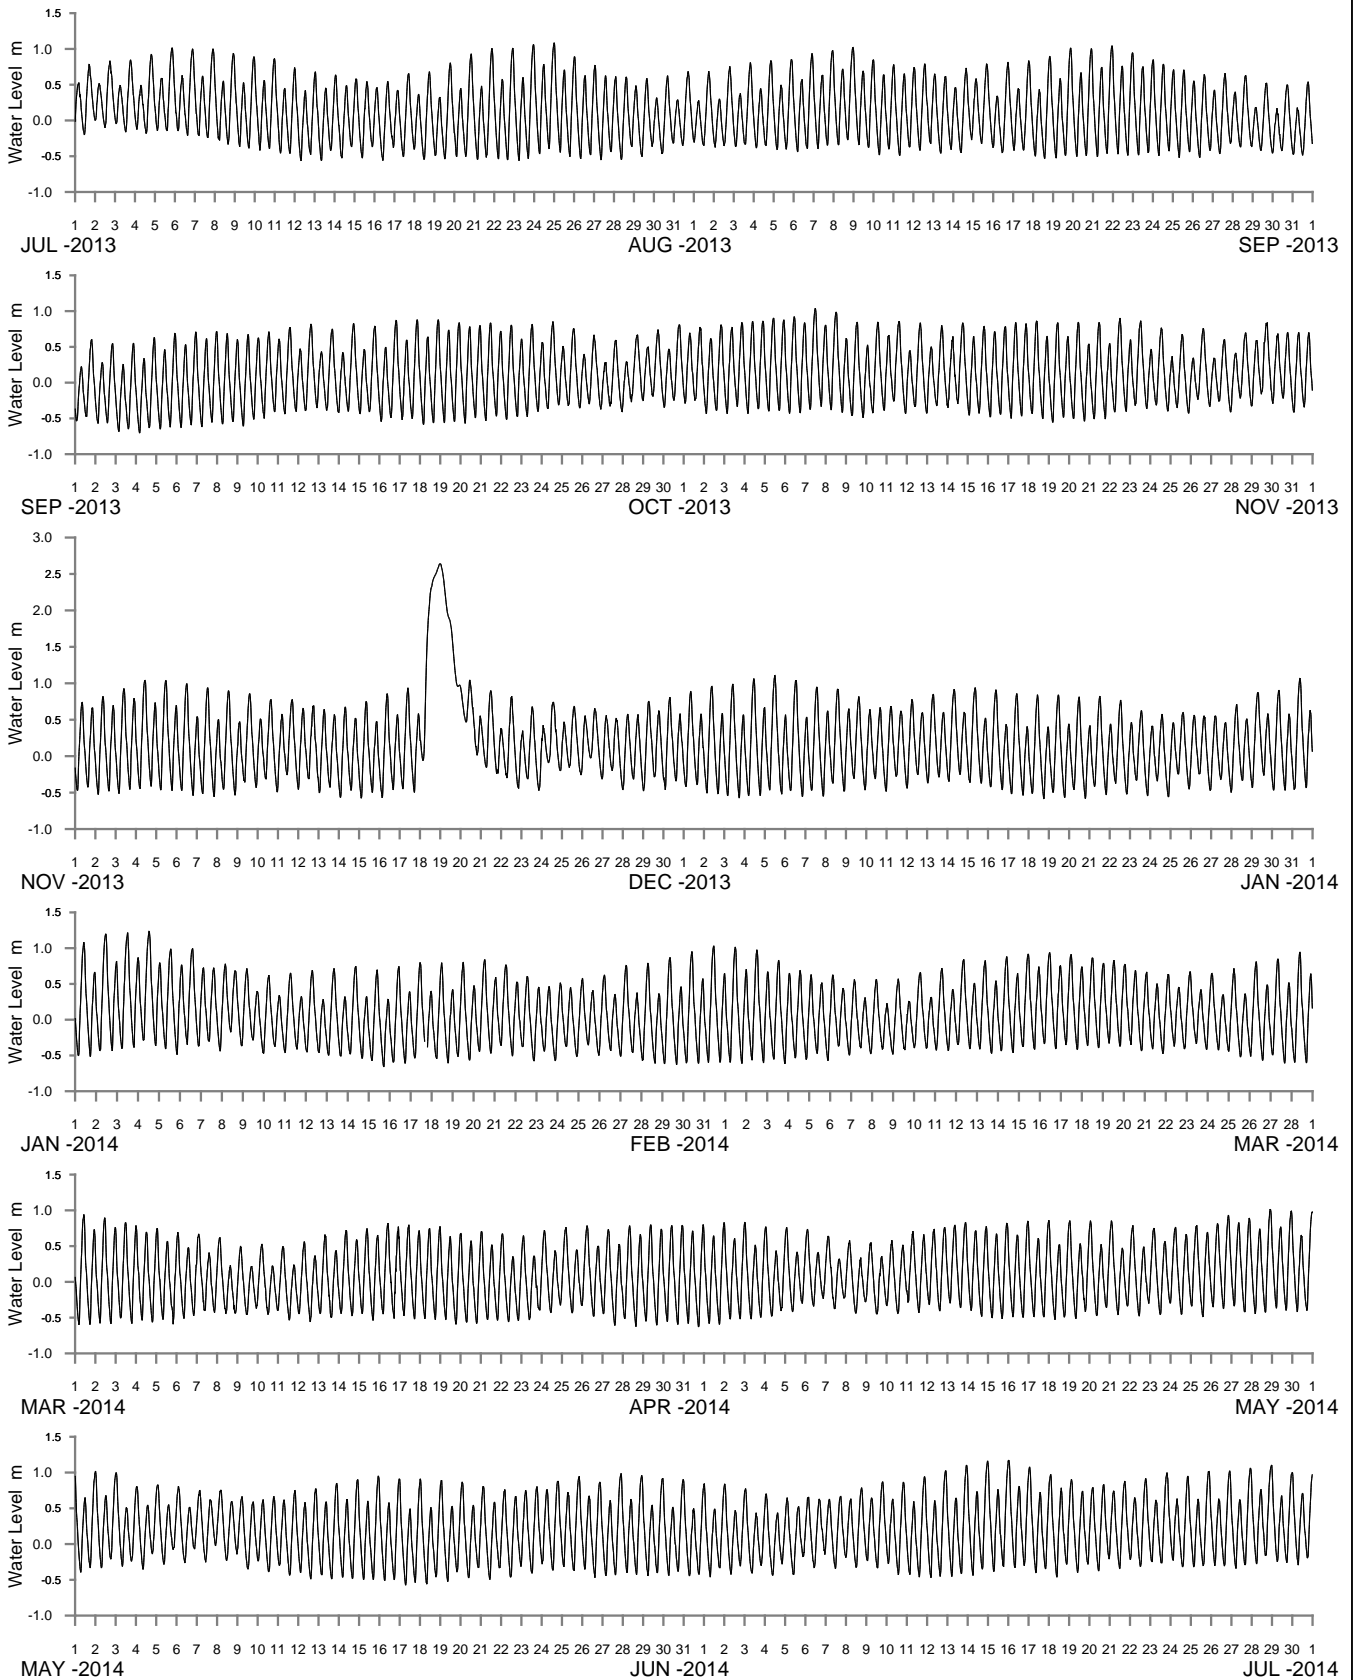
Figure
126

WATER LEVEL REFERENCED TO AUSTRALIAN HEIGHT DATUM

WILLIAMS RIVER AT SEAHAM
2013-2014

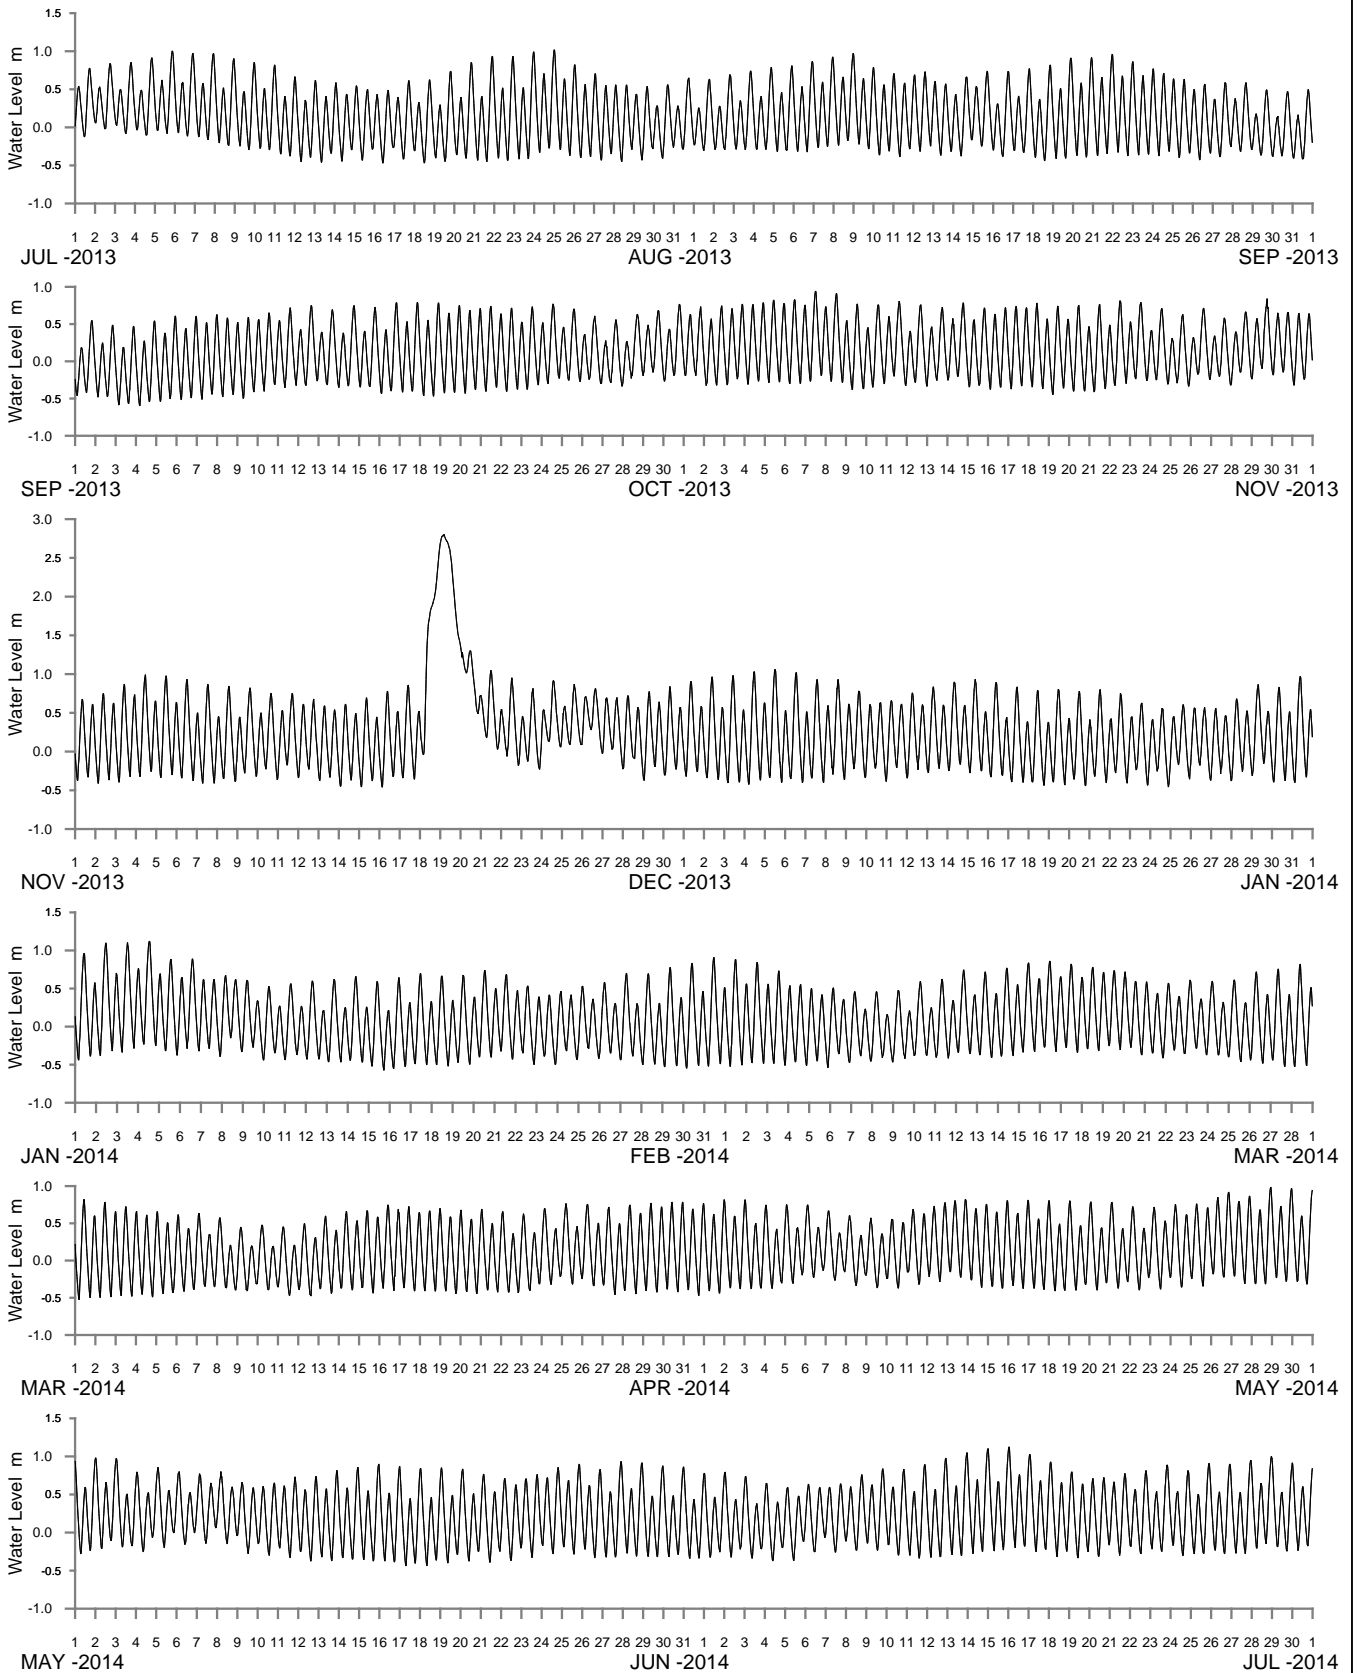
Figure
127

WATER LEVEL REFERENCED TO AUSTRALIAN HEIGHT DATUM

HUNTER RIVER AT GREEN ROCKS
2013-2014

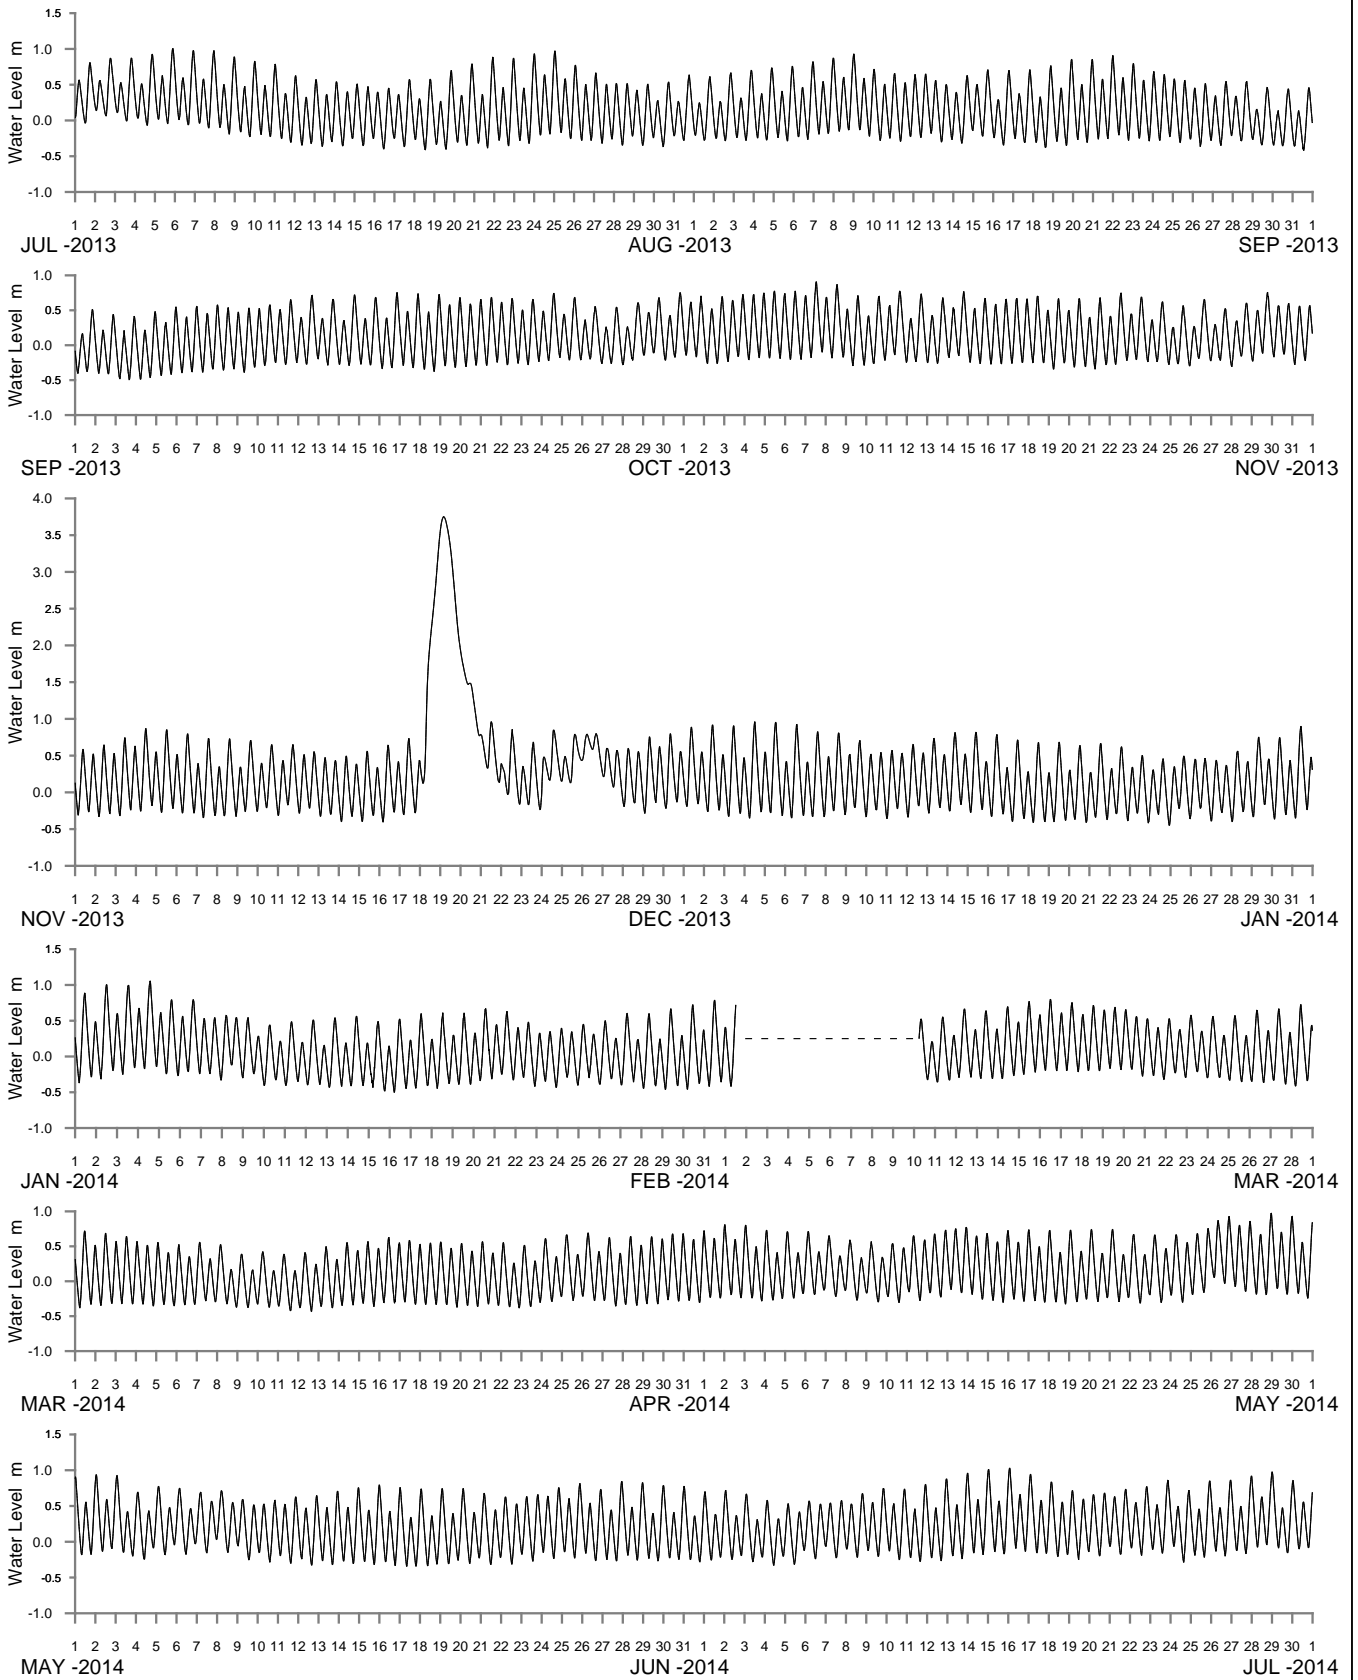
Figure
128

WATER LEVEL REFERENCED TO AUSTRALIAN HEIGHT DATUM

HUNTER RIVER AT MORPETH
2013-2014

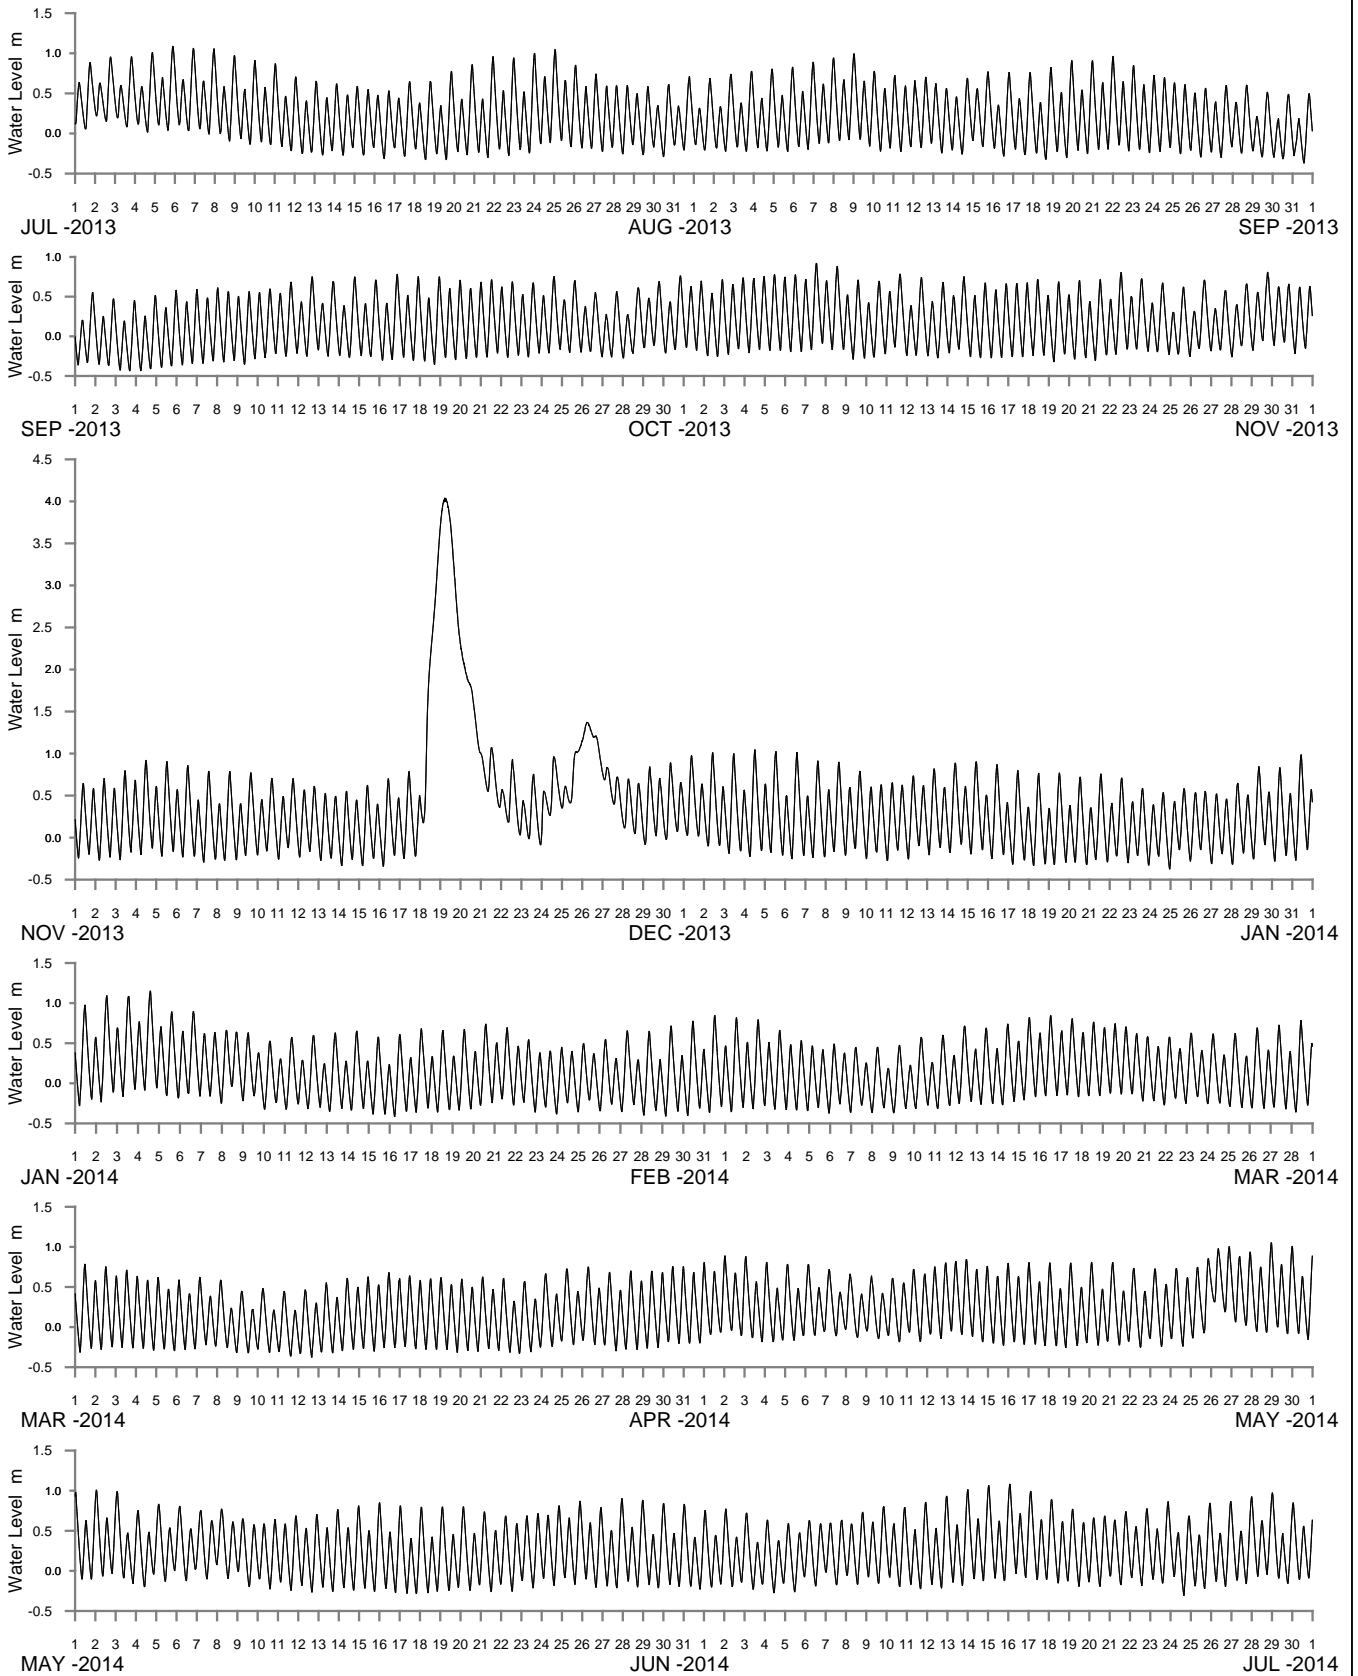
Figure
129

WATER LEVEL REFERENCED TO AUSTRALIAN HEIGHT DATUM

HUNTER RIVER AT MCKIMMS CORNER
2013-2014

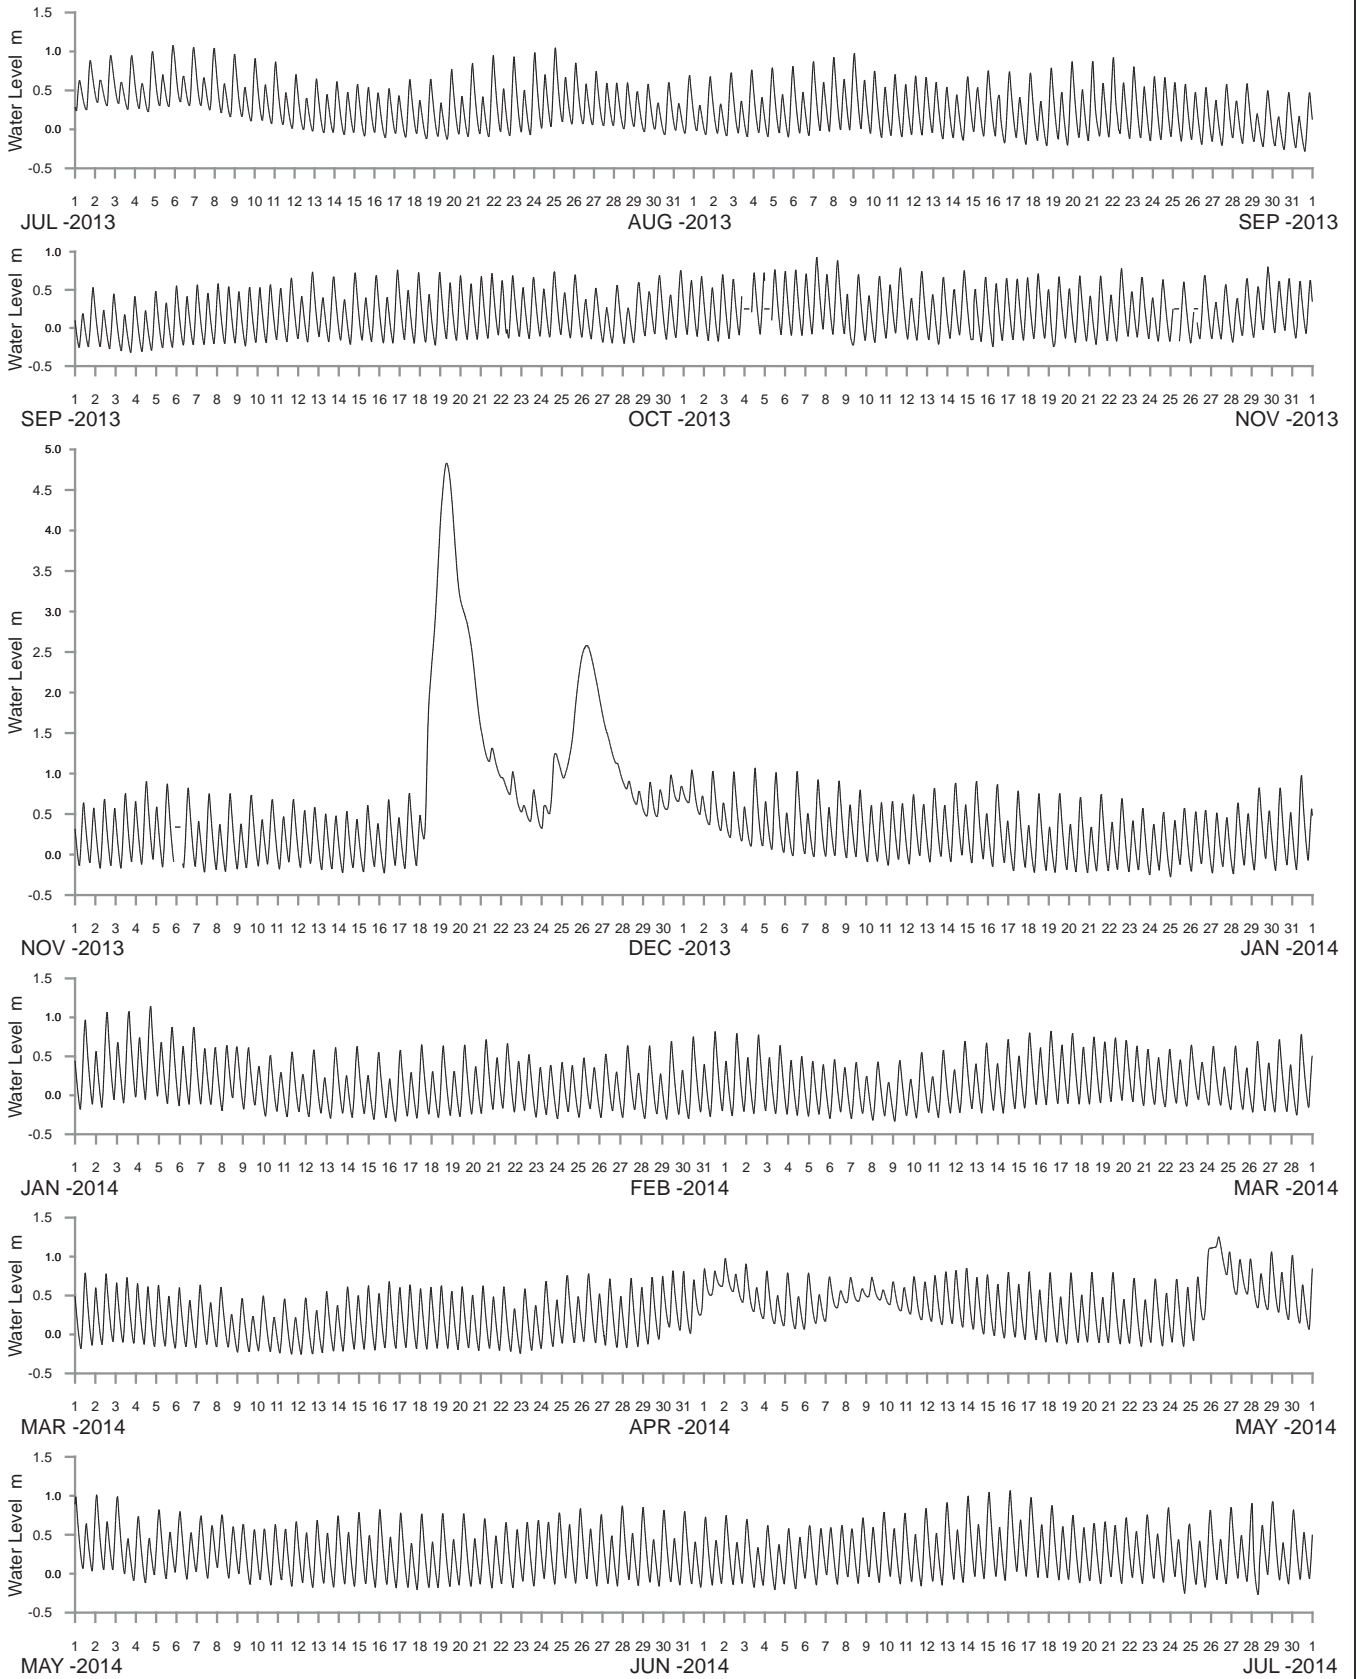
Figure
130

WATER LEVEL REFERENCED TO AUSTRALIAN HEIGHT DATUM

HUNTER RIVER AT BELMORE BRIDGE
2013-2014

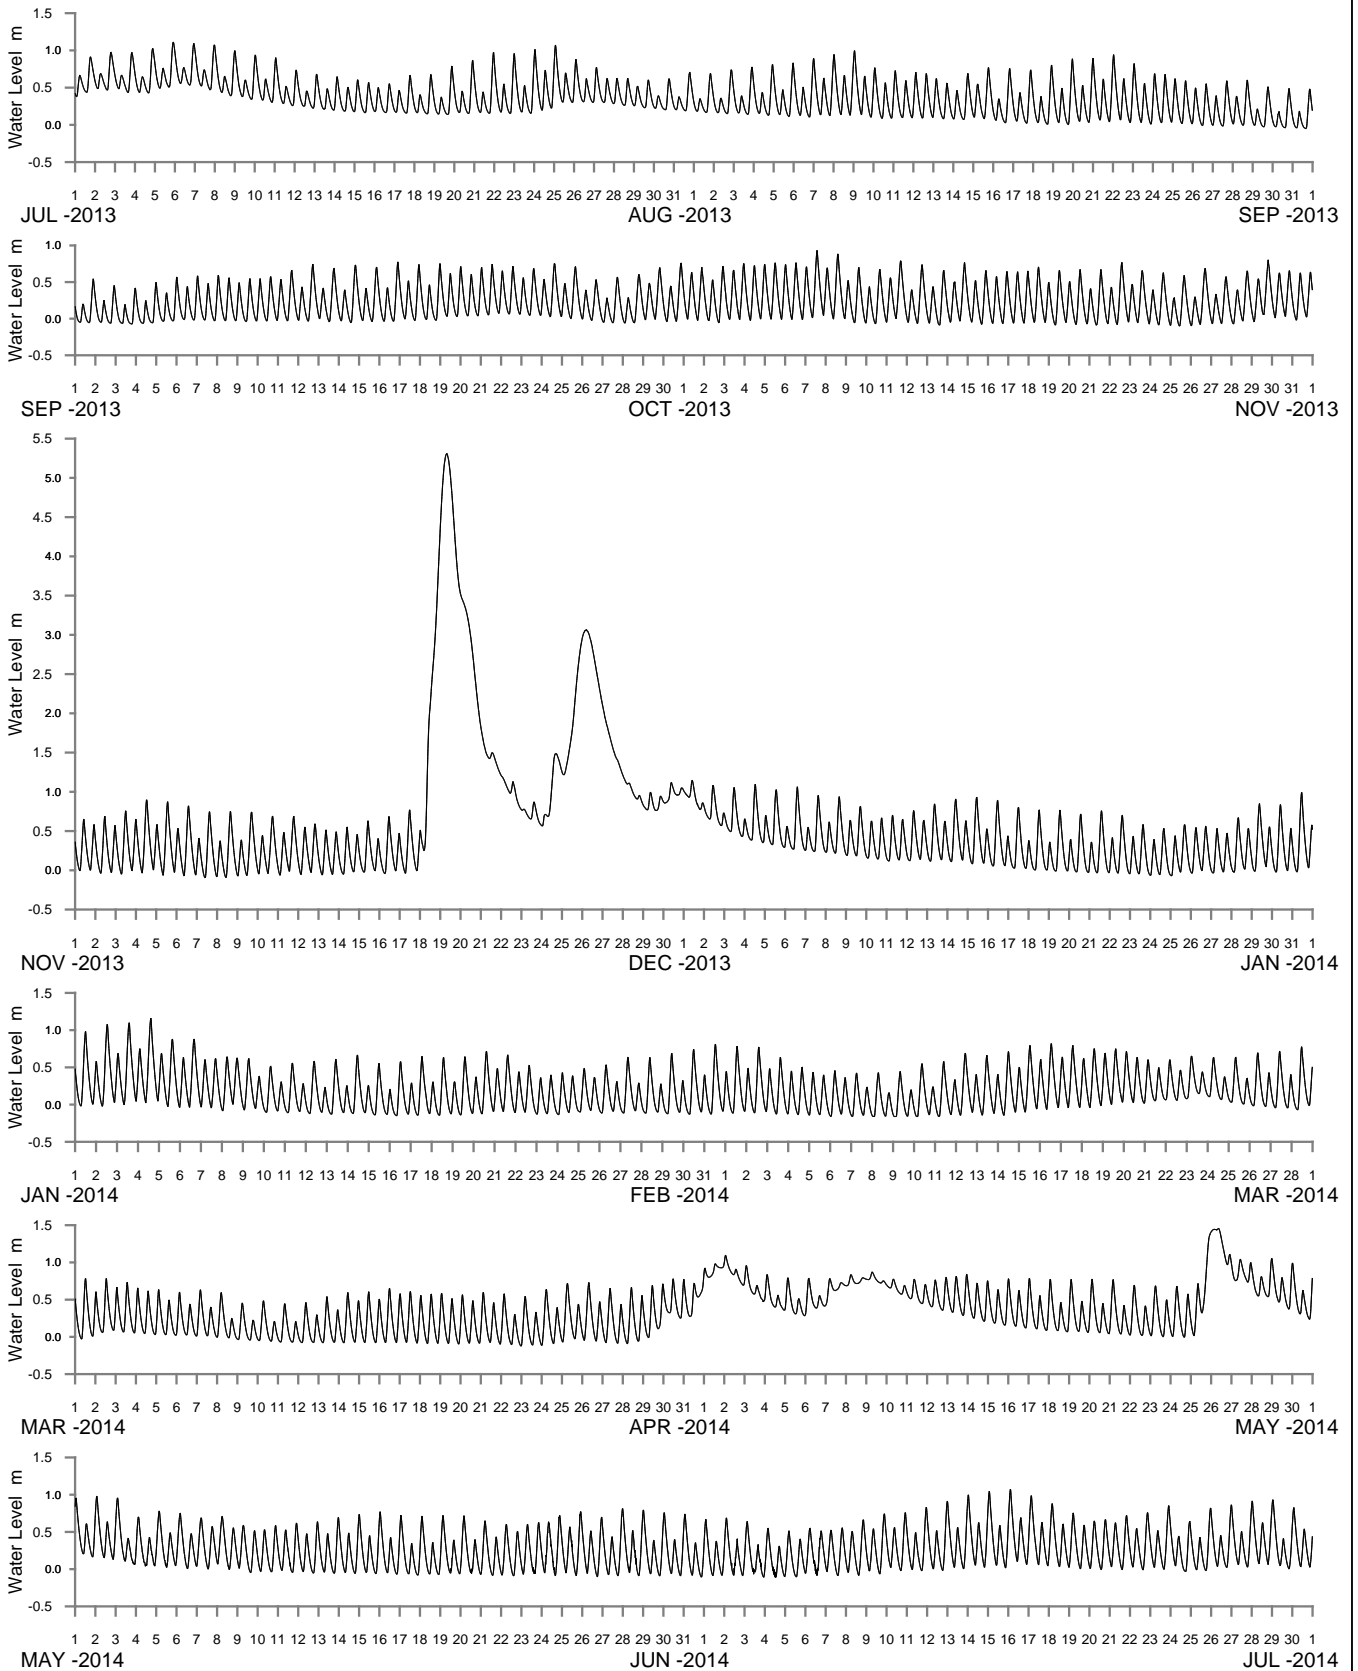
131

WATER LEVEL REFERENCED TO AUSTRALIAN HEIGHT DATUM

HUNTER RIVER AT BOLWARRA DOWNSTREAM
2013-2014

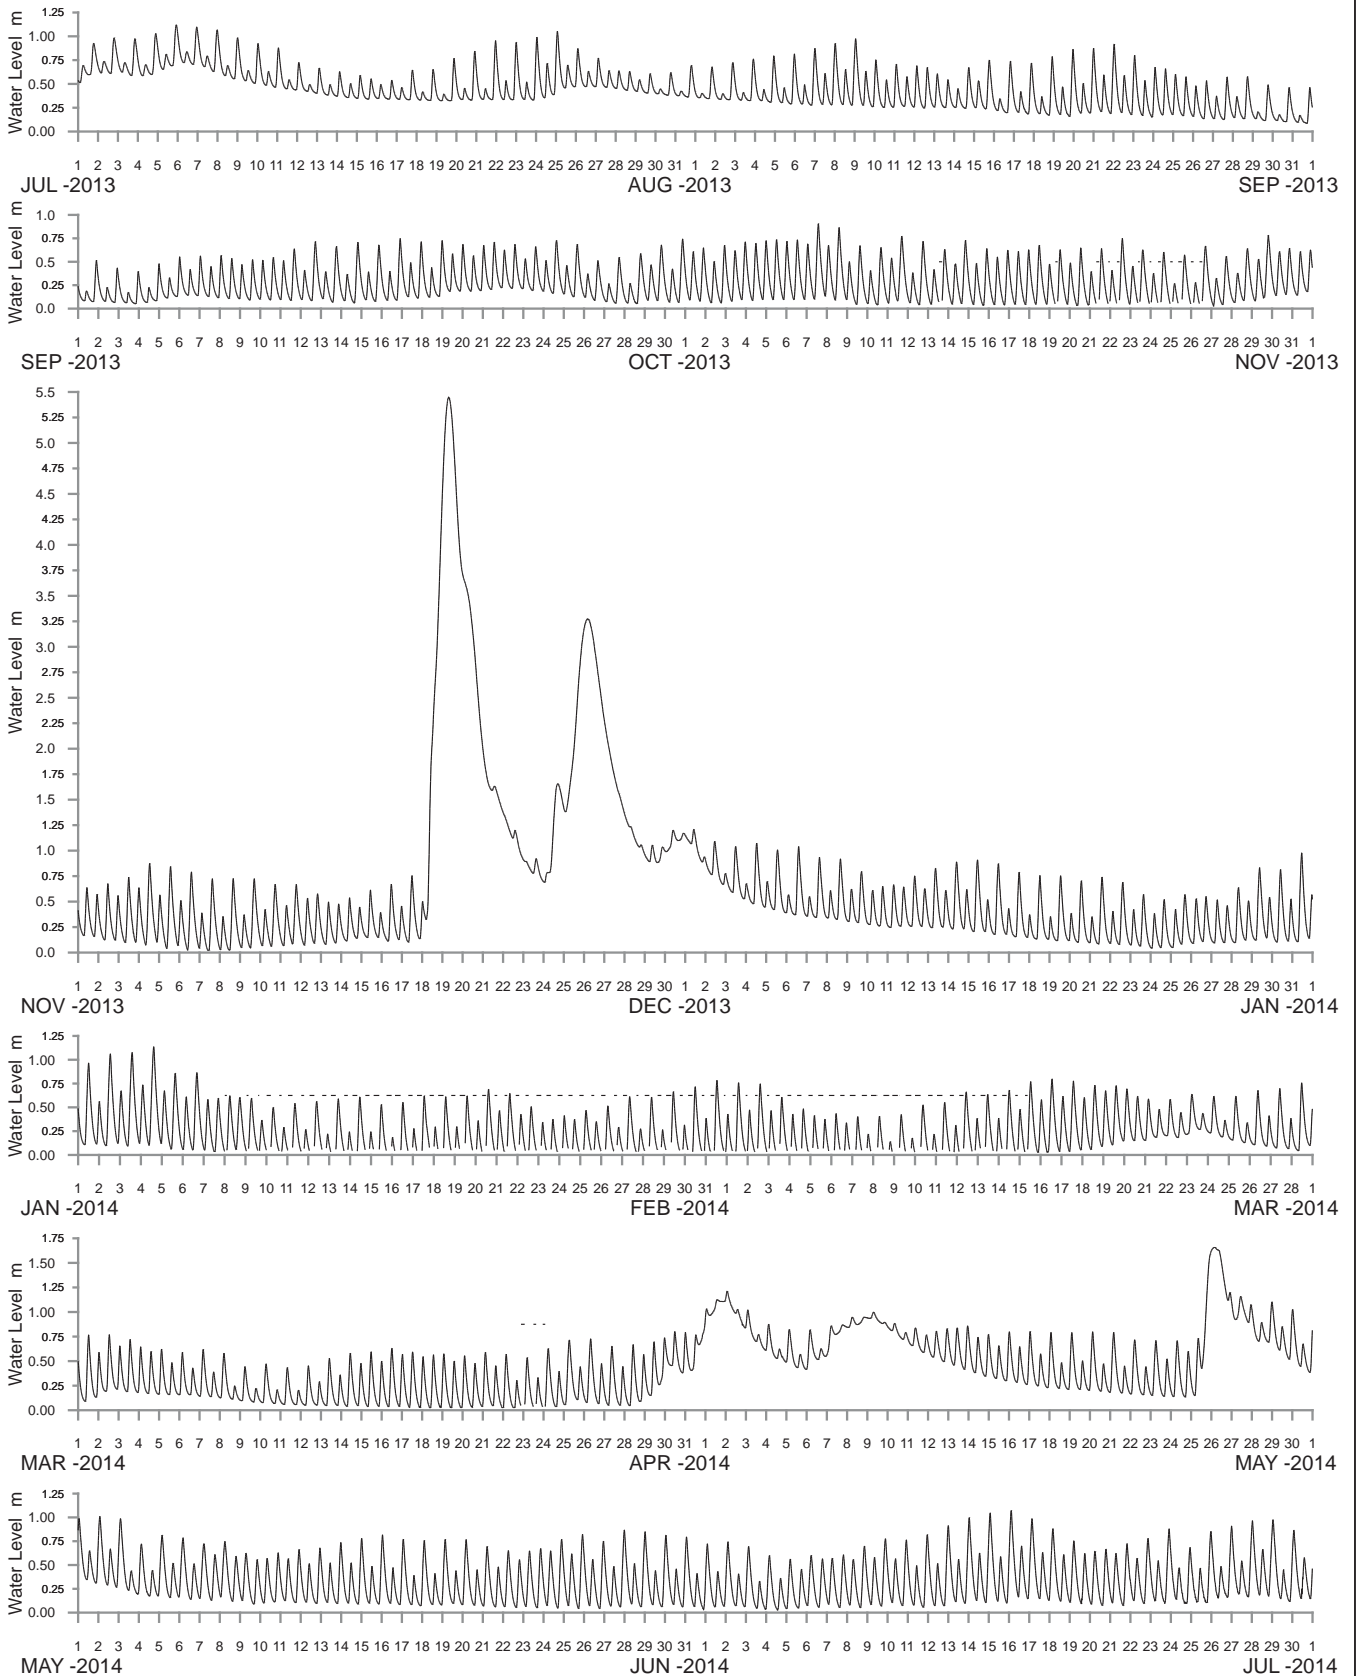
Figure
132

WATER LEVEL REFERENCED TO AUSTRALIAN HEIGHT DATUM

HUNTER RIVER AT BOLWARRA UPSTREAM
2013-2014

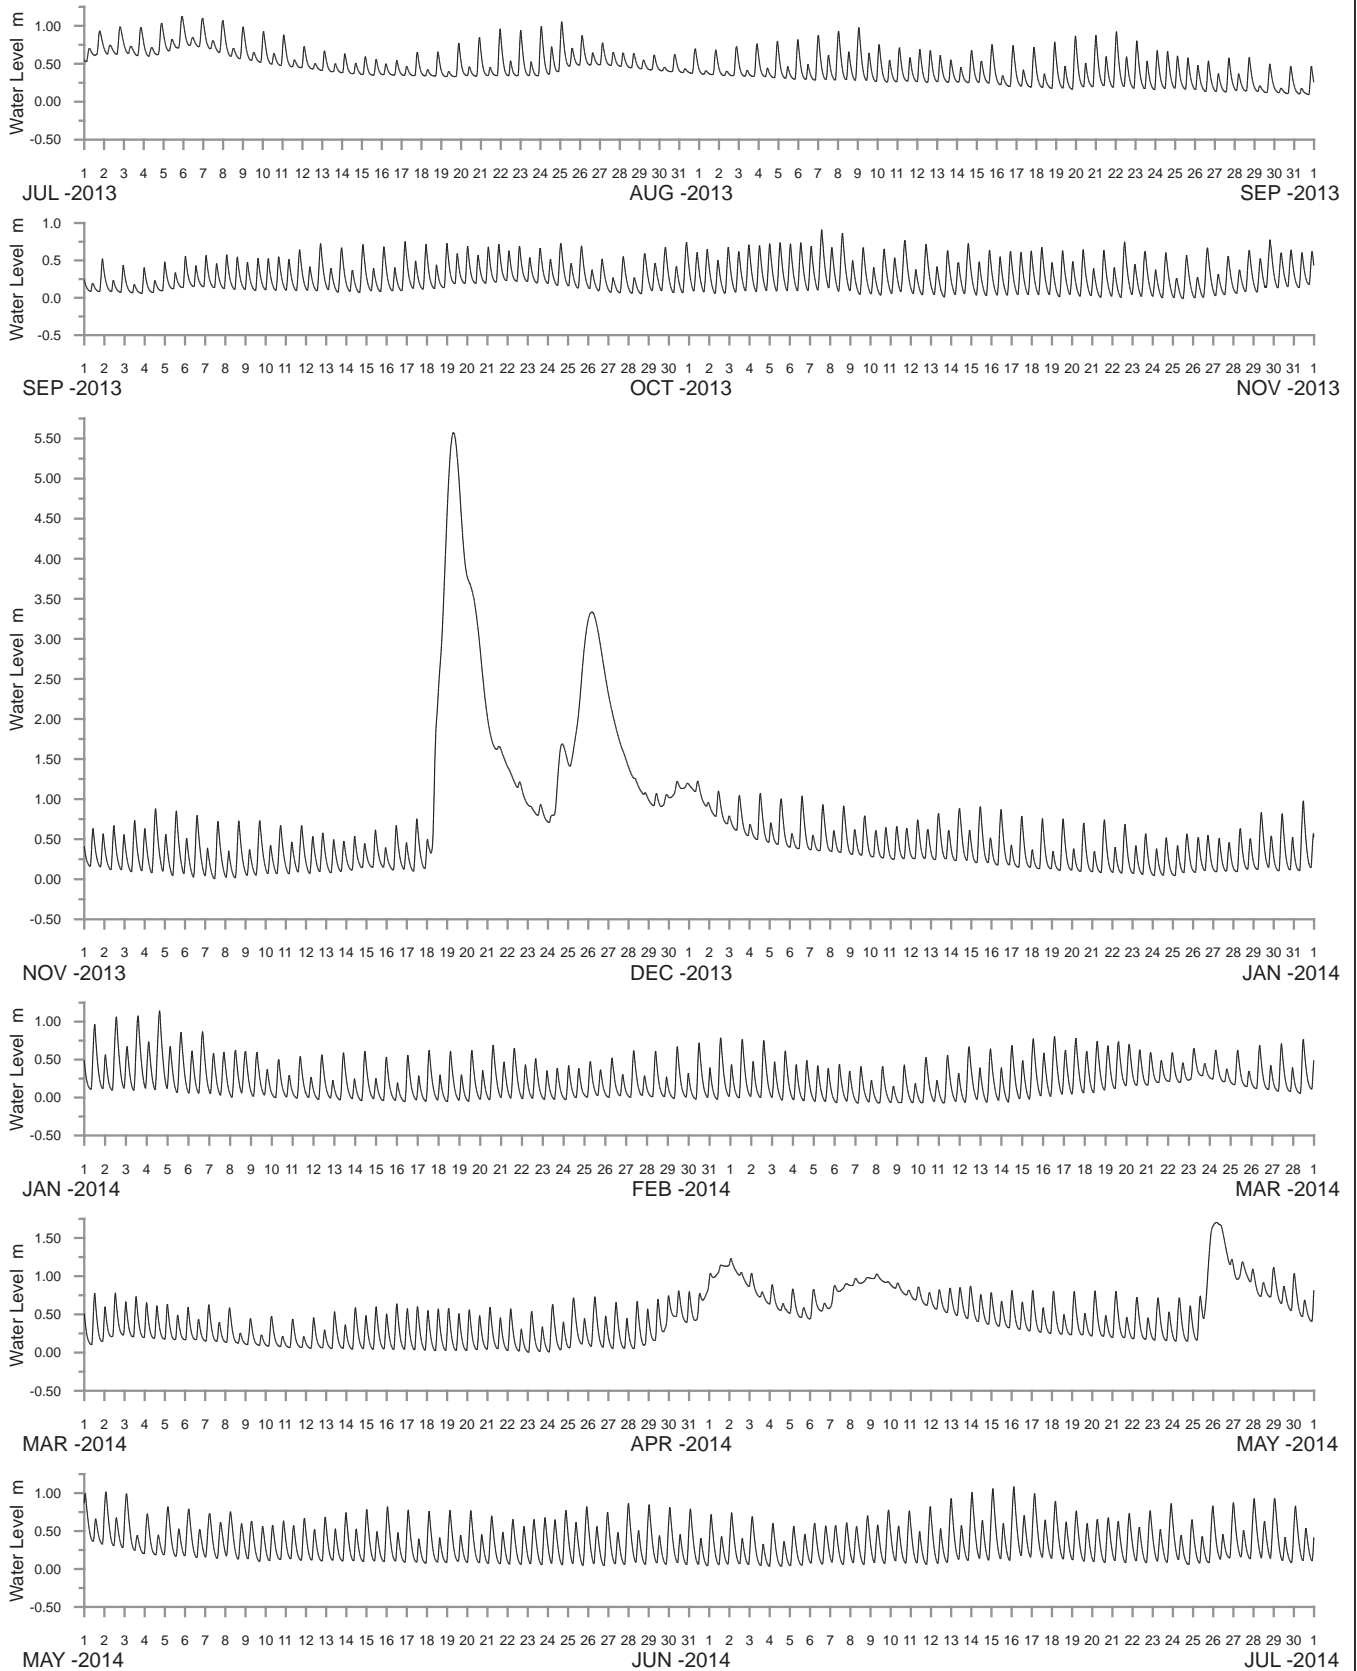
Figure
133

WATER LEVEL REFERENCED TO AUSTRALIAN HEIGHT DATUM

HUNTER RIVER OAKHAMPTON RAILWAY BRIDGE
2013-2014

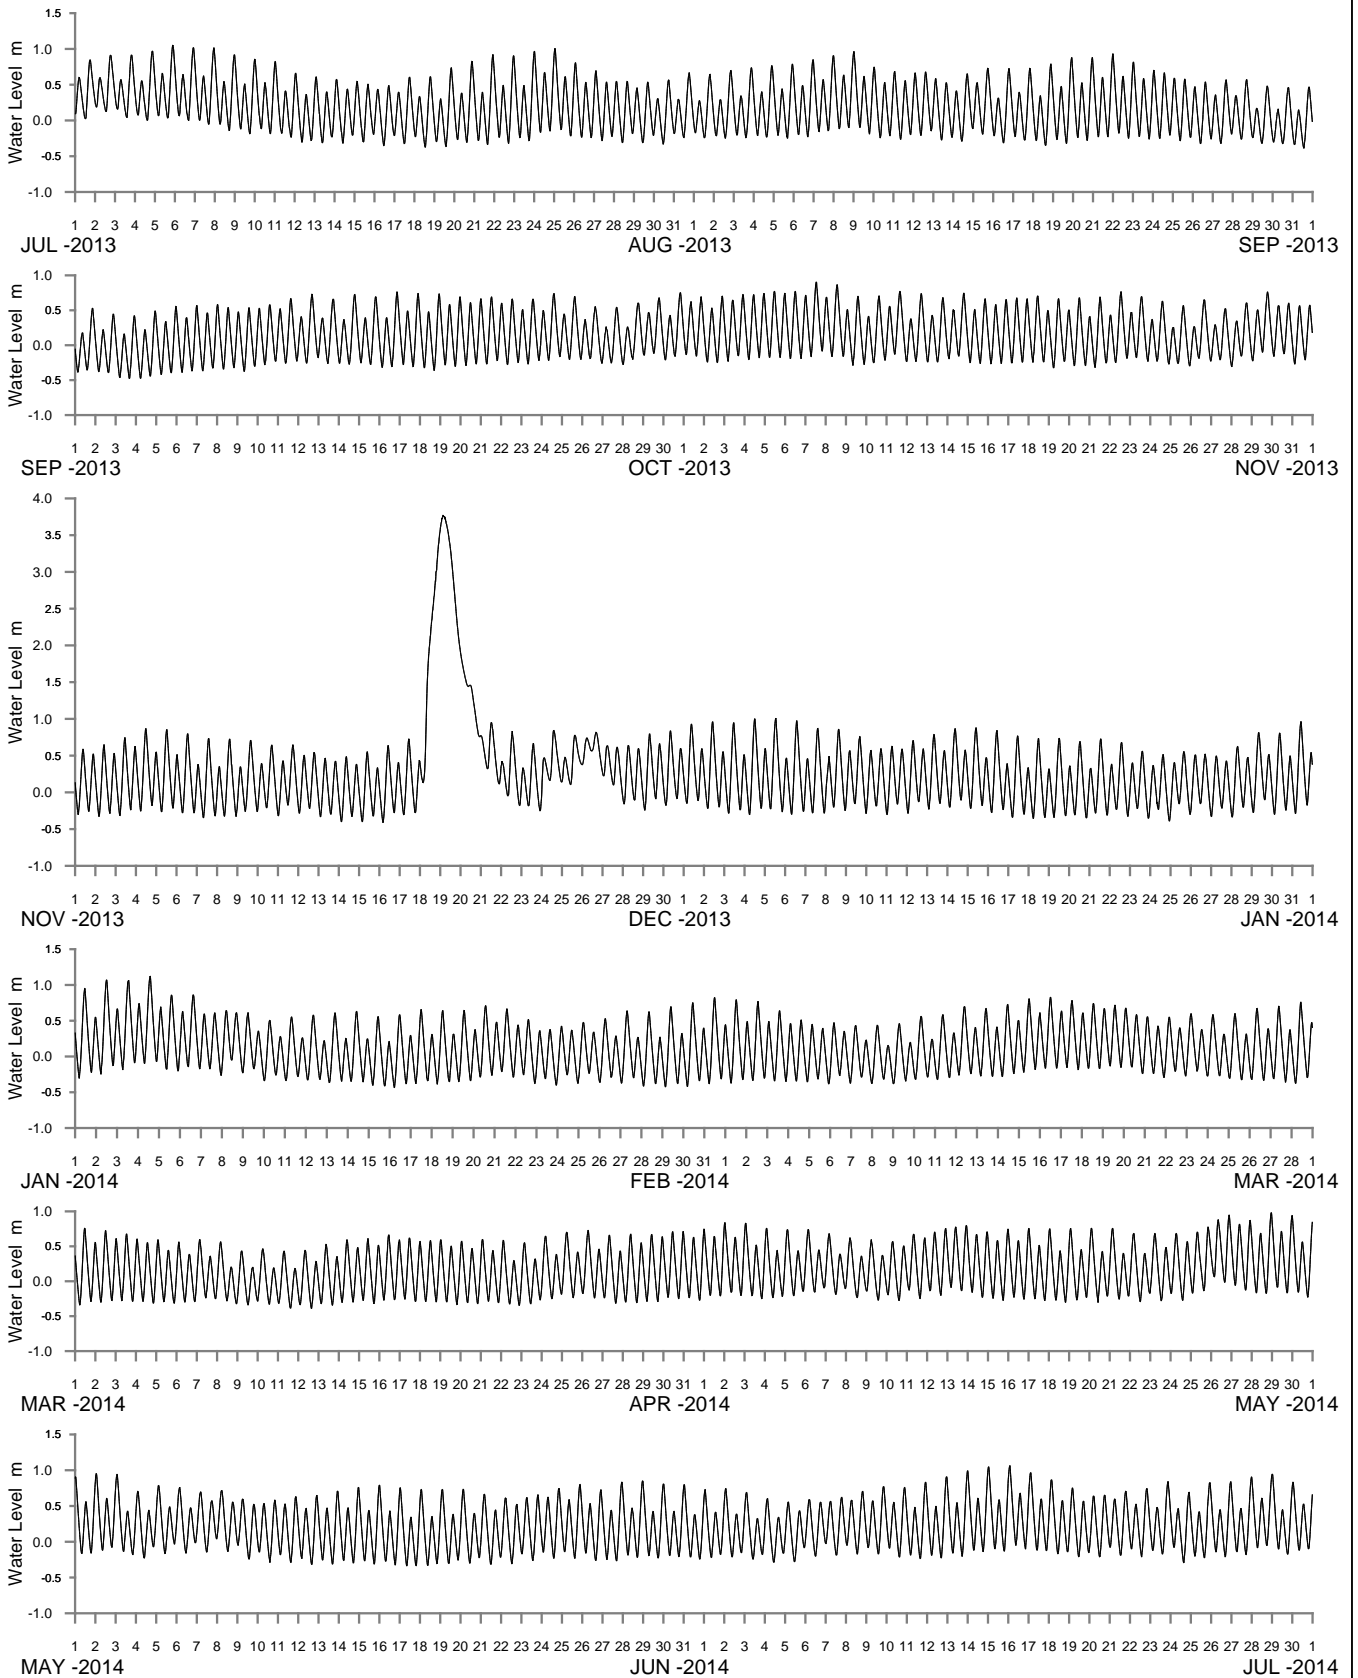
135

WATER LEVEL REFERENCED TO AUSTRALIAN HEIGHT DATUM

PATERSON RIVER AT HINTON BRIDGE
2013-2014

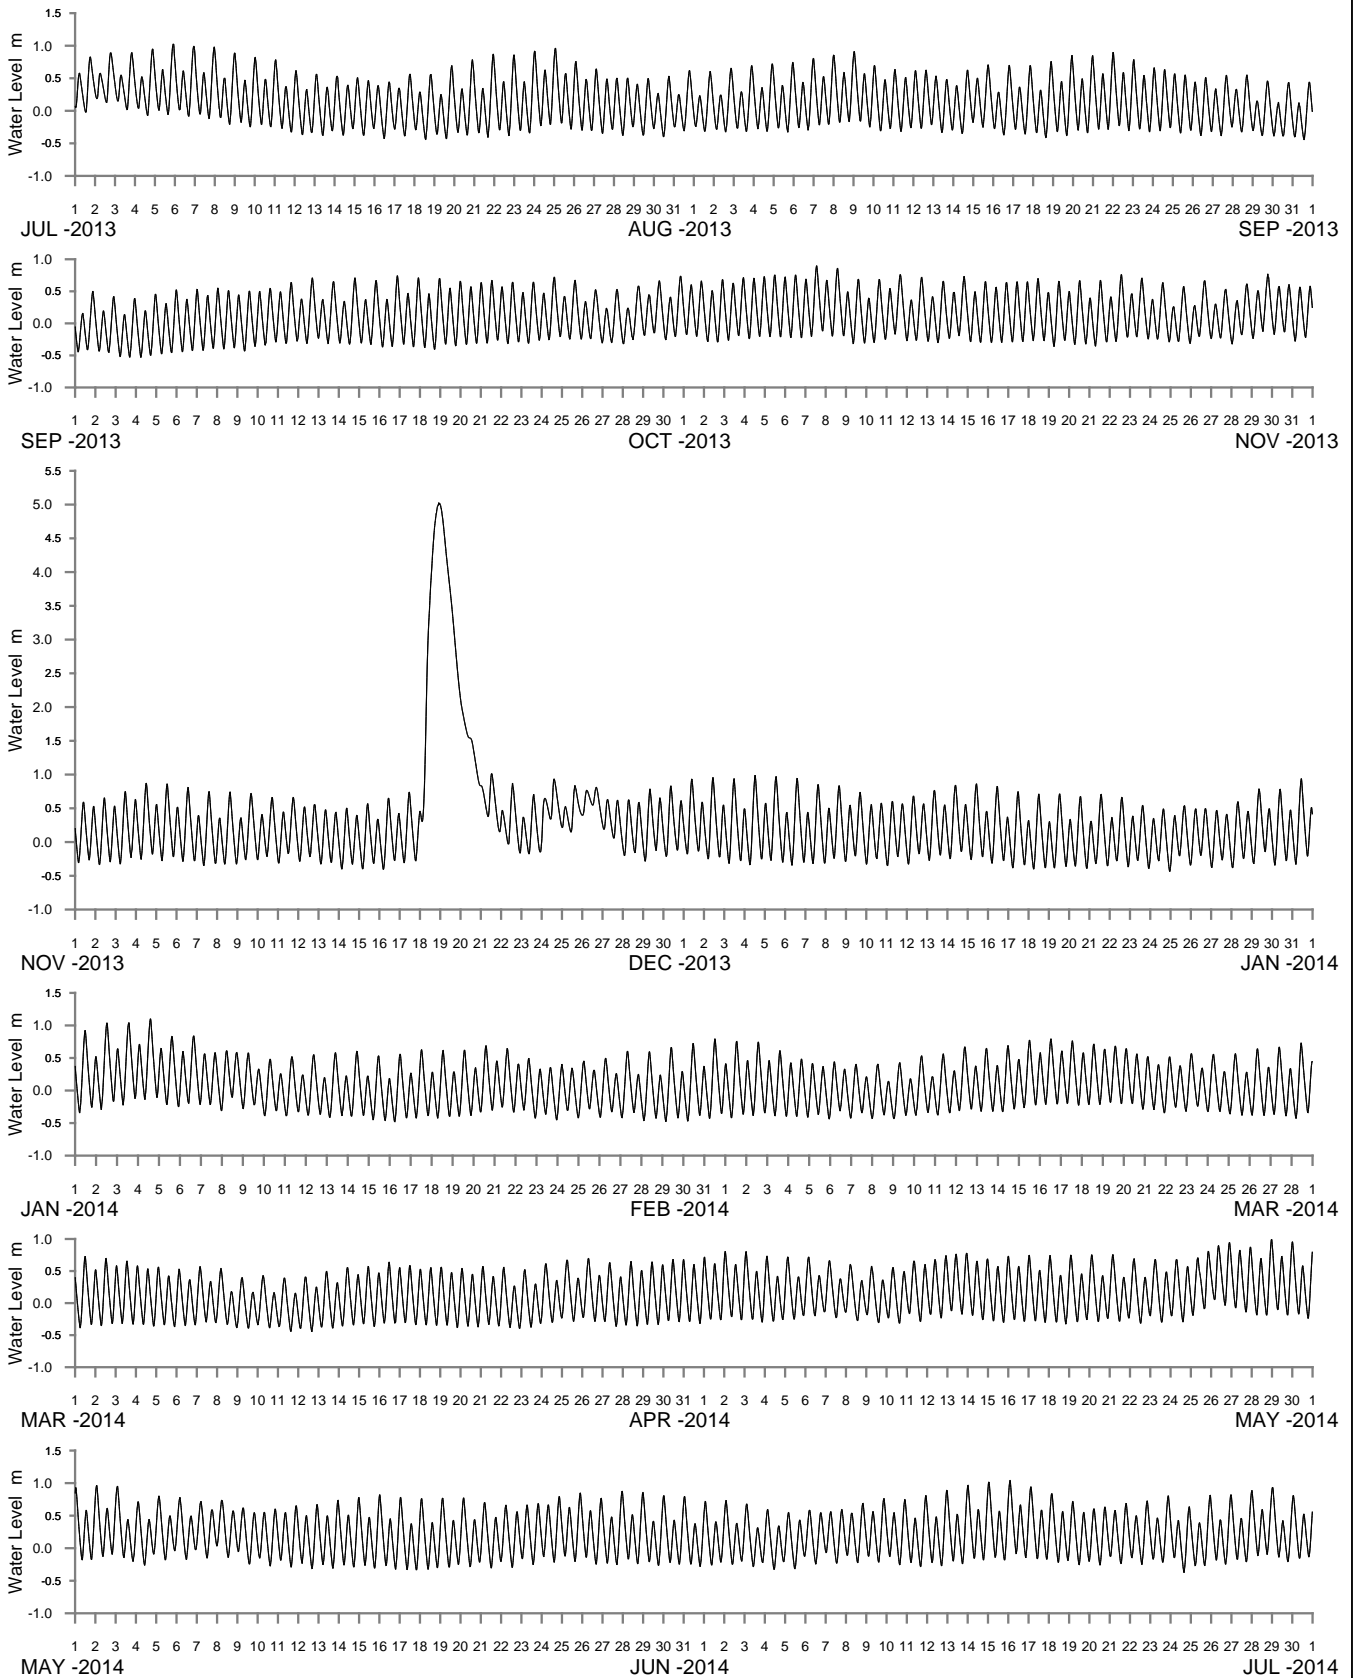
Figure
136

WATER LEVEL REFERENCED TO AUSTRALIAN HEIGHT DATUM

PATERSON RIVER AT DUNMORE
2013-2014
