Public Works
Manly Hydraulics Laboratory

MHL
Report 2291
Figure
100
DRAWING 2291-100.cdr

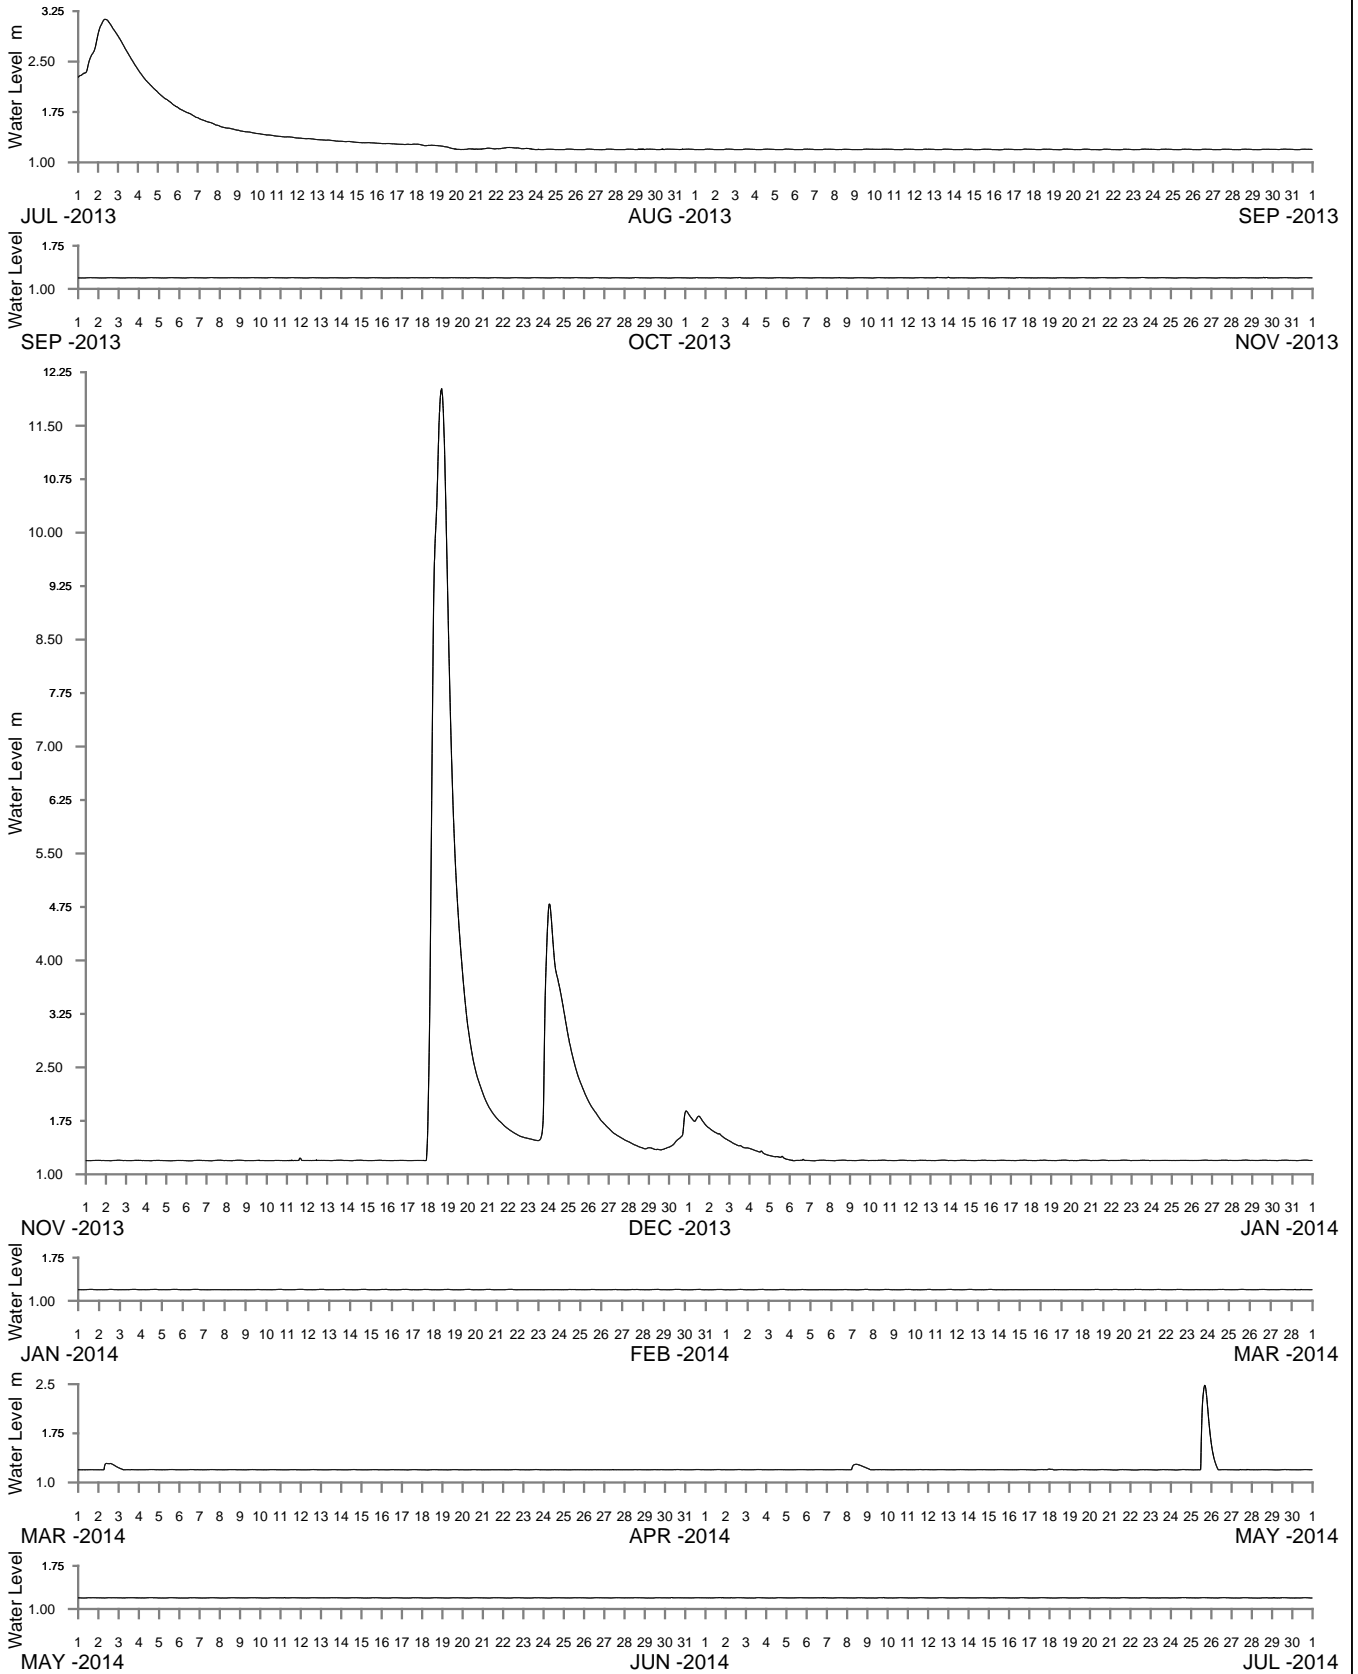
138

WATER LEVEL REFERENCED TO AUSTRALIAN HEIGHT DATUM

PATERSON RIVER AT GOSTWYCK
2013-2014

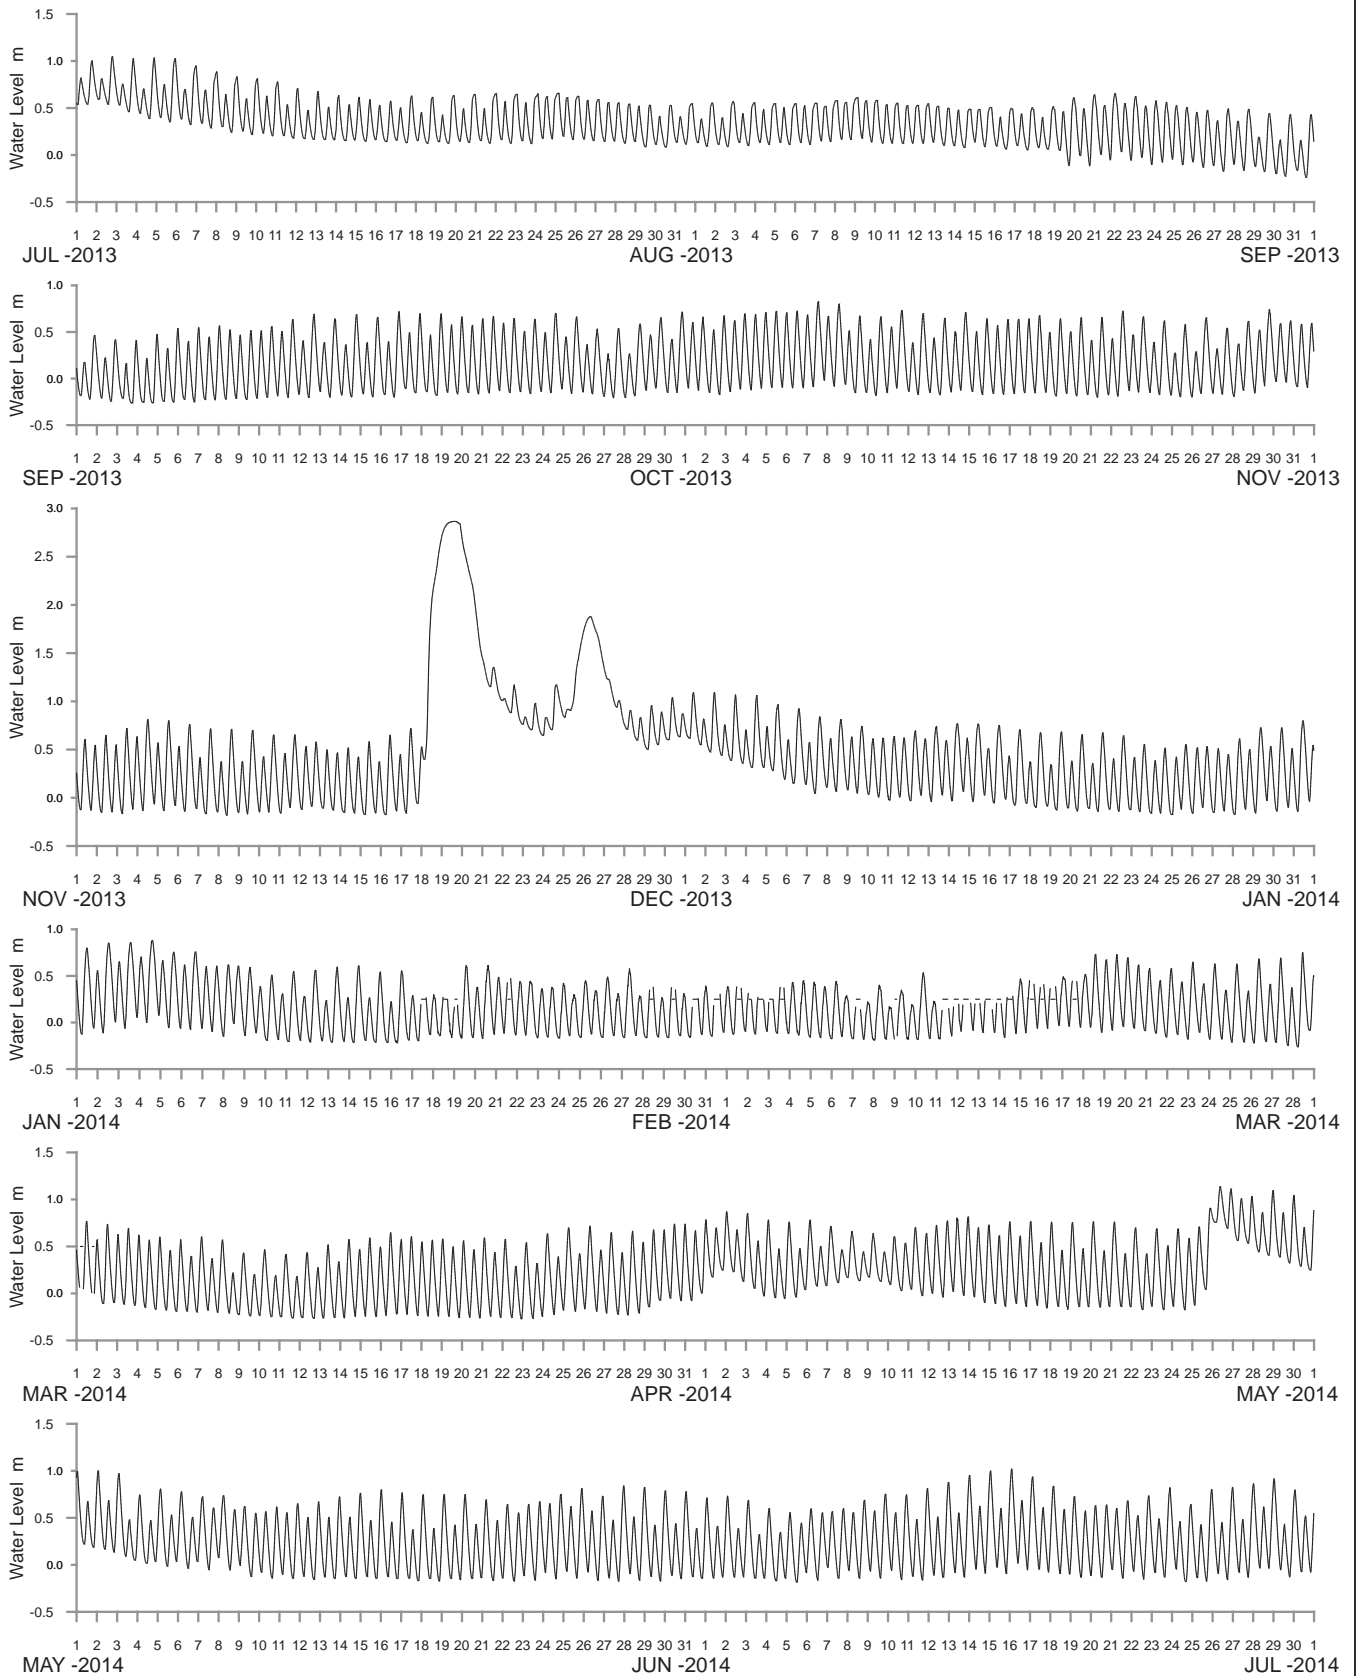
Figure
140

WATER LEVEL REFERENCED TO AUSTRALIAN HEIGHT DATUM

WALLIS CREEK AT WALLIS CREEK UPSTREAM
2013-2014

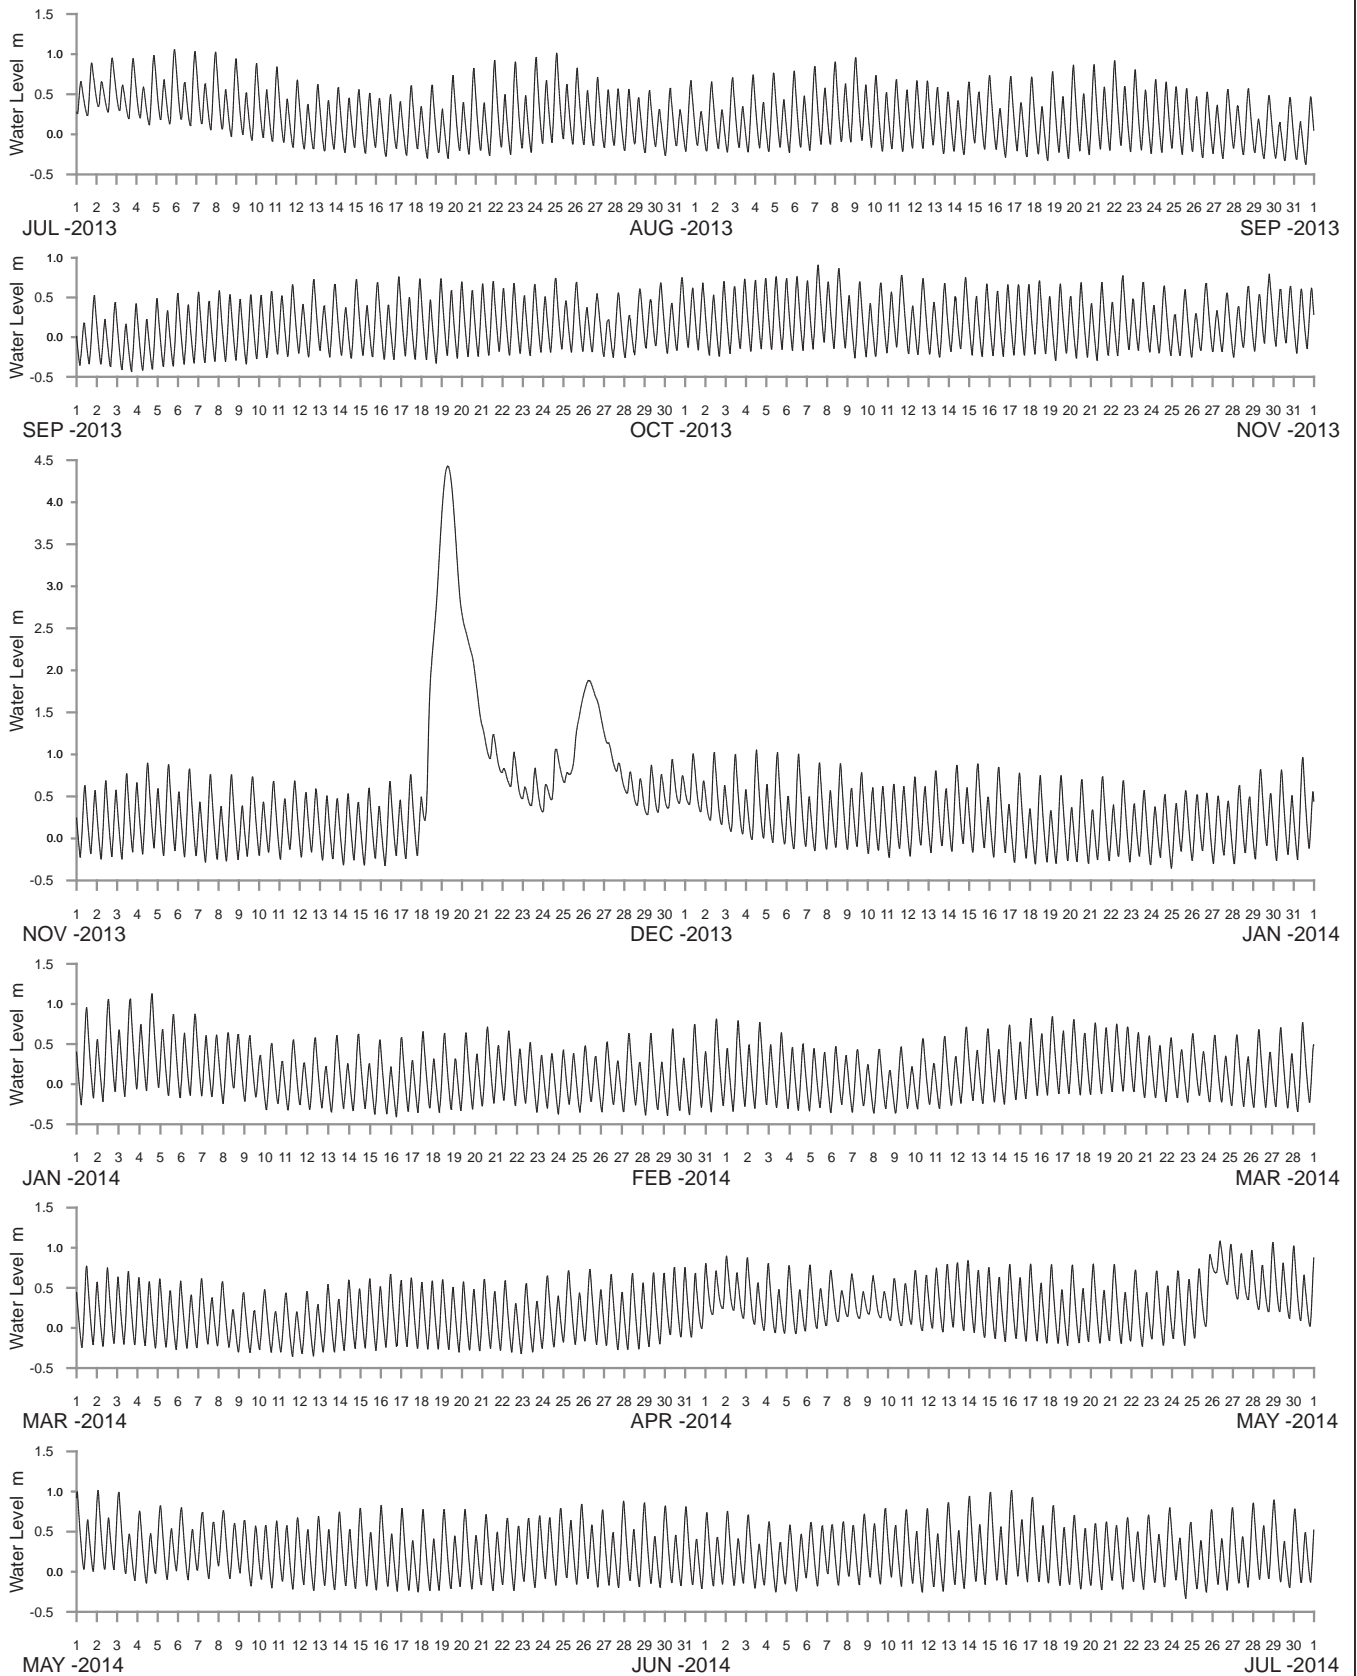
141

WATER LEVEL REFERENCED TO AUSTRALIAN HEIGHT DATUM

WALLIS CREEK AT WALLIS CREEK DOWNSTREAM
2013-2014

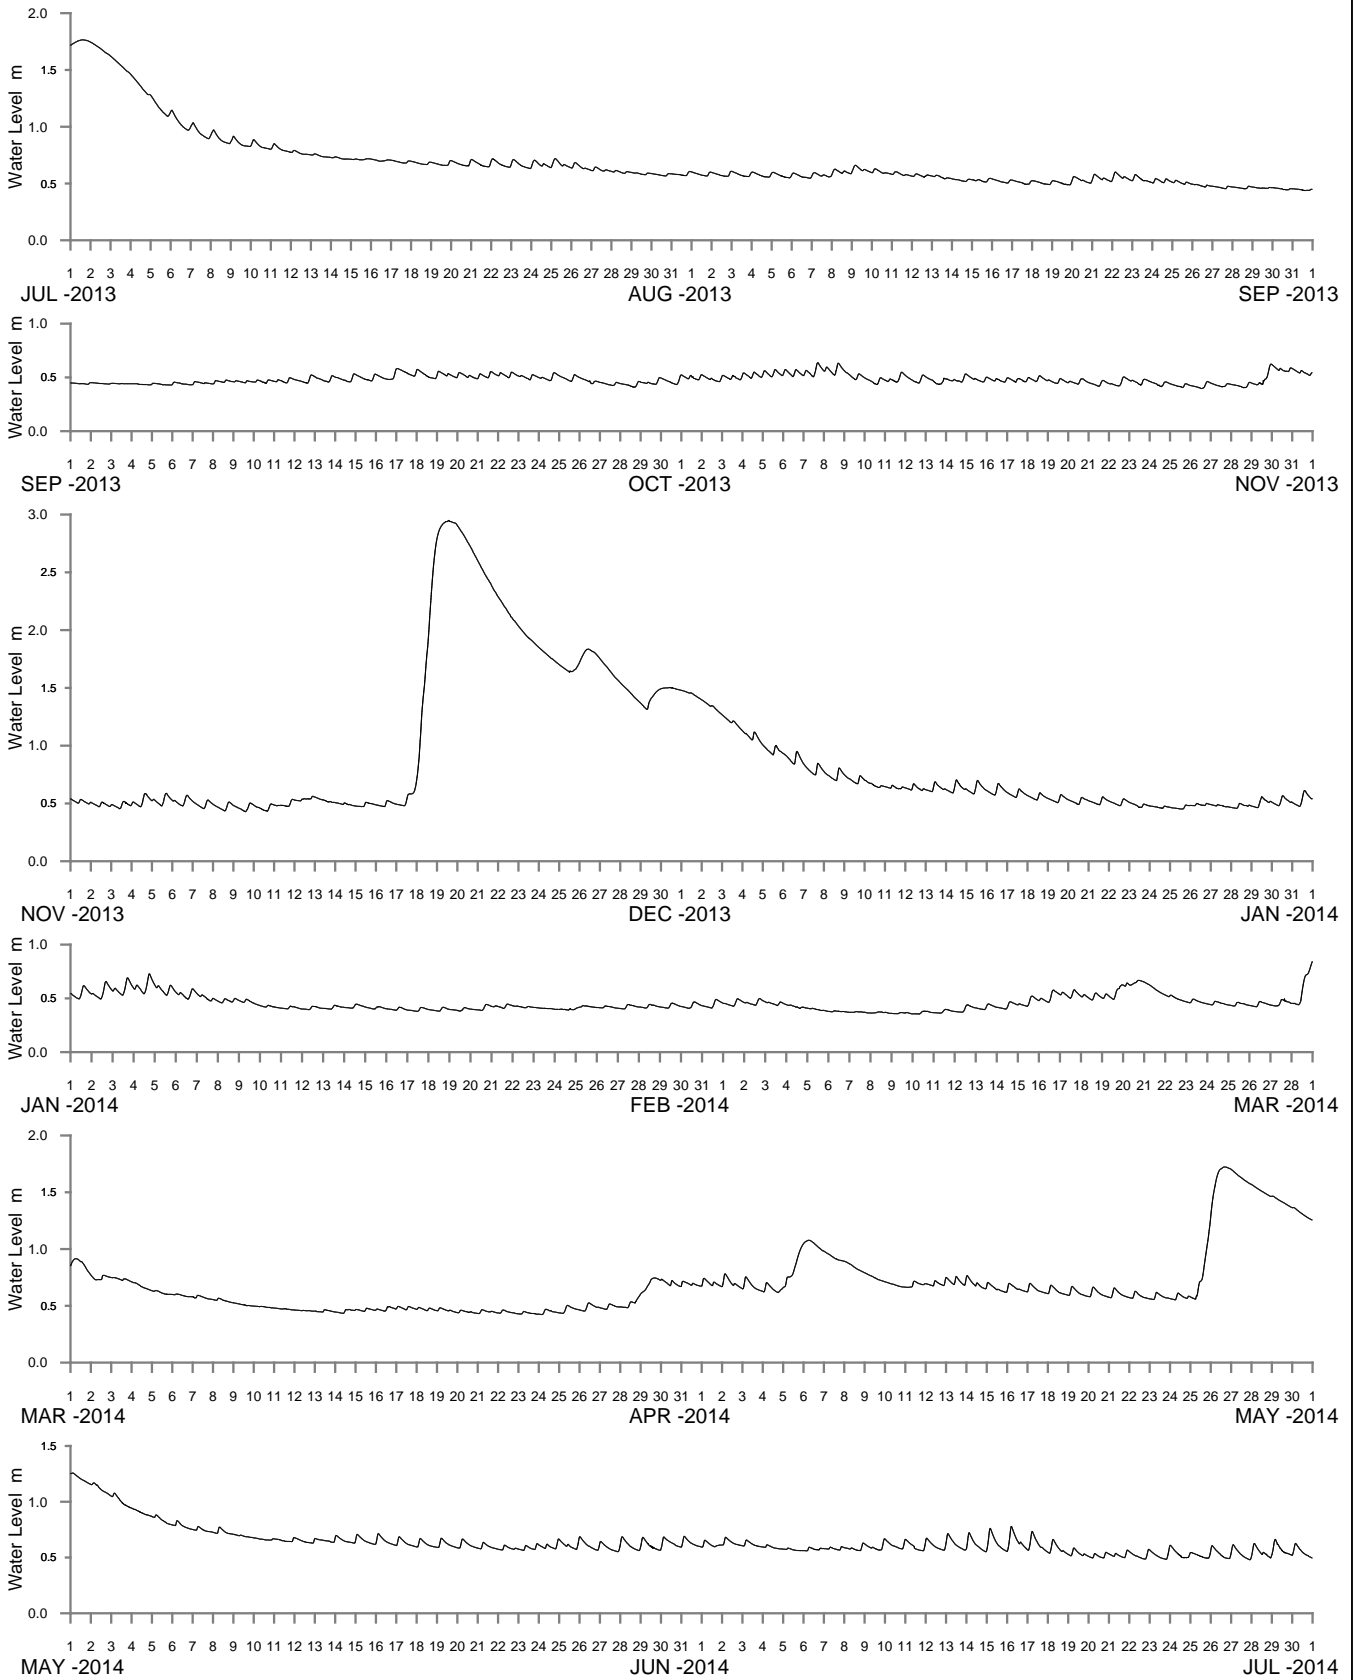
Figure
142

WATER LEVEL REFERENCED TO AUSTRALIAN HEIGHT DATUM

WALLIS CREEK AT LOUTH PARK
2013-2014

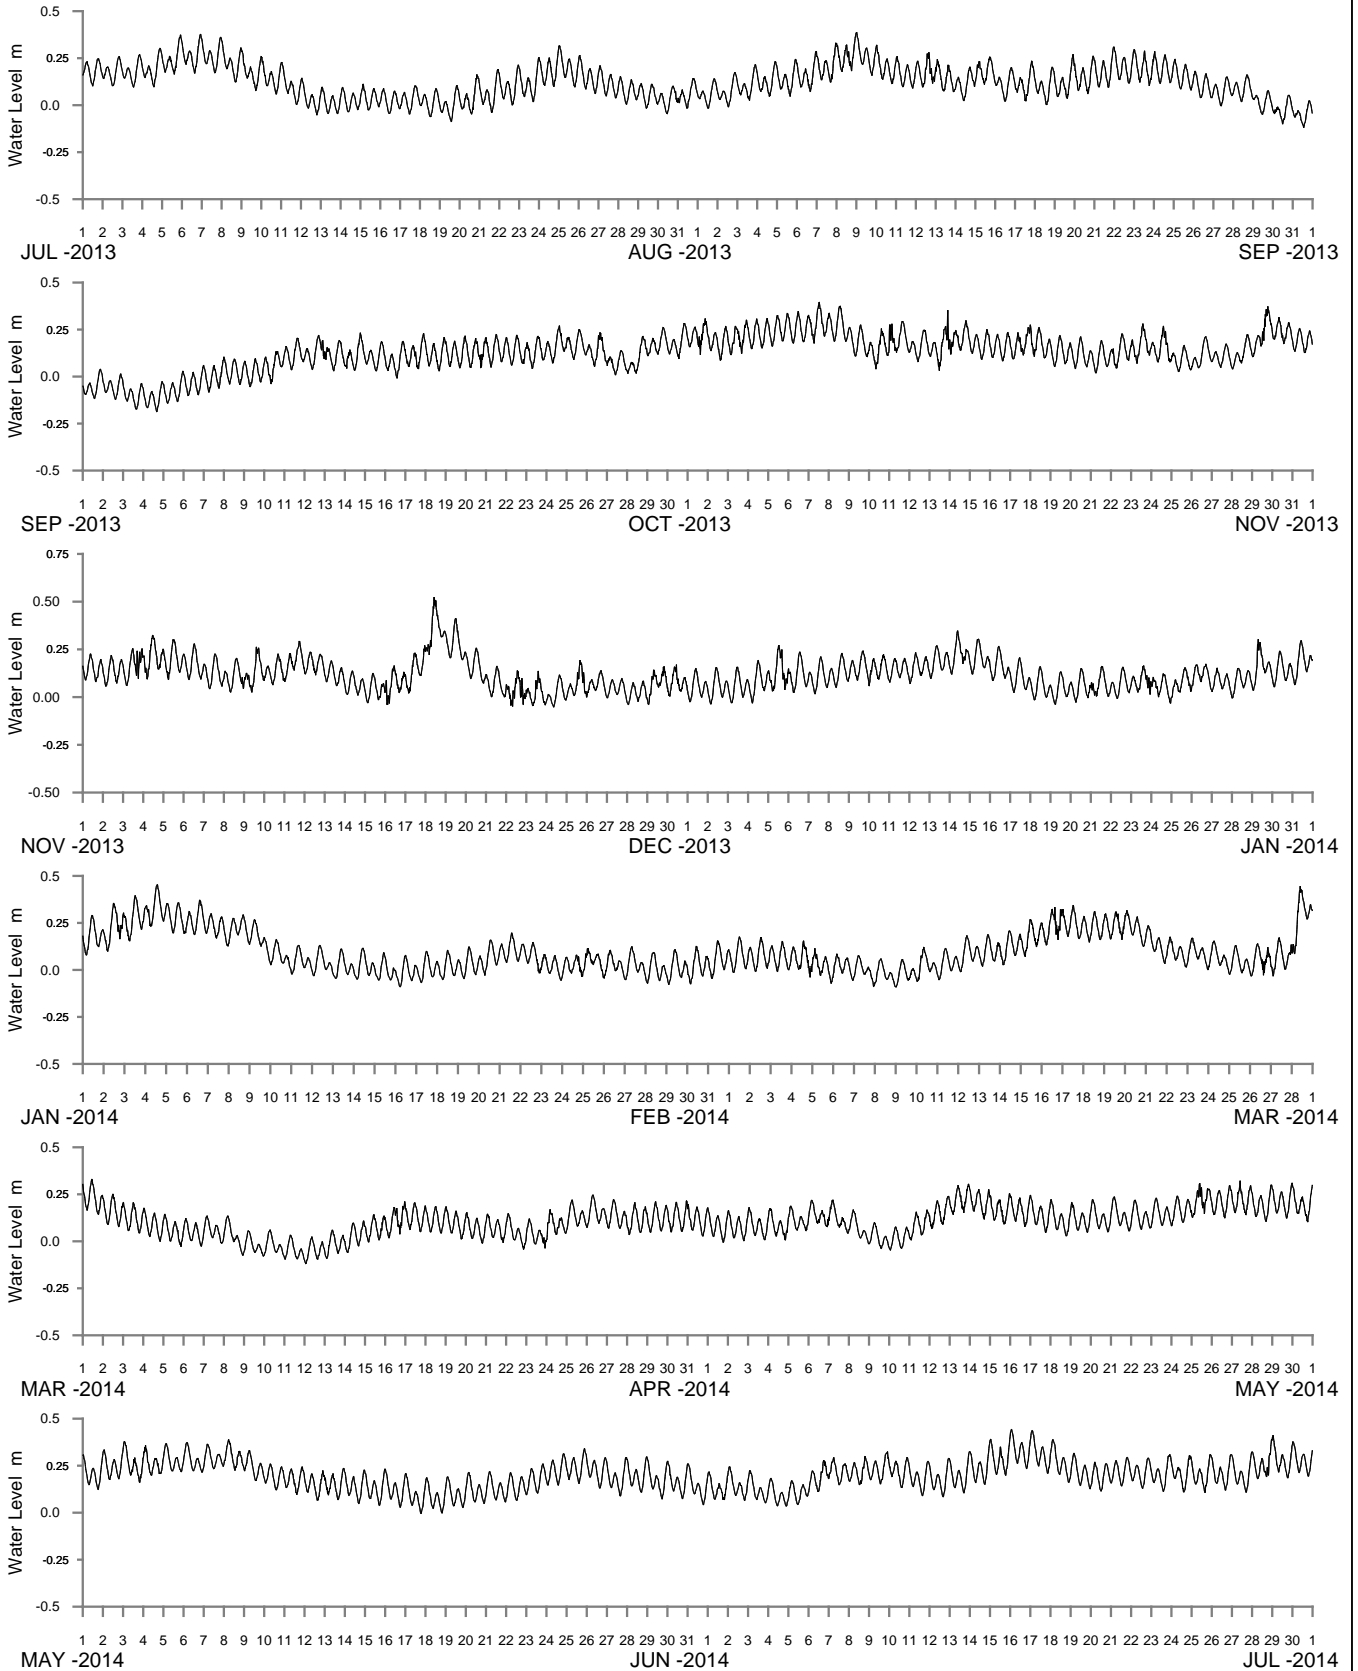
Figure
144

WATER LEVEL REFERENCED TO AUSTRALIAN HEIGHT DATUM

LAKE MACQUARIE AT MARMONG POINT
2013-2014

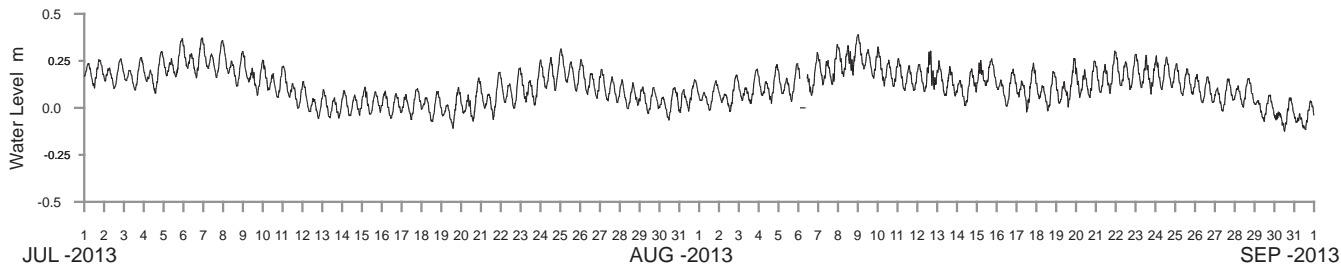
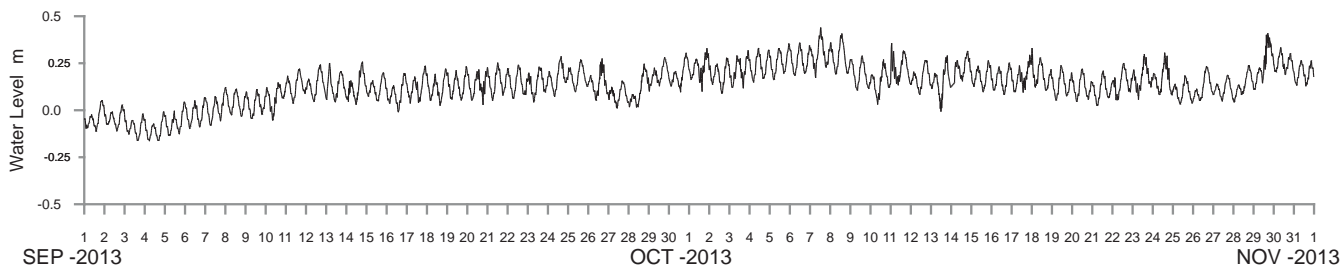
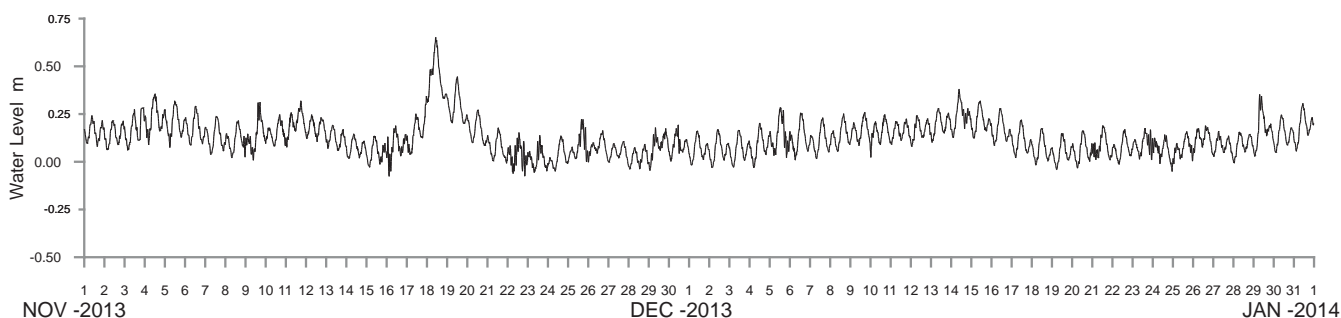
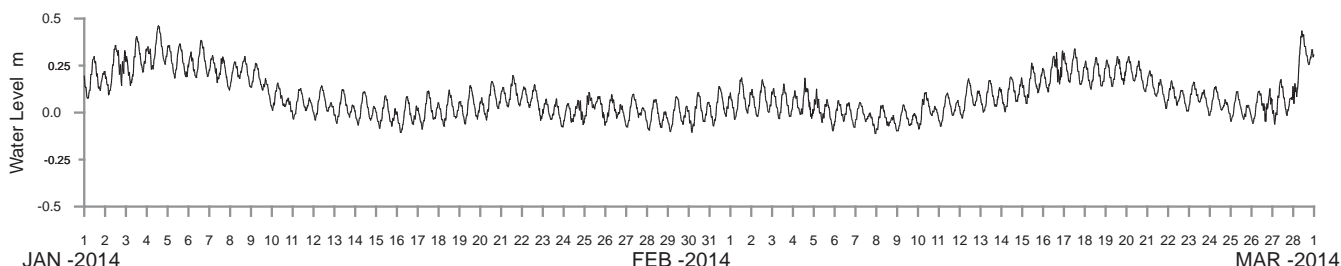
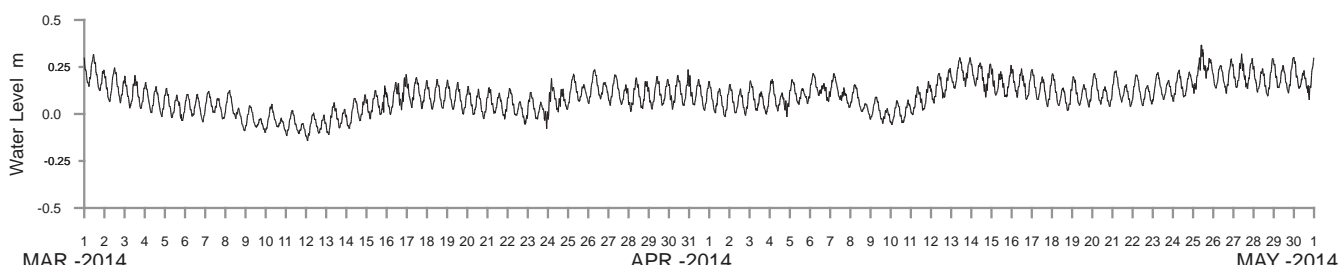
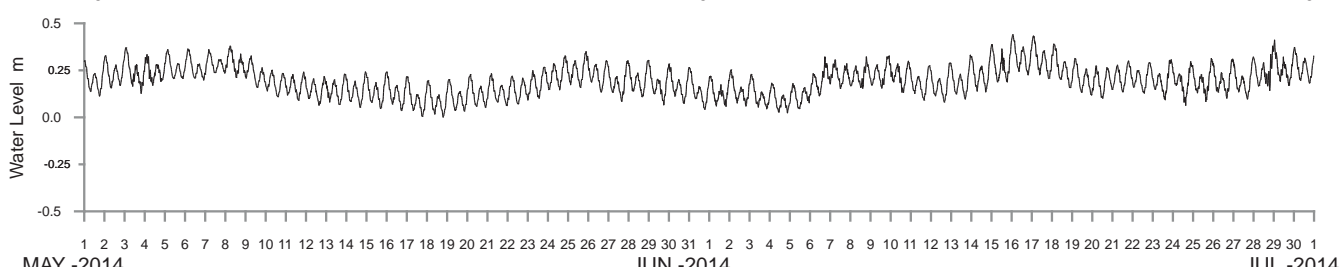
Figure
145

WATER LEVEL REFERENCED TO AUSTRALIAN HEIGHT DATUM

COCKLE CREEK AT COCKLE RAILWAY STATION
2013-2014

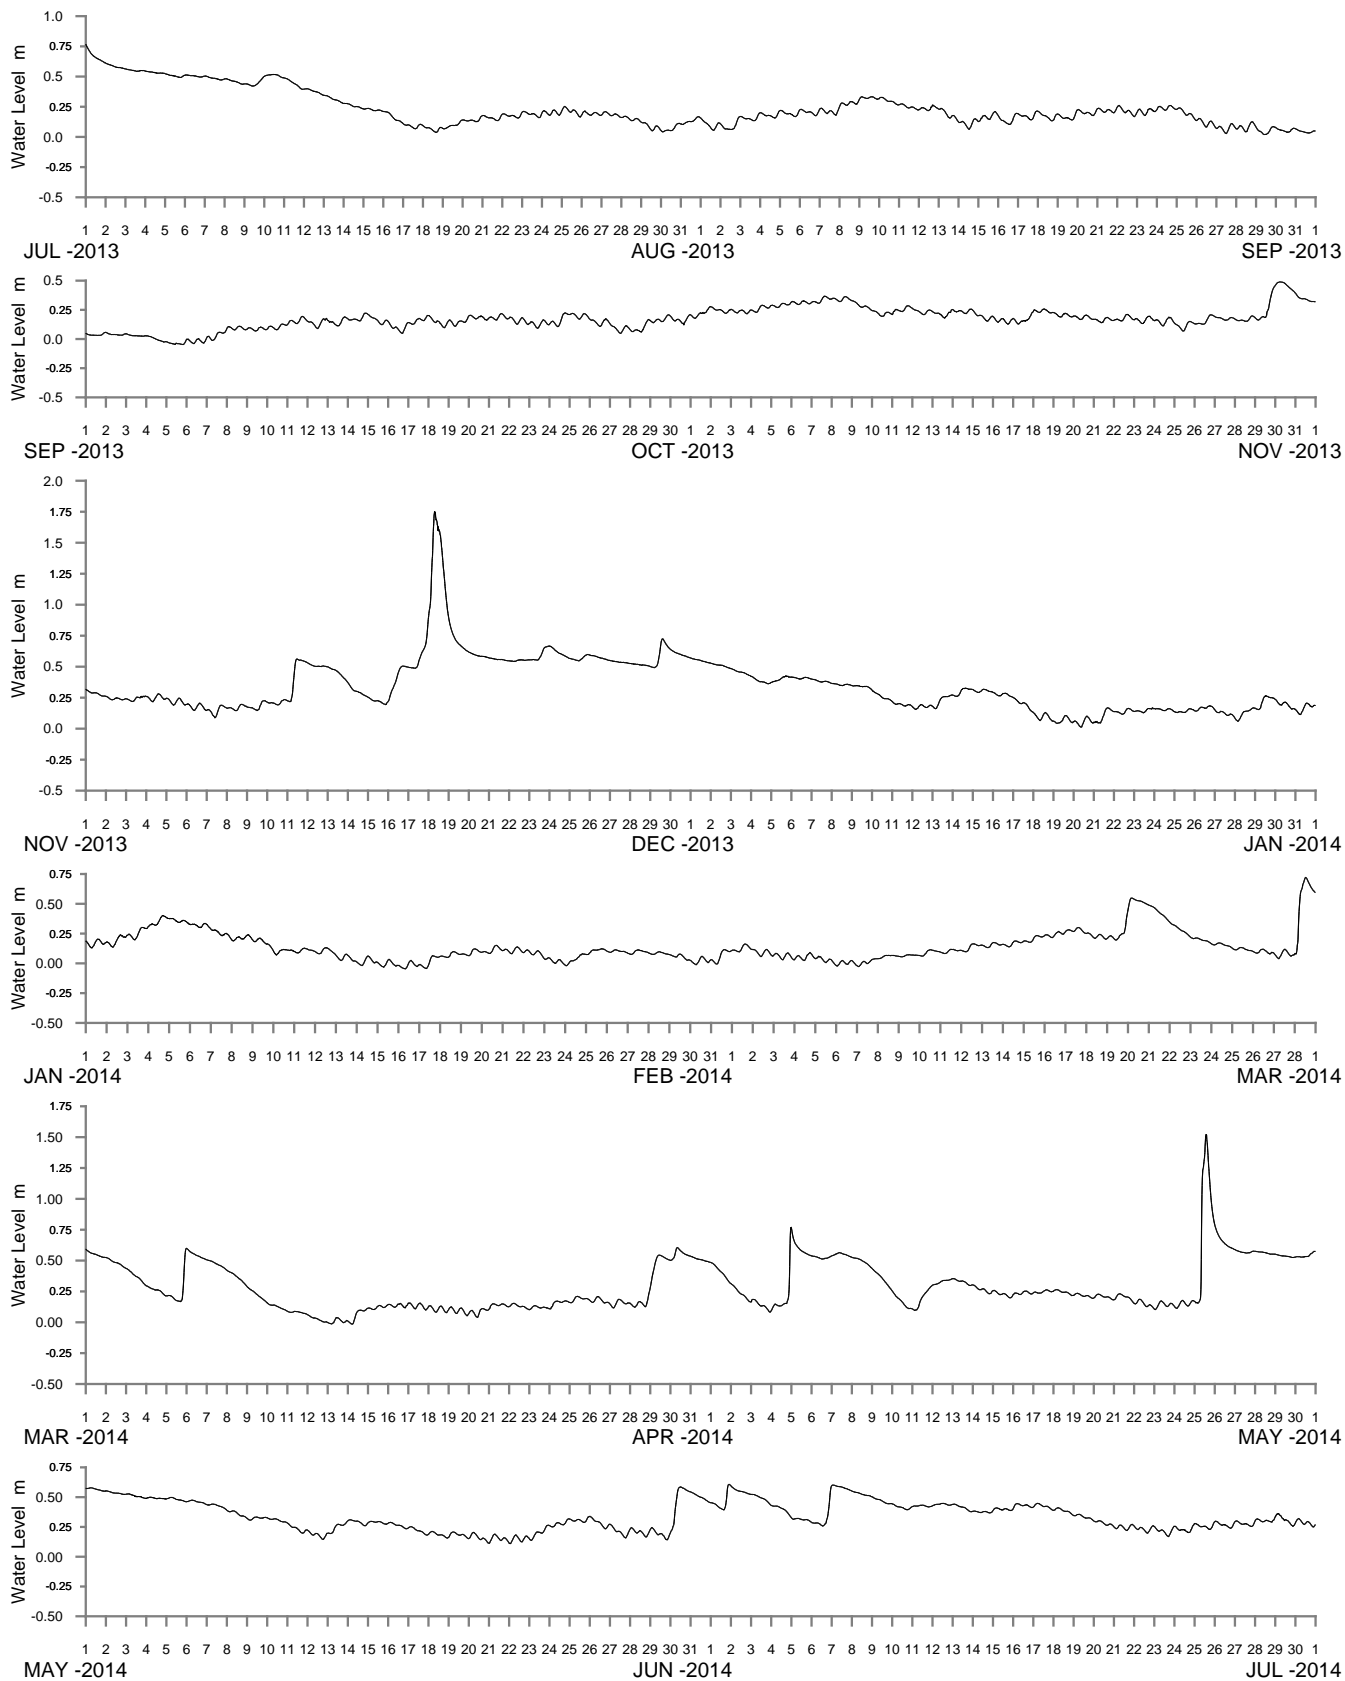
Figure
146

WATER LEVEL REFERENCED TO AUSTRALIAN HEIGHT DATUM

COCKLE CREEK AT BARNSLEY VALE
2013-2014

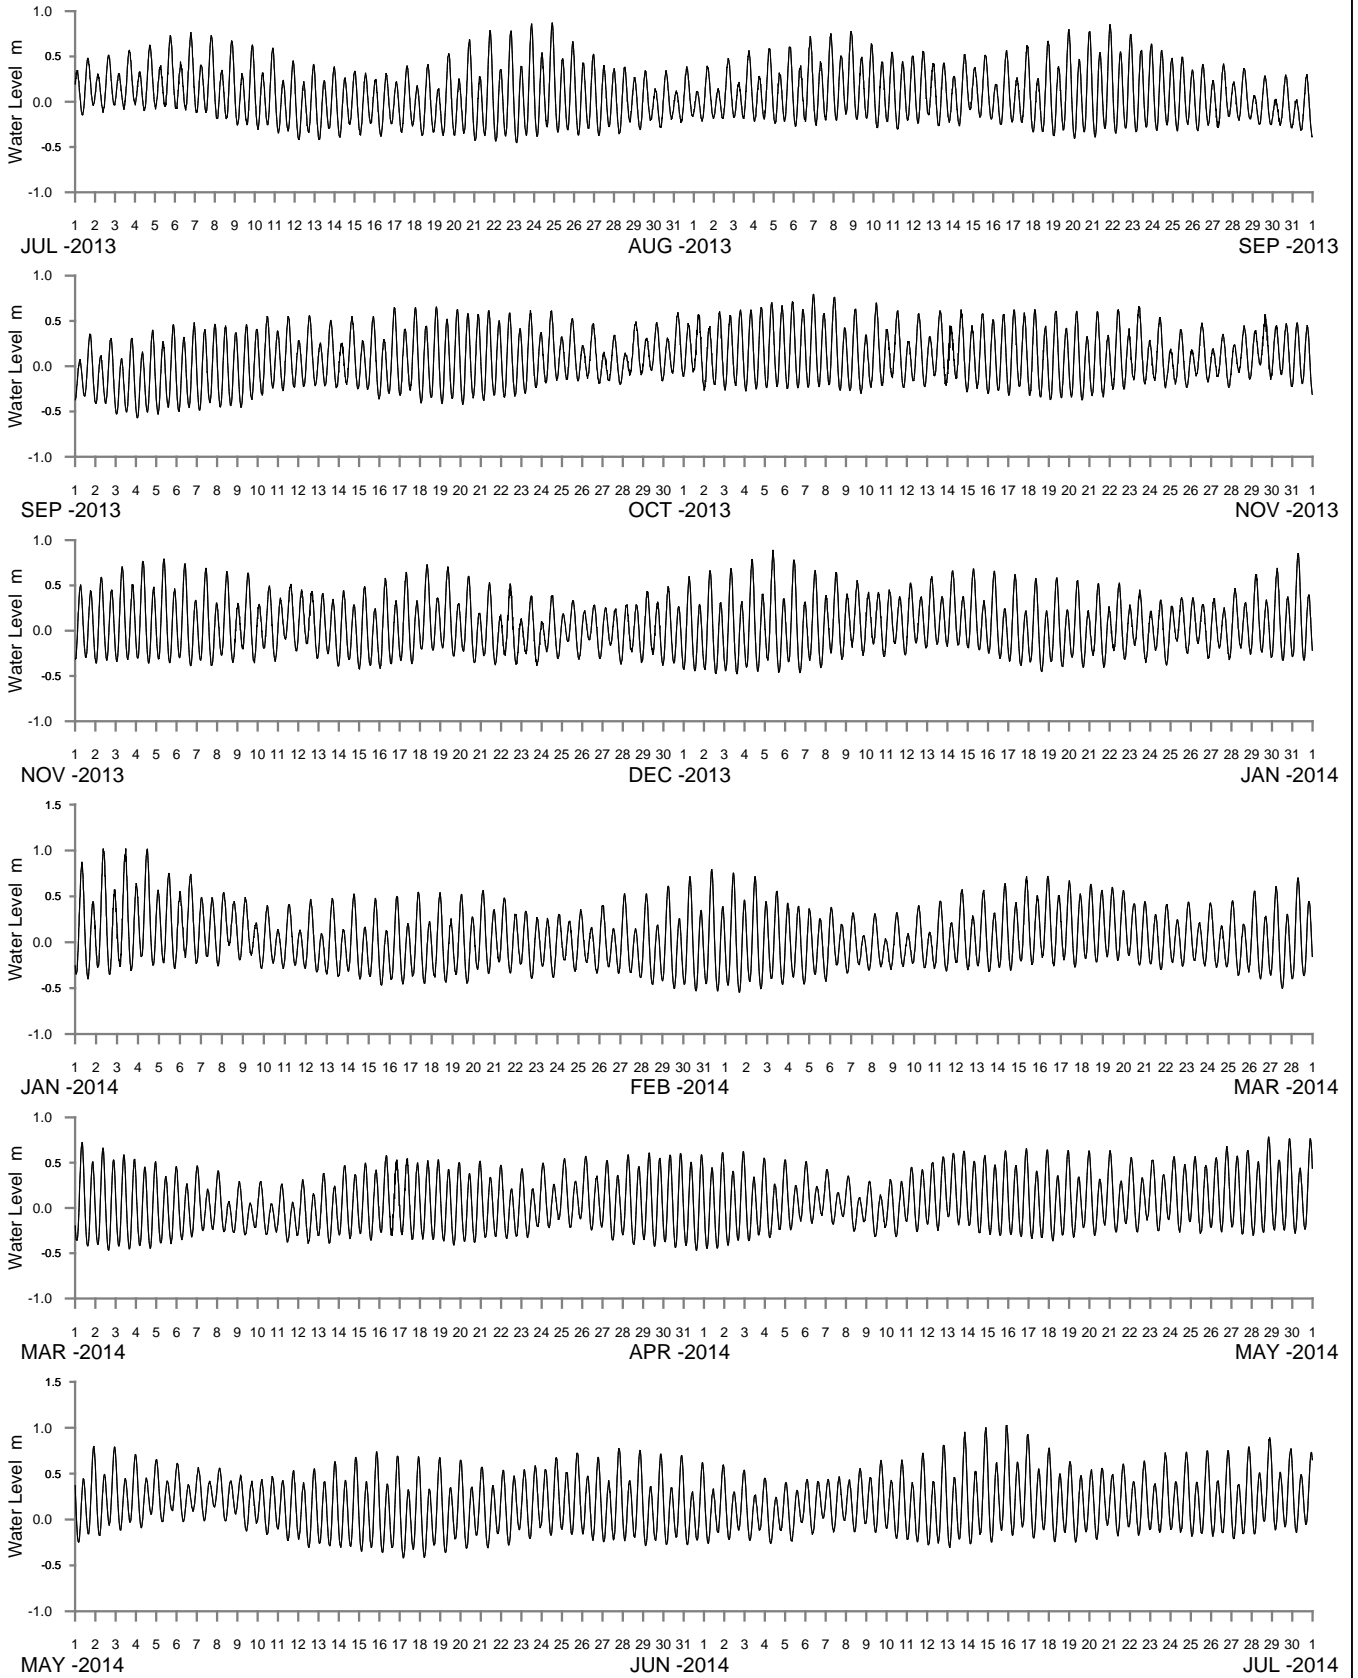
Figure
148

WATER LEVEL REFERENCED TO AUSTRALIAN HEIGHT DATUM

LAKE MACQUARIE AT SWANSEA CHANNEL
2013-2014

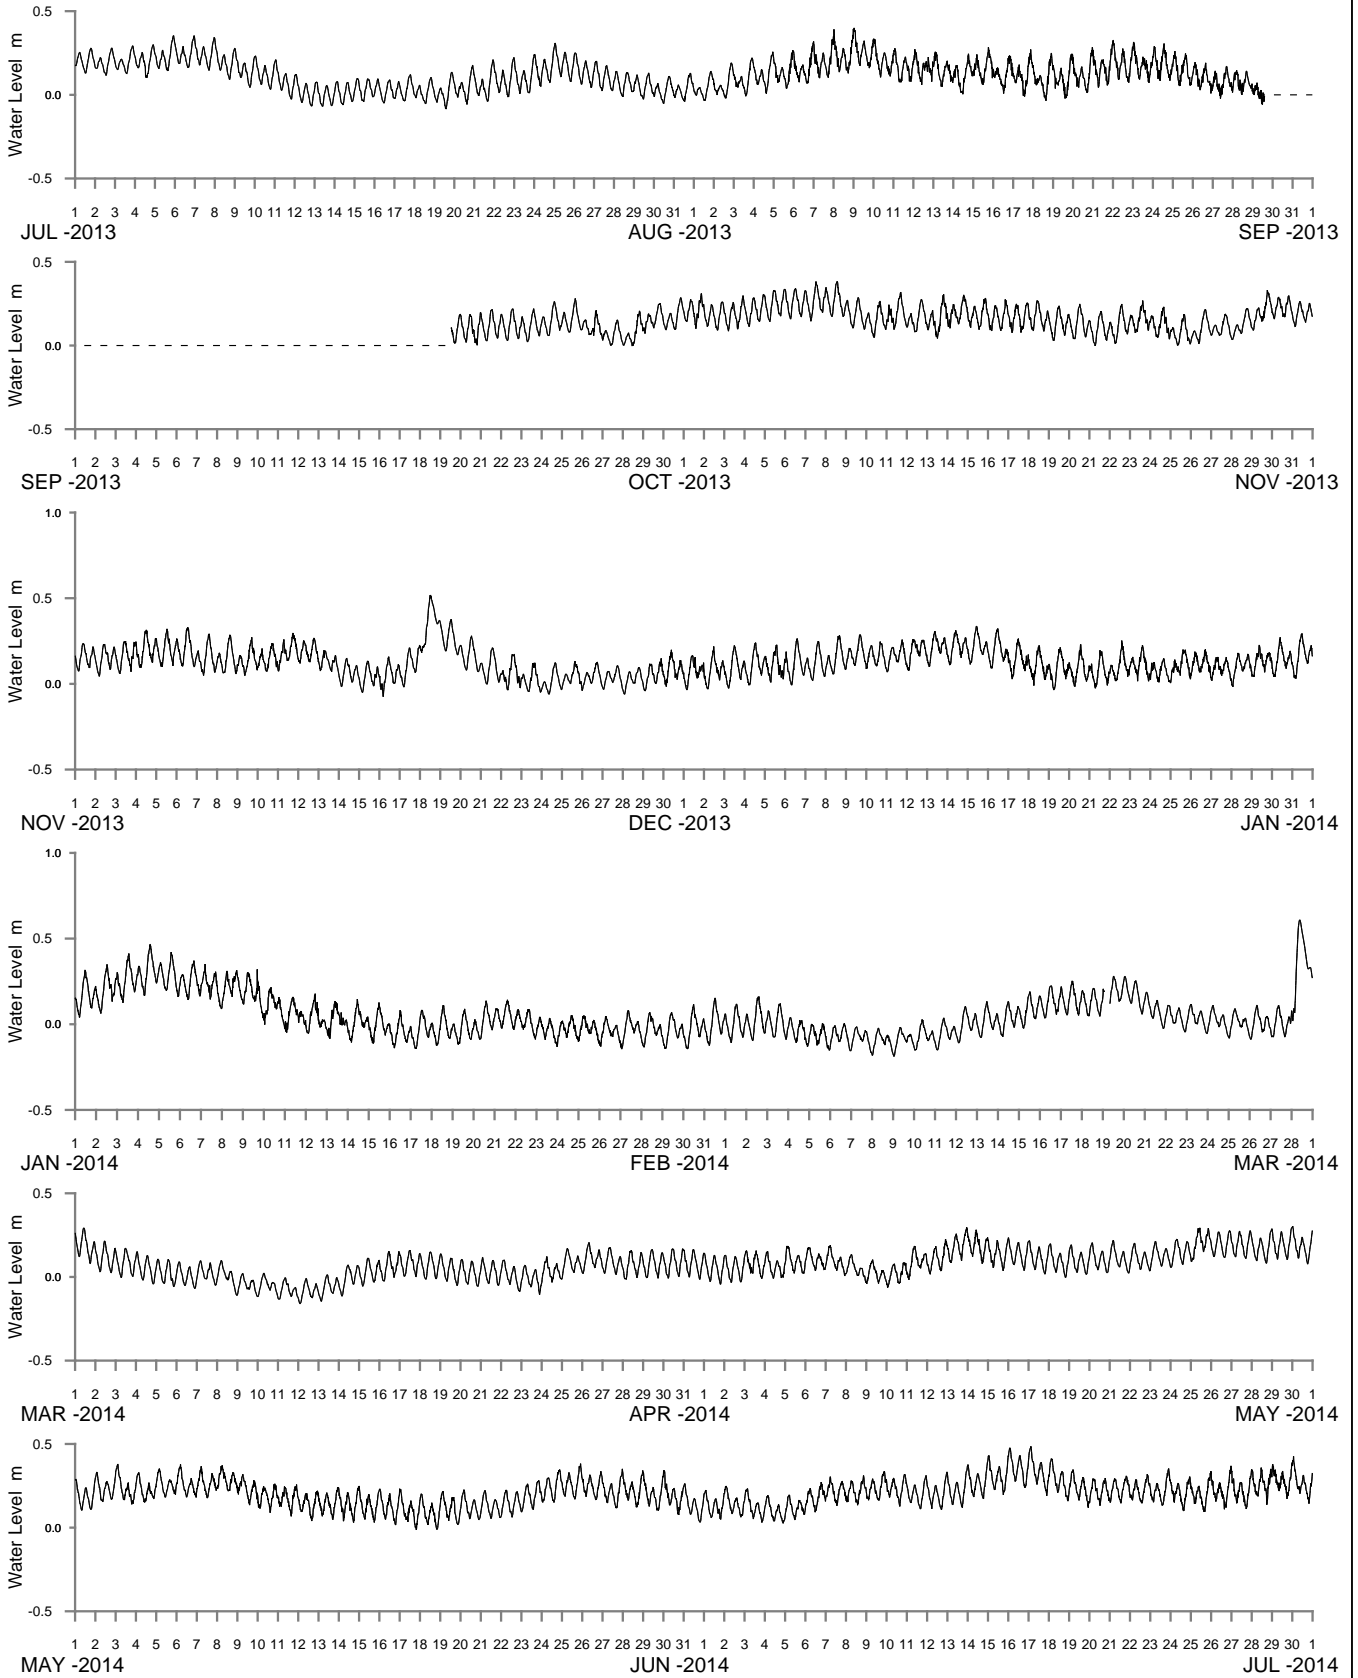
Figure
149

WATER LEVEL REFERENCED TO AUSTRALIAN HEIGHT DATUM

DORA CREEK AT KALANG ROAD
2013-2014

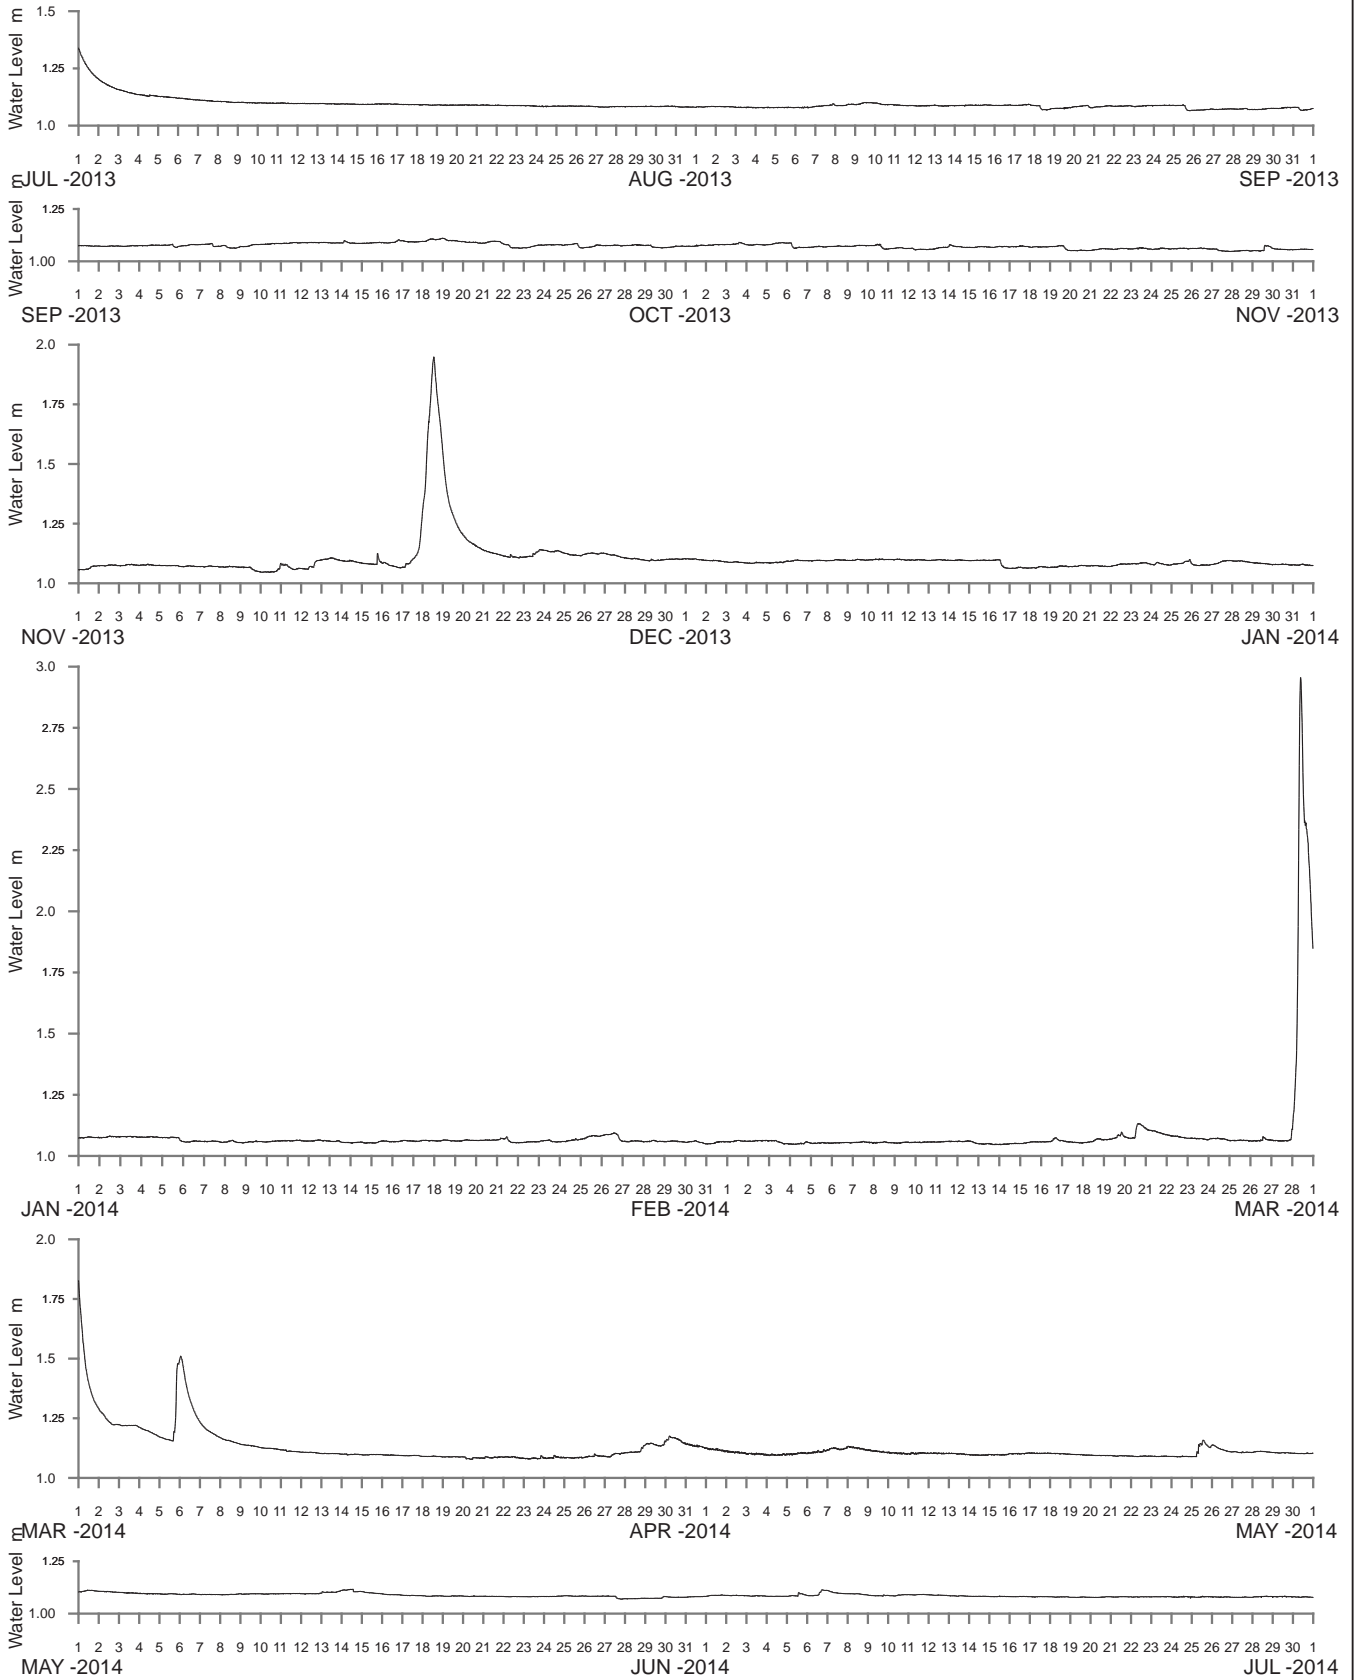
Figure
150

WATER LEVEL REFERENCED TO AUSTRALIAN HEIGHT DATUM

DORA CREEK AT COORANBONG
2013-2014
