Public Works
Manly Hydraulics Laboratory

MHL
Report 2291
Figure
100
DRAWING 2291-100.cdr

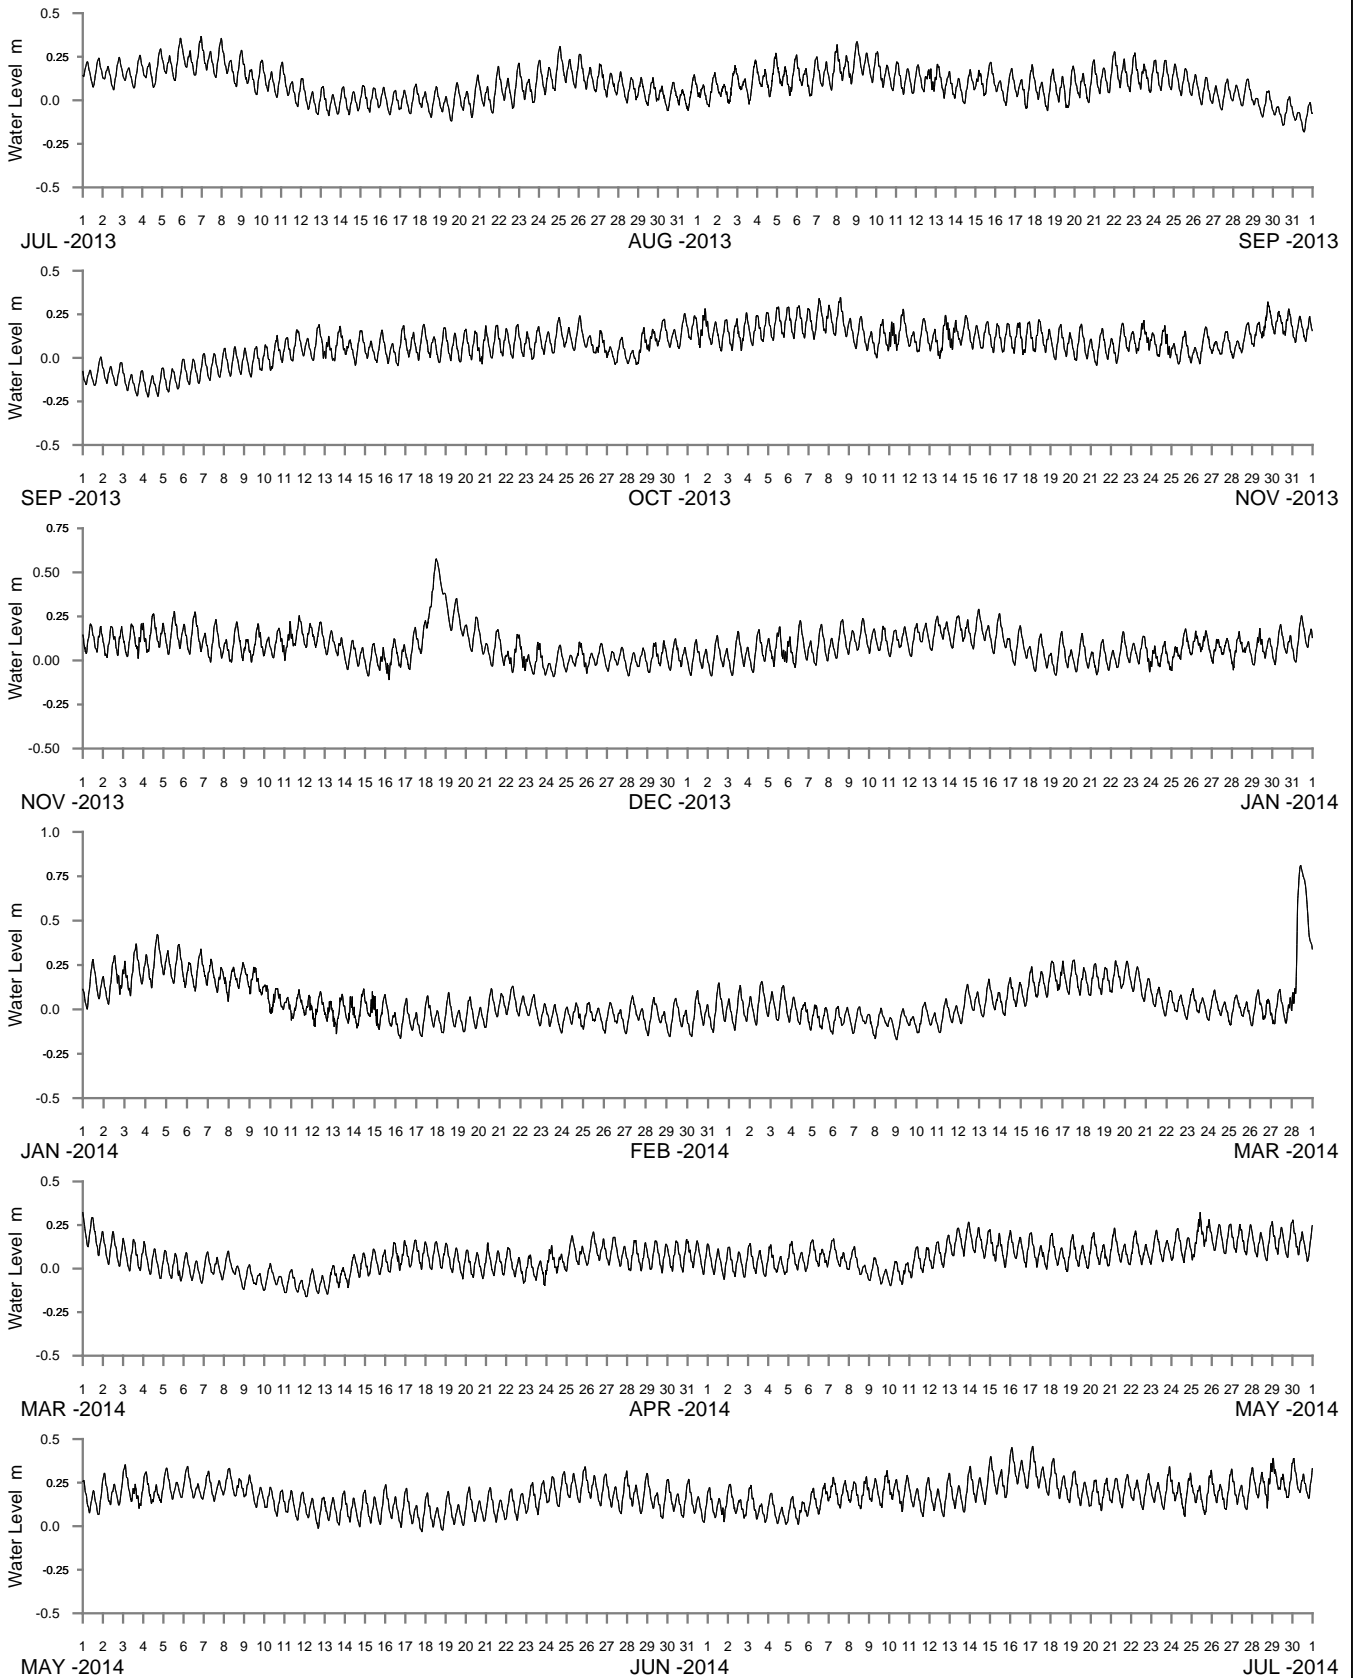
151

WATER LEVEL REFERENCED TO AUSTRALIAN HEIGHT DATUM

STOCKTON CREEK AT MORISSET
2013-2014
