<b>River/Estuary System</b>	<b>Station Name</b>	<b>Figure</b>
Station Locality Map	Woolgoolga Region	52
Wooli River	Wooli Entrance	53
Wooli River	Wooli Caravan Park	54
Corindi Creek	Red Rock	55
Woolgoolga Lake	Woolgoolga Lake	56
Woolgoolga Creek	Woolgoolga	57
Moonee Creek	Moonee Creek	58
Station Locality Map	Coffs Harbour Region	59
Coffs Creek	Coffs Creek Highway Bridge	60
Newports Creek	Newports Creek	61
Boambee Creek	Boambee	62
Boambee Creek	Boambee Entrance	63
Station Locality Map	Bellingher River Region	64
Bonville Creek	Bonville	65
Bellingher River	Repton	66
Bellingher River	Bellingher Bridge	67
Kalang River	Urunga	68
Kalang River	Upstream Newry Island	69
Kalang River	Koorowwi	70
Station Locality Map	Nambucca River Region	71
Deep Creek	Deep Creek	72
Nambucca River	Stuarts Island Downstream	73
Nambucca River	Macksville	74
Nambucca River	Utungun	75
Nambucca River	Bowraville Downstream	76
Warrell Creek	Warrell Creek	77

**Public Works**  
Manly Hydraulics Laboratory

MHL  
Report 2383

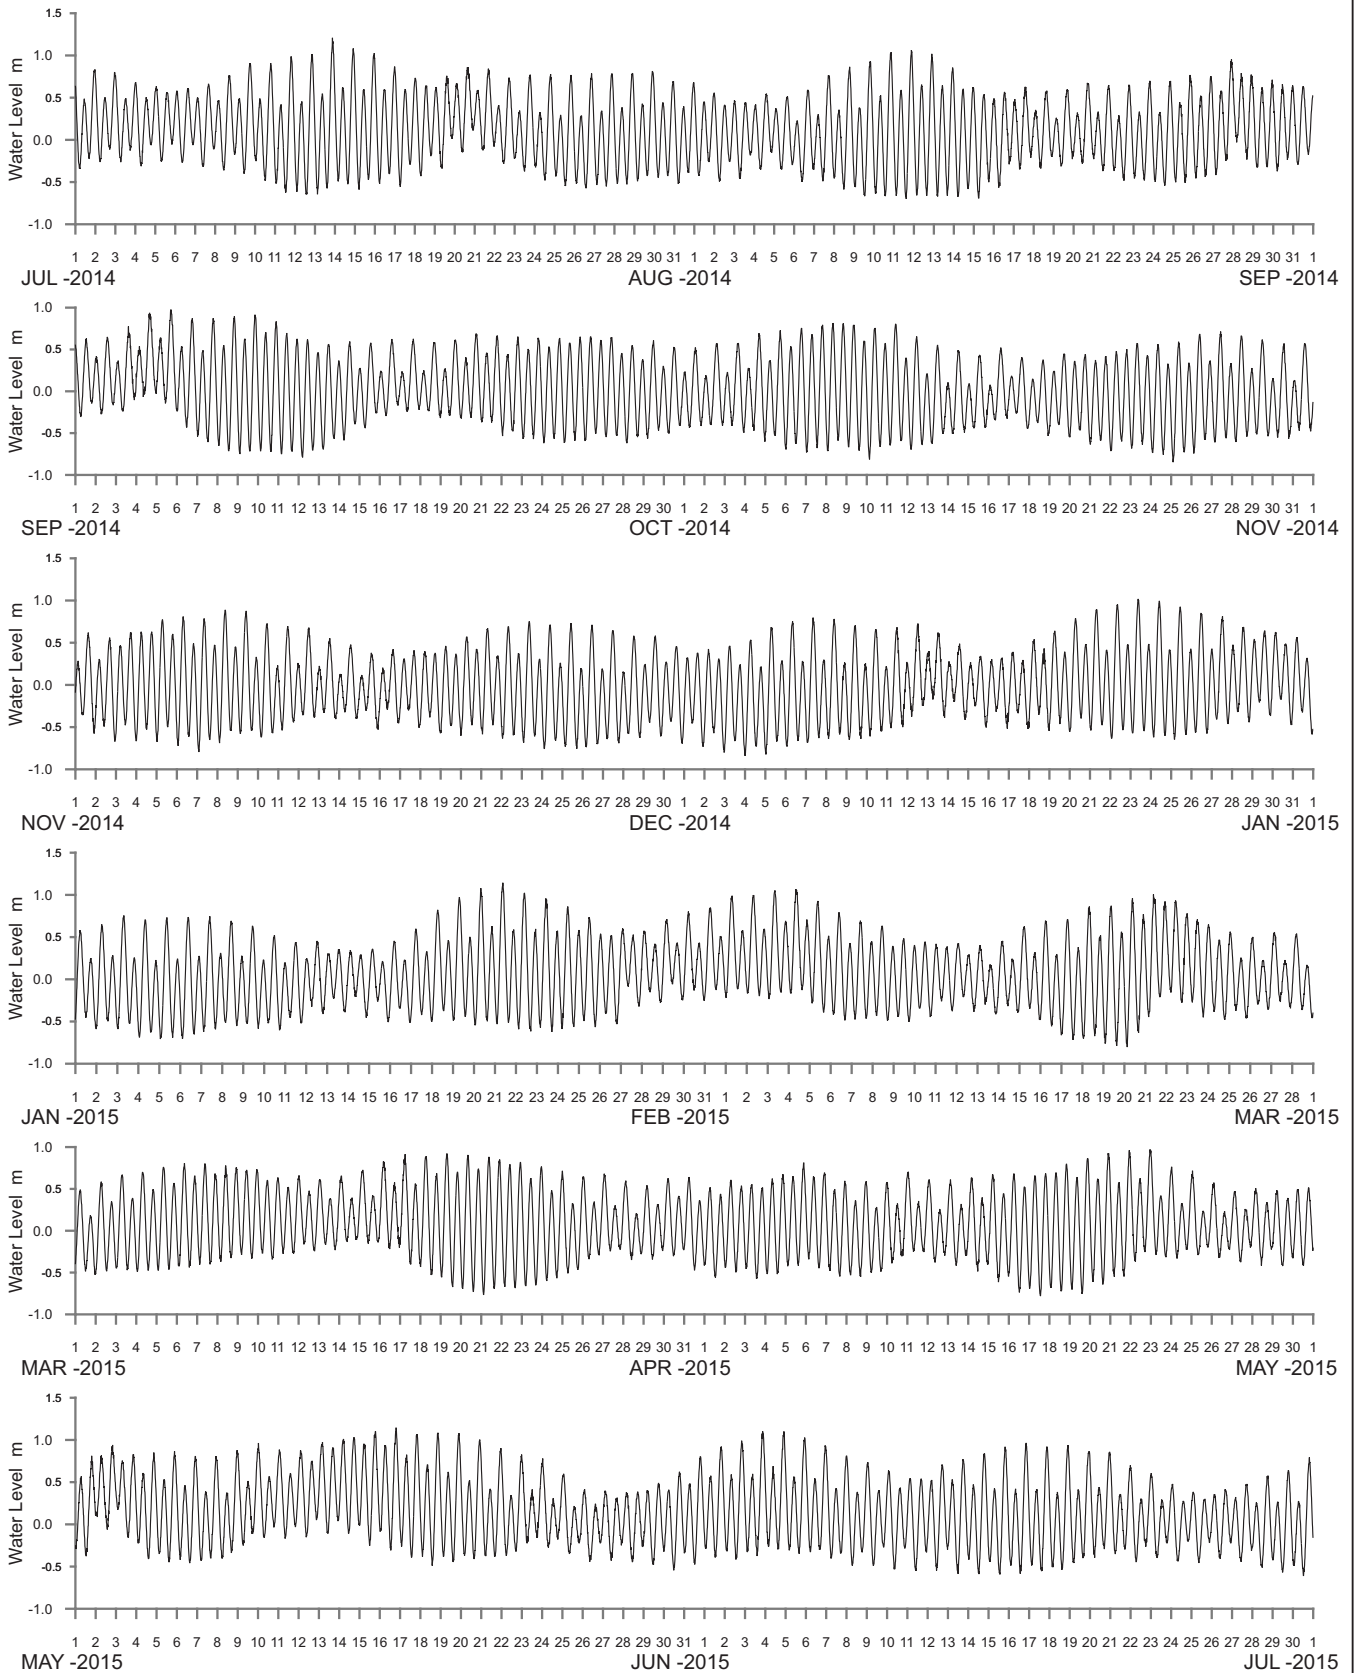
Figure  
53

WATER LEVEL REFERENCED TO AUSTRALIAN HEIGHT DATUM

----- DATA LOSS

**WOOLI RIVER AT WOOLI ENTRANCE**  
2014–2015

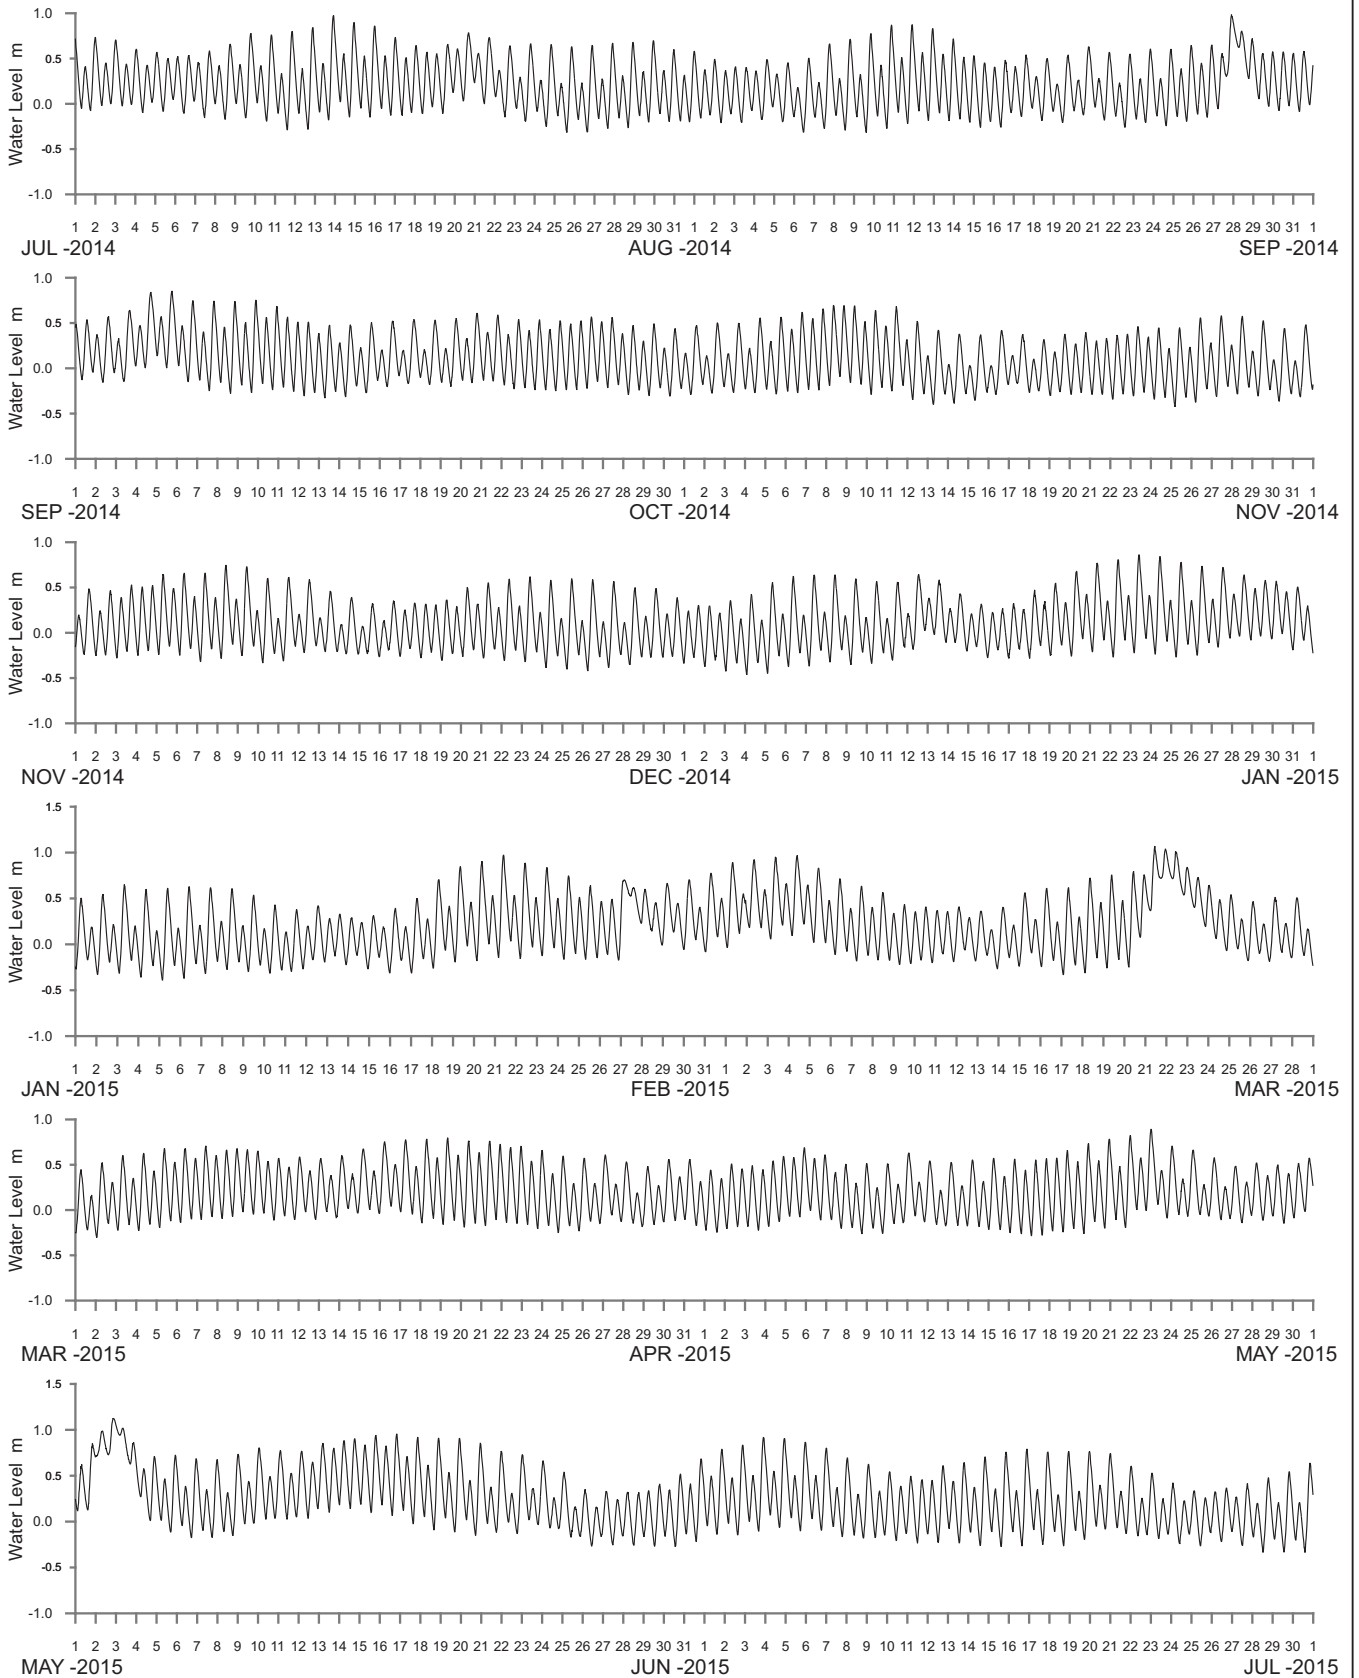
Figure  
54

WATER LEVEL REFERENCED TO AUSTRALIAN HEIGHT DATUM

----- DATA LOSS

**WOOLI RIVER AT WOOLI CARAVAN PARK**  
2014–2015

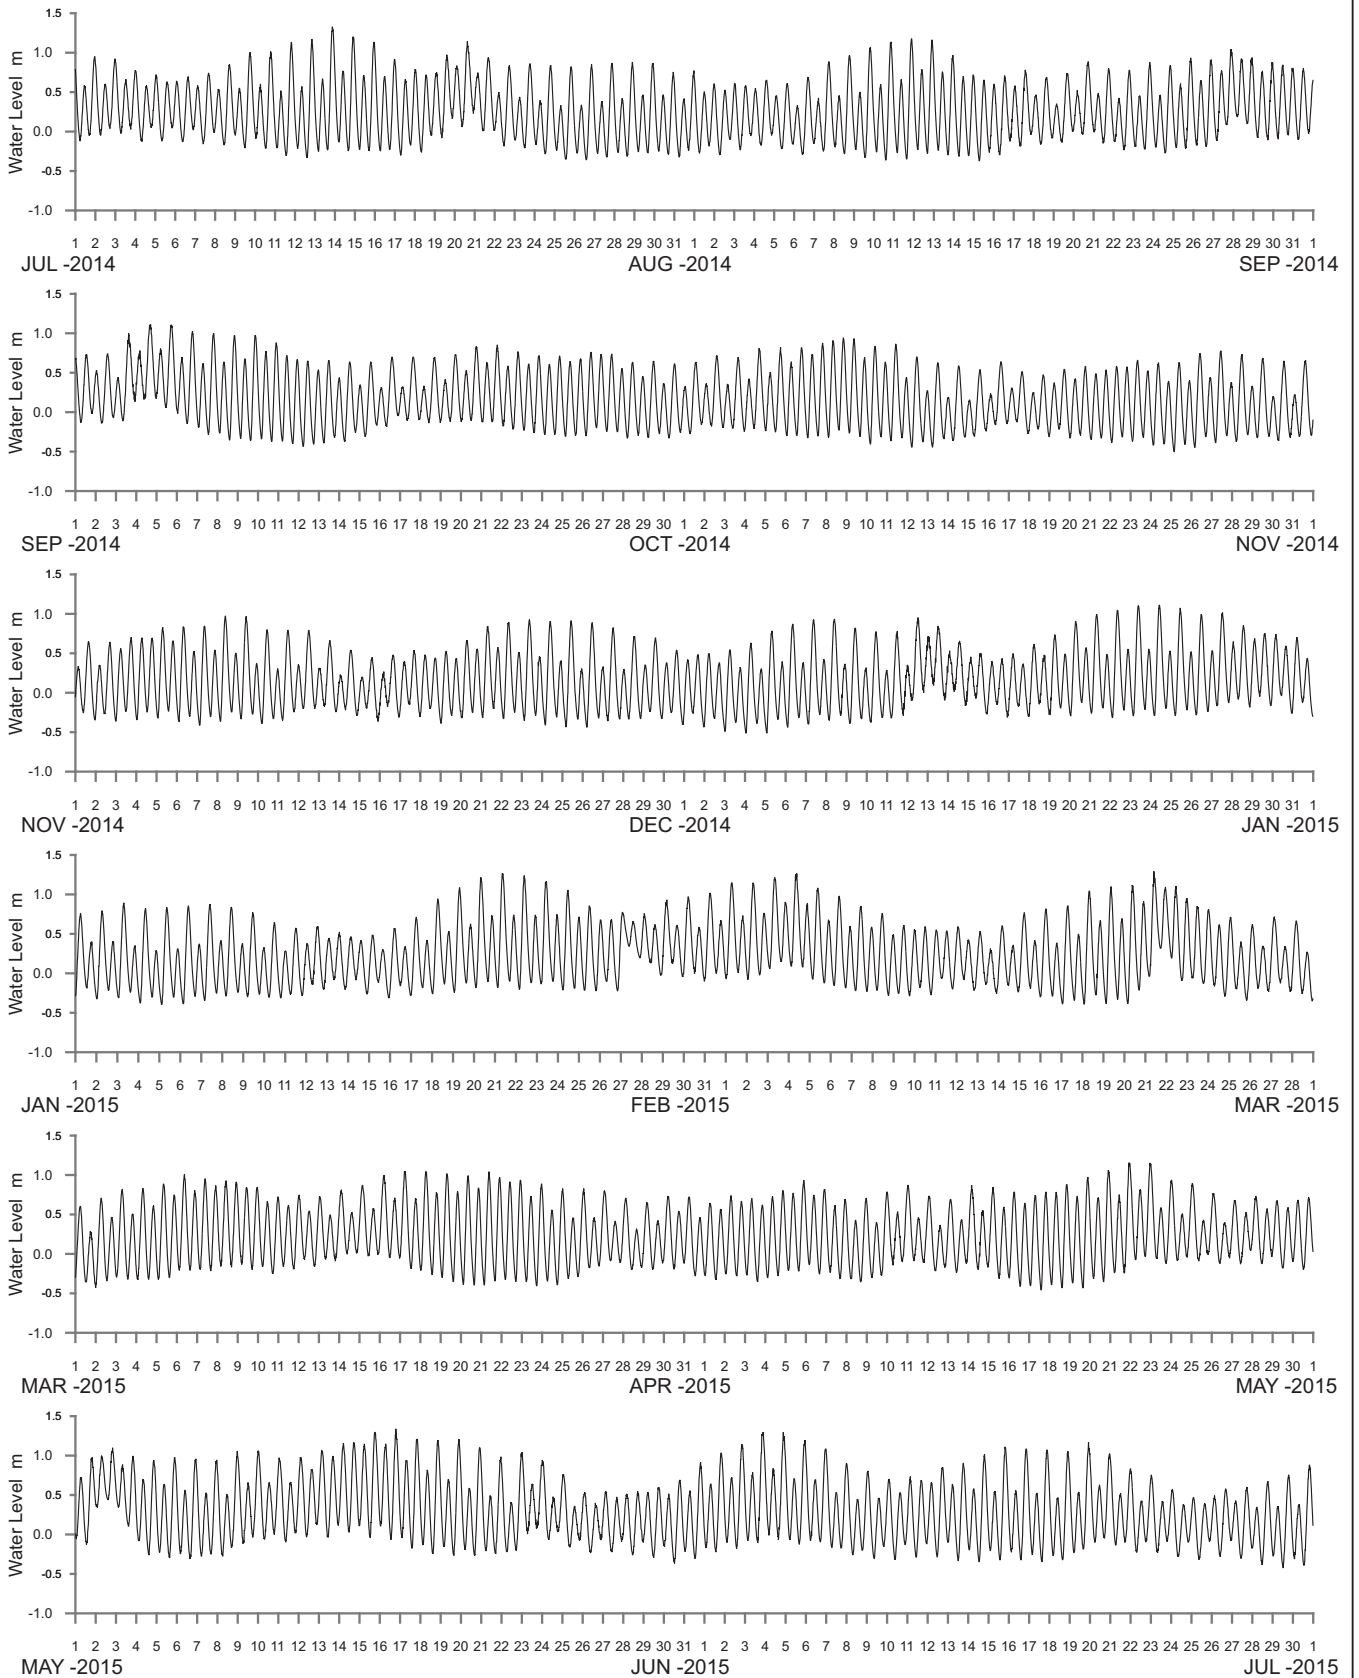
Figure  
**55**

WATER LEVEL REFERENCED TO AUSTRALIAN HEIGHT DATUM

----- DATA LOSS

**CORINDI CREEK AT RED ROCK**  
2014–2015

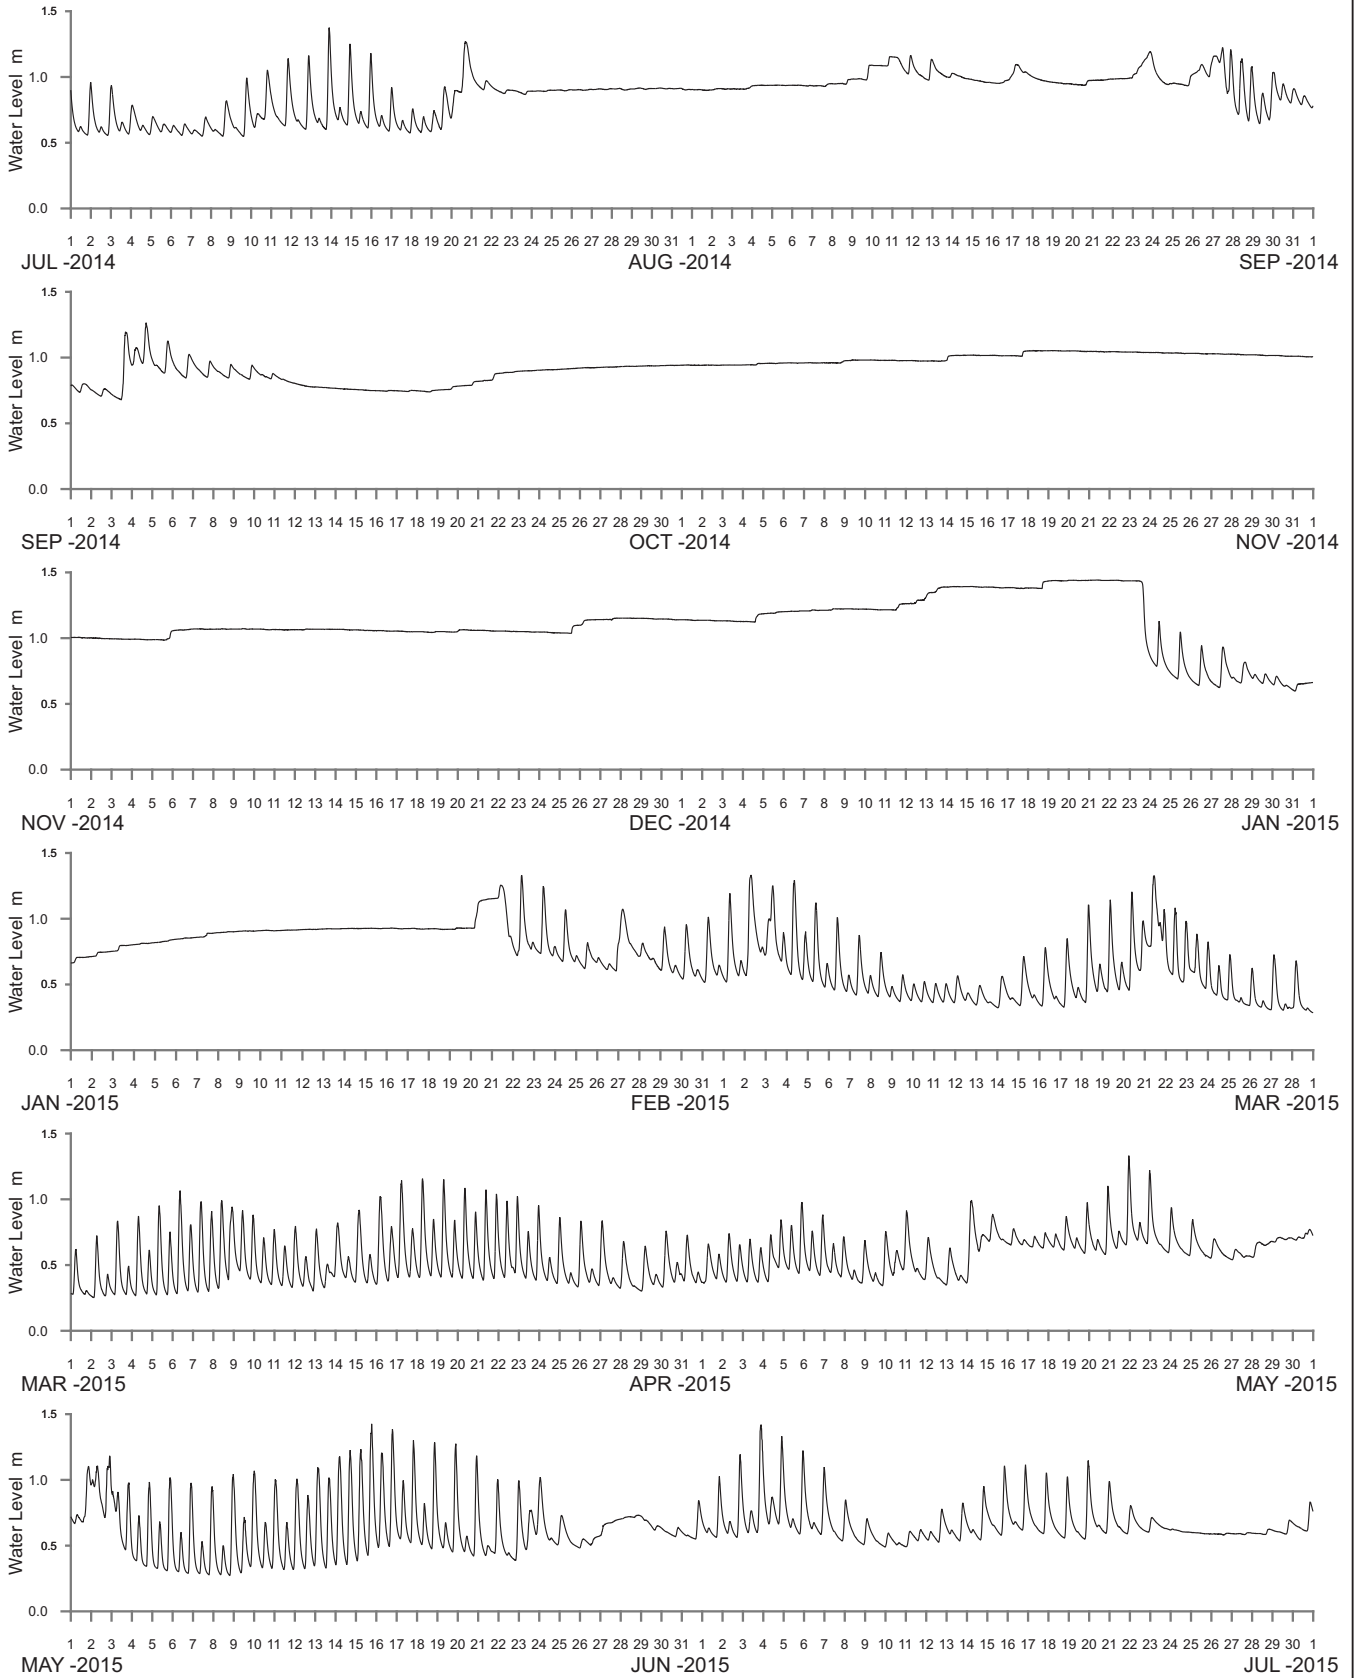
Figure  
**56**

WATER LEVEL REFERENCED TO AUSTRALIAN HEIGHT DATUM

----- DATA LOSS

**WOOLGOOLGA LAKE AT WOOLGOOLGA LAKE**  
2014-2015

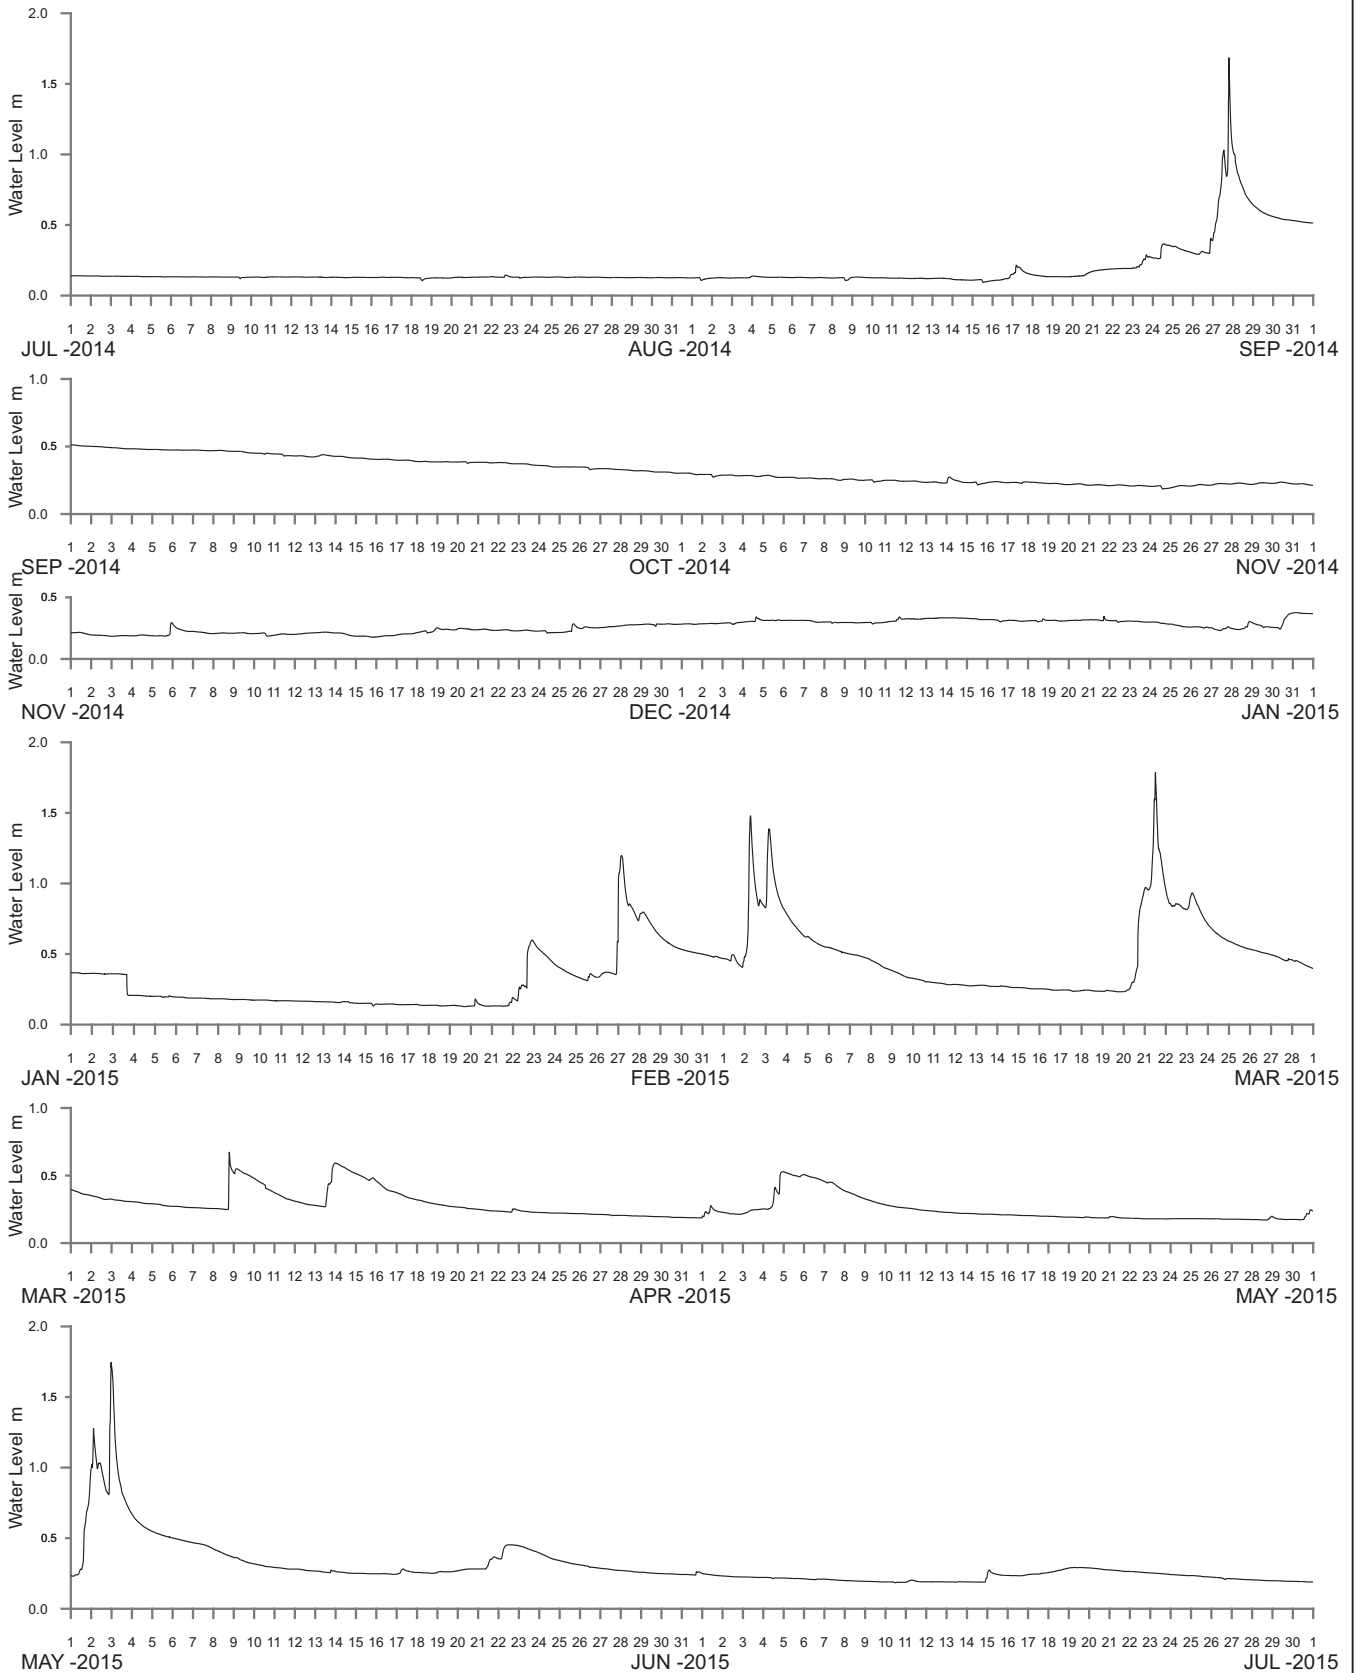
Figure  
**57**

WATER LEVEL REFERENCED TO CTF OF CONTROL STRUCTURE

----- DATA LOSS

**WOOLGOOLGA CREEK AT WOOLGOOLGA**  
2014-2015

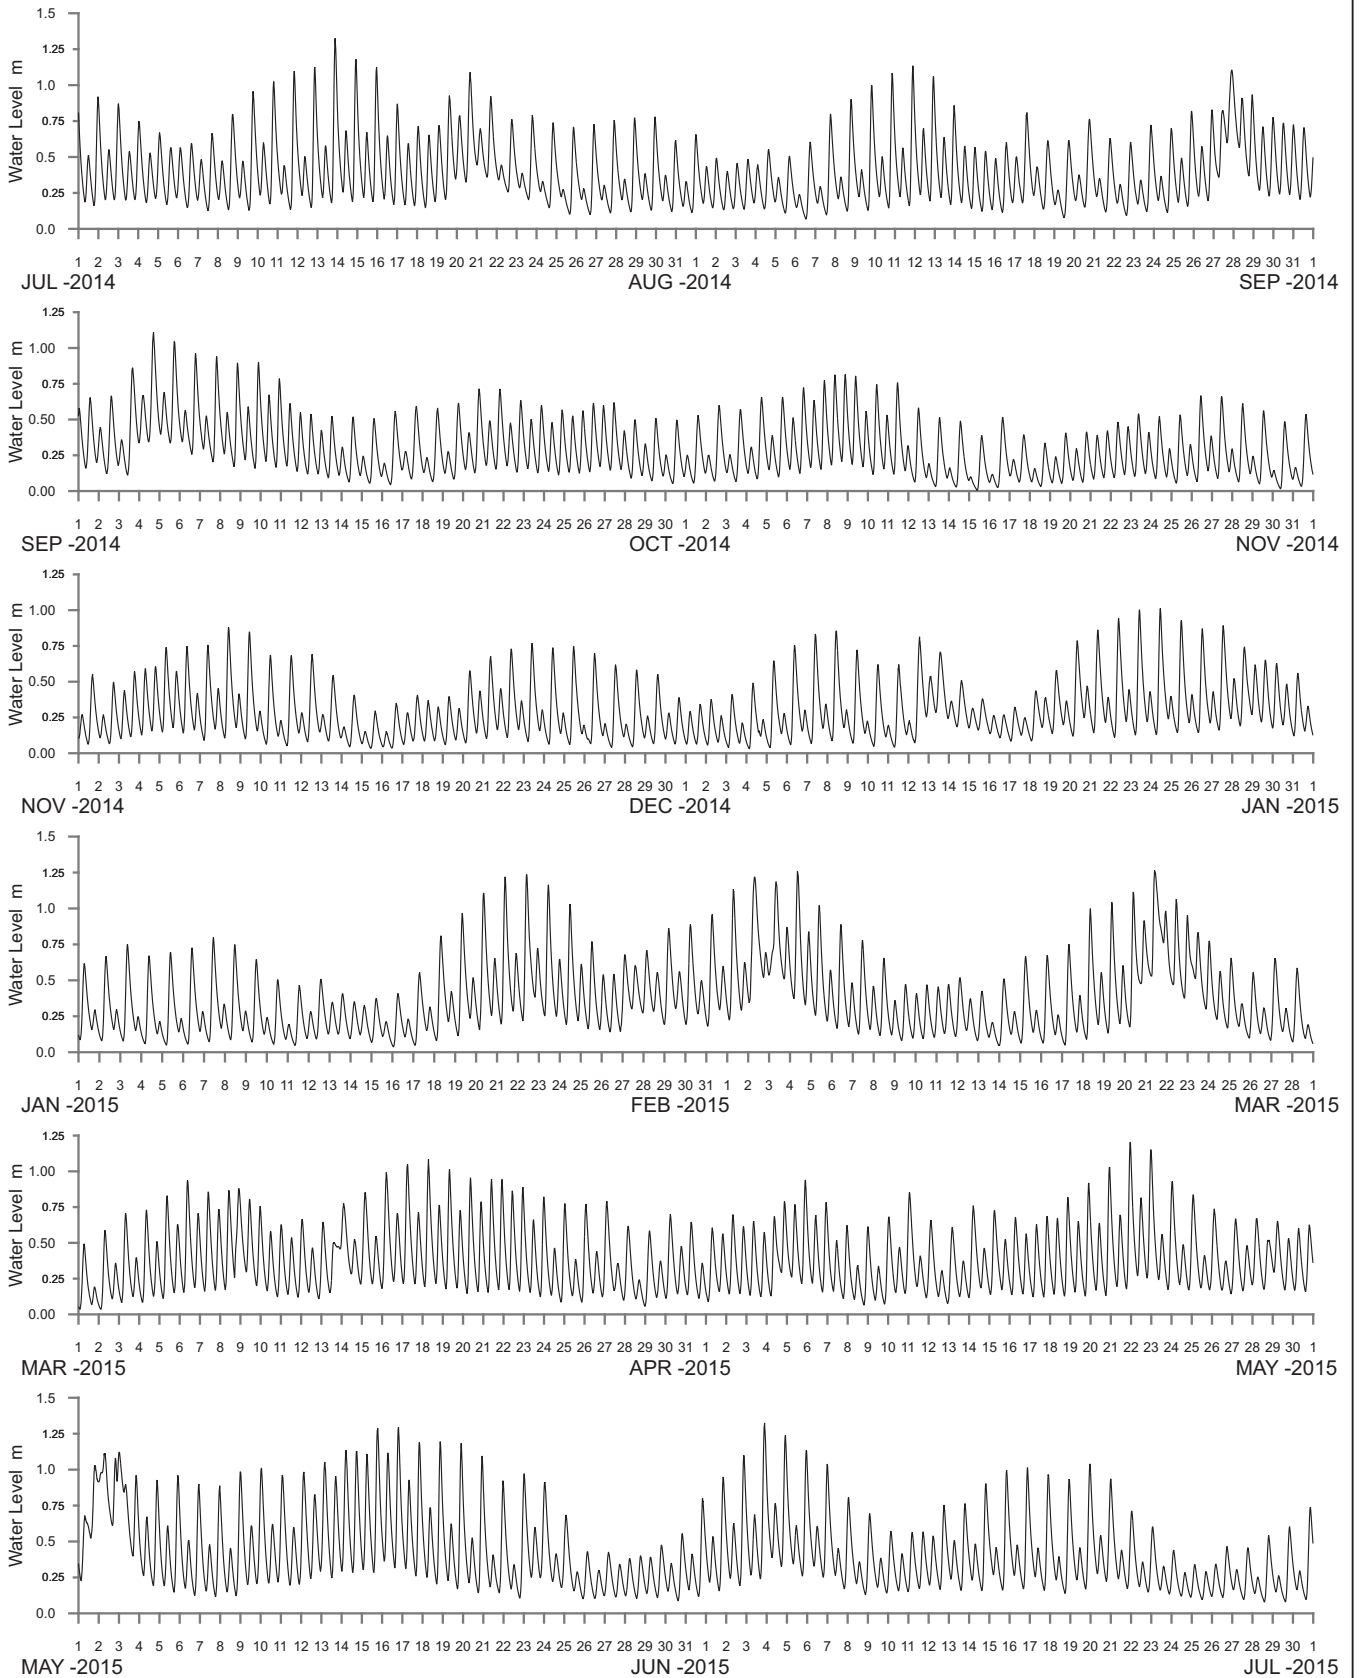
Figure  
**58**

WATER LEVEL REFERENCED TO AUSTRALIAN HEIGHT DATUM

----- DATA LOSS

**MOONEE CREEK AT MOONEE CREEK**  
2014–2015

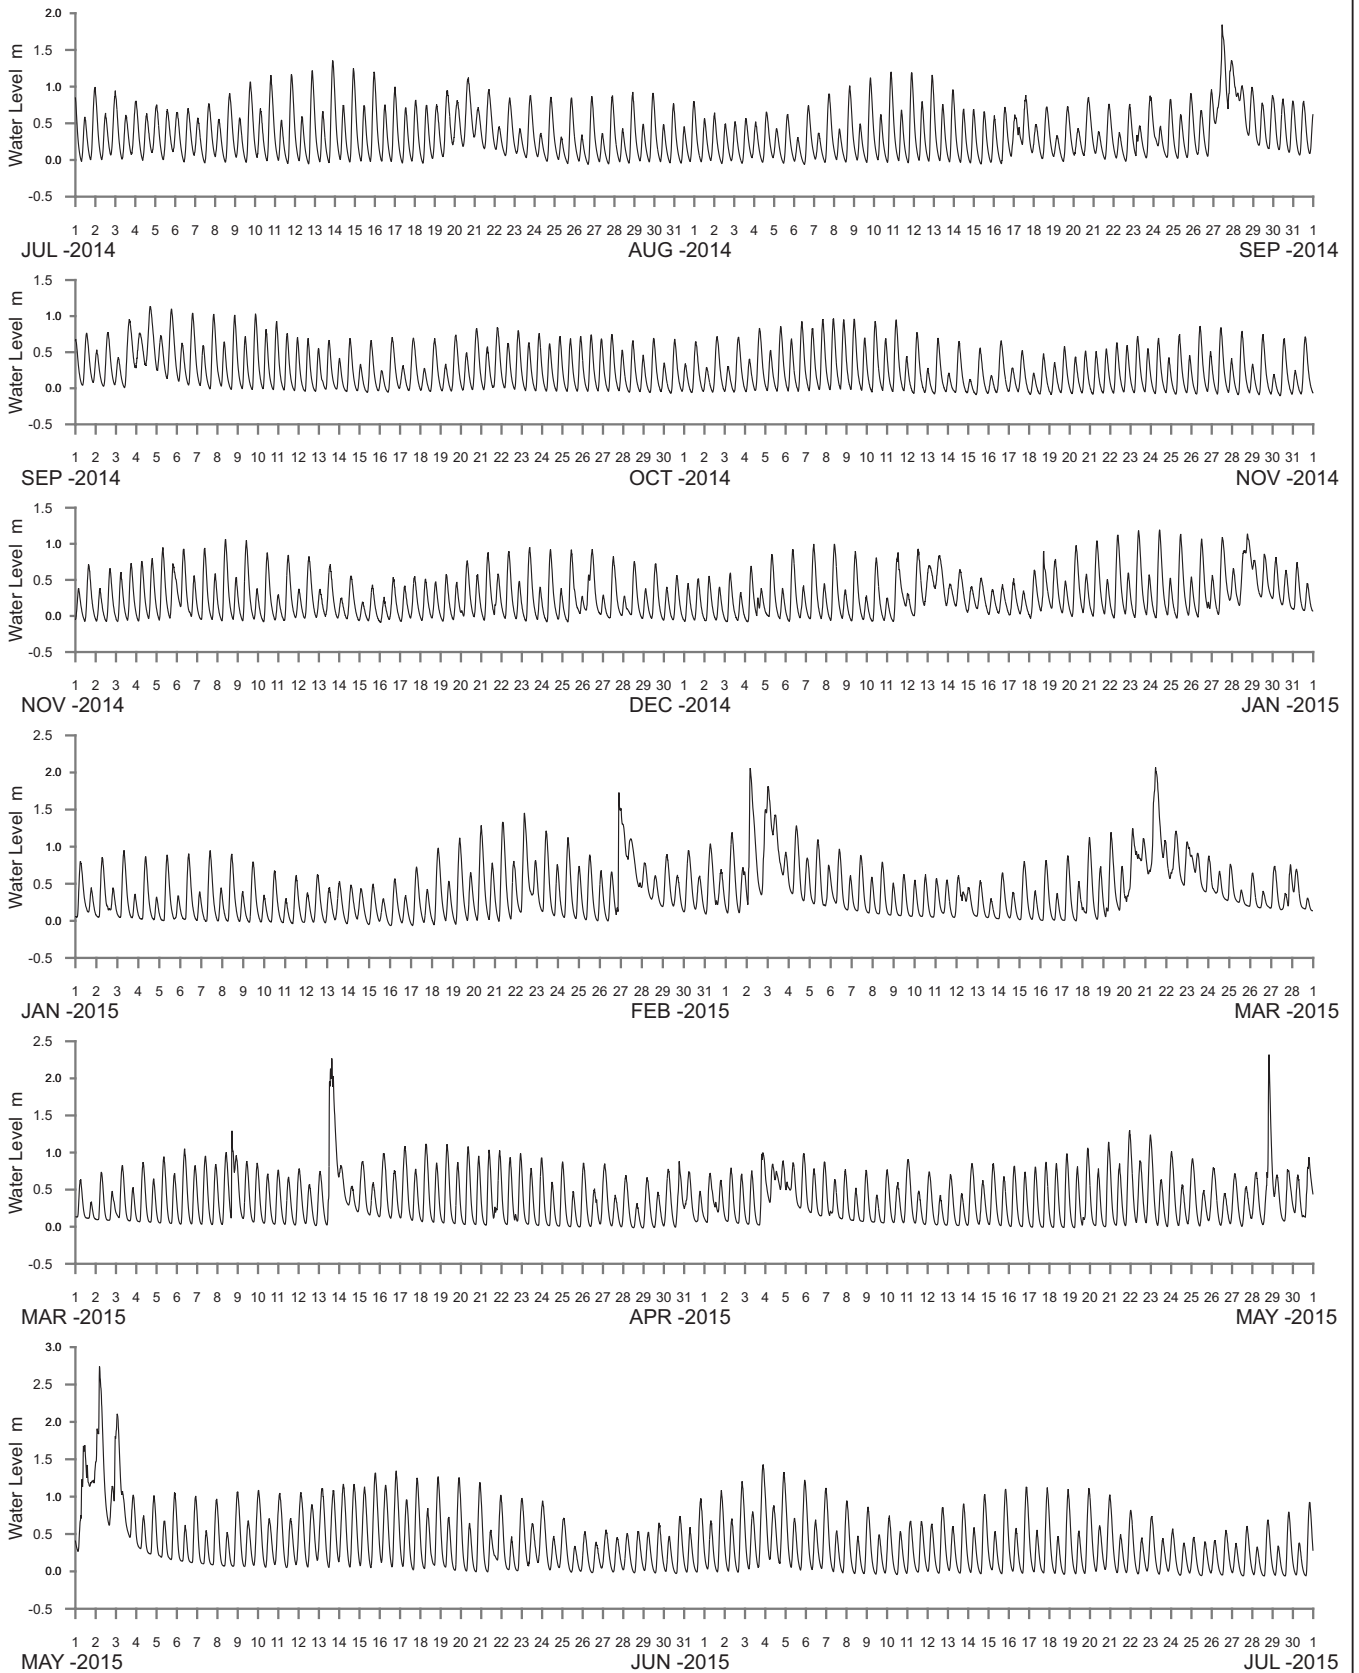
Figure  
60

WATER LEVEL REFERENCED TO AUSTRALIAN HEIGHT DATUM

----- DATA LOSS

**COFFS CREEK AT COFFS CREEK HIGHWAY BRIDGE**  
2014–2015

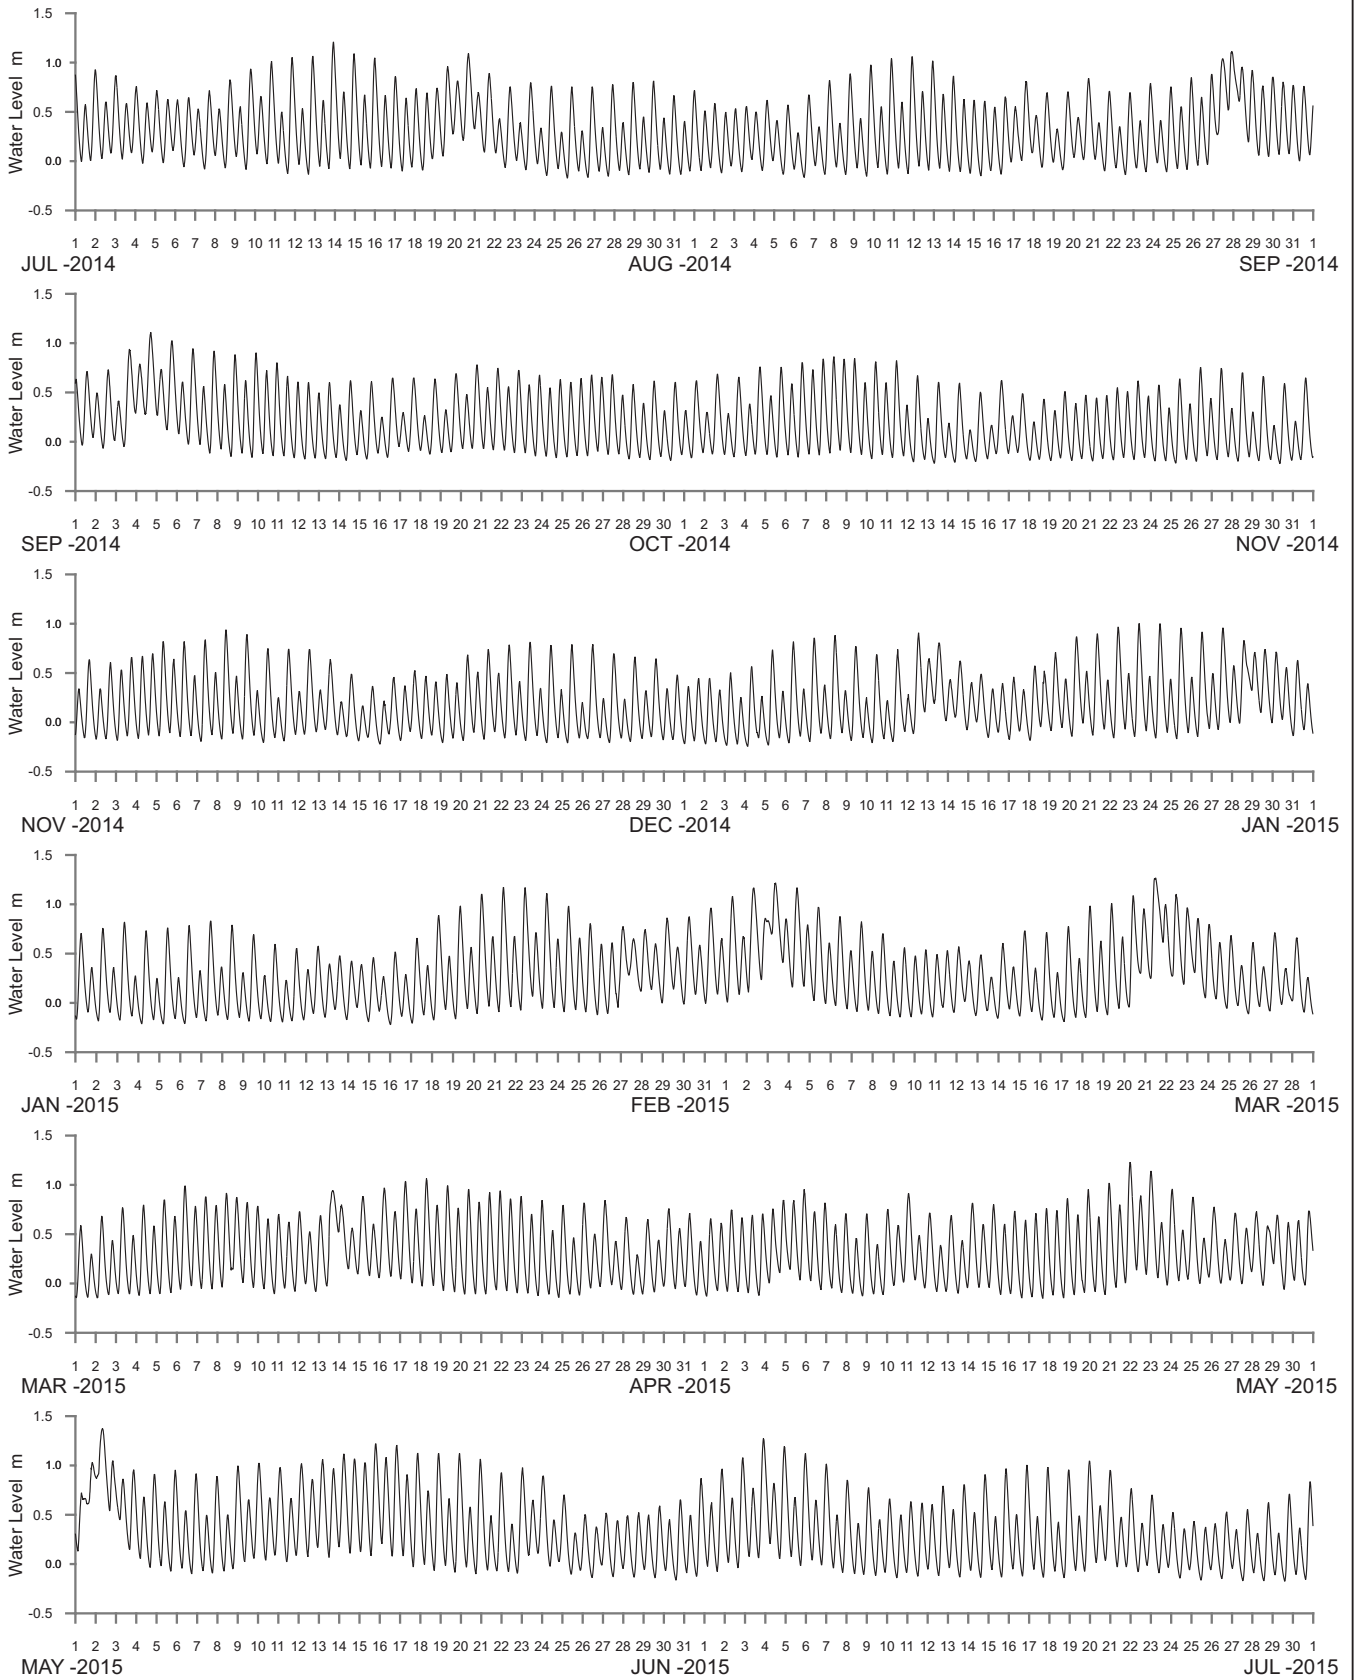
Figure  
61

WATER LEVEL REFERENCED TO AUSTRALIAN HEIGHT DATUM

----- DATA LOSS

**NEWPORTS CREEK AT NEWPORTS CREEK**  
2014–2015

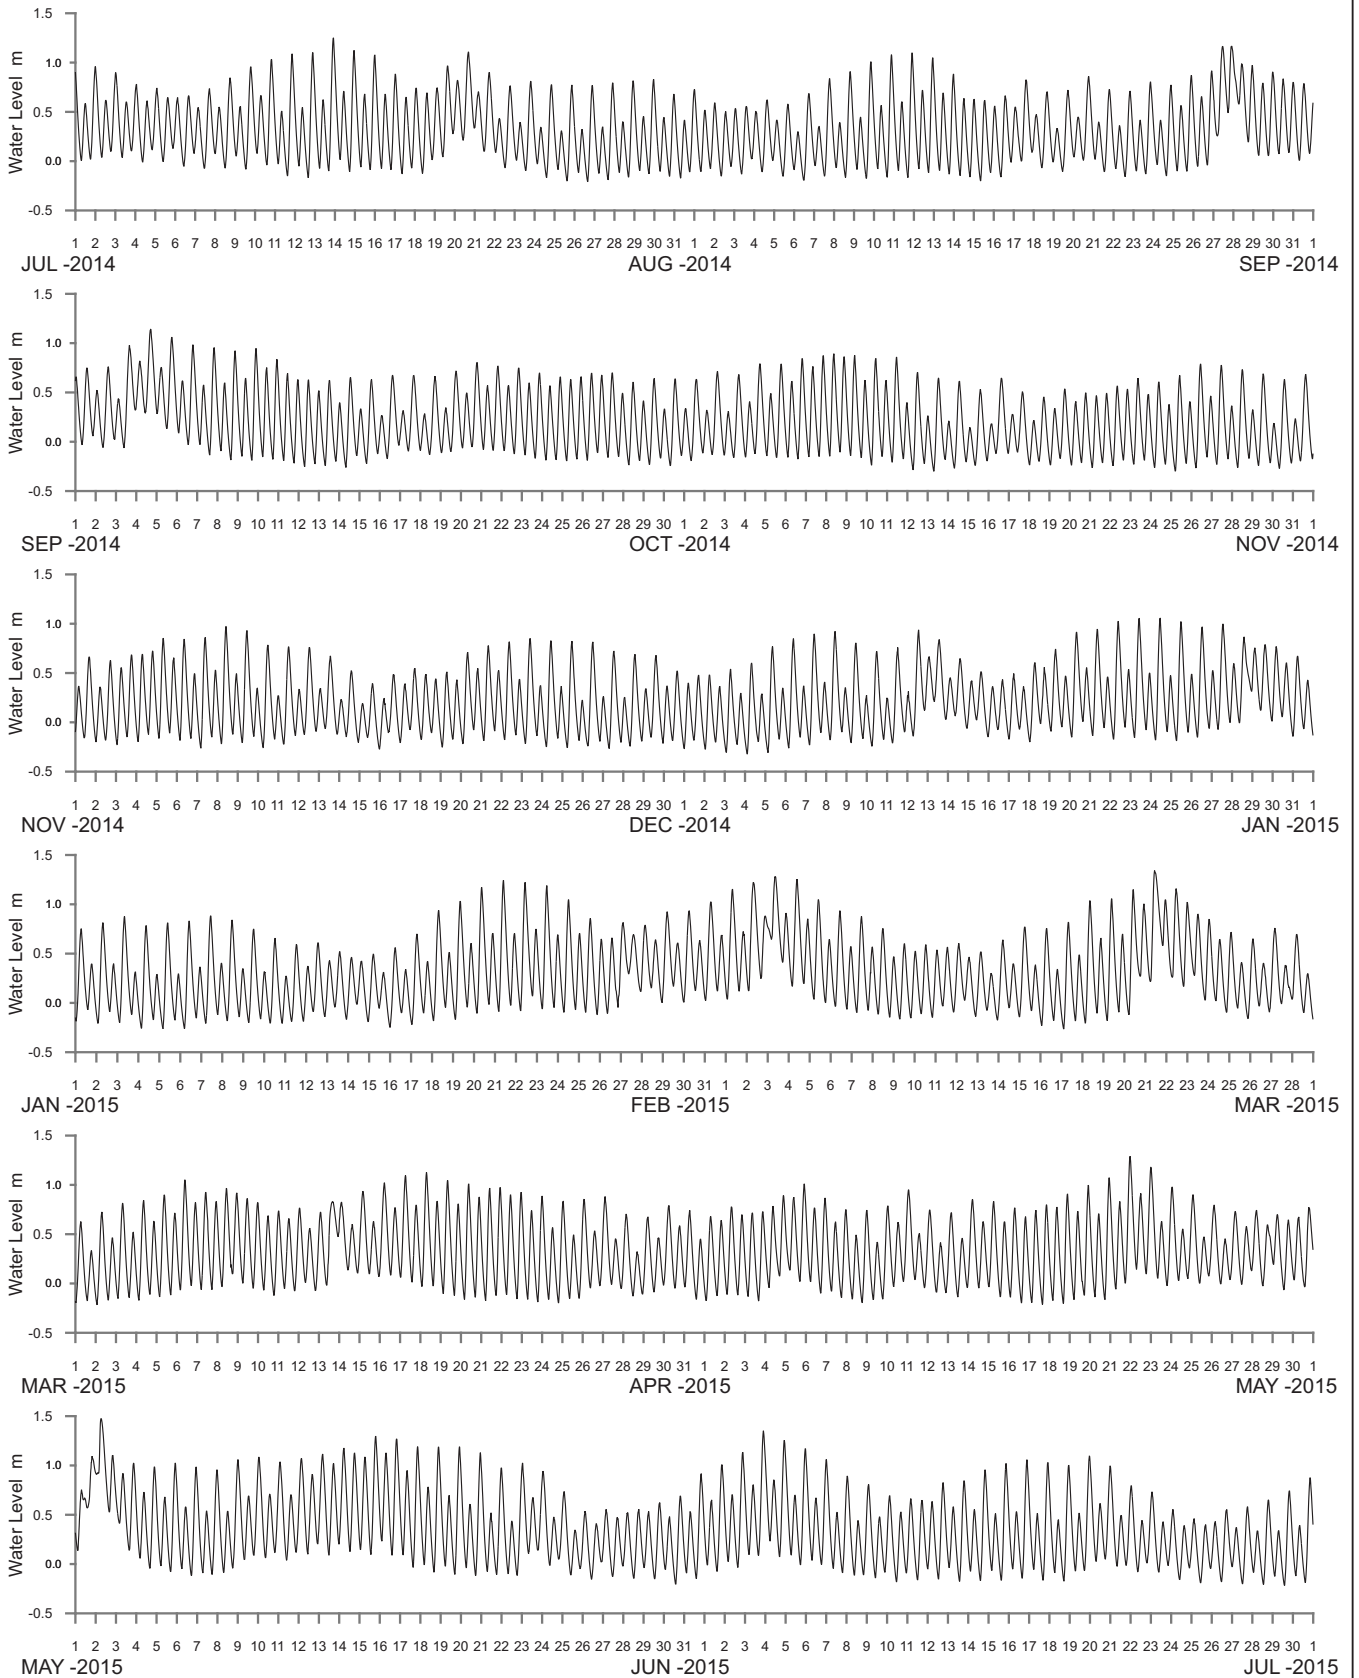
Figure  
62

WATER LEVEL REFERENCED TO AUSTRALIAN HEIGHT DATUM

----- DATA LOSS

**BOAMBEE CREEK AT BOAMBEE**  
2014–2015

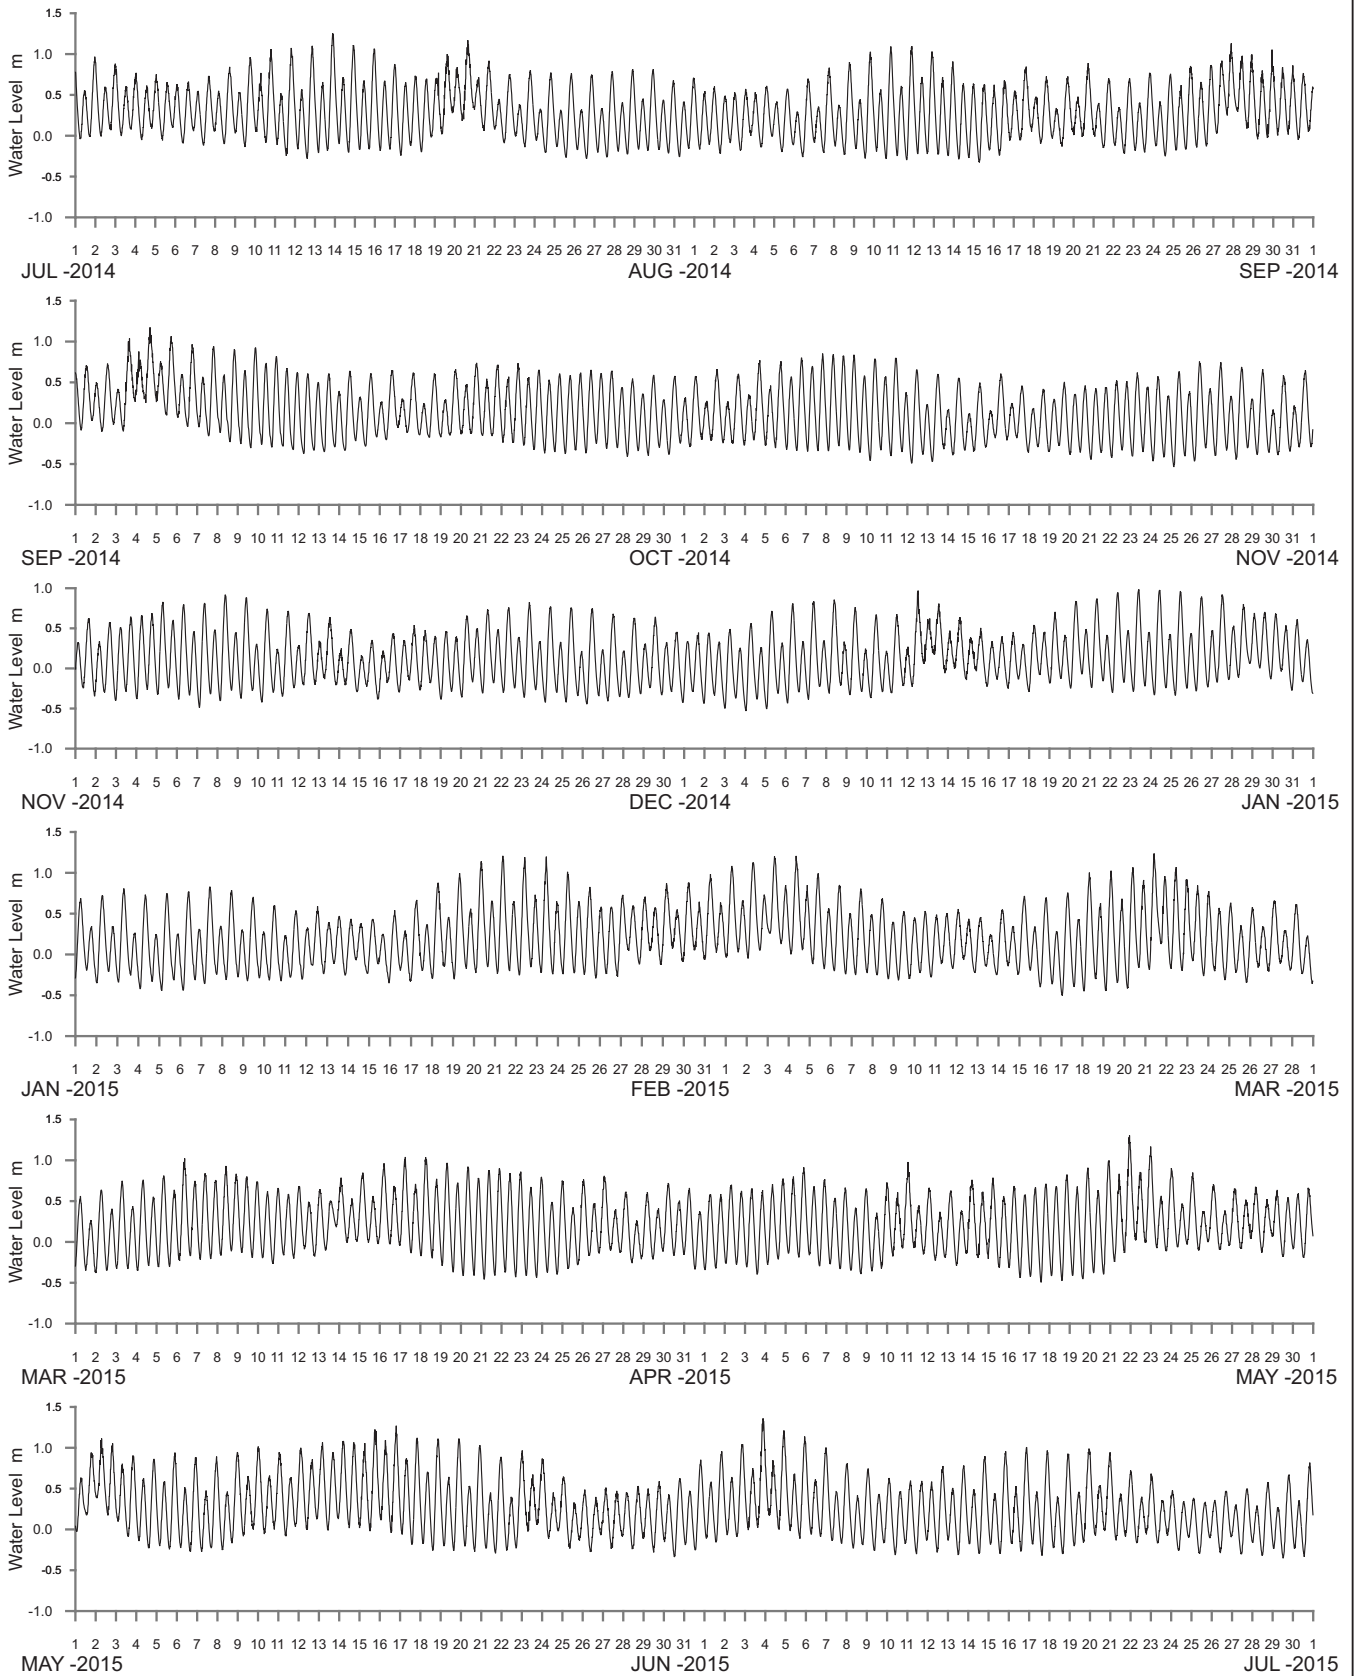
Figure  
63

WATER LEVEL REFERENCED TO AUSTRALIAN HEIGHT DATUM

----- DATA LOSS

**BOAMBEE CREEK AT BOAMBEE ENTRANCE**  
2014–2015
