<b>River/Estuary System</b>	<b>Station Name</b>	<b>Figure</b>
Station Locality Map	Woolgoolga Region	52
Wooli River	Wooli Entrance	53
Wooli River	Wooli Caravan Park	54
Corindi Creek	Red Rock	55
Woolgoolga Lake	Woolgoolga Lake	56
Woolgoolga Creek	Woolgoolga	57
Moonee Creek	Moonee Creek	58
Station Locality Map	Coffs Harbour Region	59
Coffs Creek	Coffs Creek Highway Bridge	60
Newports Creek	Newports Creek	61
Boambee Creek	Boambee	62
Boambee Creek	Boambee Entrance	63
Station Locality Map	Bellingher River Region	64
Bonville Creek	Bonville	65
Bellingher River	Repton	66
Bellingher River	Bellingher Bridge	67
Kalang River	Urunga	68
Kalang River	Upstream Newry Island	69
Kalang River	Koorowwi	70
Station Locality Map	Nambucca River Region	71
Deep Creek	Deep Creek	72
Nambucca River	Stuarts Island Downstream	73
Nambucca River	Macksville	74
Nambucca River	Utungun	75
Nambucca River	Bowraville Downstream	76
Warrell Creek	Warrell Creek	77

**Public Works**  
Manly Hydraulics Laboratory

MHL  
Report 2383

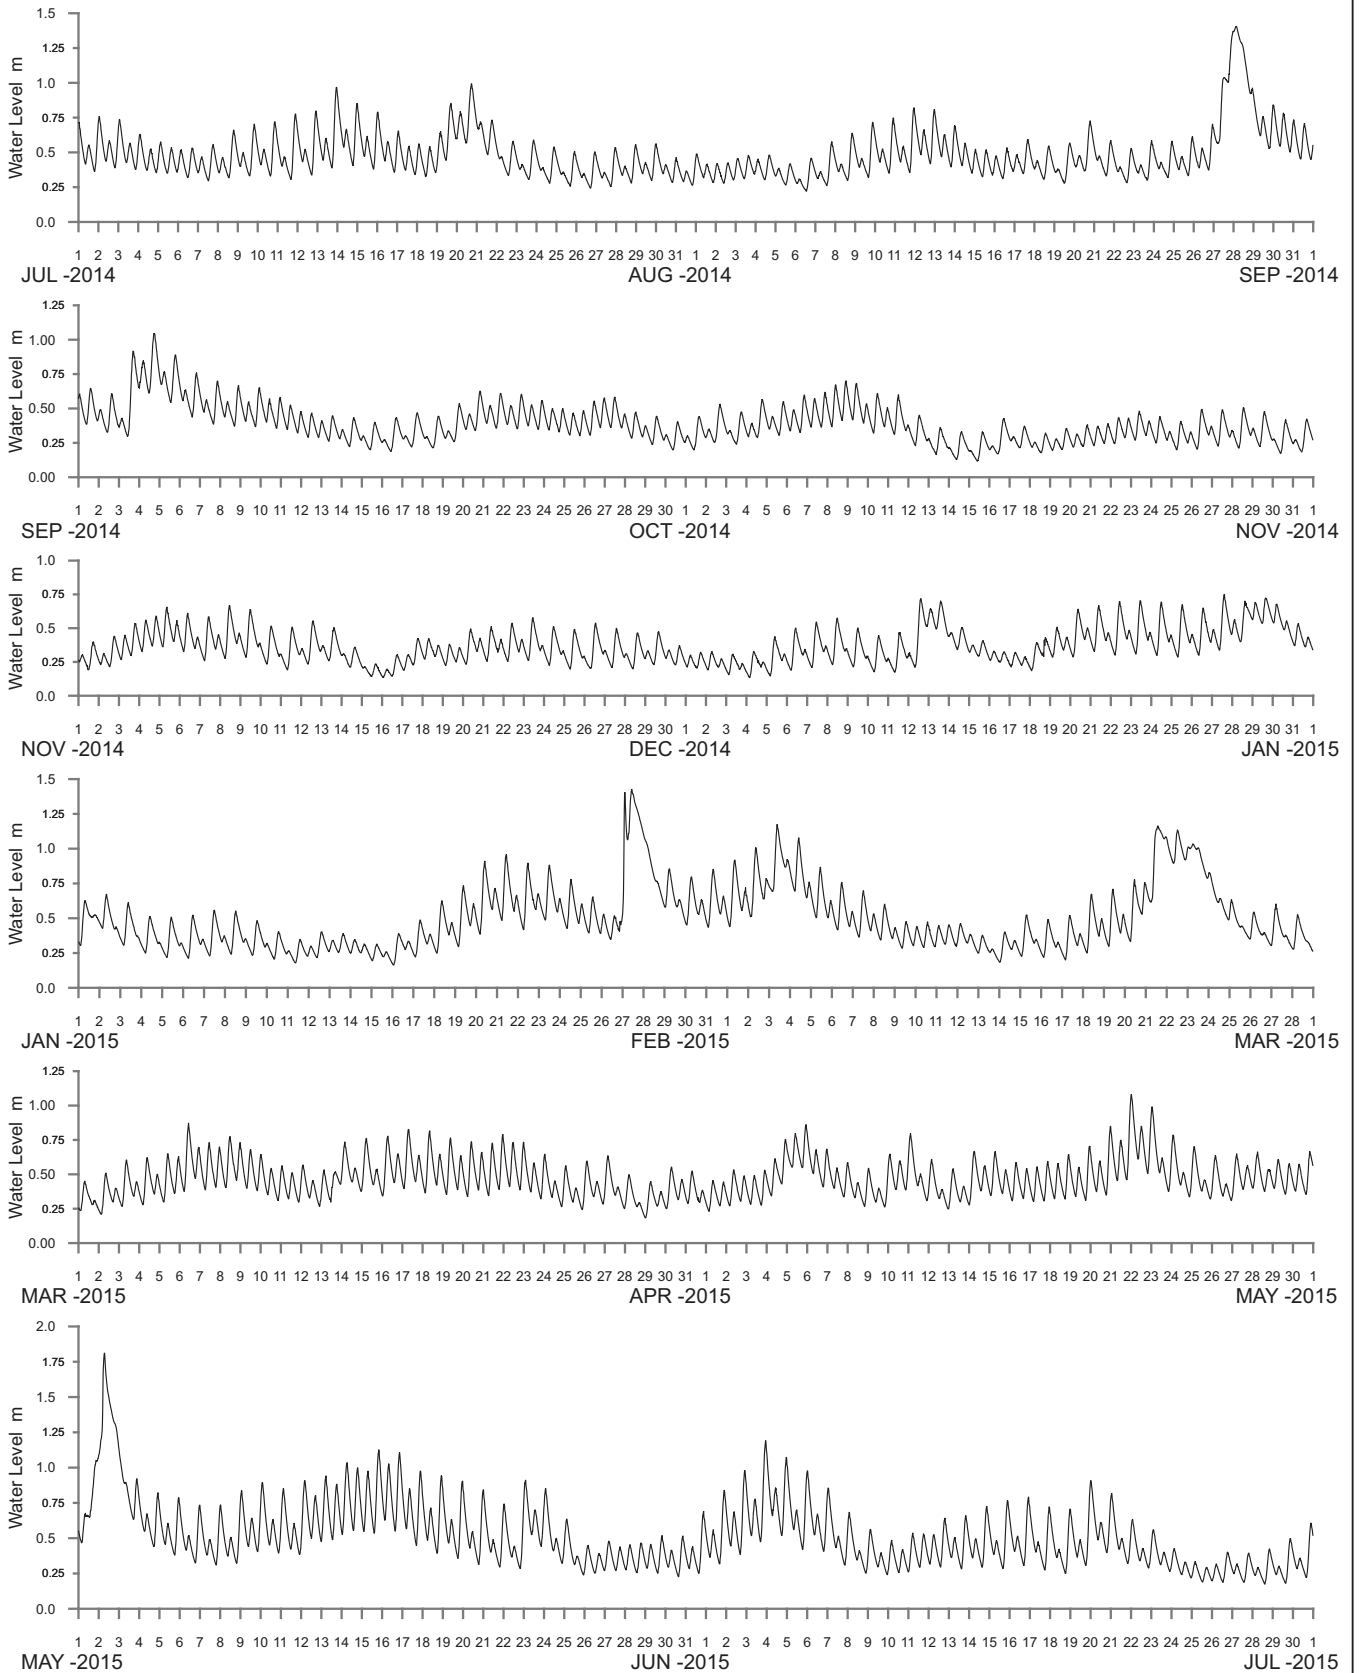
Figure  
**65**

WATER LEVEL REFERENCED TO AUSTRALIAN HEIGHT DATUM

----- DATA LOSS

**BONVILLE CREEK AT BONVILLE**  
2014–2015

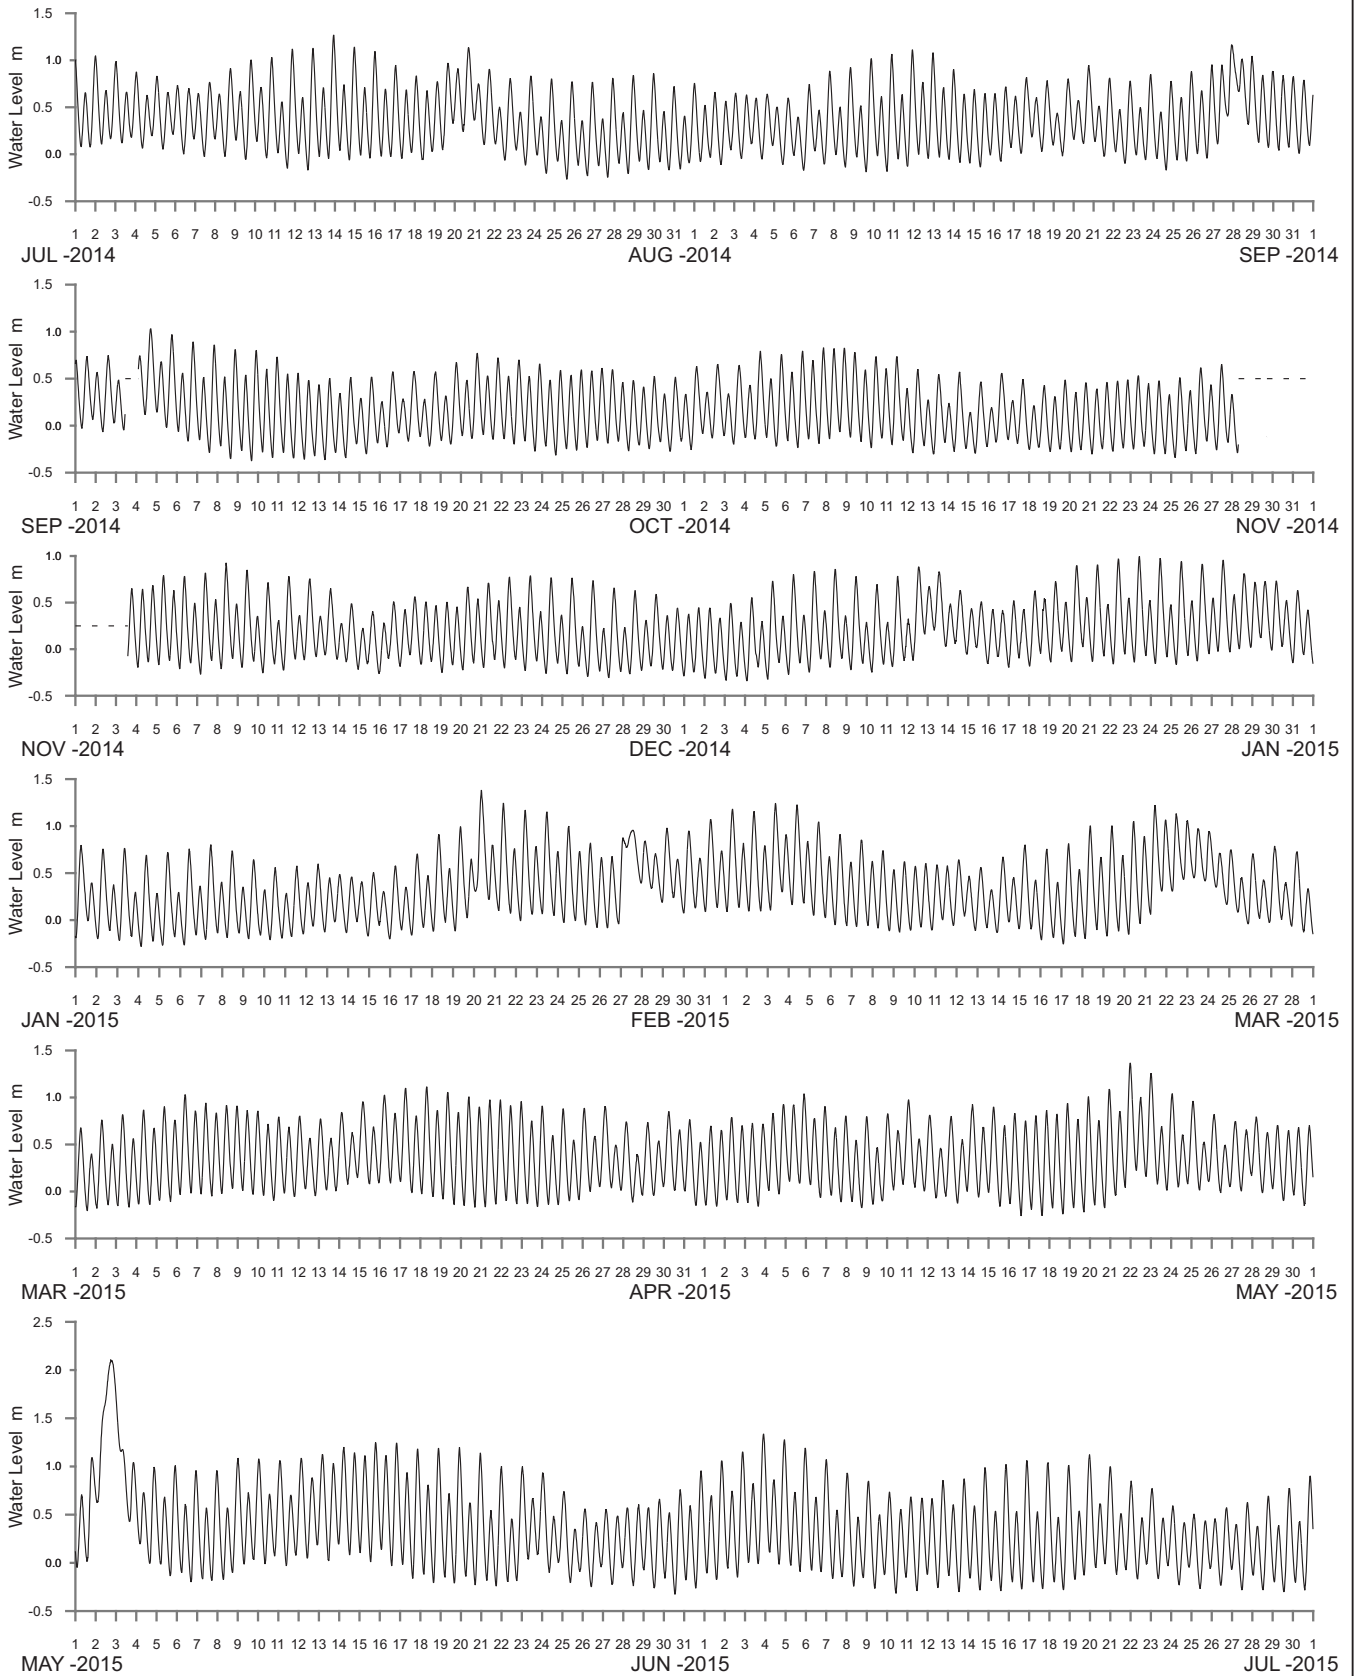
Figure  
**66**

WATER LEVEL REFERENCED TO AUSTRALIAN HEIGHT DATUM

----- DATA LOSS

**BELLINGER RIVER AT REPTON**  
2014–2015

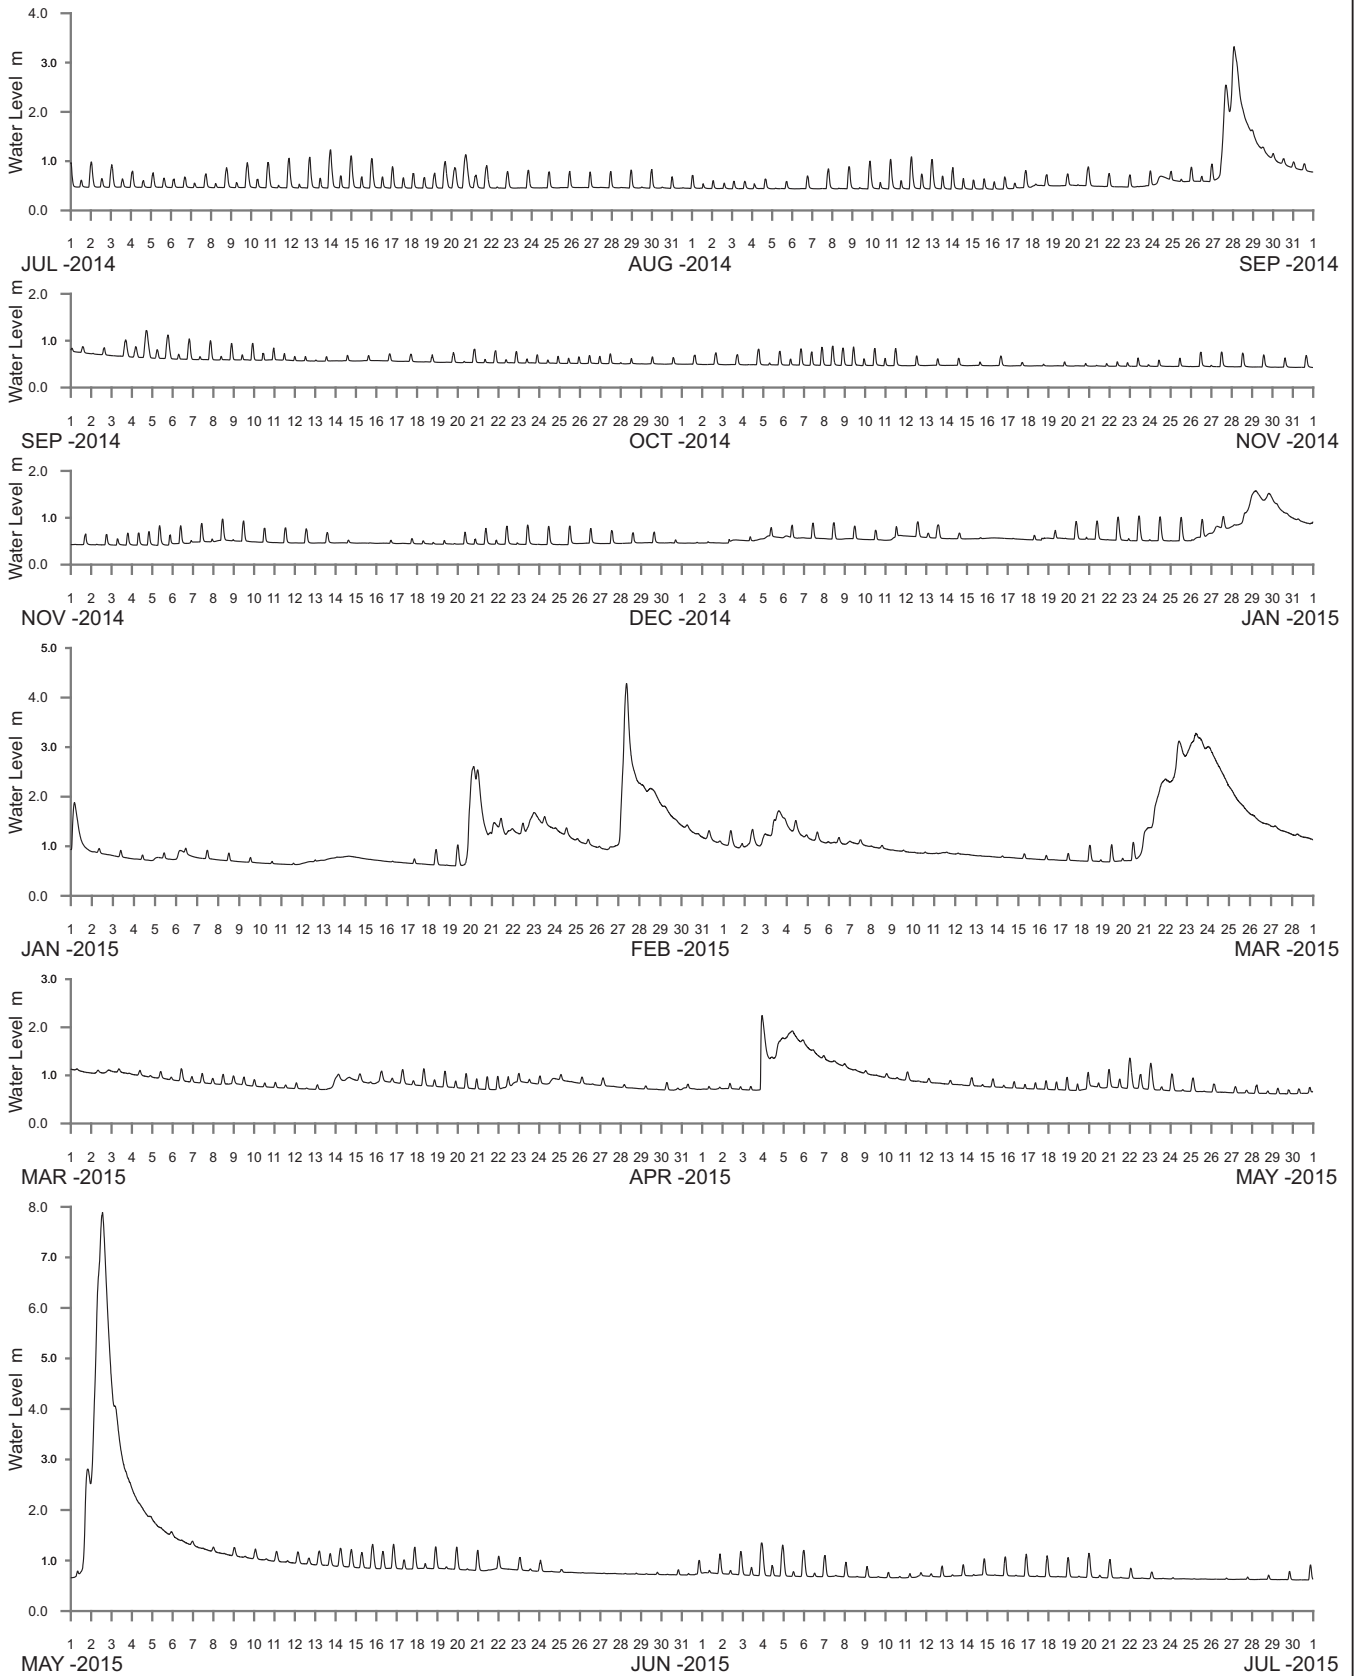
Figure  
 67

WATER LEVEL REFERENCED TO AUSTRALIAN HEIGHT DATUM

----- DATA LOSS

**BELLINGER RIVER AT BELLINGEN BRIDGE**  
 2014-2015

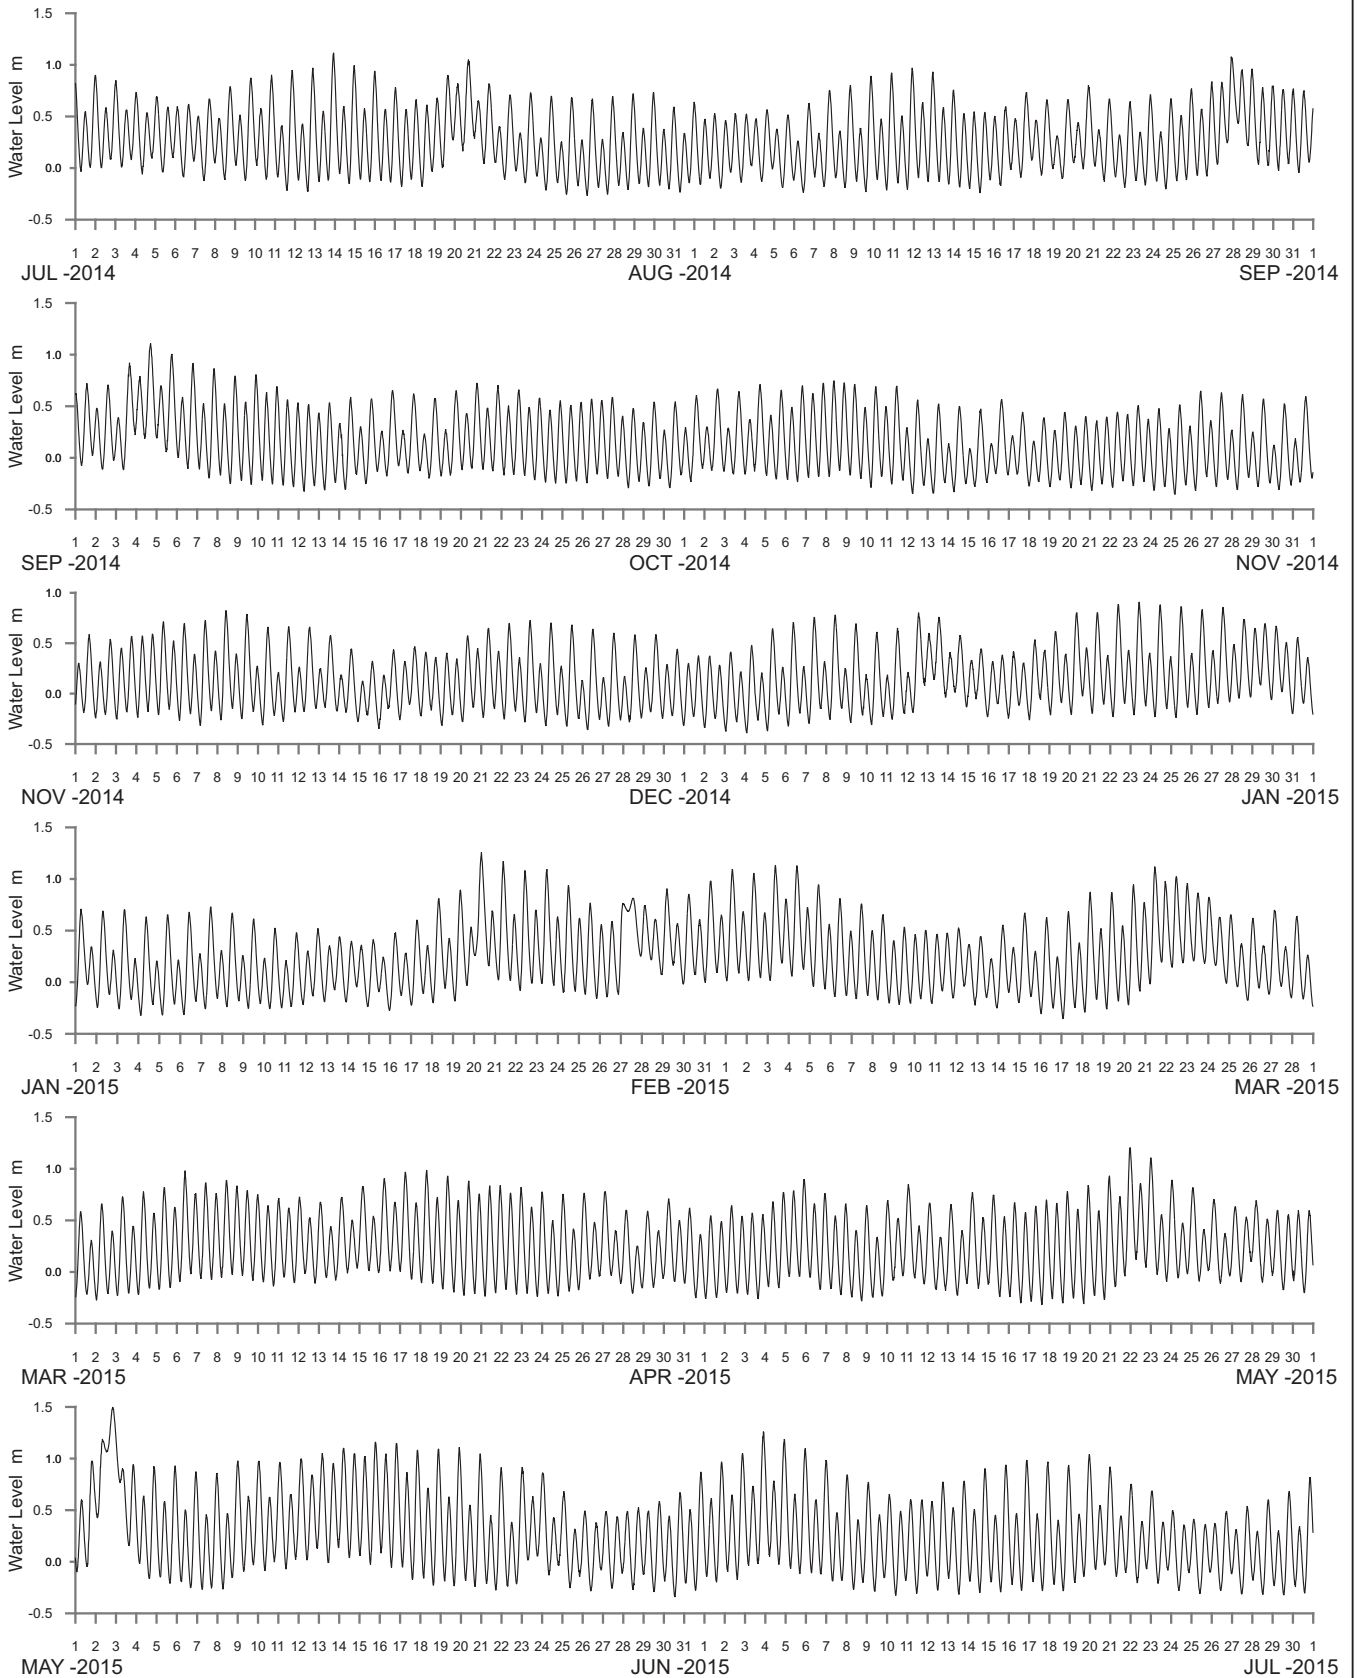
Figure  
68

WATER LEVEL REFERENCED TO AUSTRALIAN HEIGHT DATUM

----- DATA LOSS

**KALANG RIVER AT URUNGA**  
2014–2015

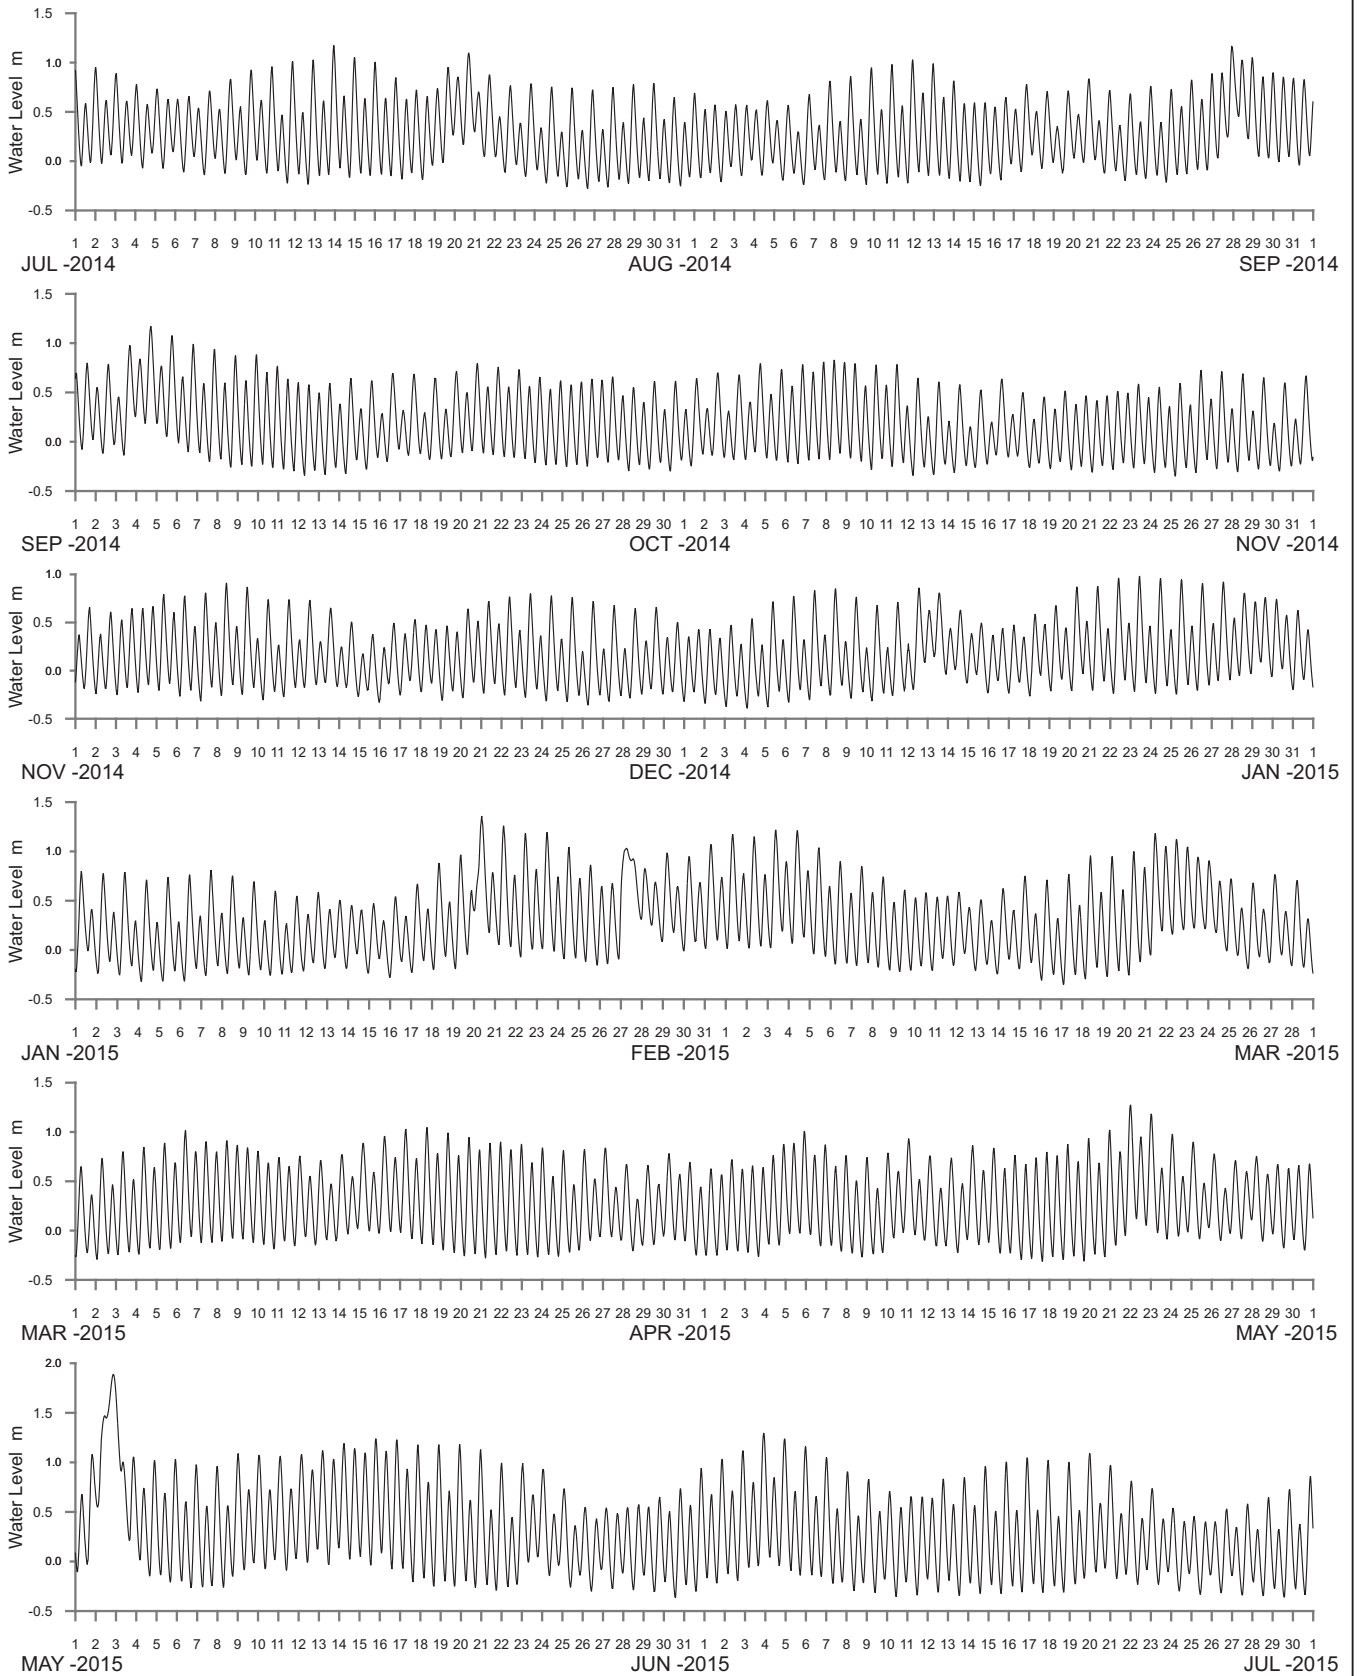
Figure  
69

WATER LEVEL REFERENCED TO AUSTRALIAN HEIGHT DATUM

----- DATA LOSS

**KALANG RIVER AT UPSTREAM NEWRY ISLAND**  
2014–2015

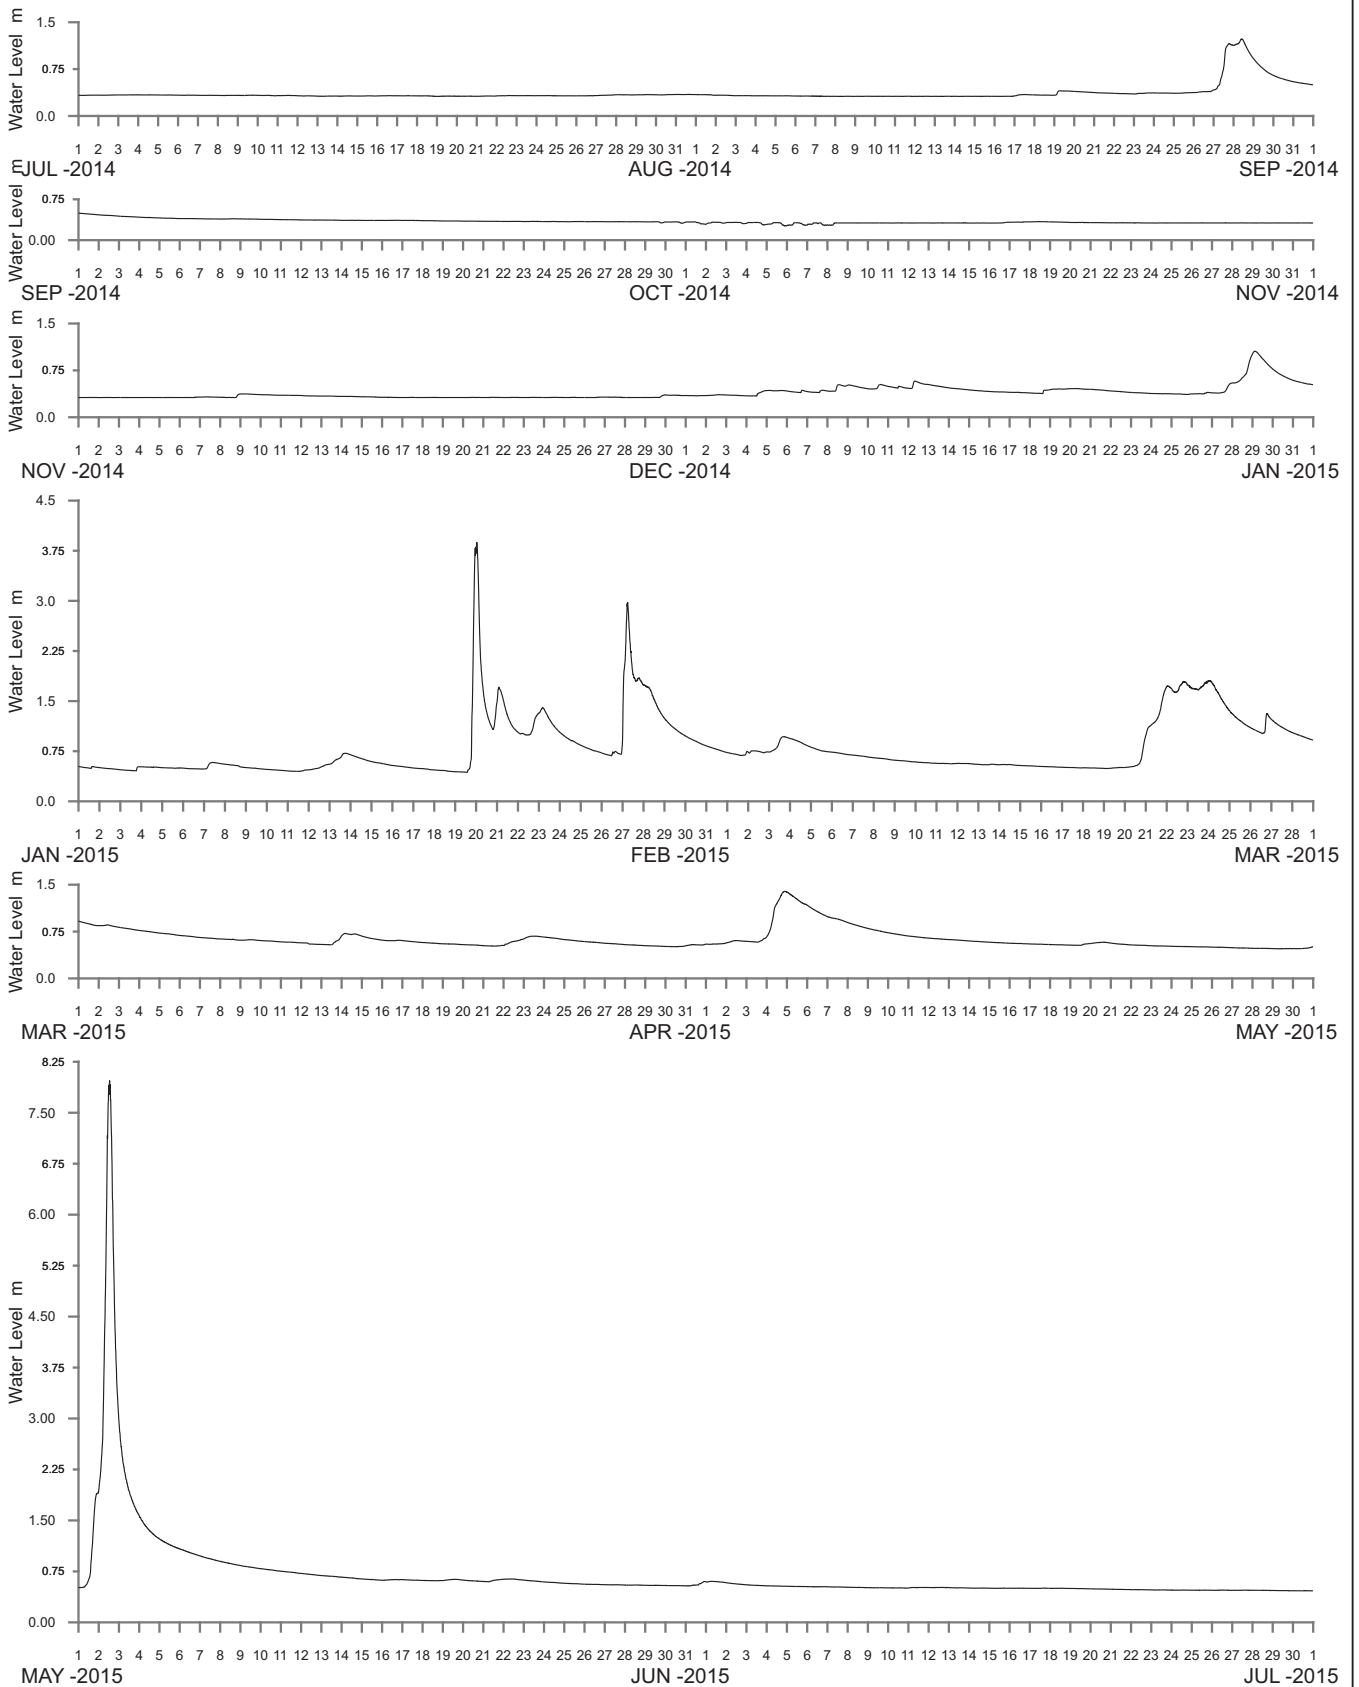
Figure  
70

WATER LEVEL REFERENCED TO ASSUMED DATUM

----- DATA LOSS

**KALANG RIVER AT KOOROOWI**  
2014-2015

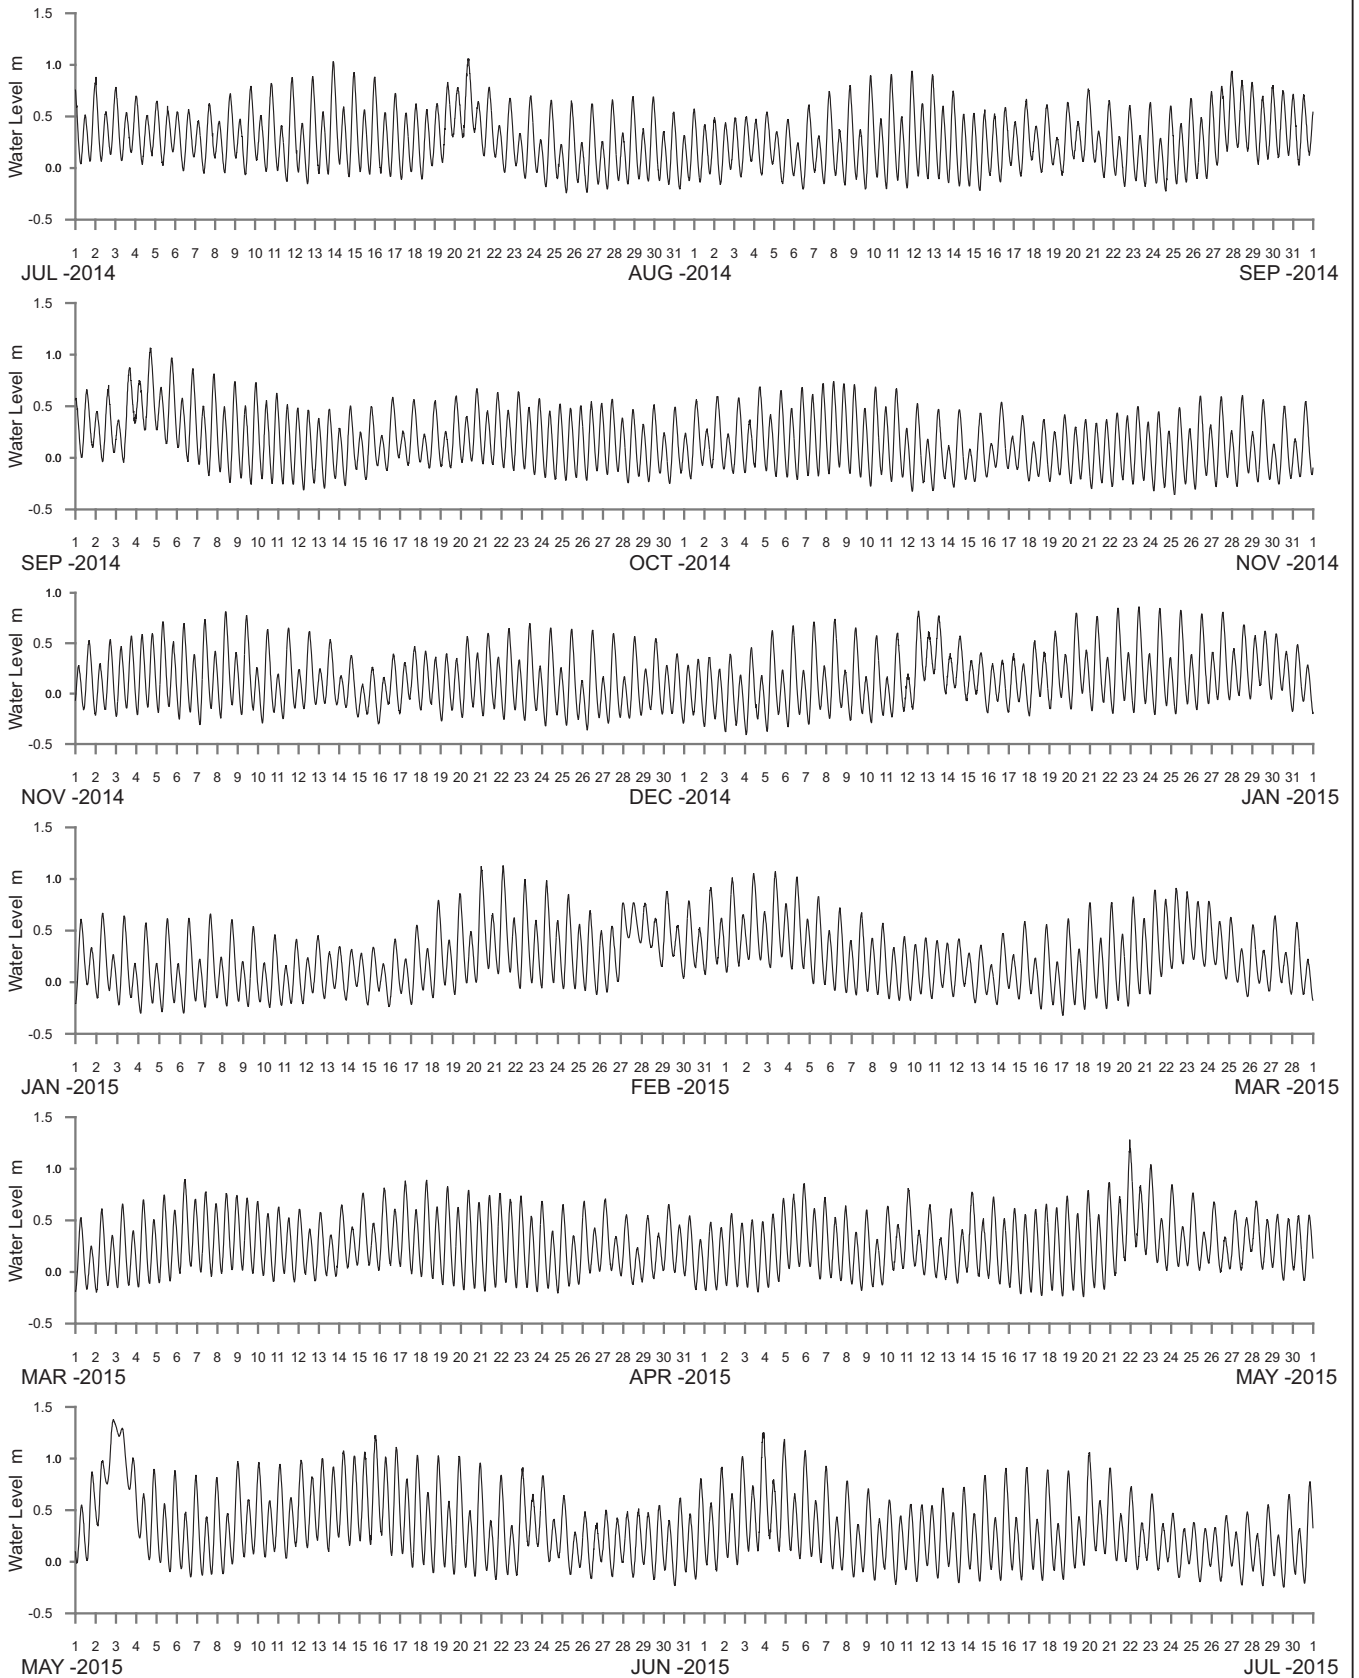
Figure  
73

WATER LEVEL REFERENCED TO AUSTRALIAN HEIGHT DATUM

----- DATA LOSS

NAMBUCCA RIVER AT STUARTS ISLAND DOWNSTREAM  
2014–2015

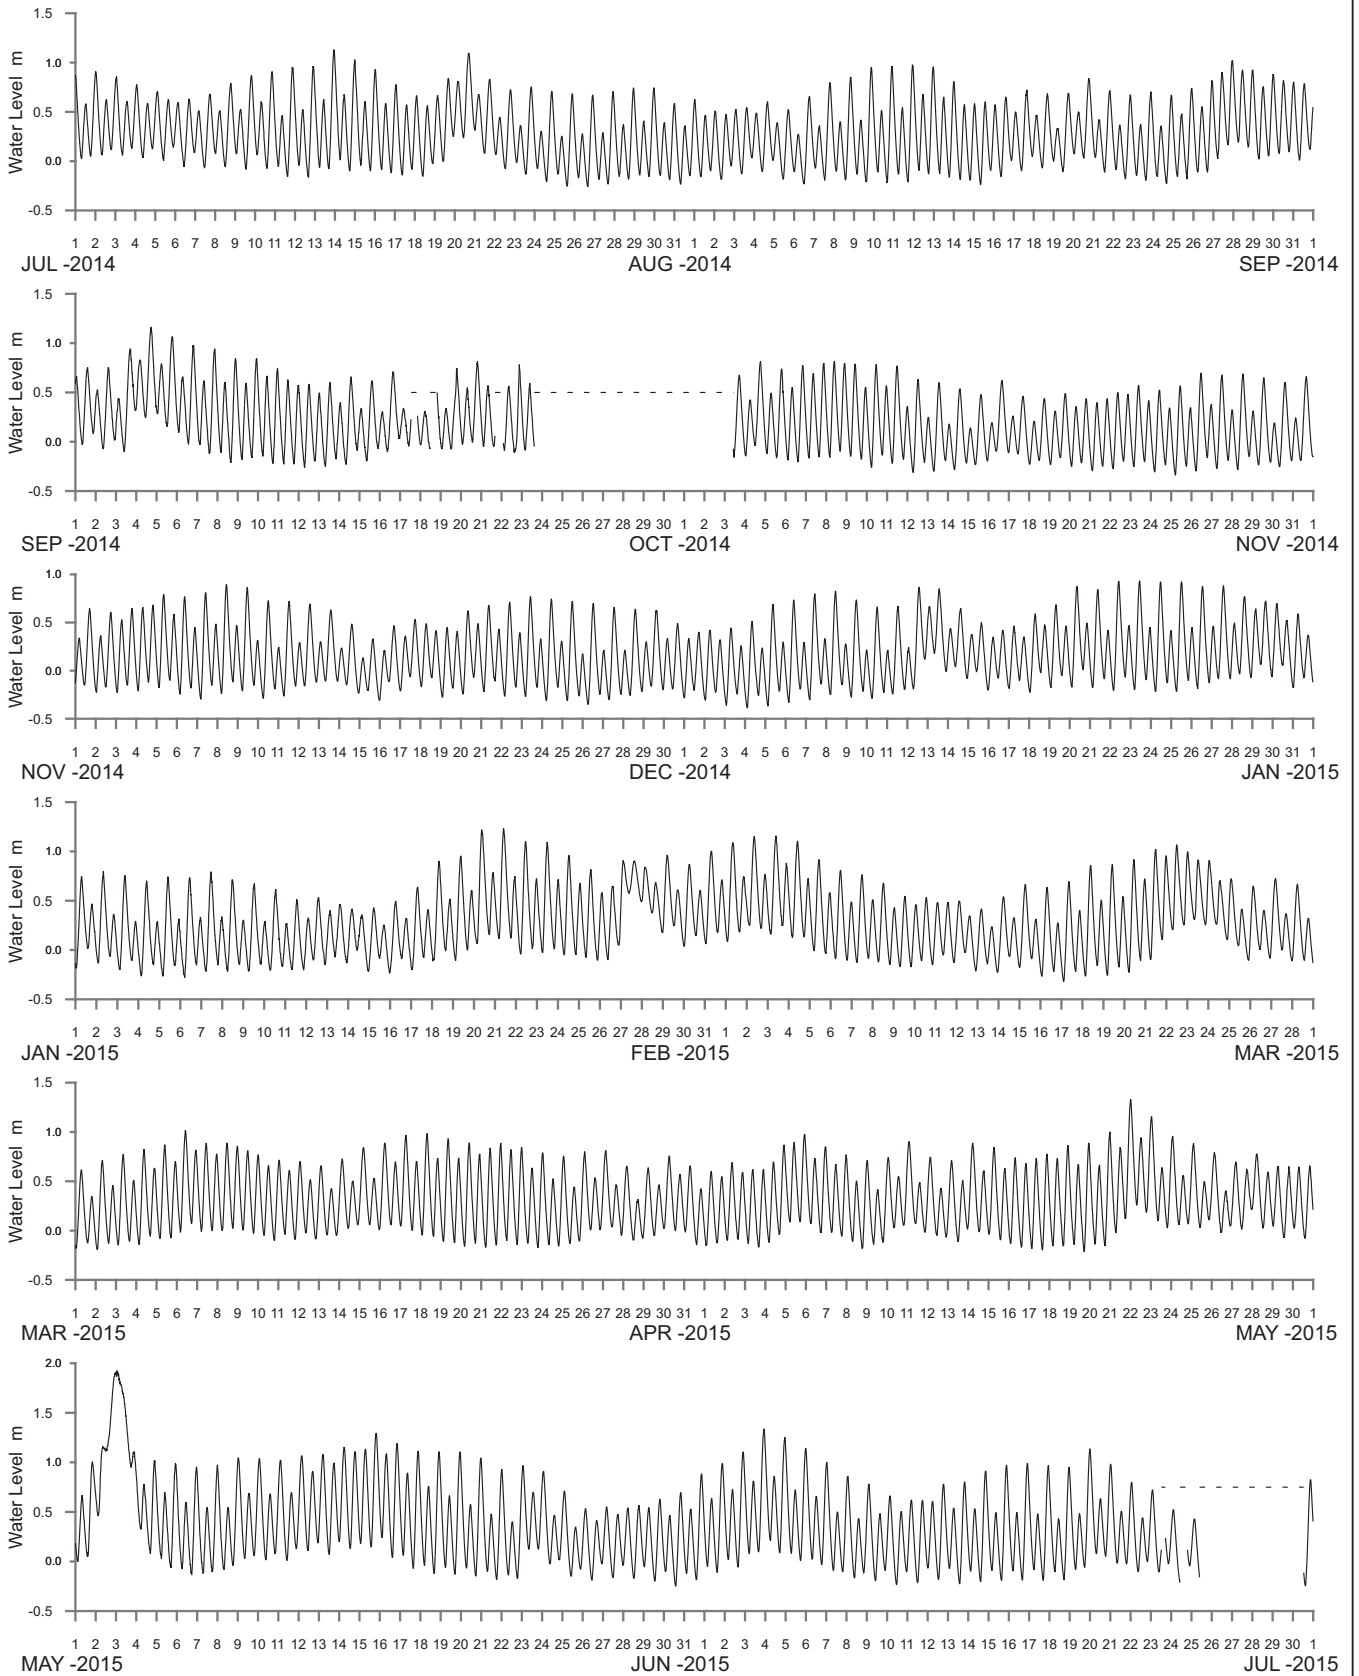
Figure  
74

WATER LEVEL REFERENCED TO AUSTRALIAN HEIGHT DATUM

----- DATA LOSS

NAMBUCCA RIVER AT MACKSVILLE  
2014–2015

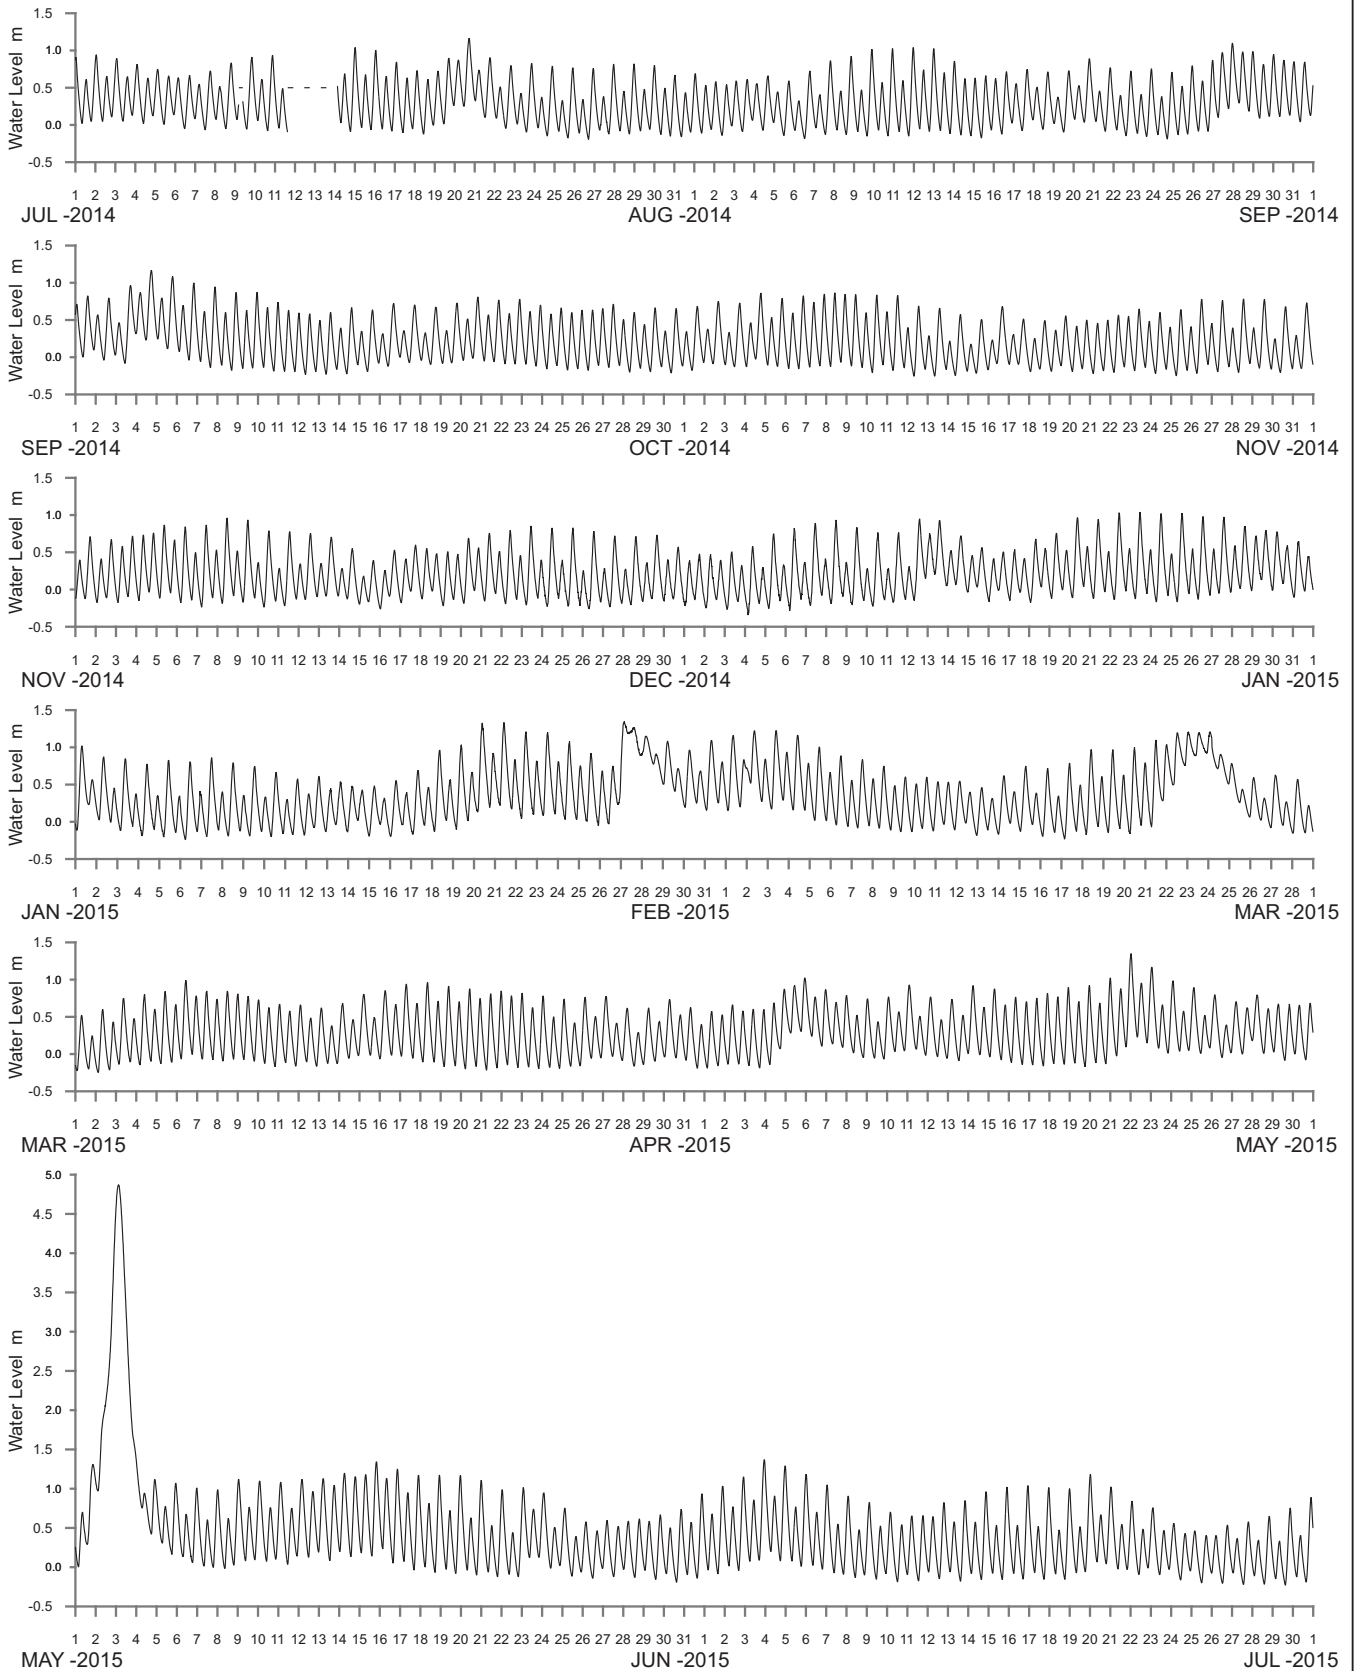
Figure  
**75**

WATER LEVEL REFERENCED TO AUSTRALIAN HEIGHT DATUM

----- DATA LOSS

**NAMBUCCA RIVER AT UTUNGUN**  
2014–2015

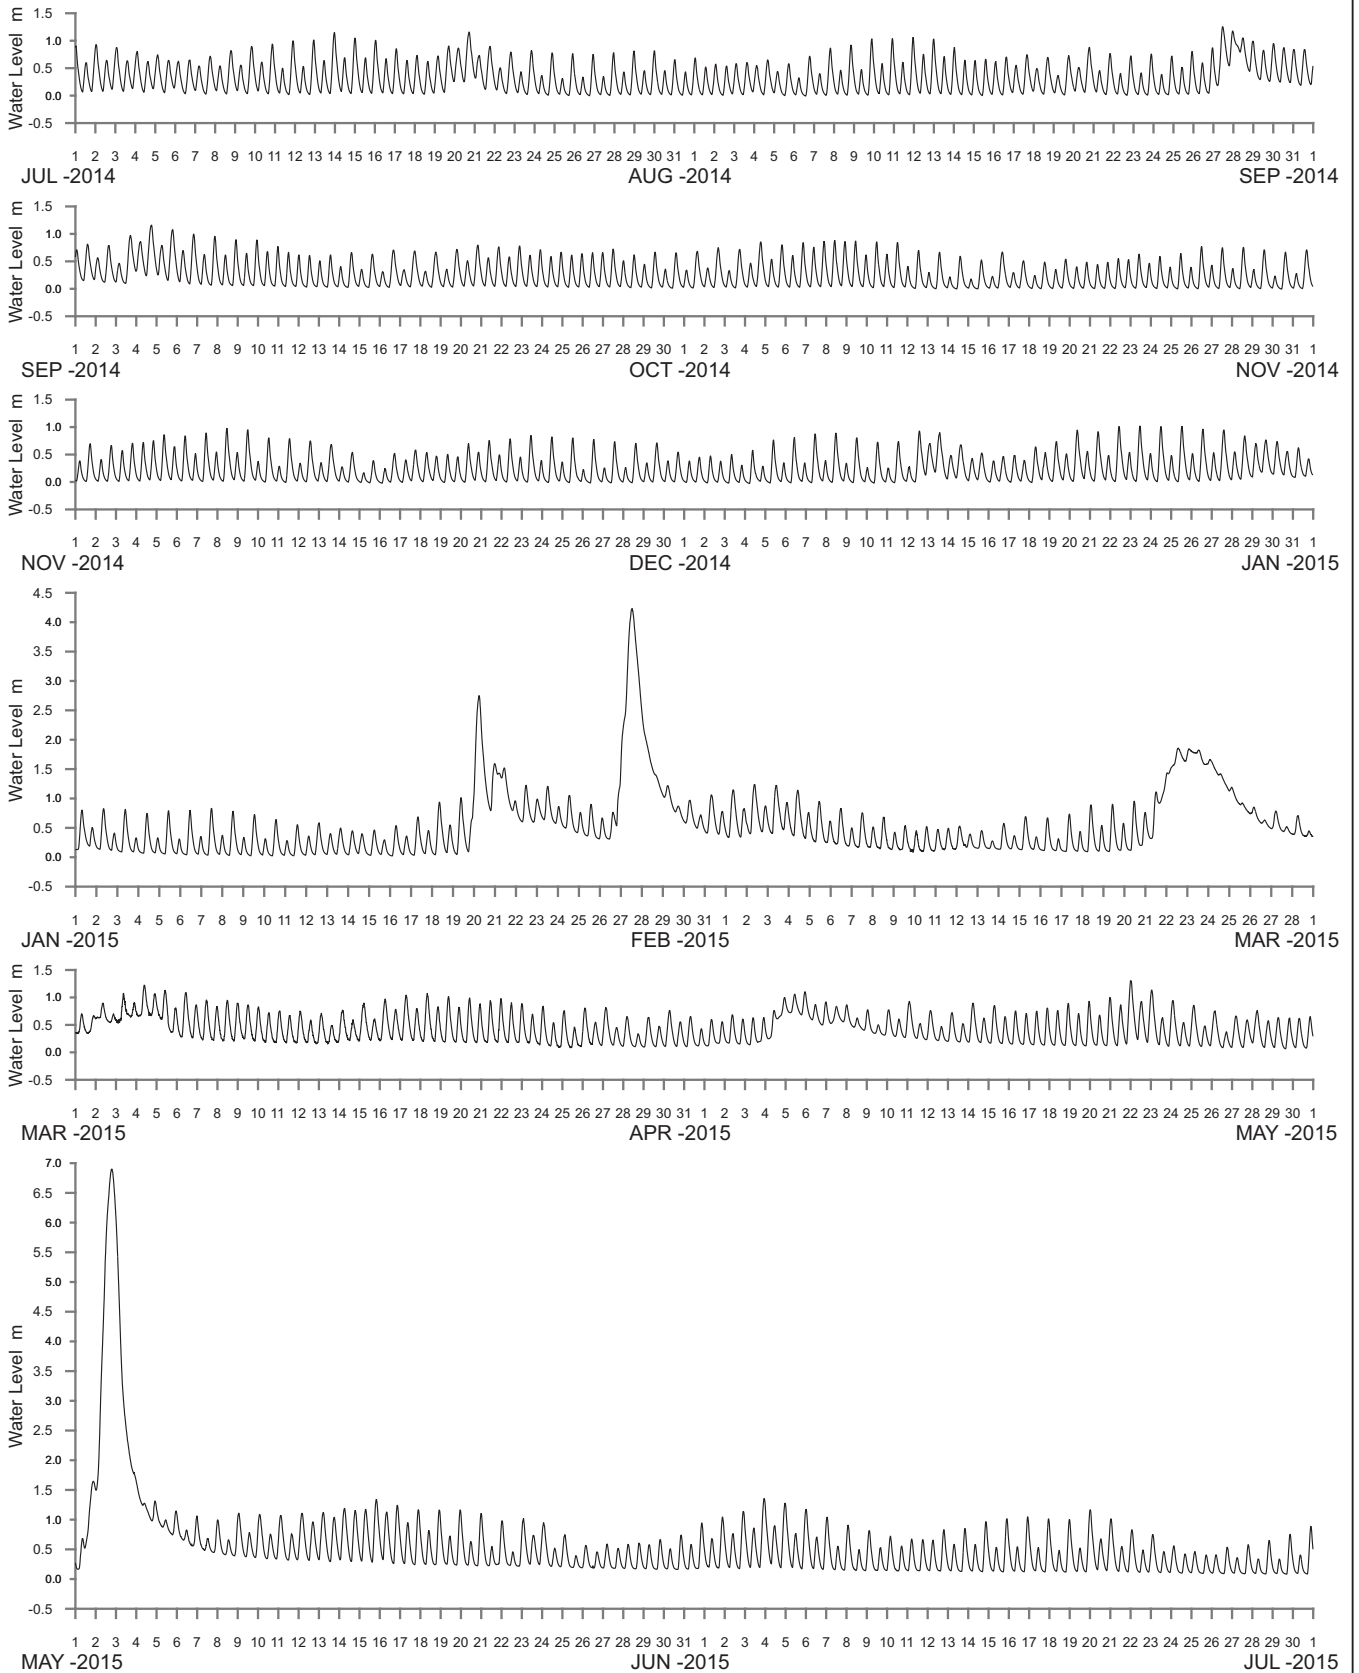
Figure  
76

WATER LEVEL REFERENCED TO ASSUMED DATUM

----- DATA LOSS

**NAMBUCCA RIVER AT BOWRAVILLE DOWNSTREAM**  
2014–2015
