<b>River/Estuary System</b>	<b>Station Name</b>	<b>Figure</b>
Station Locality Map	Woolgoolga Region	52
Wooli River	Wooli Entrance	53
Wooli River	Wooli Caravan Park	54
Corindi Creek	Red Rock	55
Woolgoolga Lake	Woolgoolga Lake	56
Woolgoolga Creek	Woolgoolga	57
Moonee Creek	Moonee Creek	58
Station Locality Map	Coffs Harbour Region	59
Coffs Creek	Coffs Creek Highway Bridge	60
Newports Creek	Newports Creek	61
Boambee Creek	Boambee	62
Boambee Creek	Boambee Entrance	63
Station Locality Map	Bellingher River Region	64
Bonville Creek	Bonville	65
Bellingher River	Repton	66
Bellingher River	Bellingher Bridge	67
Kalang River	Urunga	68
Kalang River	Upstream Newry Island	69
Kalang River	Koorowwi	70
Station Locality Map	Nambucca River Region	71
Deep Creek	Deep Creek	72
Nambucca River	Stuarts Island Downstream	73
Nambucca River	Macksville	74
Nambucca River	Utungun	75
Nambucca River	Bowraville Downstream	76
Warrell Creek	Warrell Creek	77

**Public Works**  
Manly Hydraulics Laboratory

MHL  
Report 2383

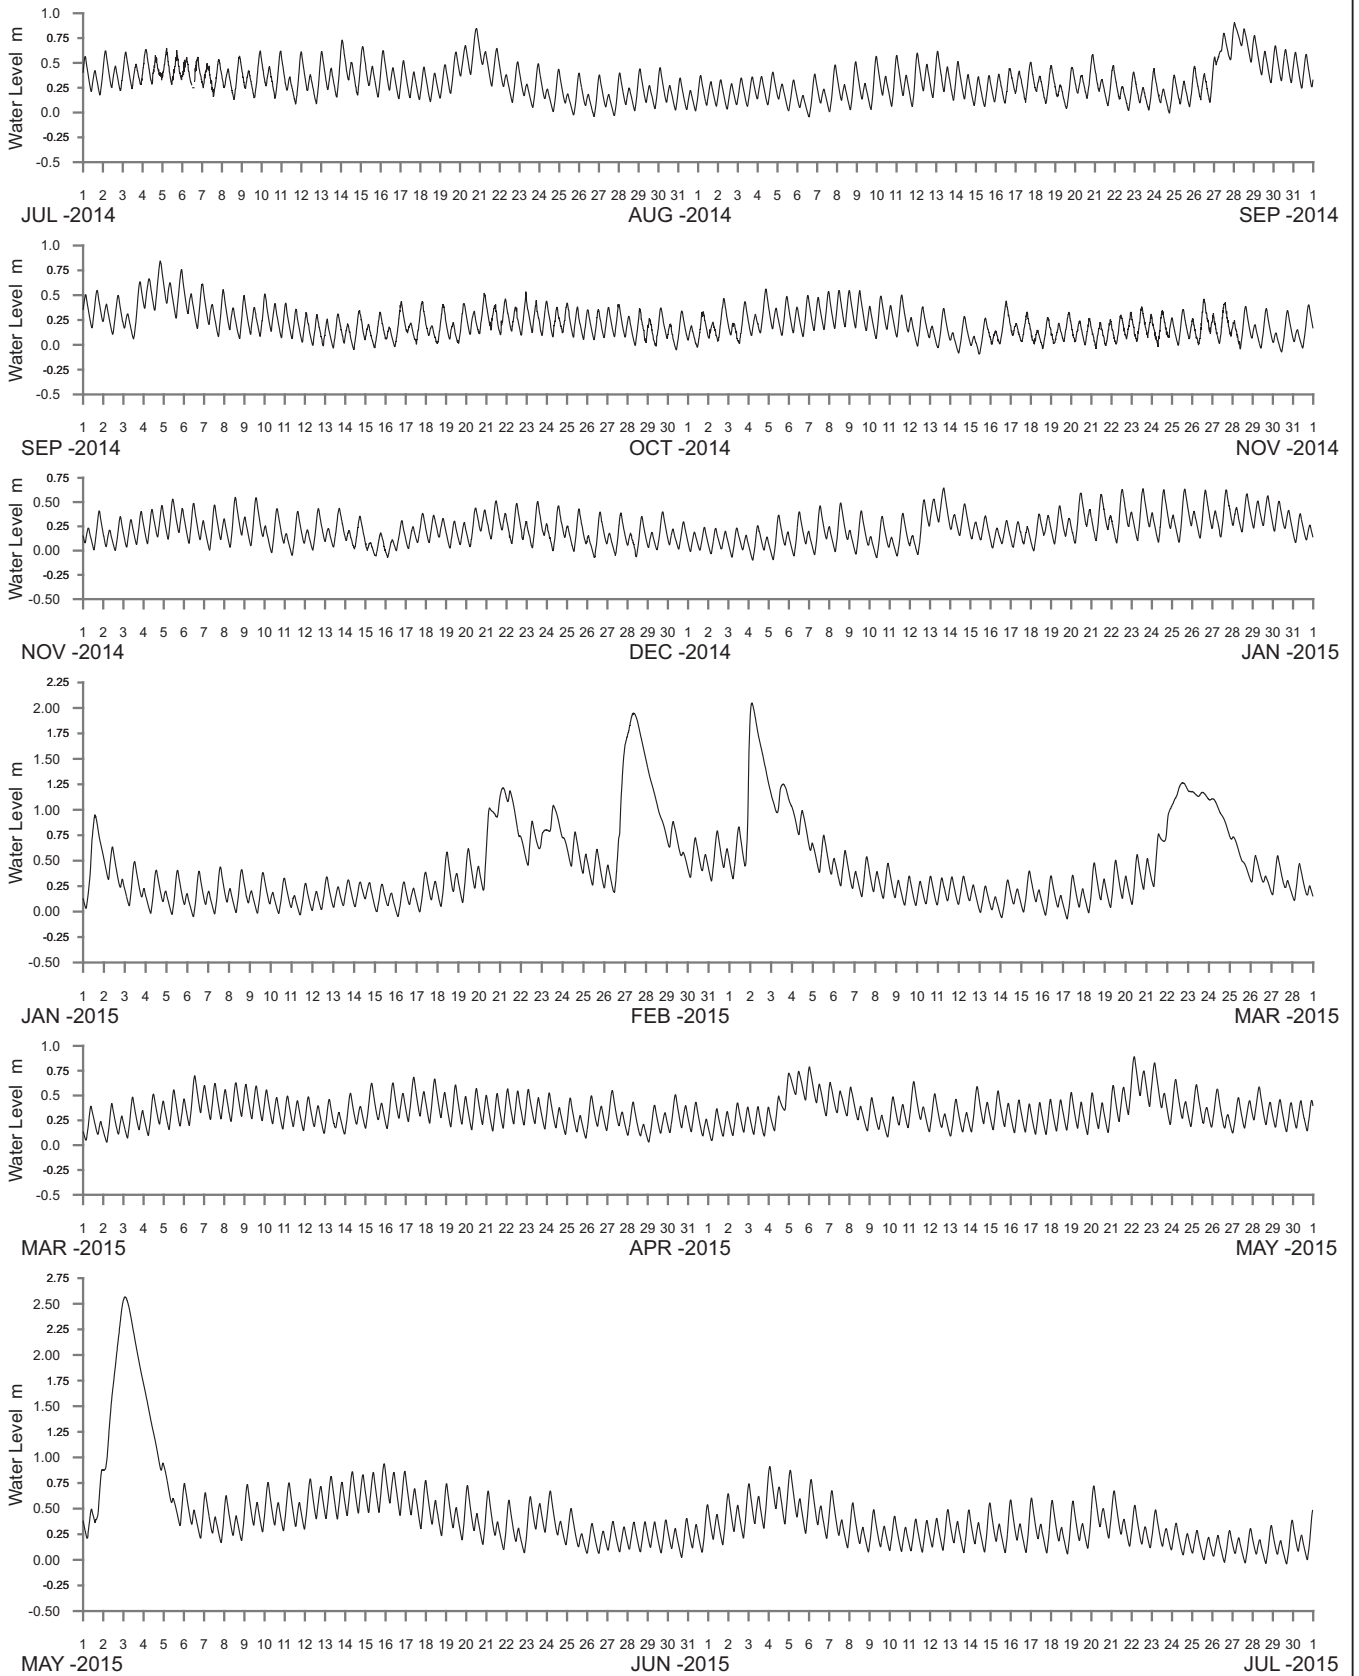
Figure  
77

WATER LEVEL REFERENCED TO AUSTRALIAN HEIGHT DATUM

----- DATA LOSS

**WARRELL CREEK AT WARRELL CREEK**  
2014-2015

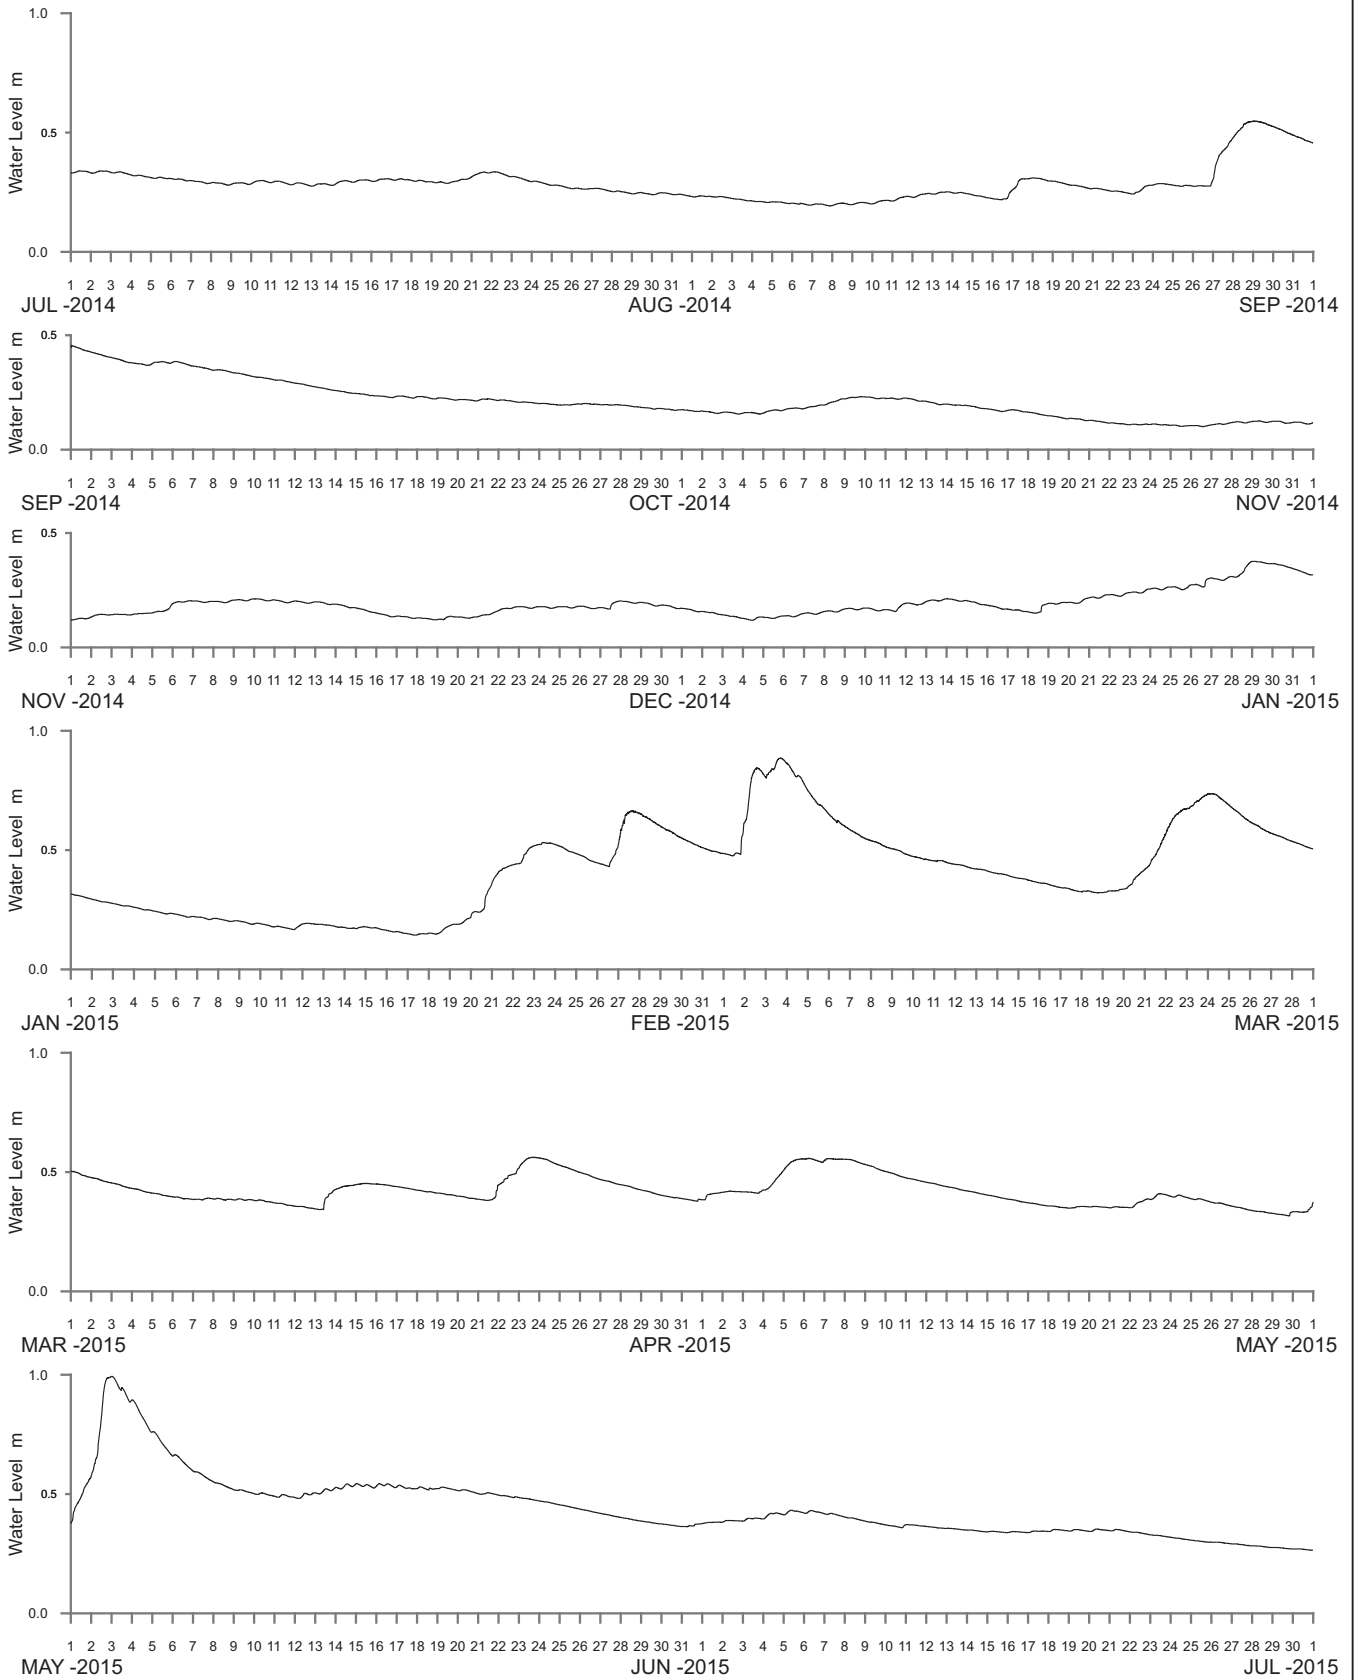
Figure  
79

WATER LEVEL REFERENCED TO AUSTRALIAN HEIGHT DATUM

----- DATA LOSS

**BORIRGALA CREEK AT BORIRGALA CREEK**  
2014–2015

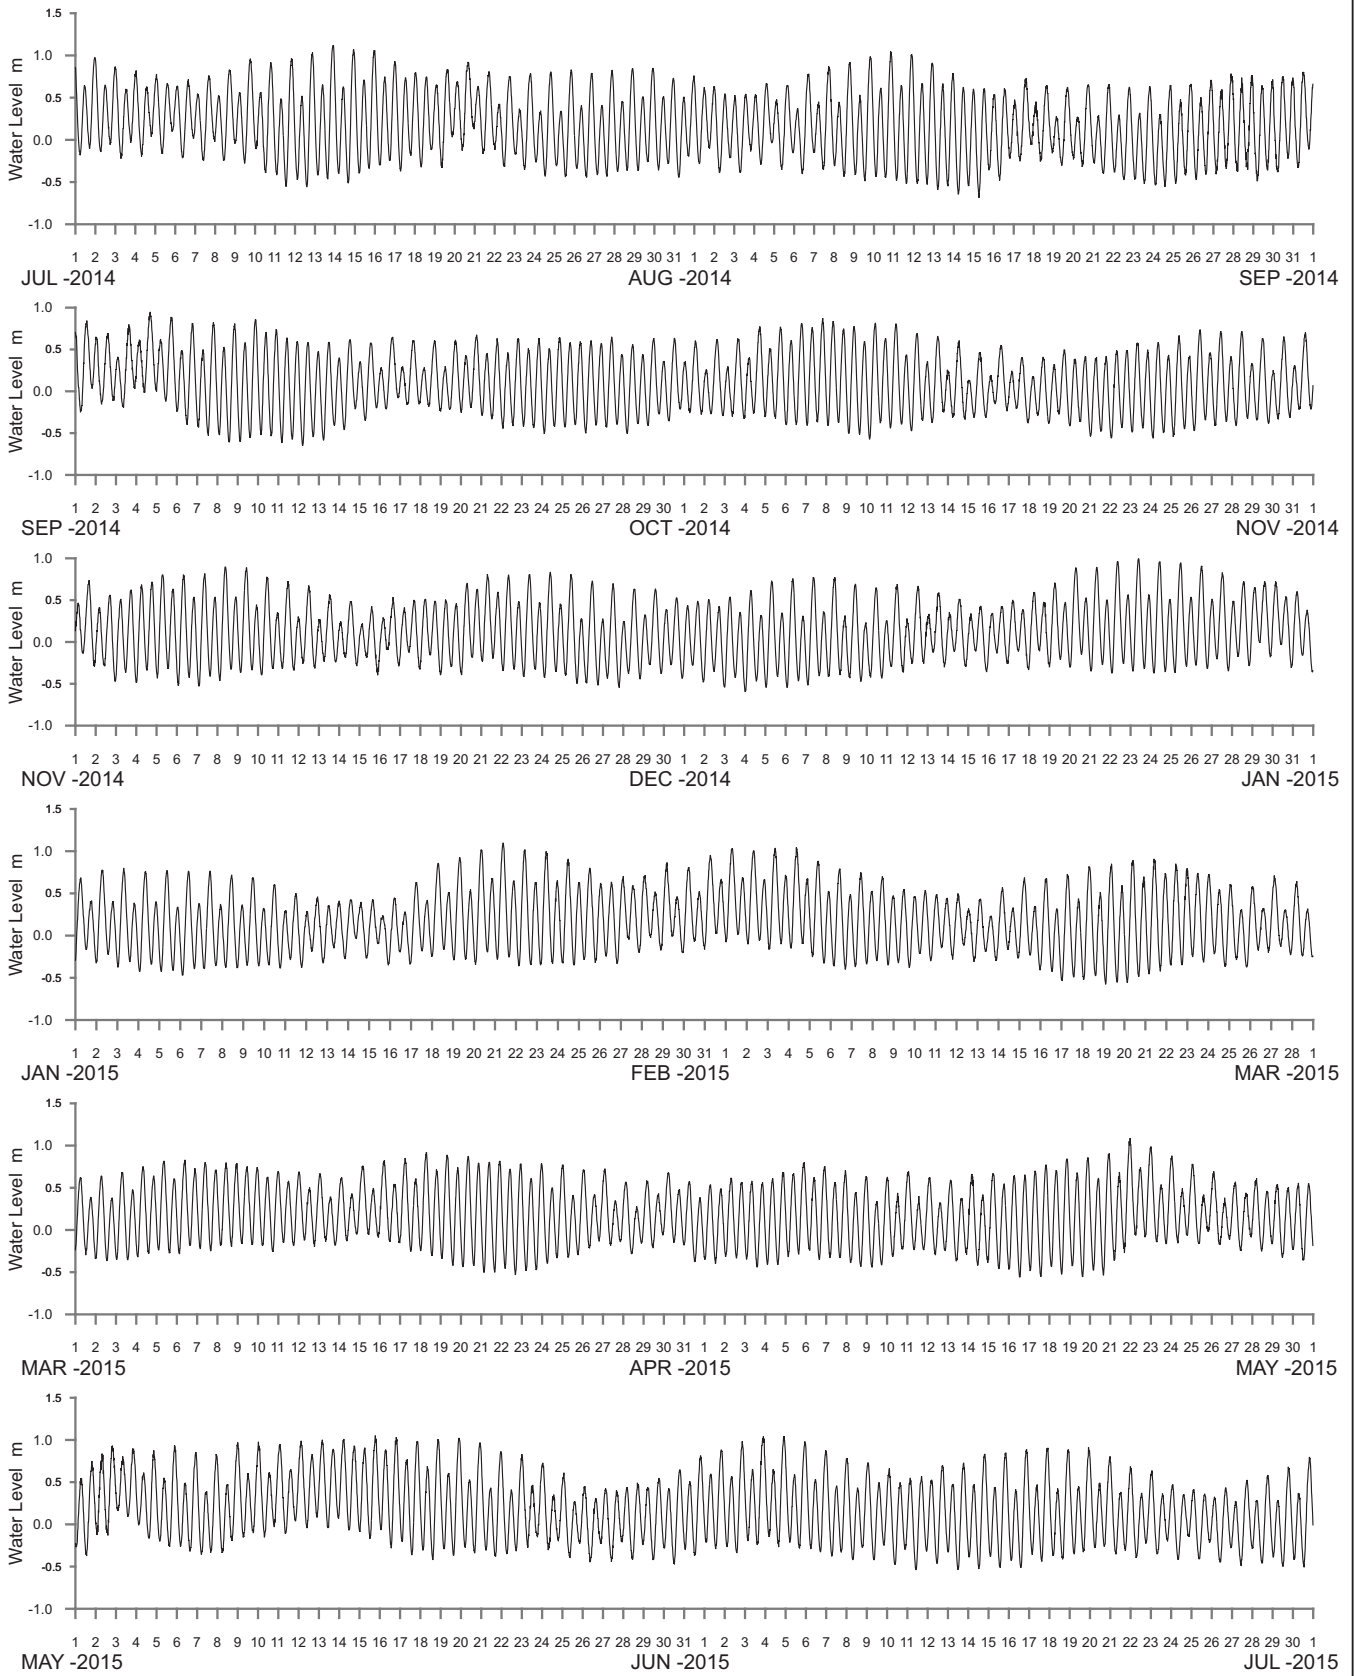
Figure  
**80**

WATER LEVEL REFERENCED TO AUSTRALIAN HEIGHT DATUM

----- DATA LOSS

**MACLEAY RIVER AT SOUTH WEST ROCKS  
2014–2015**

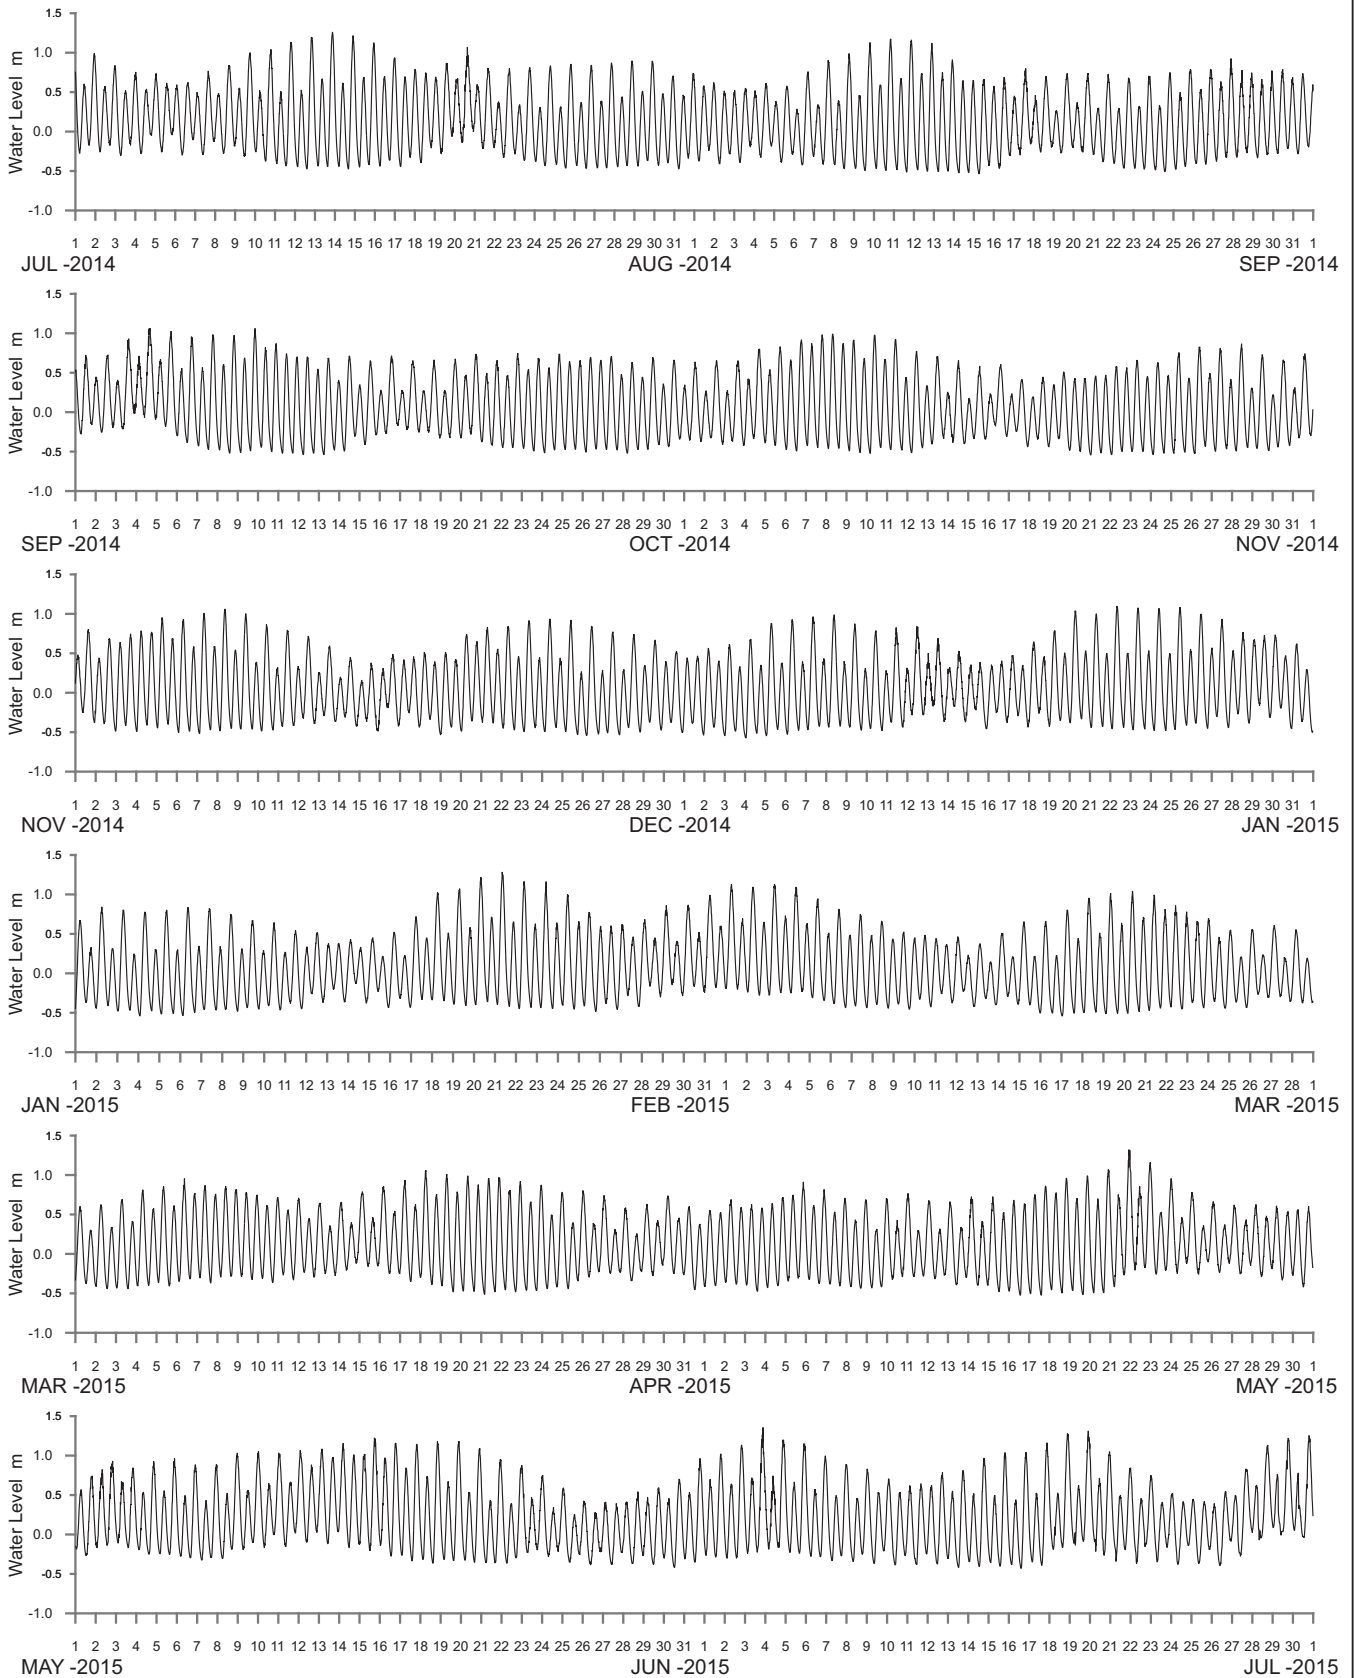
Figure  
81

WATER LEVEL REFERENCED TO AUSTRALIAN HEIGHT DATUM

----- DATA LOSS

**KOROGORO CREEK AT HAT HEAD**  
2014–2015

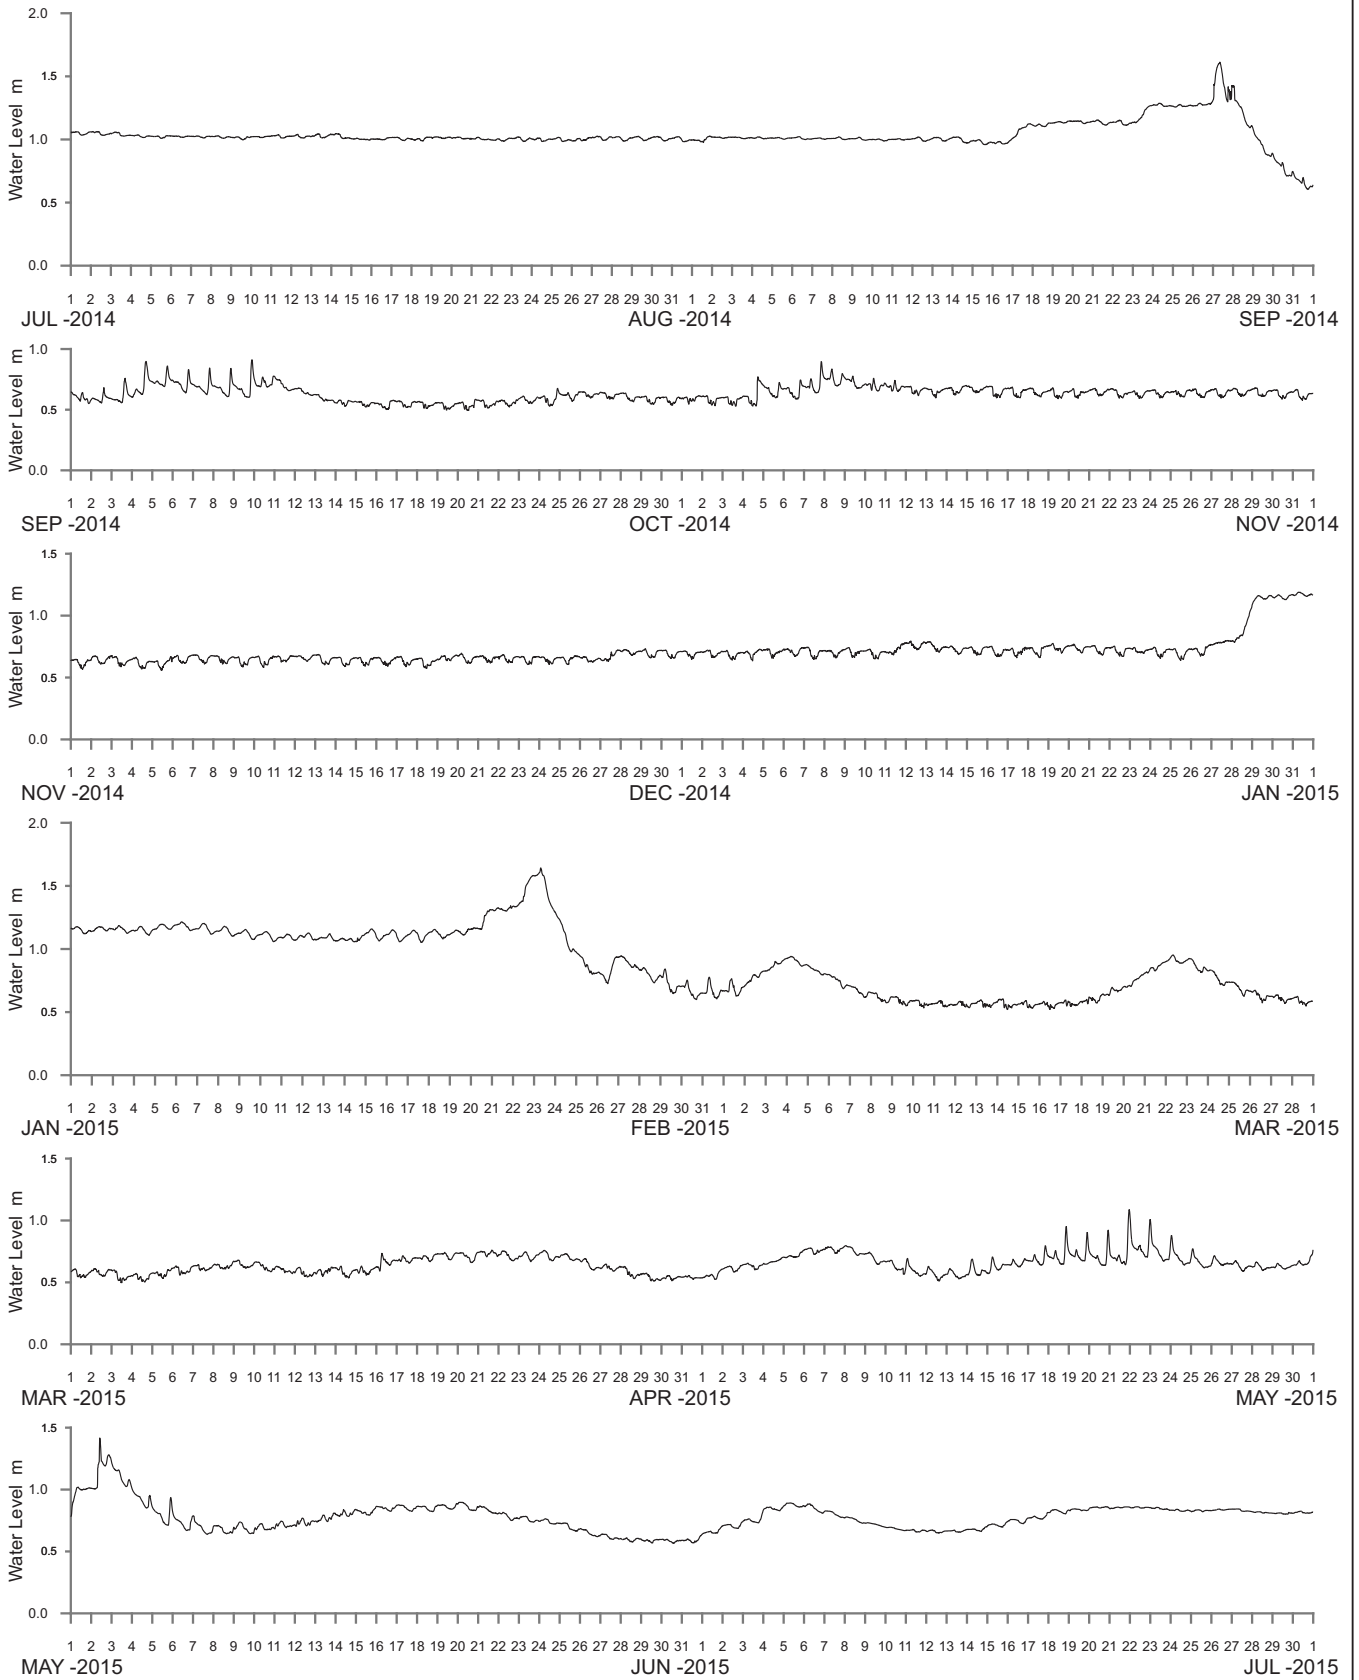
Figure  
82

WATER LEVEL REFERENCED TO AUSTRALIAN HEIGHT DATUM

----- DATA LOSS

**SALTWATER LAGOON AT SALTWATER LAGOON**  
2014-2015

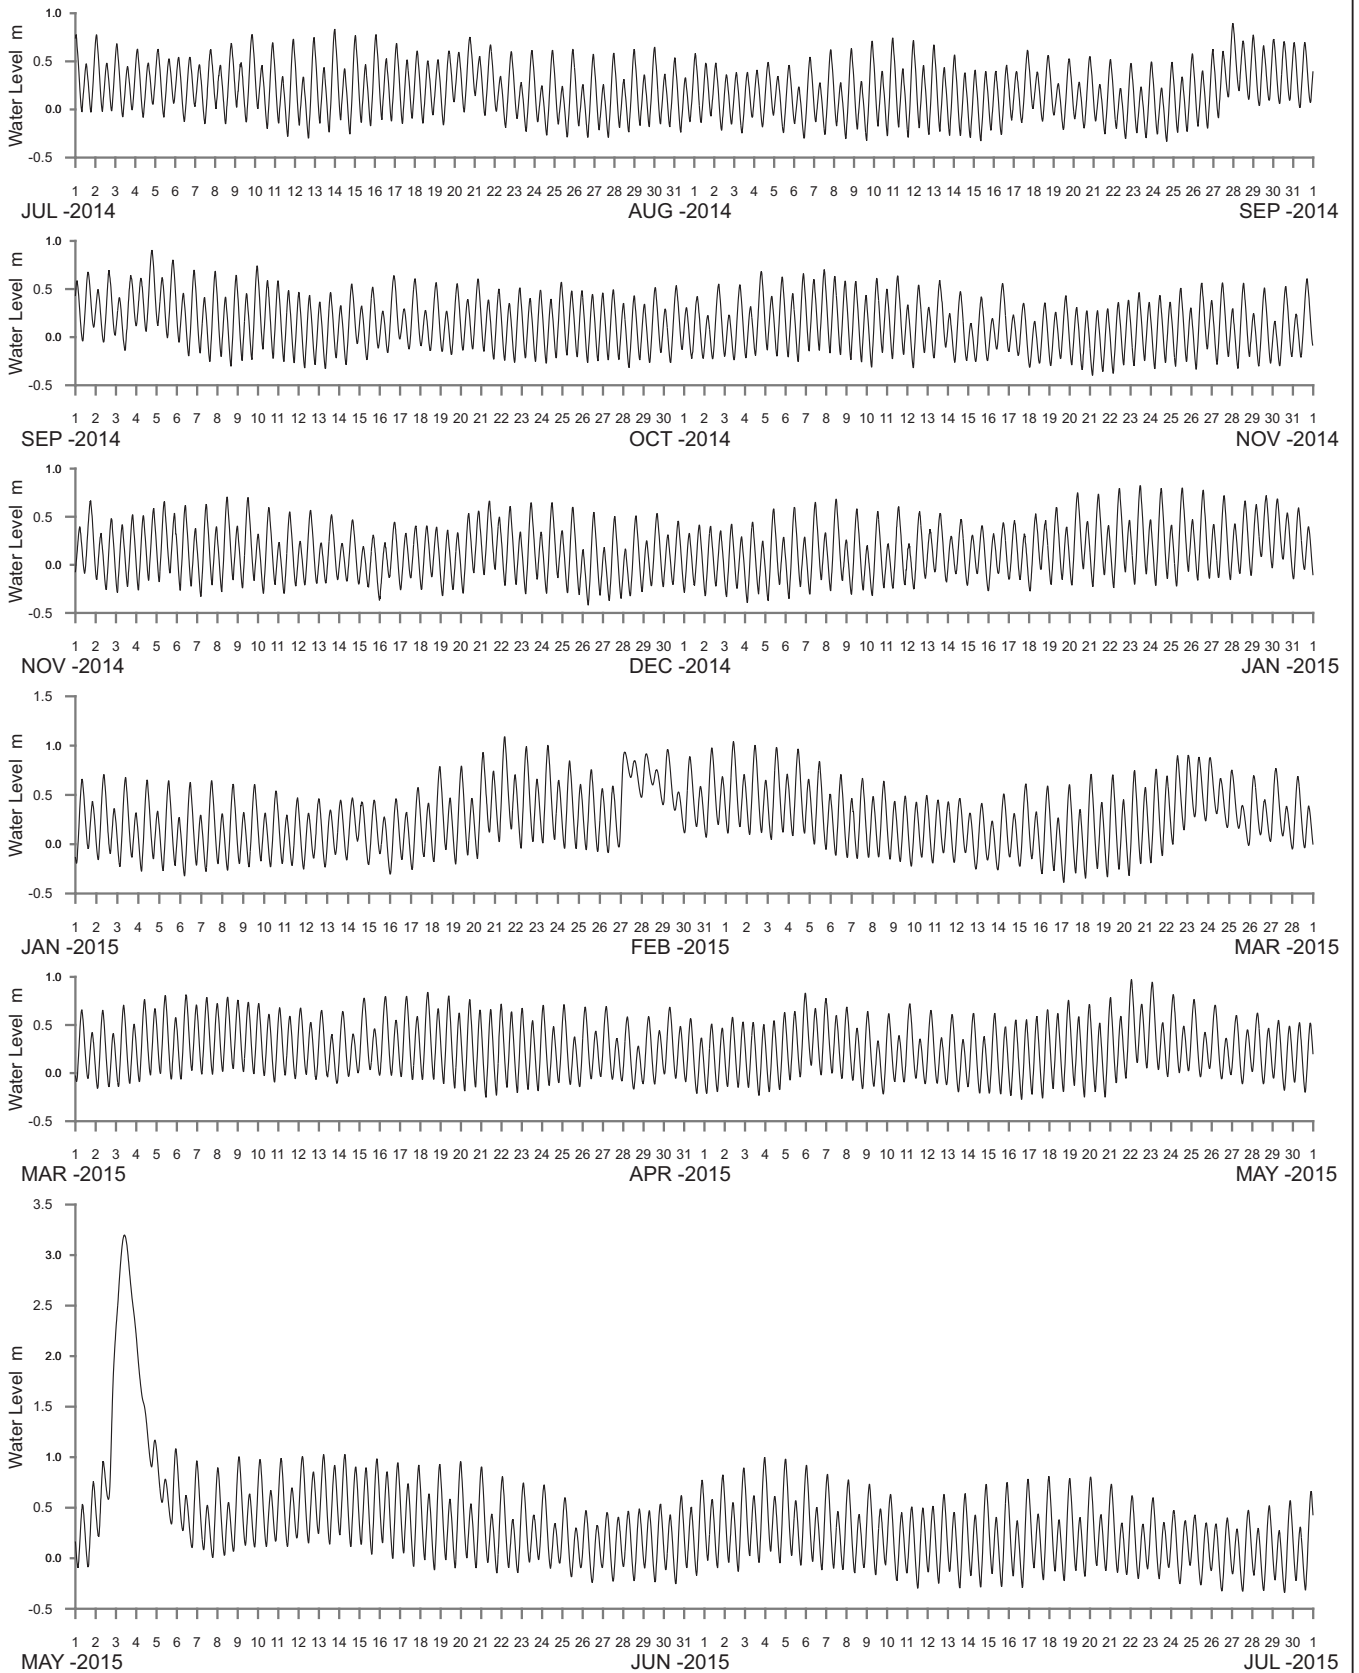
Figure  
83

WATER LEVEL REFERENCED TO AUSTRALIAN HEIGHT DATUM

----- DATA LOSS

**MACLEAY RIVER AT SMITHTOWN**  
2014–2015

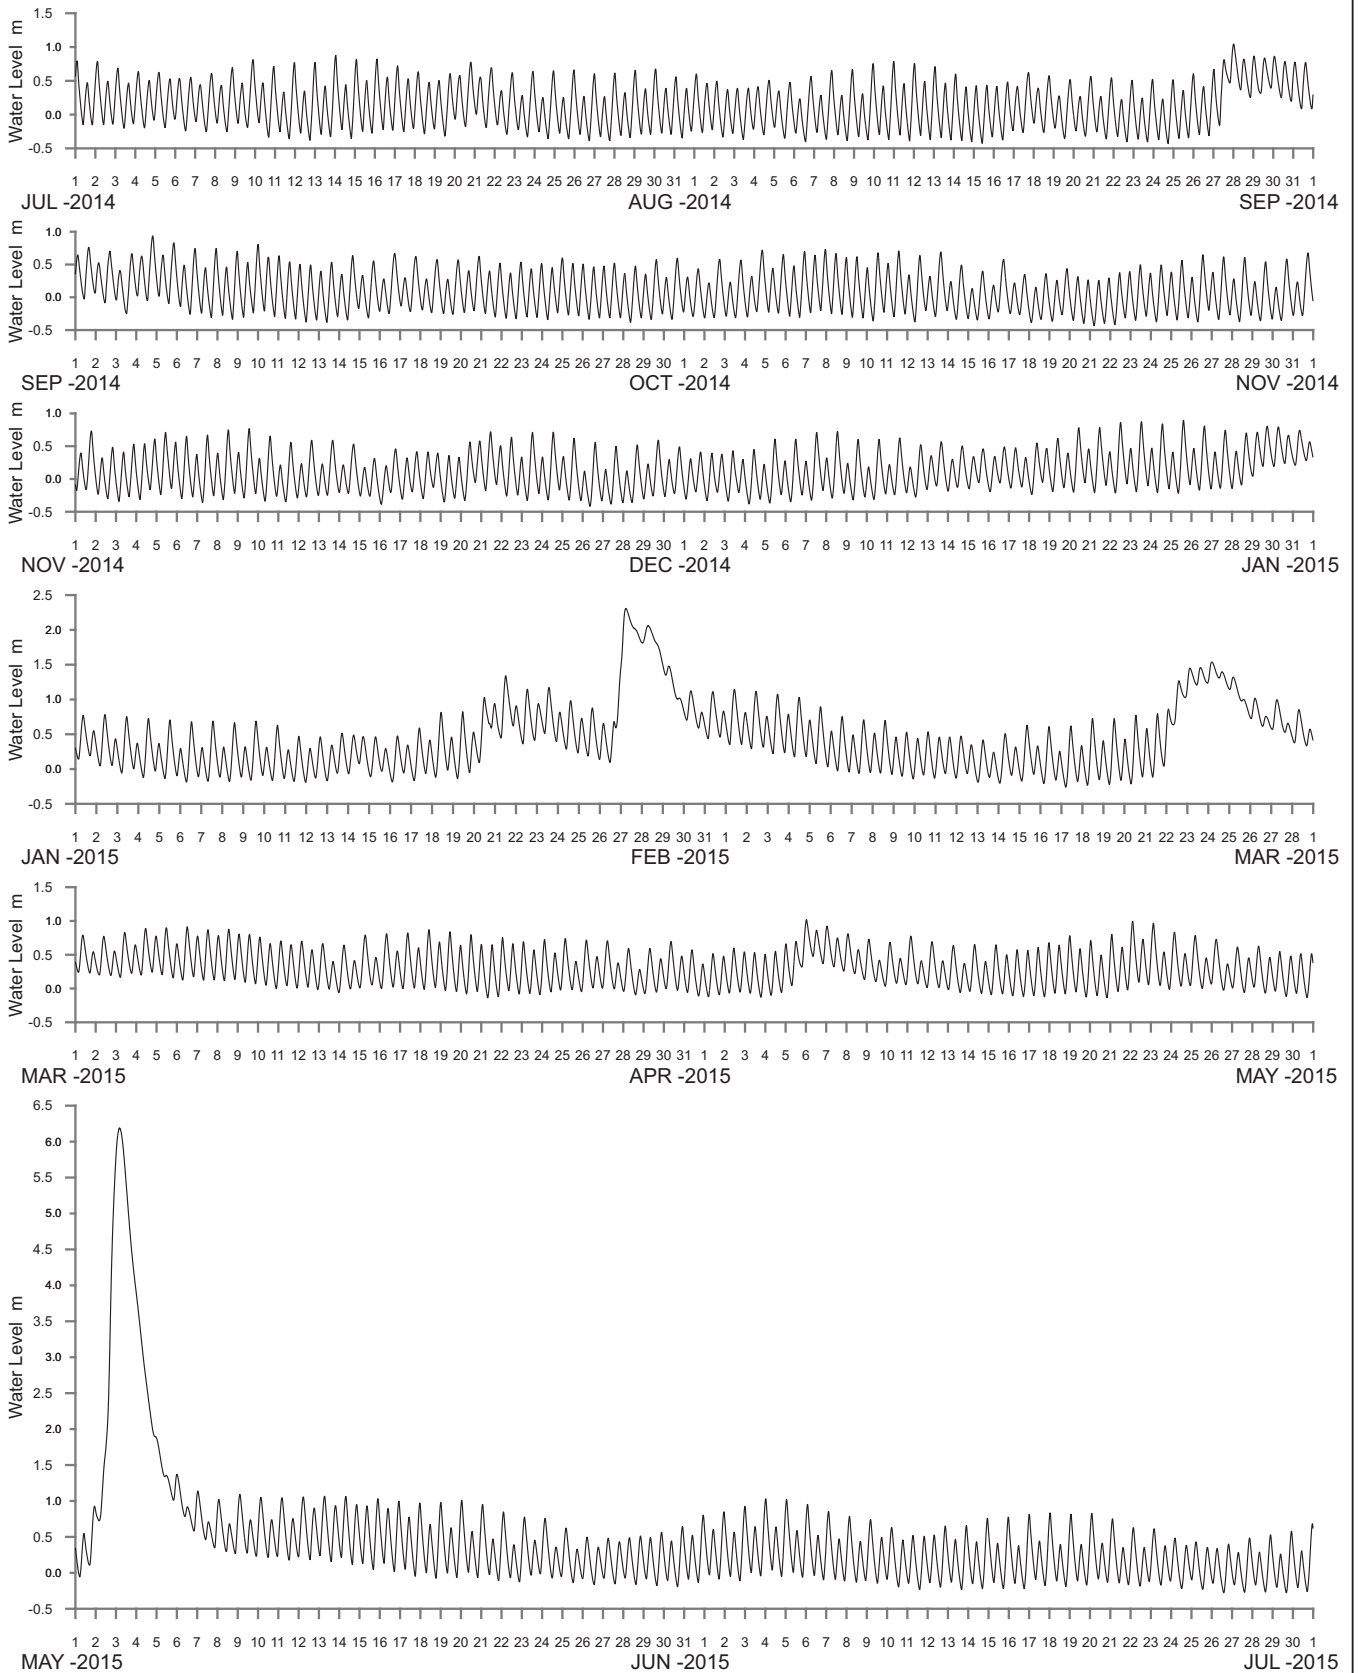
Figure  
85

WATER LEVEL REFERENCED TO AUSTRALIAN HEIGHT DATUM

----- DATA LOSS

**MACLEAY RIVER AT ALDAVILLA DOWNSTREAM**  
2014–2015

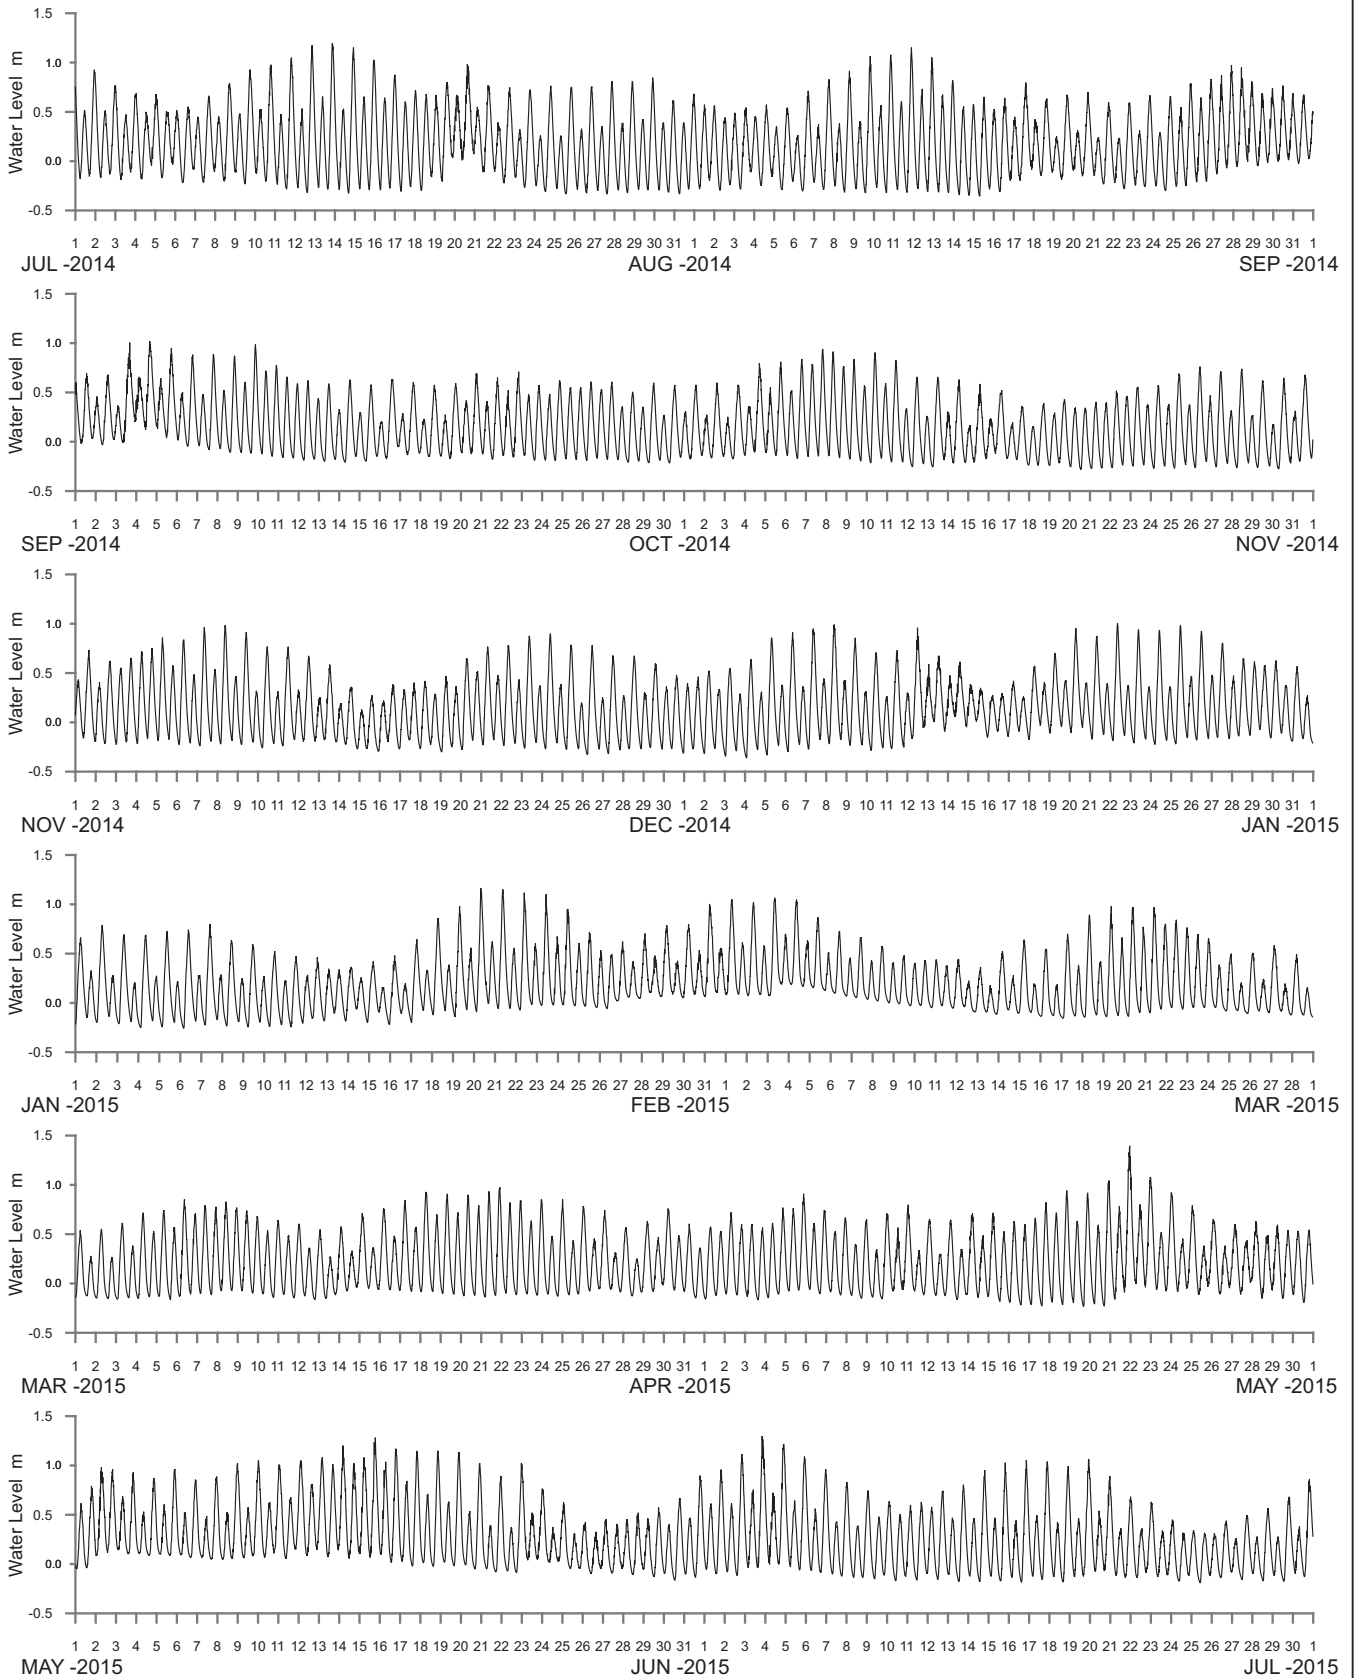
Figure  
86

WATER LEVEL REFERENCED TO AUSTRALIAN HEIGHT DATUM

----- DATA LOSS

**KILLICK CREEK AT CRESCENT HEAD**  
2014–2015

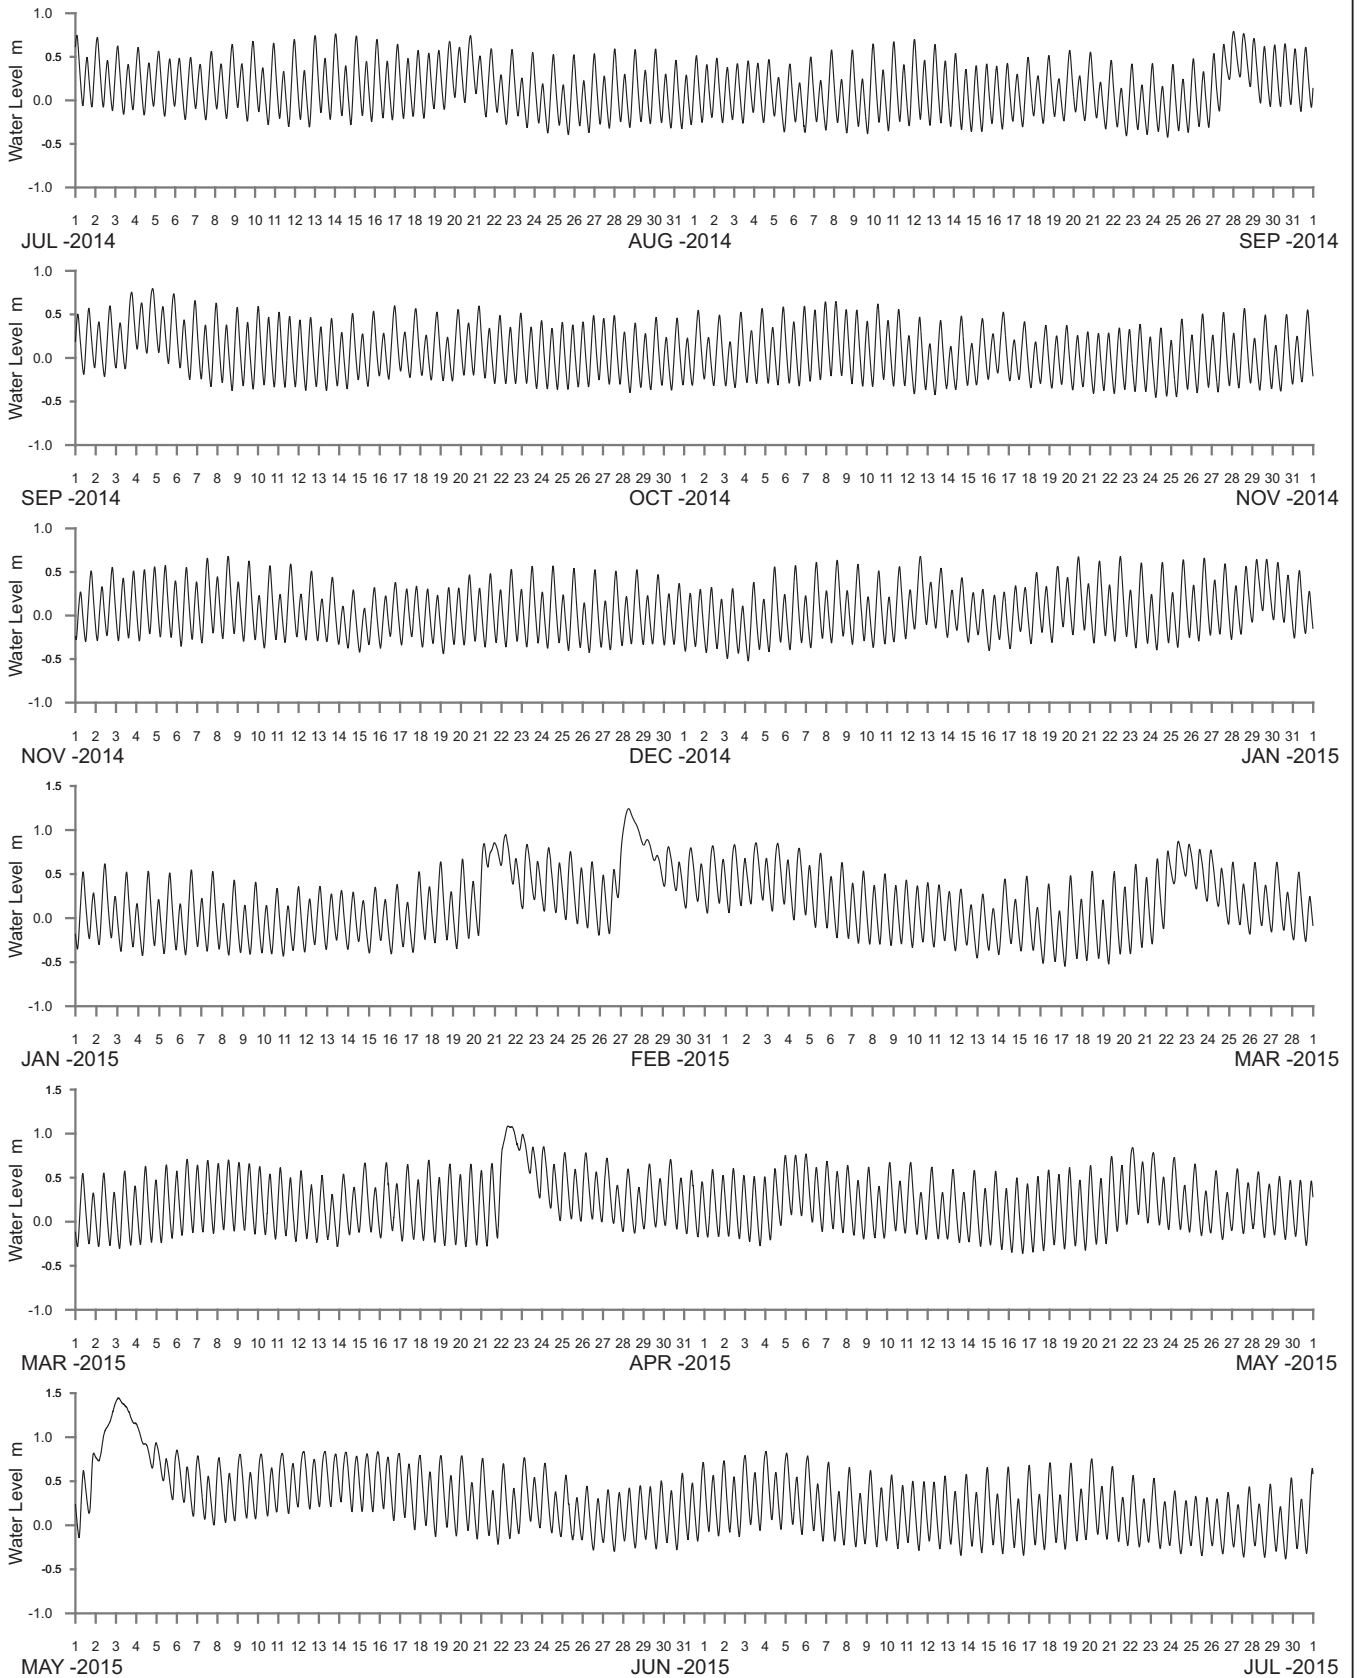
Figure  
88

WATER LEVEL REFERENCED TO AUSTRALIAN HEIGHT DATUM

----- DATA LOSS

MARIA RIVER AT GREEN VALLEY  
2014–2015

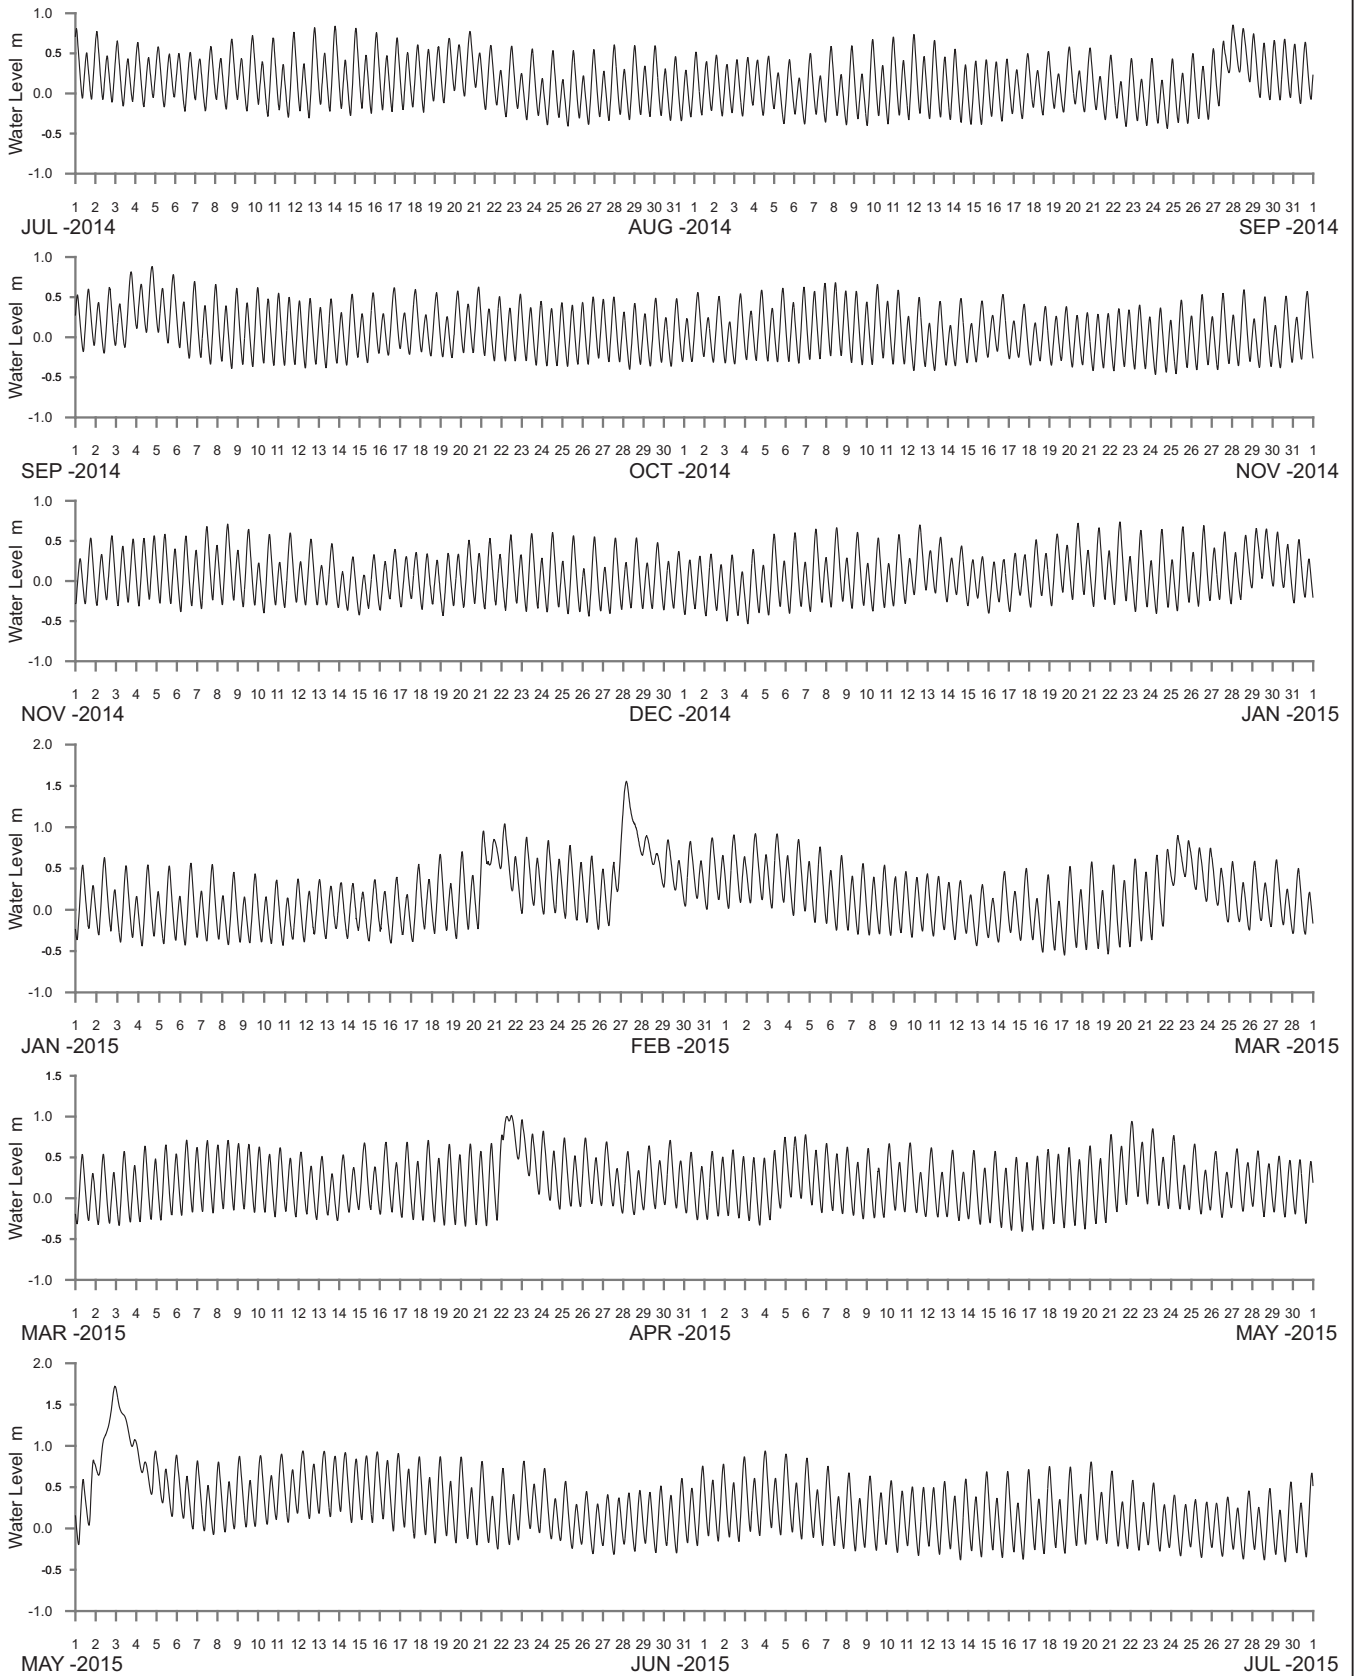
Figure  
89

WATER LEVEL REFERENCED TO AUSTRALIAN HEIGHT DATUM

----- DATA LOSS

**WILSONS RIVER AT TELEGRAPH POINT**  
2014–2015
