<b>River/Estuary System</b>	<b>Station Name</b>	<b>Figure</b>
Station Locality Map	Woolgoolga Region	52
Wooli River	Wooli Entrance	53
Wooli River	Wooli Caravan Park	54
Corindi Creek	Red Rock	55
Woolgoolga Lake	Woolgoolga Lake	56
Woolgoolga Creek	Woolgoolga	57
Moonee Creek	Moonee Creek	58
Station Locality Map	Coffs Harbour Region	59
Coffs Creek	Coffs Creek Highway Bridge	60
Newports Creek	Newports Creek	61
Boambee Creek	Boambee	62
Boambee Creek	Boambee Entrance	63
Station Locality Map	Bellingher River Region	64
Bonville Creek	Bonville	65
Bellingher River	Repton	66
Bellingher River	Bellingher Bridge	67
Kalang River	Urunga	68
Kalang River	Upstream Newry Island	69
Kalang River	Koorowwi	70
Station Locality Map	Nambucca River Region	71
Deep Creek	Deep Creek	72
Nambucca River	Stuarts Island Downstream	73
Nambucca River	Macksville	74
Nambucca River	Utungun	75
Nambucca River	Bowraville Downstream	76
Warrell Creek	Warrell Creek	77

**Public Works**  
Manly Hydraulics Laboratory

MHL  
Report 2383

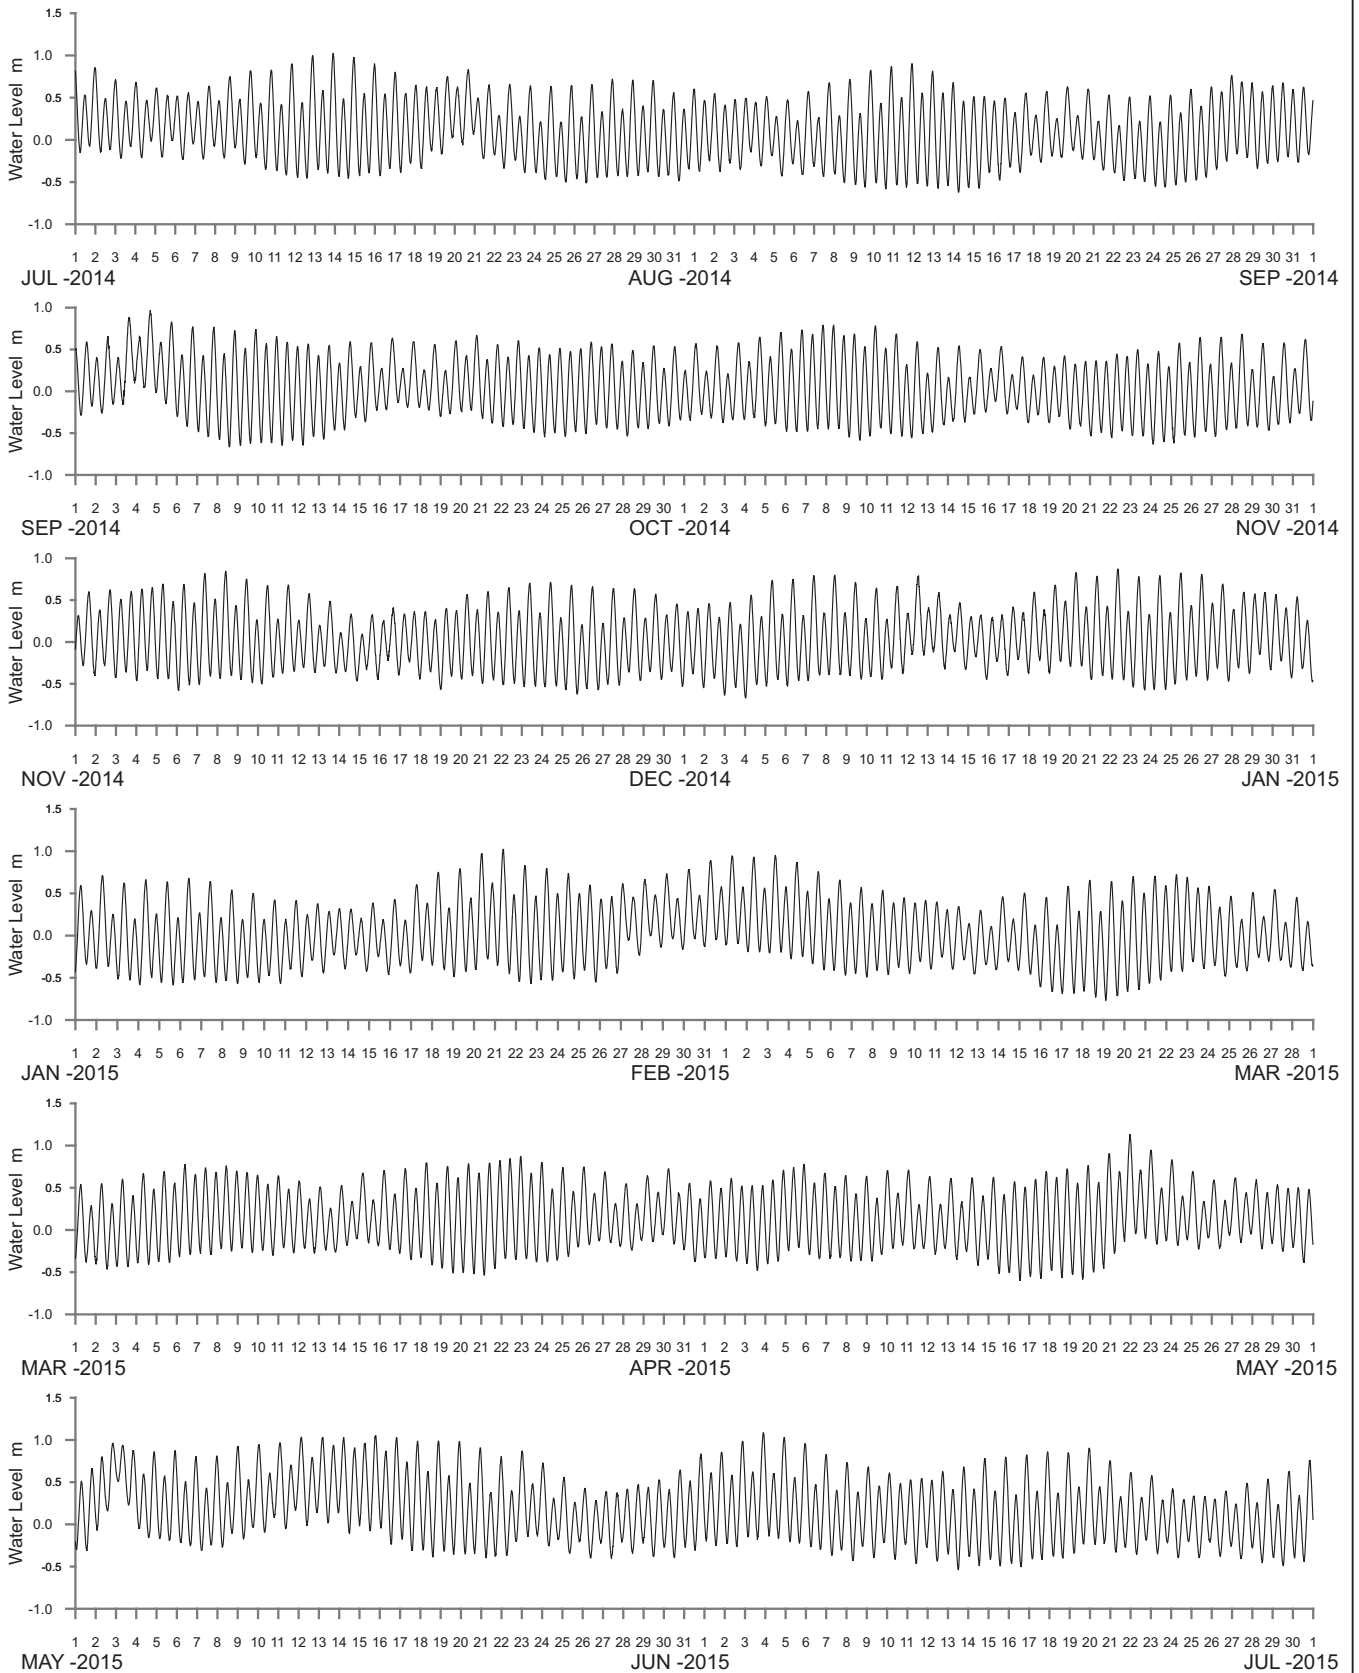
Figure  
**90**

WATER LEVEL REFERENCED TO AUSTRALIAN HEIGHT DATUM

----- DATA LOSS

**HASTINGS RIVER AT SETTLEMENT POINT  
2014–2015**

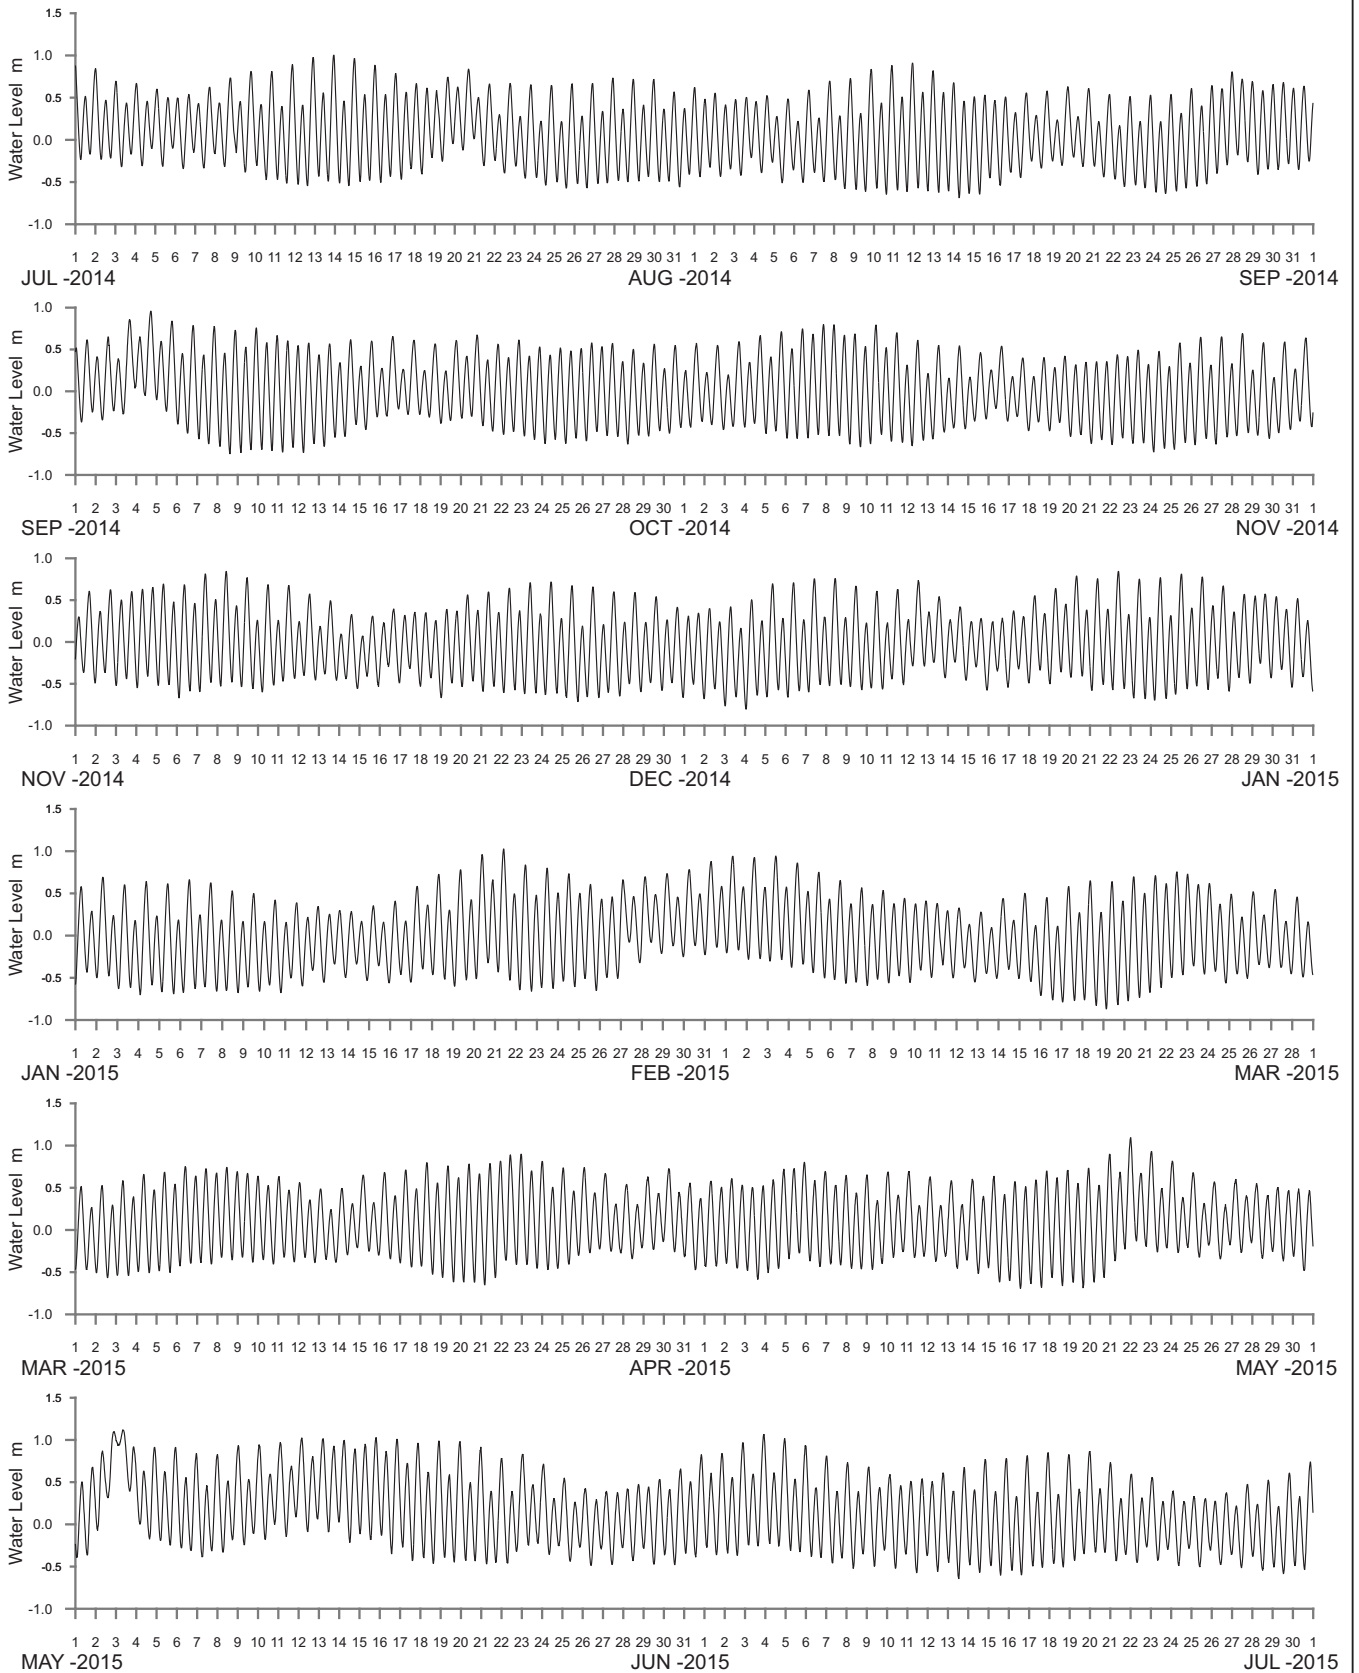
Figure  
91

WATER LEVEL REFERENCED TO AUSTRALIAN HEIGHT DATUM

----- DATA LOSS

**HASTINGS RIVER AT DENNIS BRIDGE DOWNSTREAM**  
2014–2015

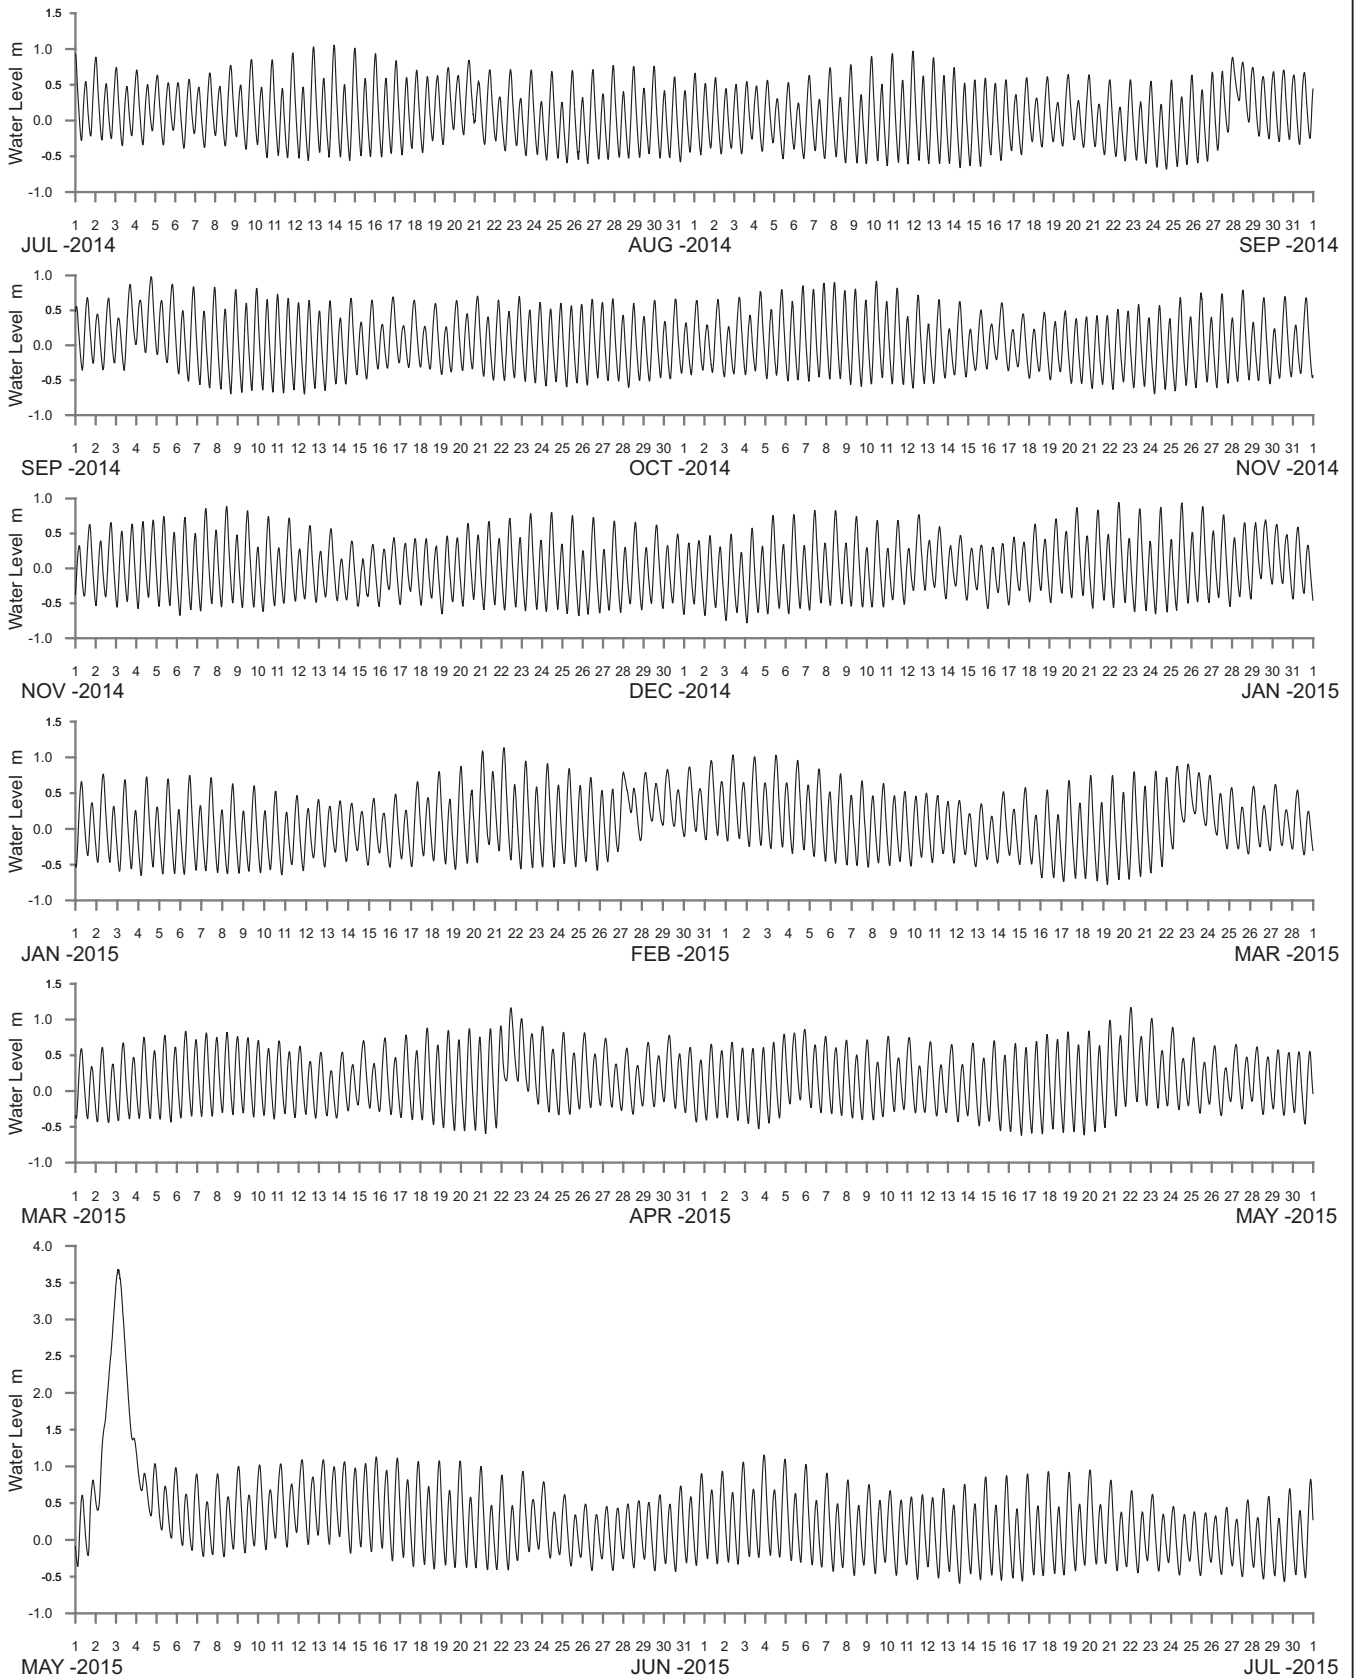
Figure  
92

WATER LEVEL REFERENCED TO AUSTRALIAN HEIGHT DATUM

----- DATA LOSS

**HASTINGS RIVER AT WAUCHOPE RAILWAY BRIDGE**  
2014–2015

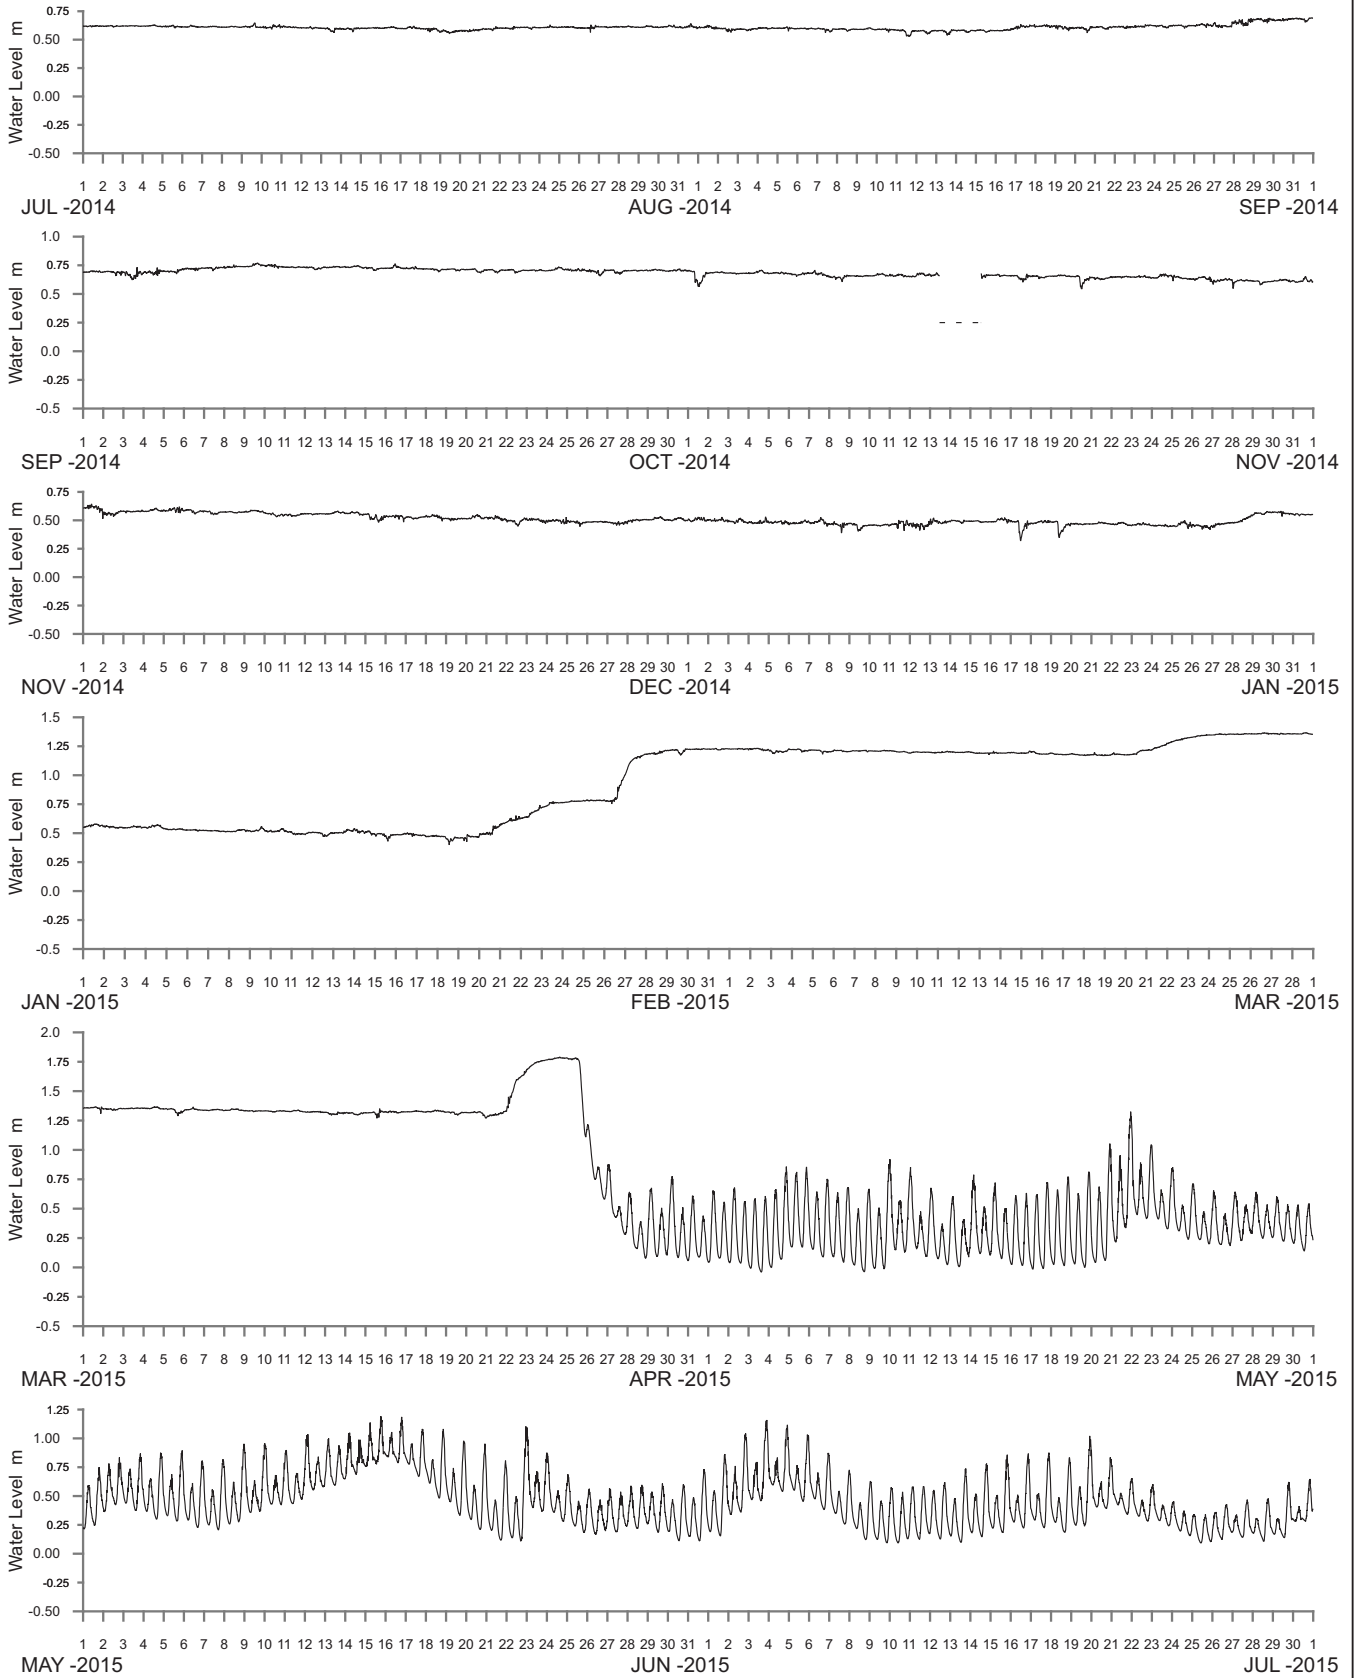
Figure  
94

WATER LEVEL REFERENCED TO AUSTRALIAN HEIGHT DATUM

----- DATA LOSS

LAKE CATHIE AT LAKE CATHIE  
2014-2015

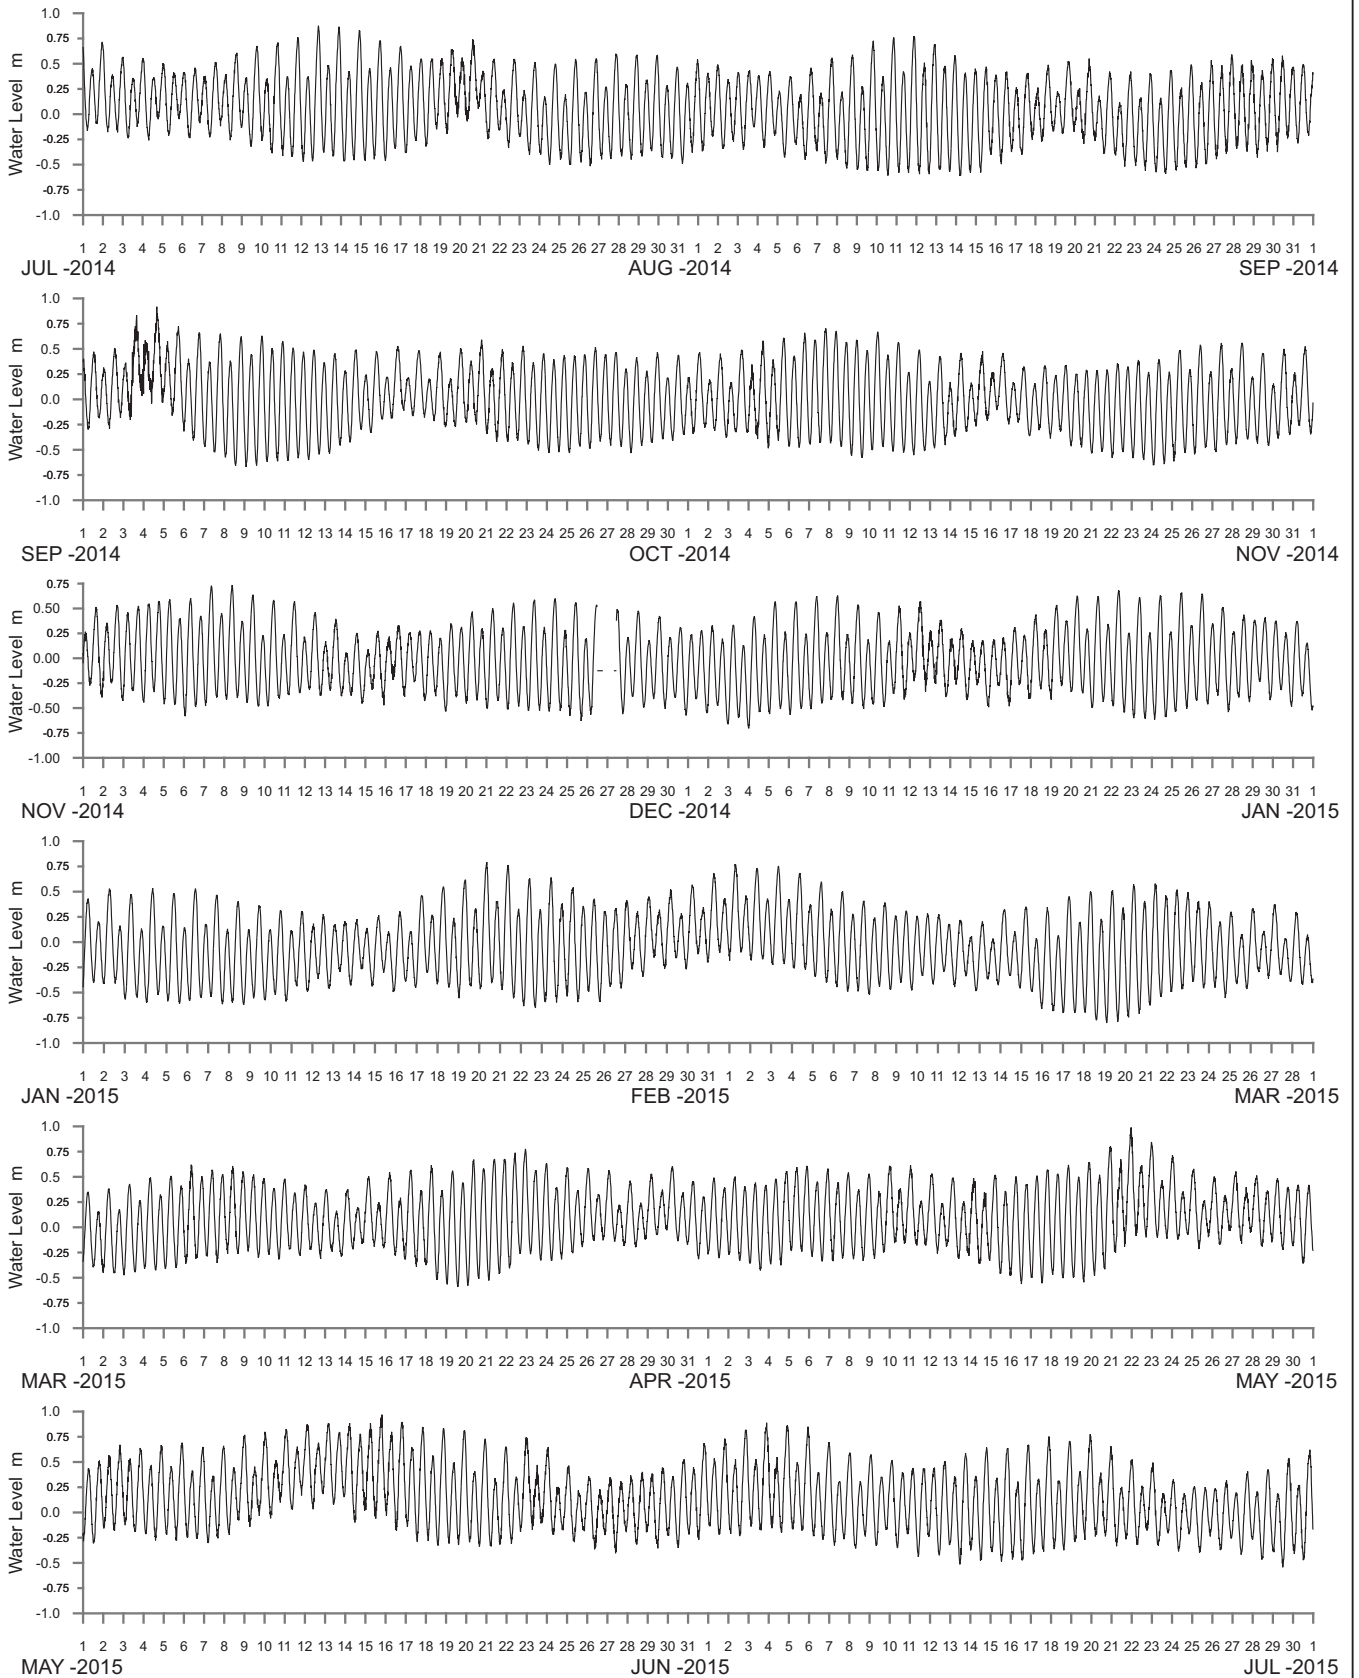
Figure  
95

WATER LEVEL REFERENCED TO AUSTRALIAN HEIGHT DATUM

----- DATA LOSS

**CAMDEN HAVEN AT NORTH HAVEN**  
2014-2015

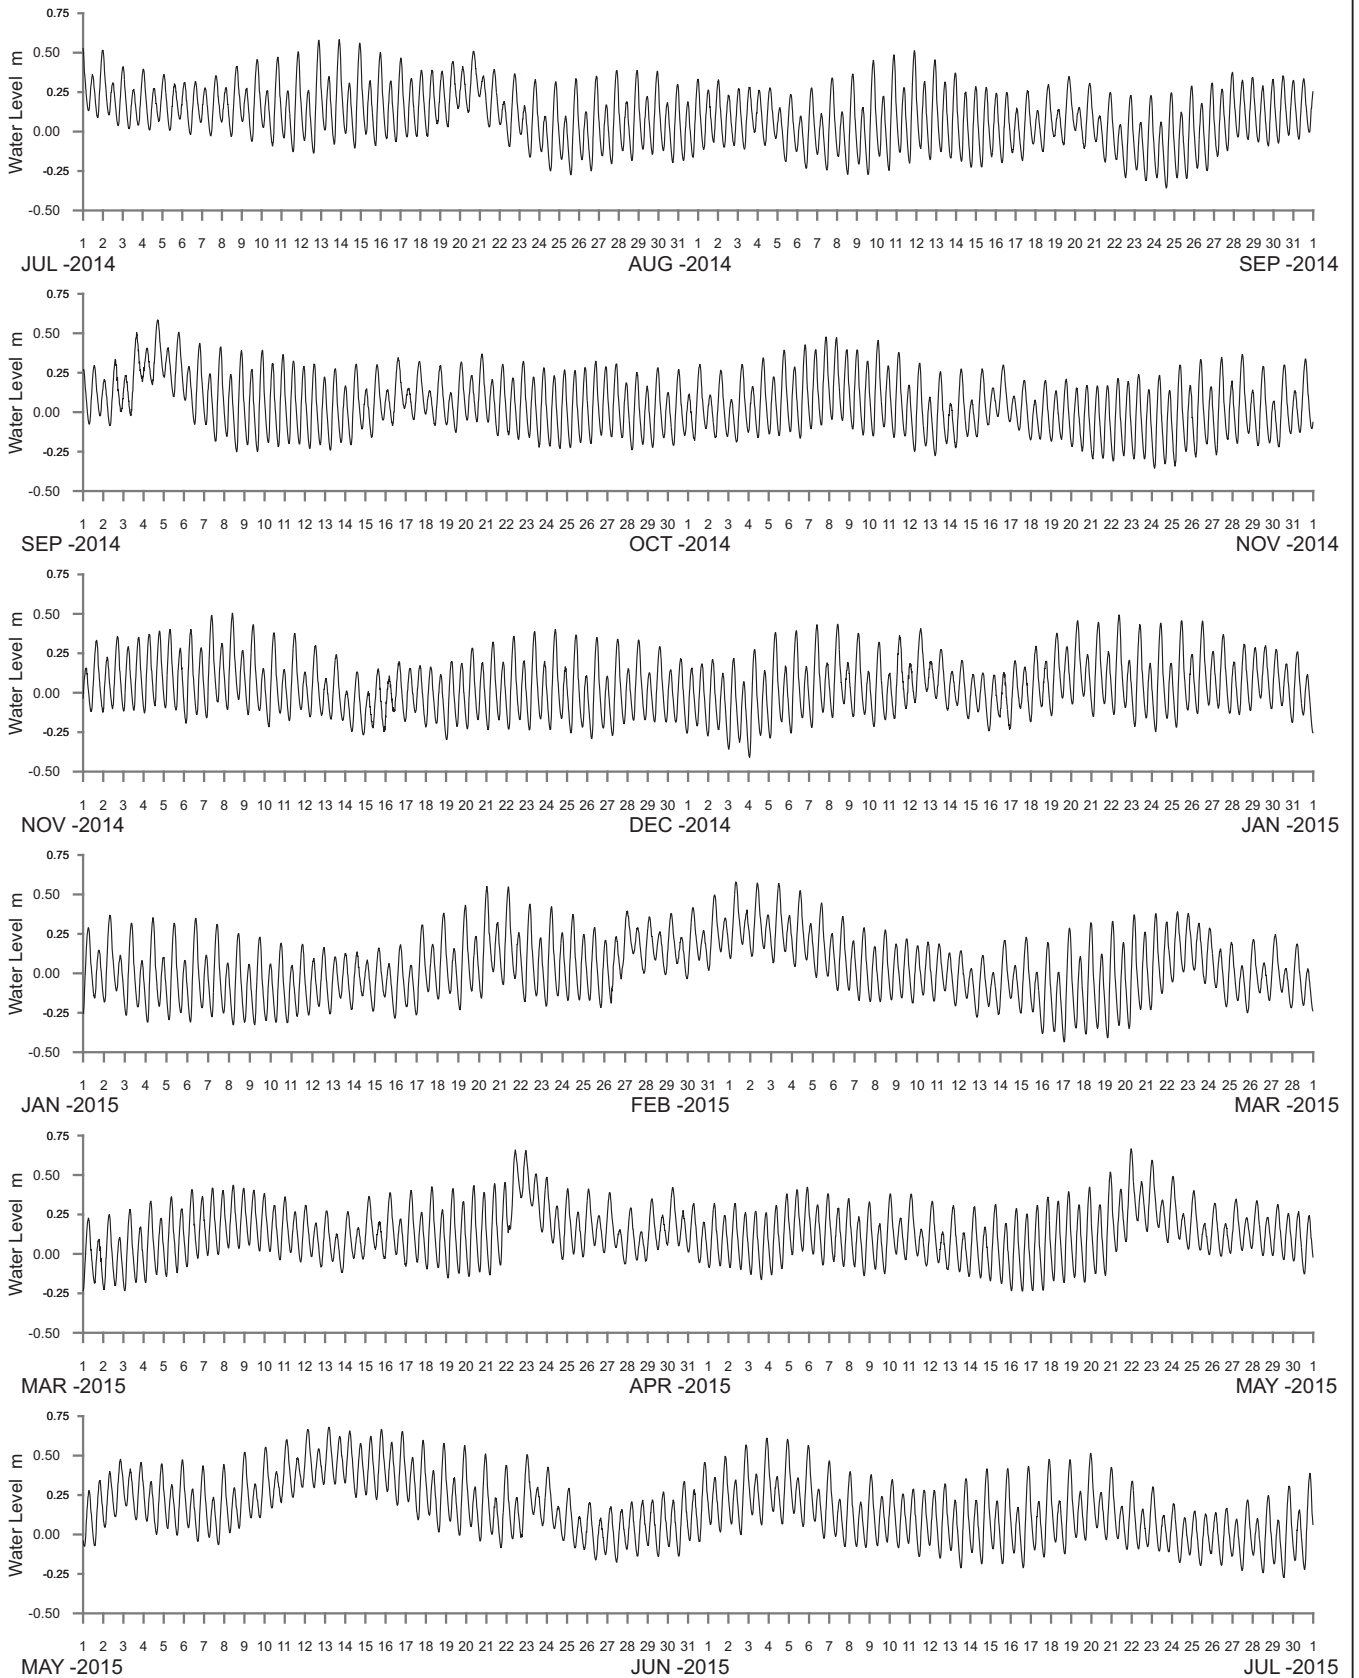
Figure  
96

WATER LEVEL REFERENCED TO AUSTRALIAN HEIGHT DATUM

----- DATA LOSS

**STINGRAY CREEK AT WEST HAVEN**  
2014–2015

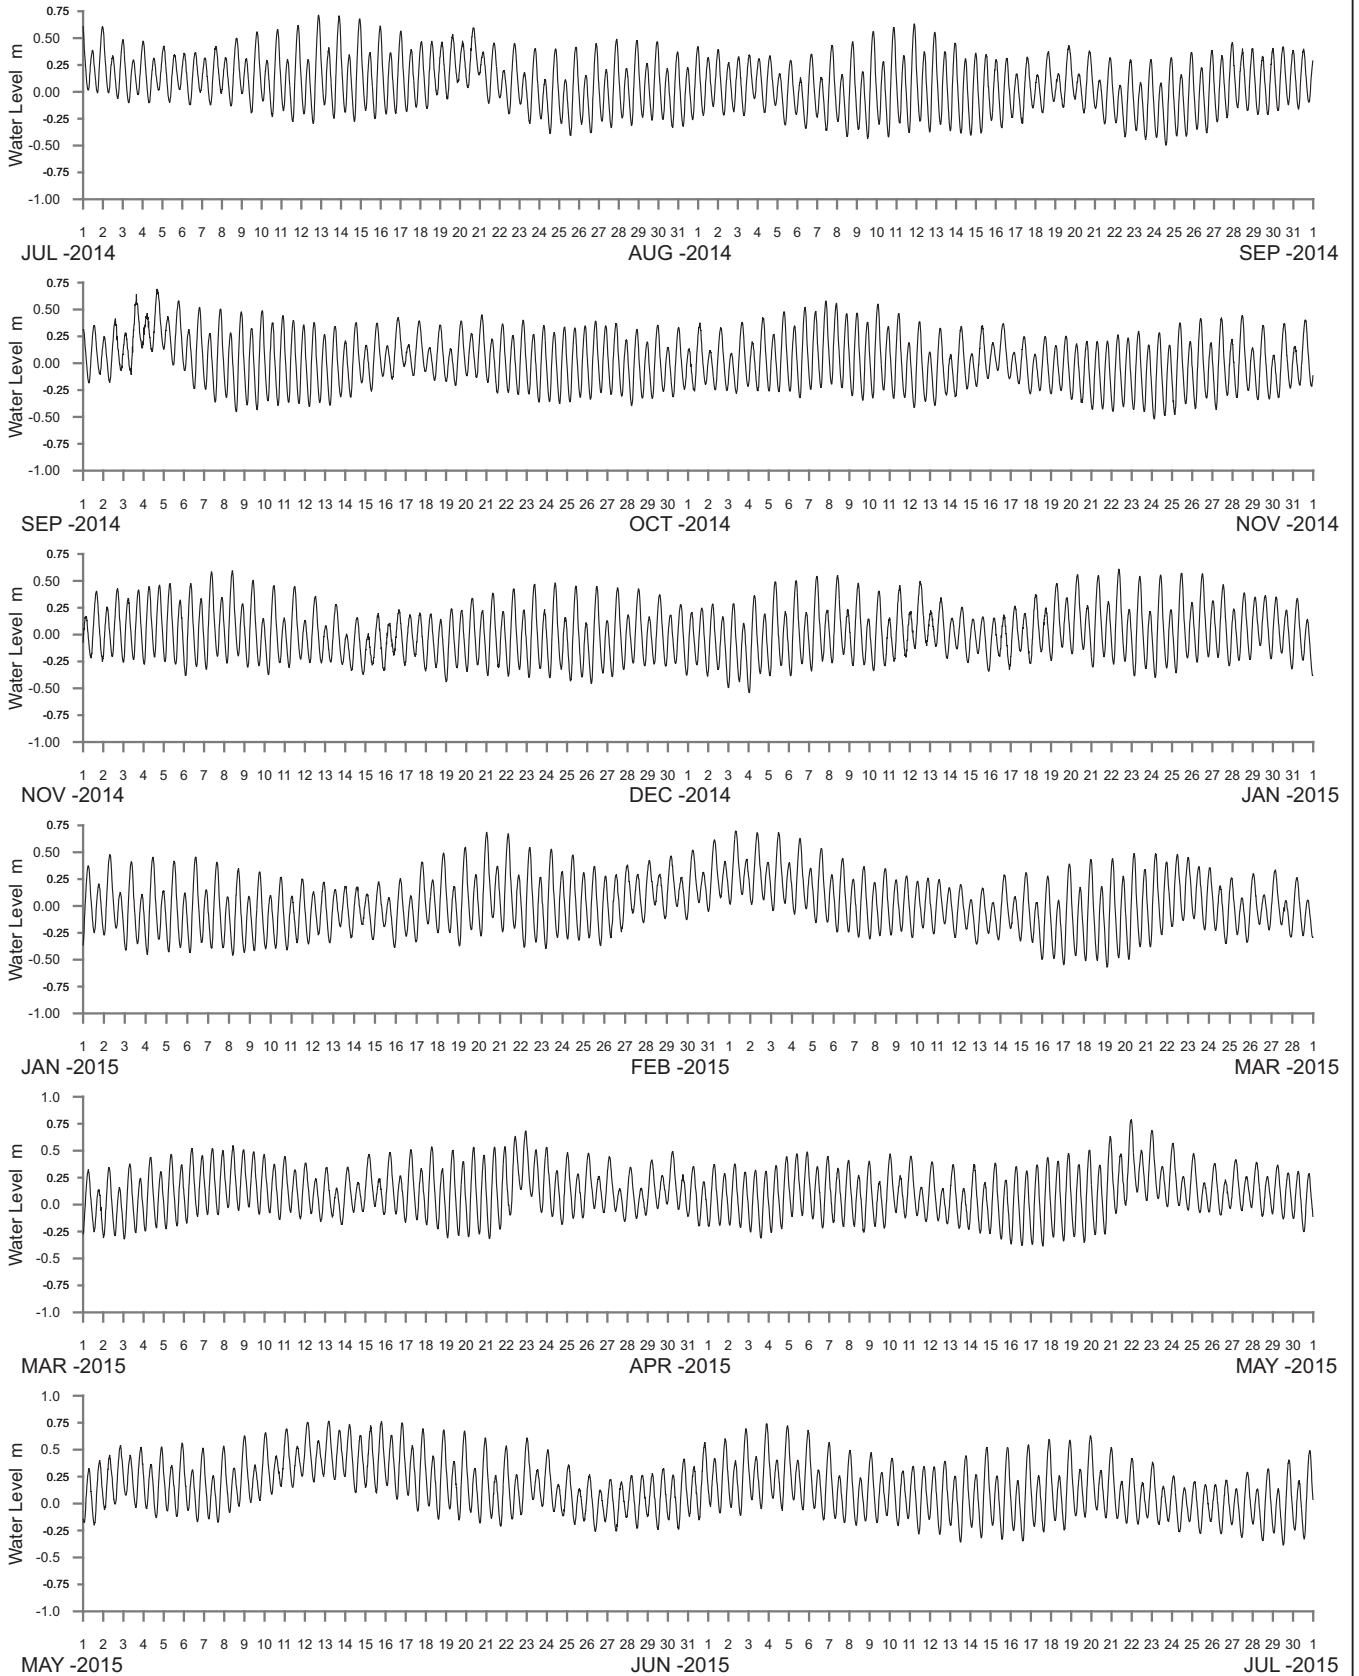
Figure  
97

WATER LEVEL REFERENCED TO AUSTRALIAN HEIGHT DATUM

----- DATA LOSS

**CAMDEN HAVEN AT LAURIETON**  
2014–2015

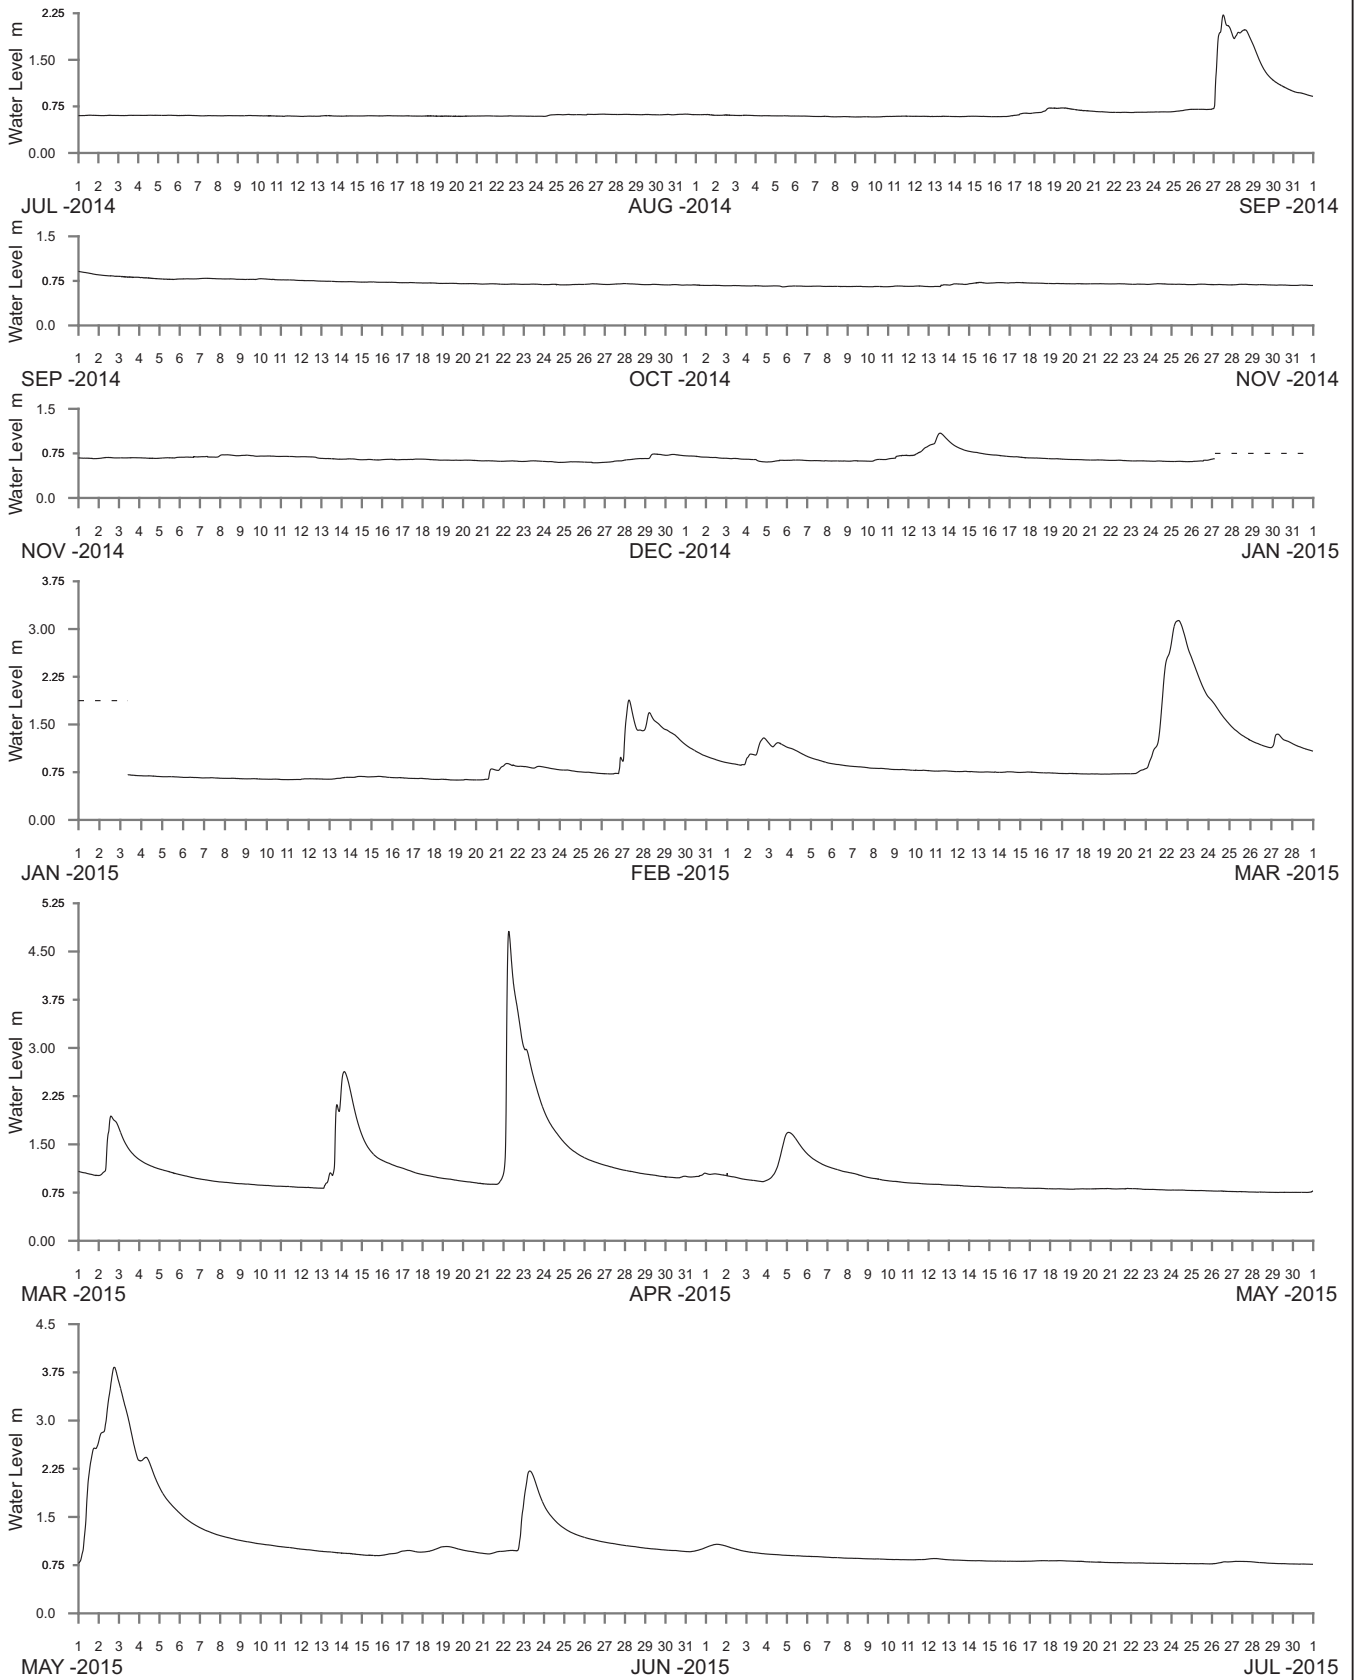
Figure  
98

WATER LEVEL REFERENCED TO LOCAL WATER RESOURCES DATUM

----- DATA LOSS

**CAMDEN HAVEN AT LOGANS CROSSING**  
2014–2015

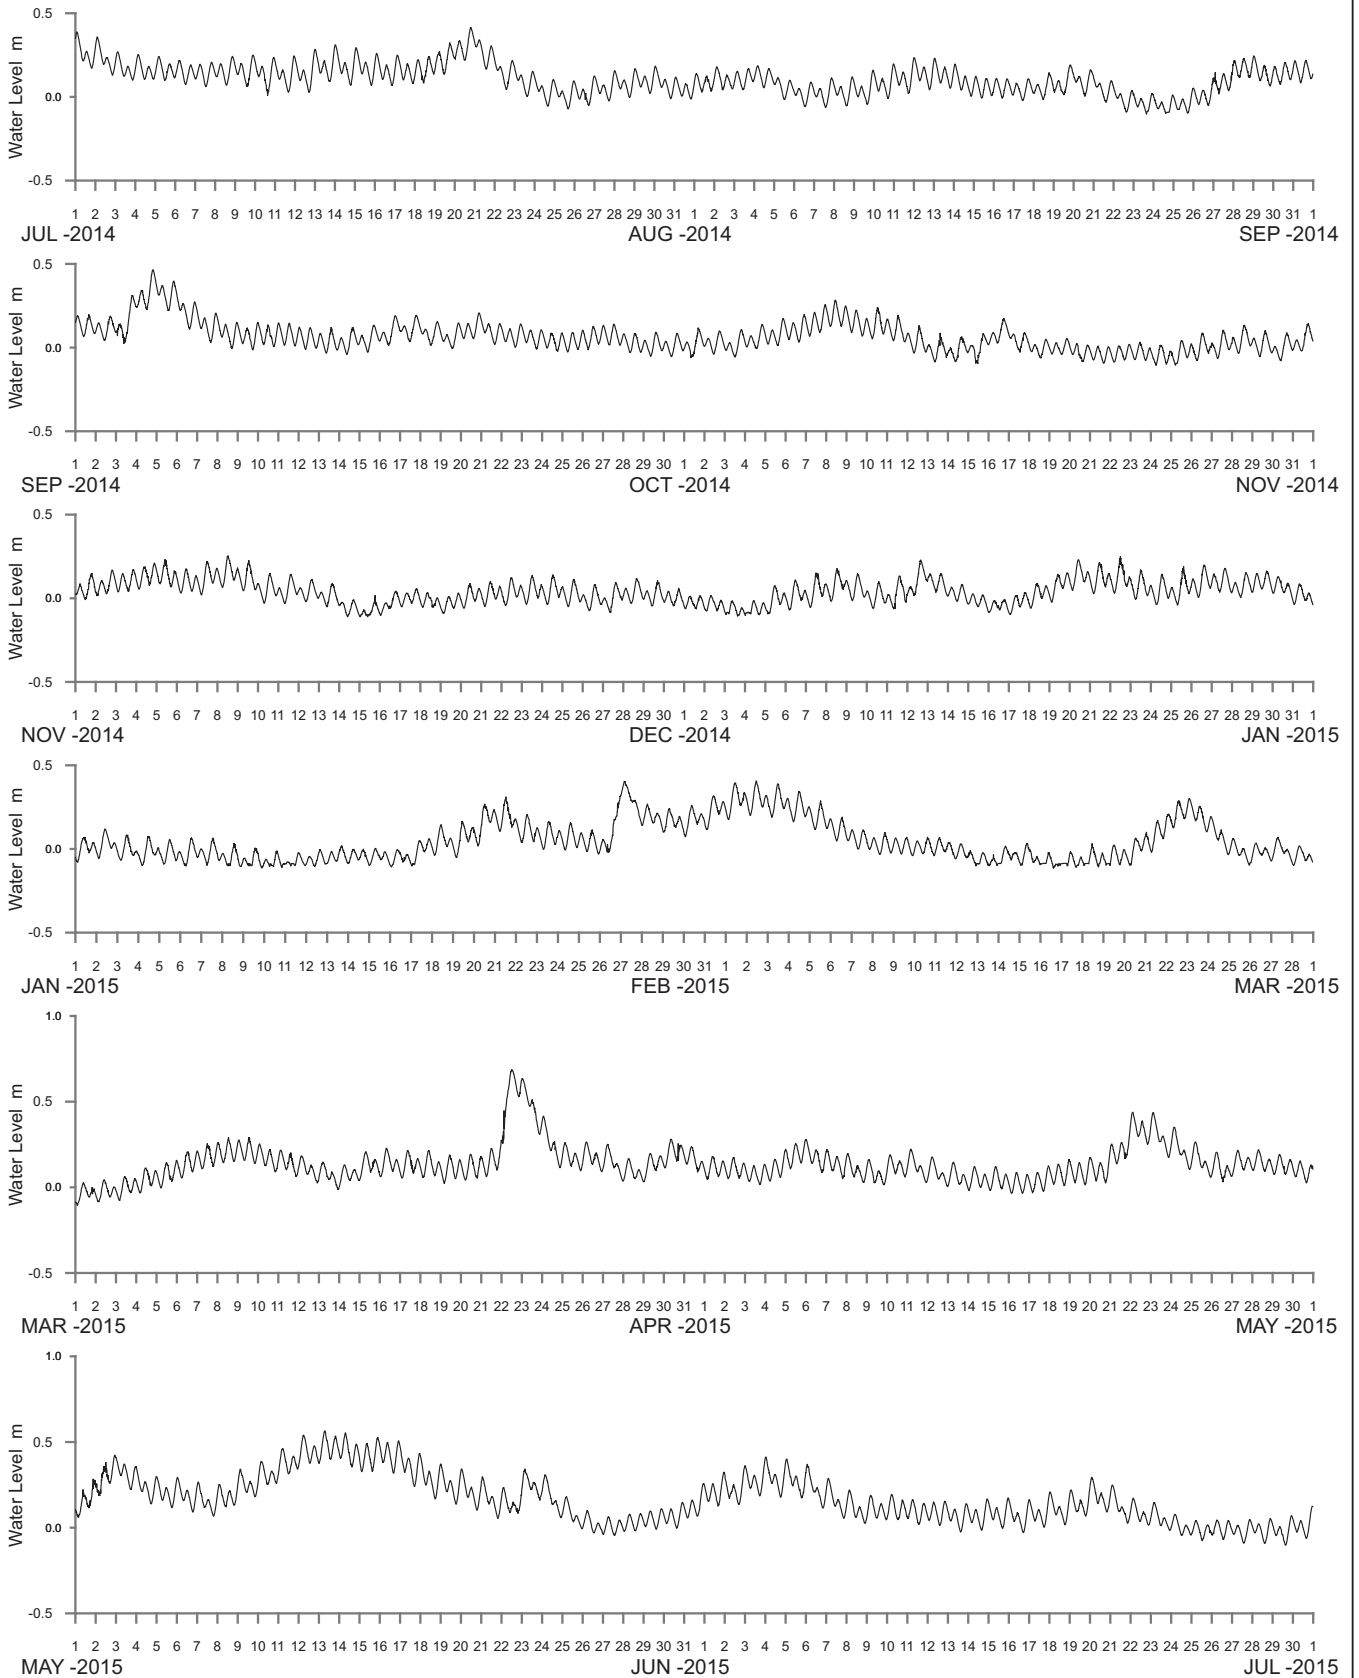
Figure  
99

WATER LEVEL REFERENCED TO AUSTRALIAN HEIGHT DATUM

----- DATA LOSS

**QUEENS LAKE AT LAKEWOOD**  
2014-2015

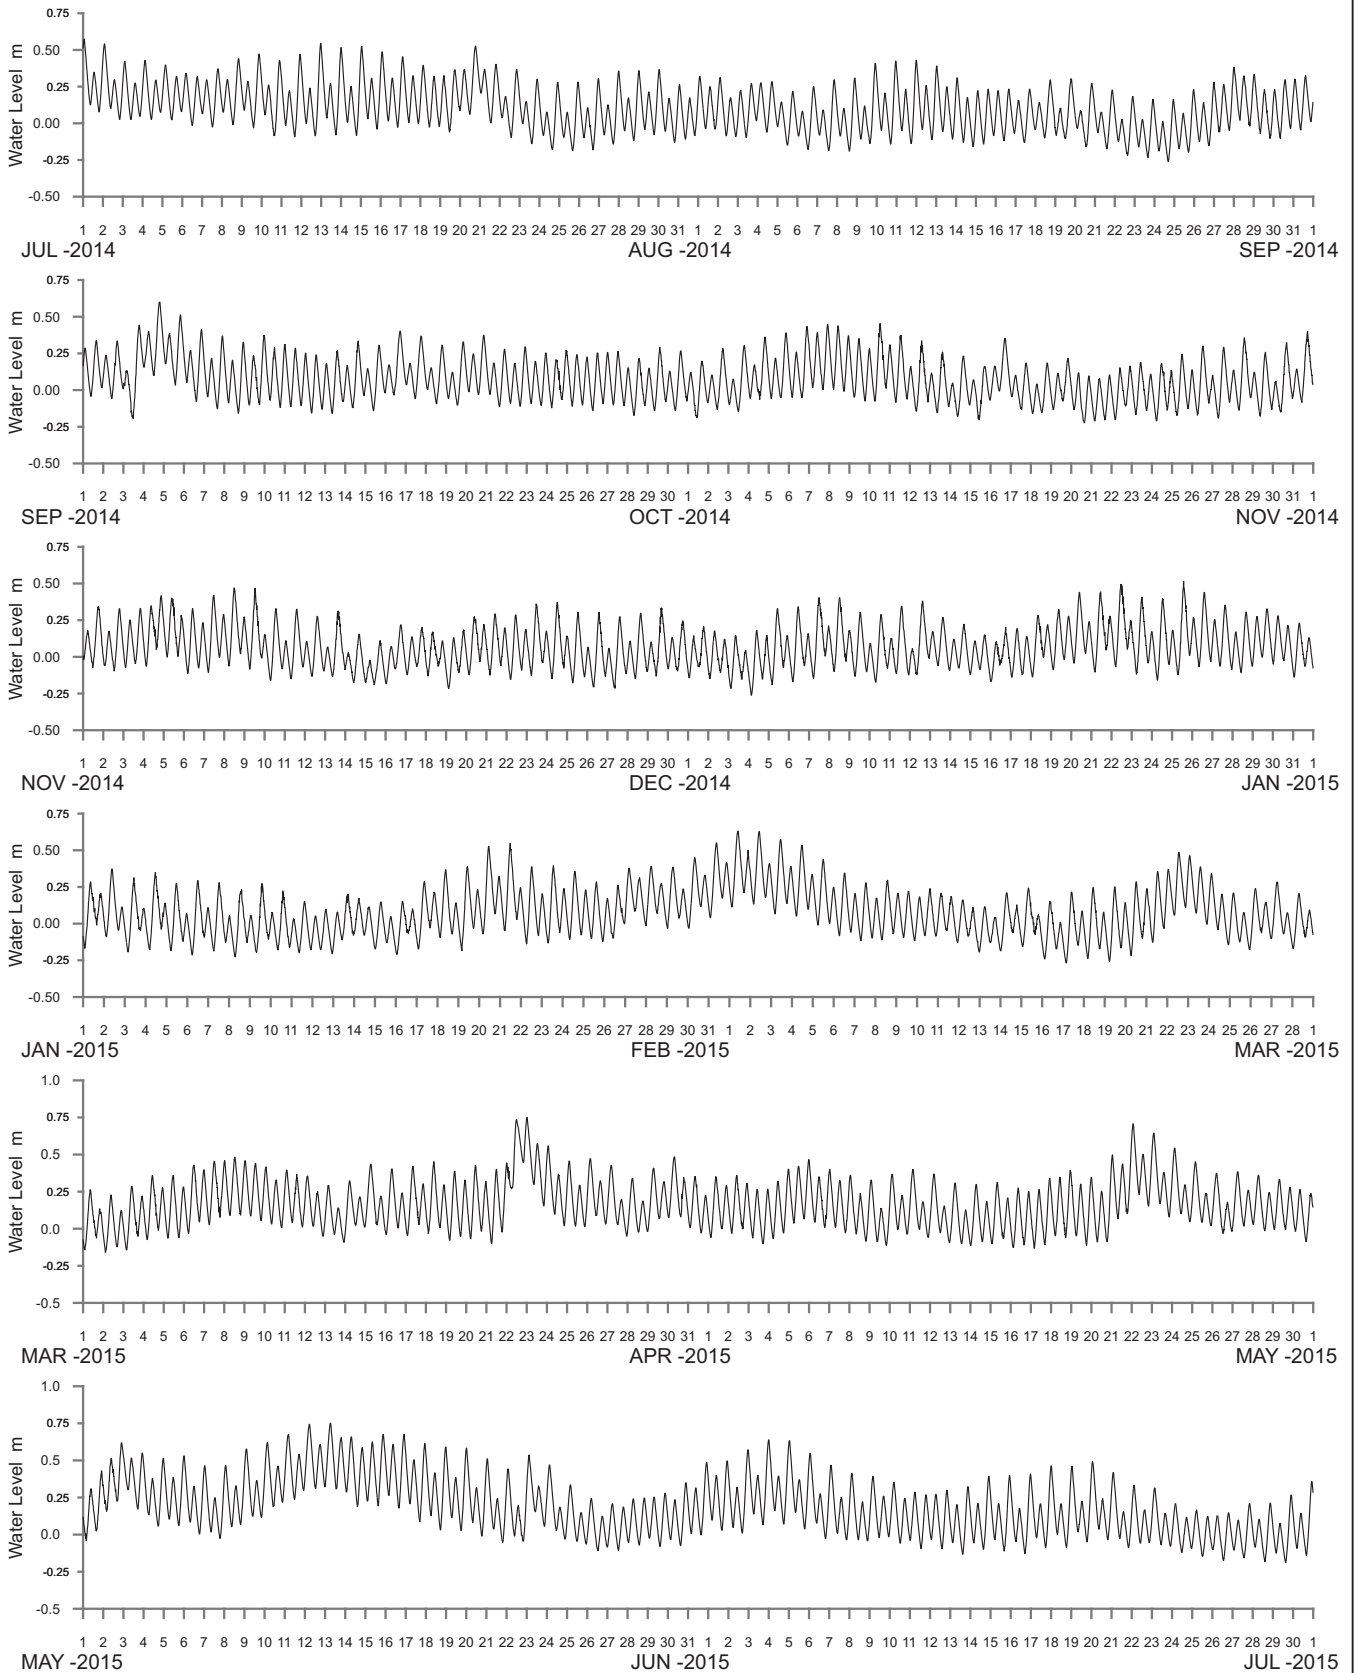
Figure  
100

WATER LEVEL REFERENCED TO AUSTRALIAN HEIGHT DATUM

----- DATA LOSS

**WATSON TAYLORS LAKE AT WATSON TAYLORS LAKE**  
2014-2015
