Public Works
Manly Hydraulics Laboratory

HEWITTS CREEK AT HEWITTS CREEK UPSTREAM
2014–2015

MHL
Report 2383

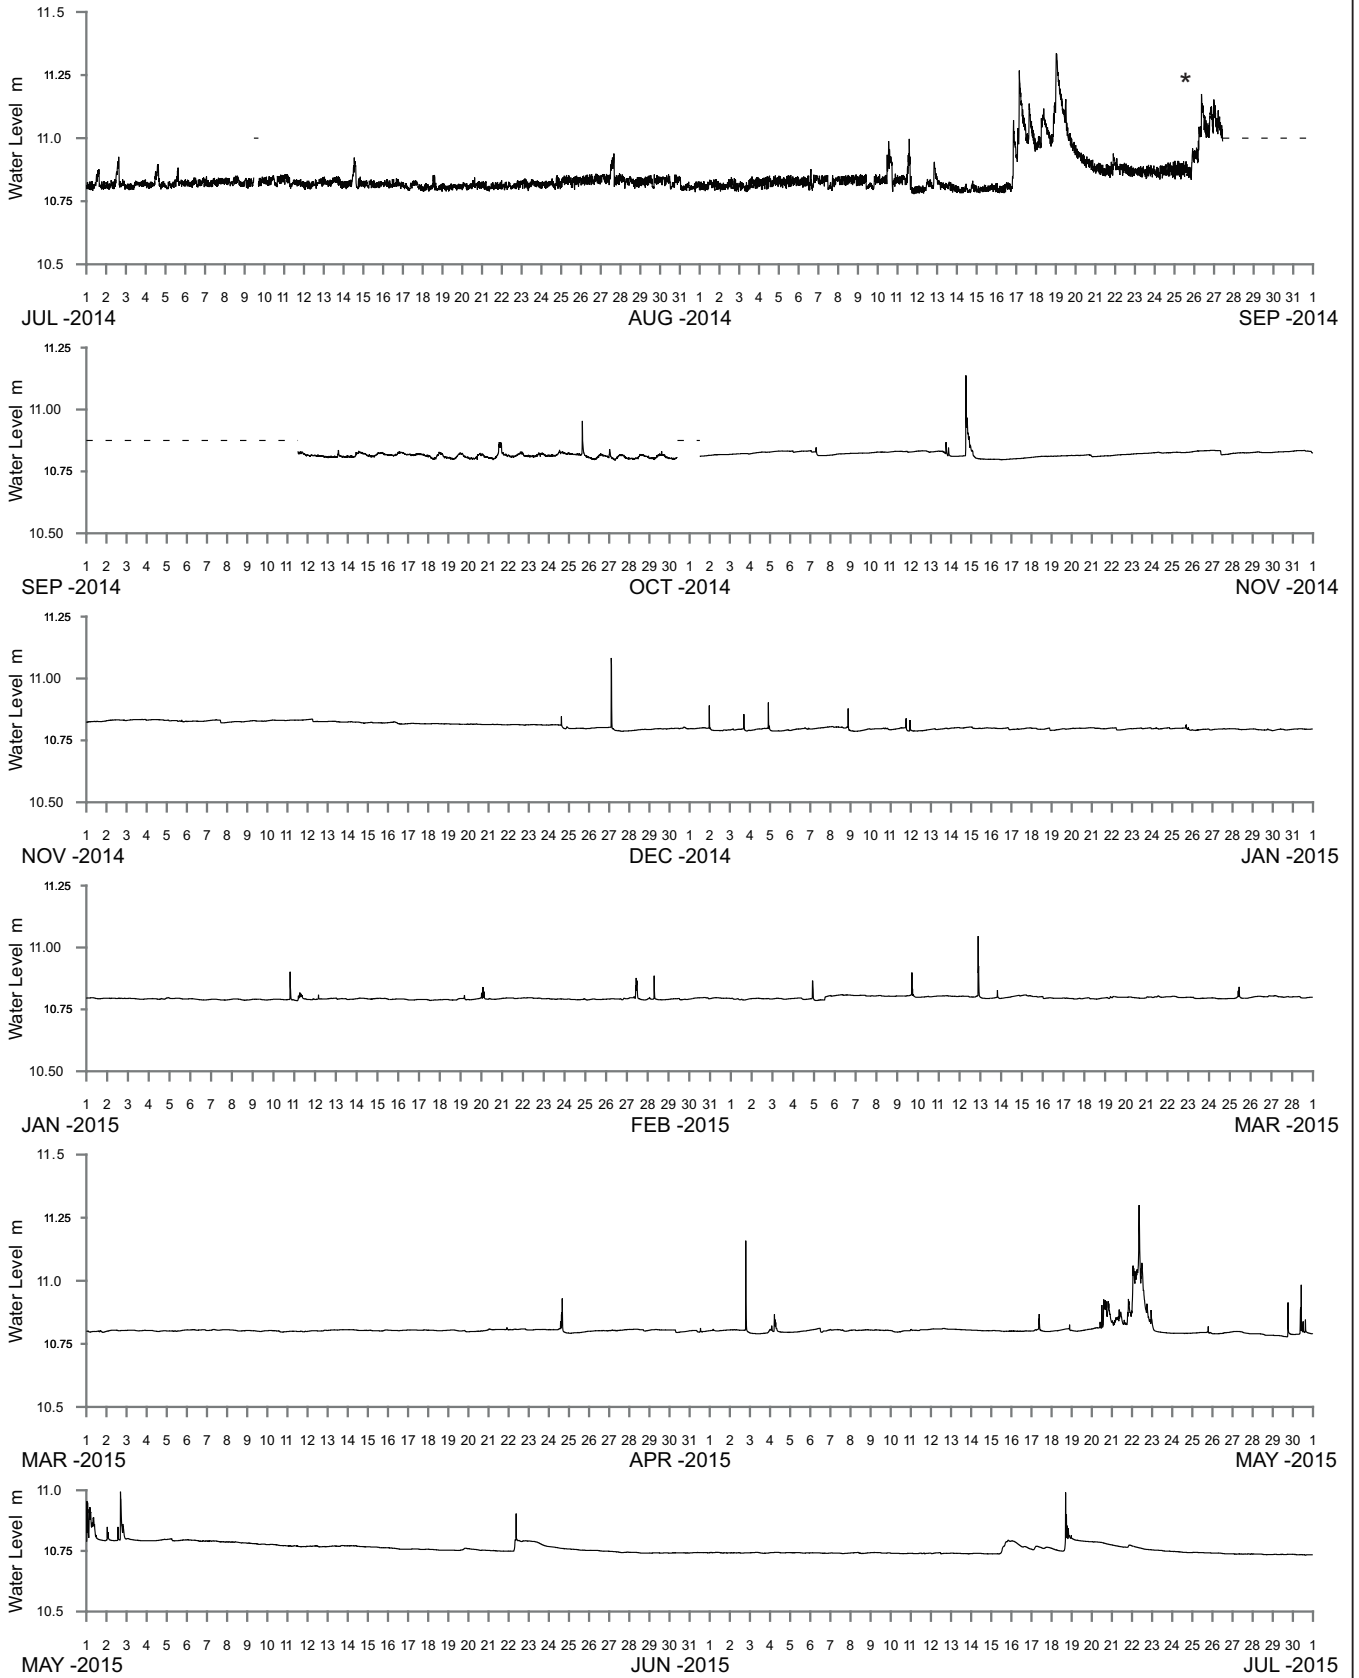
Figure
201

WATER LEVEL REFERENCED TO AUSTRALIAN HEIGHT DATUM

* 01/07/2014–27/09/2014 The culvert was inundated with silt, data has been coded as poor, the data is noisy but is a true representation of the head of water.

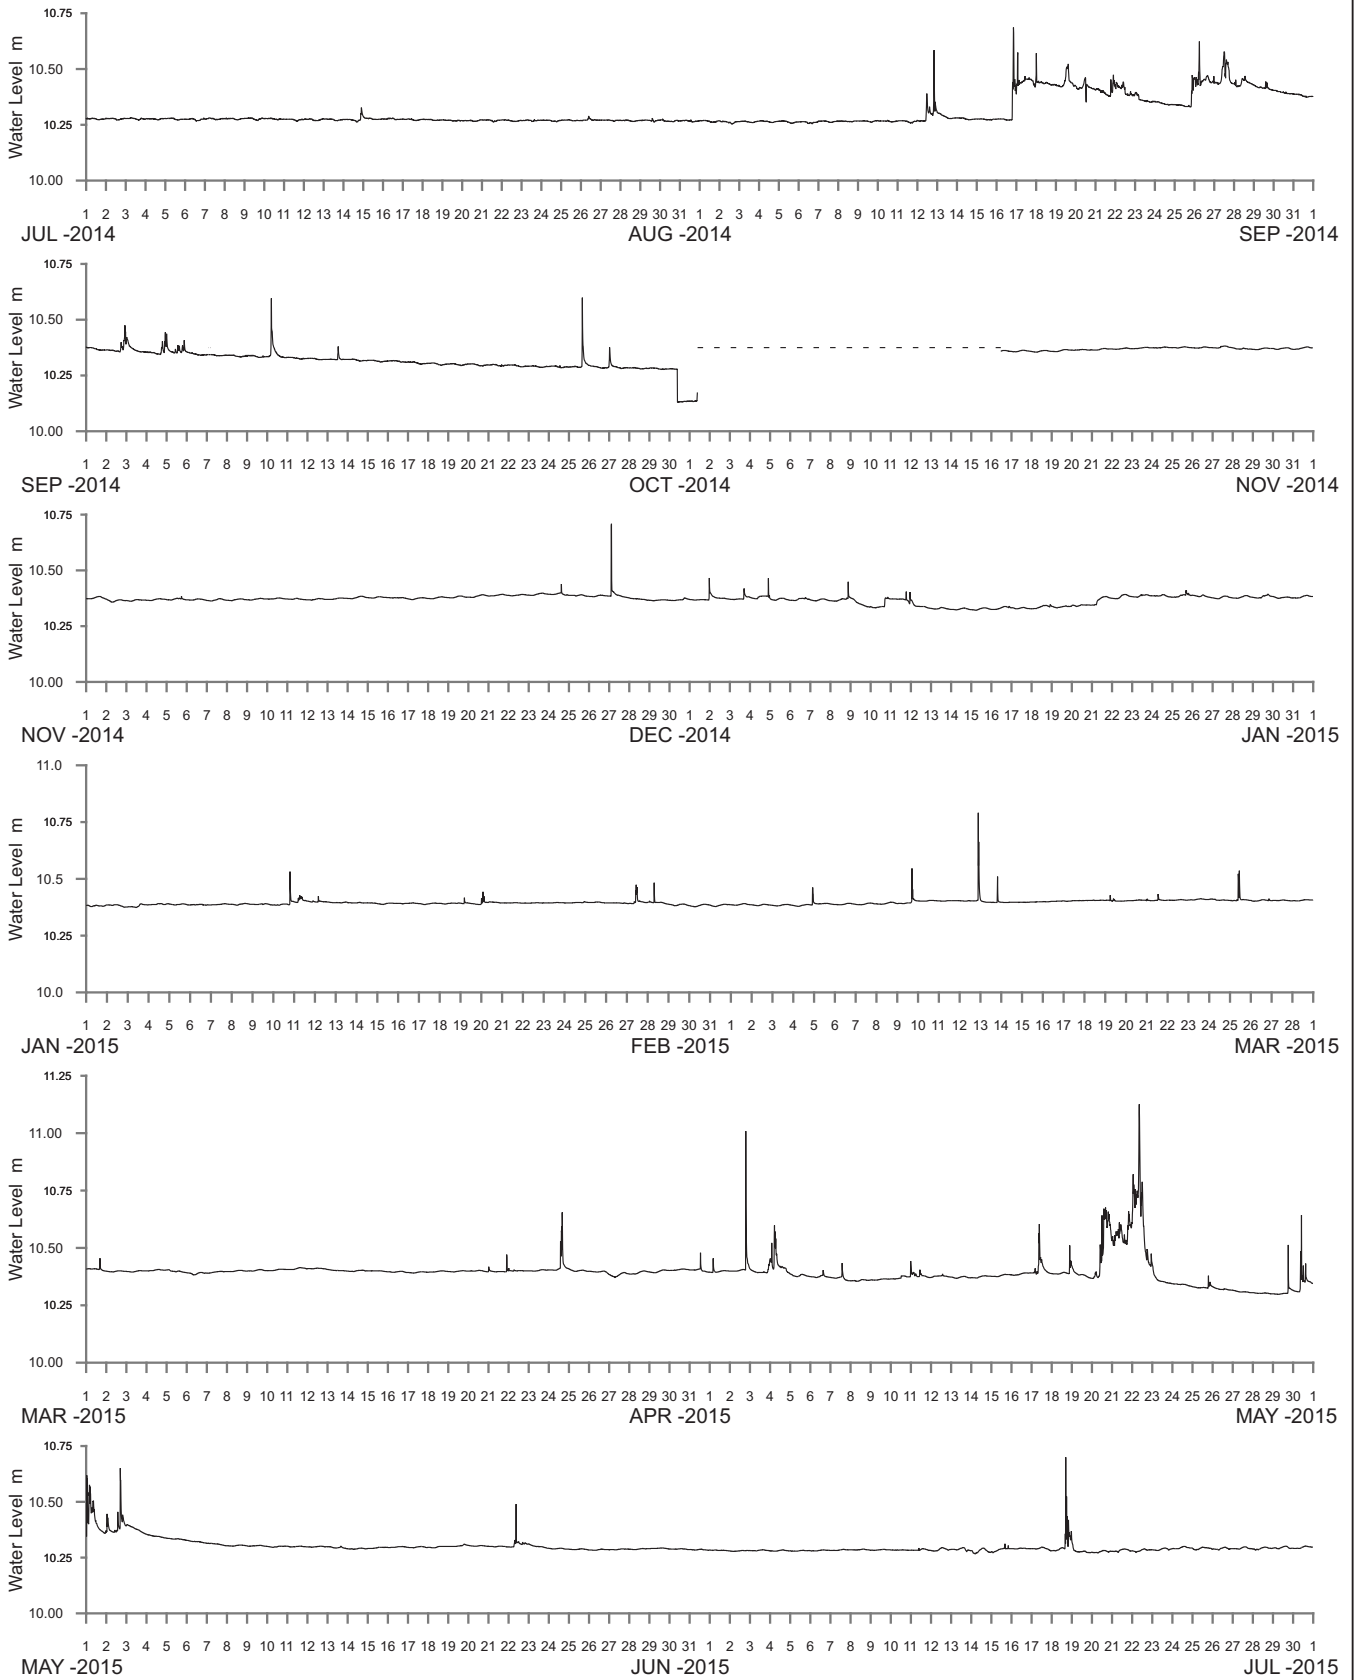
Figure
202

WATER LEVEL REFERENCED TO AUSTRALIAN HEIGHT DATUM

HEWITTS CREEK AT HEWITTS CREEK DOWNSTREAM
2014-2015

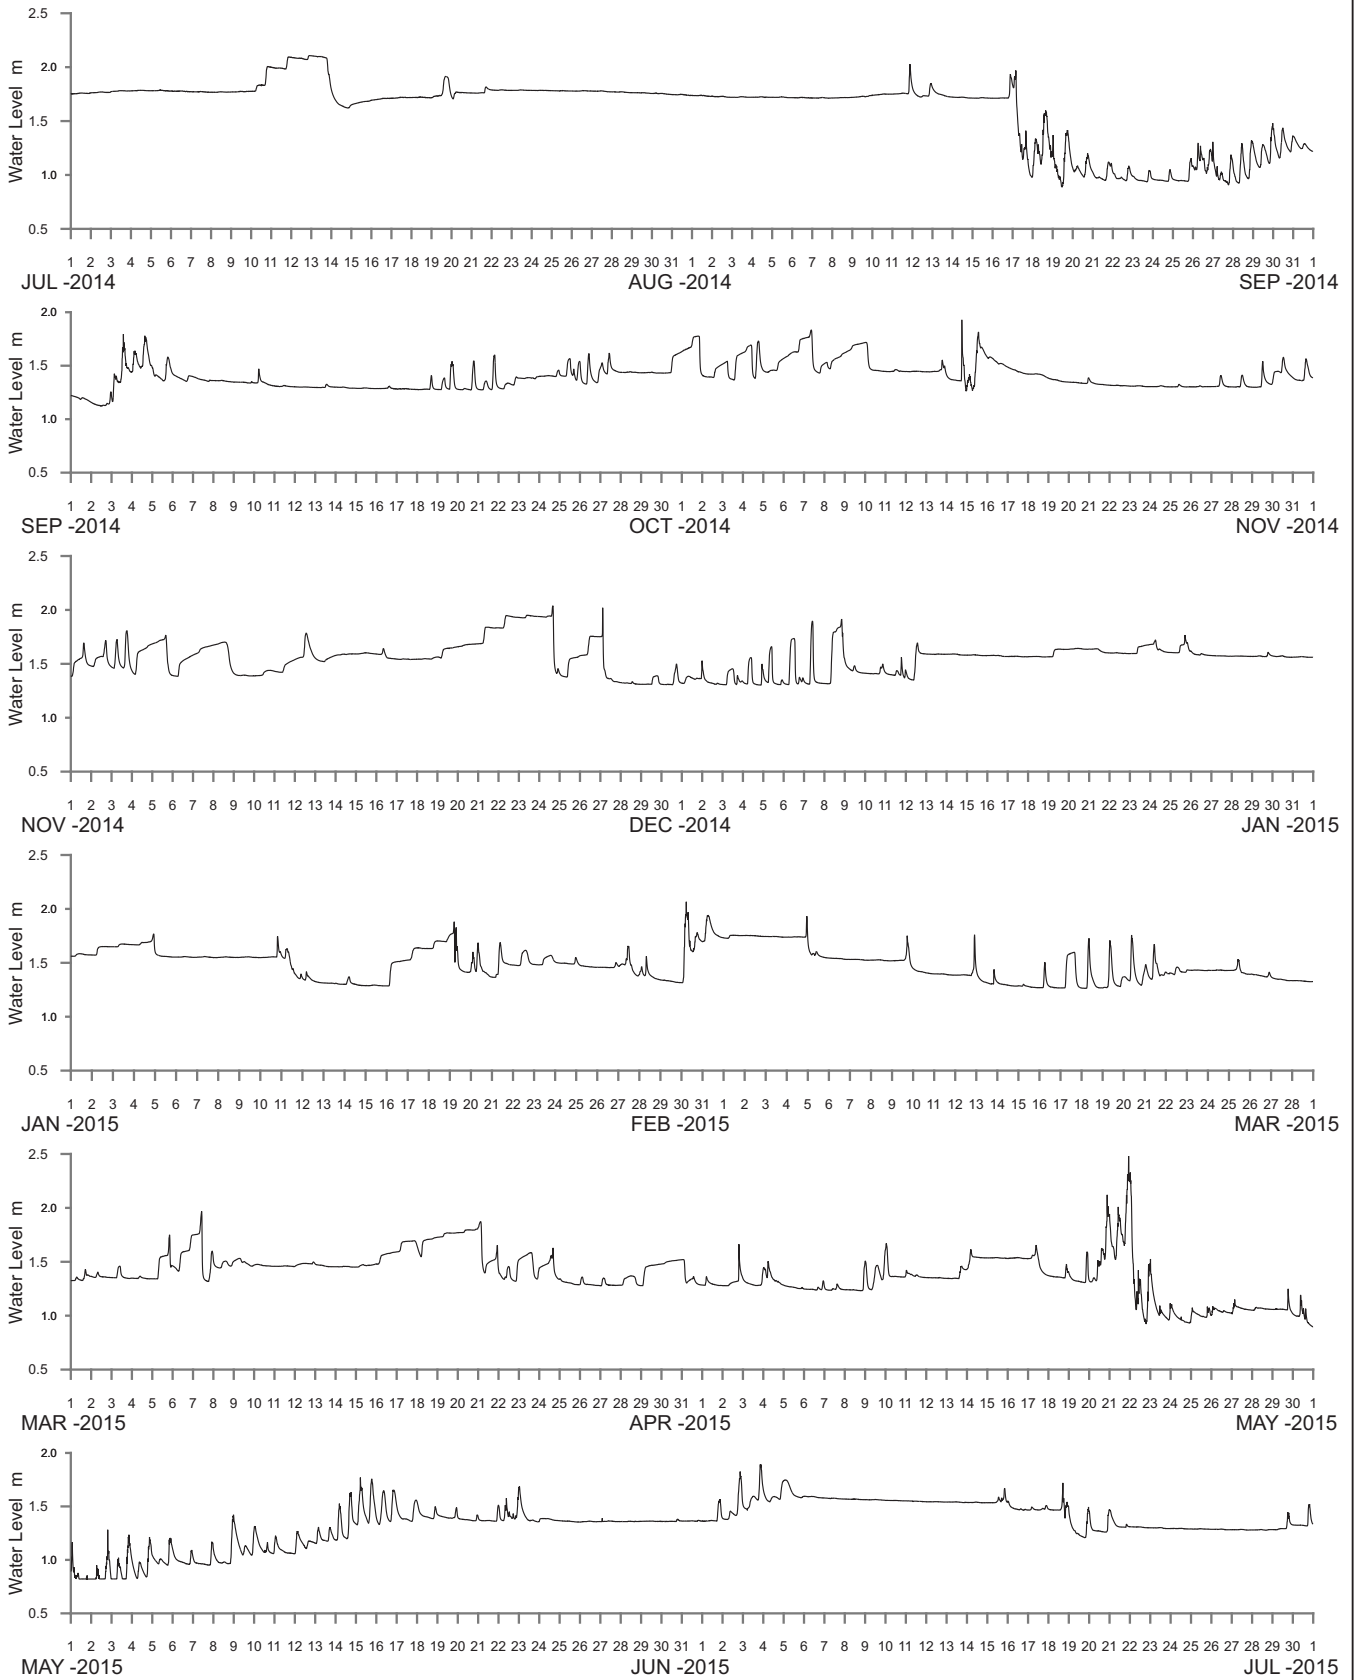
Figure
203

WATER LEVEL REFERENCED TO AUSTRALIAN HEIGHT DATUM

HEWITTS CREEK AT HEWITTS CREEK ENTRANCE
2014–2015

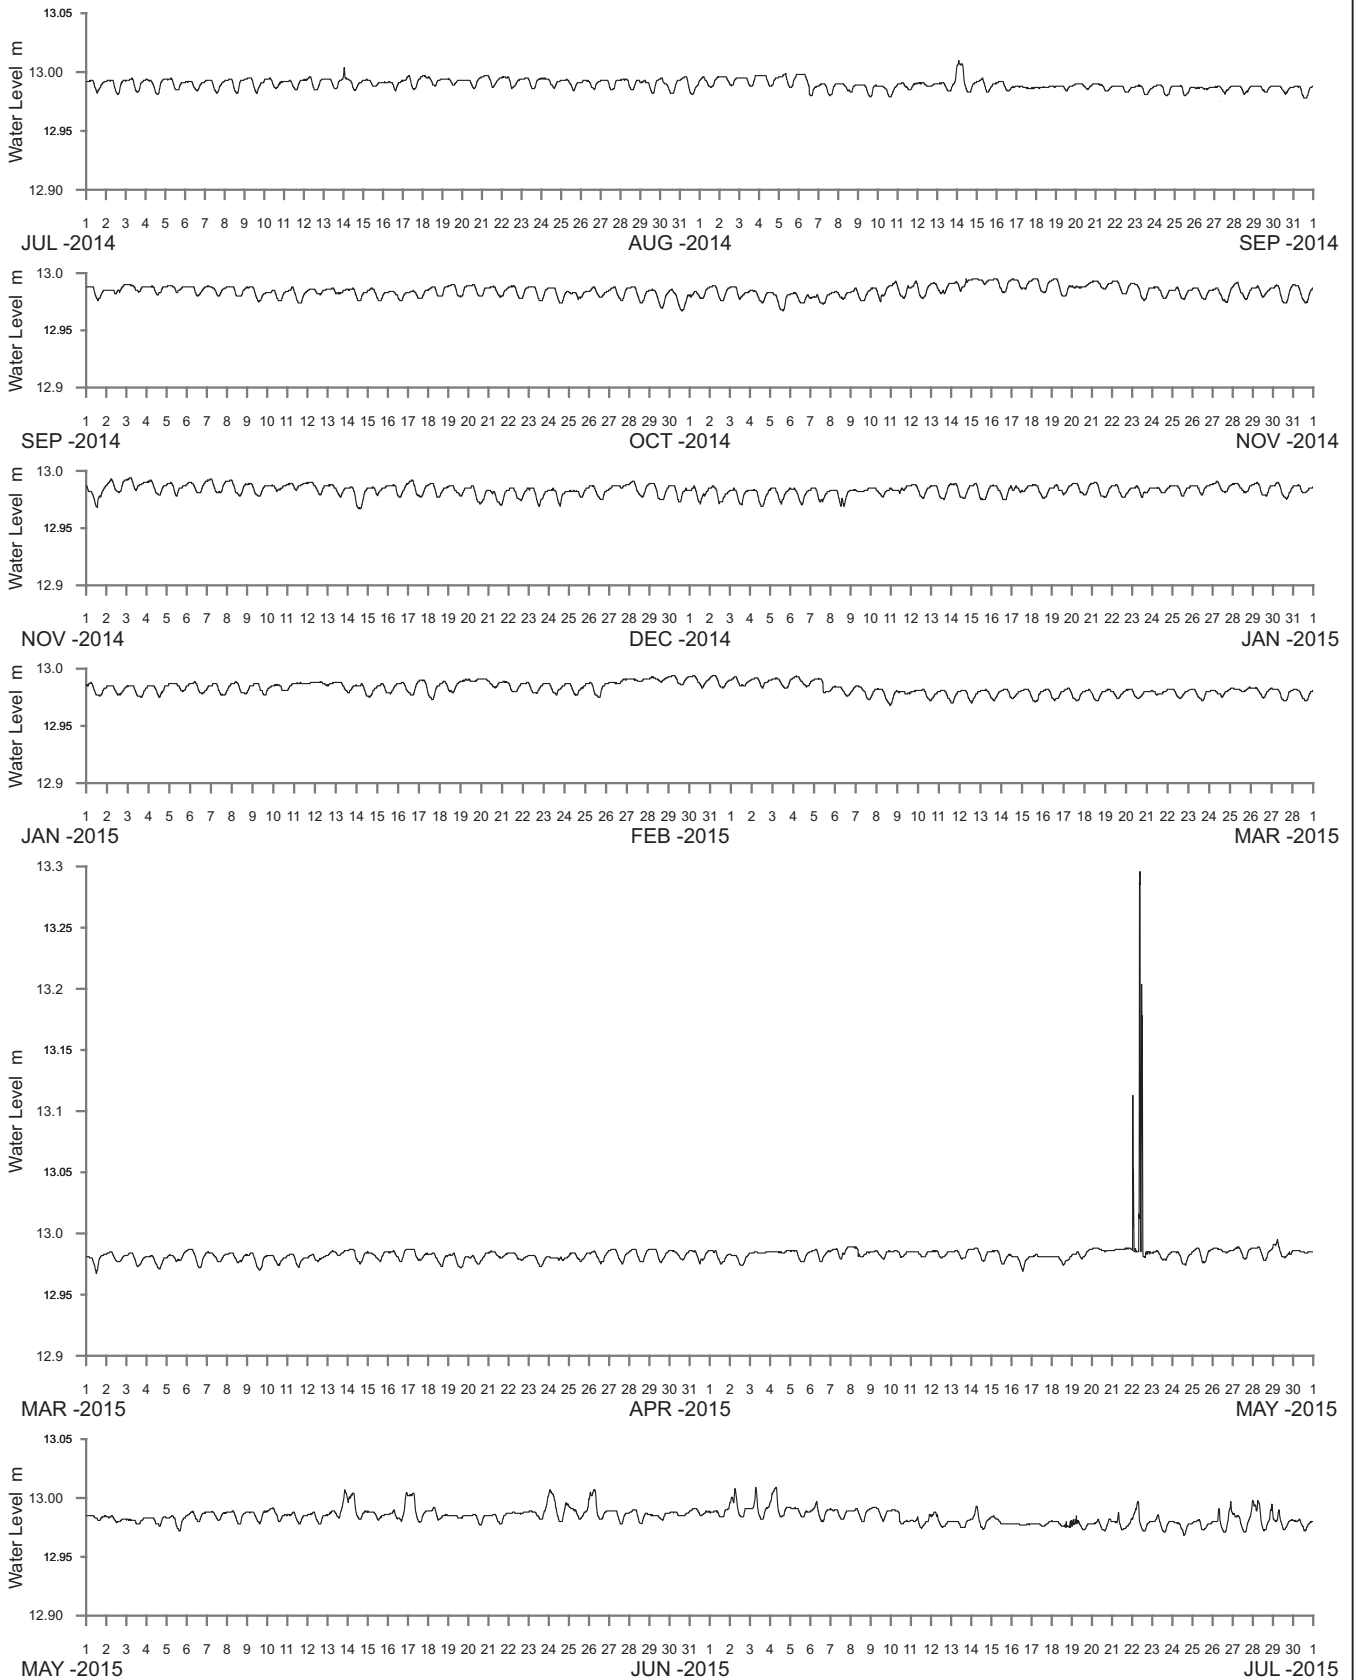
Figure
204

WATER LEVEL REFERENCED TO AUSTRALIAN HEIGHT DATUM

CABBAGE TREE CREEK AT BALGOWNIE ROAD
2014-2015

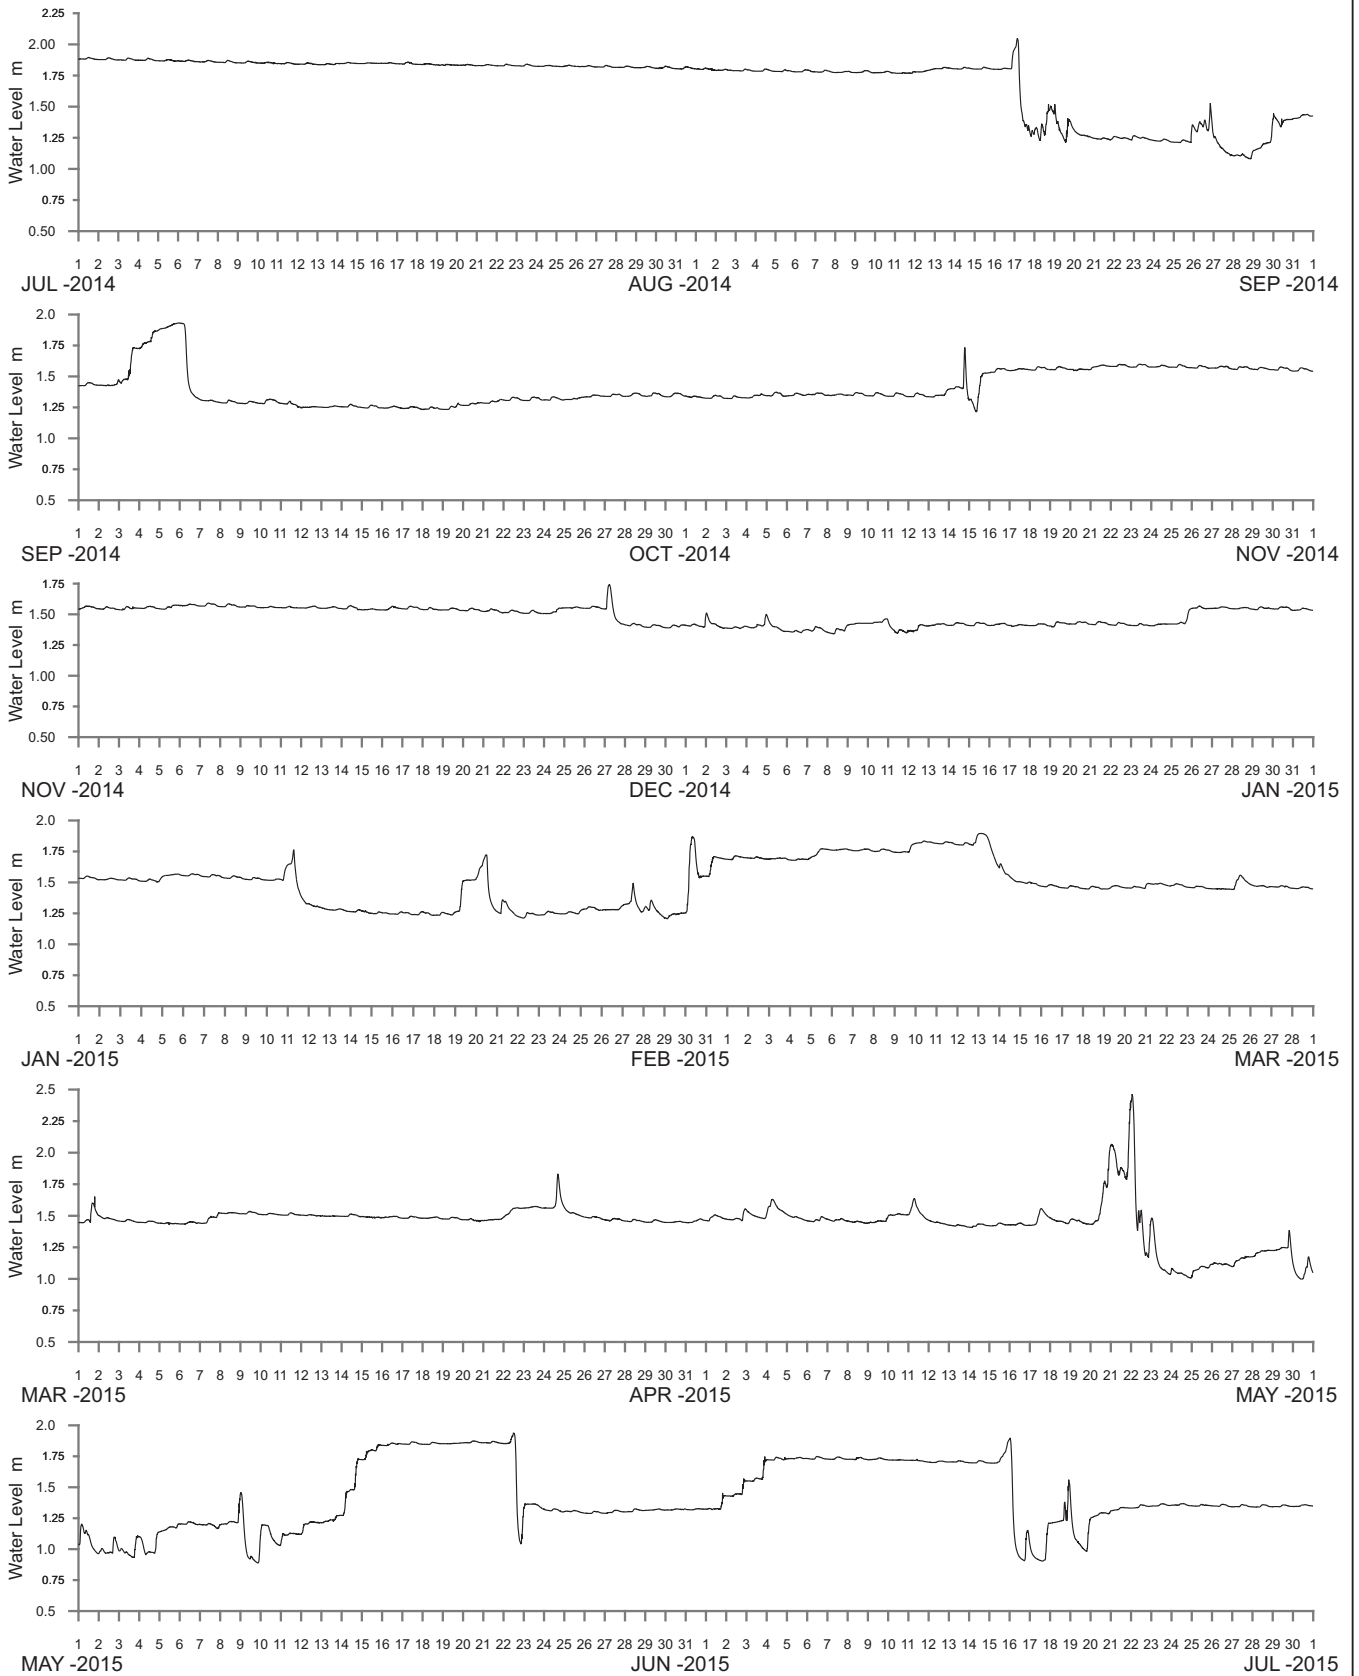
Figure
205

WATER LEVEL REFERENCED TO AUSTRALIAN HEIGHT DATUM

BELLAMBI LAGOON AT BELLAMBI
2014-2015

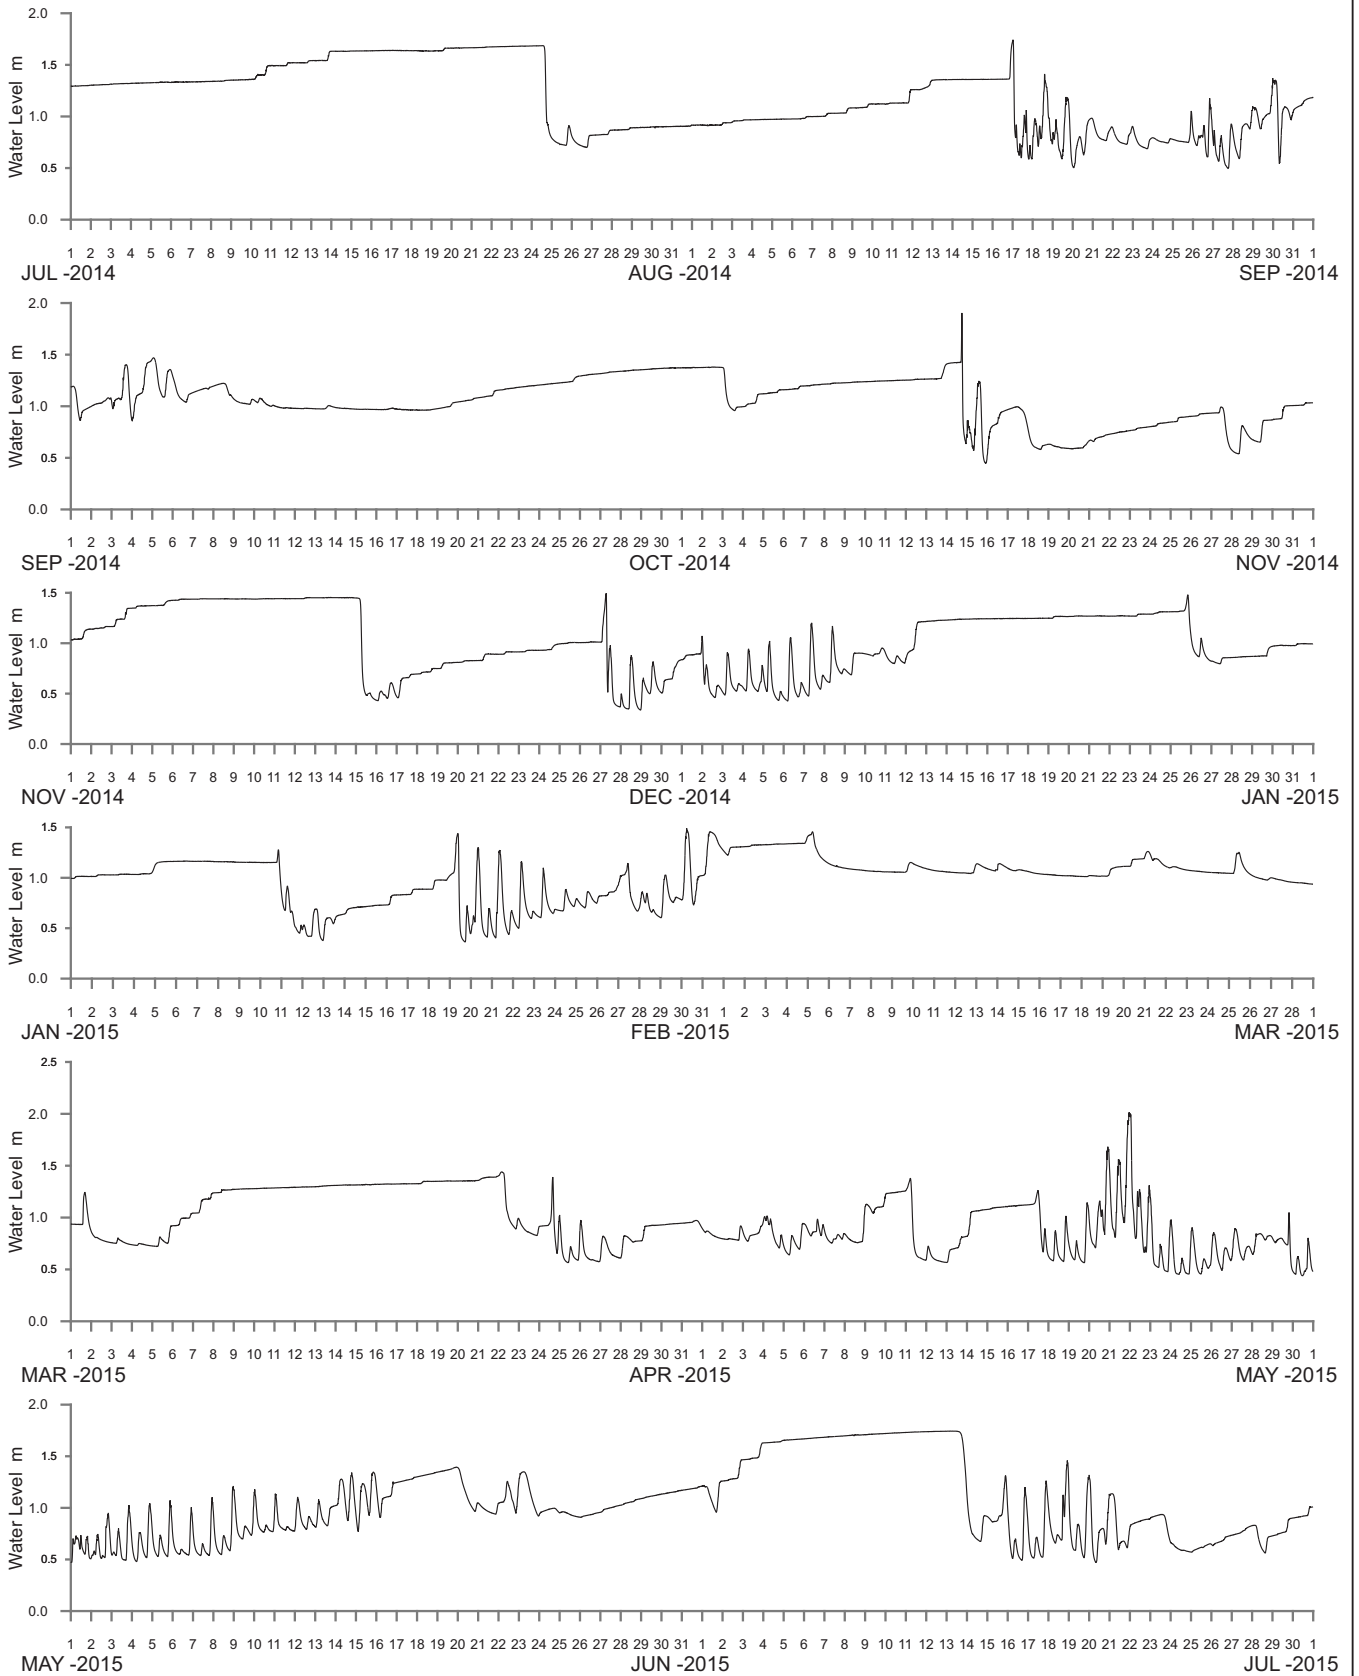
Figure
206

WATER LEVEL REFERENCED TO AUSTRALIAN HEIGHT DATUM

**TOWRADGI CREEK AT TOWRADGI CREEK UPSTREAM
2014-2015**

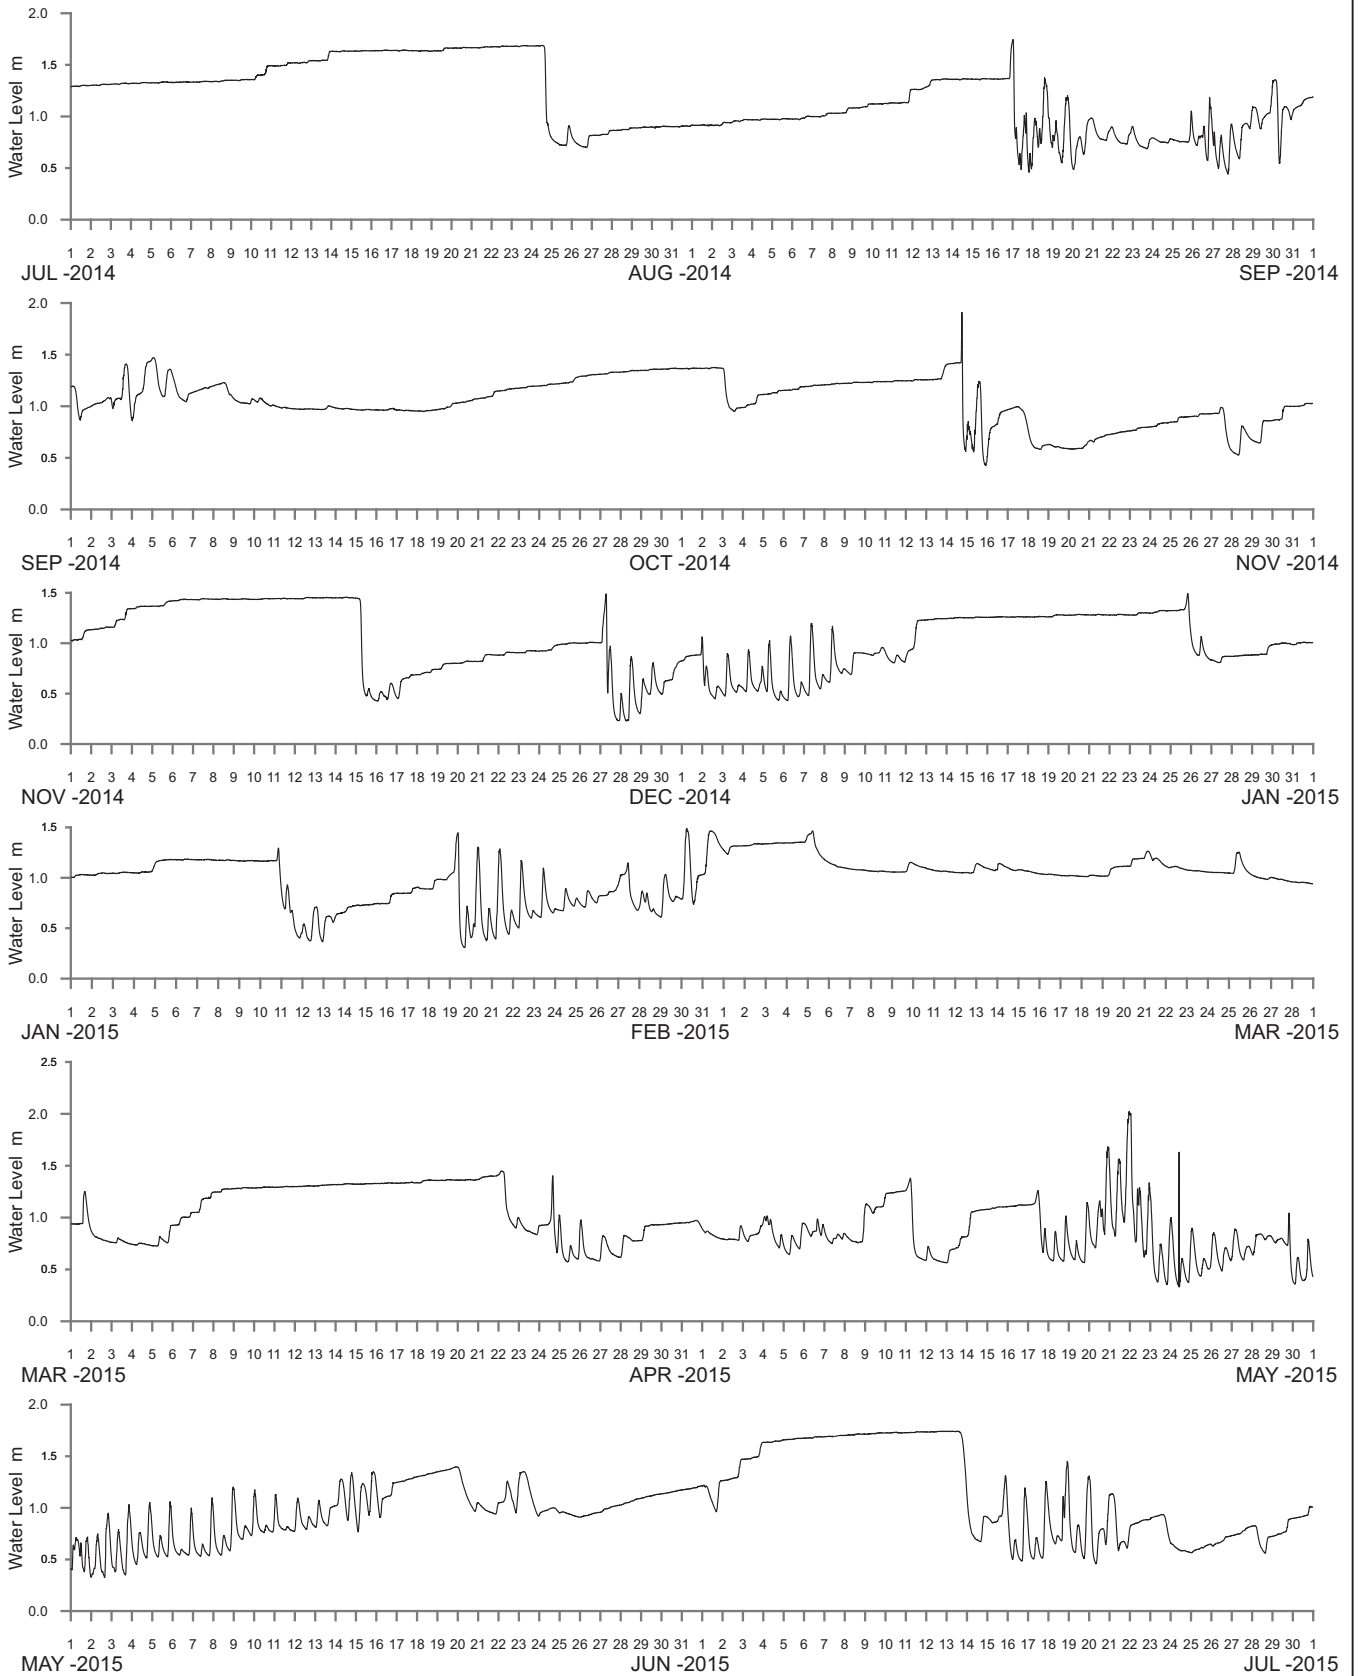
Figure
207

WATER LEVEL REFERENCED TO AUSTRALIAN HEIGHT DATUM

TOWRADGI CREEK AT TOWRADGI CREEK DOWNSTREAM
2014-2015

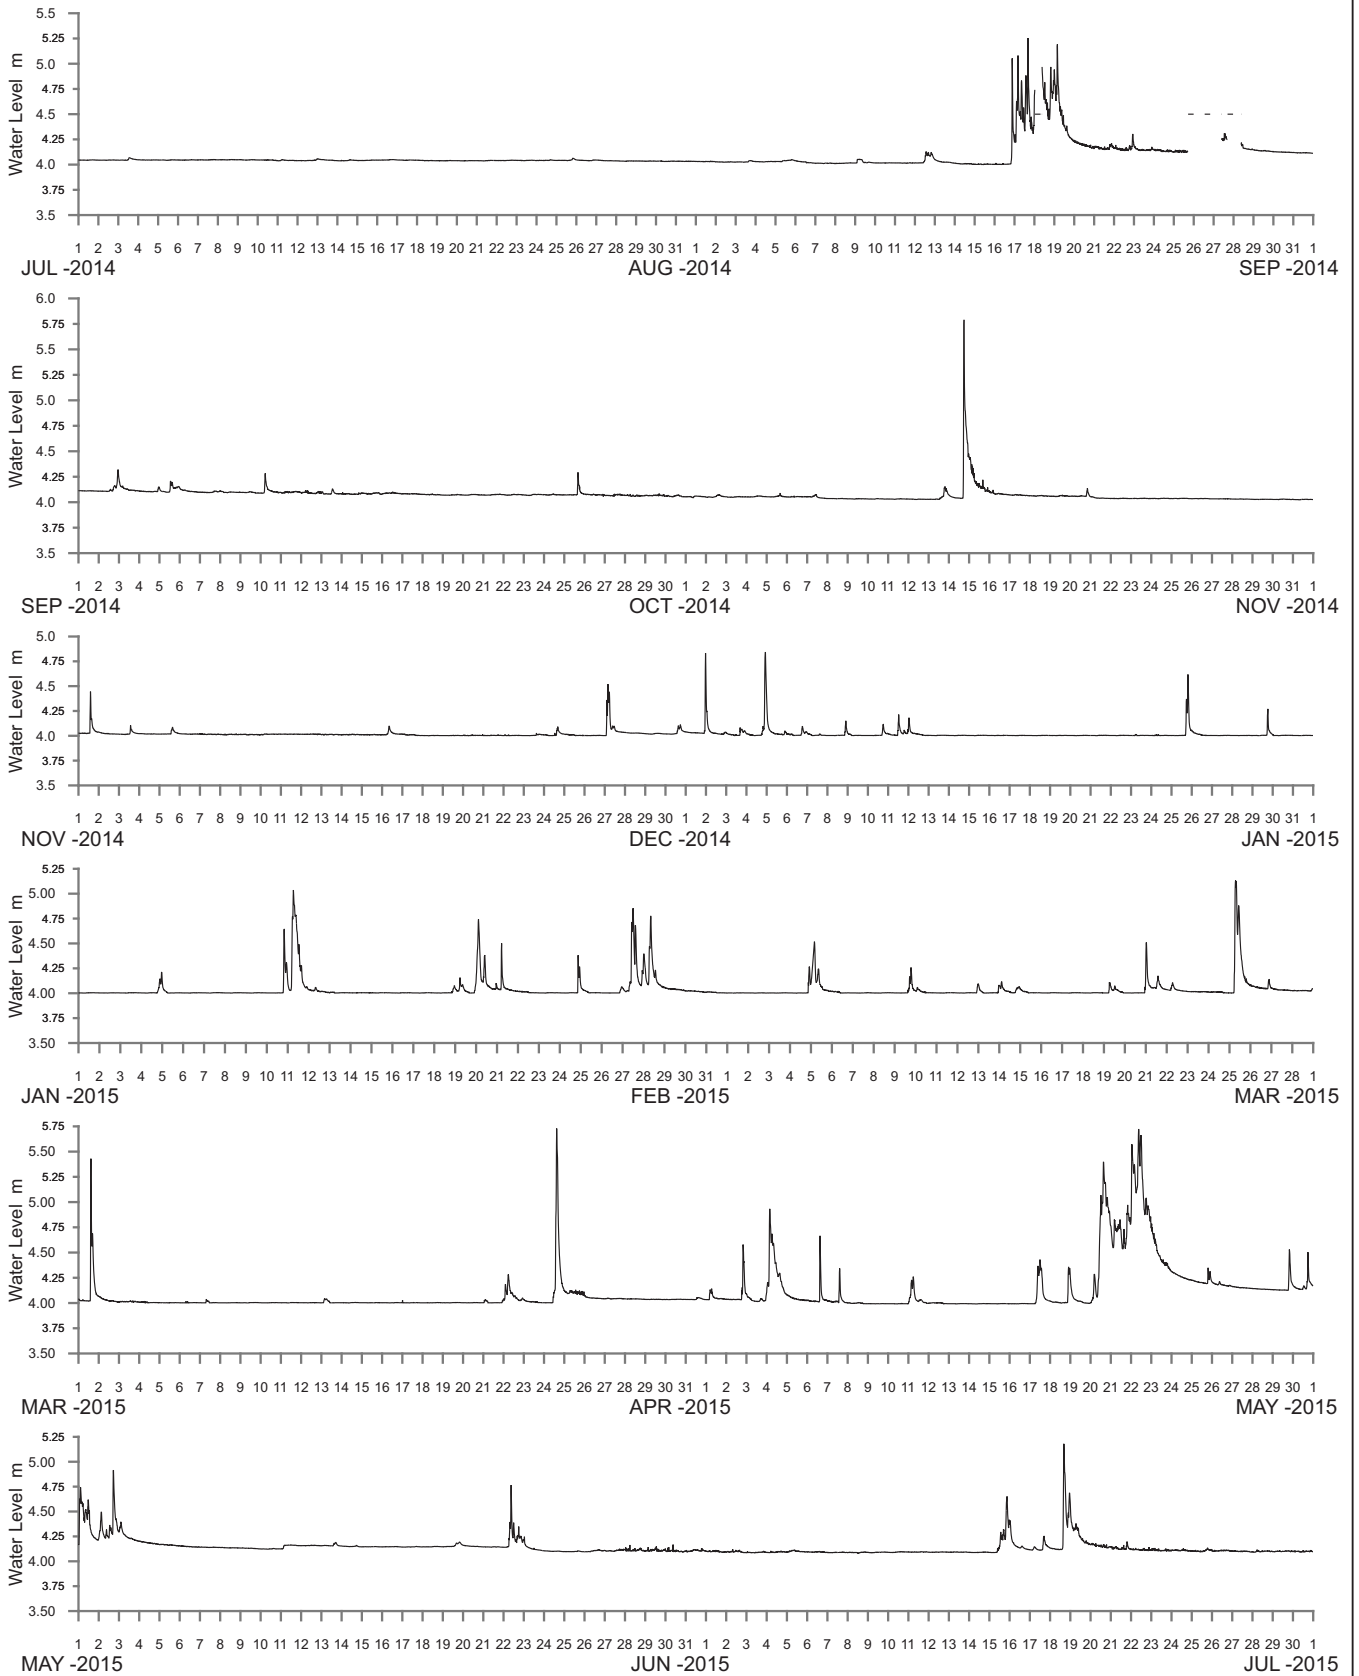
Figure
208

WATER LEVEL REFERENCED TO AUSTRALIAN HEIGHT DATUM

**CABBAGE TREE CREEK
AT CABBAGE TREE CREEK UPSTREAM
2014-2015**

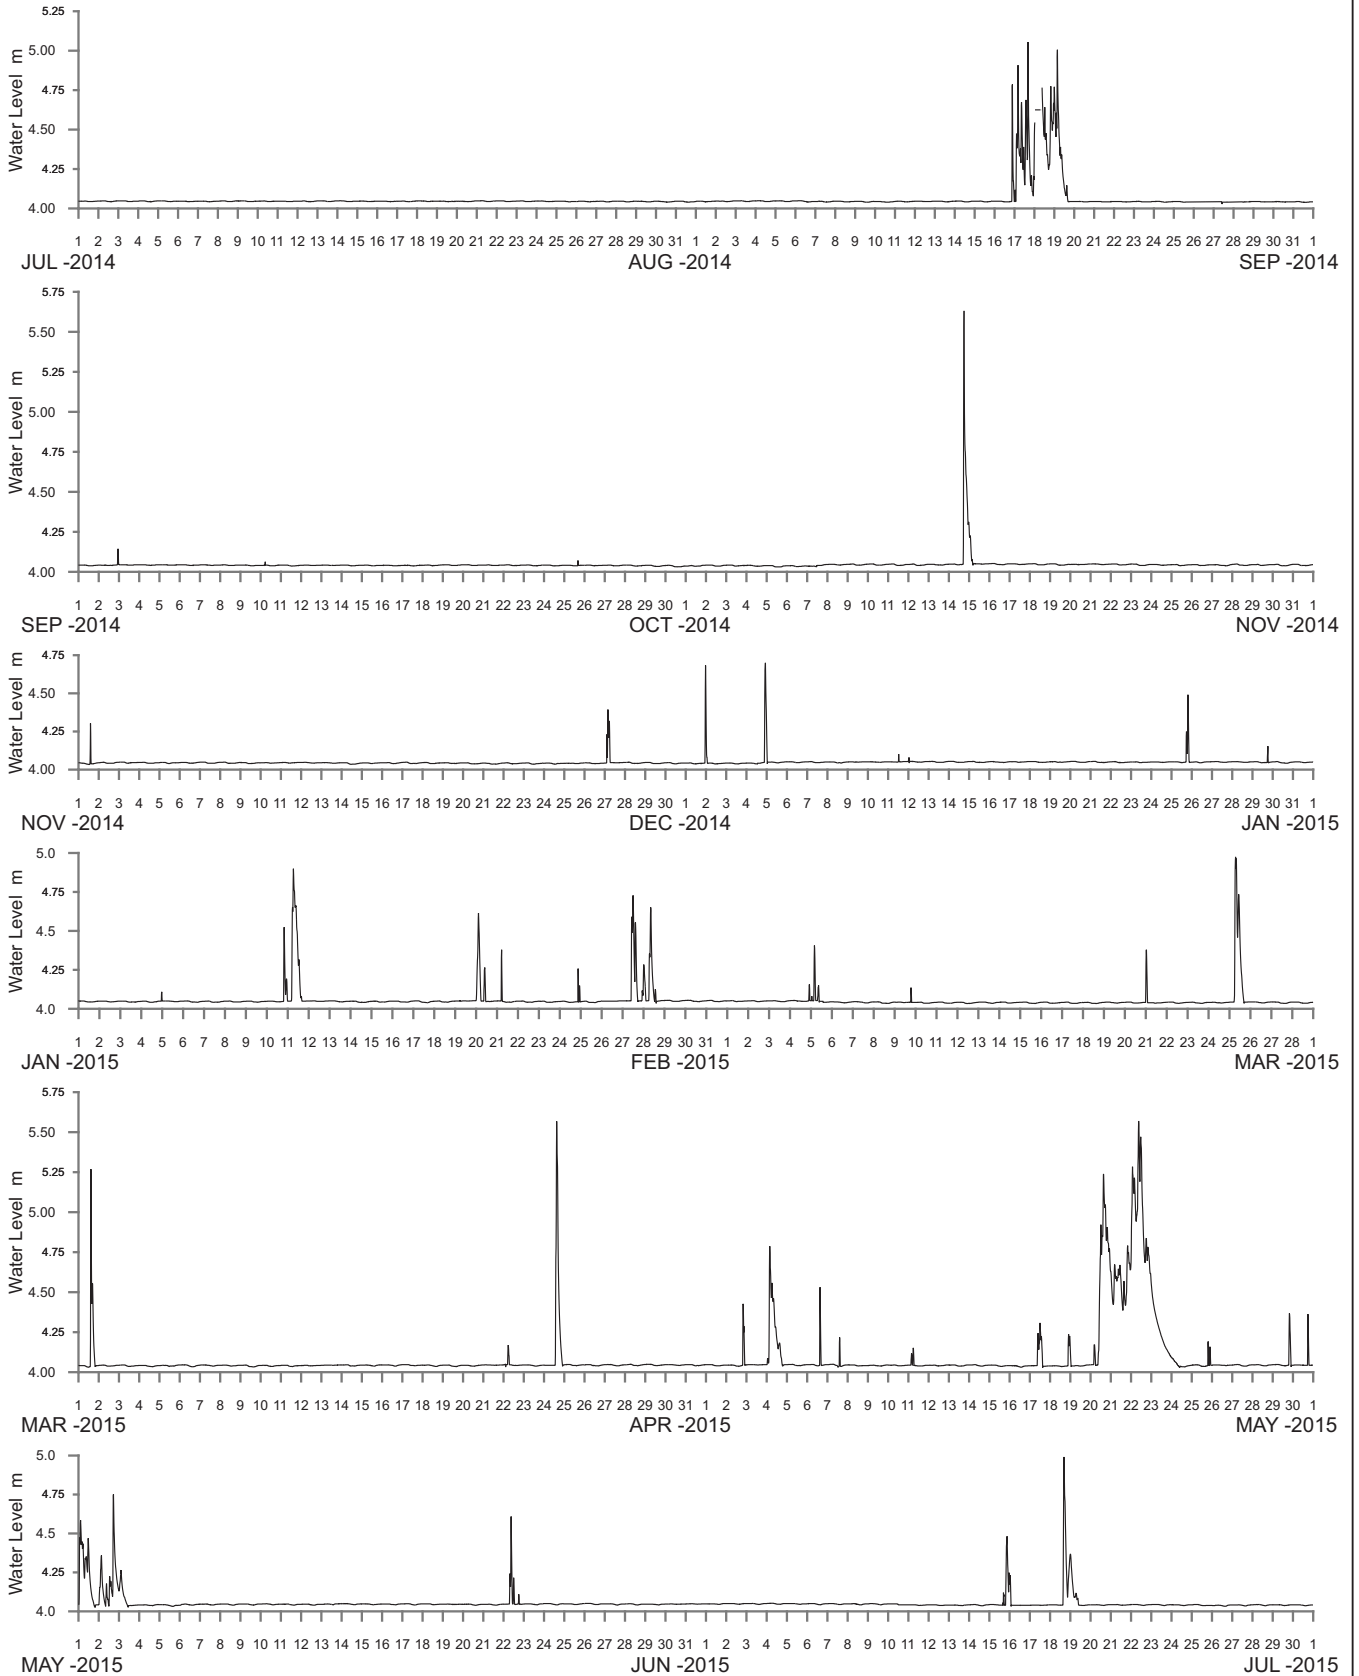
Figure
209

WATER LEVEL REFERENCED TO AUSTRALIAN HEIGHT DATUM

**CABBAGE TREE CREEK
AT CABBAGE TREE CREEK DOWNSTREAM
2014-2015**

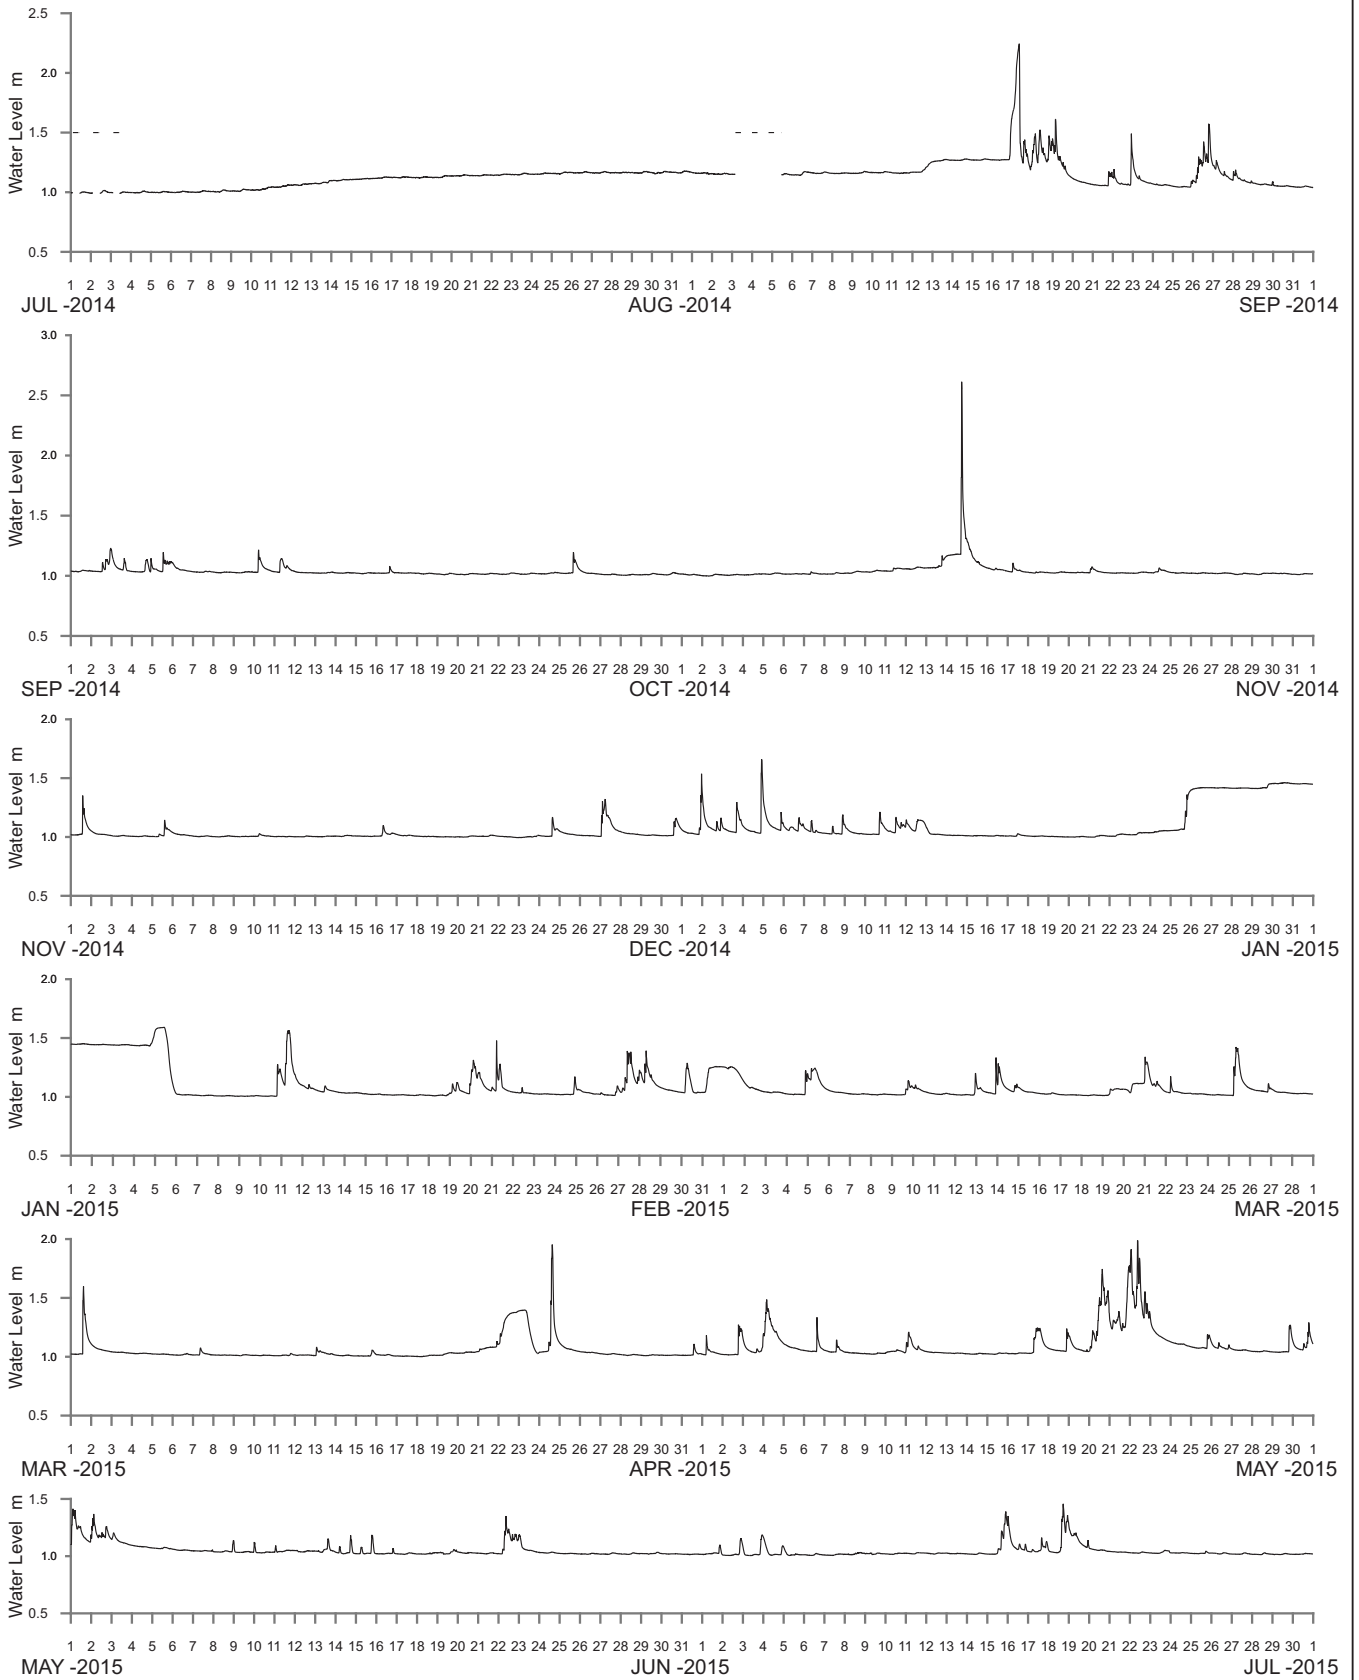
Figure
210

WATER LEVEL REFERENCED TO AUSTRALIAN HEIGHT DATUM

**FAIRY CREEK AT FAIRY CREEK UPSTREAM
2014-2015**
