Public Works
Manly Hydraulics Laboratory

HEWITTS CREEK AT HEWITTS CREEK UPSTREAM
2014–2015

MHL
Report 2383

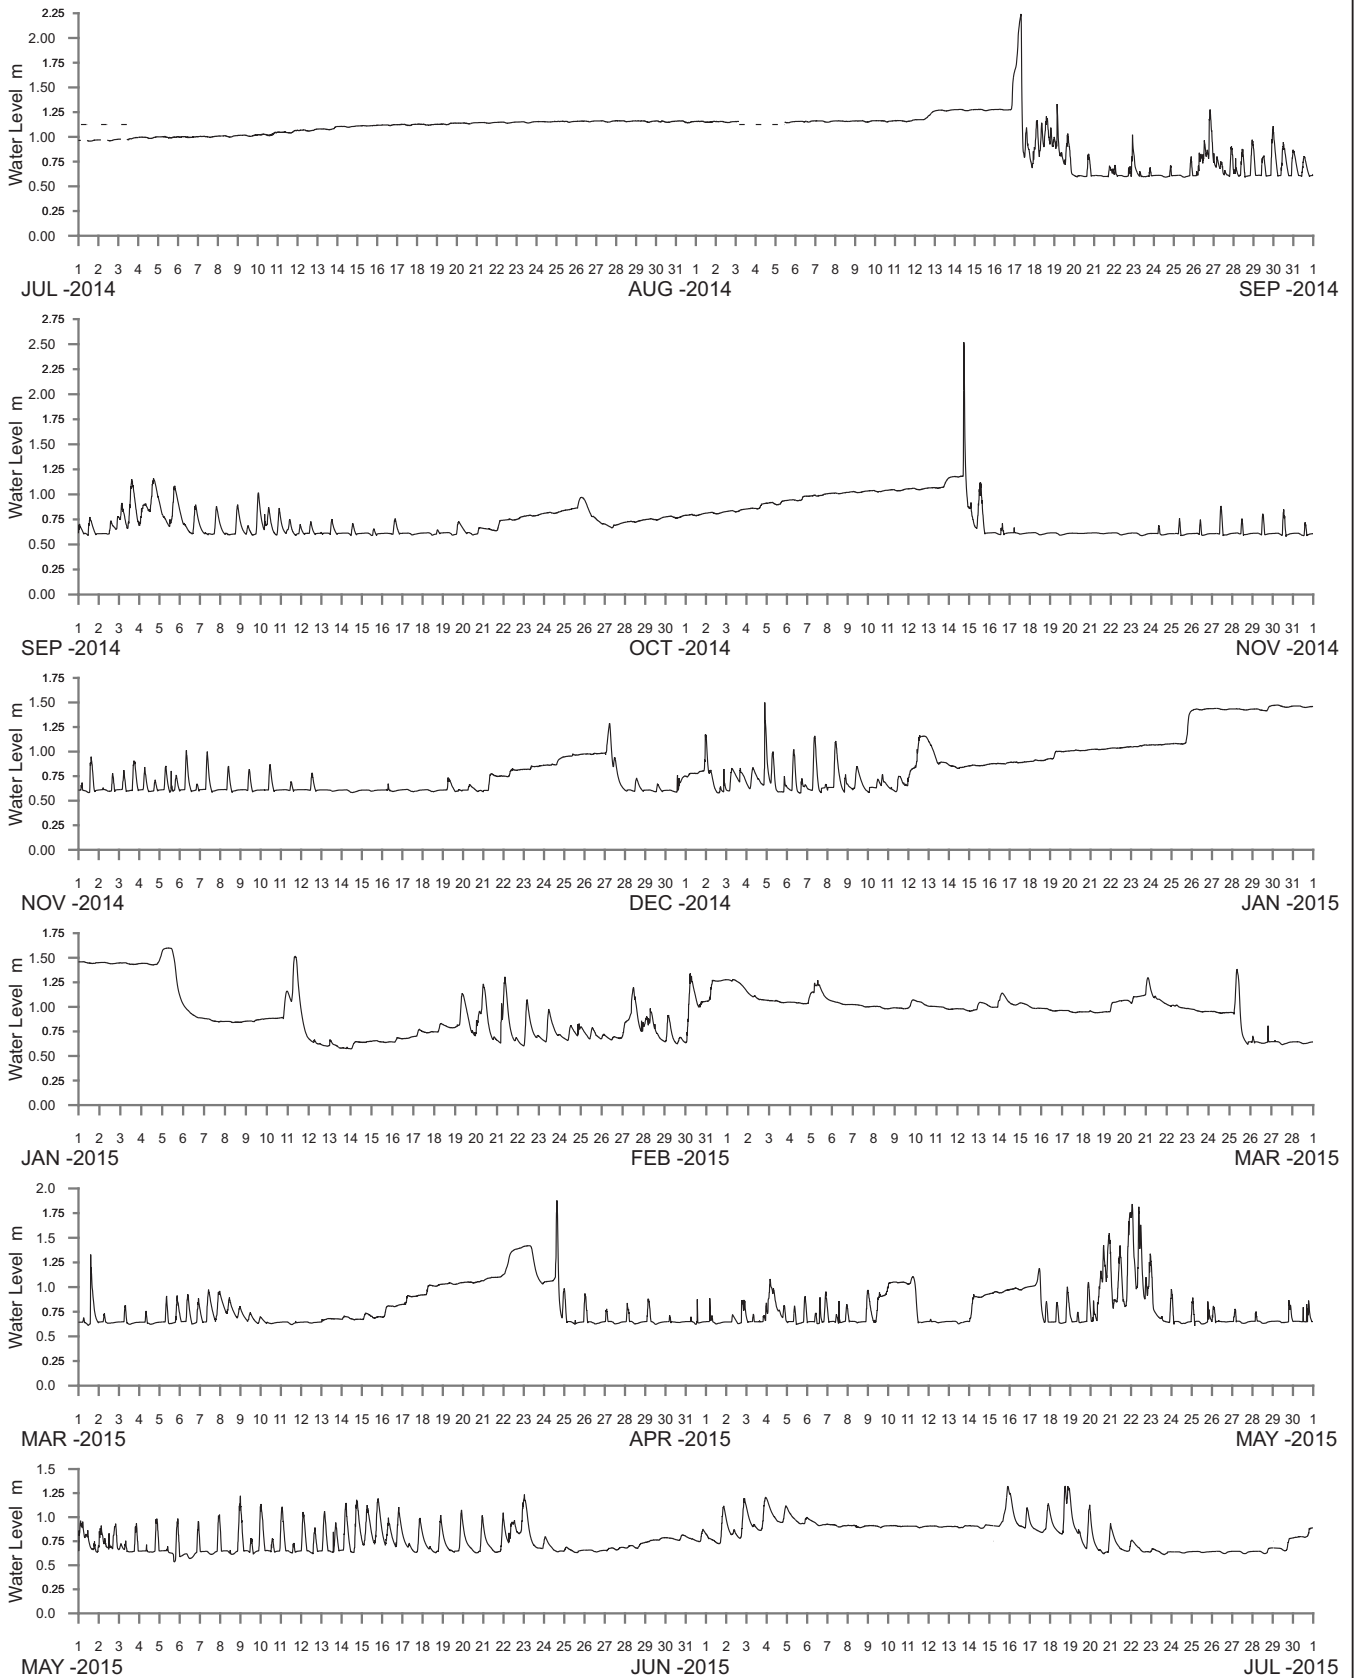
Figure
211

WATER LEVEL REFERENCED TO AUSTRALIAN HEIGHT DATUM

FAIRY CREEK AT FAIRY CREEK DOWNSTREAM
2014-2015

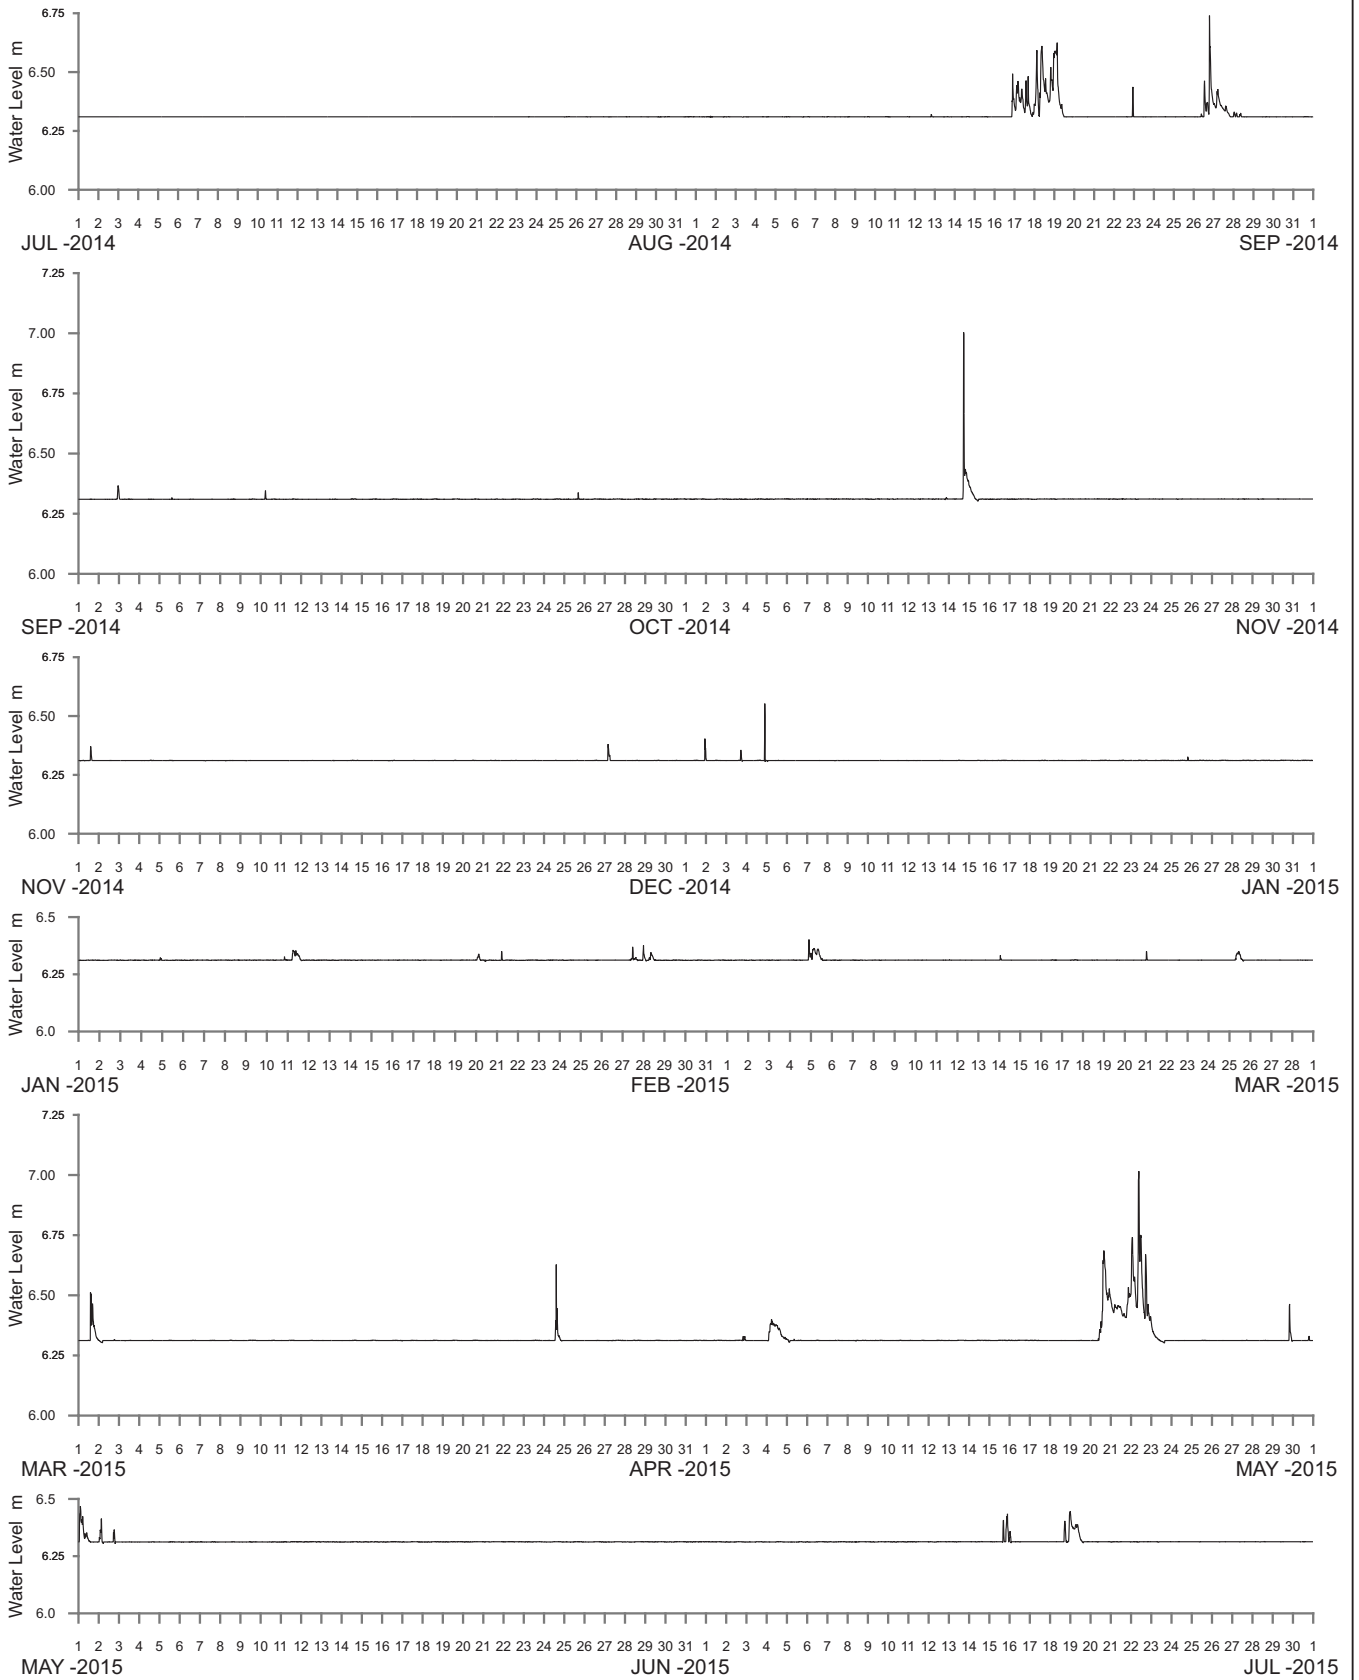
Figure
212

WATER LEVEL REFERENCED TO AUSTRALIAN HEIGHT DATUM

BYARONG CREEK AT F6 FREEWAY
2014-2015

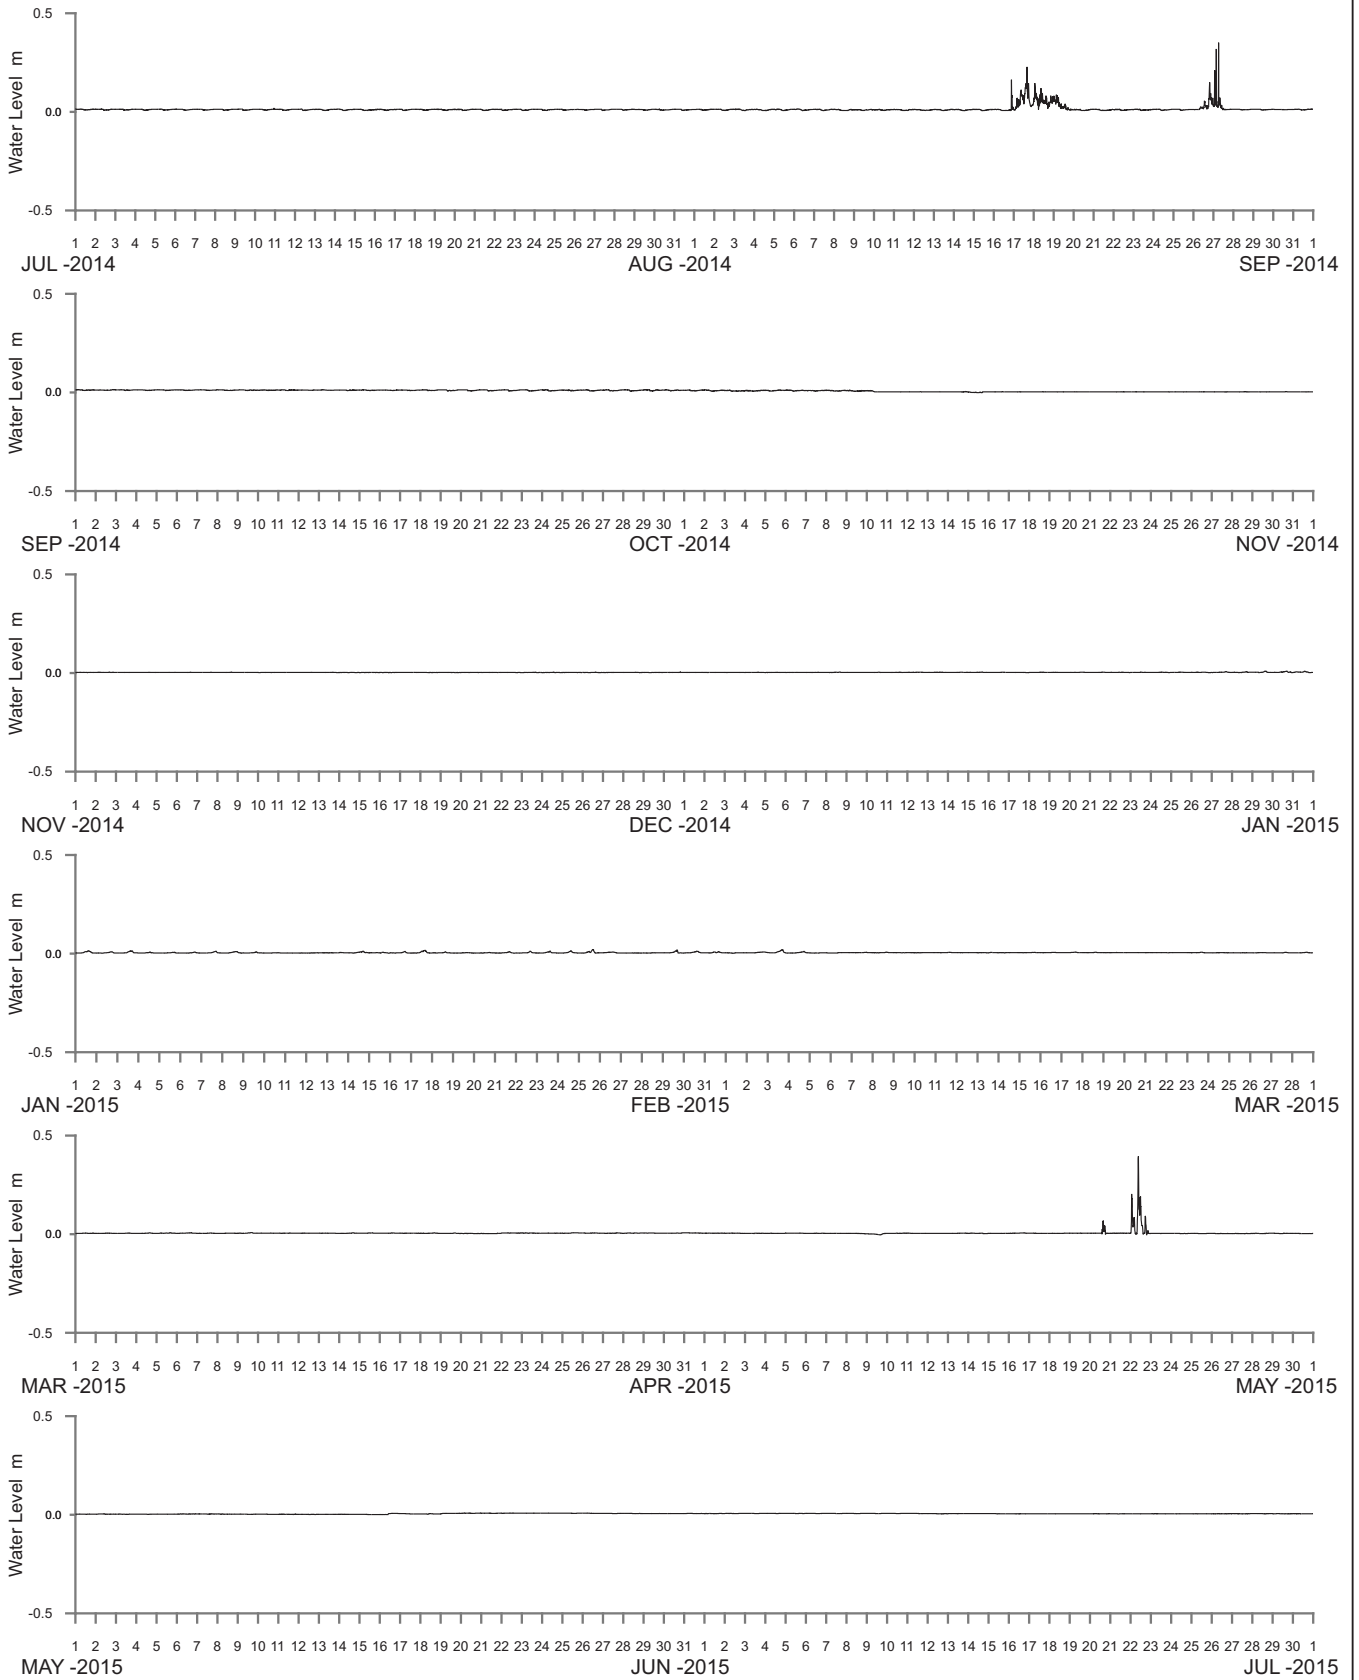
Figure
213

WATER LEVEL REFERENCED TO CULVERT BED

BYARONG CREEK AT KOLOONA AVENUE UPSTREAM
2014-2015

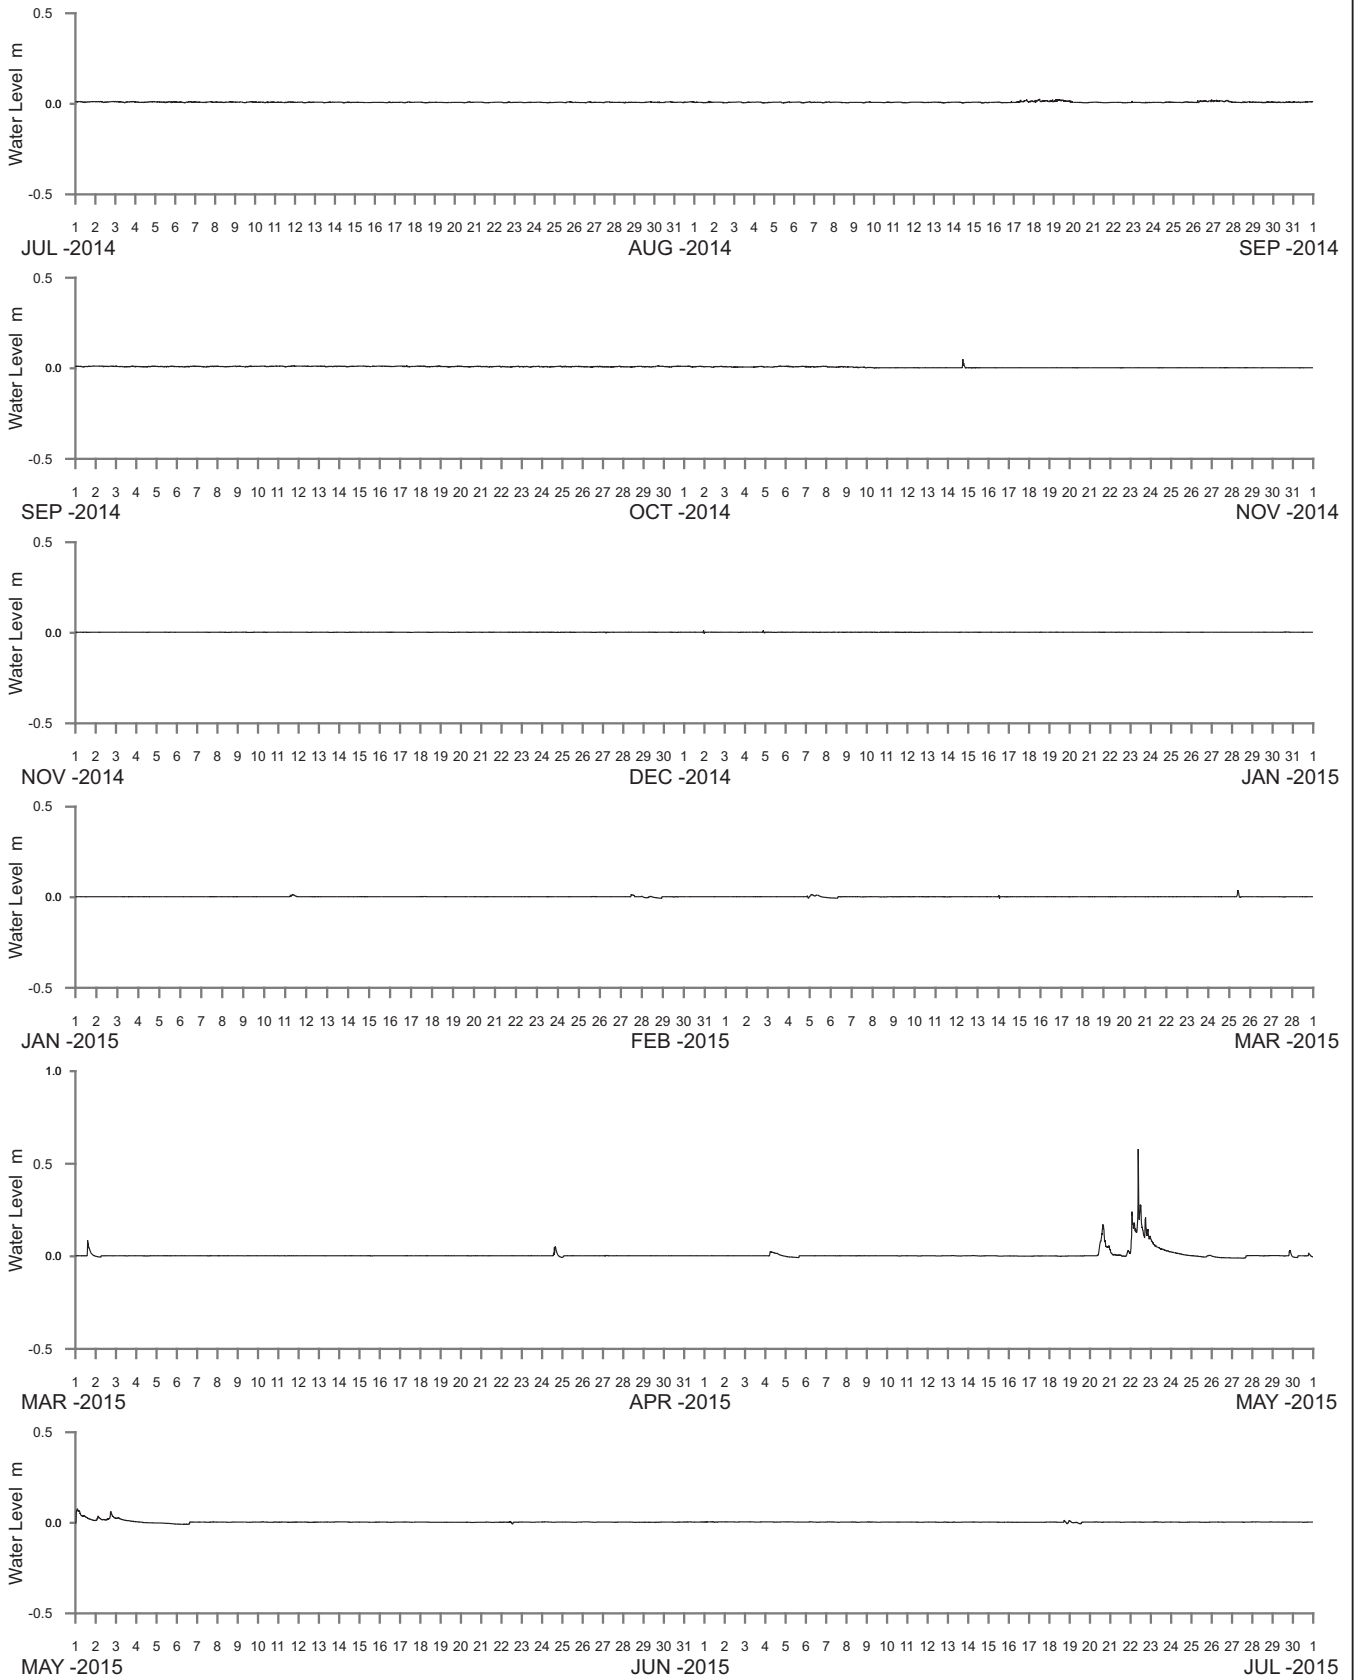
Figure
214

WATER LEVEL REFERENCED TO CULVERT BED

BYARONG CREEK AT KOLOONA AVENUE DOWNSTREAM
2014-2015

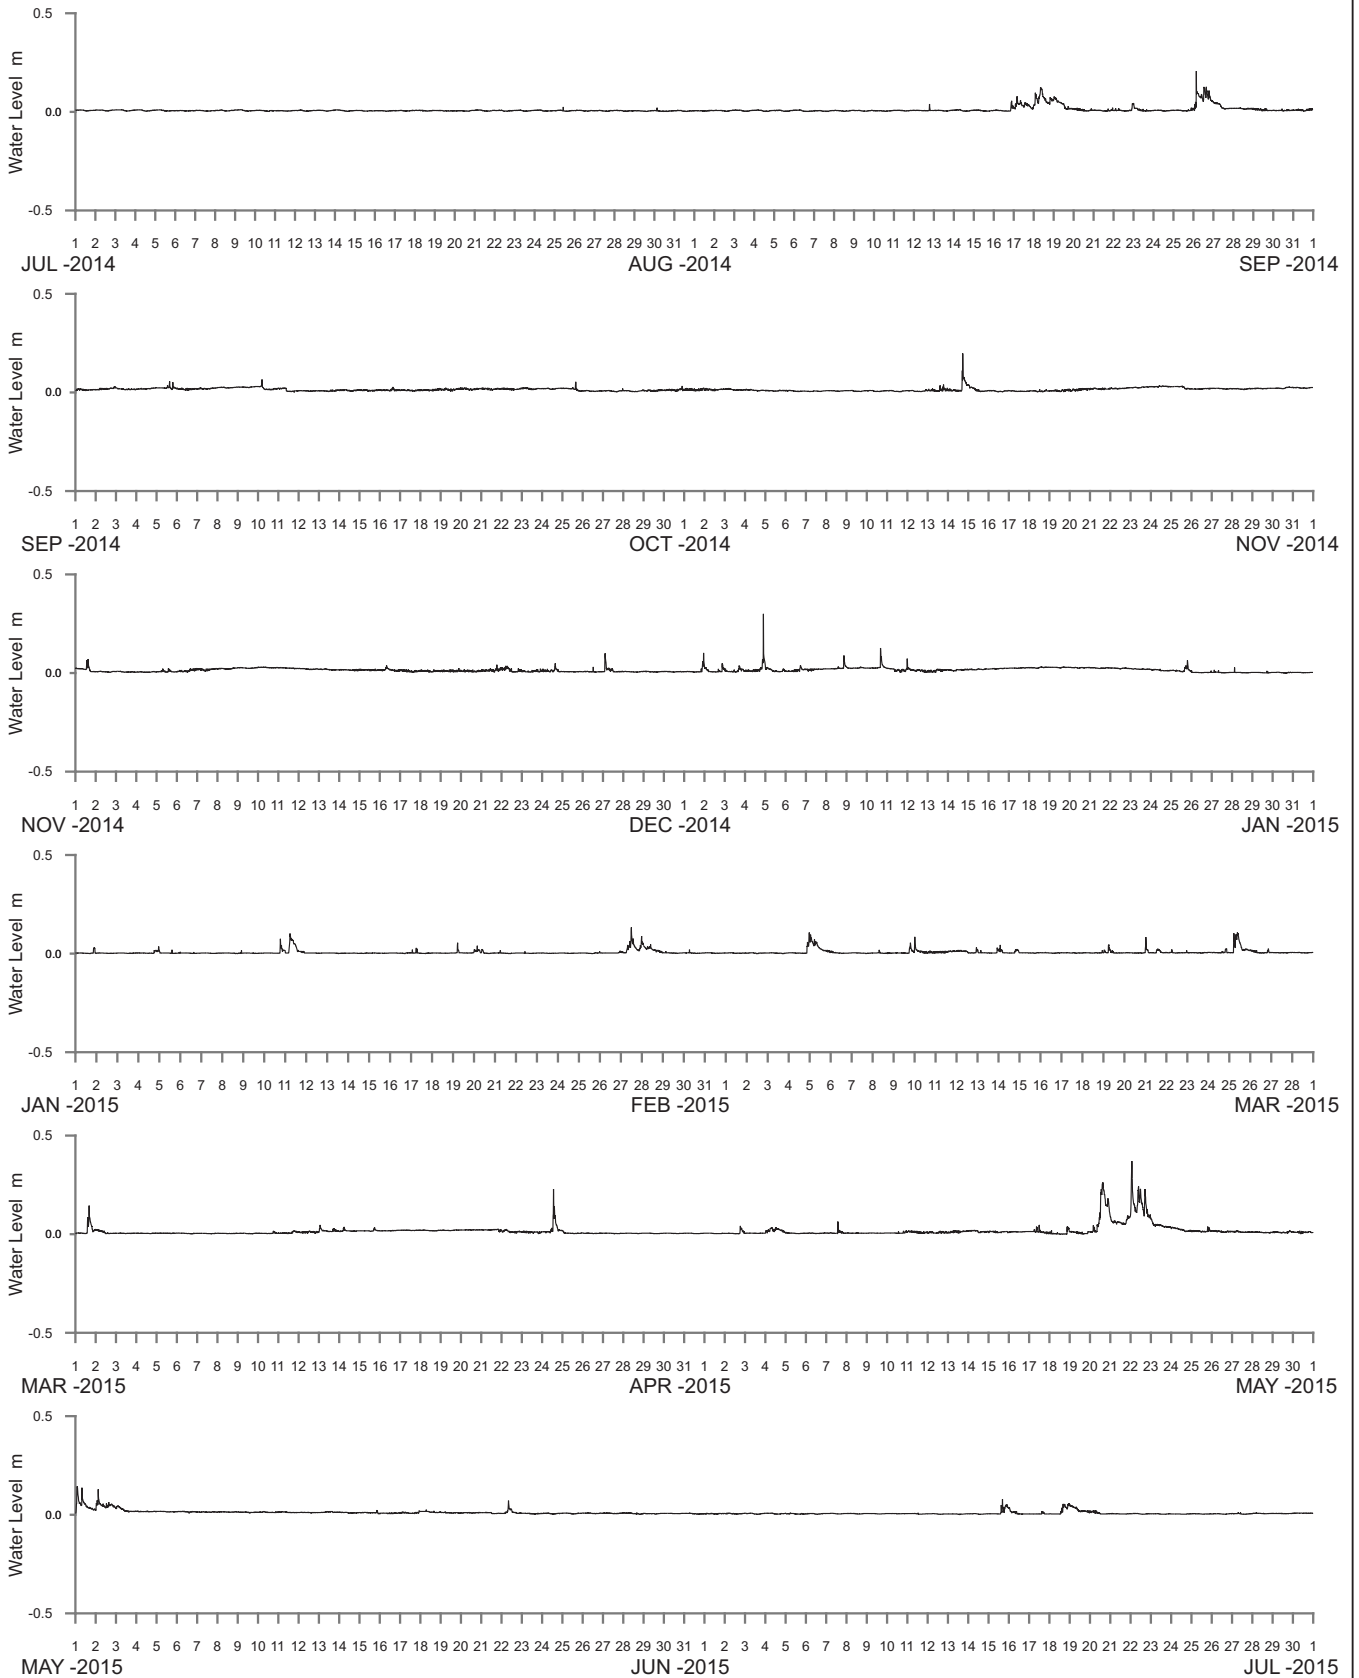
Figure
215

WATER LEVEL REFERENCED TO CULVERT BED

AMERICAN CREEK AT BLACKMANS PARADE UPSTREAM
2014–2015

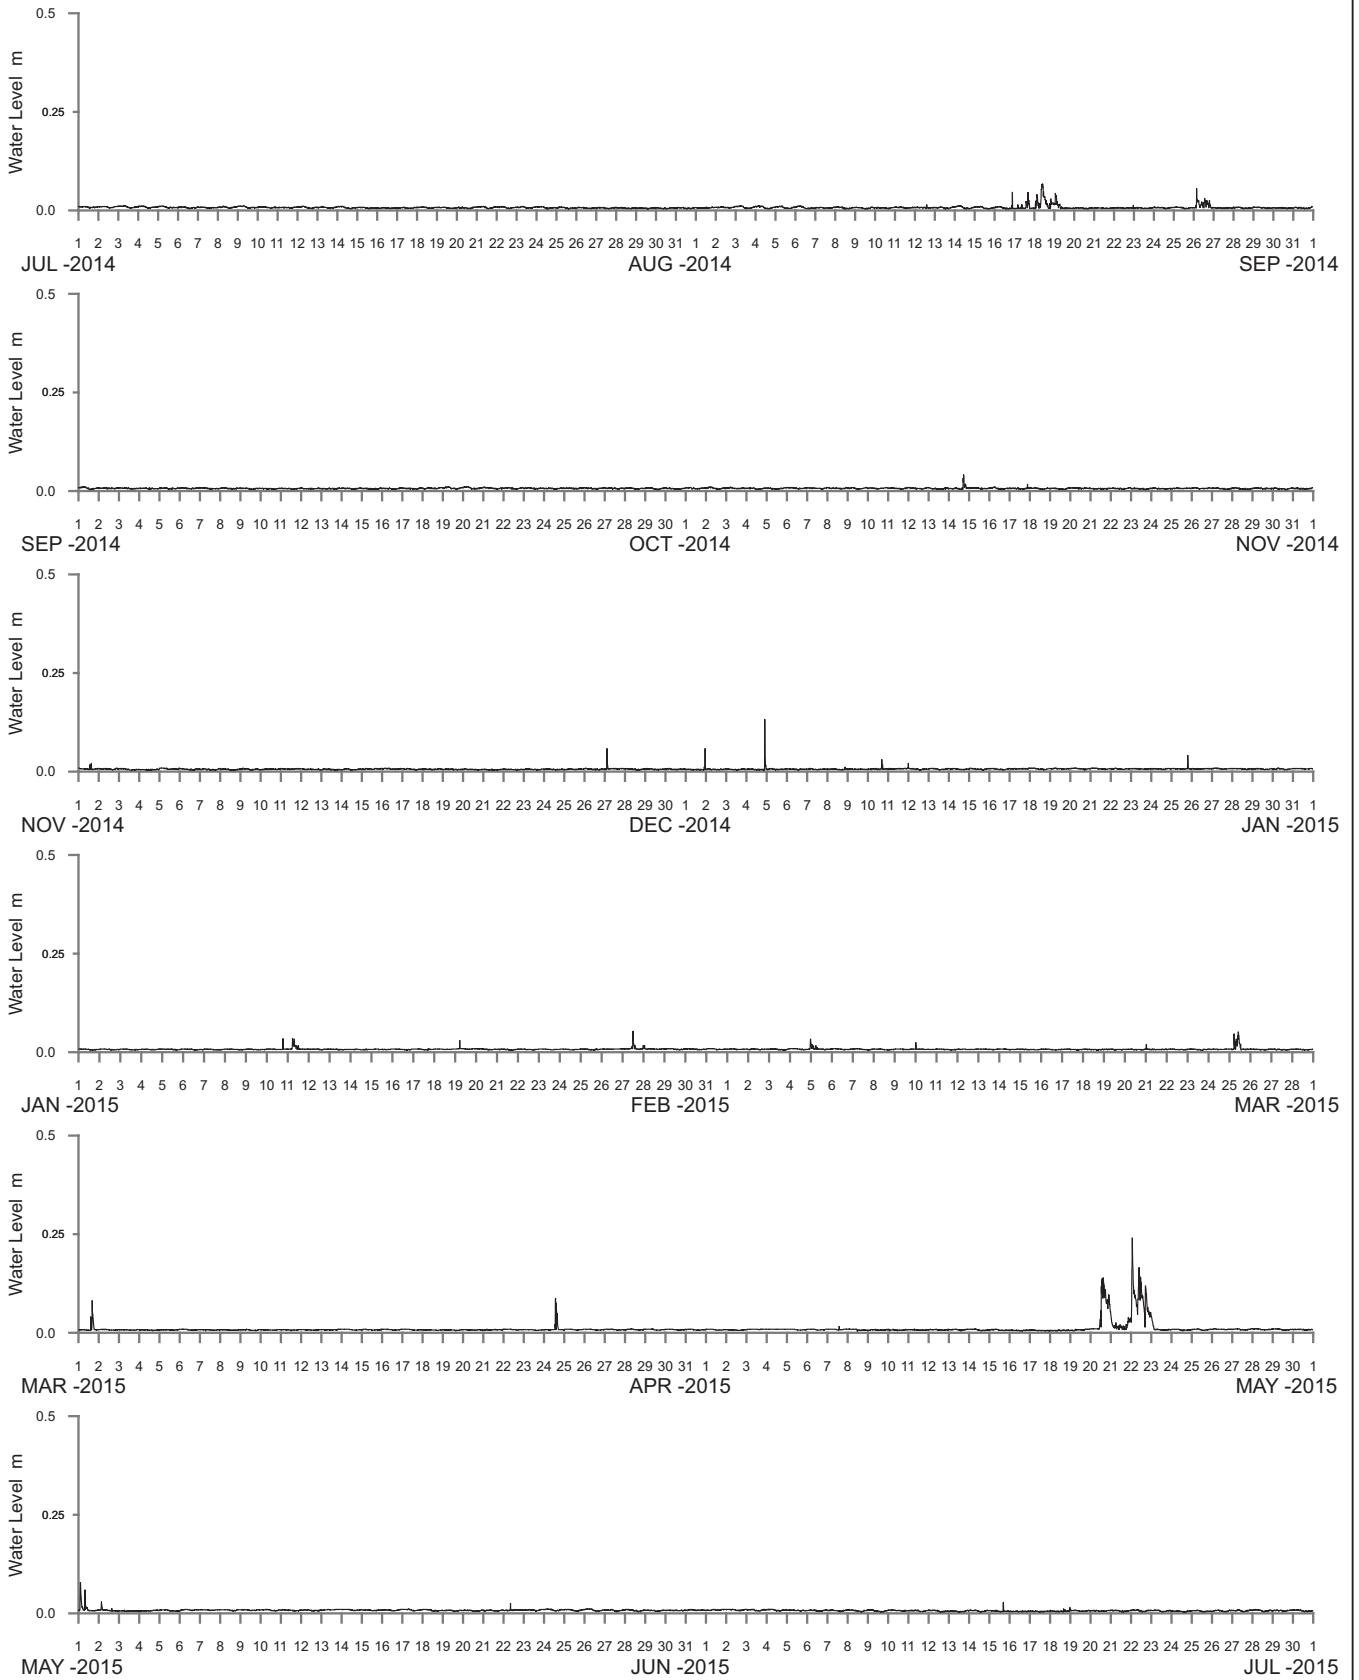
Figure
216

WATER LEVEL REFERENCED TO CULVERT BED

AMERICAN CREEK AT BLACKMANS PARADE DOWNSTREAM
2014-2015

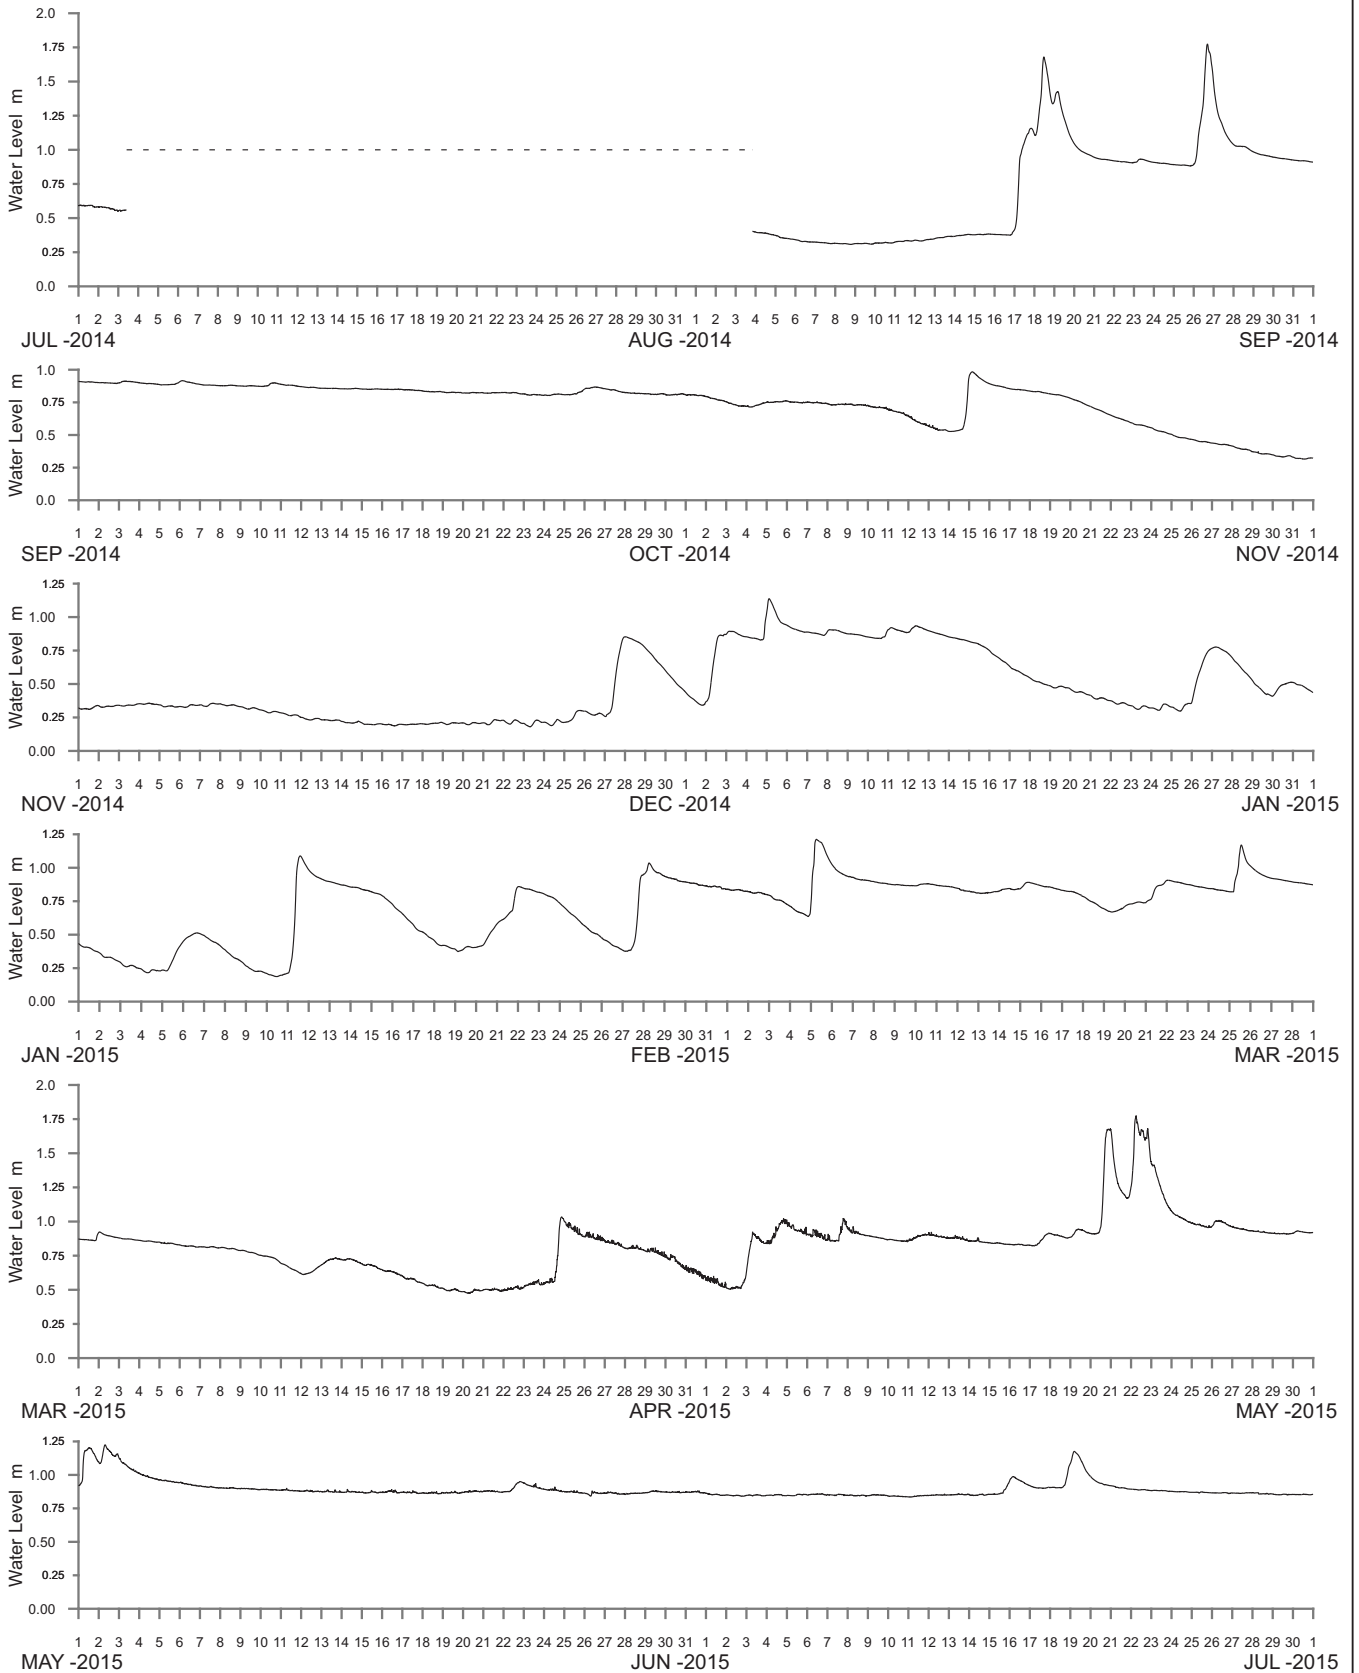
Figure
218

WATER LEVEL REFERENCED TO AUSTRALIAN HEIGHT DATUM

MULLET CREEK AT MULLET CREEK
2014-2015

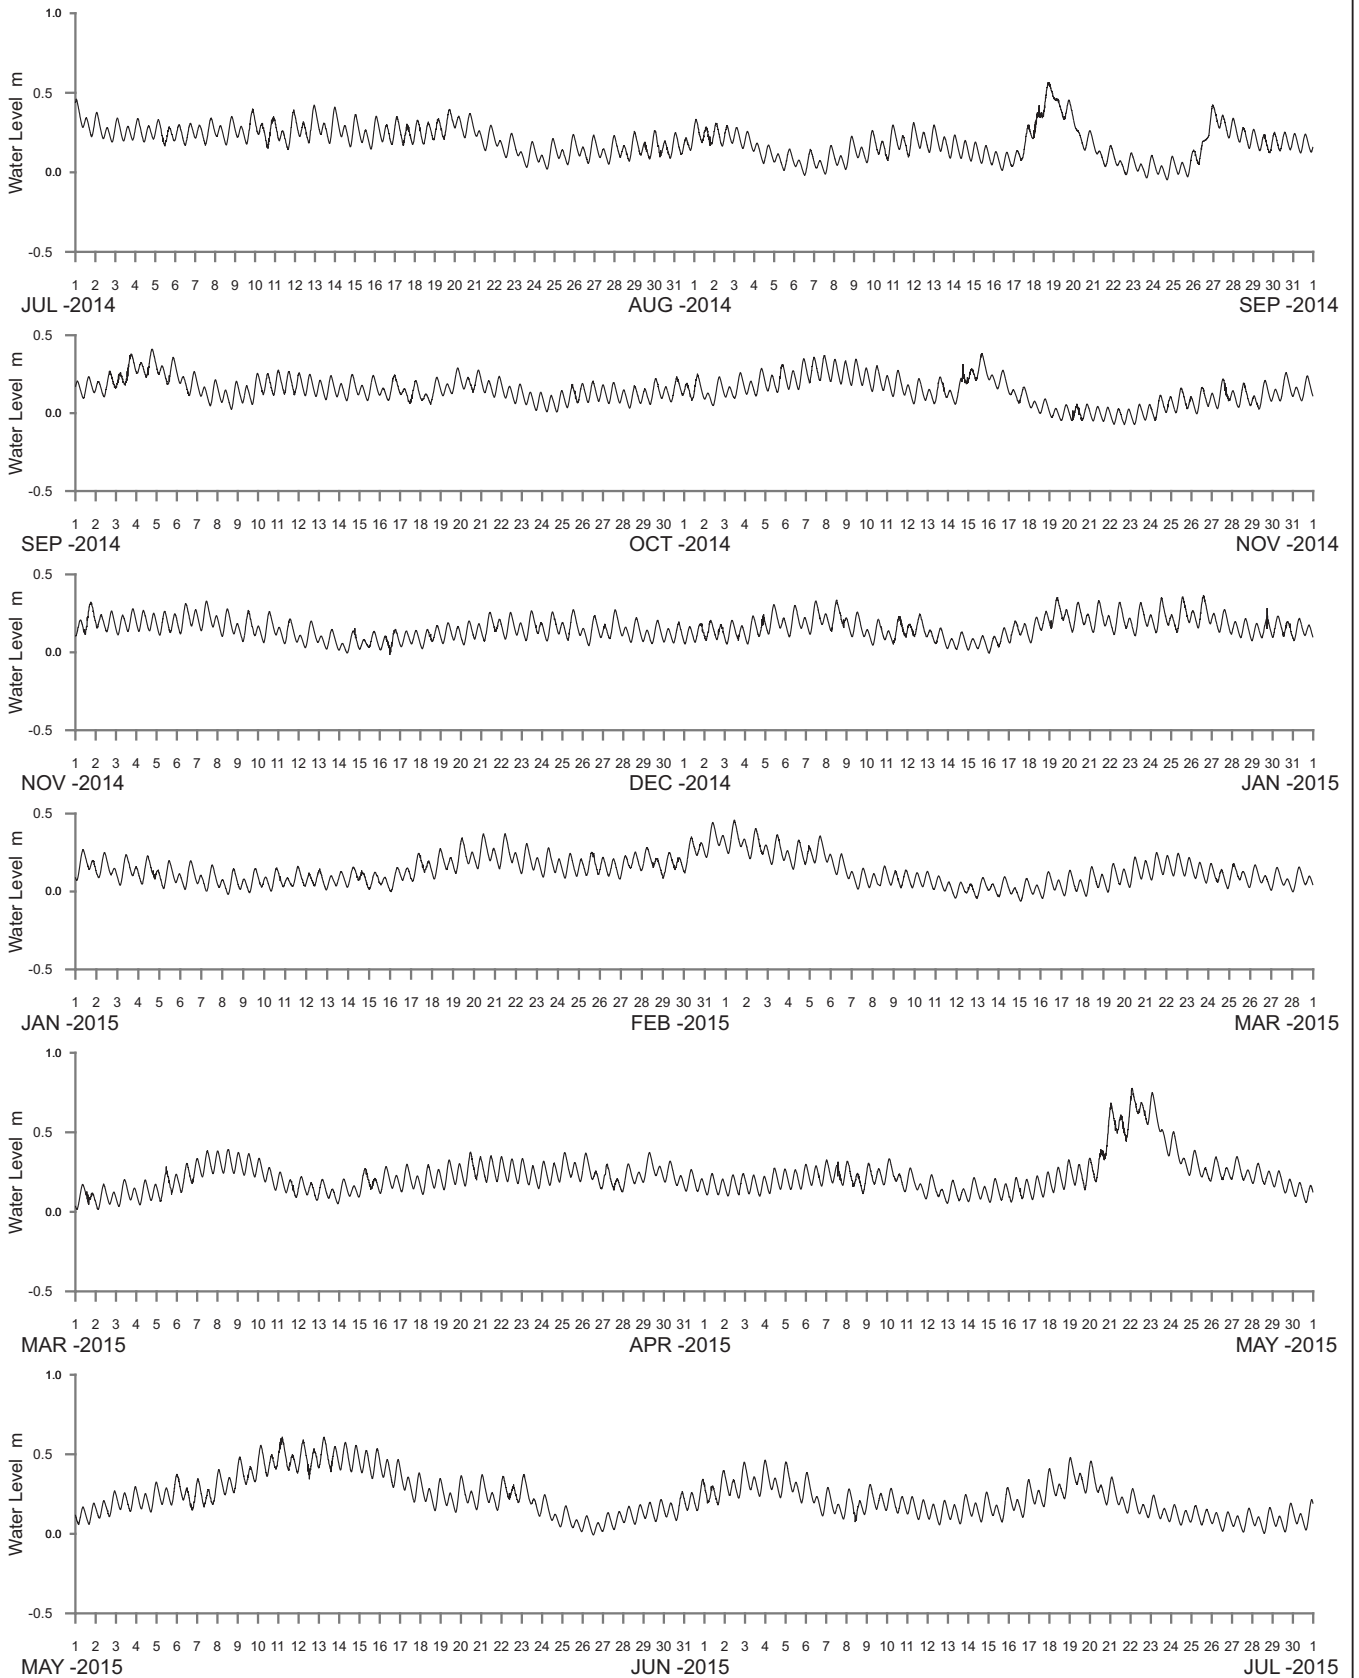
Figure
219

WATER LEVEL REFERENCED TO AUSTRALIAN HEIGHT DATUM

LAKE ILLAWARRA AT KOONAWARRA BAY
2014–2015

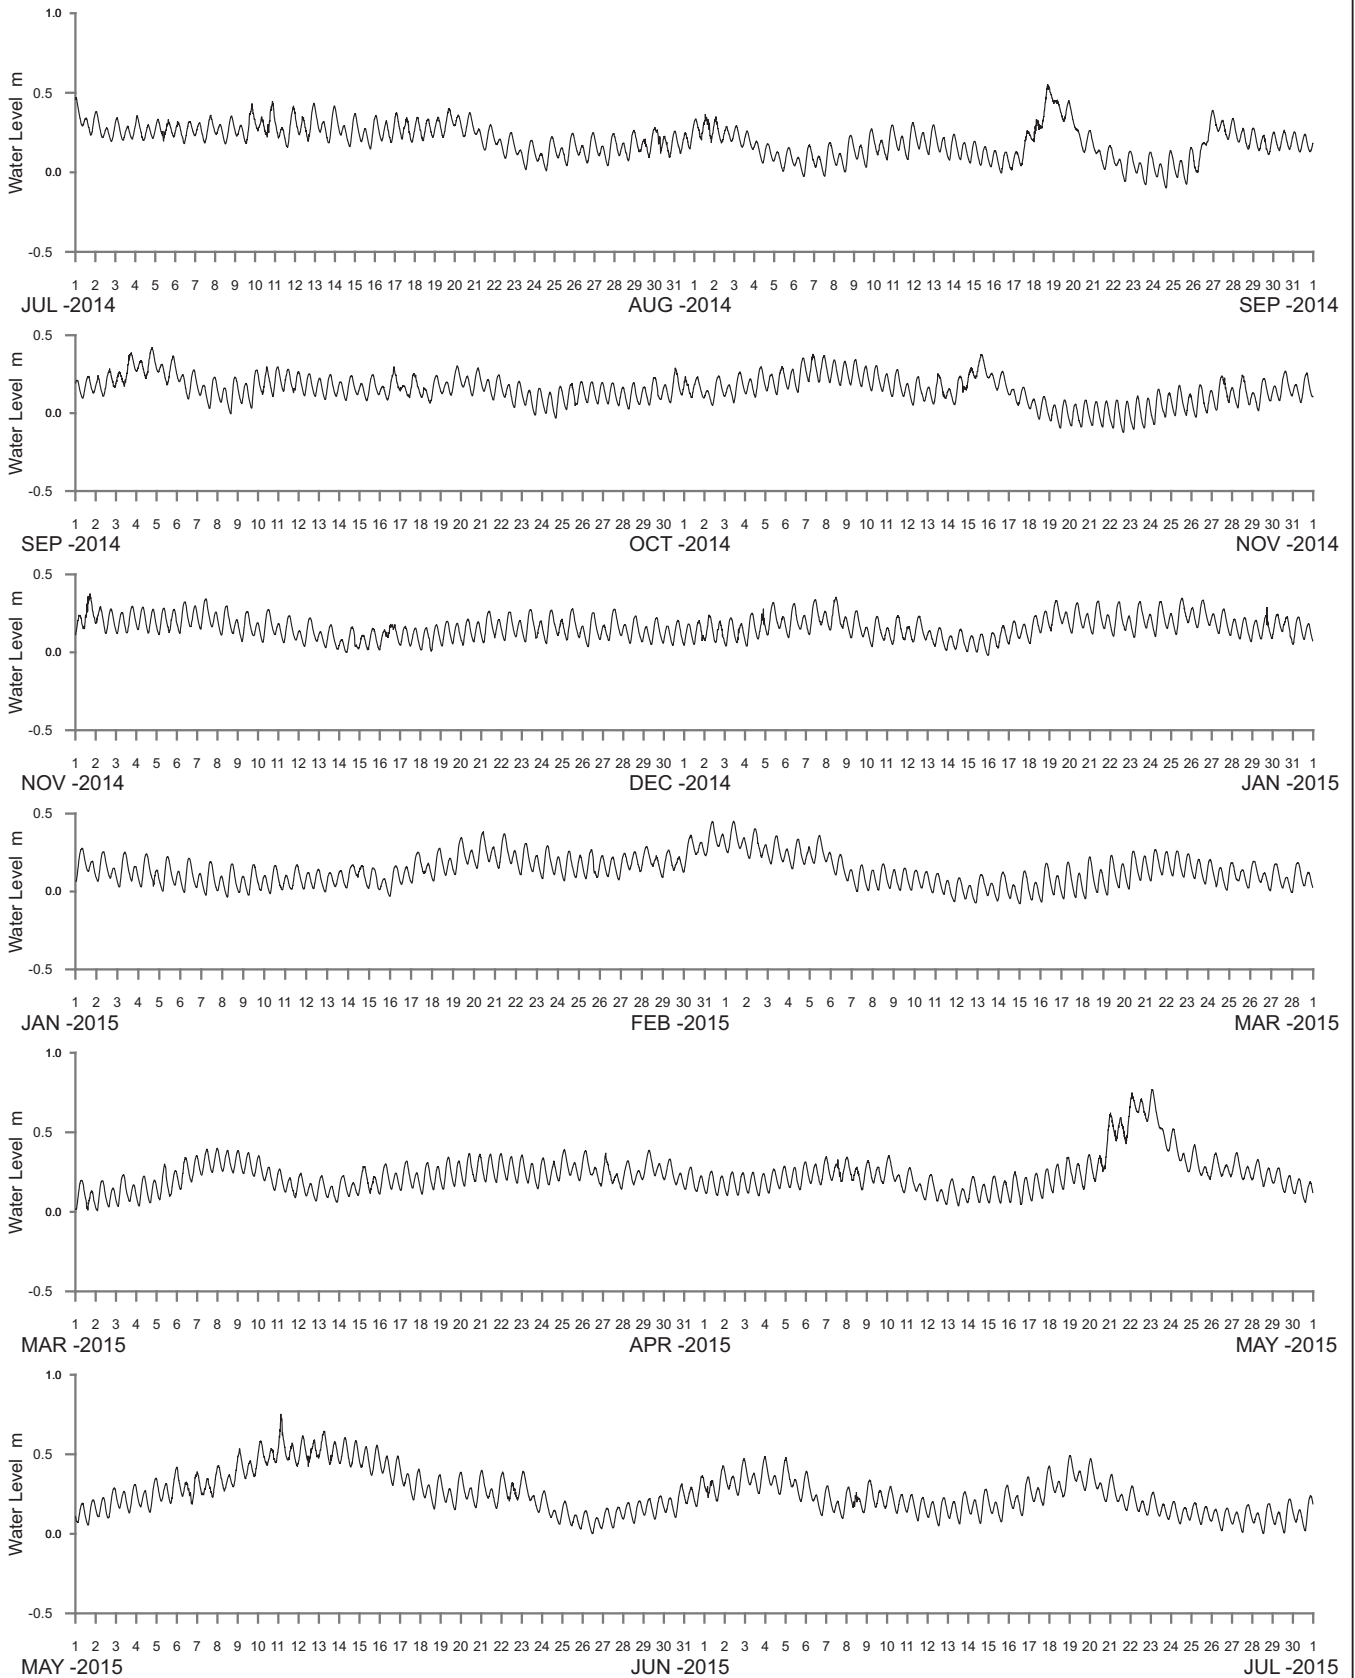
Figure
220

WATER LEVEL REFERENCED TO AUSTRALIAN HEIGHT DATUM

LAKE ILLAWARRA AT CUDGEREE BAY
2014–2015

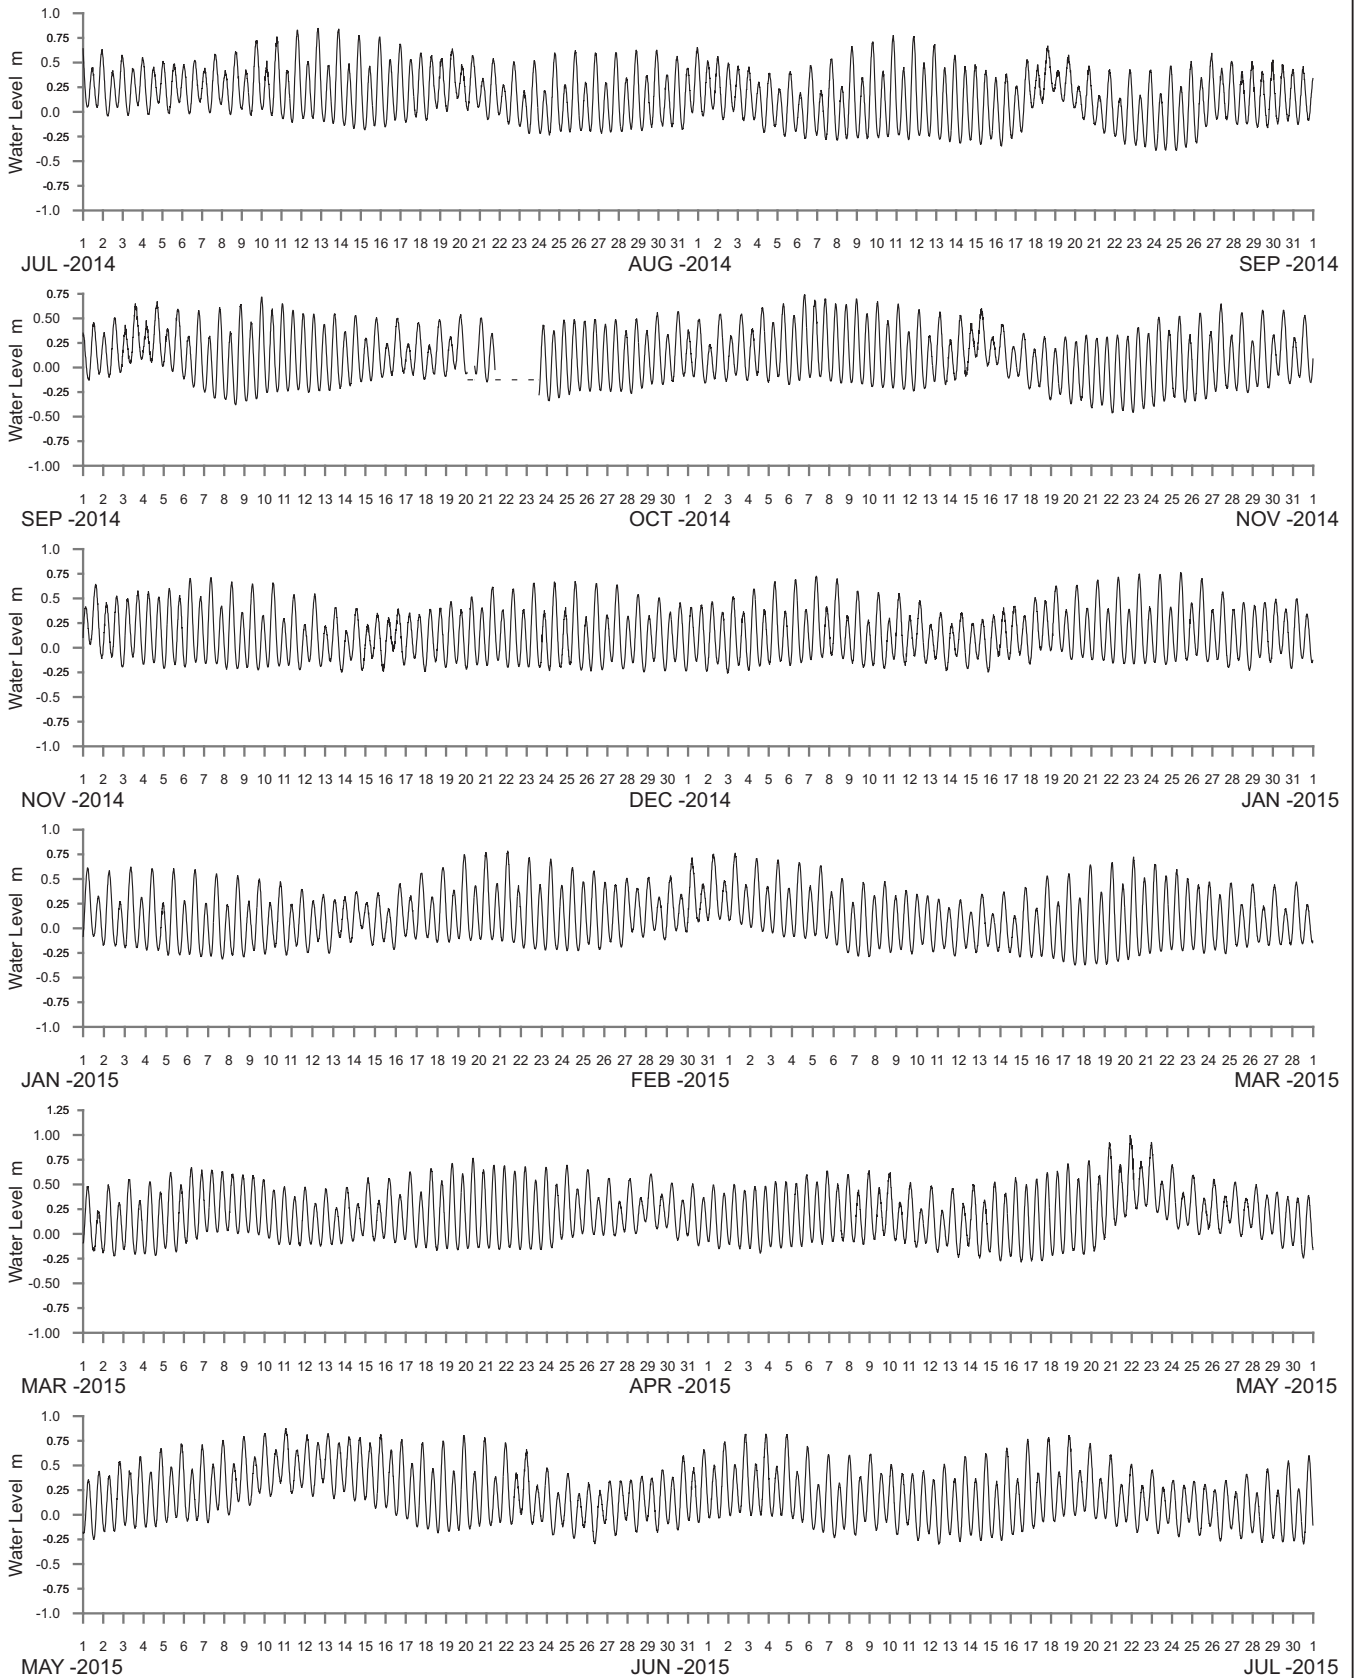
Figure
221

WATER LEVEL REFERENCED TO AUSTRALIAN HEIGHT DATUM

LAKE ILLAWARRA AT LAKE ILLAWARRA ENTRANCE
2014–2015
