Public Works
Manly Hydraulics Laboratory

HEWITTS CREEK AT HEWITTS CREEK UPSTREAM
2014–2015

MHL
Report 2383

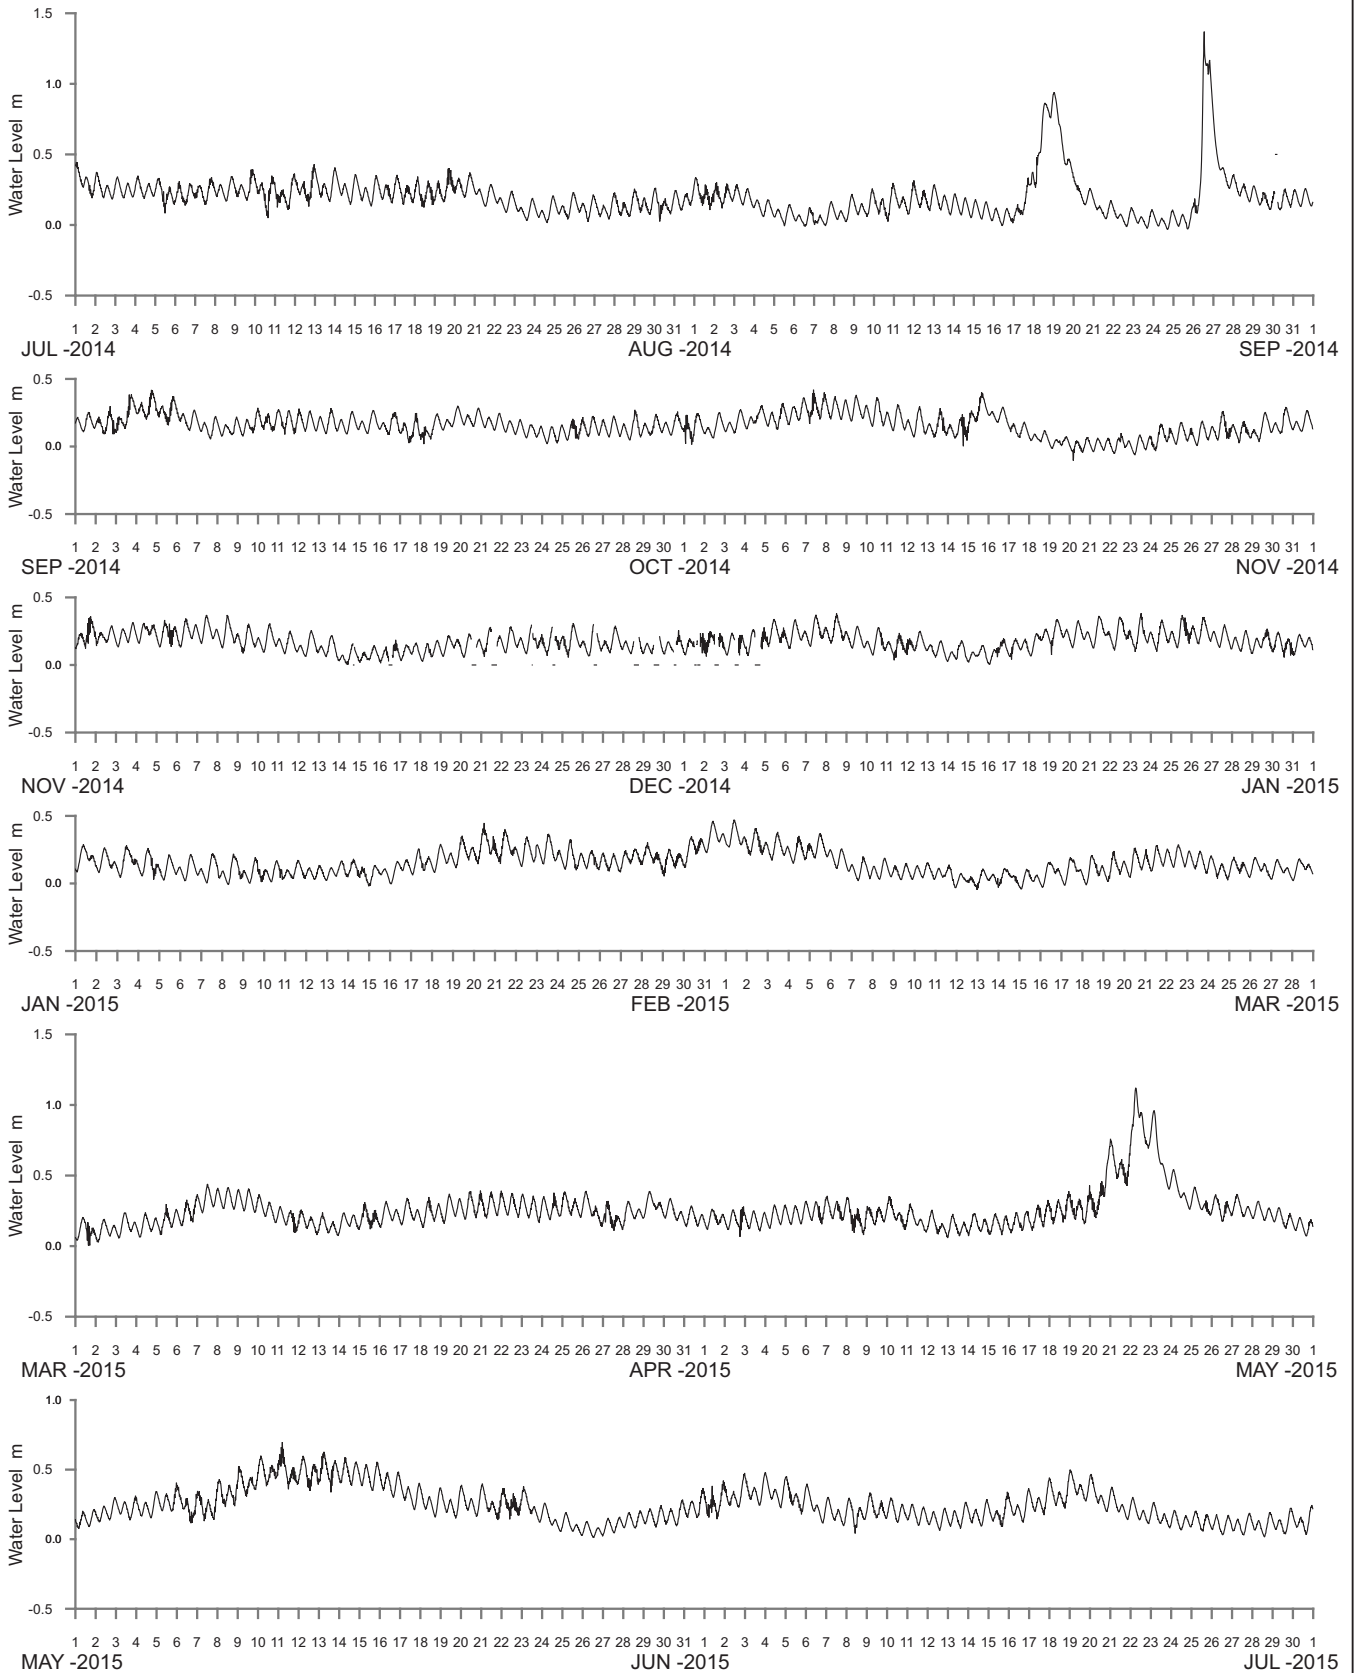
Figure
222

WATER LEVEL REFERENCED TO AUSTRALIAN HEIGHT DATUM

MACQUARIE RIVULET AT PRINCES HIGHWAY
2014–2015

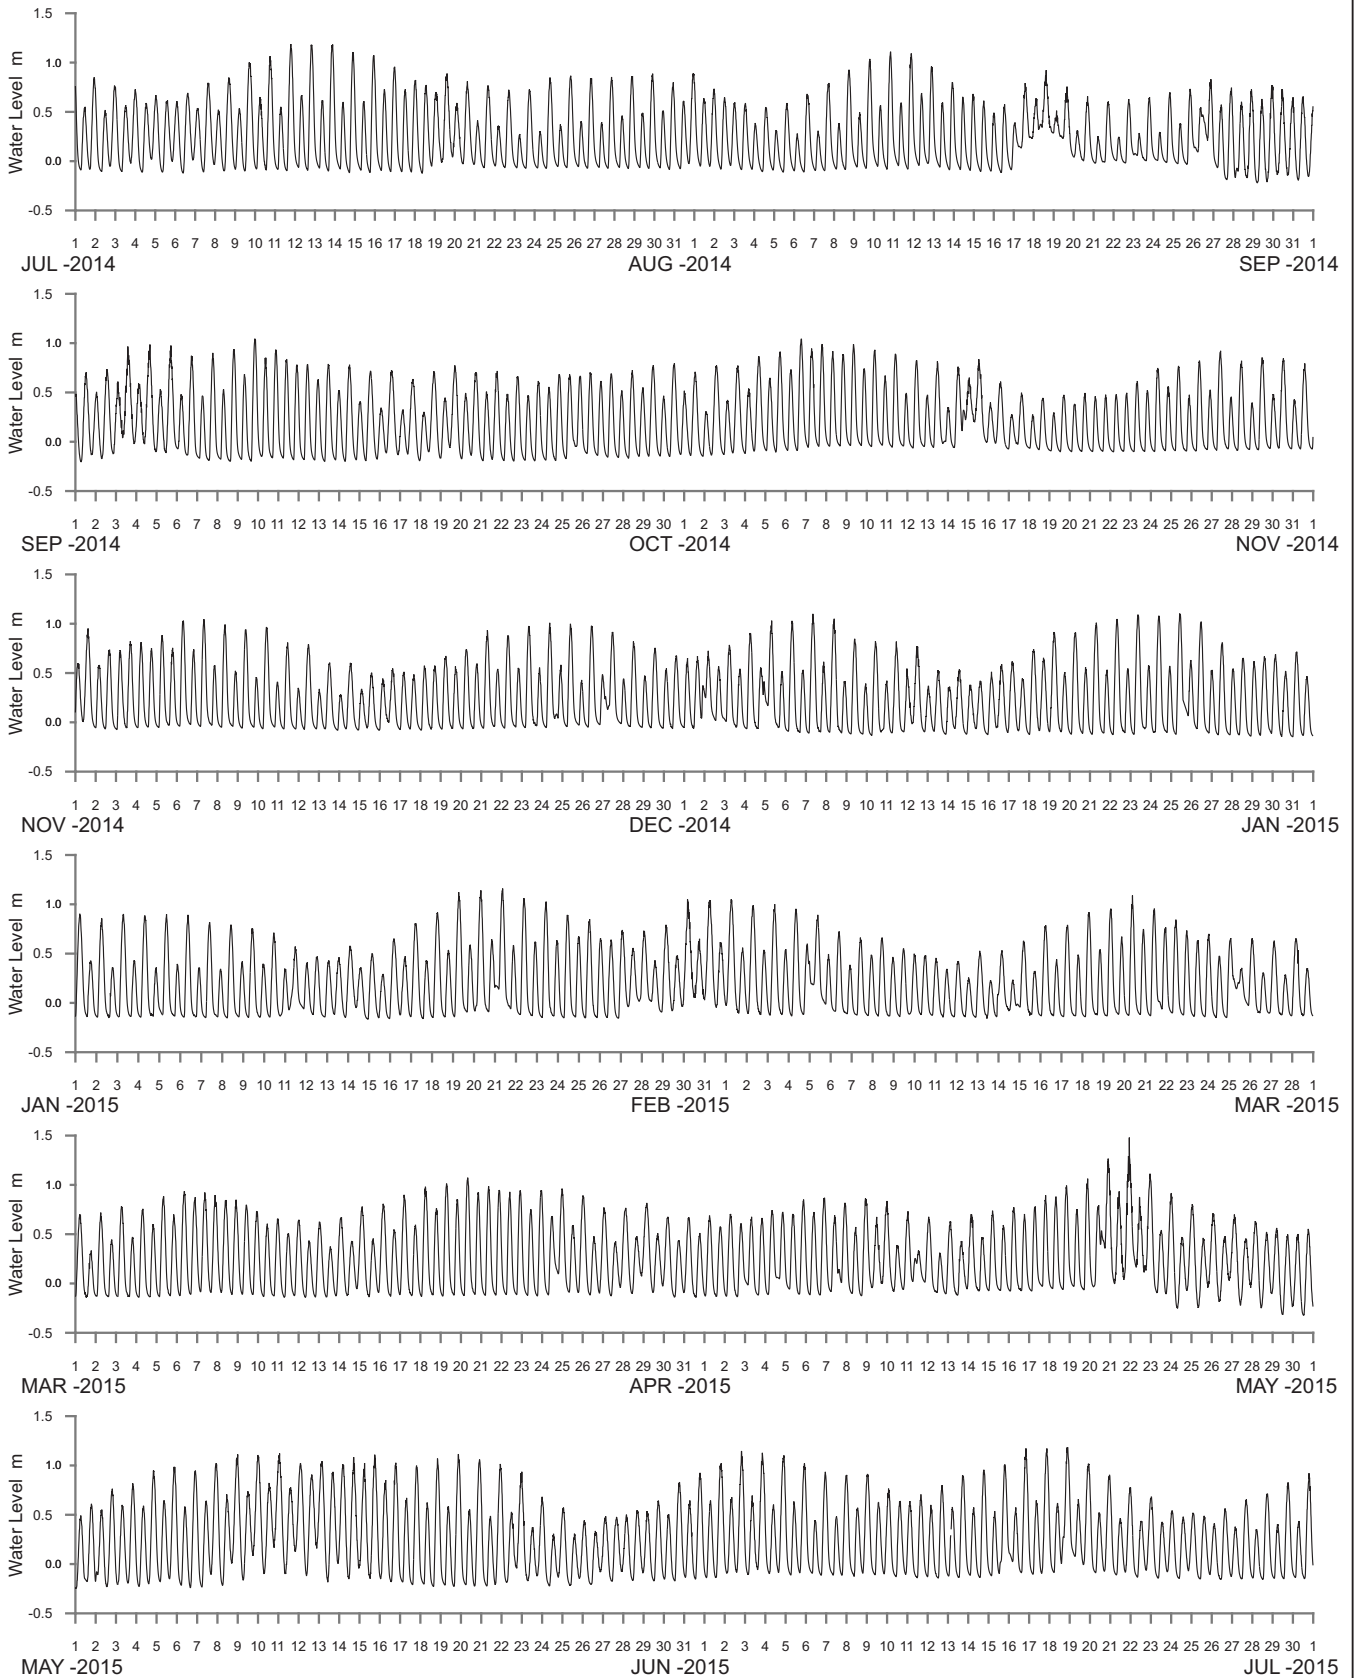
Figure
224

WATER LEVEL REFERENCED TO AUSTRALIAN HEIGHT DATUM

LITTLE LAKE ENTRANCE AT LITTLE LAKE
2014–2015

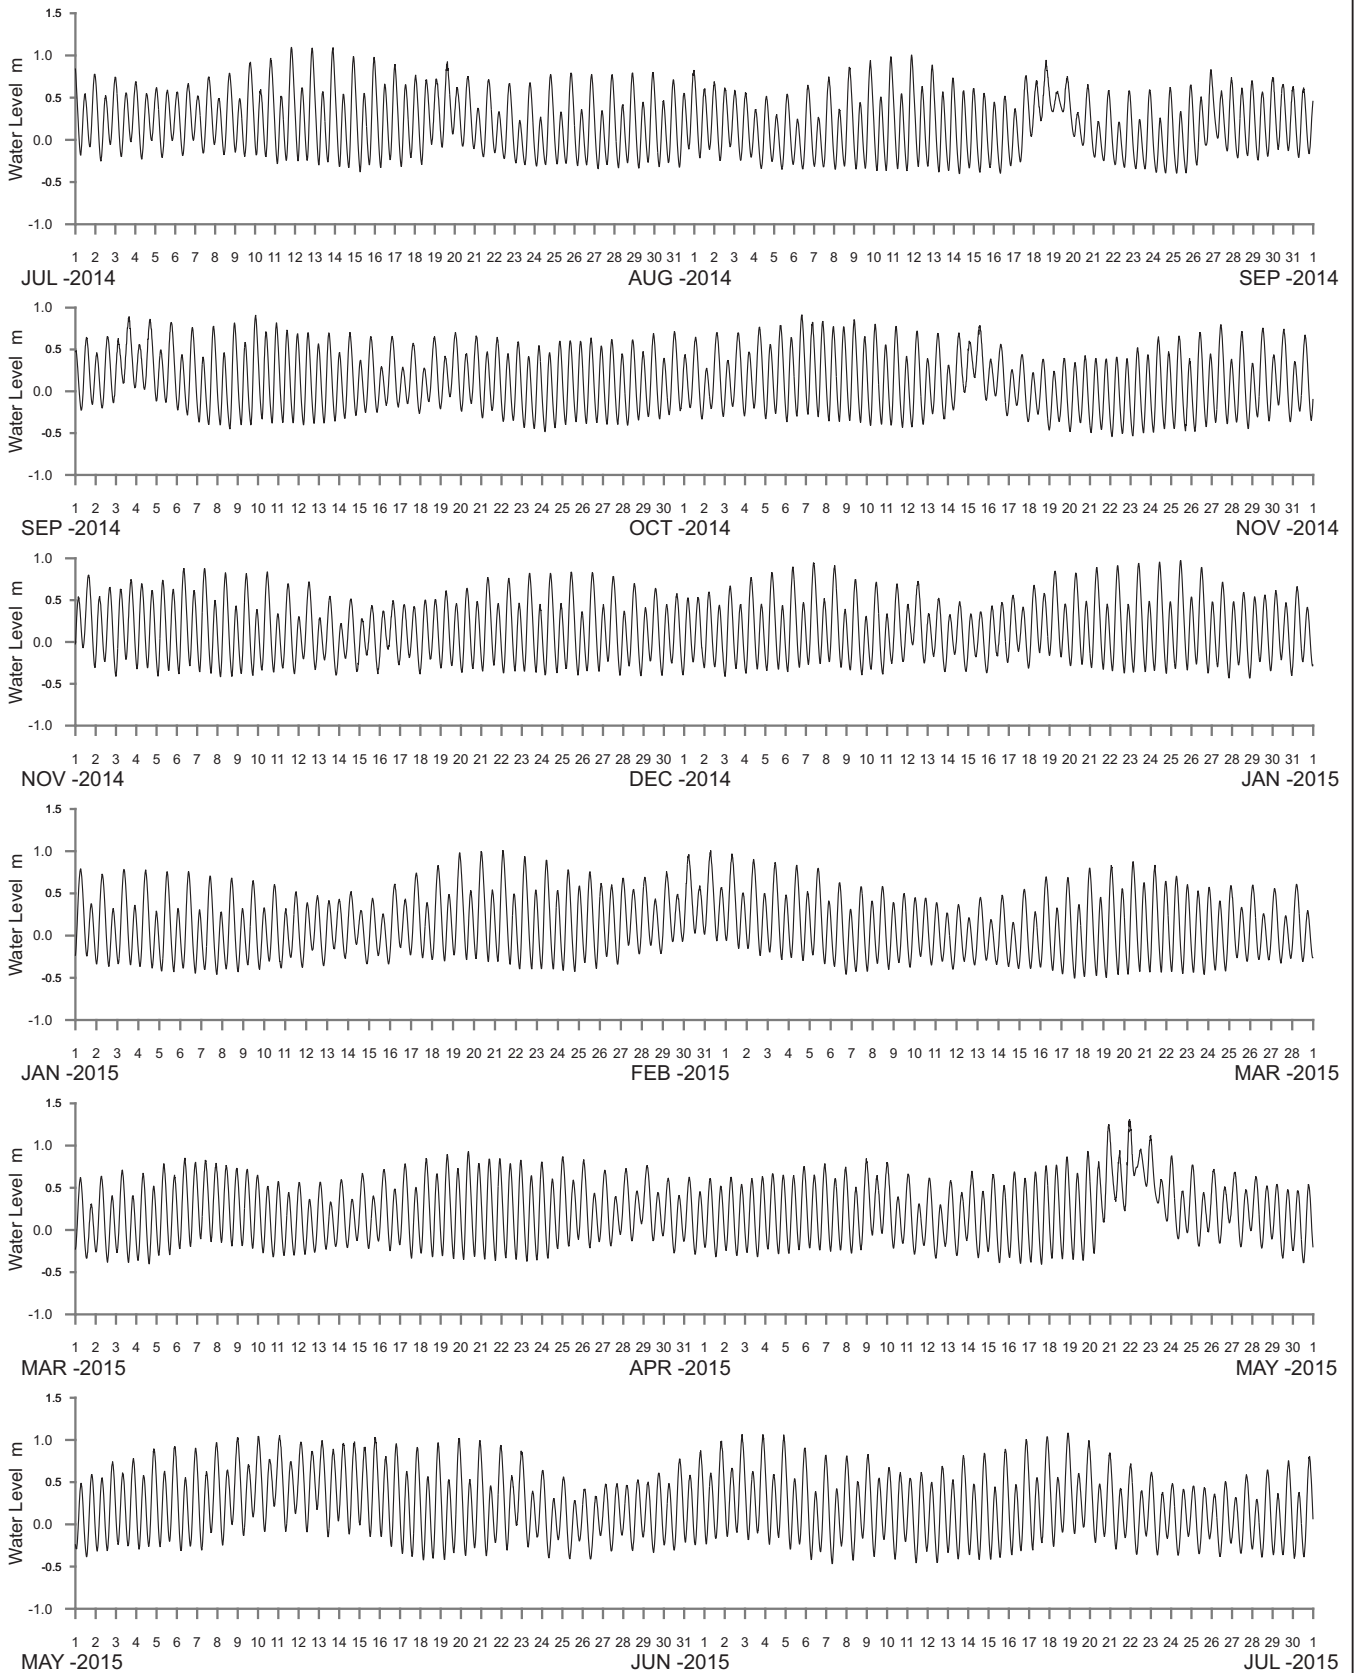
Figure
225

WATER LEVEL REFERENCED TO AUSTRALIAN HEIGHT DATUM

MINNAMURRA RIVER AT MINNAMURRA
2014–2015

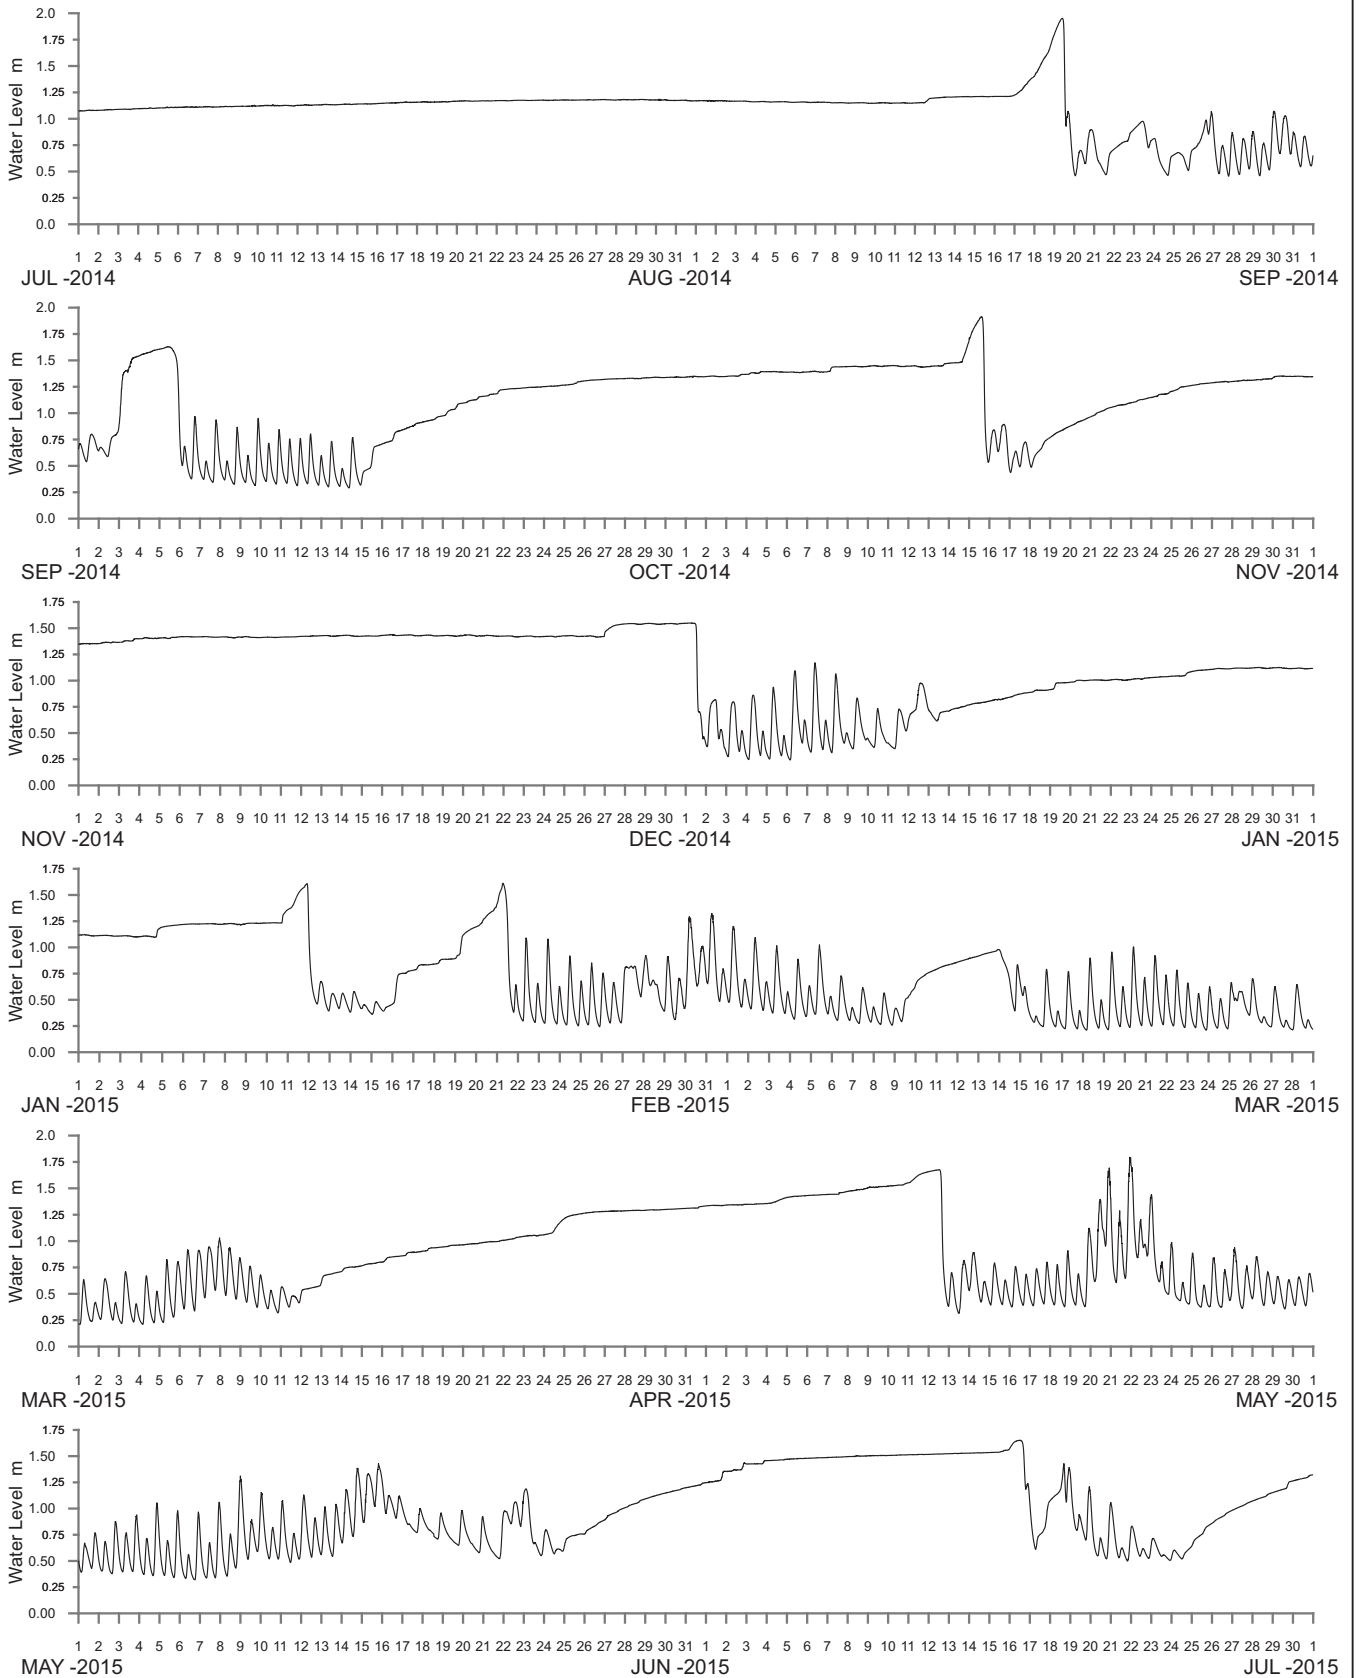
Figure
226

WATER LEVEL REFERENCED TO AUSTRALIAN HEIGHT DATUM

WERRI LAGOON AT WERRI LAGOON
2014-2015

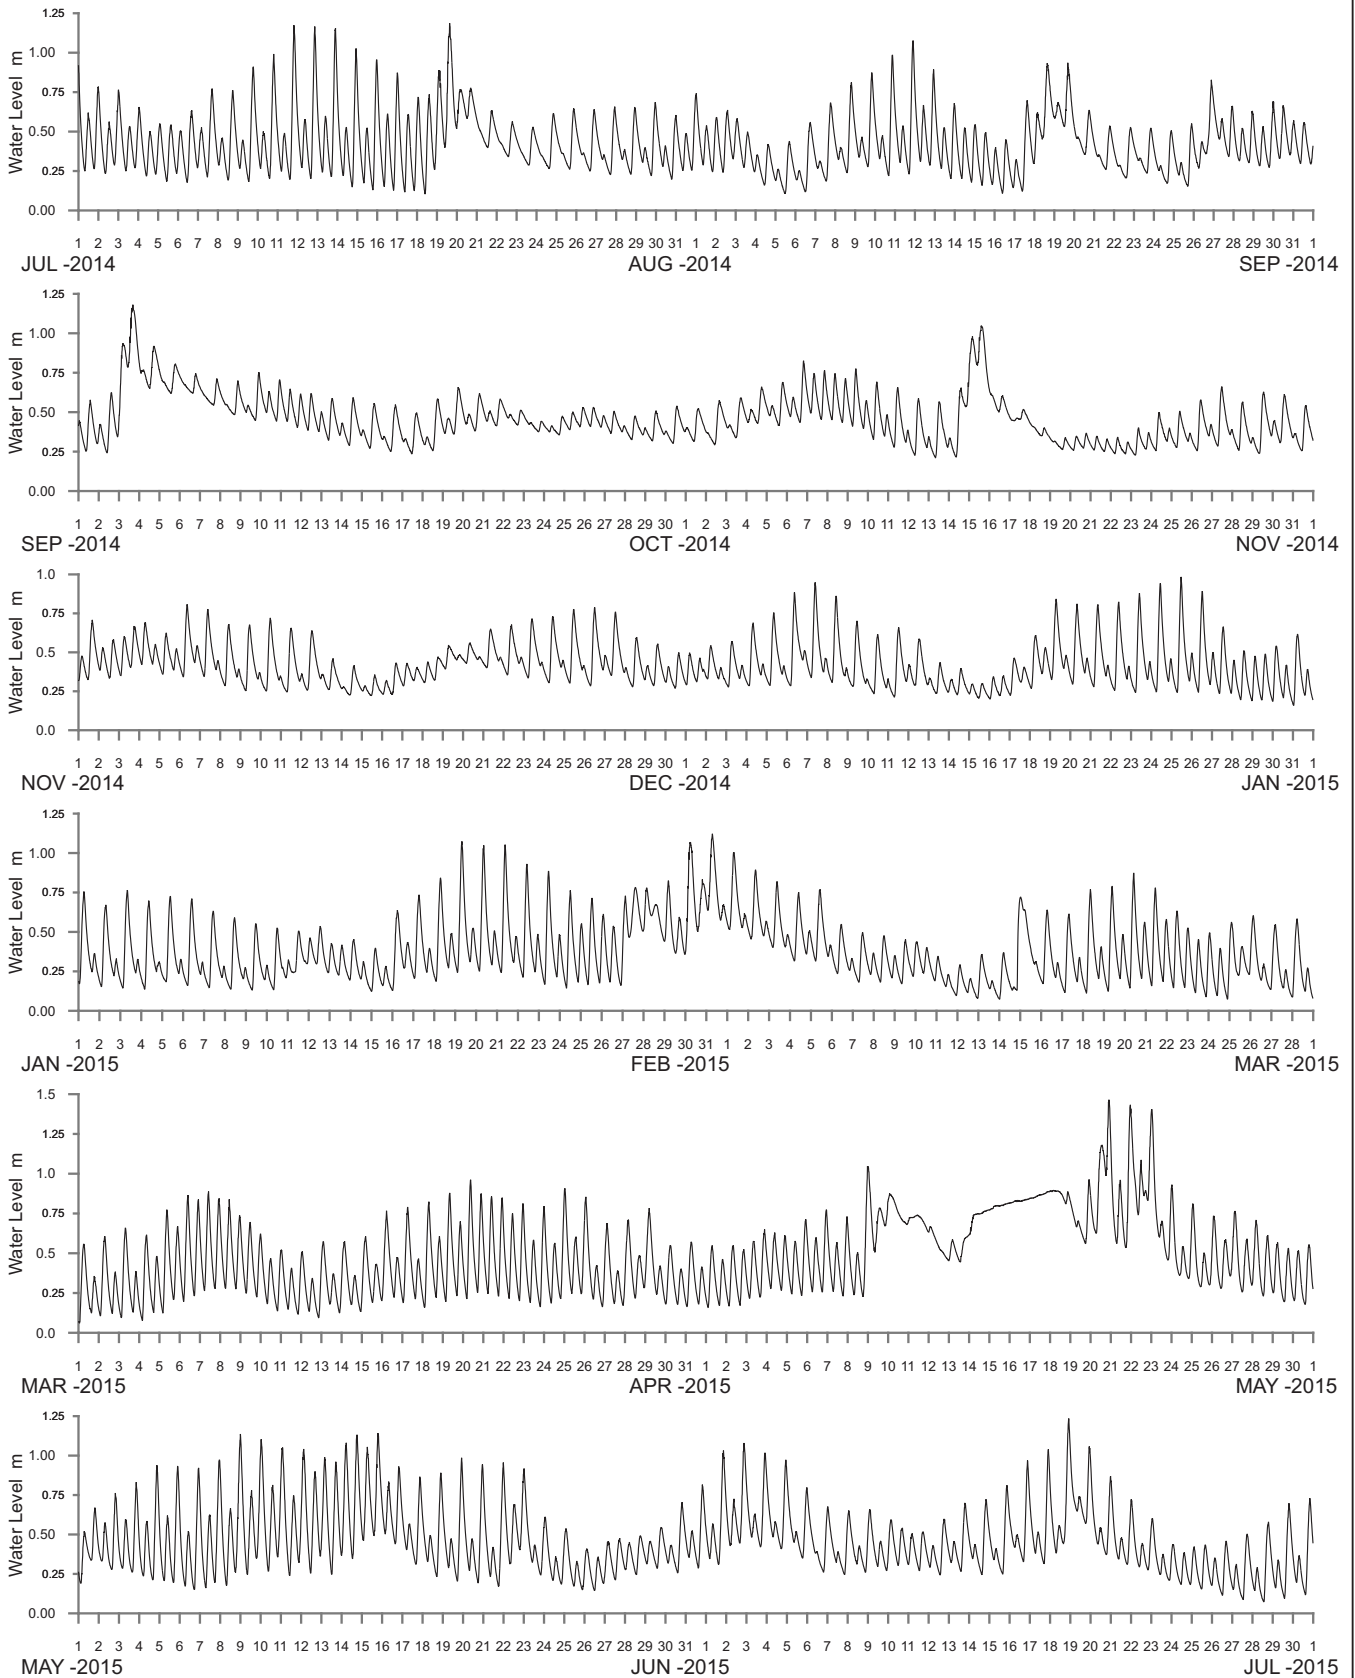
Figure
227

WATER LEVEL REFERENCED TO AUSTRALIAN HEIGHT DATUM

CROOKED CREEK AT GERROA
2014-2015

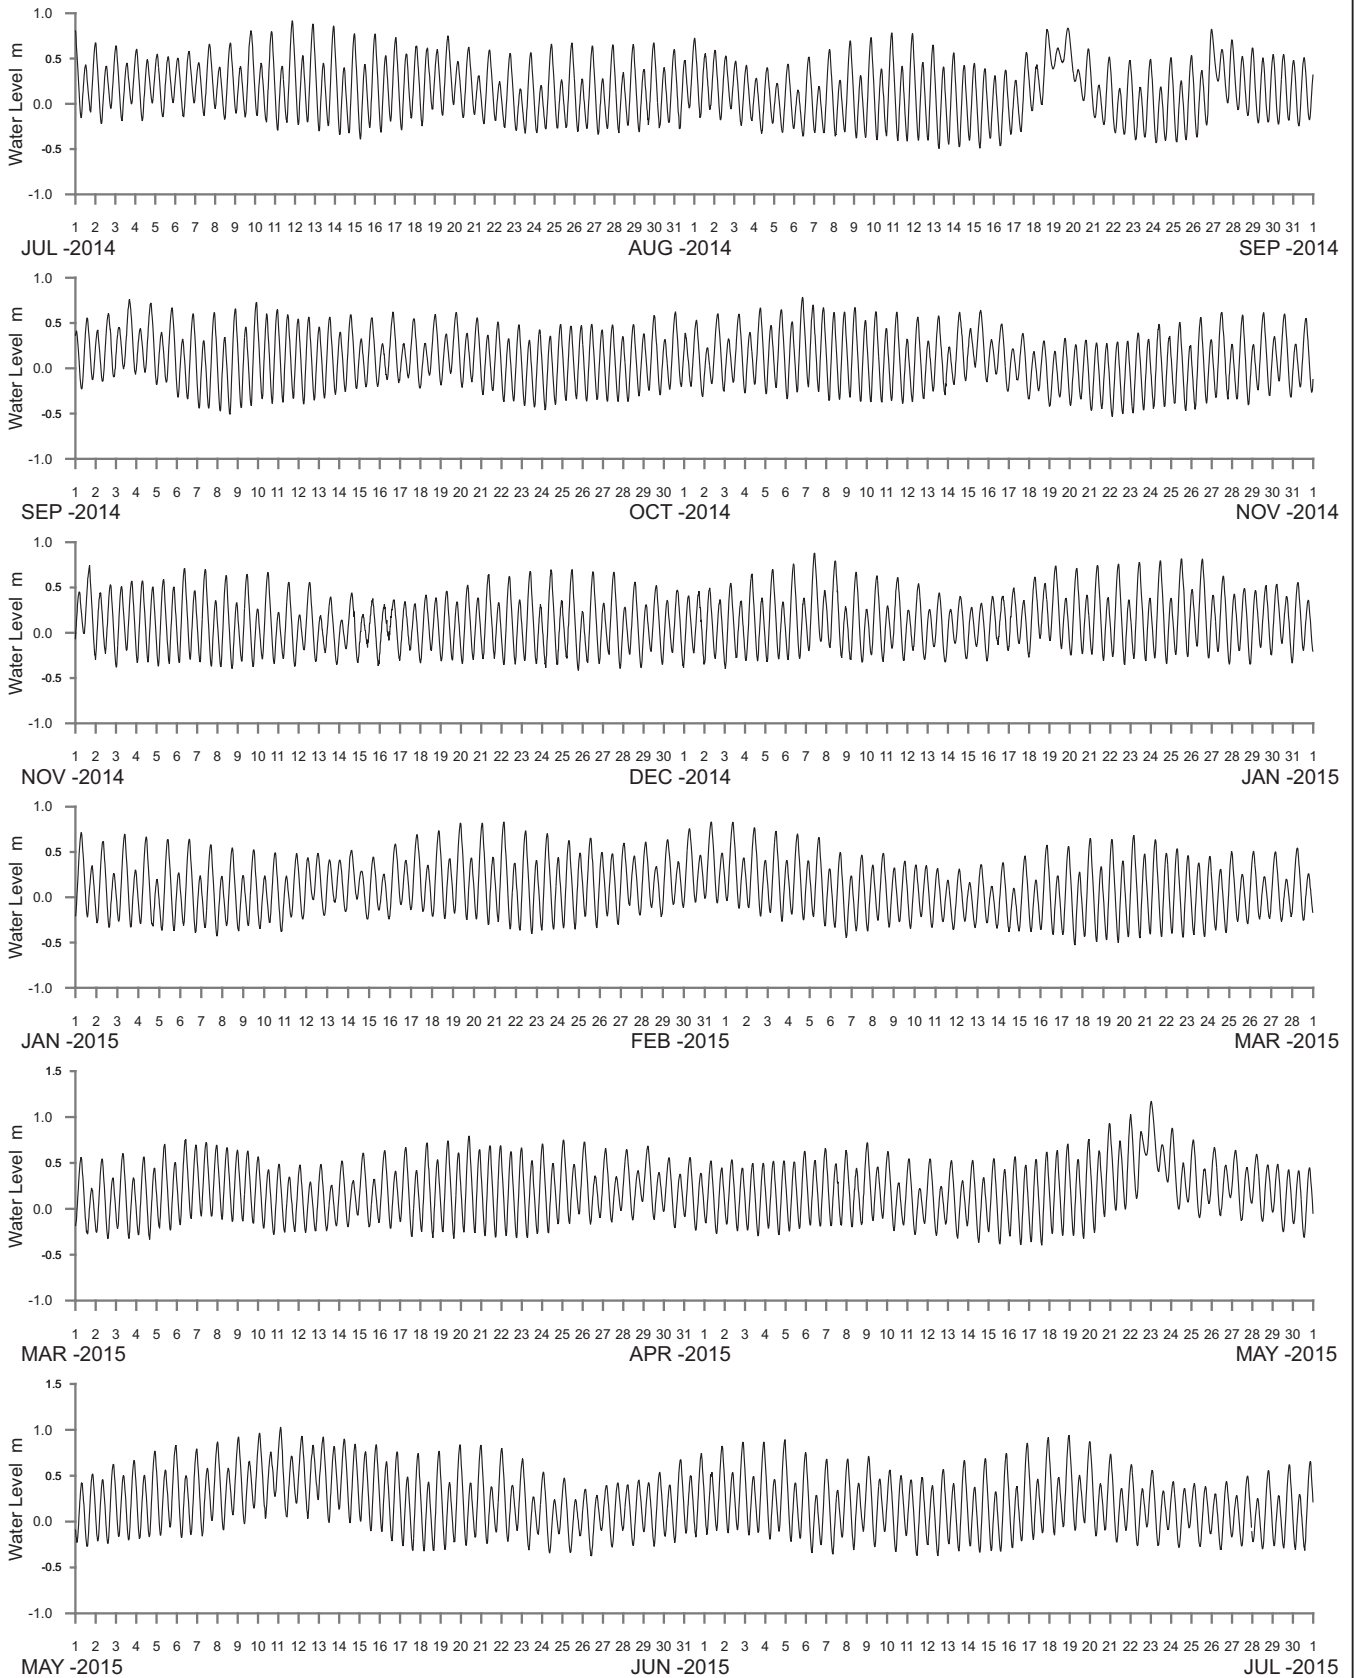
Figure
229

WATER LEVEL REFERENCED TO AUSTRALIAN HEIGHT DATUM

SHOALHAVEN RIVER AT SHOALHAVEN HEADS
2014–2015

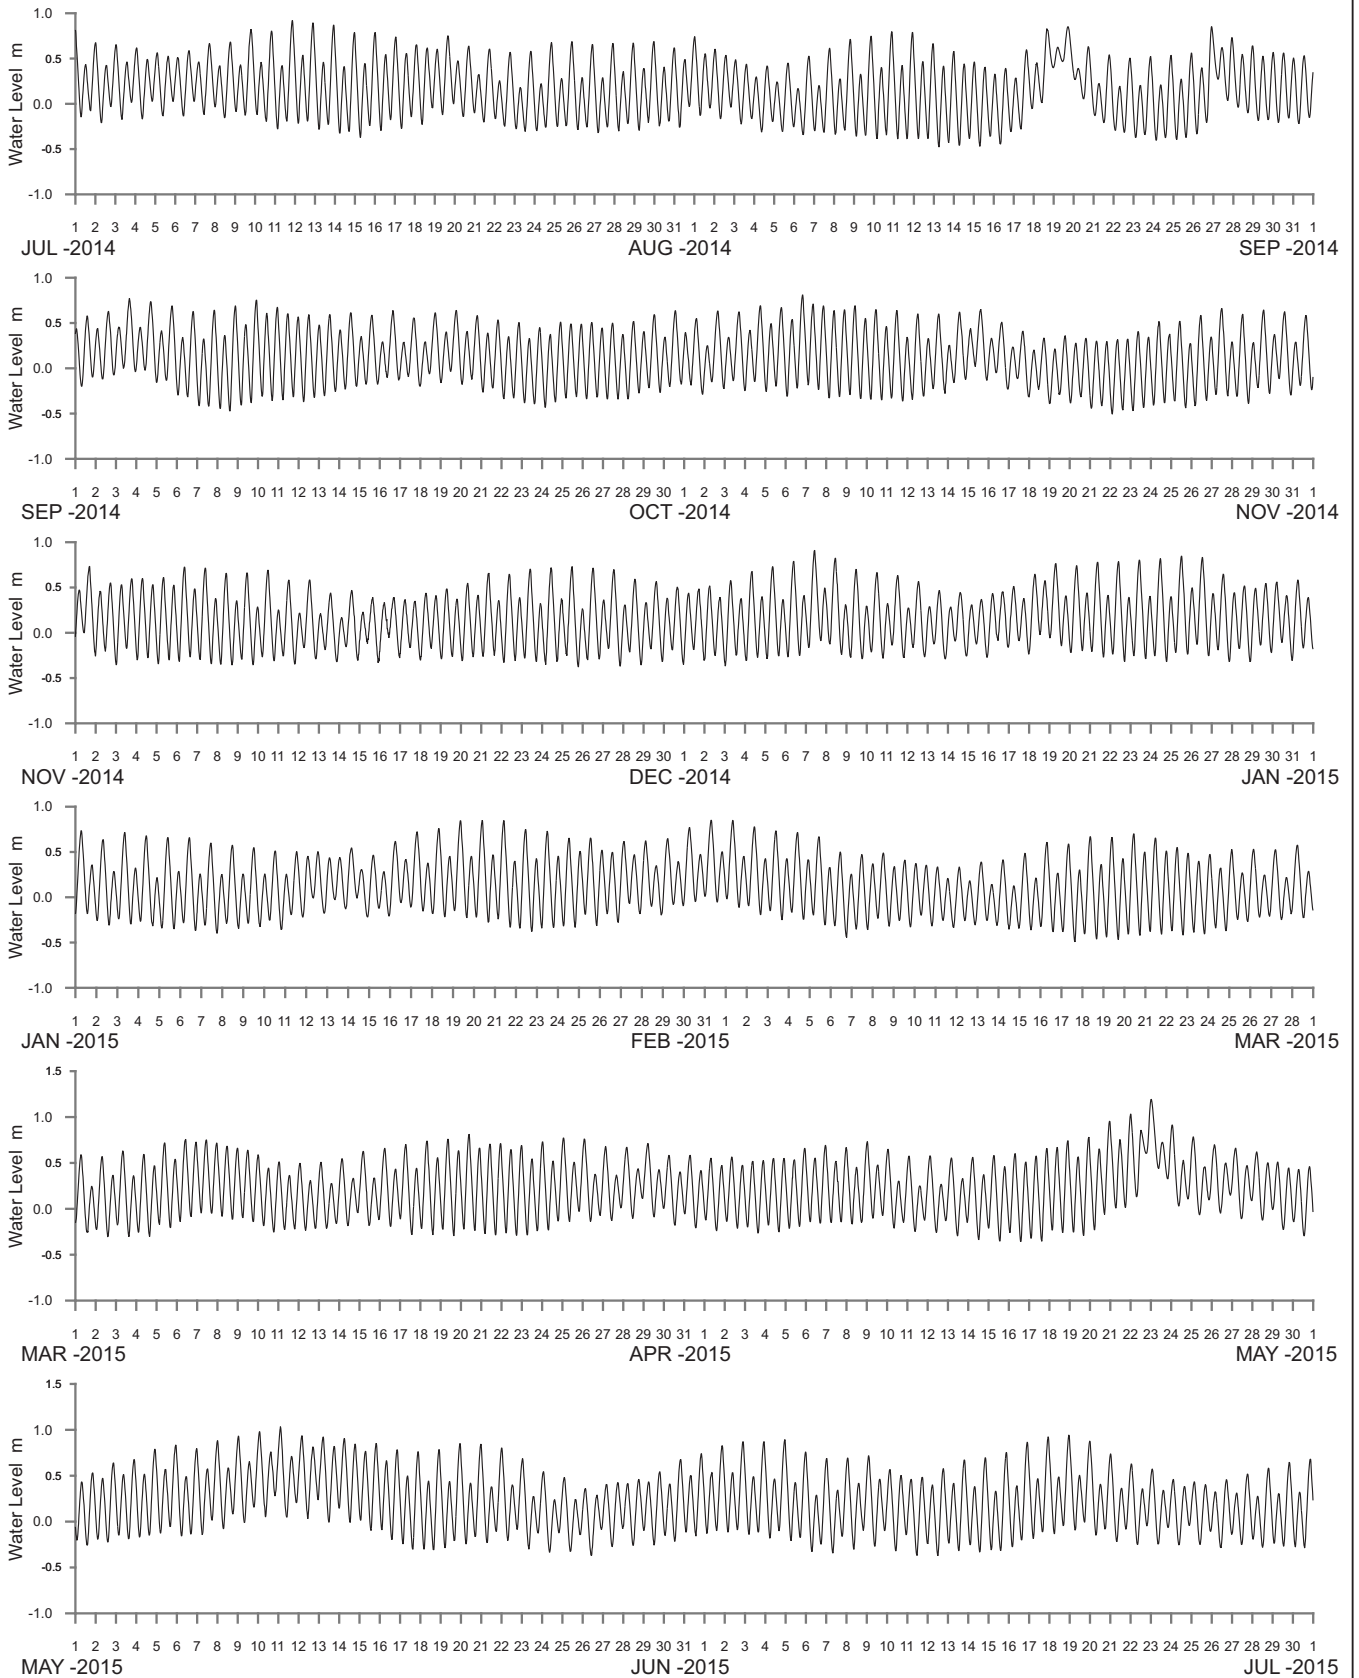
Figure
230

WATER LEVEL REFERENCED TO AUSTRALIAN HEIGHT DATUM

SHOALHAVEN RIVER AT HAY STREET
2014-2015

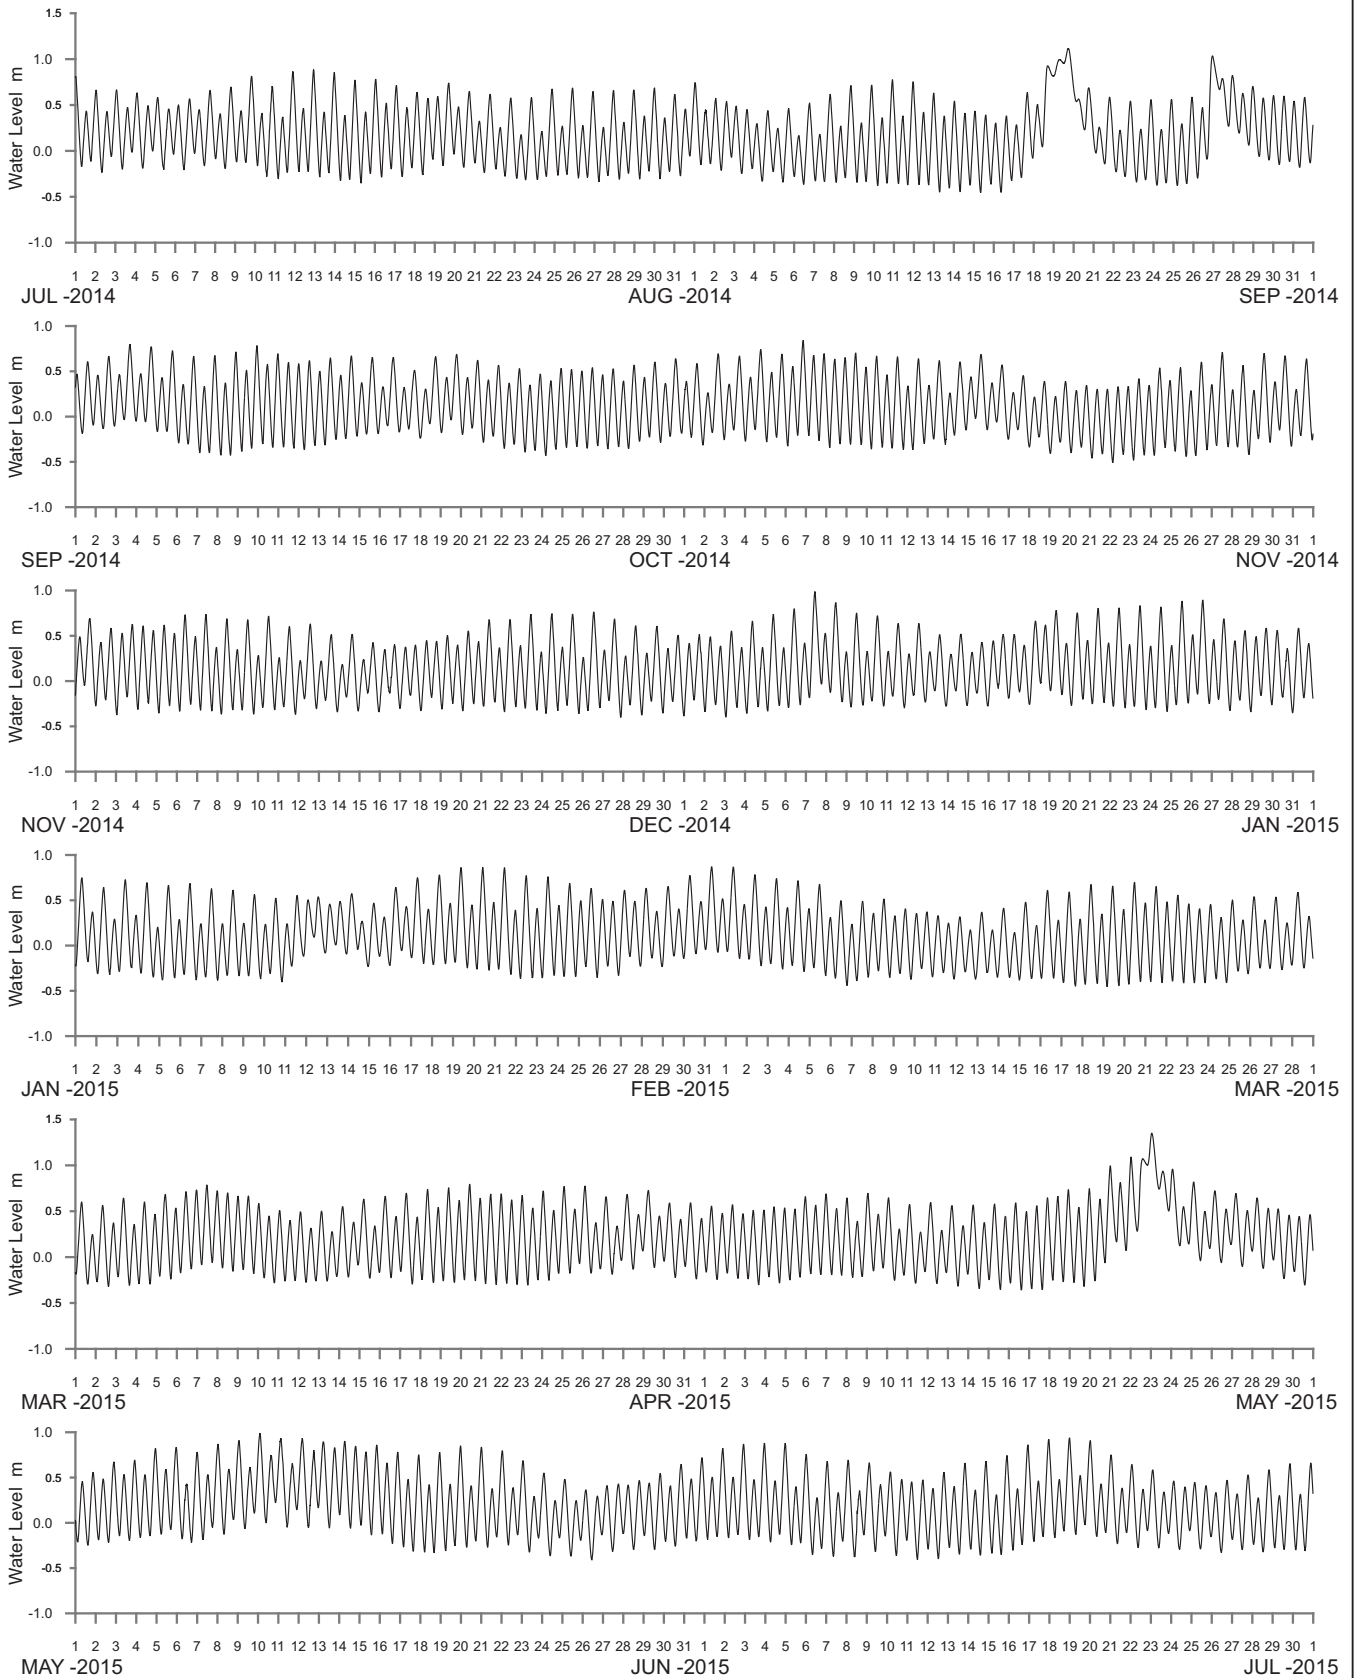
Figure
231

WATER LEVEL REFERENCED TO AUSTRALIAN HEIGHT DATUM

SHOALHAVEN RIVER AT TERARA
2014–2015

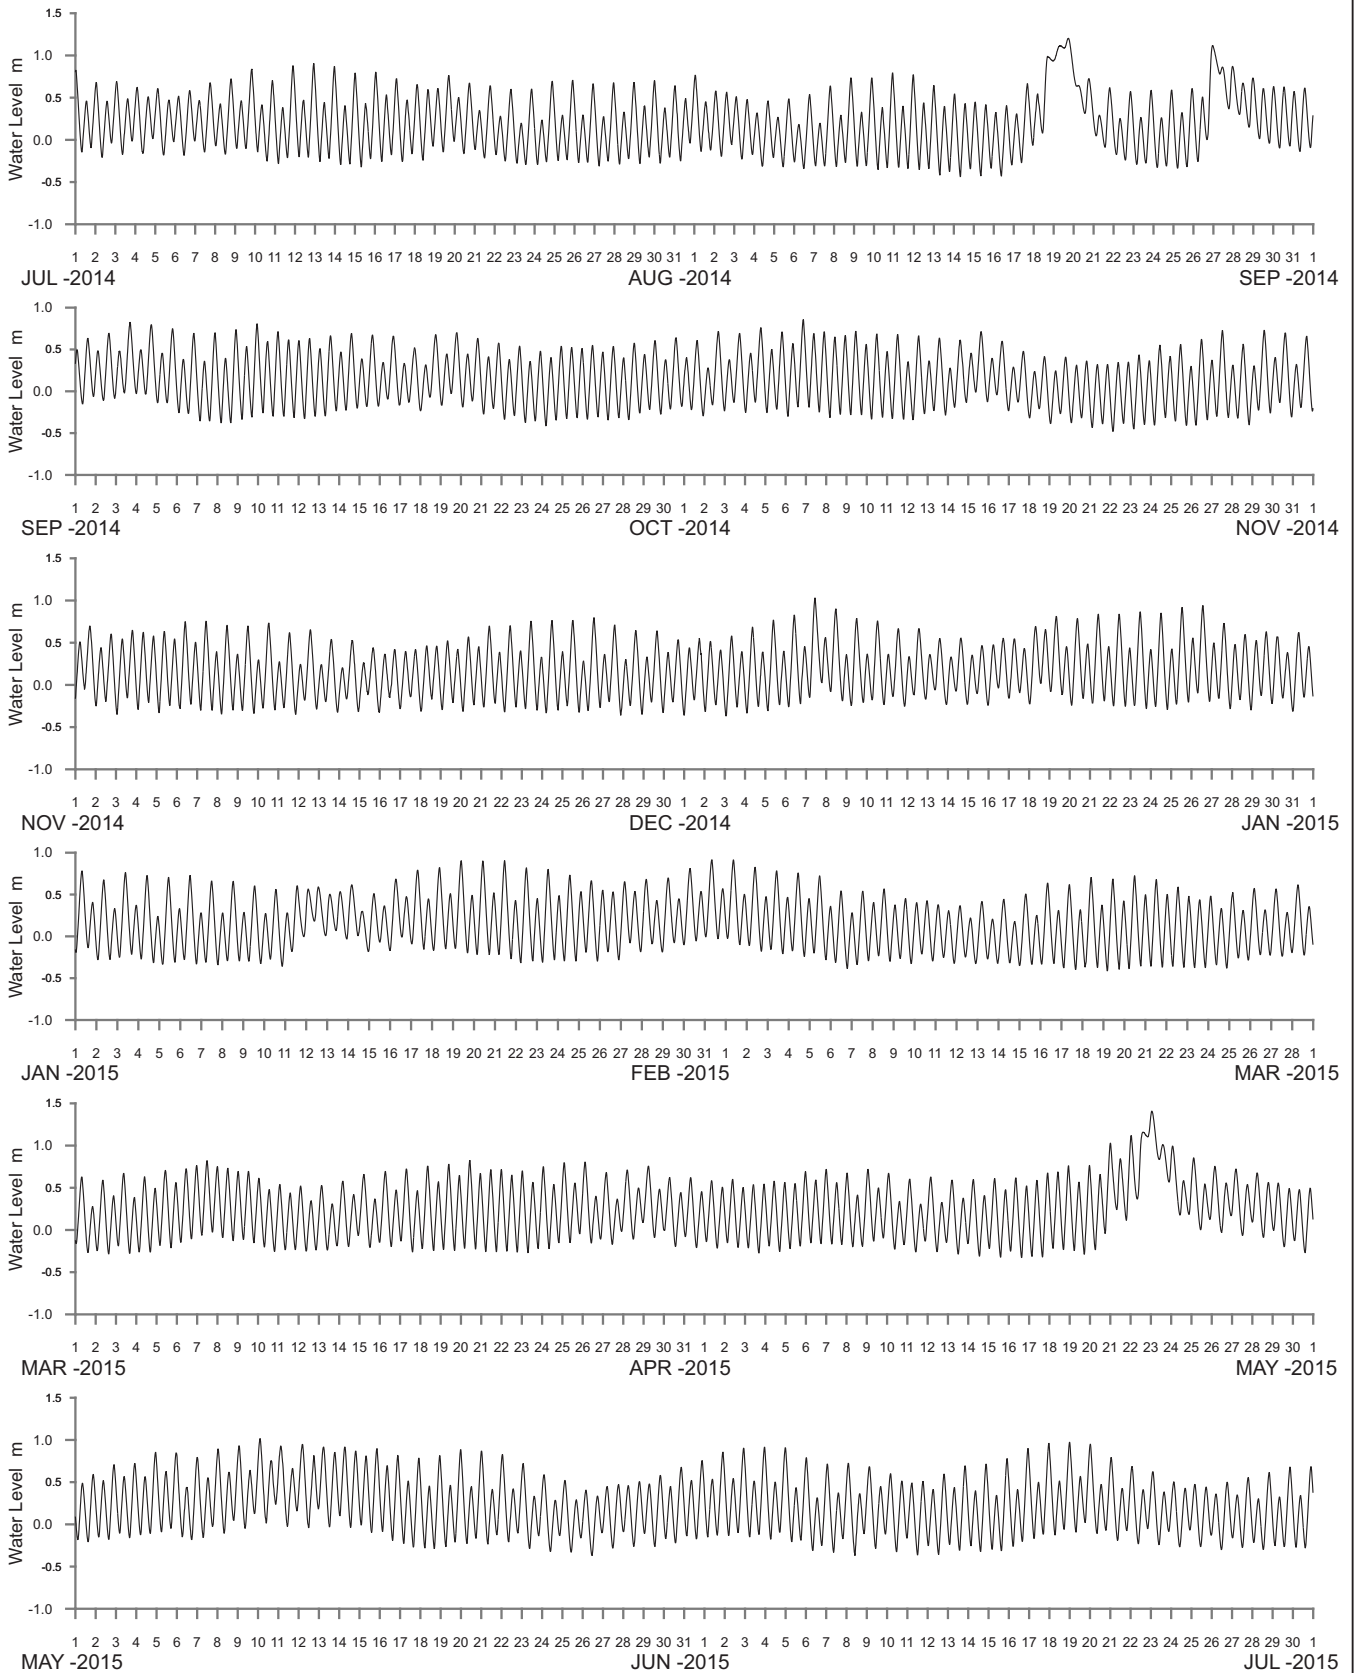
Figure
232

WATER LEVEL REFERENCED TO AUSTRALIAN HEIGHT DATUM

SHOALHAVEN RIVER AT NOWRA BRIDGE
2014–2015

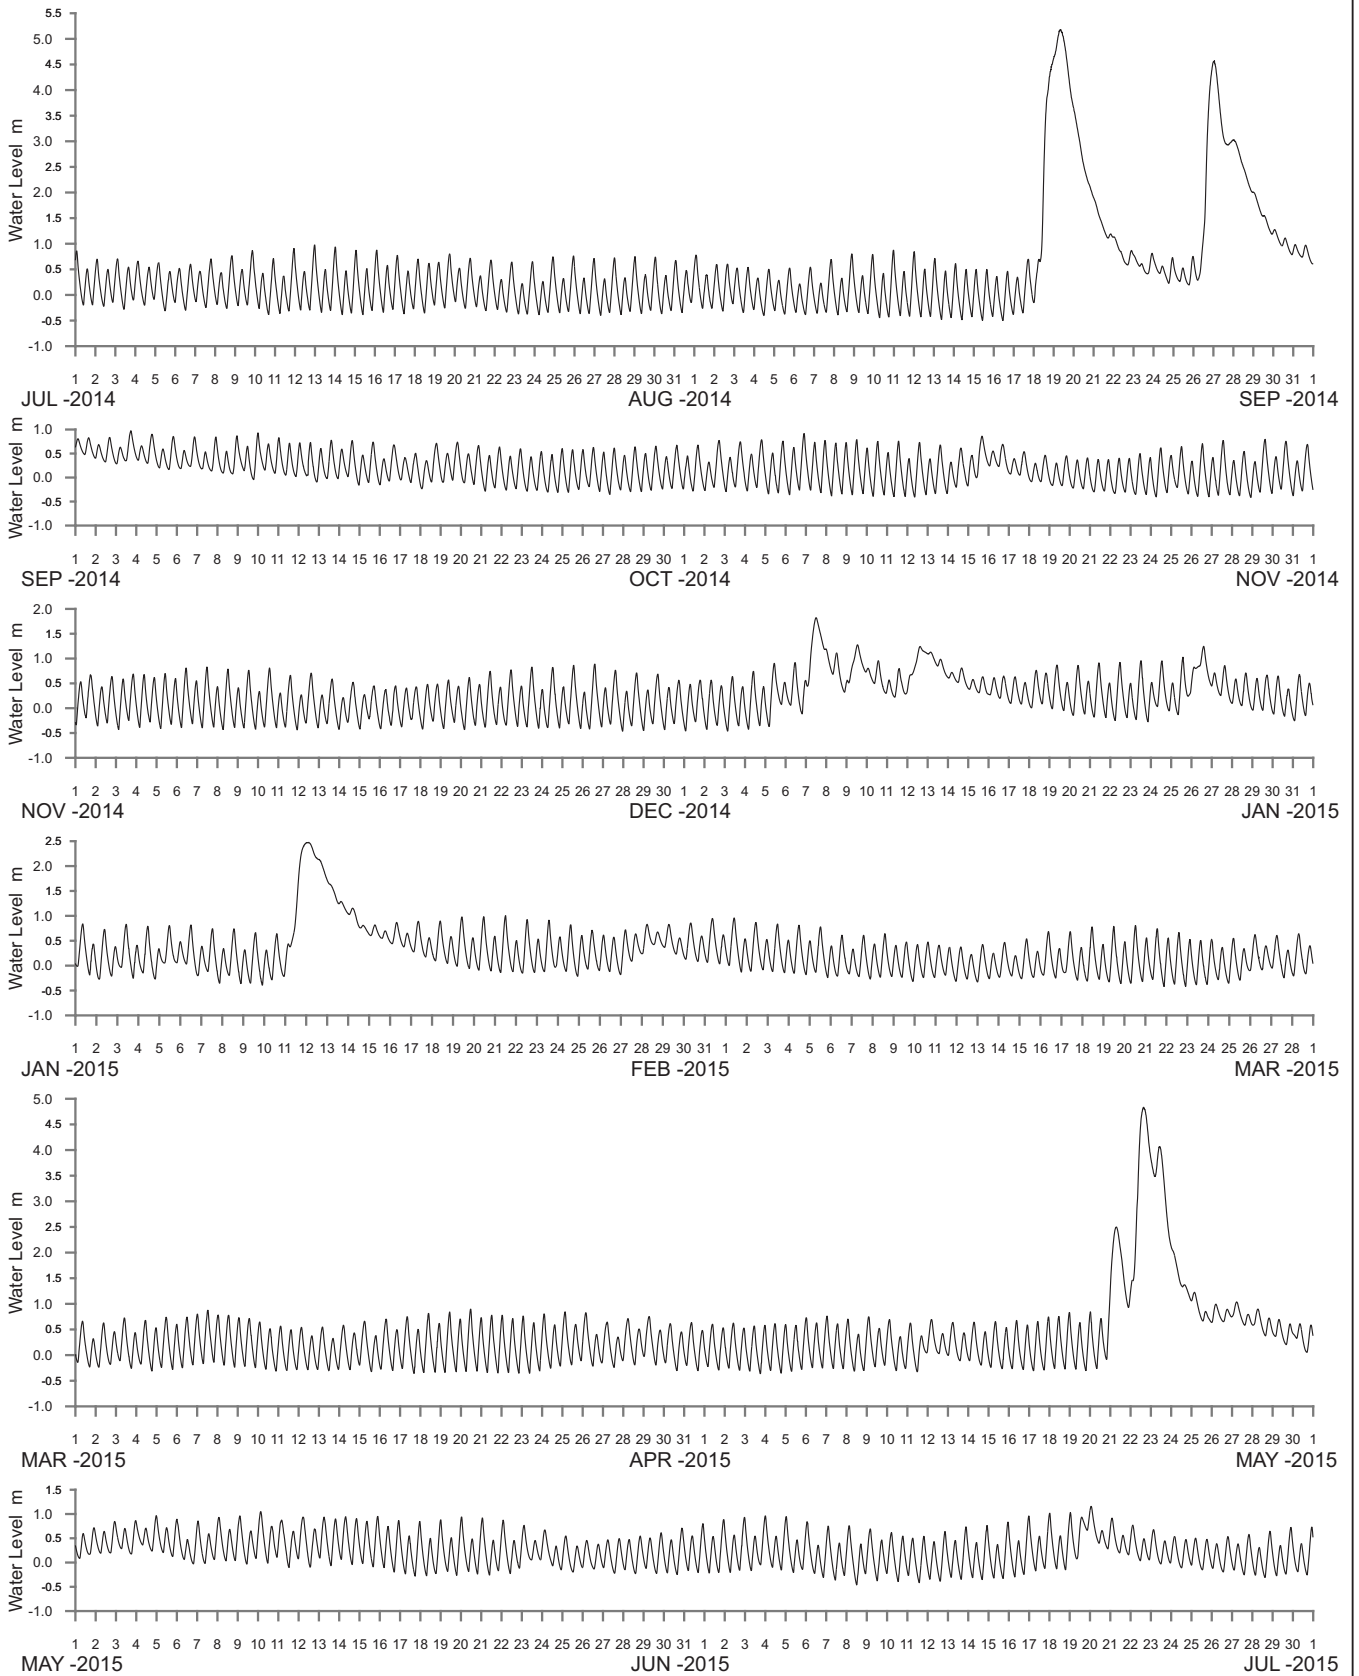
Figure
233

WATER LEVEL REFERENCED TO AUSTRALIAN HEIGHT DATUM

SHOALHAVEN RIVER AT GRADYS CARAVAN PARK
2014-2015
