Public Works
Manly Hydraulics Laboratory

HEWITTS CREEK AT HEWITTS CREEK UPSTREAM
2014–2015

MHL
Report 2383

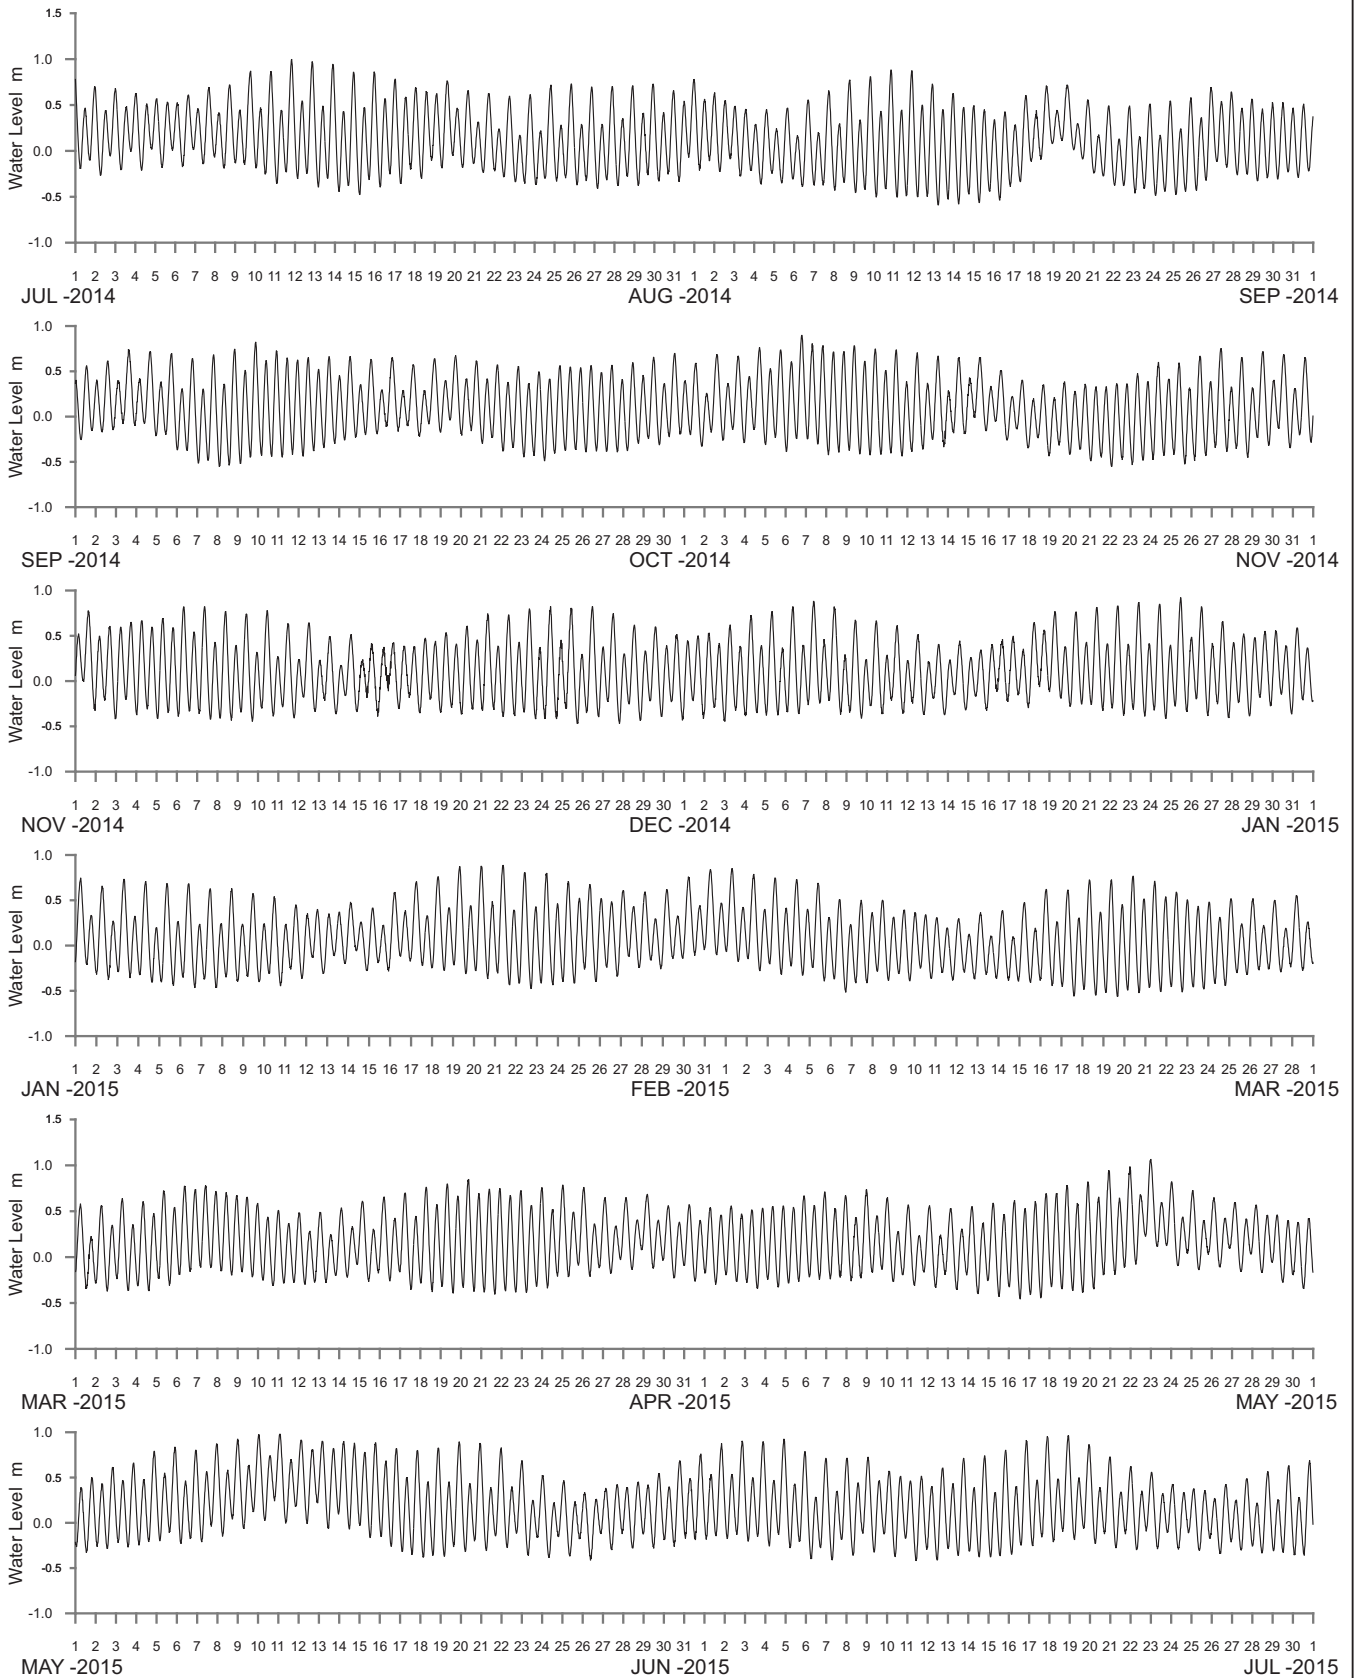
Figure
234

WATER LEVEL REFERENCED TO AUSTRALIAN HEIGHT DATUM

CROOKHAVEN RIVER AT GREENWELL POINT
2014–2015

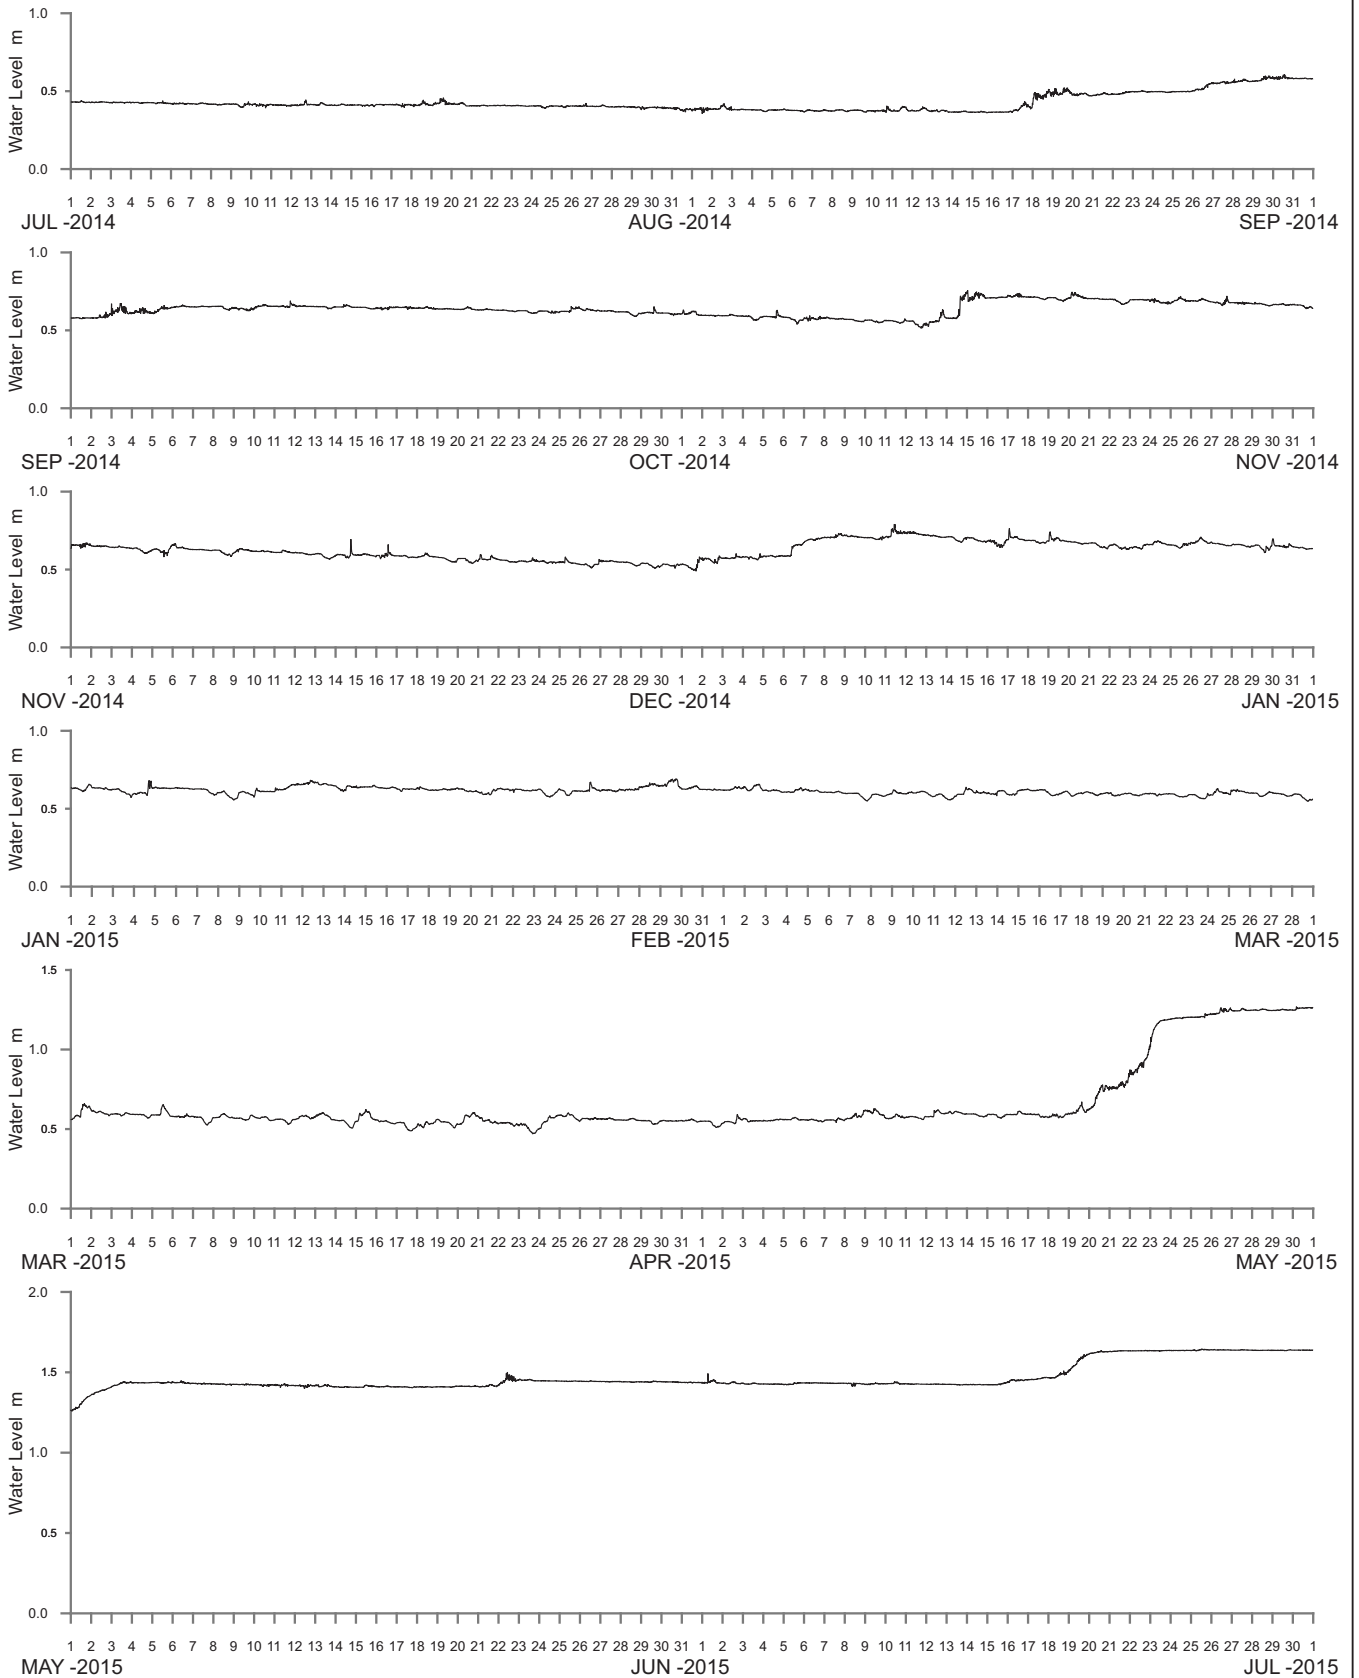
Figure
235

WATER LEVEL REFERENCED TO AUSTRALIAN HEIGHT DATUM

WOLLUMBOOLA LAKE AT WOLLUMBOOLA
2014-2015

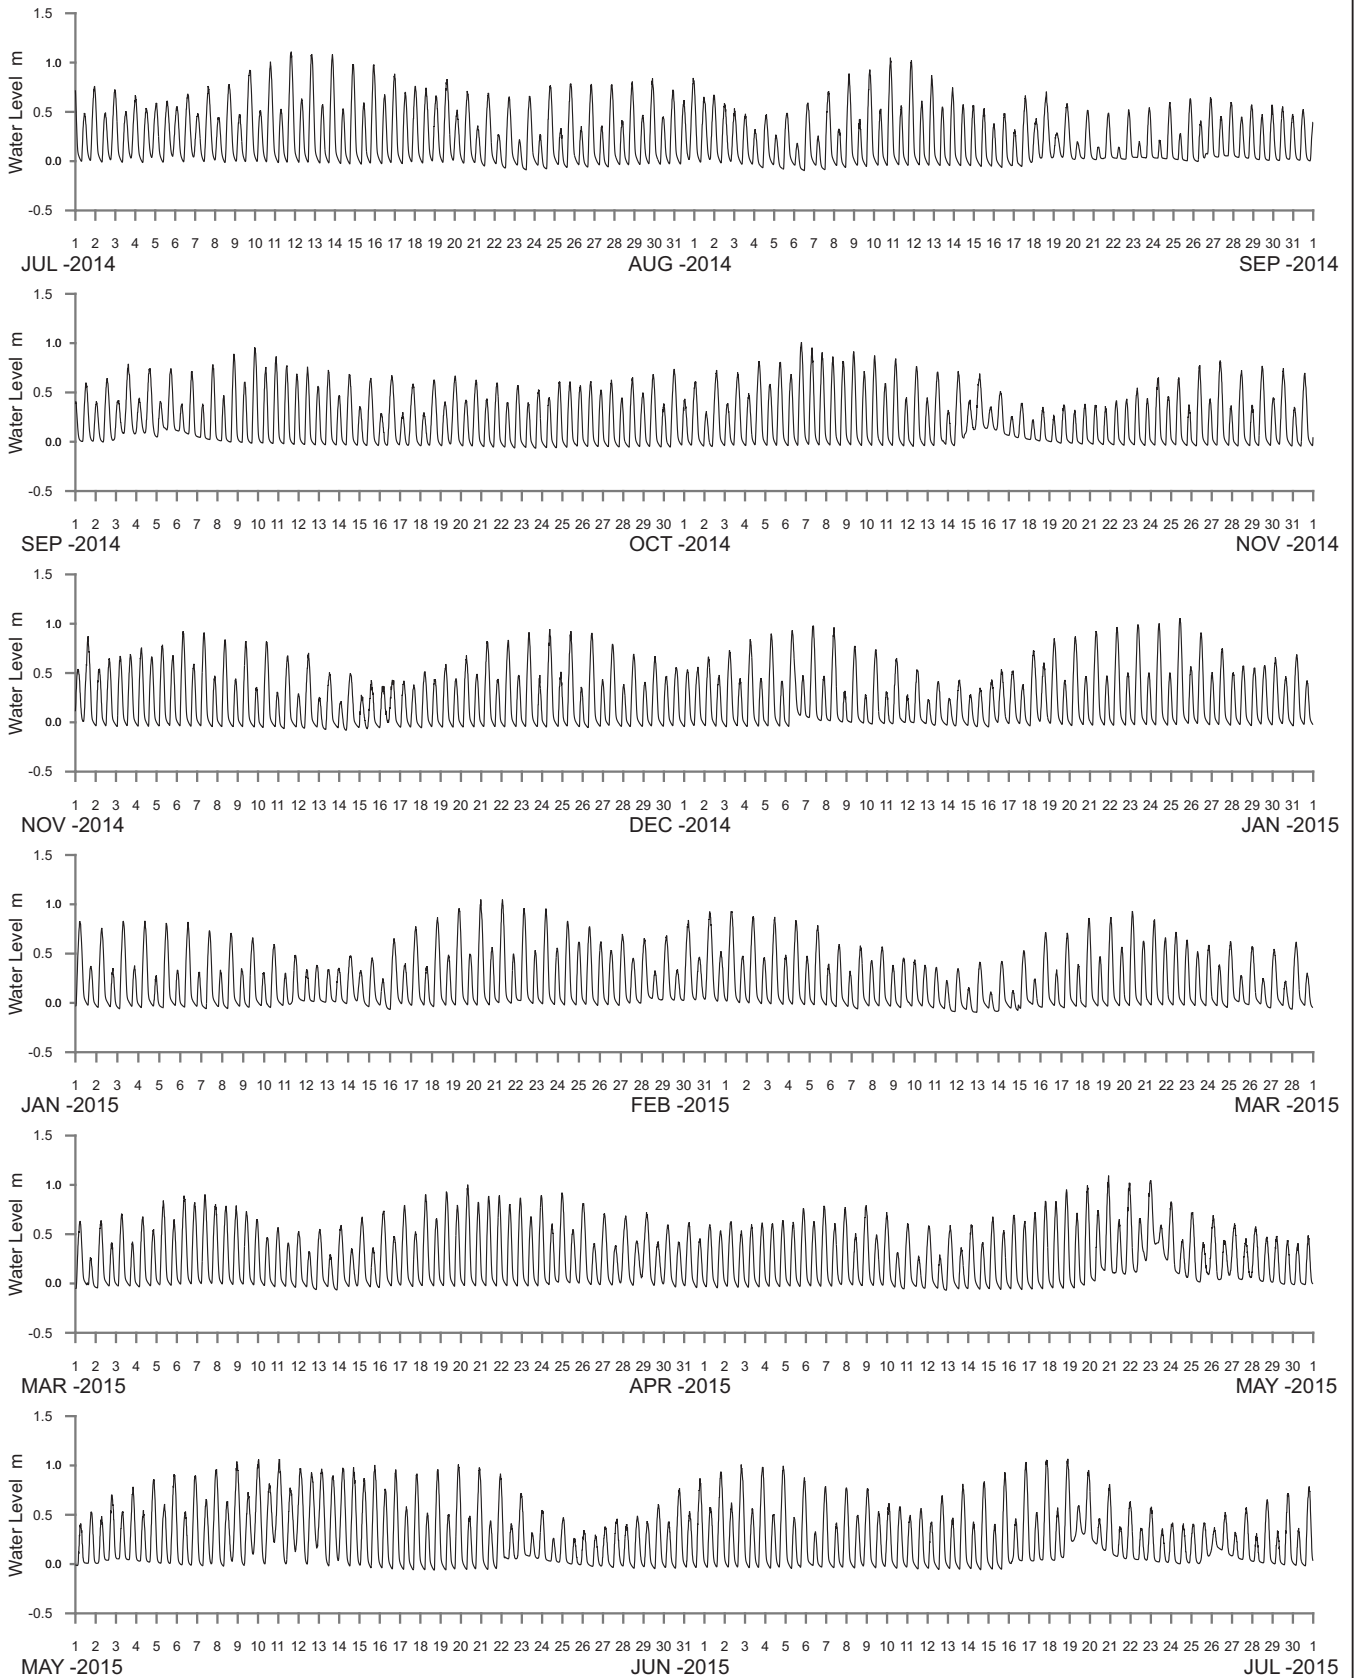
Figure
237

WATER LEVEL REFERENCED TO AUSTRALIAN HEIGHT DATUM

CURRARONG CREEK AT CURRARONG CREEK
2014–2015

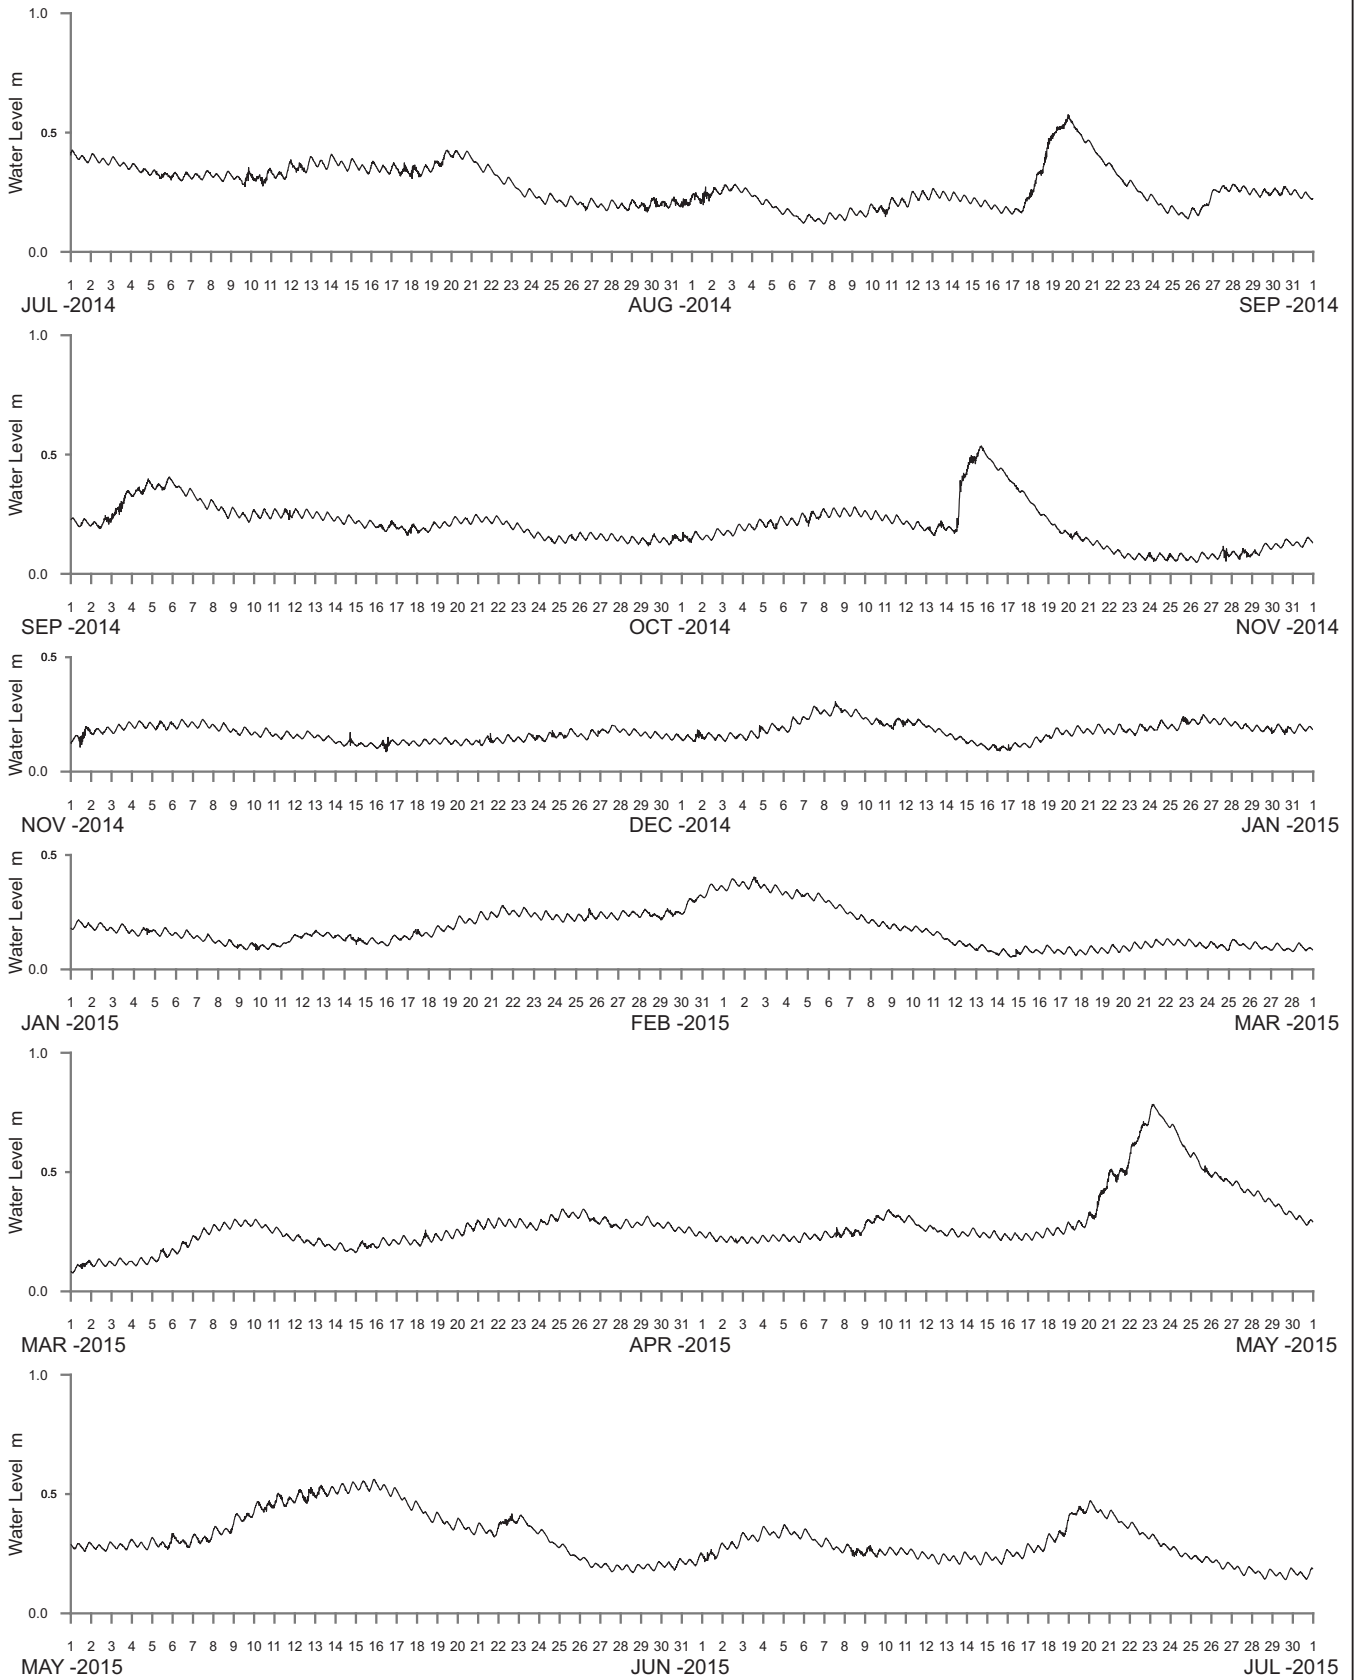
Figure
238

WATER LEVEL REFERENCED TO AUSTRALIAN HEIGHT DATUM

ST GEORGES BASIN AT ISLAND POINT
2014–2015

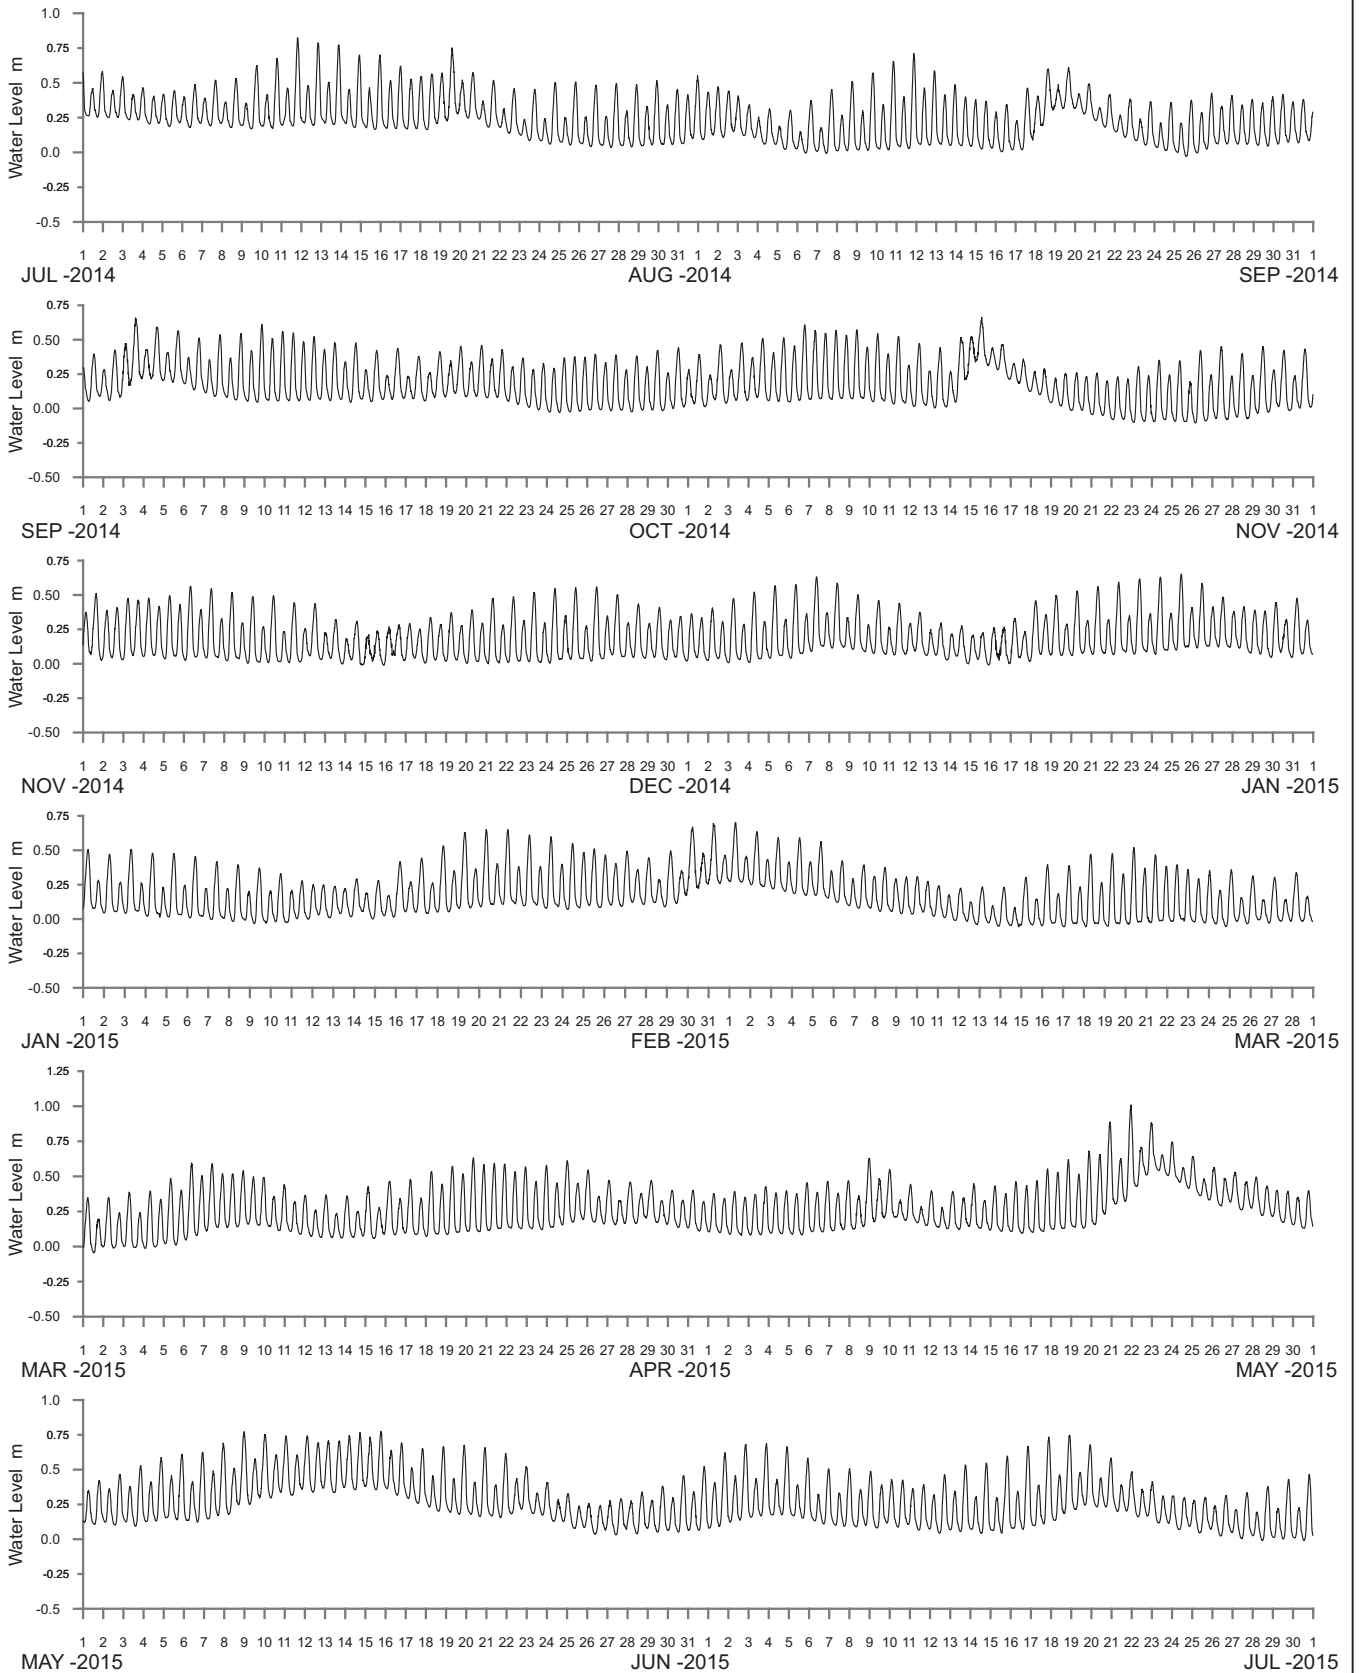
Figure
239

WATER LEVEL REFERENCED TO AUSTRALIAN HEIGHT DATUM

SUSSEX INLET AT SUSSEX INLET
2014–2015

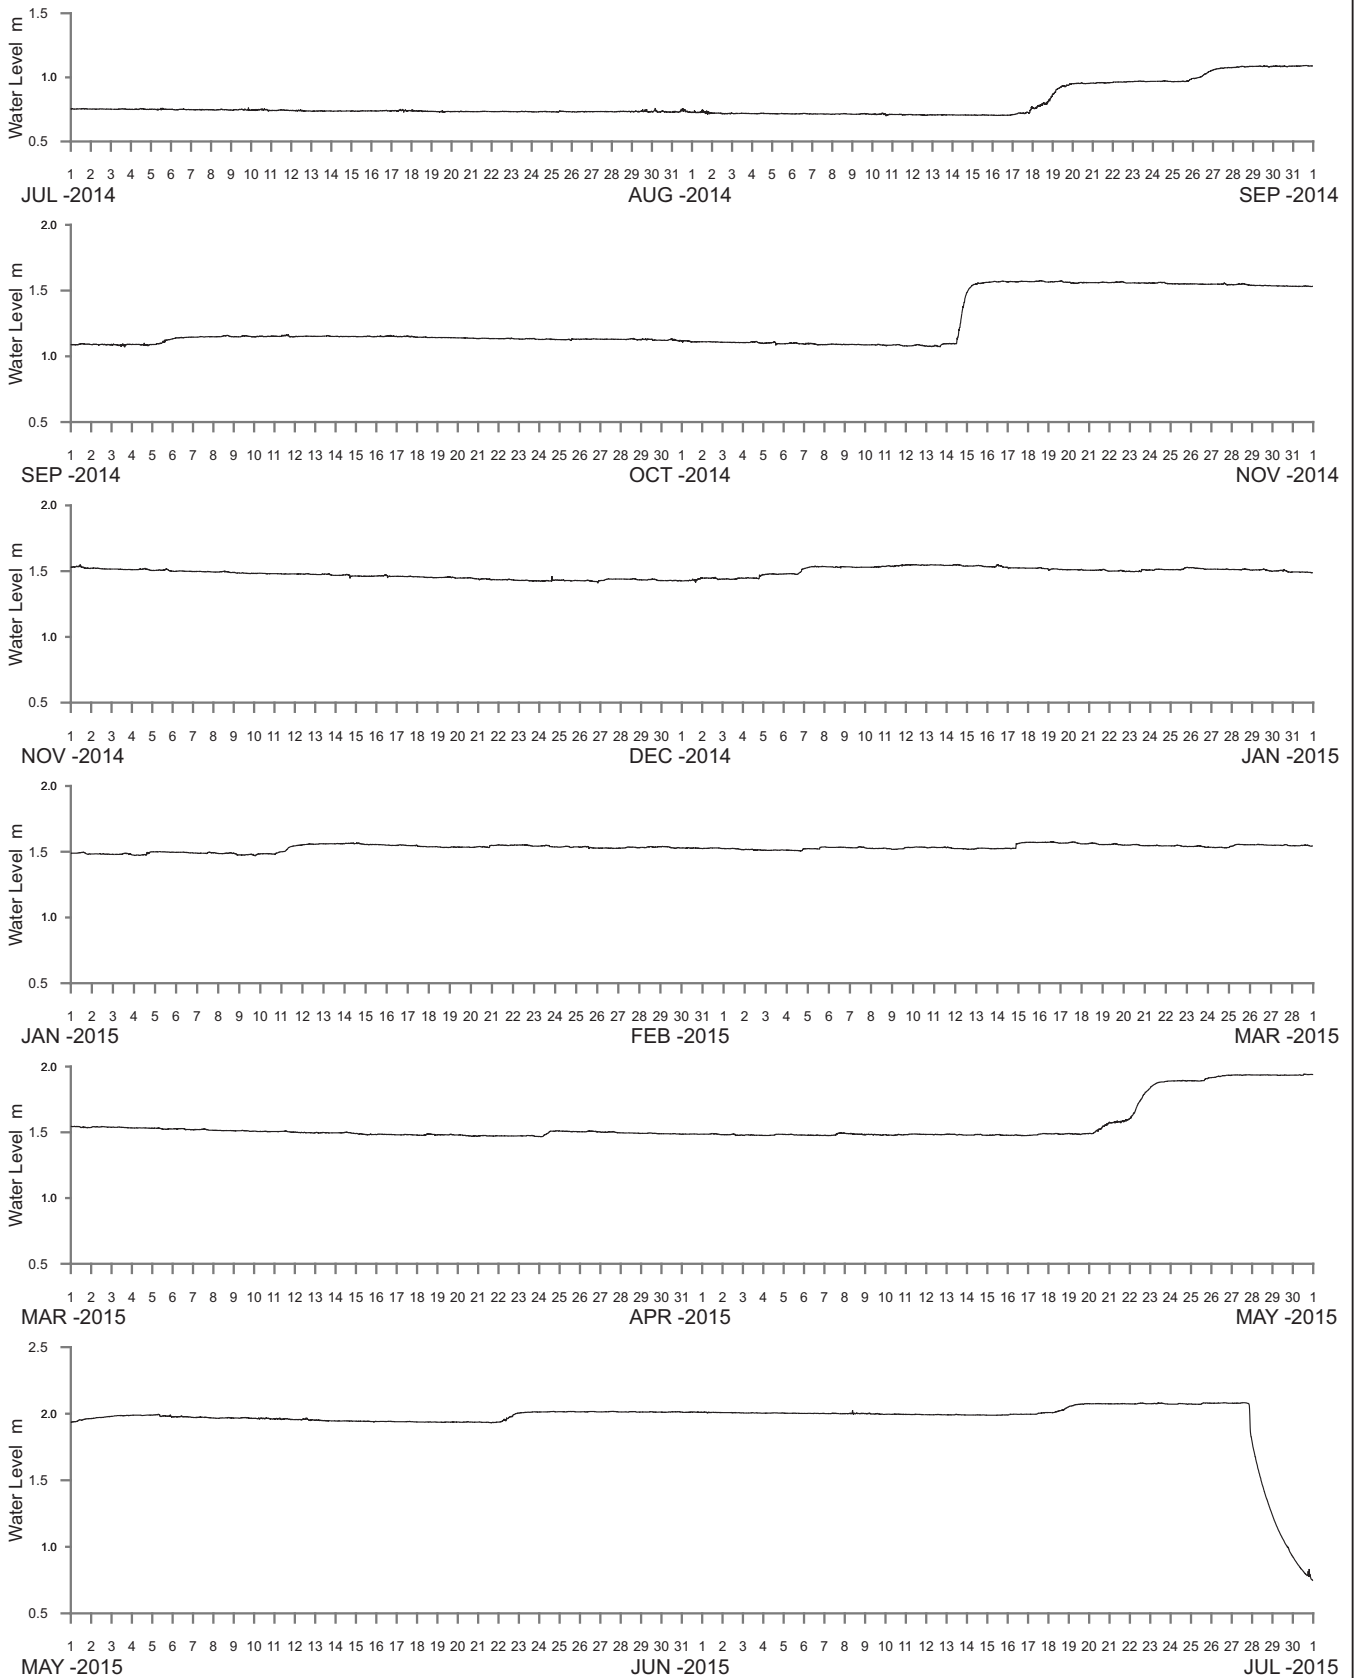
Figure
240

WATER LEVEL REFERENCED TO AUSTRALIAN HEIGHT DATUM

SWAN LAKE AT SWAN LAKE
2014-2015

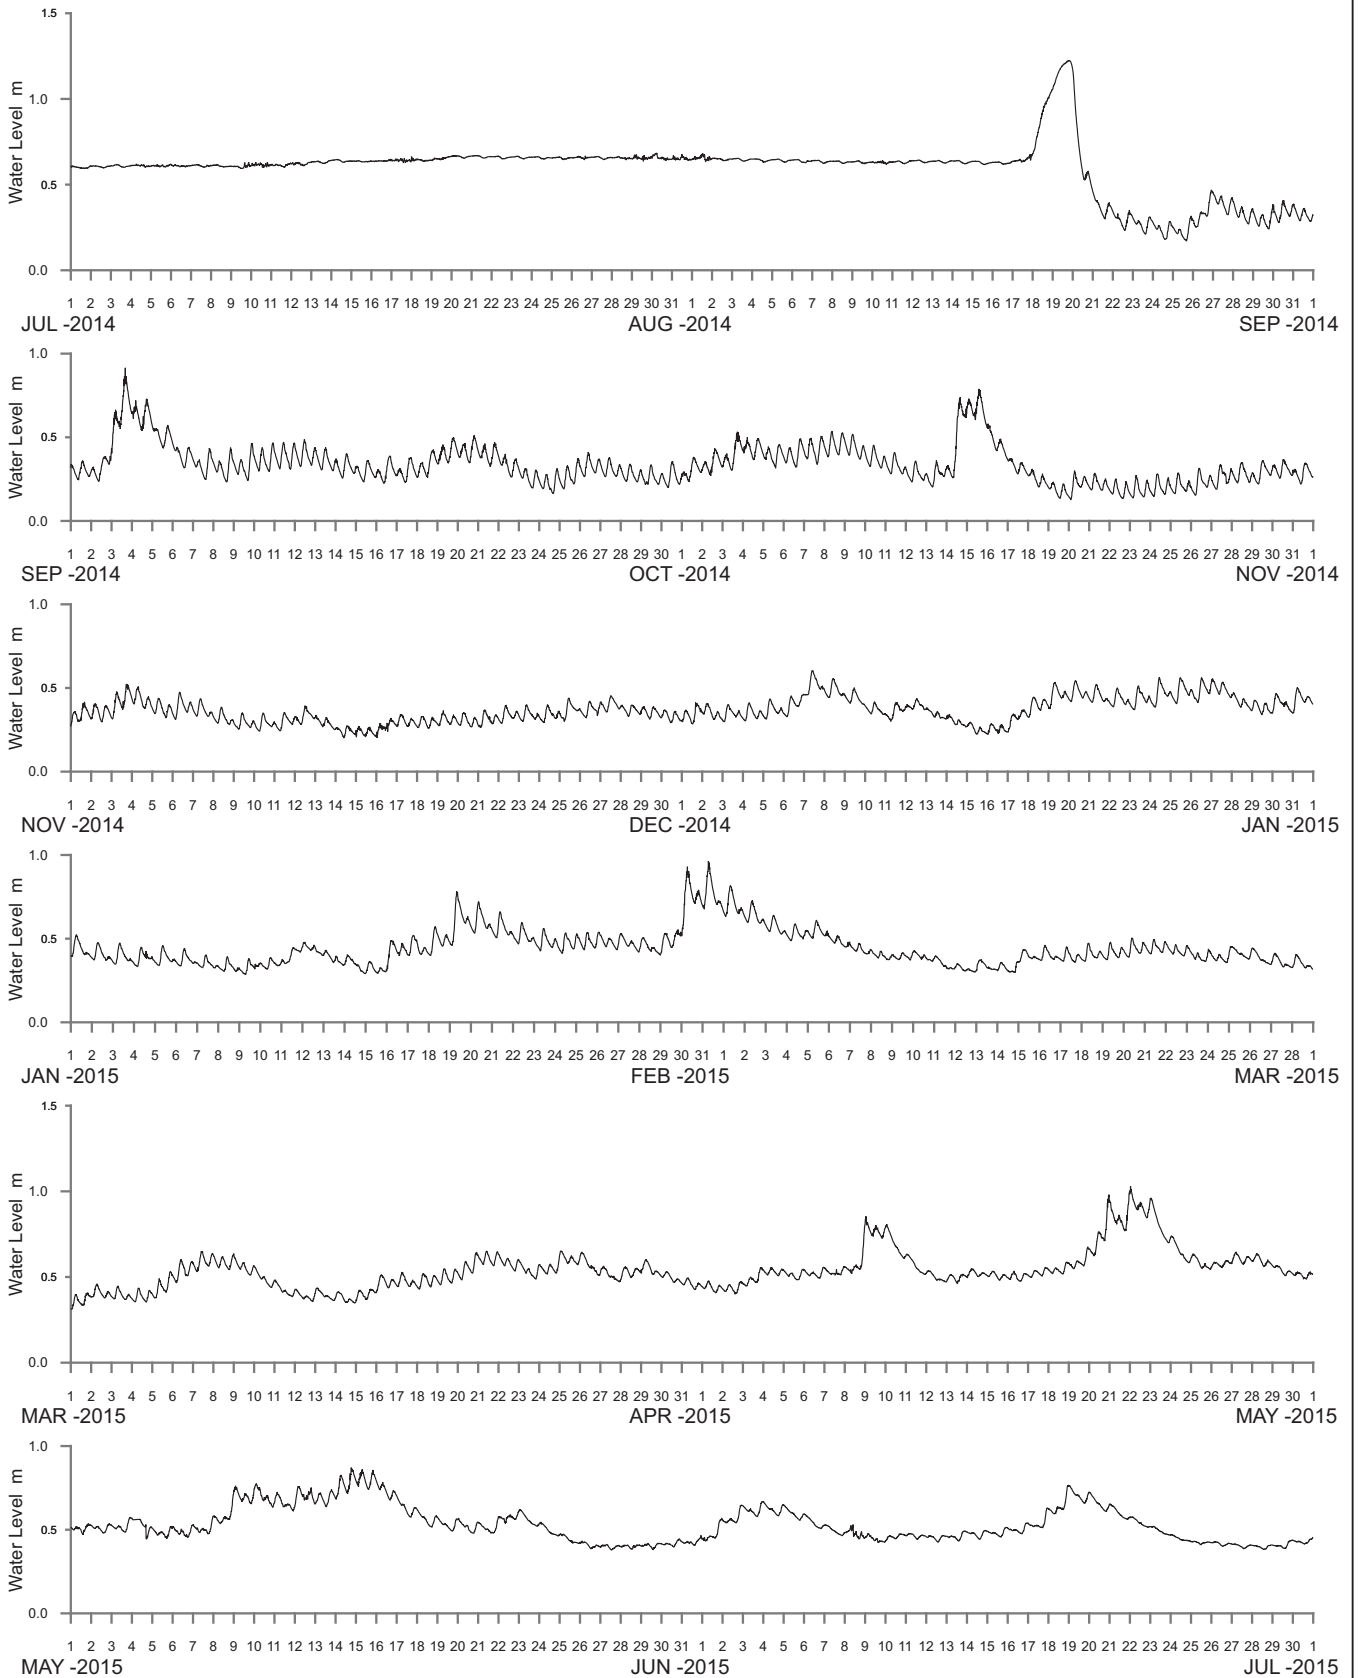
Figure
242

WATER LEVEL REFERENCED TO AUSTRALIAN HEIGHT DATUM

LAKE CONJOLA AT LAKE CONJOLA
2014-2015

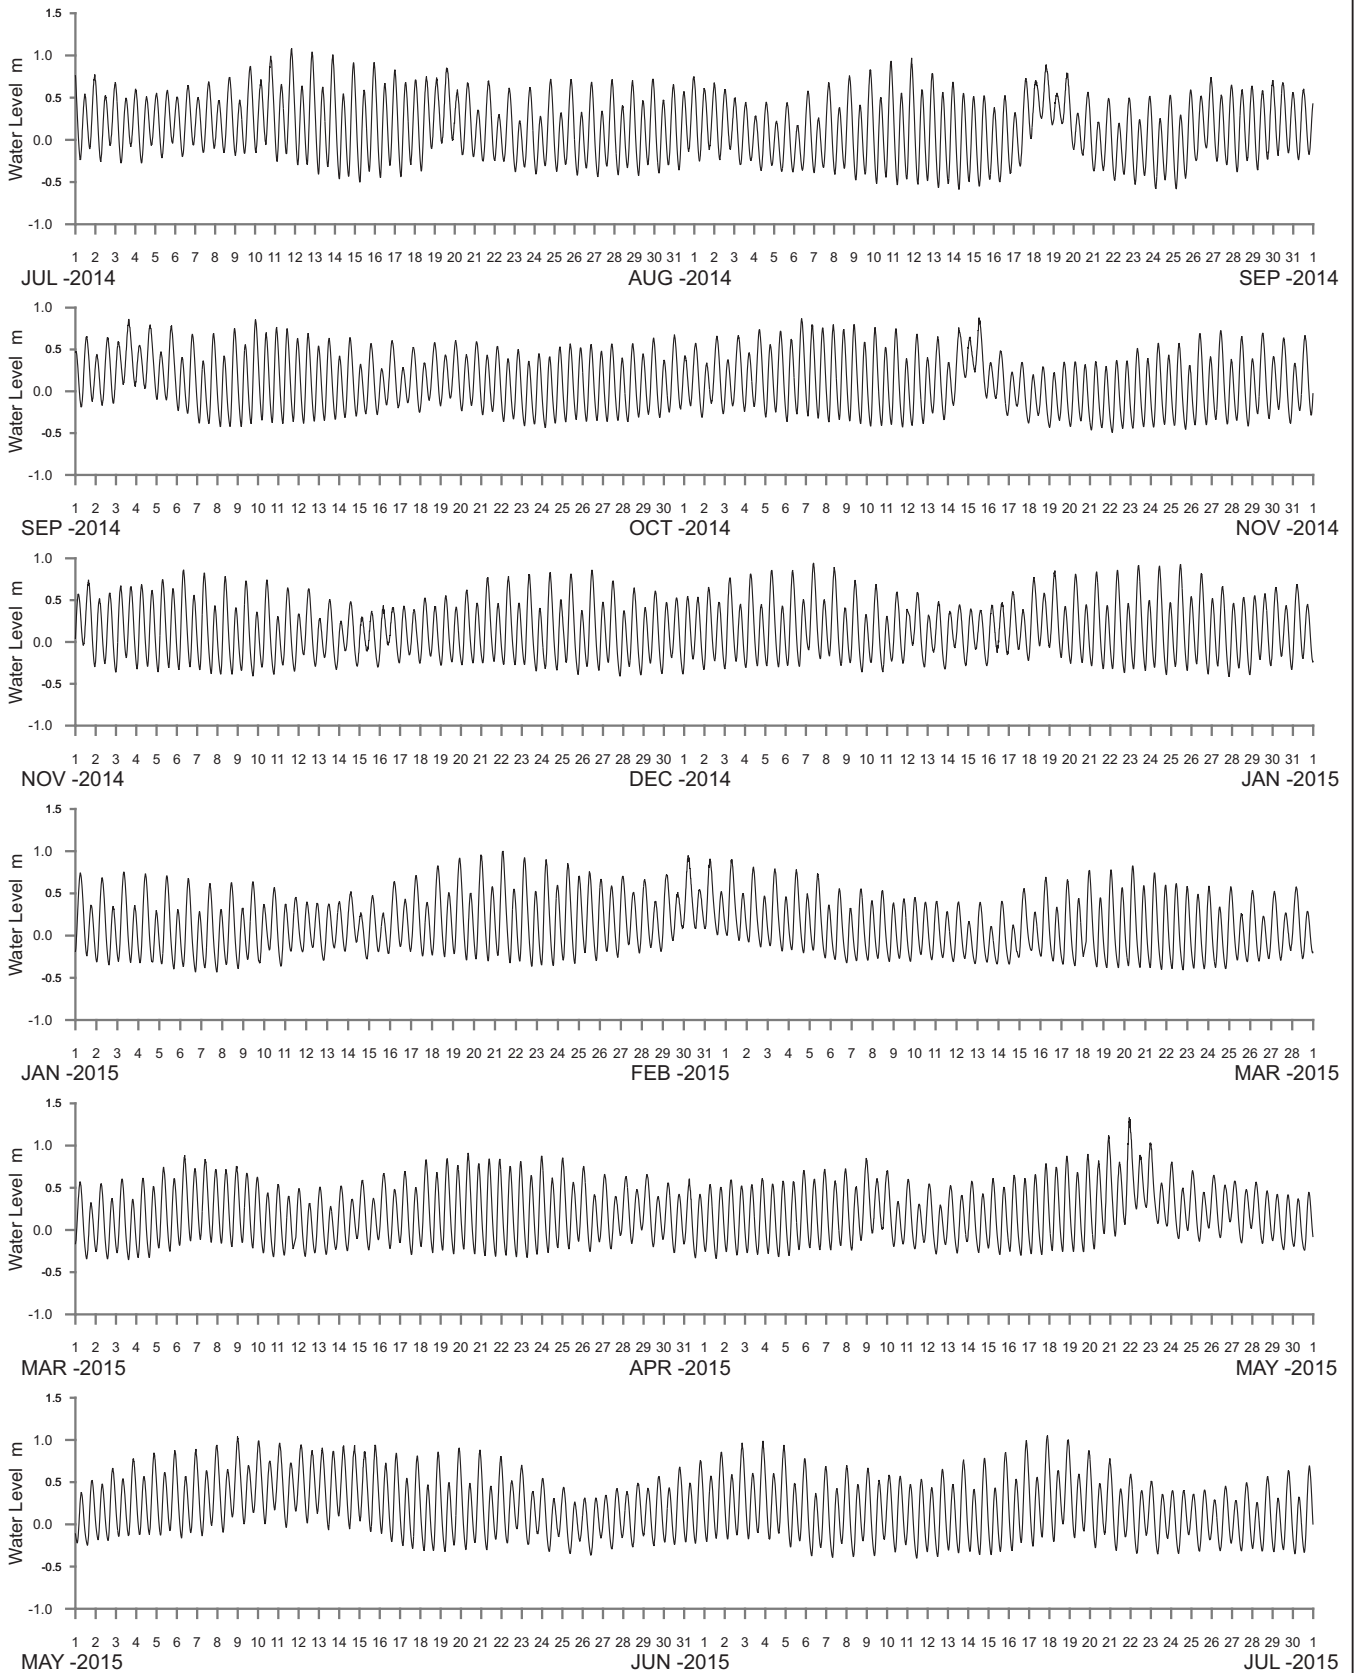
Figure
243

WATER LEVEL REFERENCED TO AUSTRALIAN HEIGHT DATUM

NARRAWALLEE CREEK AT NARRAWALLEE
2014–2015

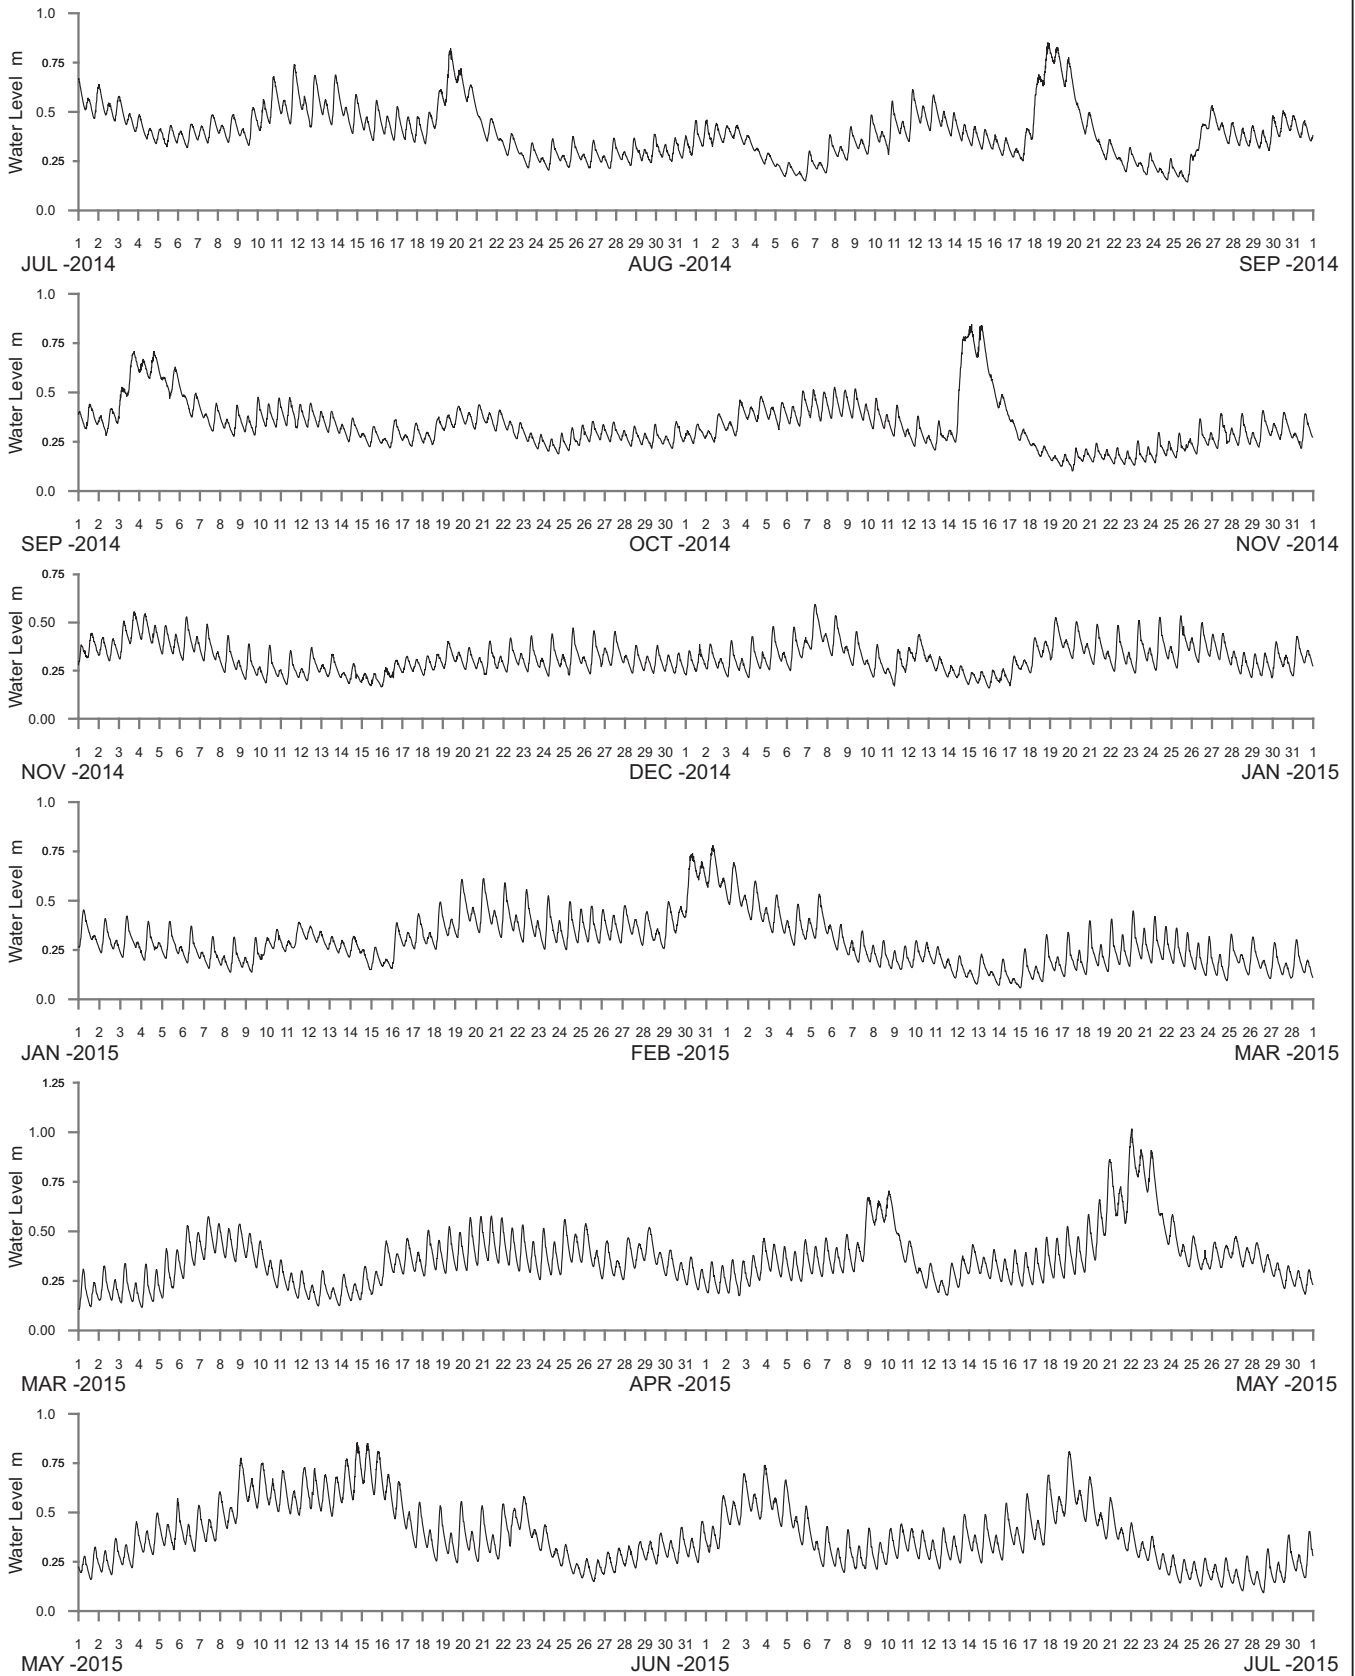
Figure
244

WATER LEVEL REFERENCED TO AUSTRALIAN HEIGHT DATUM

BURRILL LAKE AT BURRILL LAKE BRIDGE
2014-2015

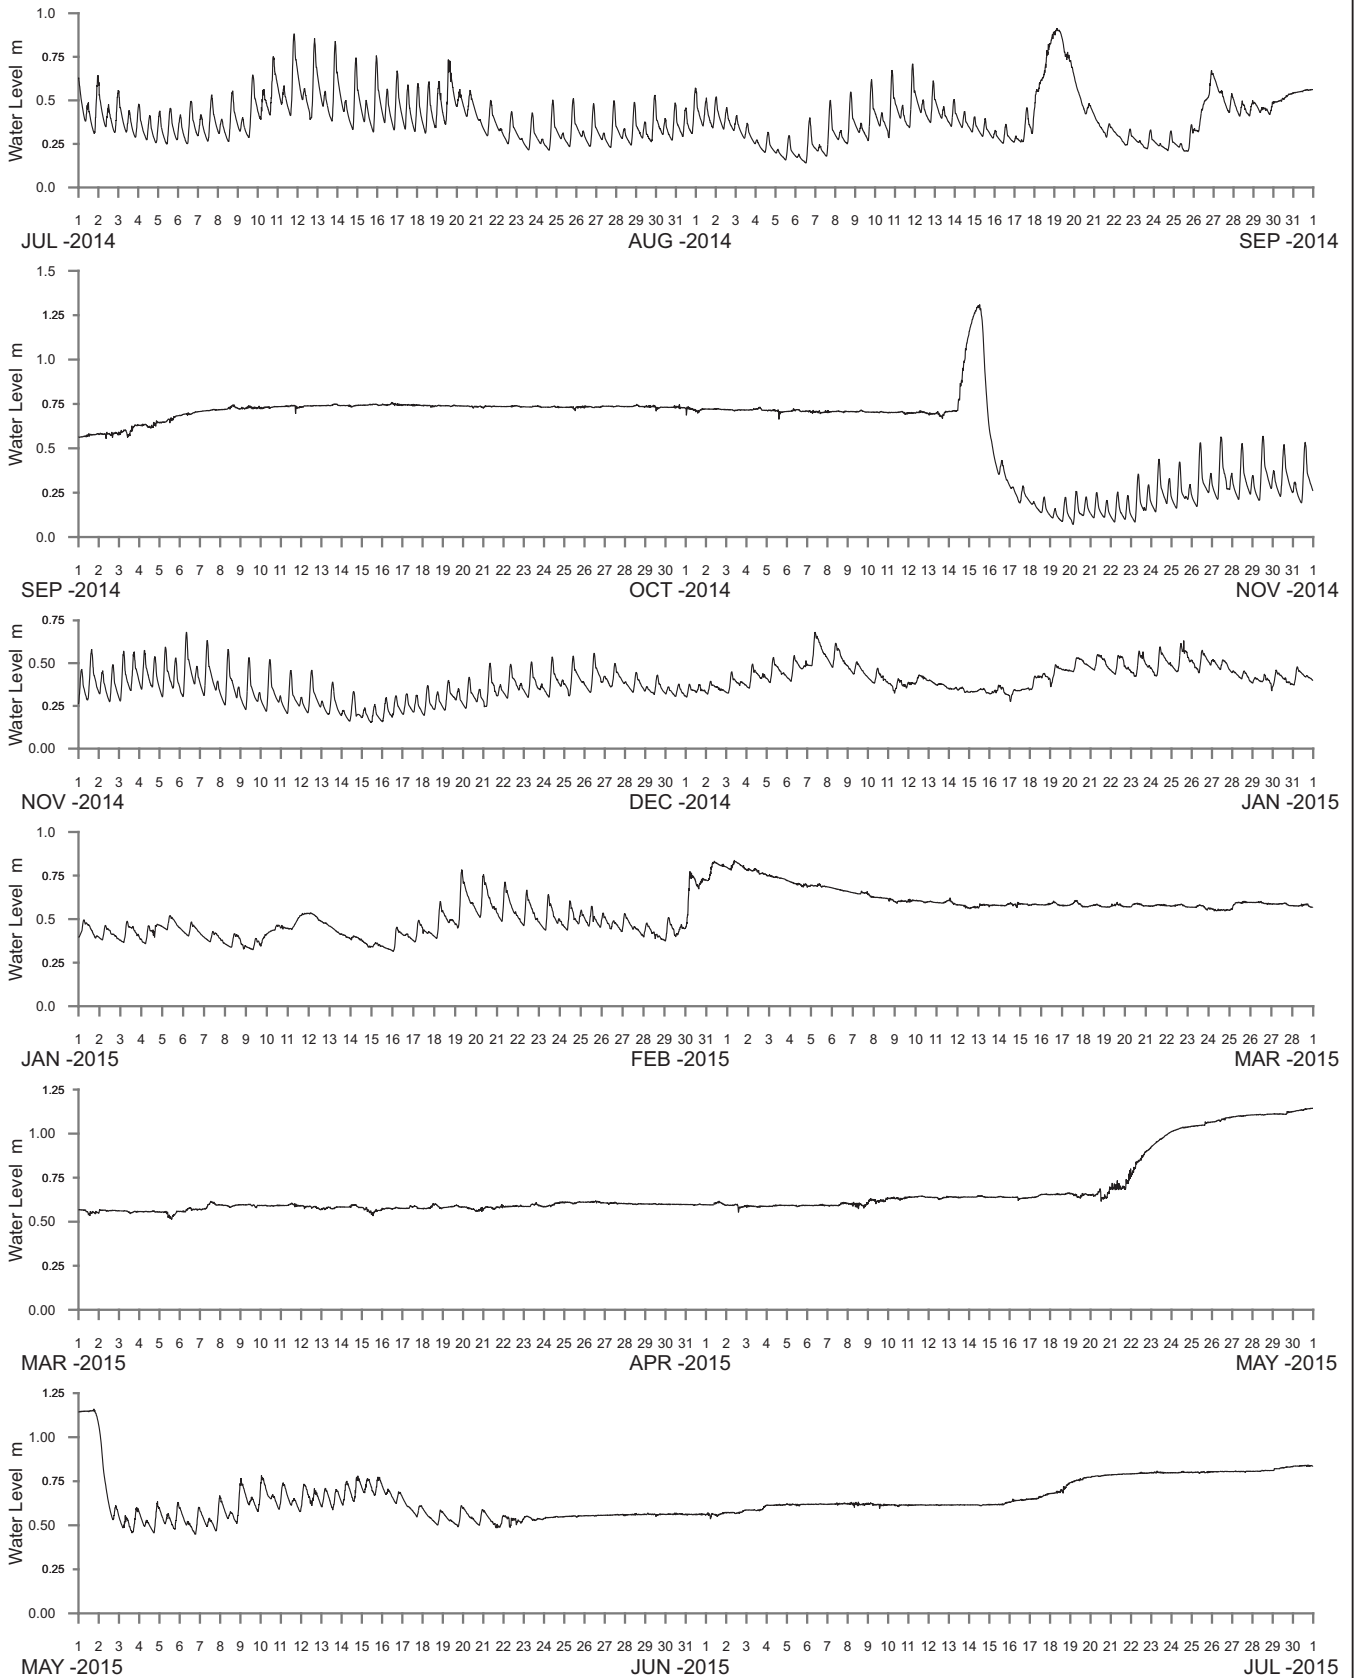
Figure
245

WATER LEVEL REFERENCED TO AUSTRALIAN HEIGHT DATUM

LAKE TABOURIE AT LAKE TABOURIE
2014-2015
