Public Works
Manly Hydraulics Laboratory

HEWITTS CREEK AT HEWITTS CREEK UPSTREAM
2014–2015

MHL
Report 2383

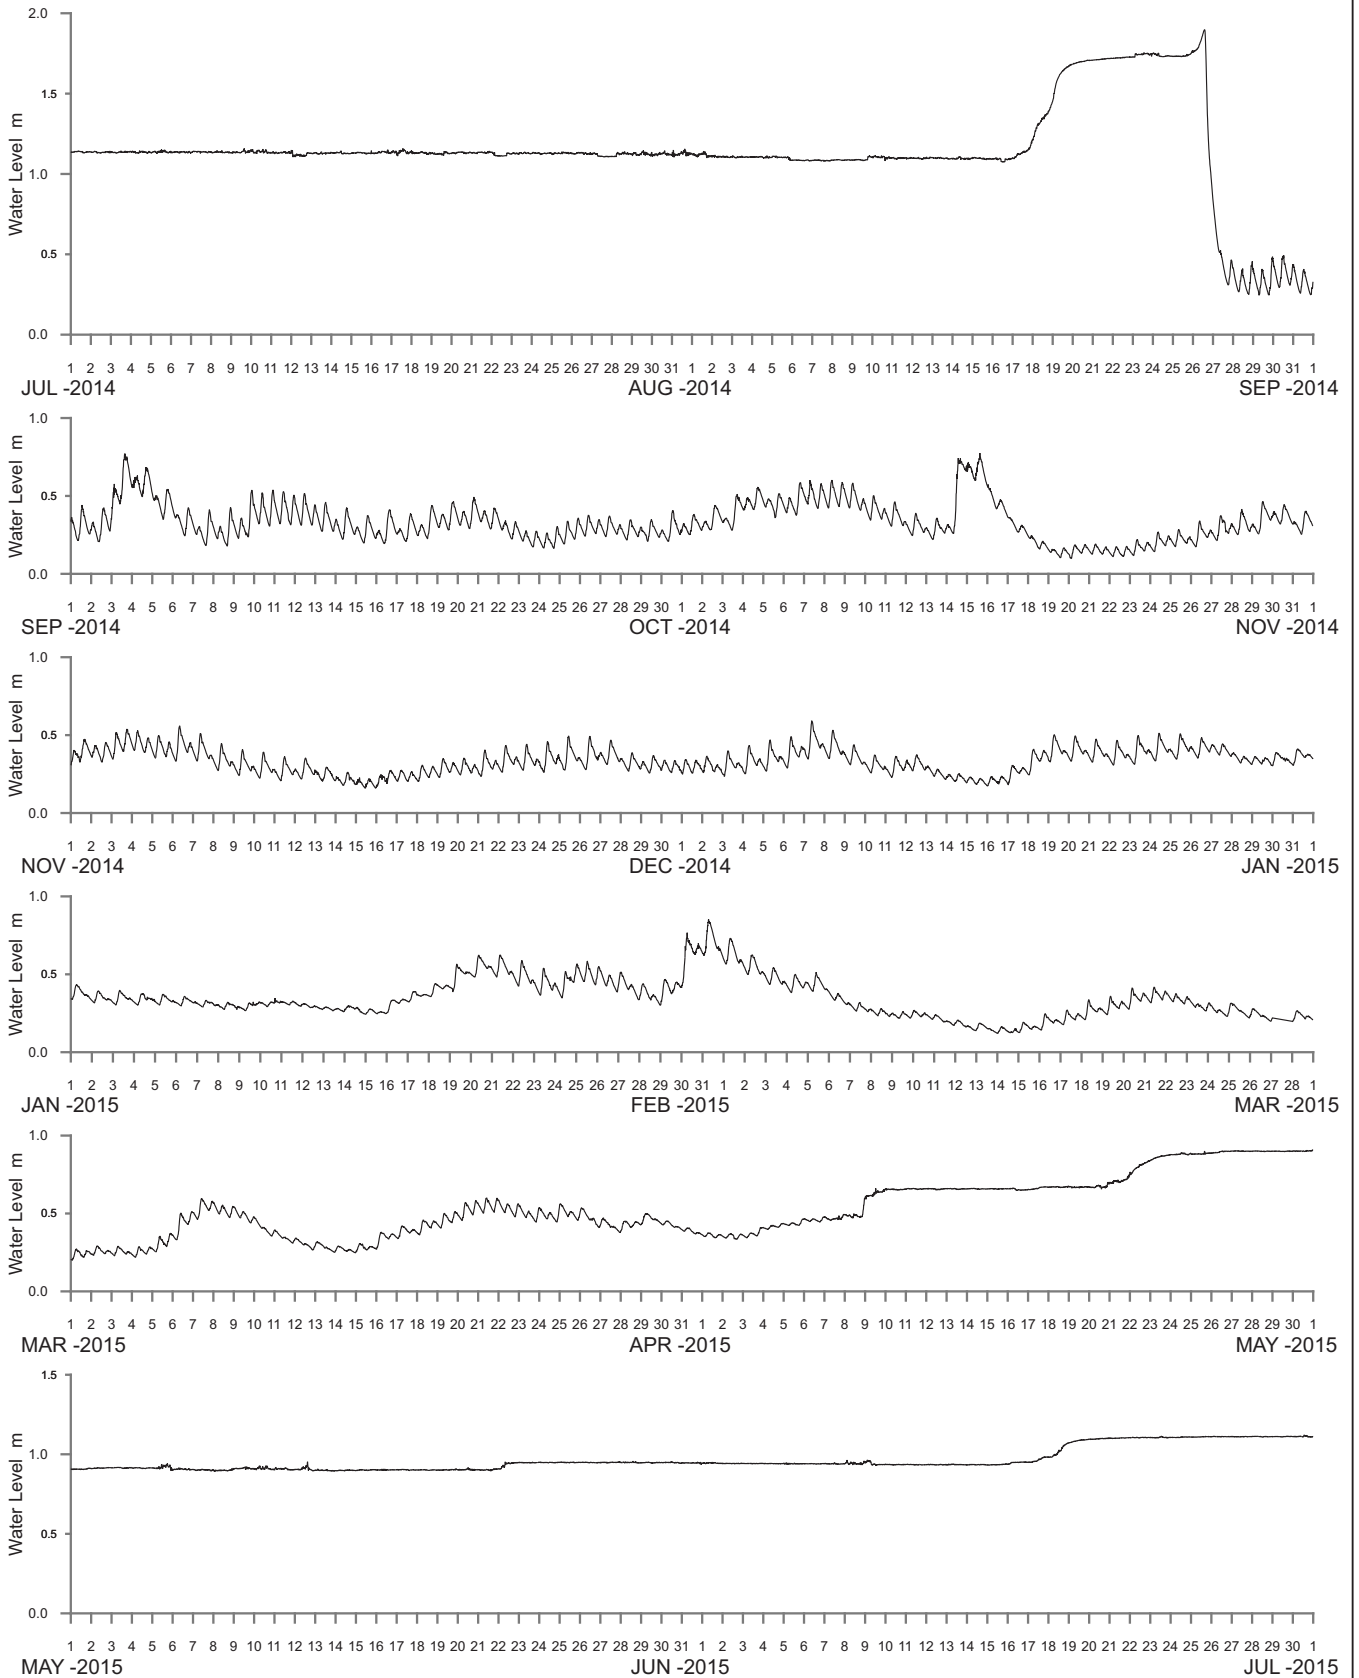
Figure
247

WATER LEVEL REFERENCED TO AUSTRALIAN HEIGHT DATUM

DURRAS LAKE AT DURRAS LAKE
2014-2015

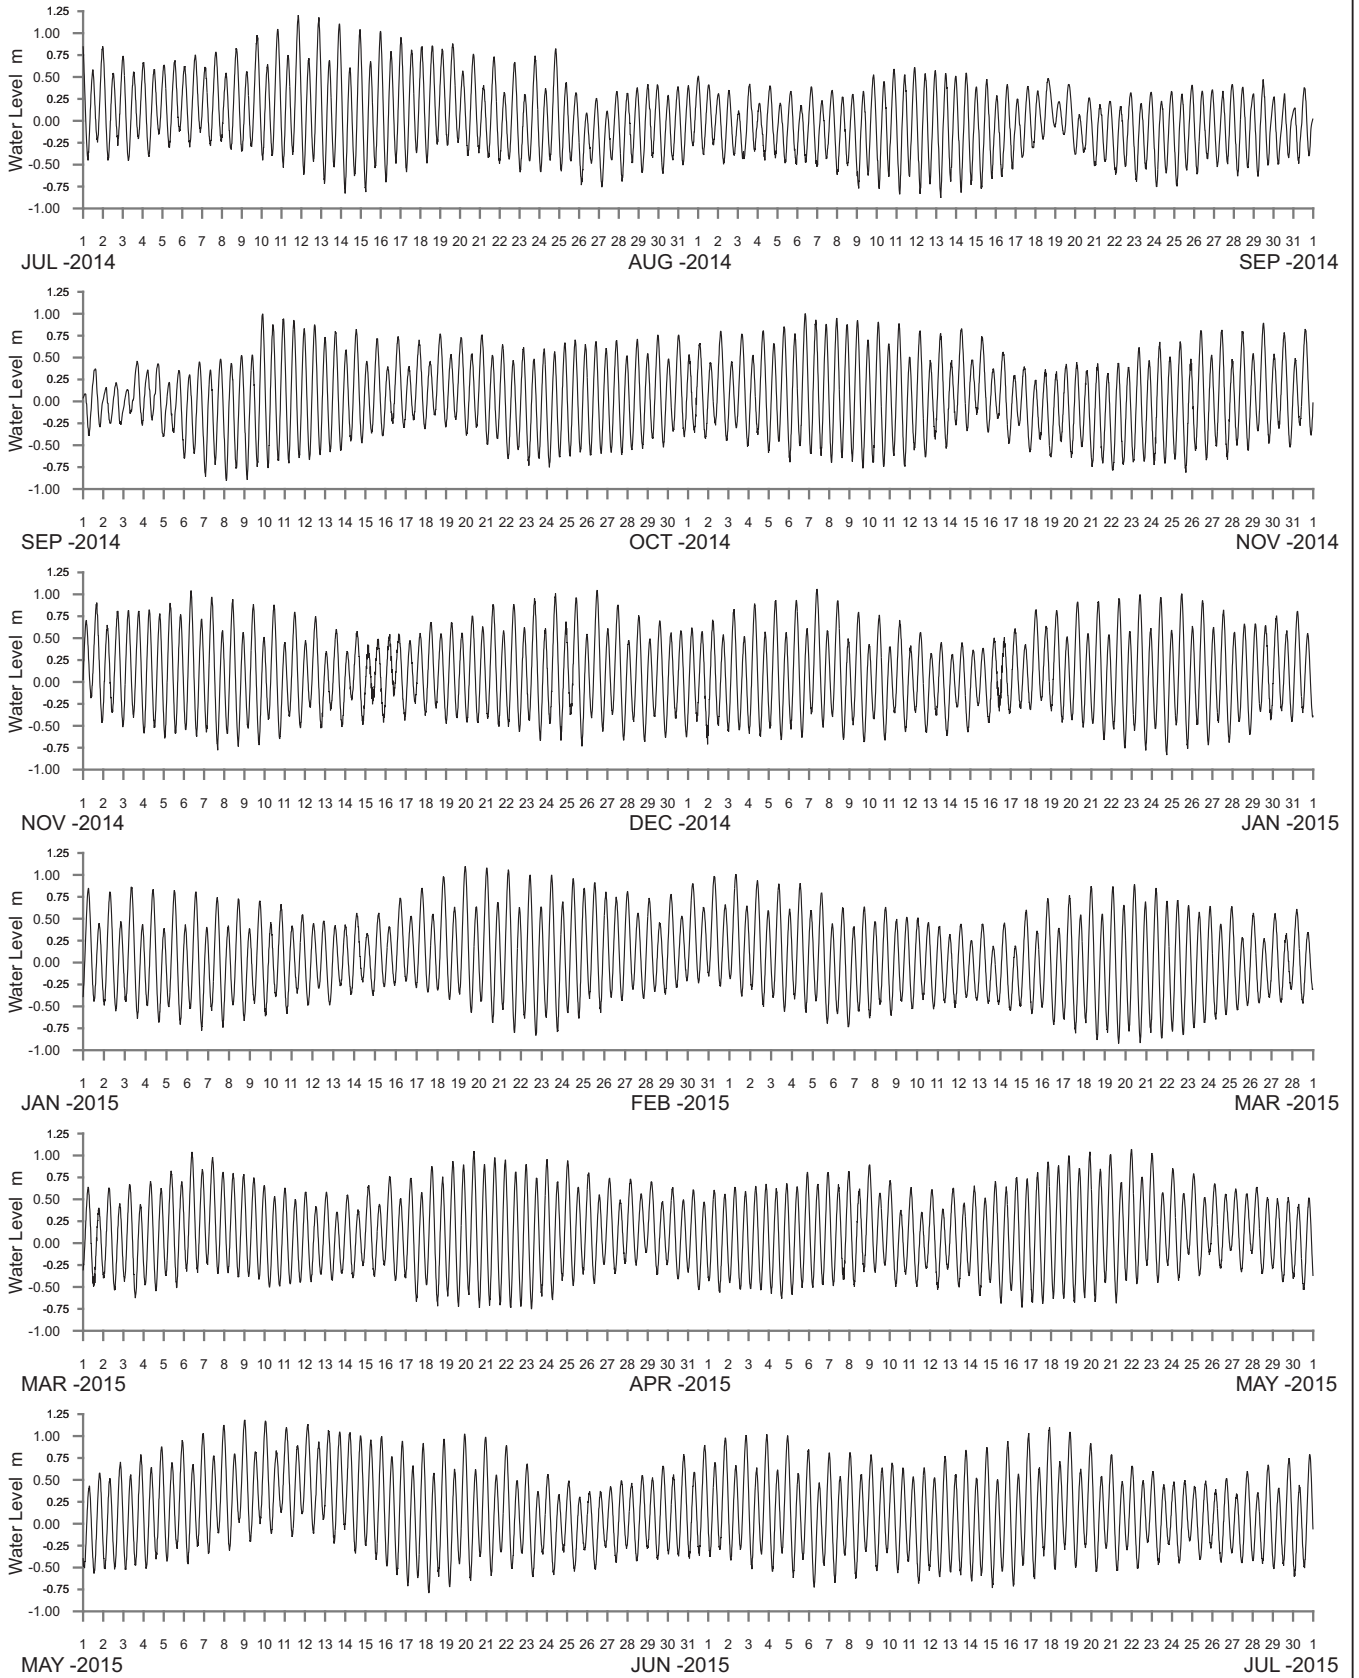
Figure
248

WATER LEVEL REFERENCED TO AUSTRALIAN HEIGHT DATUM

CLYDE RIVER AT NELLIGEN
2014–2015

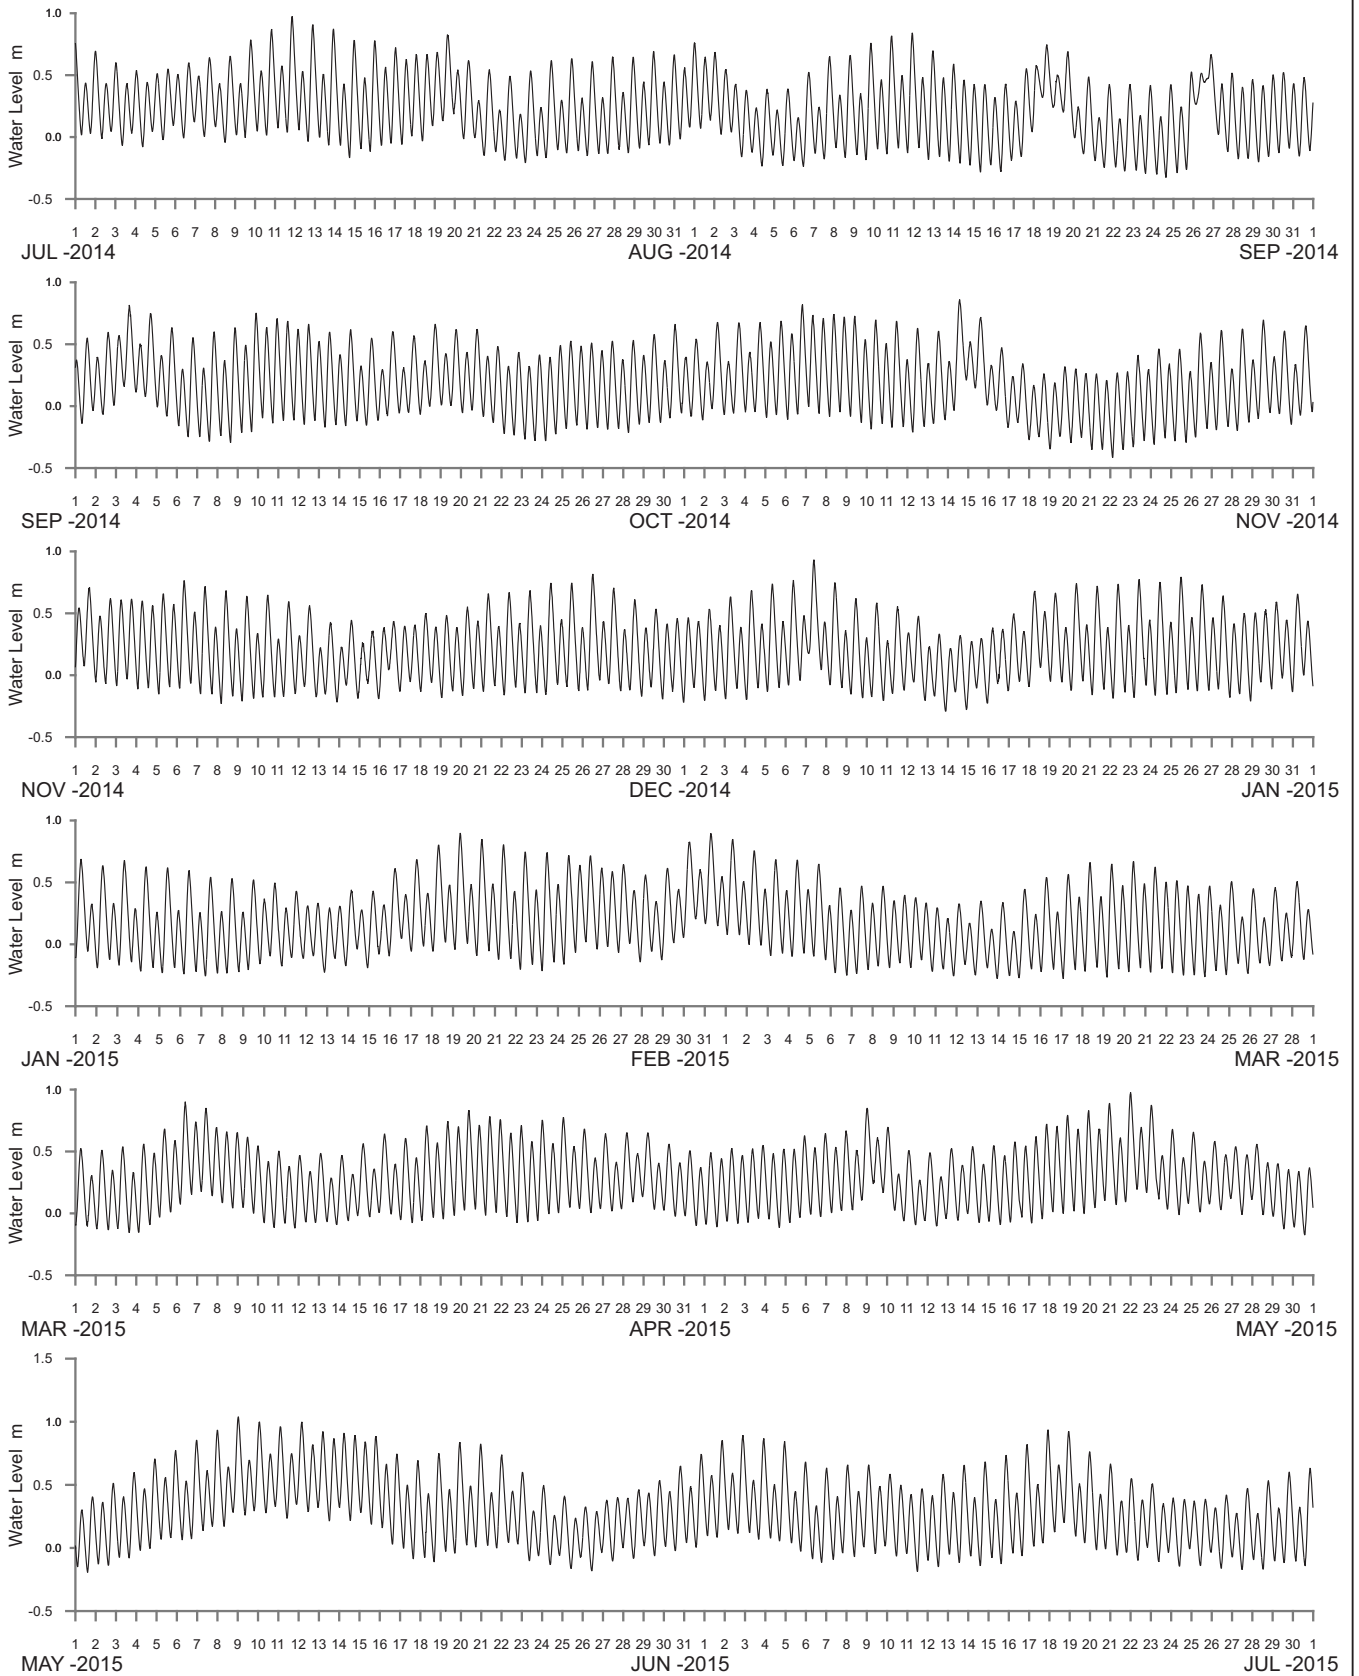
Figure
250

WATER LEVEL REFERENCED TO AUSTRALIAN HEIGHT DATUM

TOMAGA RIVER AT GEORGE BASS DRIVE
2014–2015

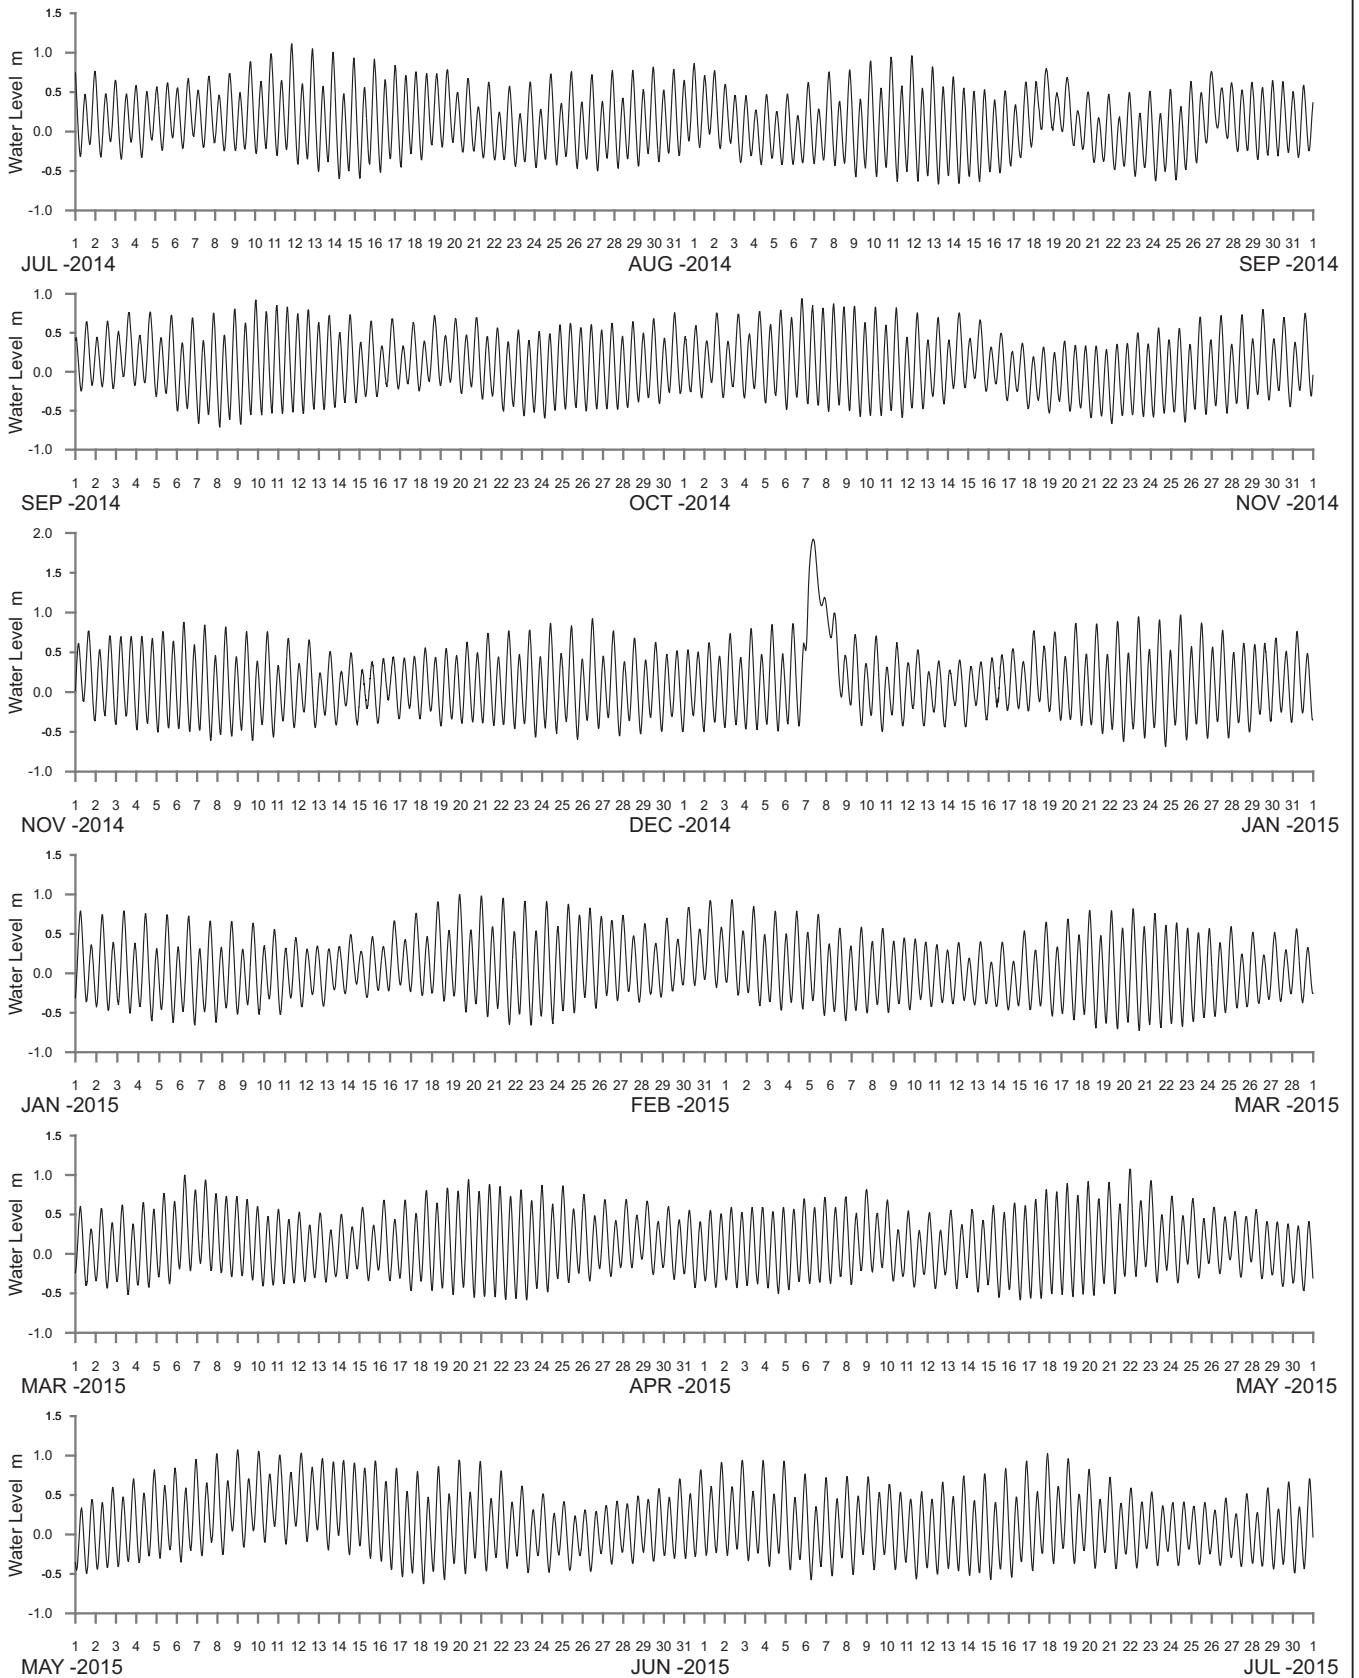
Figure
251

WATER LEVEL REFERENCED TO AUSTRALIAN HEIGHT DATUM

MORUYA RIVER AT MORUYA BRIDGE
2014–2015

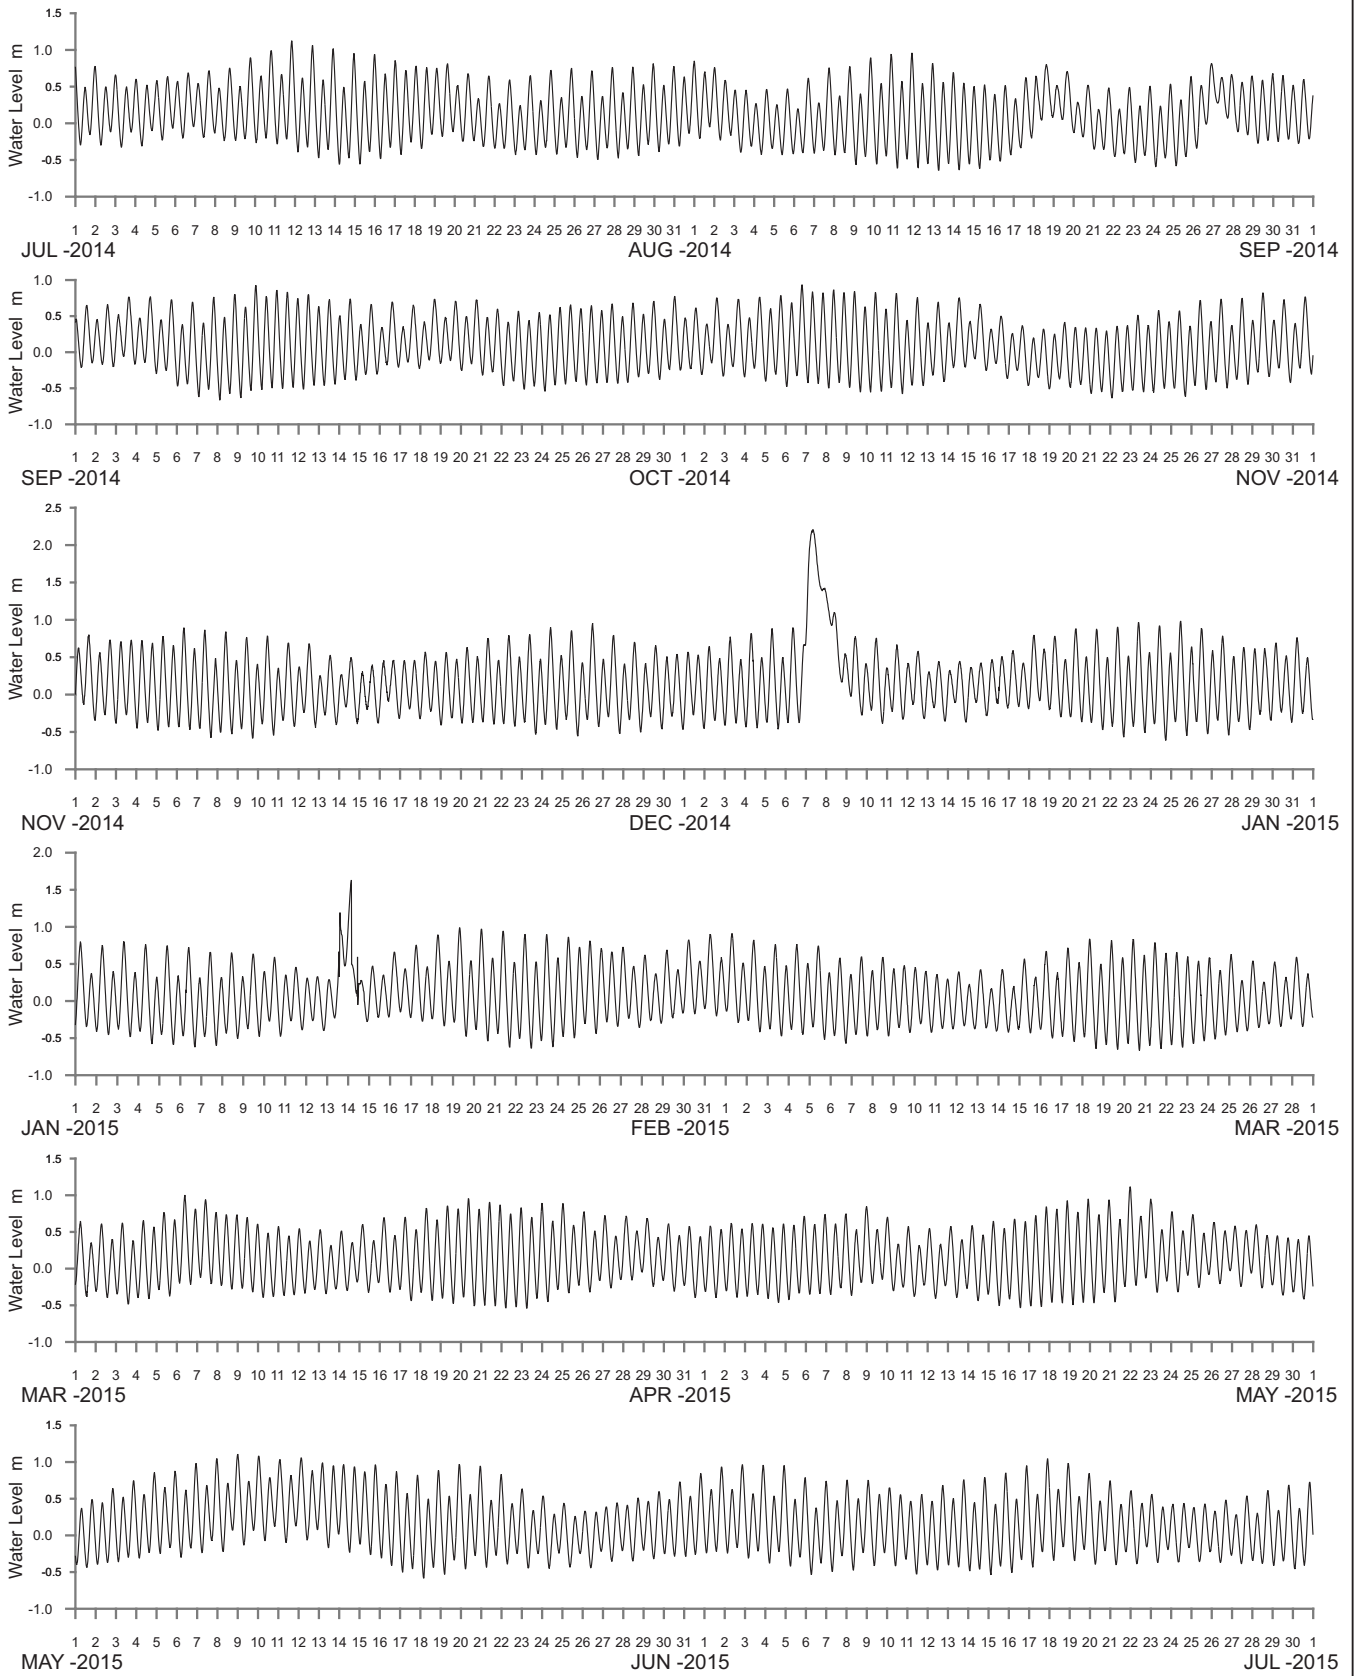
Figure
252

WATER LEVEL REFERENCED TO AUSTRALIAN HEIGHT DATUM

MORUYA RIVER AT MORUYA HOSPITAL
2014–2015

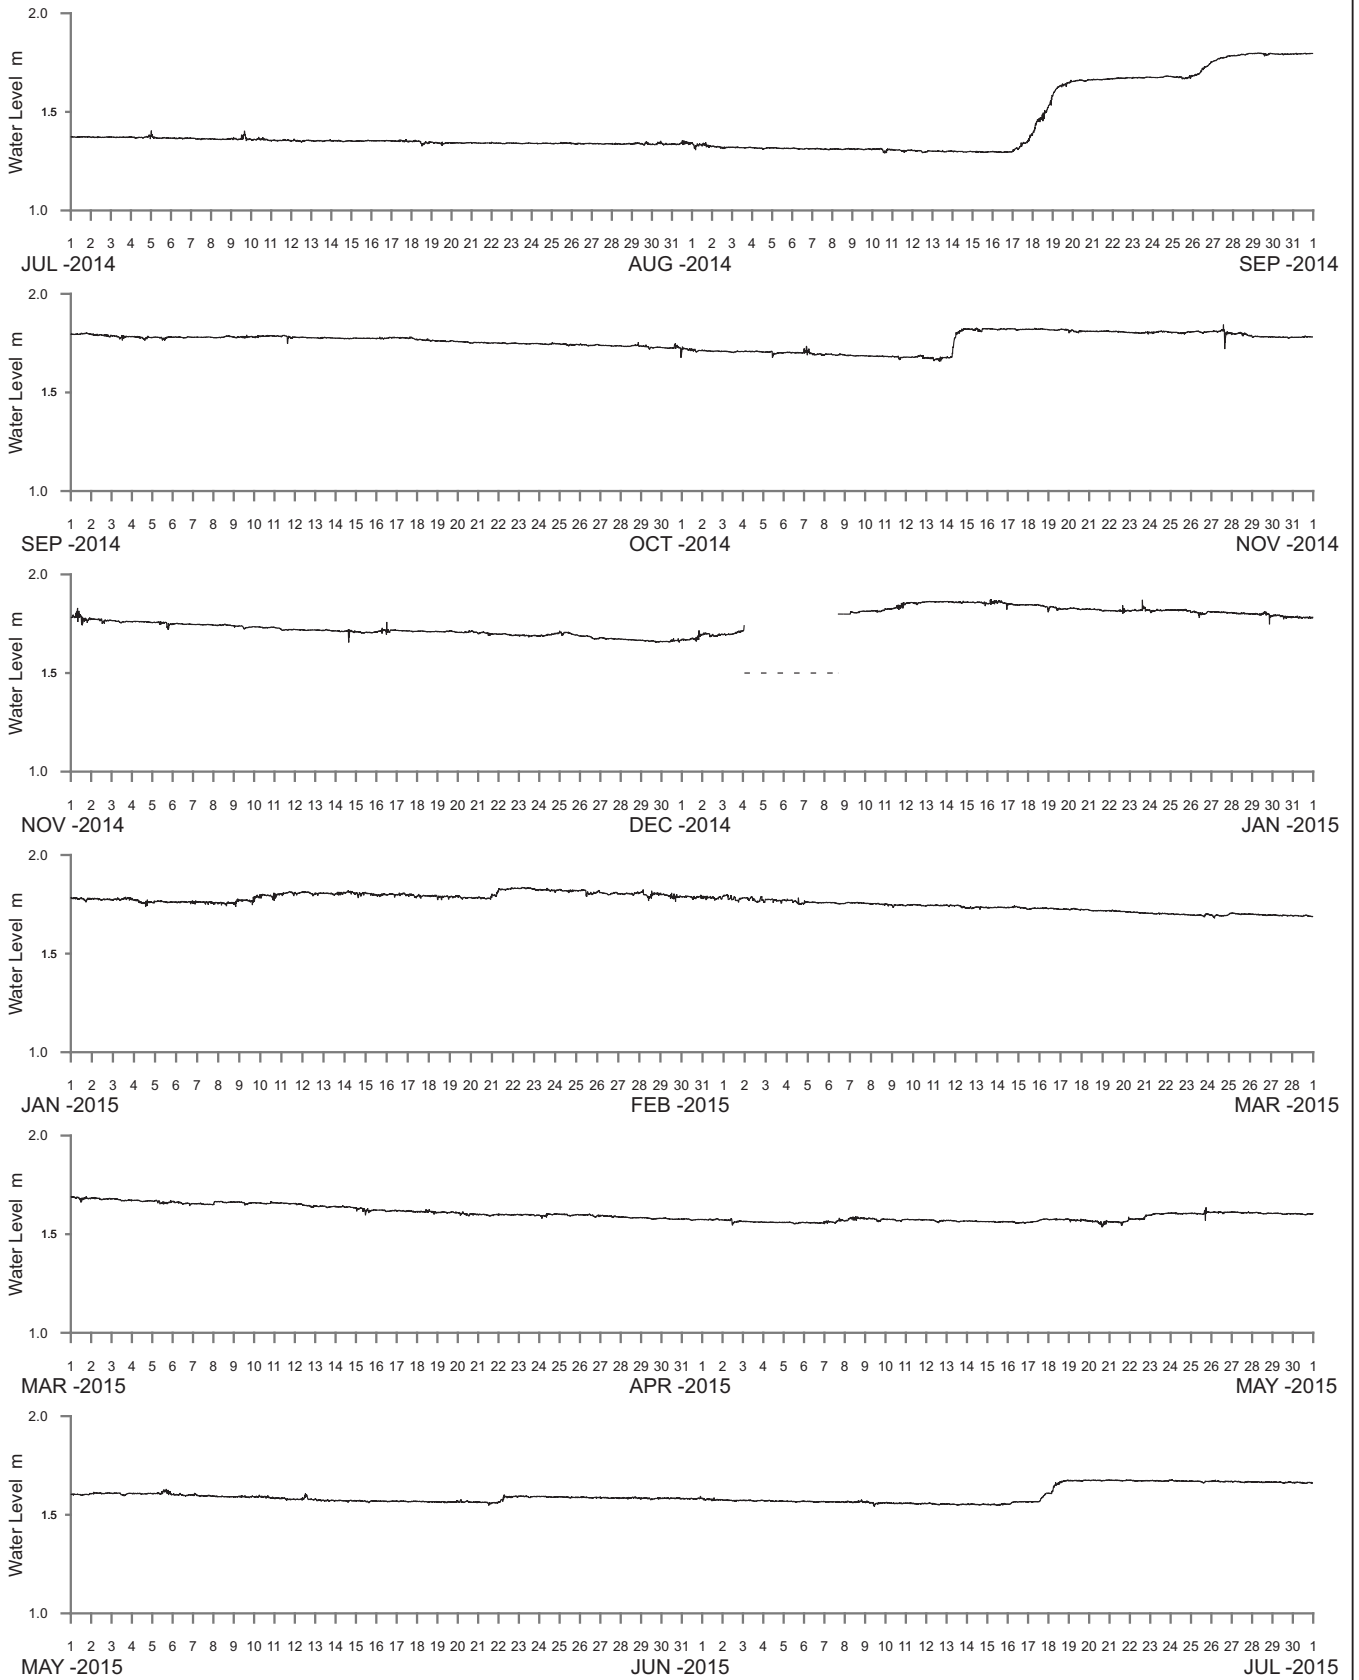
Figure
254

WATER LEVEL REFERENCED TO AUSTRALIAN HEIGHT DATUM

COILA LAKE AT COILA LAKE
2014-2015

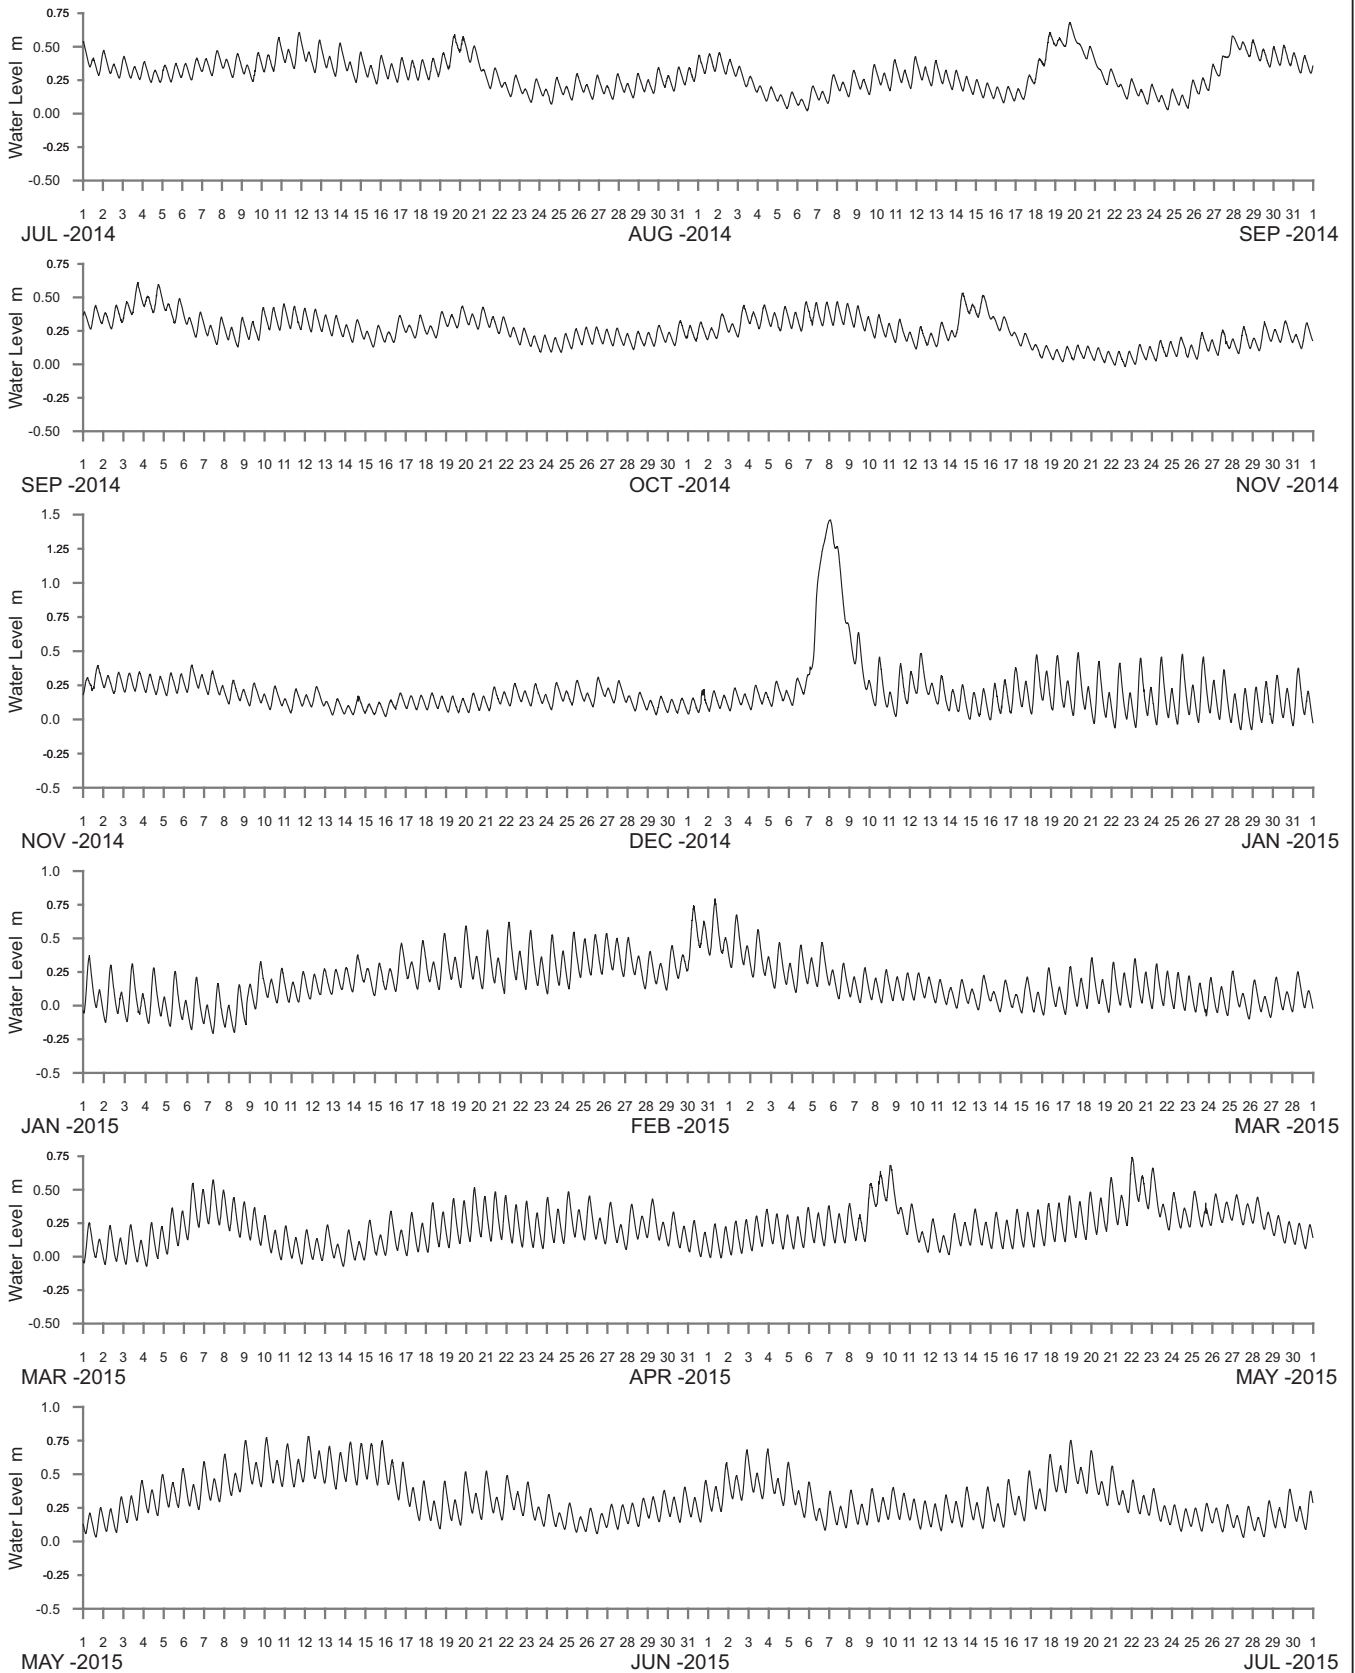
Figure
255

WATER LEVEL REFERENCED TO AUSTRALIAN HEIGHT DATUM

TUROSS RIVER AT TUROSS HEAD
2014-2015

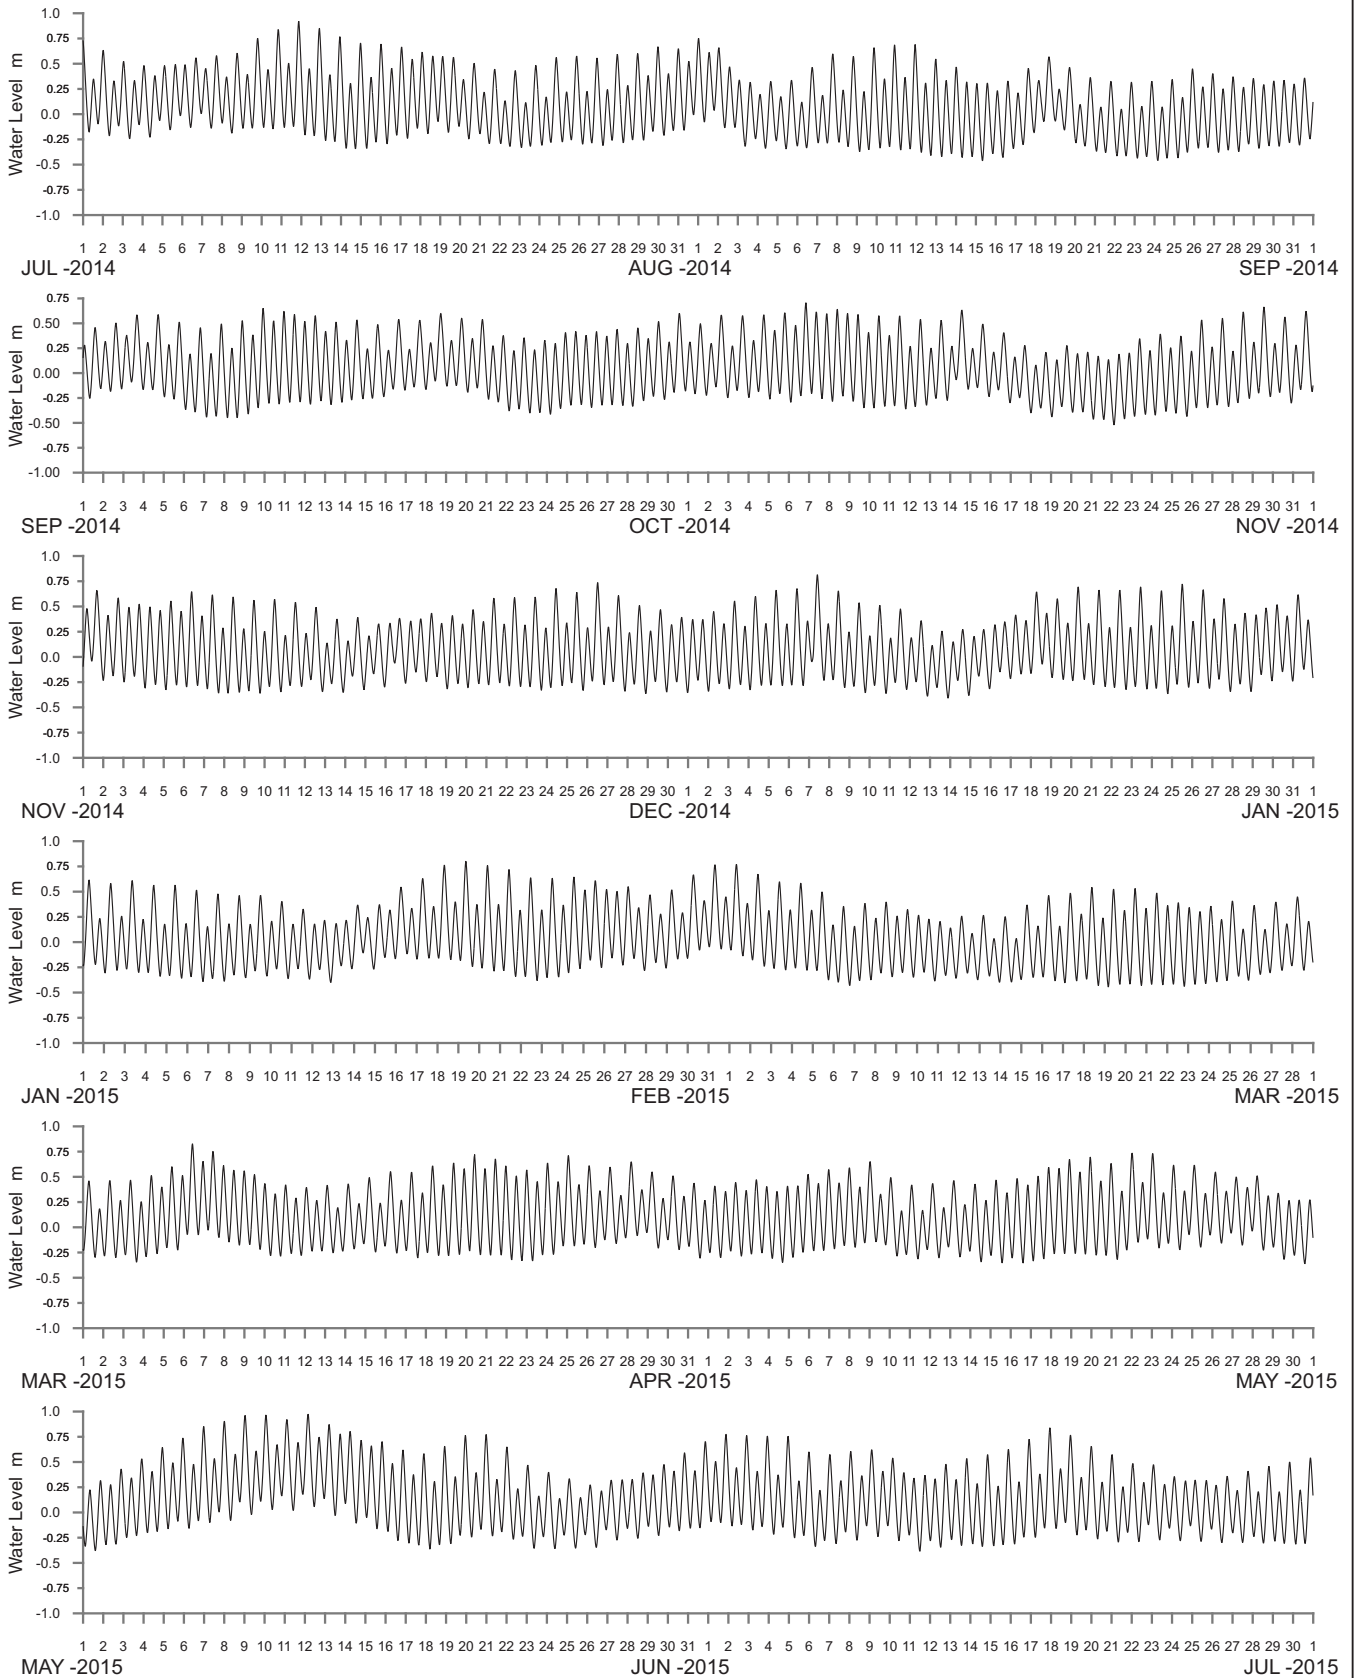
Figure
257

WATER LEVEL REFERENCED TO AUSTRALIAN HEIGHT DATUM

WAGONGA INLET AT BARLOWS BAY
2014–2015

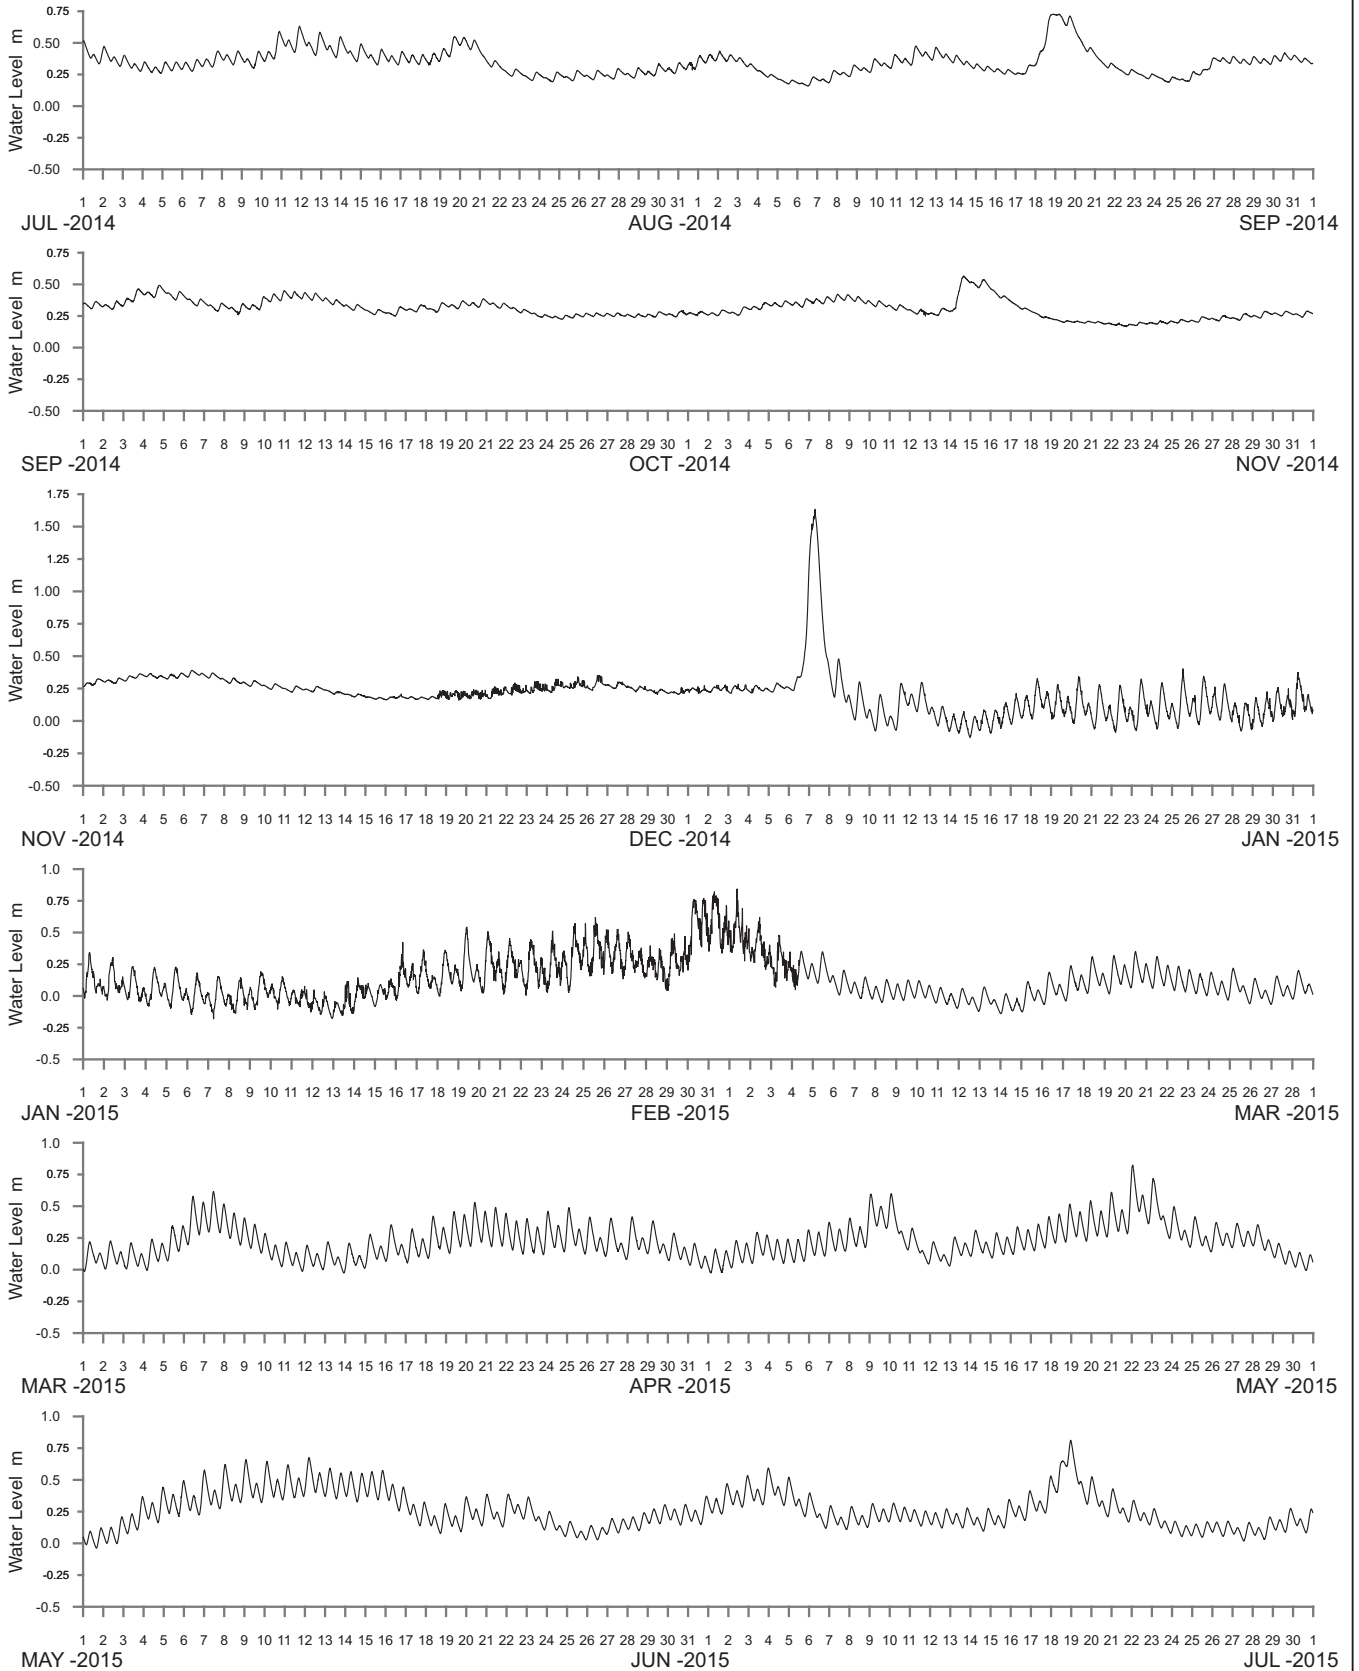
Figure
258

WATER LEVEL REFERENCED TO AUSTRALIAN HEIGHT DATUM

WALLAGA LAKE AT REGATTA POINT
2014-2015

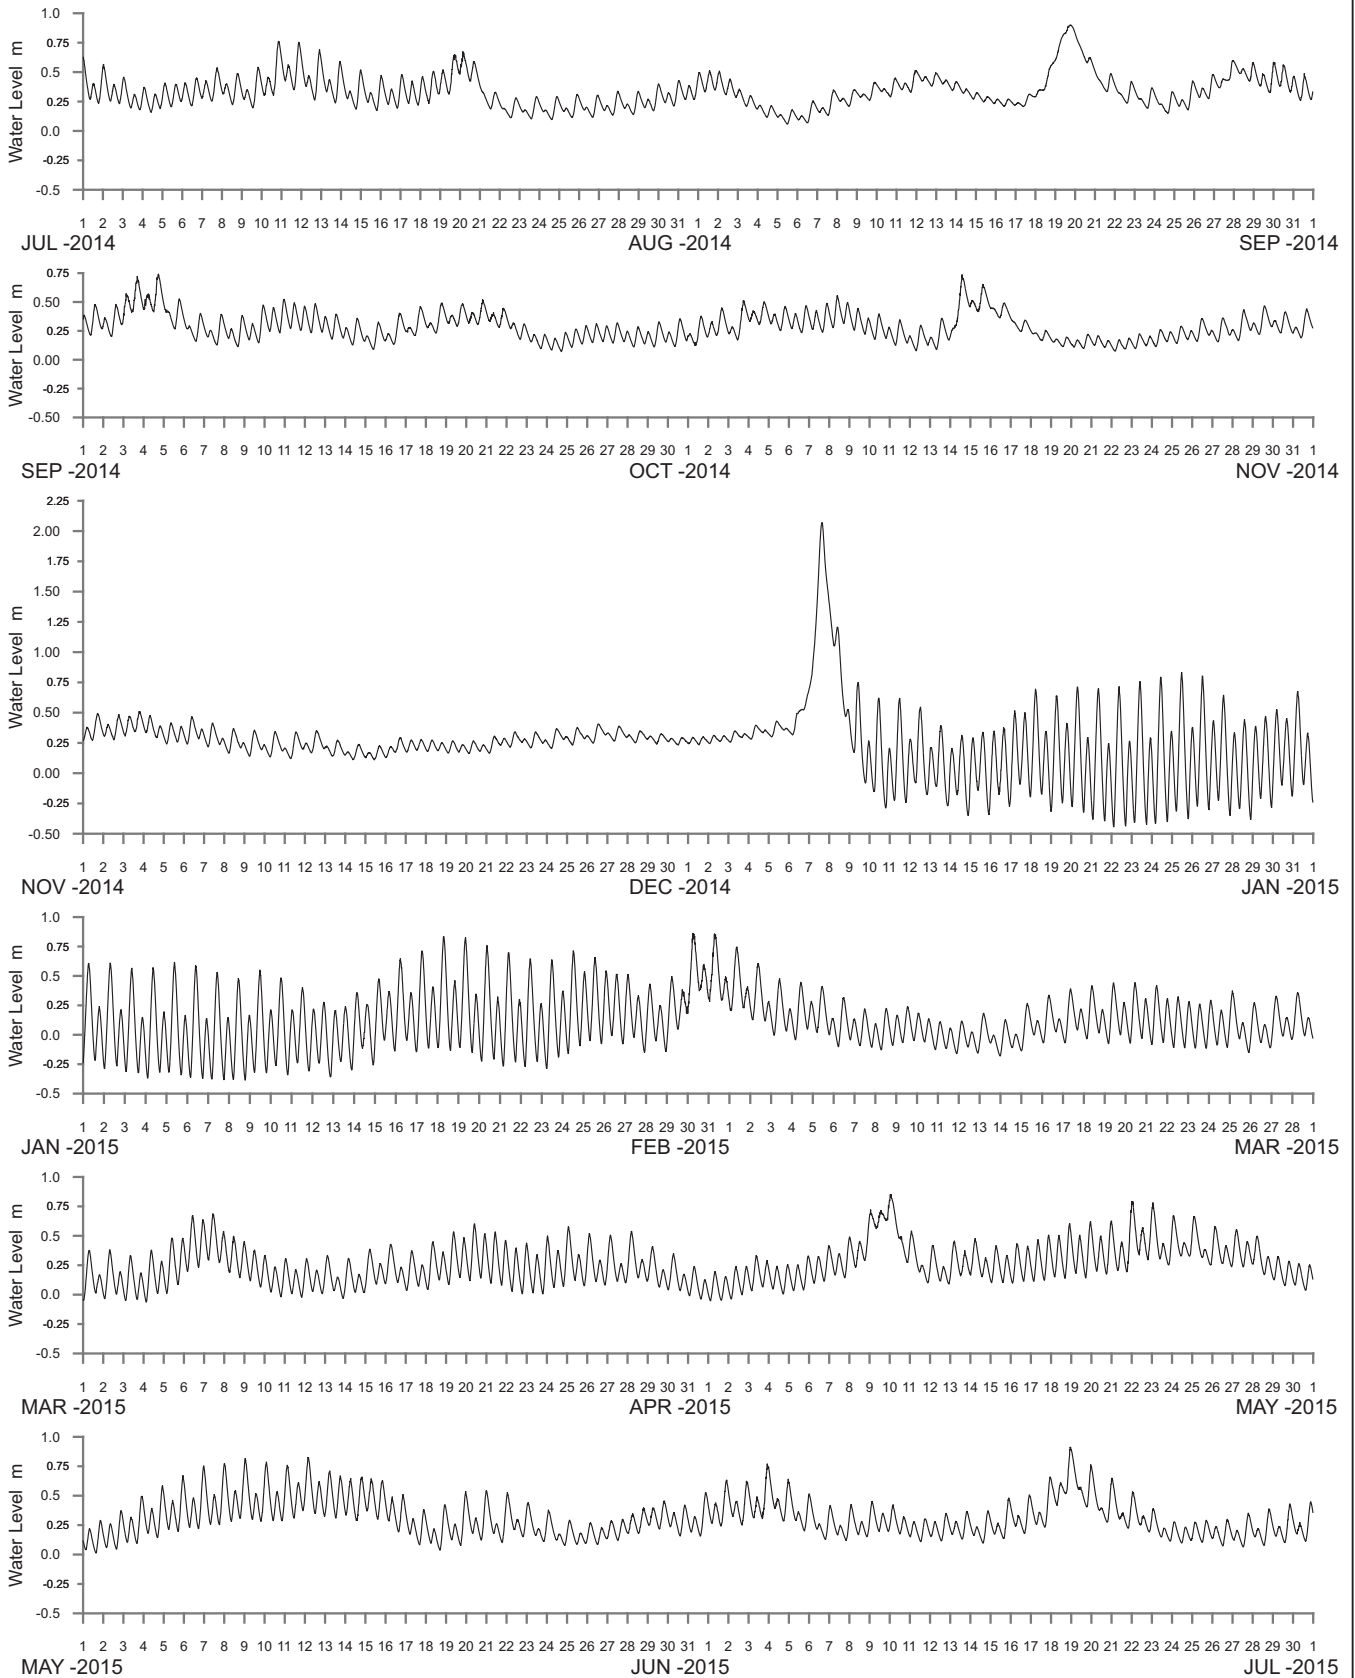
Figure
260

WATER LEVEL REFERENCED TO AUSTRALIAN HEIGHT DATUM

BEGA RIVER AT BEGA RIVER
2014–2015
