Public Works
Manly Hydraulics Laboratory

HEWITTS CREEK AT HEWITTS CREEK UPSTREAM
2014–2015

MHL
Report 2383

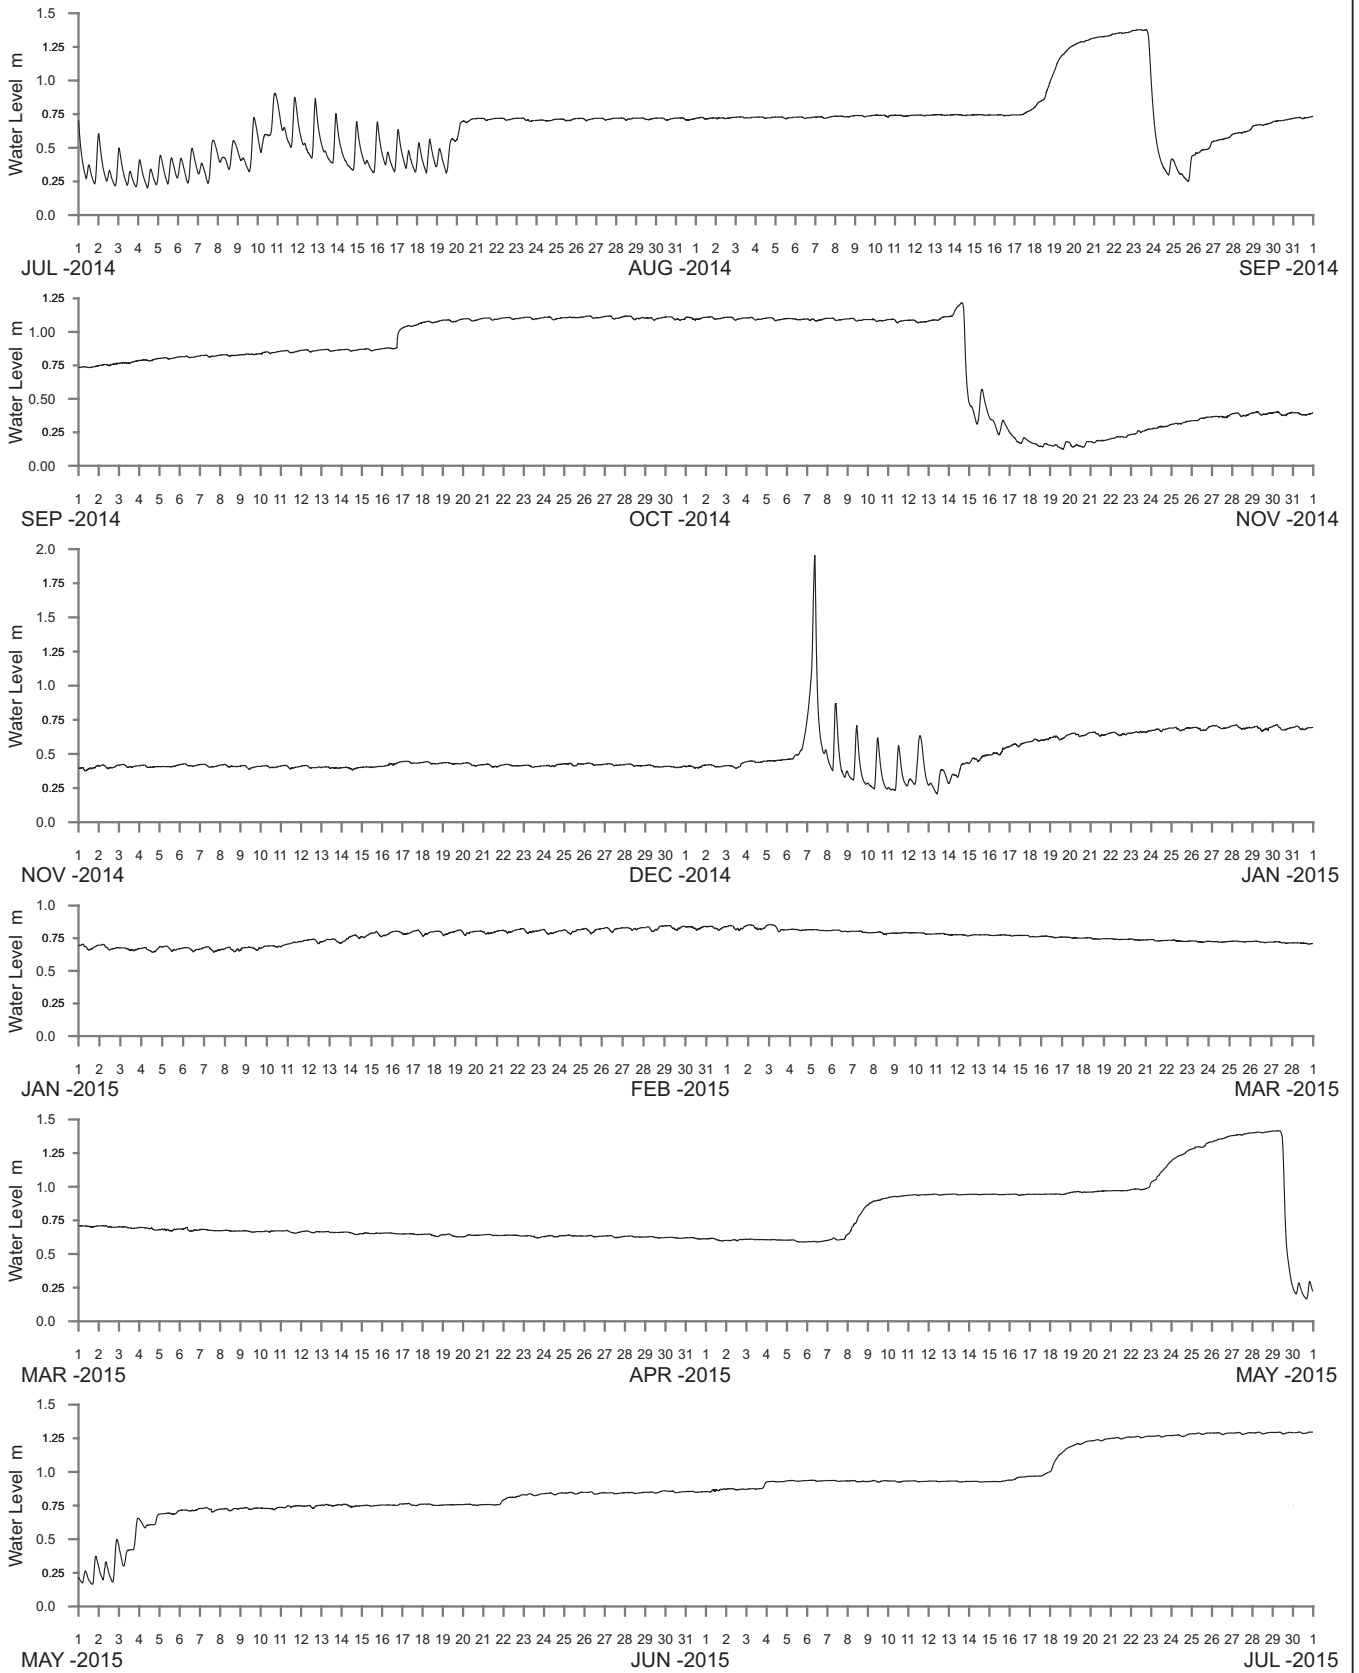
Figure
262

WATER LEVEL REFERENCED TO AUSTRALIAN HEIGHT DATUM

BACK LAGOON AT BACK LAGOON
2014-2015

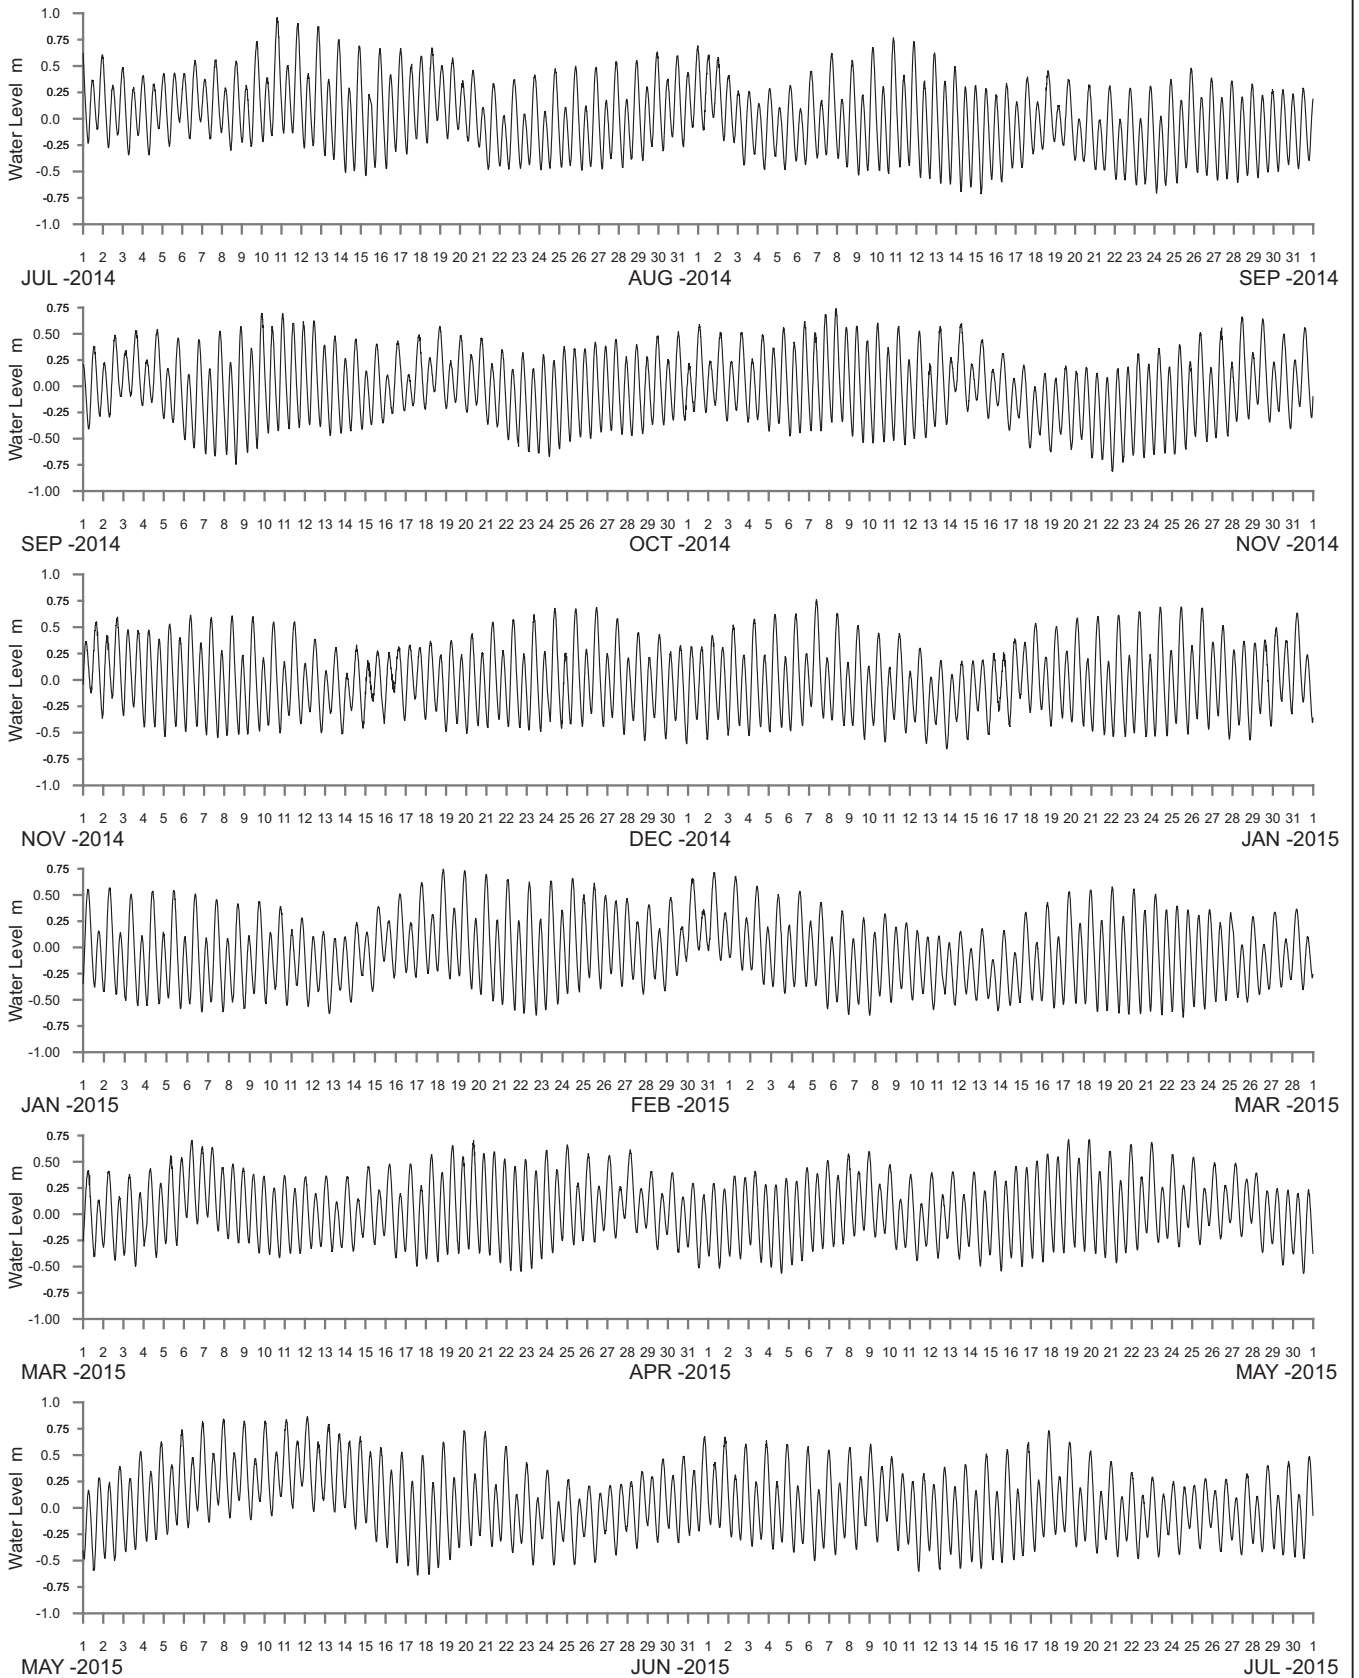
Figure
263

WATER LEVEL REFERENCED TO AUSTRALIAN HEIGHT DATUM

MERIMBULA LAKE AT MERIMBULA WHARF
2014–2015

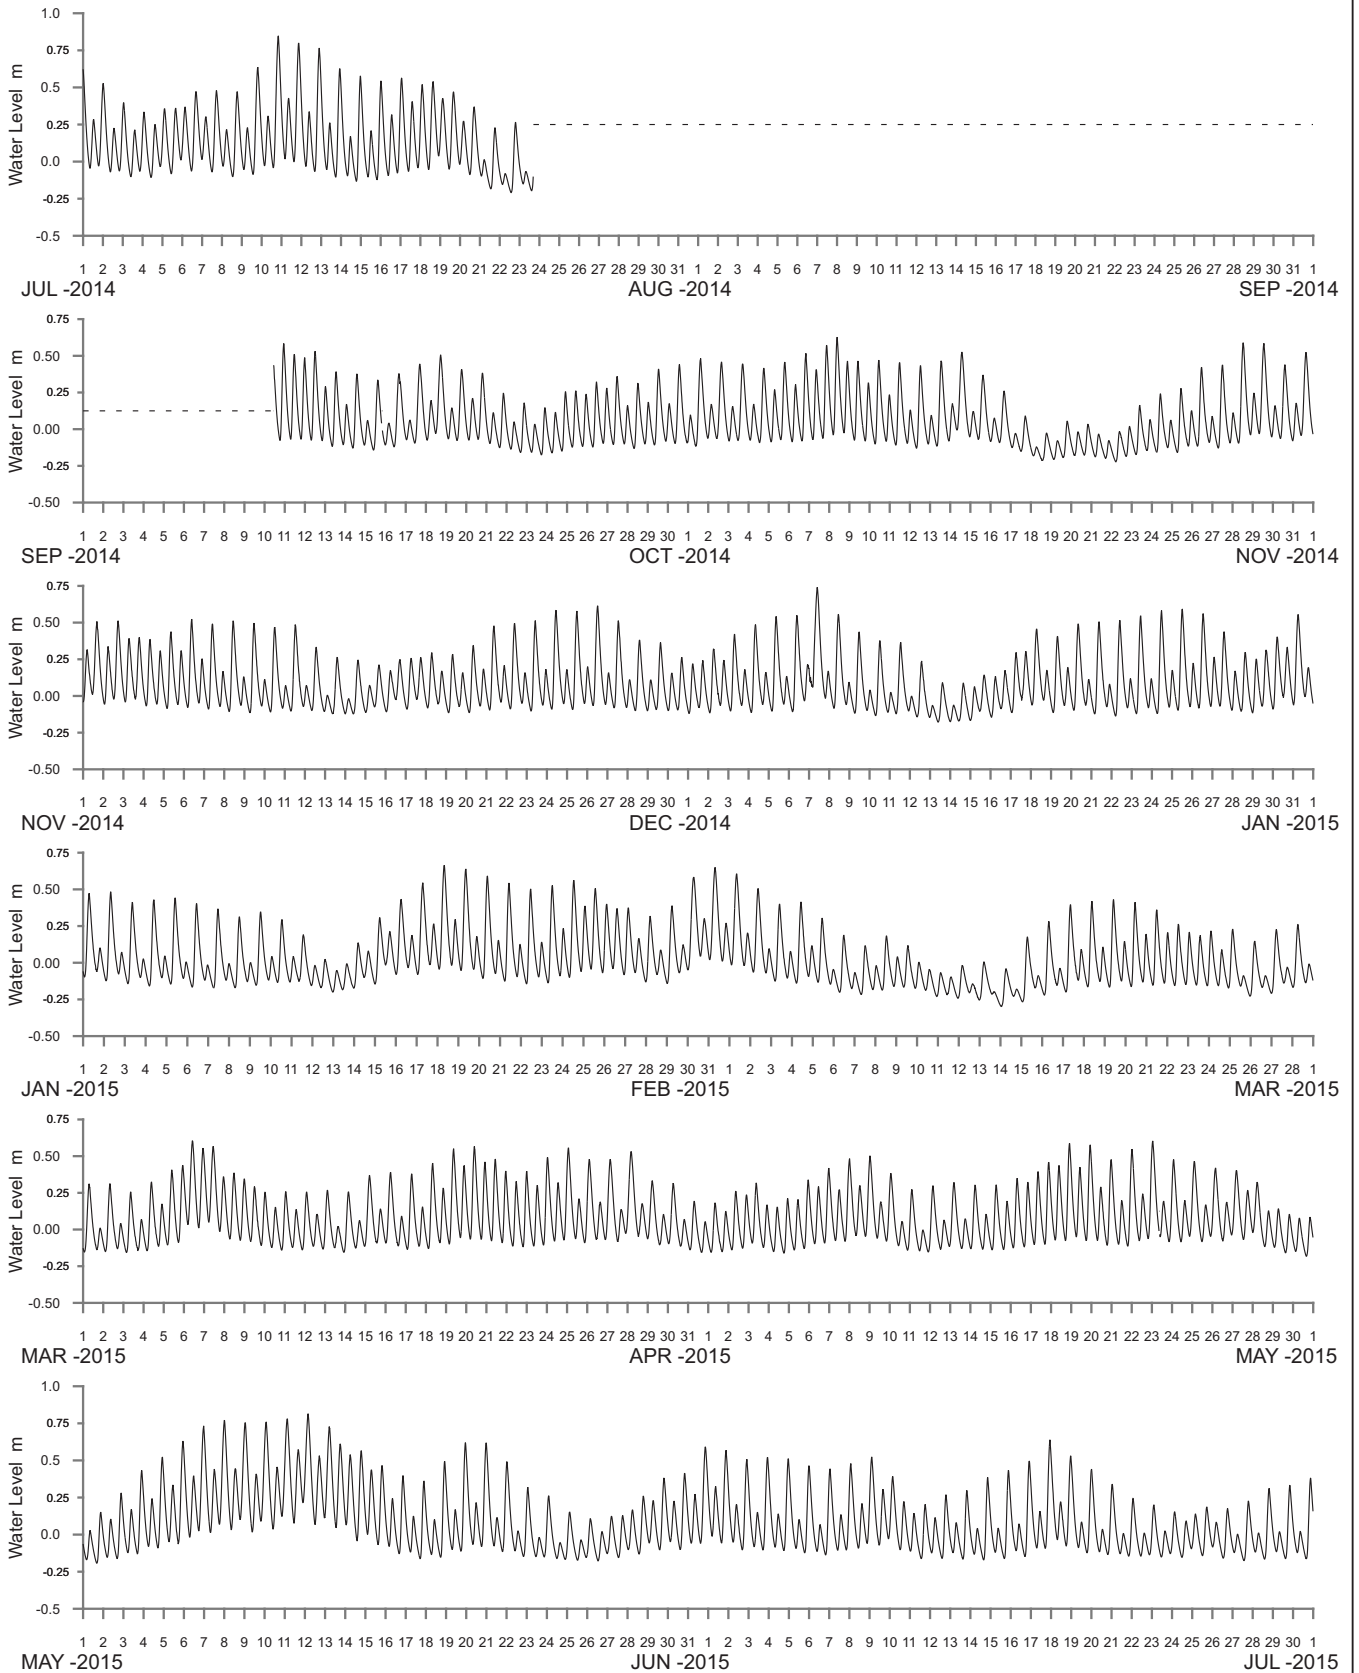
Figure
264

WATER LEVEL REFERENCED TO AUSTRALIAN HEIGHT DATUM

MERIMBULA LAKE AT MERIMBULA LAKE
2014–2015

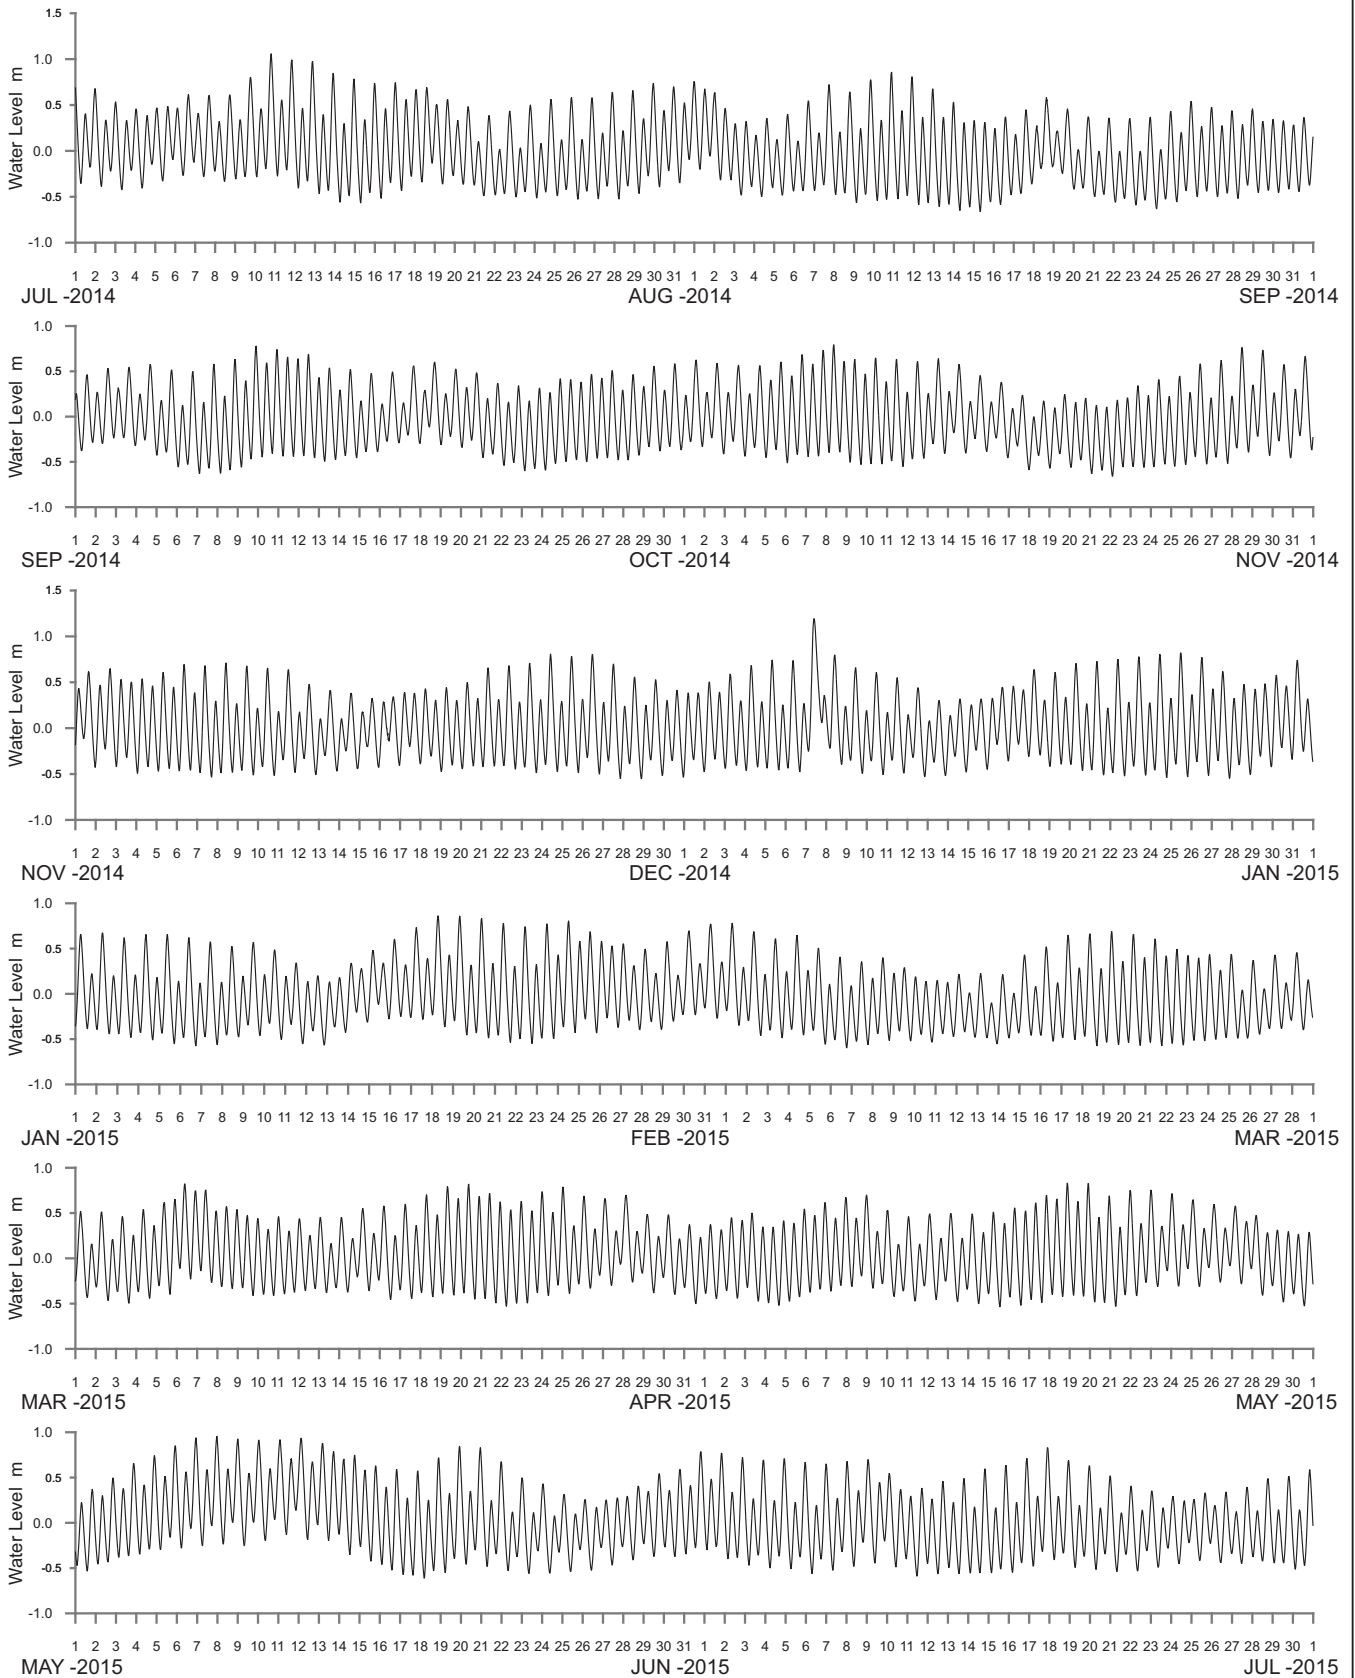
Figure
265

WATER LEVEL REFERENCED TO AUSTRALIAN HEIGHT DATUM

PAMBULA LAKE AT PAMBULA LAKE
2014–2015

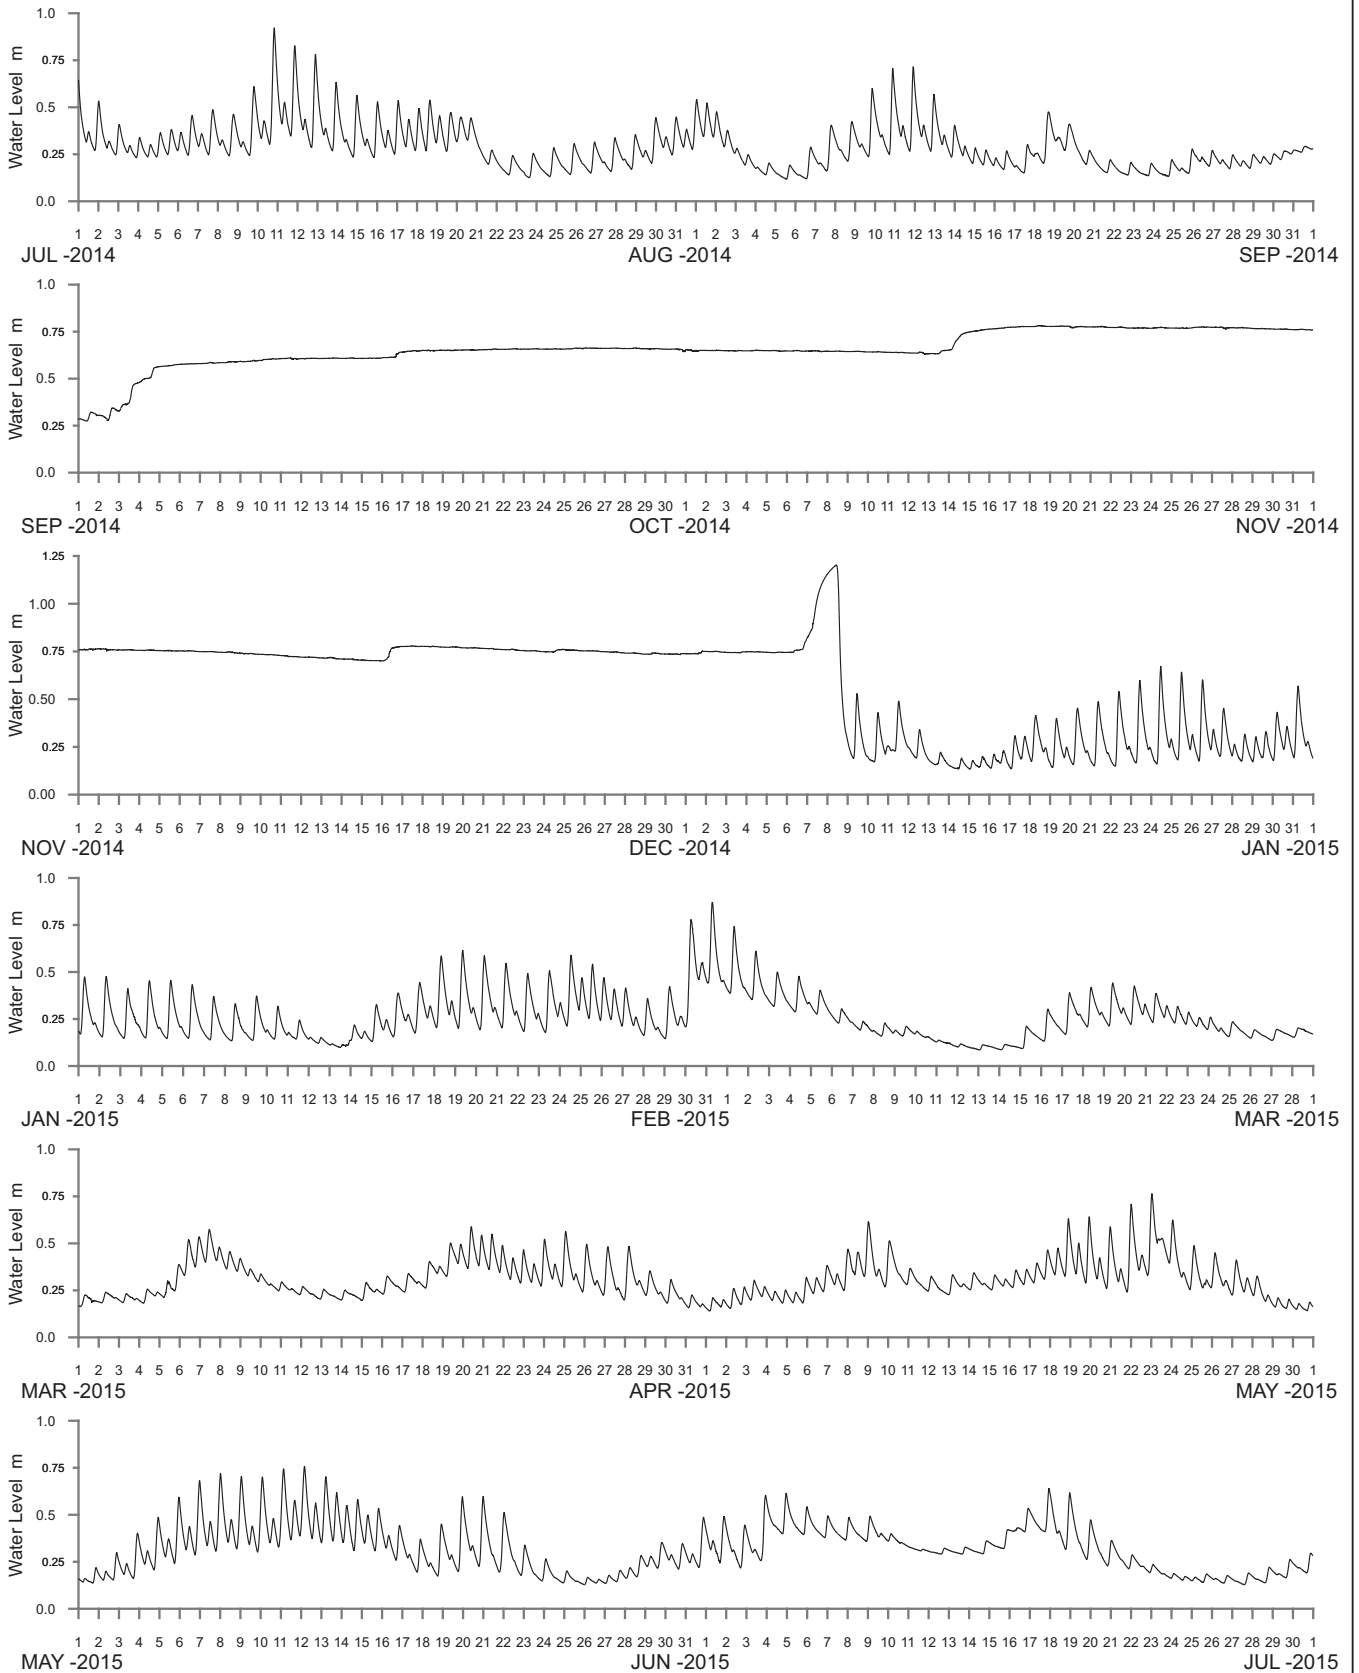
Figure
266

WATER LEVEL REFERENCED TO AUSTRALIAN HEIGHT DATUM

LAKE CURALO AT LAKE CURALO
2014–2015

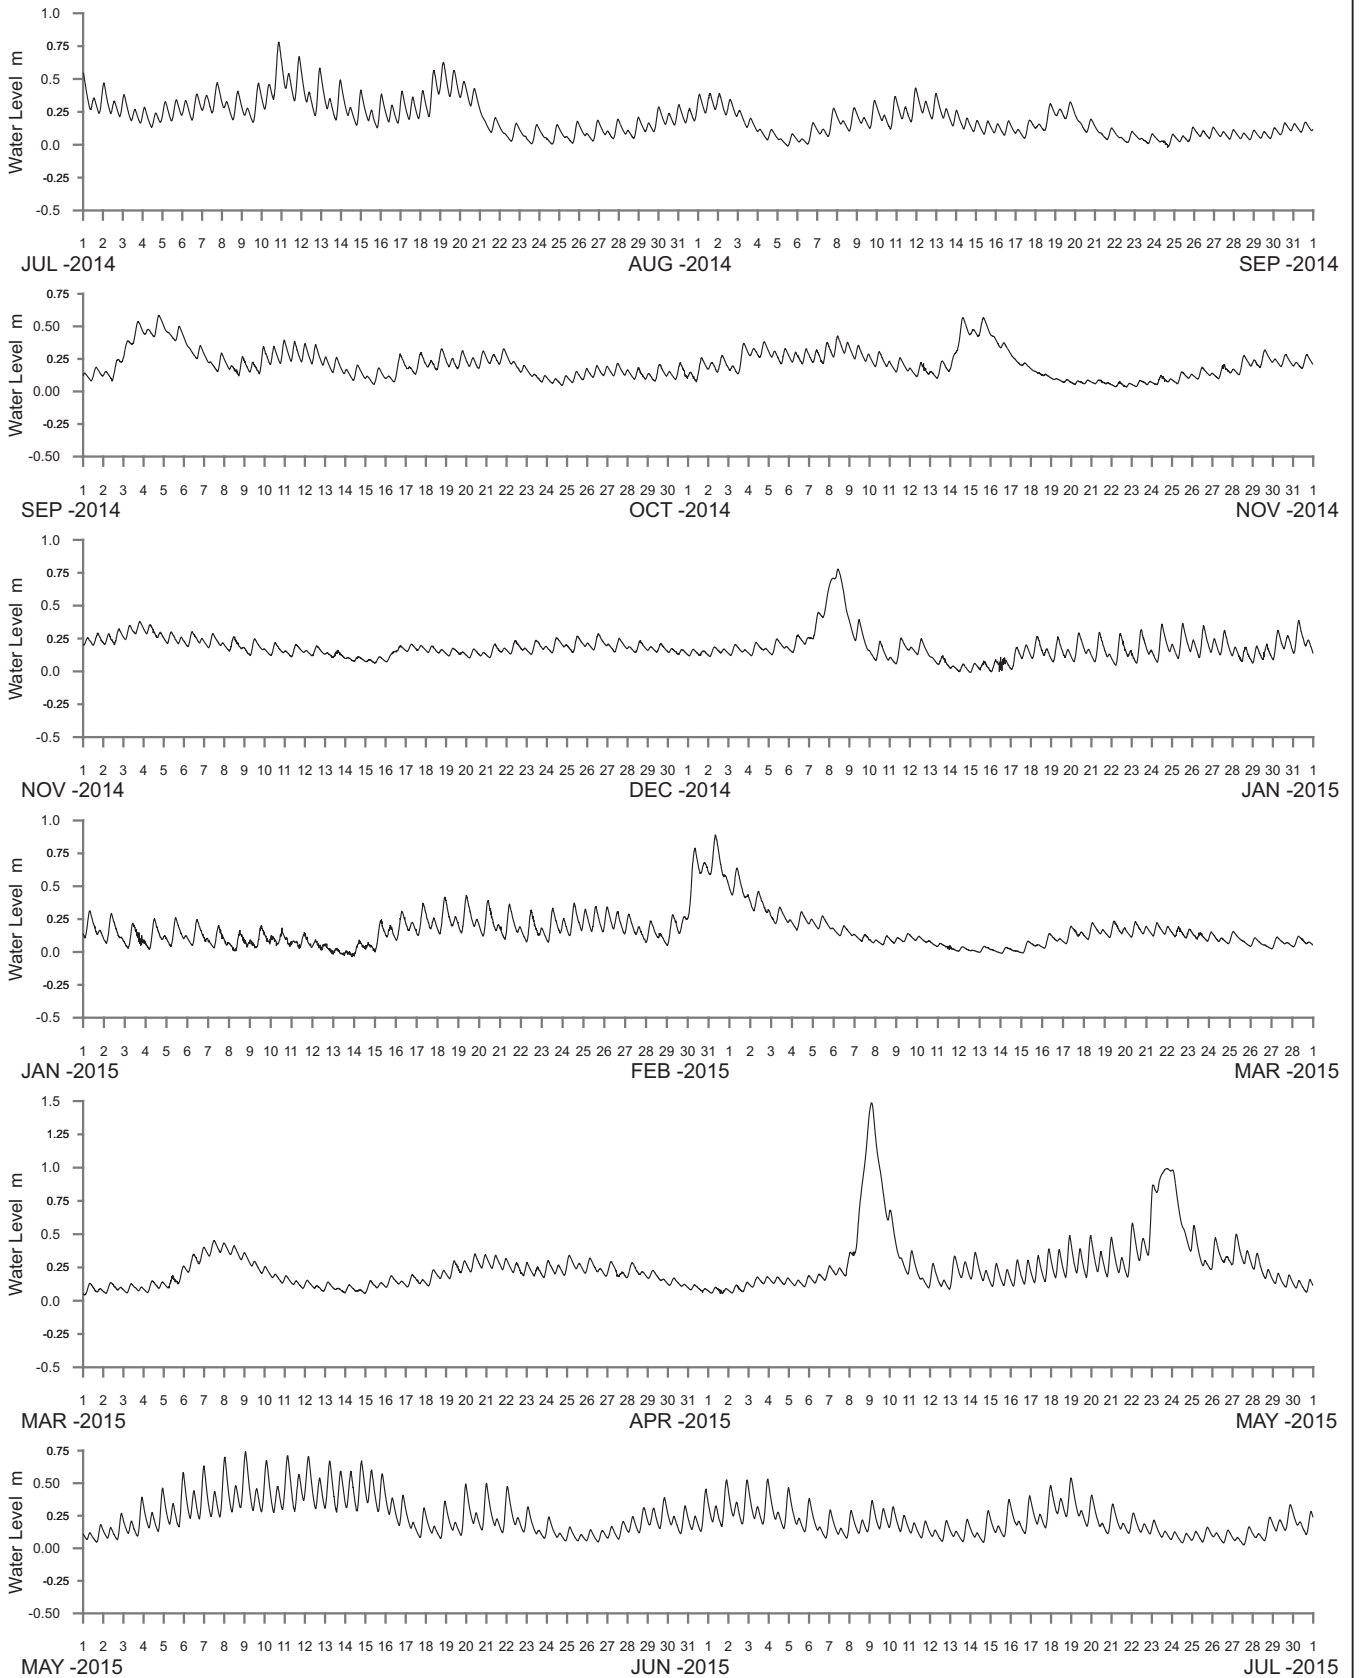
Figure
267

WATER LEVEL REFERENCED TO AUSTRALIAN HEIGHT DATUM

WONBOYN RIVER AT AGNEW WHARF
2014-2015
