**Public Works**  
Manly Hydraulics Laboratory

MHL  
Report 2383

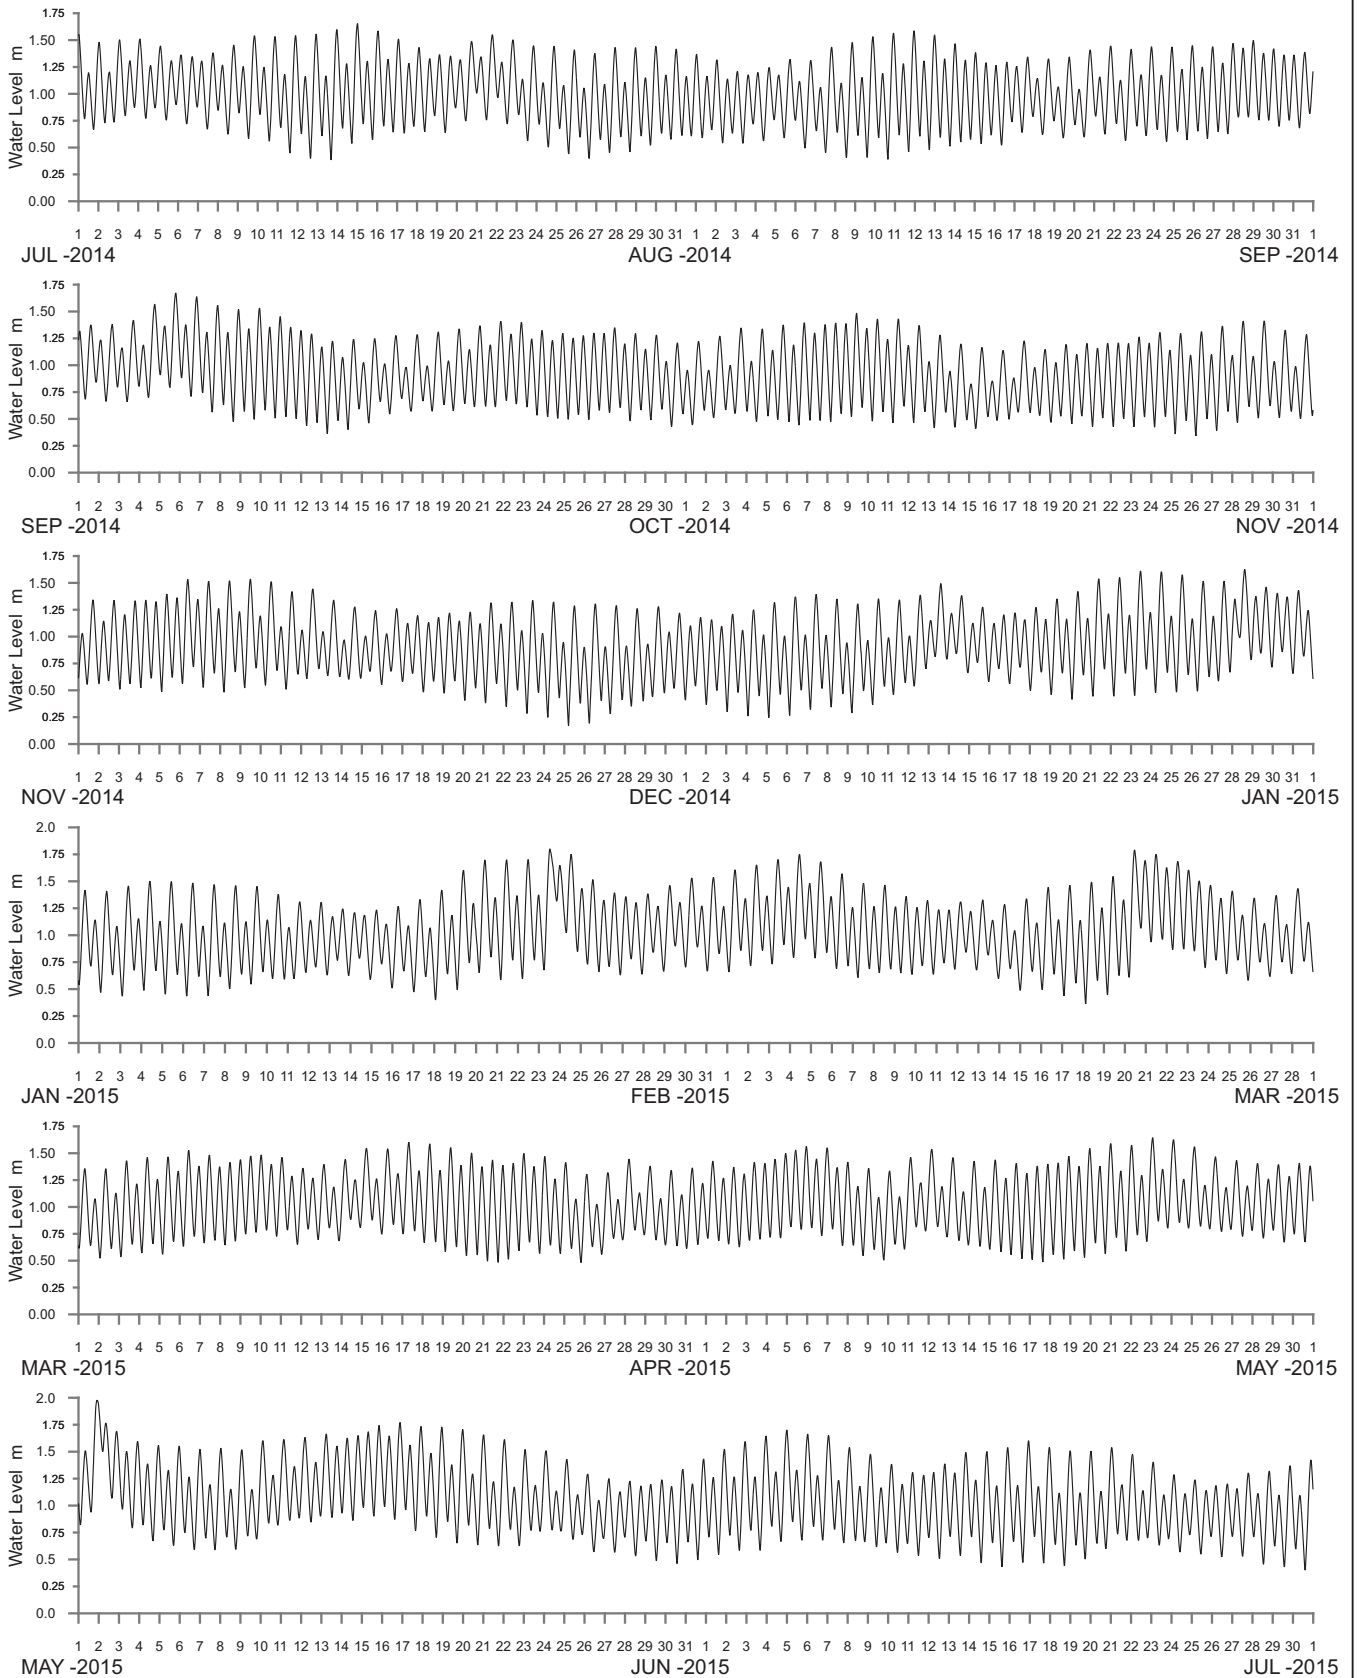
Figure  
7

WATER LEVEL REFERENCED TO TWEED RIVER HYDRO DATUM

**BROADWATER AT COBAKI**  
2014–2015

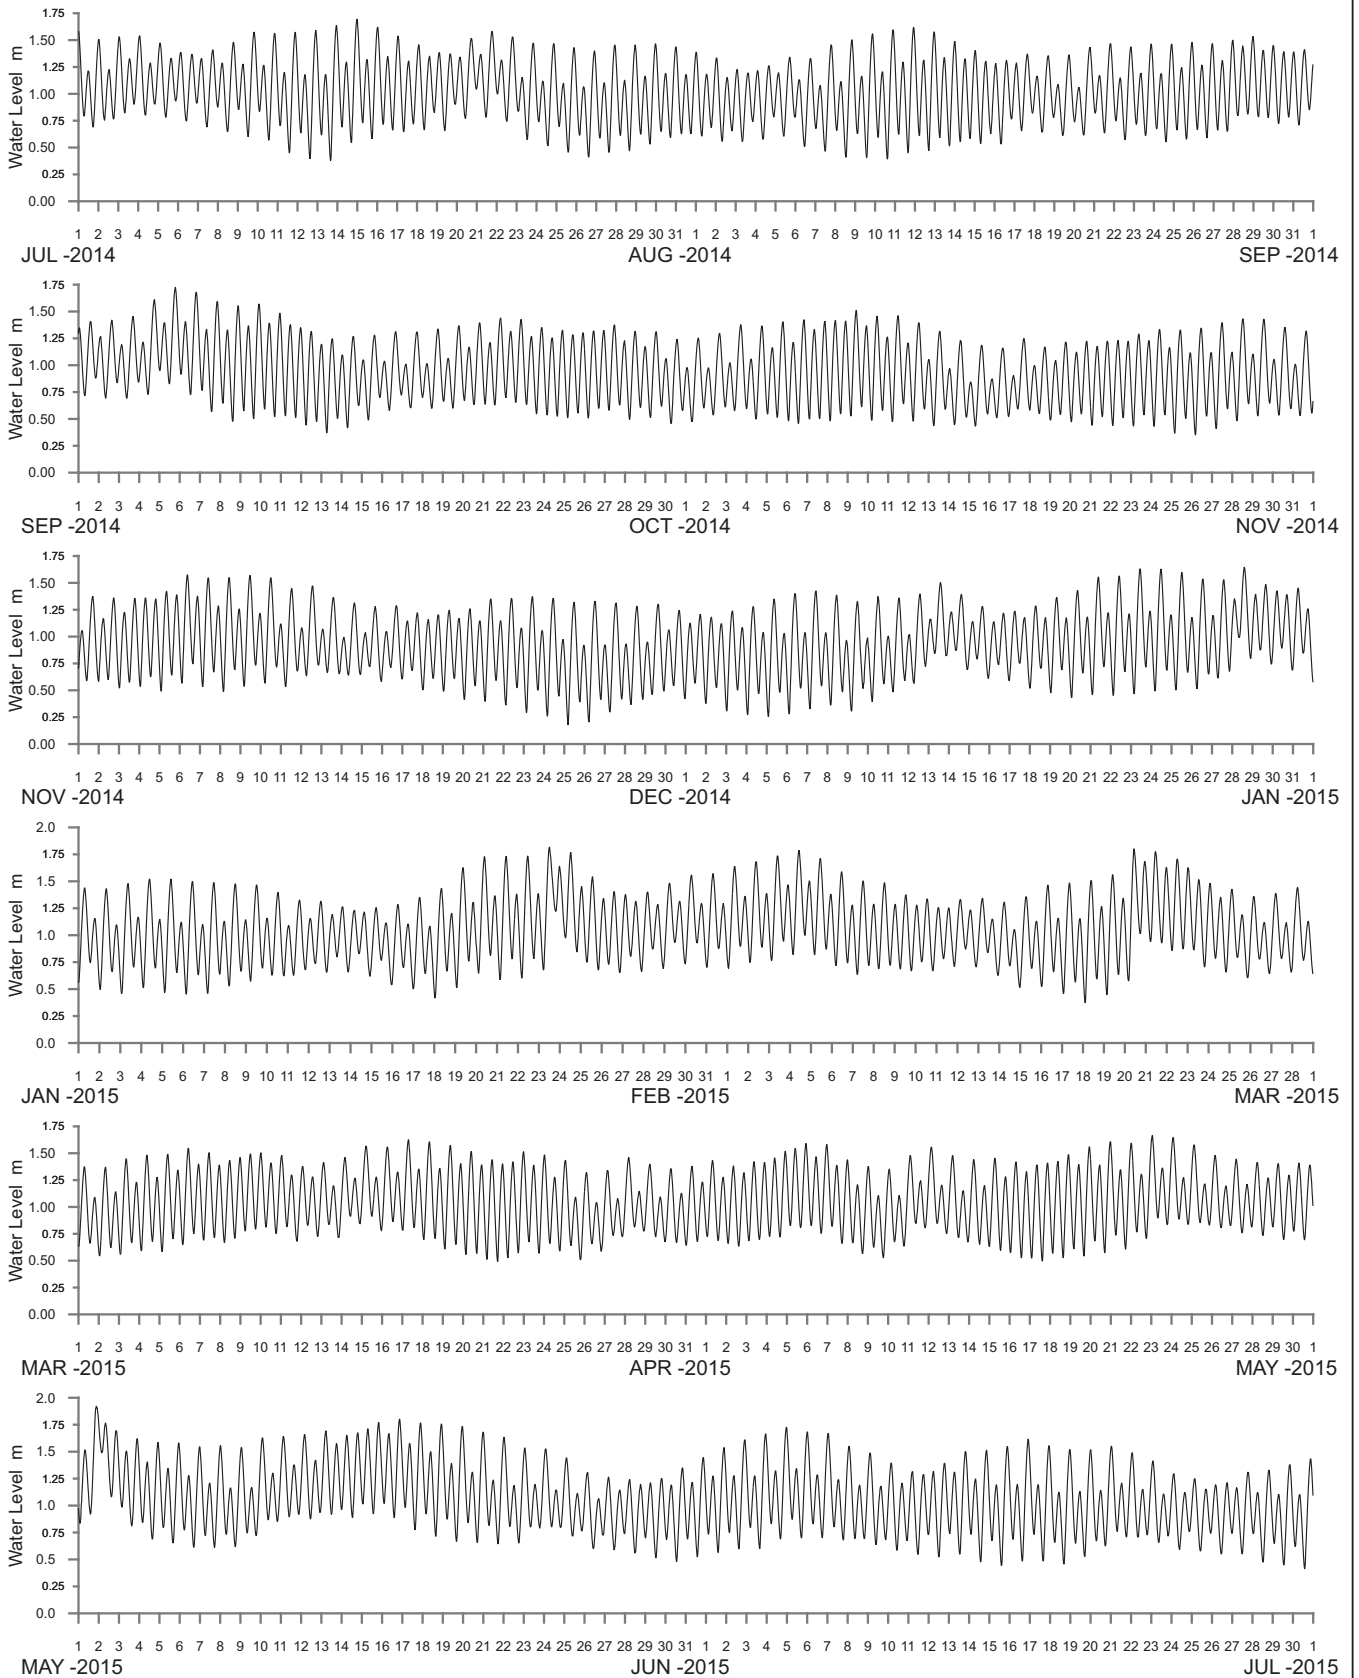
Figure  
**8**

WATER LEVEL REFERENCED TO TWEED RIVER HYDRO DATUM

**TERRANORA INLET AT DRY DOCK**  
2014–2015

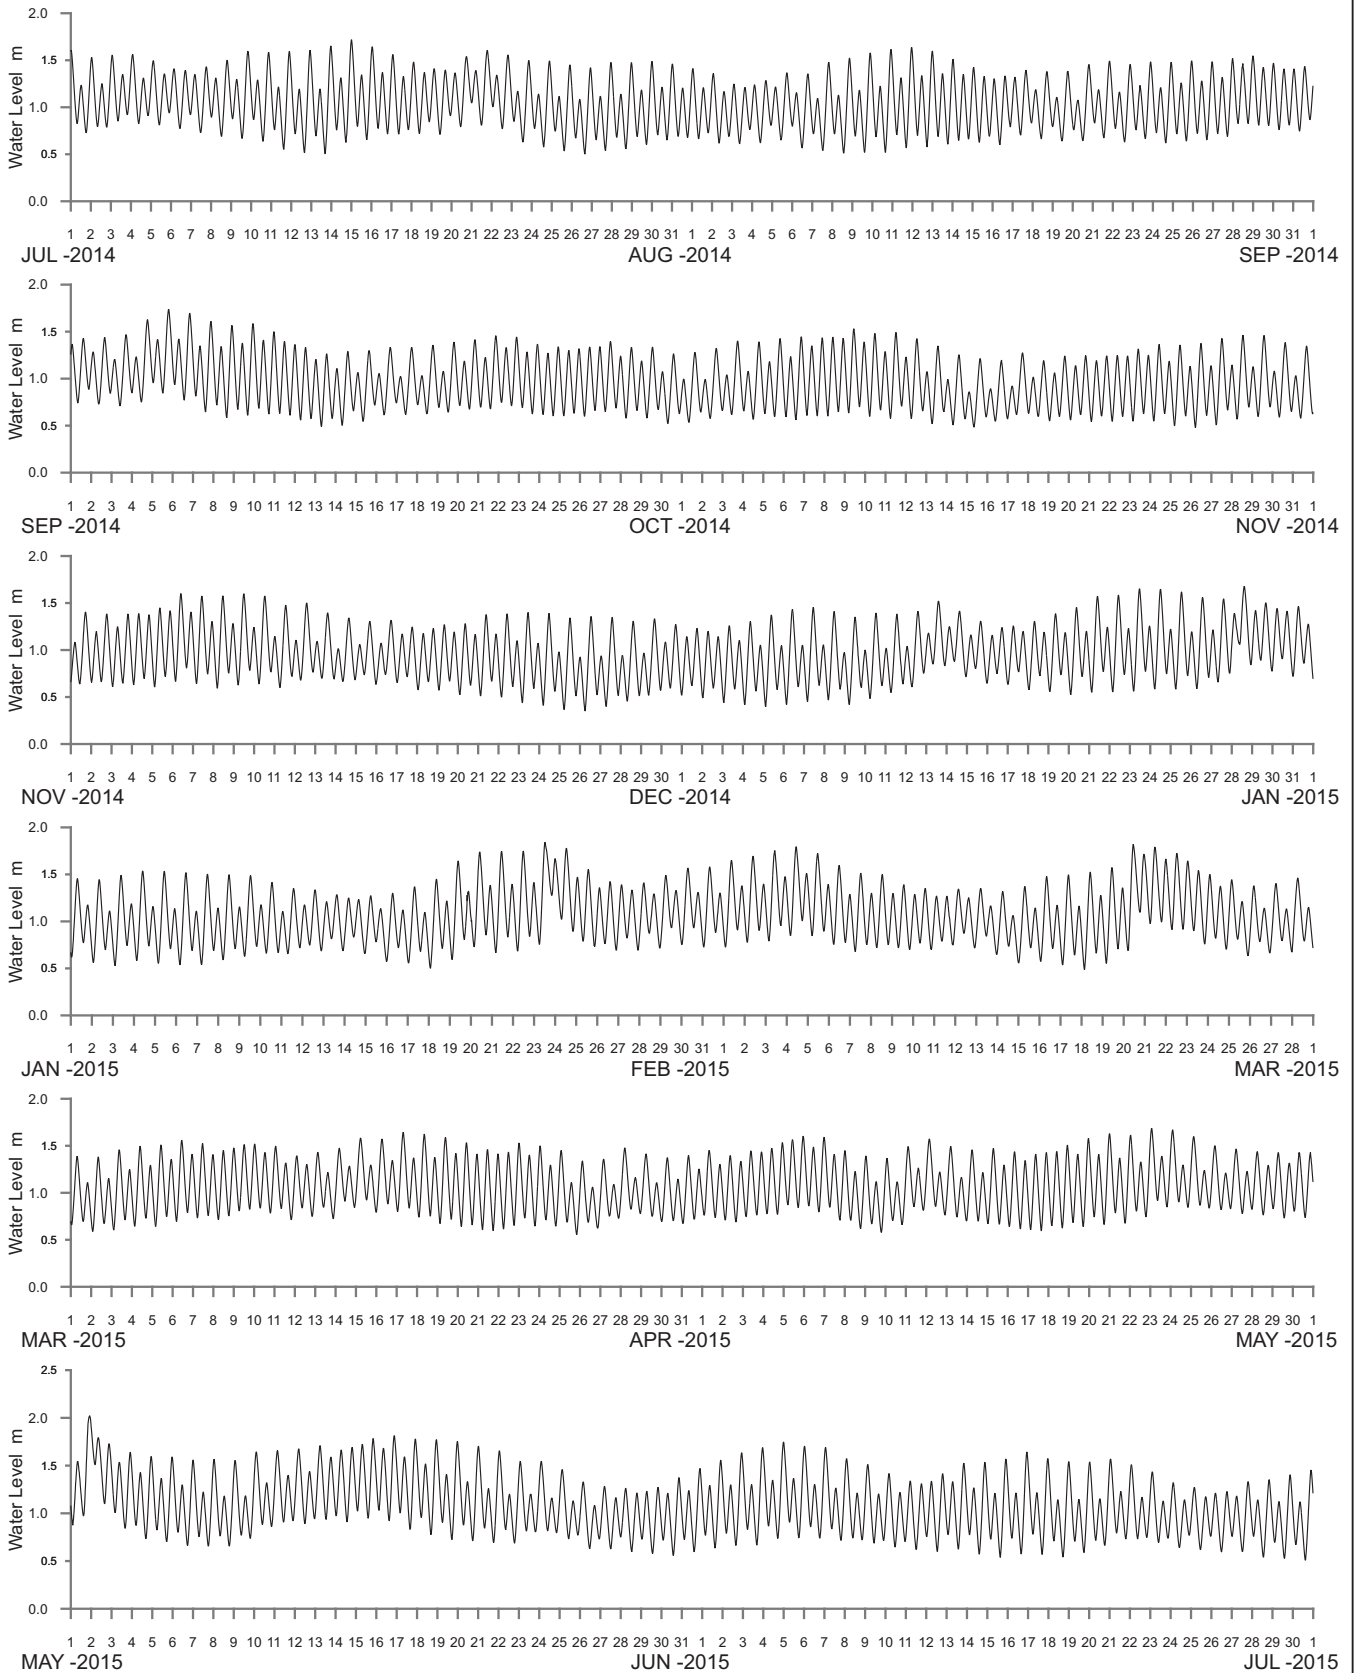
Figure  
9

WATER LEVEL REFERENCED TO TWEED RIVER HYDRO DATUM

**TERRANORA INLET AT TERRANORA**  
2014–2015

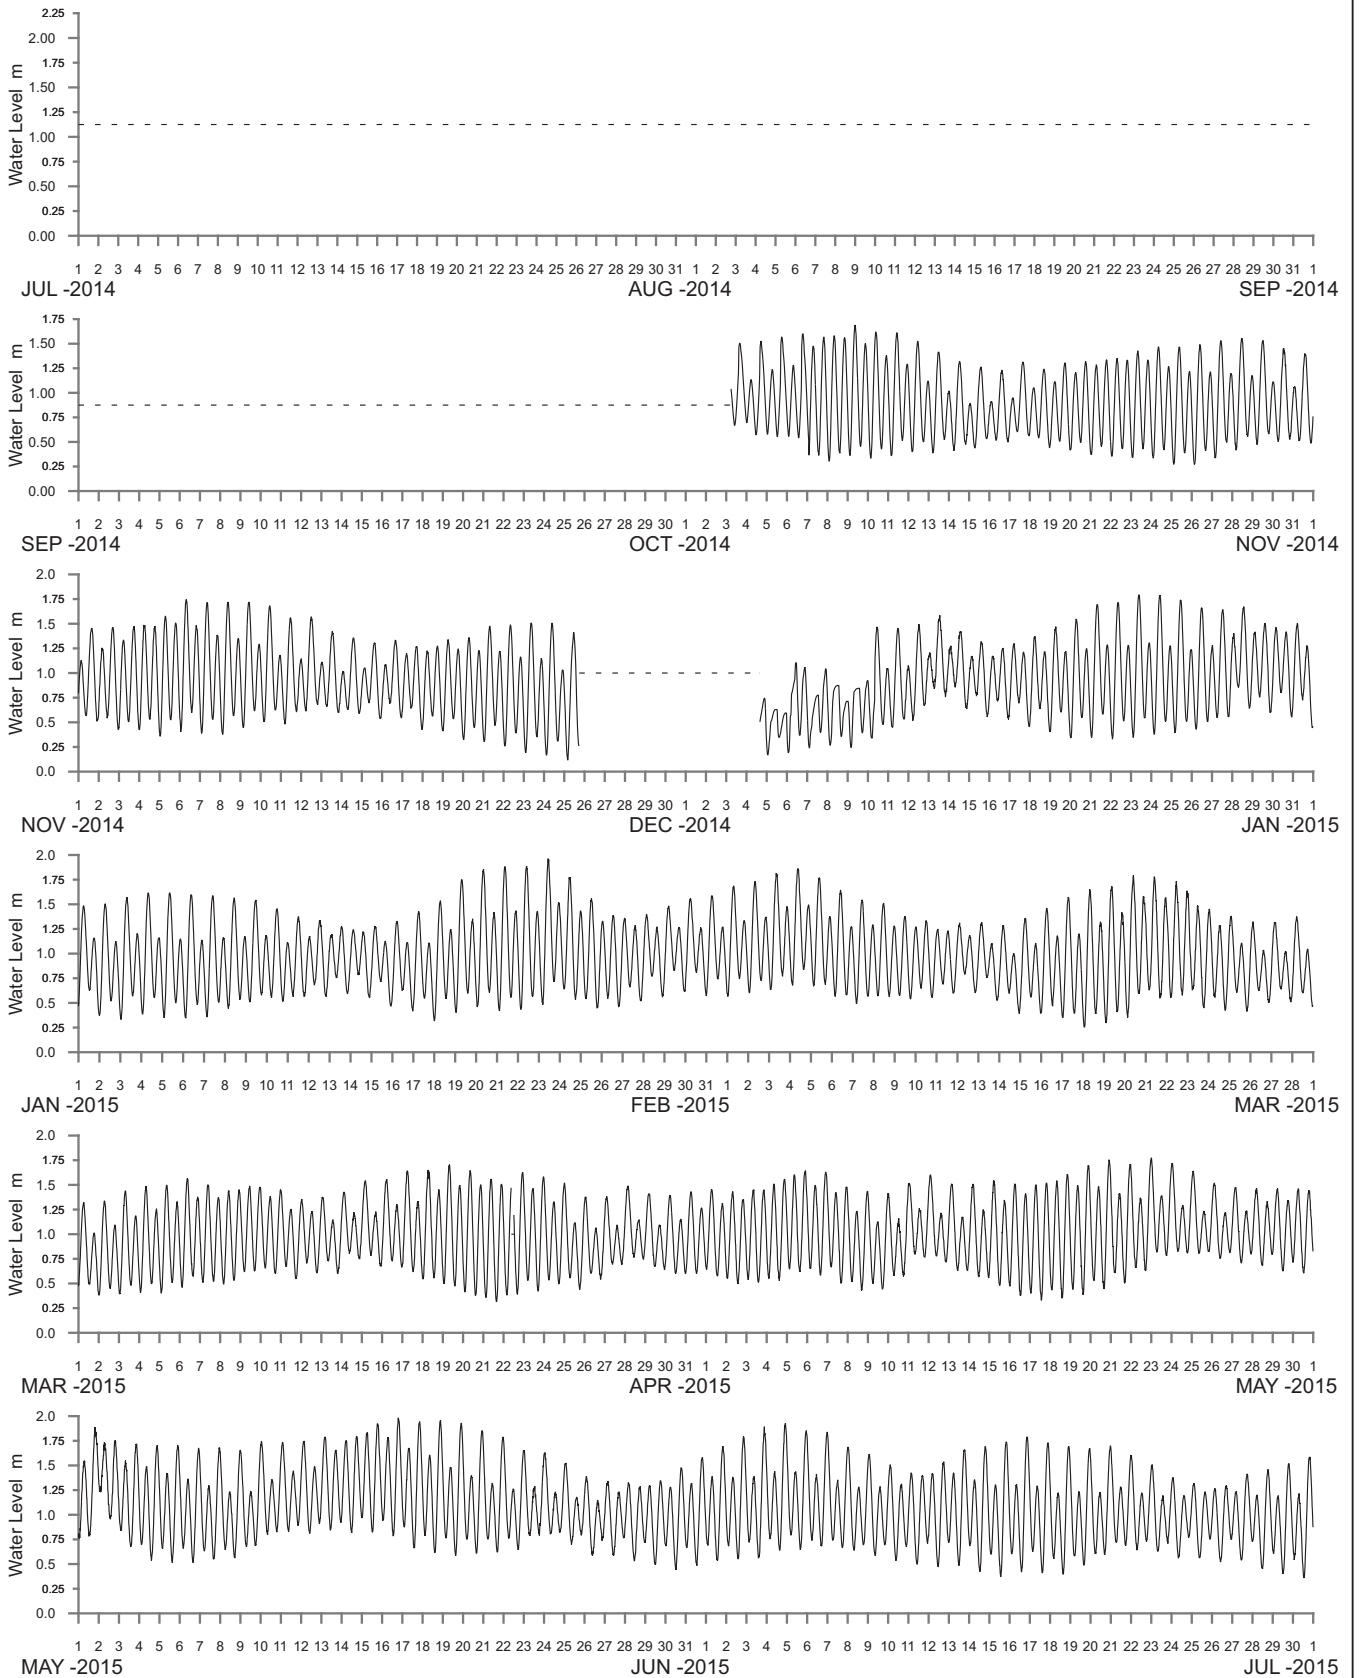
Figure  
10

WATER LEVEL REFERENCED TO TWEED RIVER HYDRO DATUM

**TWEED RIVER AT LETITIA 2A**  
2014-2015

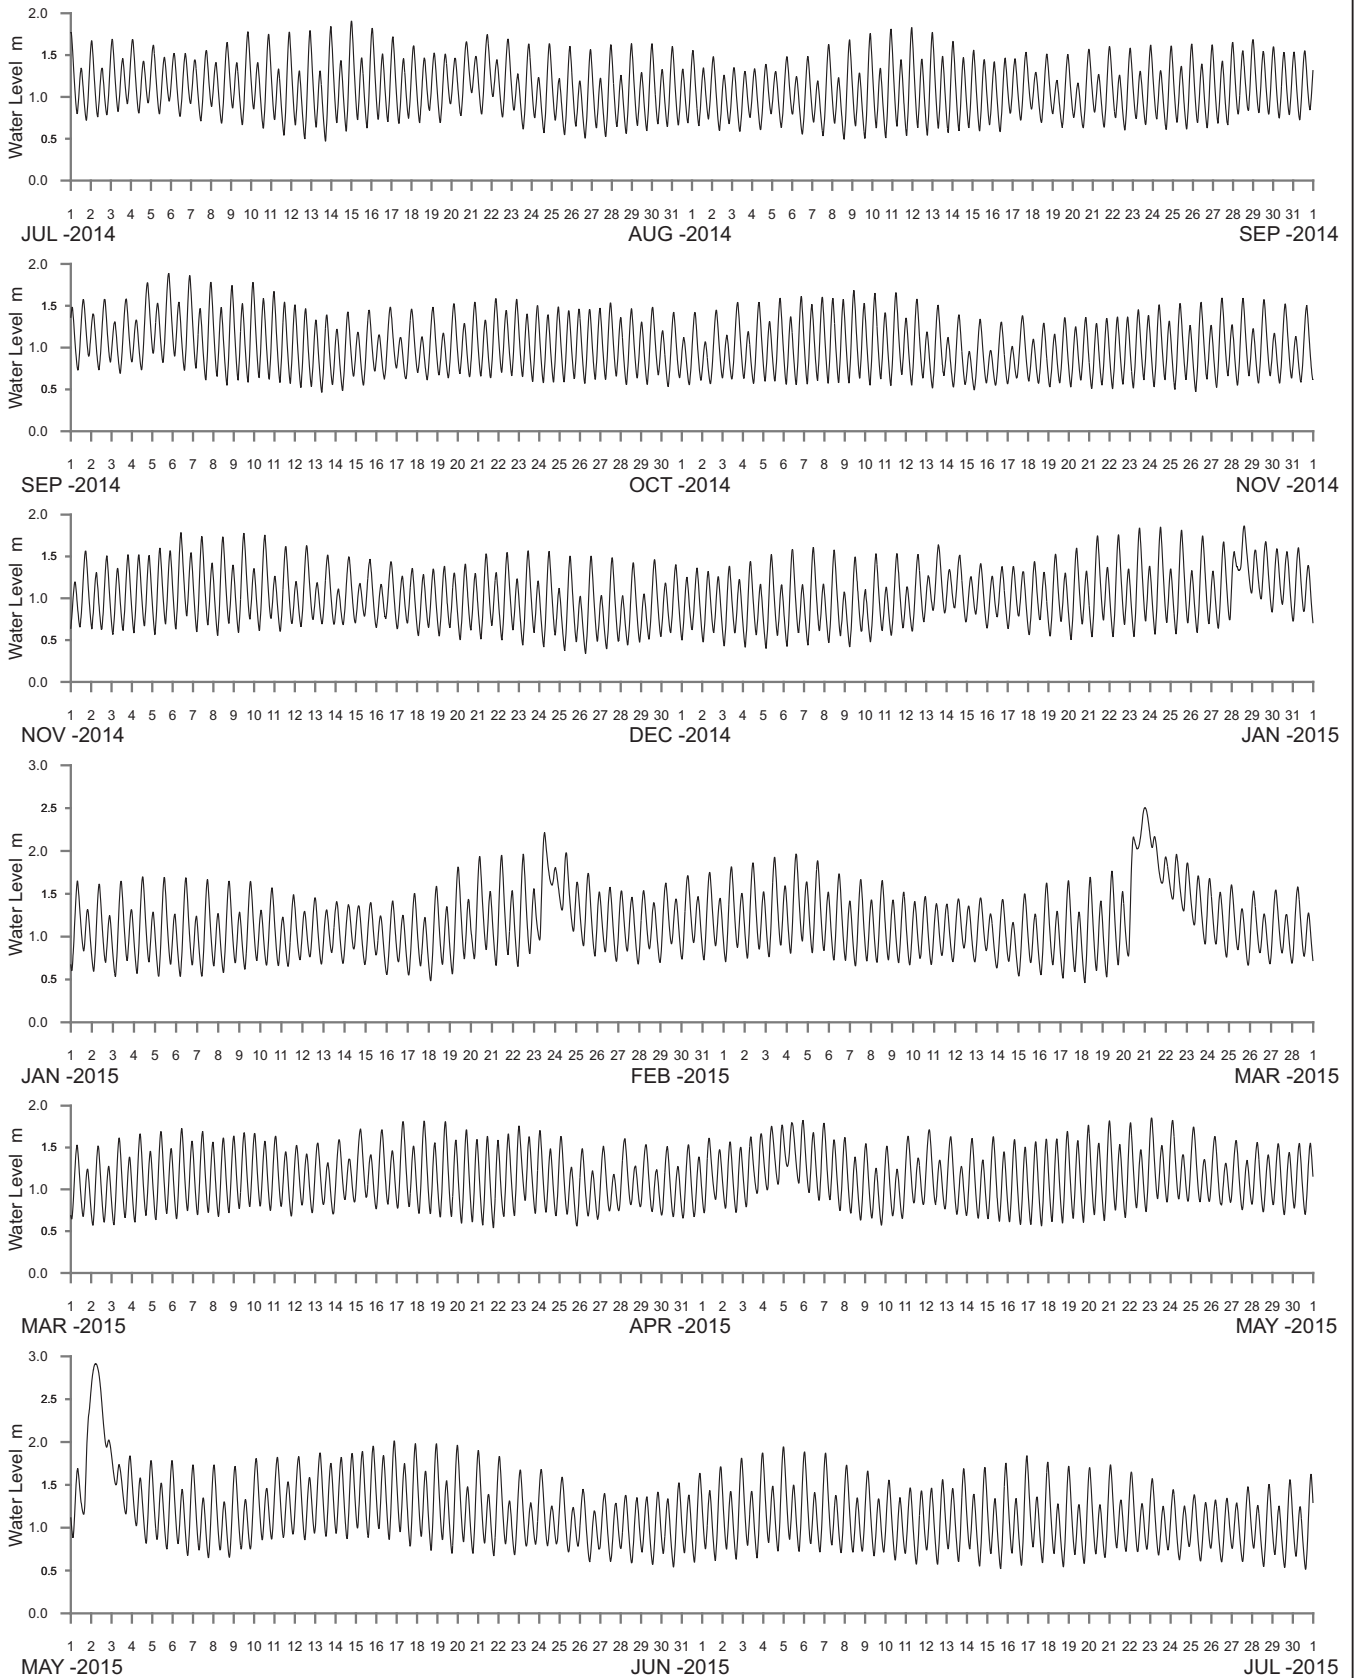
Figure  
12

WATER LEVEL REFERENCED TO TWEED RIVER HYDRO DATUM

**TWEED RIVER AT TUMBULGUM**  
2014–2015

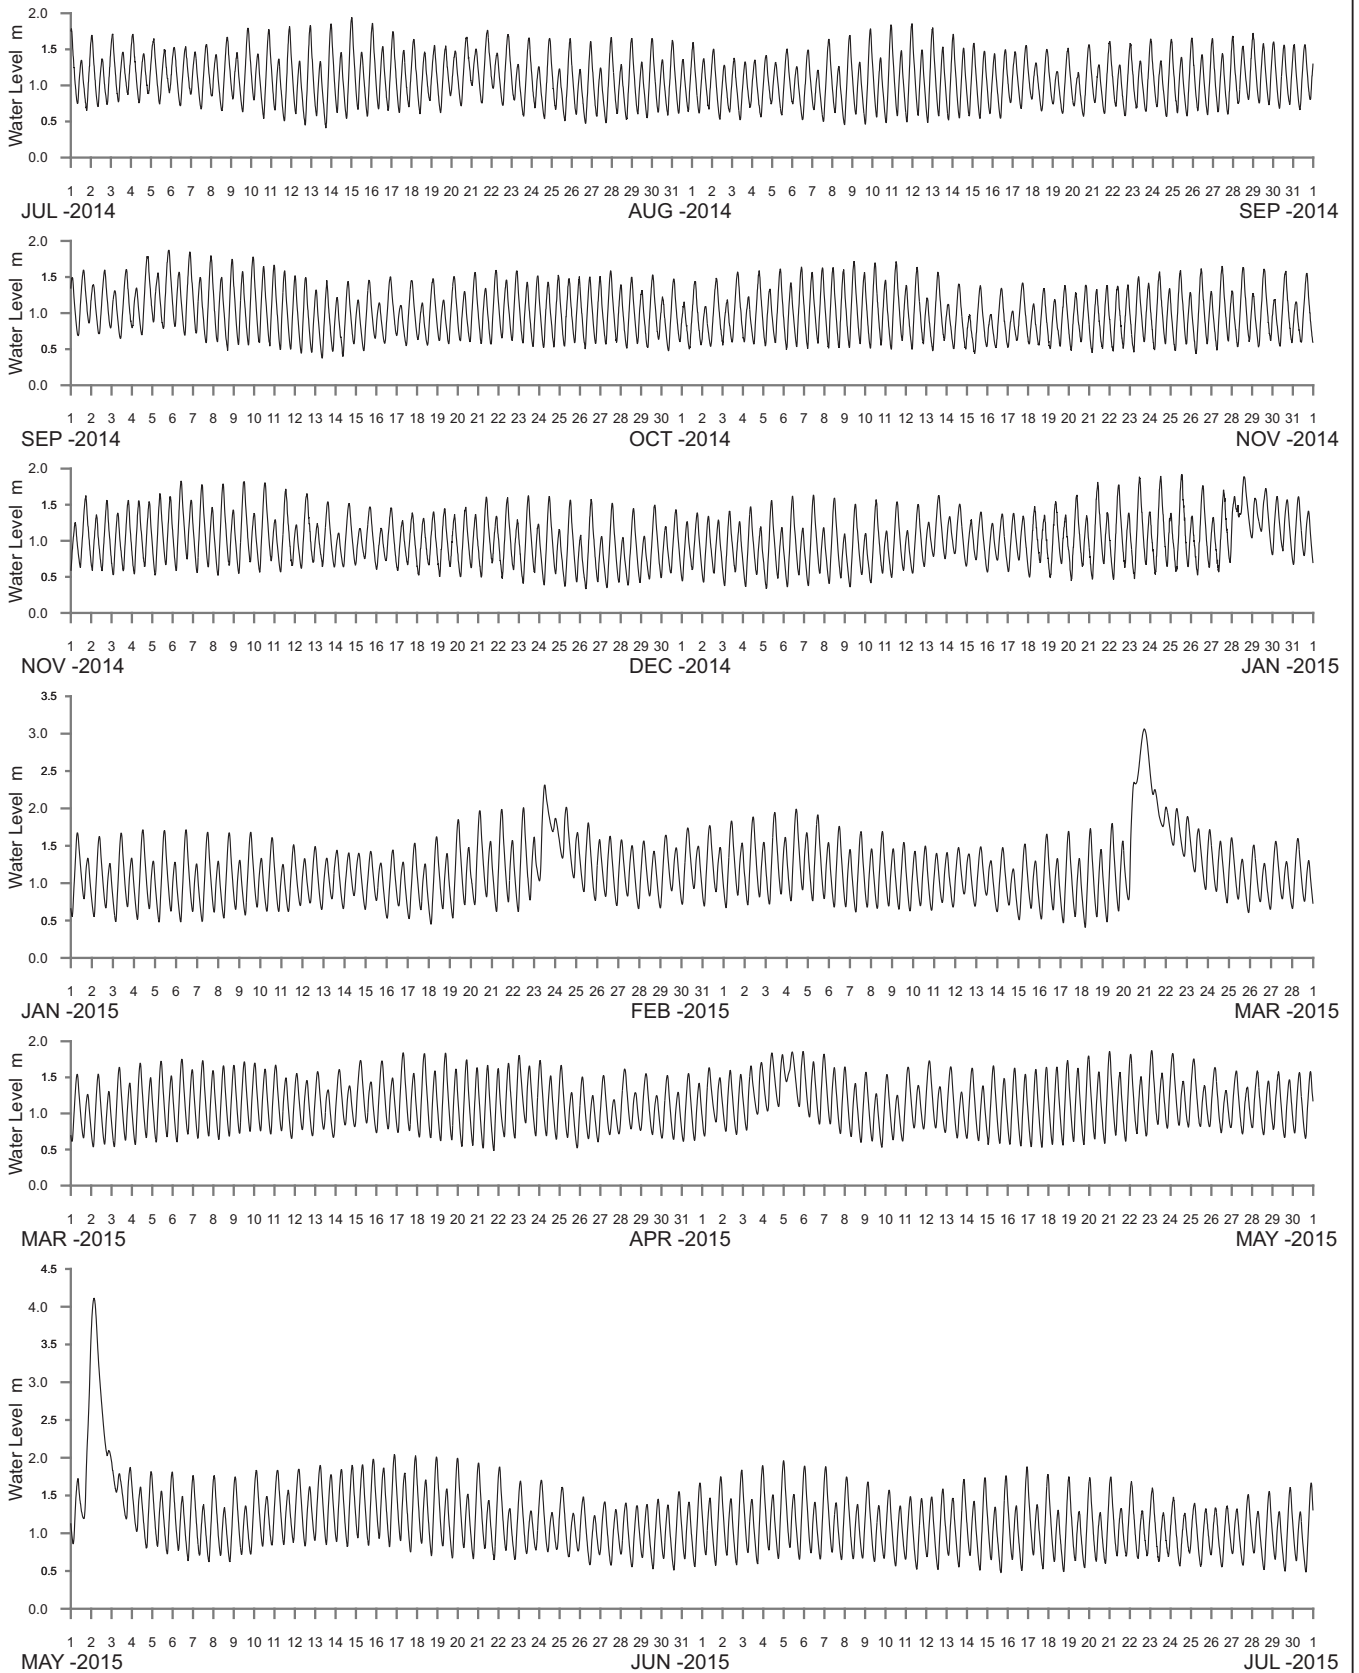
Figure  
13

WATER LEVEL REFERENCED TO TWEED RIVER HYDRO DATUM

**TWEED RIVER AT NORTH MURWILLUMBAH**  
2014–2015

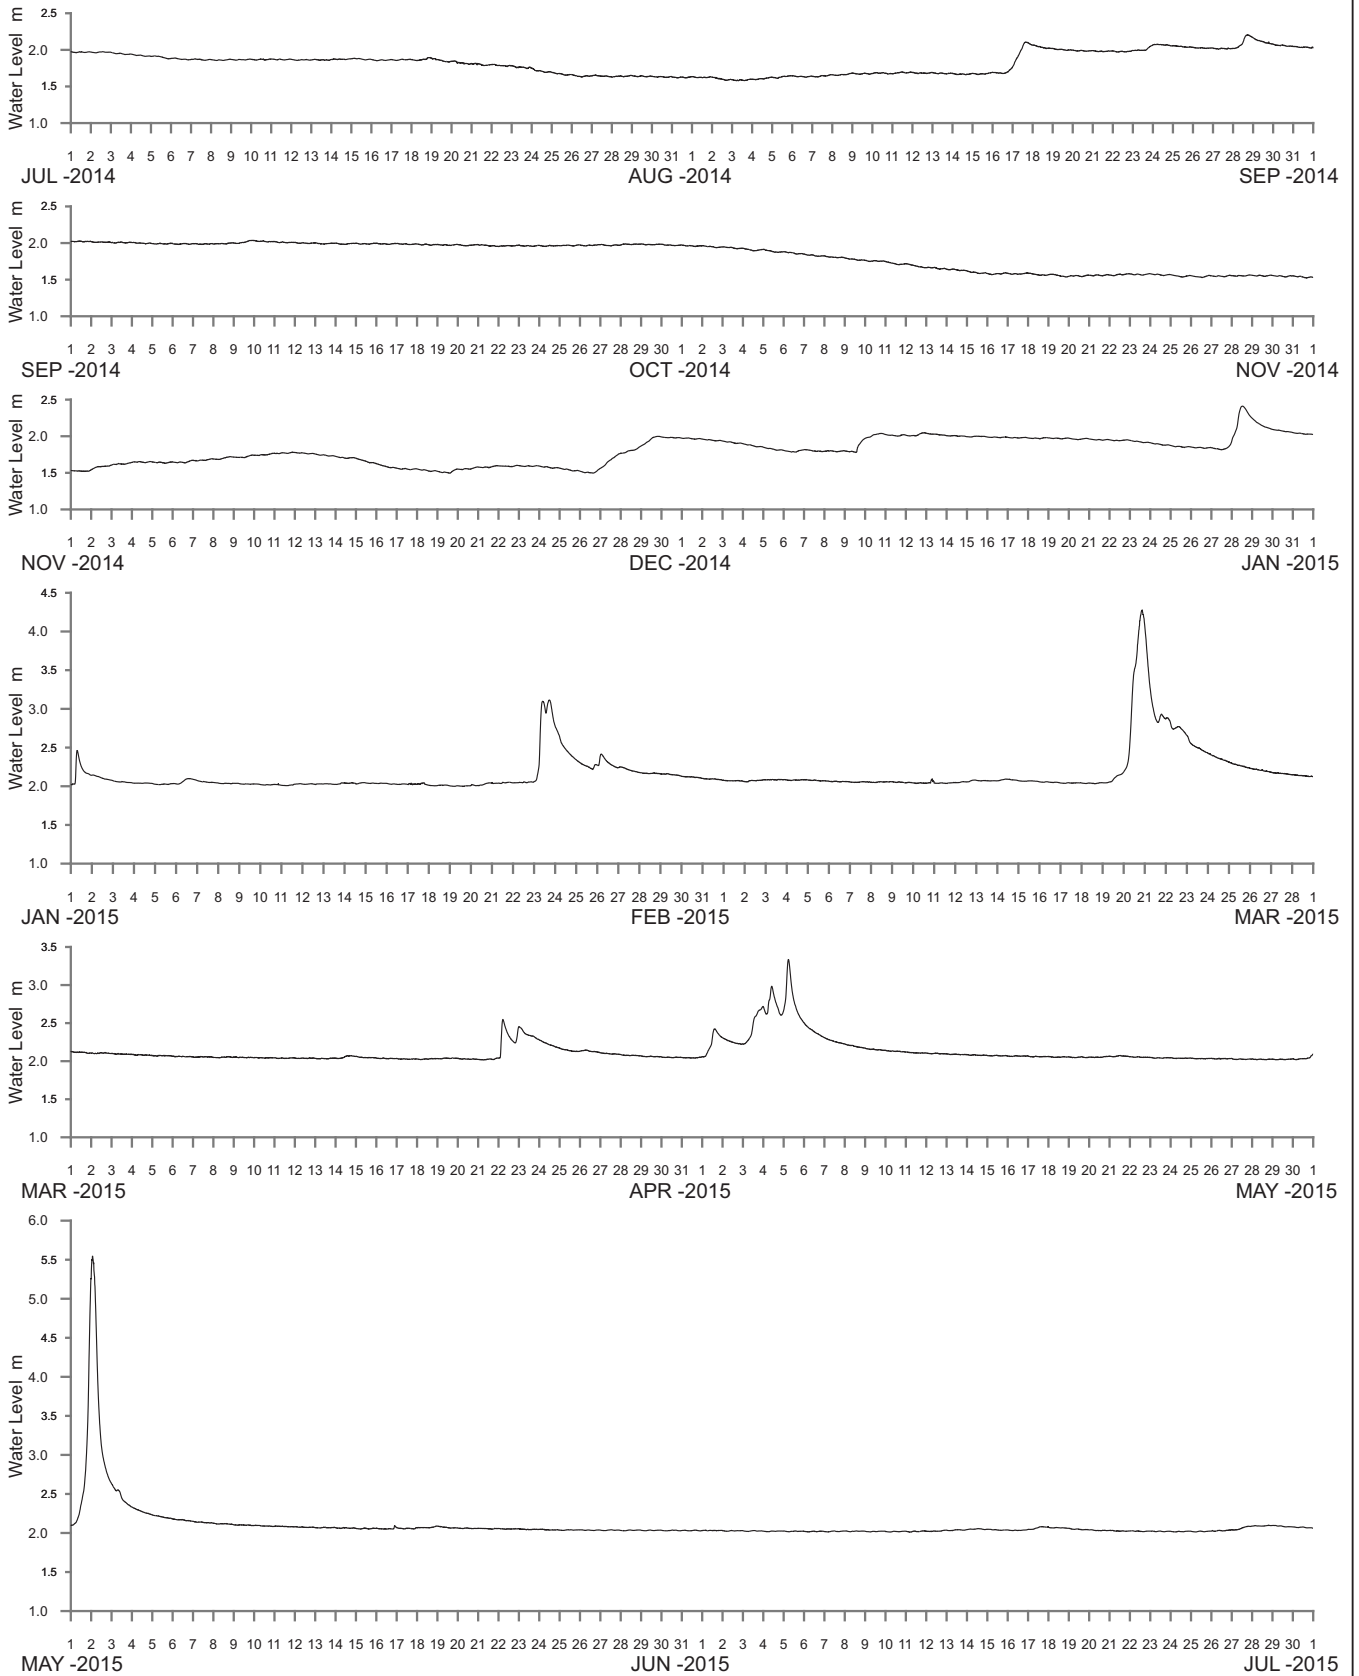
Figure  
14

WATER LEVEL REFERENCED TO TWEED RIVER HYDRO DATUM

**TWEED RIVER AT BRAY PARK WEIR**  
2014-2015

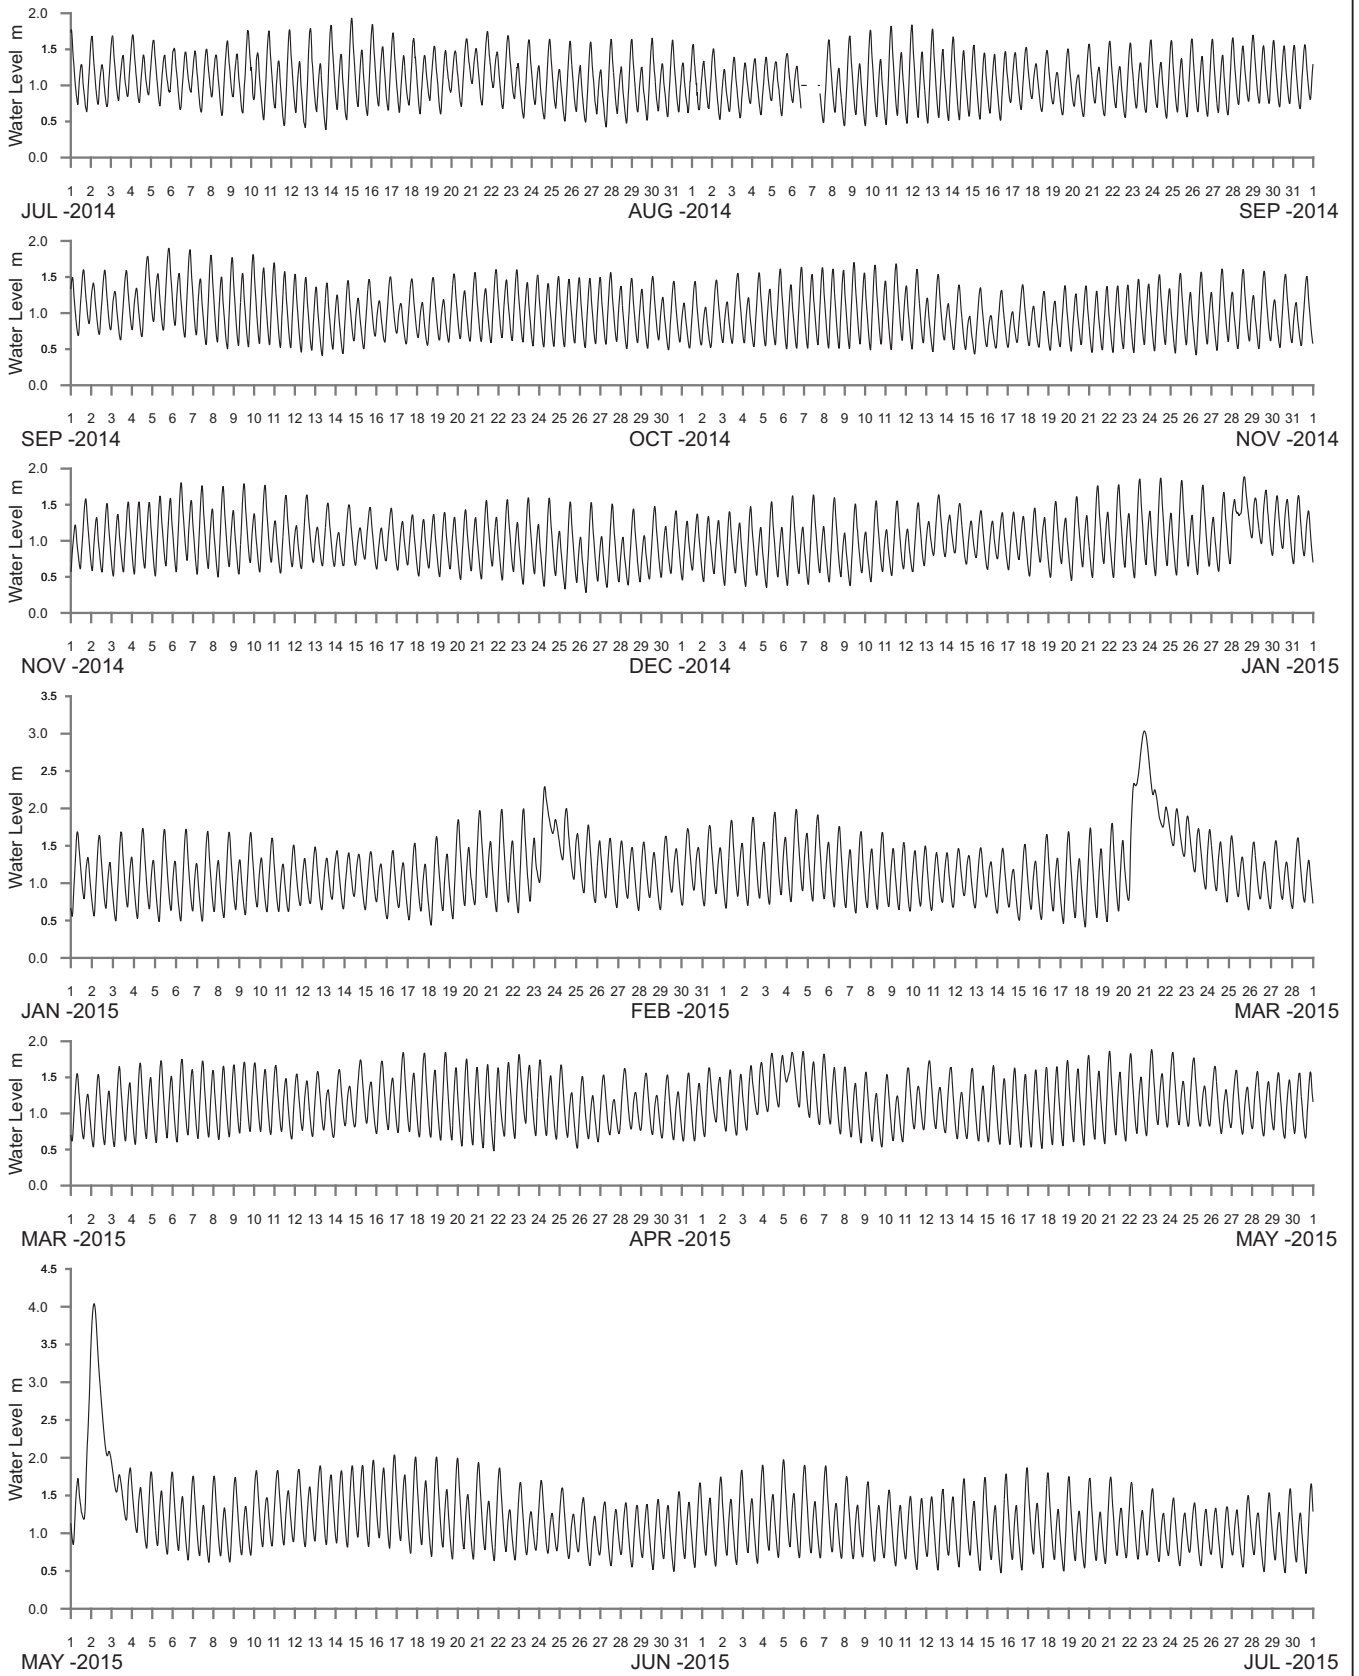
Figure  
**15**

WATER LEVEL REFERENCED TO TWEED RIVER HYDRO DATUM

**TWEED RIVER AT MURWILLUMBAH BRIDGE**  
2014–2015

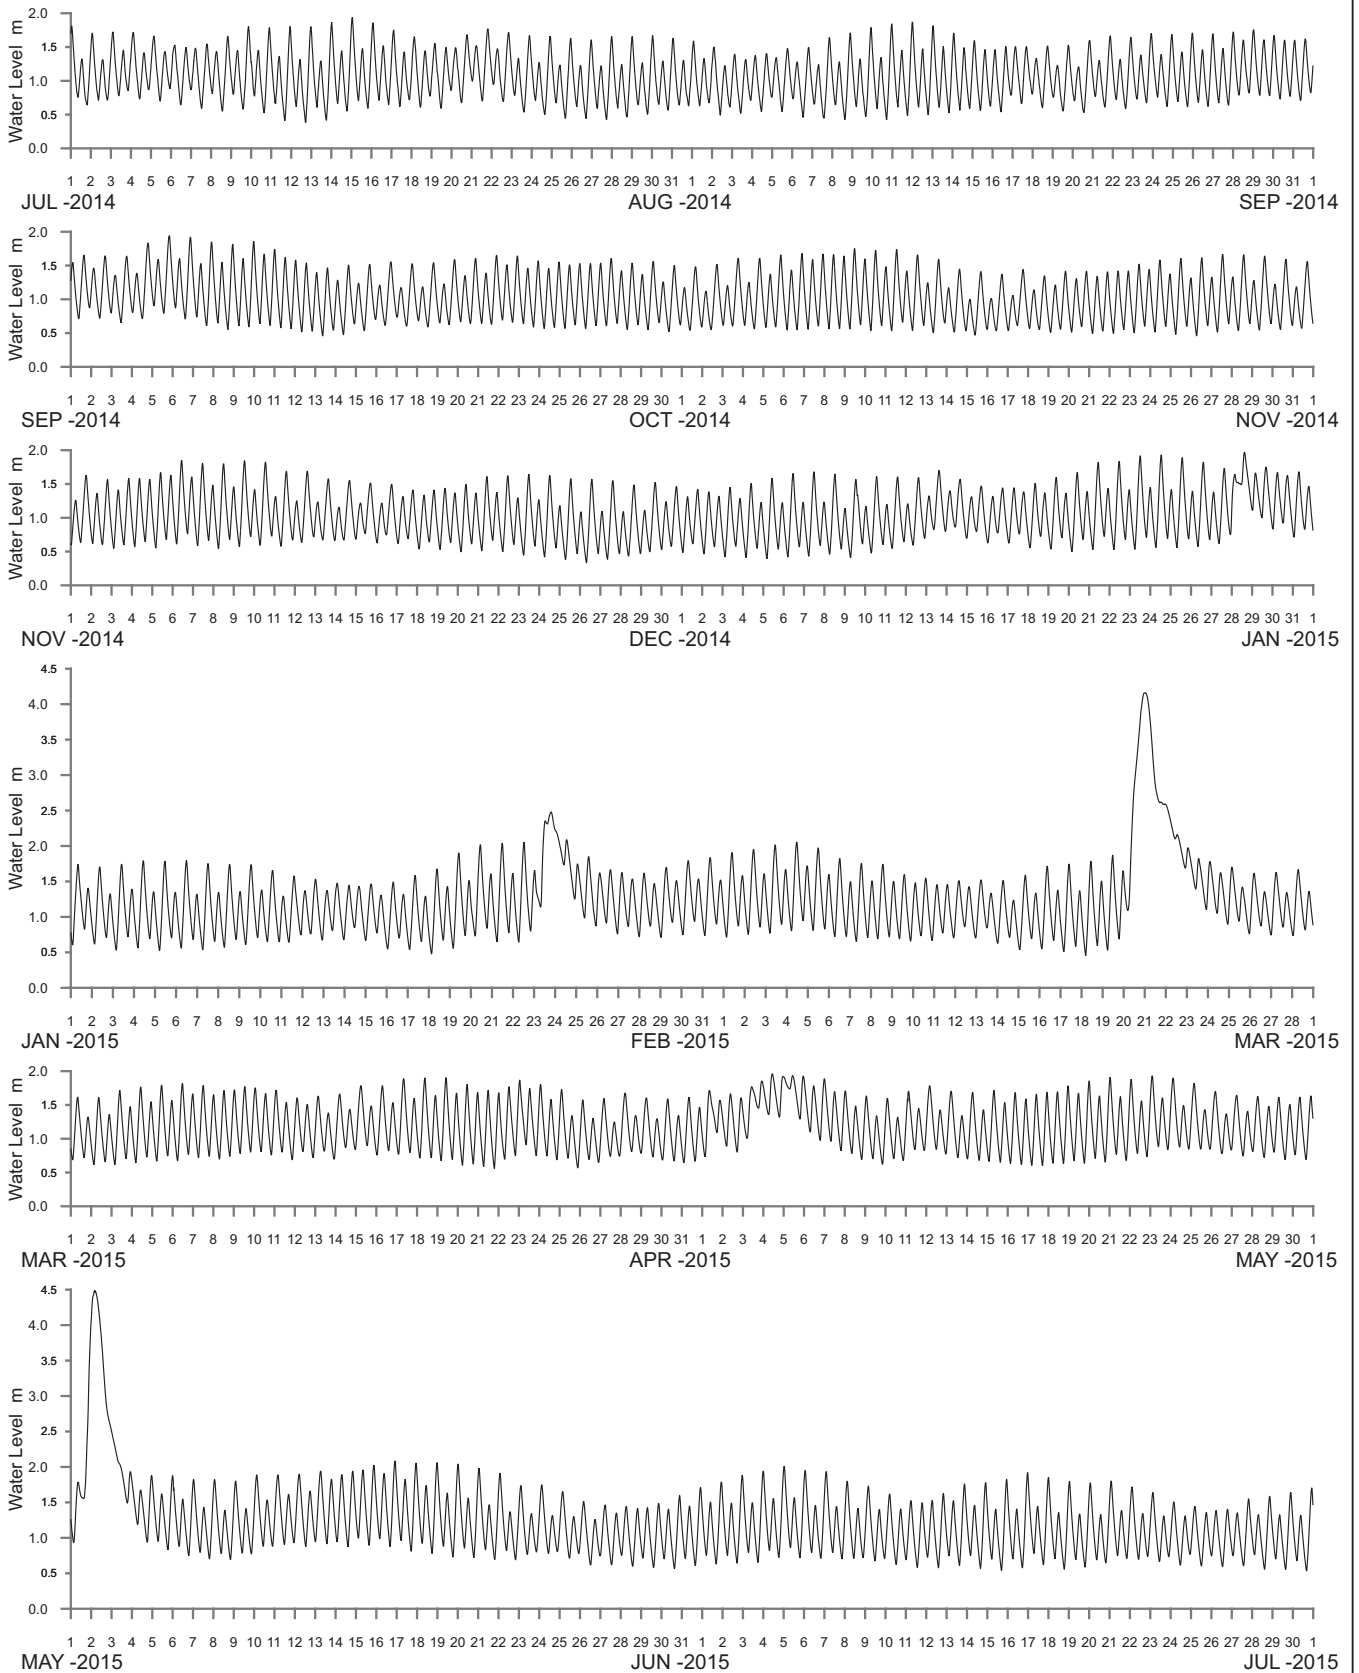
Figure  
16

WATER LEVEL REFERENCED TO TWEED RIVER HYDRO DATUM

**ROUS RIVER AT KYNNUMBOON**  
2014–2015

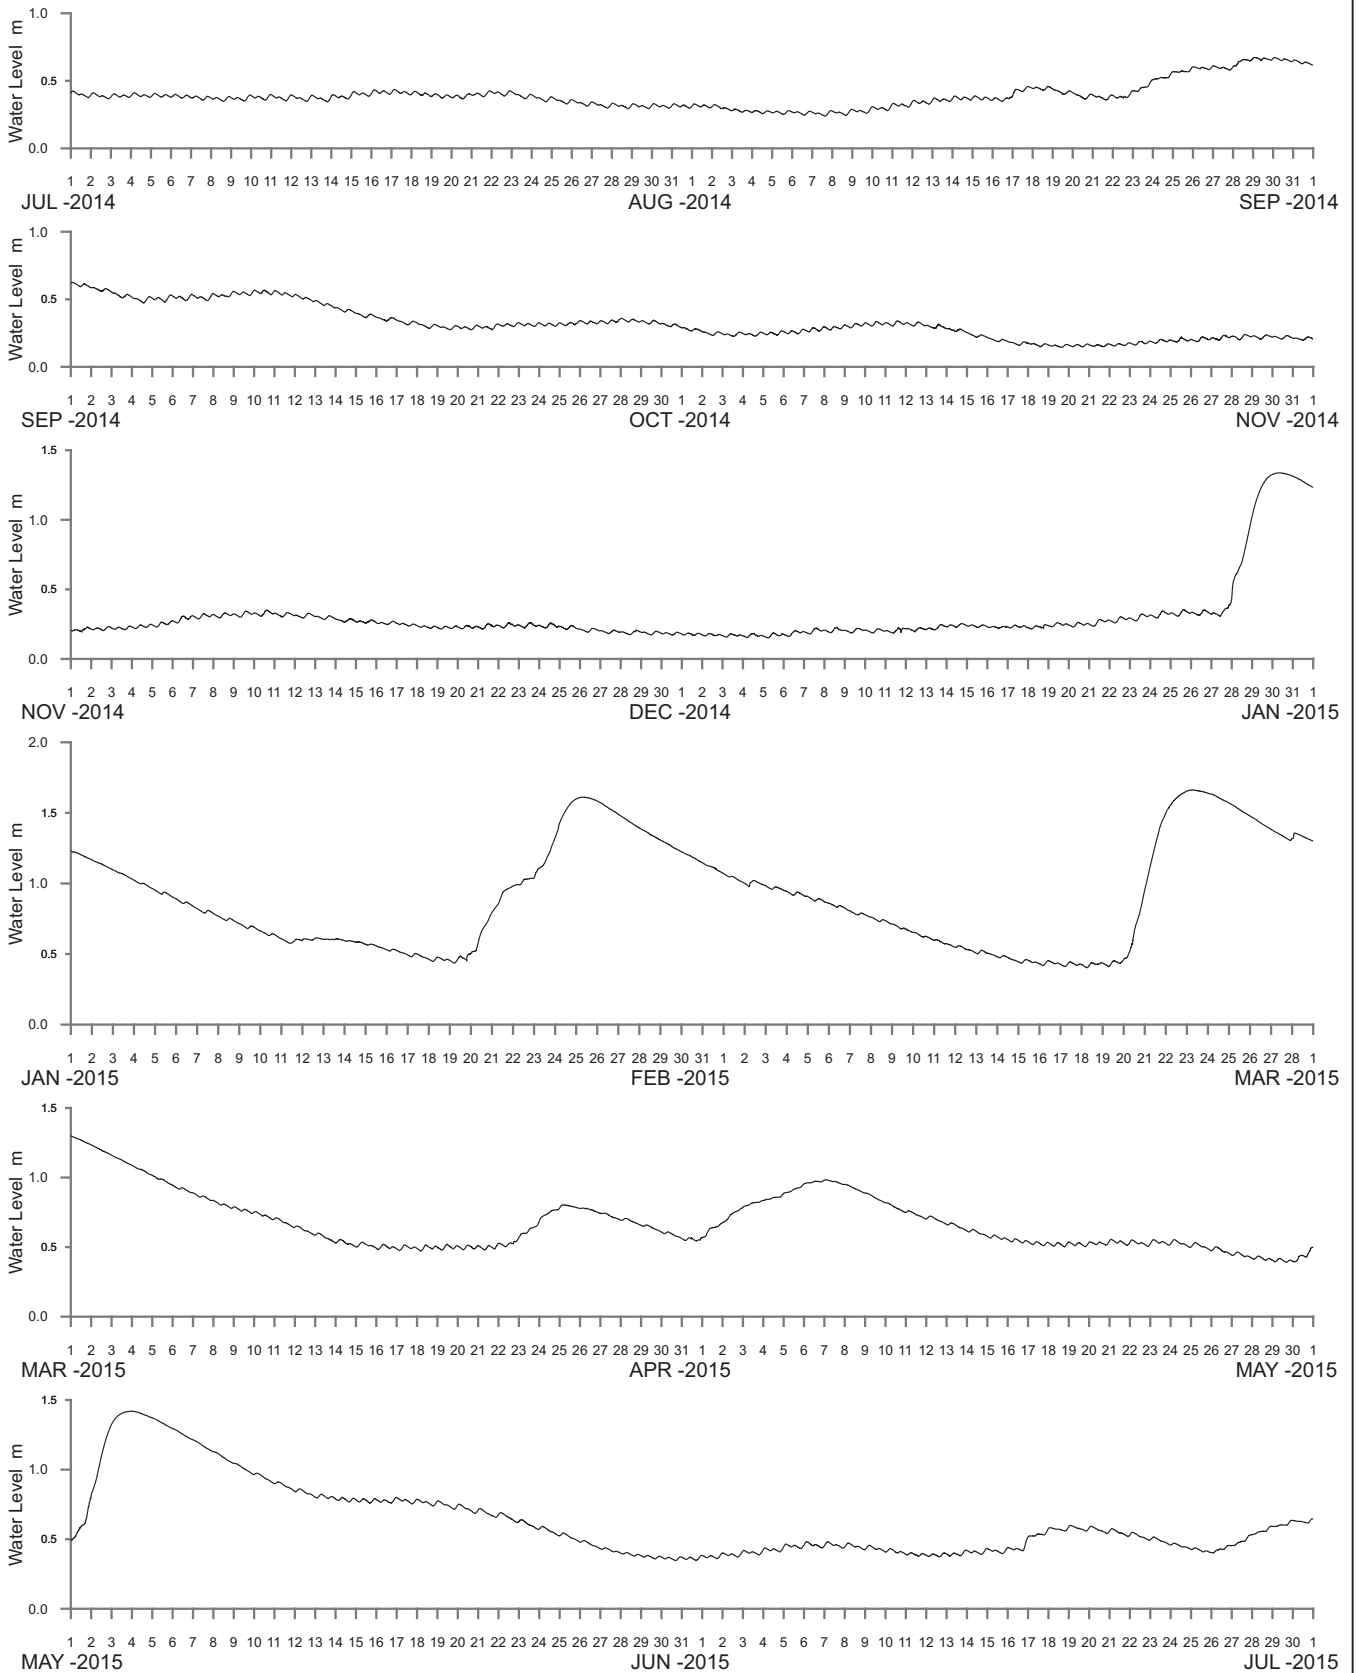
Figure  
17

WATER LEVEL REFERENCED TO BRUNSWICK RIVER FLOOD MITIGATION DATUM

**CUDGEN LAKE AT BOGANGAR**  
2014-2015
