**Public Works**  
Manly Hydraulics Laboratory

MHL  
Report 2383

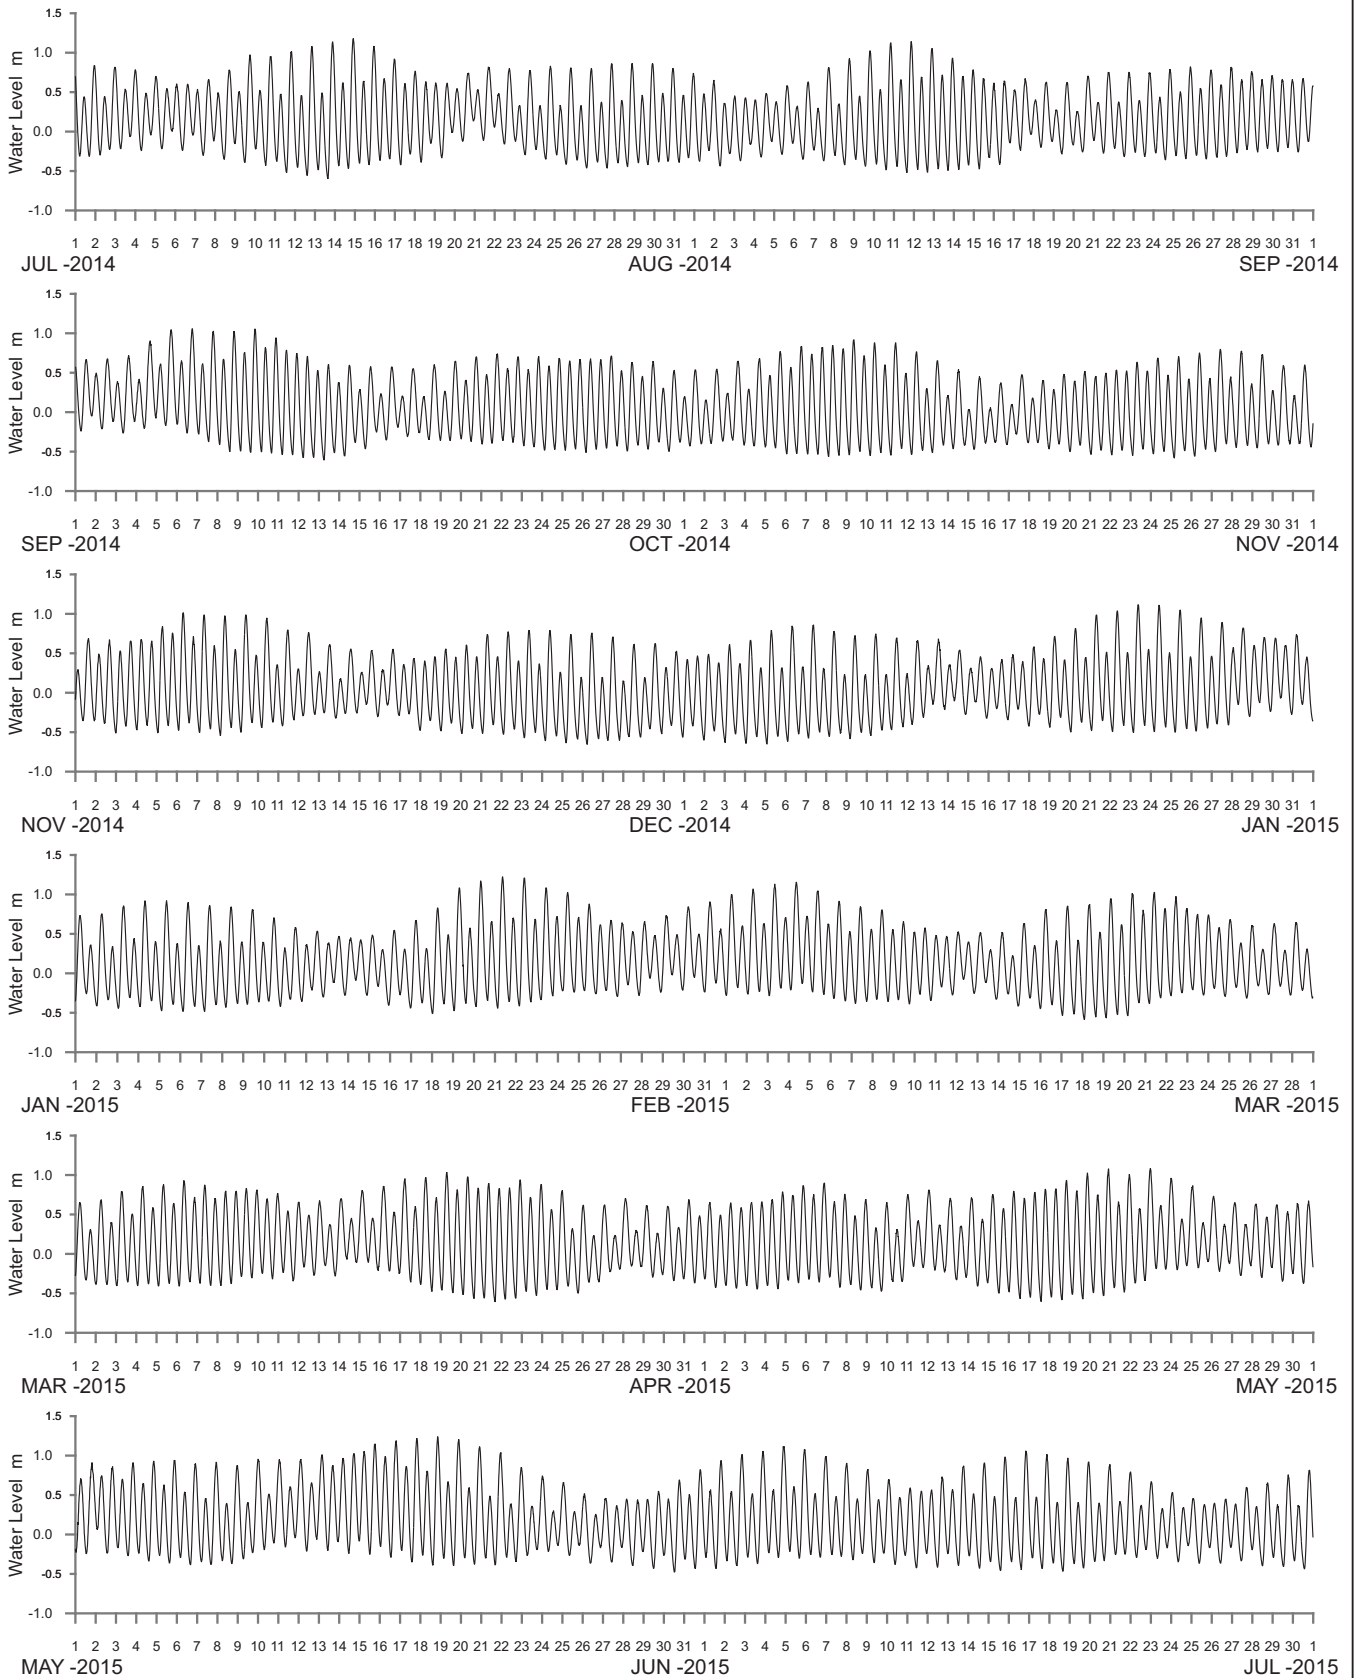
Figure  
**18**

WATER LEVEL REFERENCED TO BRUNSWICK RIVER FLOOD MITIGATION DATUM

**CUDGEN CREEK AT KINGSCLIFF UPSTREAM  
2014–2015**

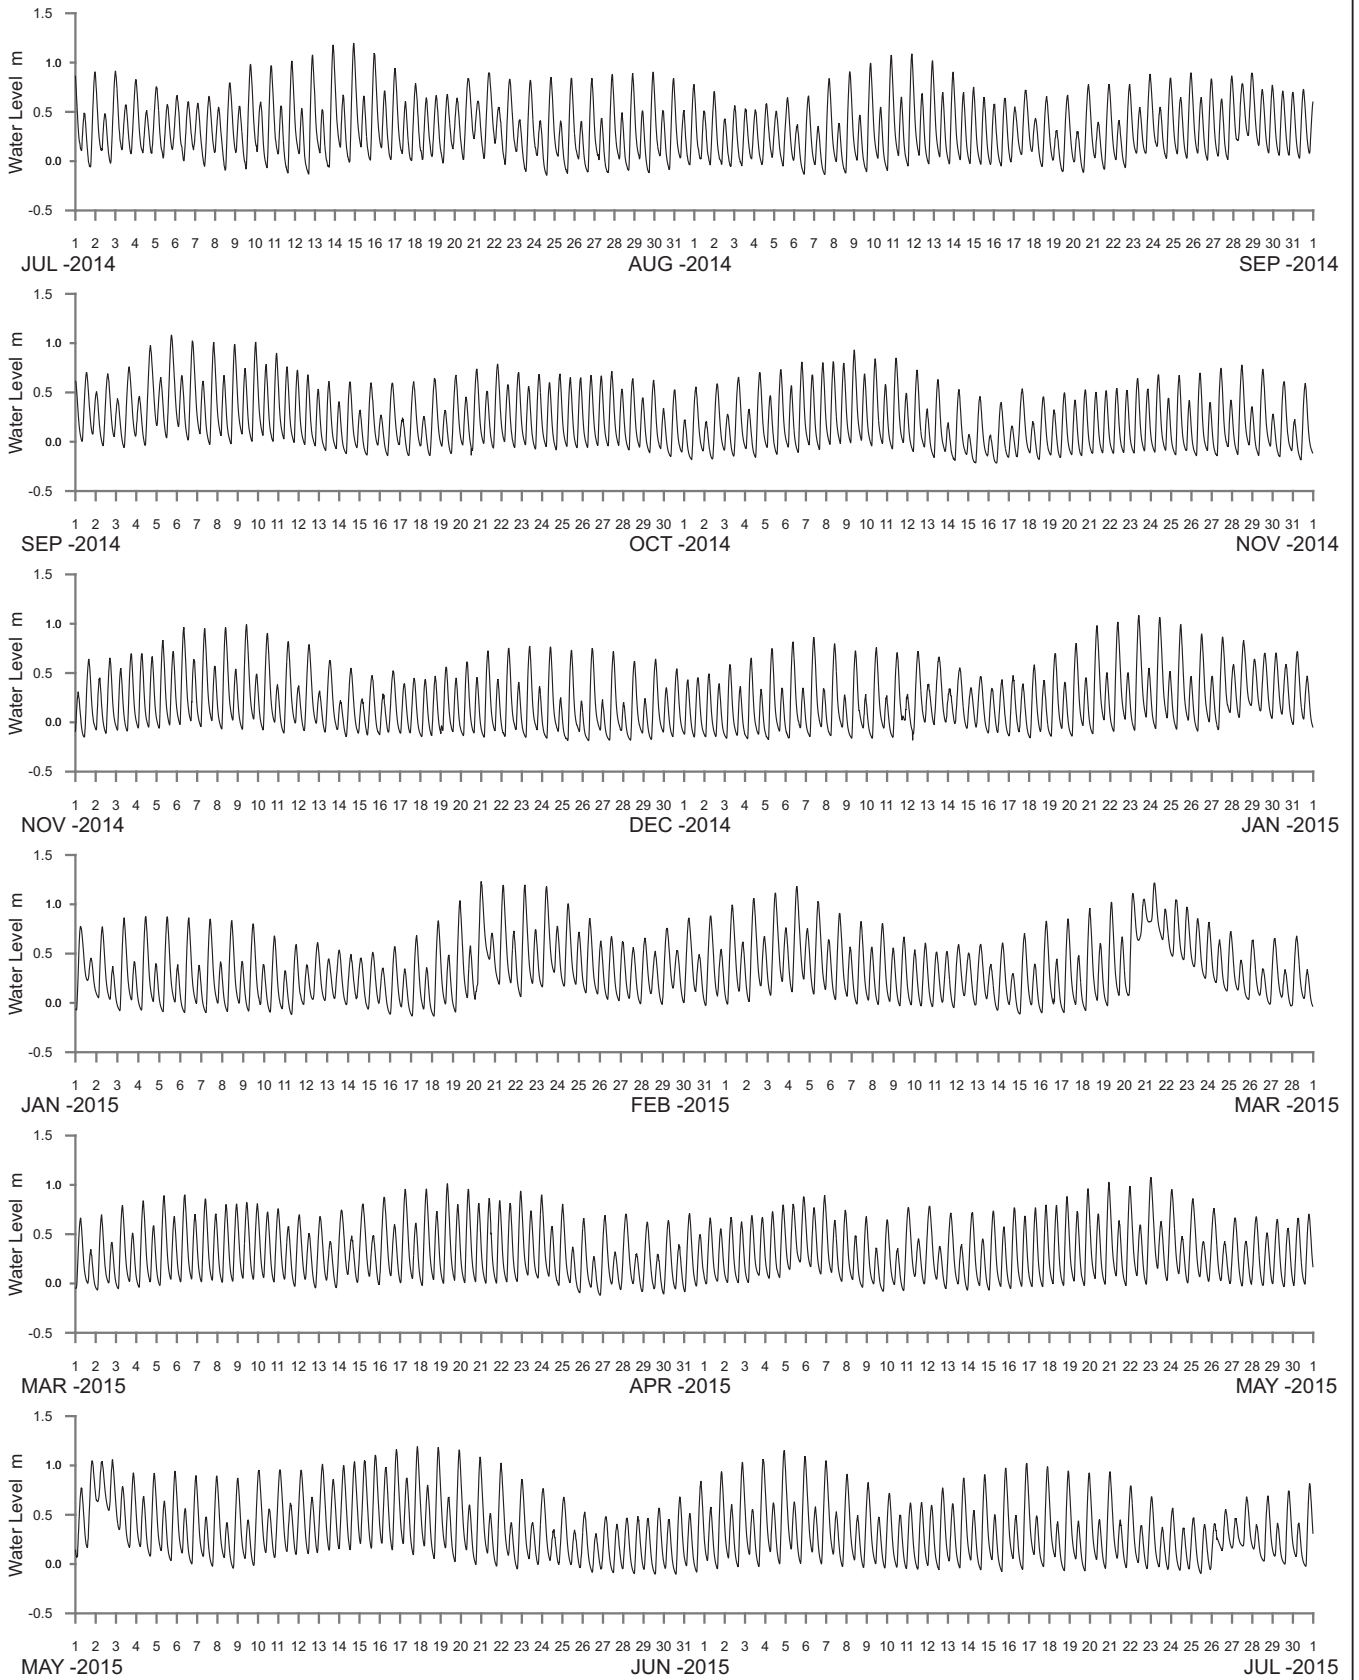
Figure  
20

WATER LEVEL REFERENCED TO BRUNSWICK RIVER FLOOD MITIGATION DATUM

**MARSHALLS CREEK AT ORANA BRIDGE**  
2014–2015

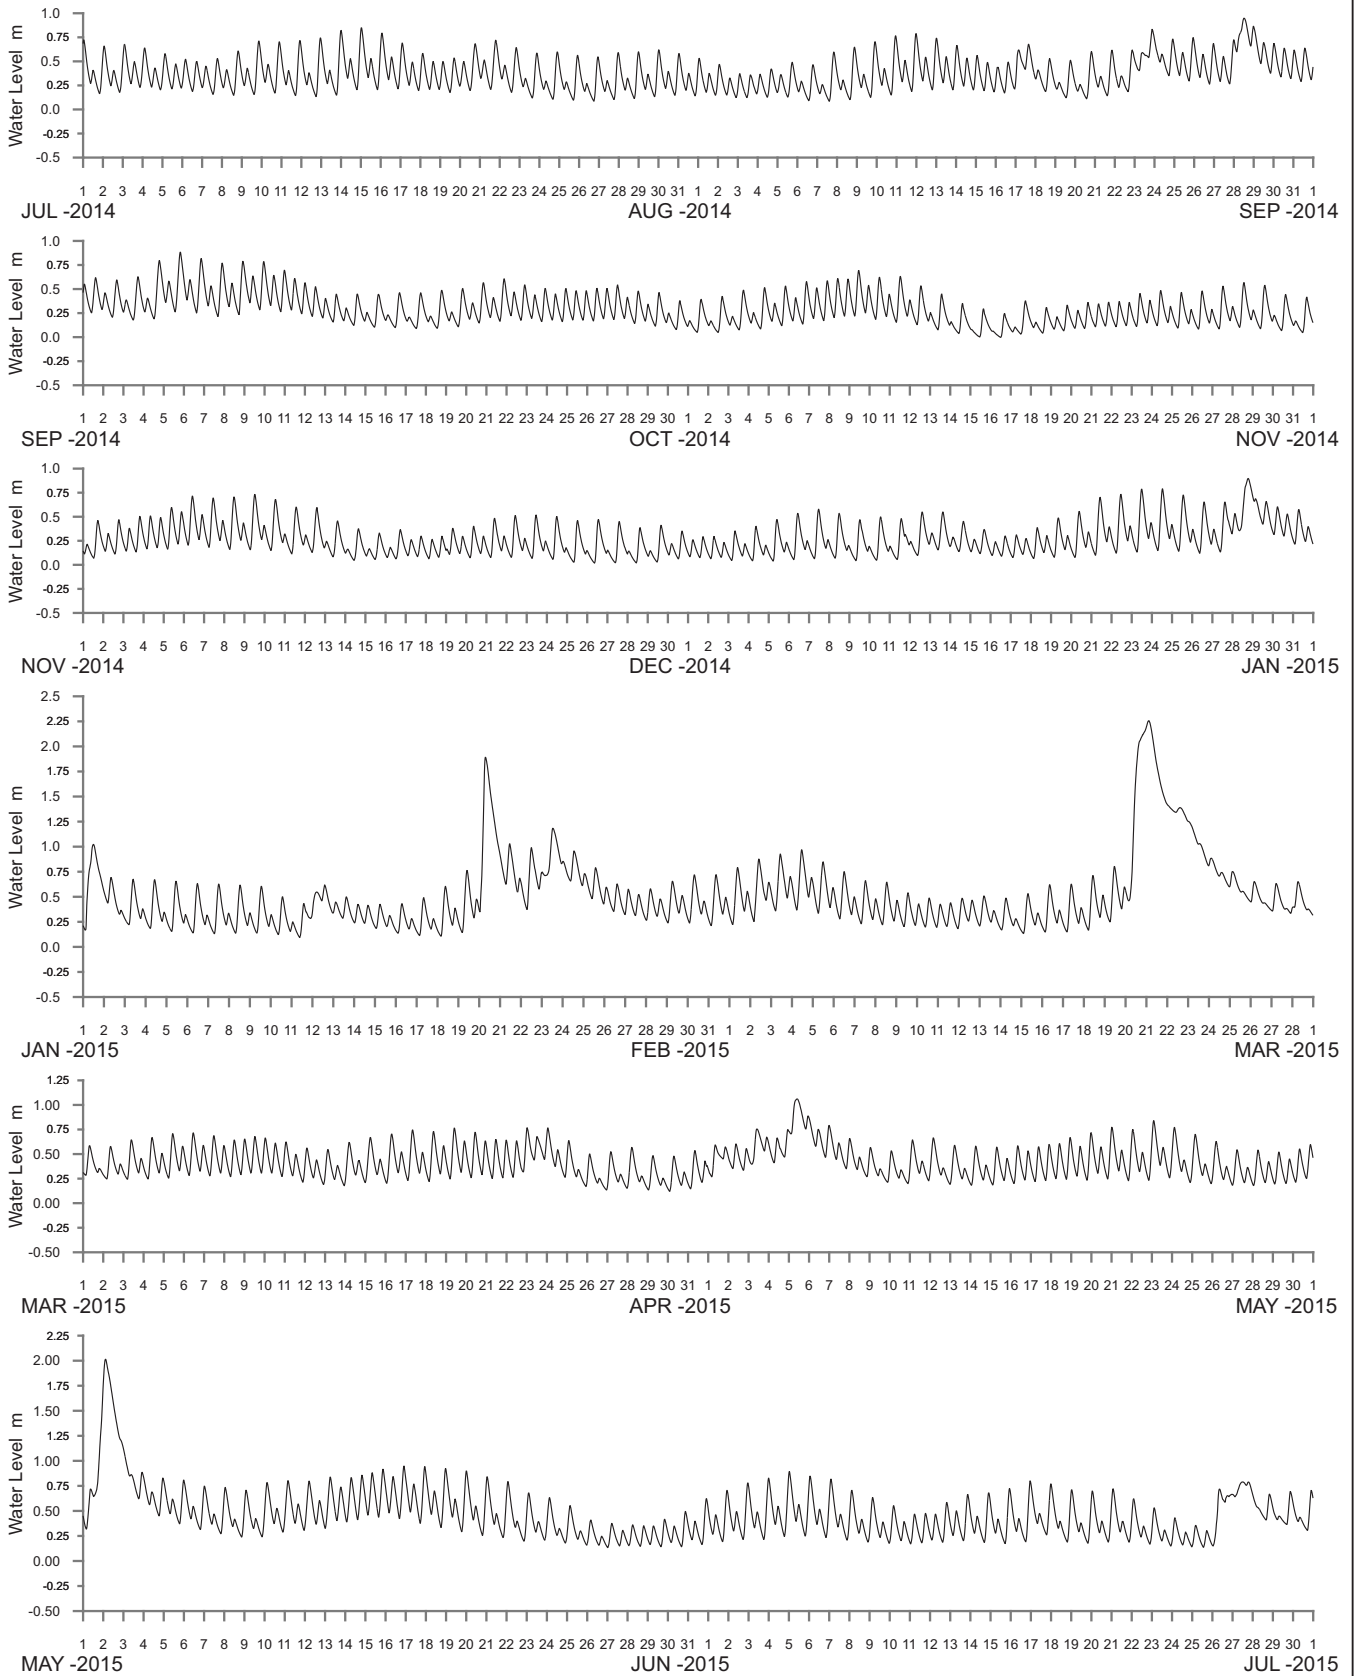
Figure  
21

WATER LEVEL REFERENCED TO BRUNSWICK RIVER FLOOD MITIGATION DATUM

**MARSHALLS CREEK AT BILLINUDGEL**  
2014–2015

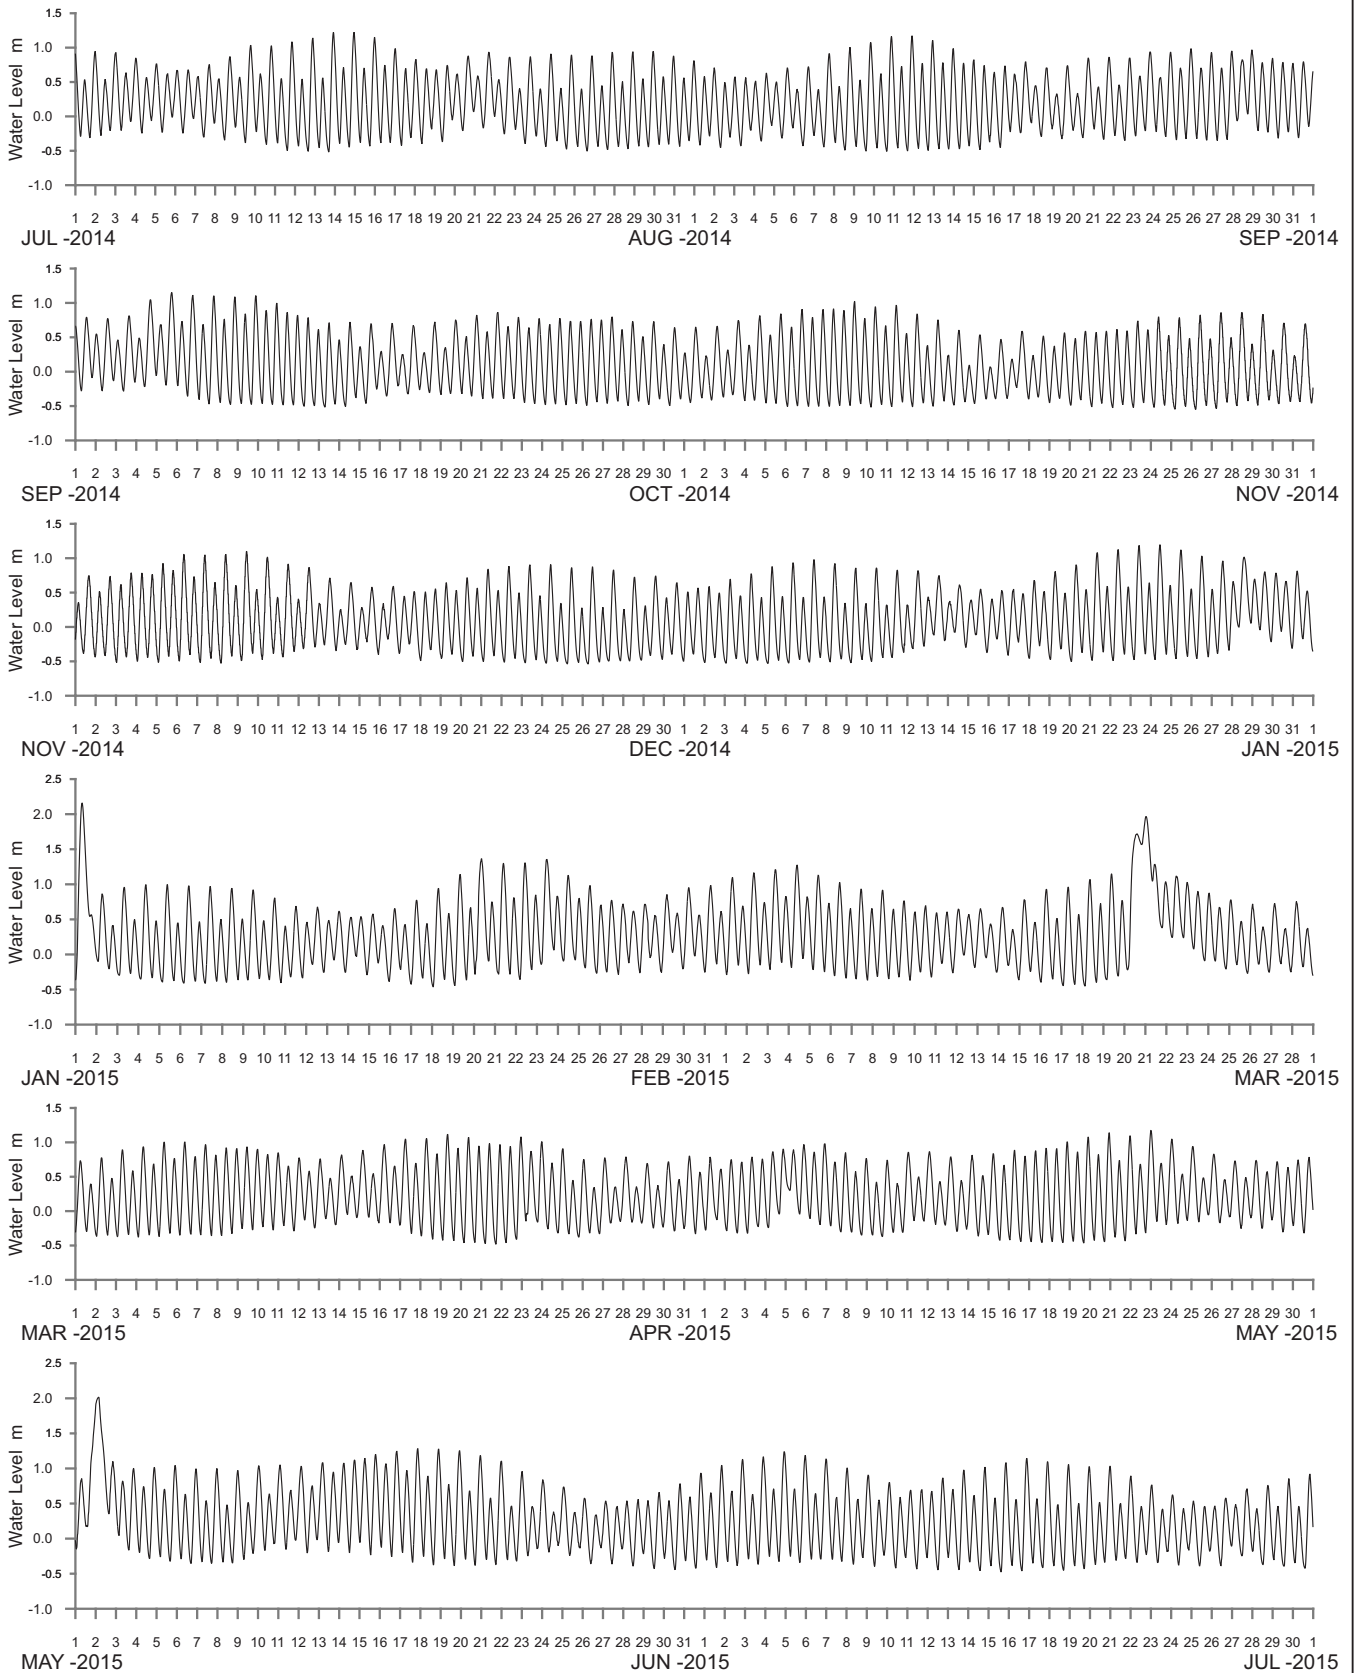
Figure  
22

WATER LEVEL REFERENCED TO BRUNSWICK RIVER FLOOD MITIGATION DATUM

**BRUNSWICK RIVER AT MULLUMBIMBY**  
2014–2015

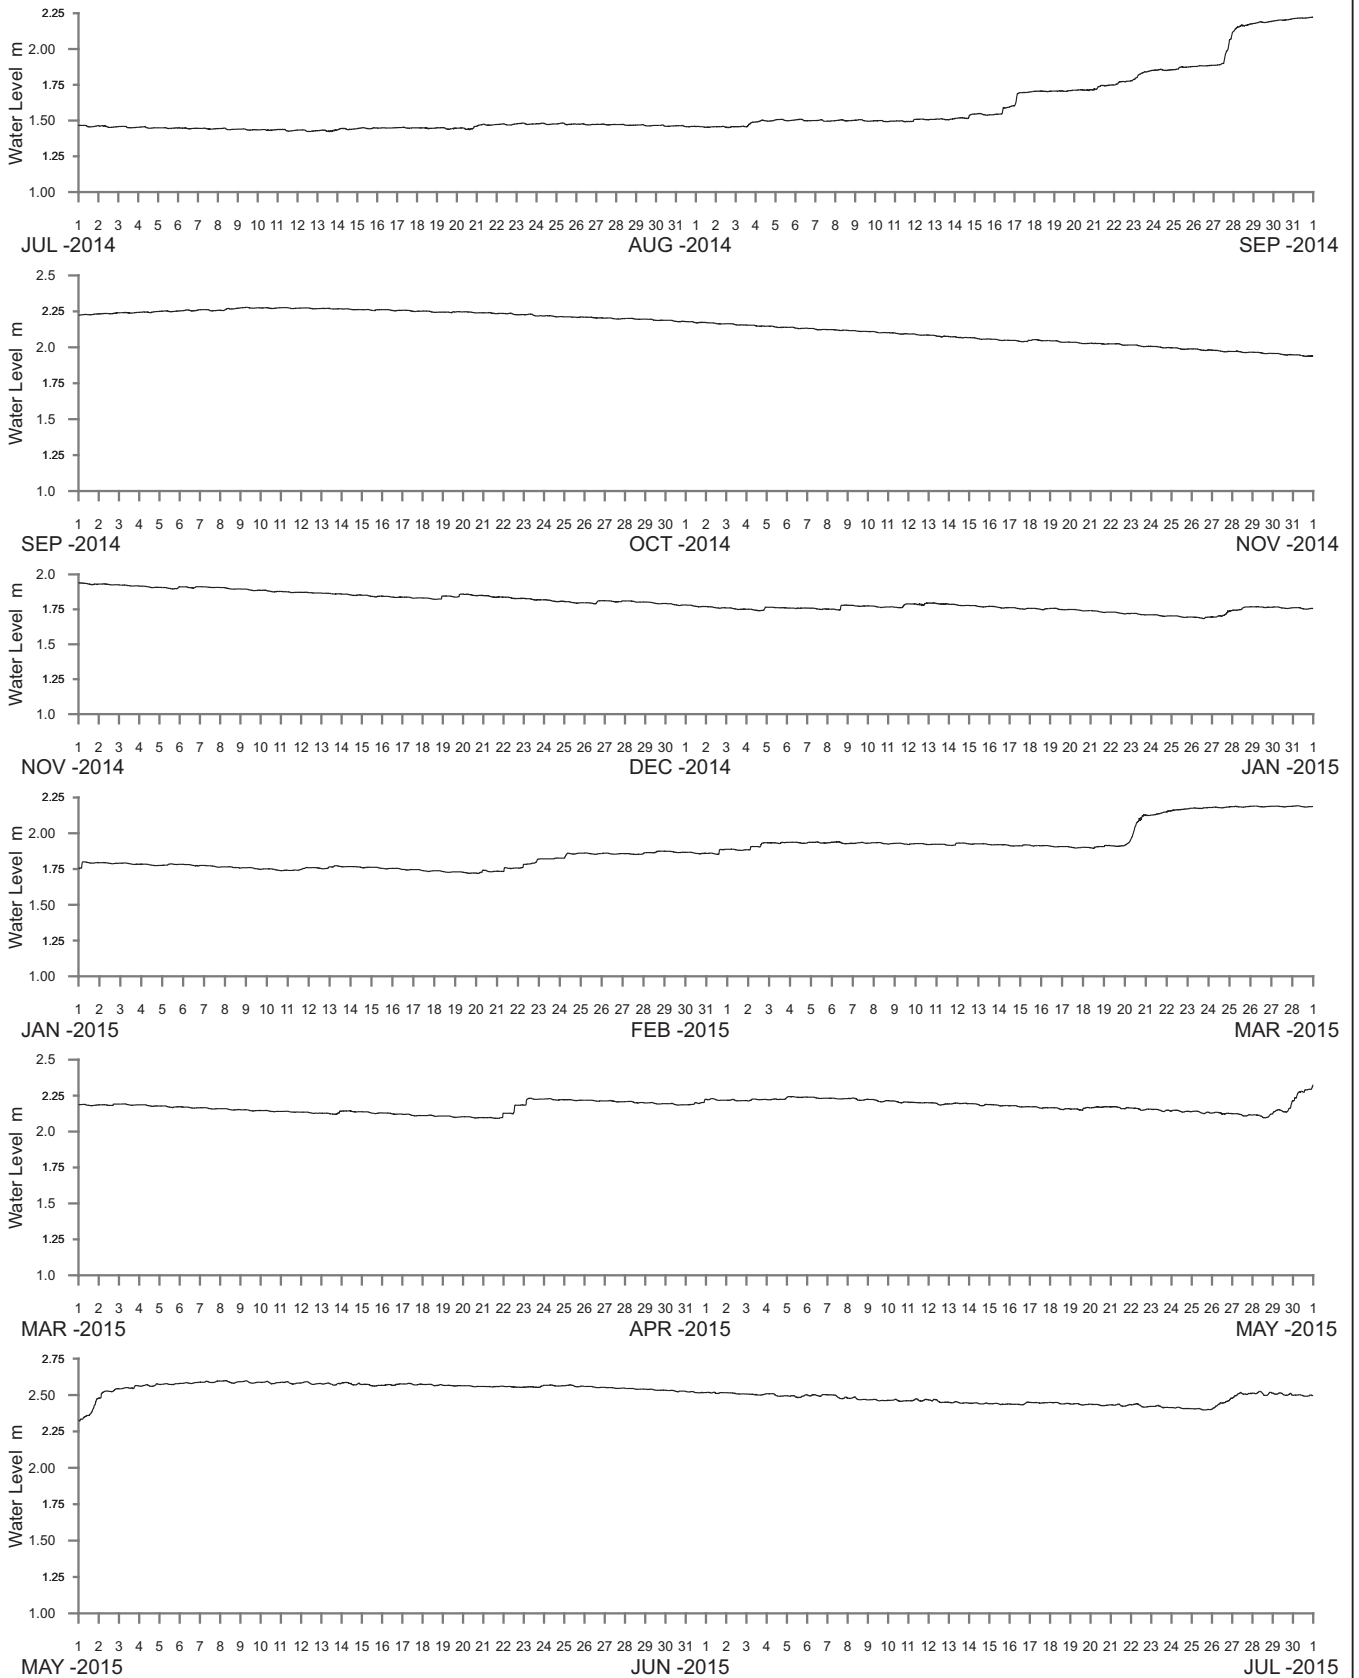
Figure  
24

WATER LEVEL REFERENCED TO AUSTRALIAN HEIGHT DATUM

**LENNOX HEAD AT LAKE AINSWORTH**  
2014-2015

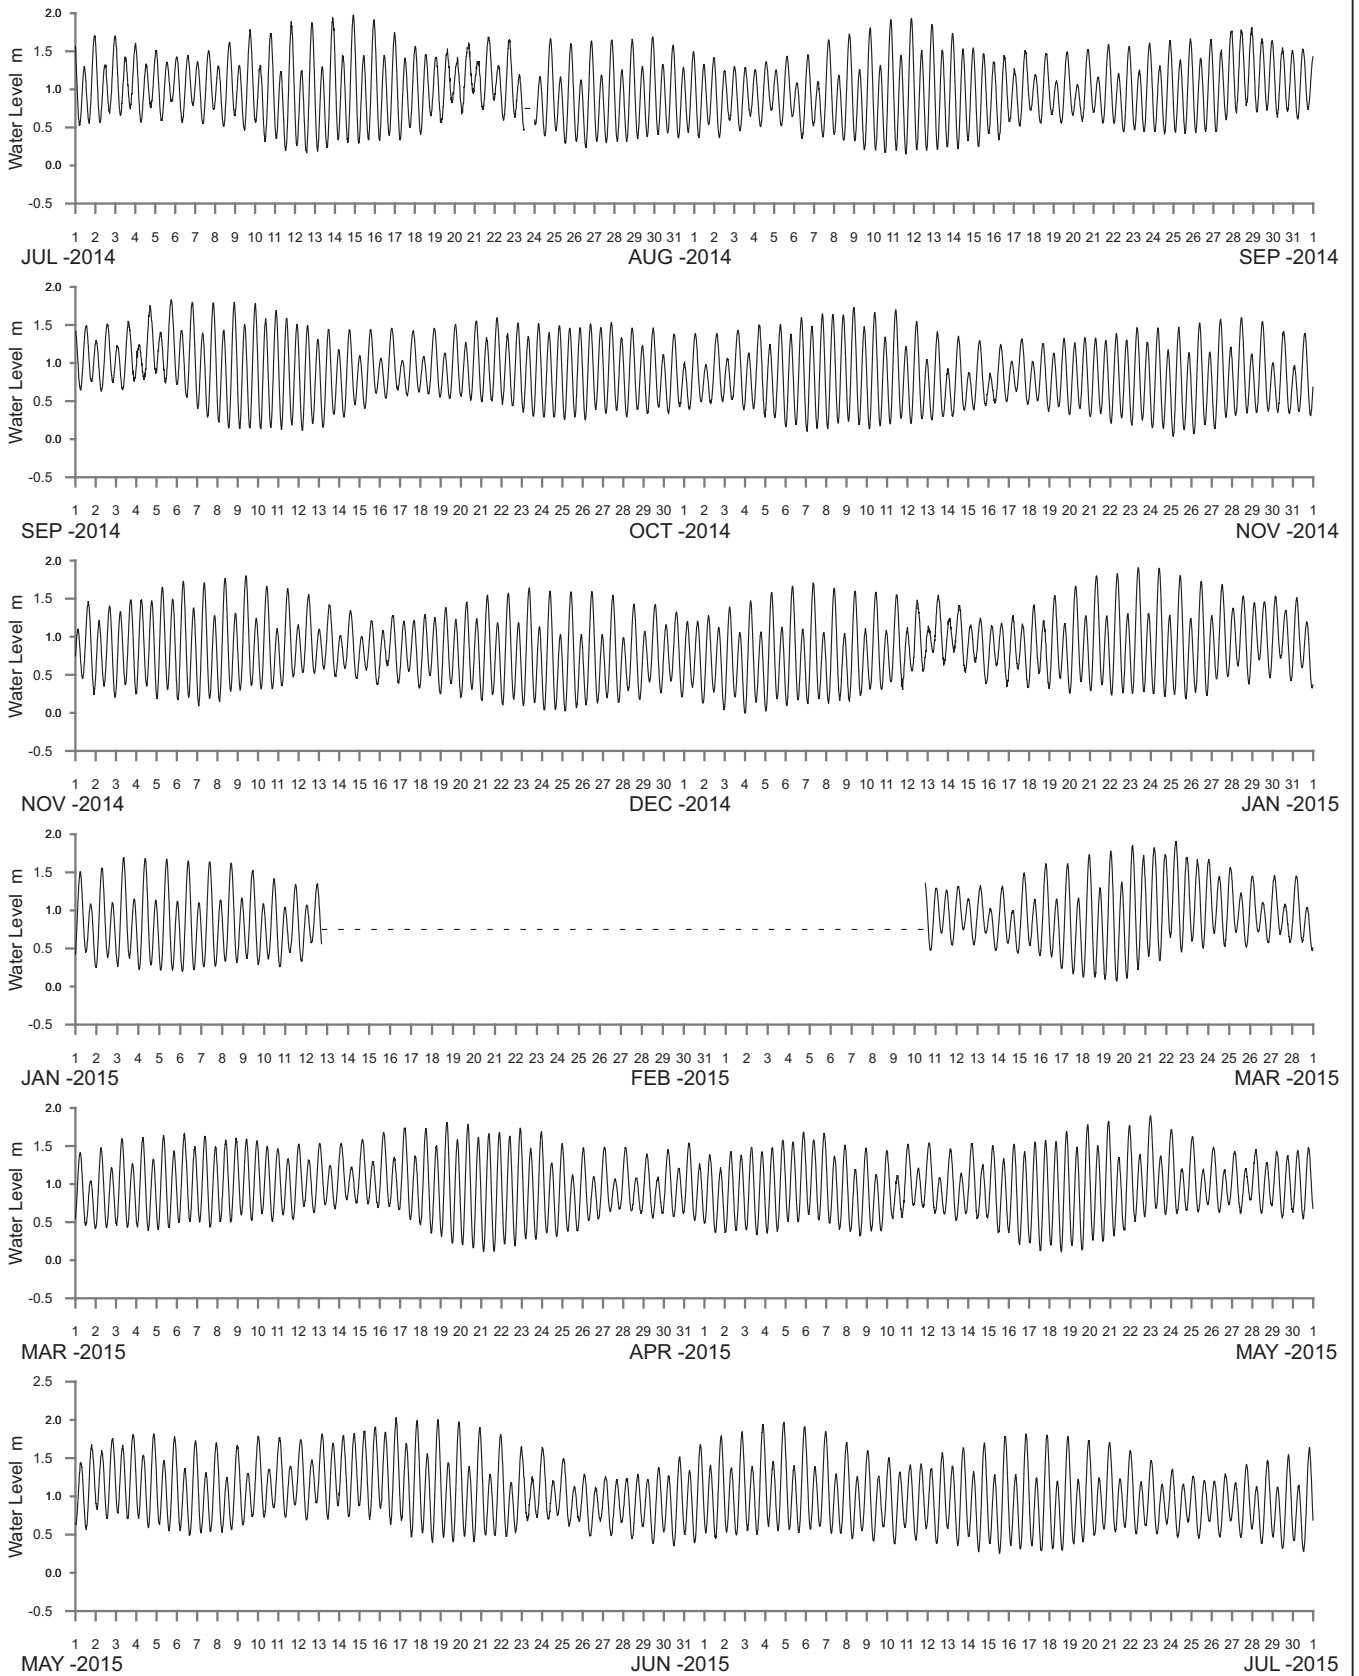
Figure  
**25**

WATER LEVEL REFERENCED TO RICHMOND RIVER VALLEY DATUM

**RICHMOND RIVER AT MISSINGHAM BRIDGE**  
2014–2015

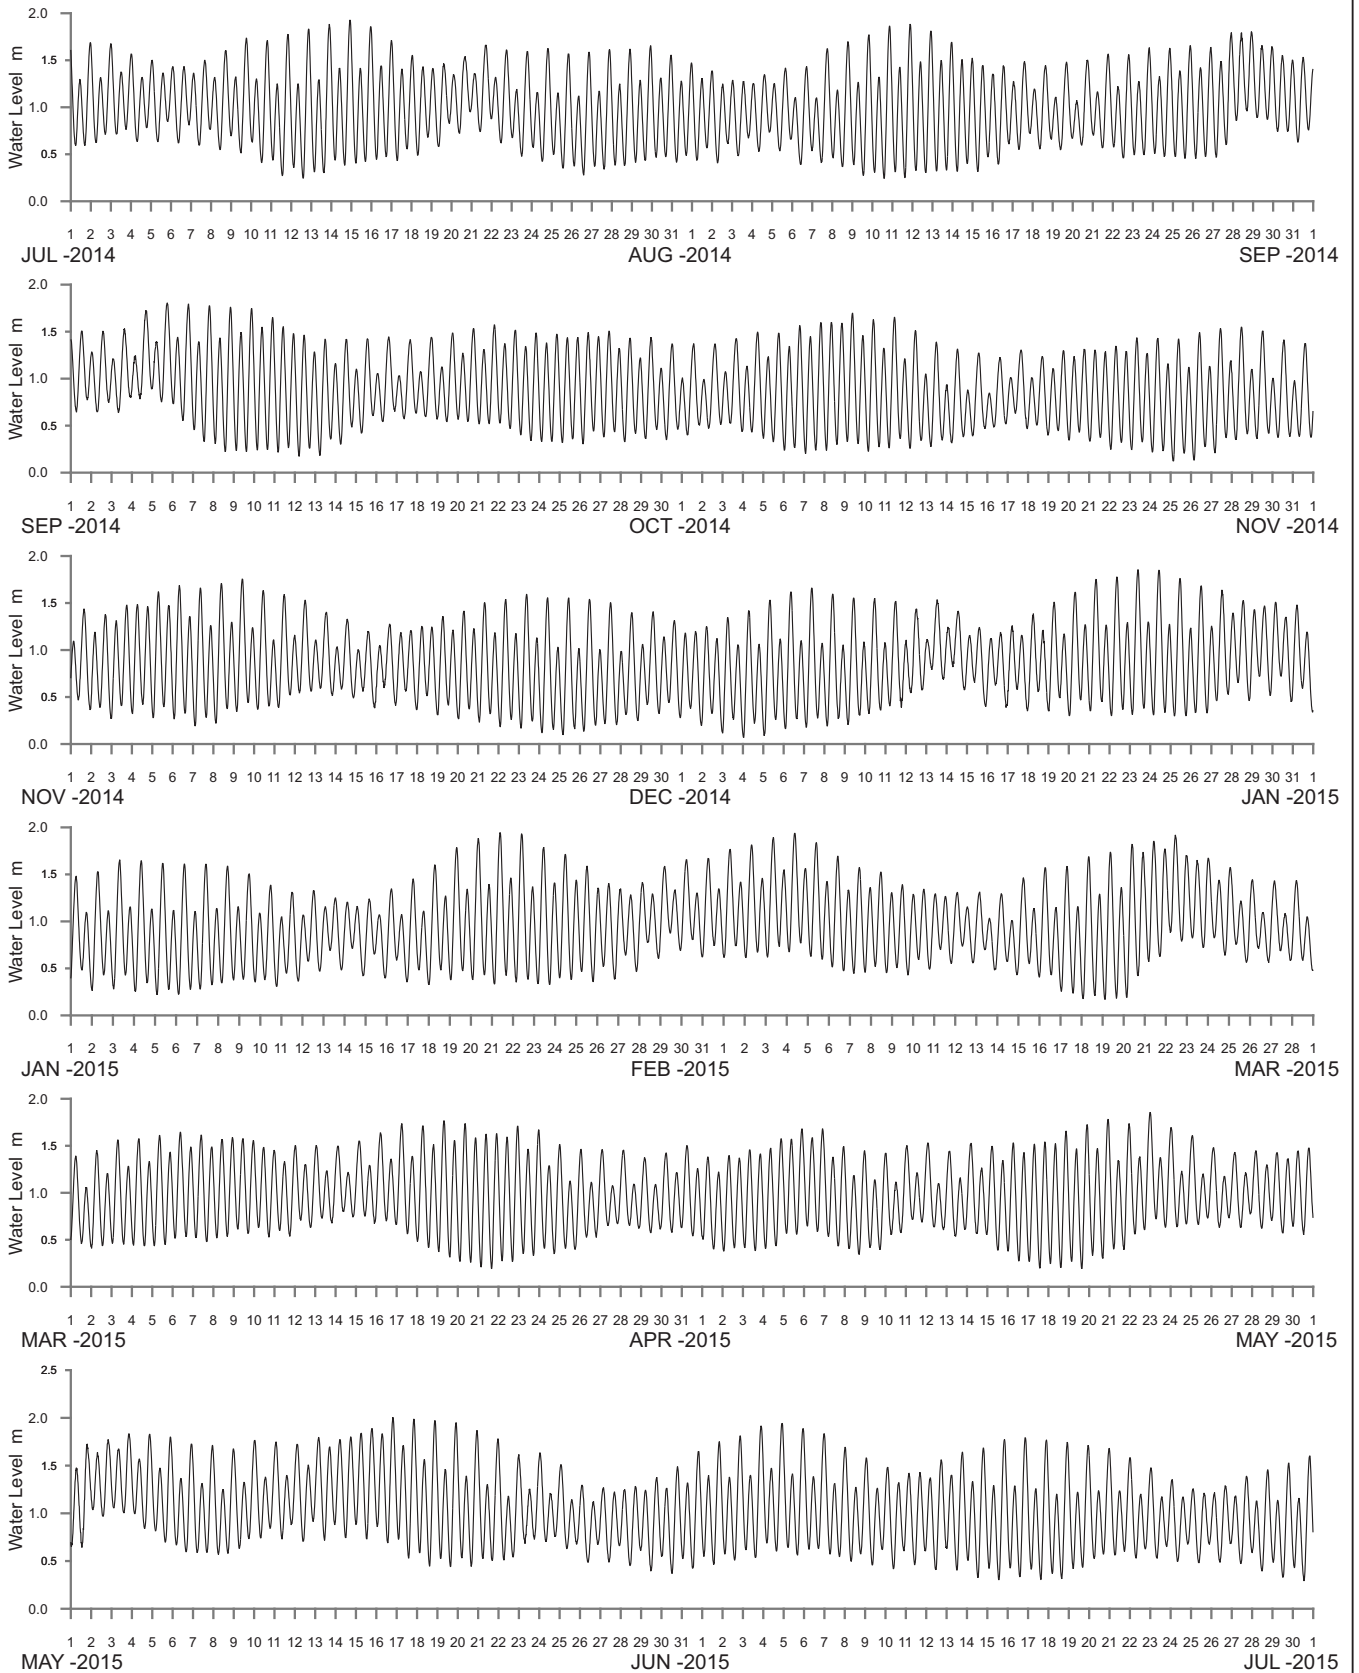
Figure  
26

WATER LEVEL REFERENCED TO RICHMOND RIVER VALLEY DATUM

**RICHMOND RIVER AT BYRNES POINT**  
2014–2015

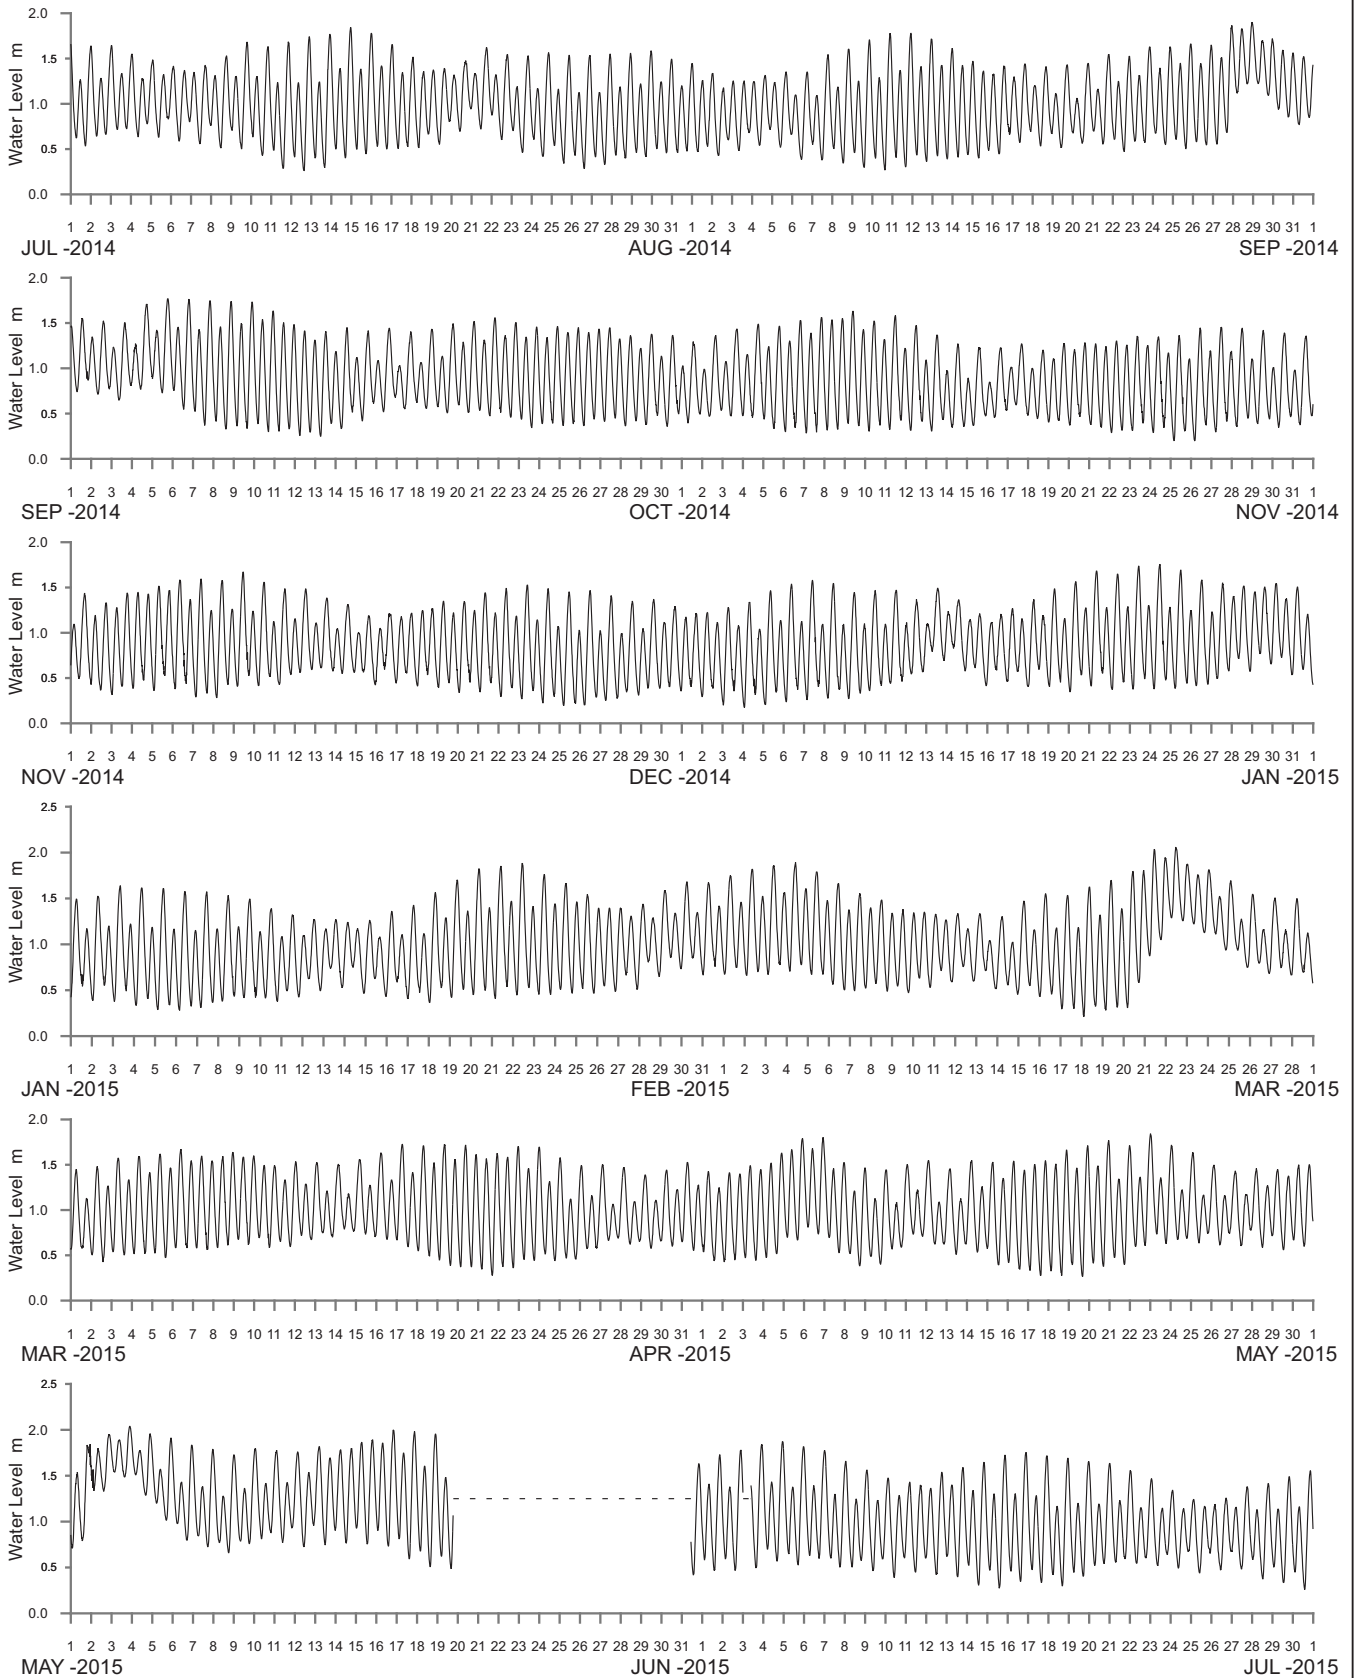
Figure  
27

WATER LEVEL REFERENCED TO RICHMOND RIVER VALLEY DATUM

RICHMOND RIVER AT WARDELL  
2014–2015

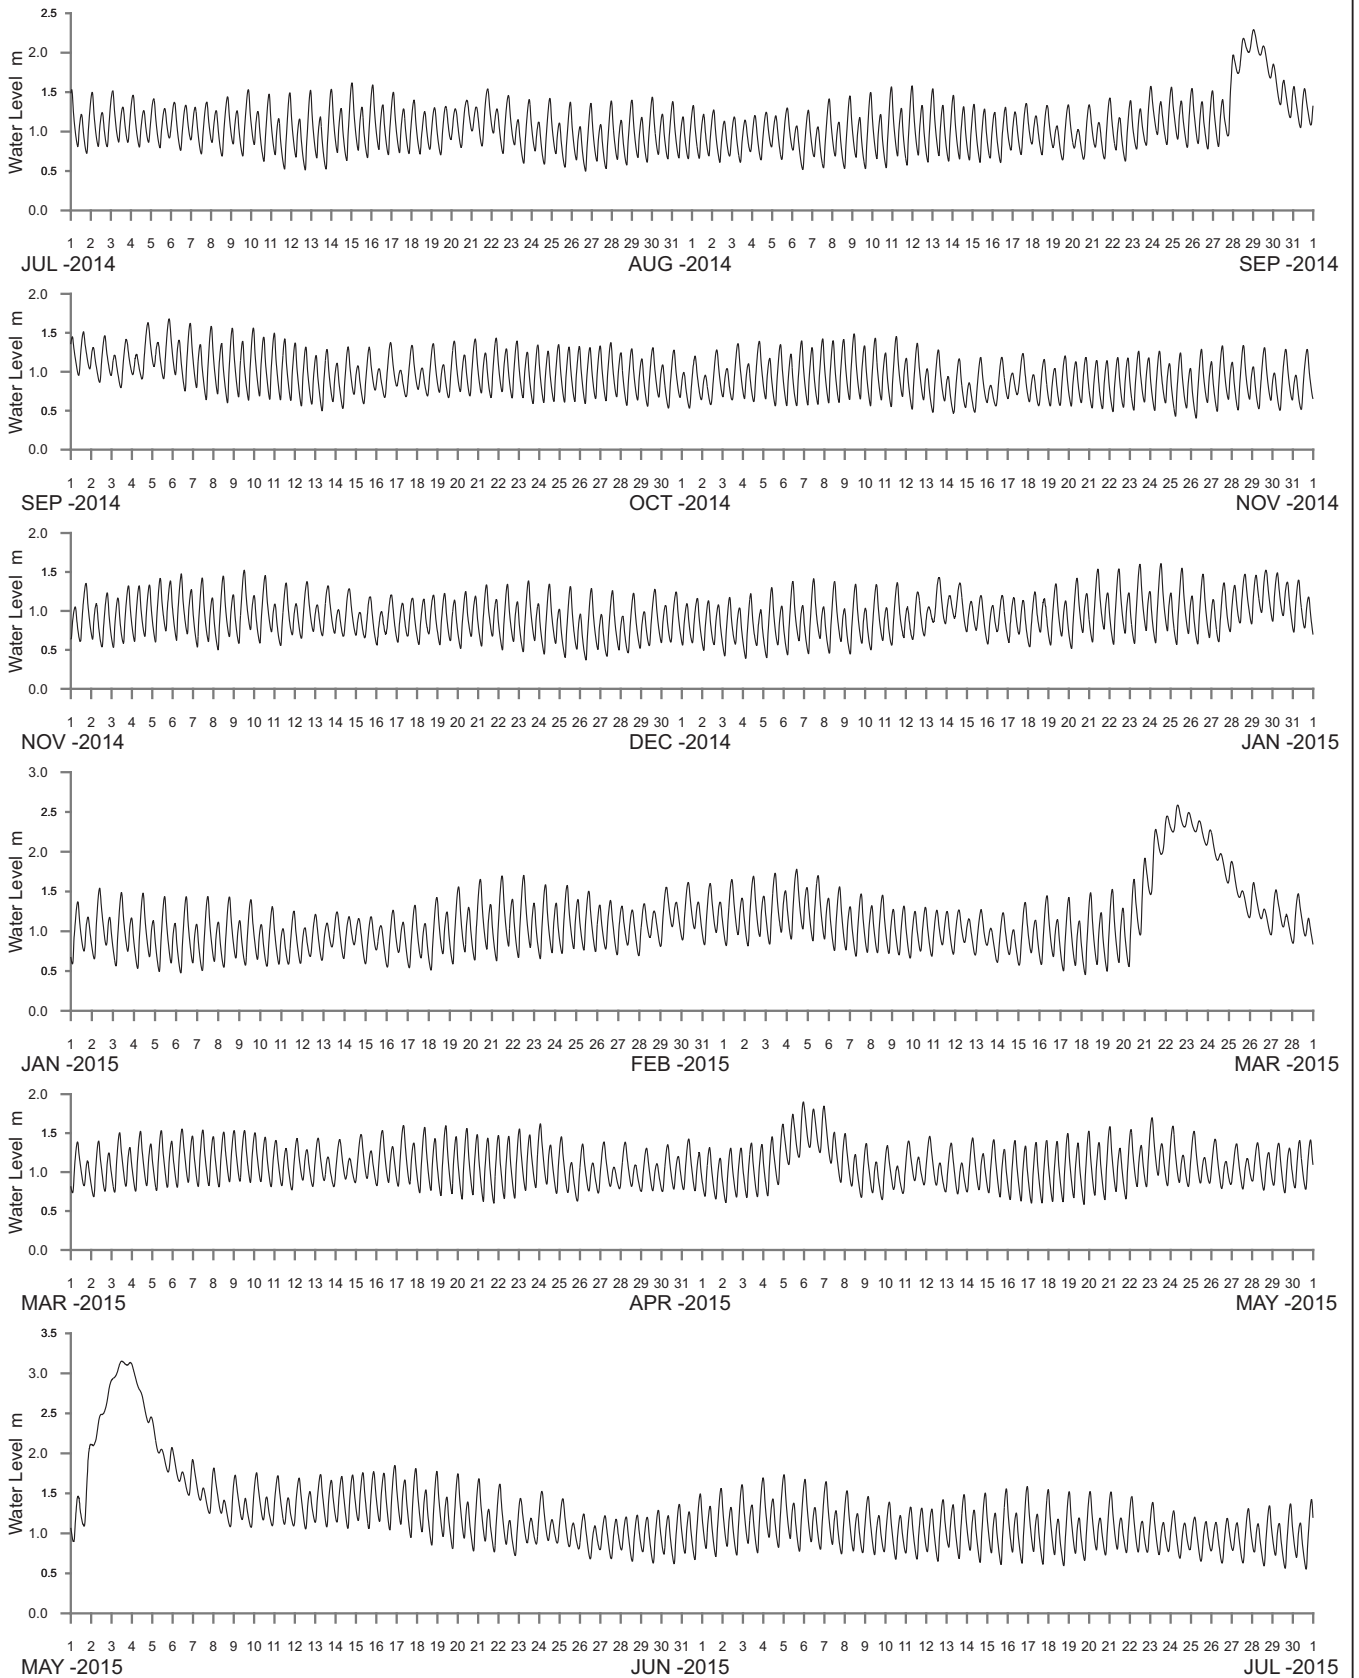
Figure  
28

WATER LEVEL REFERENCED TO RICHMOND RIVER VALLEY DATUM

**RICHMOND RIVER AT WOODBURN**  
2014–2015

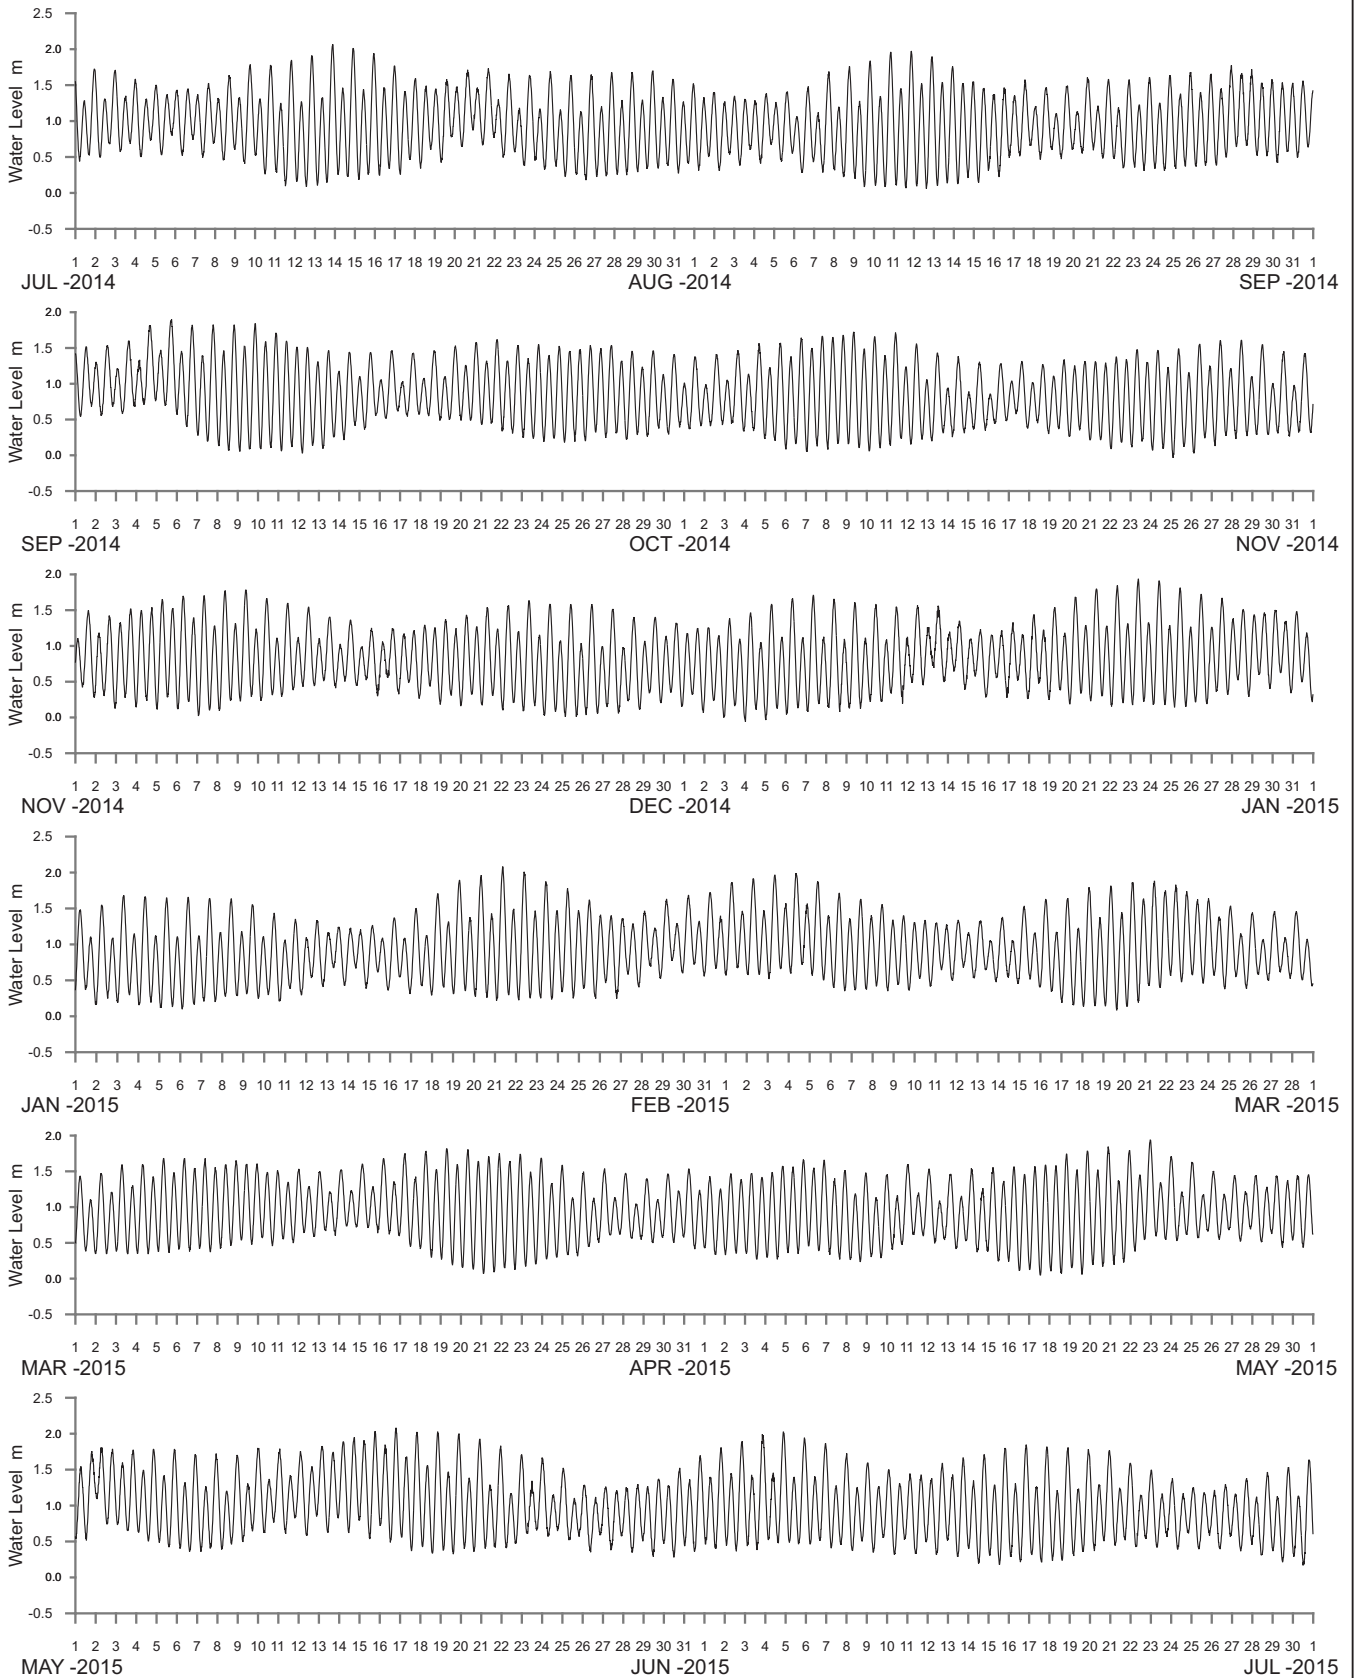
Figure  
29

WATER LEVEL REFERENCED TO RICHMOND RIVER VALLEY DATUM

**EVANS RIVER AT EVANS RIVER FISHING CO-OP**  
2014–2015
