**Public Works**  
Manly Hydraulics Laboratory

MHL  
Report 2383

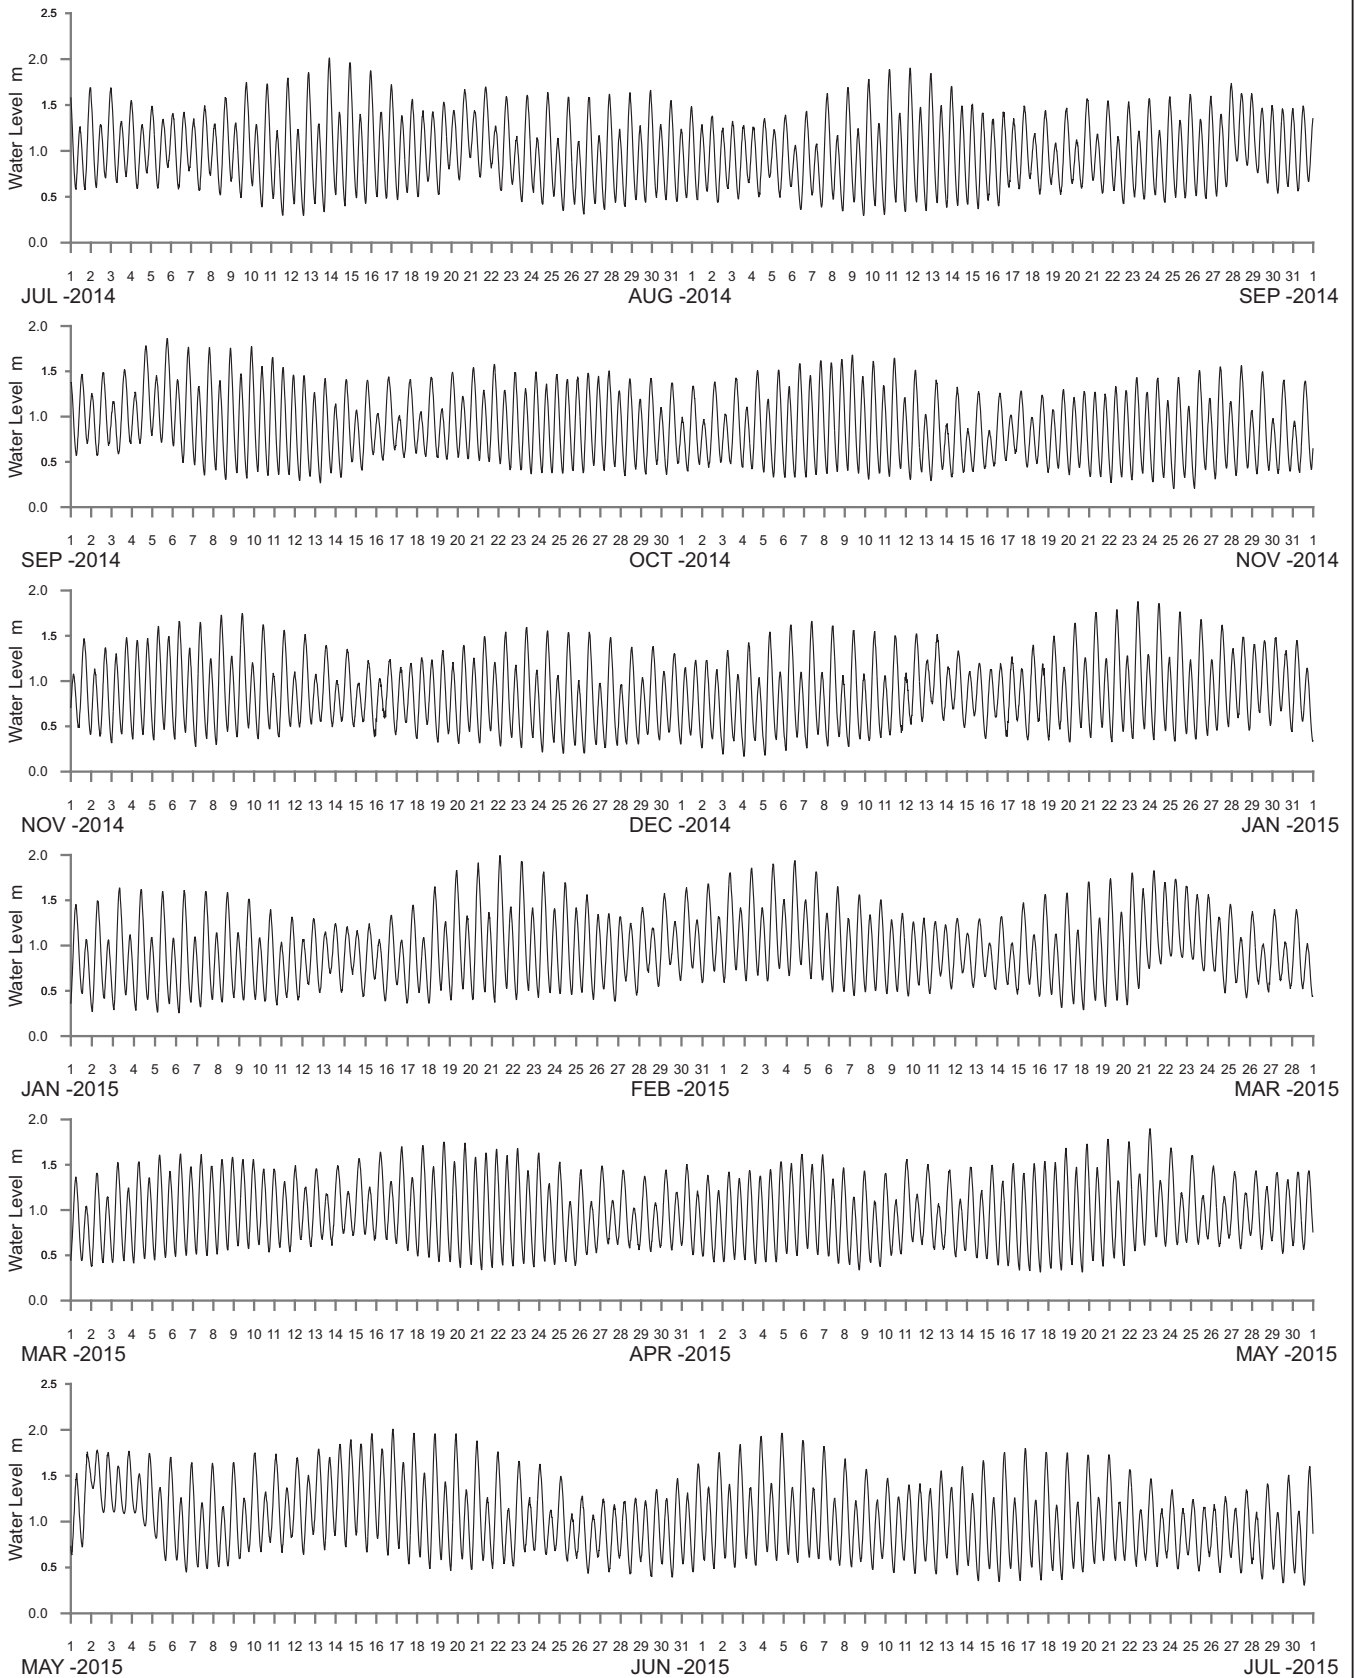
Figure  
30

WATER LEVEL REFERENCED TO RICHMOND RIVER VALLEY DATUM

**EVANS RIVER AT IRON GATES**  
2014–2015

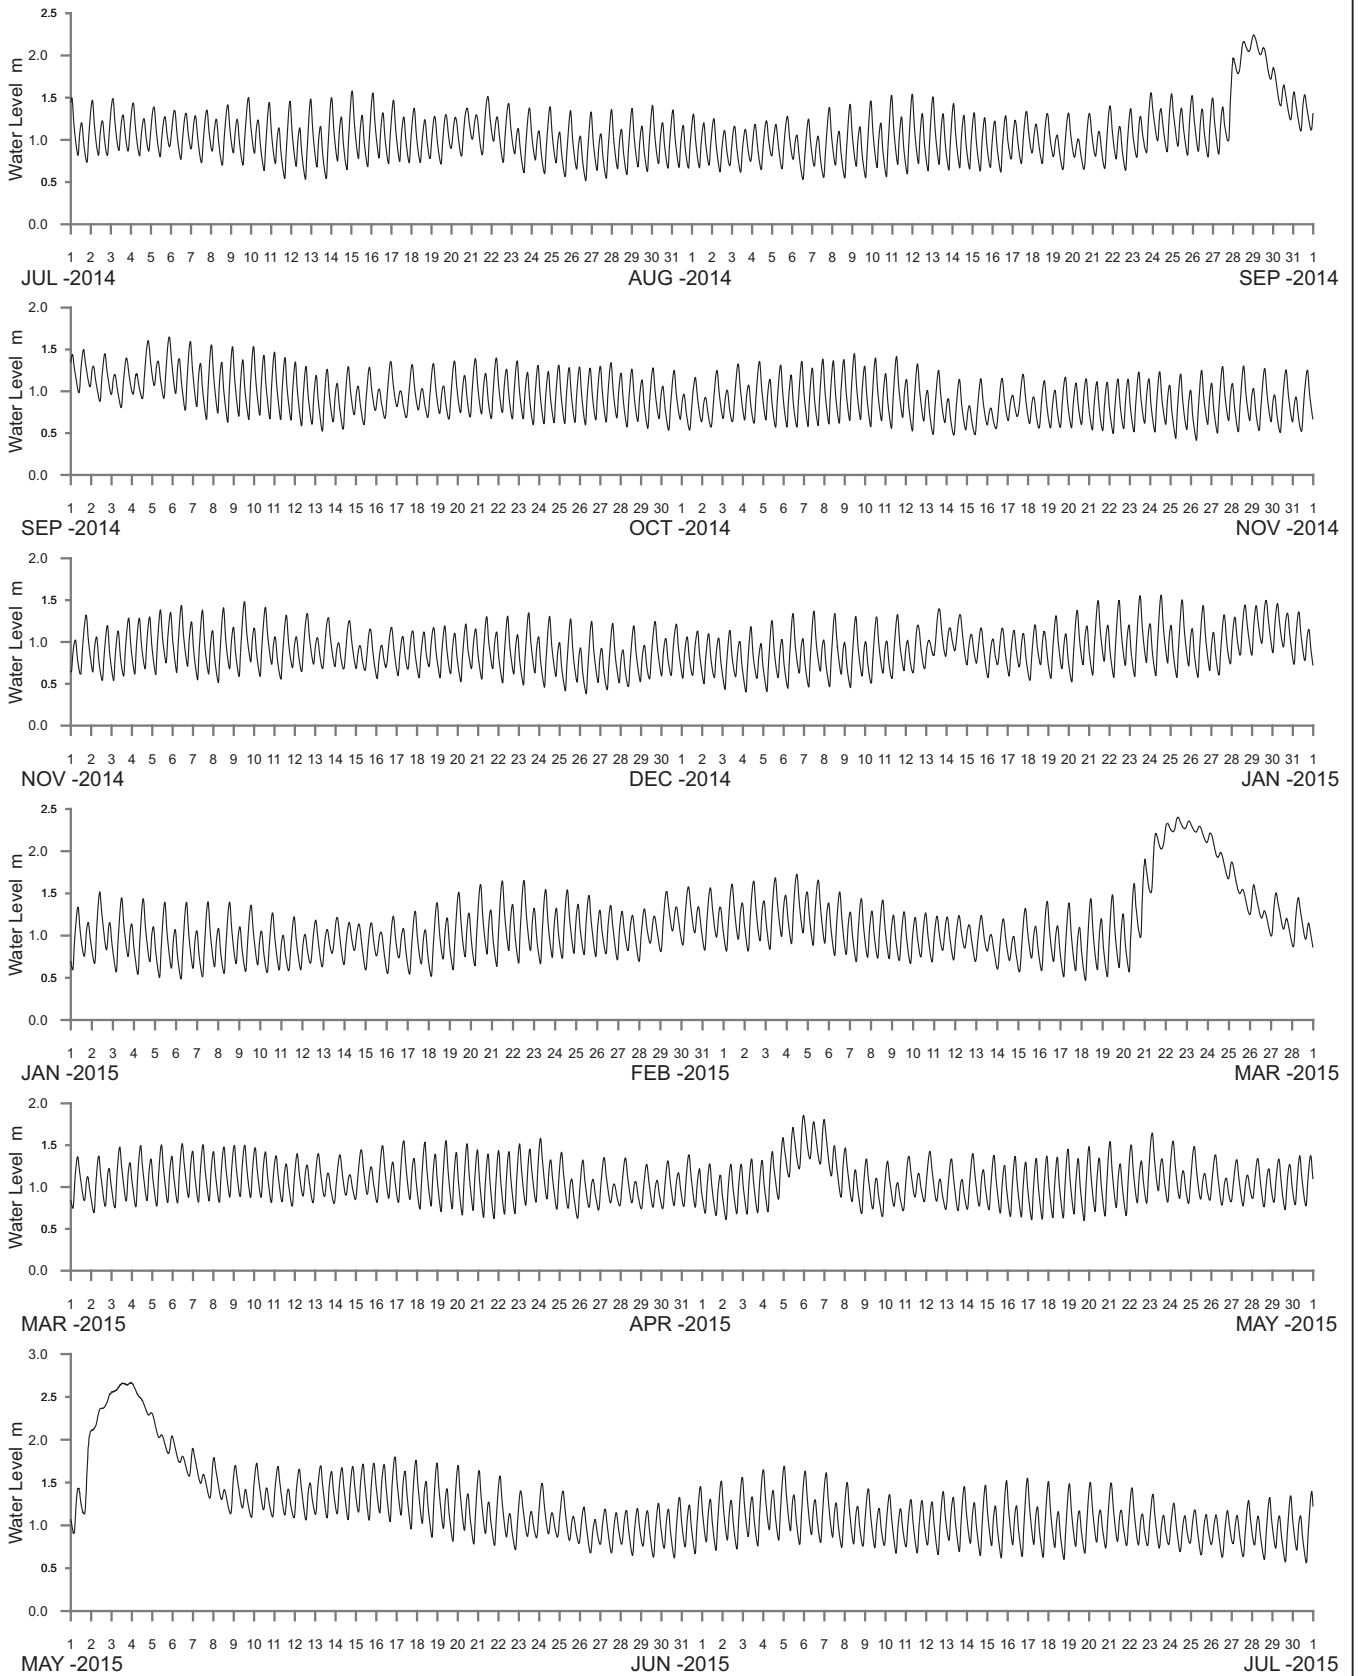
Figure  
31

WATER LEVEL REFERENCED TO RICHMOND RIVER VALLEY DATUM

**TUCOMBIL CANAL AT TUCOMBIL HIGHWAY BRIDGE**  
2014–2015

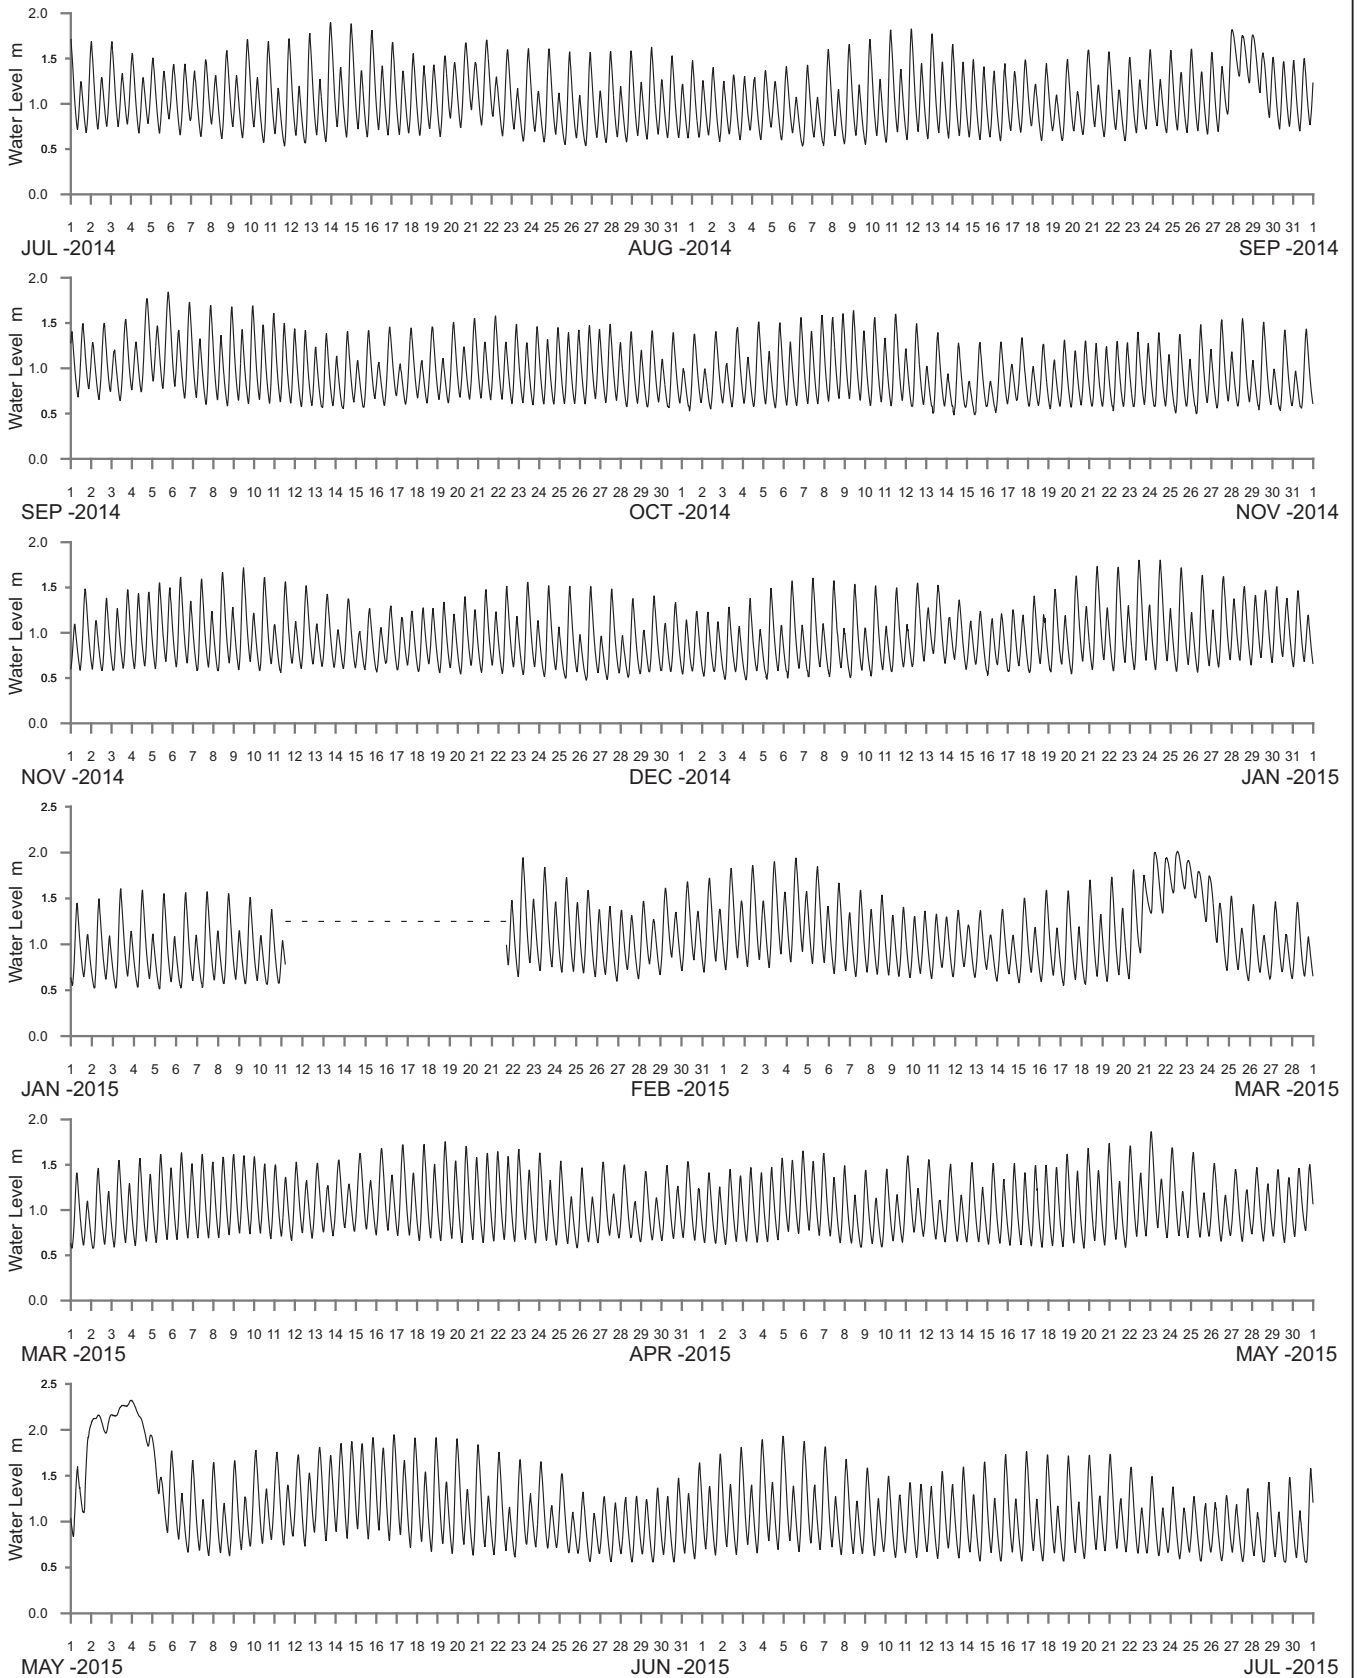
Figure  
32

WATER LEVEL REFERENCED TO RICHMOND RIVER VALLEY DATUM

**TUCOMBIL CANAL AT TUCOMBIL FLOODGATE**  
2014-2015

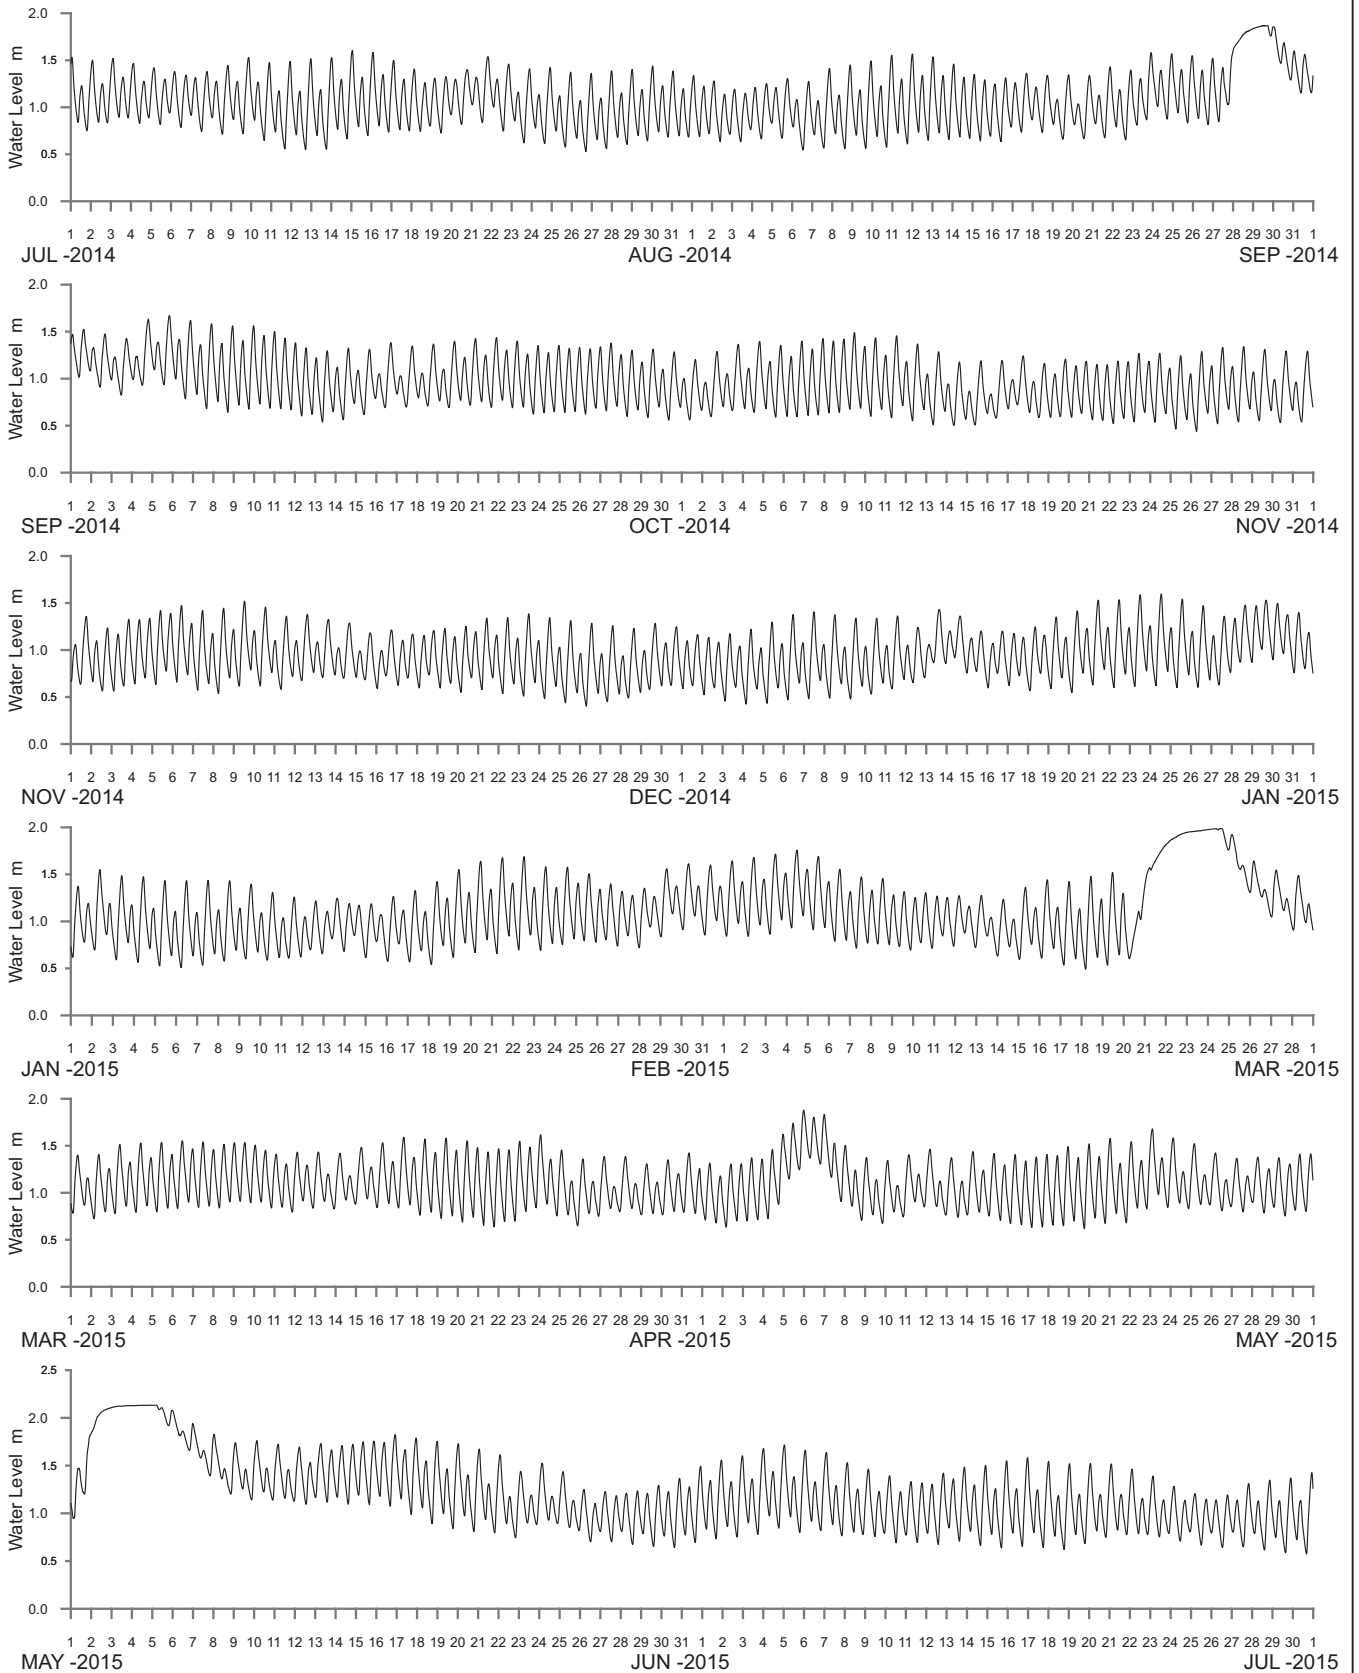
Figure  
33

WATER LEVEL REFERENCED TO RICHMOND RIVER VALLEY DATUM

**ROCKY MOUTH CREEK AT ROCKY MOUTH CREEK**  
2014–2015

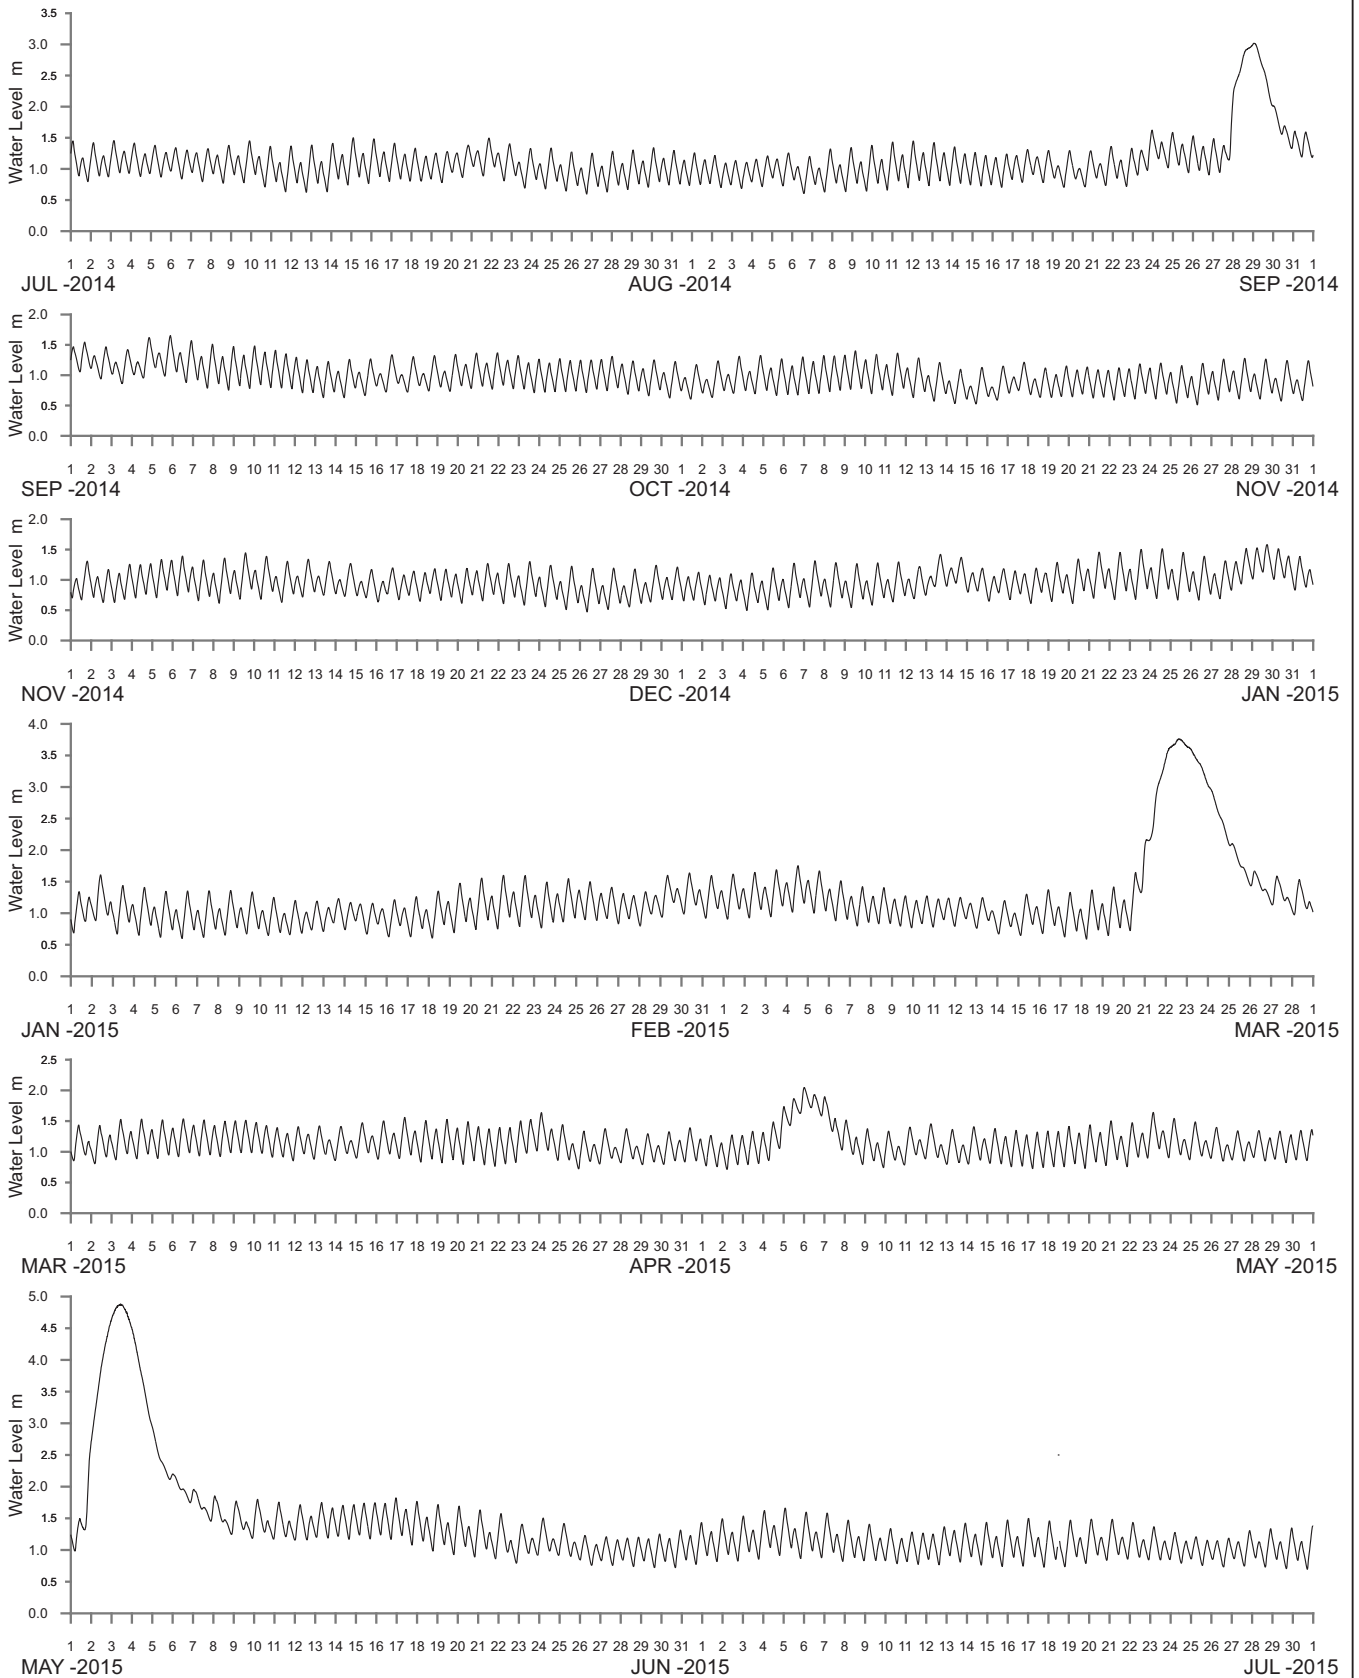
Figure  
**35**

WATER LEVEL REFERENCED TO RICHMOND RIVER VALLEY DATUM

**RICHMOND RIVER AT CORAKI**  
2014–2015

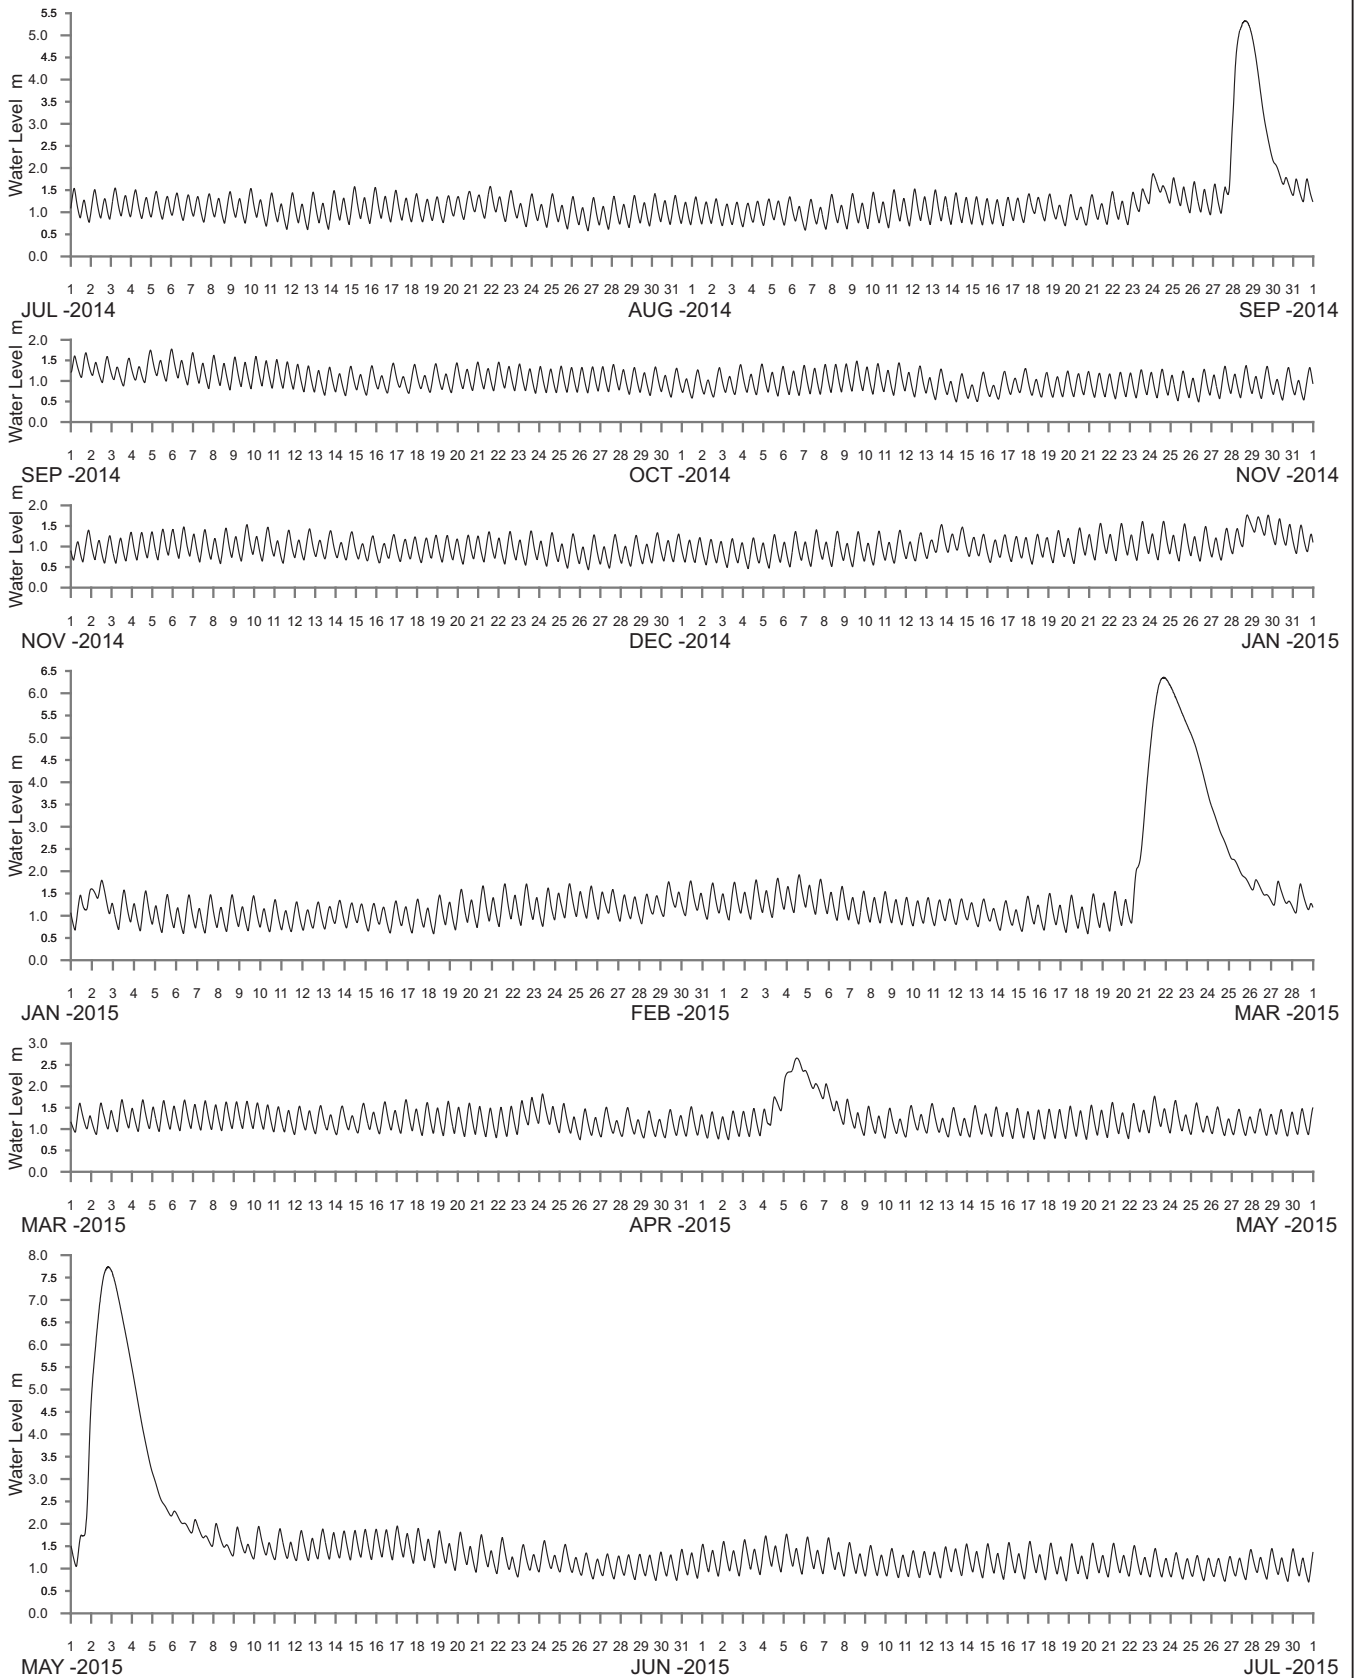
Figure  
36

WATER LEVEL REFERENCED TO RICHMOND RIVER VALLEY DATUM

**WILSONS RIVER AT EAST GUNDURIMBA**  
2014–2015

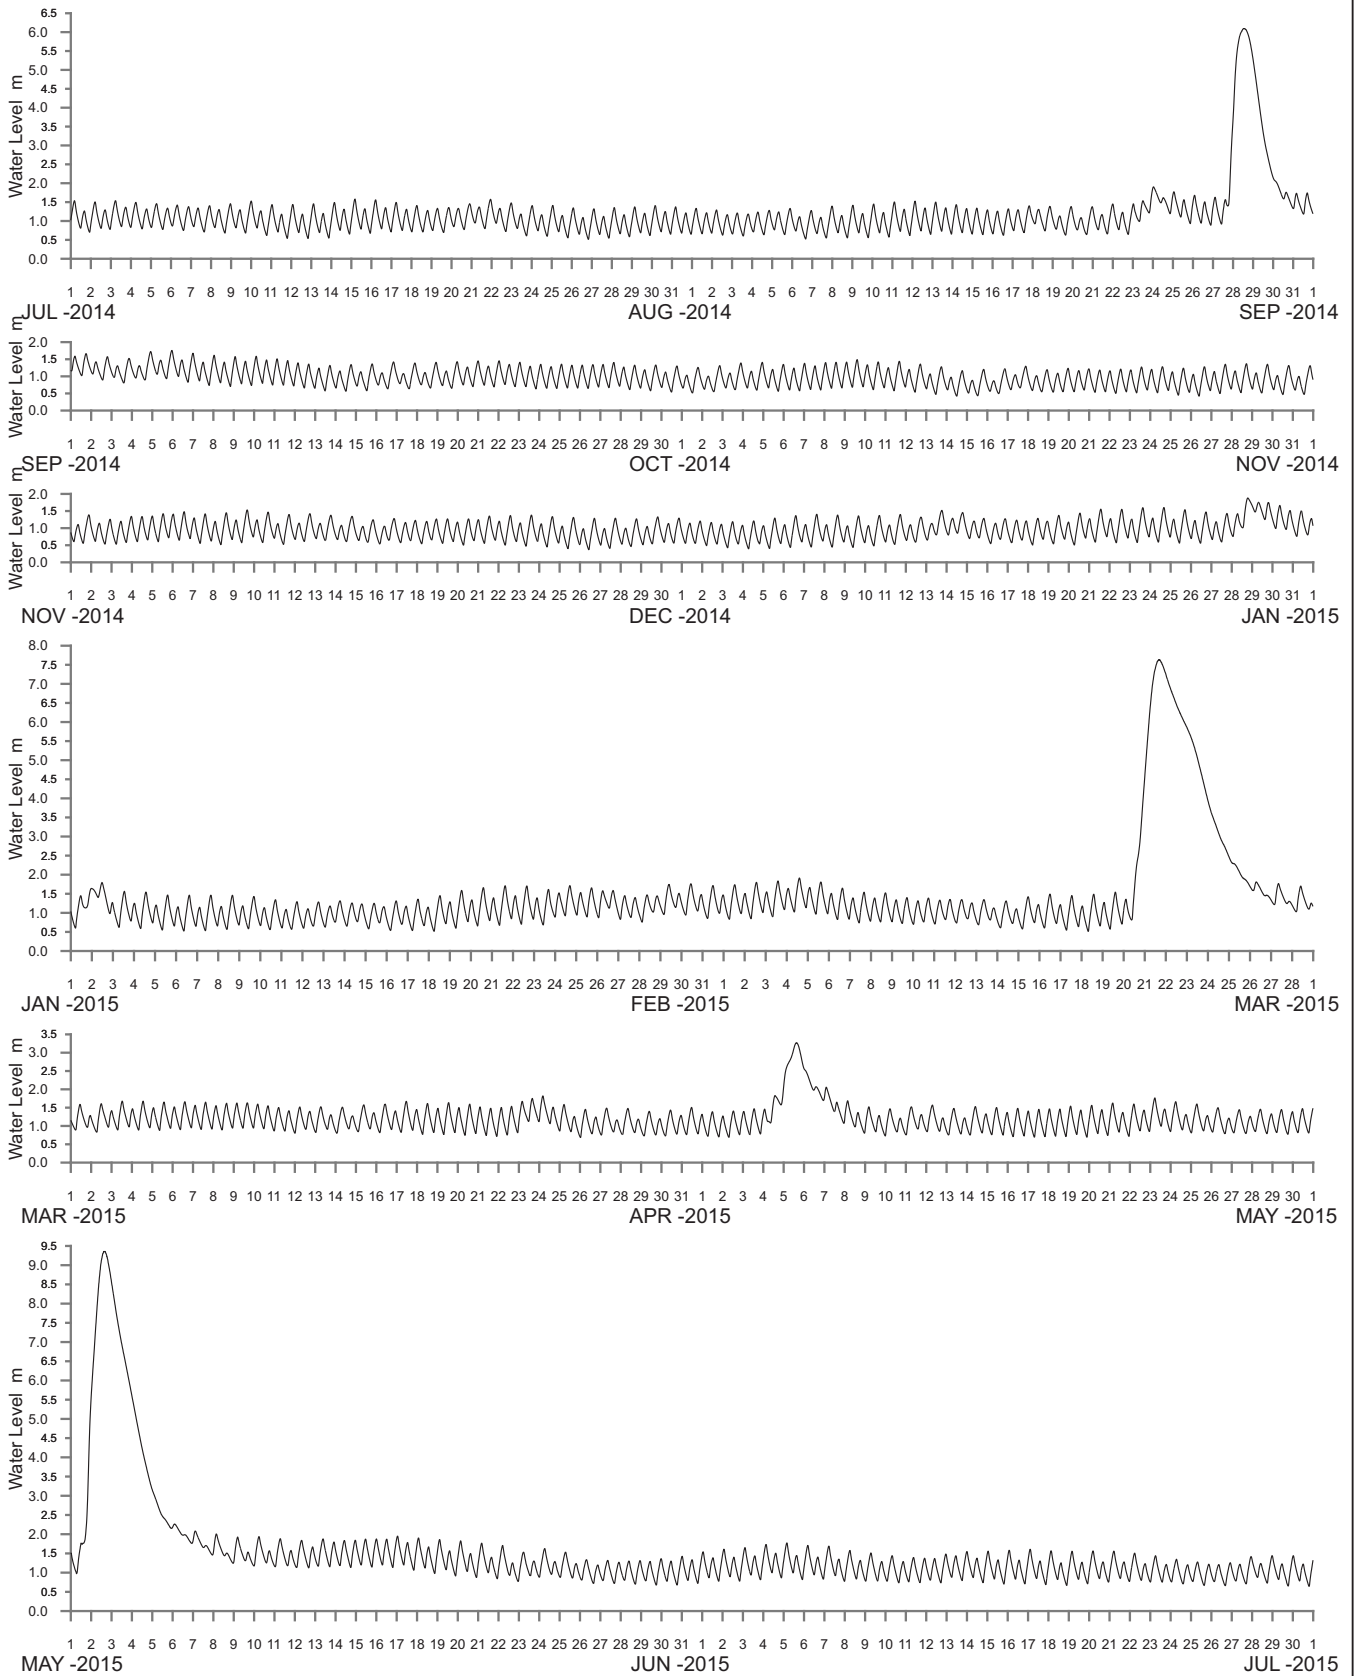
Figure  
37

WATER LEVEL REFERENCED TO RICHMOND RIVER VALLEY DATUM

LEYCESTER CREEK AT TUNCESTER  
2014-2015

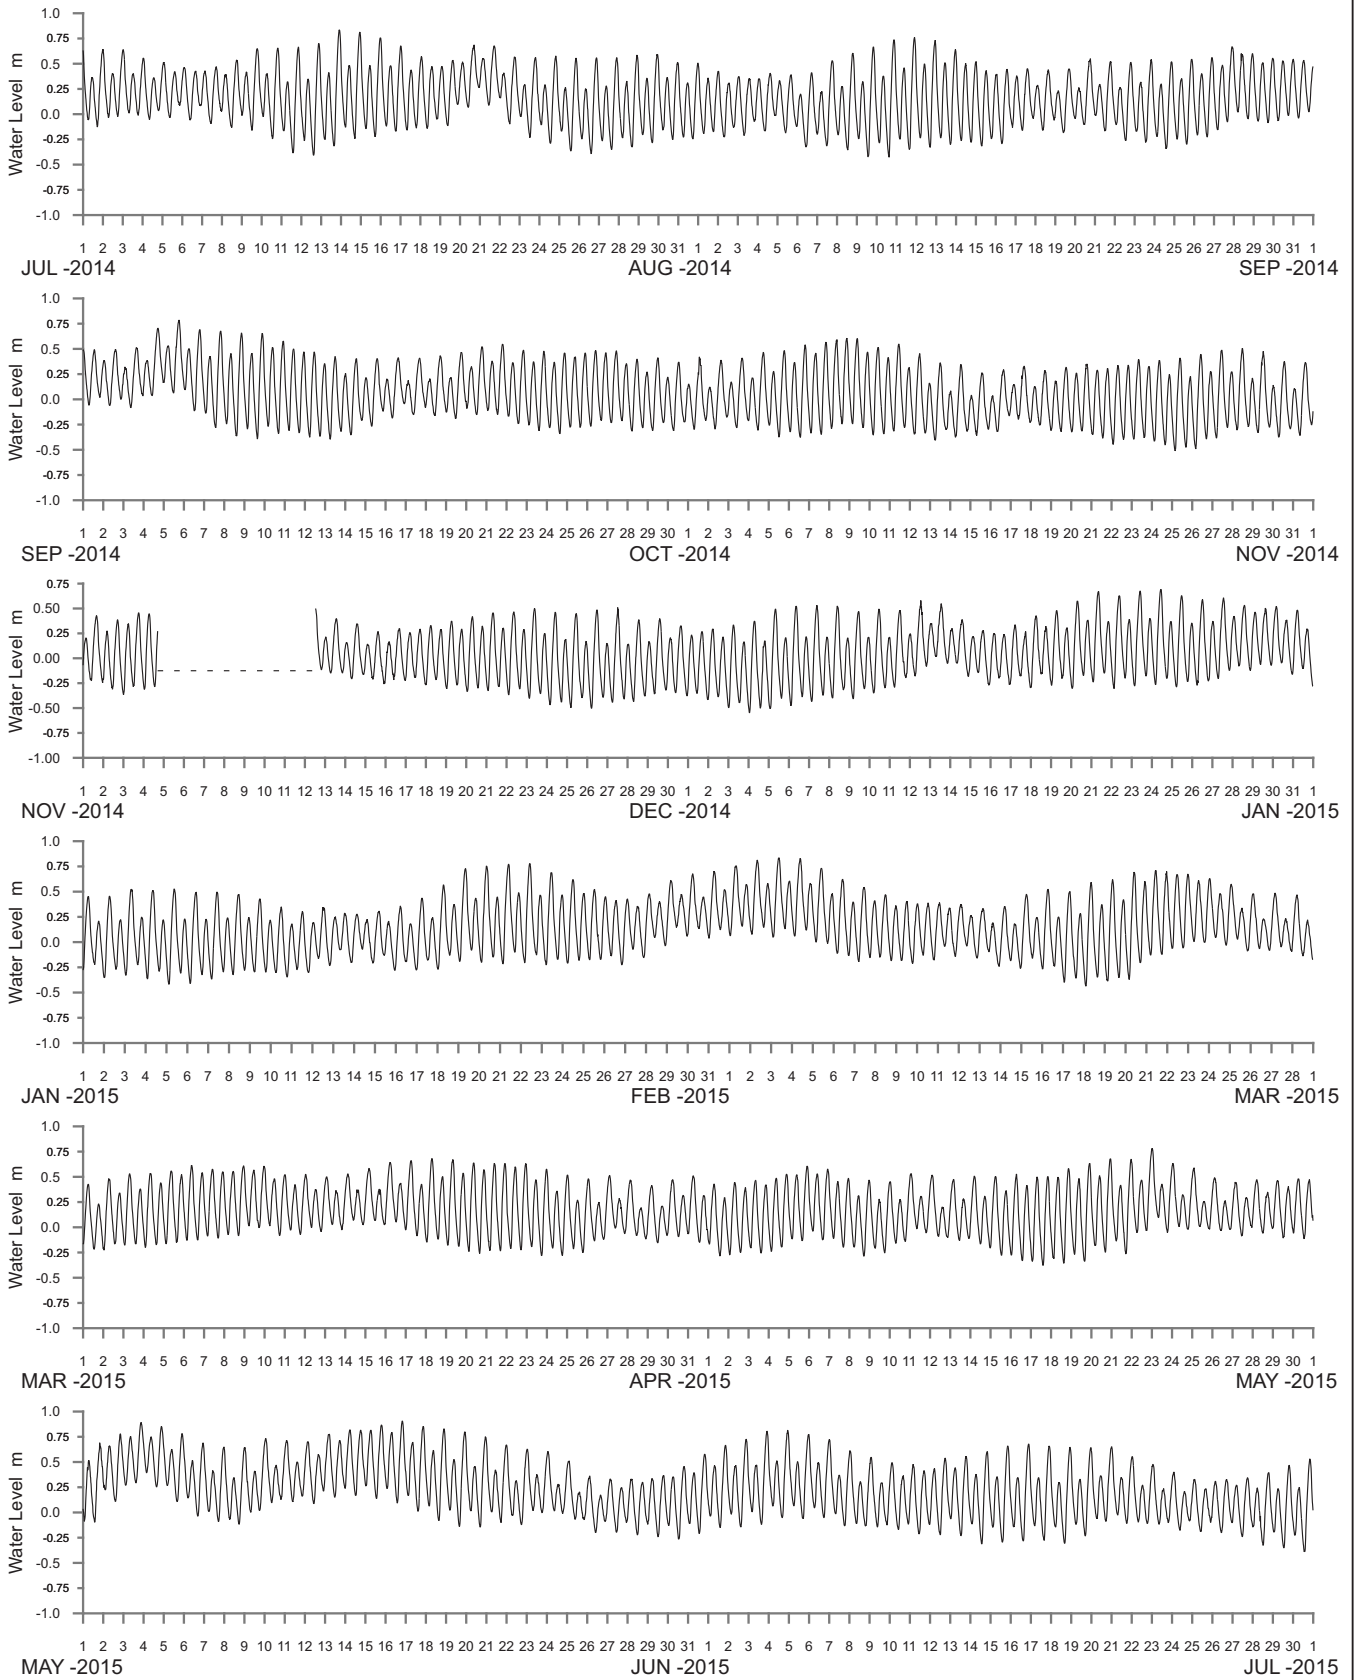
Figure  
40

WATER LEVEL REFERENCED TO AUSTRALIAN HEIGHT DATUM

CLARENCE RIVER AT OYSTER CHANNEL  
2014–2015

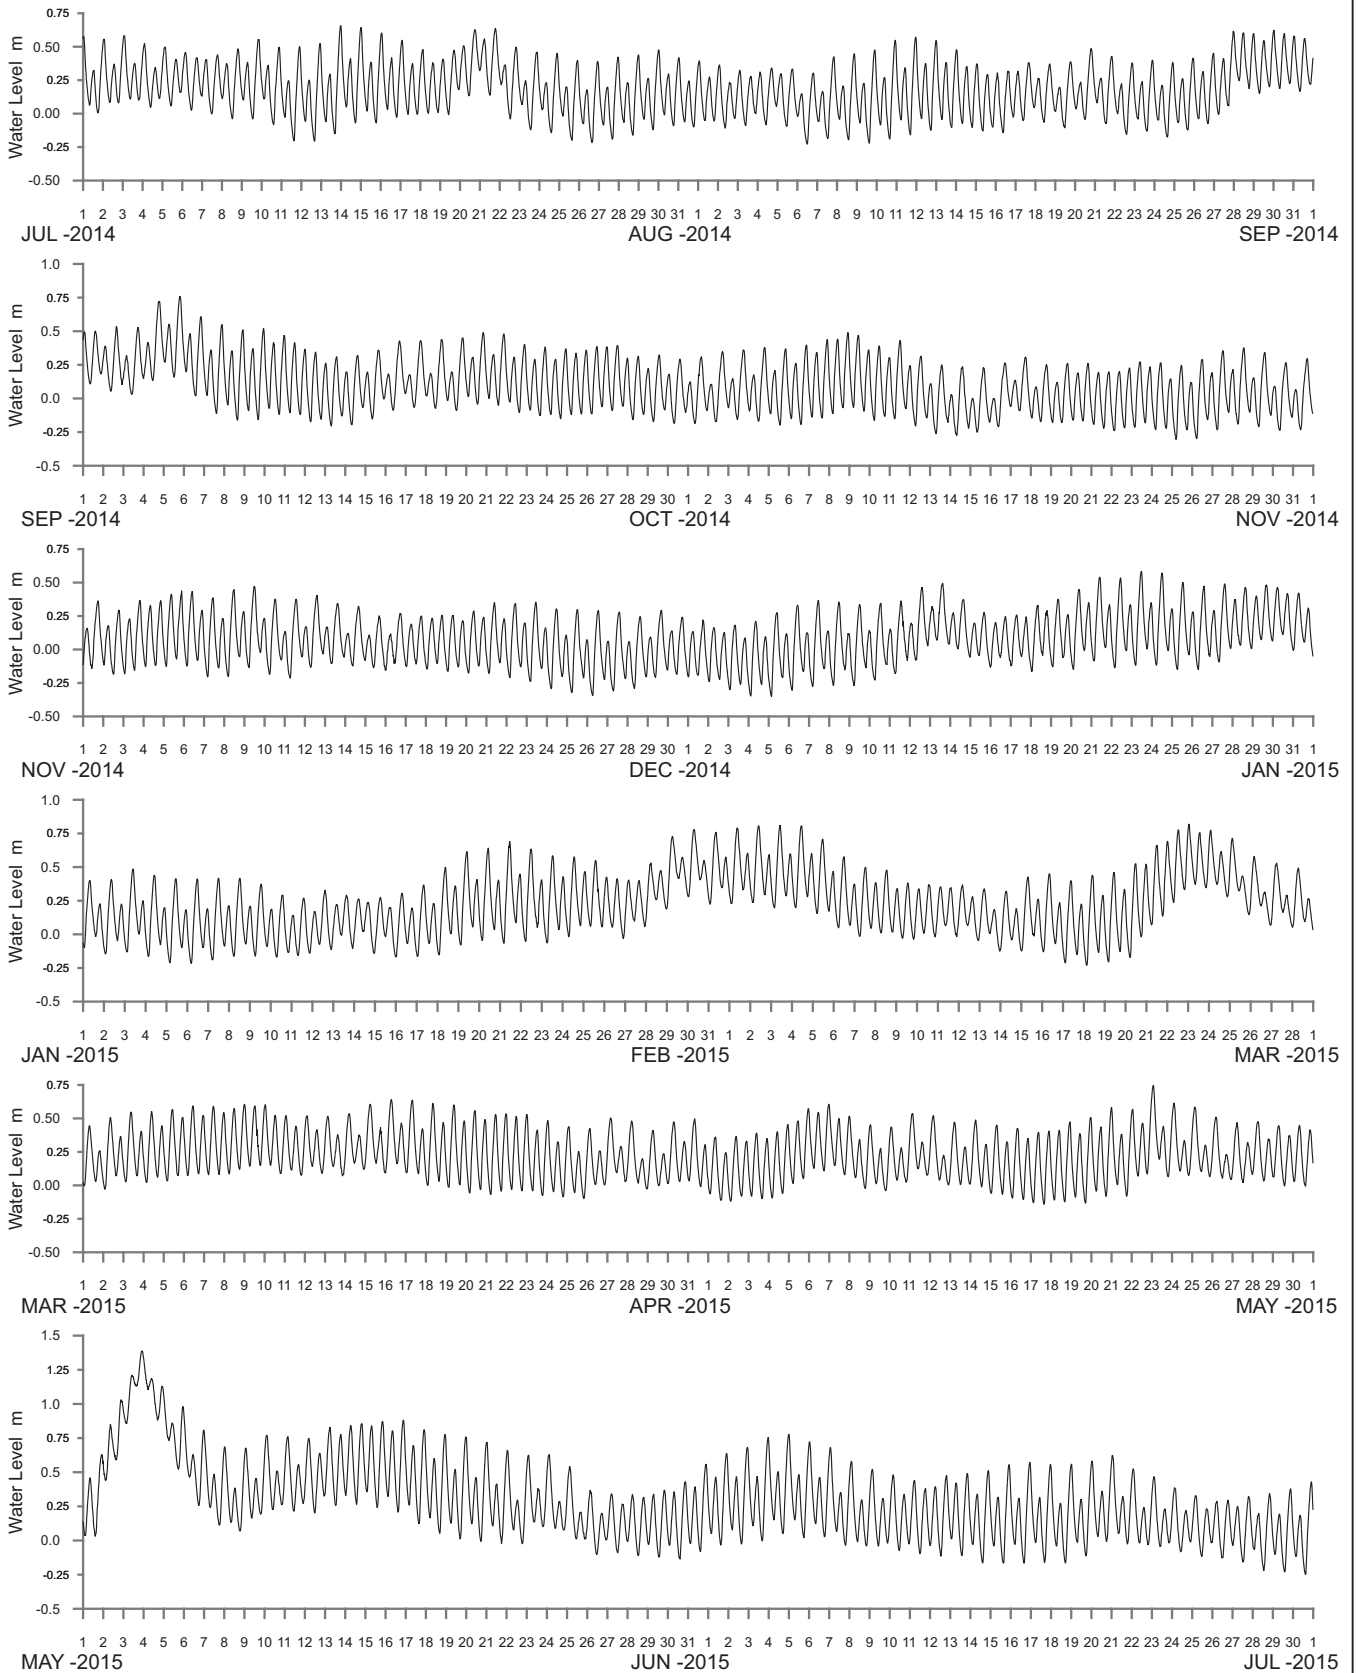
Figure  
41

WATER LEVEL REFERENCED TO AUSTRALIAN HEIGHT DATUM

CLARENCE RIVER AT MACLEAN  
2014–2015

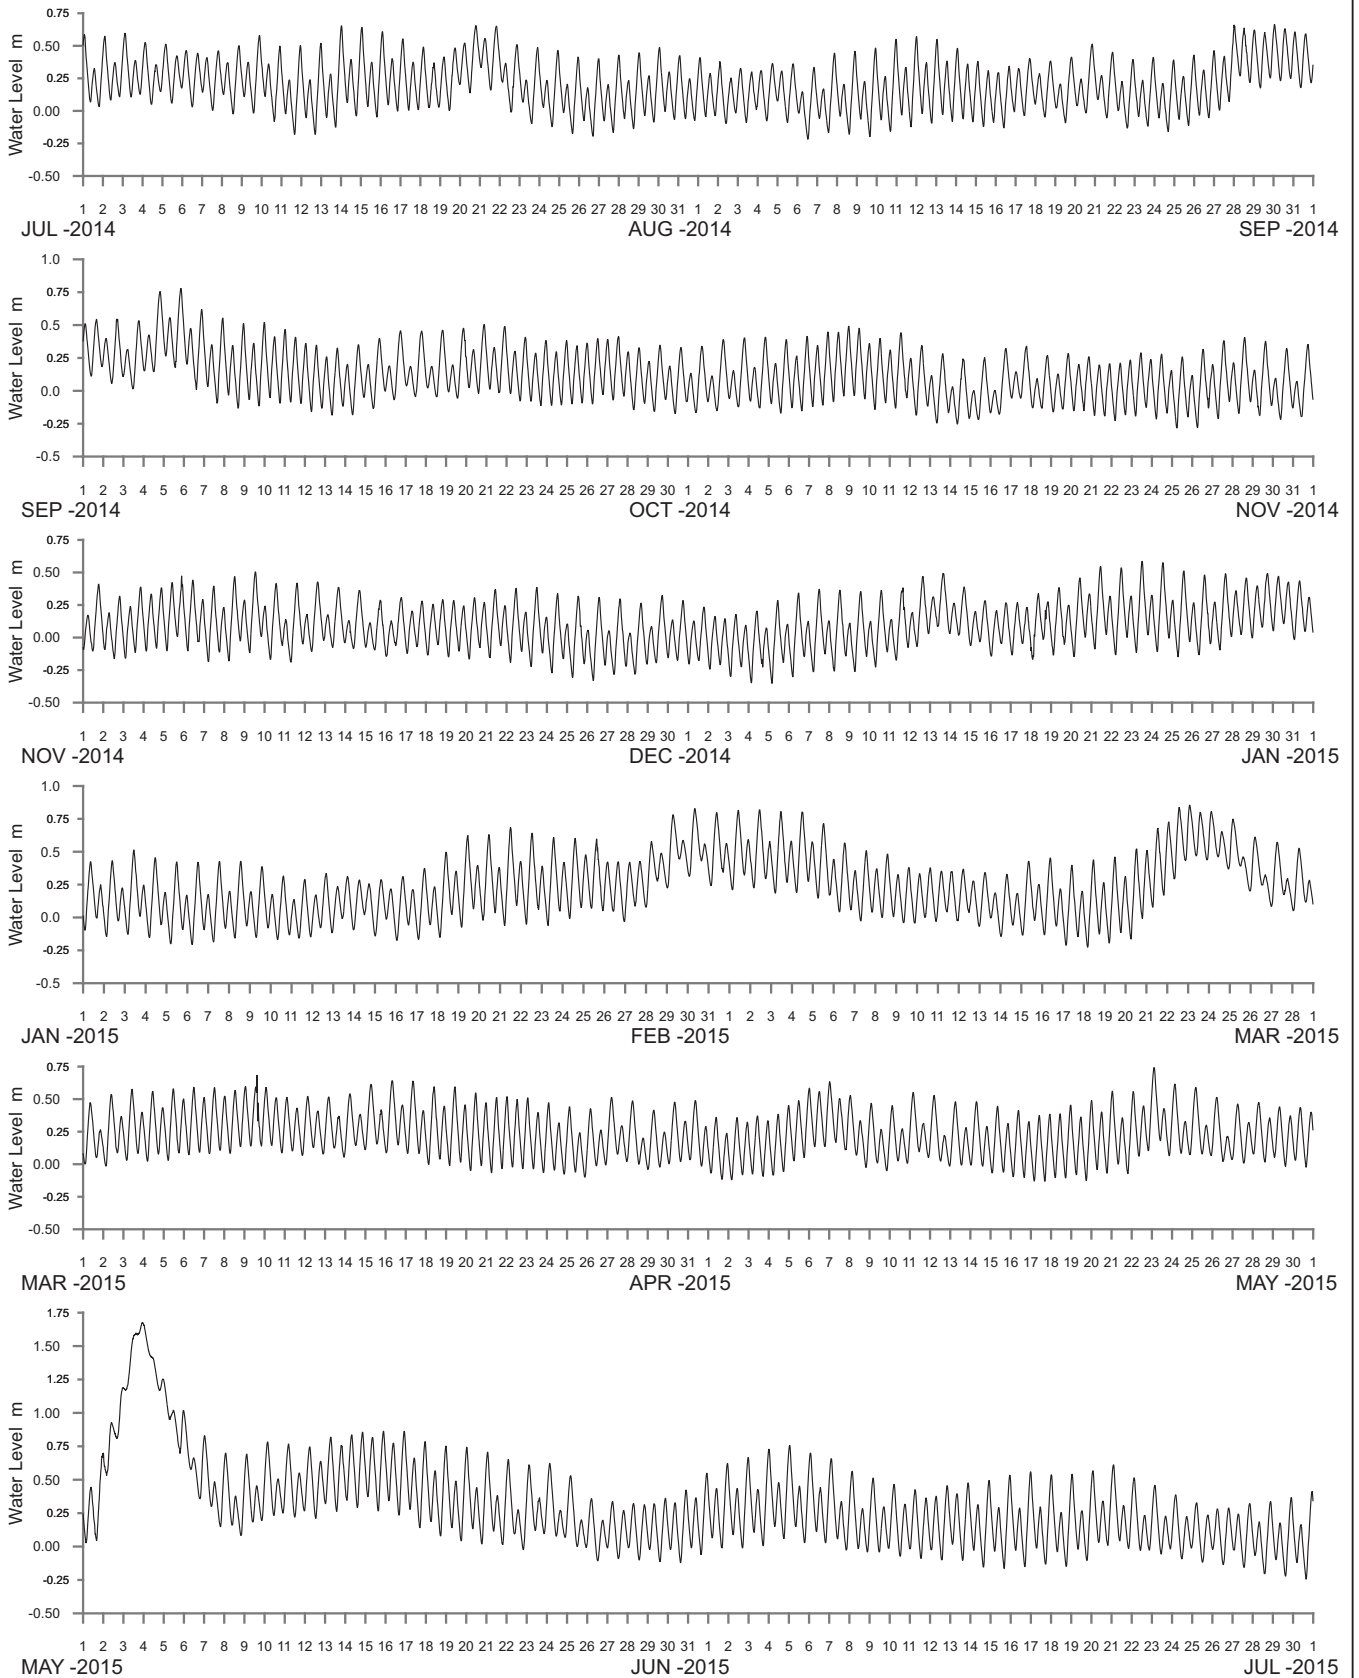
Figure  
42

WATER LEVEL REFERENCED TO AUSTRALIAN HEIGHT DATUM

**CLARENCE RIVER AT LAWRENCE**  
2014–2015
