**Public Works**  
Manly Hydraulics Laboratory

MHL  
Report 2383

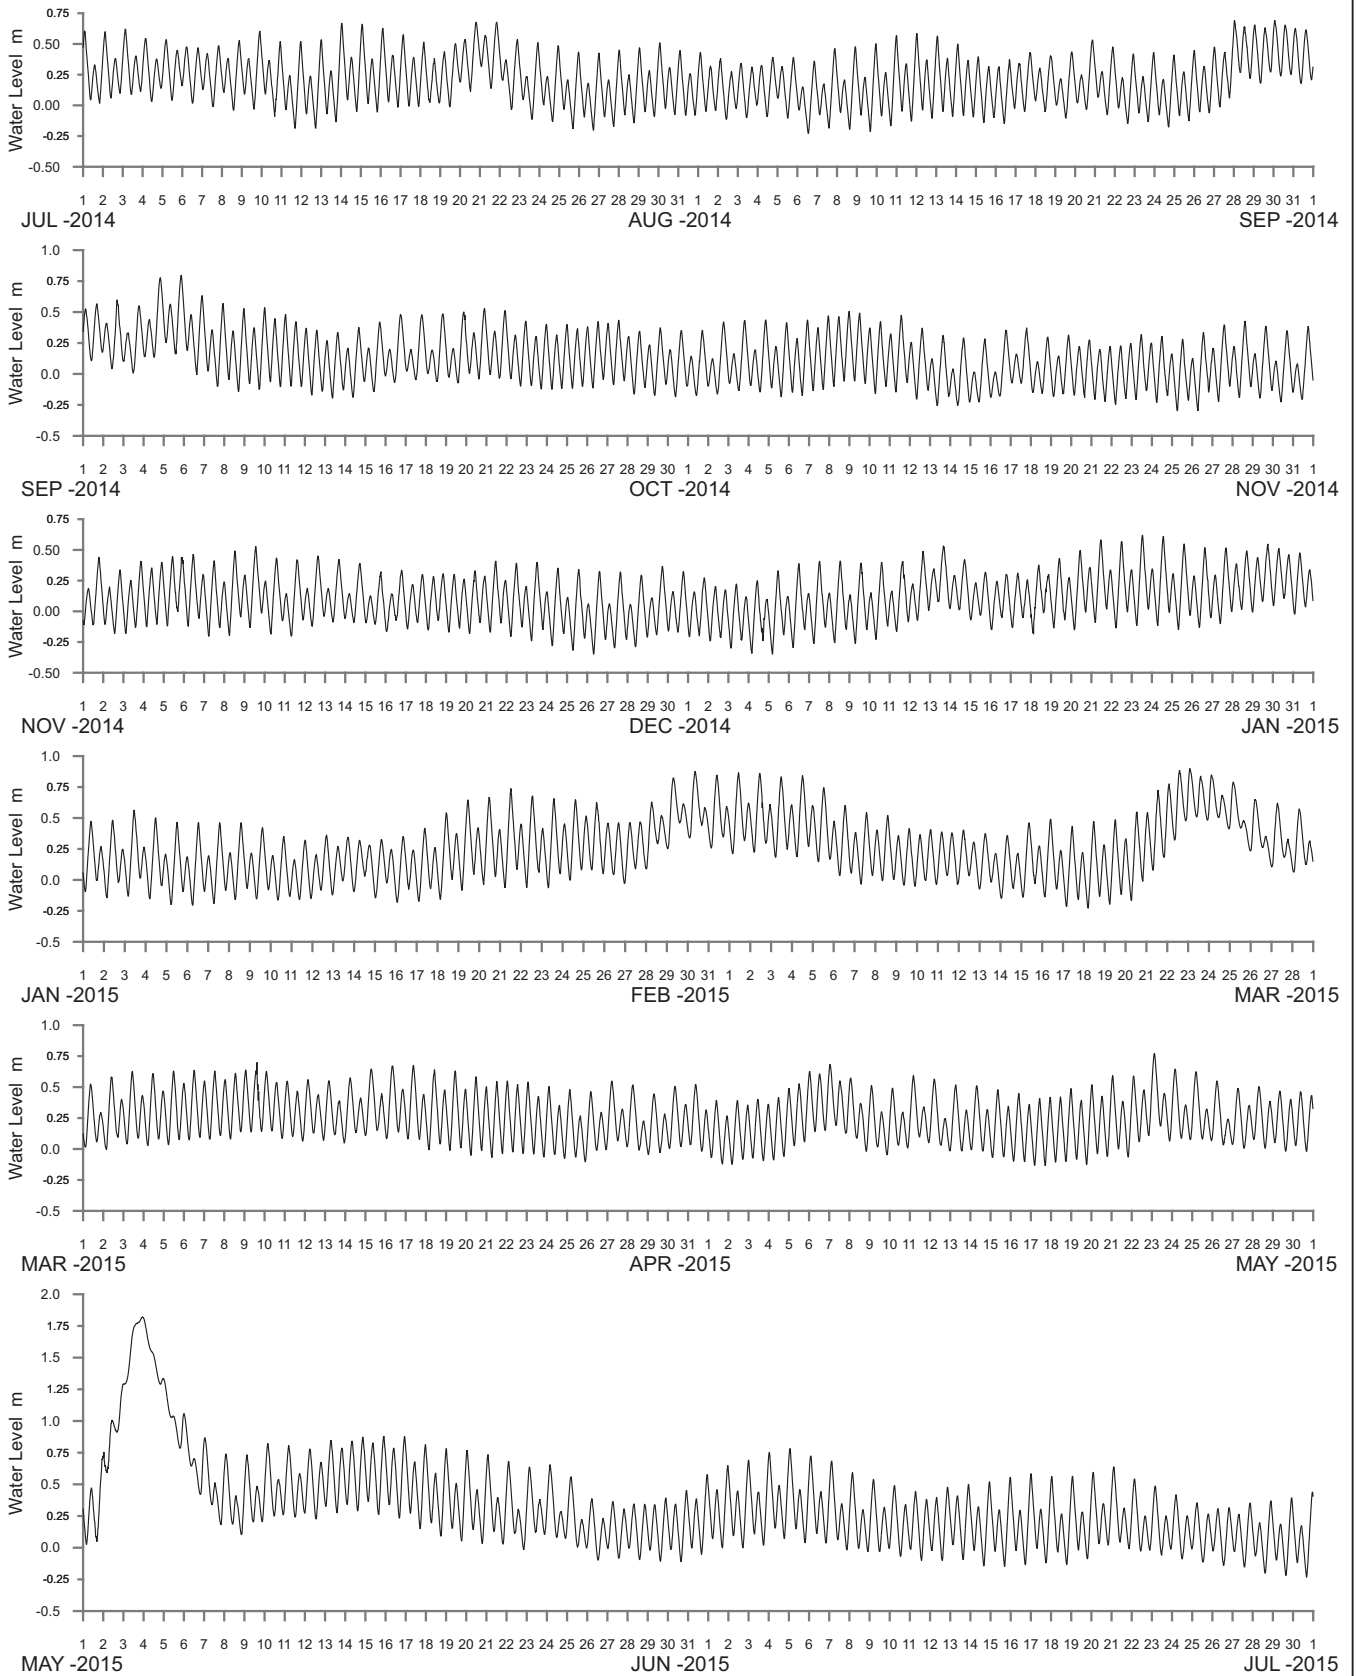
Figure  
43

WATER LEVEL REFERENCED TO AUSTRALIAN HEIGHT DATUM

CLARENCE RIVER AT TYNDALE  
2014-2015

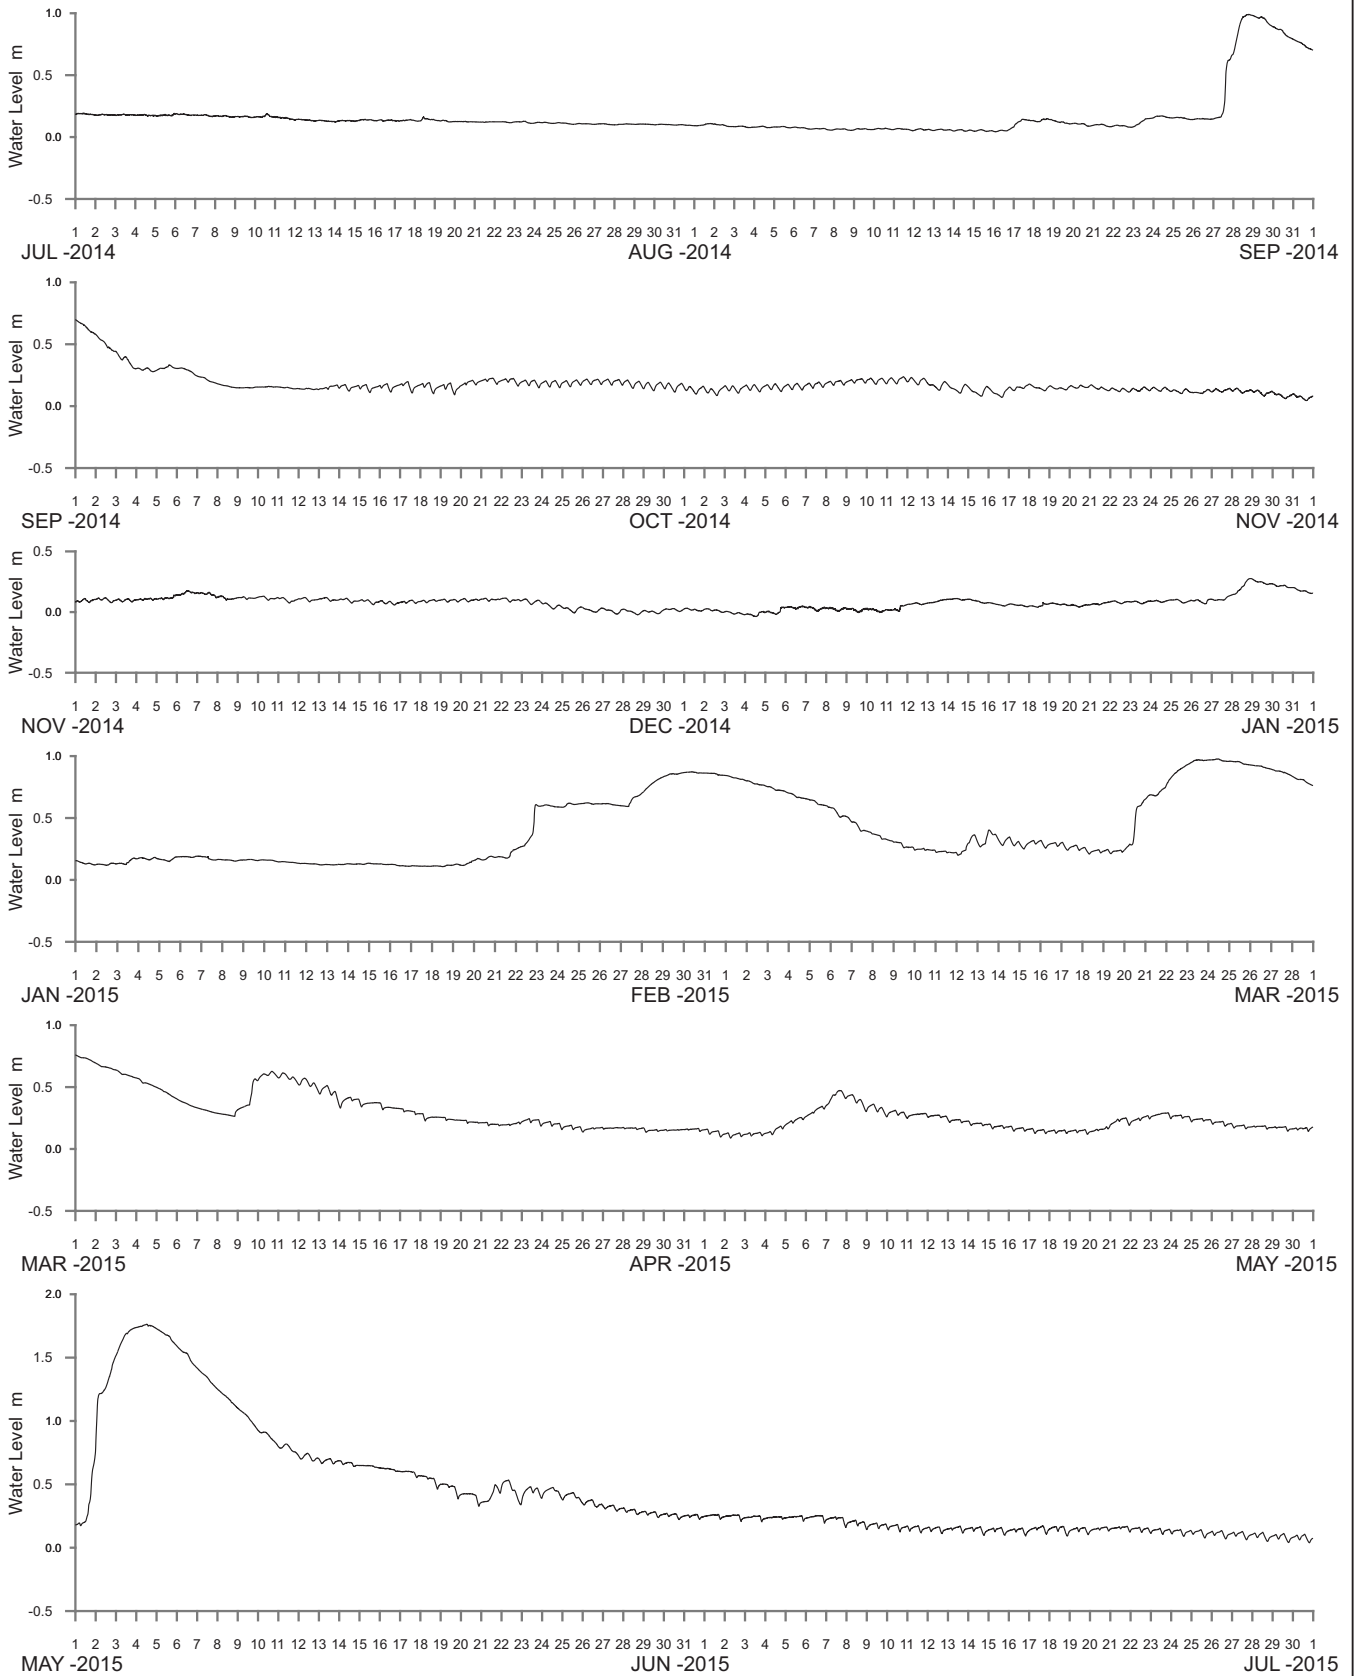
Figure  
44

WATER LEVEL REFERENCED TO AUSTRALIAN HEIGHT DATUM

CLARENCE RIVER AT THE AVENUE UPSTREAM  
2014–2015

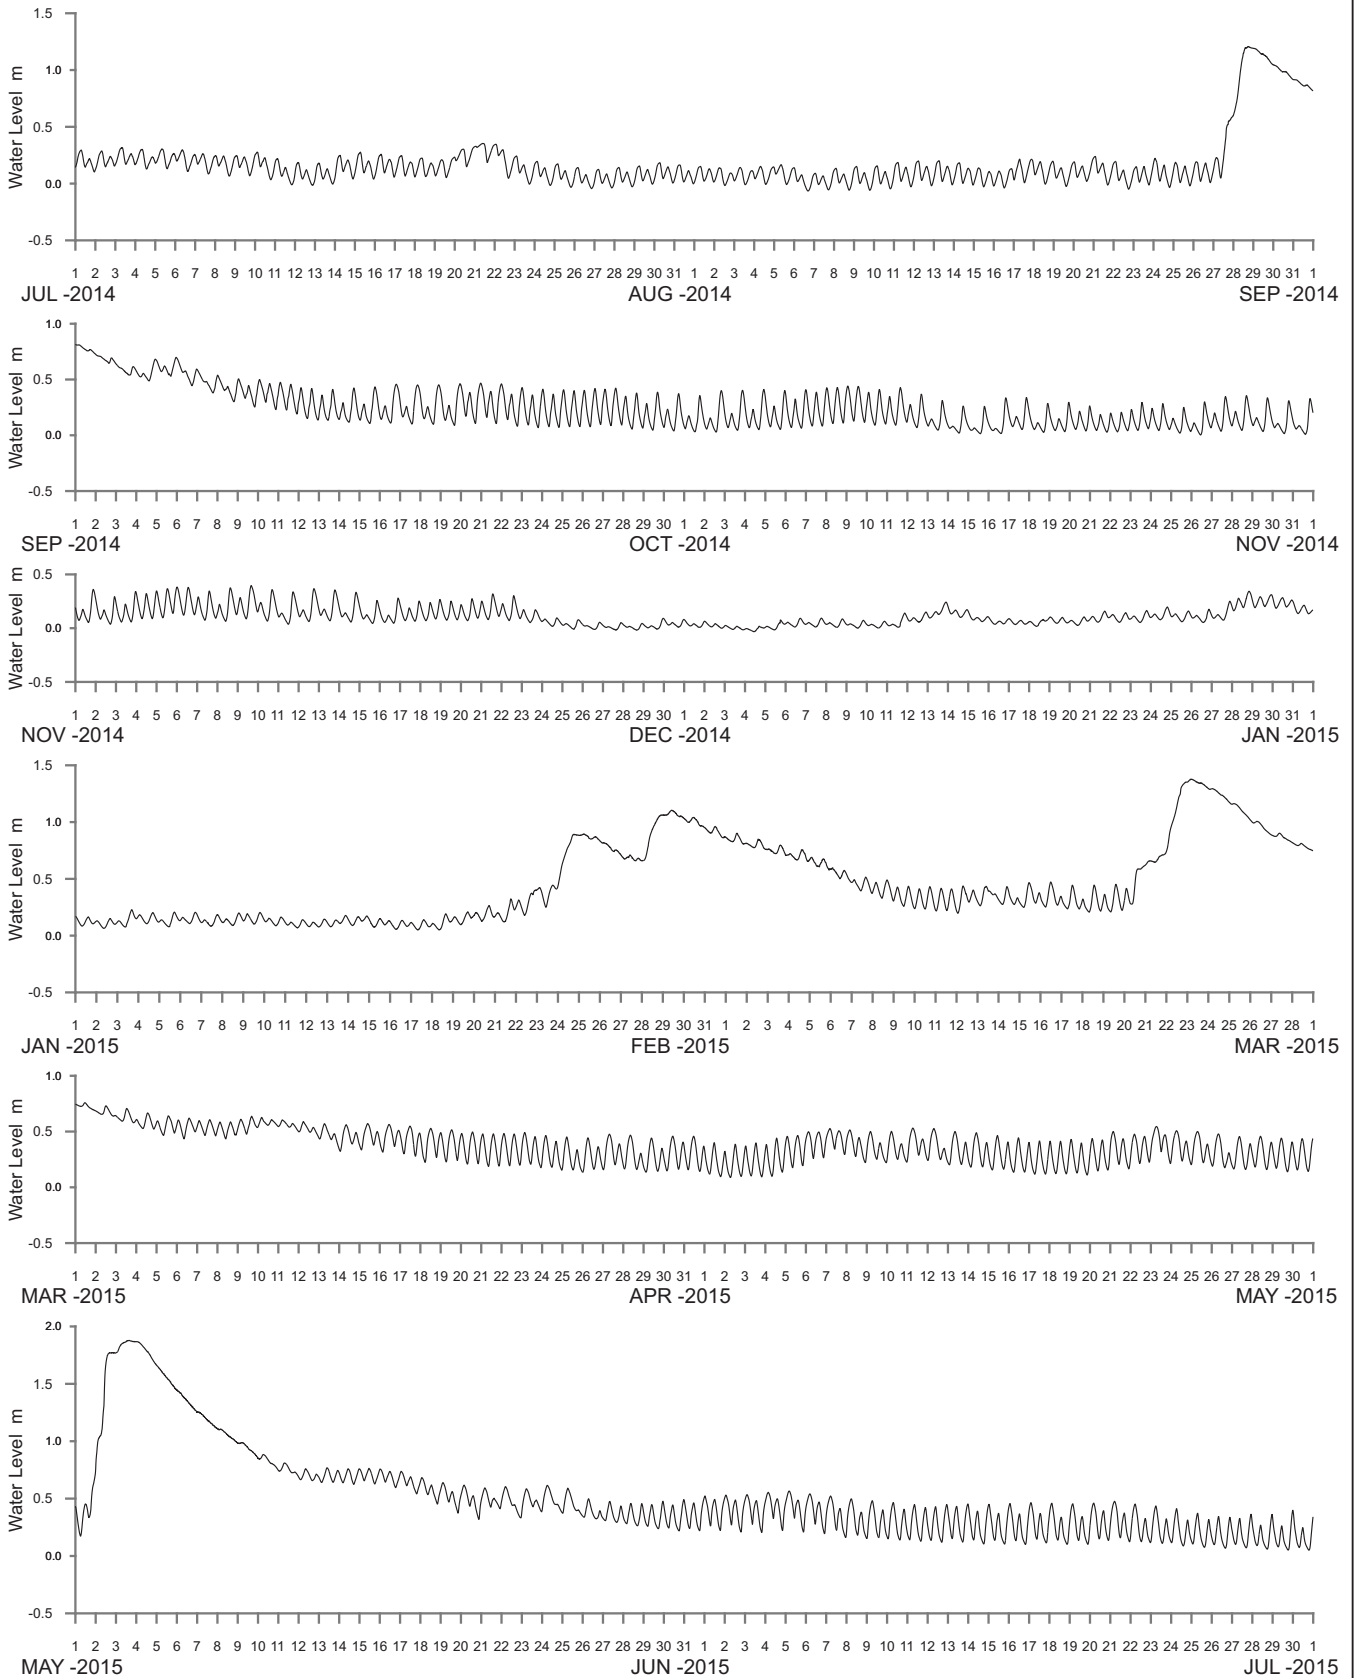
Figure  
45

WATER LEVEL REFERENCED TO AUSTRALIAN HEIGHT DATUM

**CLARENCE RIVER AT THE AVENUE DOWNSTREAM**  
2014-2015

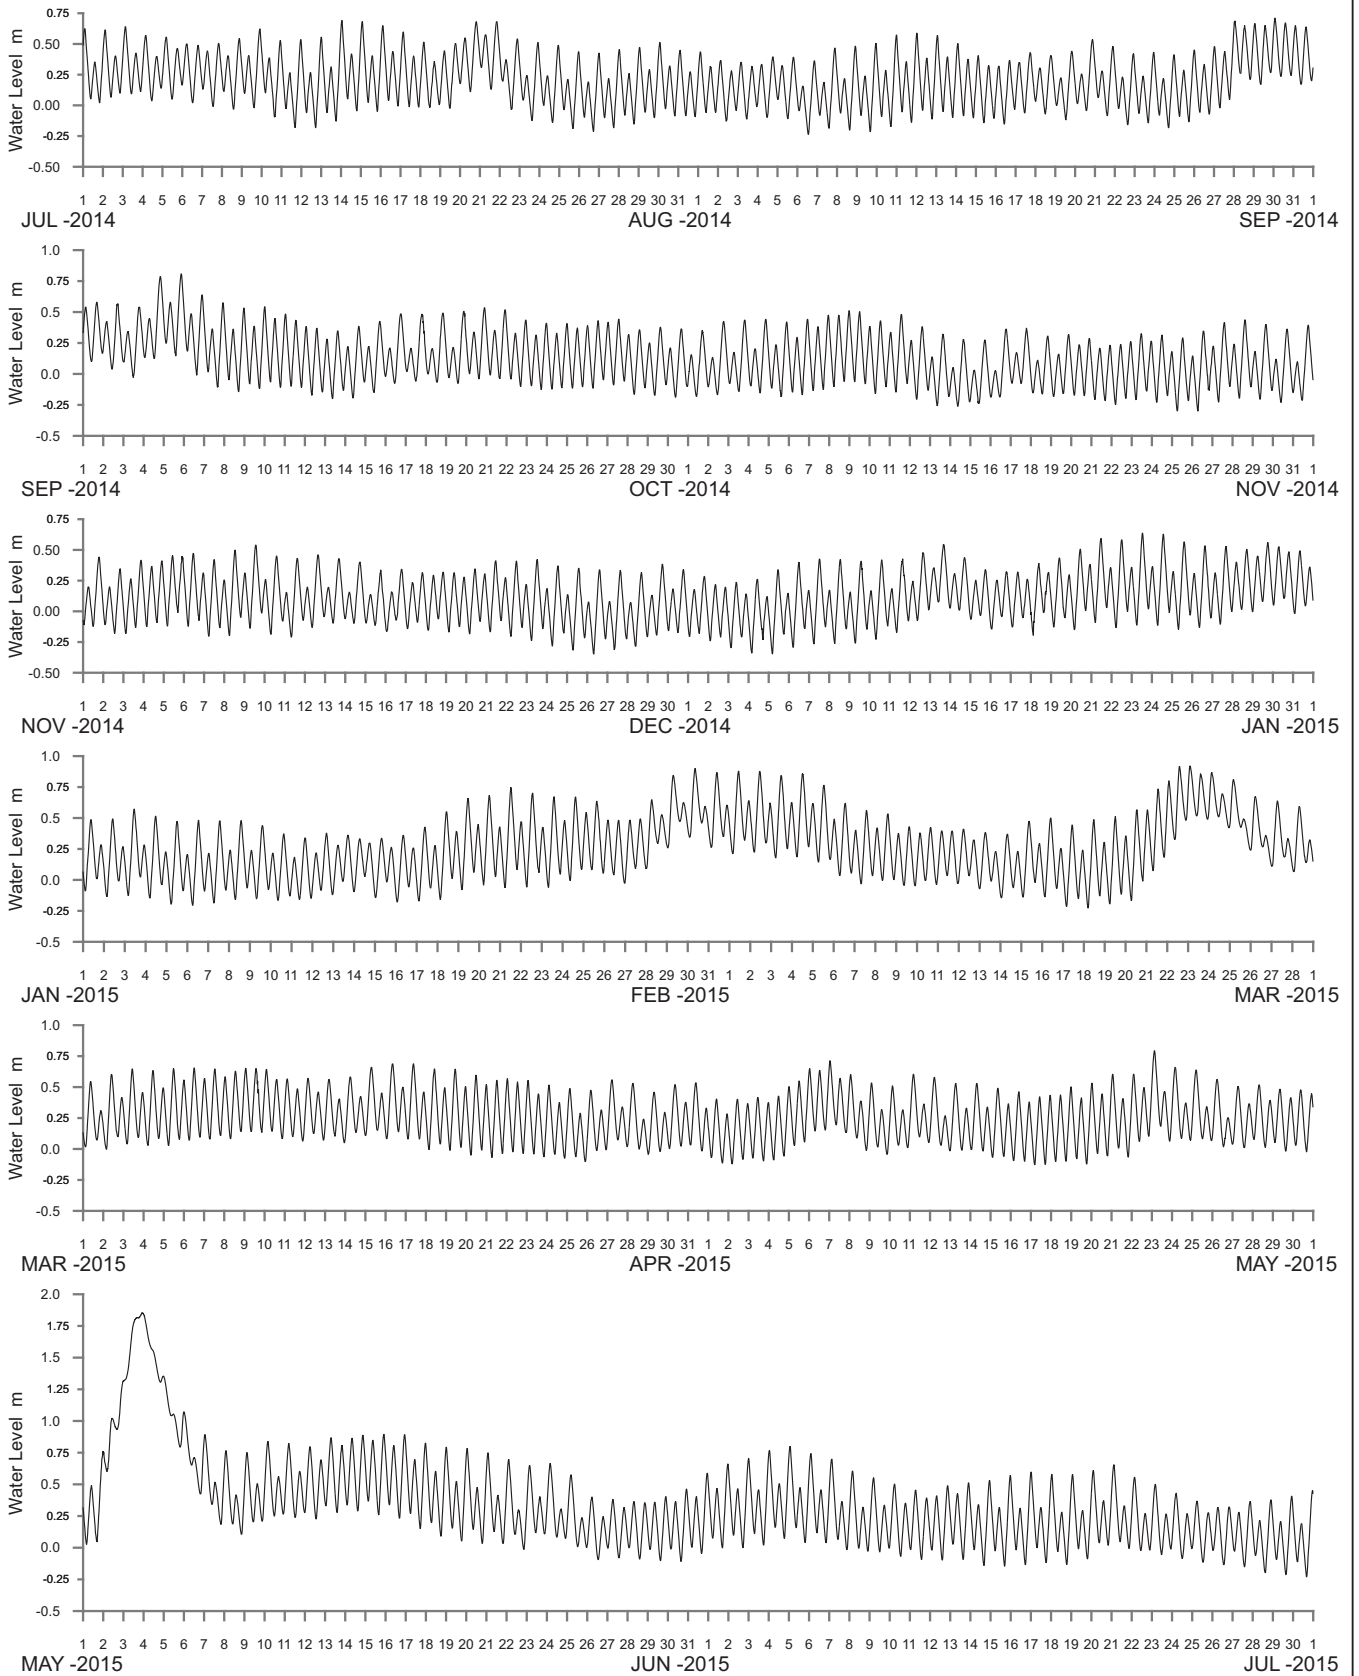
Figure  
46

WATER LEVEL REFERENCED TO AUSTRALIAN HEIGHT DATUM

CLARENCE RIVER AT BRUSHGROVE  
2014-2015

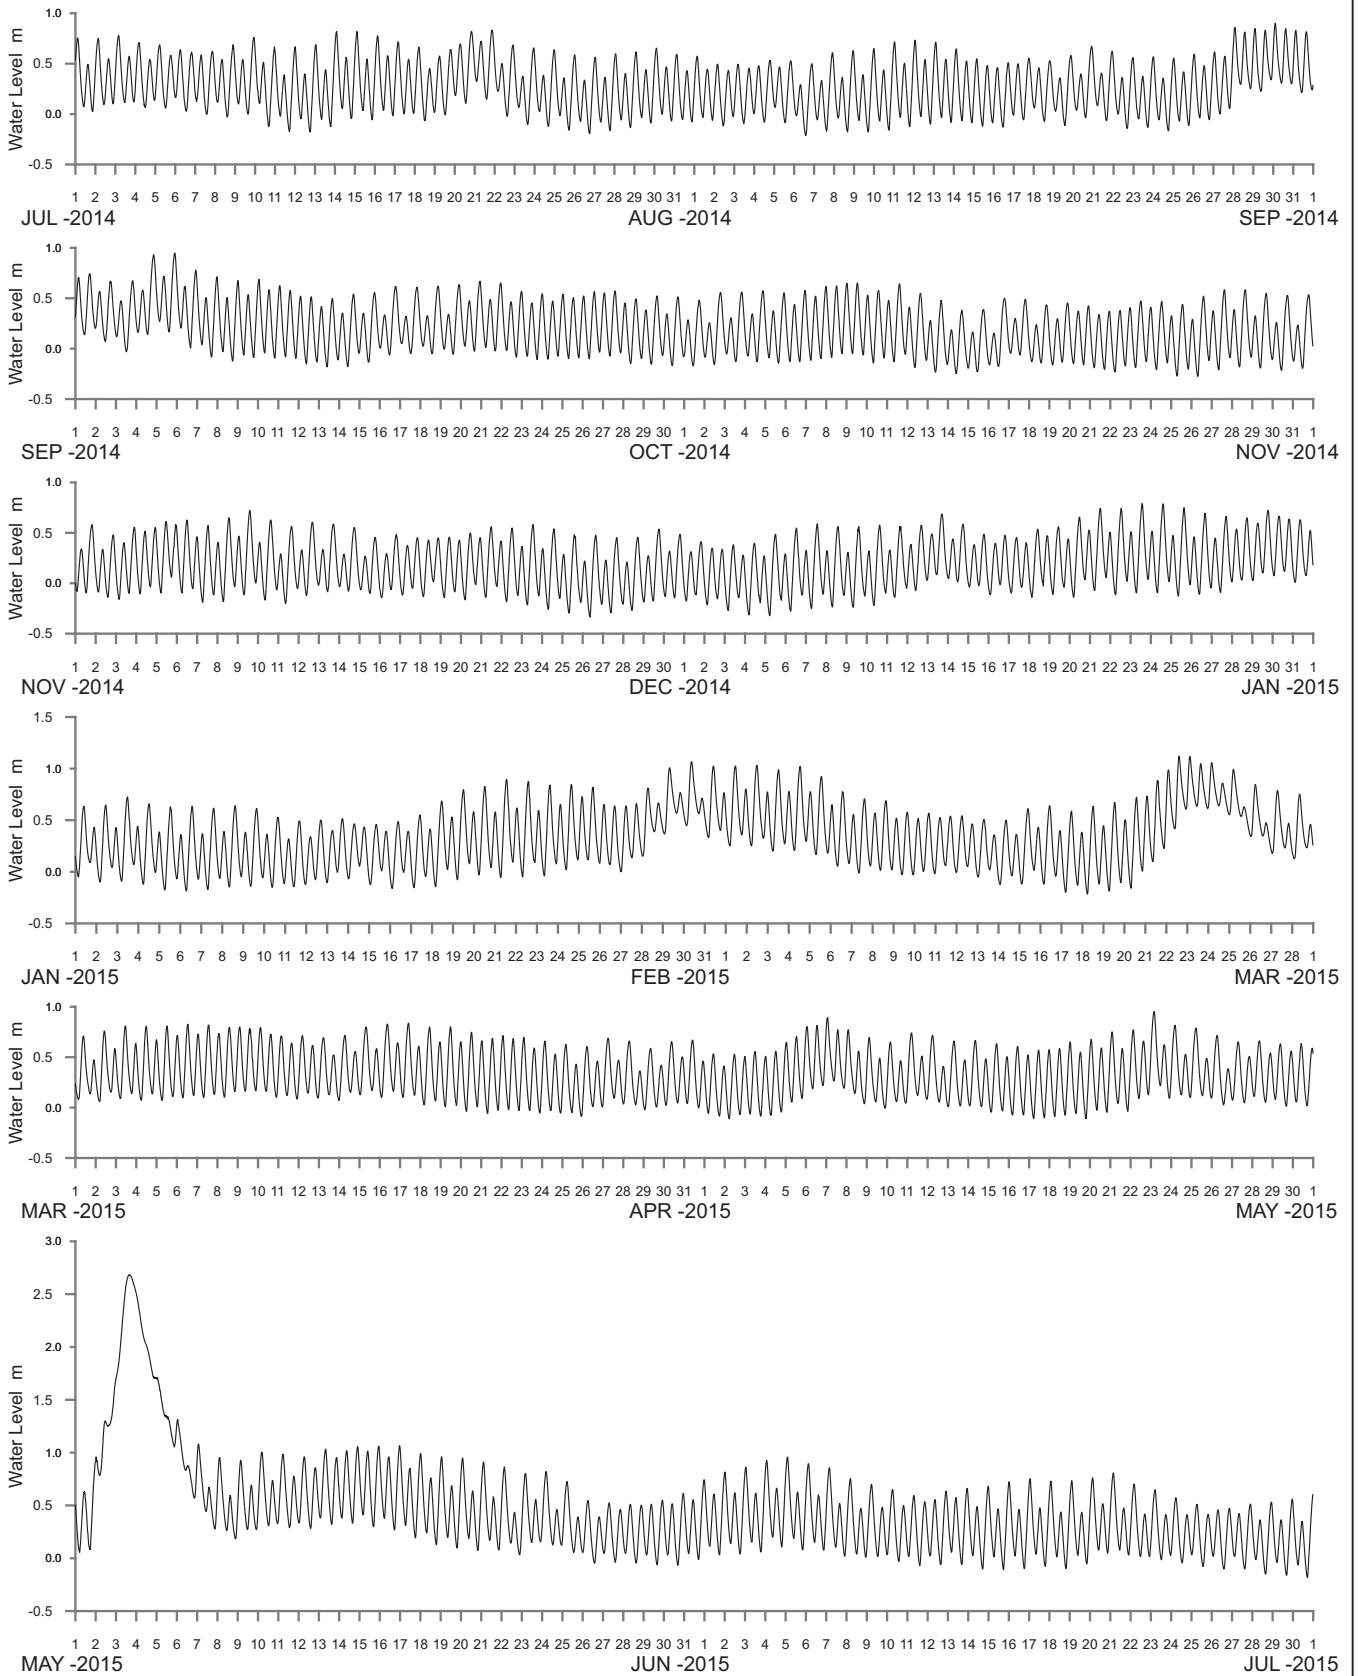
Figure  
48

WATER LEVEL REFERENCED TO AUSTRALIAN HEIGHT DATUM

CLARENCE RIVER AT GRAFTON  
2014–2015

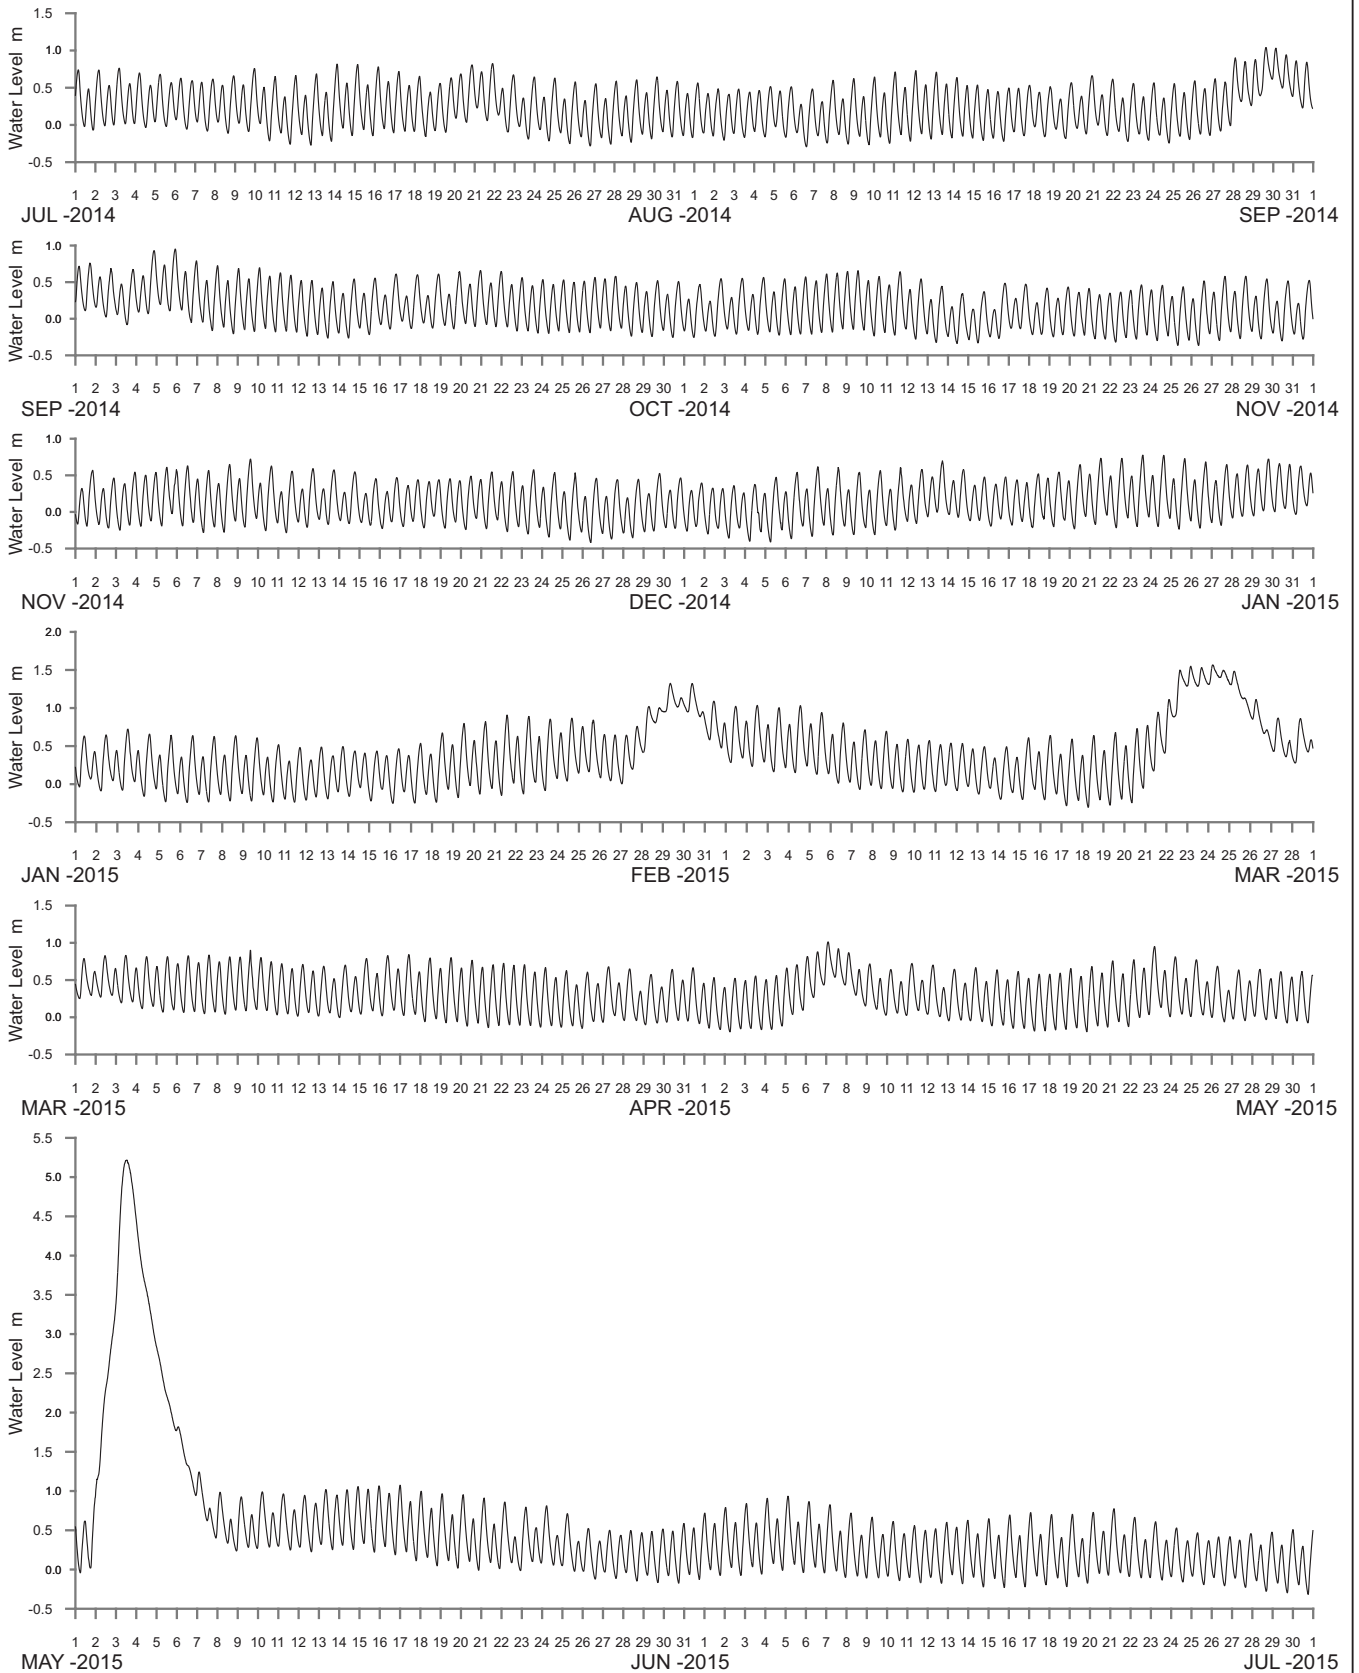
Figure  
49

WATER LEVEL REFERENCED TO AUSTRALIAN HEIGHT DATUM

CLARENCE RIVER AT ROGANS BRIDGE  
2014-2015

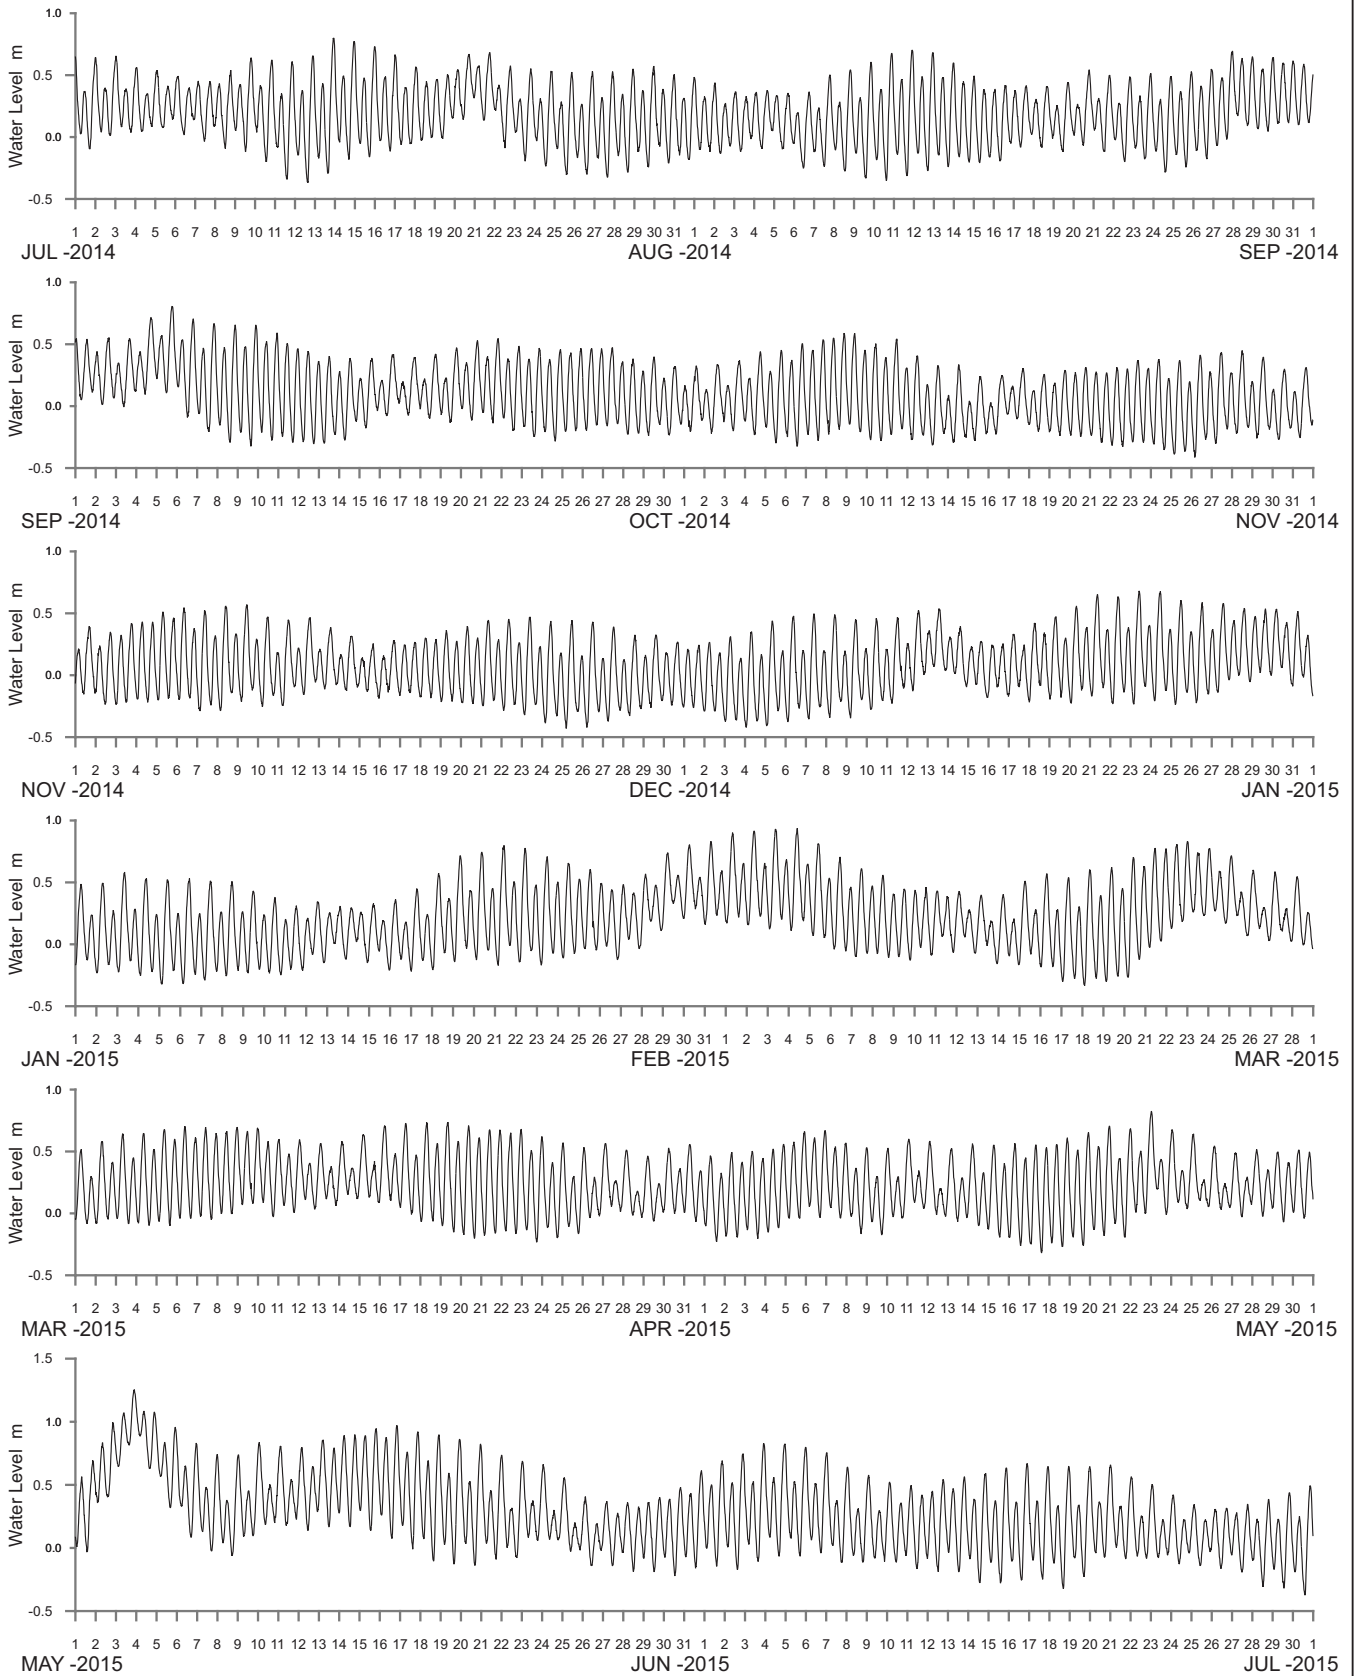
Figure  
50

WATER LEVEL REFERENCED TO AUSTRALIAN HEIGHT DATUM

**PALMERS CHANNEL AT PALMERS ISLAND BRIDGE**  
2014–2015

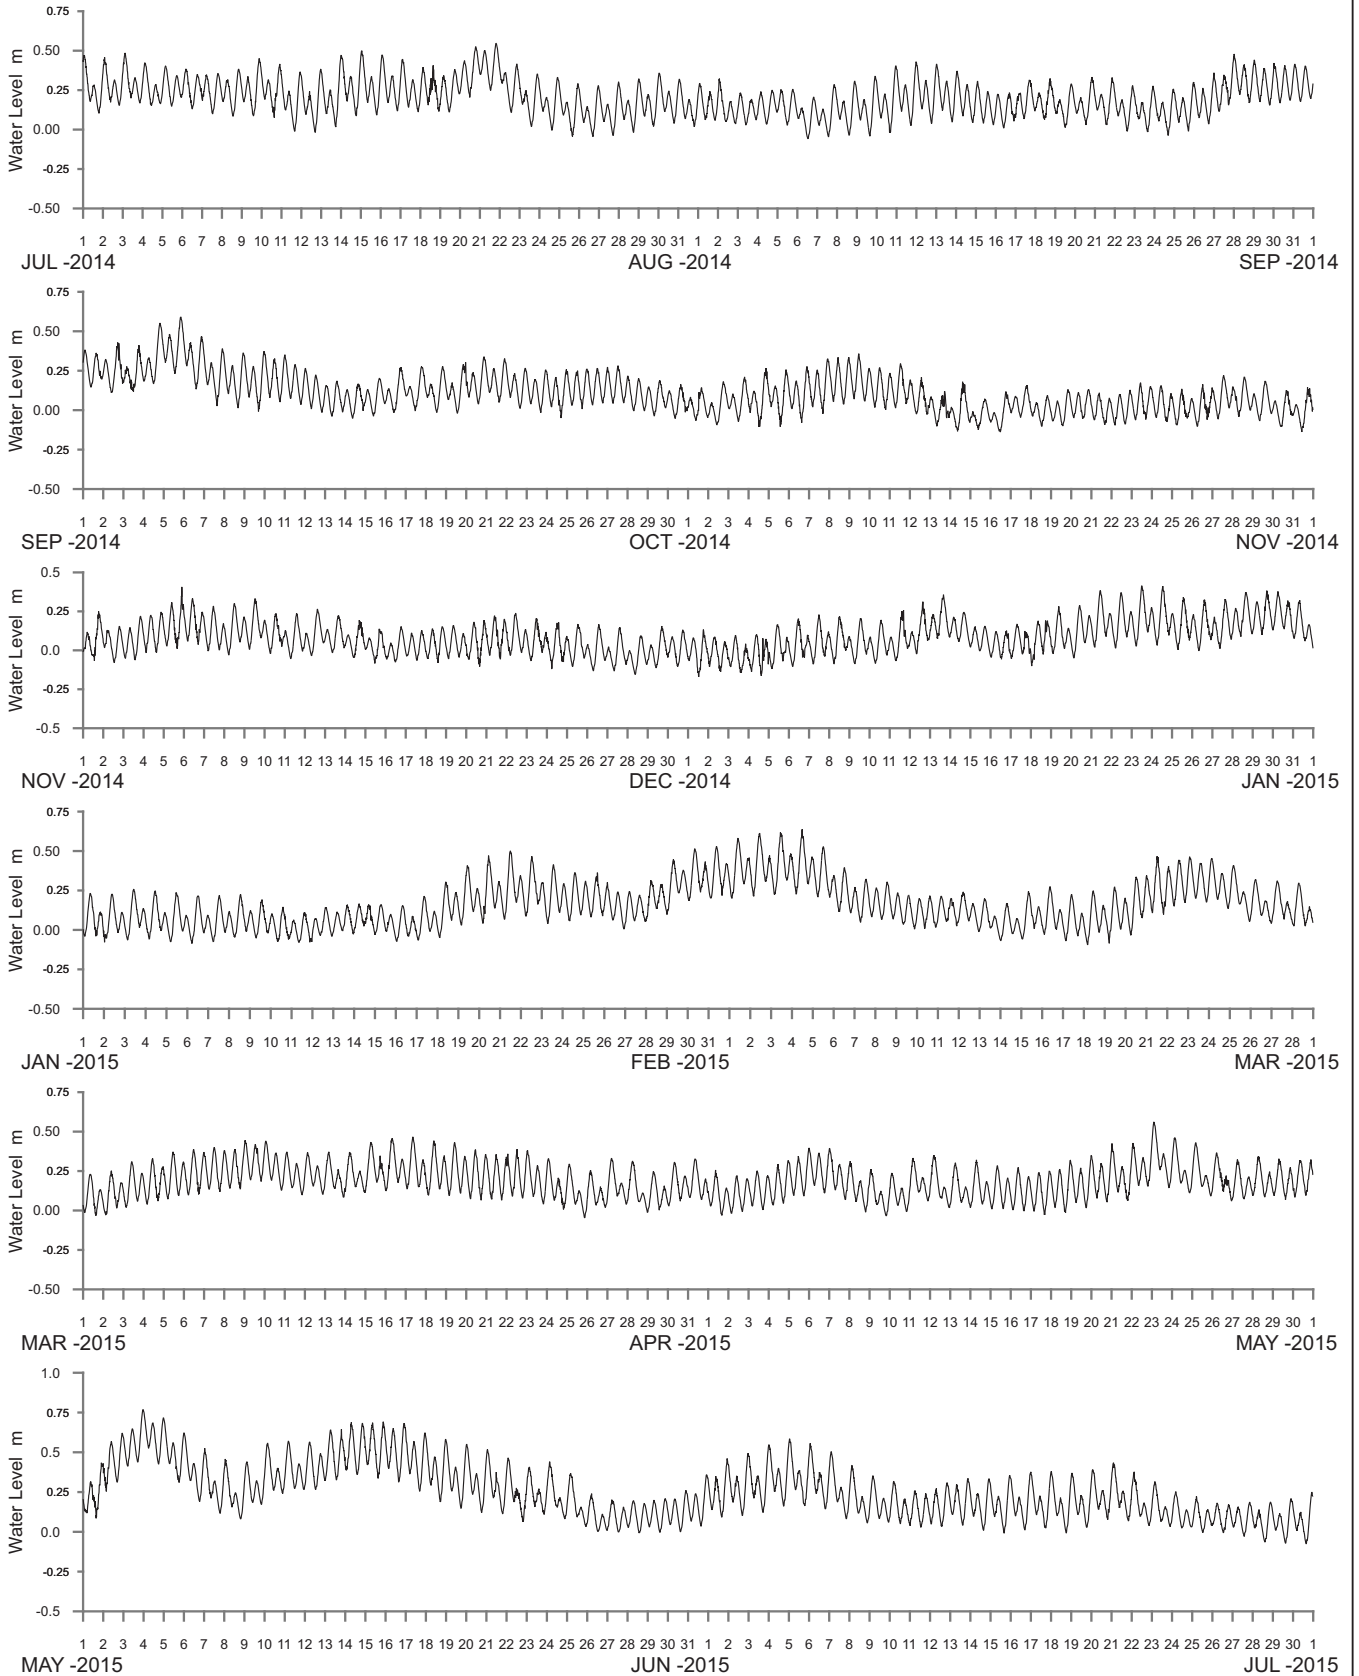
Figure  
**51**

WATER LEVEL REFERENCED TO AUSTRALIAN HEIGHT DATUM

**LAKE WOLOWEYAH AT LAKE WOLOWEYAH**  
2014–2015
