Public Works
Manly Hydraulics Laboratory

MHL
Report 2474

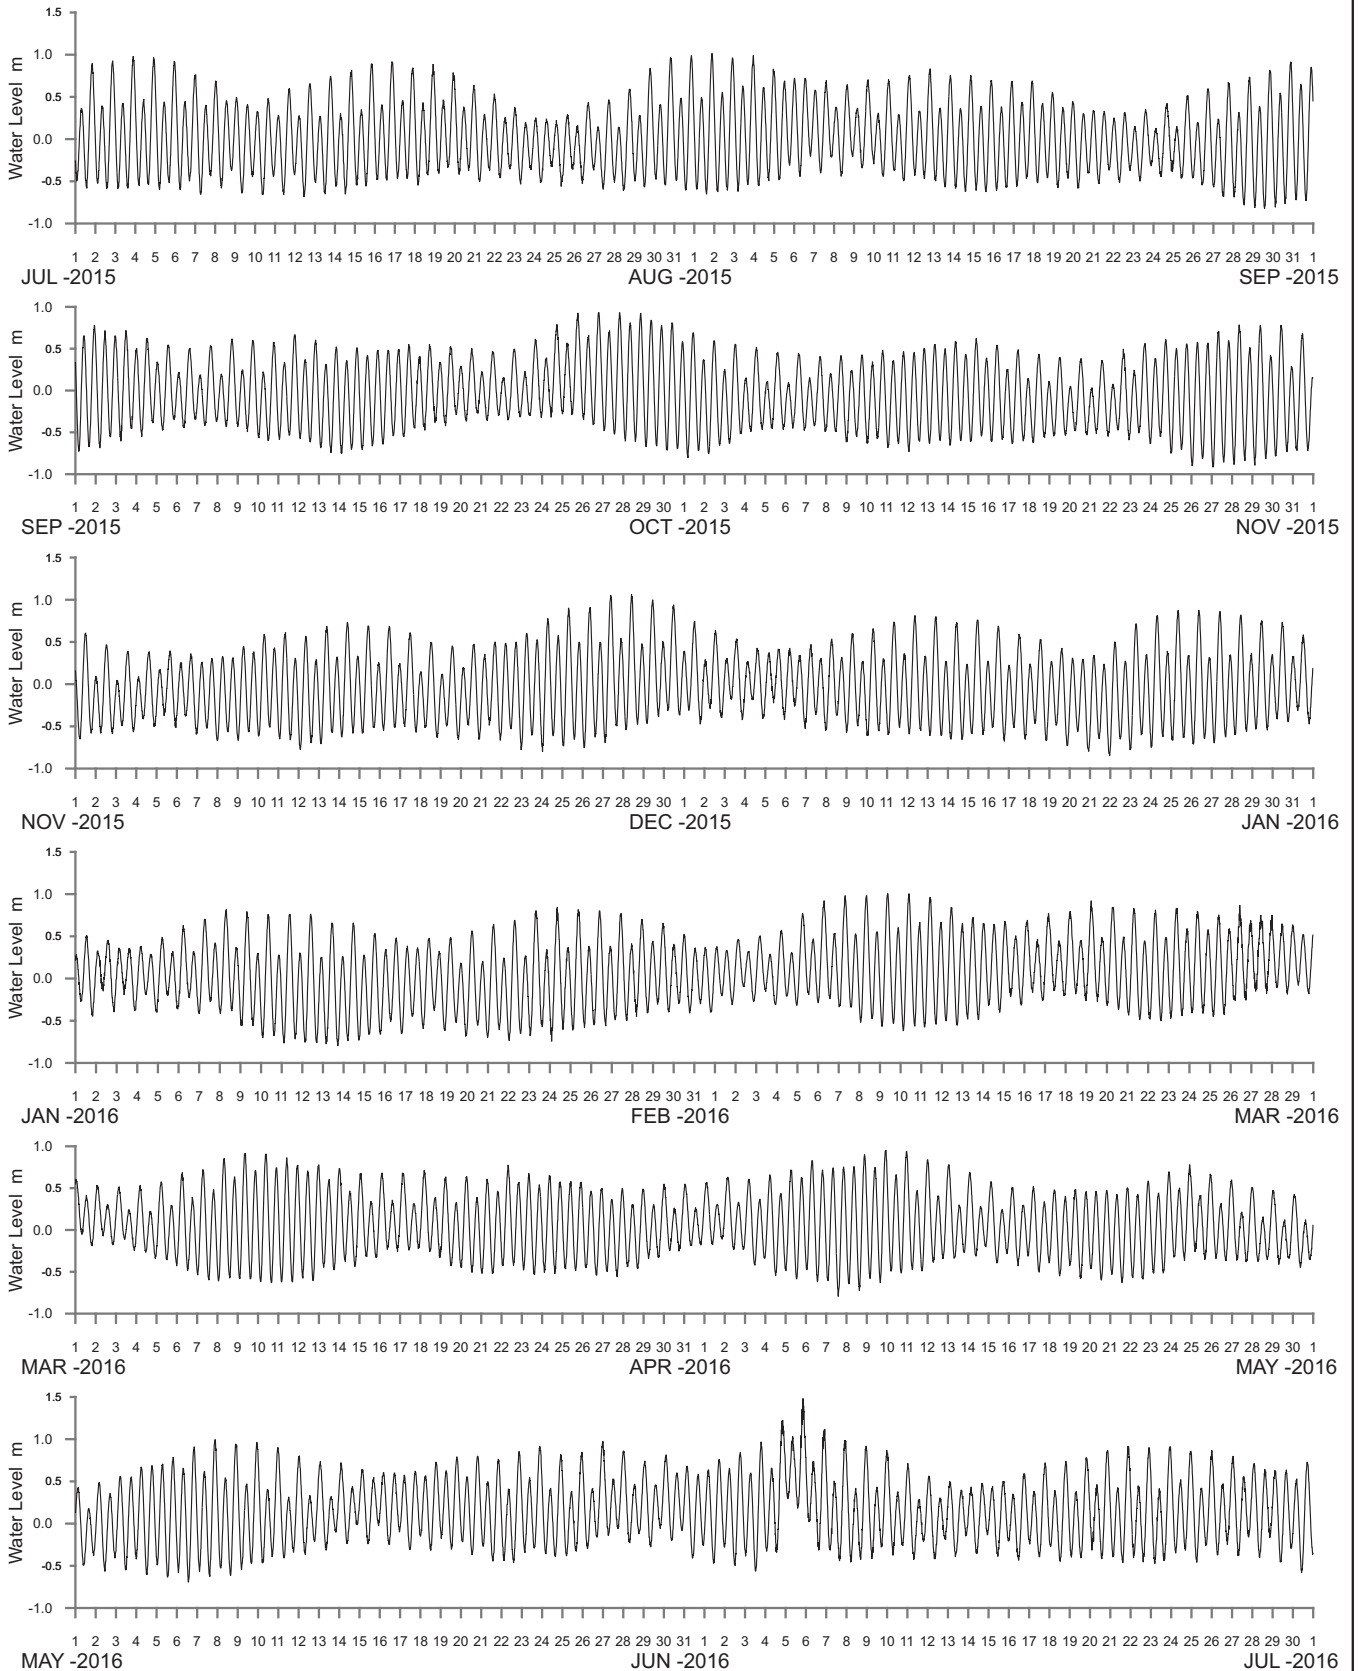
Figure
53

WATER LEVEL REFERENCED TO AUSTRALIAN HEIGHT DATUM

WOOLI RIVER AT WOOLI ENTRANCE
2015–2016

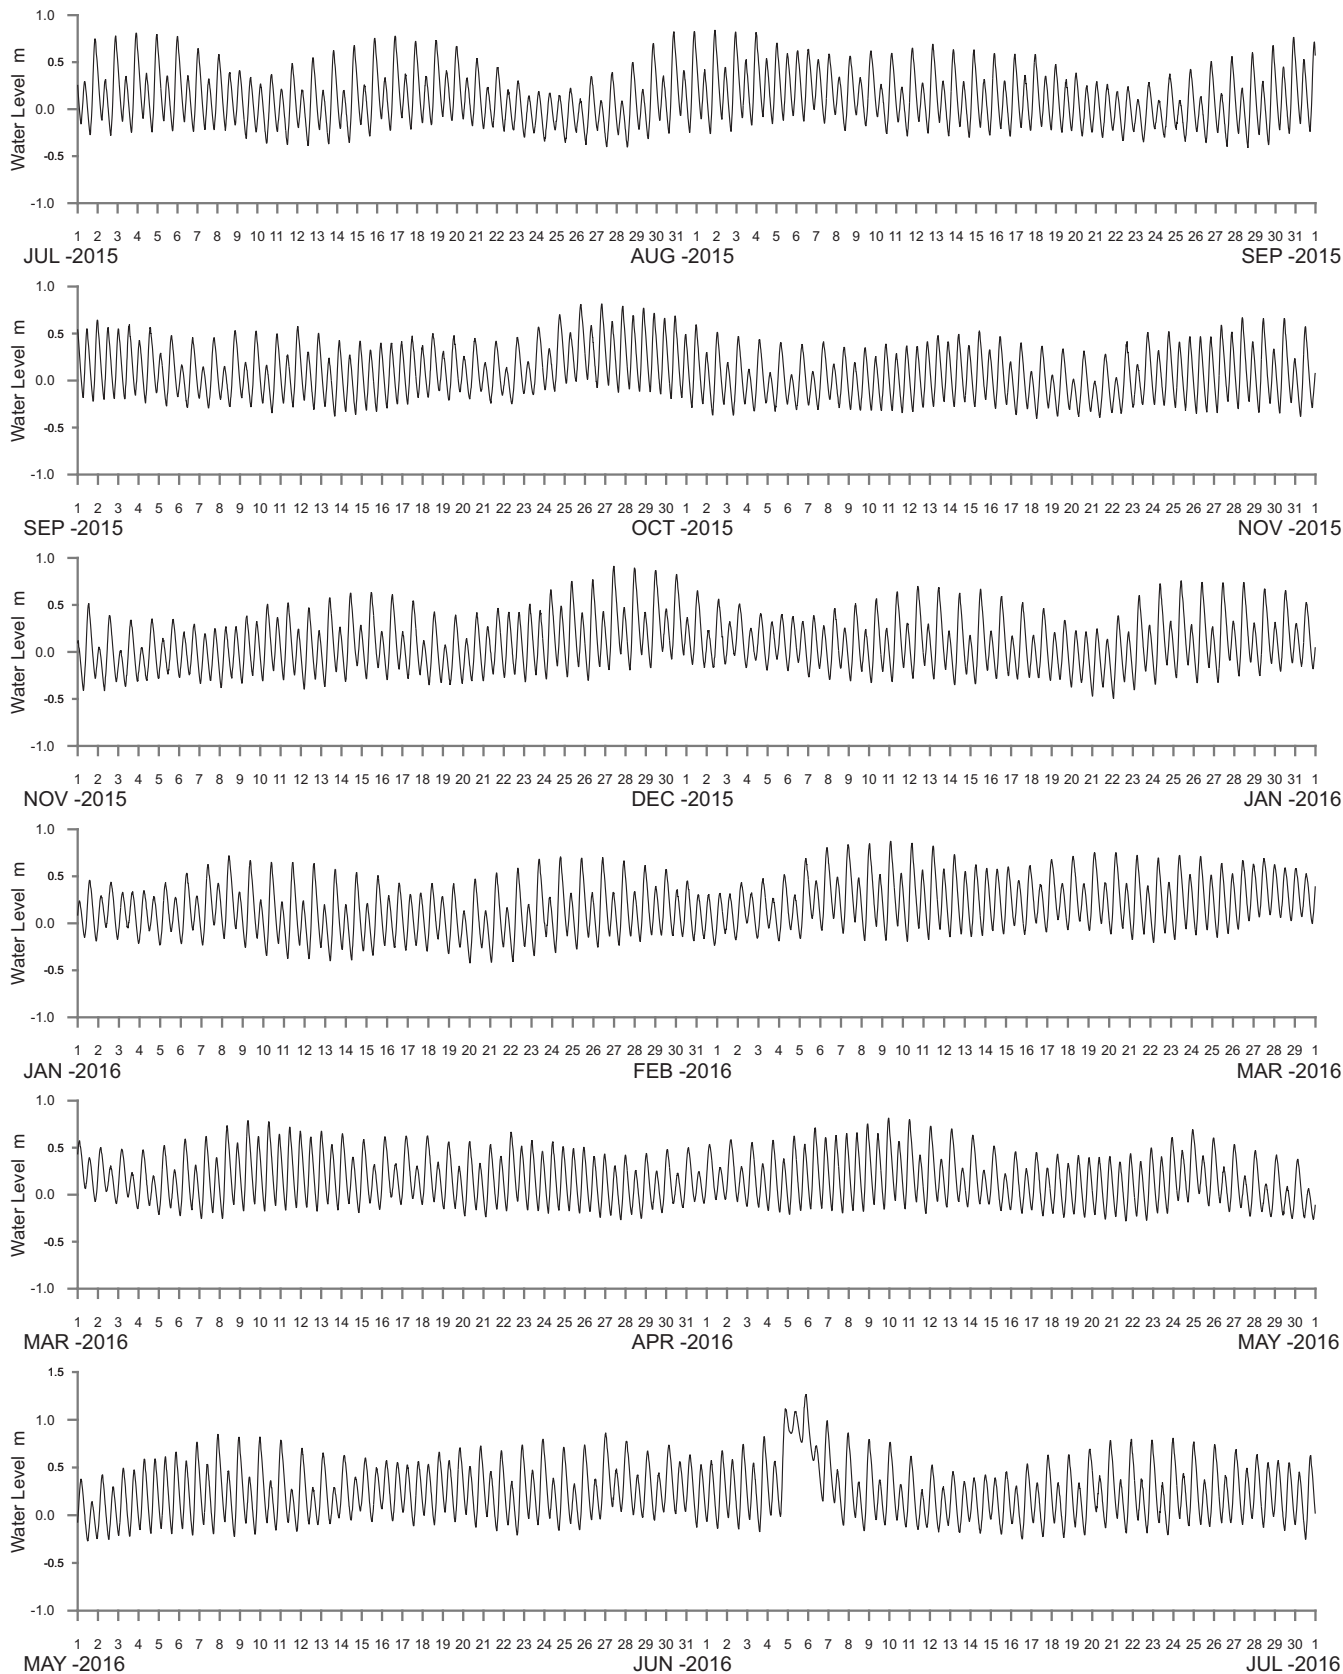
Figure
54

WATER LEVEL REFERENCED TO AUSTRALIAN HEIGHT DATUM

WOOLI RIVER AT WOOLI CARAVAN PARK
2015–2016

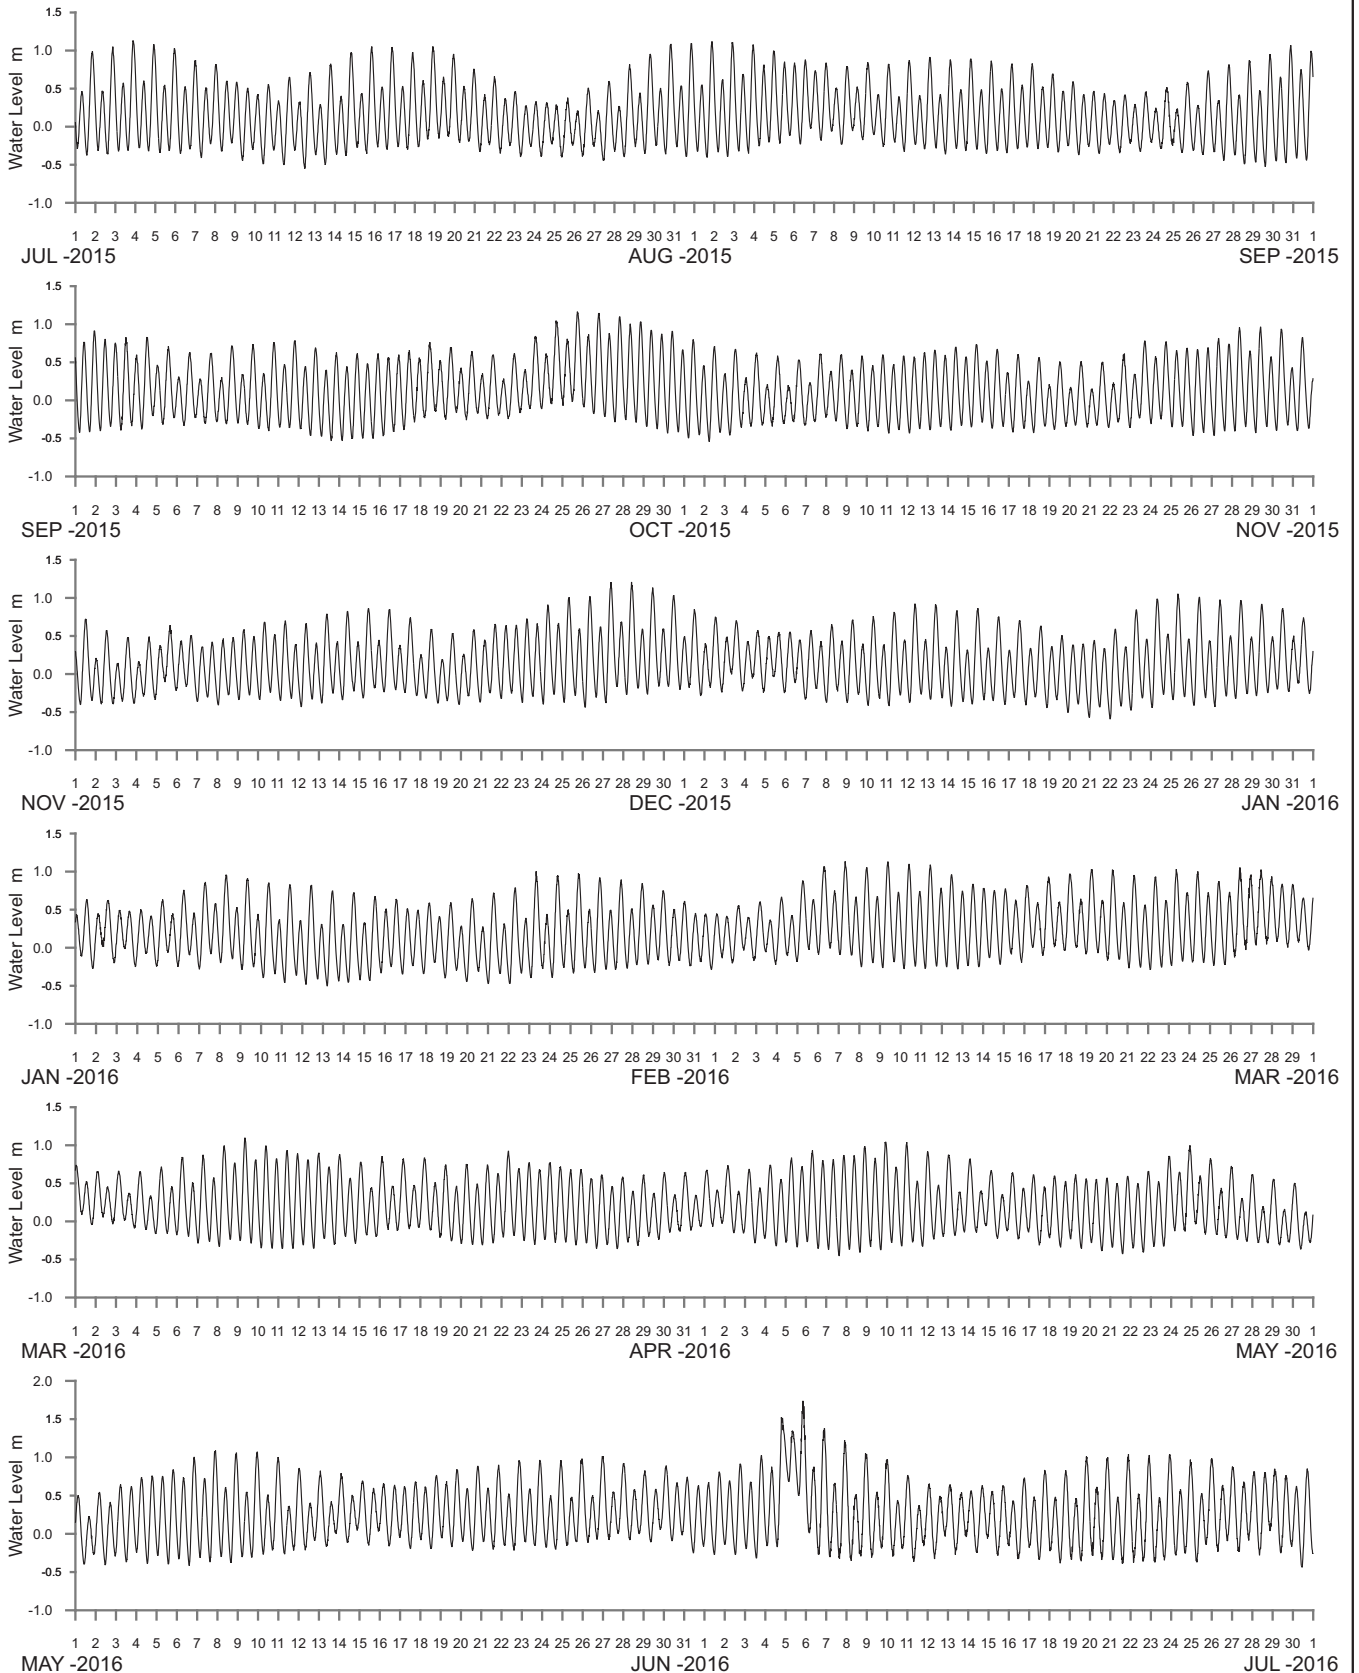
Figure
55

WATER LEVEL REFERENCED TO AUSTRALIAN HEIGHT DATUM

CORINDI CREEK AT RED ROCK
2015–2016

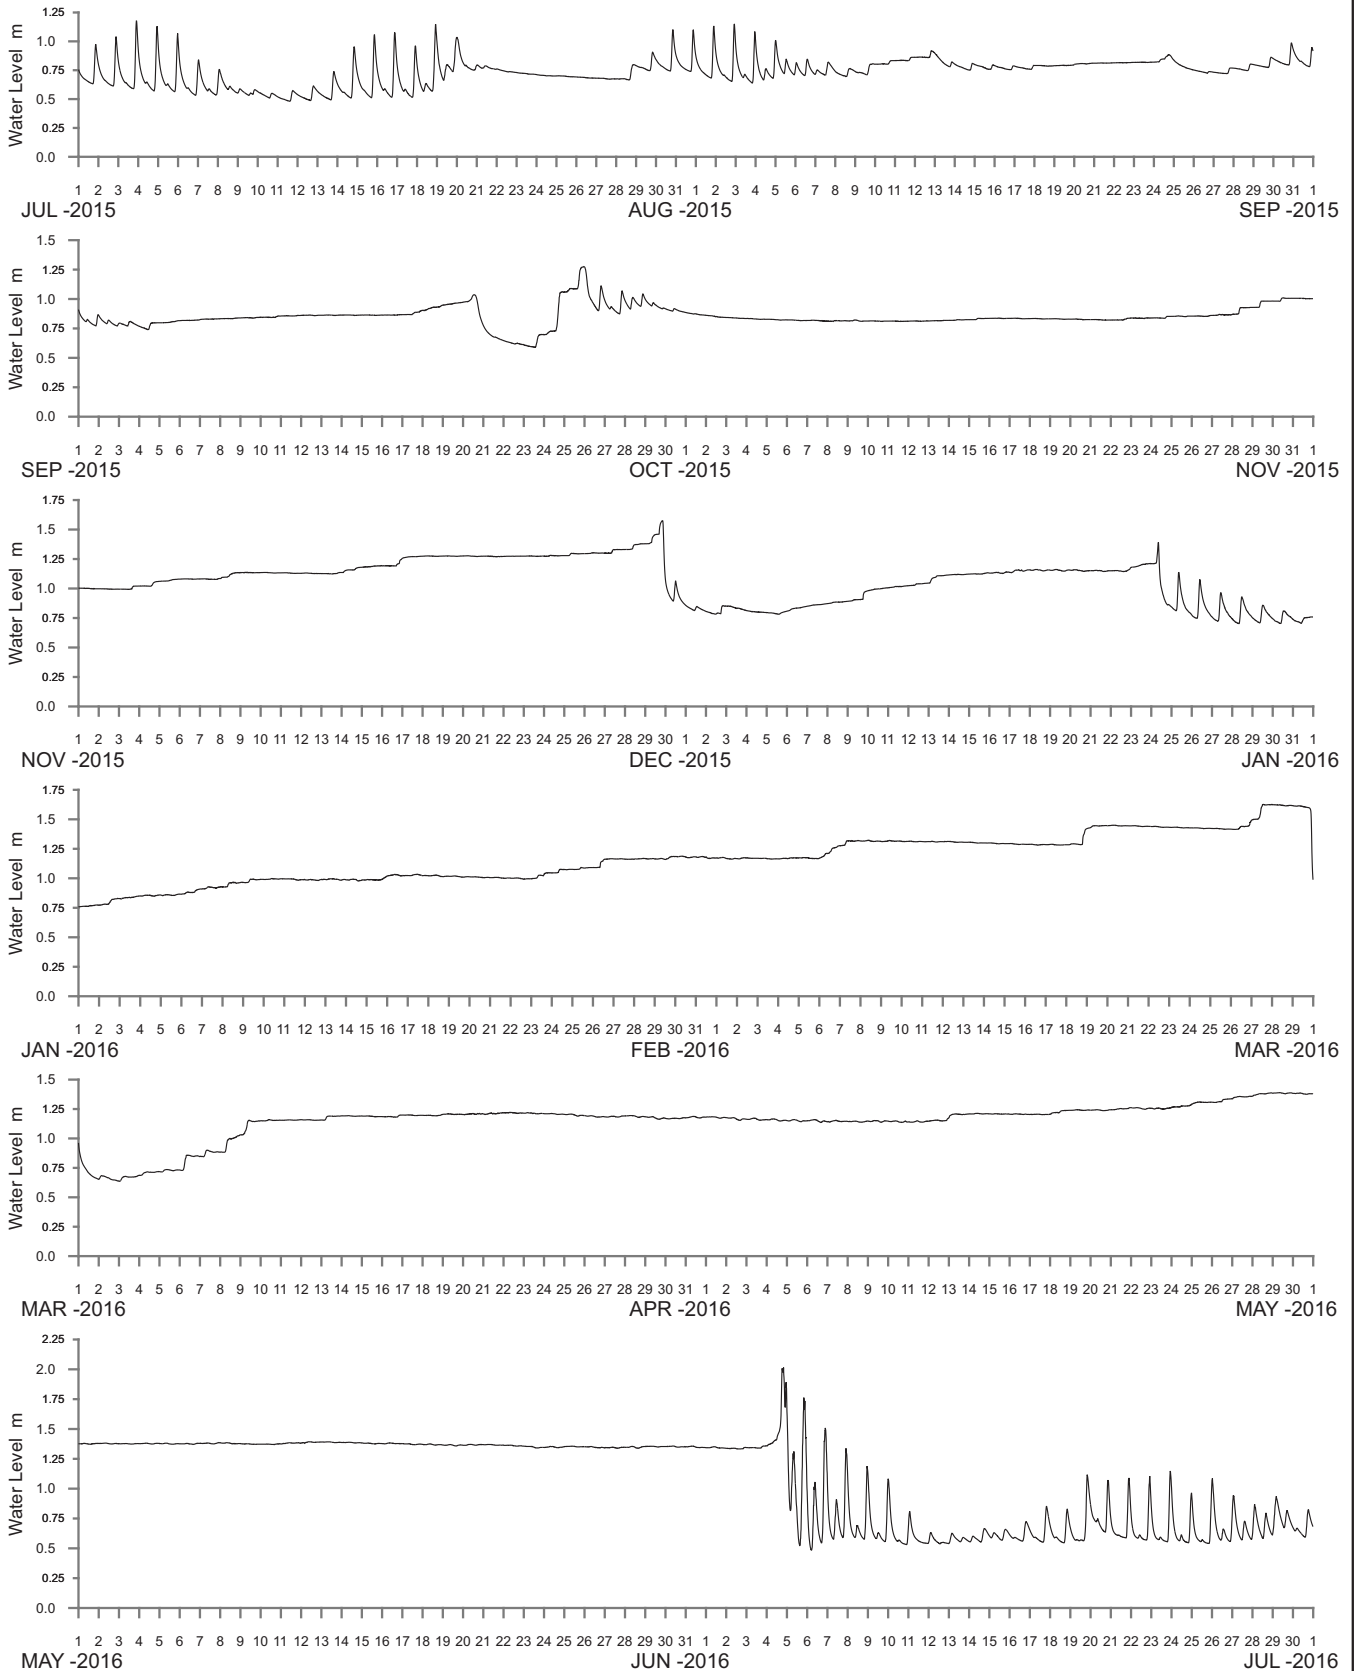
Figure
56

WATER LEVEL REFERENCED TO AUSTRALIAN HEIGHT DATUM

WOOLGOOLGA LAKE AT WOOLGOOLGA LAKE
2015–2016

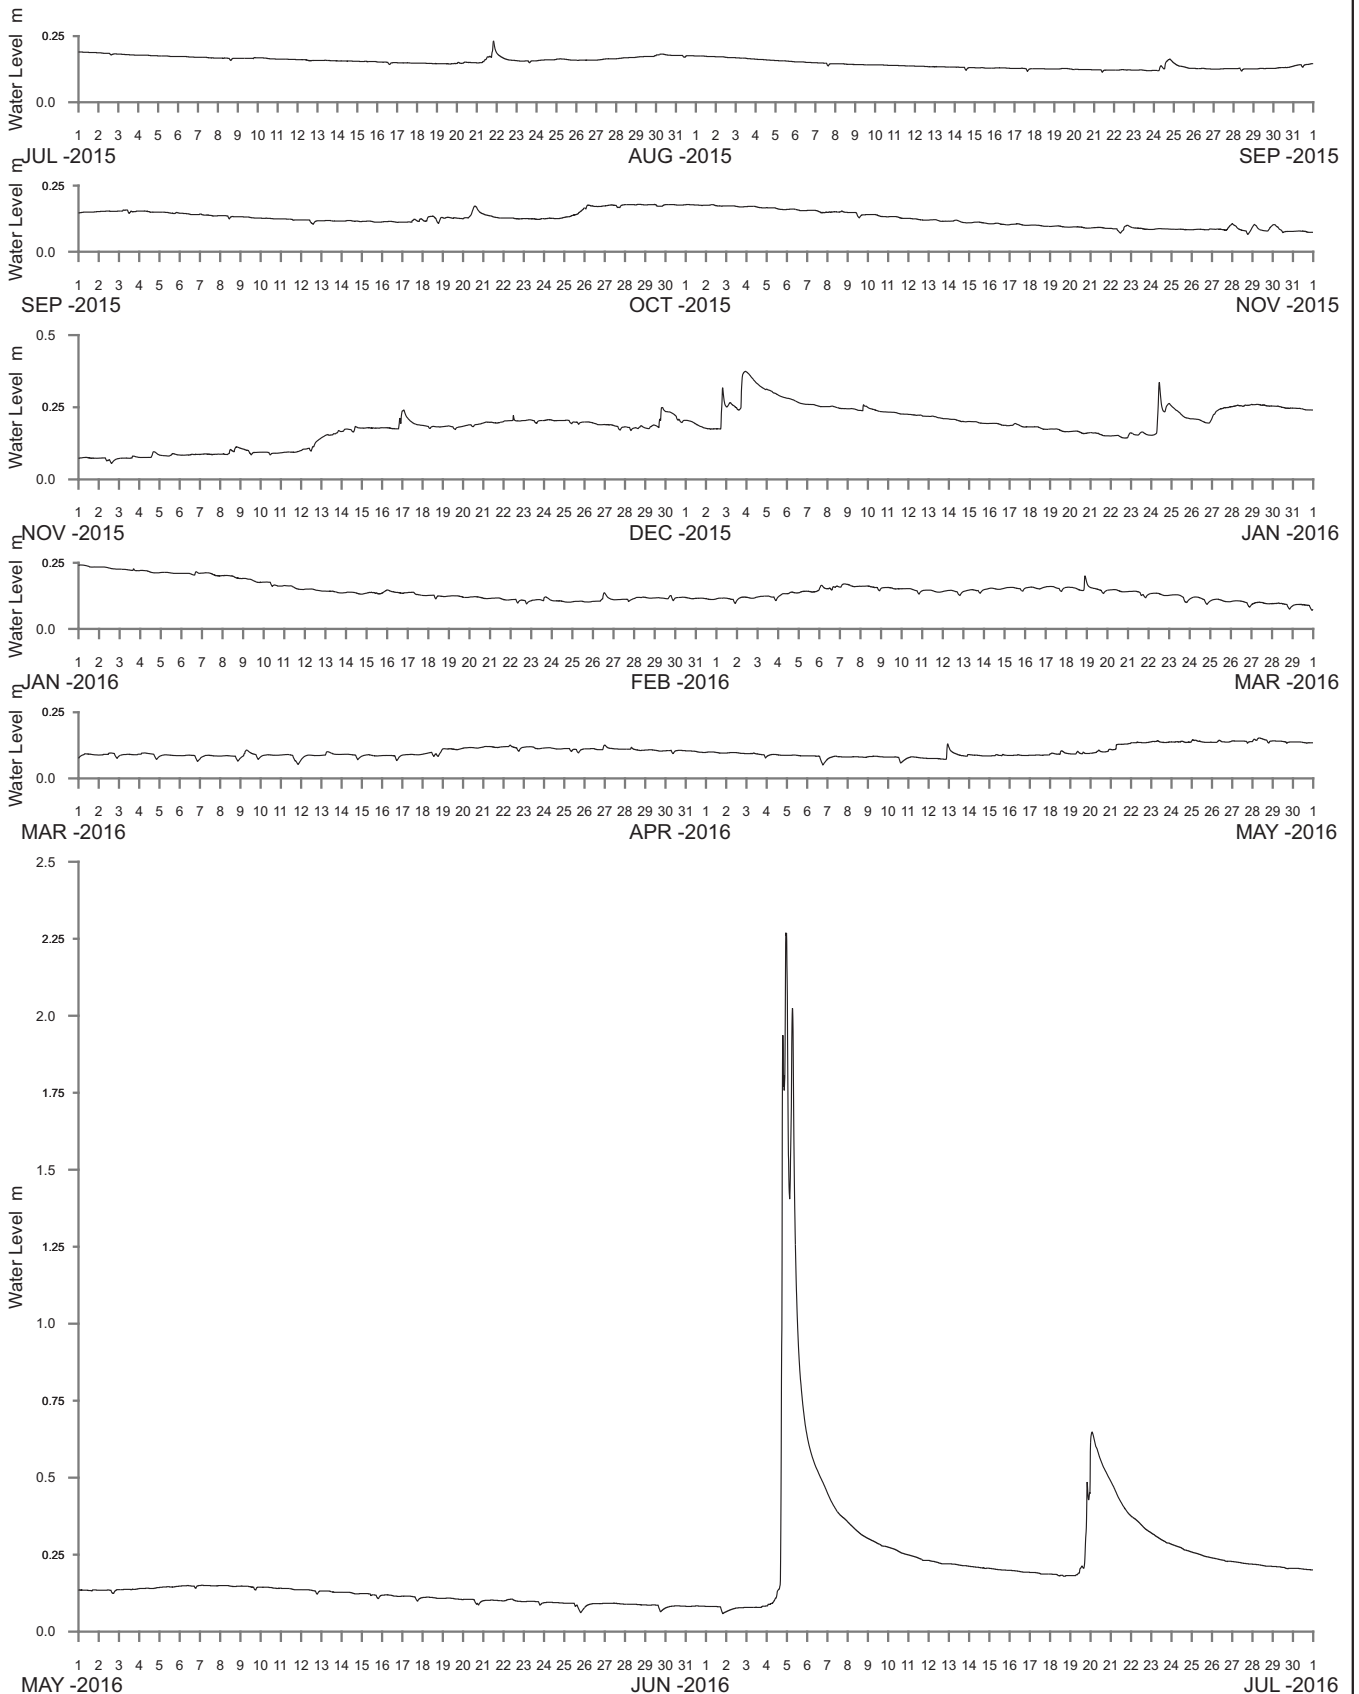
Figure
57

WATER LEVEL REFERENCED TO CTF OF CONTROL STRUCTURE

WOOLGOOLGA CREEK AT WOOLGOOLGA
2015–2016

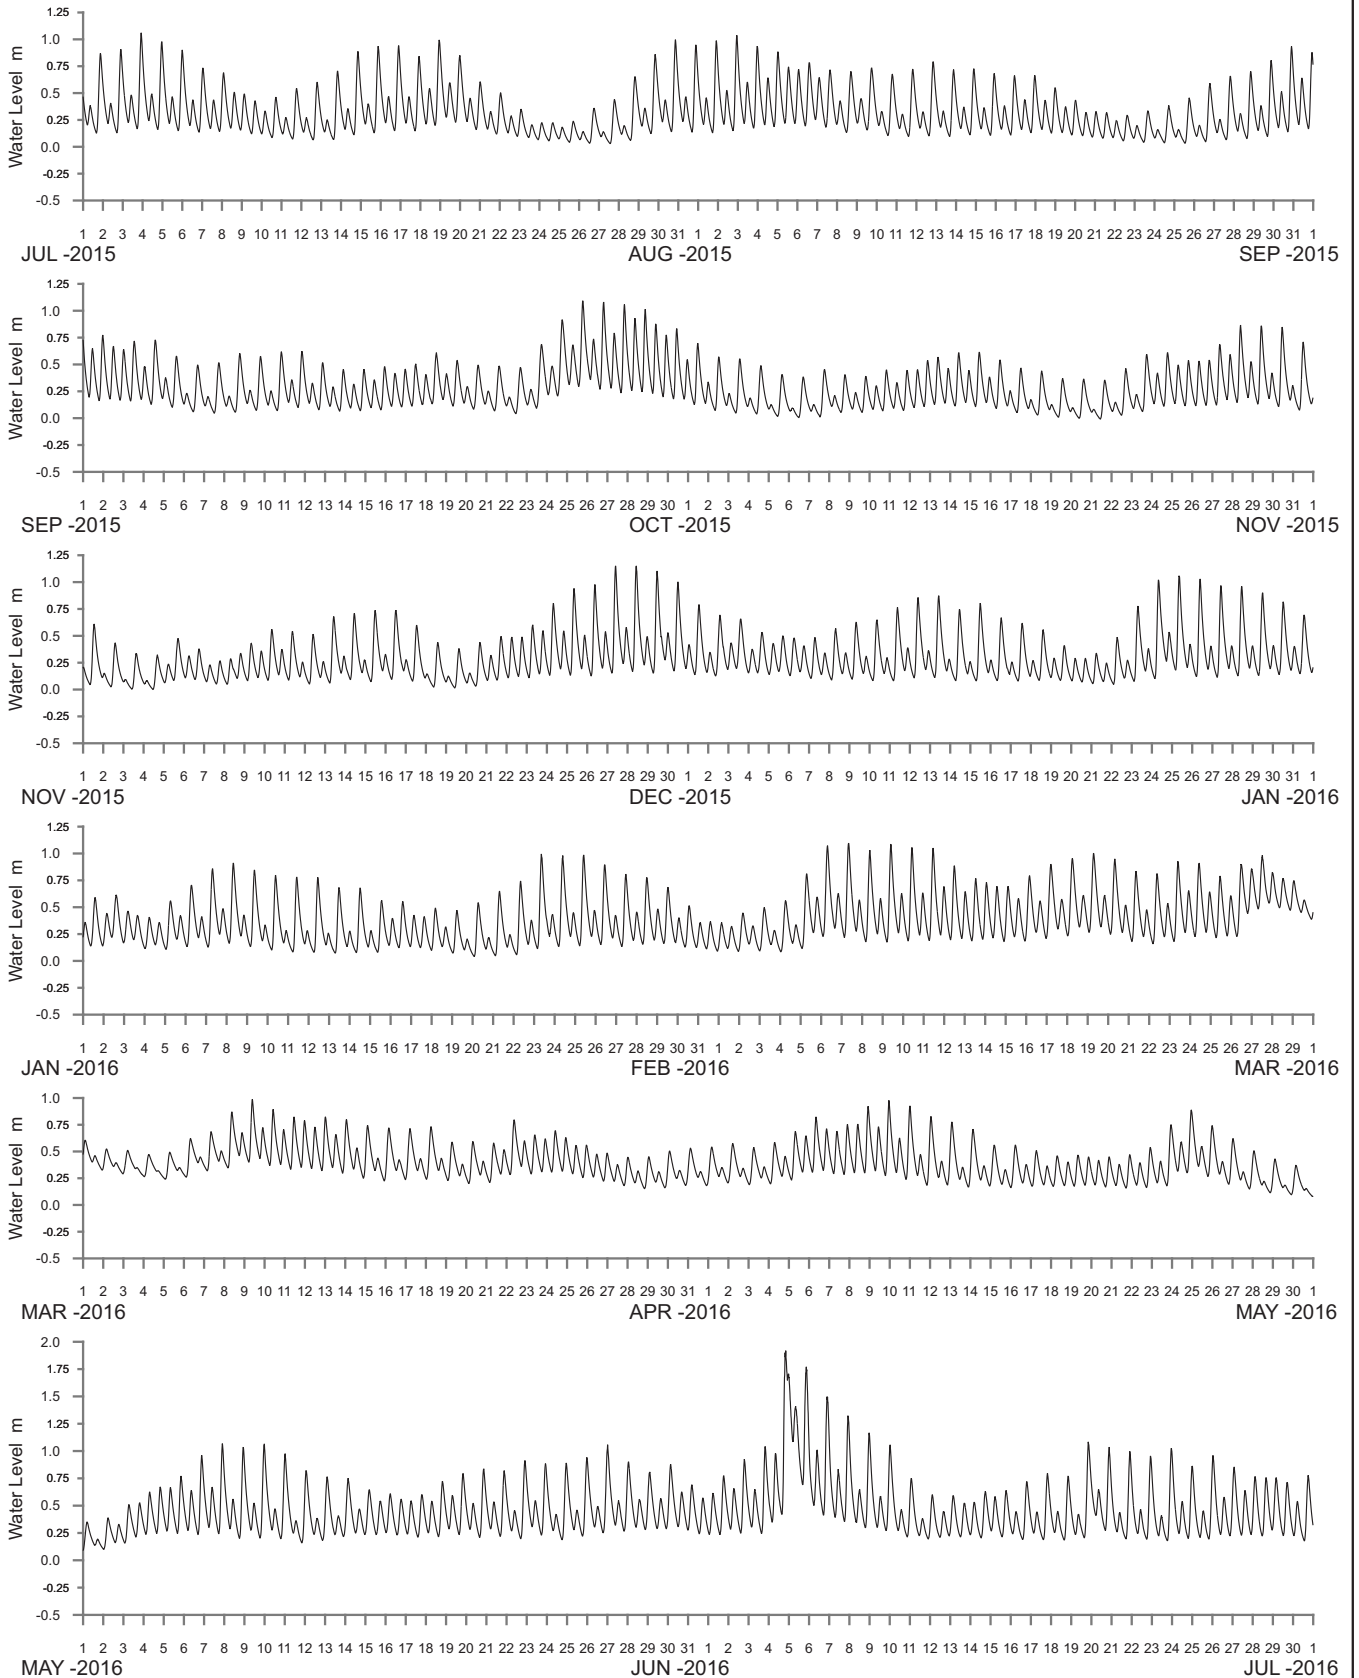
Figure
58

WATER LEVEL REFERENCED TO AUSTRALIAN HEIGHT DATUM

MOONEE CREEK AT MOONEE CREEK
2015–2016

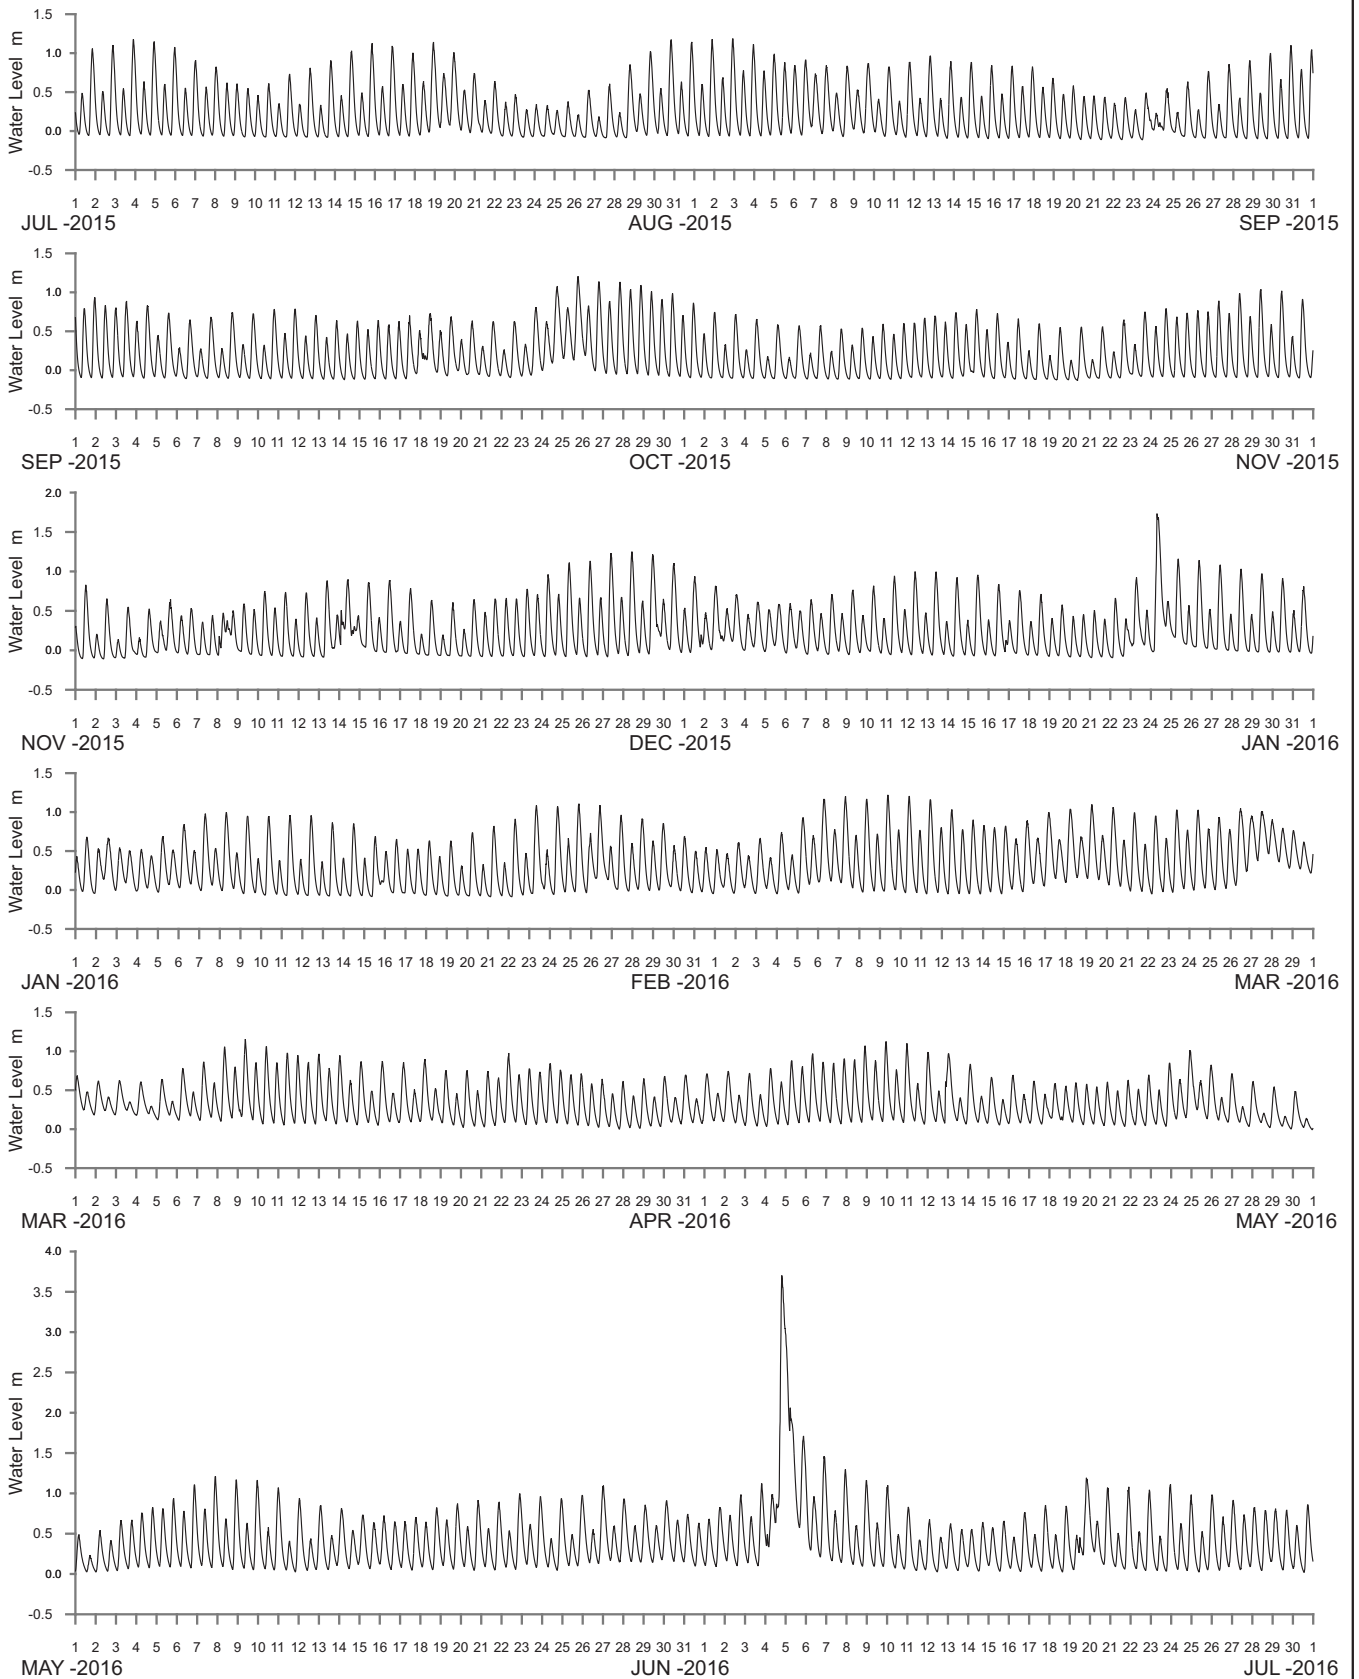
Figure
60

WATER LEVEL REFERENCED TO AUSTRALIAN HEIGHT DATUM

COFFS CREEK AT COFFS CREEK HIGHWAY BRIDGE
2015–2016

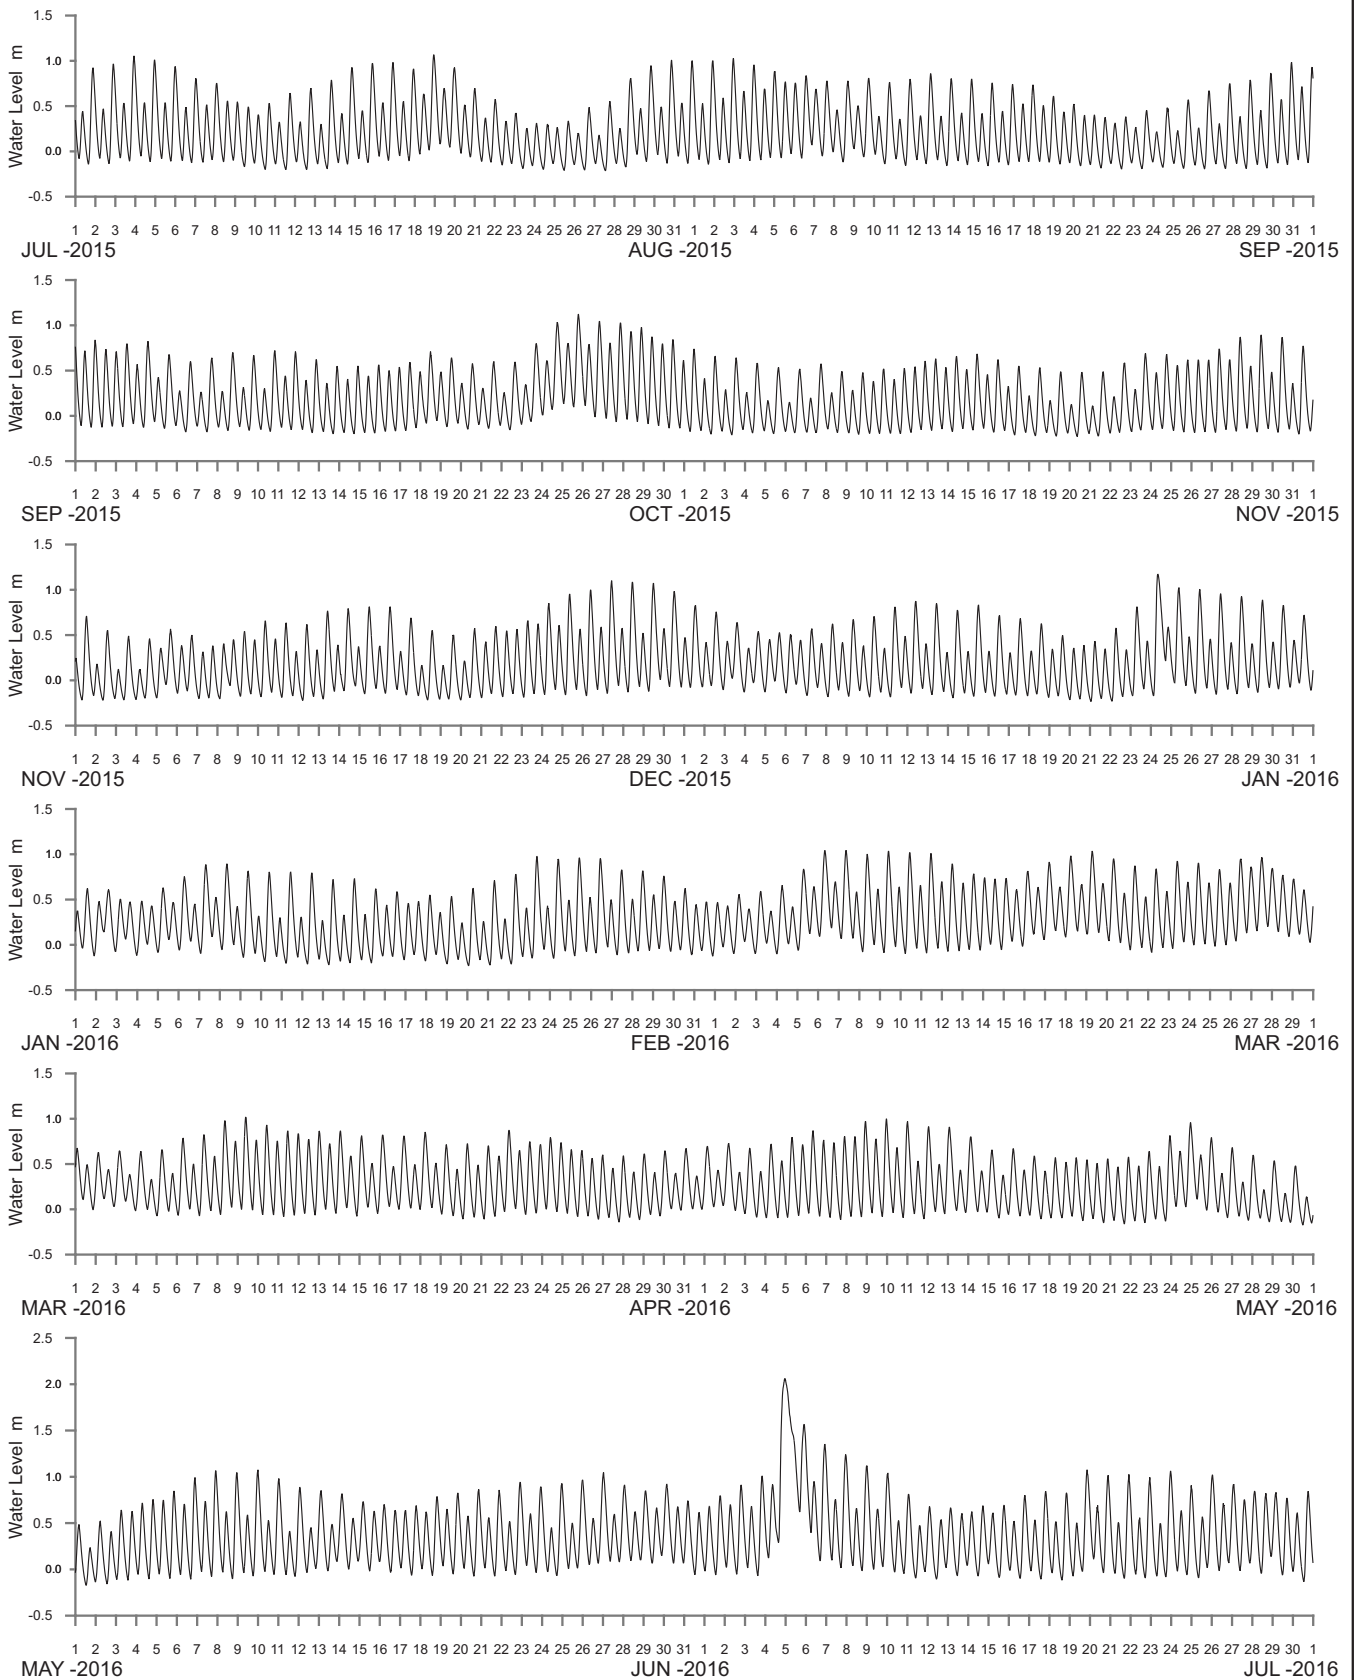
Figure
61

WATER LEVEL REFERENCED TO AUSTRALIAN HEIGHT DATUM

NEWPORTS CREEK AT NEWPORTS CREEK
2015–2016

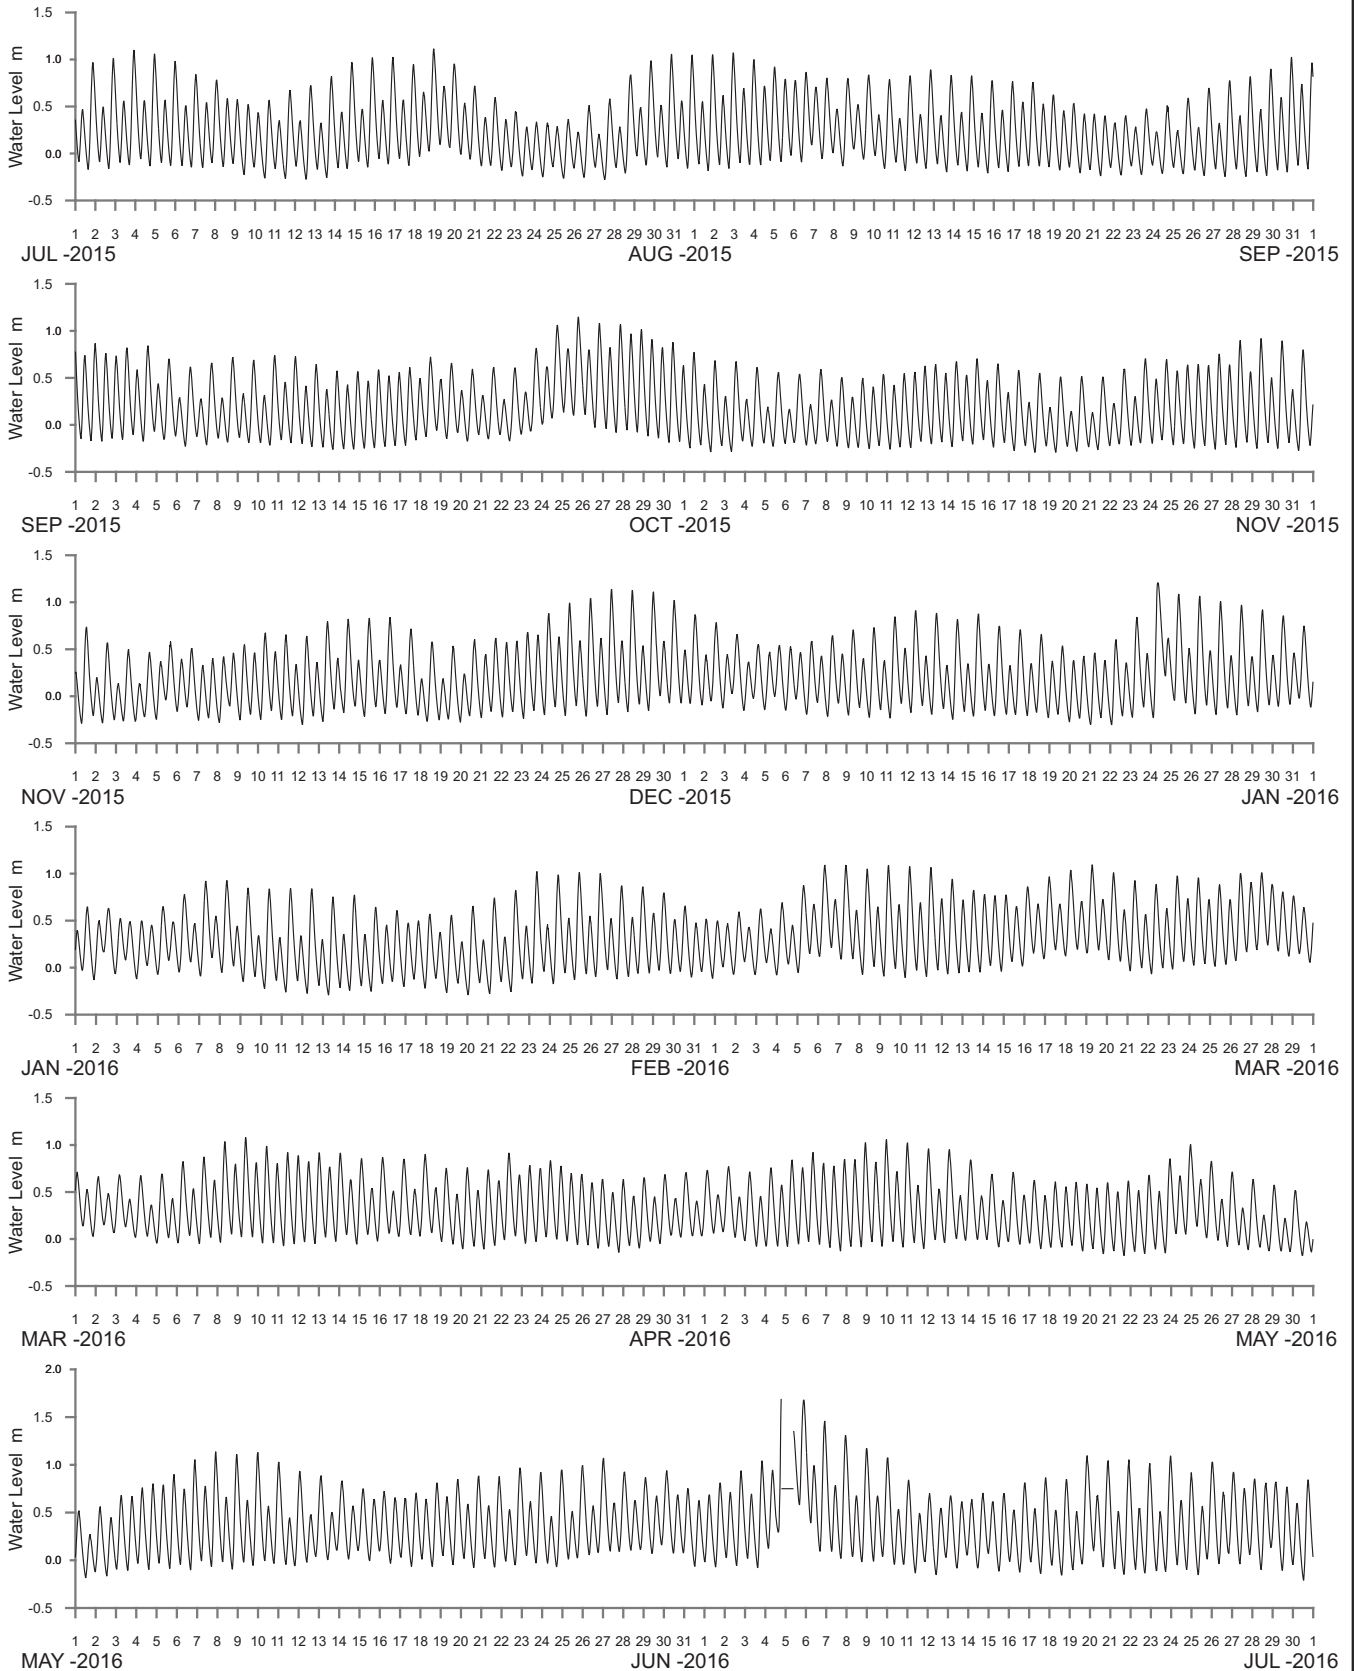
Figure
62

WATER LEVEL REFERENCED TO AUSTRALIAN HEIGHT DATUM

BOAMBEE CREEK AT BOAMBEE
2015–2016

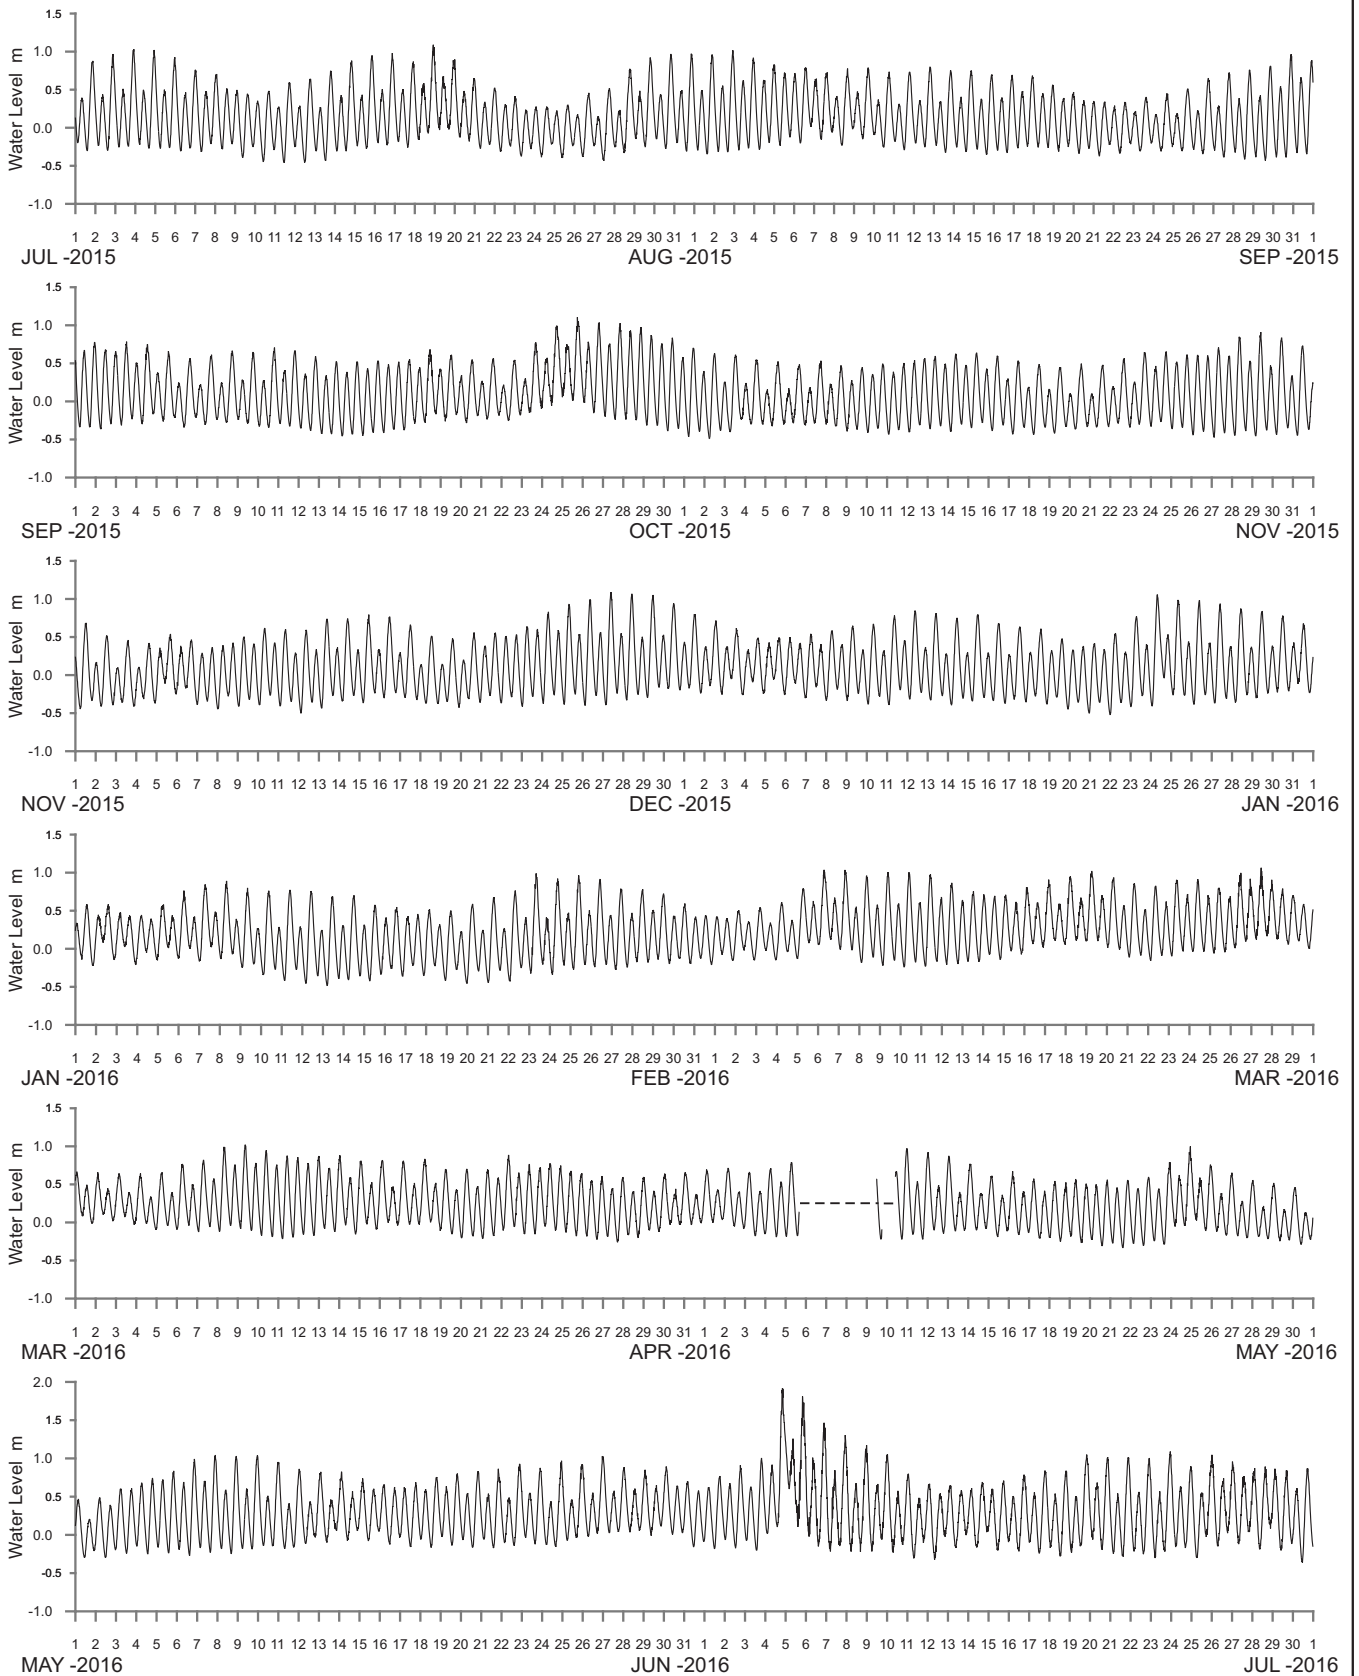
Figure
63

WATER LEVEL REFERENCED TO AUSTRALIAN HEIGHT DATUM

BOAMBEE CREEK AT BOAMBEE ENTRANCE
2015–2016
