Public Works
Manly Hydraulics Laboratory

MHL
Report 2474

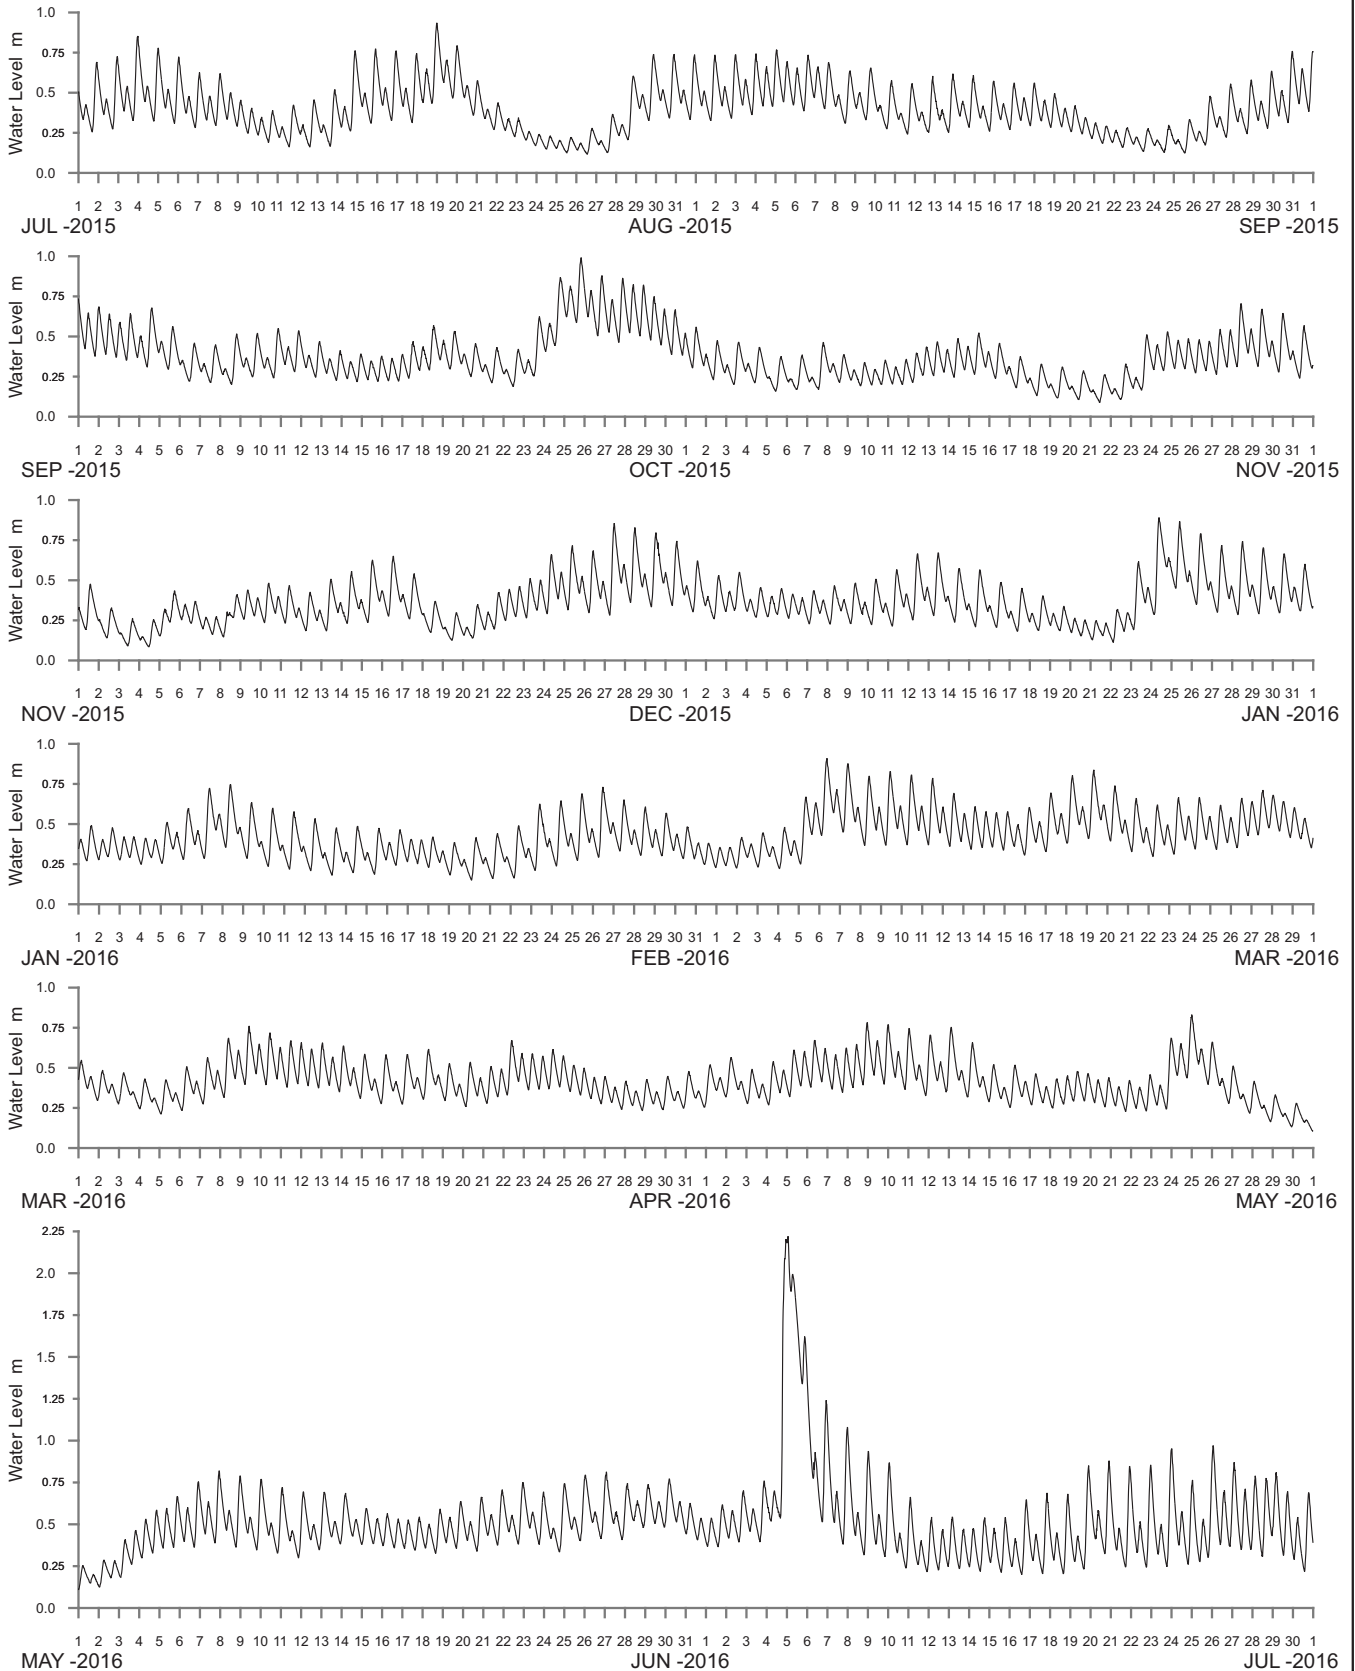
Figure
65

WATER LEVEL REFERENCED TO AUSTRALIAN HEIGHT DATUM

BONVILLE CREEK AT BONVILLE
2015–2016

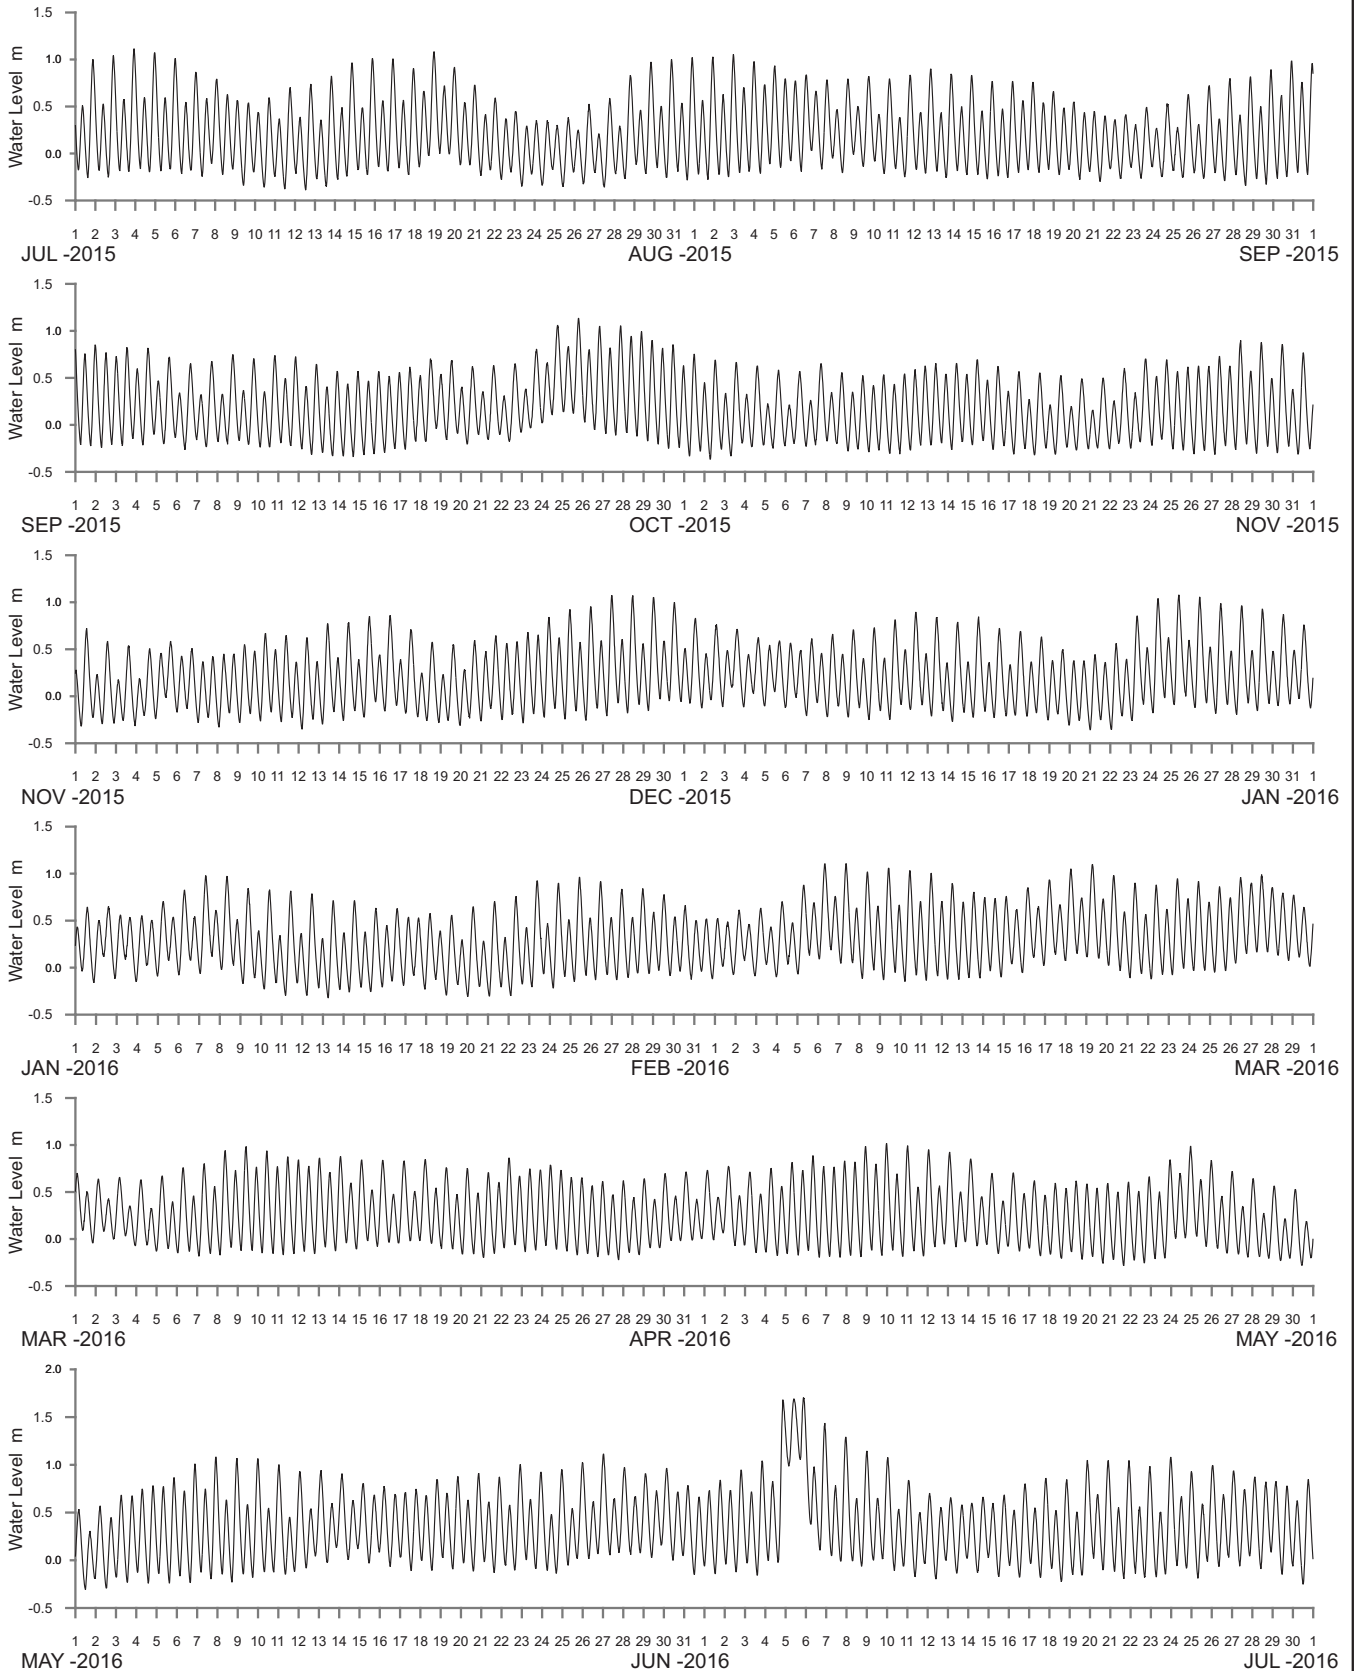
Figure
66

WATER LEVEL REFERENCED TO AUSTRALIAN HEIGHT DATUM

BELLINGER RIVER AT REPTON
2015–2016

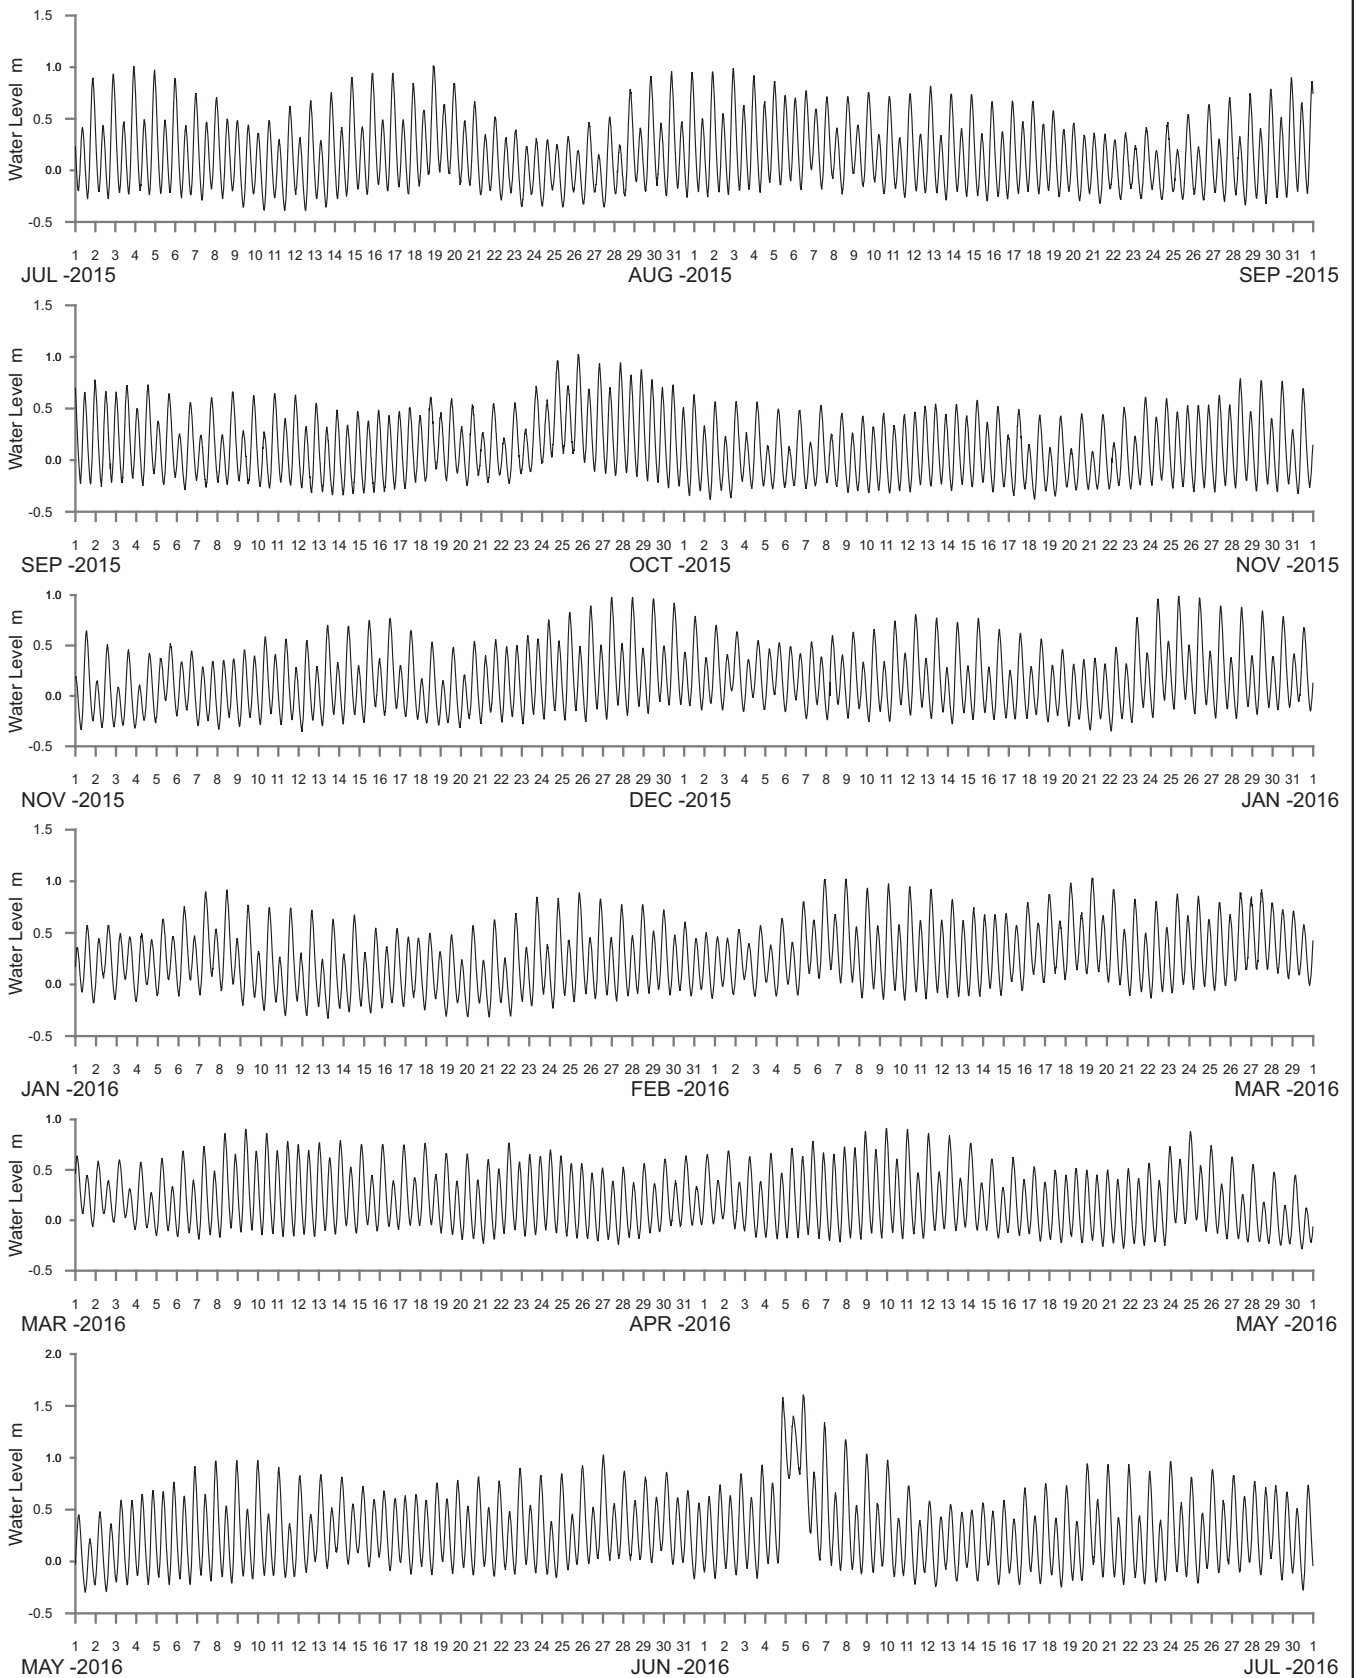
Figure
68

WATER LEVEL REFERENCED TO AUSTRALIAN HEIGHT DATUM

KALANG RIVER AT URUNGA
2015–2016

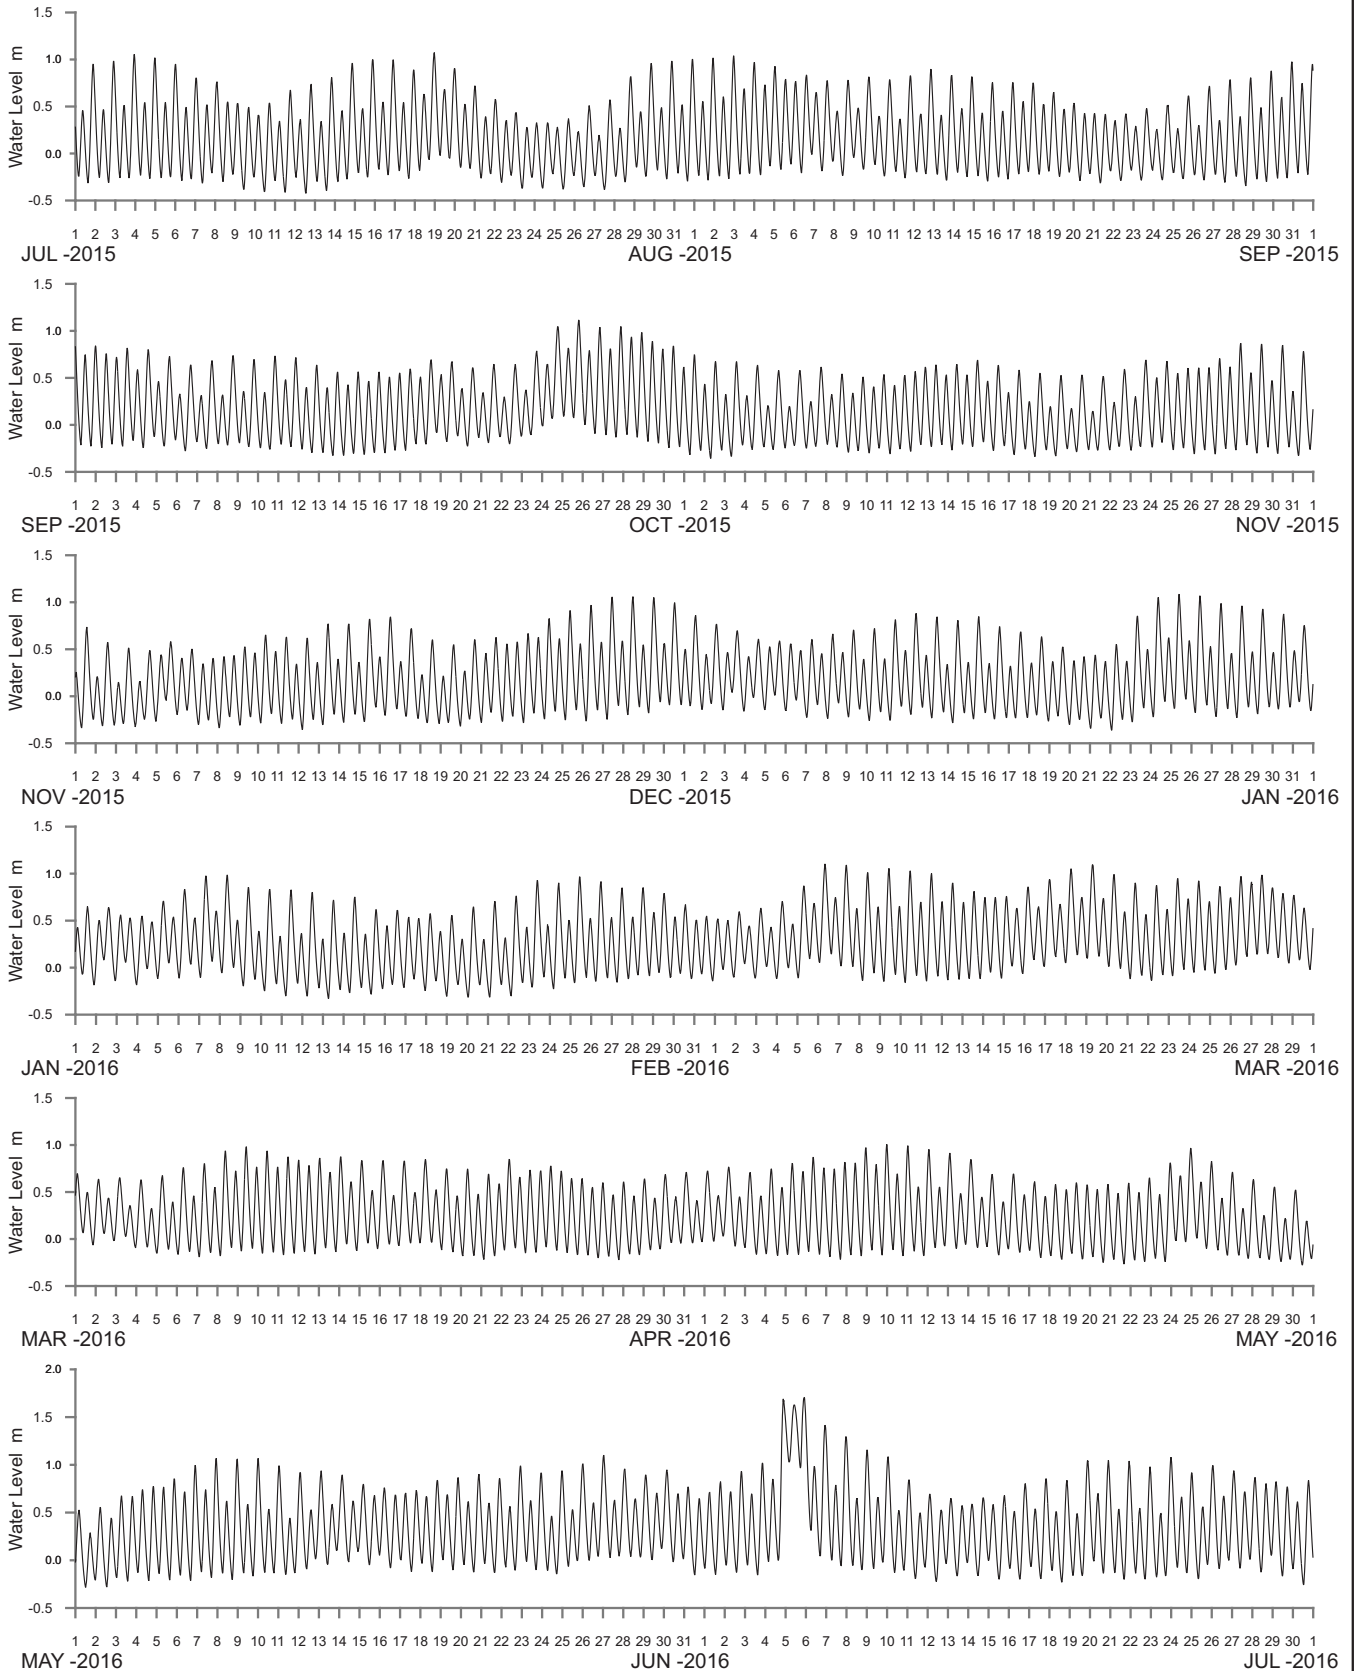
Figure
69

WATER LEVEL REFERENCED TO AUSTRALIAN HEIGHT DATUM

KALANG RIVER AT UPSTREAM NEWRY ISLAND
2015–2016

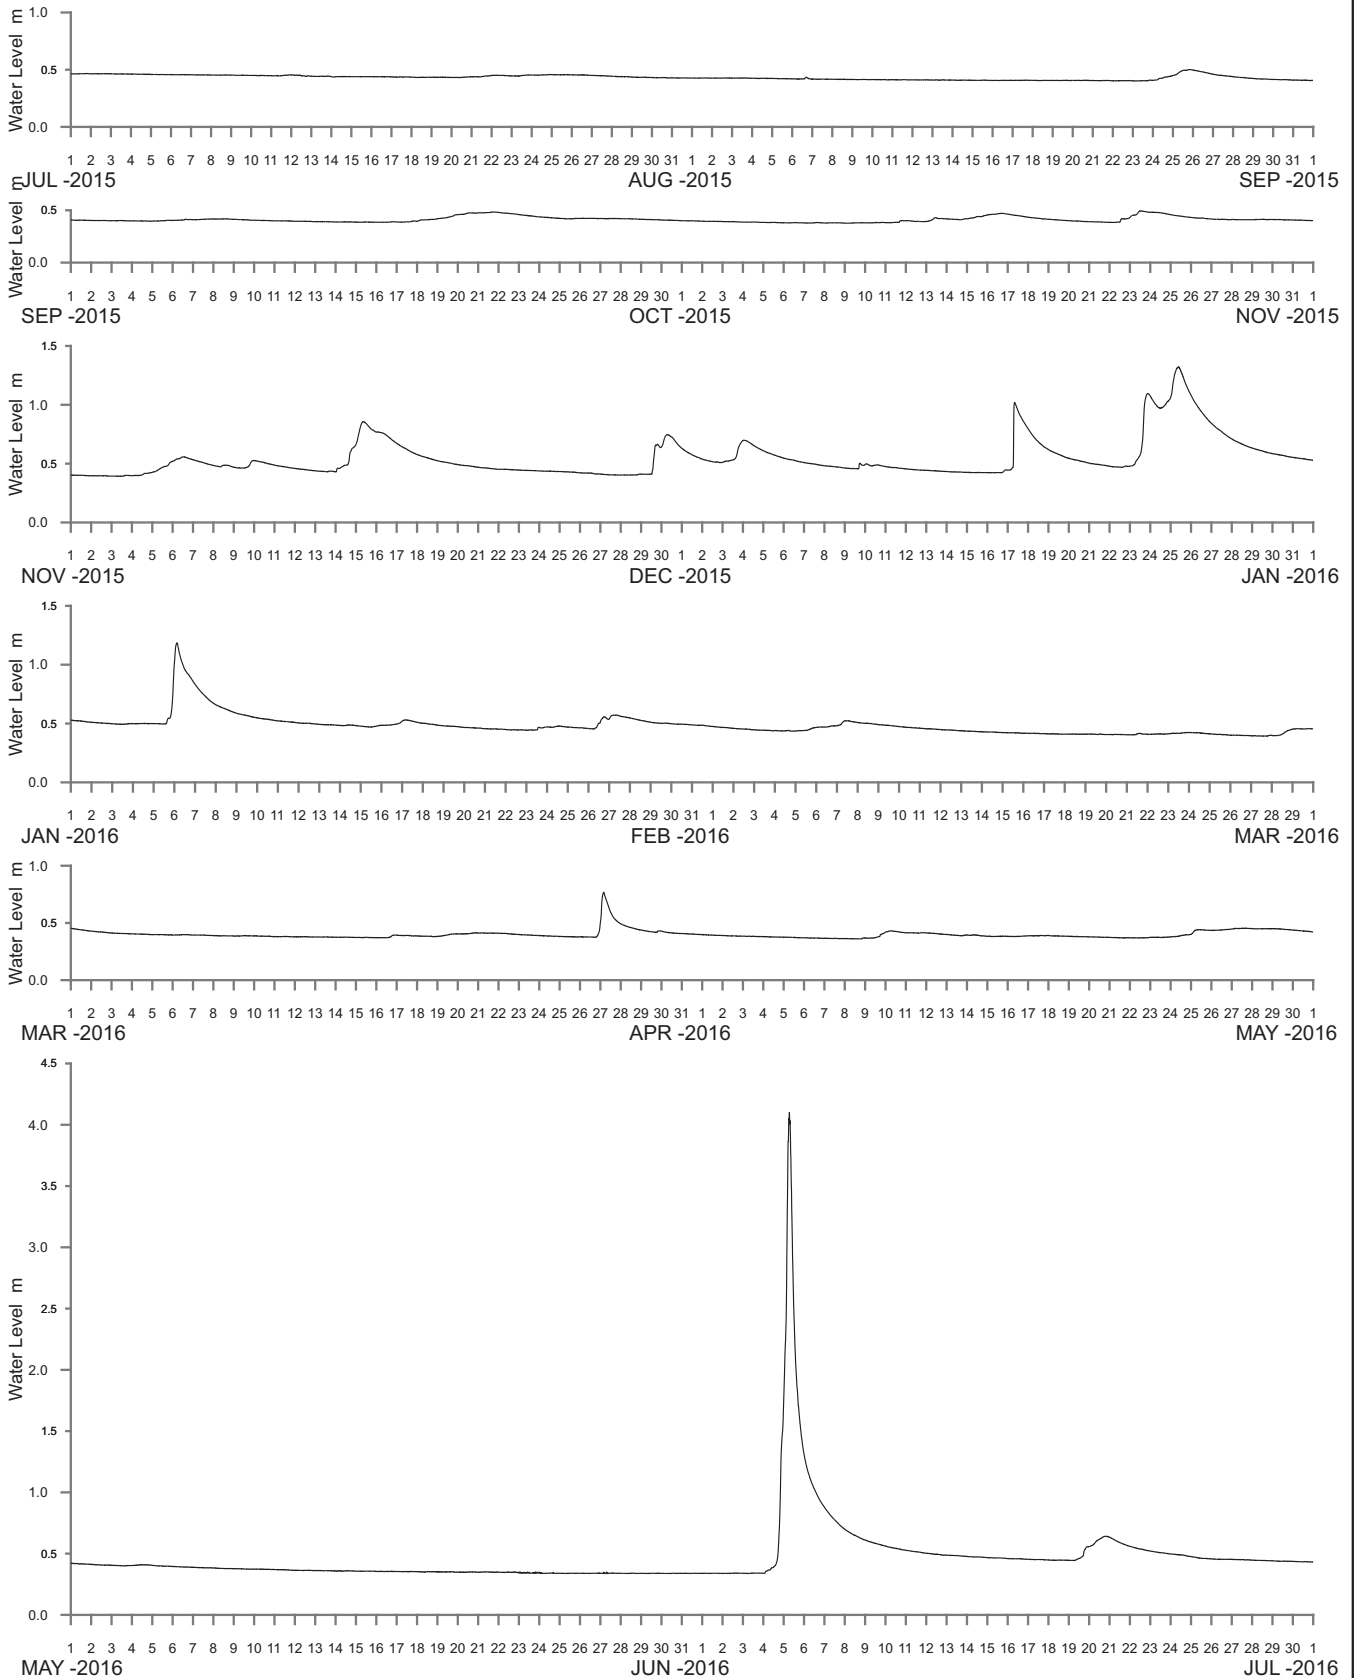
Figure
70

WATER LEVEL REFERENCED TO ASSUMED DATUM

KALANG RIVER AT KOOROOWI
2015-2016

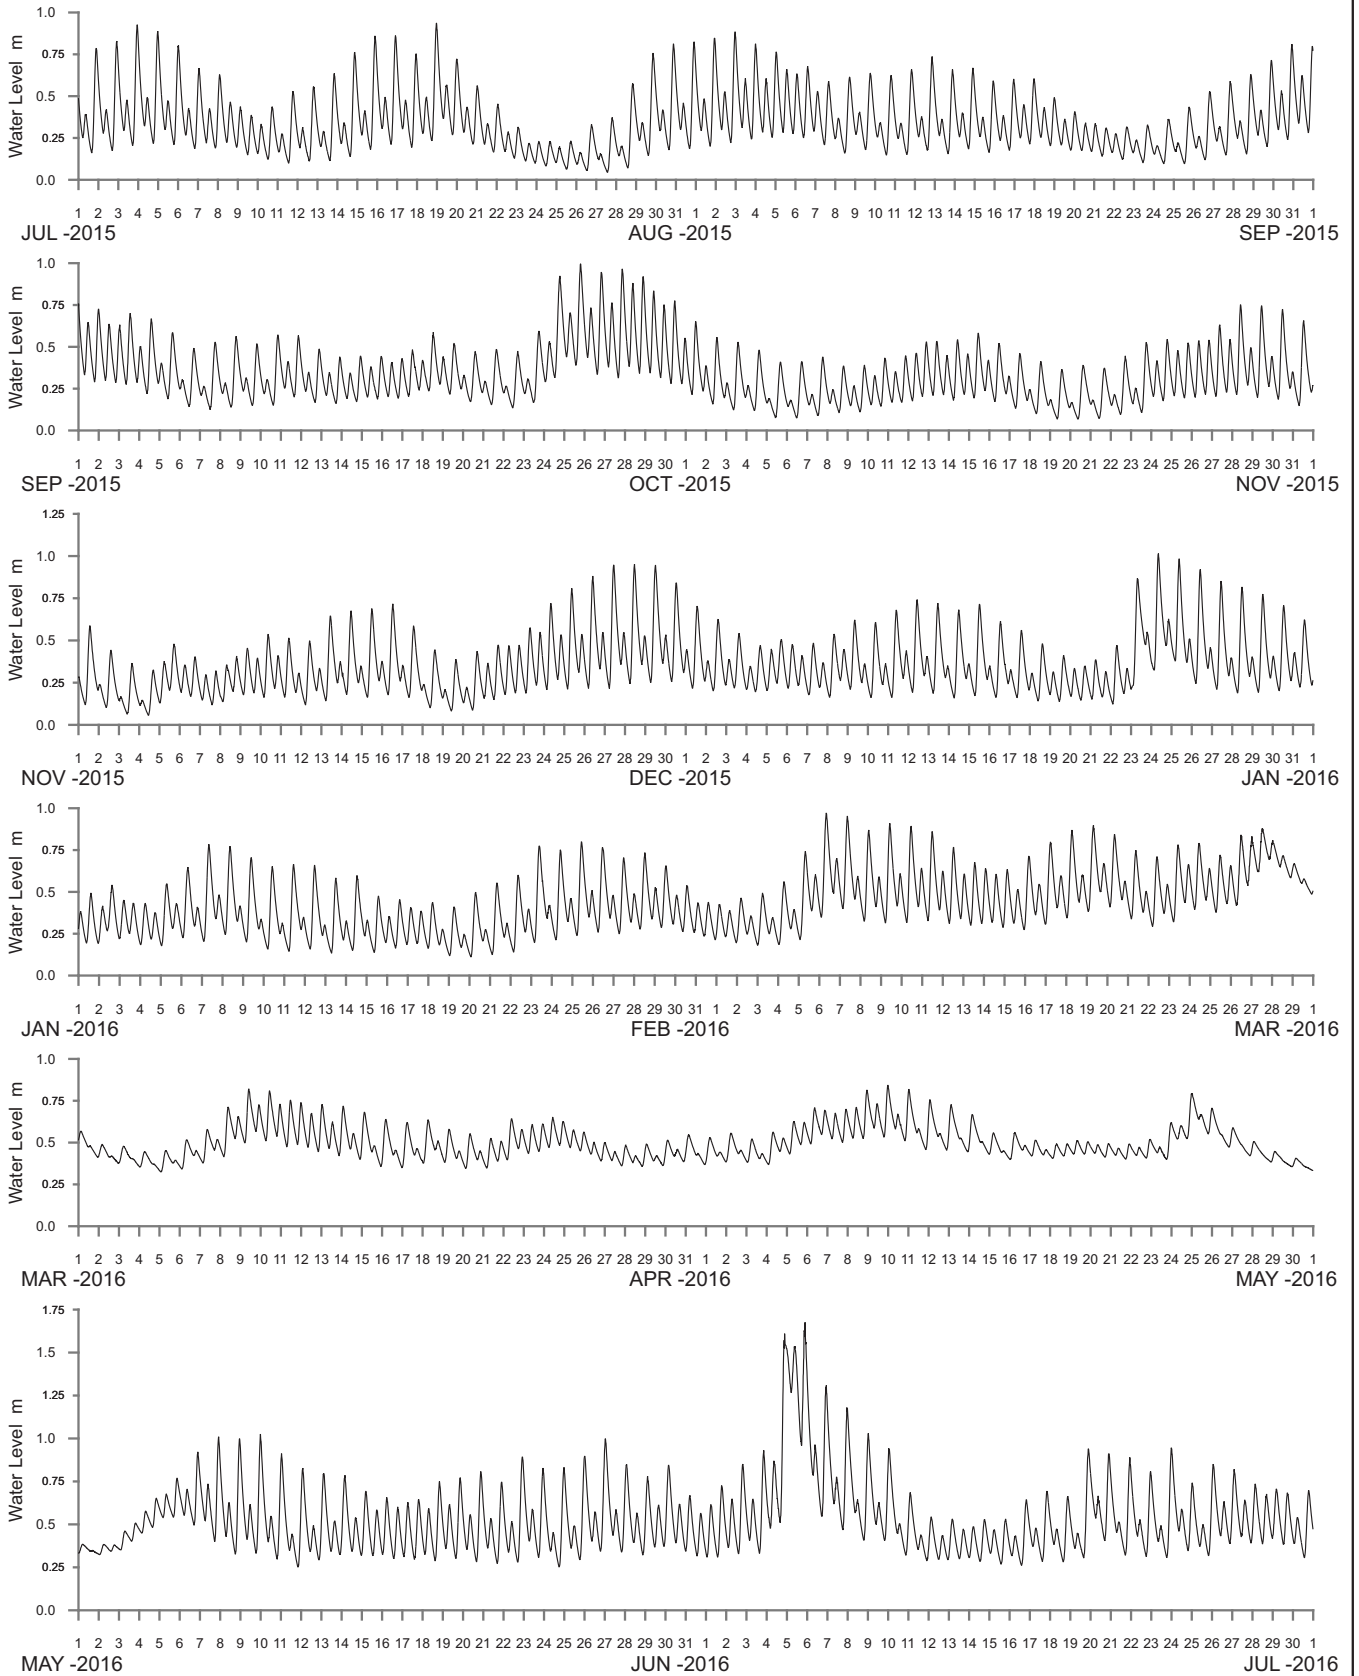
Figure
72

WATER LEVEL REFERENCED TO AUSTRALIAN HEIGHT DATUM

DEEP CREEK AT DEEP CREEK
2015–2016

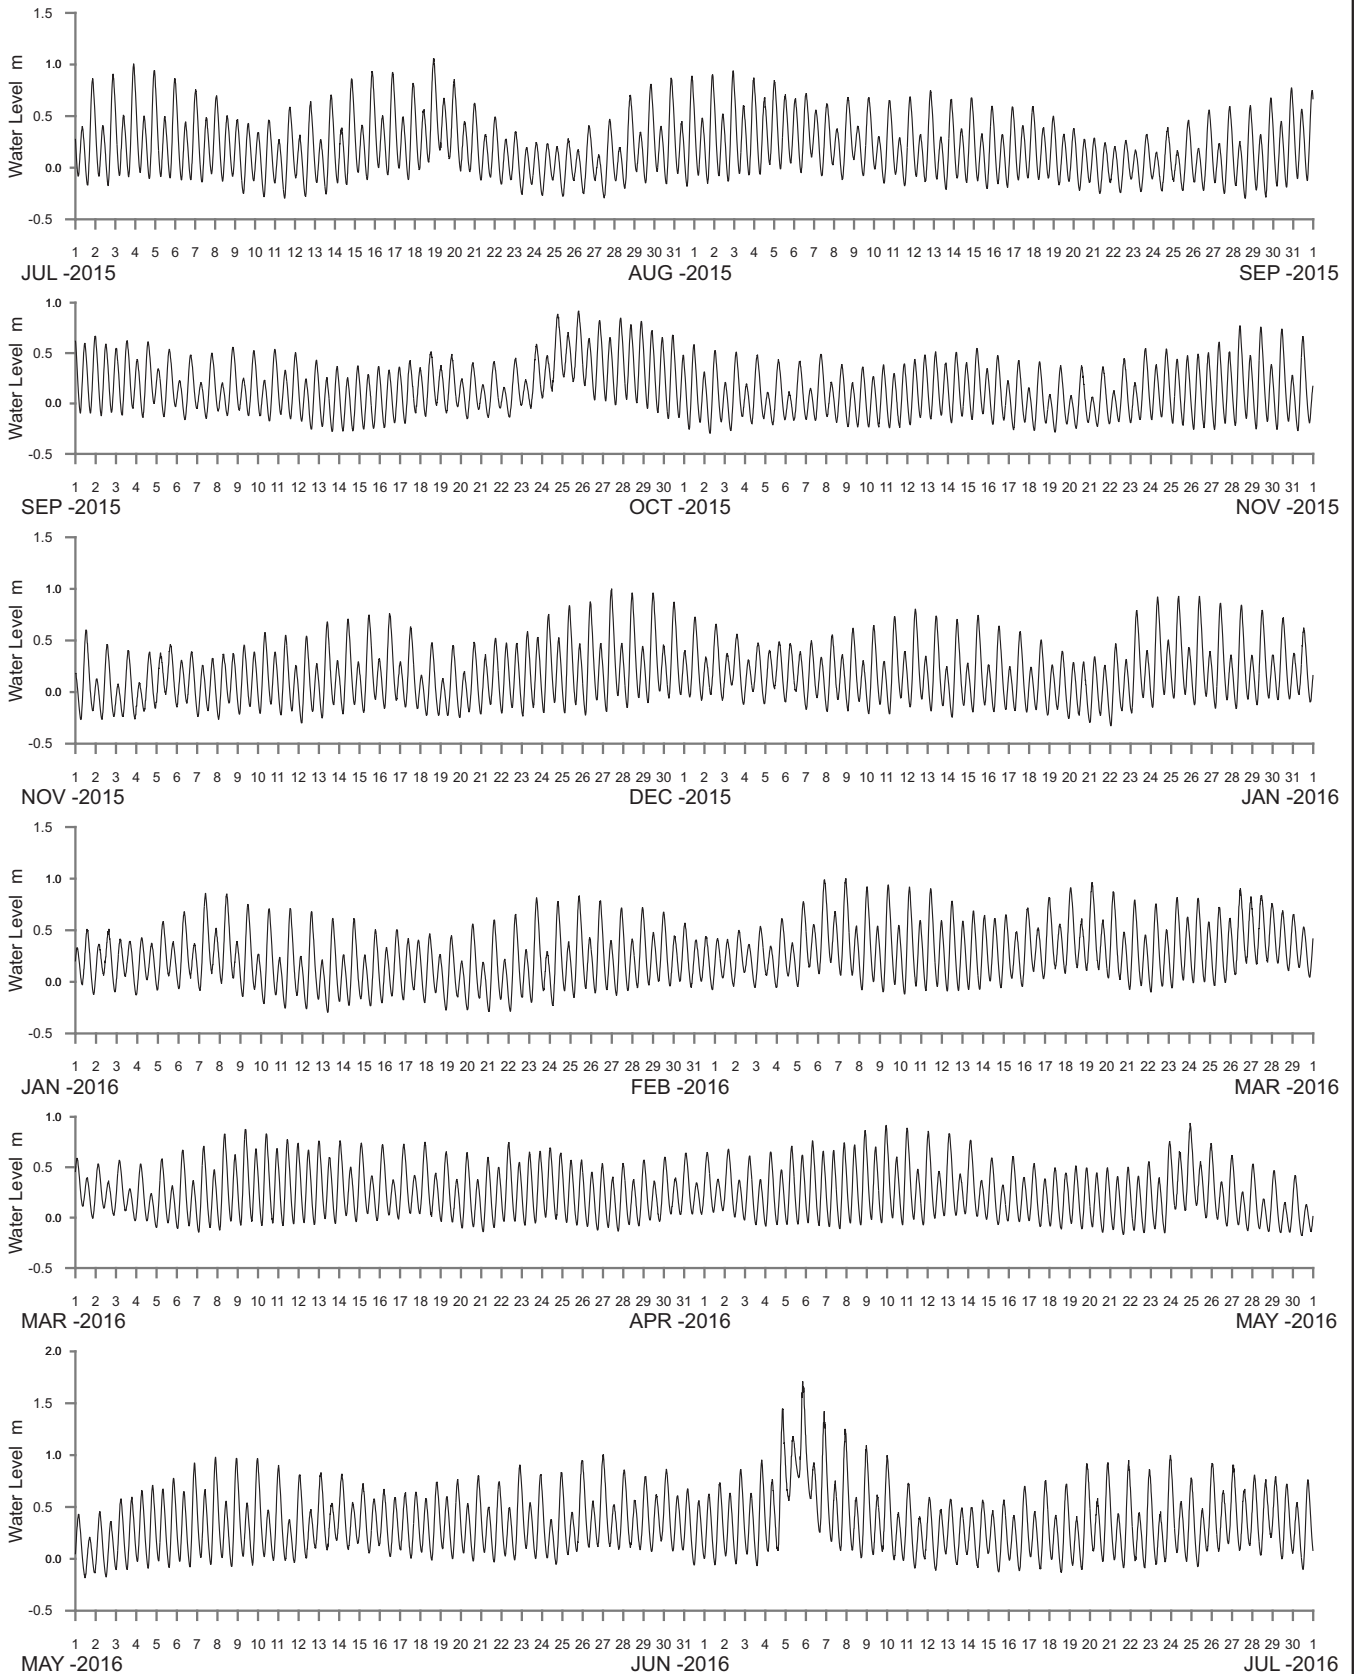
Figure
73

WATER LEVEL REFERENCED TO AUSTRALIAN HEIGHT DATUM

NAMBUCCA RIVER AT STUARTS ISLAND DOWNSTREAM
2015–2016

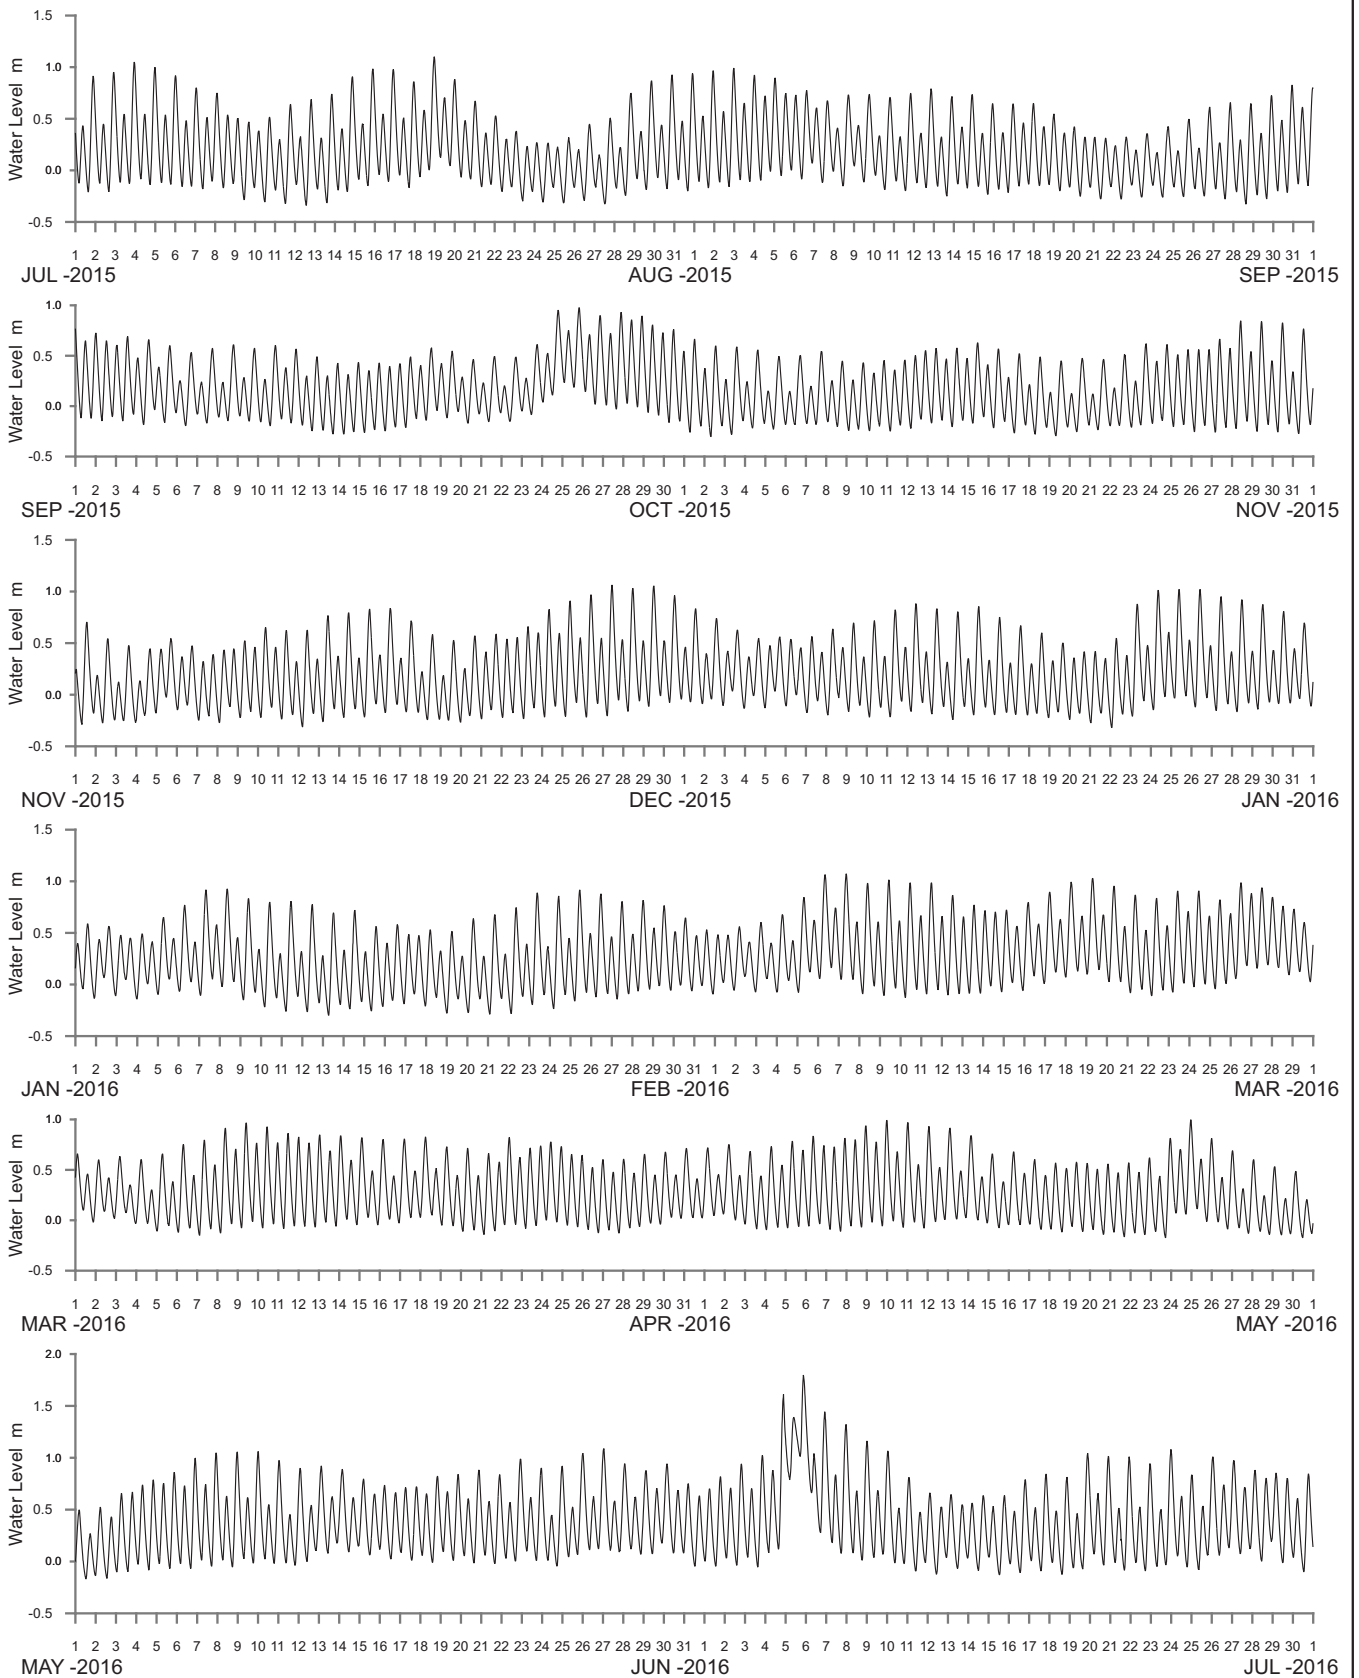
Figure
74

WATER LEVEL REFERENCED TO AUSTRALIAN HEIGHT DATUM

NAMBUCCA RIVER AT MACKSVILLE
2015–2016

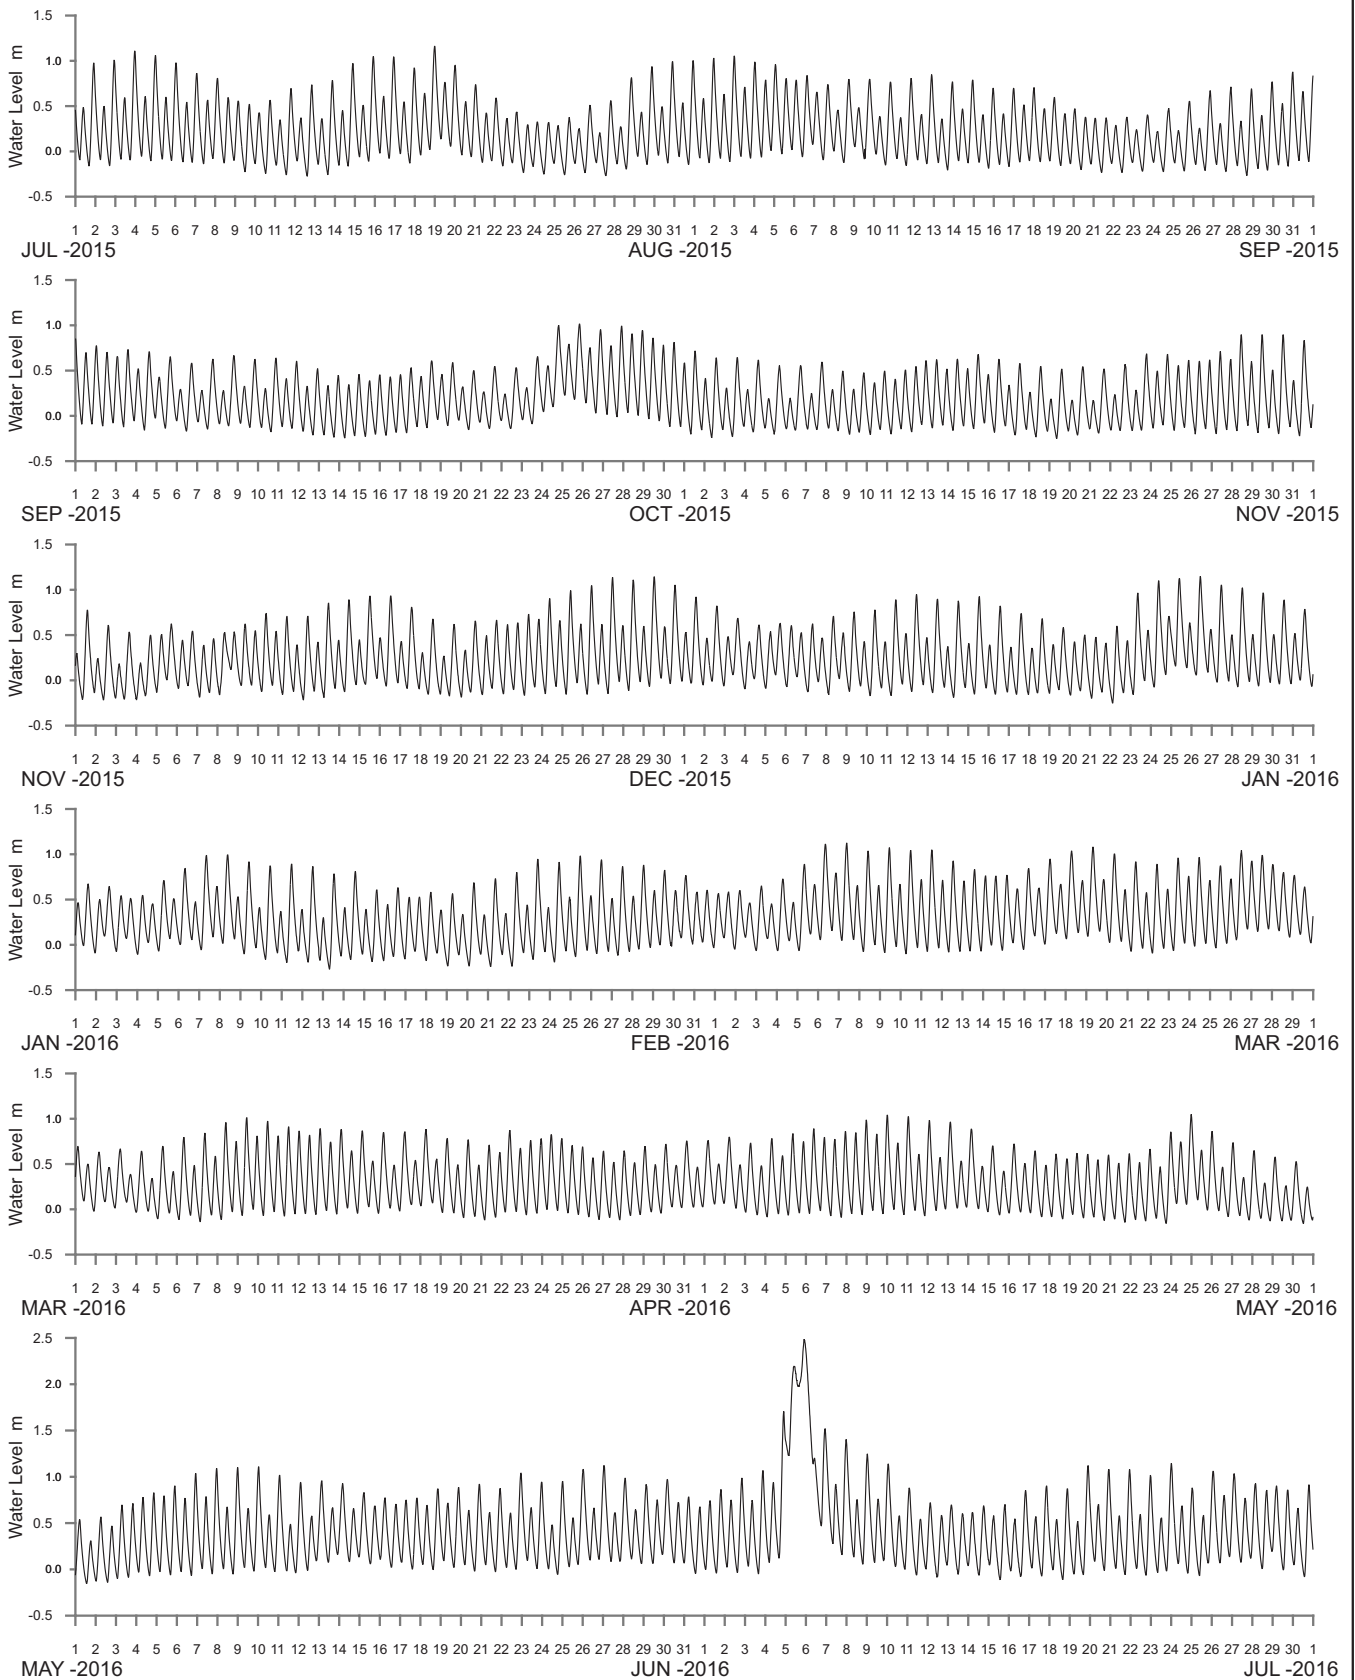
Figure
75

WATER LEVEL REFERENCED TO AUSTRALIAN HEIGHT DATUM

TAYLORS ARM AT UTUNGUN
2015–2016

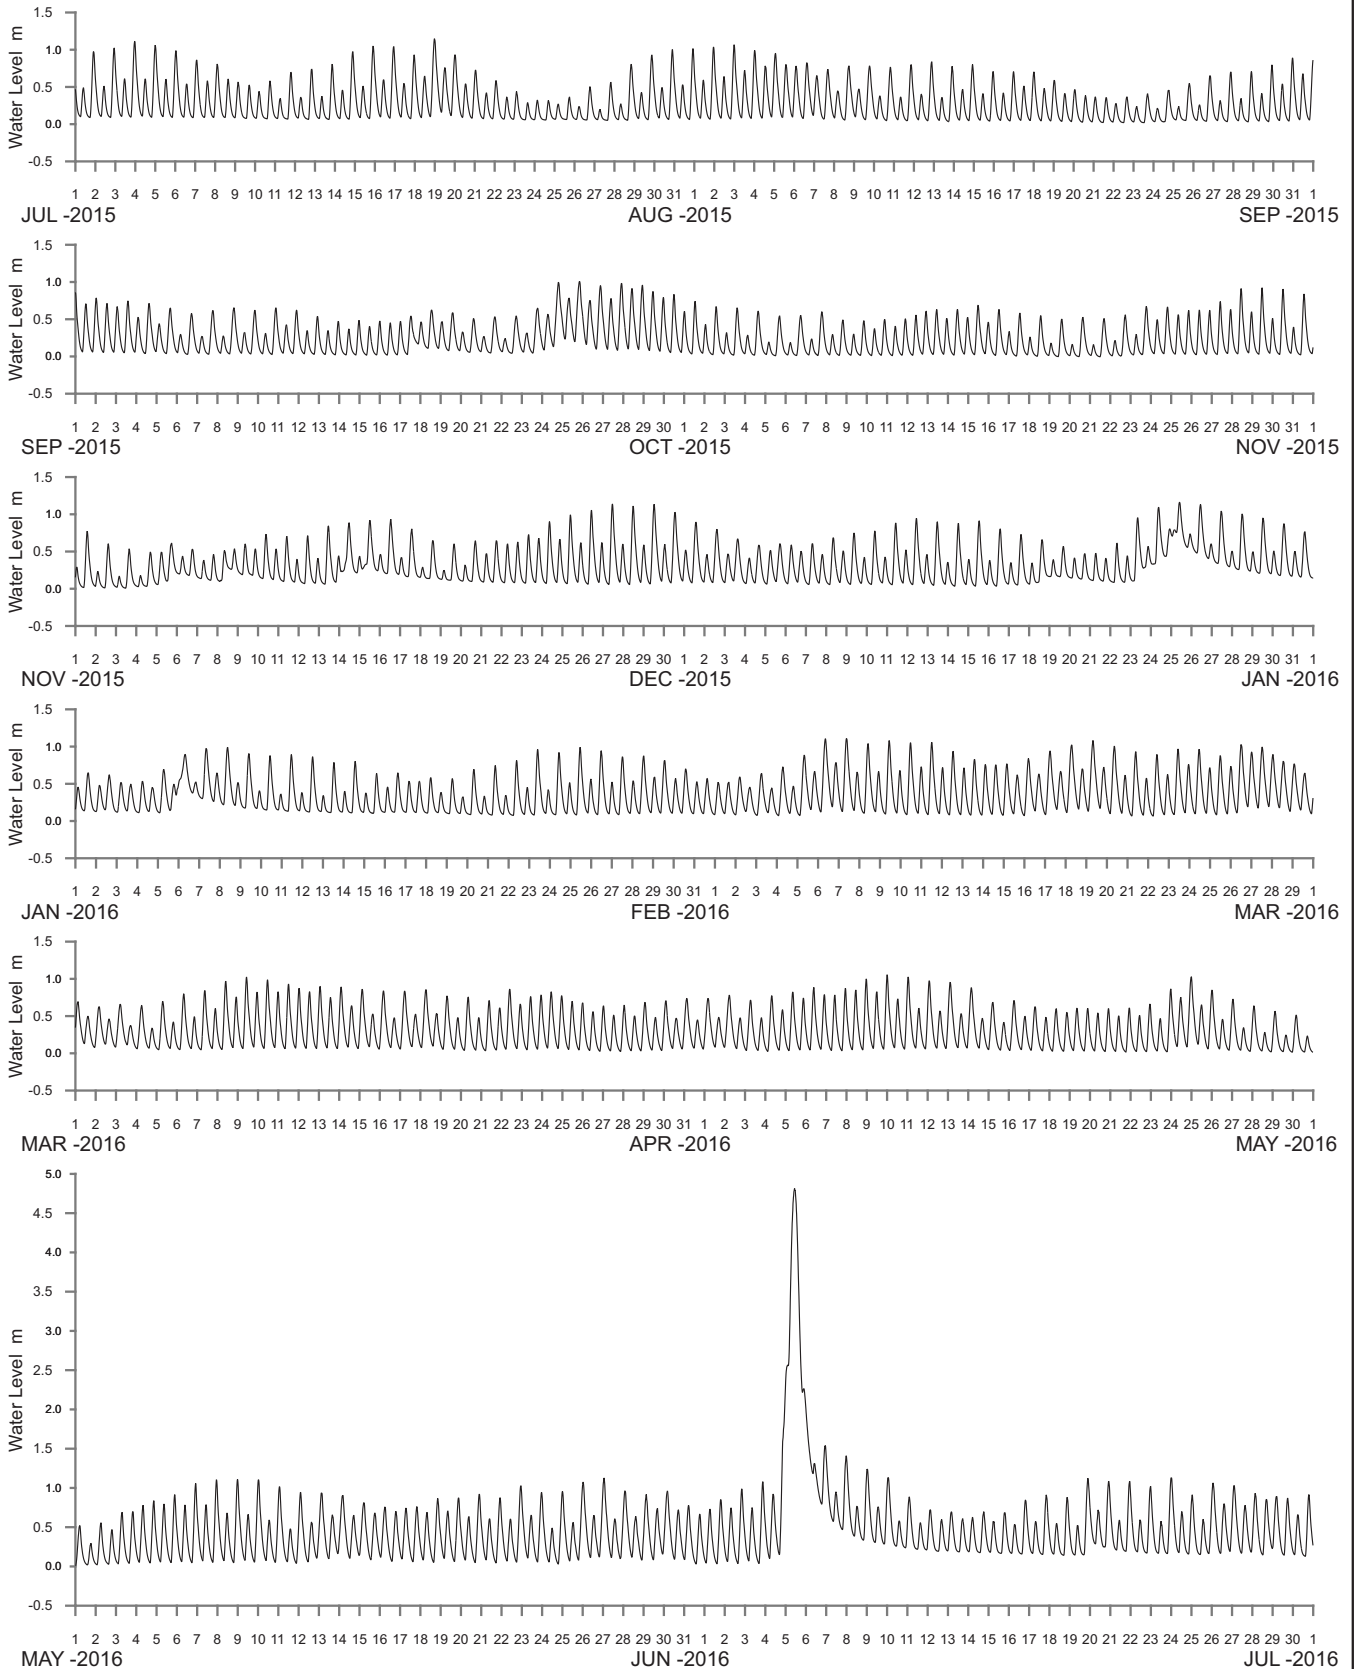
Figure
76

WATER LEVEL REFERENCED TO AUSTRALIAN HEIGHT DATUM

NAMBUCCA RIVER AT BOWRAVILLE DOWNSTREAM
2015–2016
