Public Works
Manly Hydraulics Laboratory

MHL
Report 2474

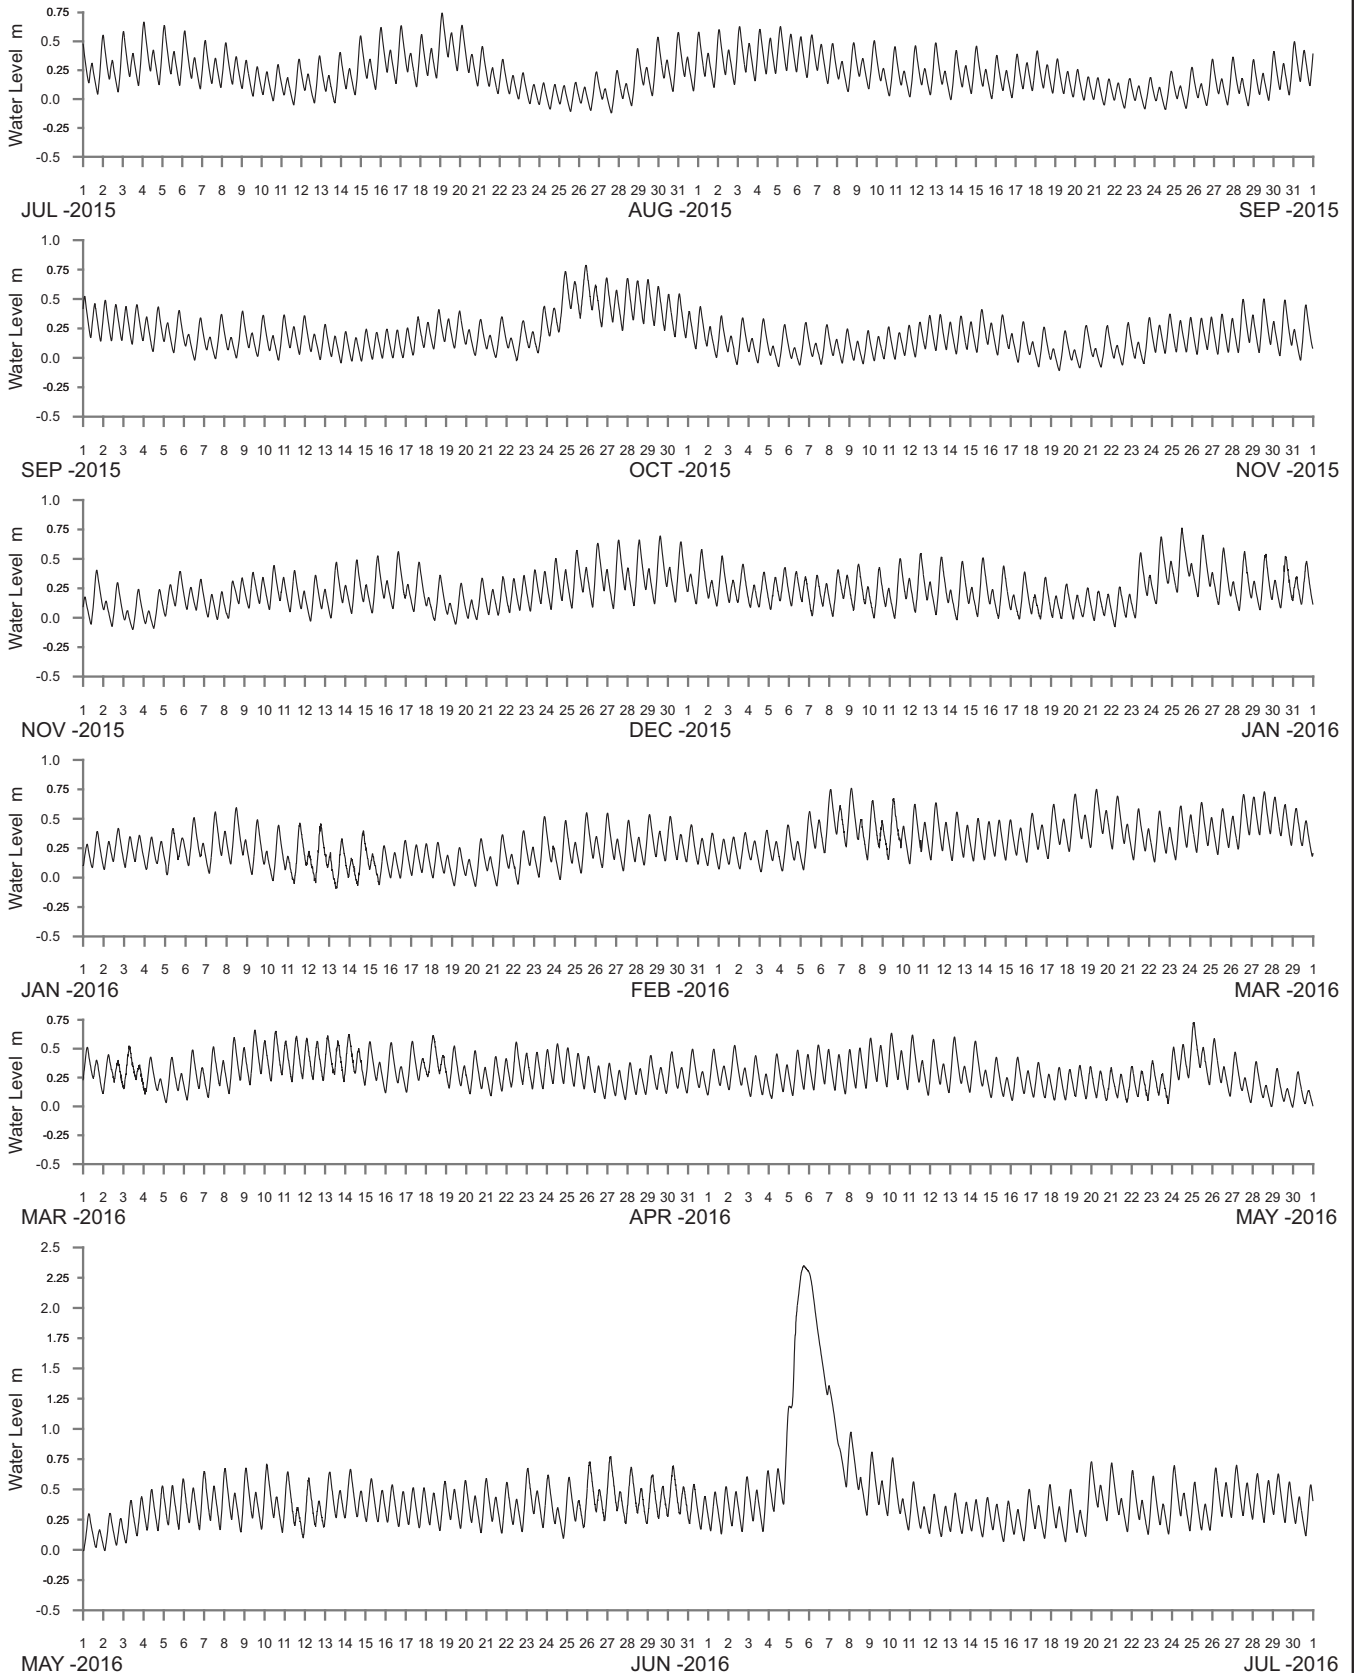
Figure
77

WATER LEVEL REFERENCED TO AUSTRALIAN HEIGHT DATUM

WARRELL CREEK AT WARRELL CREEK
2015–2016

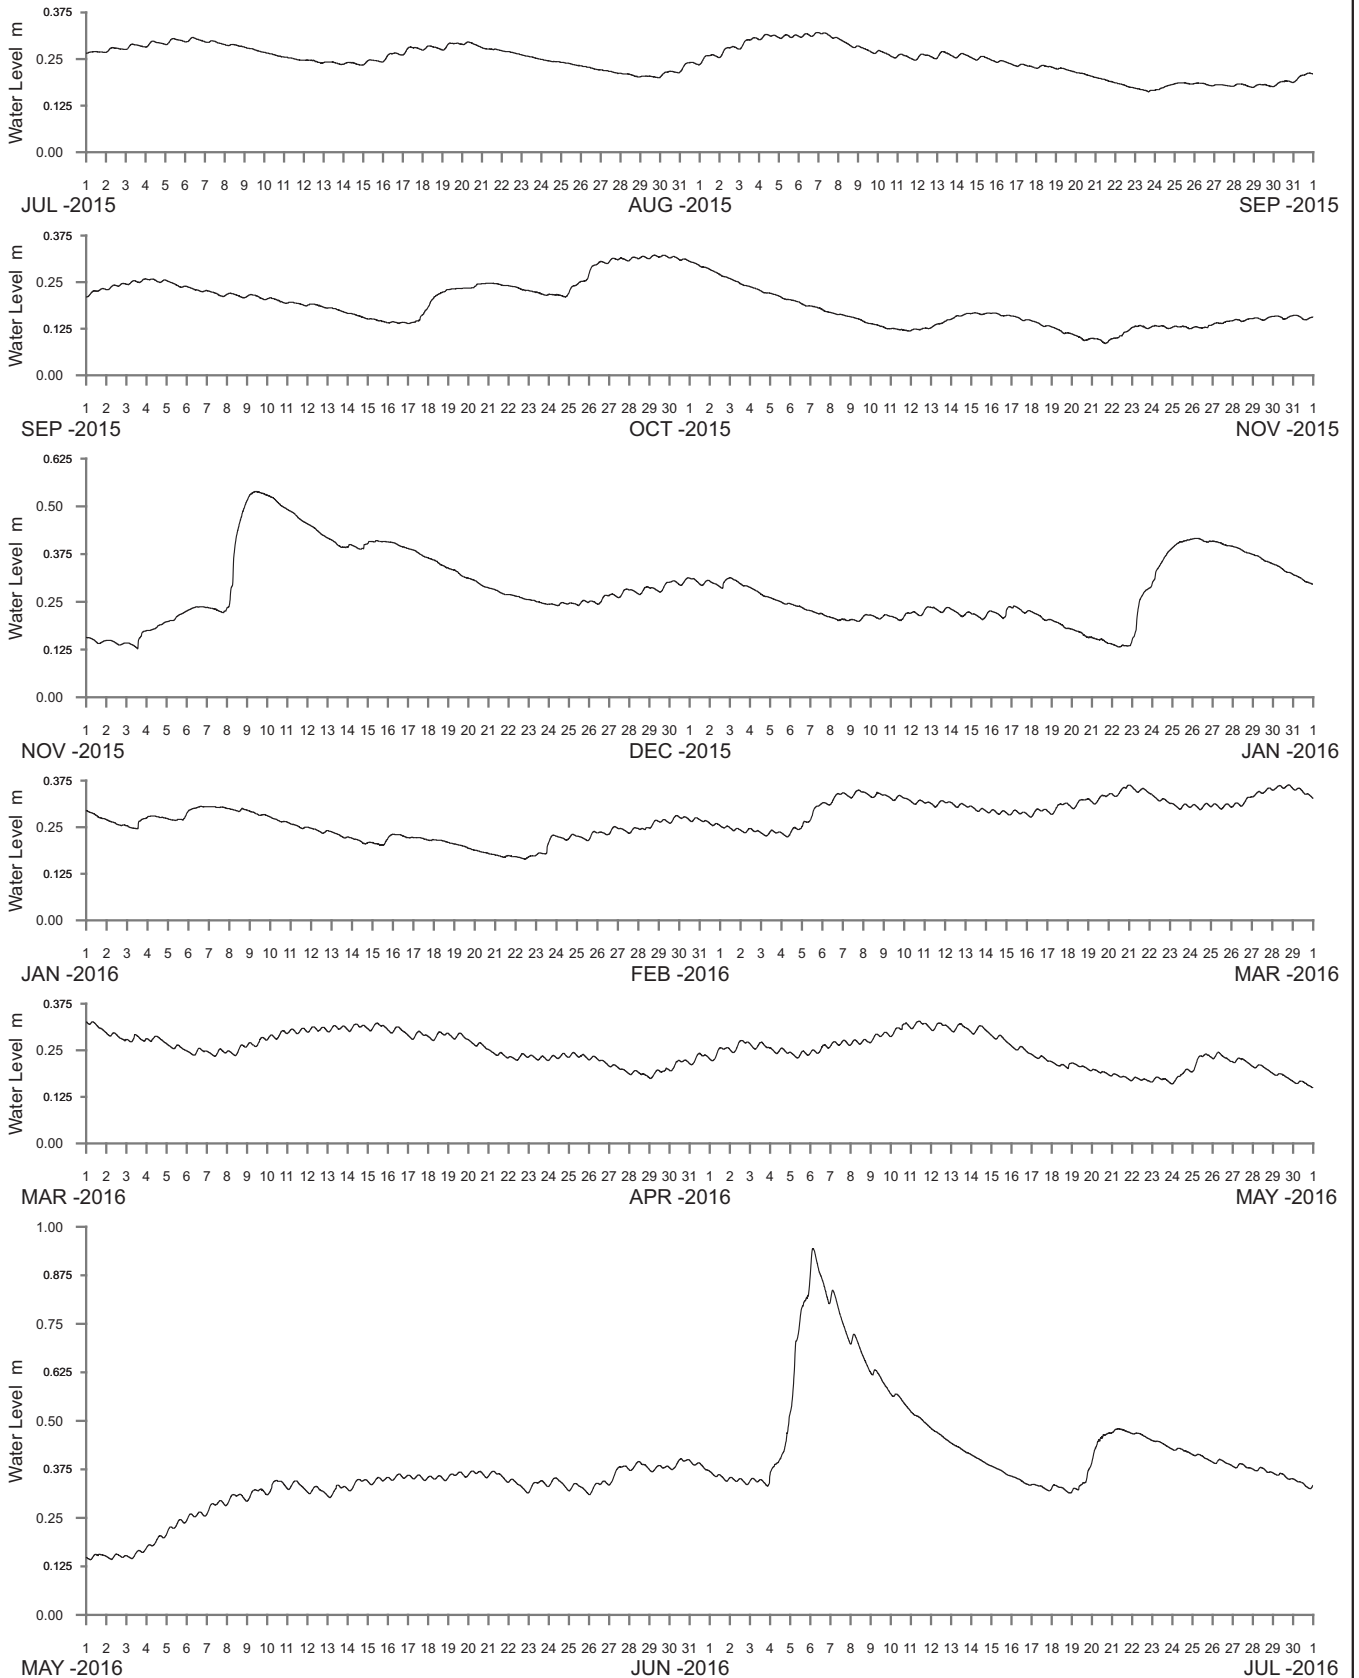
Figure
79

WATER LEVEL REFERENCED TO AUSTRALIAN HEIGHT DATUM

BORIRGALA CREEK AT BORIRGALA CREEK
2015–2016

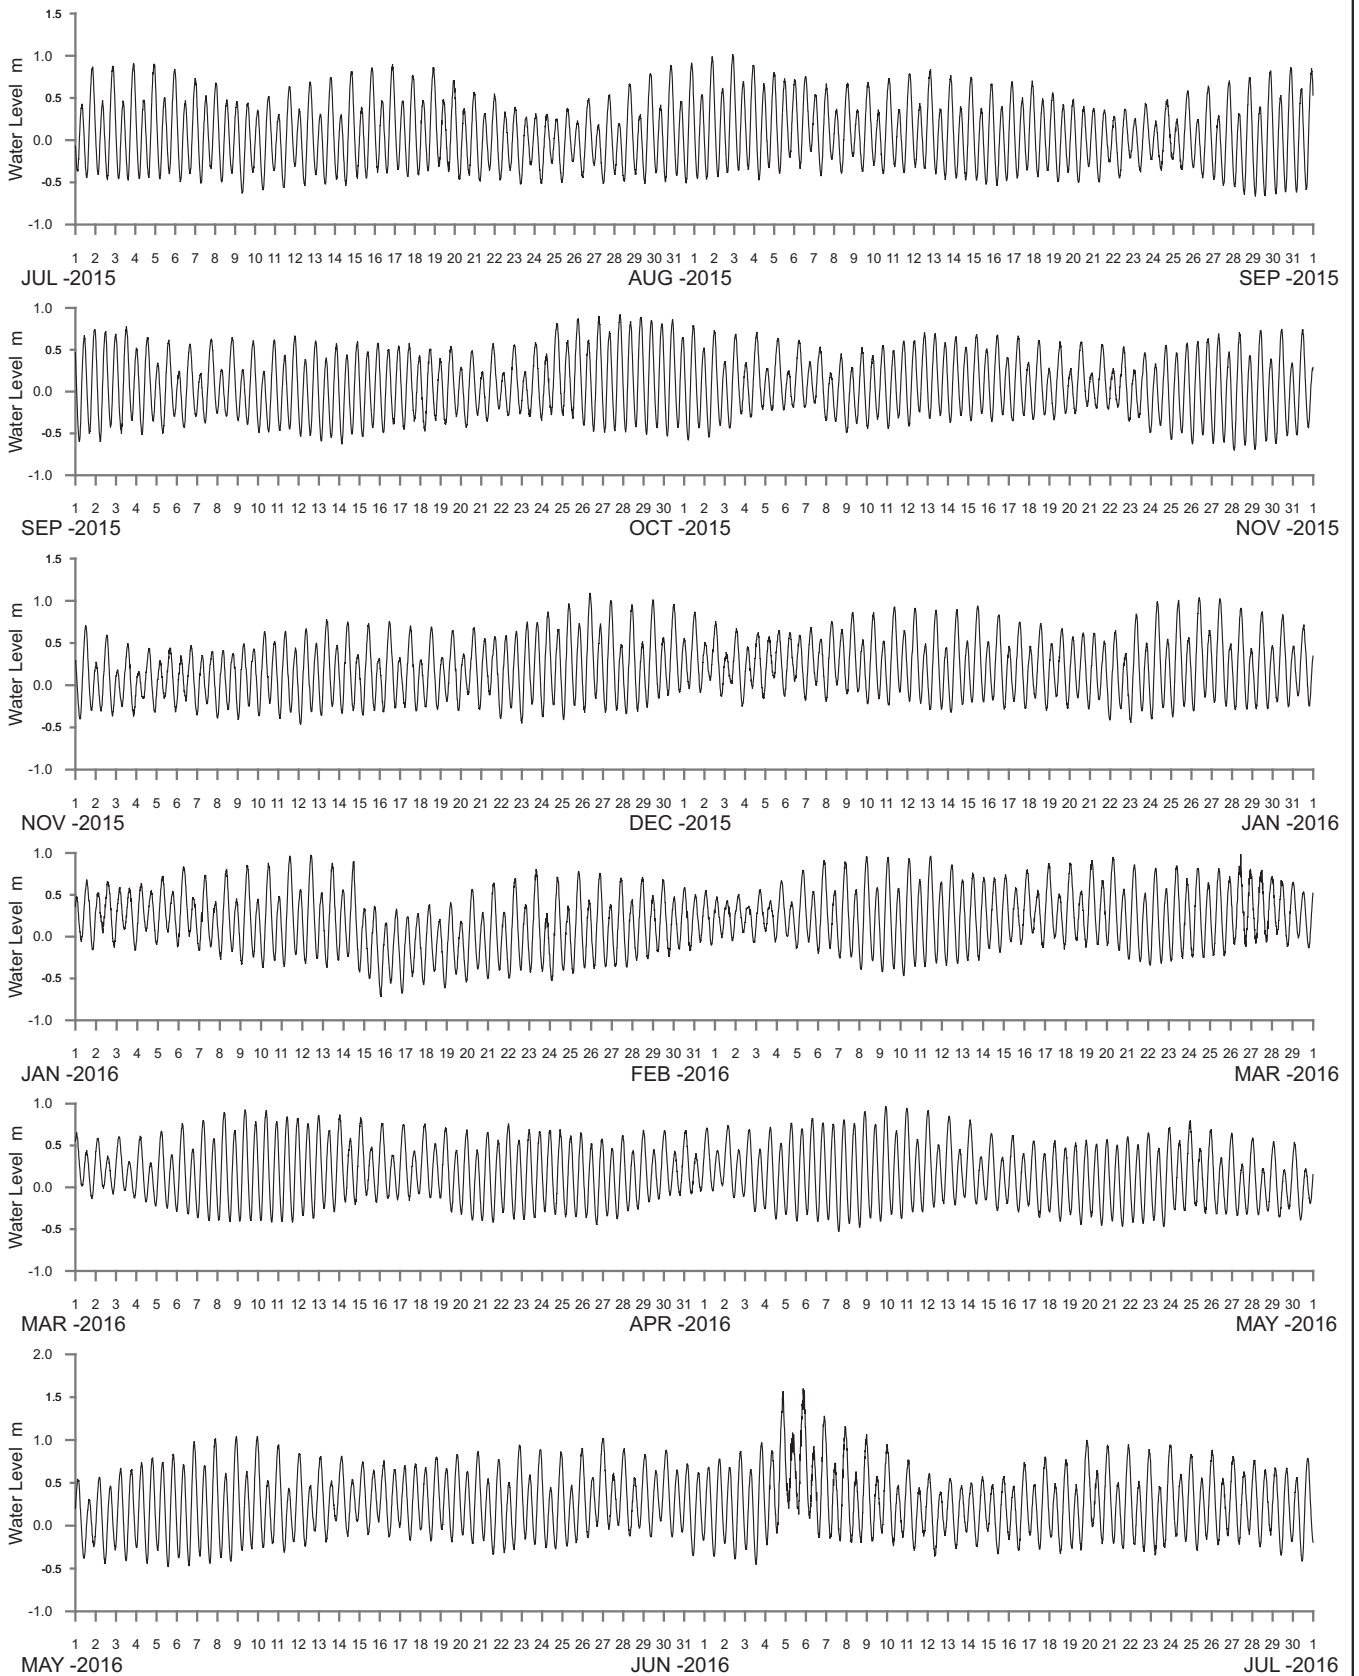
Figure
80

WATER LEVEL REFERENCED TO AUSTRALIAN HEIGHT DATUM

MACLEAY RIVER AT SOUTH WEST ROCKS
2015–2016

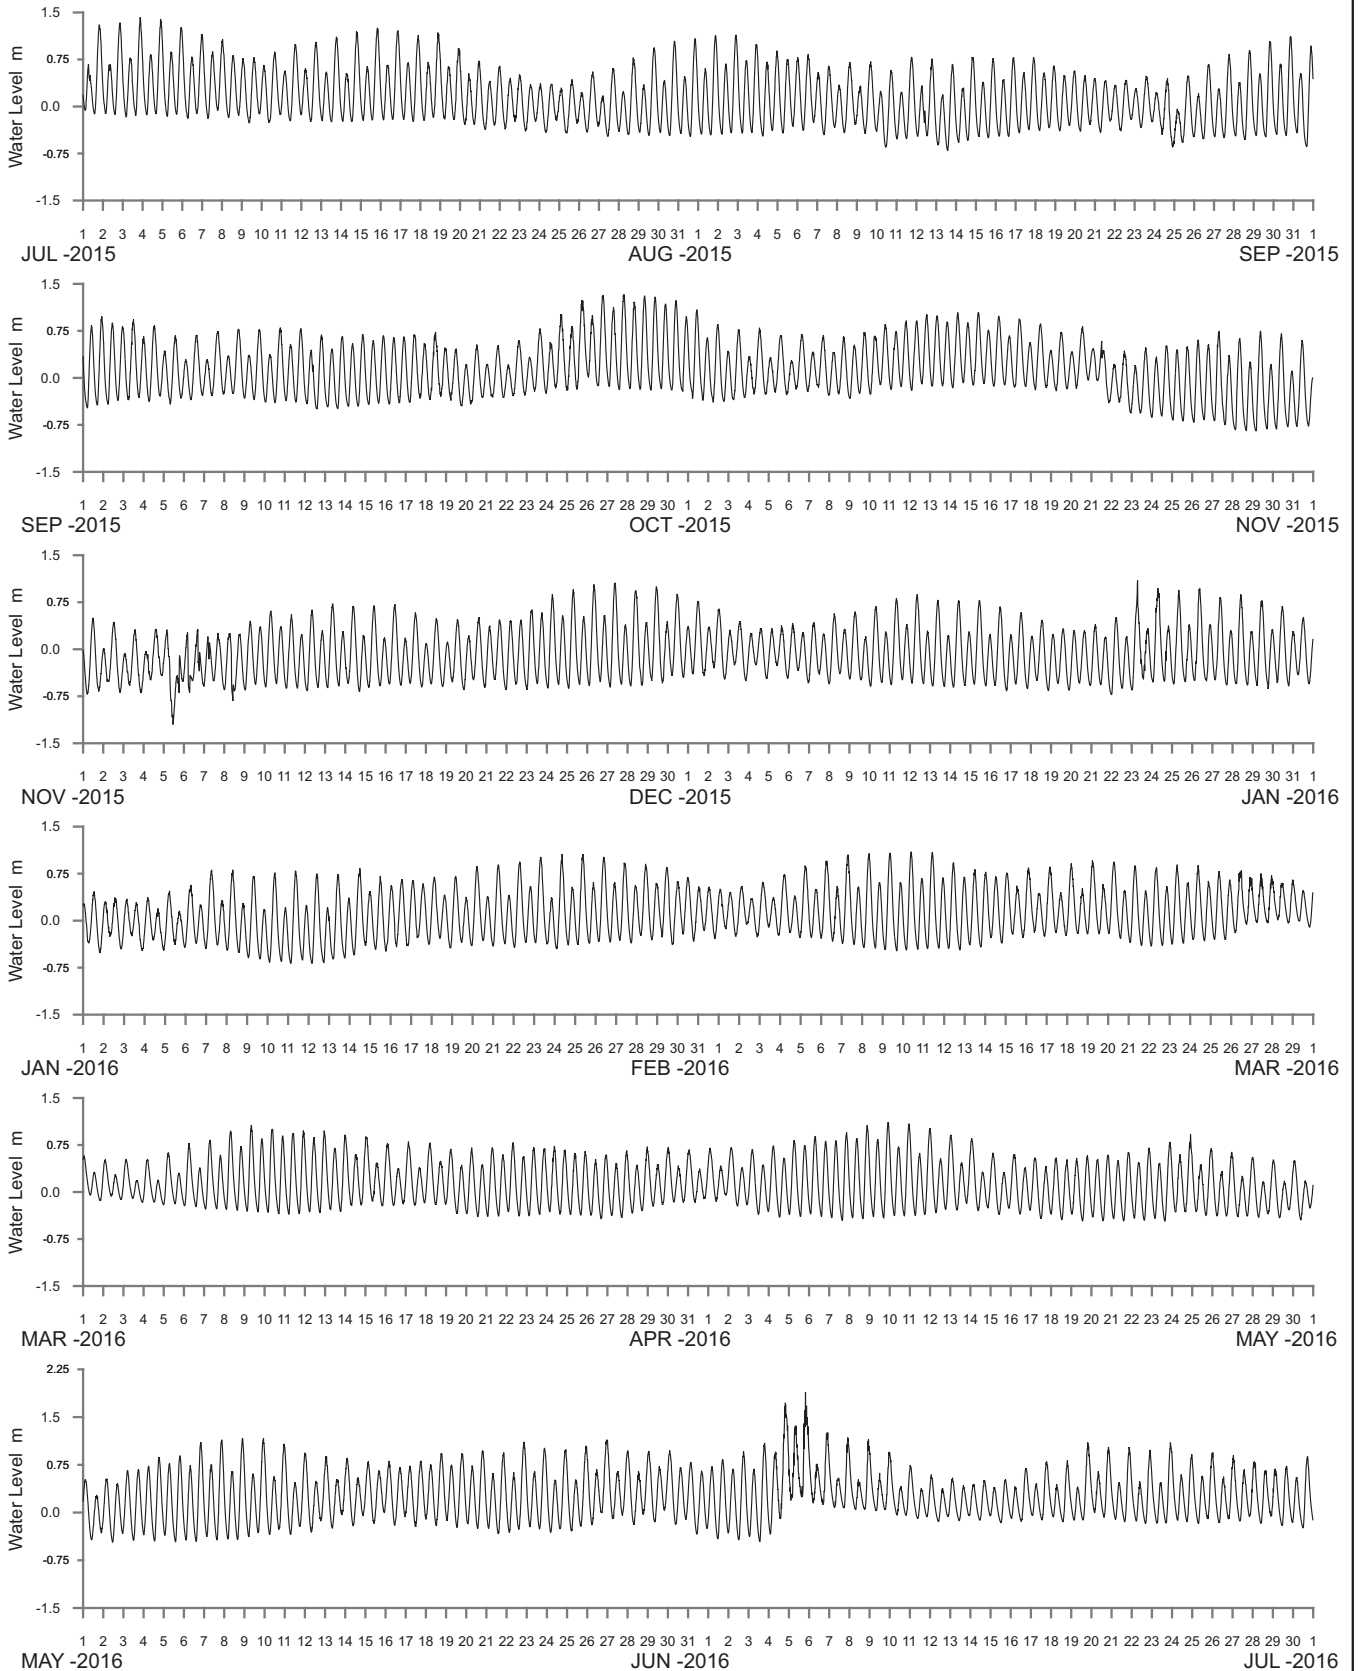
Figure
81

WATER LEVEL REFERENCED TO AUSTRALIAN HEIGHT DATUM

KOROGORO CREEK AT HAT HEAD
2015–2016

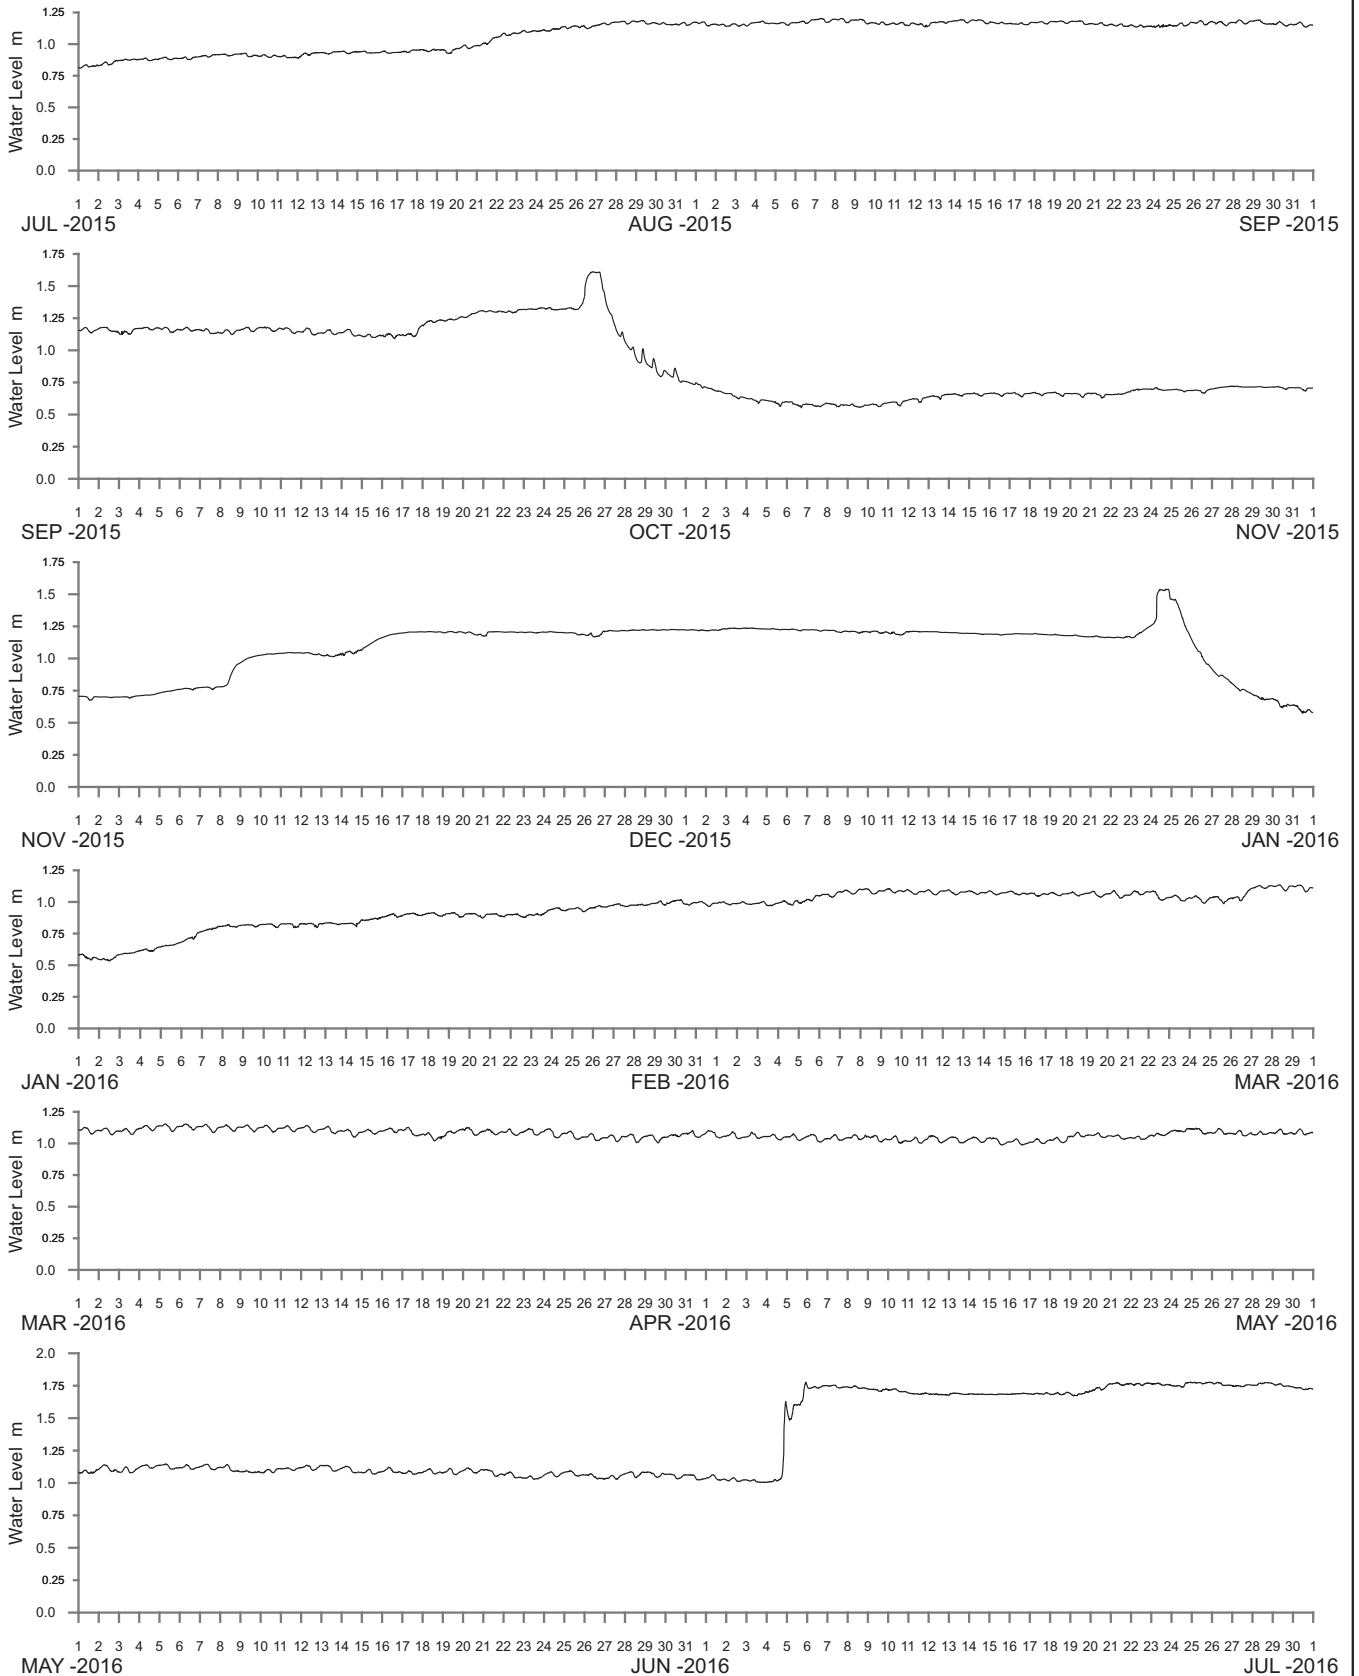
Figure
82

WATER LEVEL REFERENCED TO AUSTRALIAN HEIGHT DATUM

SALTWATER LAGOON AT SALTWATER LAGOON
2015–2016

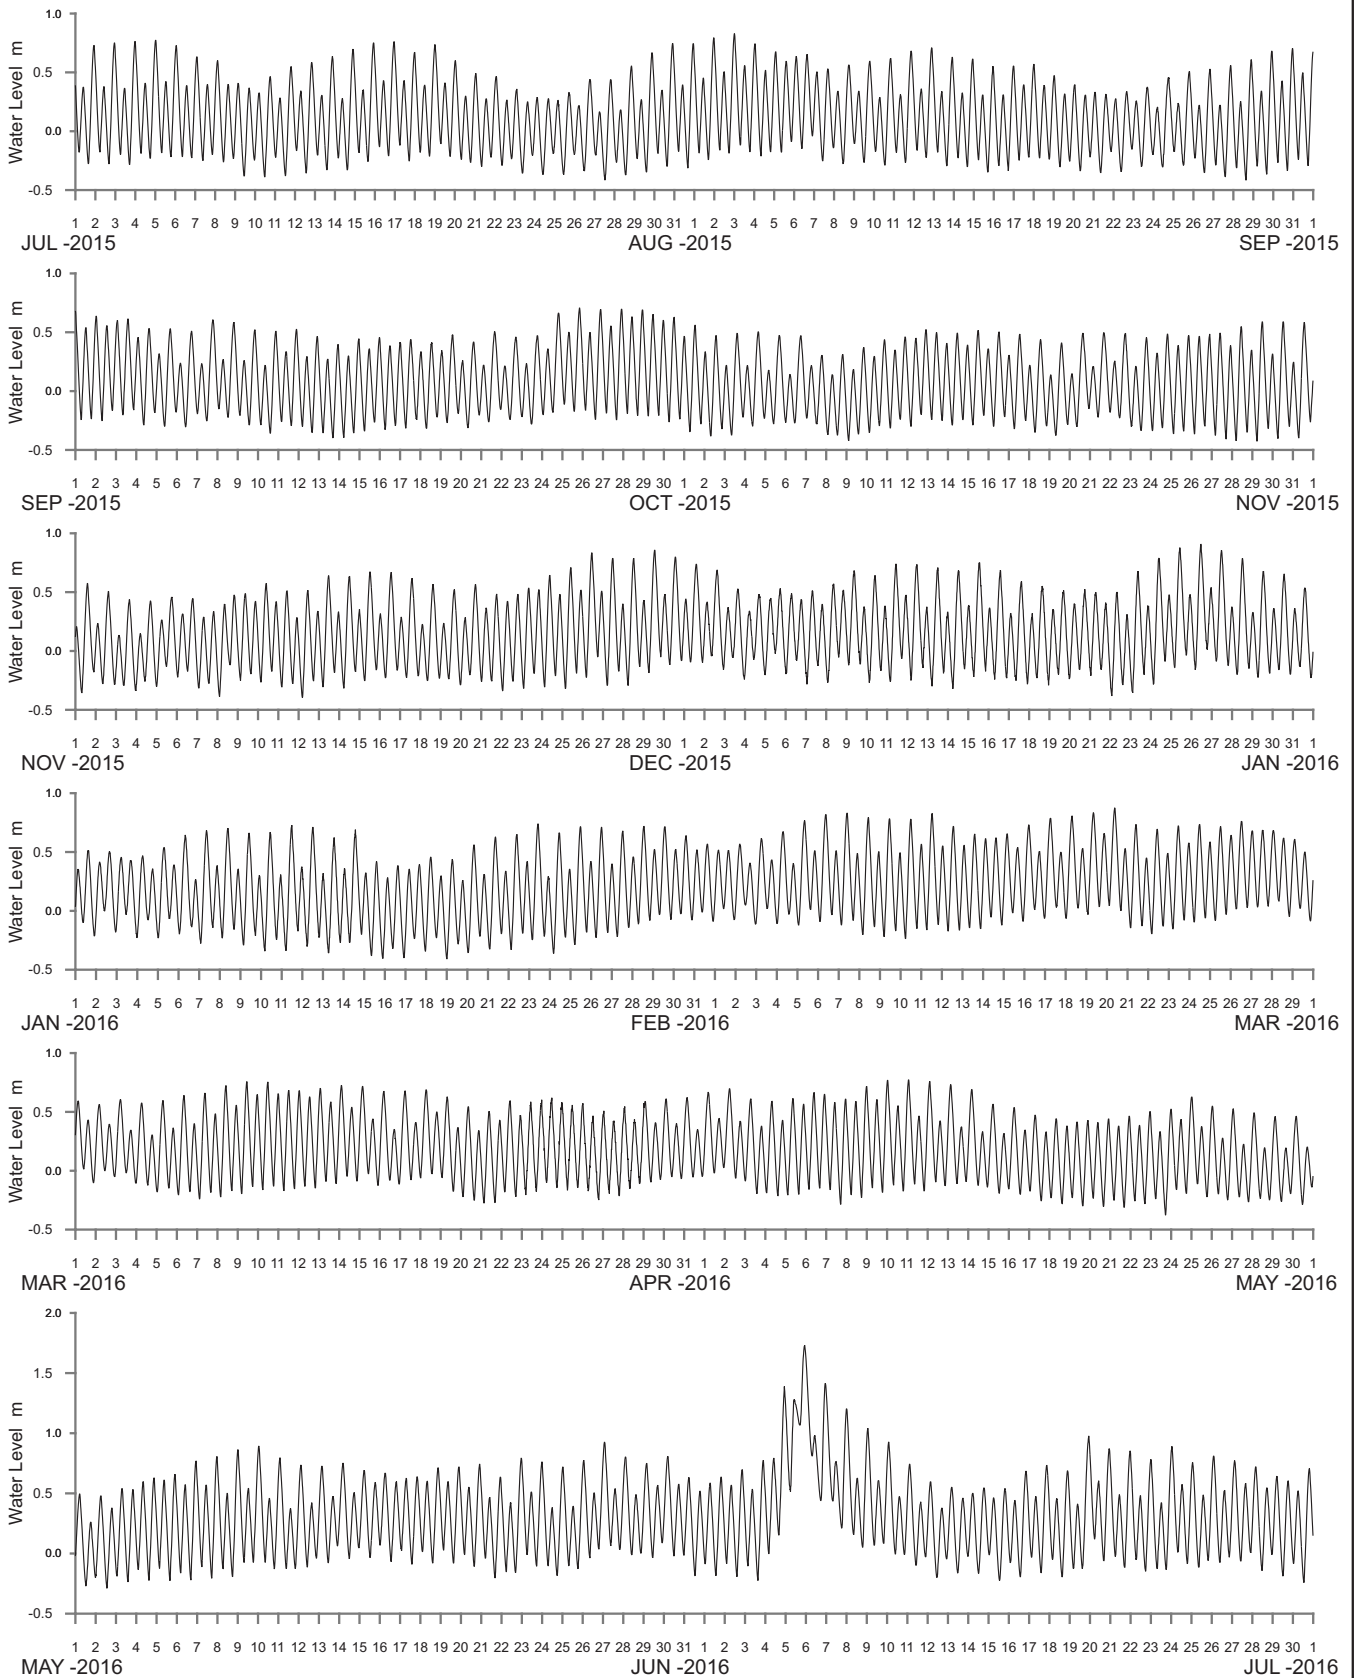
Figure
83

WATER LEVEL REFERENCED TO AUSTRALIAN HEIGHT DATUM

MACLEAY RIVER AT SMITHTOWN
2015–2016

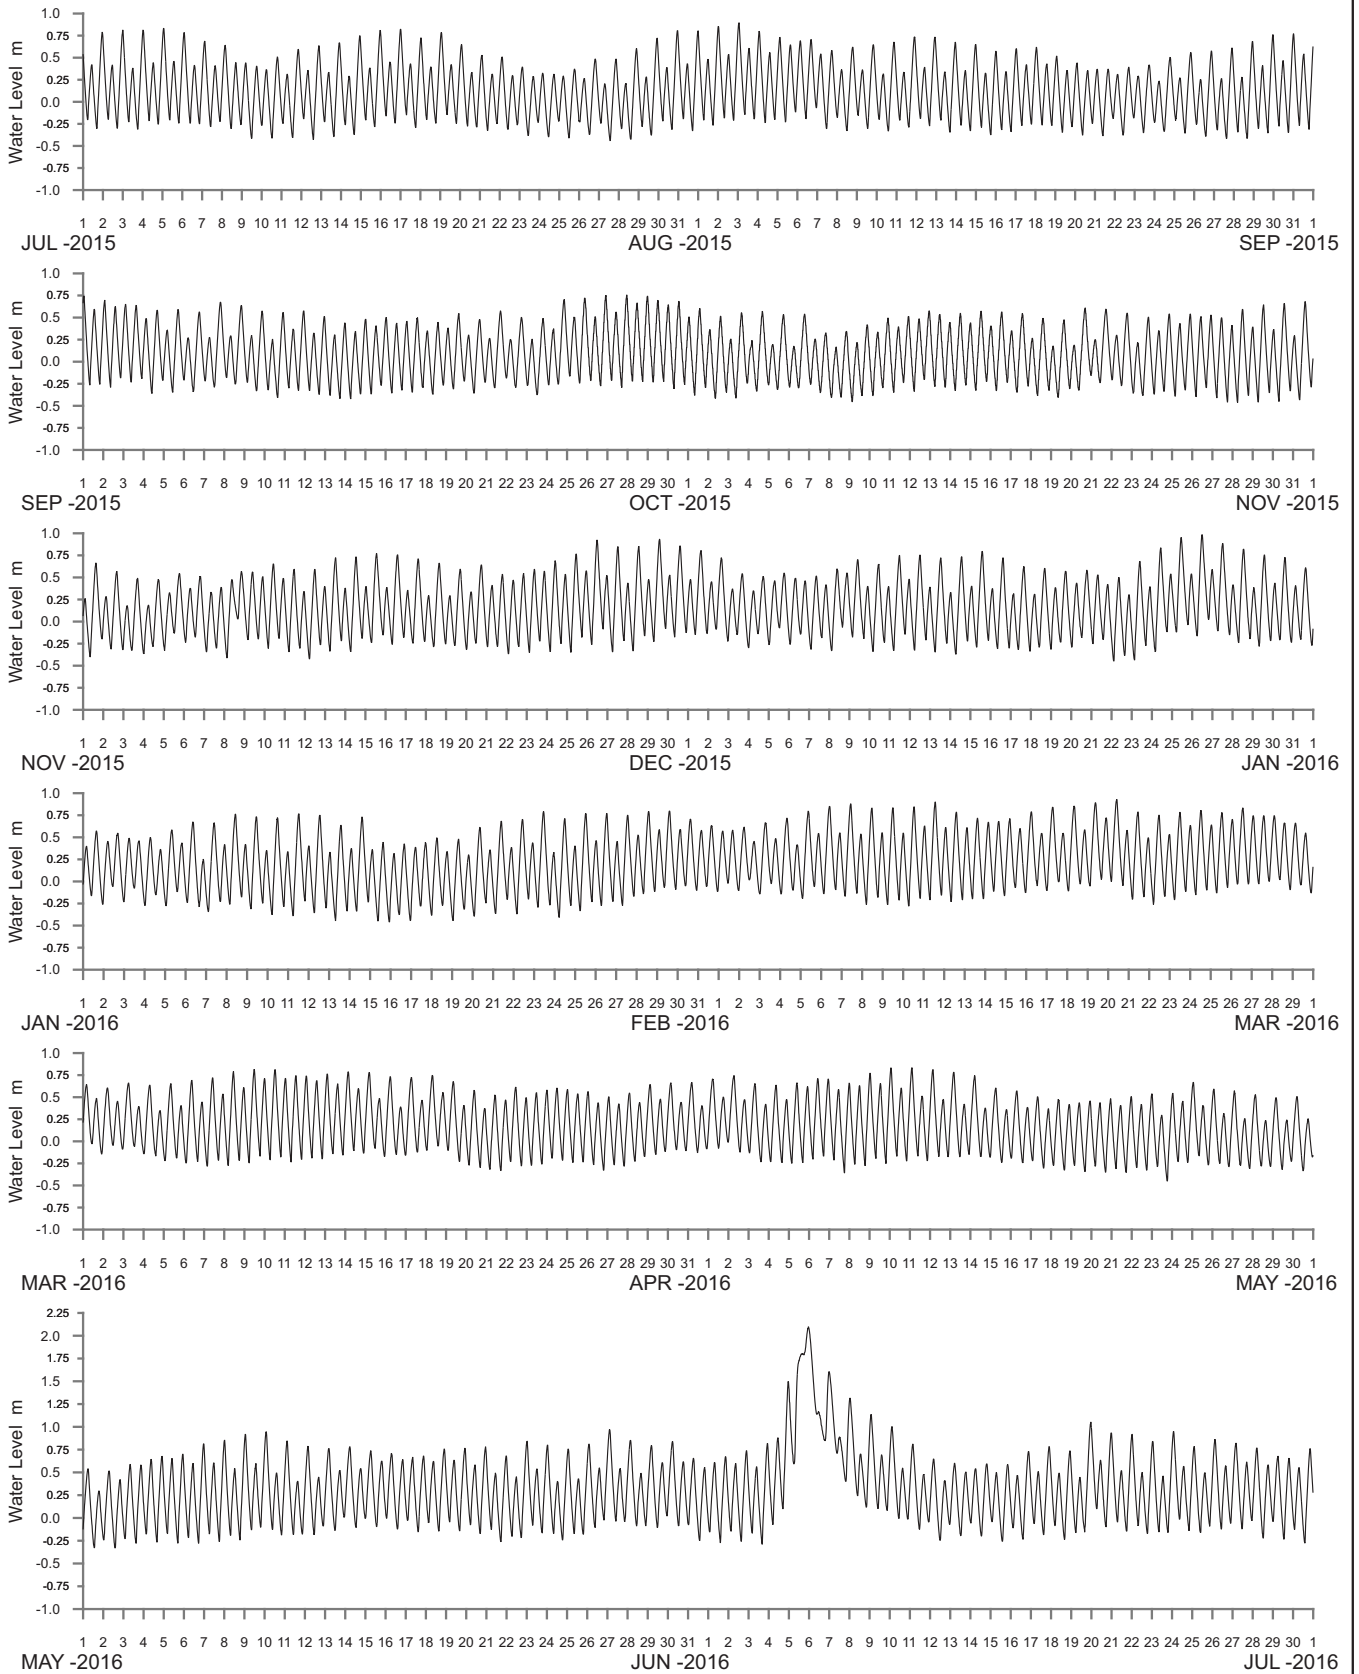
Figure
84

WATER LEVEL REFERENCED TO AUSTRALIAN HEIGHT DATUM

MACLEAY RIVER AT KEMPSEY
2015–2016

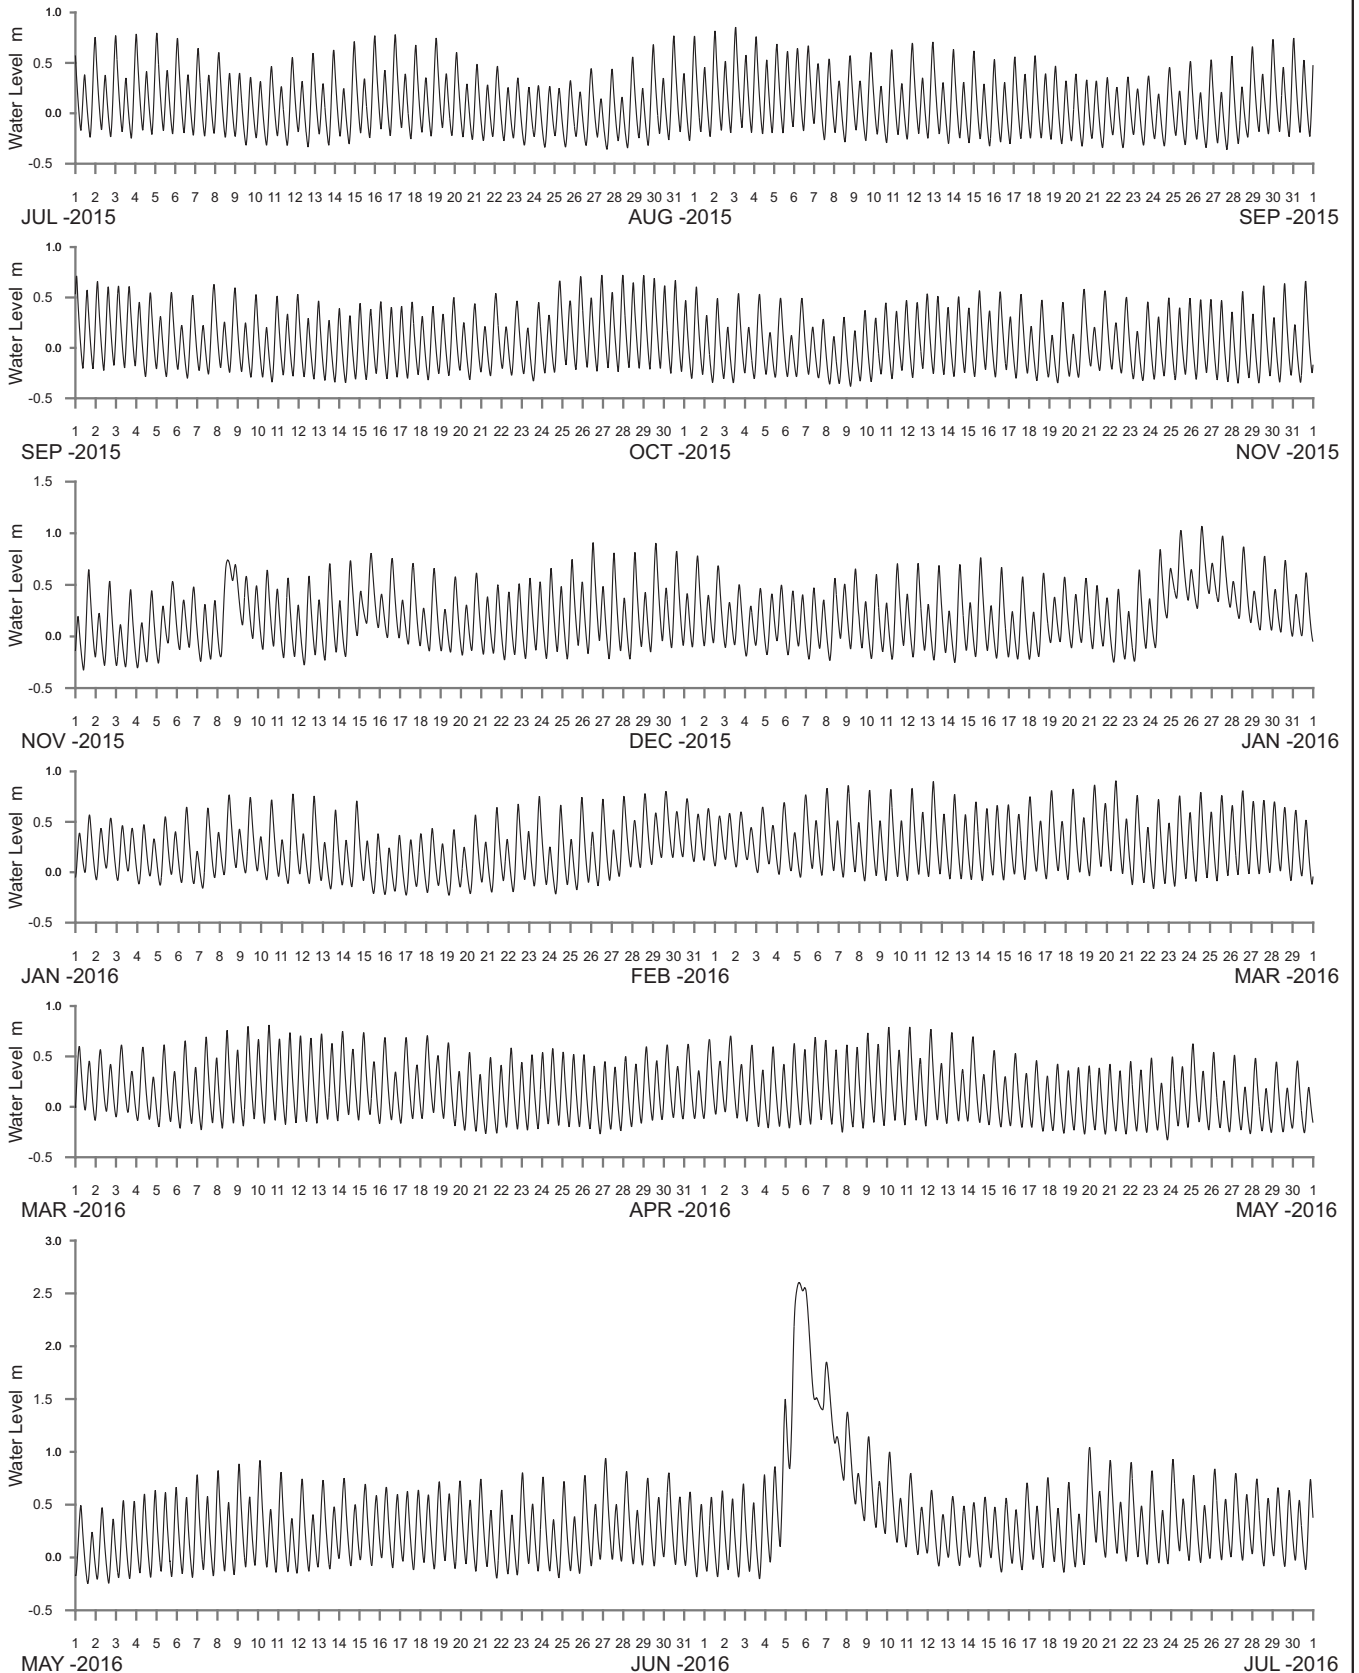
Figure
85

WATER LEVEL REFERENCED TO AUSTRALIAN HEIGHT DATUM

MACLEAY RIVER AT ALDAVILLA DOWNSTREAM
2015–2016

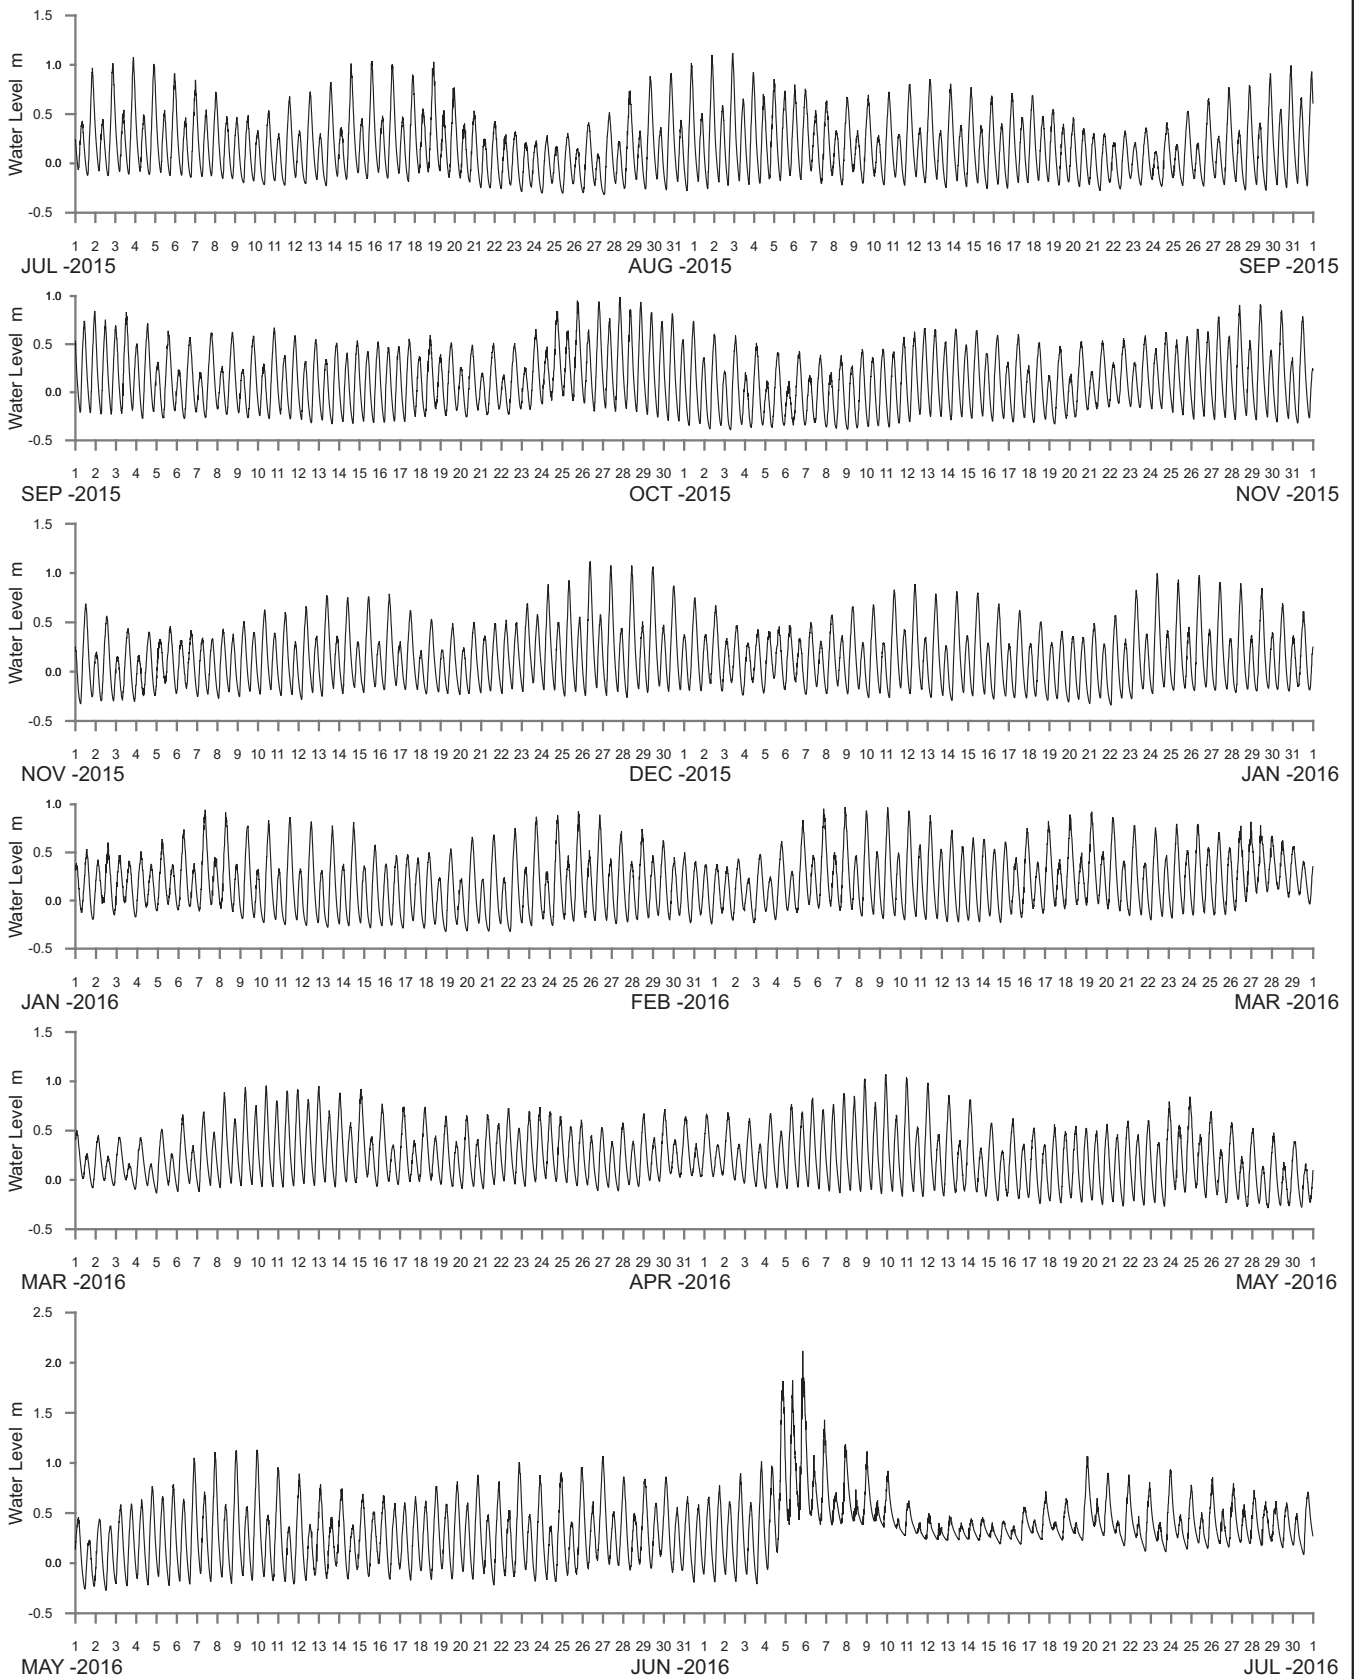
Figure
86

WATER LEVEL REFERENCED TO AUSTRALIAN HEIGHT DATUM

KILLICK CREEK AT CRESCENT HEAD
2015–2016

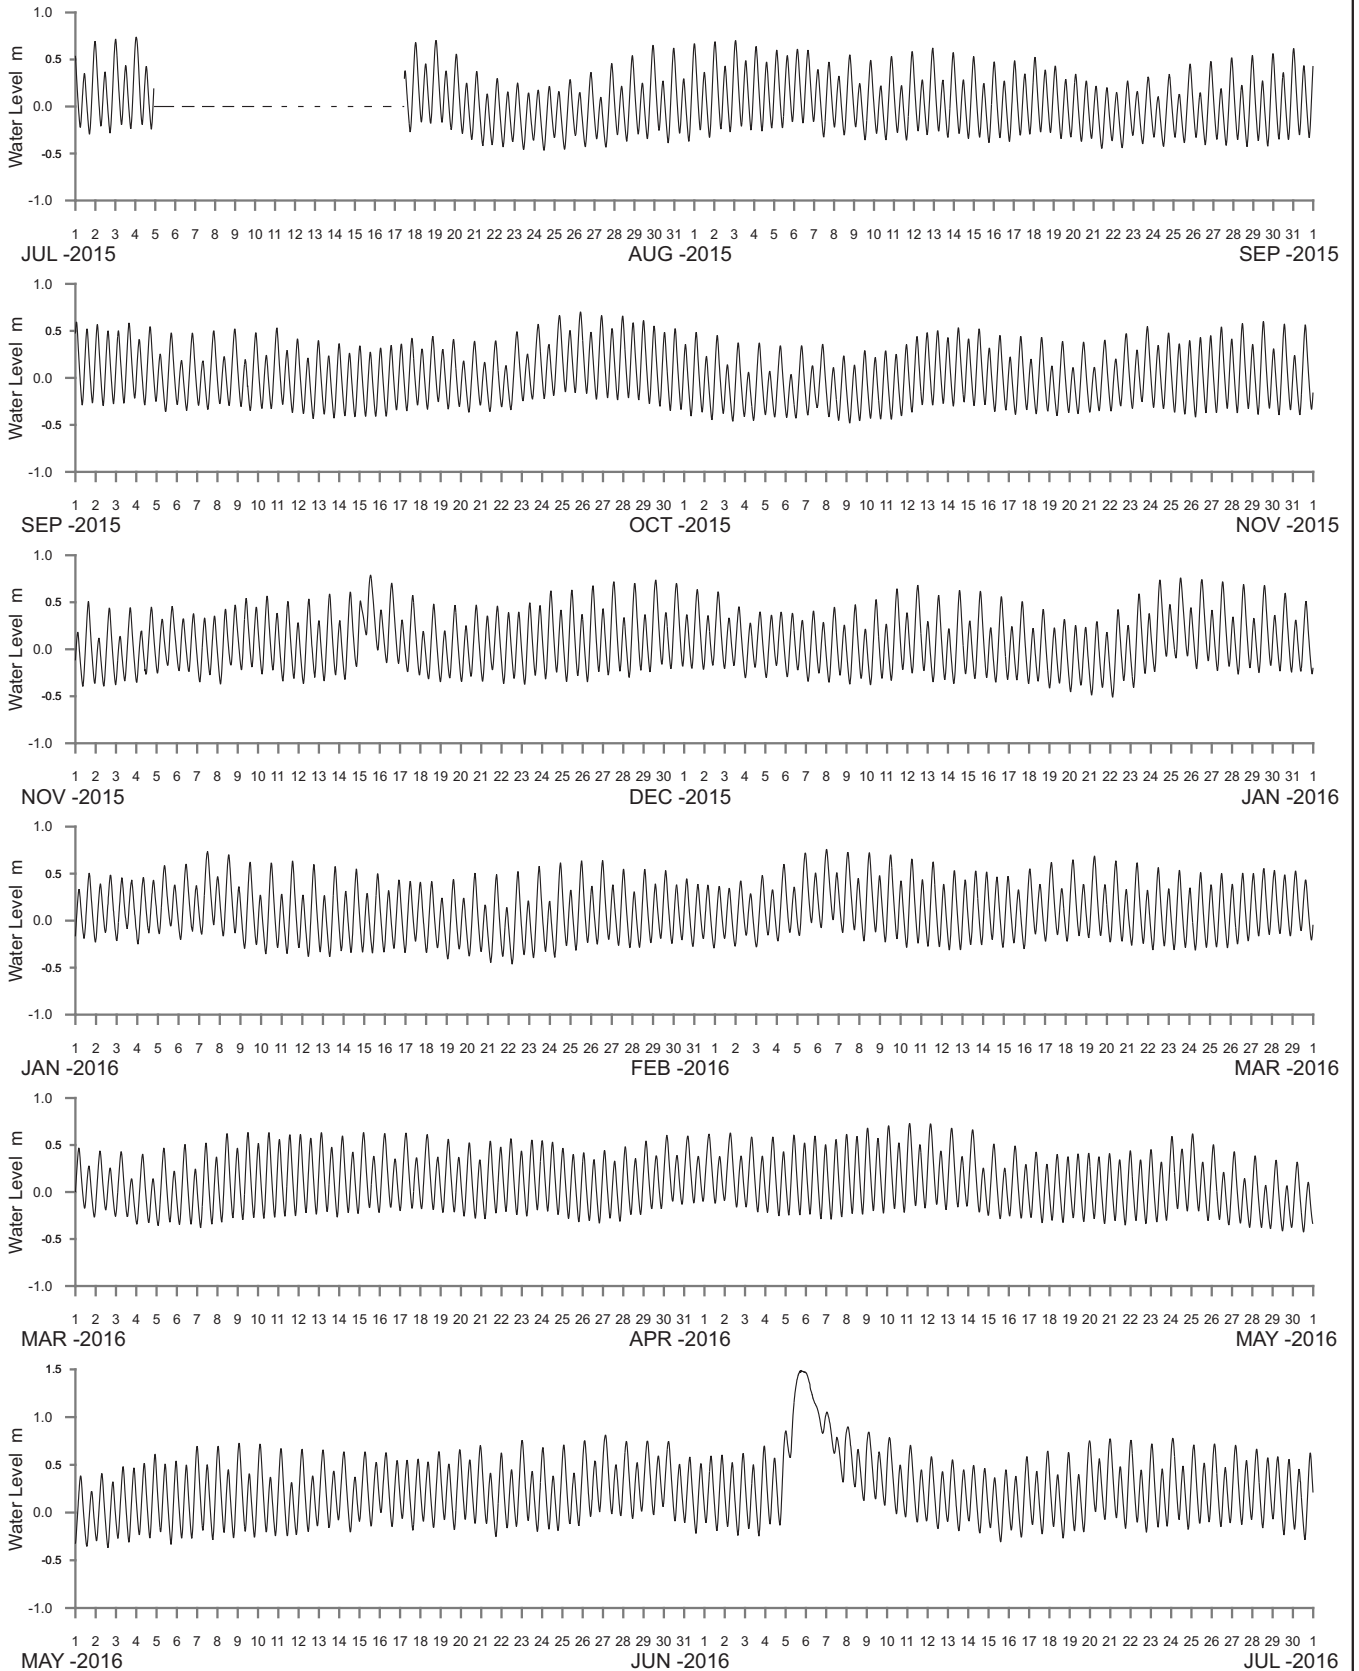
Figure
88

WATER LEVEL REFERENCED TO AUSTRALIAN HEIGHT DATUM

MARIA RIVER AT GREEN VALLEY
2015–2016
