Public Works
Manly Hydraulics Laboratory

MHL
Report 2474

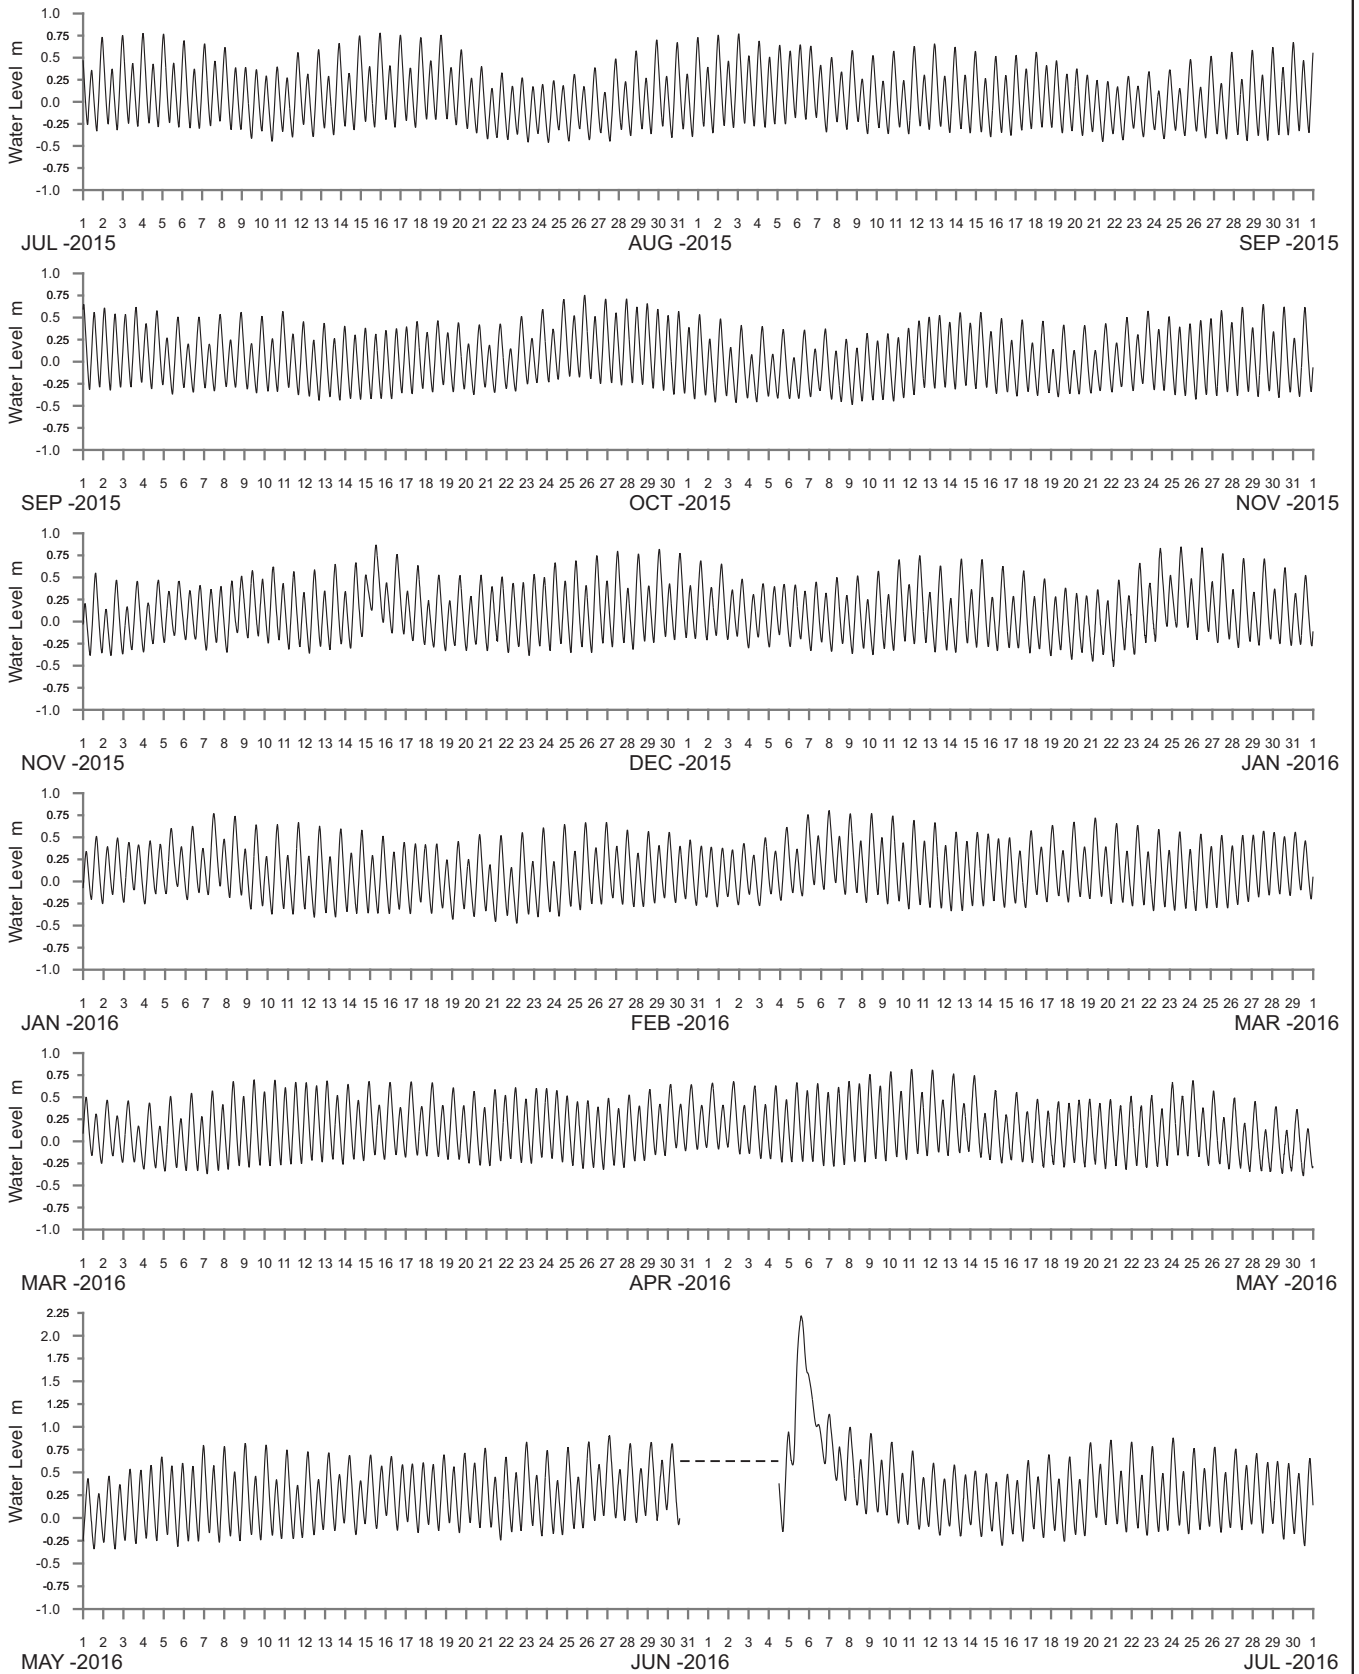
Figure
89

WATER LEVEL REFERENCED TO AUSTRALIAN HEIGHT DATUM

WILSON RIVER AT TELEGRAPH POINT
2015–2016

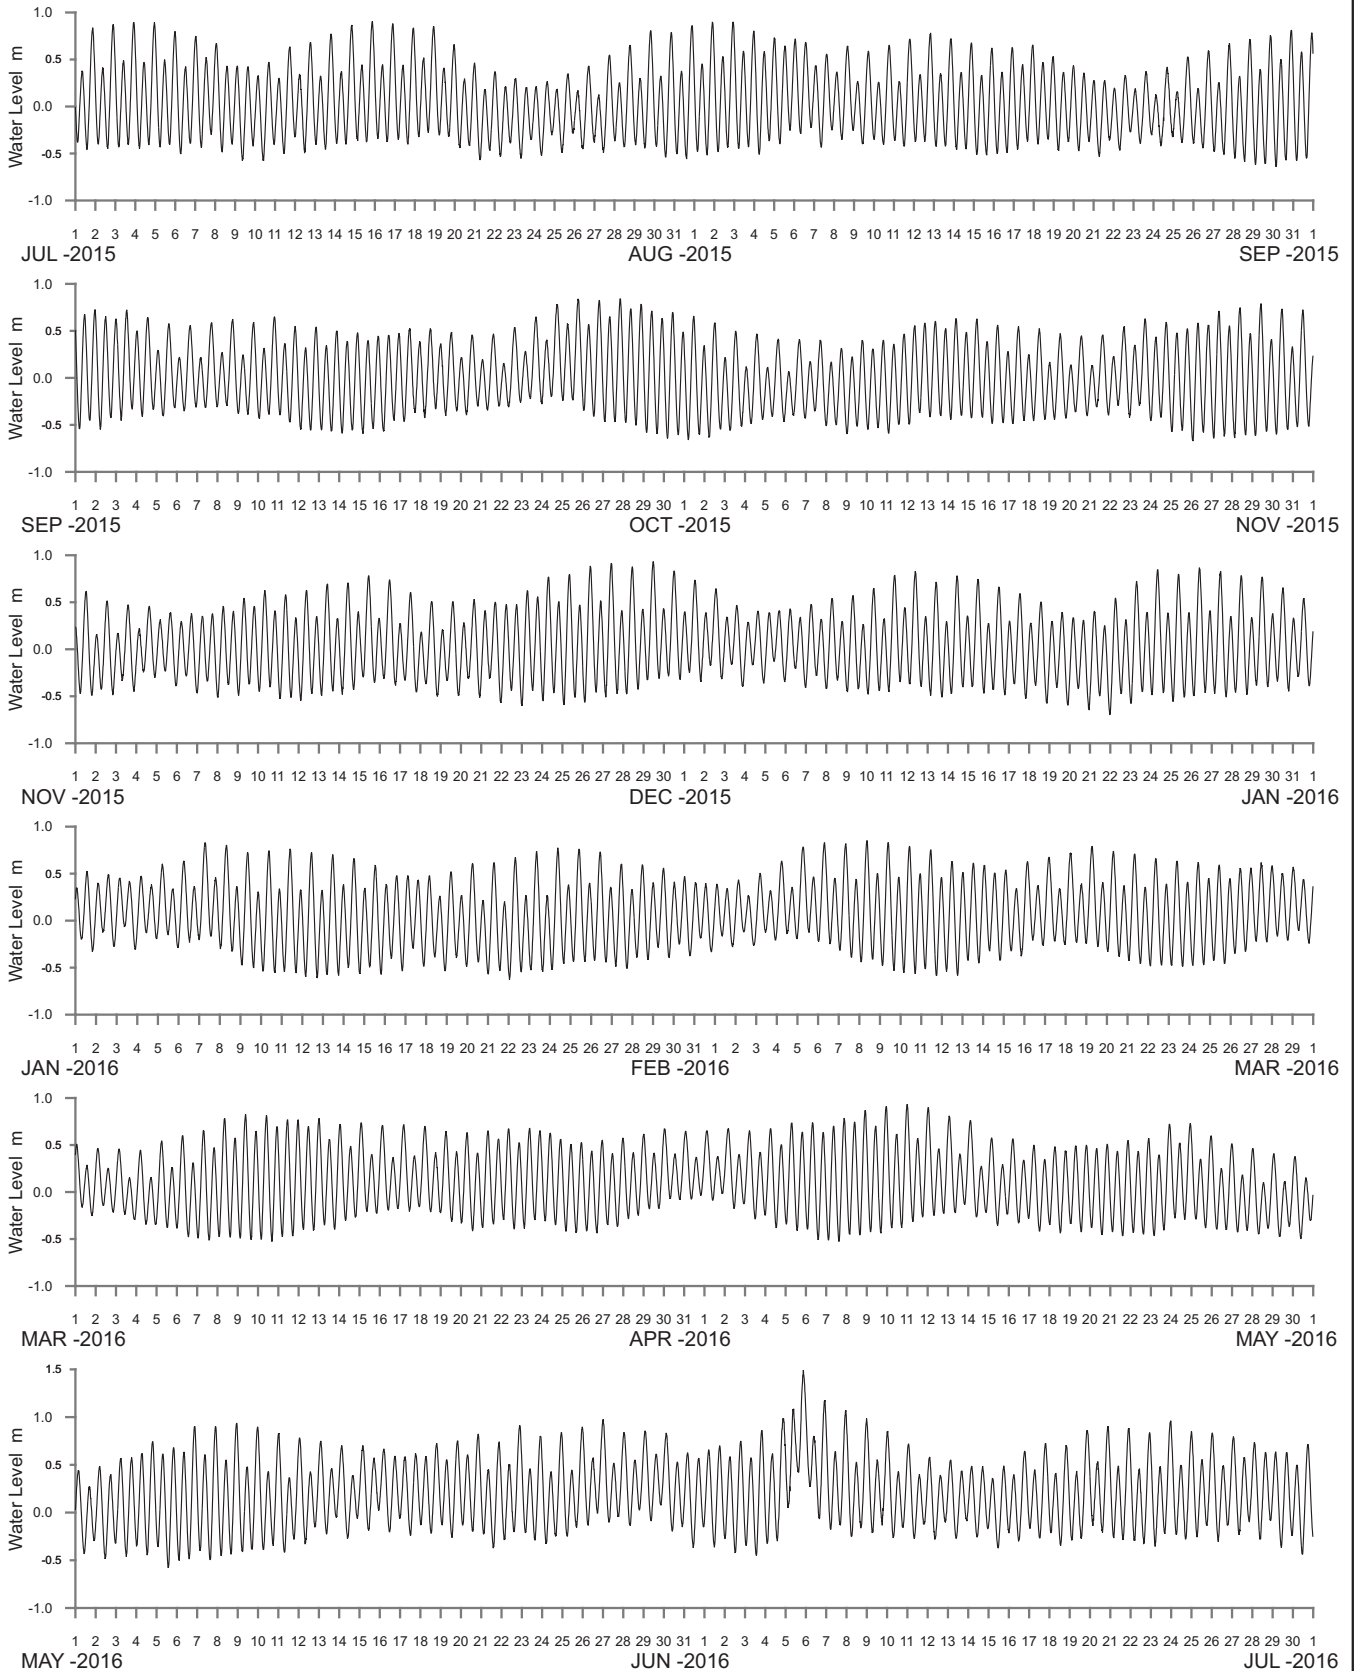
Figure
90

WATER LEVEL REFERENCED TO AUSTRALIAN HEIGHT DATUM

**HASTINGS RIVER AT SETTLEMENT POINT
2015–2016**

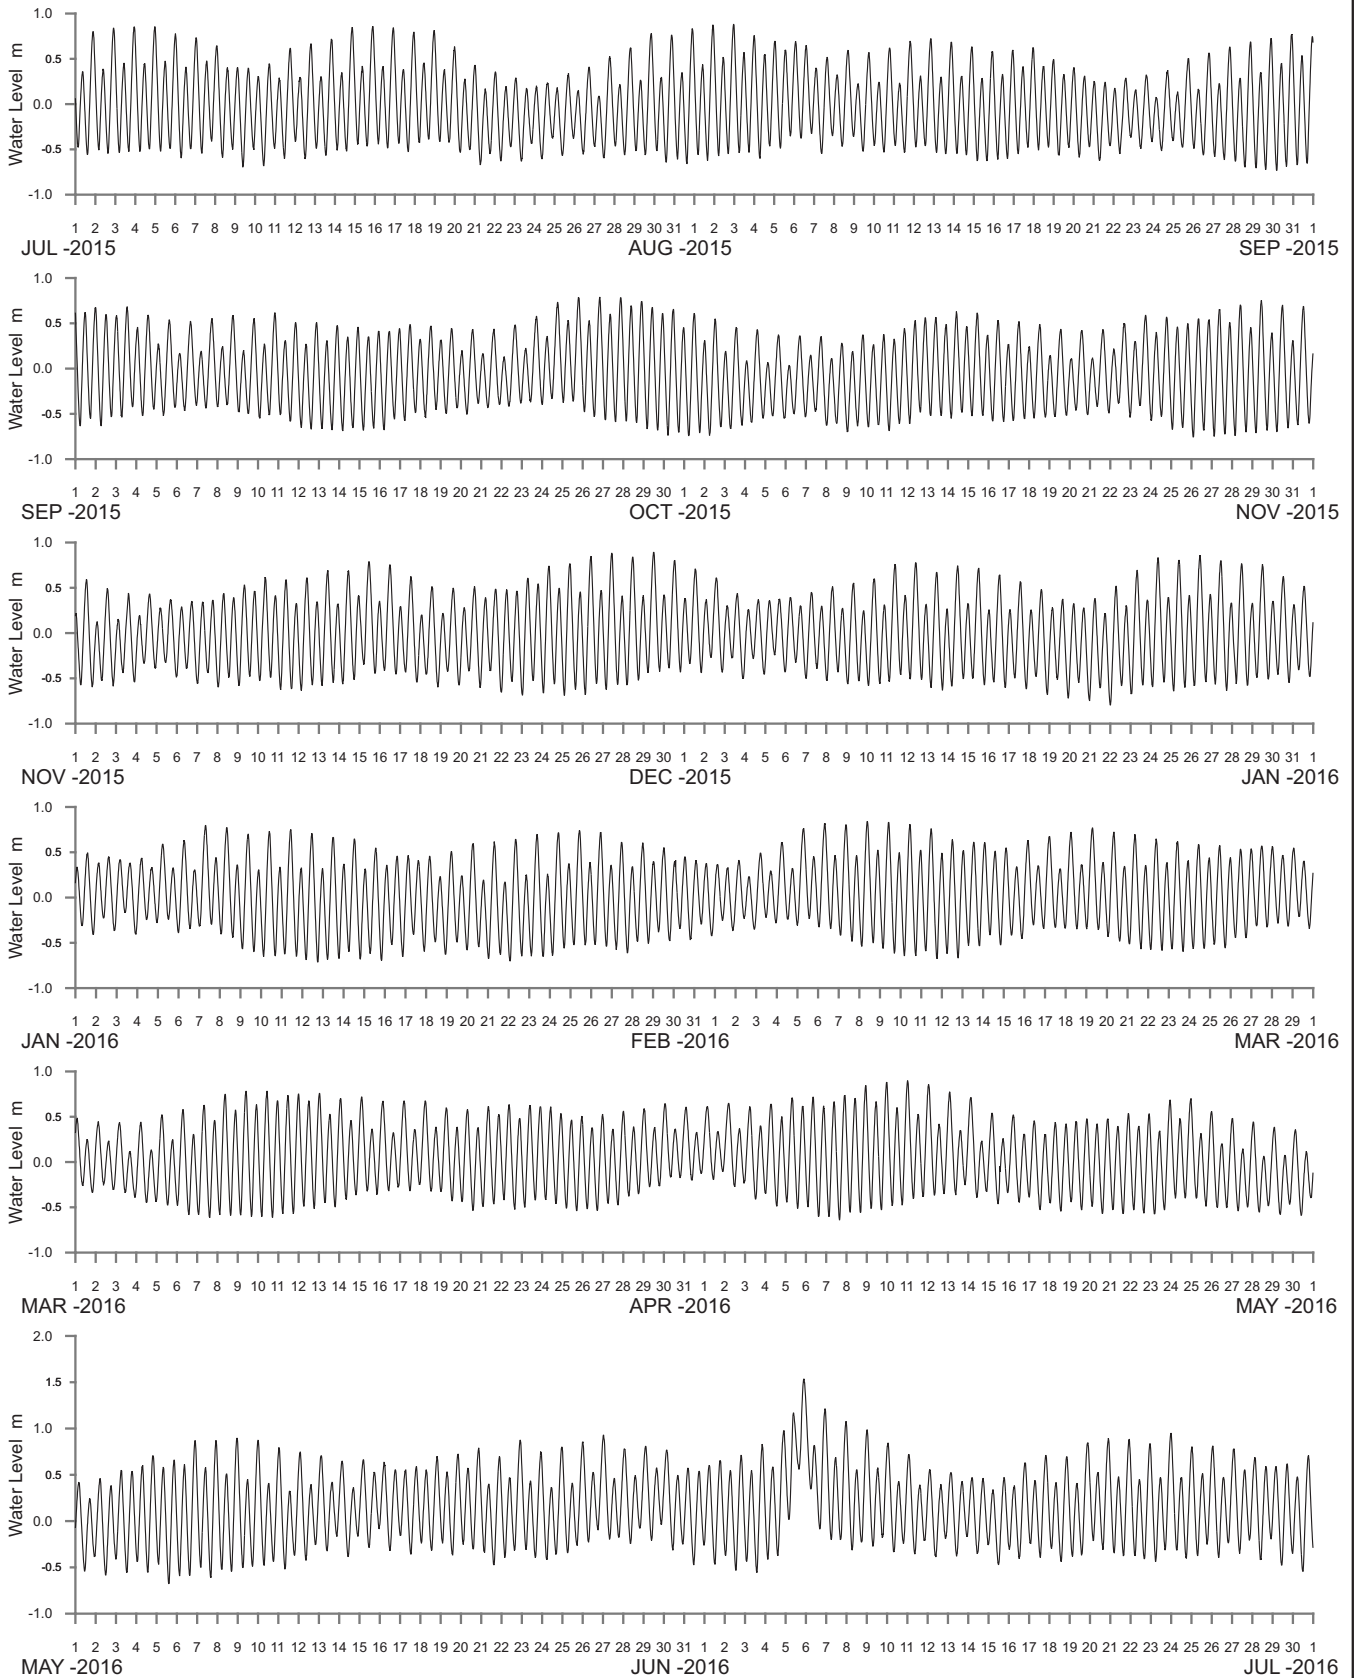
Figure
91

WATER LEVEL REFERENCED TO AUSTRALIAN HEIGHT DATUM

HASTINGS RIVER AT DENNIS BRIDGE DOWNSTREAM
2015–2016

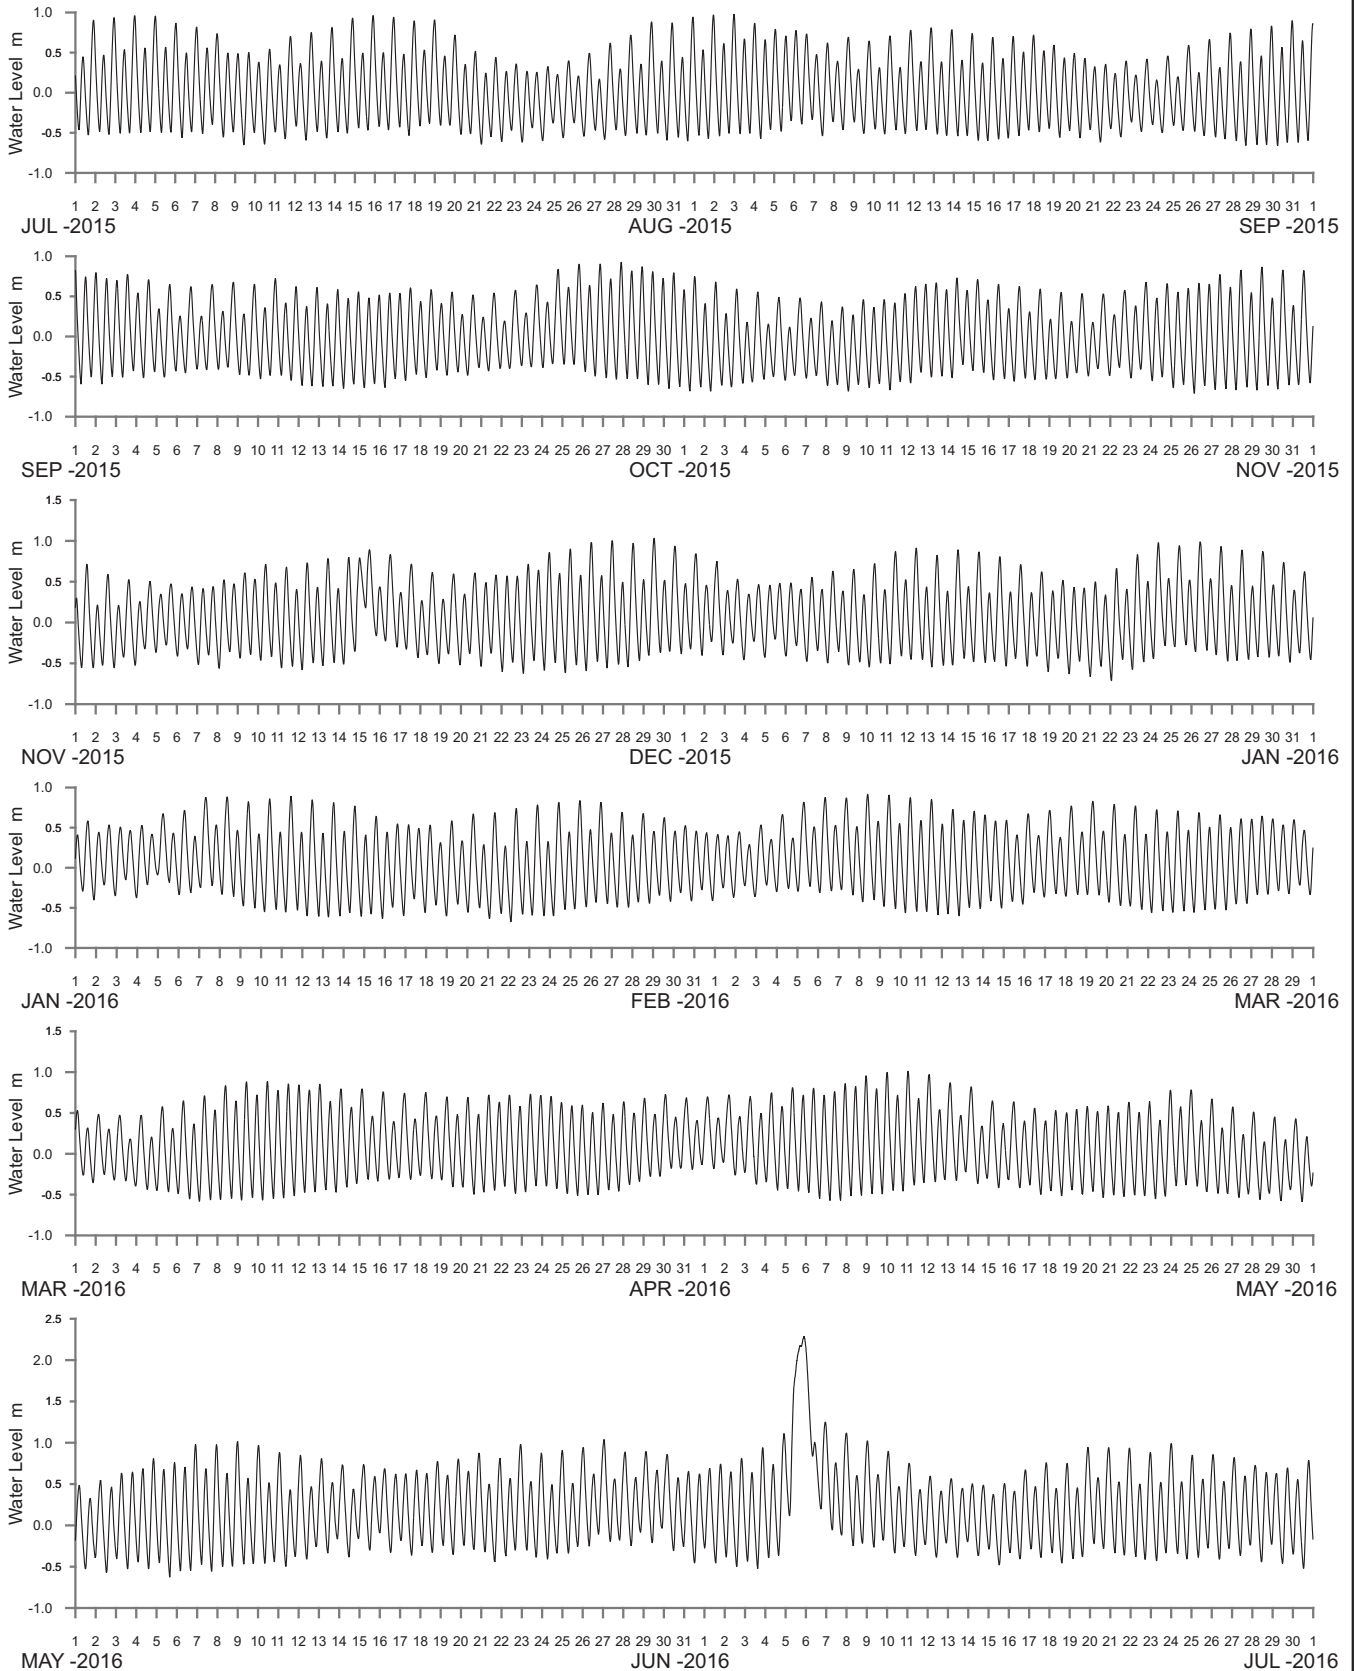
Figure
92

WATER LEVEL REFERENCED TO AUSTRALIAN HEIGHT DATUM

HASTINGS RIVER AT WAUCHOPE RAILWAY BRIDGE
2015–2016

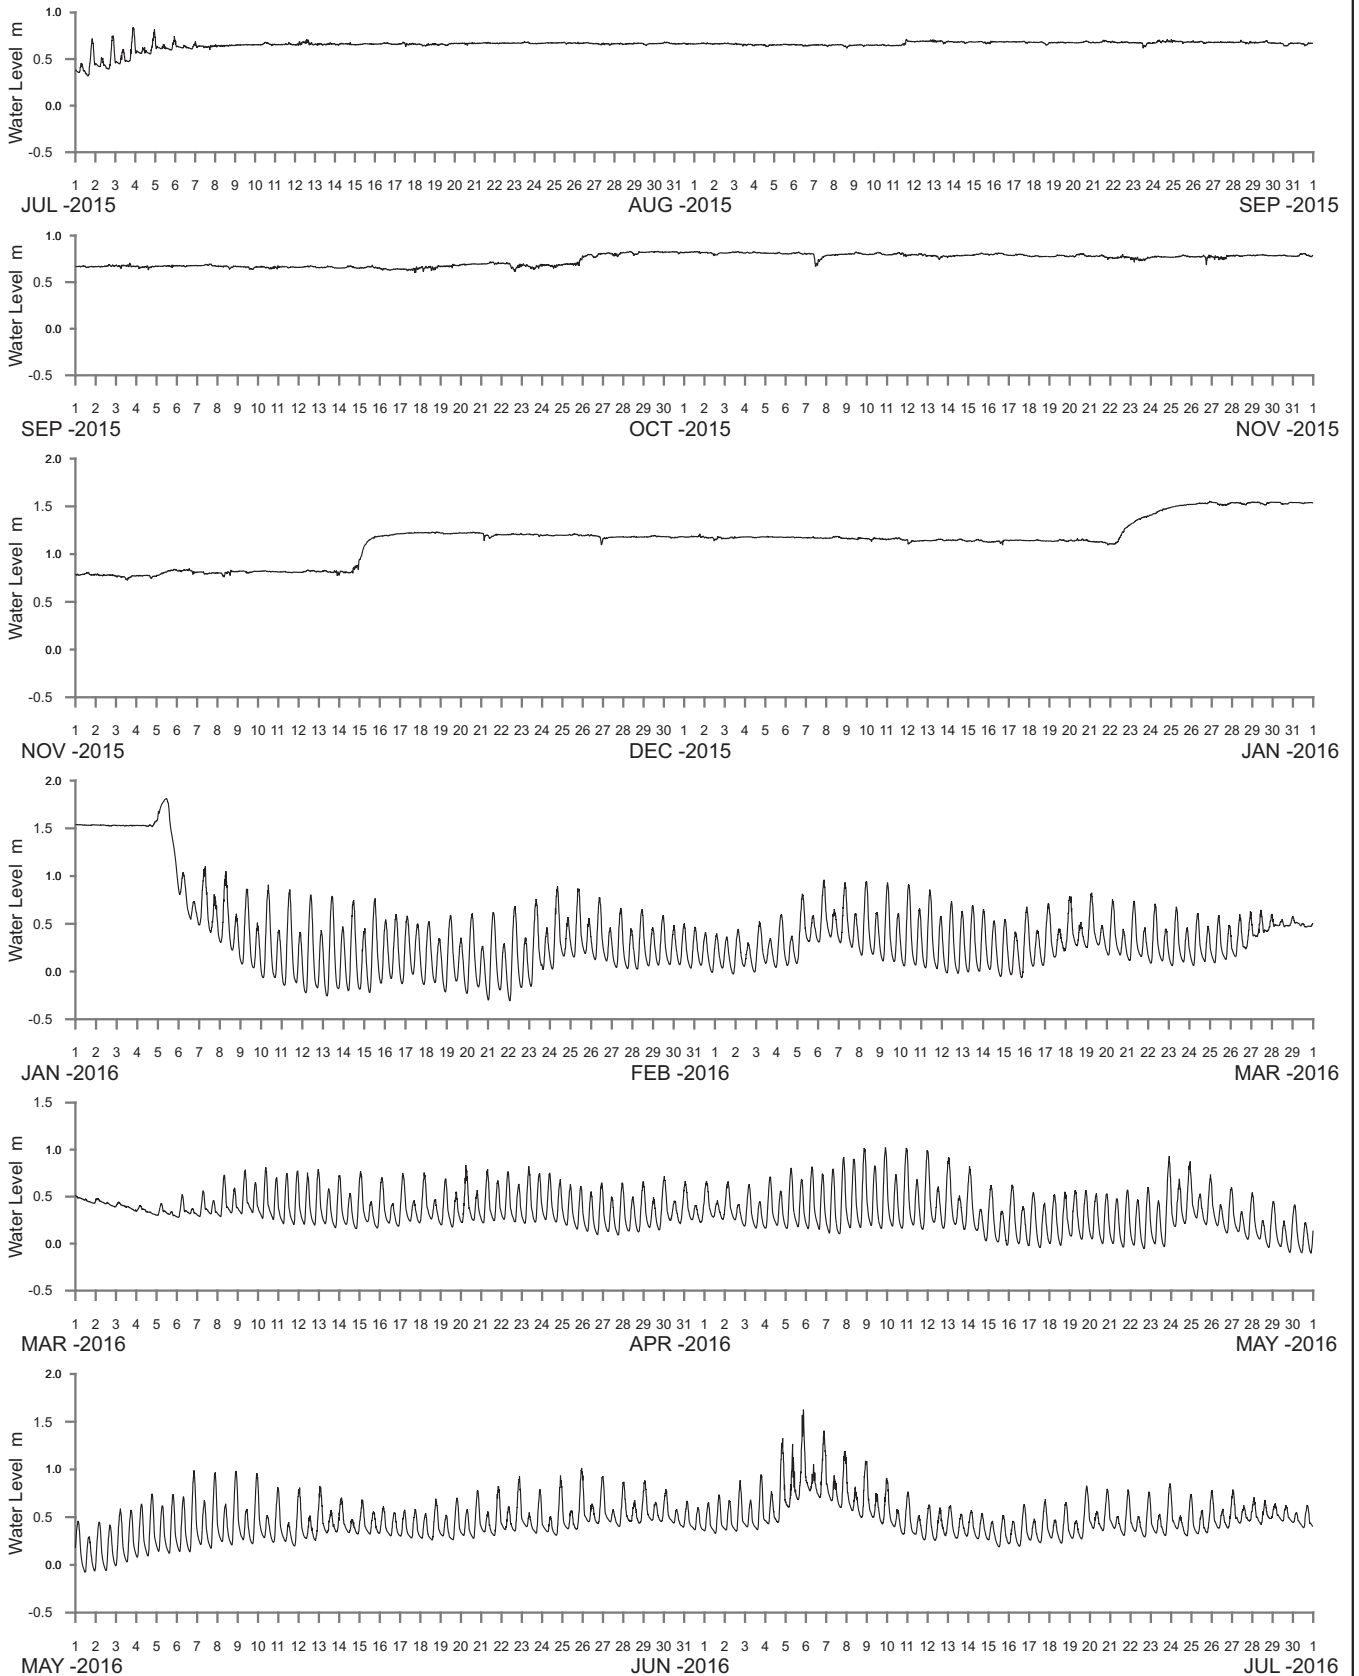
Figure
94

WATER LEVEL REFERENCED TO AUSTRALIAN HEIGHT DATUM

LAKE CATHIE AT LAKE CATHIE
2015-2016

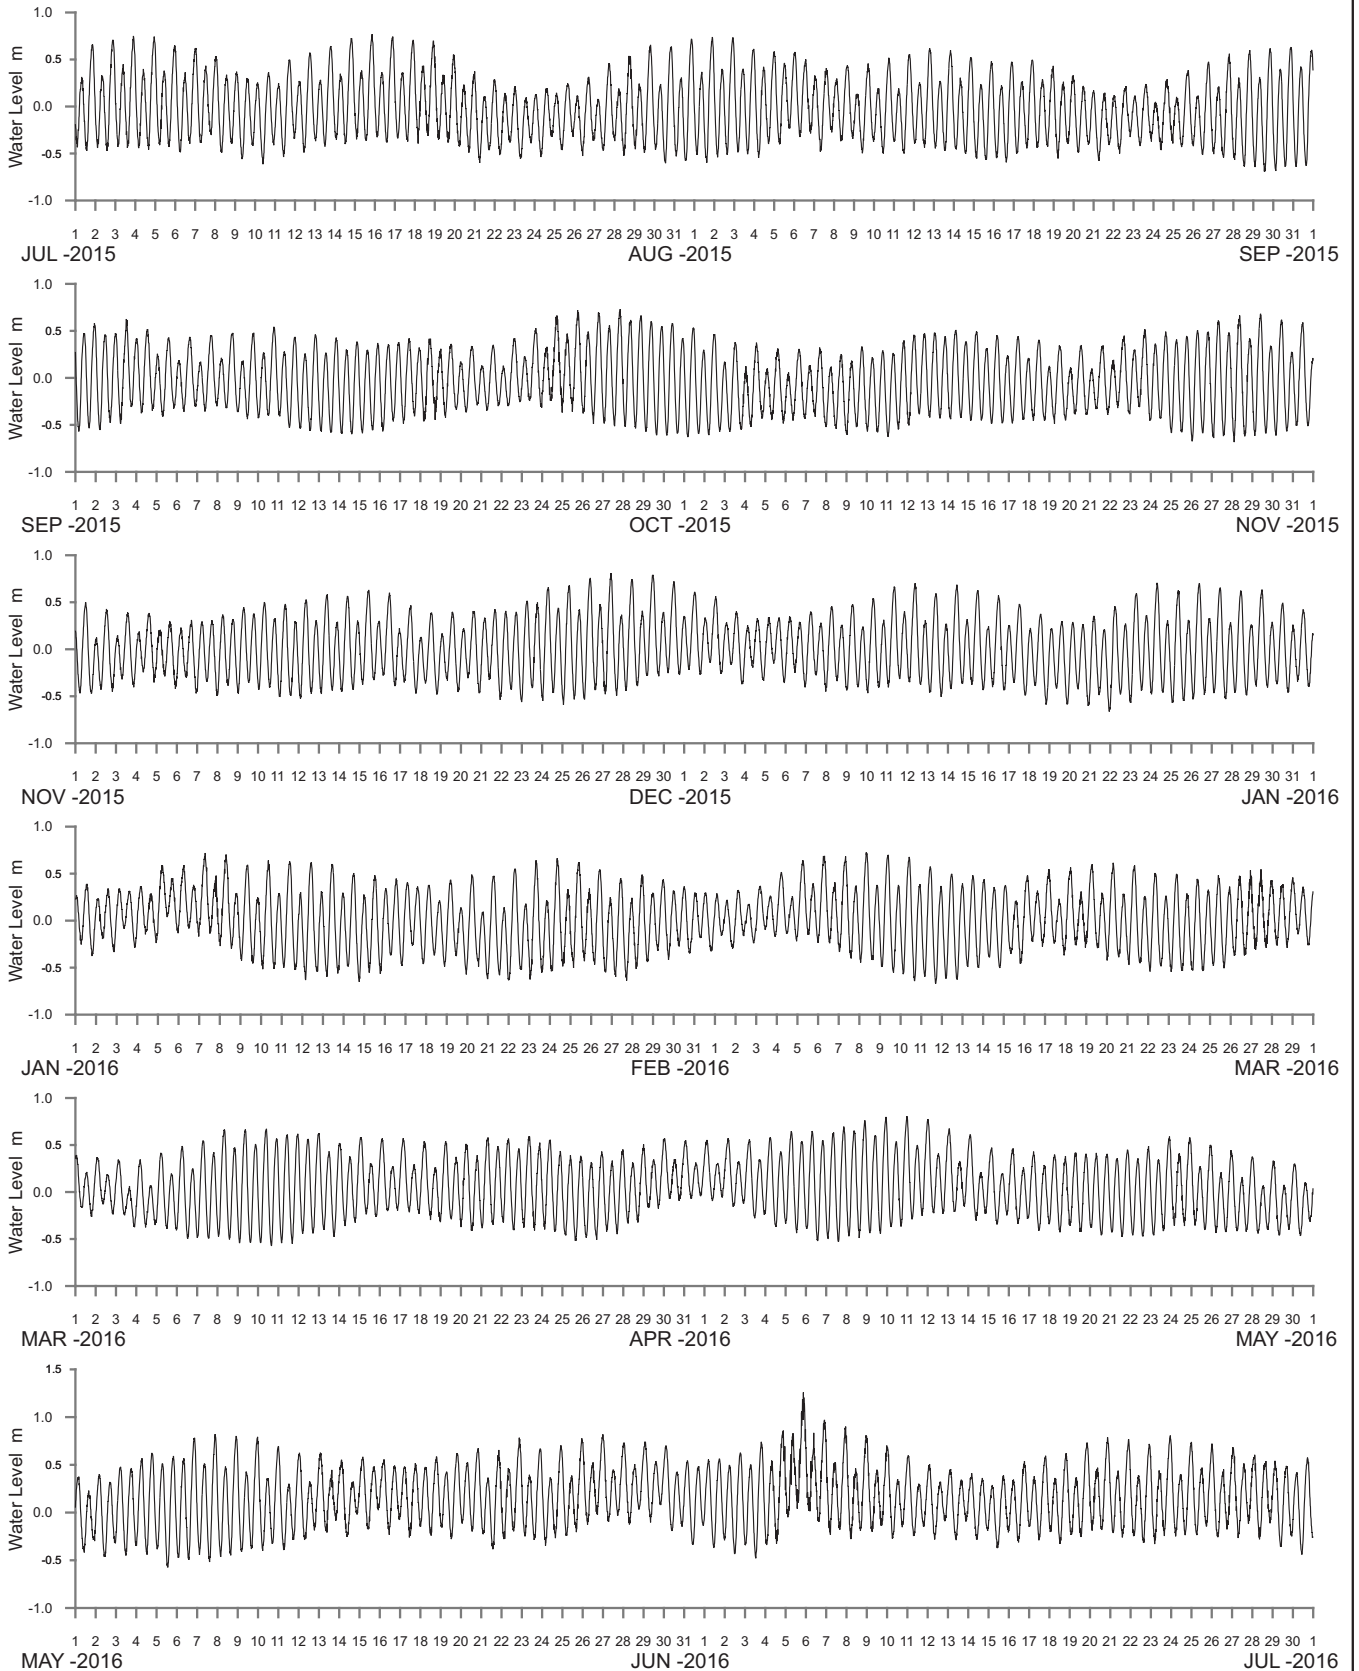
Figure
95

WATER LEVEL REFERENCED TO AUSTRALIAN HEIGHT DATUM

CAMDEN HAVEN RIVER AT NORTH HAVEN
2015–2016

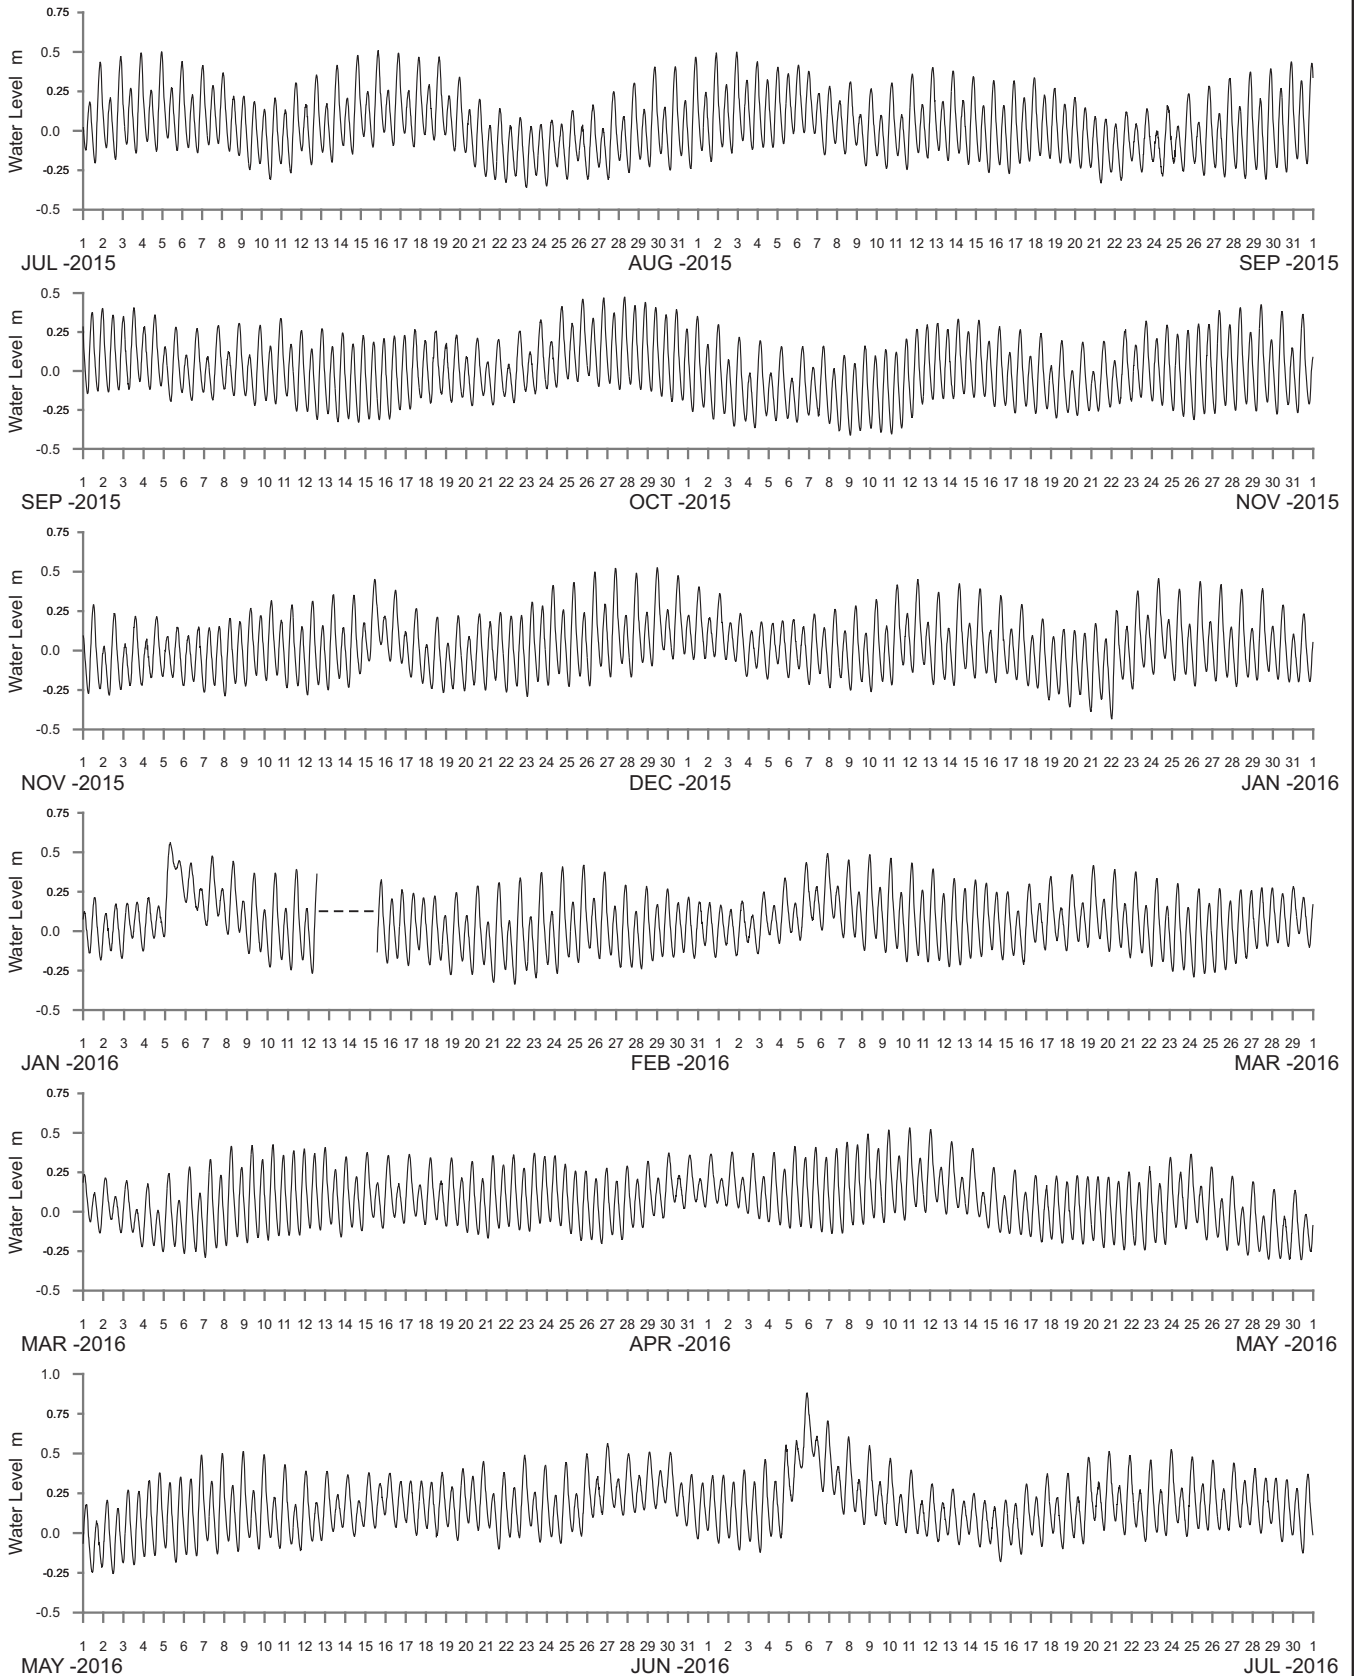
Figure
96

WATER LEVEL REFERENCED TO AUSTRALIAN HEIGHT DATUM

STINGRAY CREEK AT WEST HAVEN
2015–2016

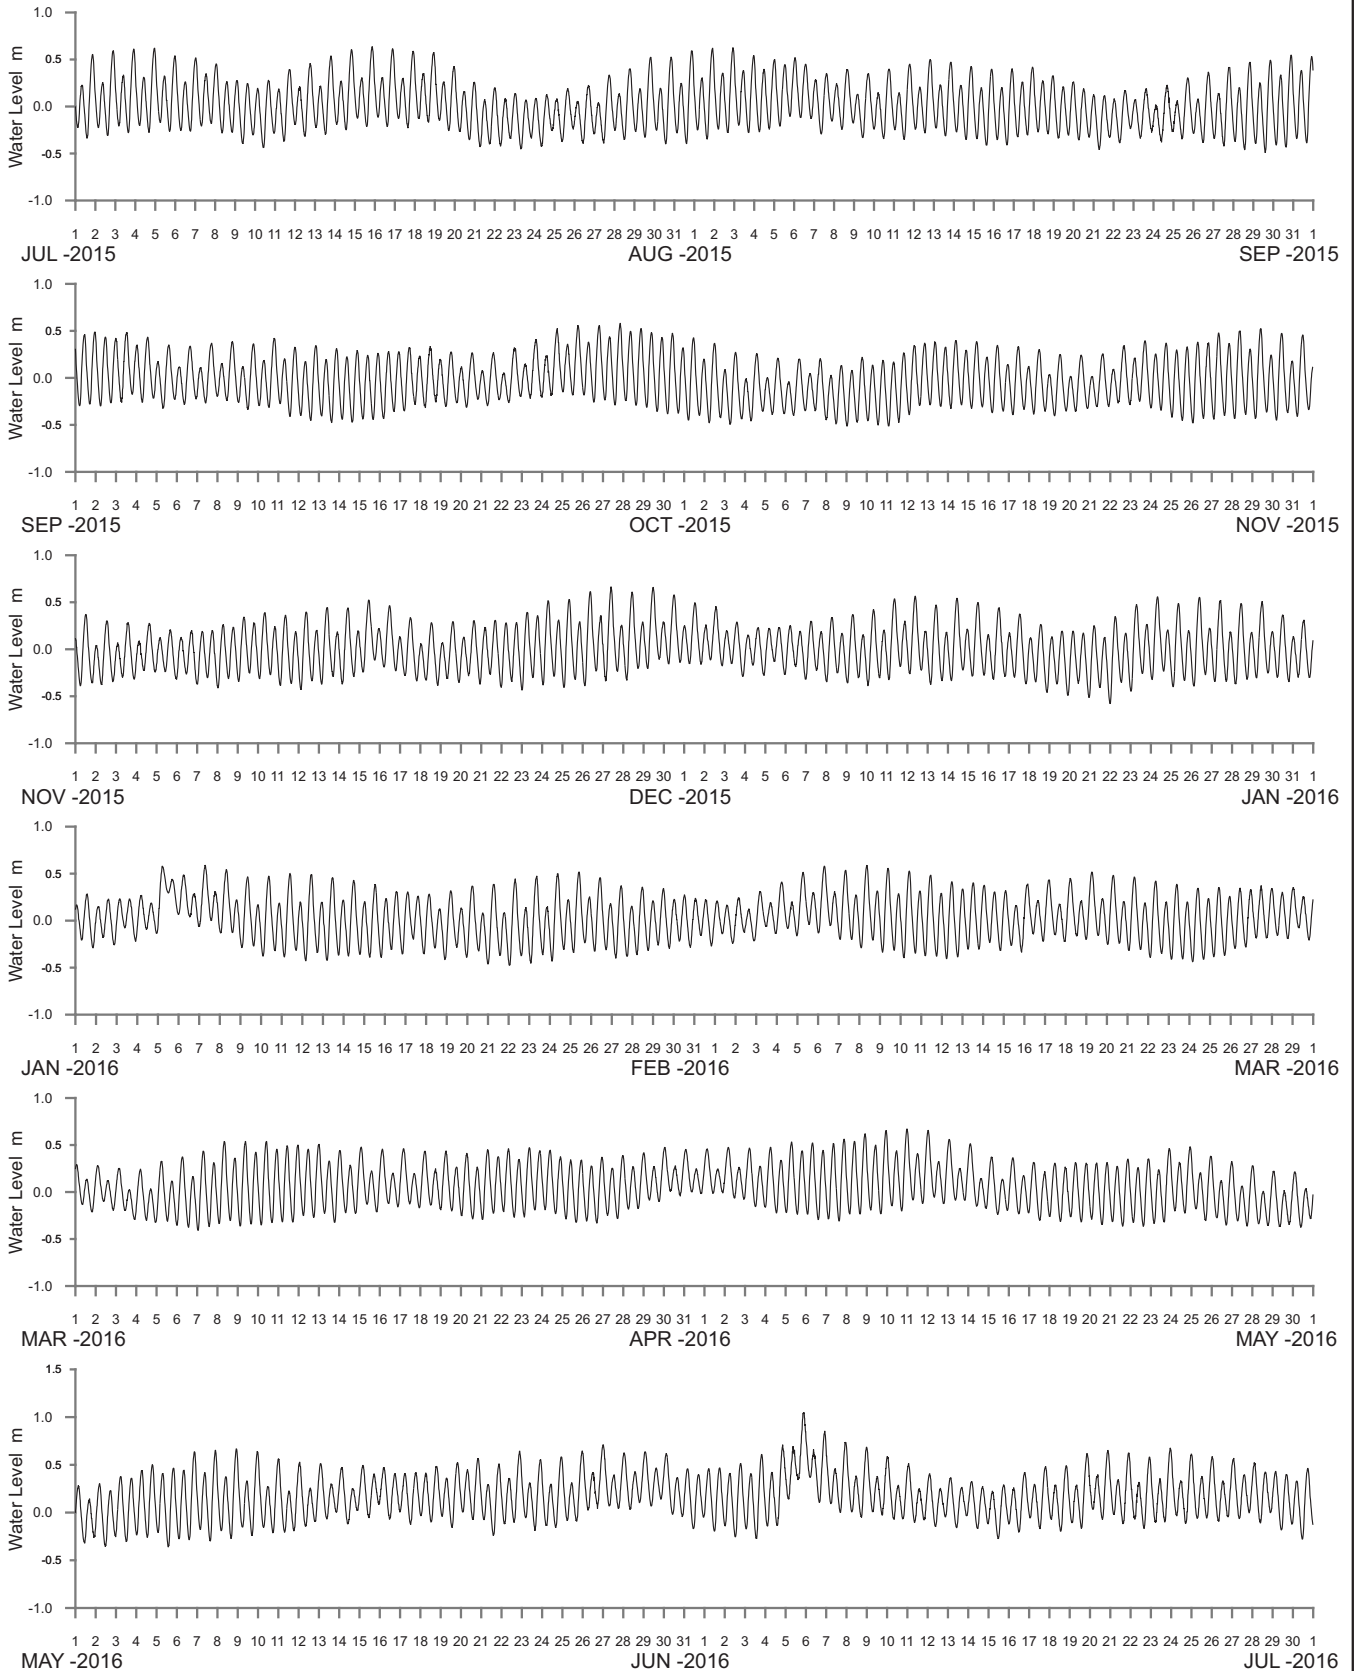
Figure
97

WATER LEVEL REFERENCED TO AUSTRALIAN HEIGHT DATUM

CAMDEN HAVEN RIVER AT LAURIETON
2015–2016

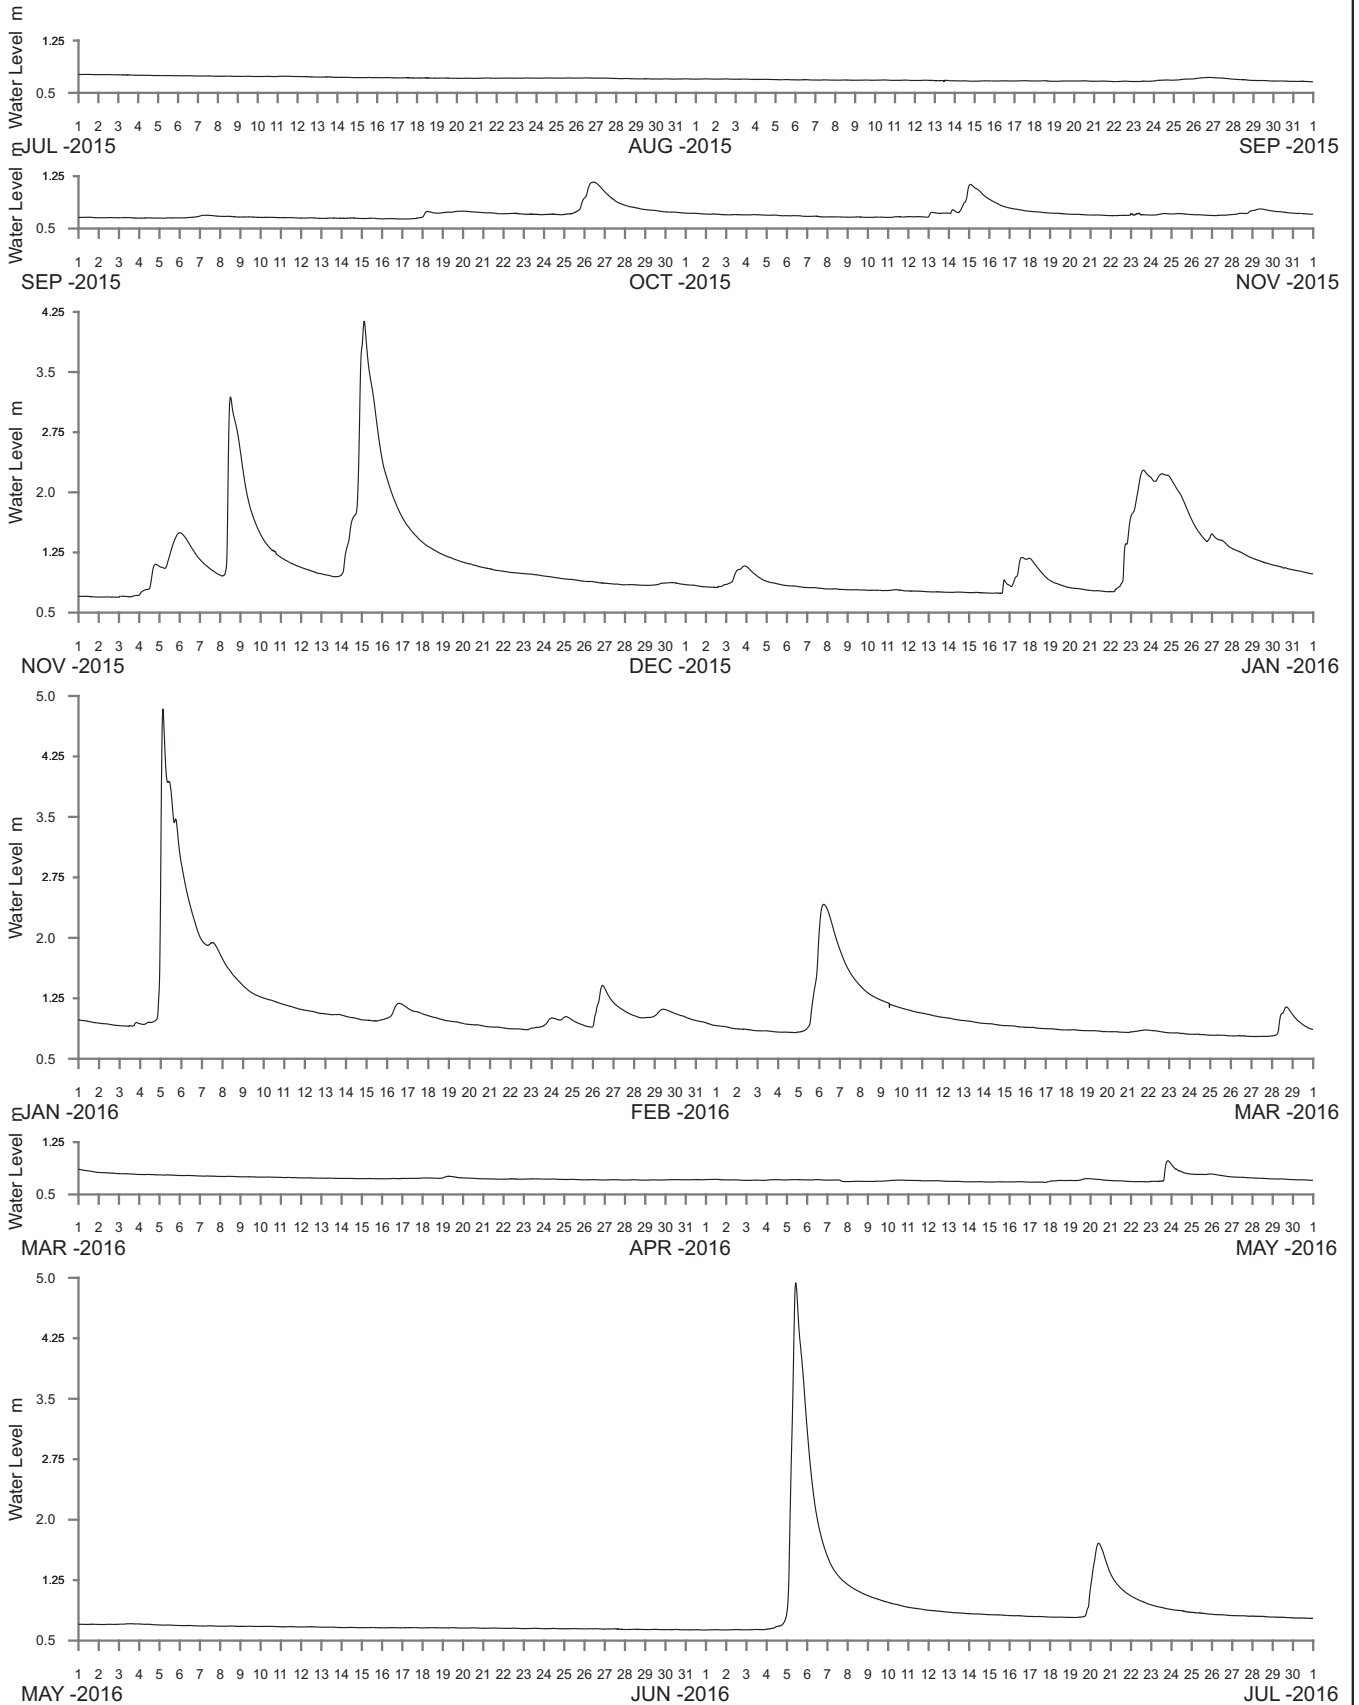
Figure
98

WATER LEVEL REFERENCED TO LOCAL WATER RESOURCES DATUM

CAMDEN HAVEN RIVER AT LOGANS CROSSING
2015–2016

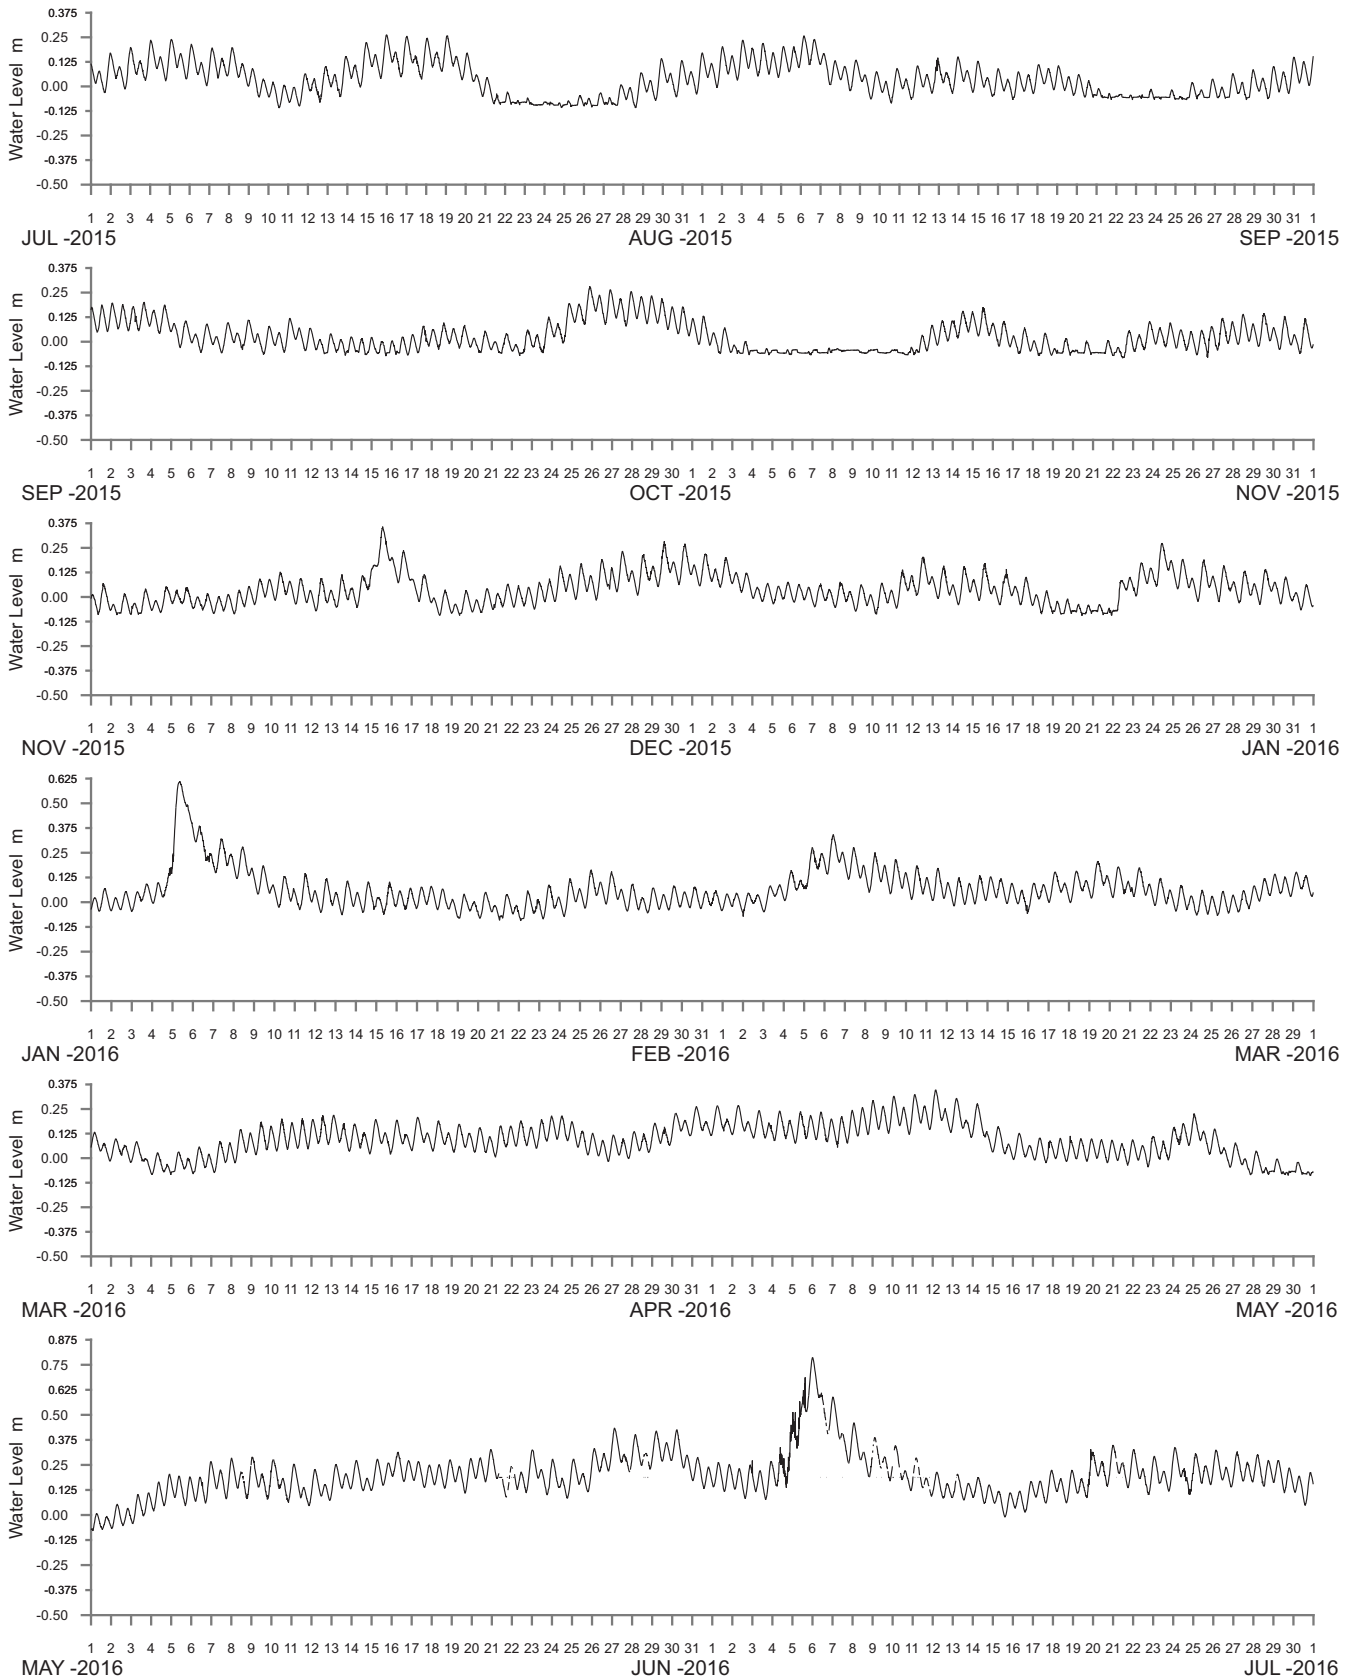
Figure
99

WATER LEVEL REFERENCED TO AUSTRALIAN HEIGHT DATUM

QUEENS LAKE AT LAKEWOOD
2015–2016
