Public Works
Manly Hydraulics Laboratory

MHL
Report 2474

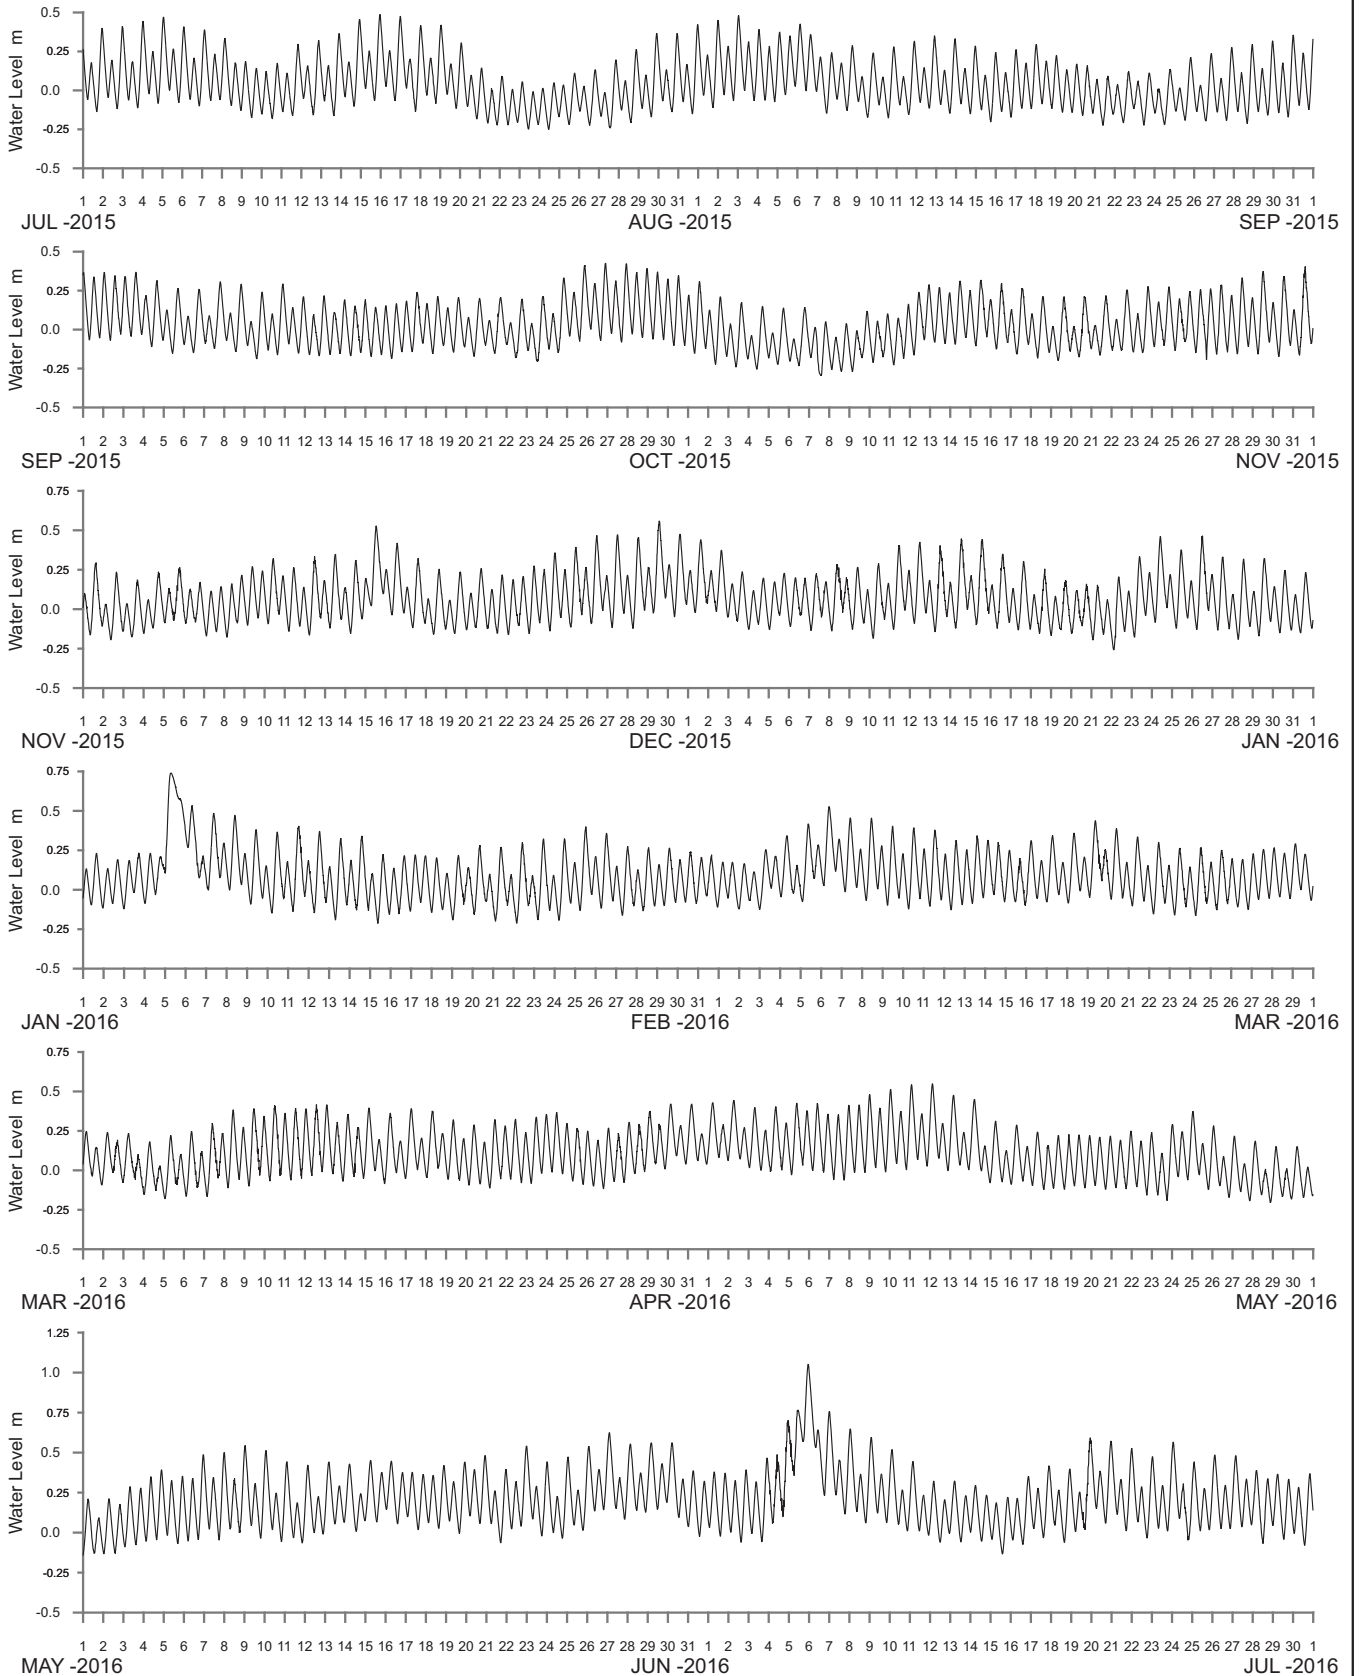
Figure
100

WATER LEVEL REFERENCED TO AUSTRALIAN HEIGHT DATUM

WATSON TAYLORS LAKE AT WATSON TAYLORS LAKE
2015–2016
