River/estuary system	Station name	Figure
Station Locality Map	Wollongong Region	201
Hewitts Creek	Hewitts Creek Upstream	202
Hewitts Creek	Hewitts Creek Downstream	203
Hewitts Creek	Hewitts Creek Entrance	204
Cabbage Tree Creek	Balgownie Road	205
Bellambi	Bellambi	206
Towradgi Creek	Towradgi Creek Upstream	207
Towradgi Creek	Towradgi Creek Downstream	208
Cabbage Tree Creek	Cabbage Tree Creek Upstream	209
Cabbage Tree Creek	Cabbage Tree Creek Downstream	210
Fairy Creek	Fairy Creek Upstream	211
Fairy Creek	Fairy Creek Downstream	212
Byarong Creek	Byarong Creek	213
Byarong Creek	Koloona Avenue Upstream	214
Byarong Creek	Koloona Avenue Downstream	215
American Creek	Blackmans Parade Upstream	216
American Creek	Blackmans Parade Downstream	217
Station Locality Map	Lake Illawarra Region	218
Mullet Creek	Mullet Creek	219
Lake Illawarra	Koonawarra Bay	220
Lake Illawarra	Cudgeree Bay	221
Lake Illawarra	Lake Illawarra Entrance	222

MHL
Report 2474

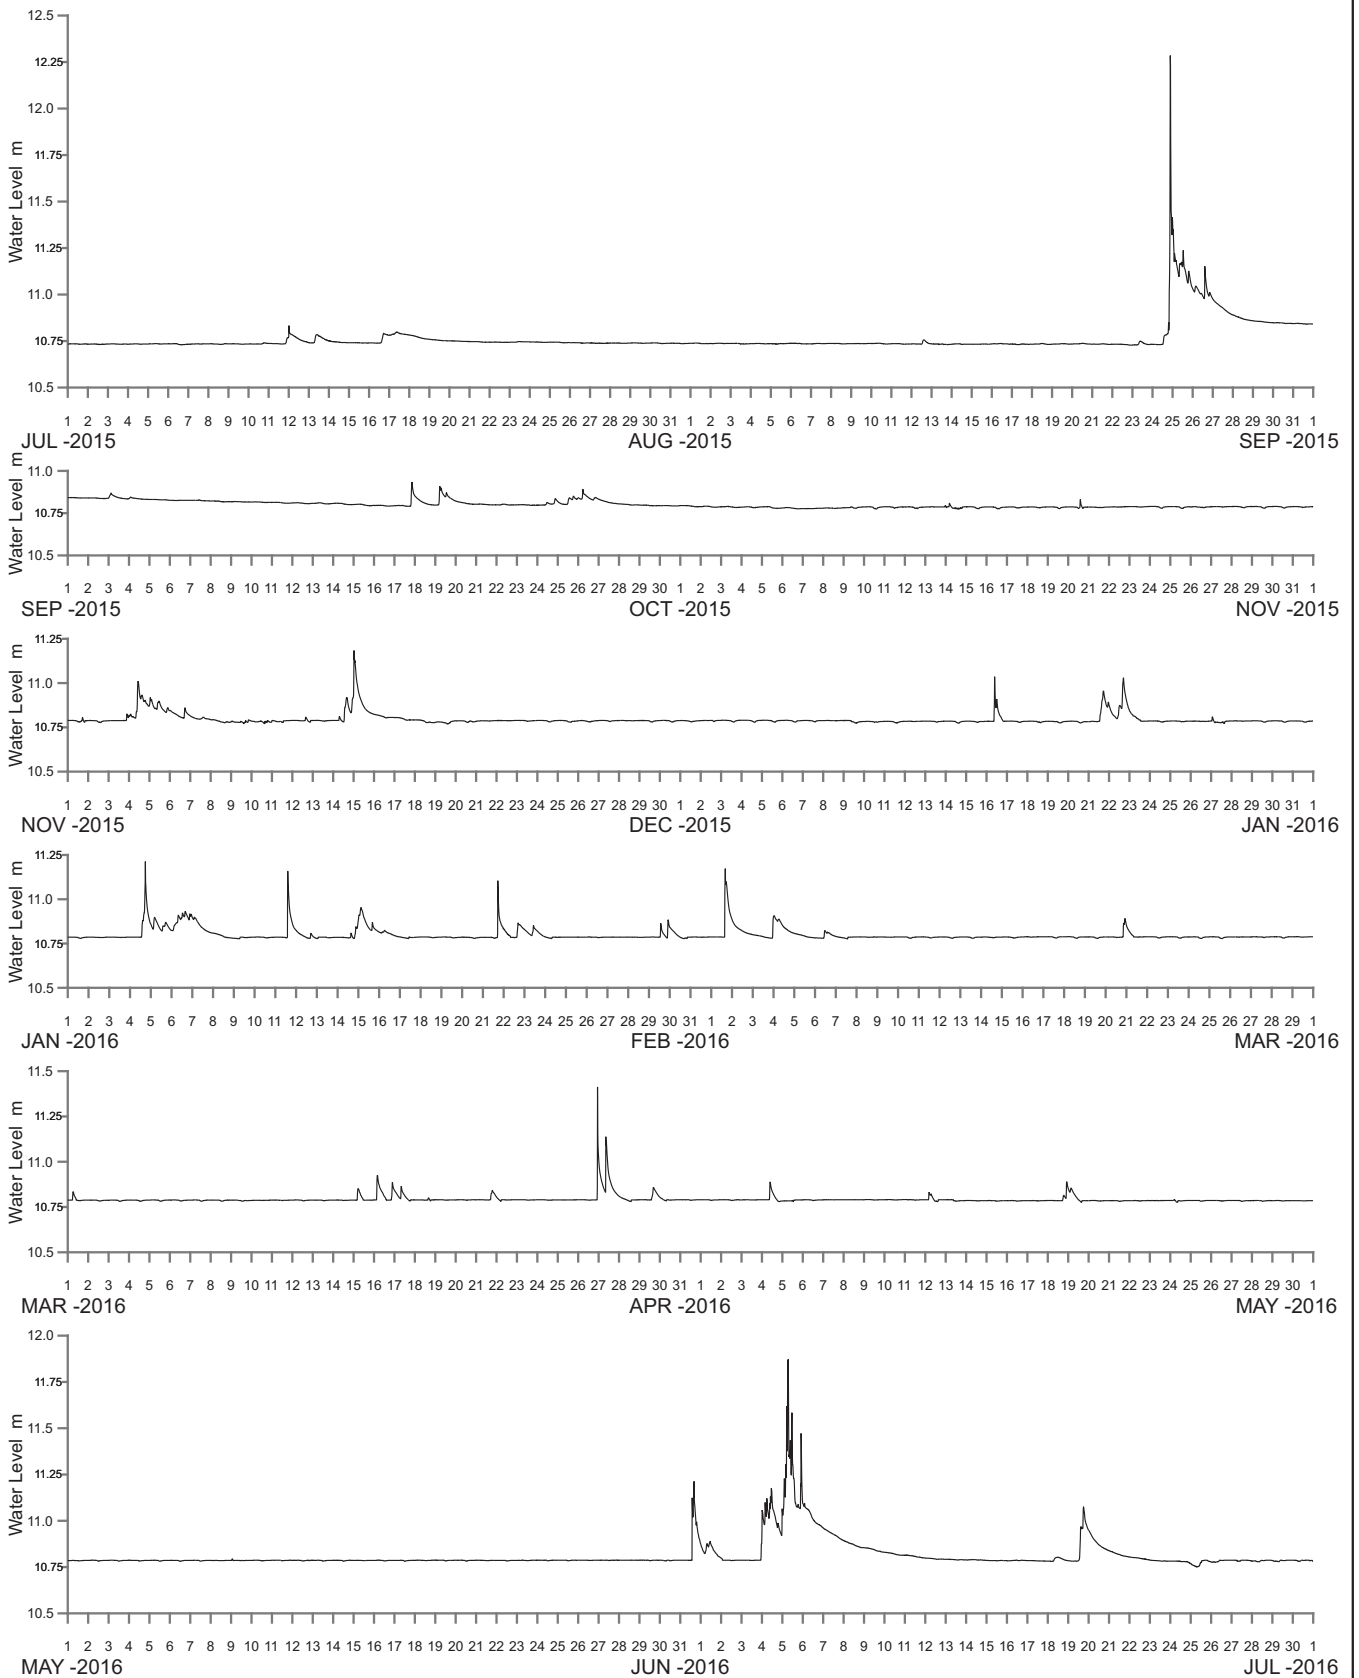
Figure
202

WATER LEVEL REFERENCED TO AUSTRALIAN HEIGHT DATUM

----- DATA LOSS

HEWITTS CREEK AT HEWITTS CREEK UPSTREAM
2015–2016

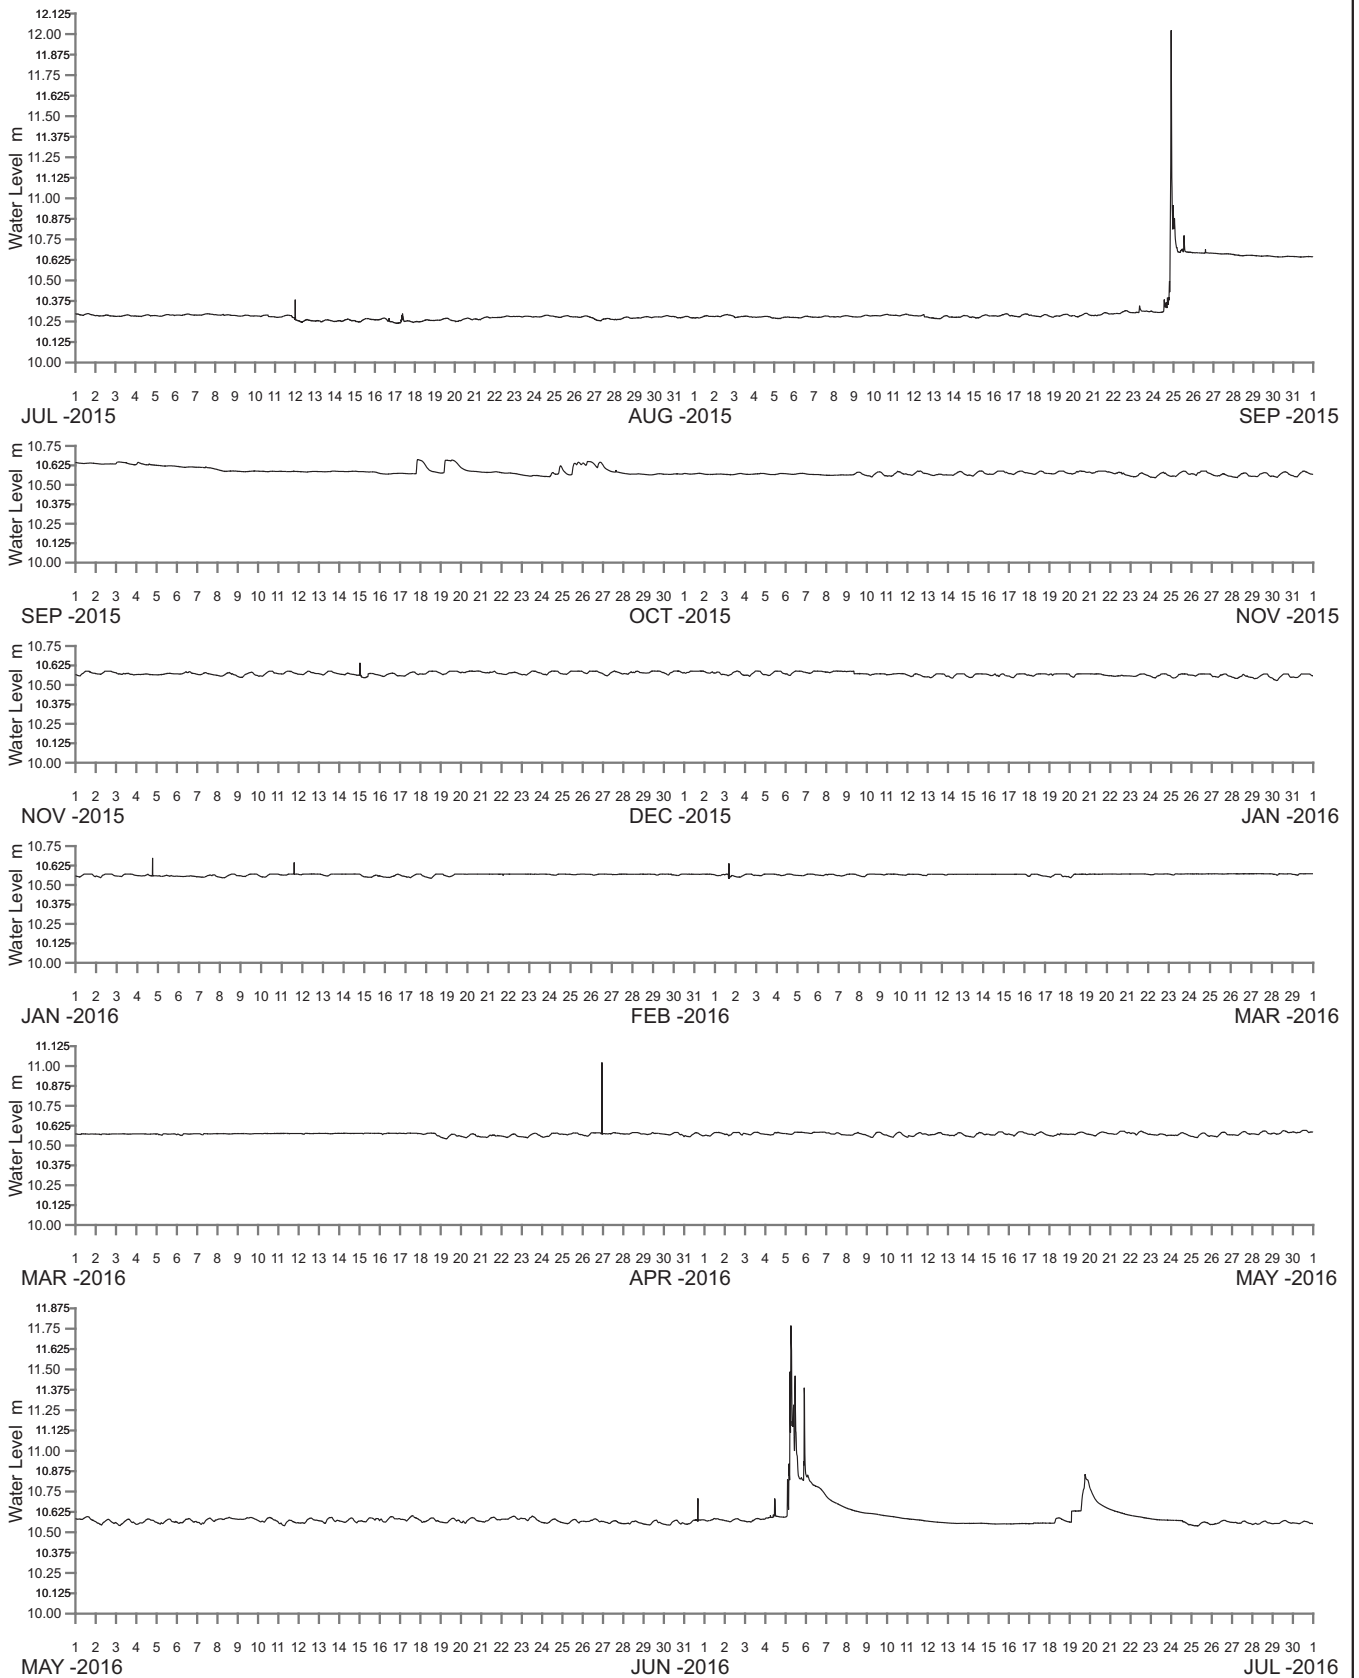
**Figure
203**

WATER LEVEL REFERENCED TO AUSTRALIAN HEIGHT DATUM

----- DATA LOSS

**HEWITTS CREEK AT HEWITTS CREEK DOWNSTREAM
2015-2016**

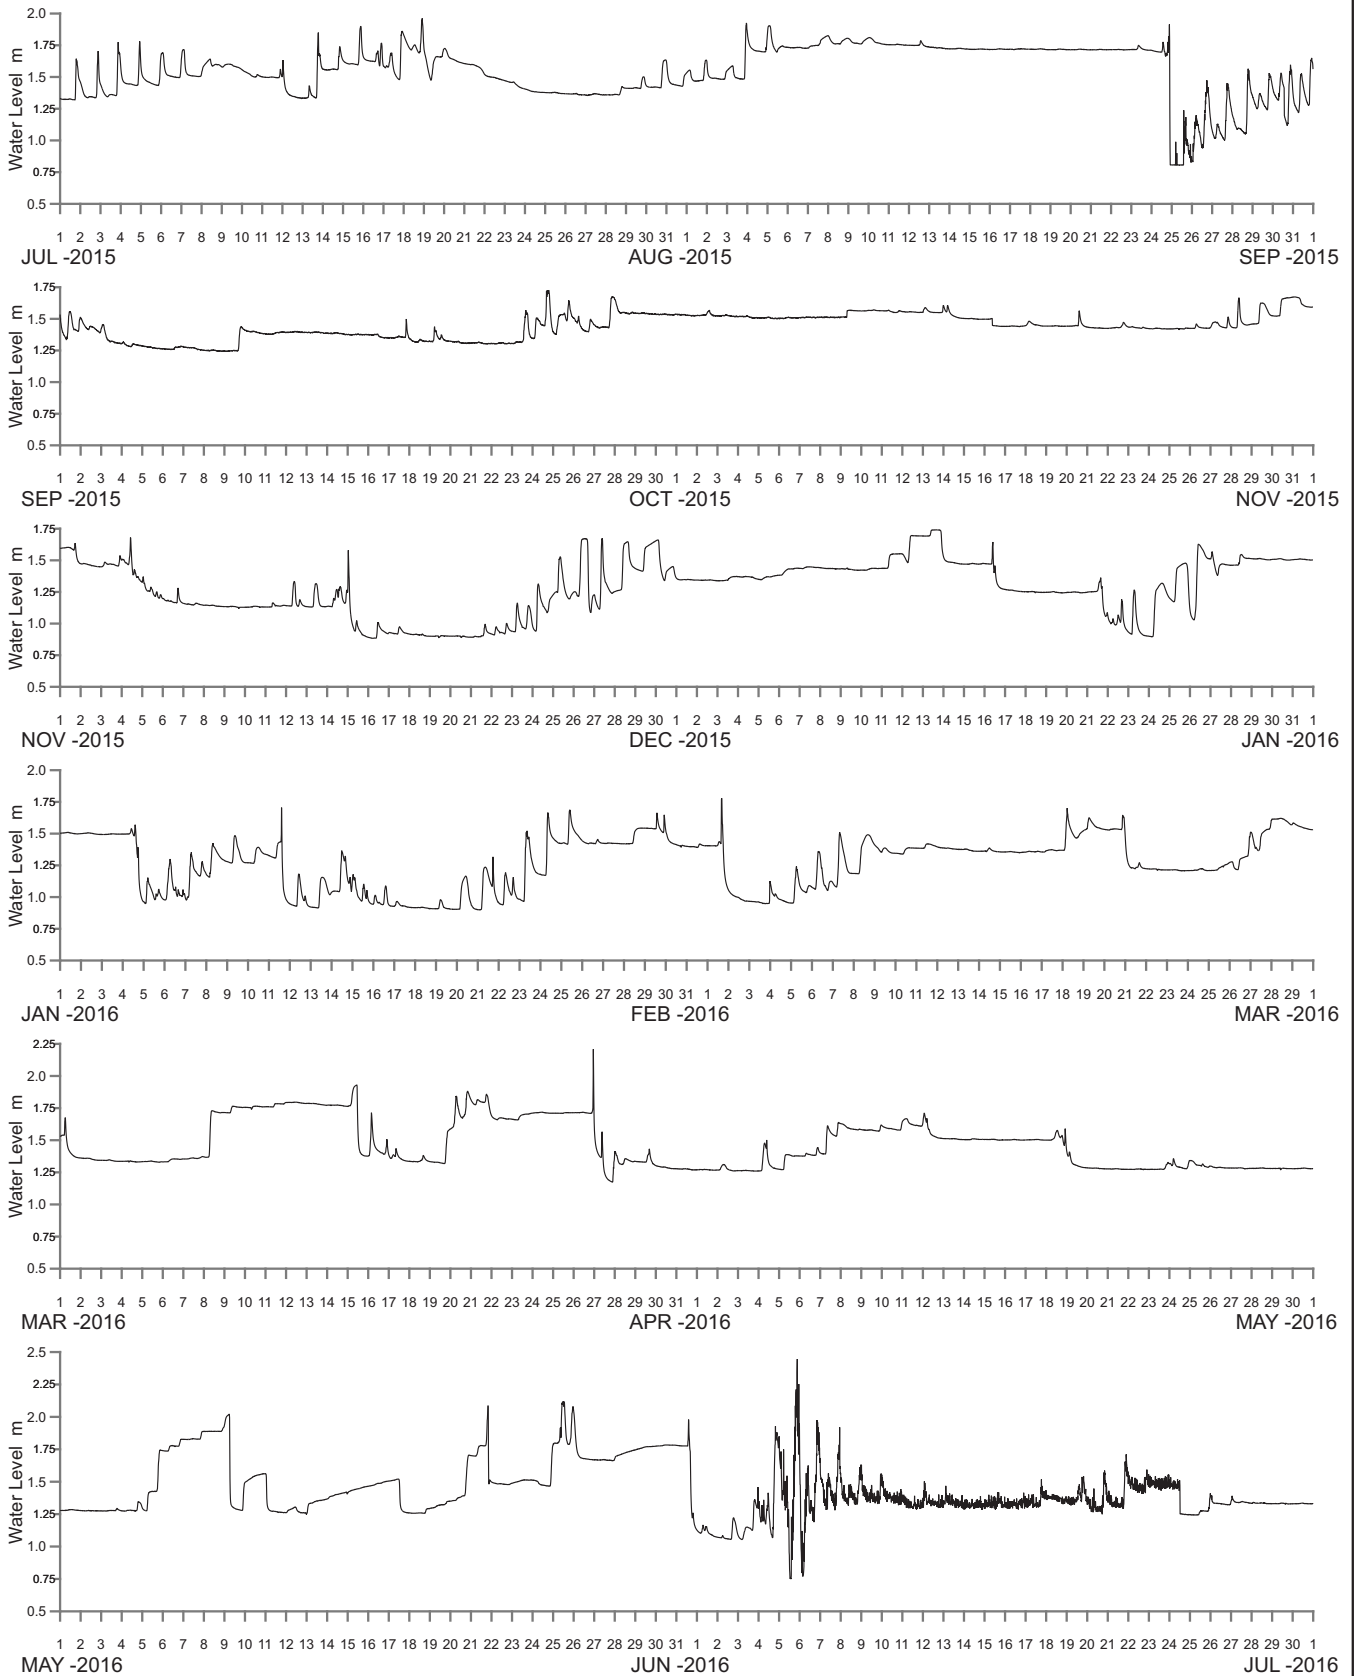
Figure
204

WATER LEVEL REFERENCED TO AUSTRALIAN HEIGHT DATUM

HEWITTS CREEK AT HEWITTS CREEK ENTRANCE
2015–2016

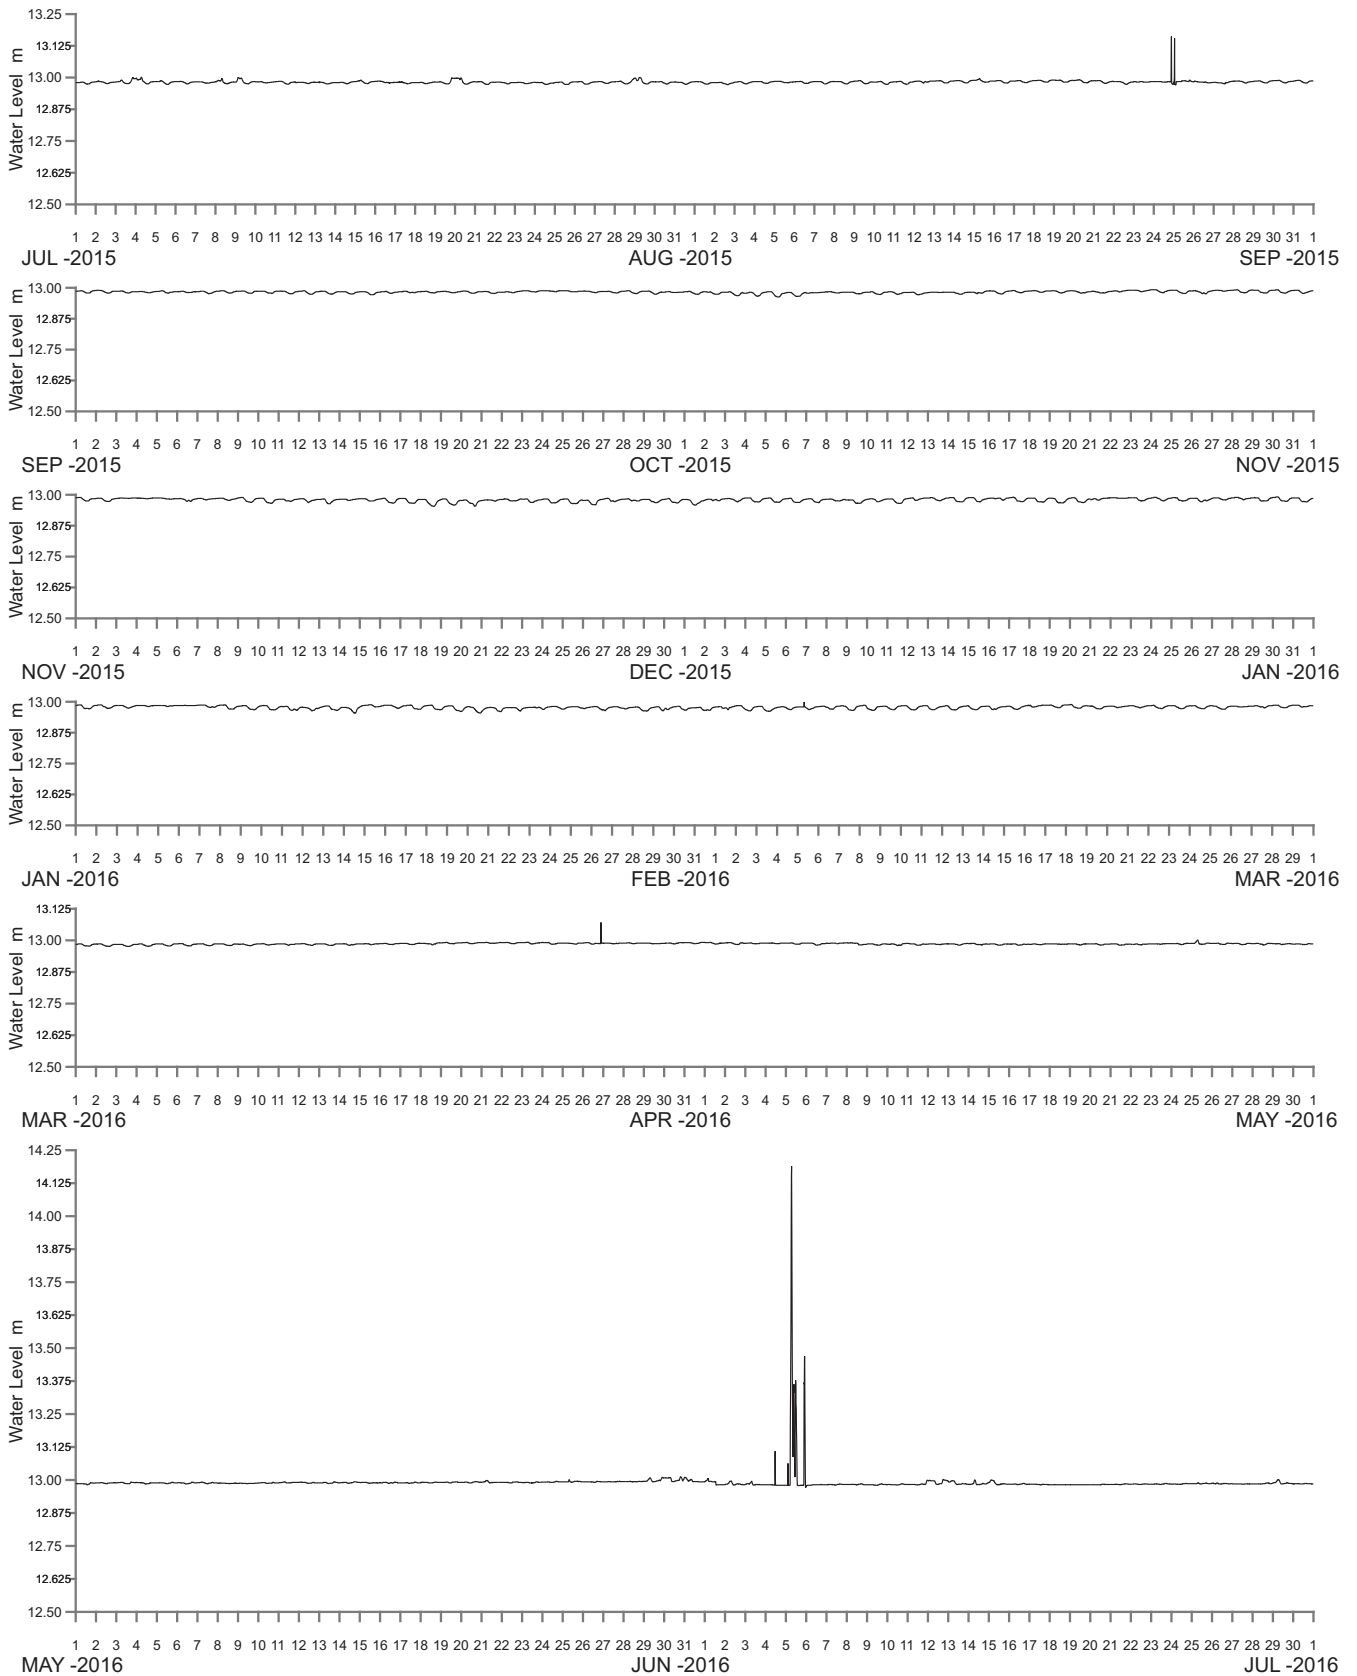
Figure
205

WATER LEVEL REFERENCED TO AUSTRALIAN HEIGHT DATUM

**CABBAGE TREE CREEK AT BALGOWNIE ROAD
2015–2016**

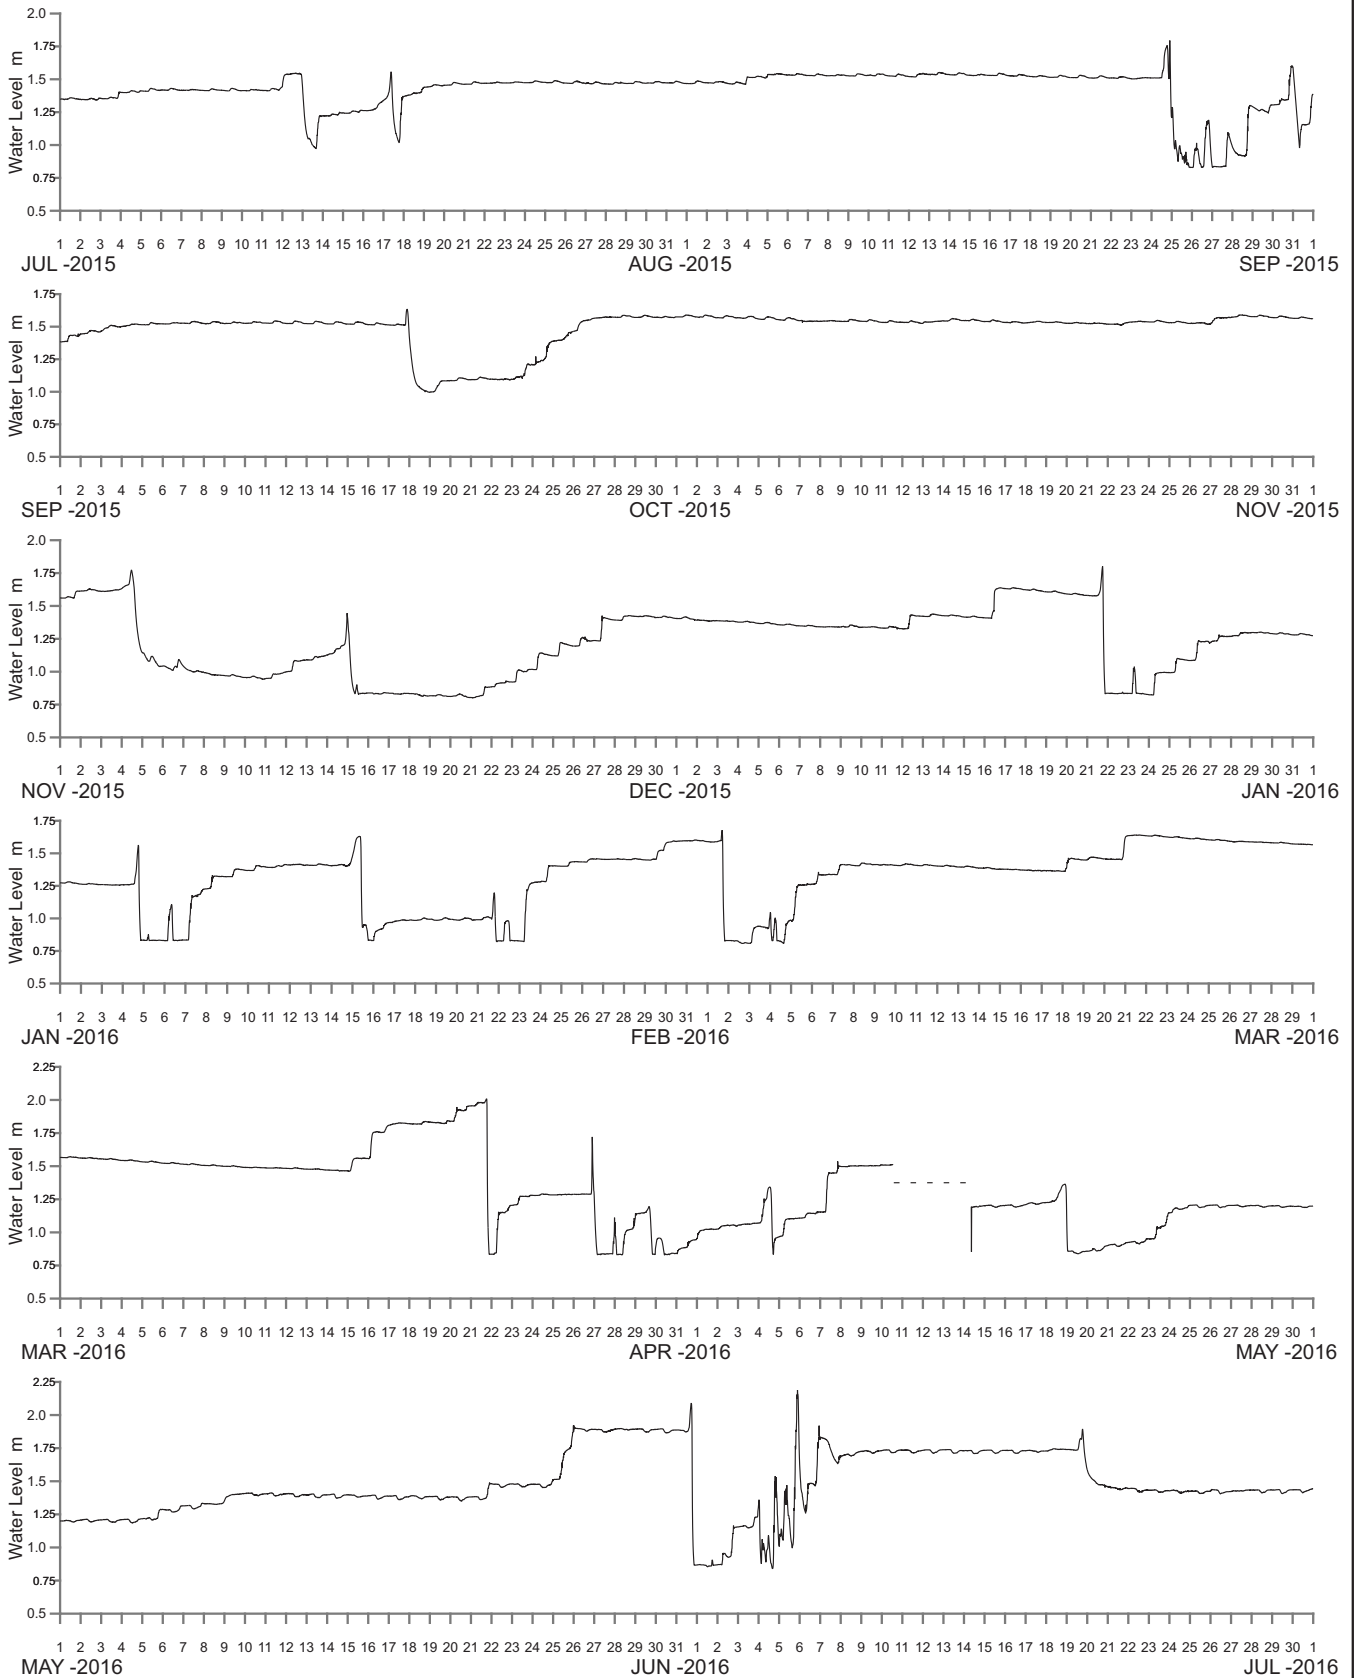
Figure
206

WATER LEVEL REFERENCED TO AUSTRALIAN HEIGHT DATUM

BELLAMBI LAGOON AT BELLAMBI
2015–2016

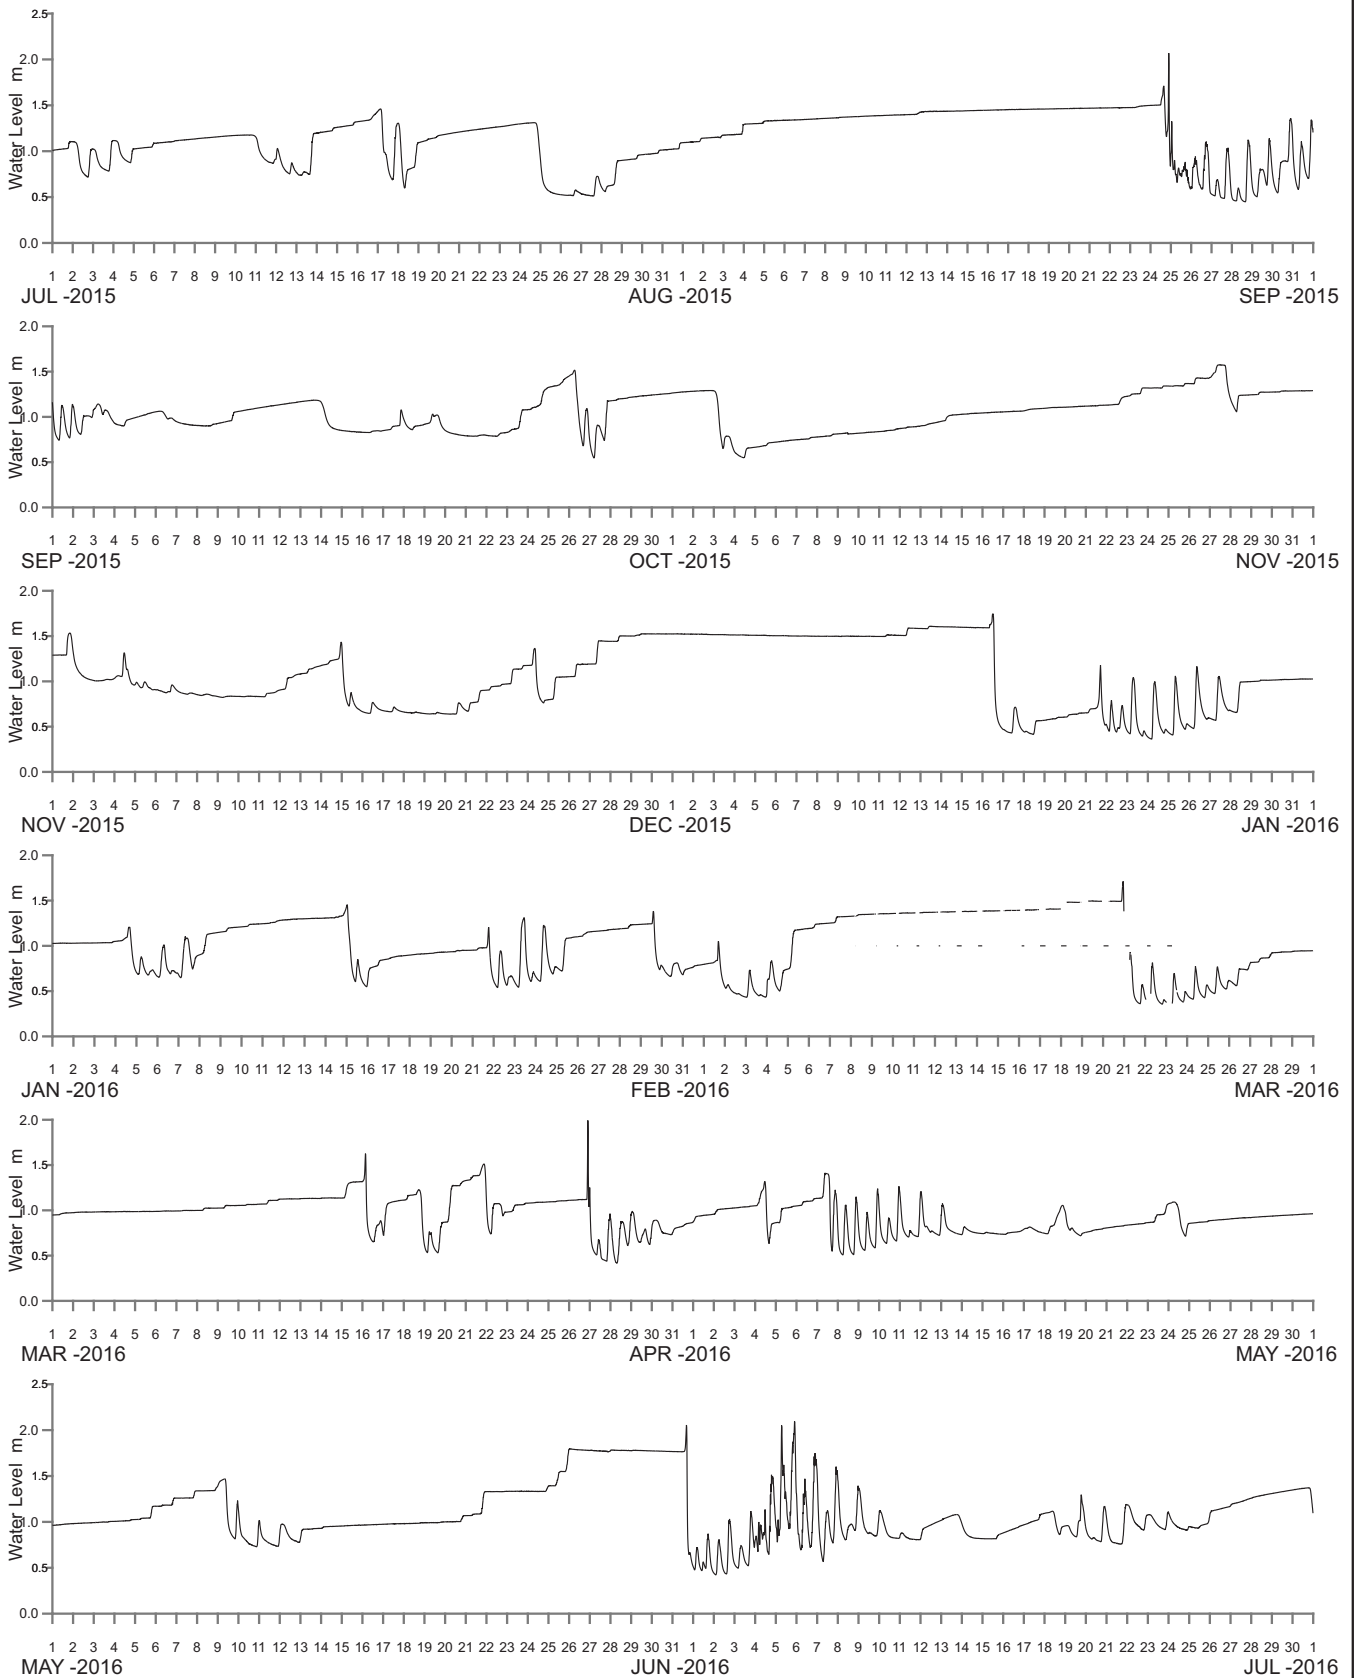
**Figure
207**

WATER LEVEL REFERENCED TO AUSTRALIAN HEIGHT DATUM

**TOWRADGI CREEK AT TOWRADGI CREEK
UPSTREAM
2015-2016**

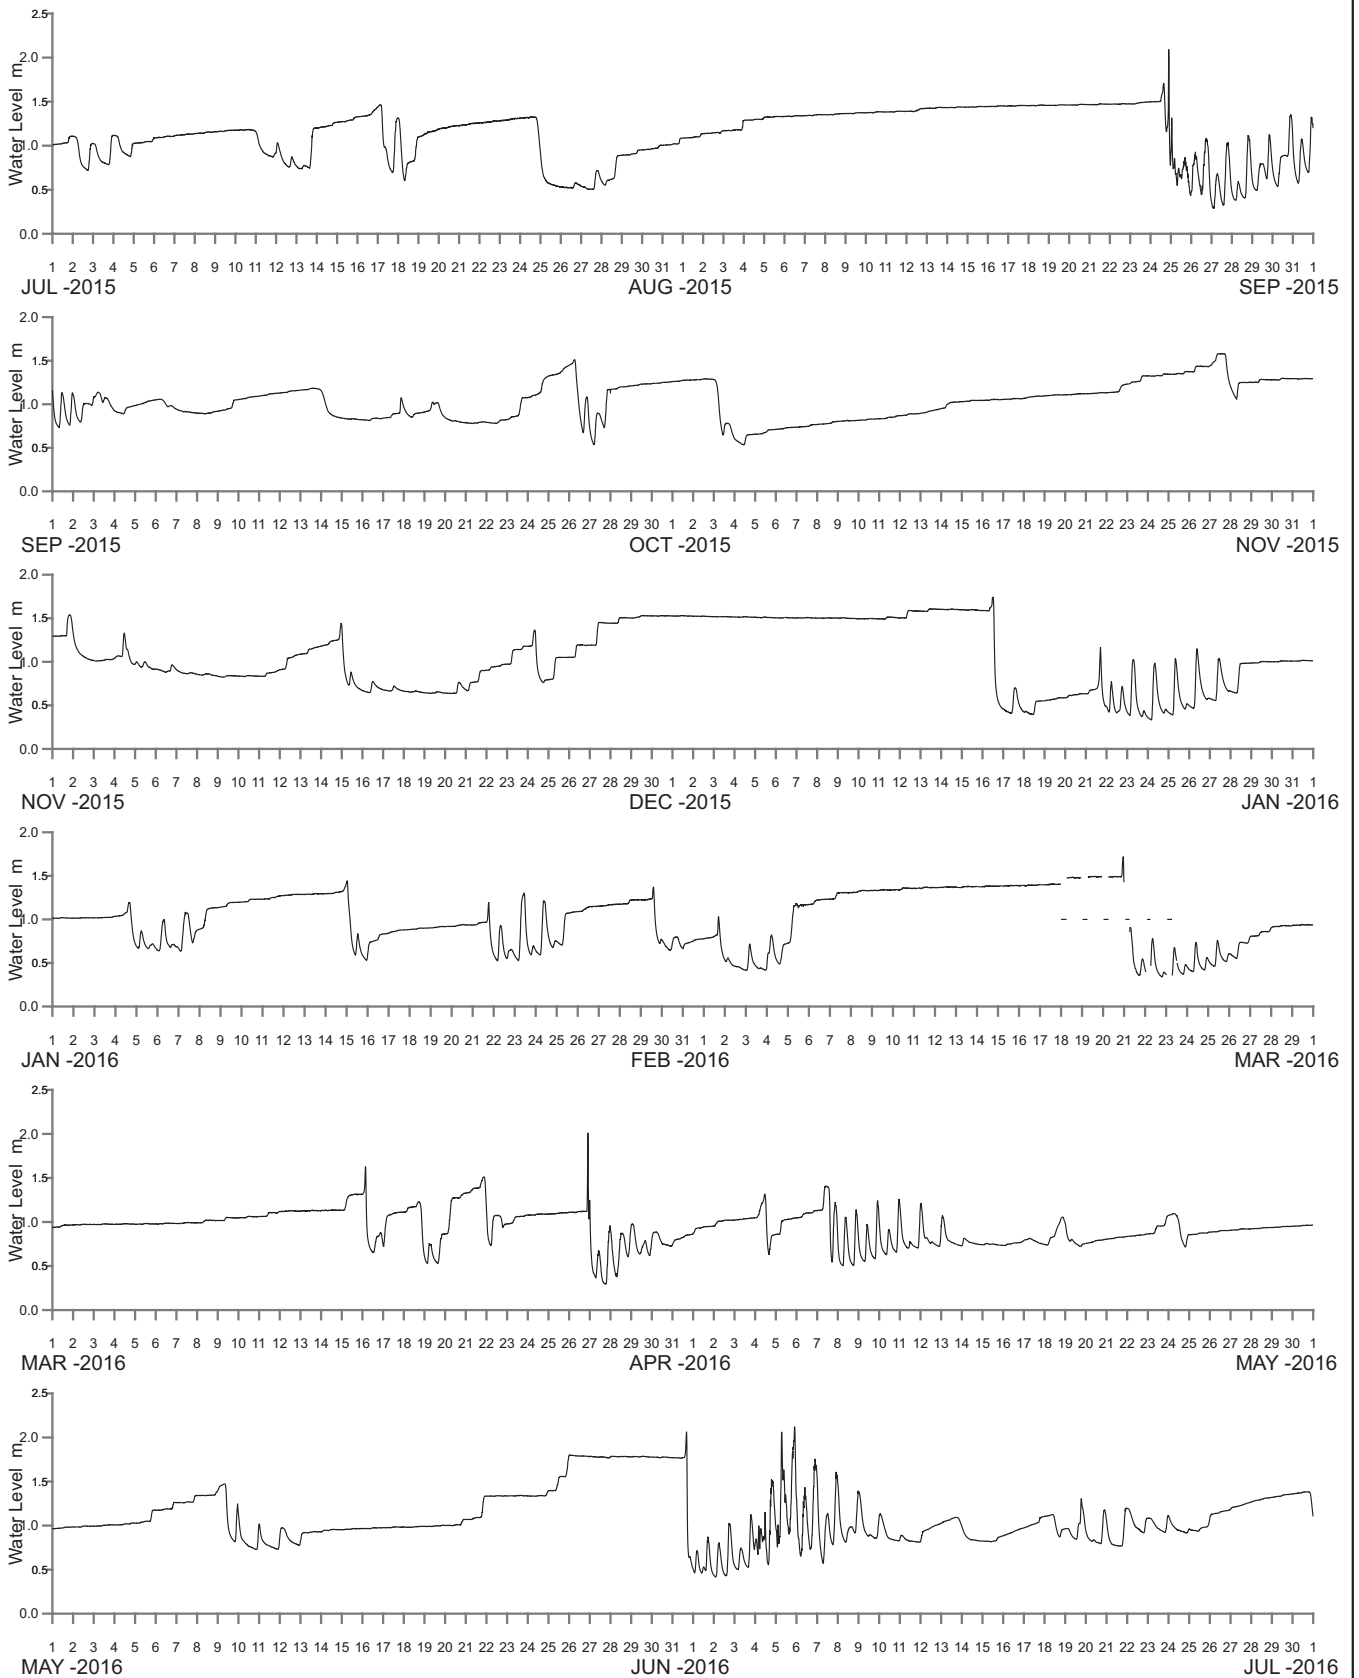
Figure
208

WATER LEVEL REFERENCED TO AUSTRALIAN HEIGHT DATUM

**TOWRADGI CREEK AT TOWRADGI CREEK
DOWNSTREAM
2015-2016**

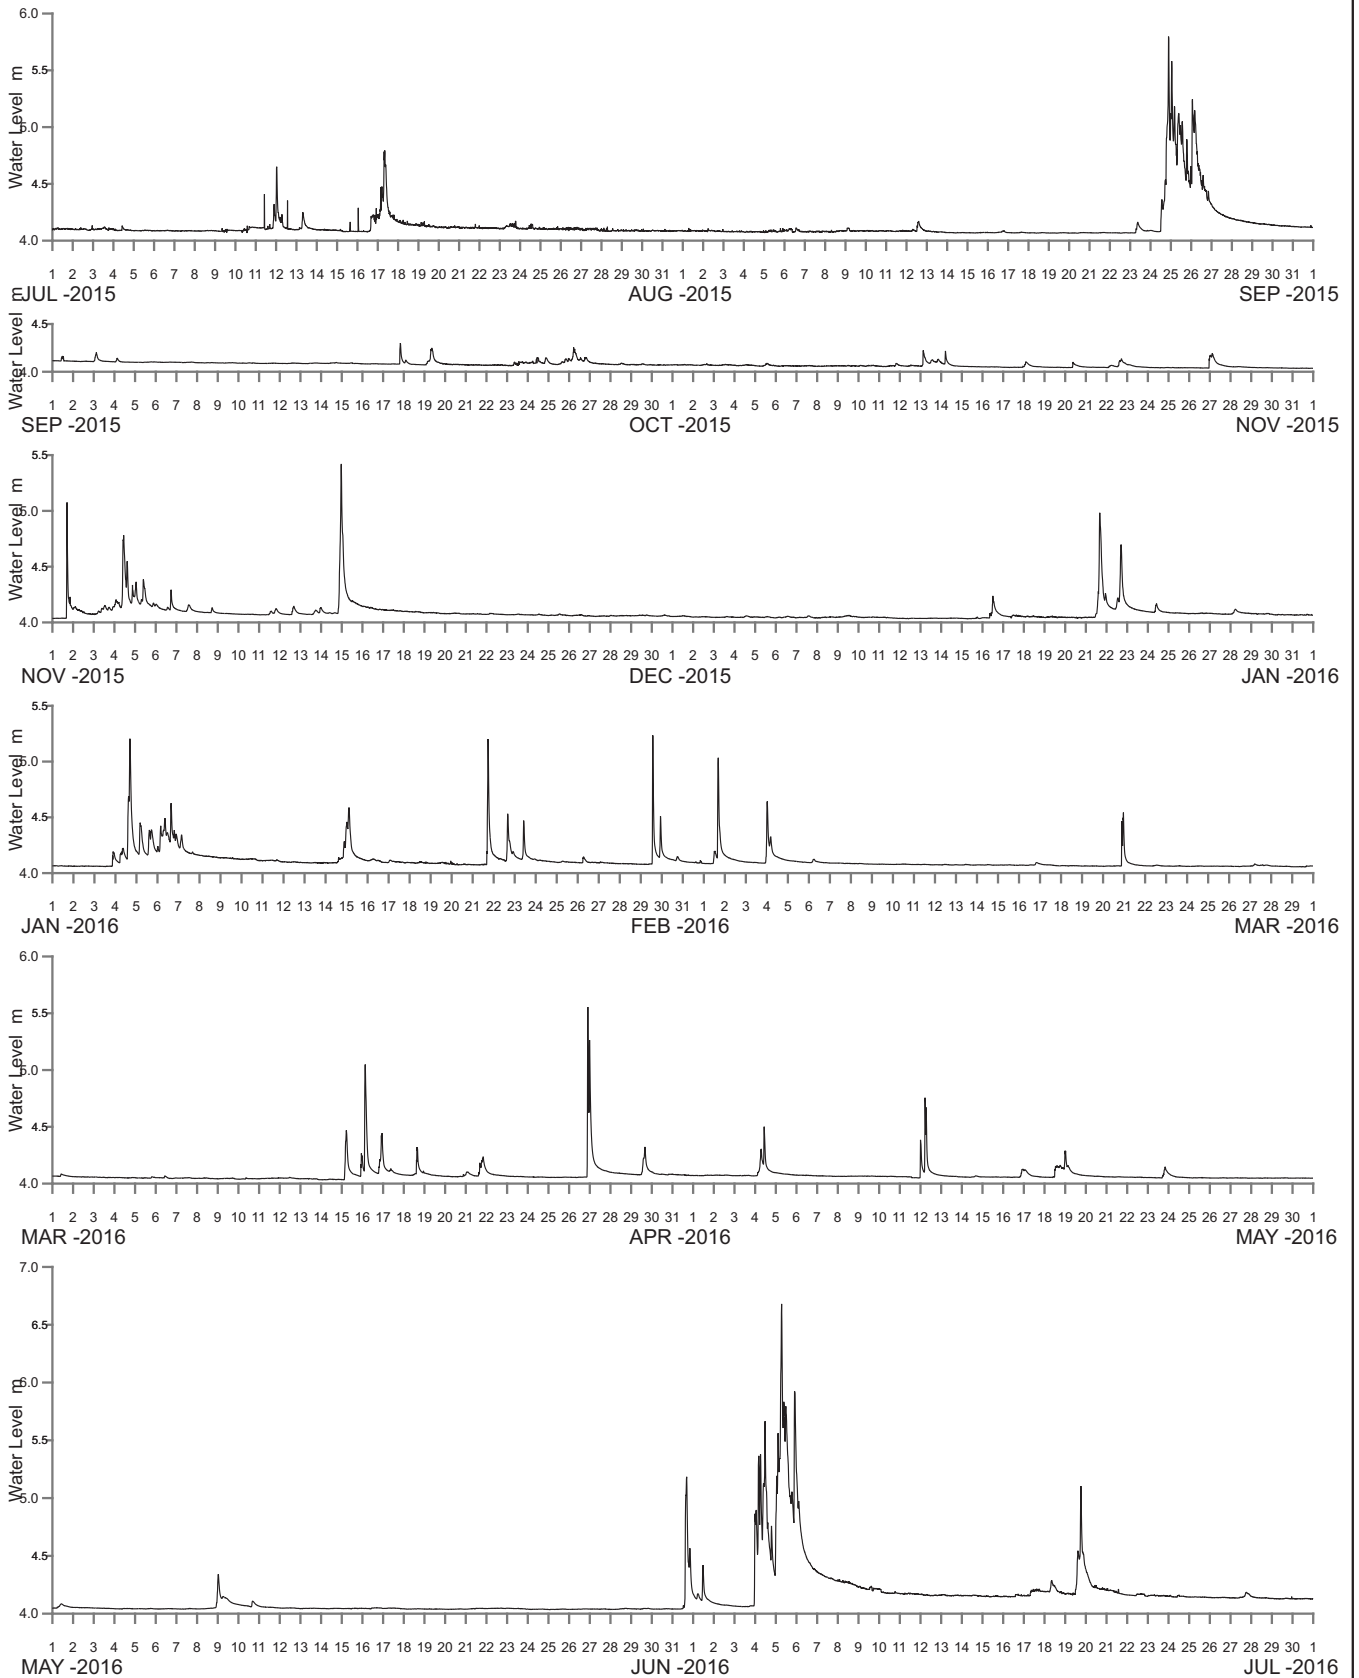
Figure
209

WATER LEVEL REFERENCED TO AUSTRALIAN HEIGHT DATUM

**CABBAGE TREE CREEK AT CABBAGE TREE CREEK
UPSTREAM
2015-2016**

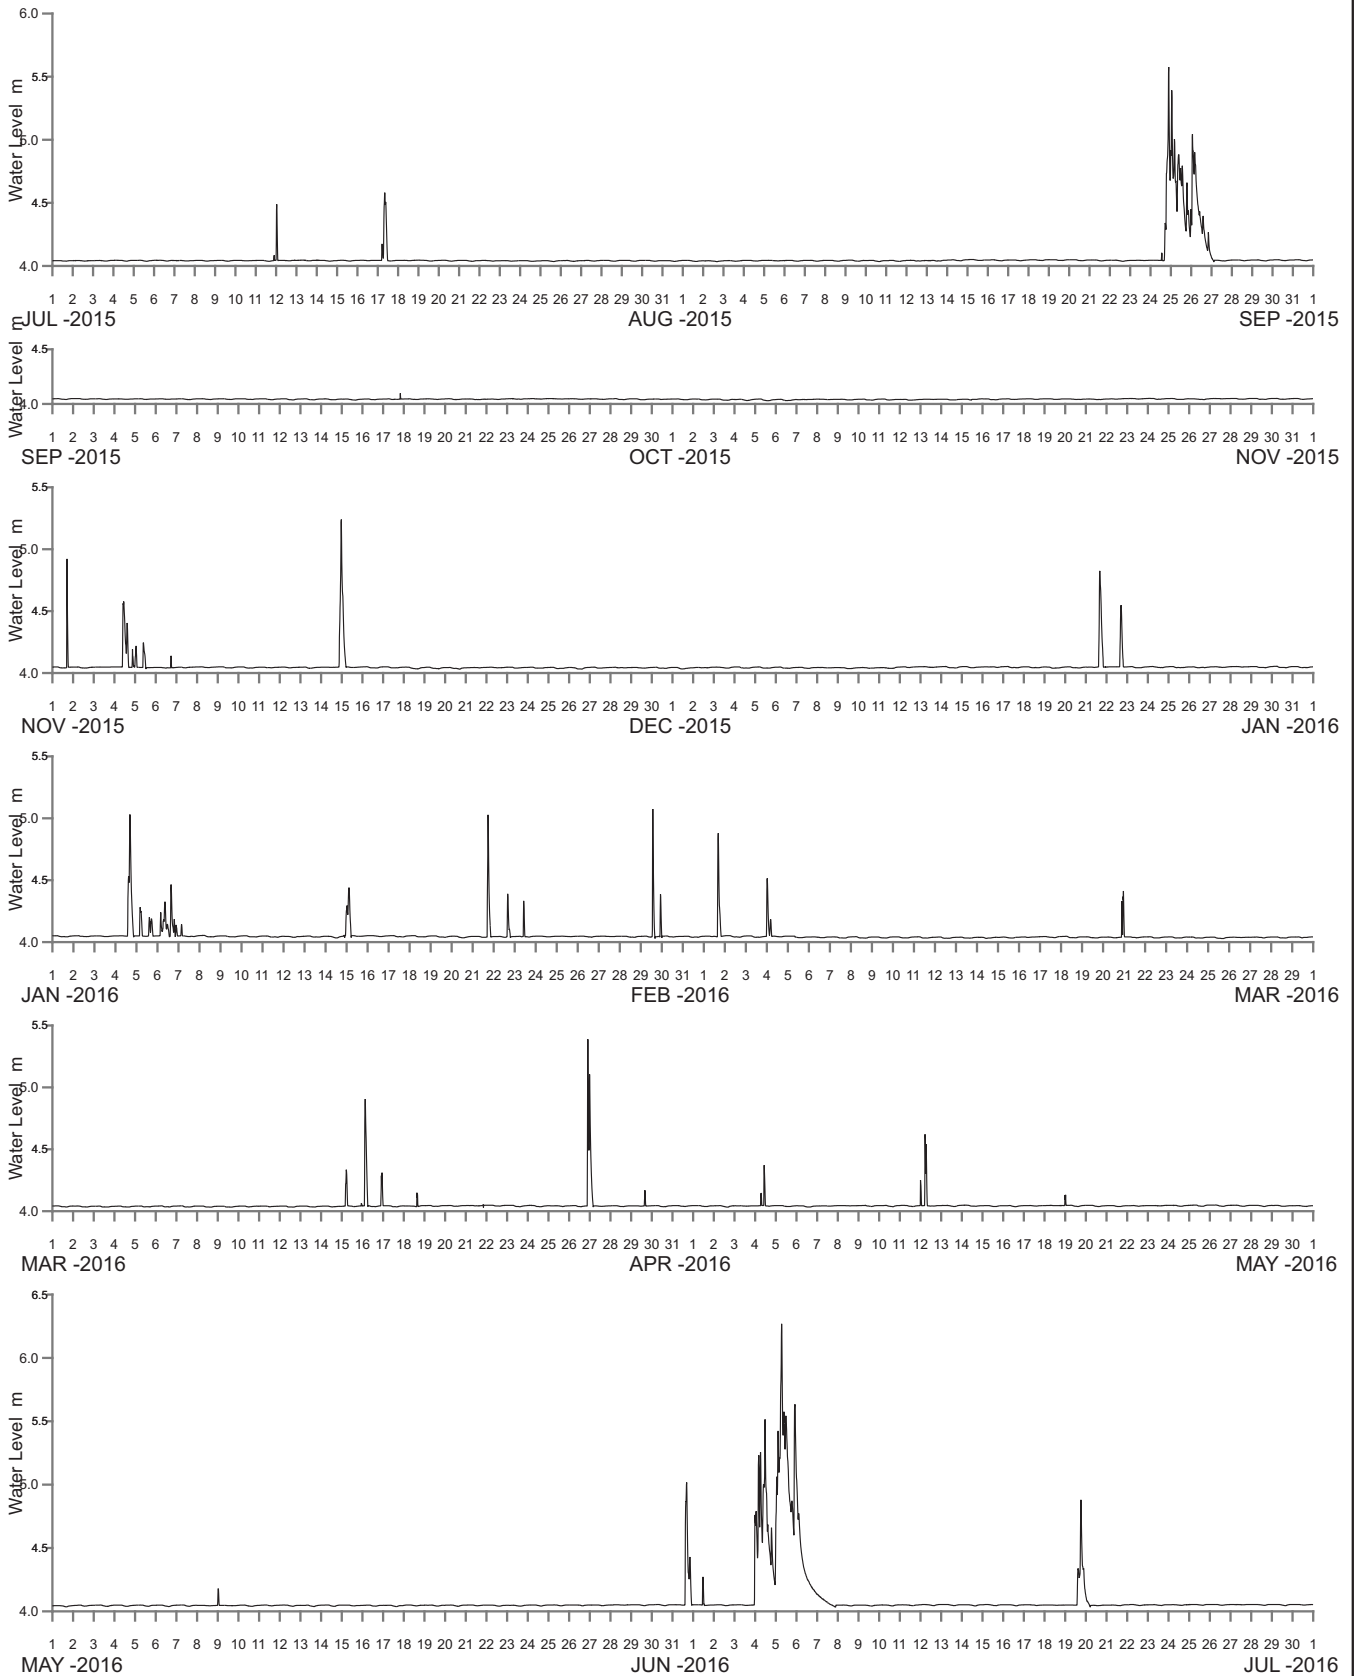
Figure
210

WATER LEVEL REFERENCED TO AUSTRALIAN HEIGHT DATUM

**CABBAGE TREE CREEK AT CABBAGE TREE CREEK
DOWNSTREAM
2015-2016**

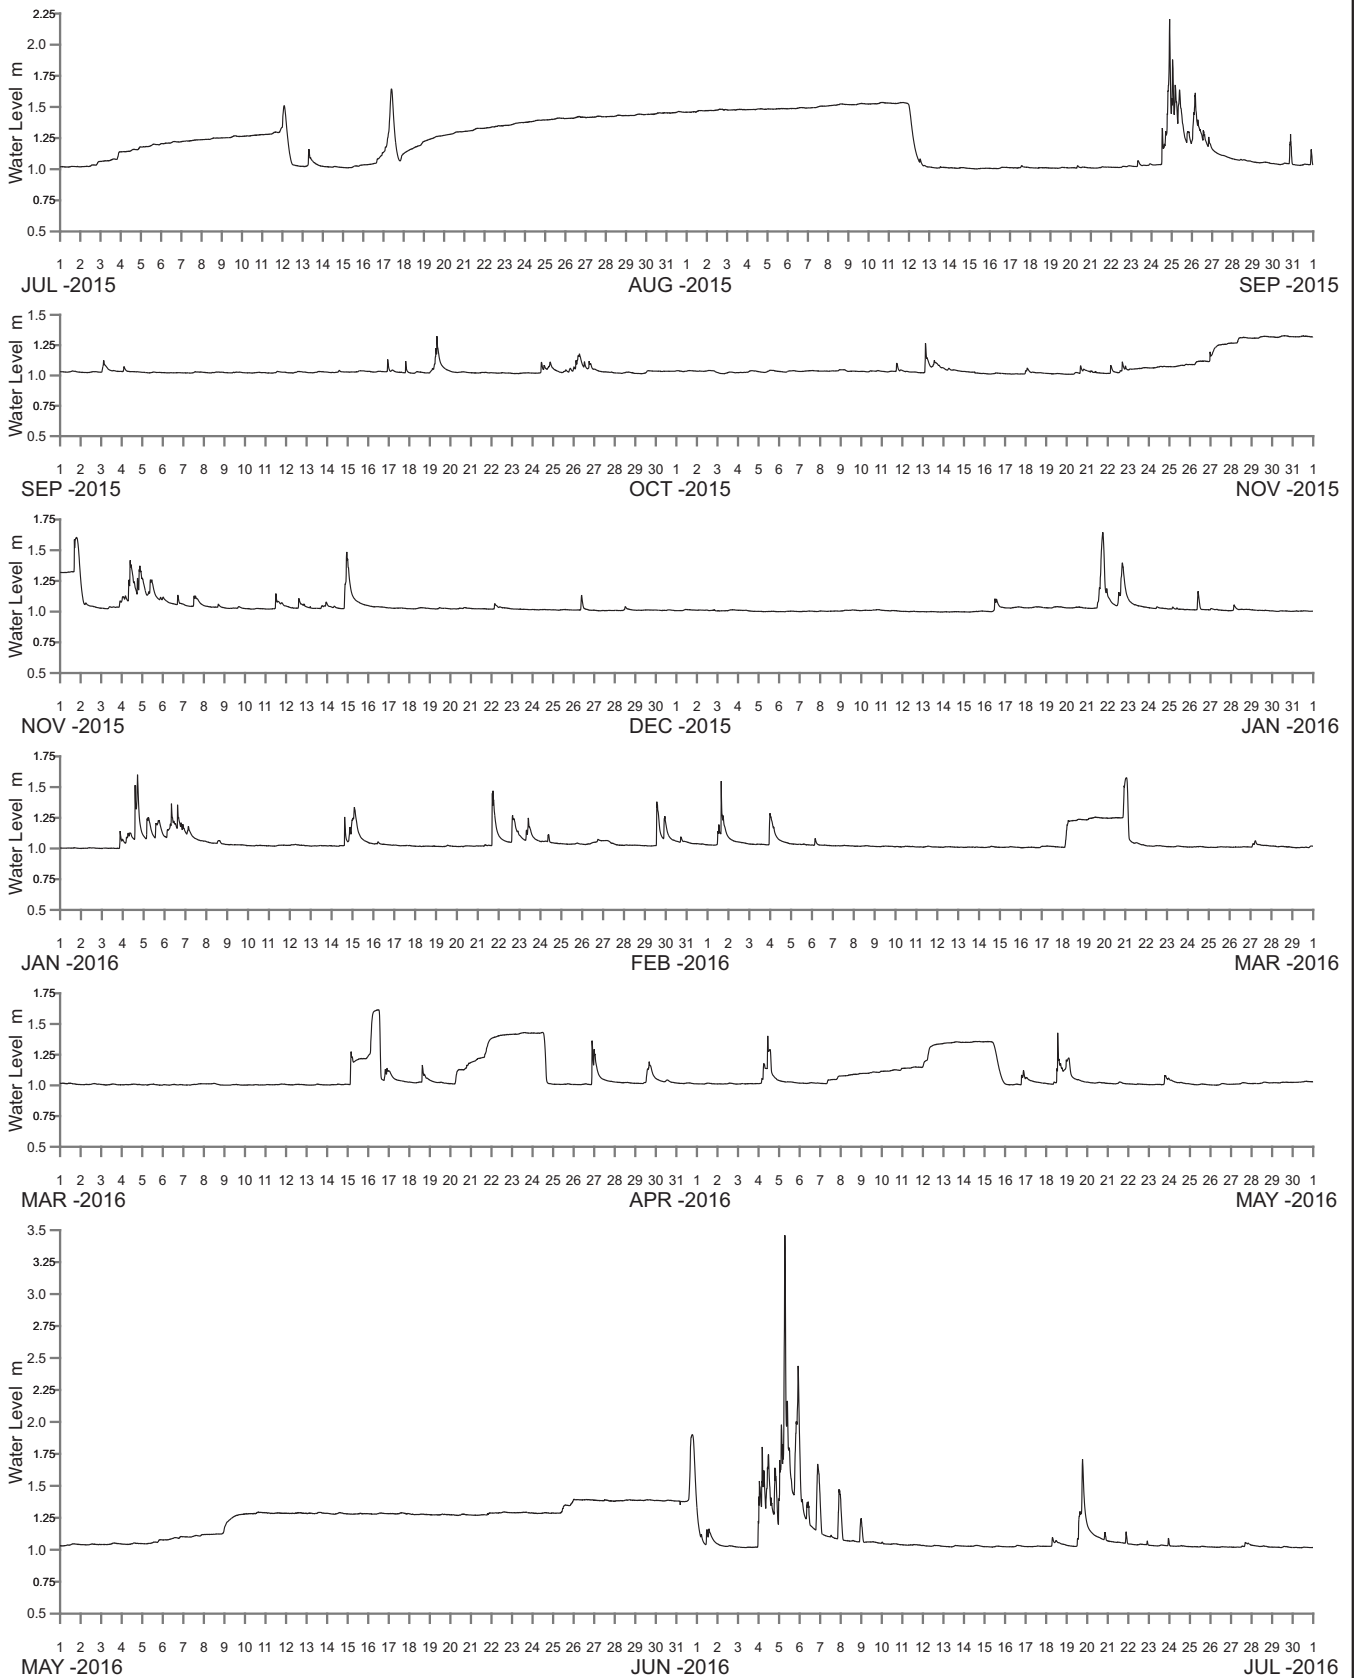
Figure
211

WATER LEVEL REFERENCED TO AUSTRALIAN HEIGHT DATUM

FAIRY CREEK AT FAIRY CREEK UPSTREAM
2015–2016
