River/estuary system	Station name	Figure
Station Locality Map	Wollongong Region	201
Hewitts Creek	Hewitts Creek Upstream	202
Hewitts Creek	Hewitts Creek Downstream	203
Hewitts Creek	Hewitts Creek Entrance	204
Cabbage Tree Creek	Balgownie Road	205
Bellambi	Bellambi	206
Towradgi Creek	Towradgi Creek Upstream	207
Towradgi Creek	Towradgi Creek Downstream	208
Cabbage Tree Creek	Cabbage Tree Creek Upstream	209
Cabbage Tree Creek	Cabbage Tree Creek Downstream	210
Fairy Creek	Fairy Creek Upstream	211
Fairy Creek	Fairy Creek Downstream	212
Byarong Creek	Byarong Creek	213
Byarong Creek	Koloona Avenue Upstream	214
Byarong Creek	Koloona Avenue Downstream	215
American Creek	Blackmans Parade Upstream	216
American Creek	Blackmans Parade Downstream	217
Station Locality Map	Lake Illawarra Region	218
Mullet Creek	Mullet Creek	219
Lake Illawarra	Koonawarra Bay	220
Lake Illawarra	Cudgeree Bay	221
Lake Illawarra	Lake Illawarra Entrance	222

MHL
Report 2474

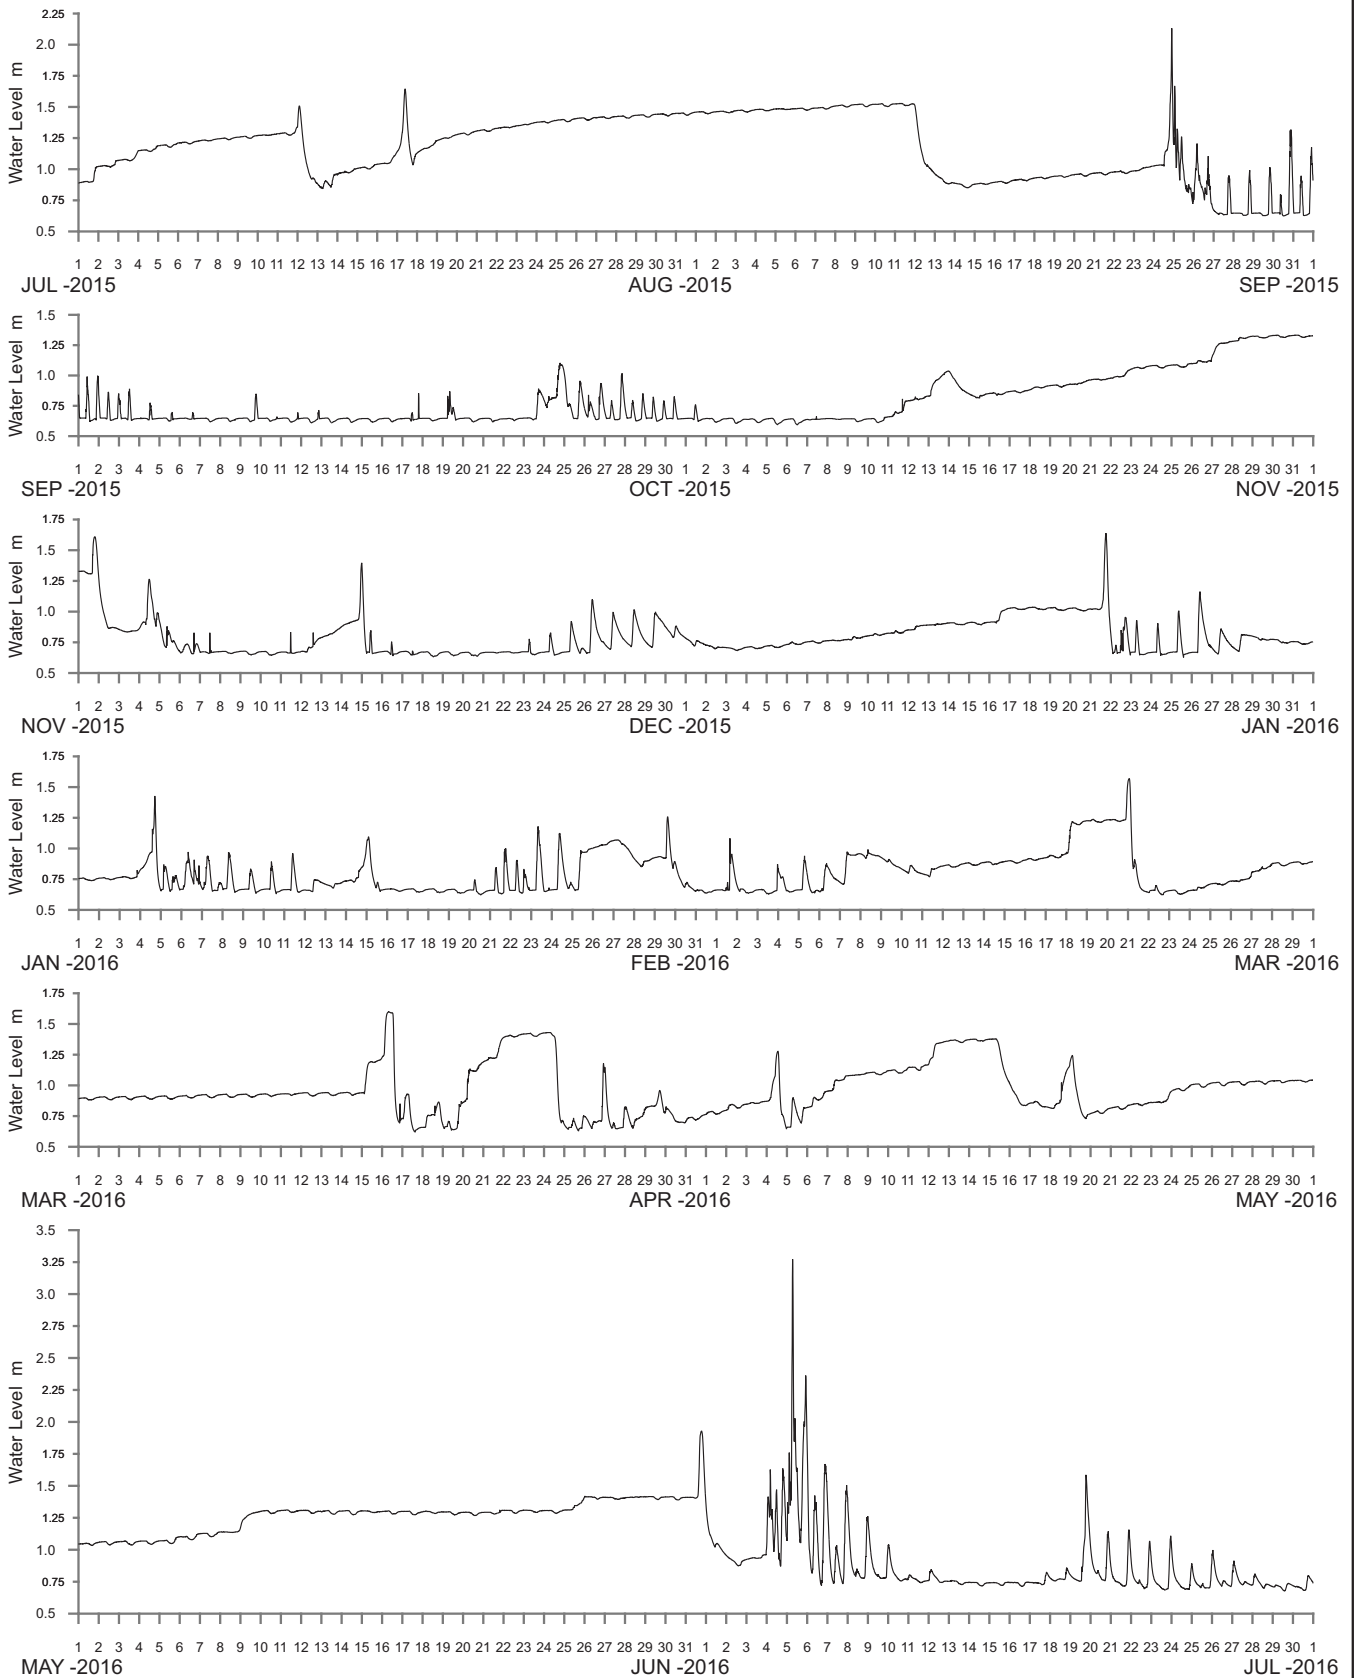
Figure
212

WATER LEVEL REFERENCED TO AUSTRALIAN HEIGHT DATUM

FAIRY CREEK AT FAIRY CREEK DOWNSTREAM
2015–2016

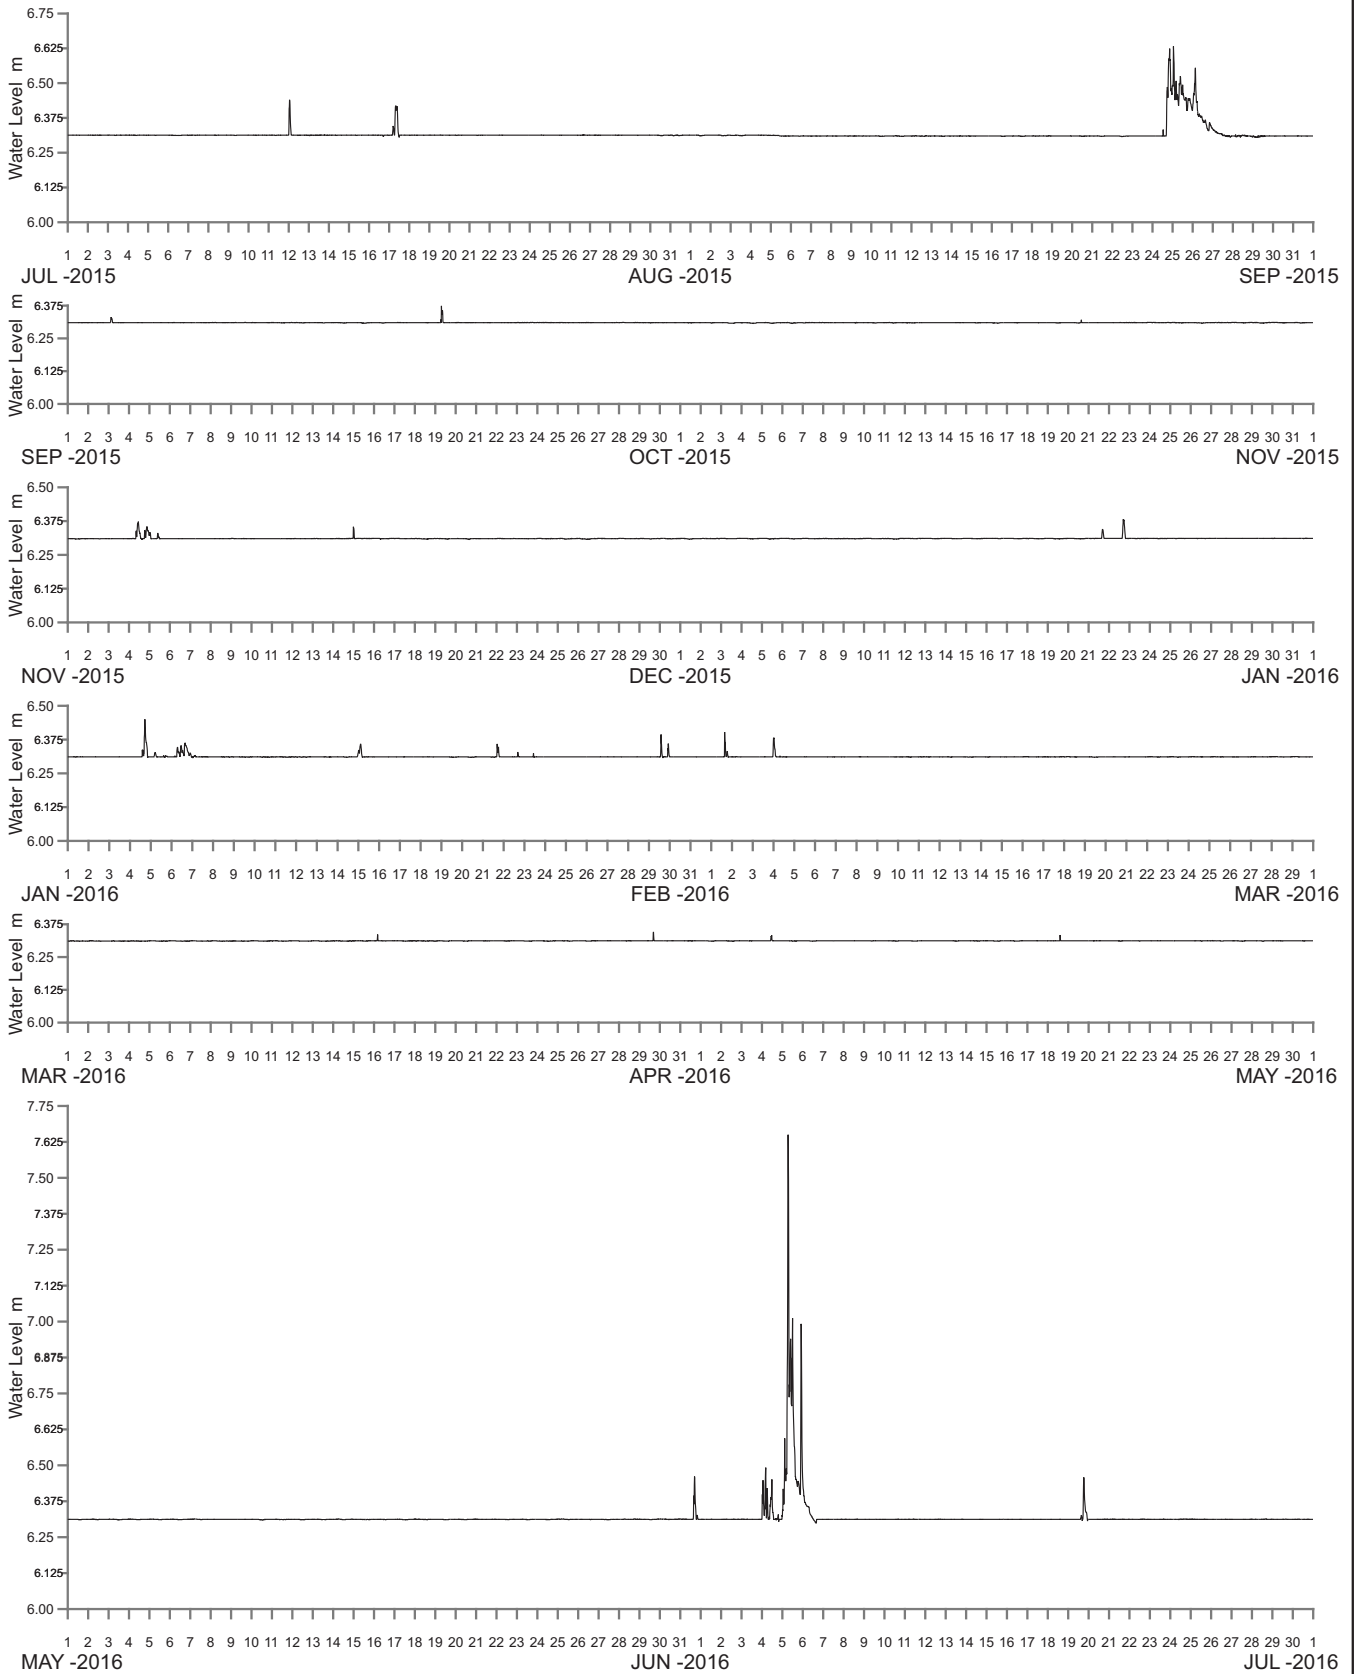
Figure
213

WATER LEVEL REFERENCED TO AUSTRALIAN HEIGHT DATUM

BYARONG CREEK AT F6 FREEWAY
2015-2016

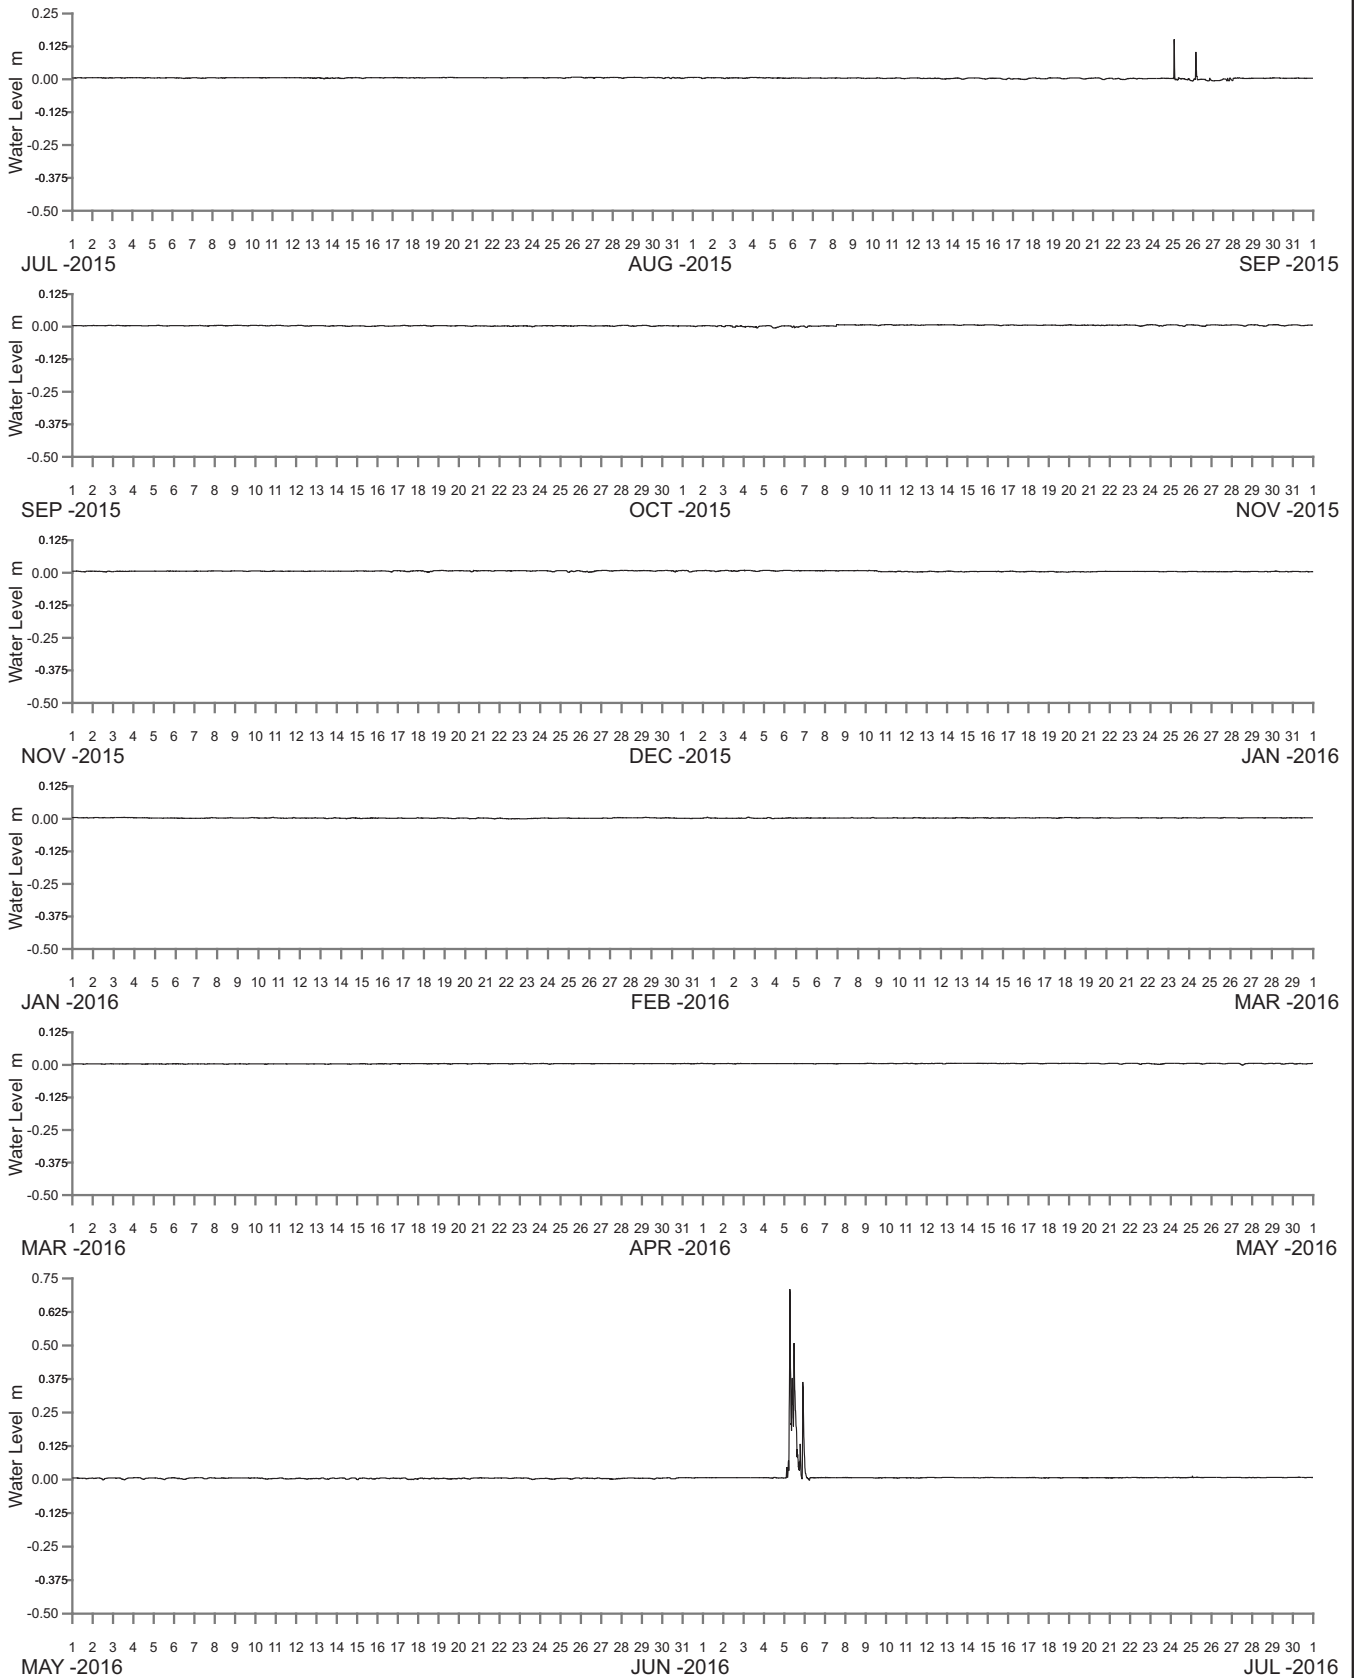
Figure
214

WATER LEVEL REFERENCED TO CULVERT BED

**BYARONG CREEK AT KOLOONA AVENUE UPSTREAM
2015-2016**

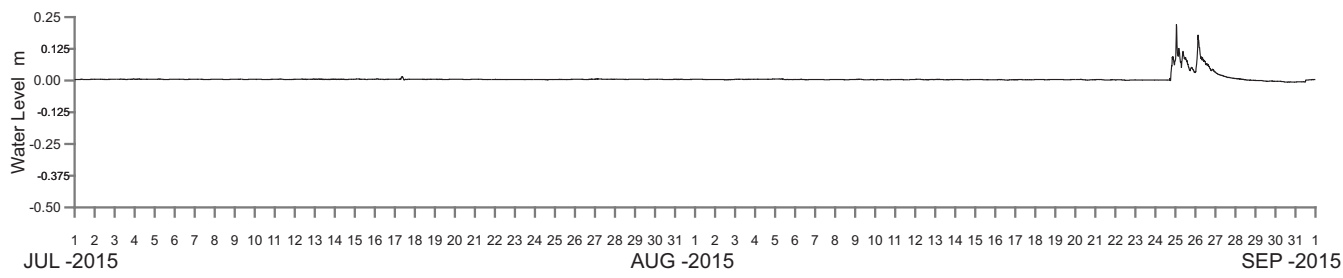
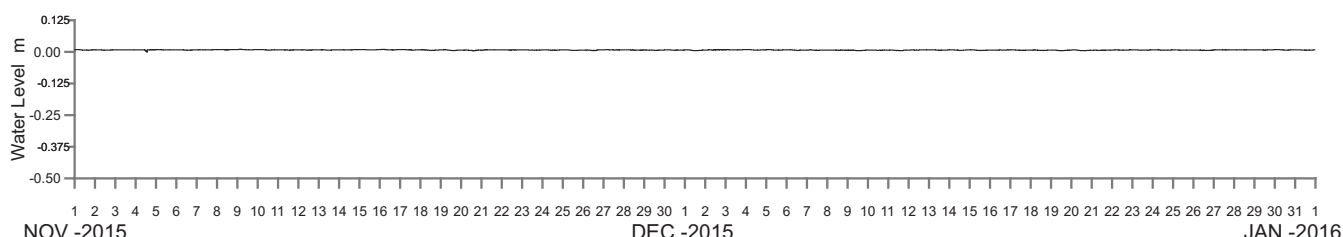
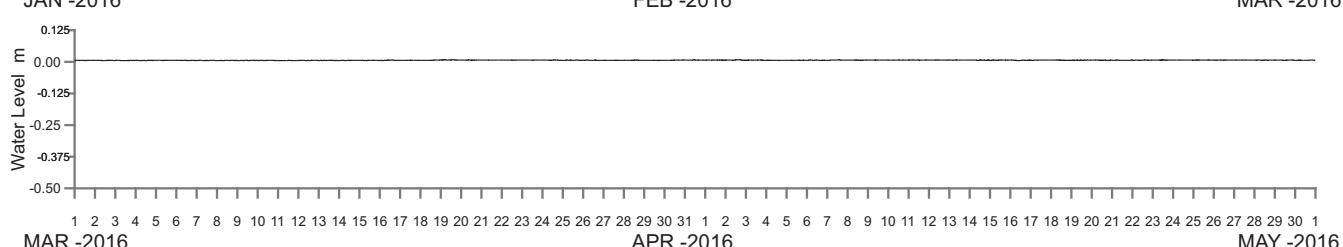
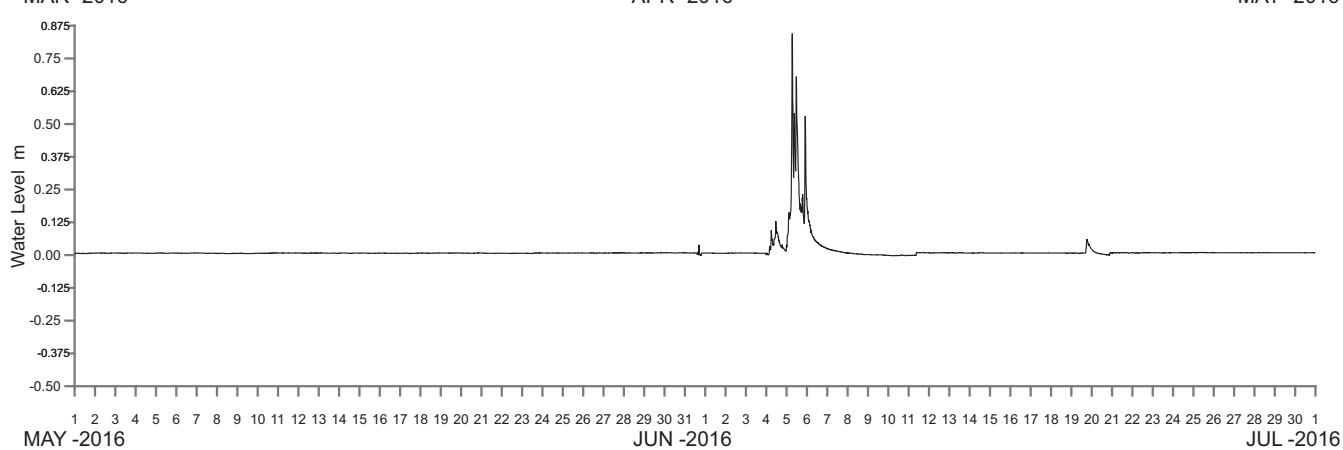
Figure
215

WATER LEVEL REFERENCED TO CULVERT BED

BYARONG CREEK AT KOLOONA AVENUE DOWNSTREAM
2015-2016

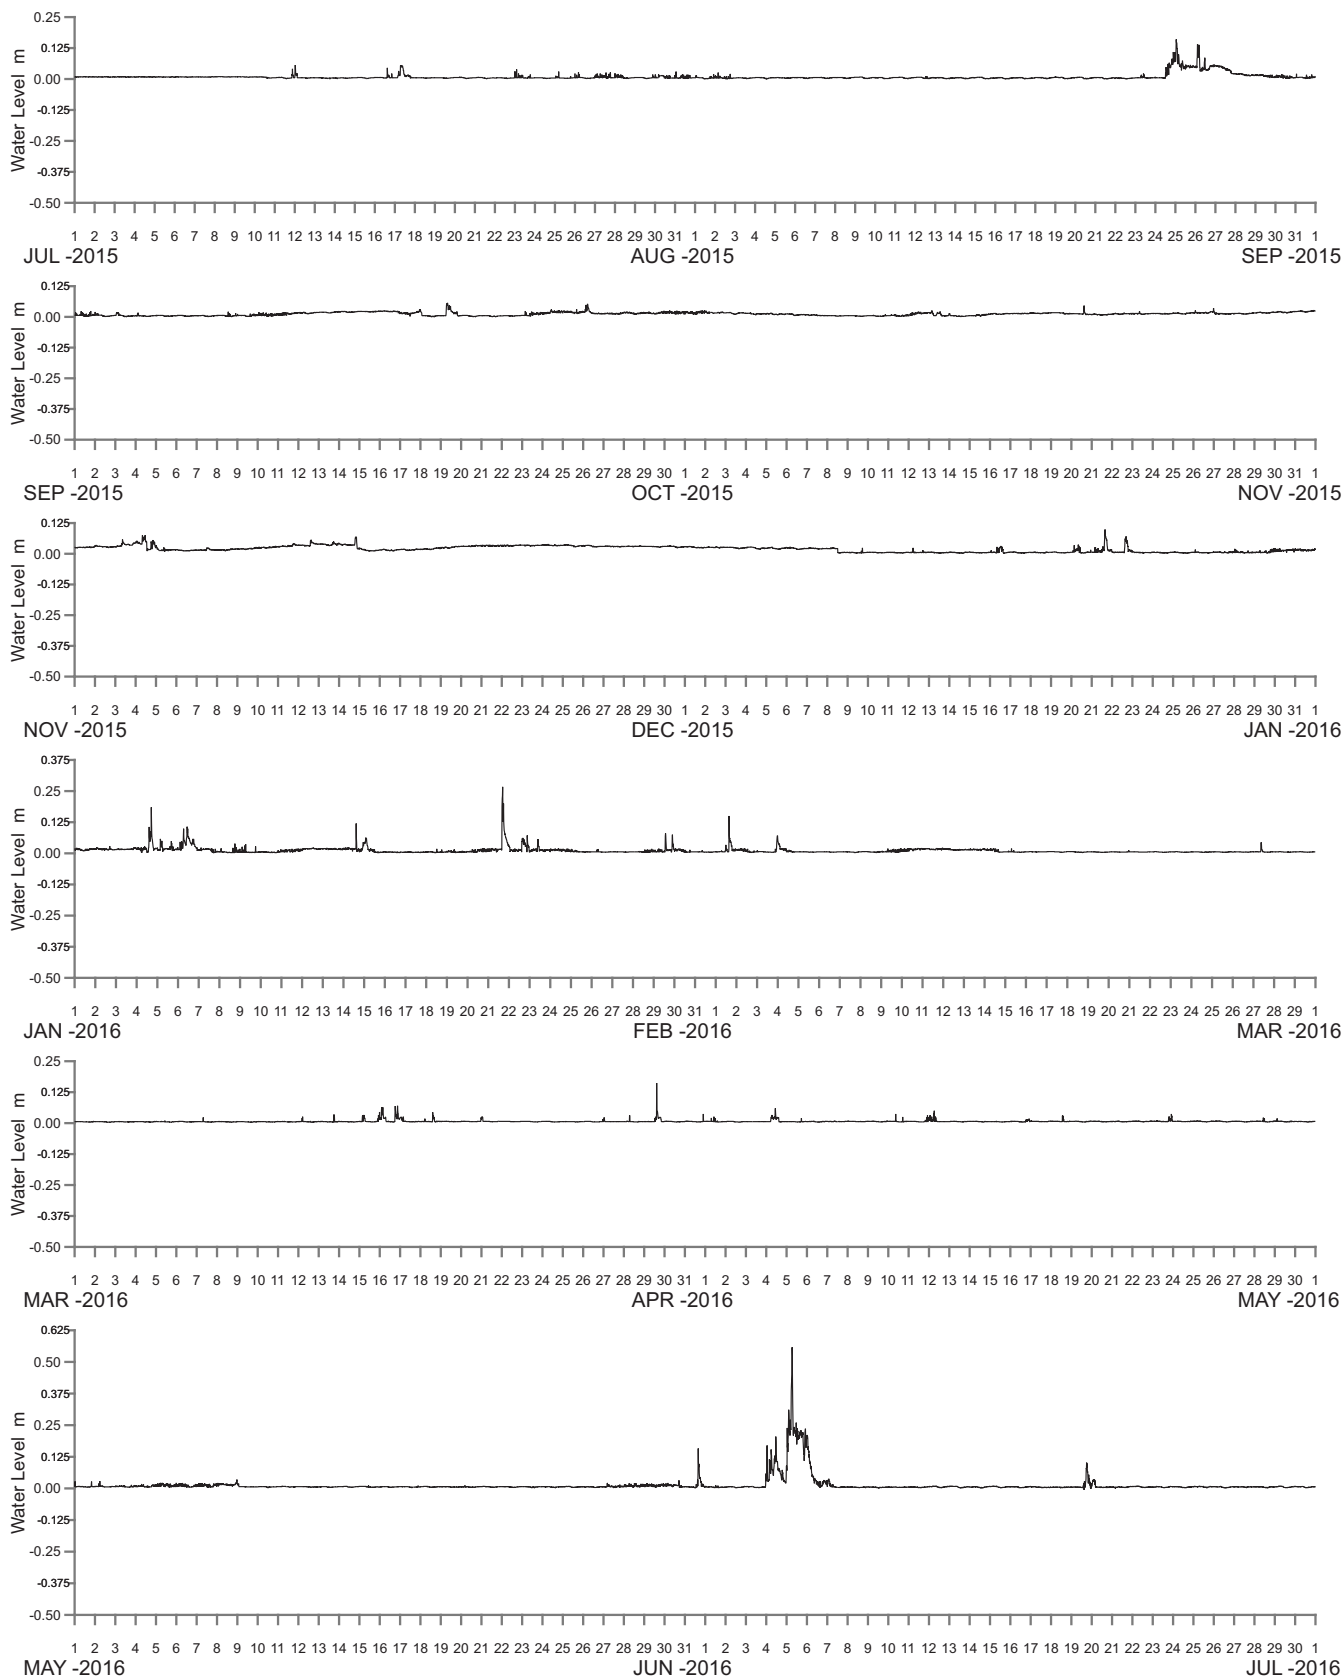
Figure
216

WATER LEVEL REFERENCED TO CULVERT BED

AMERICAN CREEK AT BLACKMANS PARADE
UPSTREAM
2015-2016

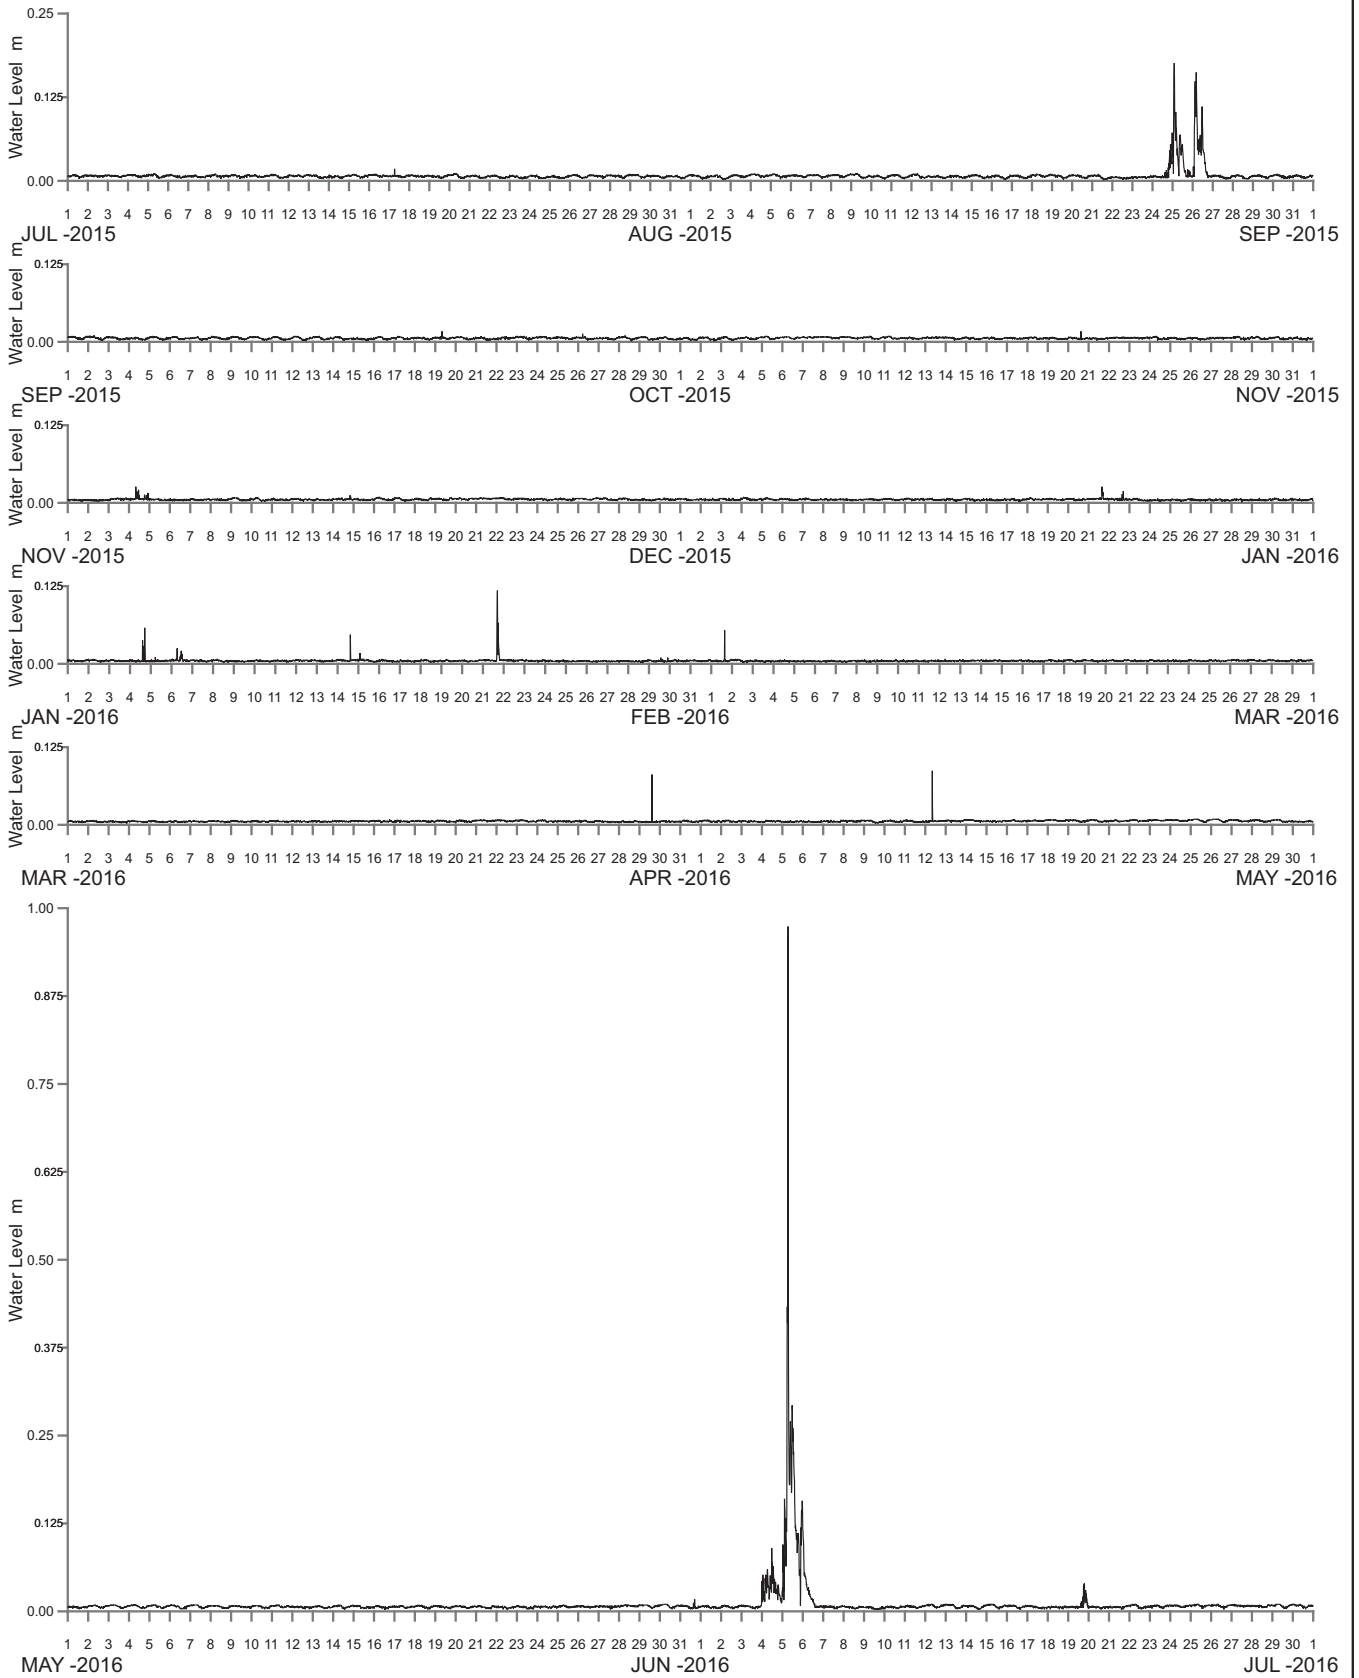
**Figure
217**

WATER LEVEL REFERENCED TO CULVERT BED

**AMERICAN CREEK AT BLACKMANS PARADE
DOWNSTREAM
2015-2016**

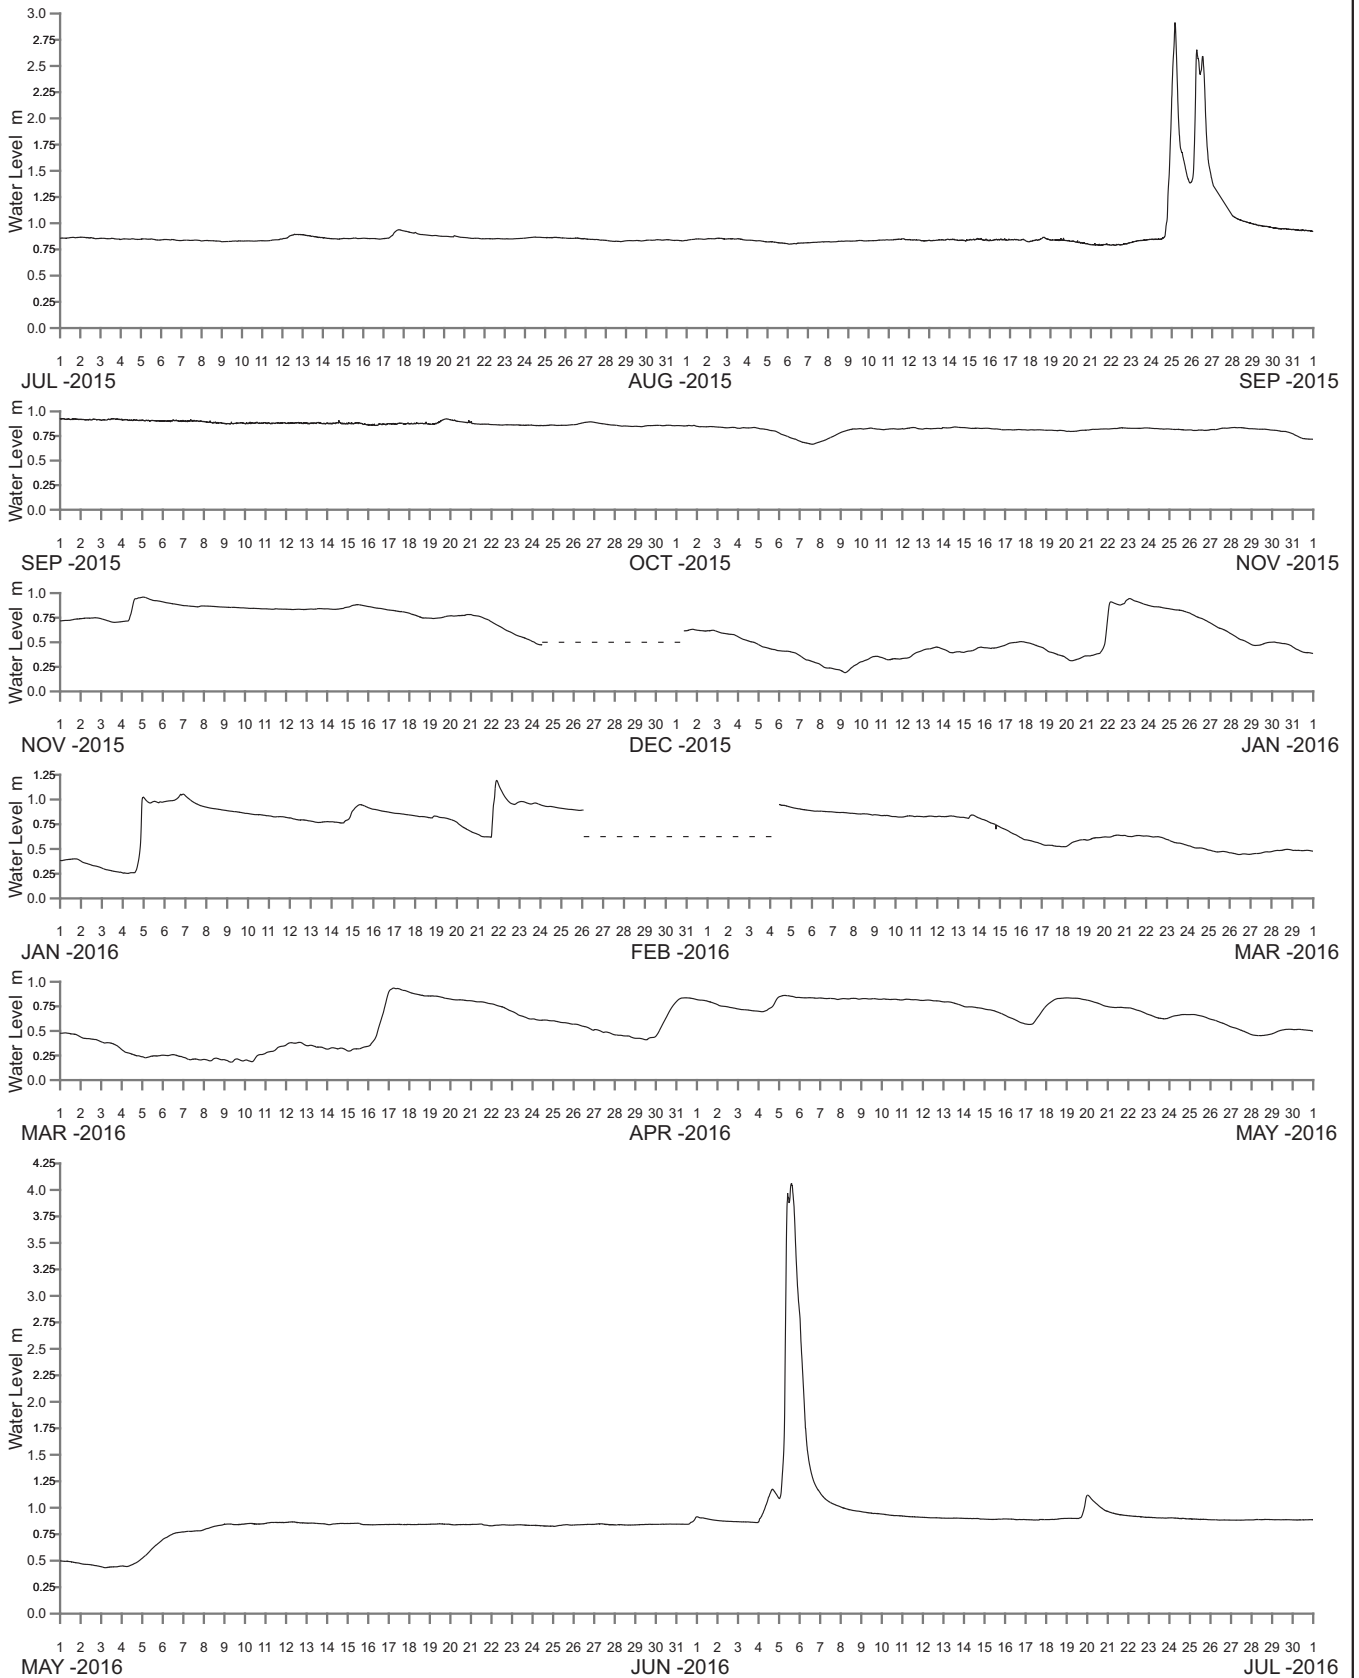
Figure
219

WATER LEVEL REFERENCED TO AUSTRALIAN HEIGHT DATUM

MULLET CREEK AT MULLET CREEK
2015–2016

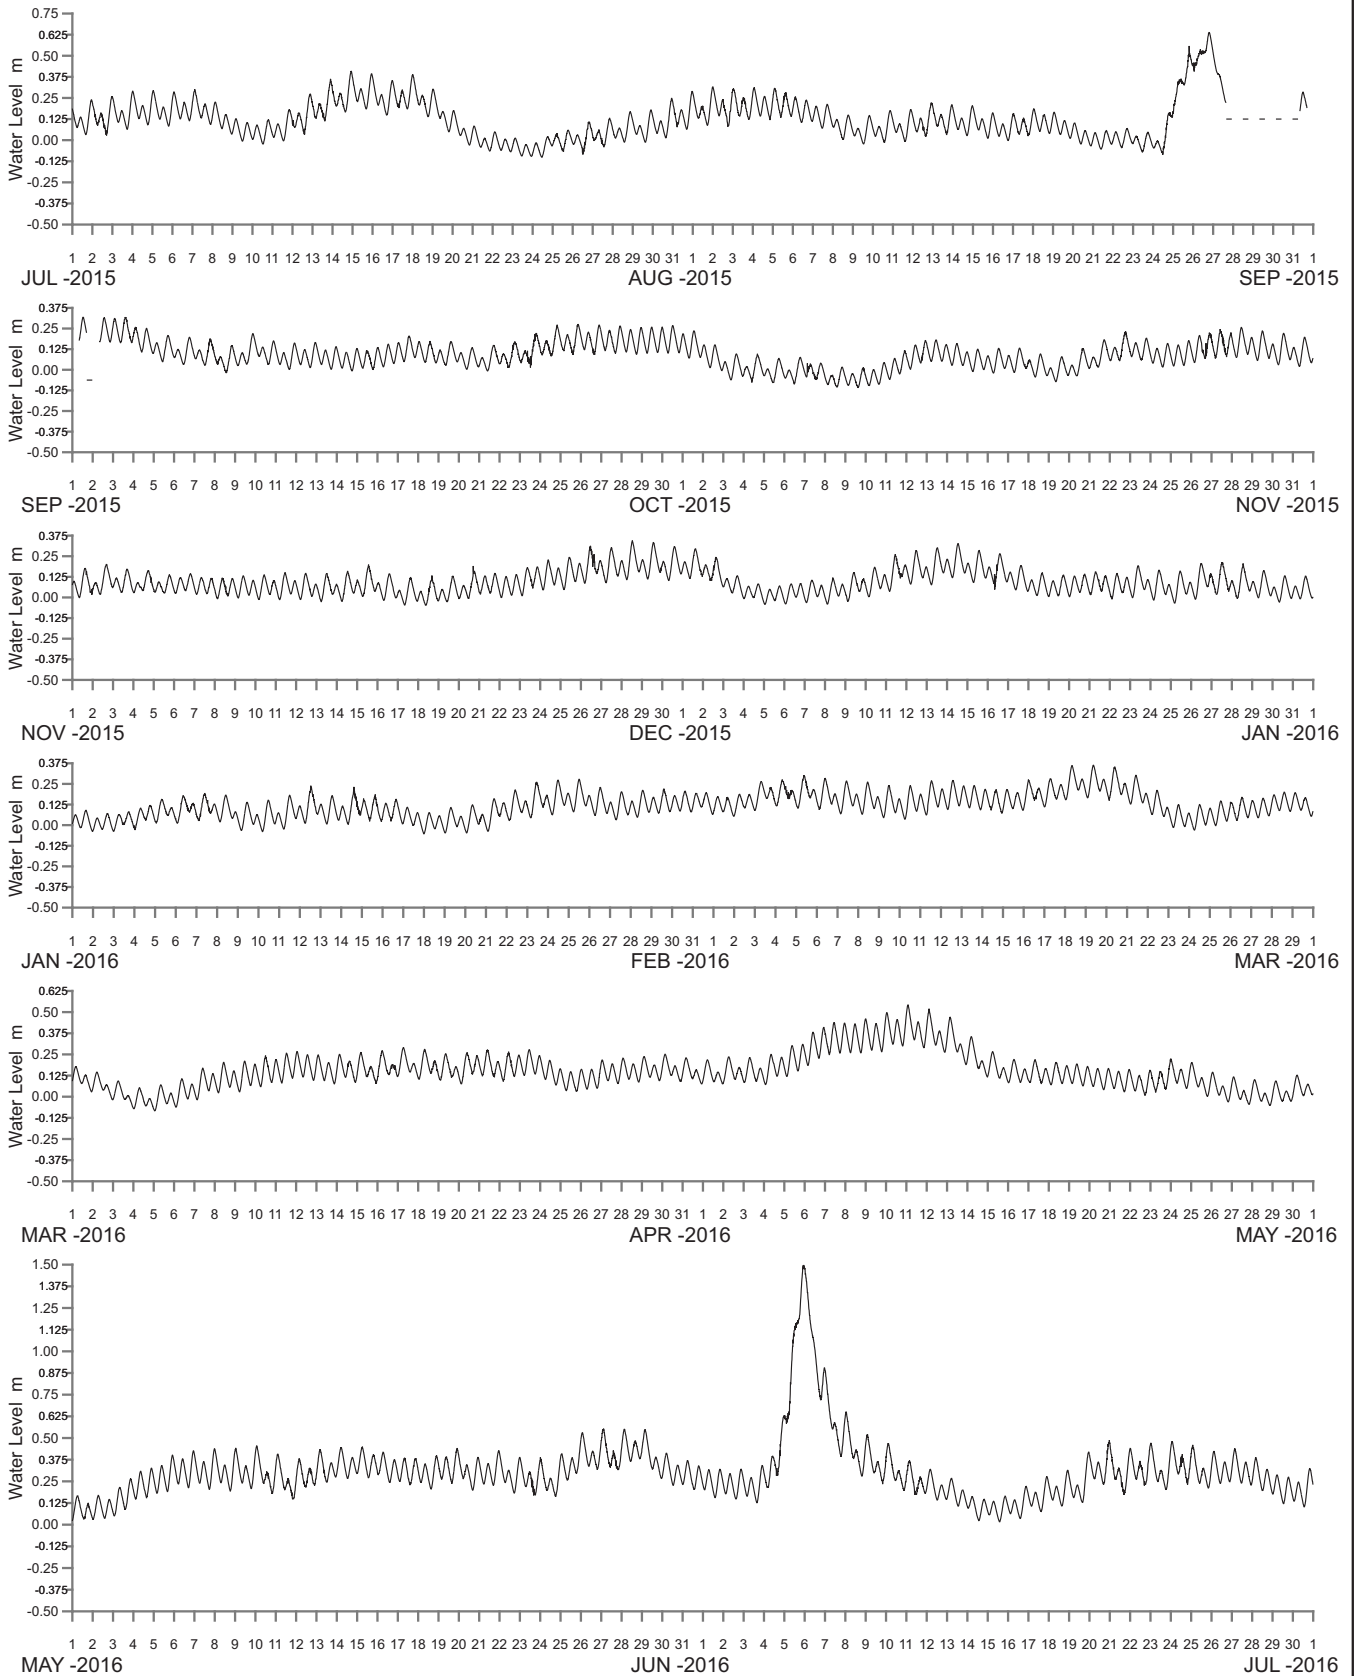
Figure
220

WATER LEVEL REFERENCED TO AUSTRALIAN HEIGHT DATUM

LAKE ILLAWARRA AT KOONAWARRA BAY
2015–2016

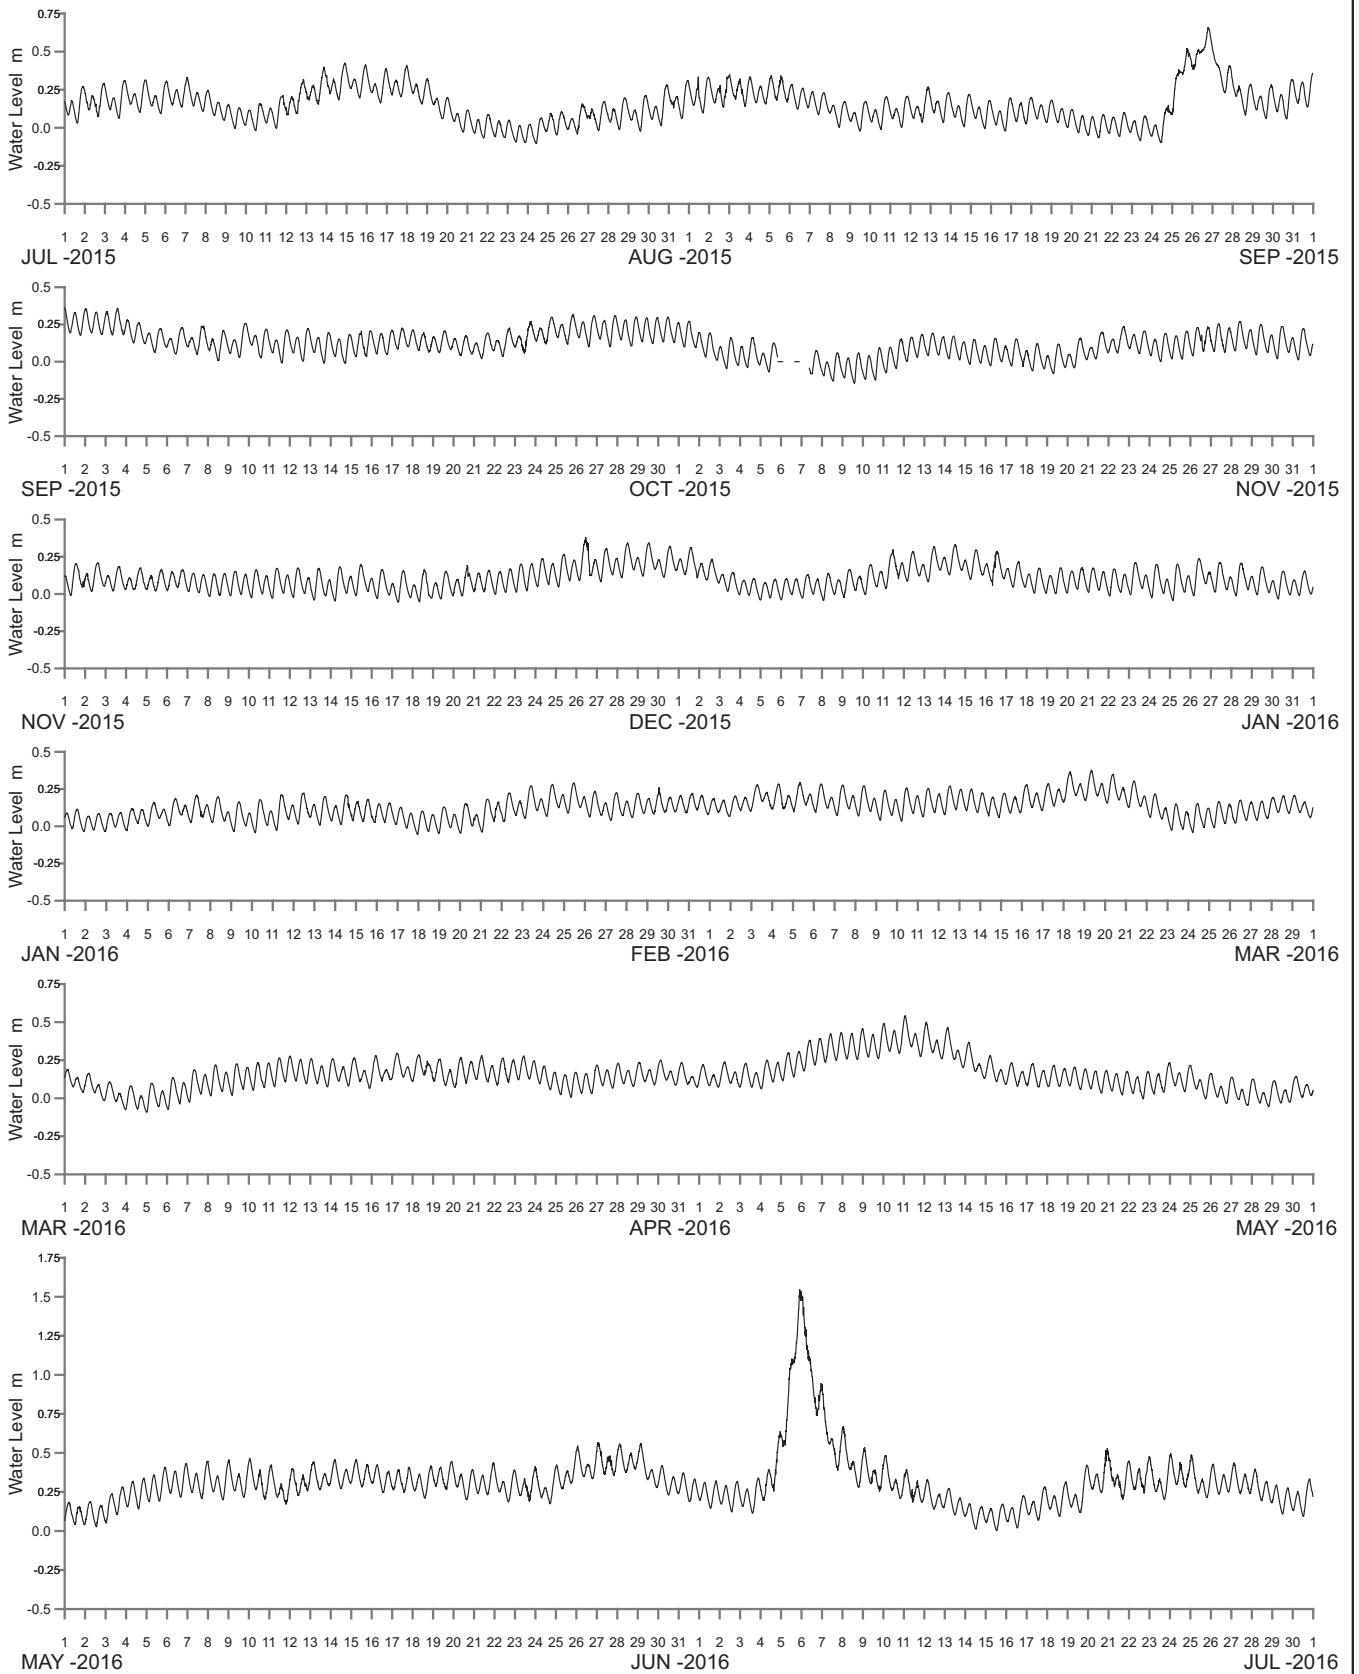
Figure
221

WATER LEVEL REFERENCED TO AUSTRALIAN HEIGHT DATUM

LAKE ILLAWARRA AT CUDGEREE BAY
2015–2016

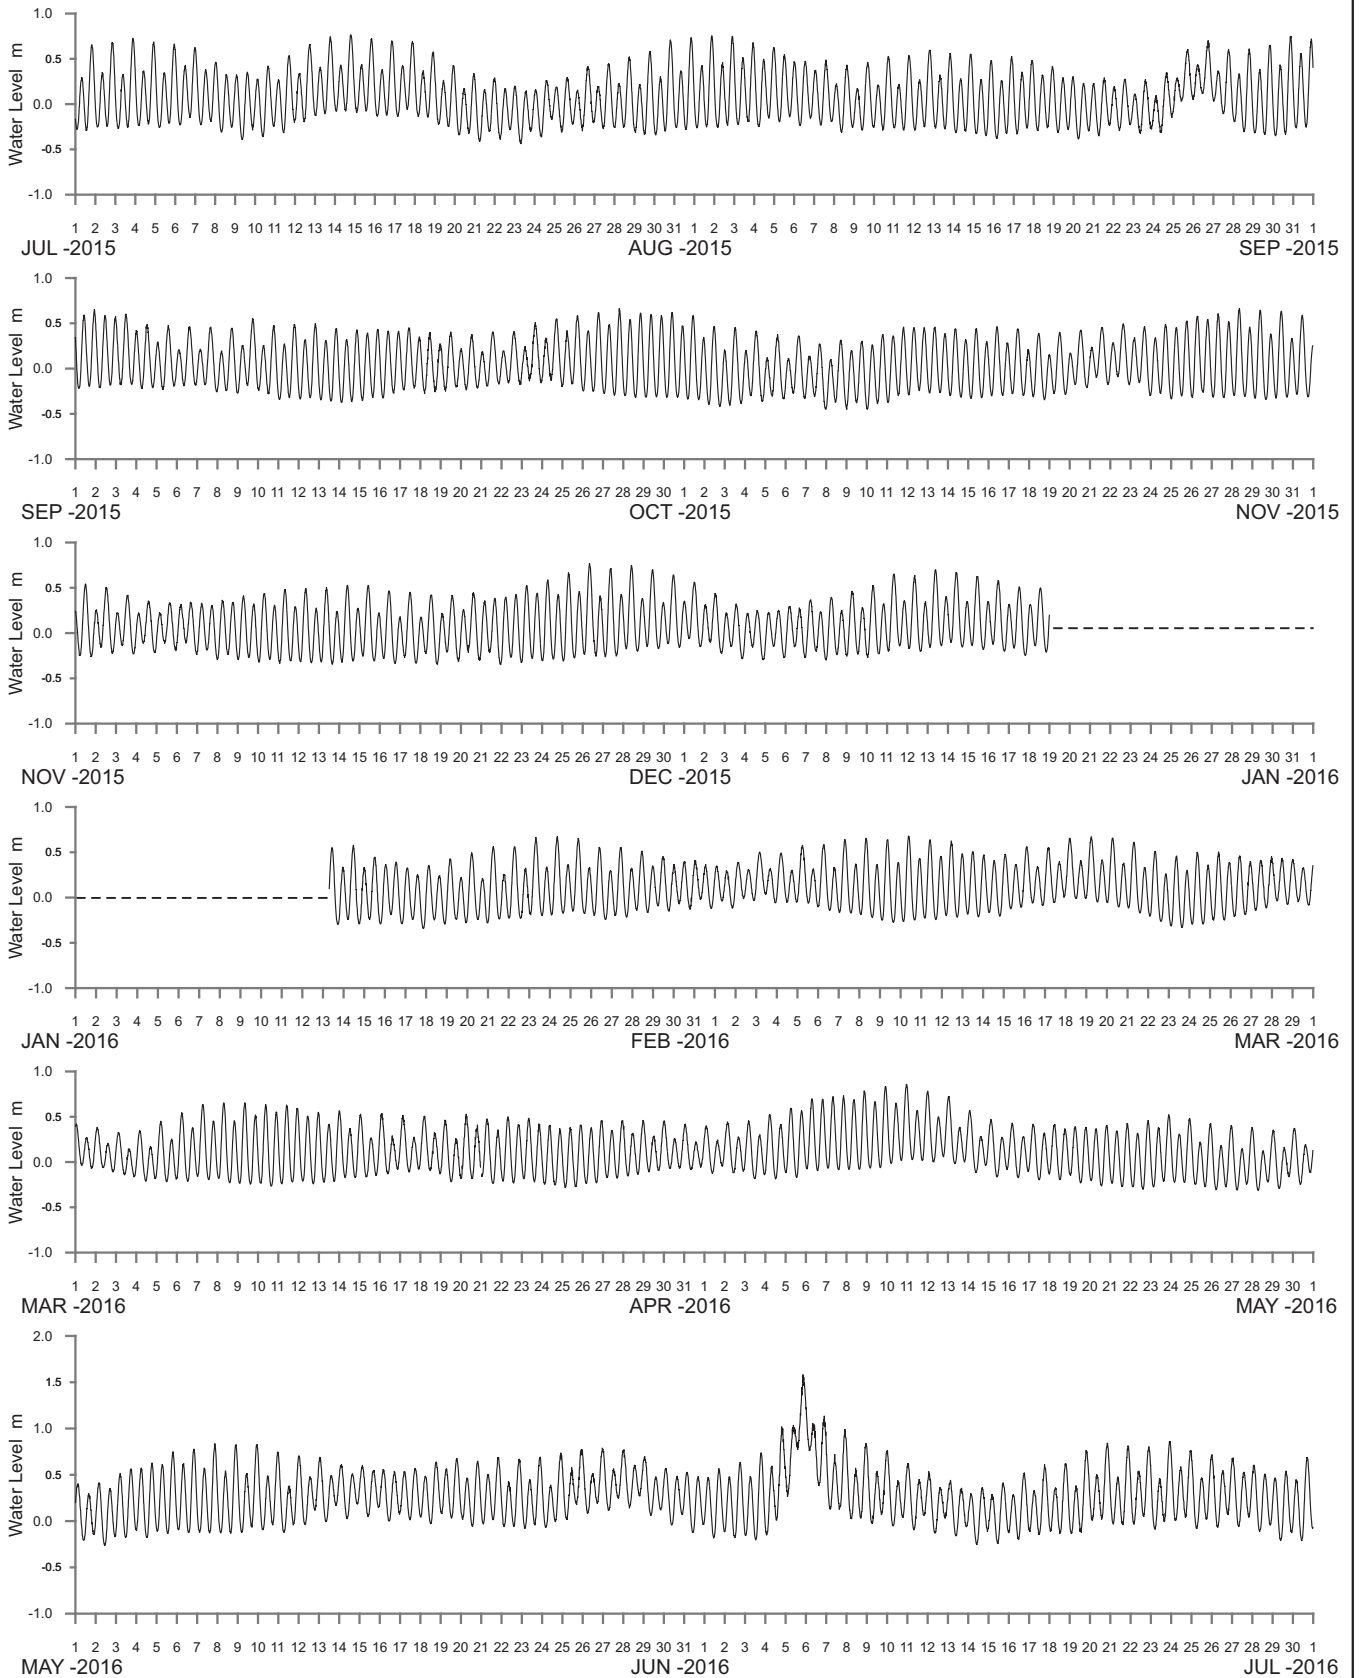
Figure
222

WATER LEVEL REFERENCED TO AUSTRALIAN HEIGHT DATUM

LAKE ILLAWARRA AT LAKE ILLAWARRA ENTRANCE
2015–2016
