River/estuary system	Station name	Figure
Station Locality Map	Wollongong Region	201
Hewitts Creek	Hewitts Creek Upstream	202
Hewitts Creek	Hewitts Creek Downstream	203
Hewitts Creek	Hewitts Creek Entrance	204
Cabbage Tree Creek	Balgownie Road	205
Bellambi	Bellambi	206
Towradgi Creek	Towradgi Creek Upstream	207
Towradgi Creek	Towradgi Creek Downstream	208
Cabbage Tree Creek	Cabbage Tree Creek Upstream	209
Cabbage Tree Creek	Cabbage Tree Creek Downstream	210
Fairy Creek	Fairy Creek Upstream	211
Fairy Creek	Fairy Creek Downstream	212
Byarong Creek	Byarong Creek	213
Byarong Creek	Koloona Avenue Upstream	214
Byarong Creek	Koloona Avenue Downstream	215
American Creek	Blackmans Parade Upstream	216
American Creek	Blackmans Parade Downstream	217
Station Locality Map	Lake Illawarra Region	218
Mullet Creek	Mullet Creek	219
Lake Illawarra	Koonawarra Bay	220
Lake Illawarra	Cudgeree Bay	221
Lake Illawarra	Lake Illawarra Entrance	222

MHL
Report 2474

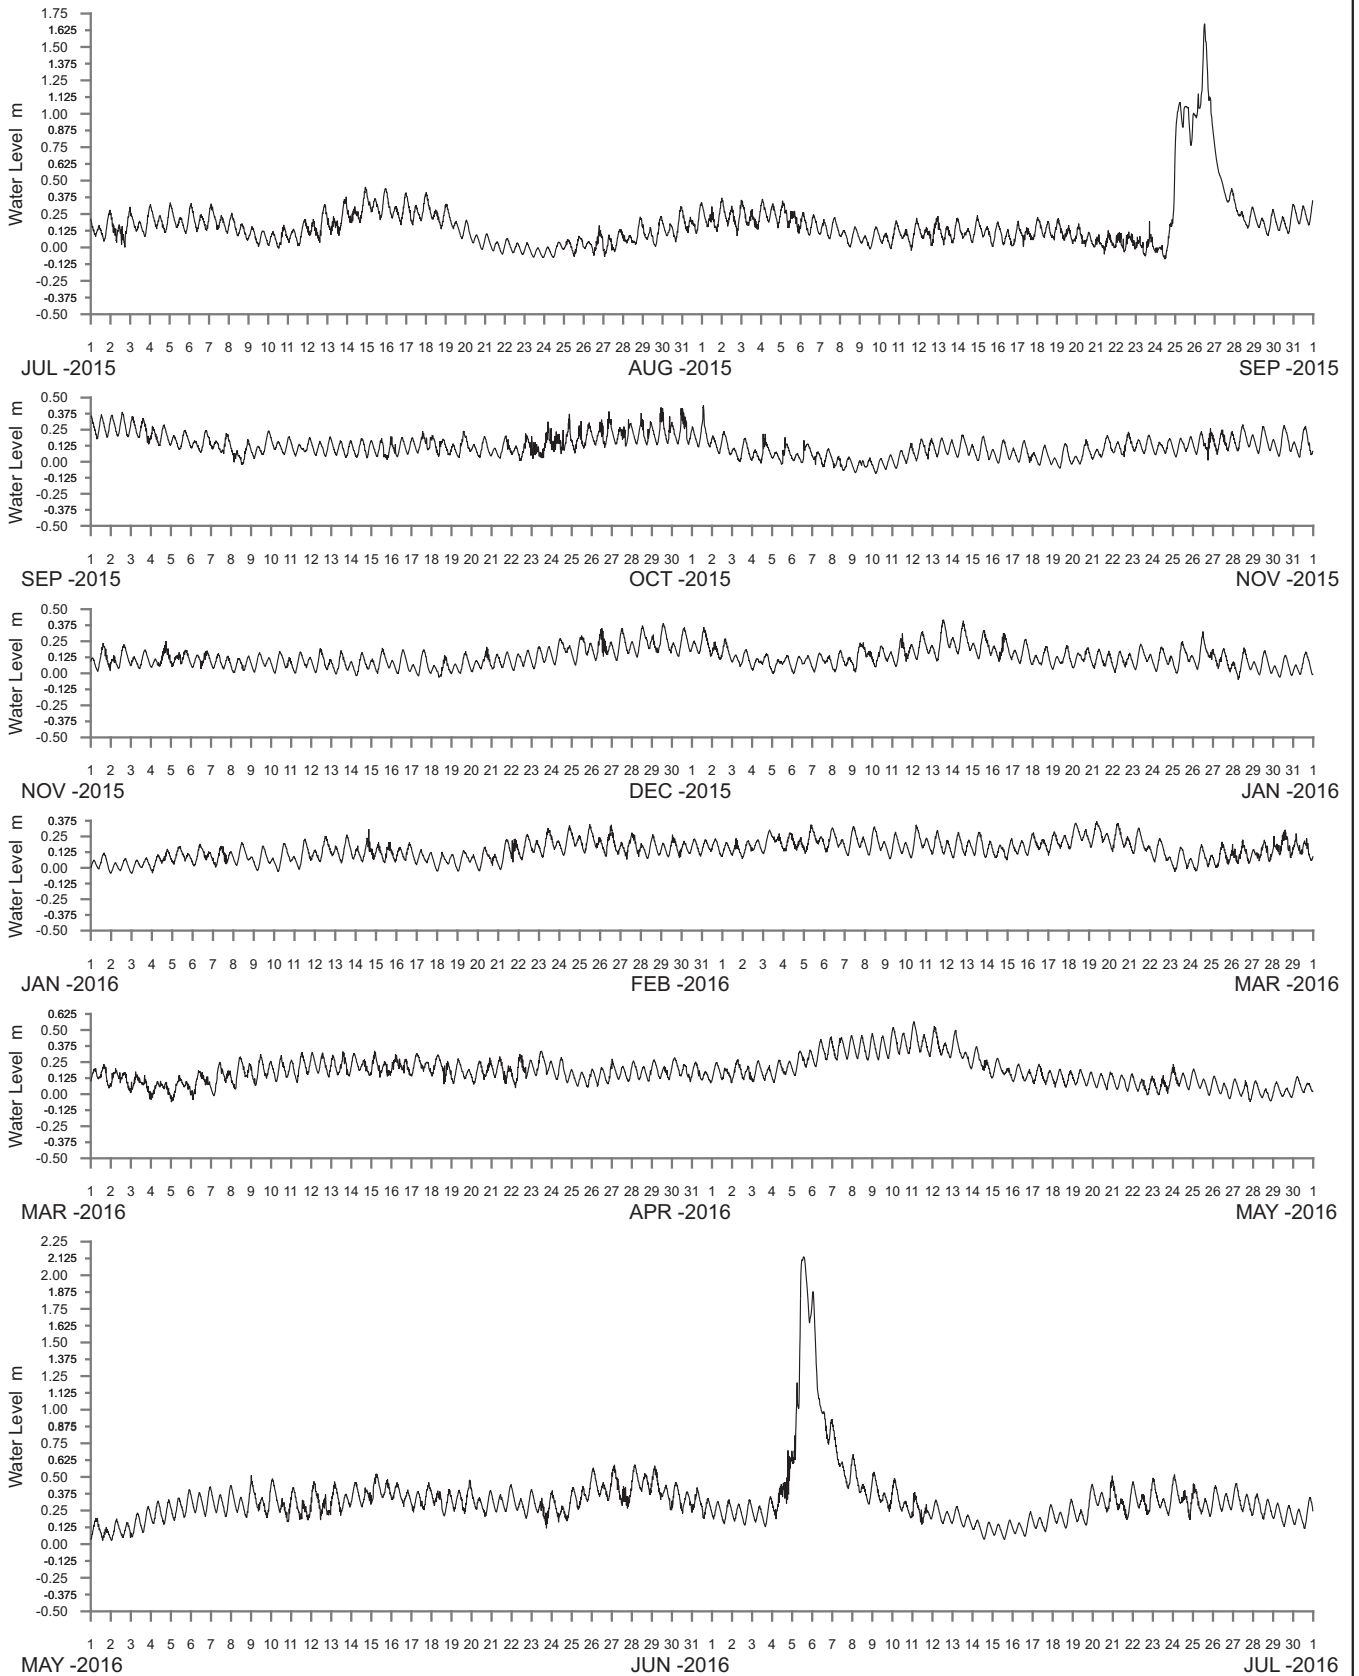
Figure
223

WATER LEVEL REFERENCED TO AUSTRALIAN HEIGHT DATUM

MACQUARIE RIVULET AT PRINCES HIGHWAY
2015–2016

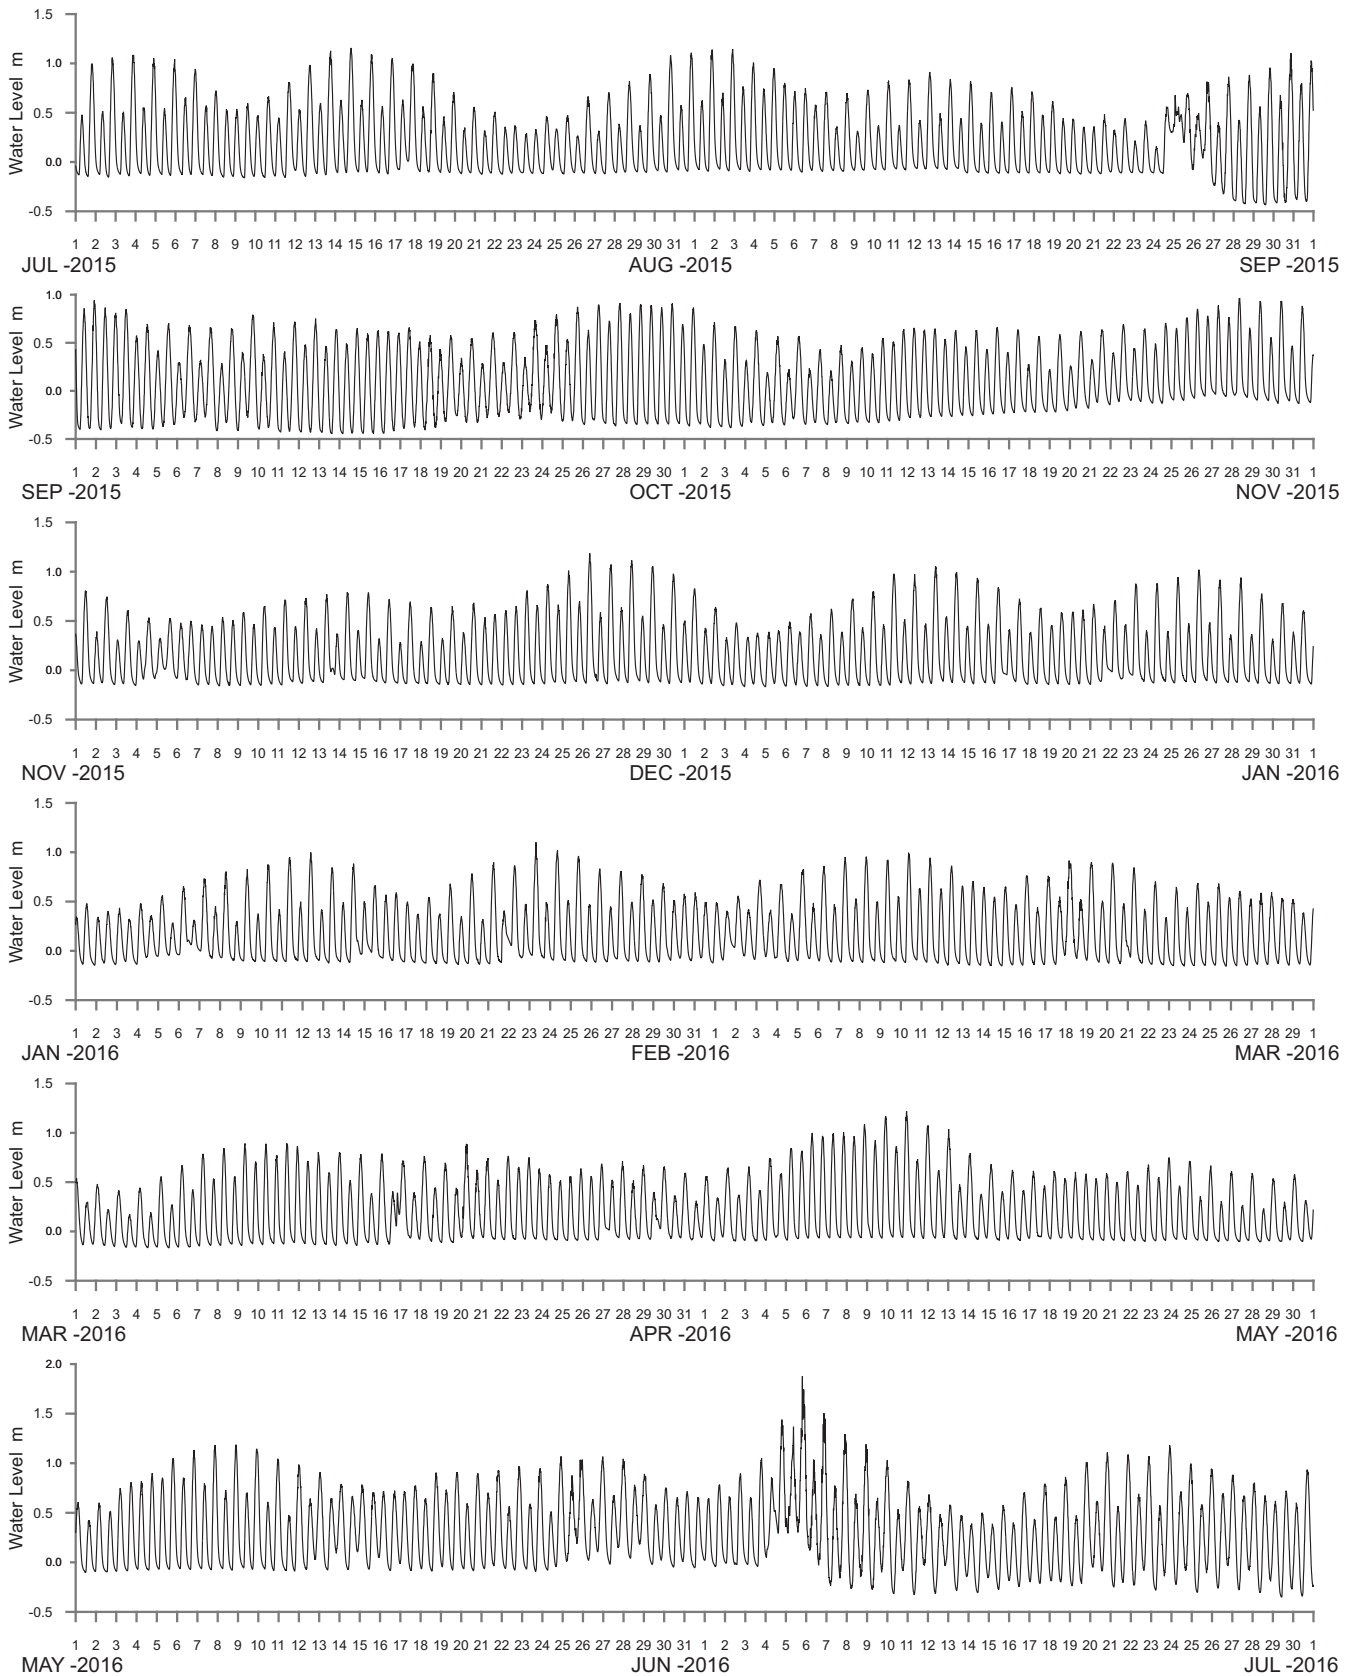
Figure
224

WATER LEVEL REFERENCED TO AUSTRALIAN HEIGHT DATUM

LITTLE LAKE AT LITTLE LAKE ENTRANCE
2015–2016

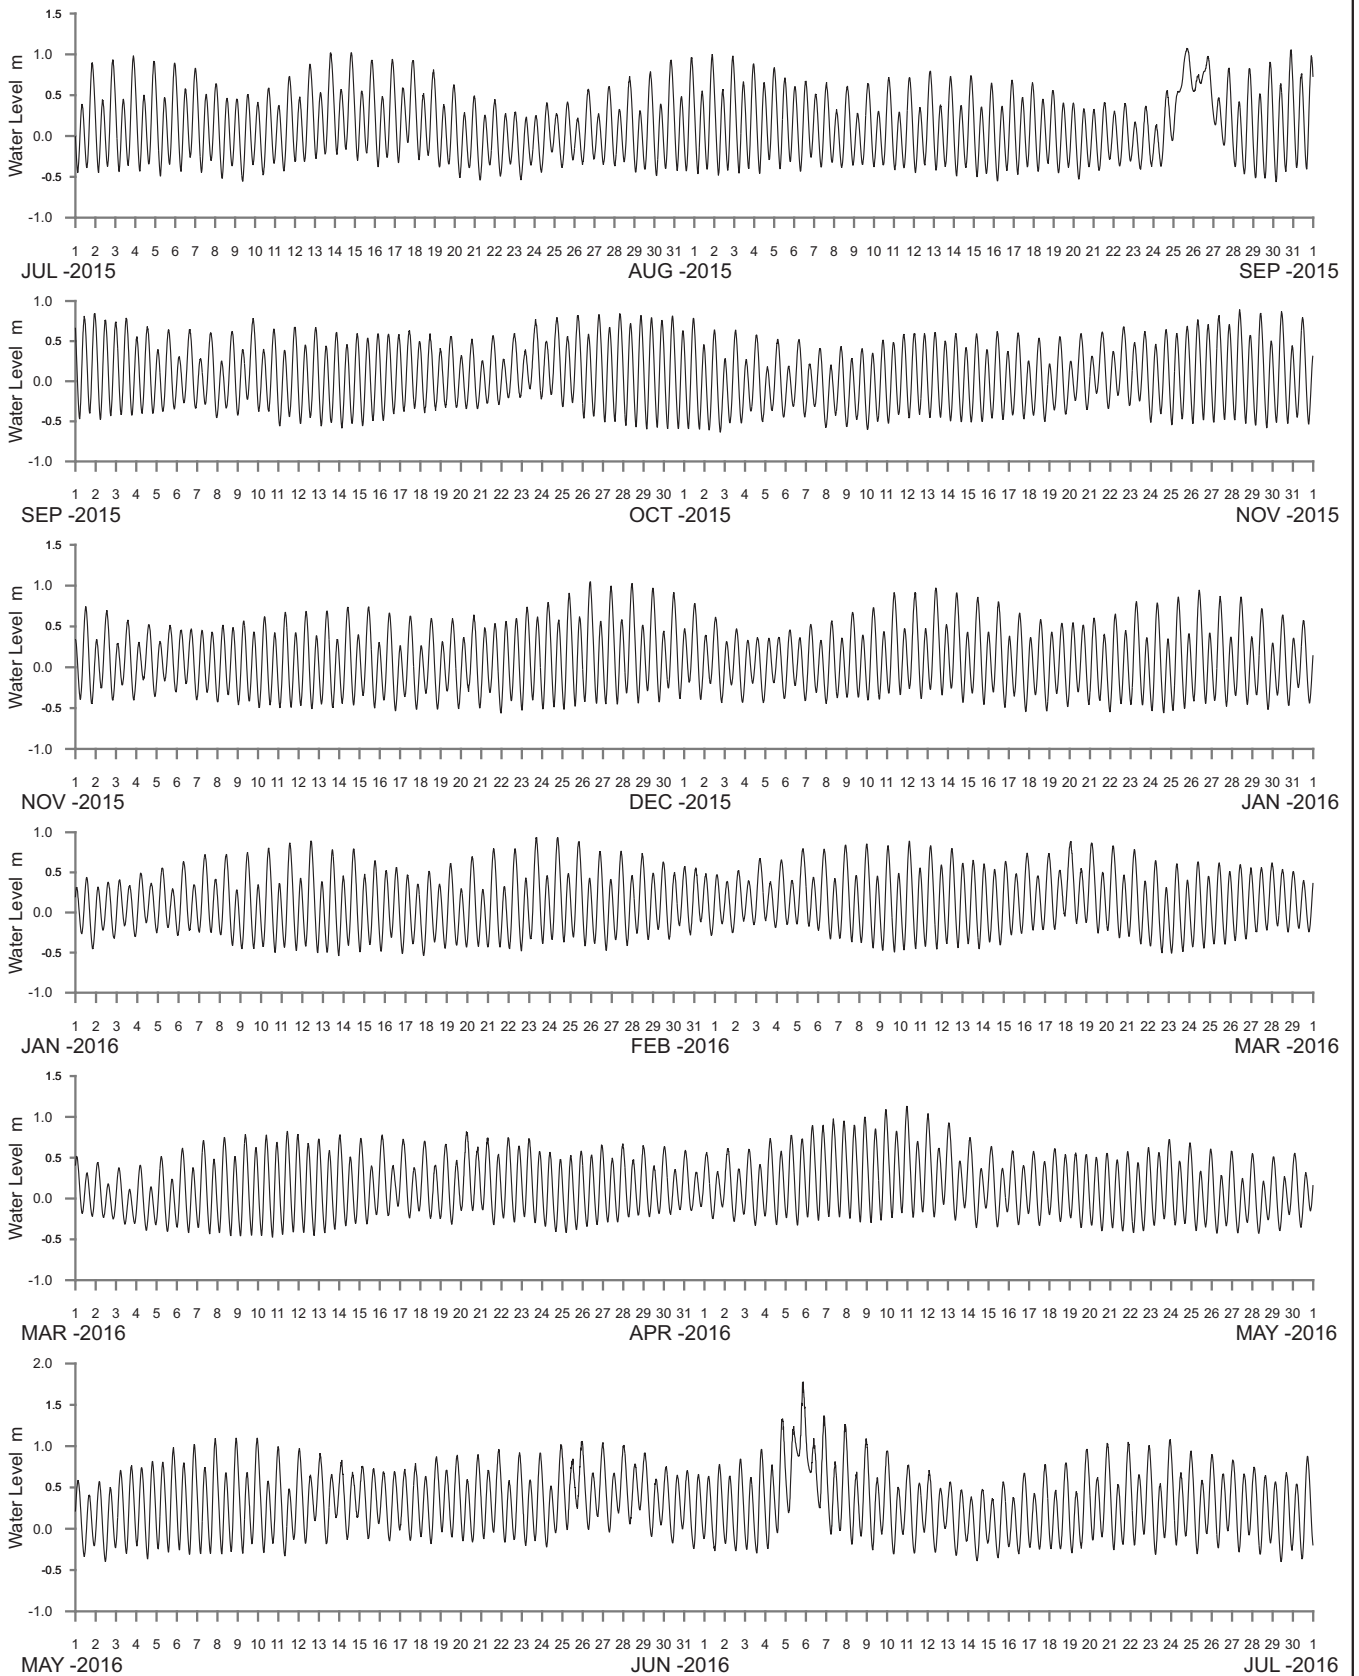
Figure
226

WATER LEVEL REFERENCED TO AUSTRALIAN HEIGHT DATUM

MINNAMURRA RIVER AT MINNAMURRA
2015–2016

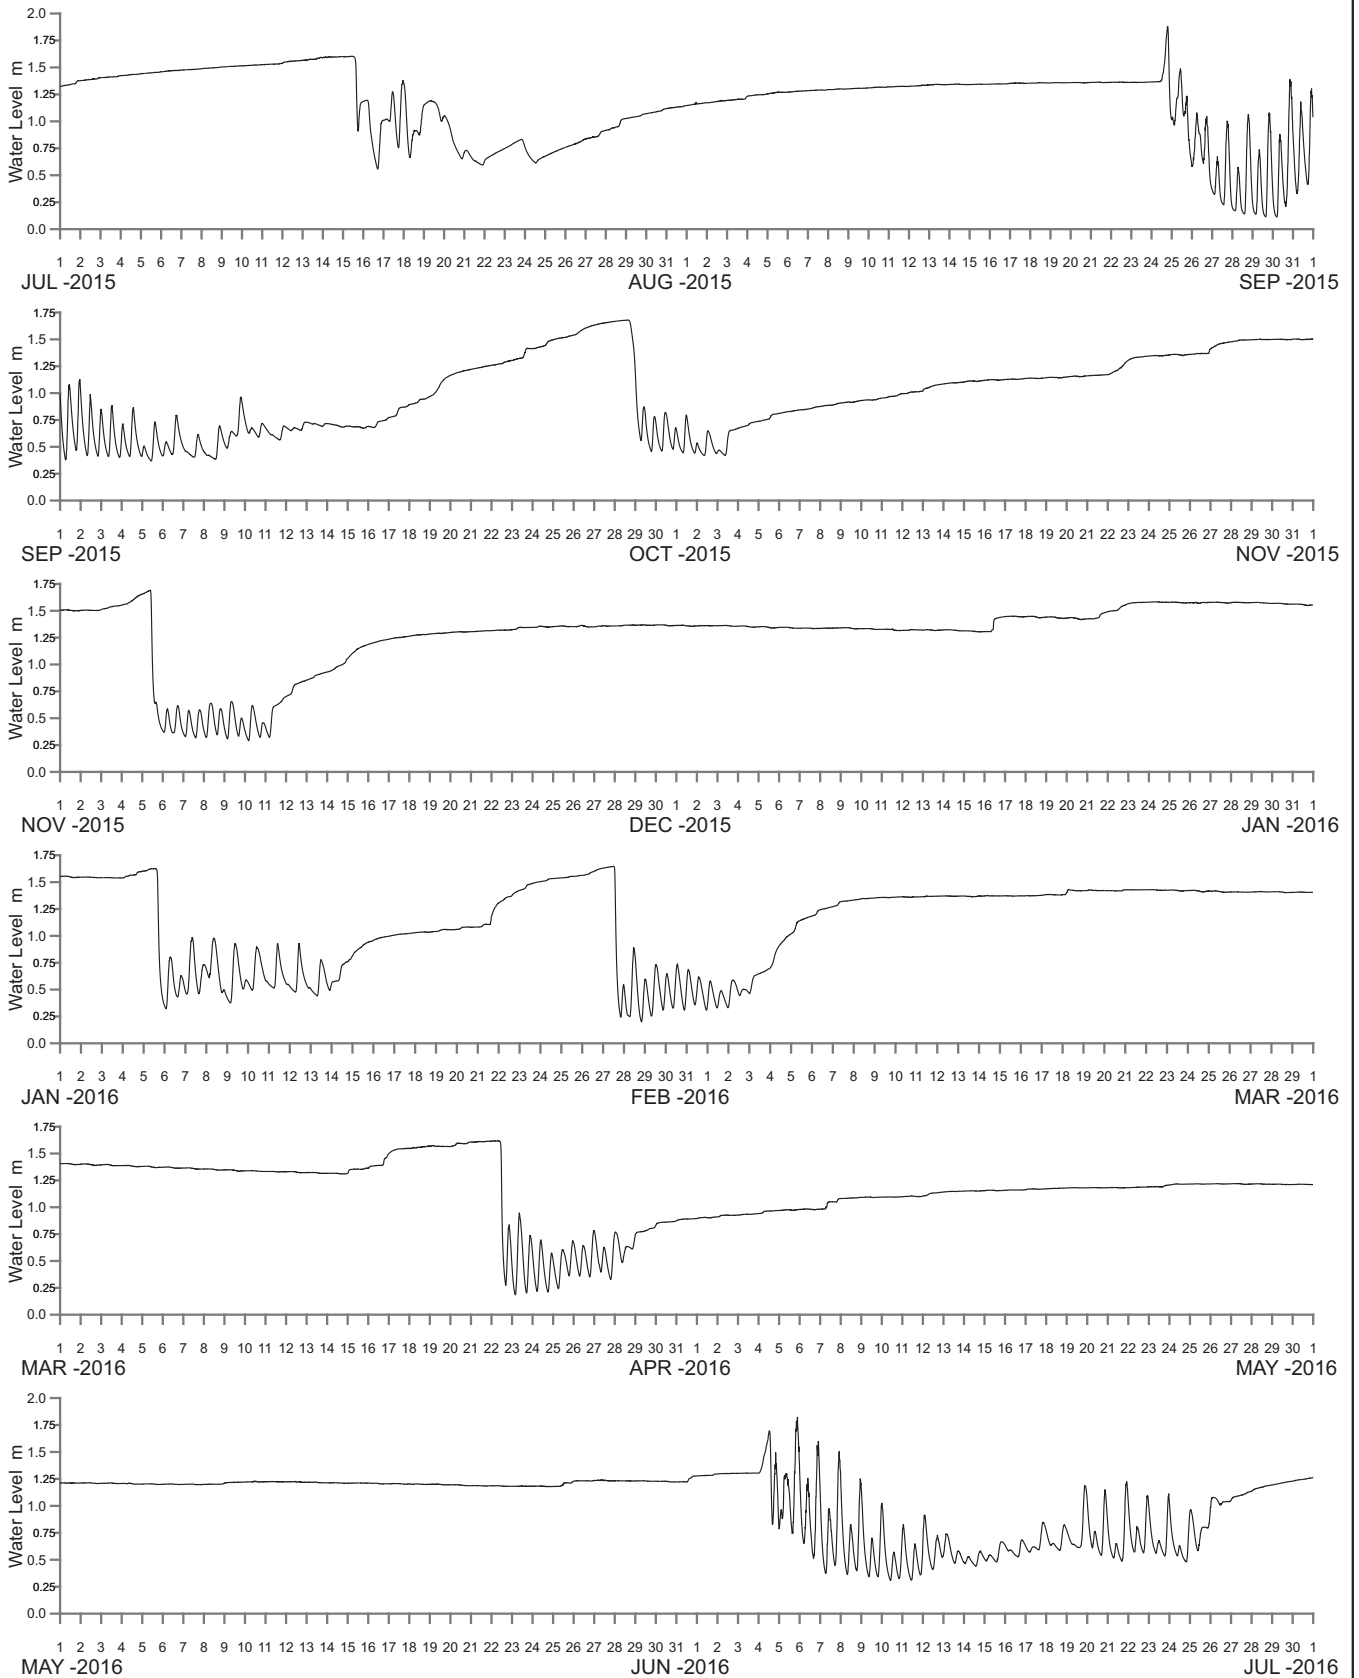
Figure
227

WATER LEVEL REFERENCED TO AUSTRALIAN HEIGHT DATUM

WERRI LAGOON AT WERRI LAGOON
2015–2016

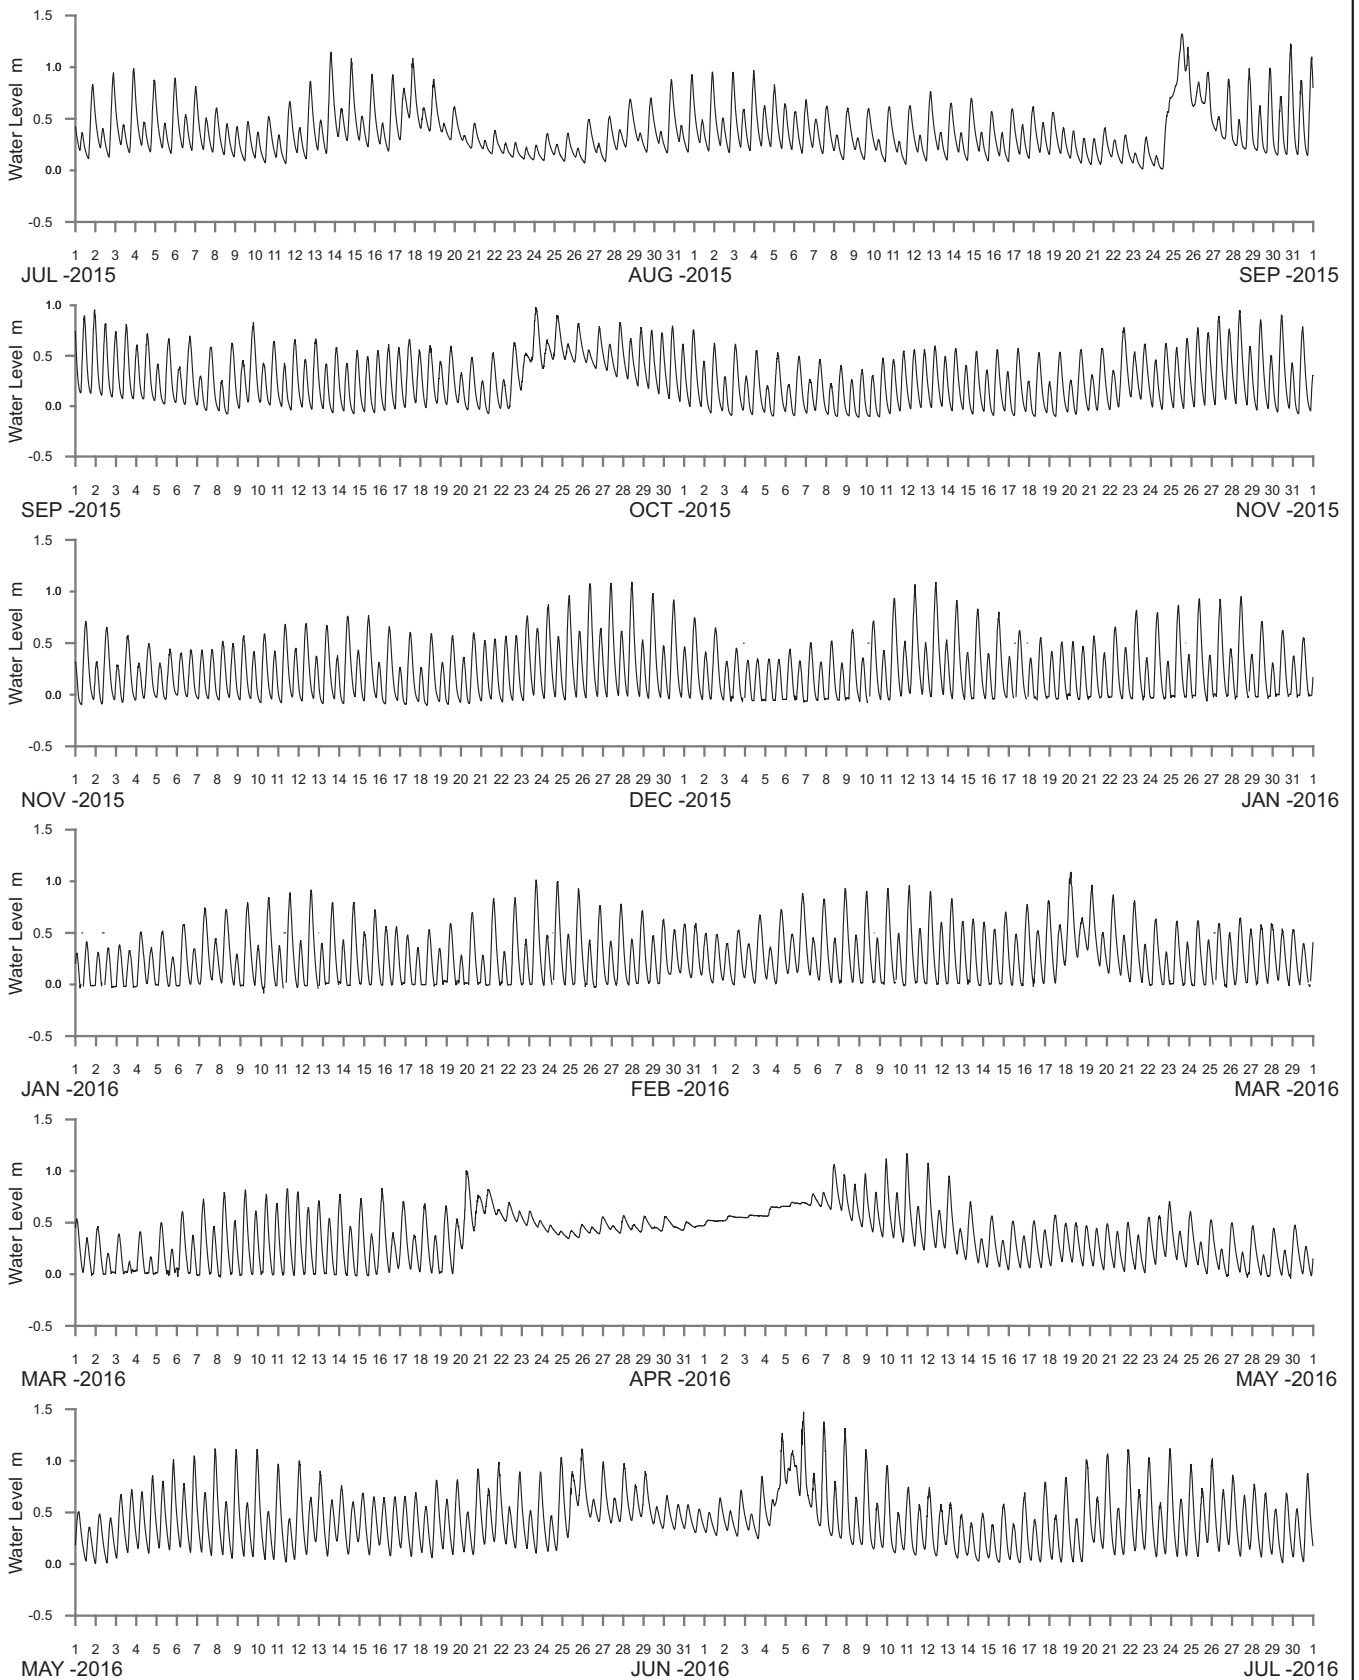
Figure
228

WATER LEVEL REFERENCED TO AUSTRALIAN HEIGHT DATUM

CROOKED CREEK AT GERROA
2015–2016

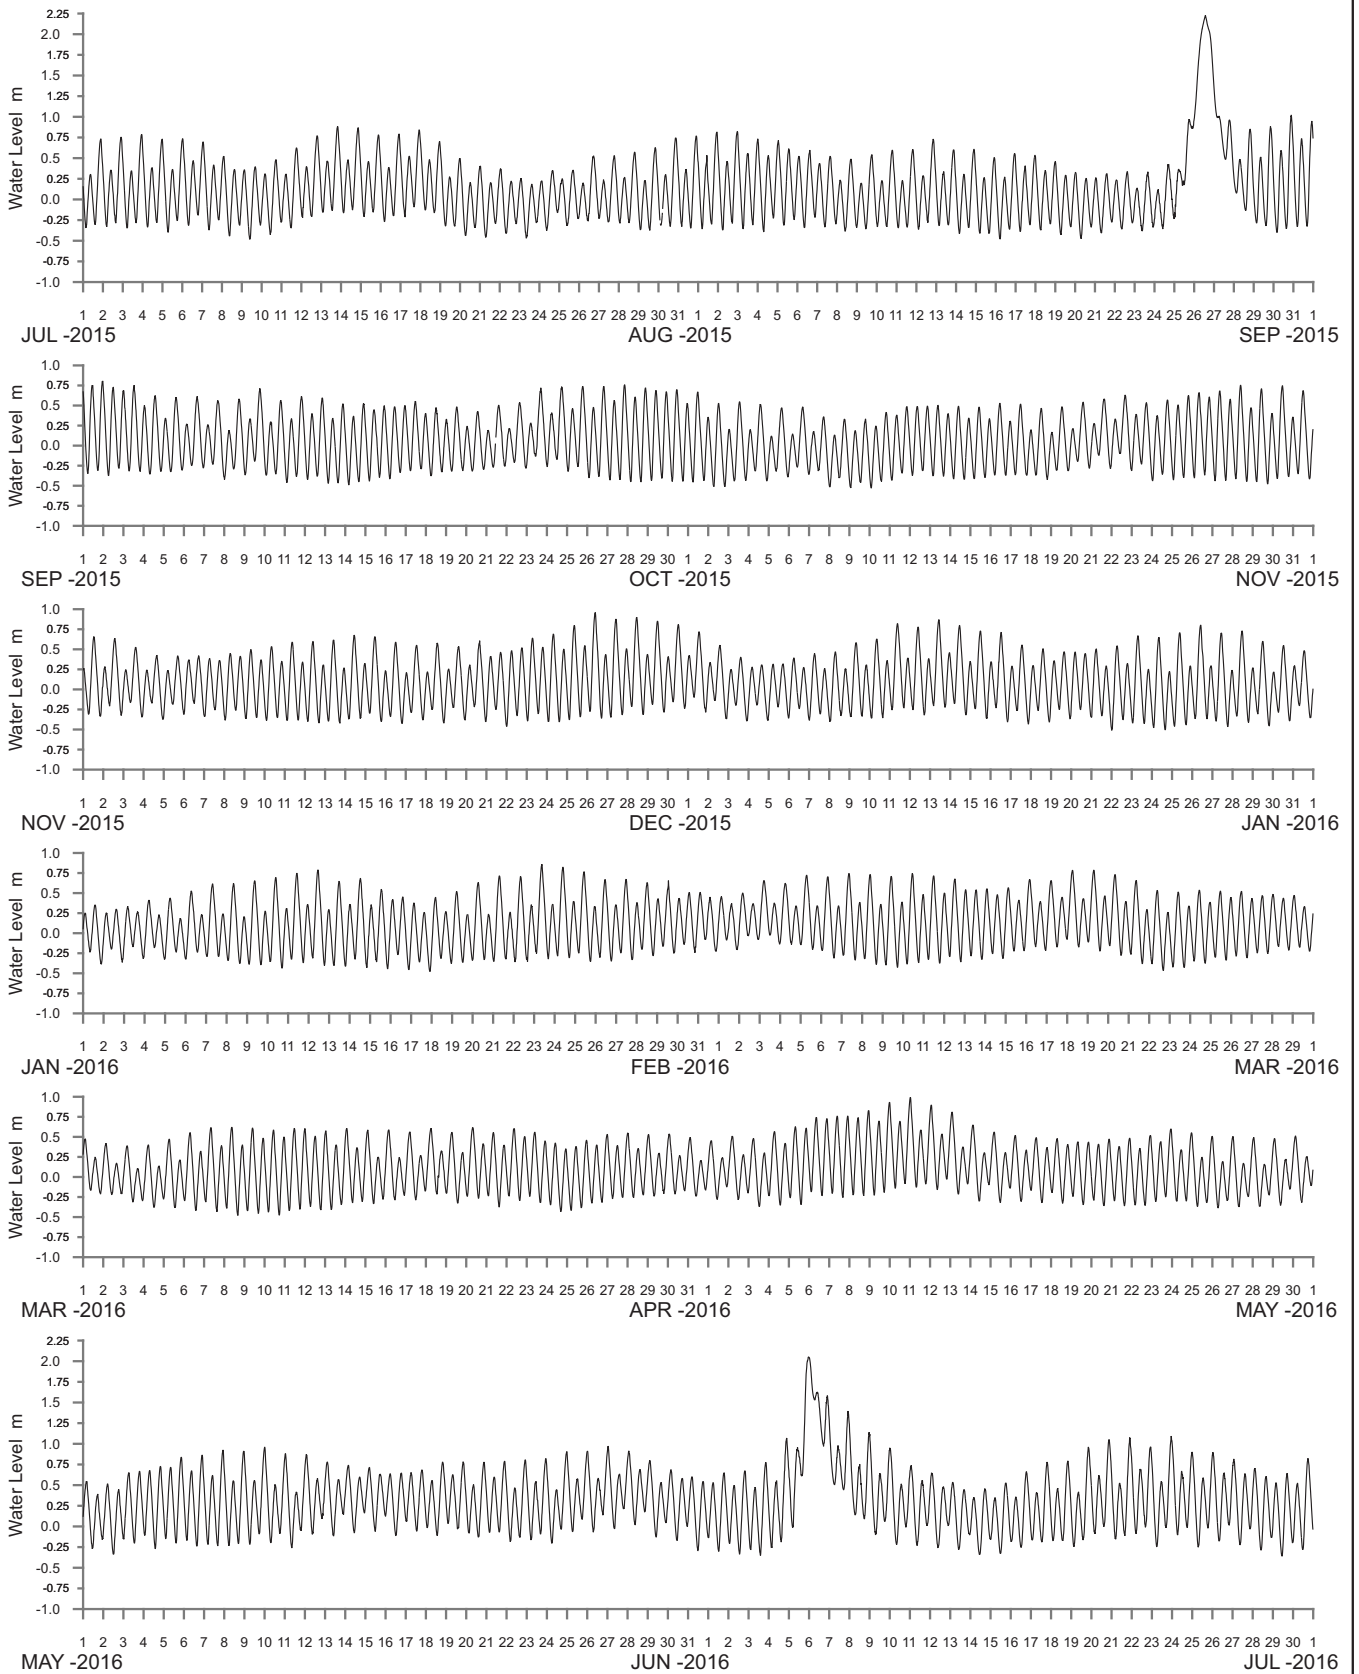
Figure
230

WATER LEVEL REFERENCED TO AUSTRALIAN HEIGHT DATUM

SHOALHAVEN RIVER AT SHOALHAVEN HEADS
2015–2016

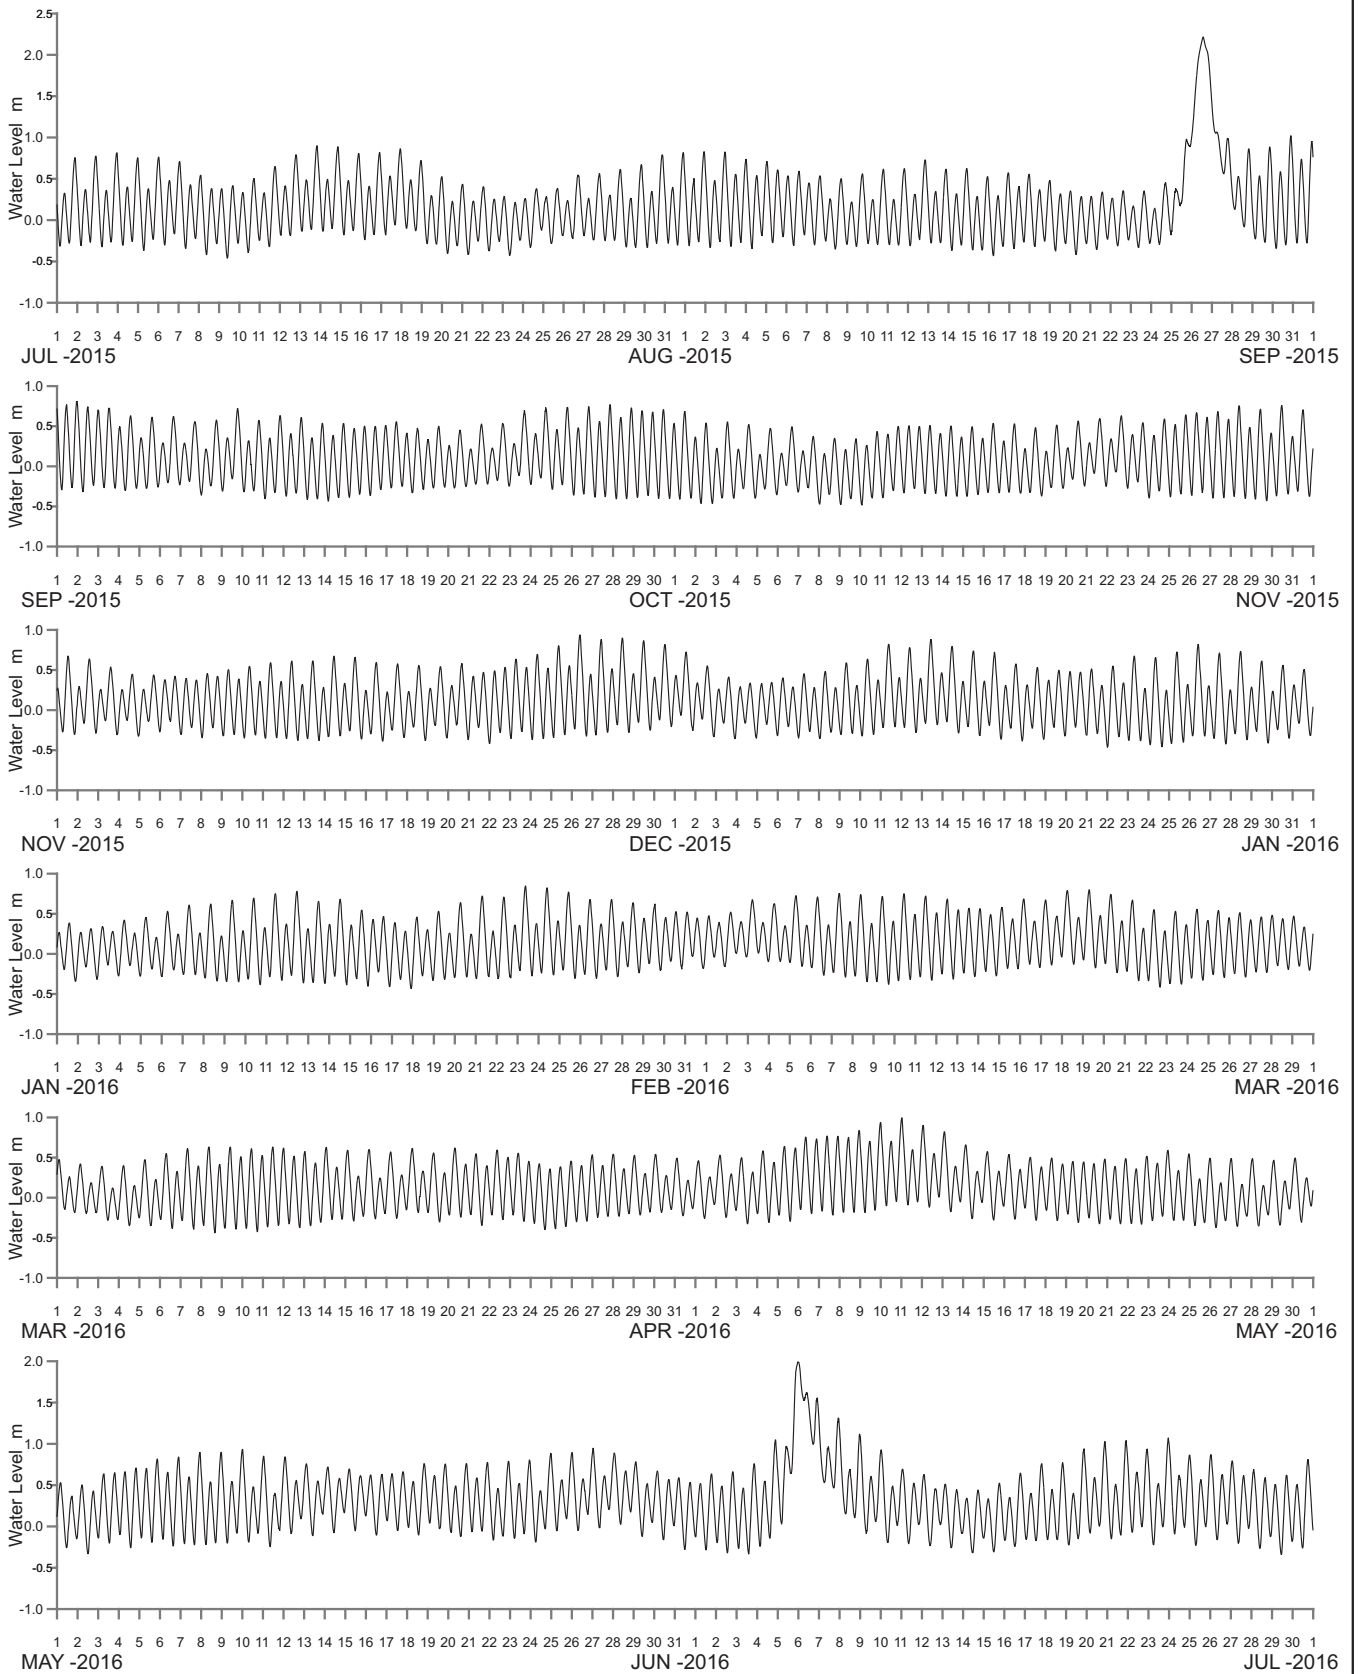
Figure
231

WATER LEVEL REFERENCED TO AUSTRALIAN HEIGHT DATUM

SHOALHAVEN RIVER AT HAY STREET
2015–2016

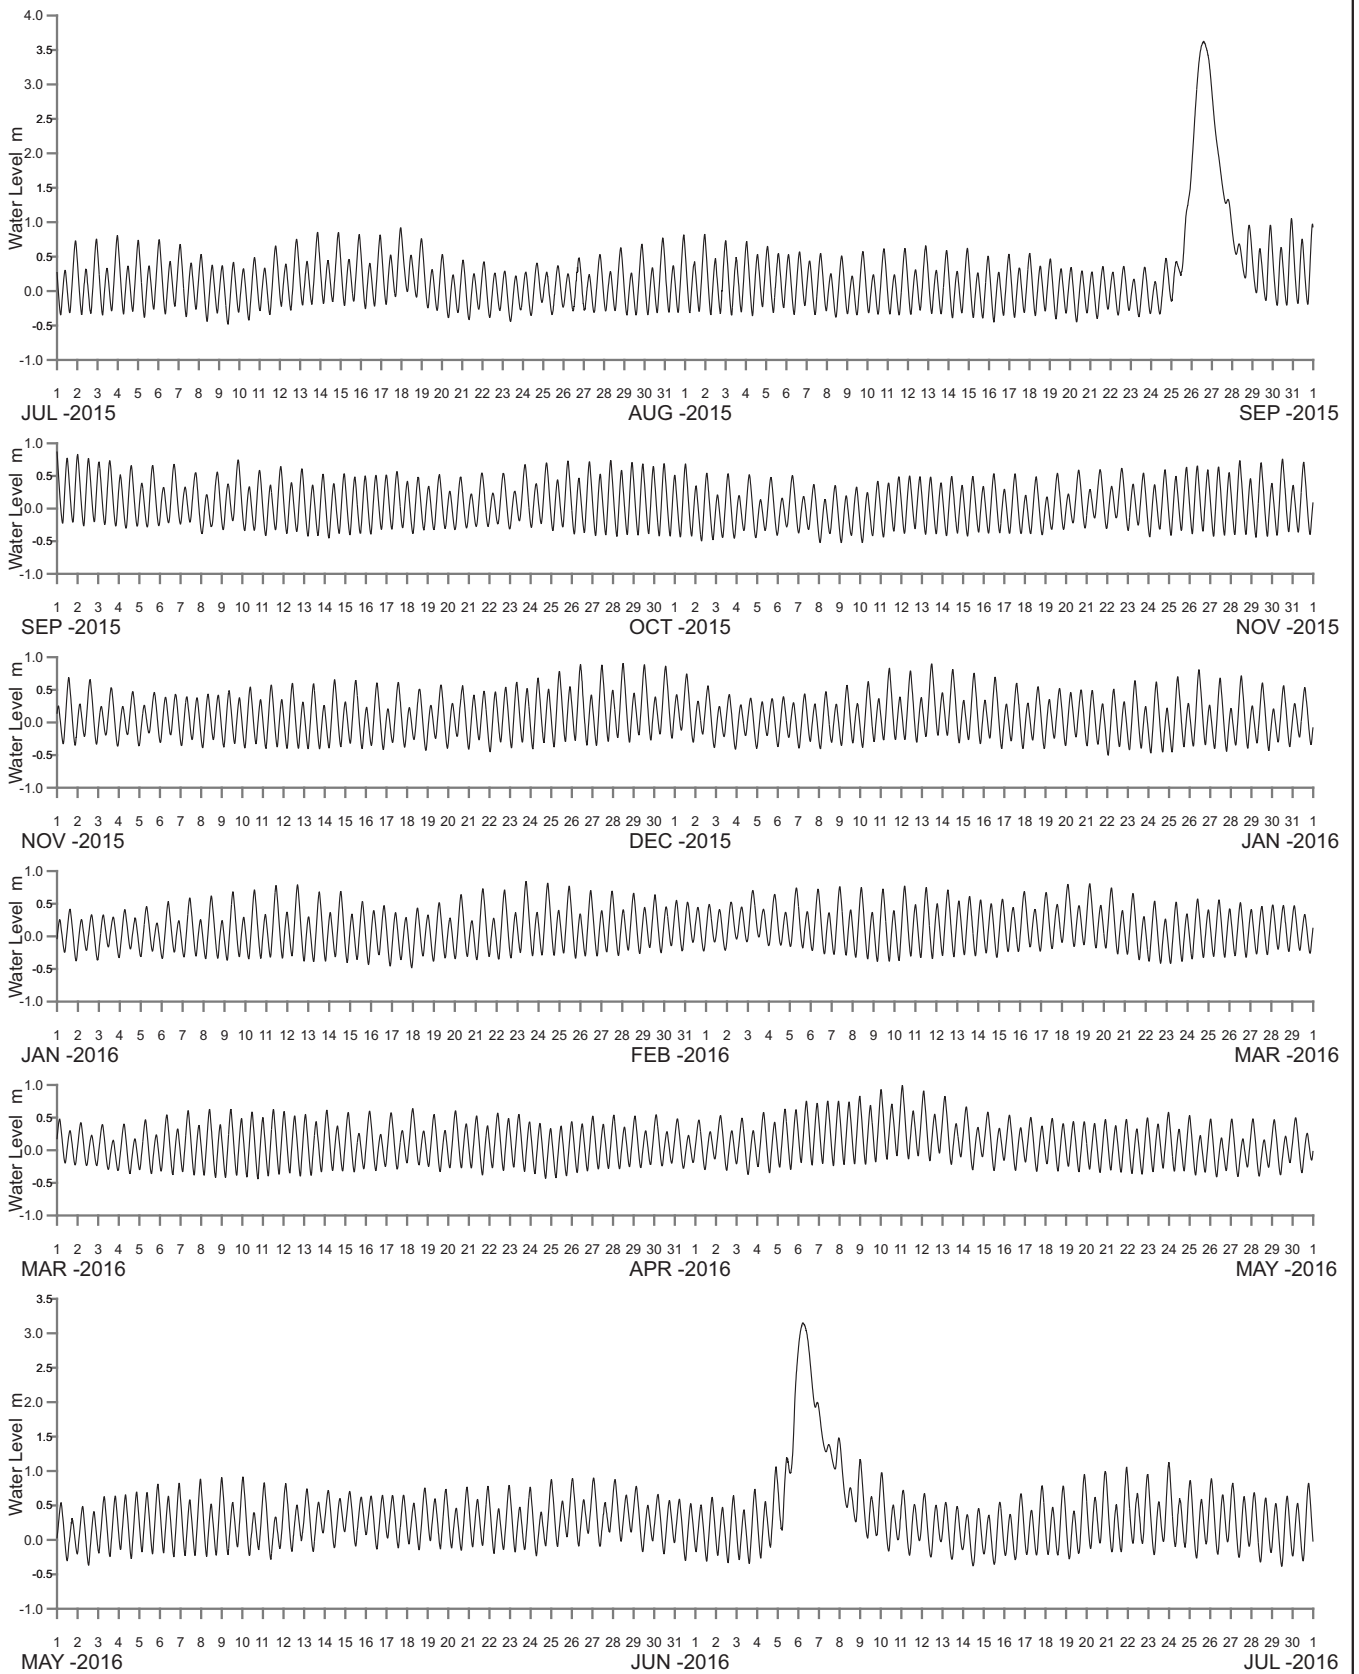
Figure
232

WATER LEVEL REFERENCED TO AUSTRALIAN HEIGHT DATUM

SHOALHAVEN RIVER AT TERARA
2015–2016

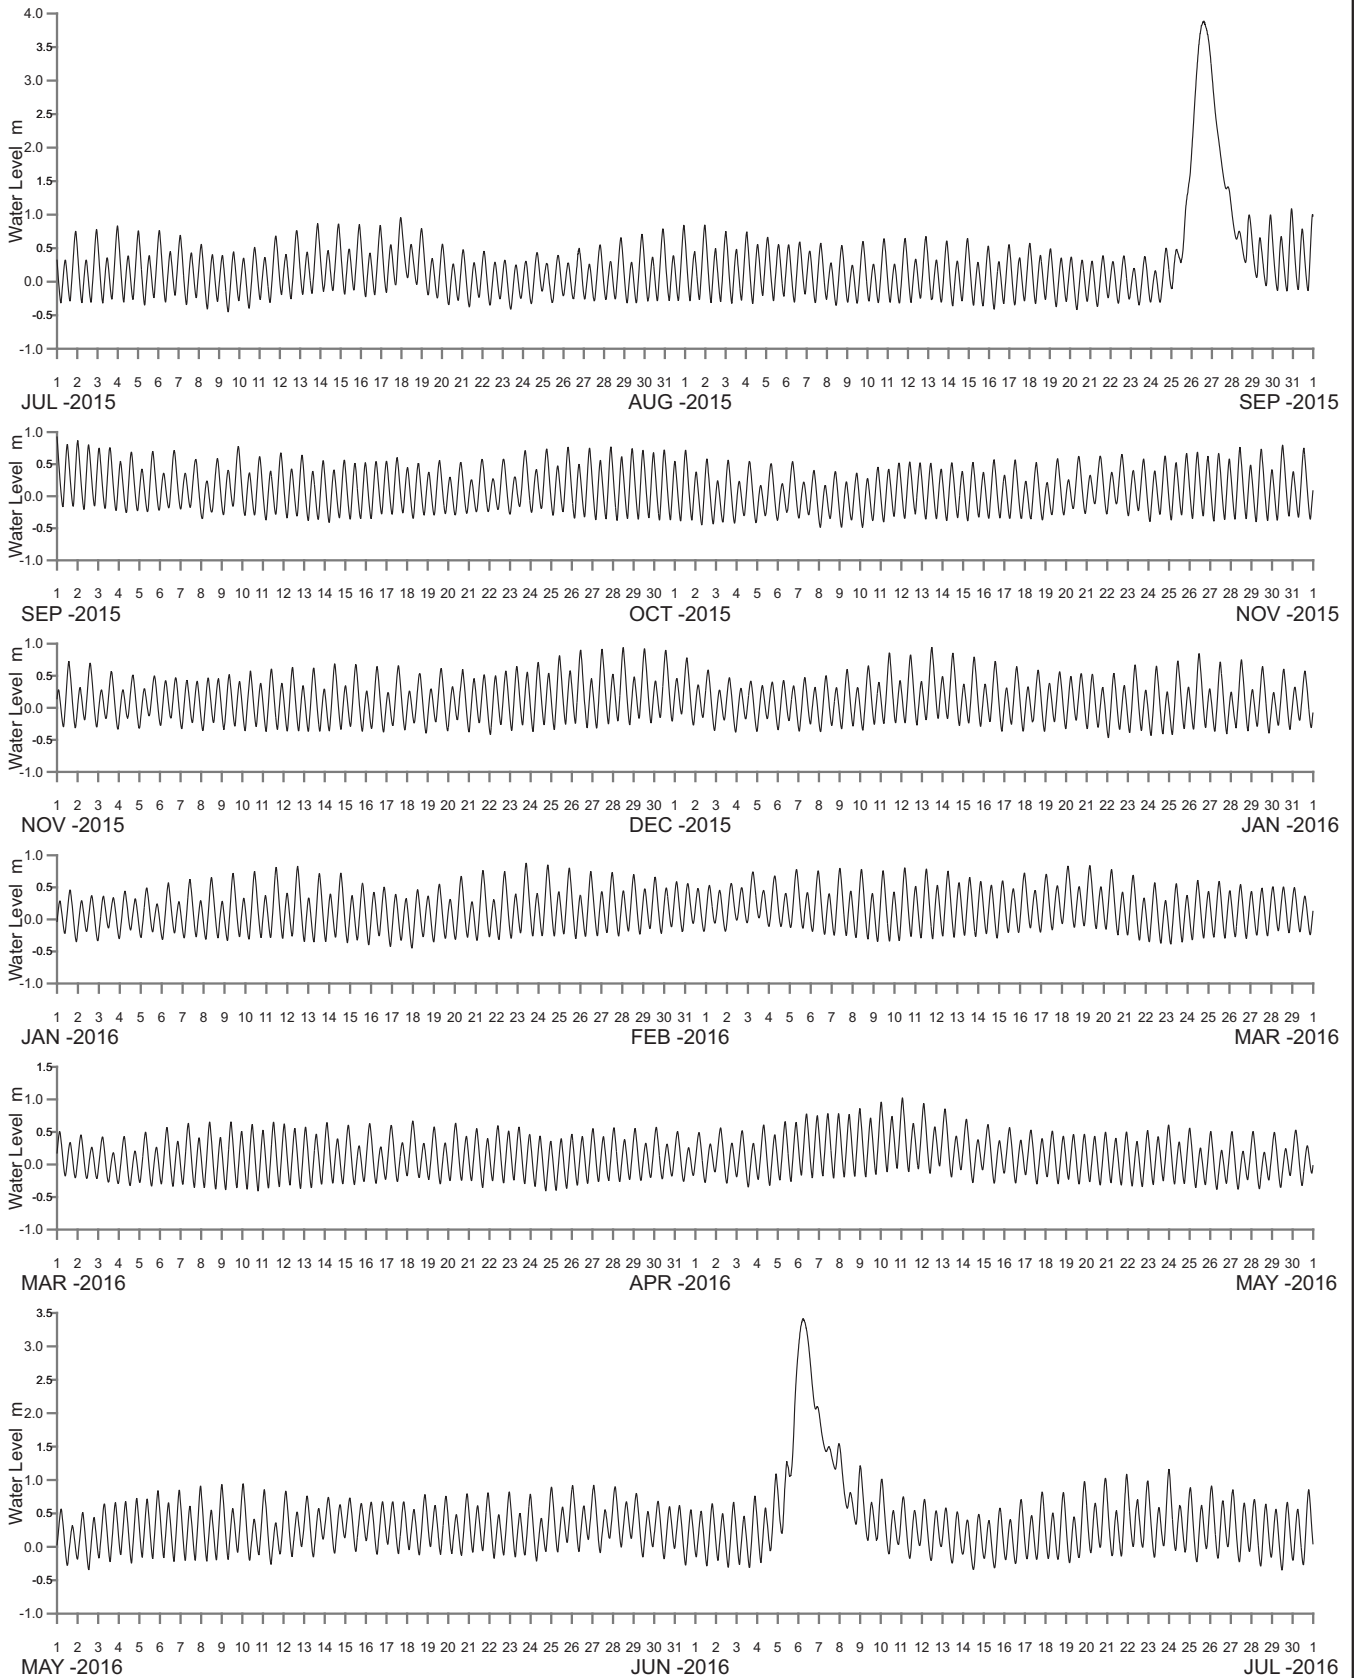
Figure
233

WATER LEVEL REFERENCED TO AUSTRALIAN HEIGHT DATUM

SHOALHAVEN RIVER AT NOWRA BRIDGE
2015–2016

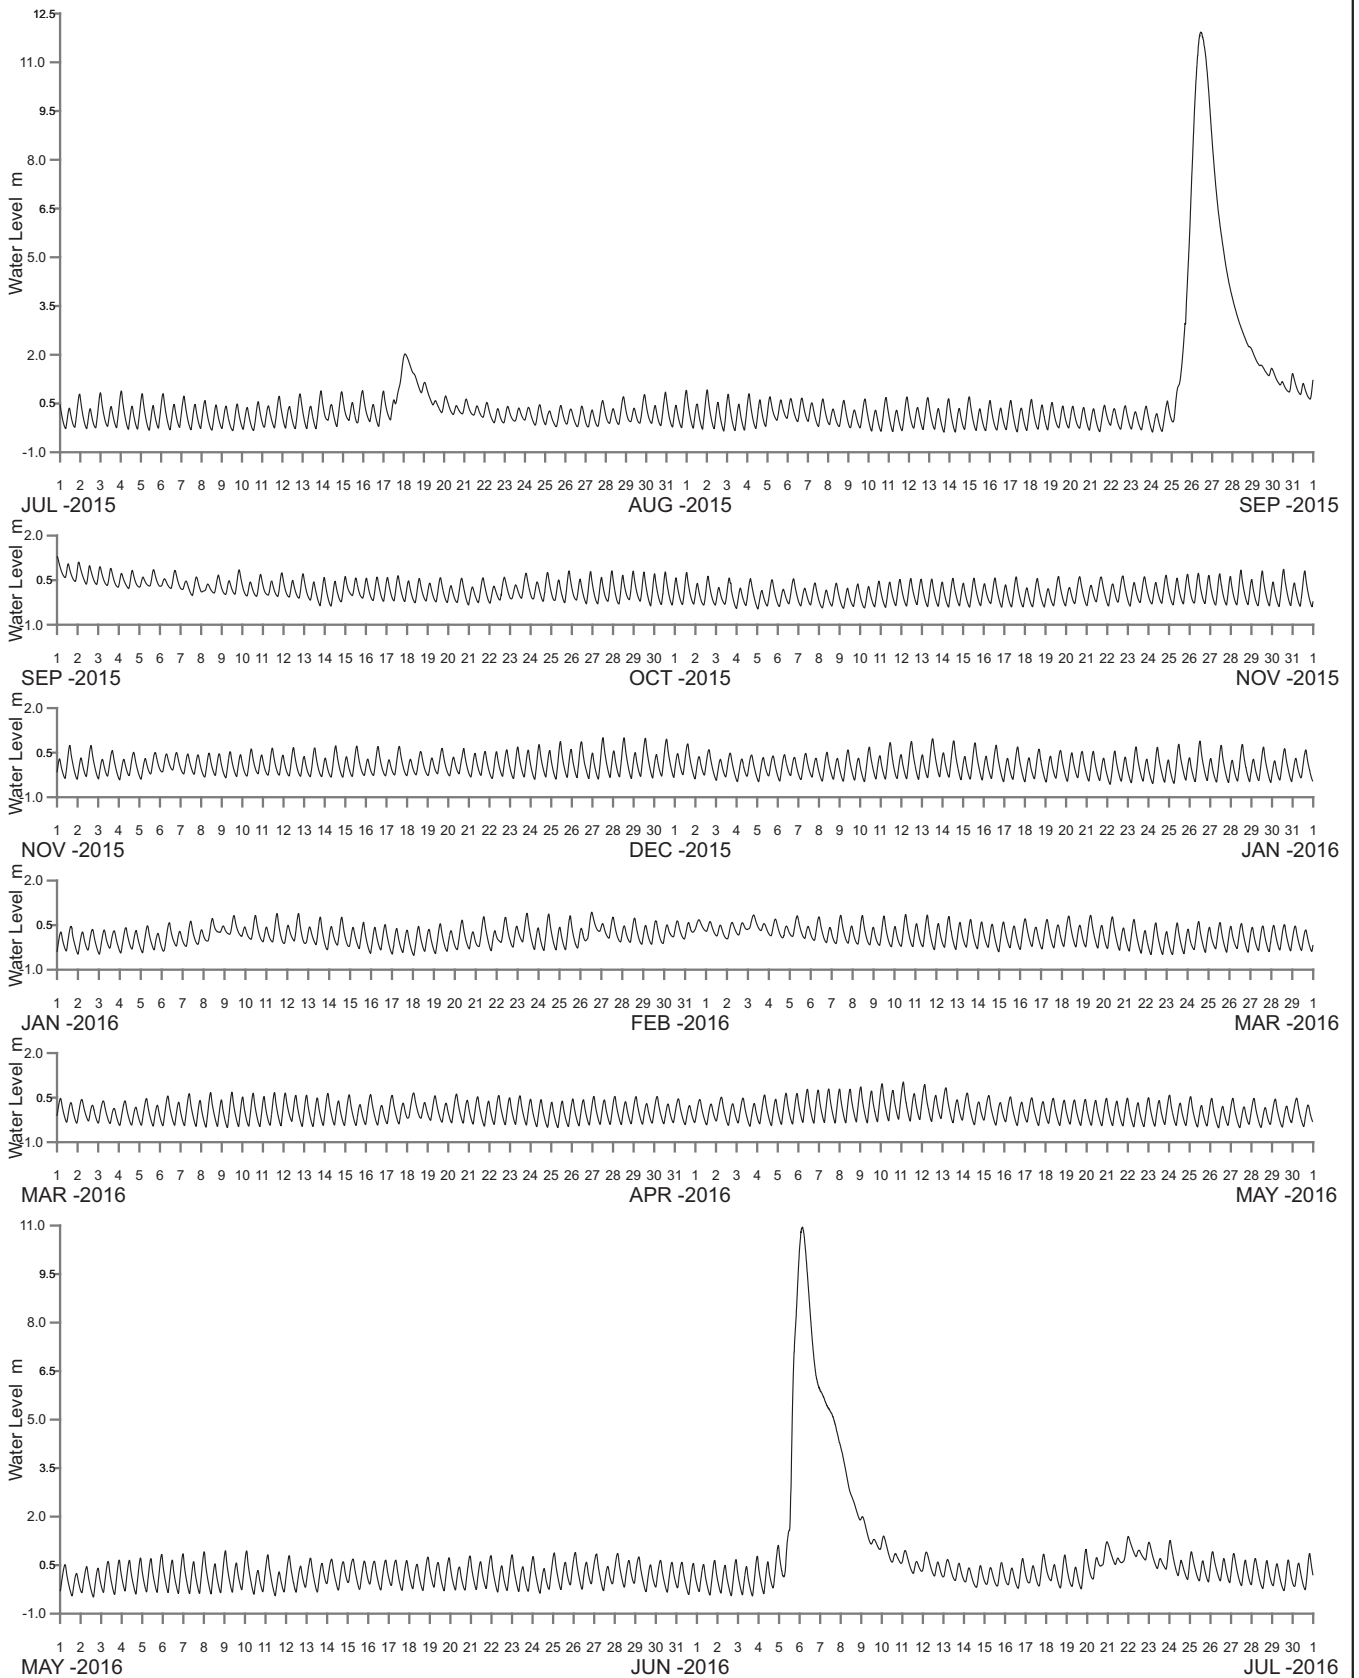
Figure
234

WATER LEVEL REFERENCED TO AUSTRALIAN HEIGHT DATUM

SHOALHAVEN RIVER AT GRADYS CARAVAN PARK
2015–2016
