River/estuary system	Station name	Figure
Station Locality Map	Wollongong Region	201
Hewitts Creek	Hewitts Creek Upstream	202
Hewitts Creek	Hewitts Creek Downstream	203
Hewitts Creek	Hewitts Creek Entrance	204
Cabbage Tree Creek	Balgownie Road	205
Bellambi	Bellambi	206
Towradgi Creek	Towradgi Creek Upstream	207
Towradgi Creek	Towradgi Creek Downstream	208
Cabbage Tree Creek	Cabbage Tree Creek Upstream	209
Cabbage Tree Creek	Cabbage Tree Creek Downstream	210
Fairy Creek	Fairy Creek Upstream	211
Fairy Creek	Fairy Creek Downstream	212
Byarong Creek	Byarong Creek	213
Byarong Creek	Koloona Avenue Upstream	214
Byarong Creek	Koloona Avenue Downstream	215
American Creek	Blackmans Parade Upstream	216
American Creek	Blackmans Parade Downstream	217
Station Locality Map	Lake Illawarra Region	218
Mullet Creek	Mullet Creek	219
Lake Illawarra	Koonawarra Bay	220
Lake Illawarra	Cudgeree Bay	221
Lake Illawarra	Lake Illawarra Entrance	222

MHL
Report 2474

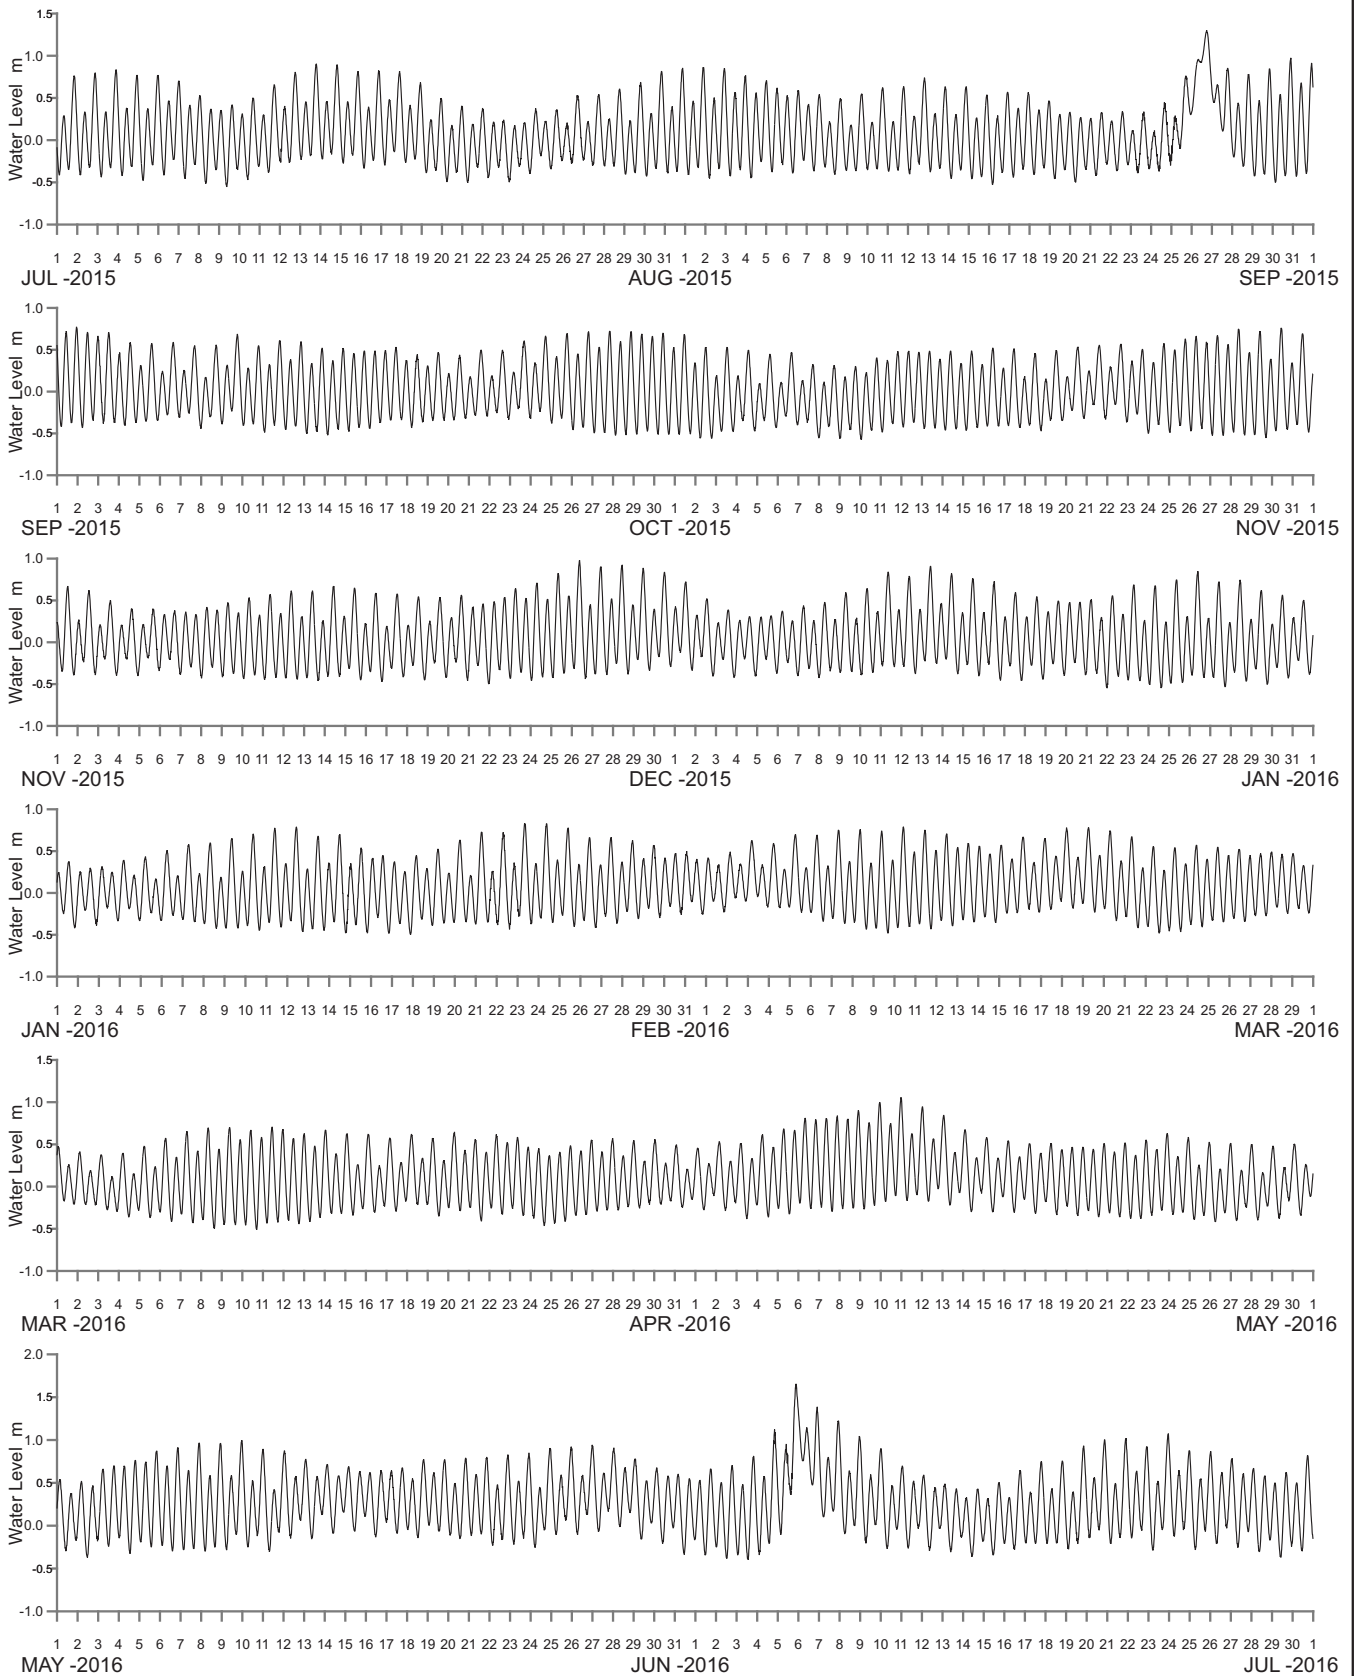
Figure
235

WATER LEVEL REFERENCED TO AUSTRALIAN HEIGHT DATUM

CROOKHAVEN RIVER AT GREENWELL POINT
2015–2016

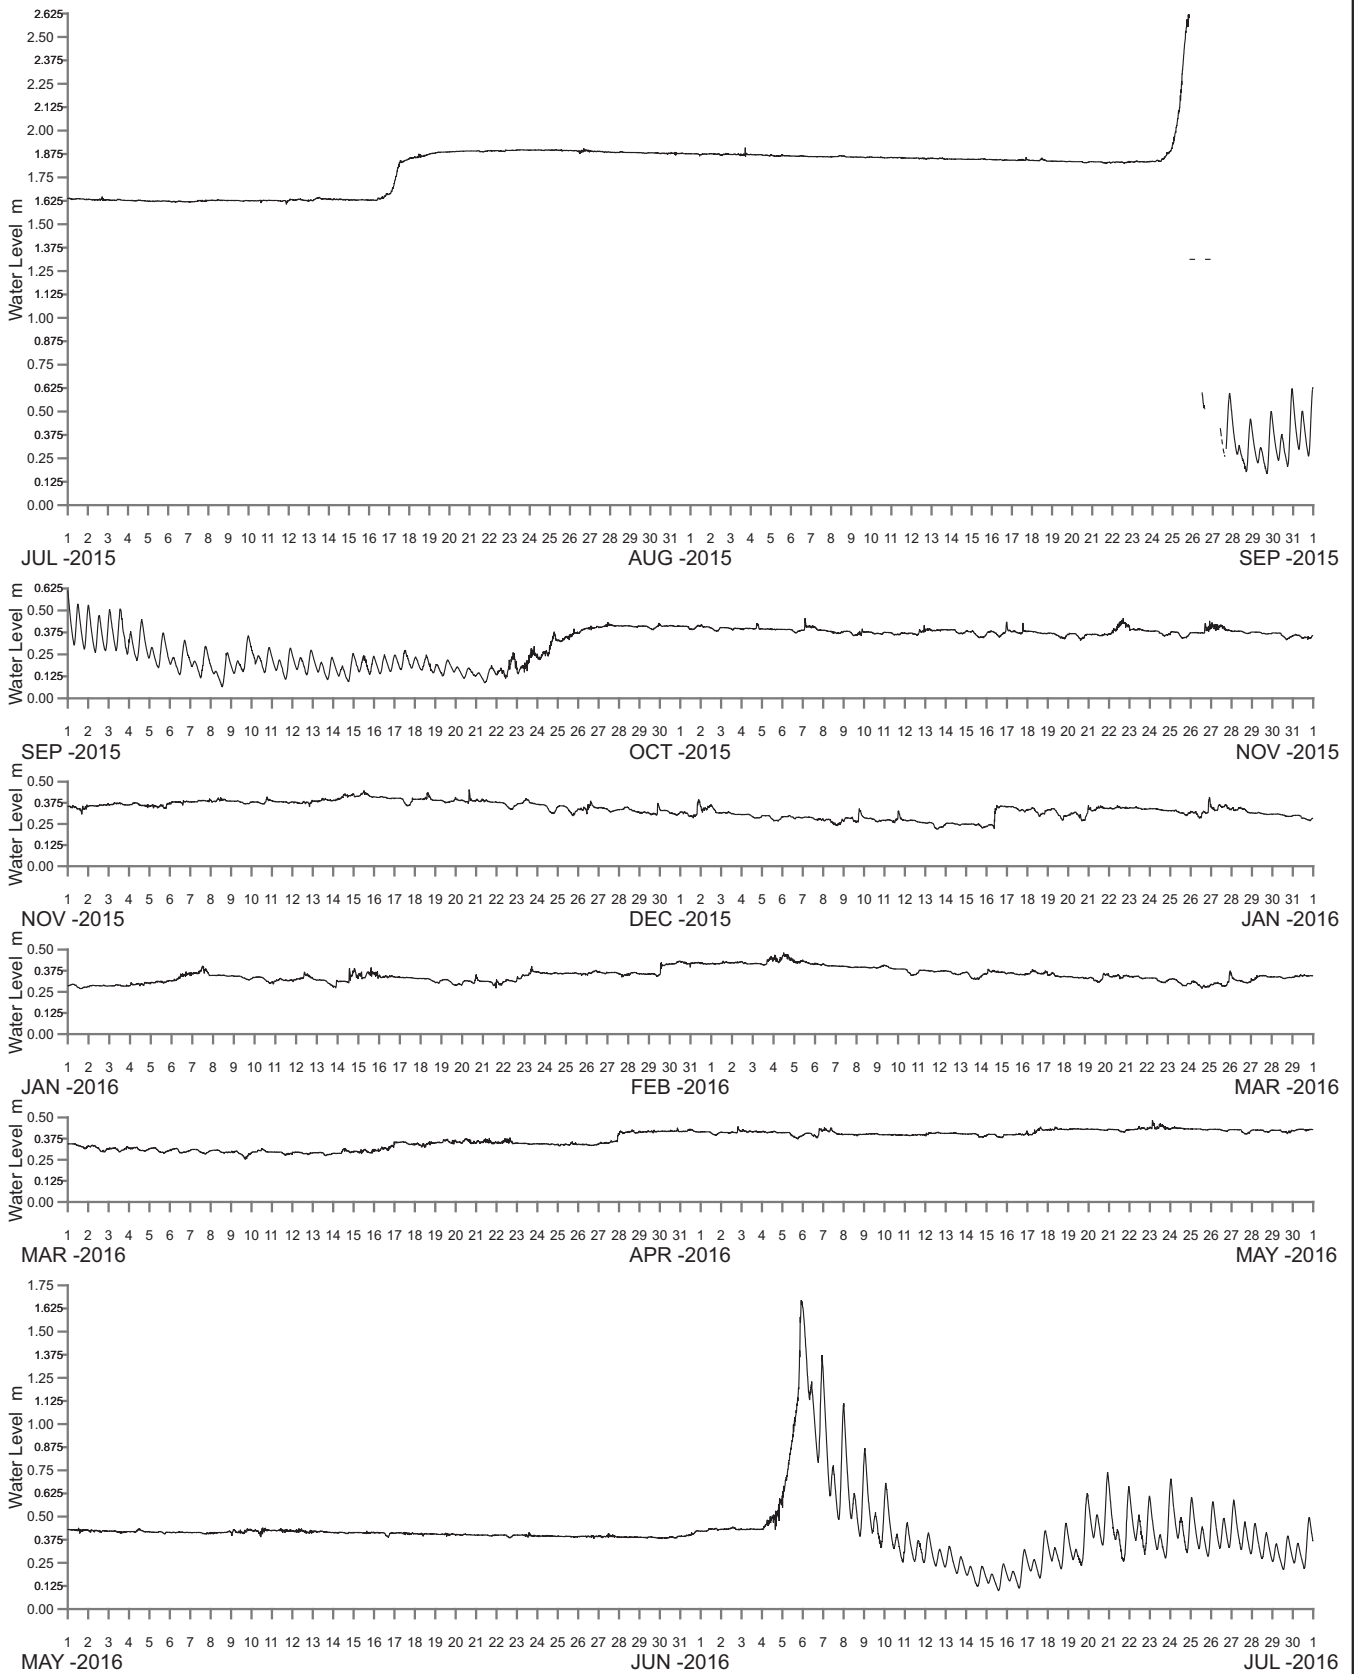
Figure
236

WATER LEVEL REFERENCED TO AUSTRALIAN HEIGHT DATUM

WOLLUMBOOLA LAKE AT WOLLUMBOOLA
2015–2016

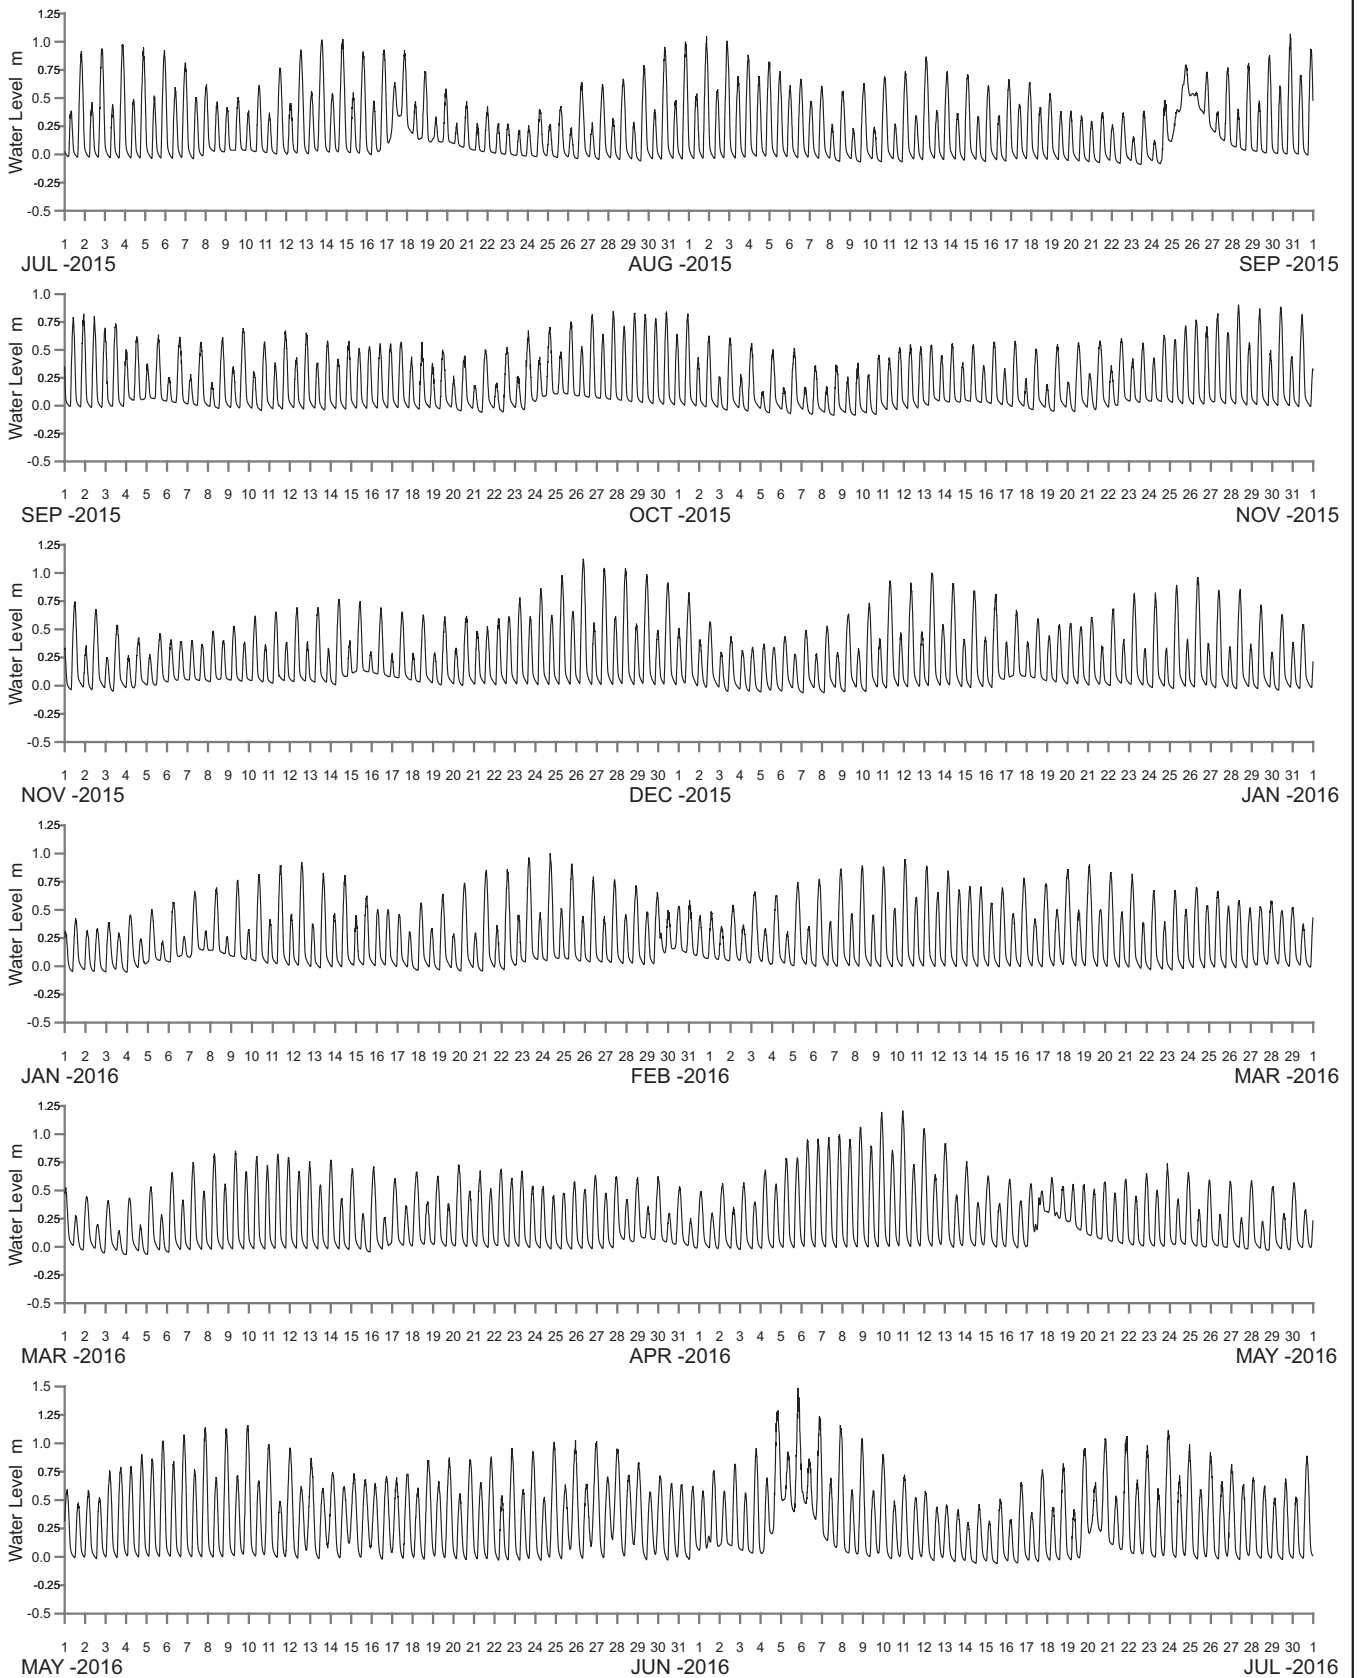
Figure
238

WATER LEVEL REFERENCED TO AUSTRALIAN HEIGHT DATUM

**CURRARONG CREEK AT CURRARONG CREEK
2015–2016**

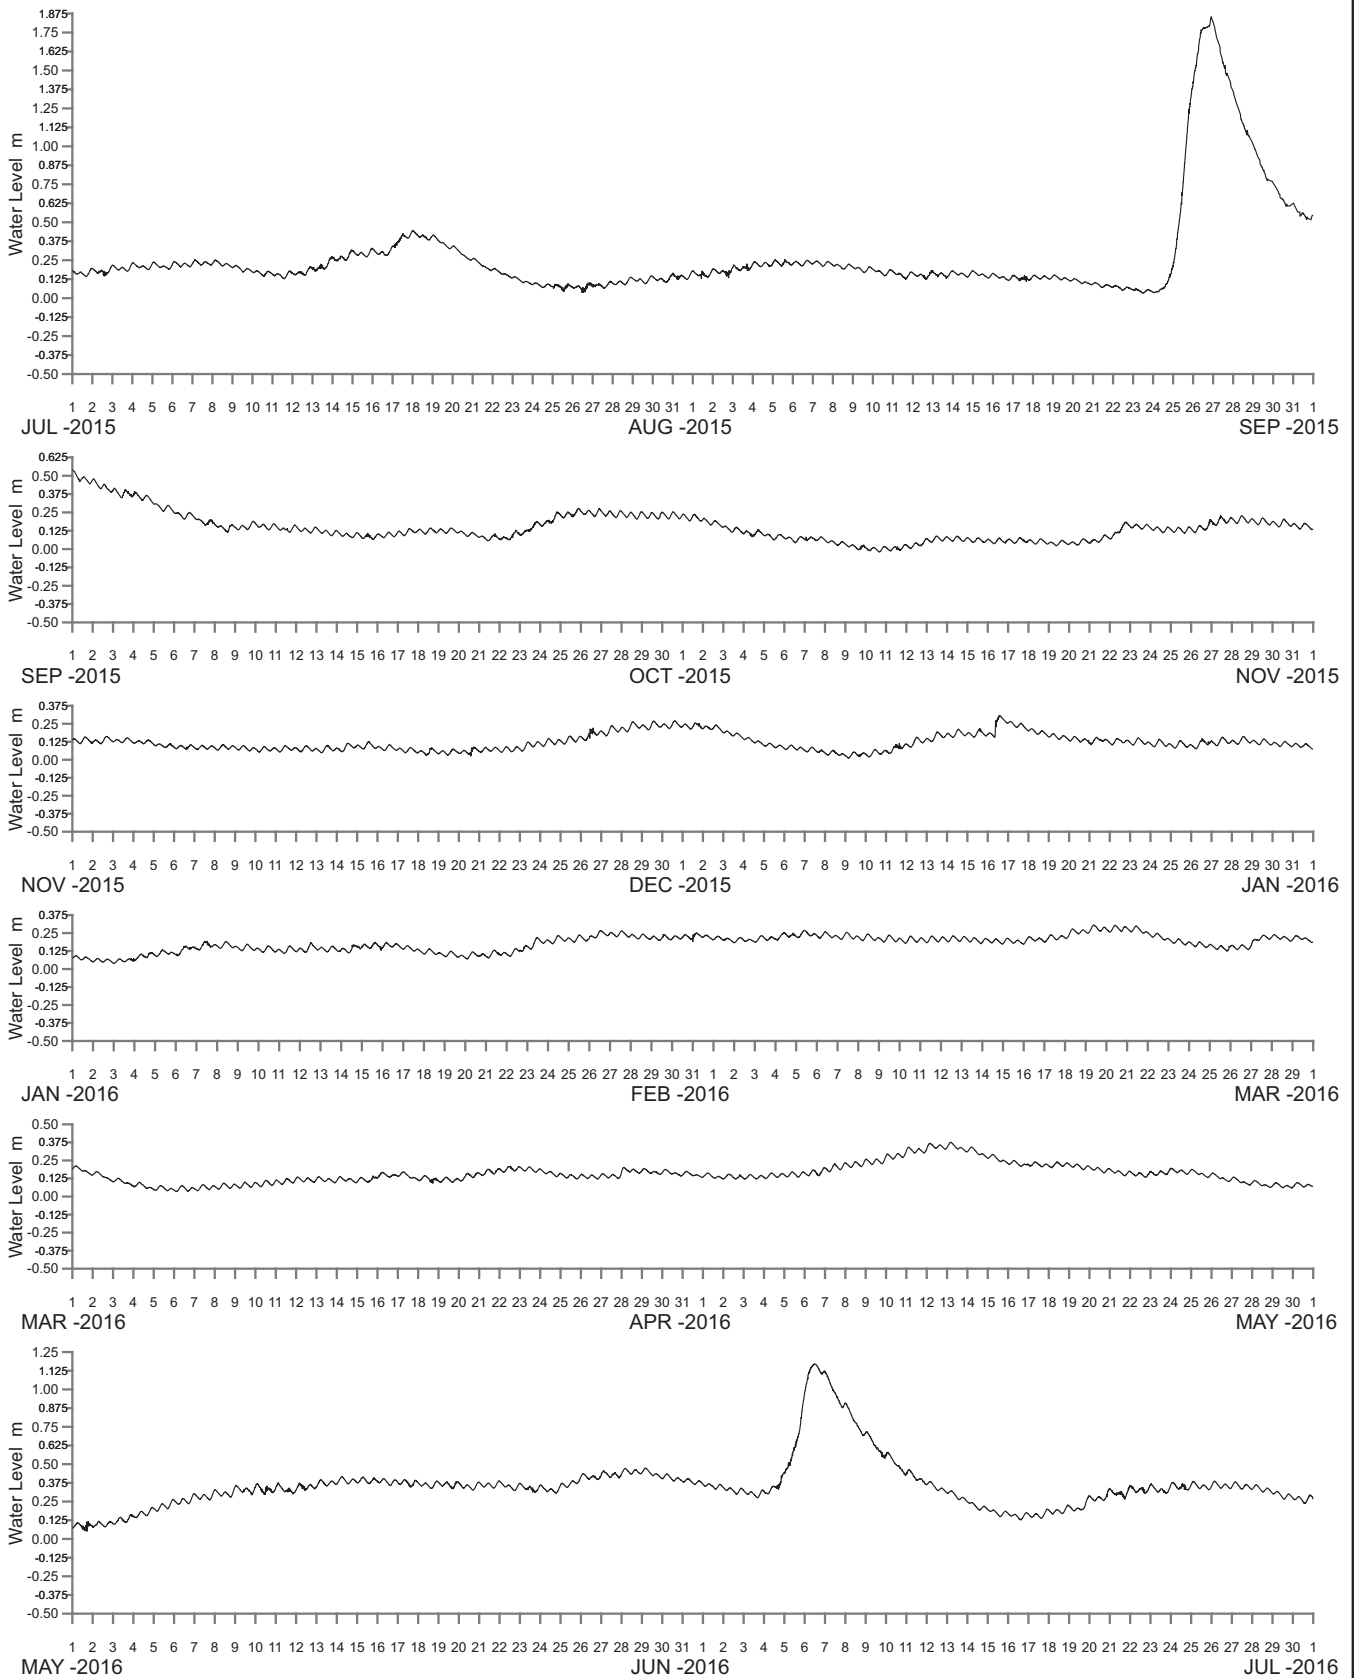
Figure
239

WATER LEVEL REFERENCED TO AUSTRALIAN HEIGHT DATUM

ST GEORGES BASIN AT ISLAND POINT
2015–2016

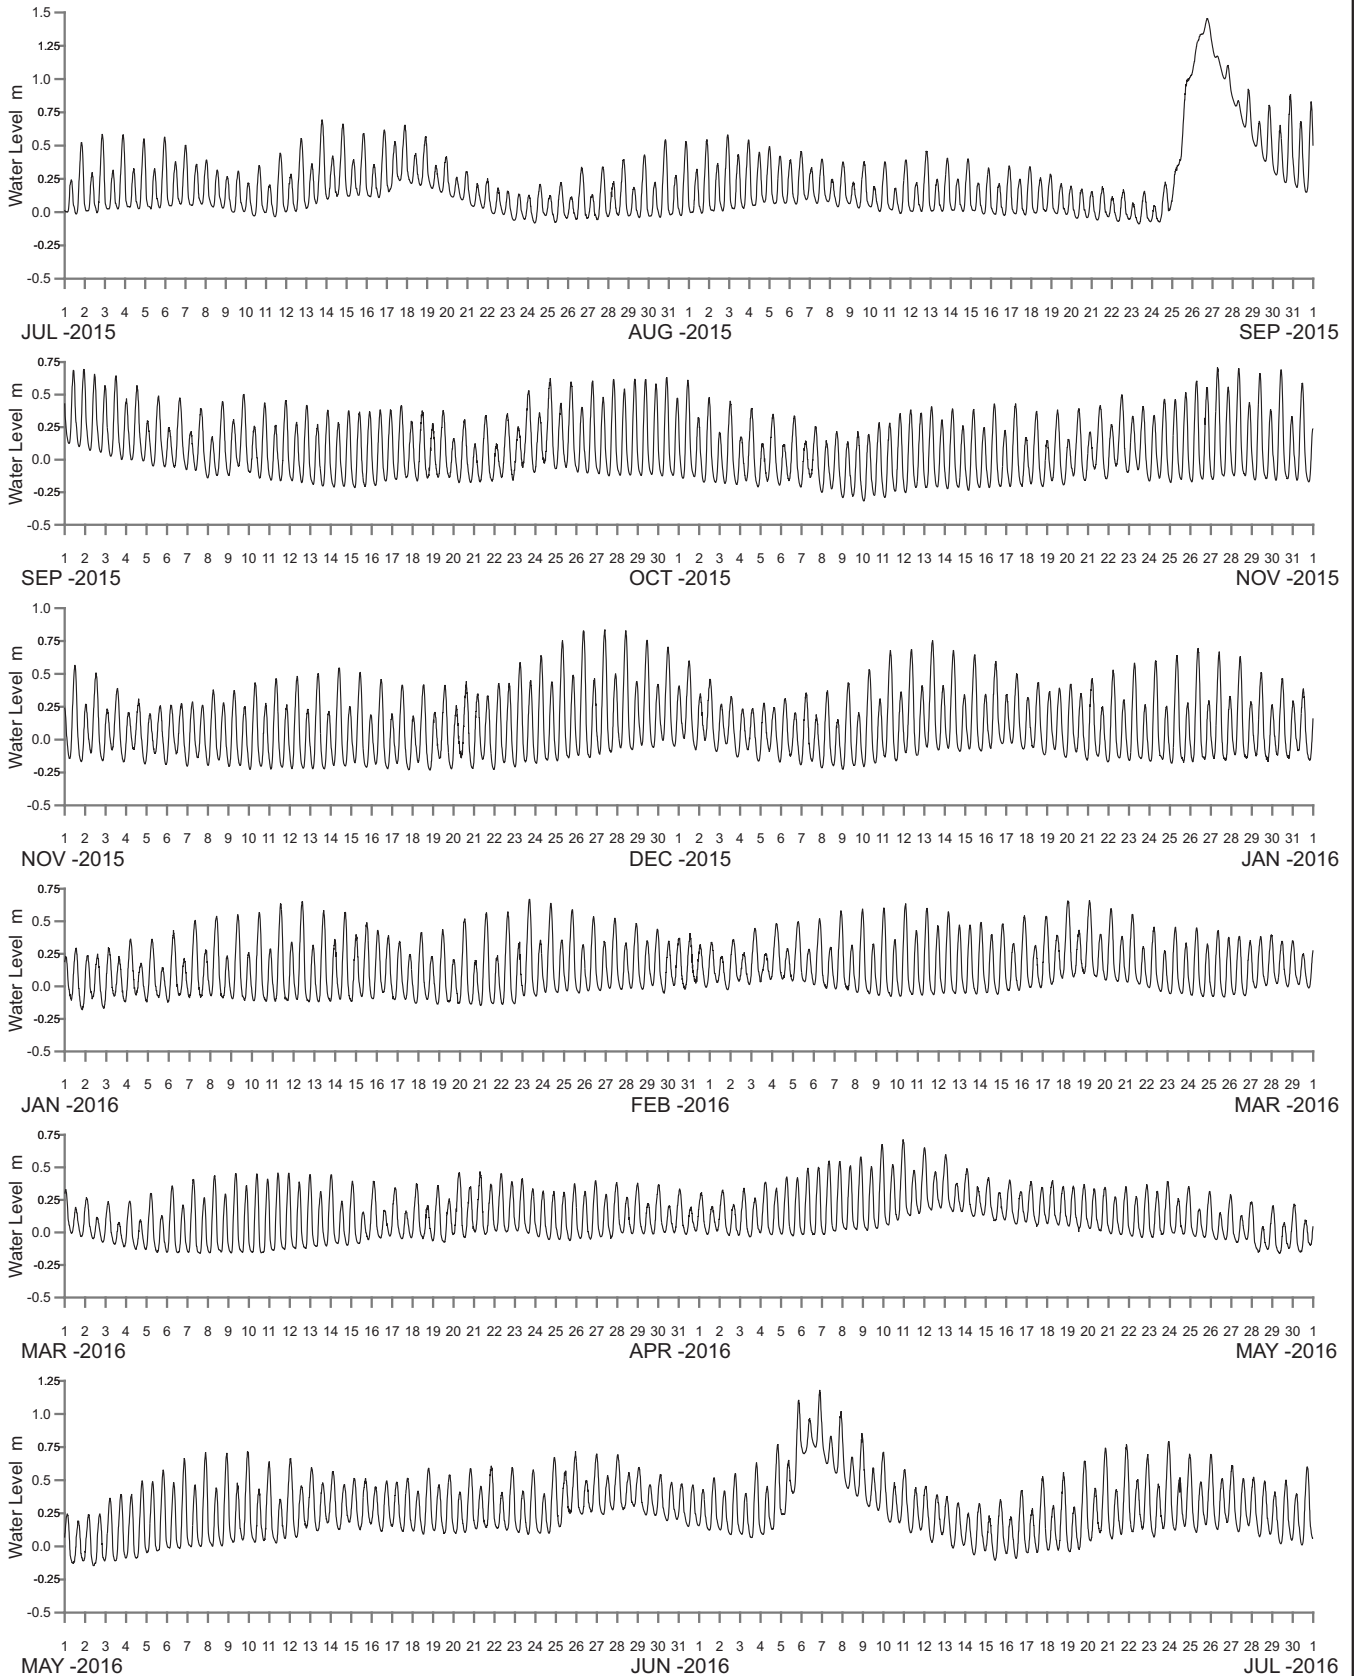
Figure
240

WATER LEVEL REFERENCED TO AUSTRALIAN HEIGHT DATUM

SUSSEX INLET AT SUSSEX INLET
2015–2016

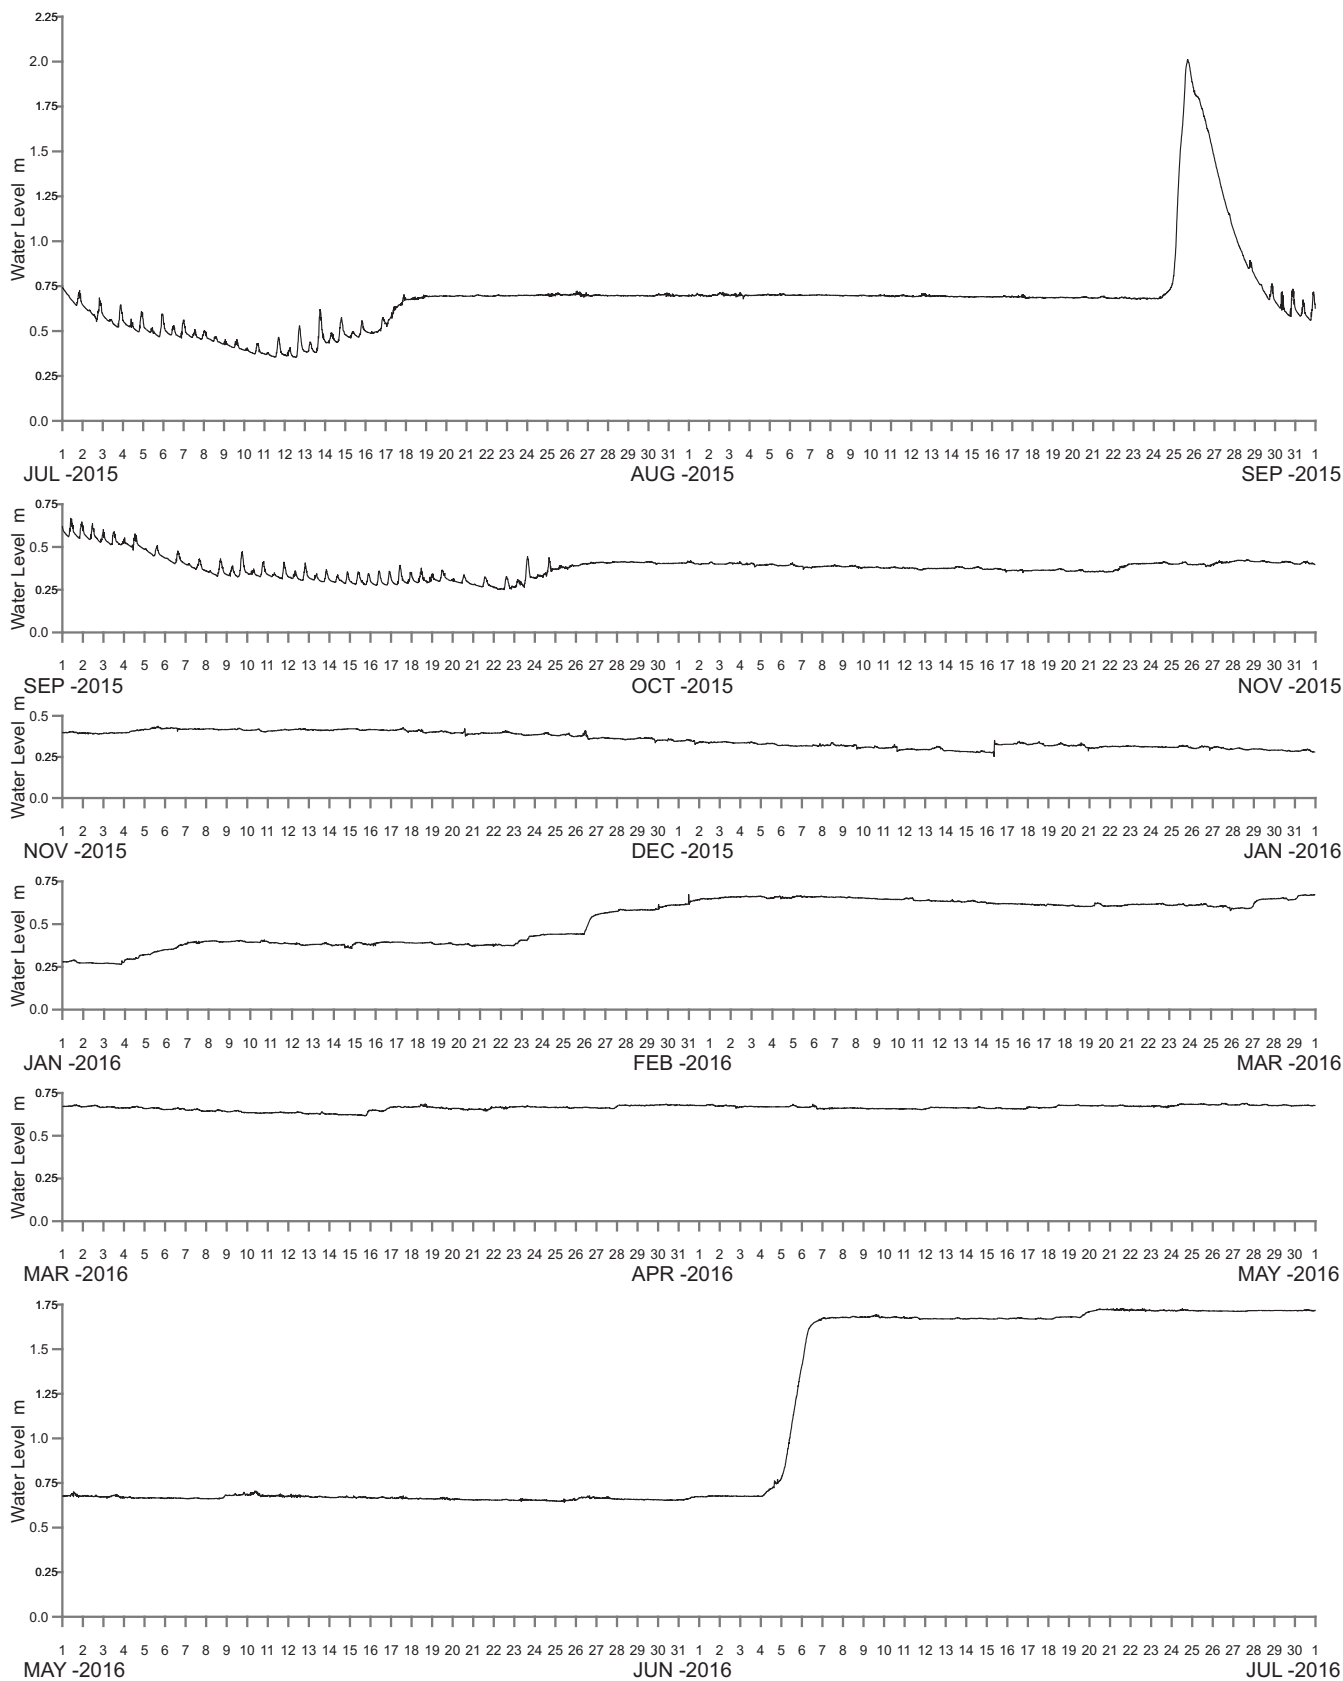
Figure
241

WATER LEVEL REFERENCED TO AUSTRALIAN HEIGHT DATUM

SWAN LAKE AT SWAN LAKE
2015-2016

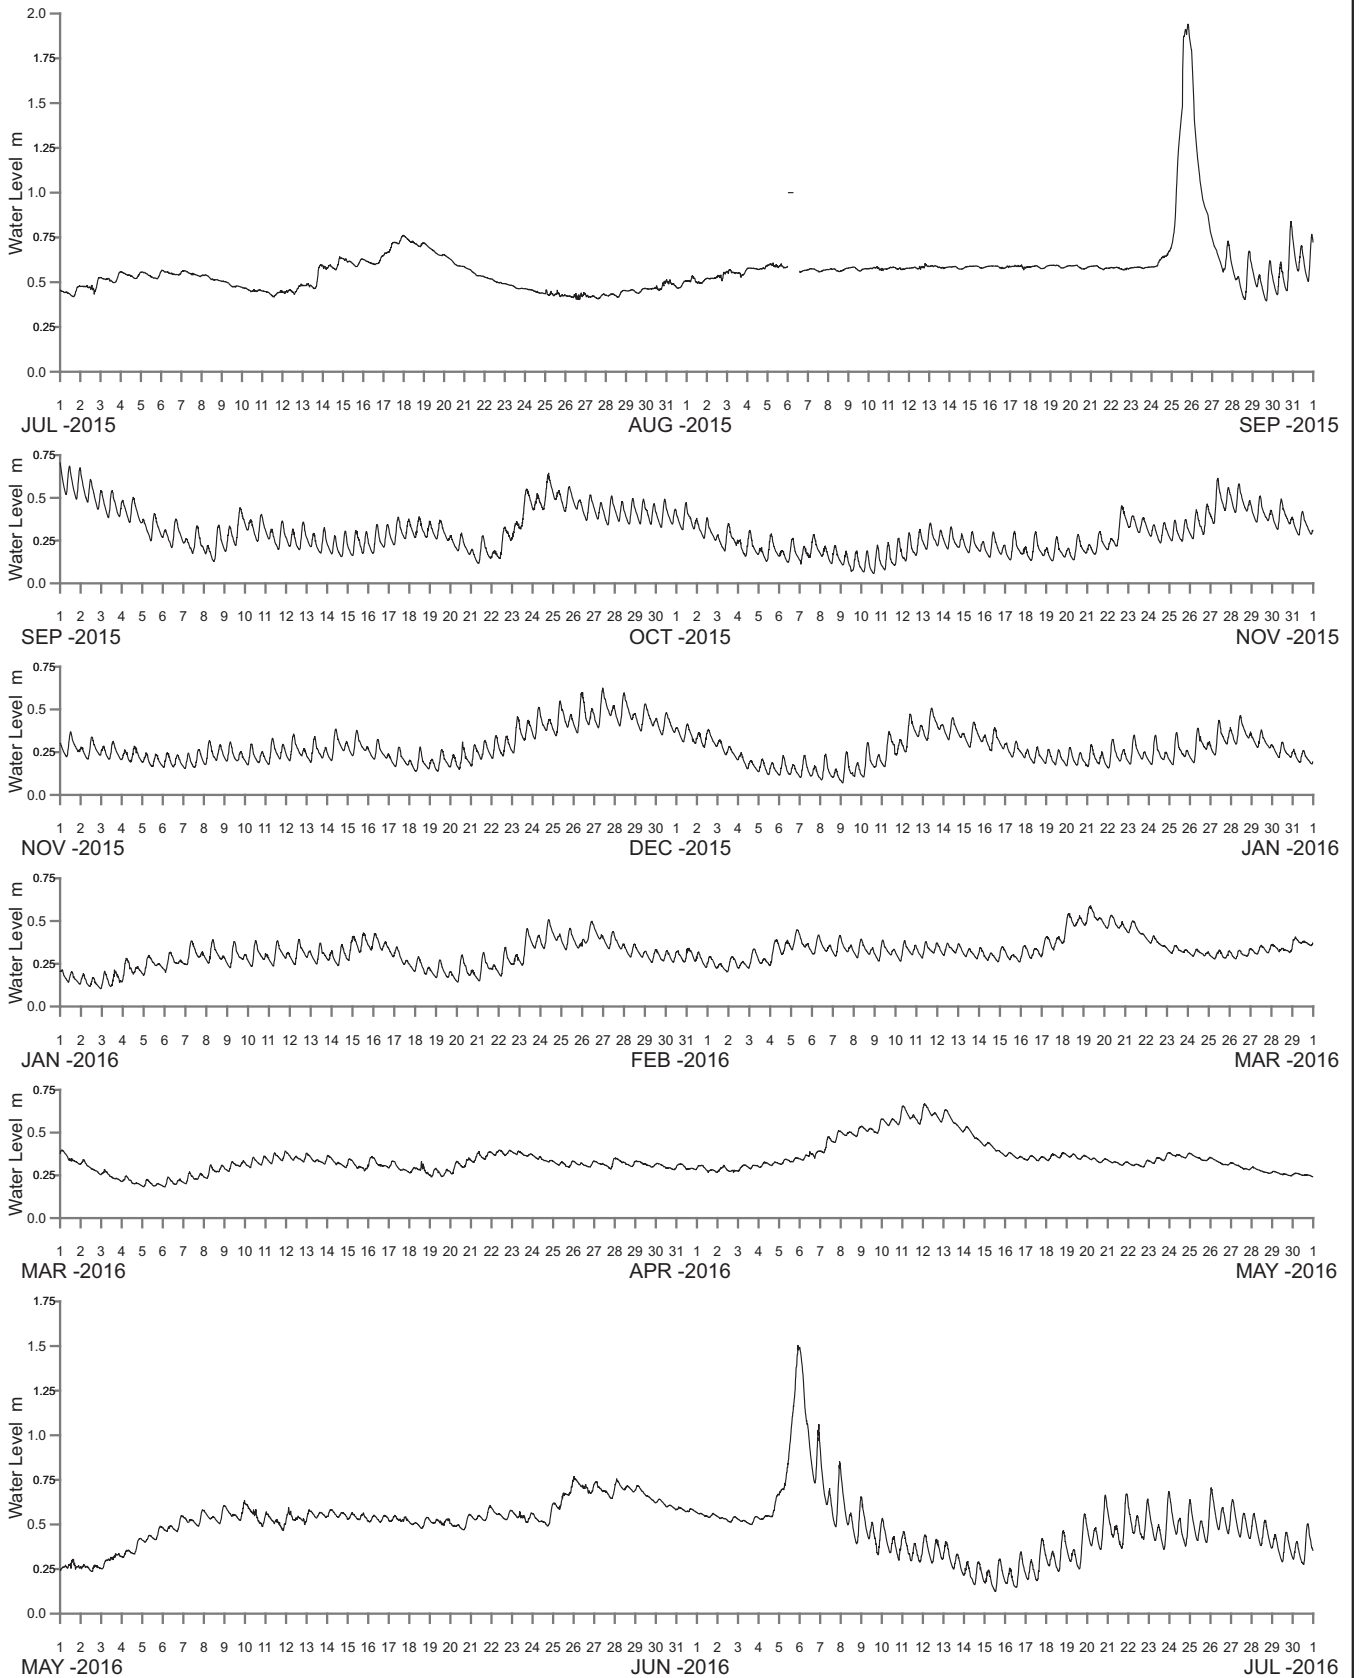
Figure
243

WATER LEVEL REFERENCED TO AUSTRALIAN HEIGHT DATUM

CONJOLA LAKE AT LAKE CONJOLA
2015–2016

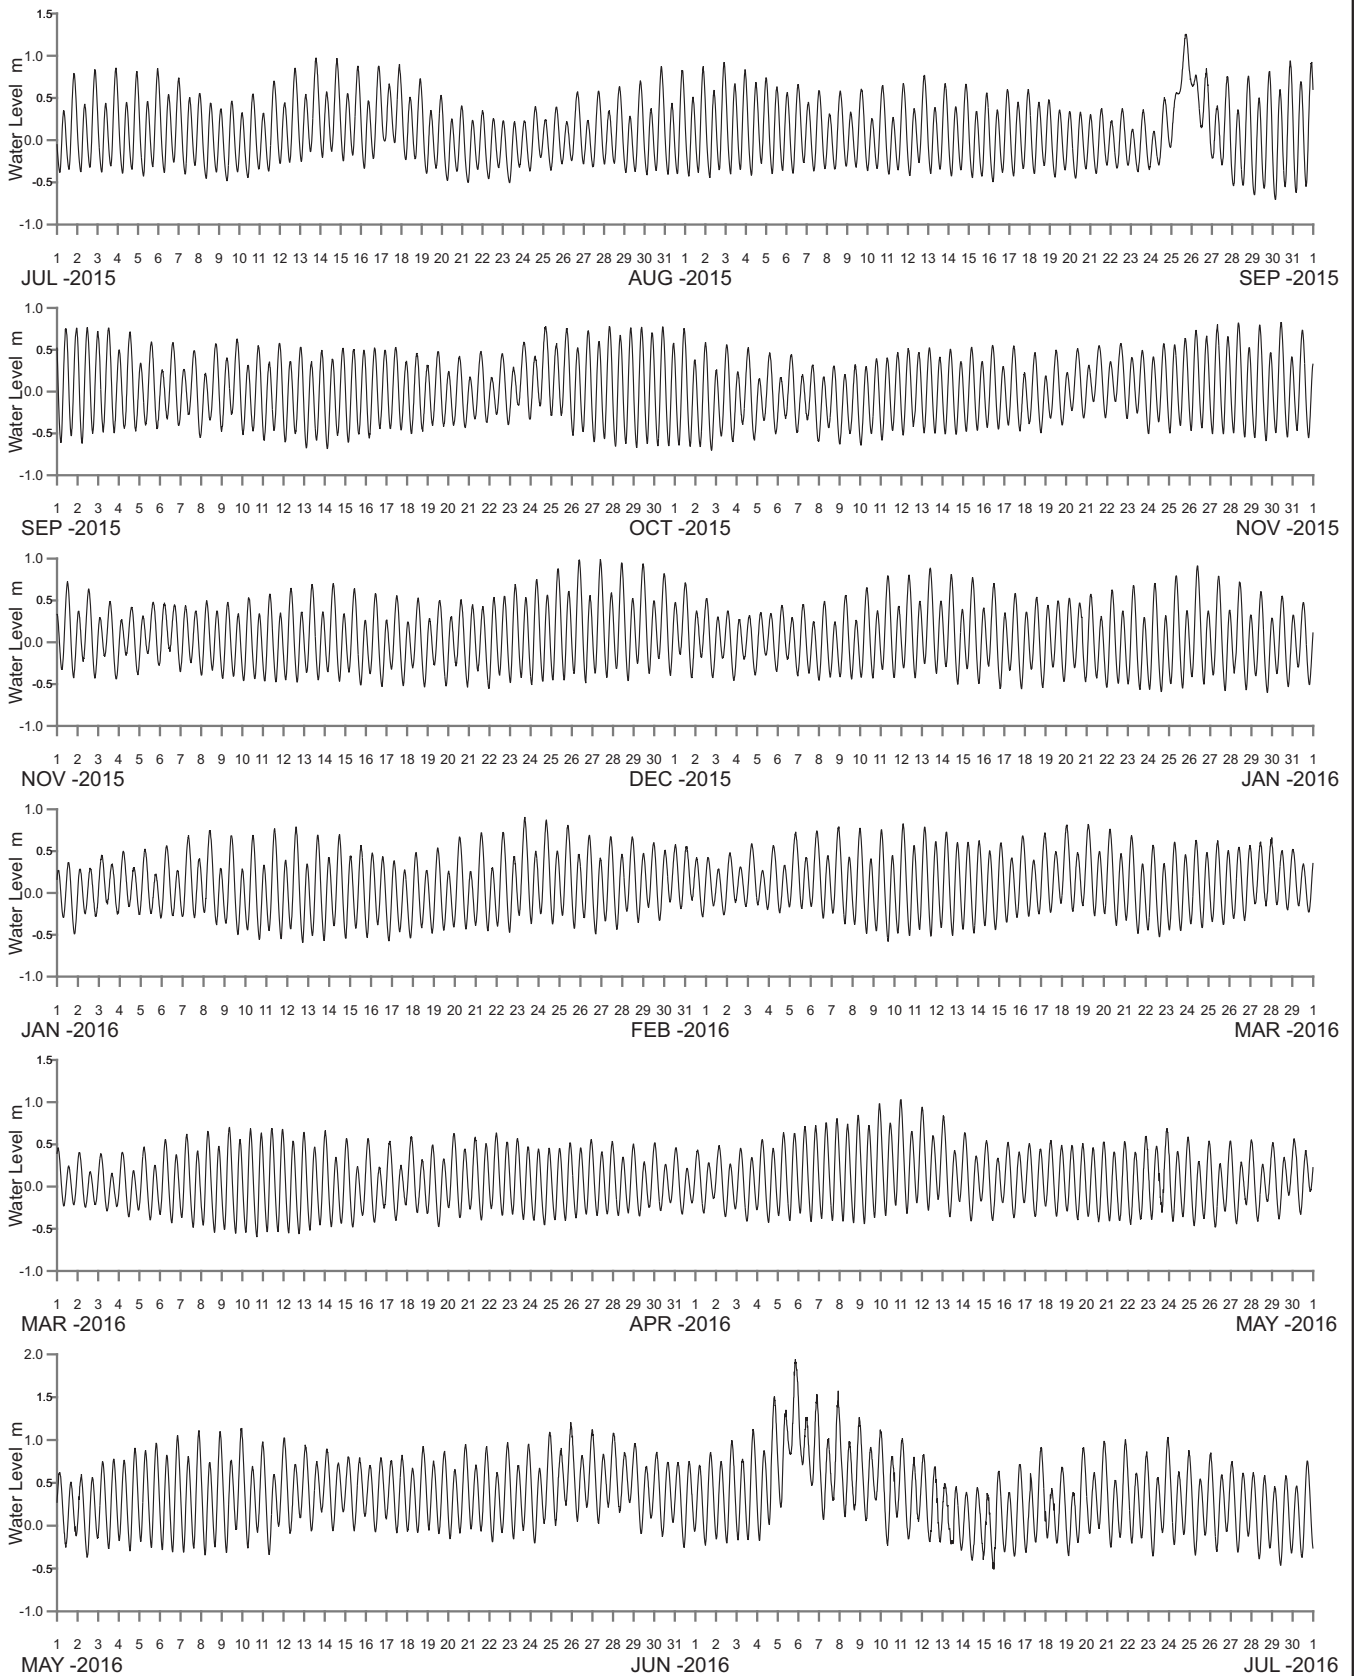
Figure
244

WATER LEVEL REFERENCED TO AUSTRALIAN HEIGHT DATUM

NARRAWALLEE CREEK AT NARRAWALLEE
2015–2016

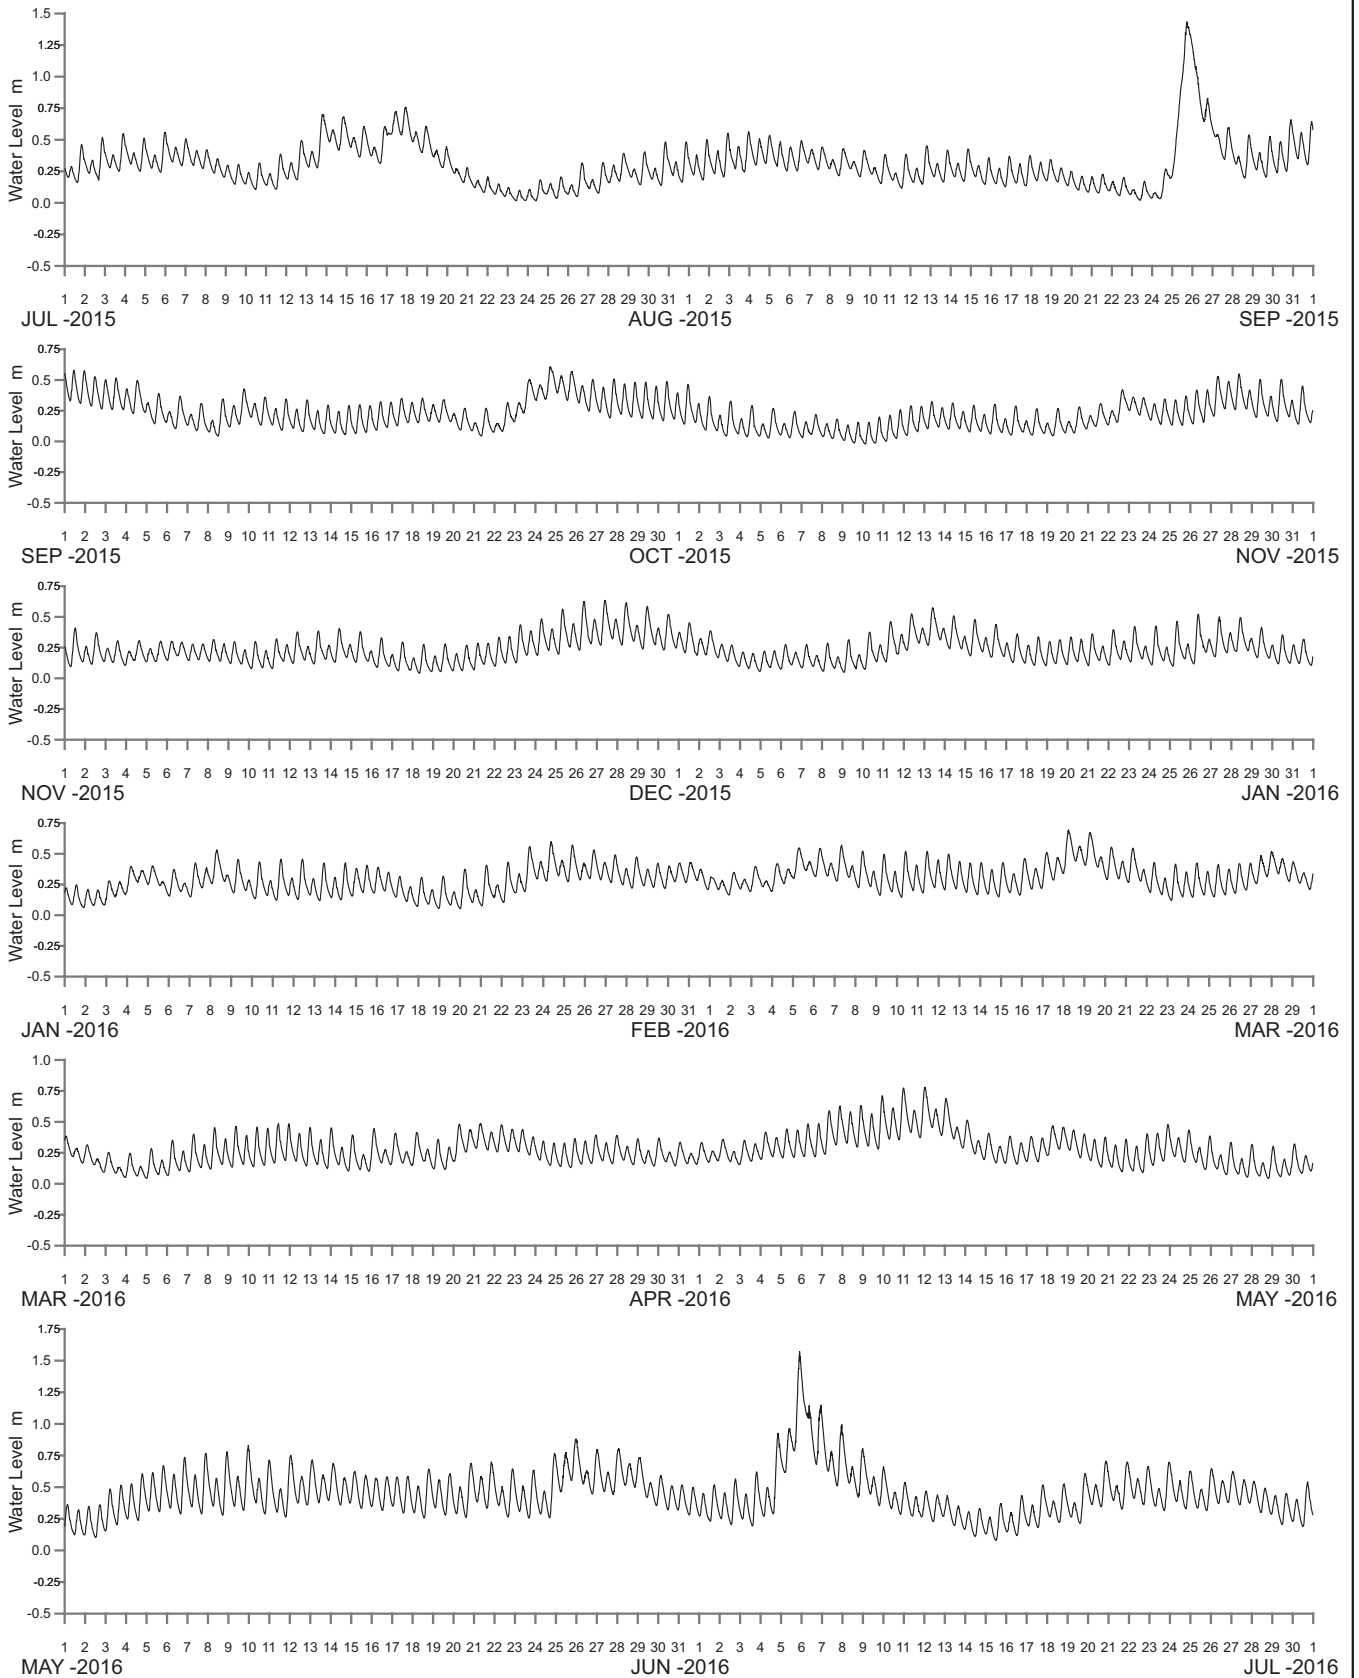
Figure
245

WATER LEVEL REFERENCED TO AUSTRALIAN HEIGHT DATUM

BURRILL LAKE AT BURRILL LAKE BRIDGE
2015–2016

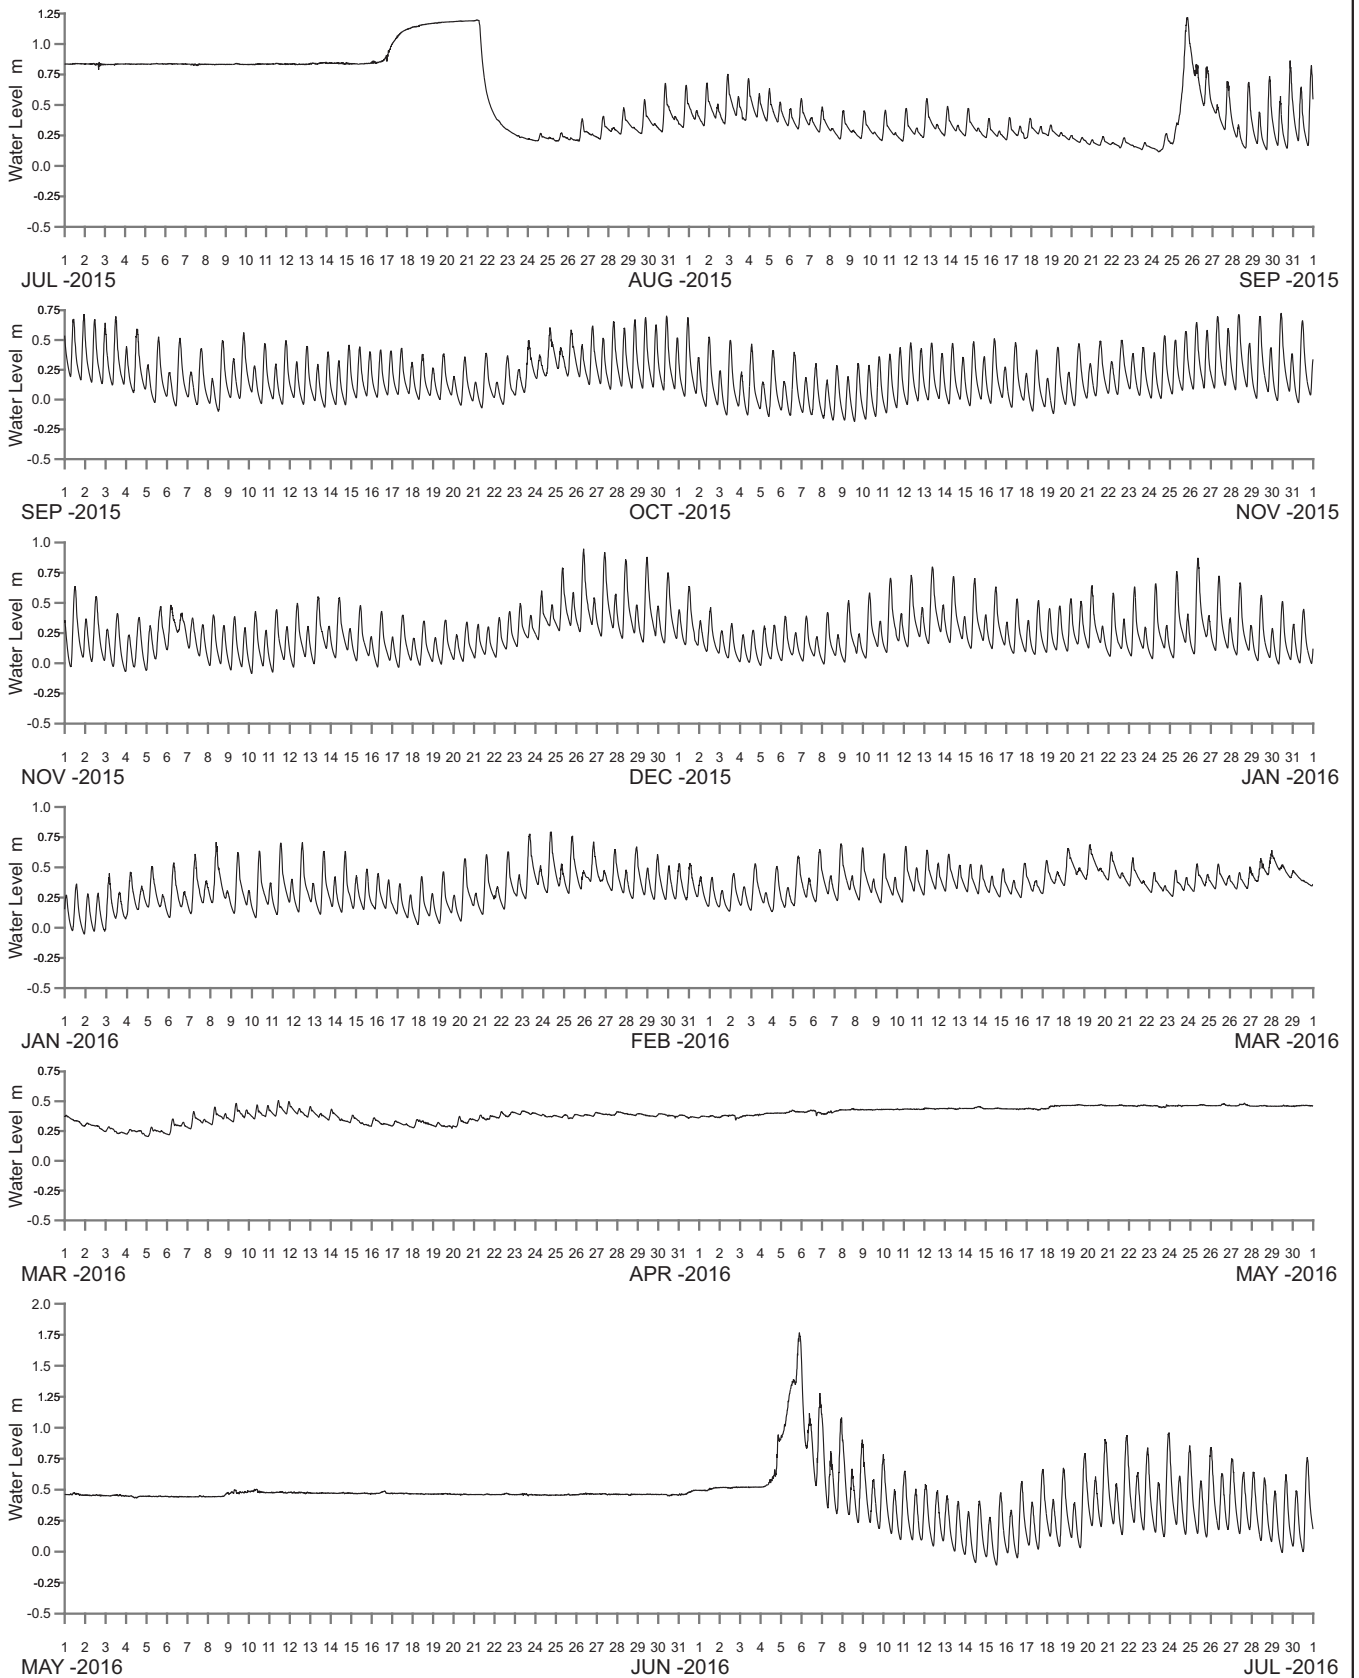
Figure
246

WATER LEVEL REFERENCED TO AUSTRALIAN HEIGHT DATUM

LAKE TABOURIE AT LAKE TABOURIE
2015–2016
