River/estuary system	Station name	Figure
Station Locality Map	Wollongong Region	201
Hewitts Creek	Hewitts Creek Upstream	202
Hewitts Creek	Hewitts Creek Downstream	203
Hewitts Creek	Hewitts Creek Entrance	204
Cabbage Tree Creek	Balgownie Road	205
Bellambi	Bellambi	206
Towradgi Creek	Towradgi Creek Upstream	207
Towradgi Creek	Towradgi Creek Downstream	208
Cabbage Tree Creek	Cabbage Tree Creek Upstream	209
Cabbage Tree Creek	Cabbage Tree Creek Downstream	210
Fairy Creek	Fairy Creek Upstream	211
Fairy Creek	Fairy Creek Downstream	212
Byarong Creek	Byarong Creek	213
Byarong Creek	Koloona Avenue Upstream	214
Byarong Creek	Koloona Avenue Downstream	215
American Creek	Blackmans Parade Upstream	216
American Creek	Blackmans Parade Downstream	217
Station Locality Map	Lake Illawarra Region	218
Mullet Creek	Mullet Creek	219
Lake Illawarra	Koonawarra Bay	220
Lake Illawarra	Cudgeree Bay	221
Lake Illawarra	Lake Illawarra Entrance	222

MHL
Report 2474

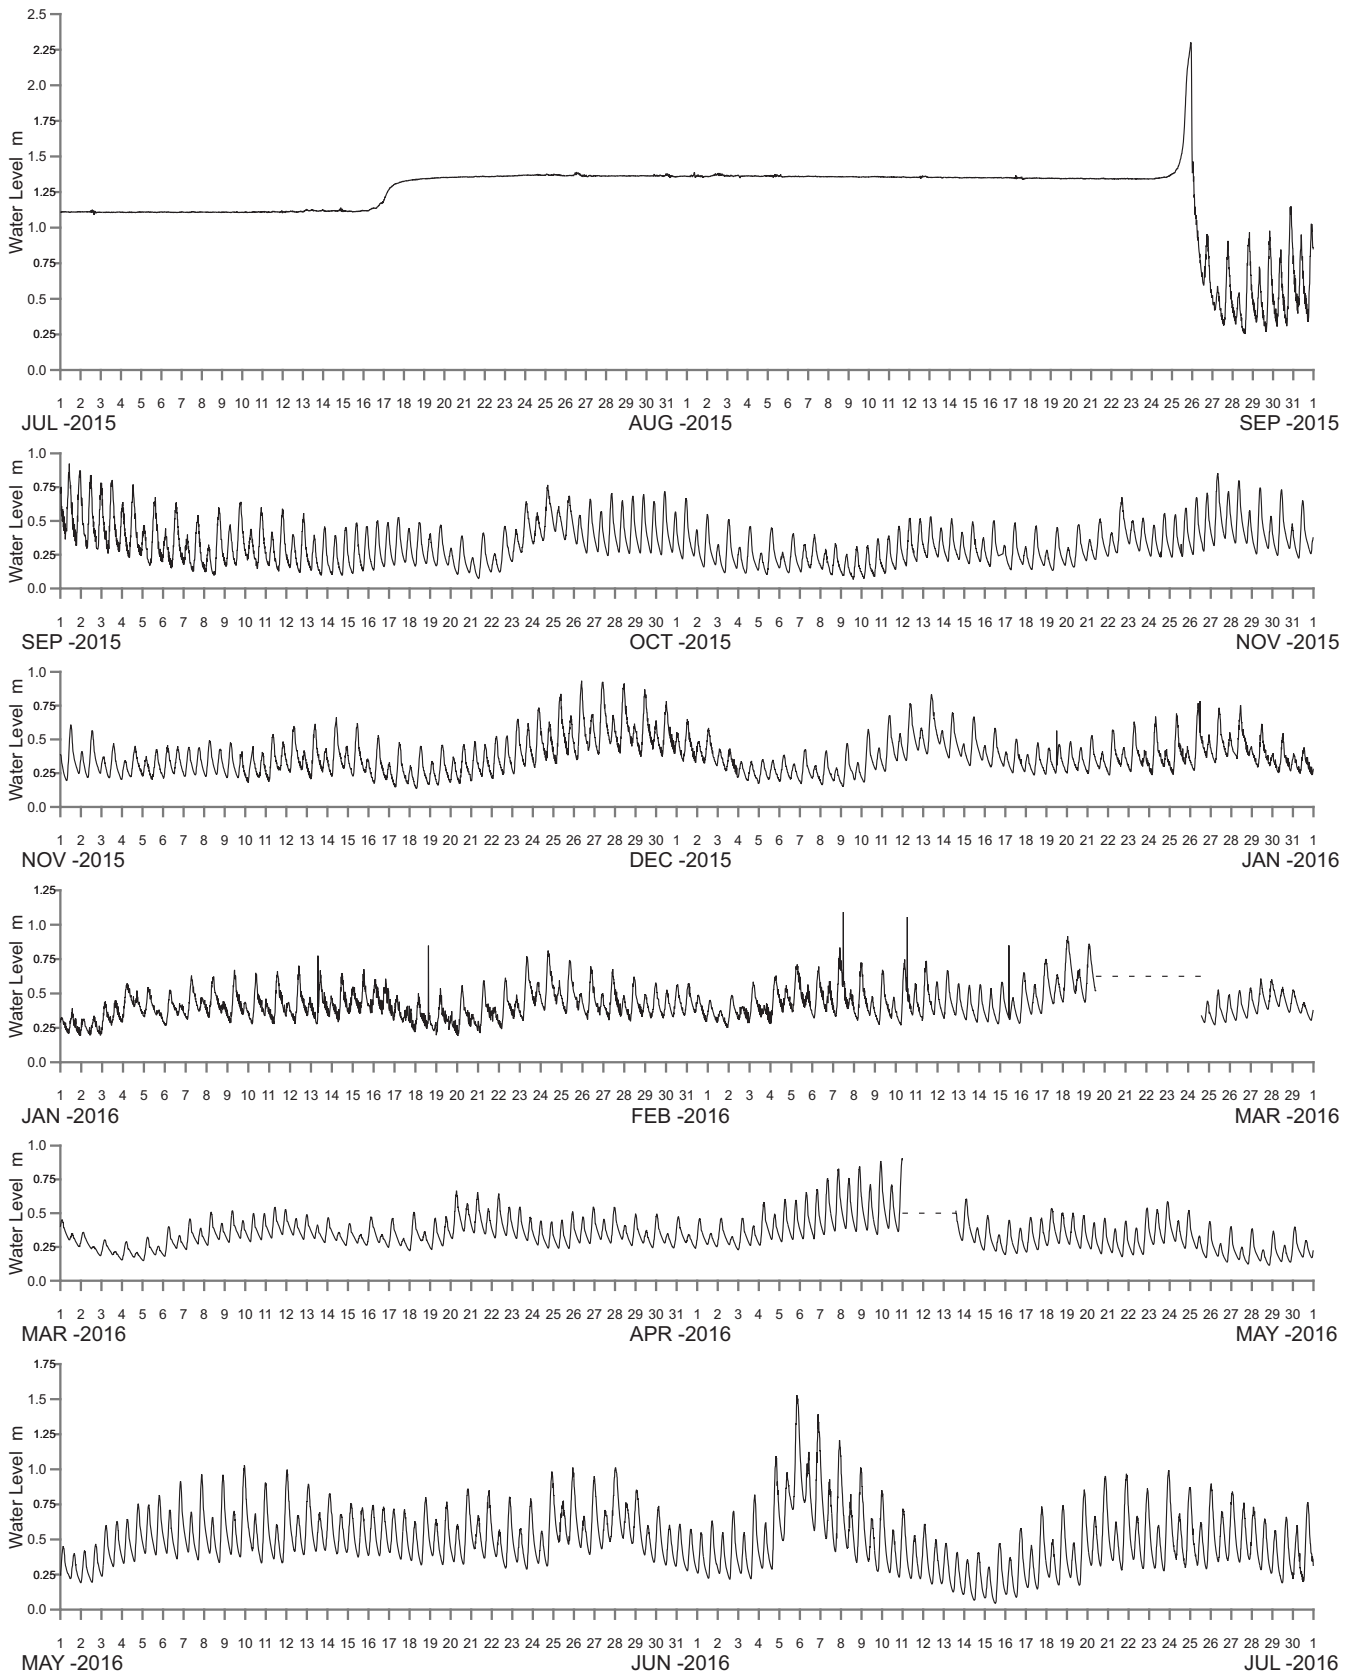
Figure
248

WATER LEVEL REFERENCED TO AUSTRALIAN HEIGHT DATUM

DURRAS LAKE AT DURRAS LAKE
2015–2016

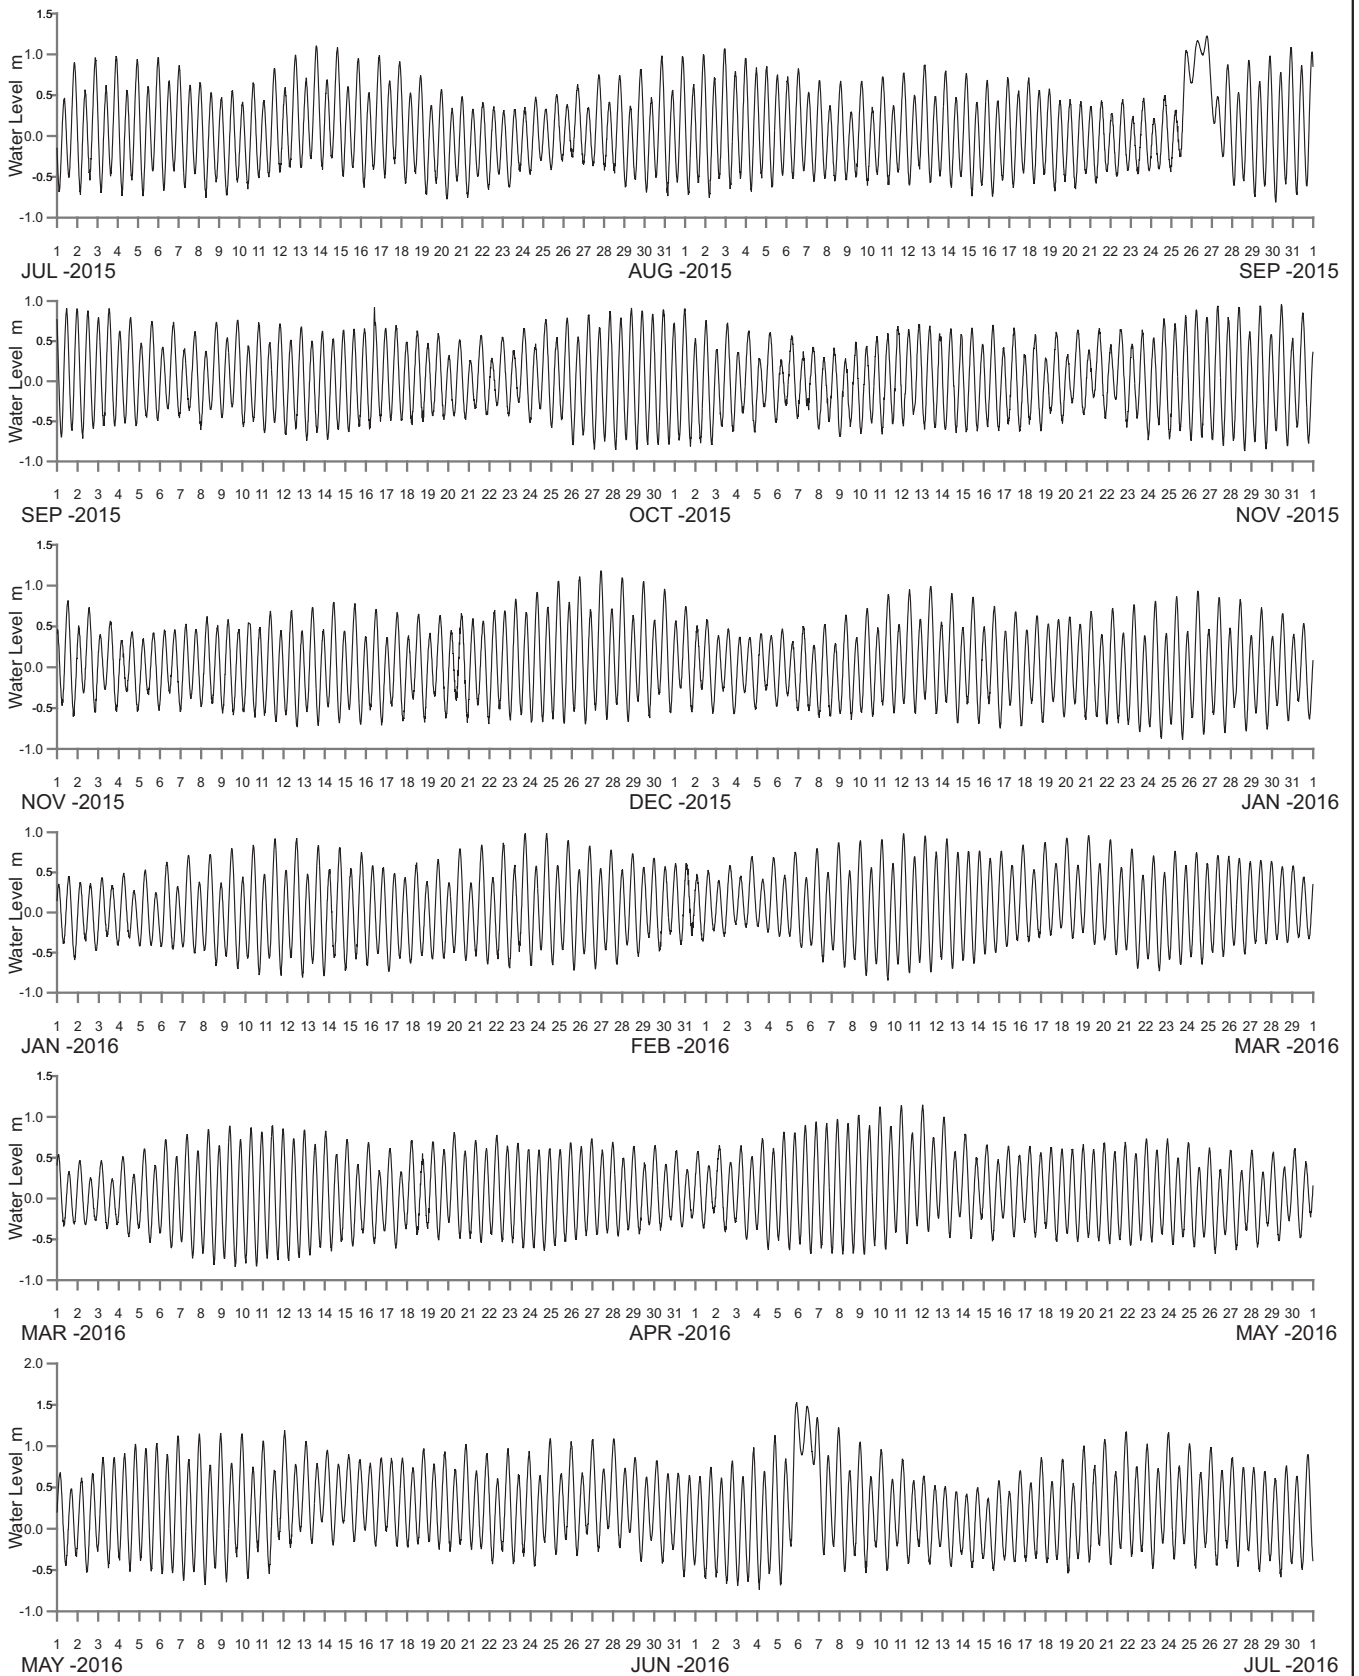
Figure
249

WATER LEVEL REFERENCED TO AUSTRALIAN HEIGHT DATUM

CLYDE RIVER AT NELLIGEN
2015–2016

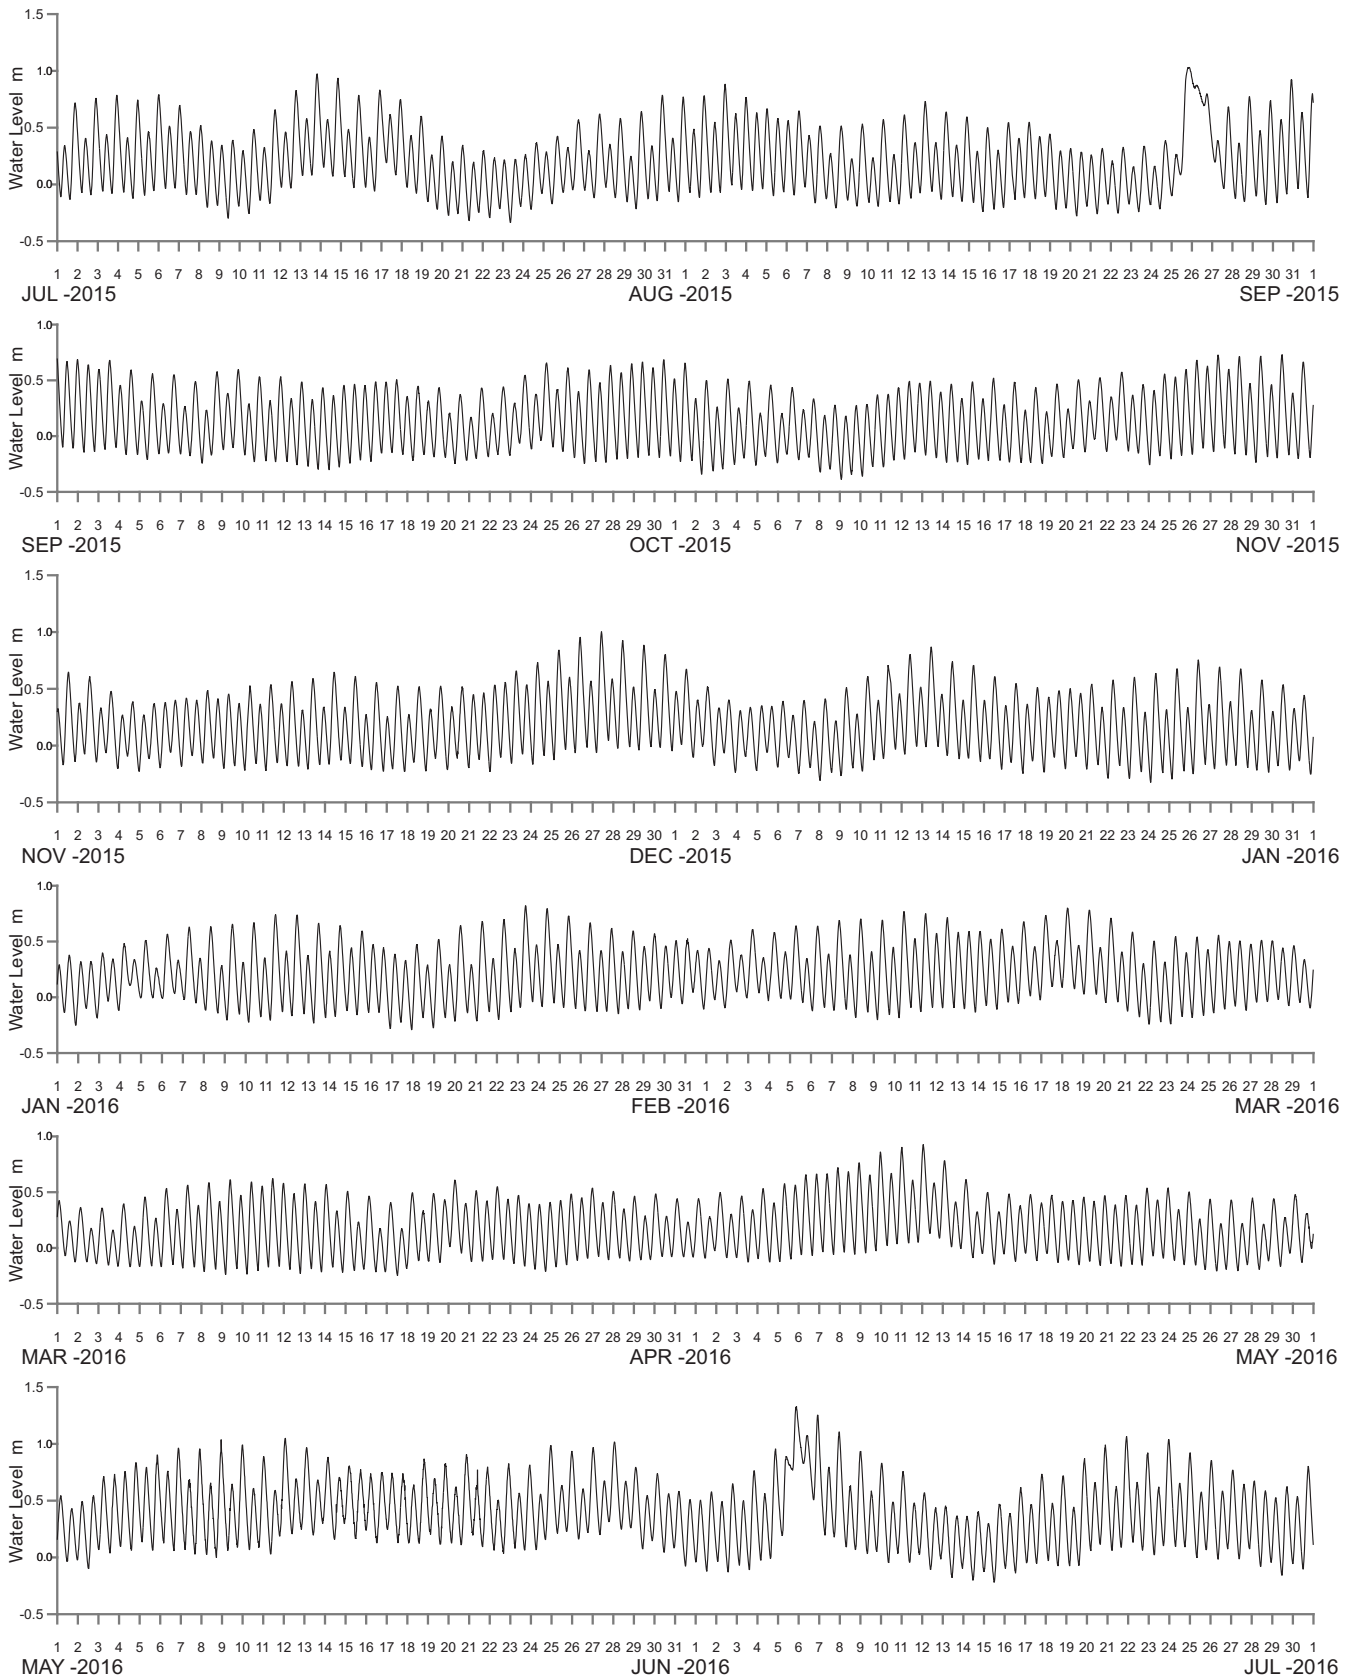
Figure
251

WATER LEVEL REFERENCED TO AUSTRALIAN HEIGHT DATUM

TOMAGA RIVER AT GEORGE BASS DRIVE
2015–2016

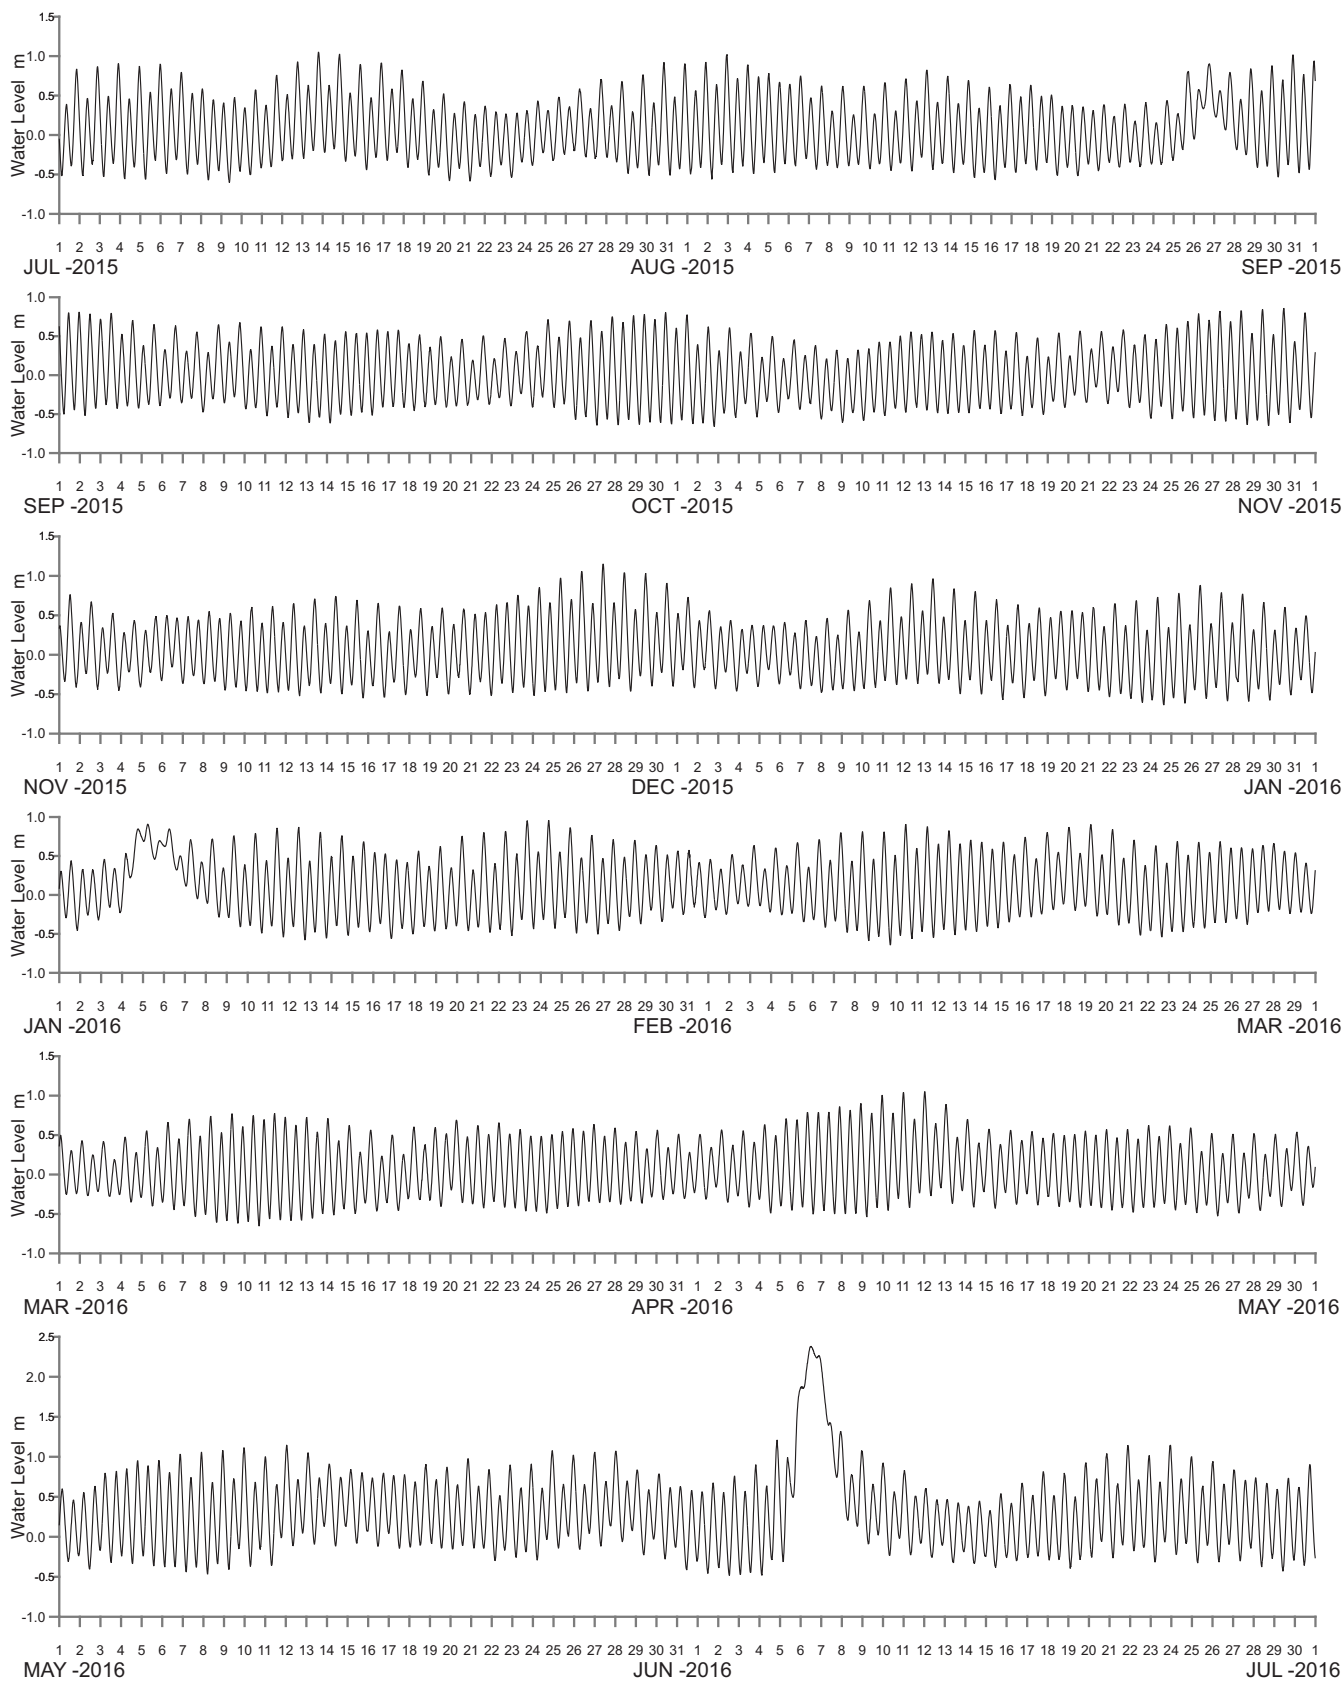
Figure
253

WATER LEVEL REFERENCED TO AUSTRALIAN HEIGHT DATUM

MORUYA RIVER AT MORUYA HOSPITAL
2015–2016

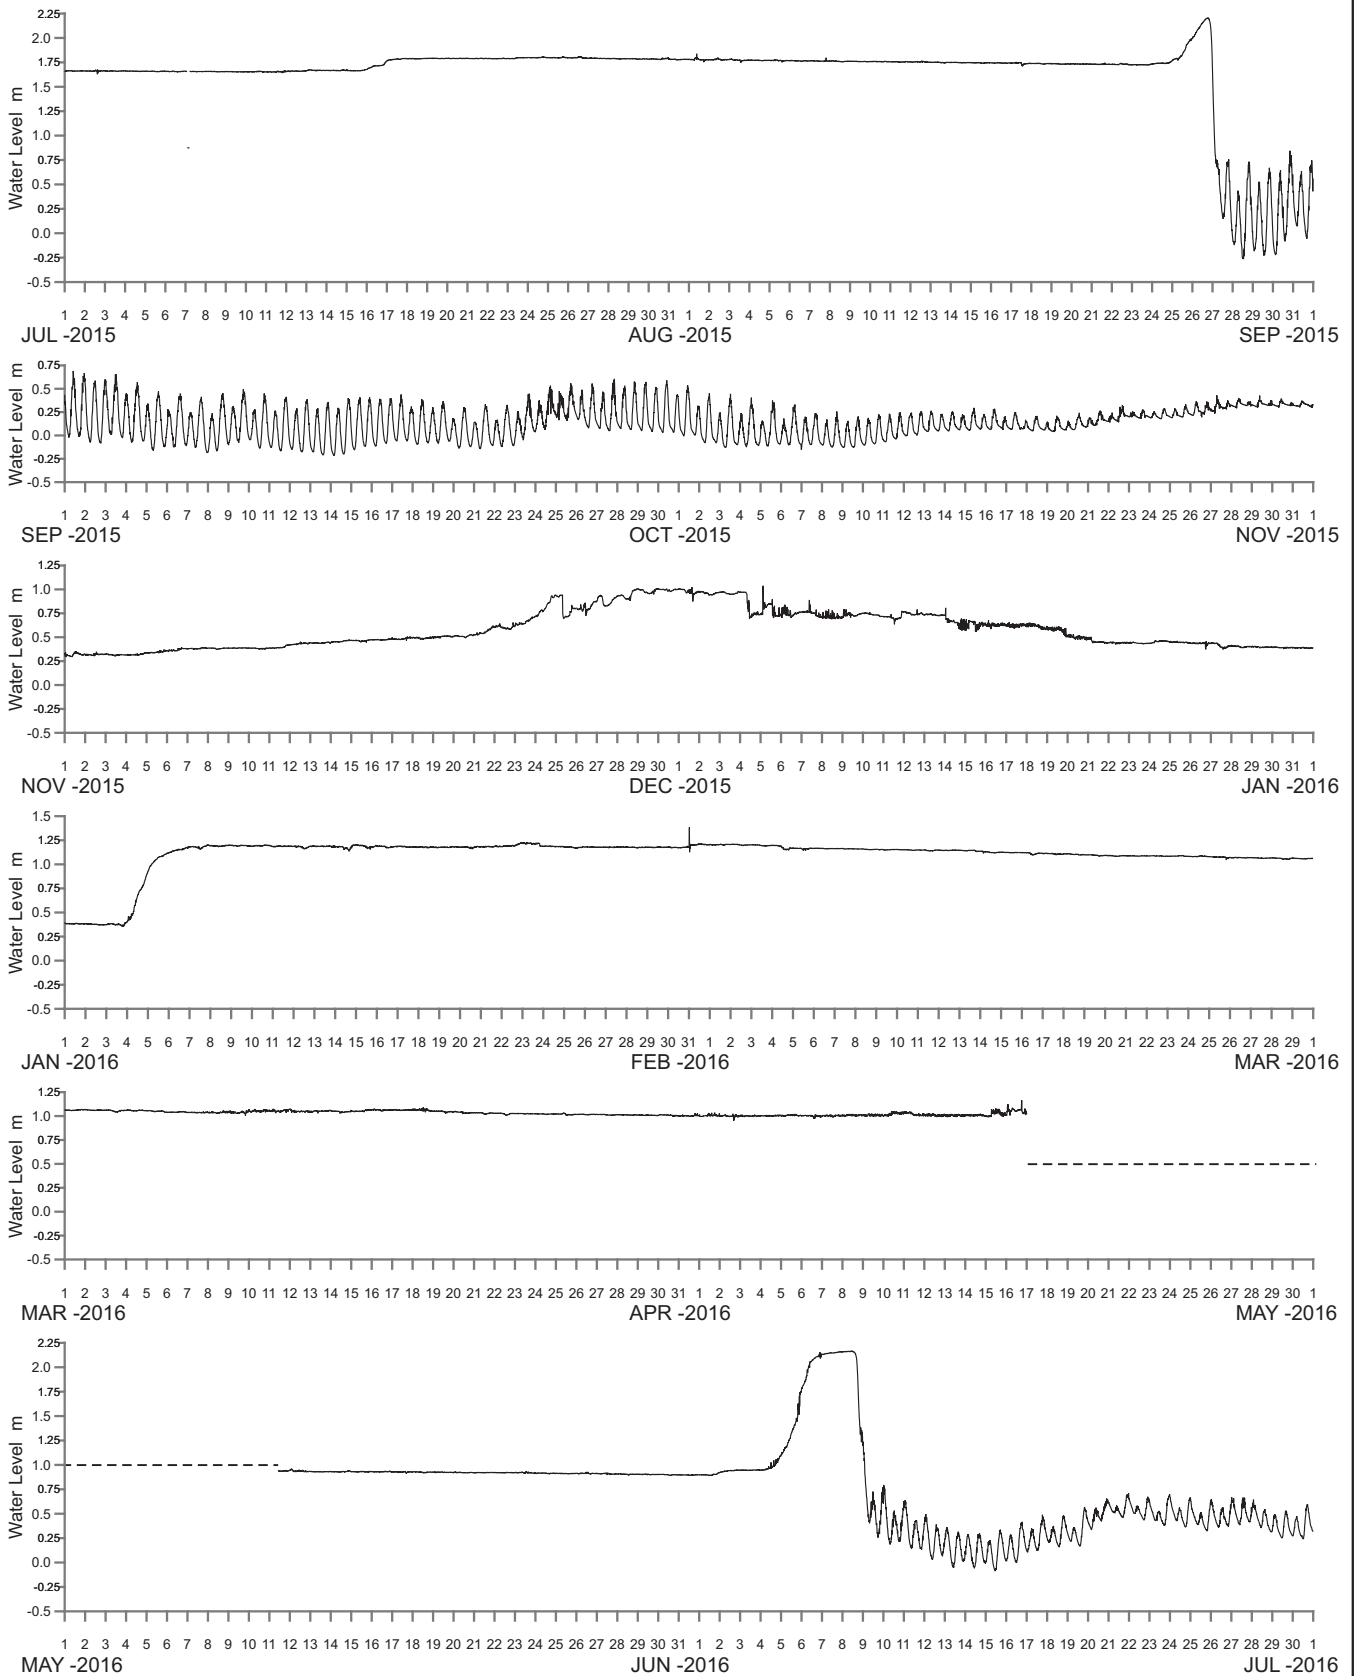
Figure
255

WATER LEVEL REFERENCED TO AUSTRALIAN HEIGHT DATUM

COILA LAKE AT COILA LAKE
2015-2016

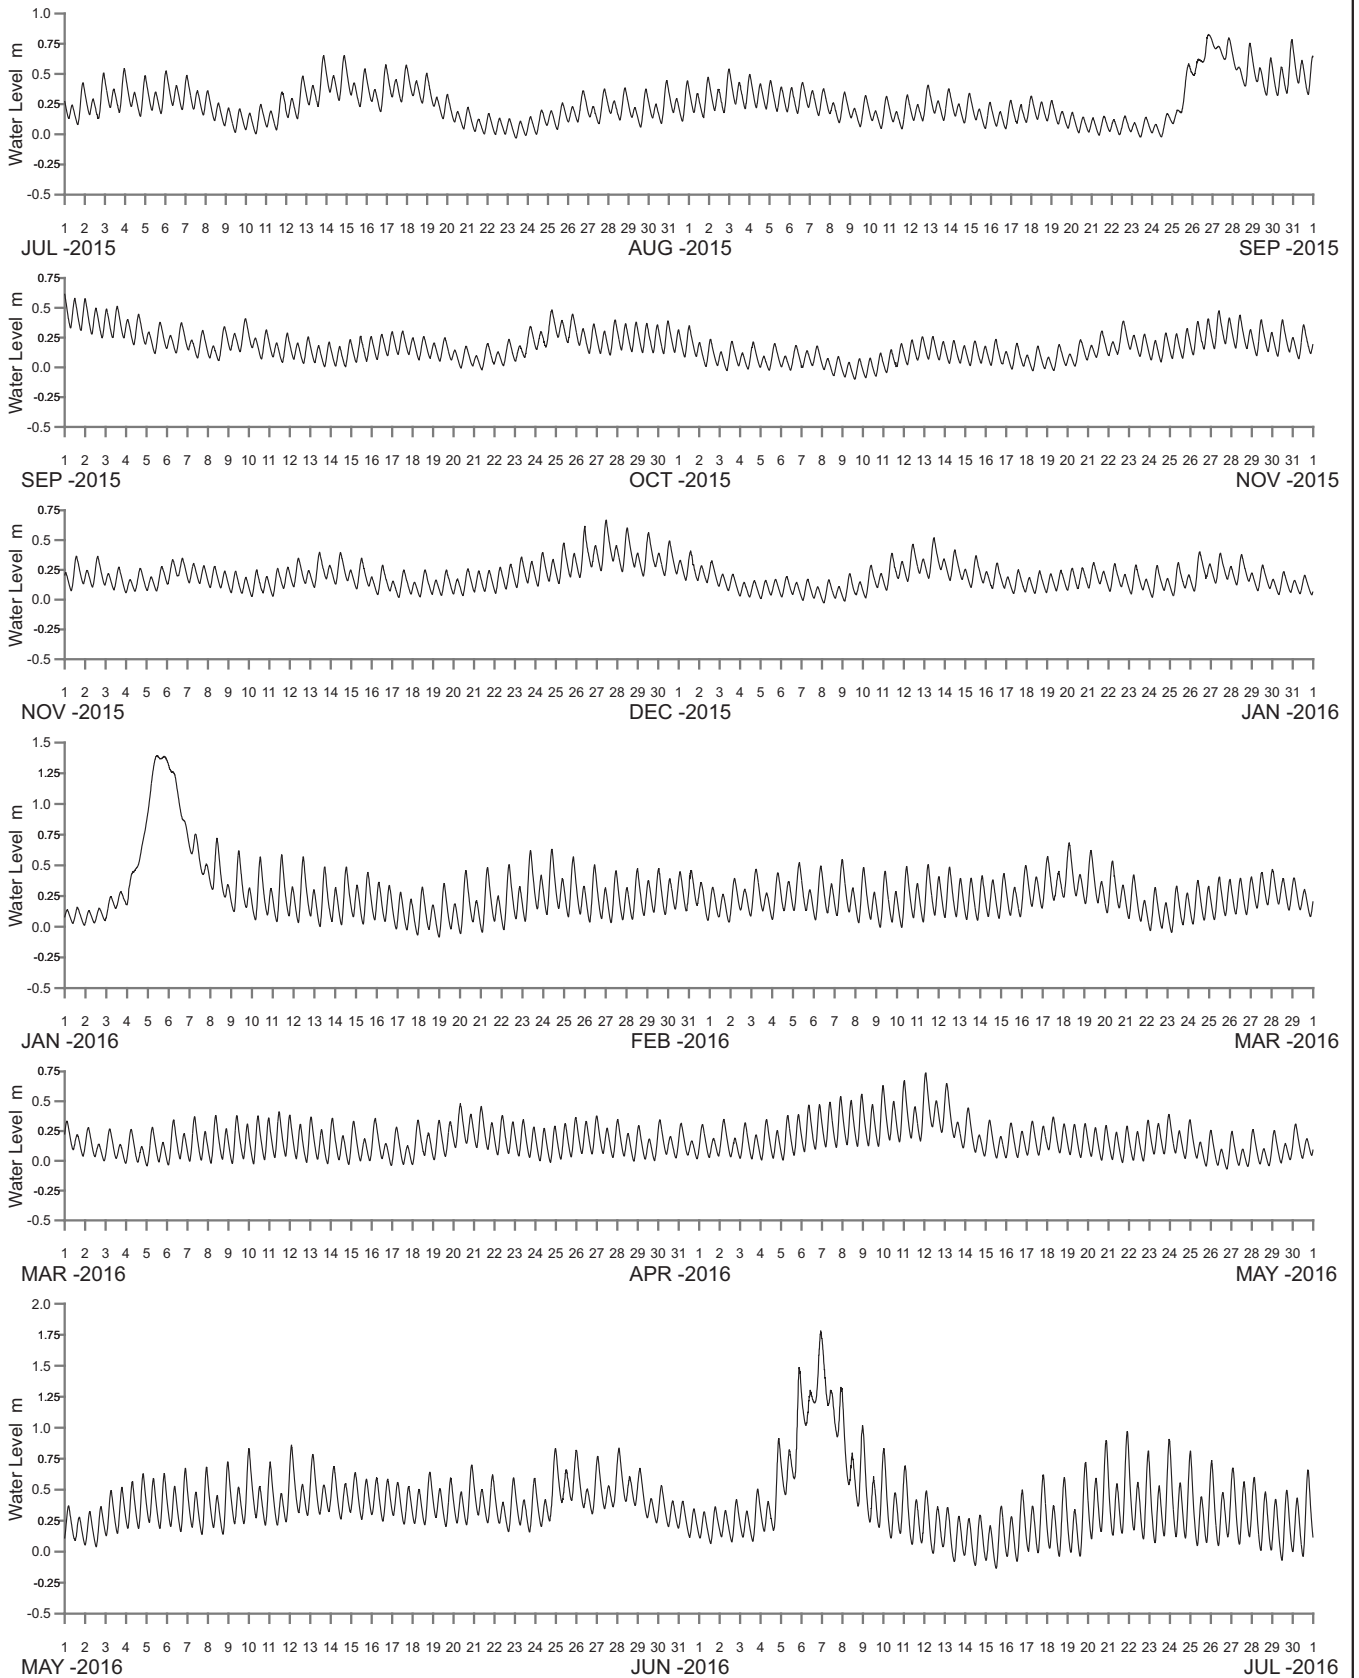
Figure
256

WATER LEVEL REFERENCED TO AUSTRALIAN HEIGHT DATUM

TUROSS RIVER AT TUROSS HEAD
2015–2016

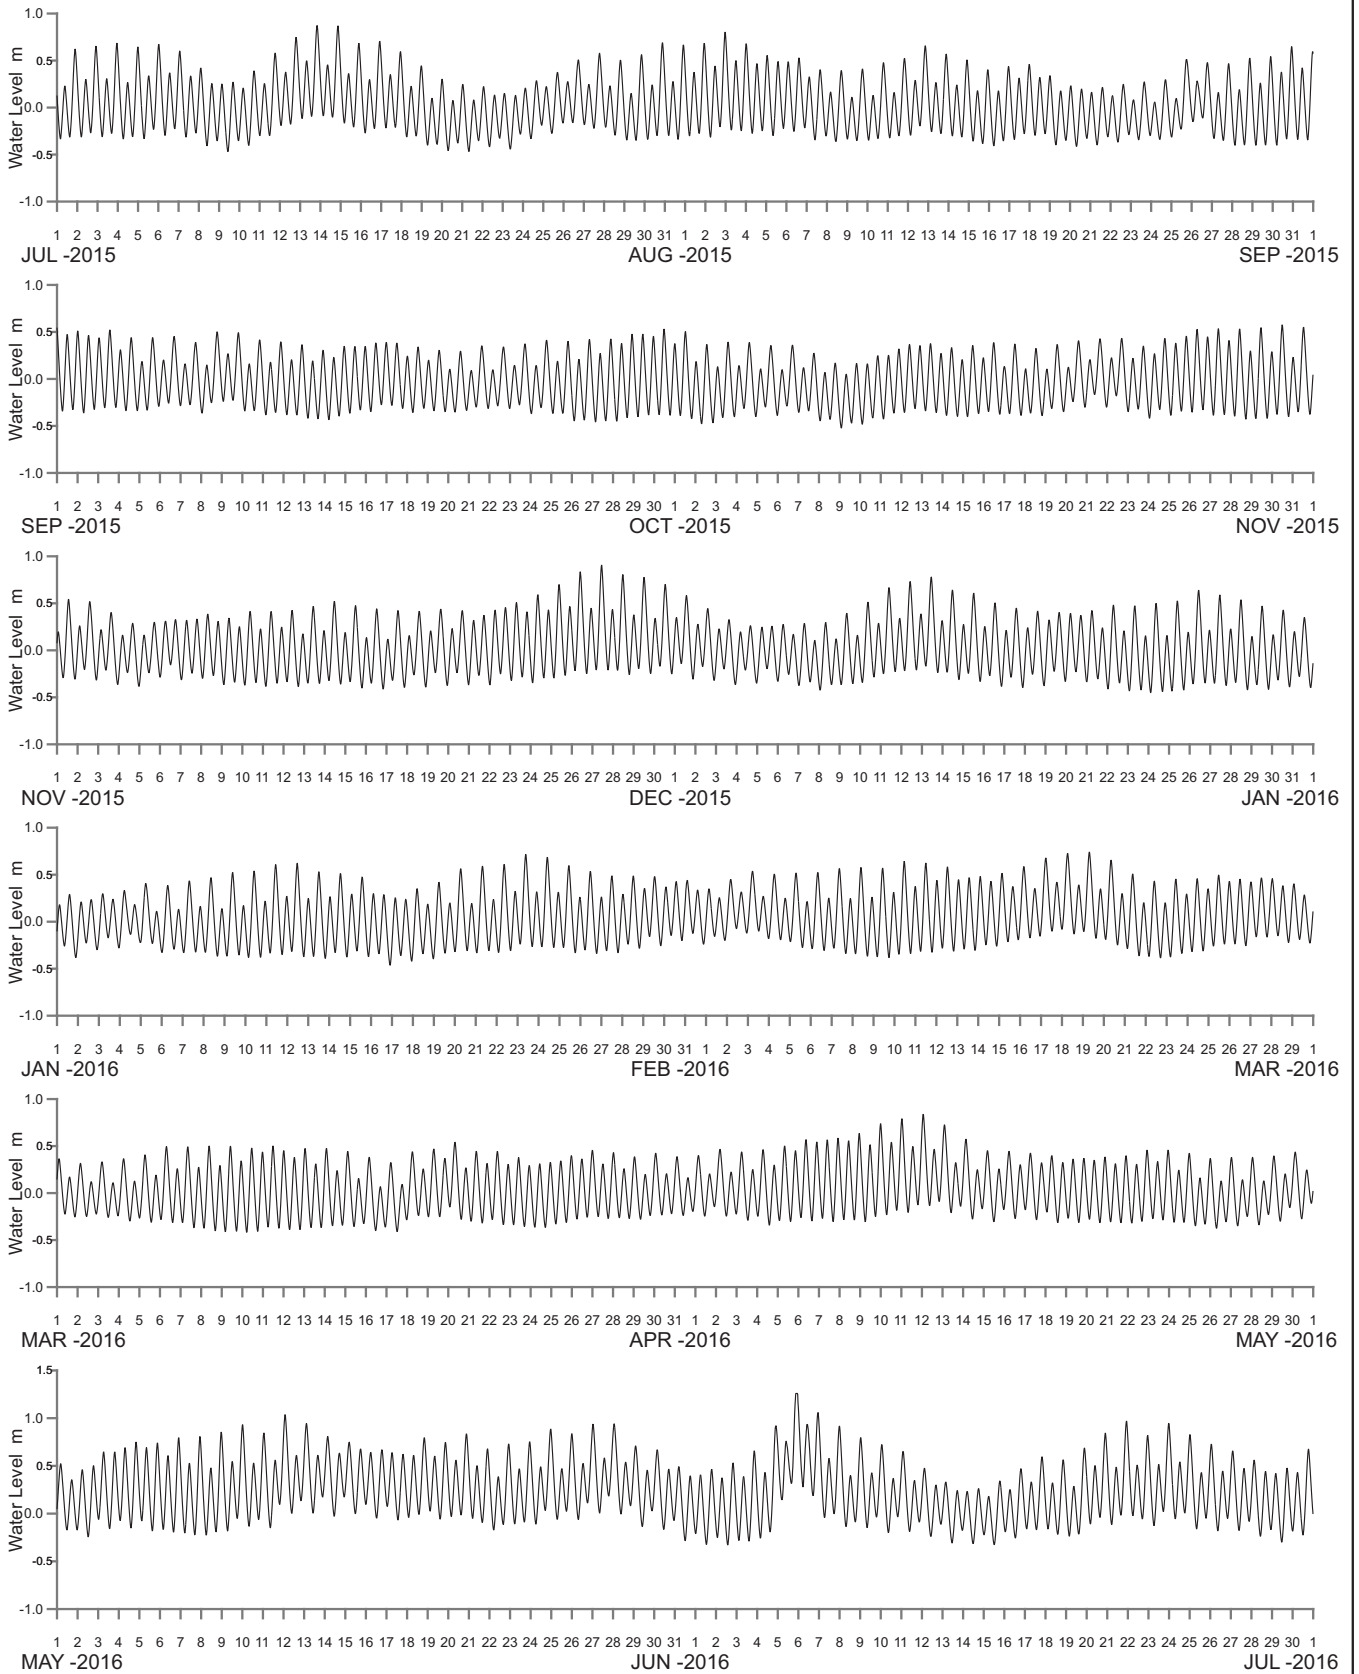
Figure
258

WATER LEVEL REFERENCED TO AUSTRALIAN HEIGHT DATUM

WAGONGA INLET AT BARLOWS BAY
2015–2016

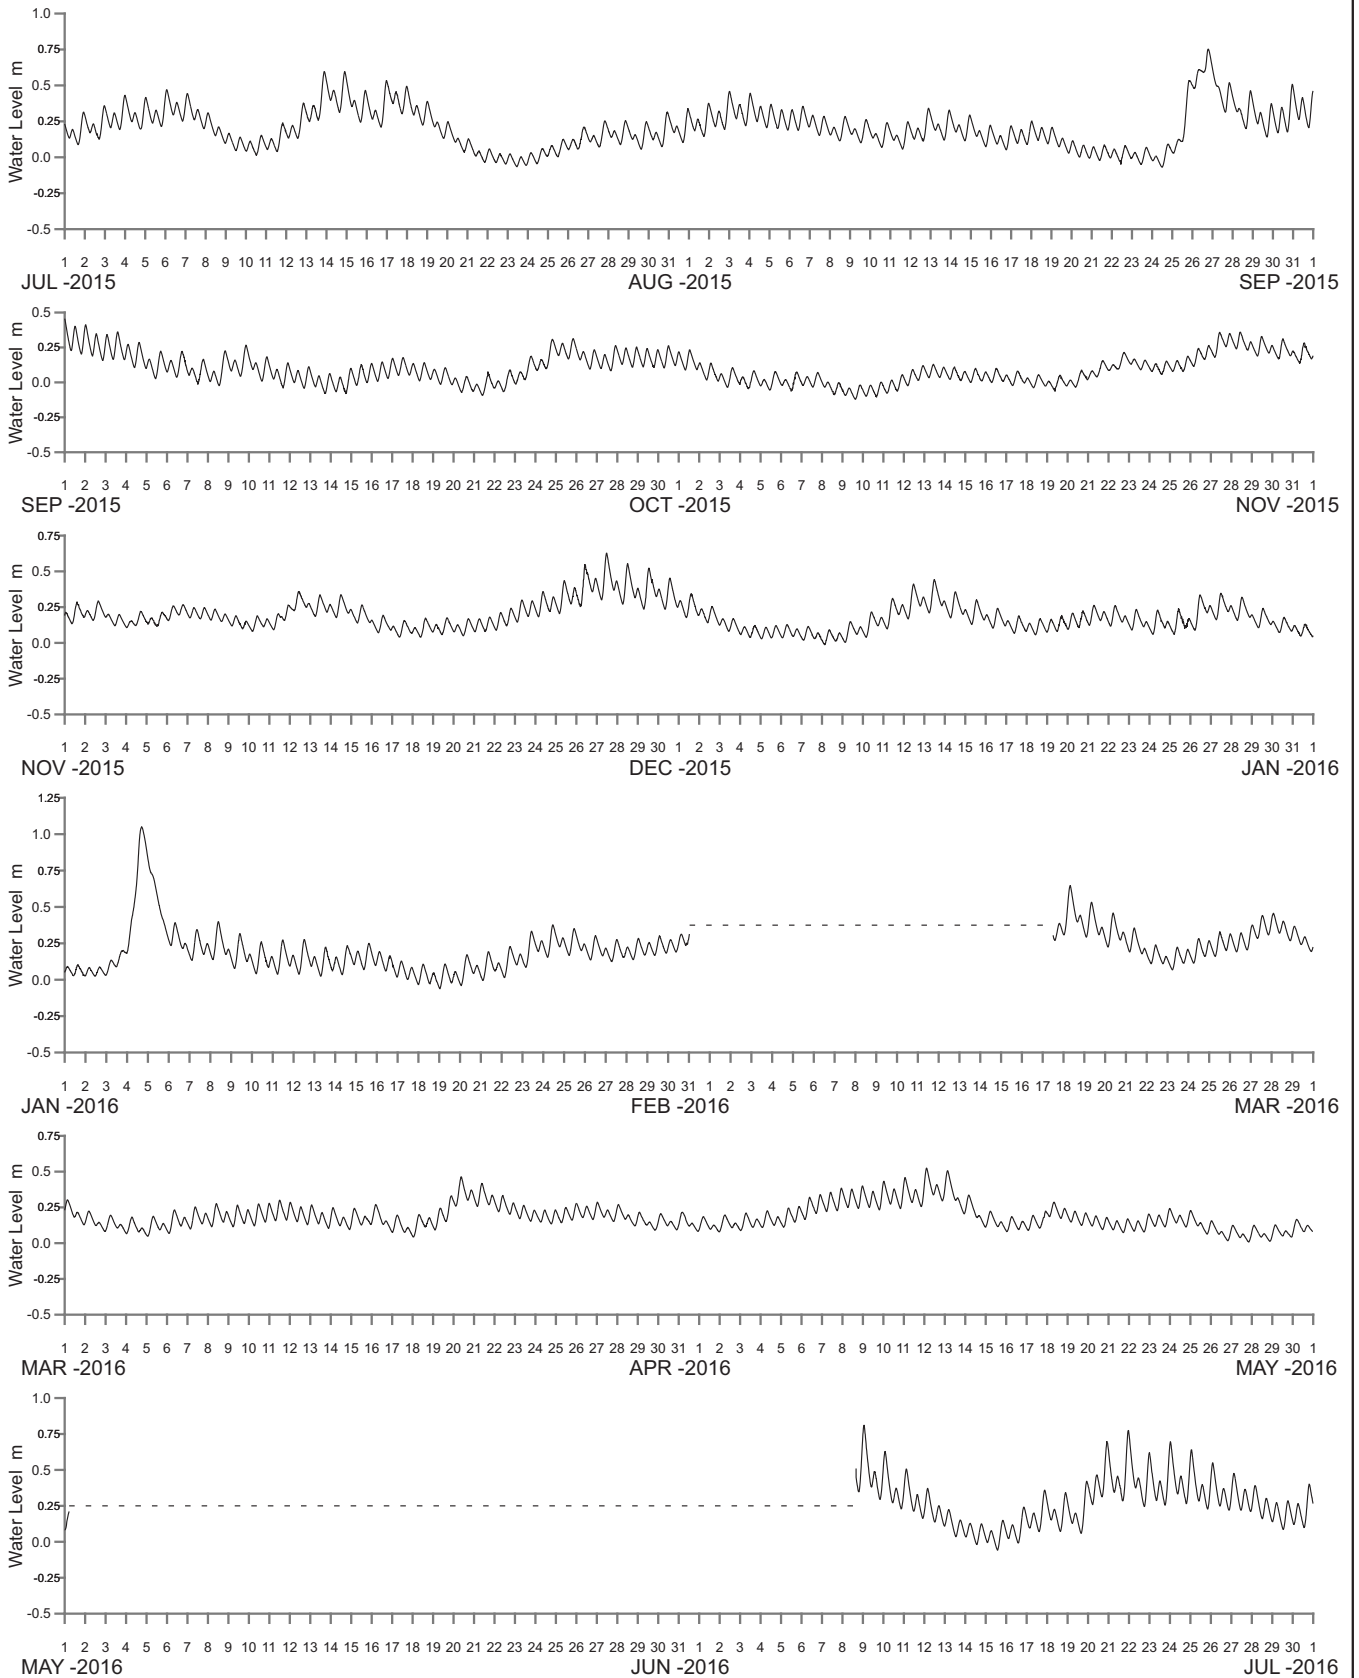
Figure
259

WATER LEVEL REFERENCED TO AUSTRALIAN HEIGHT DATUM

WALLAGA LAKE AT REGATTA POINT
2015–2016

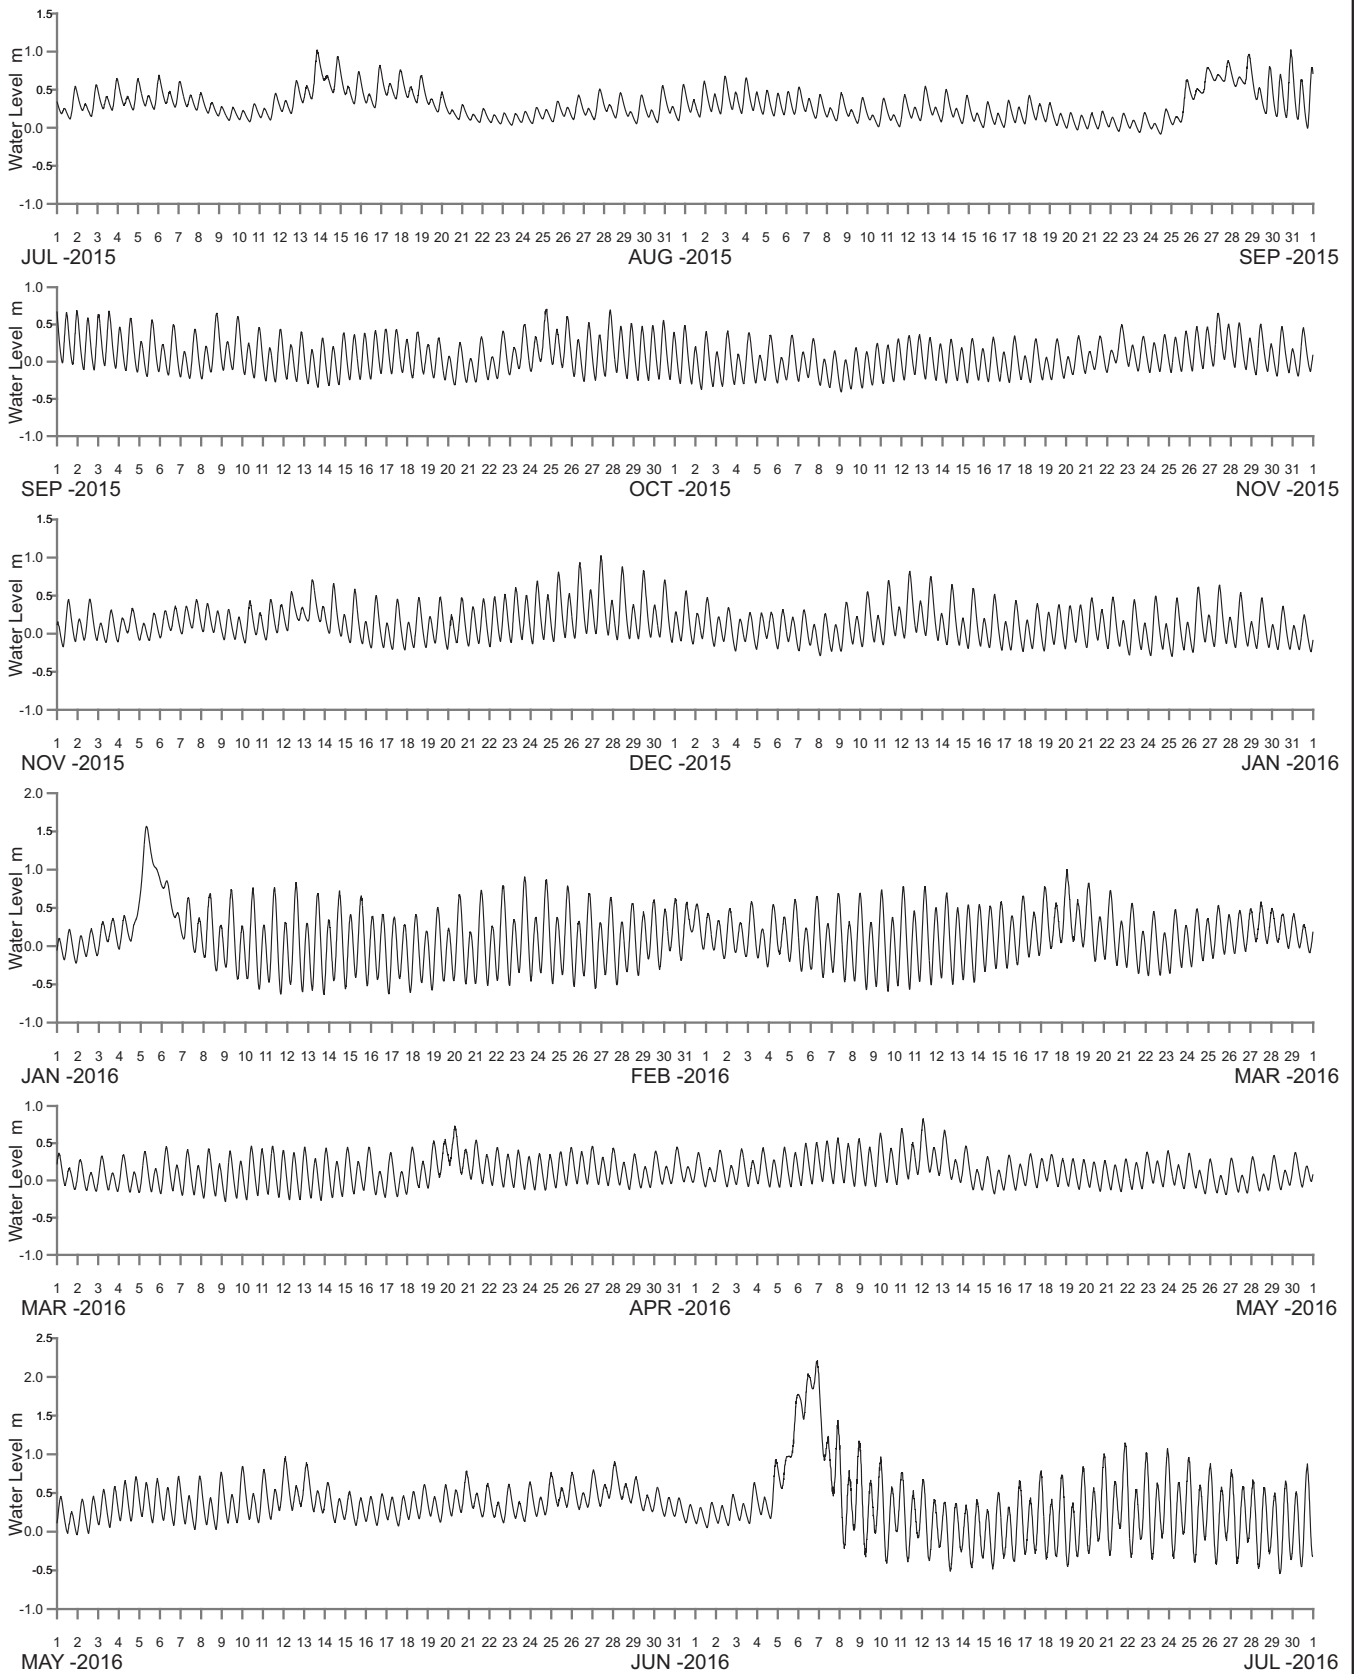
Figure
261

WATER LEVEL REFERENCED TO AUSTRALIAN HEIGHT DATUM

BEGA RIVER AT BEGA RIVER
2015–2016

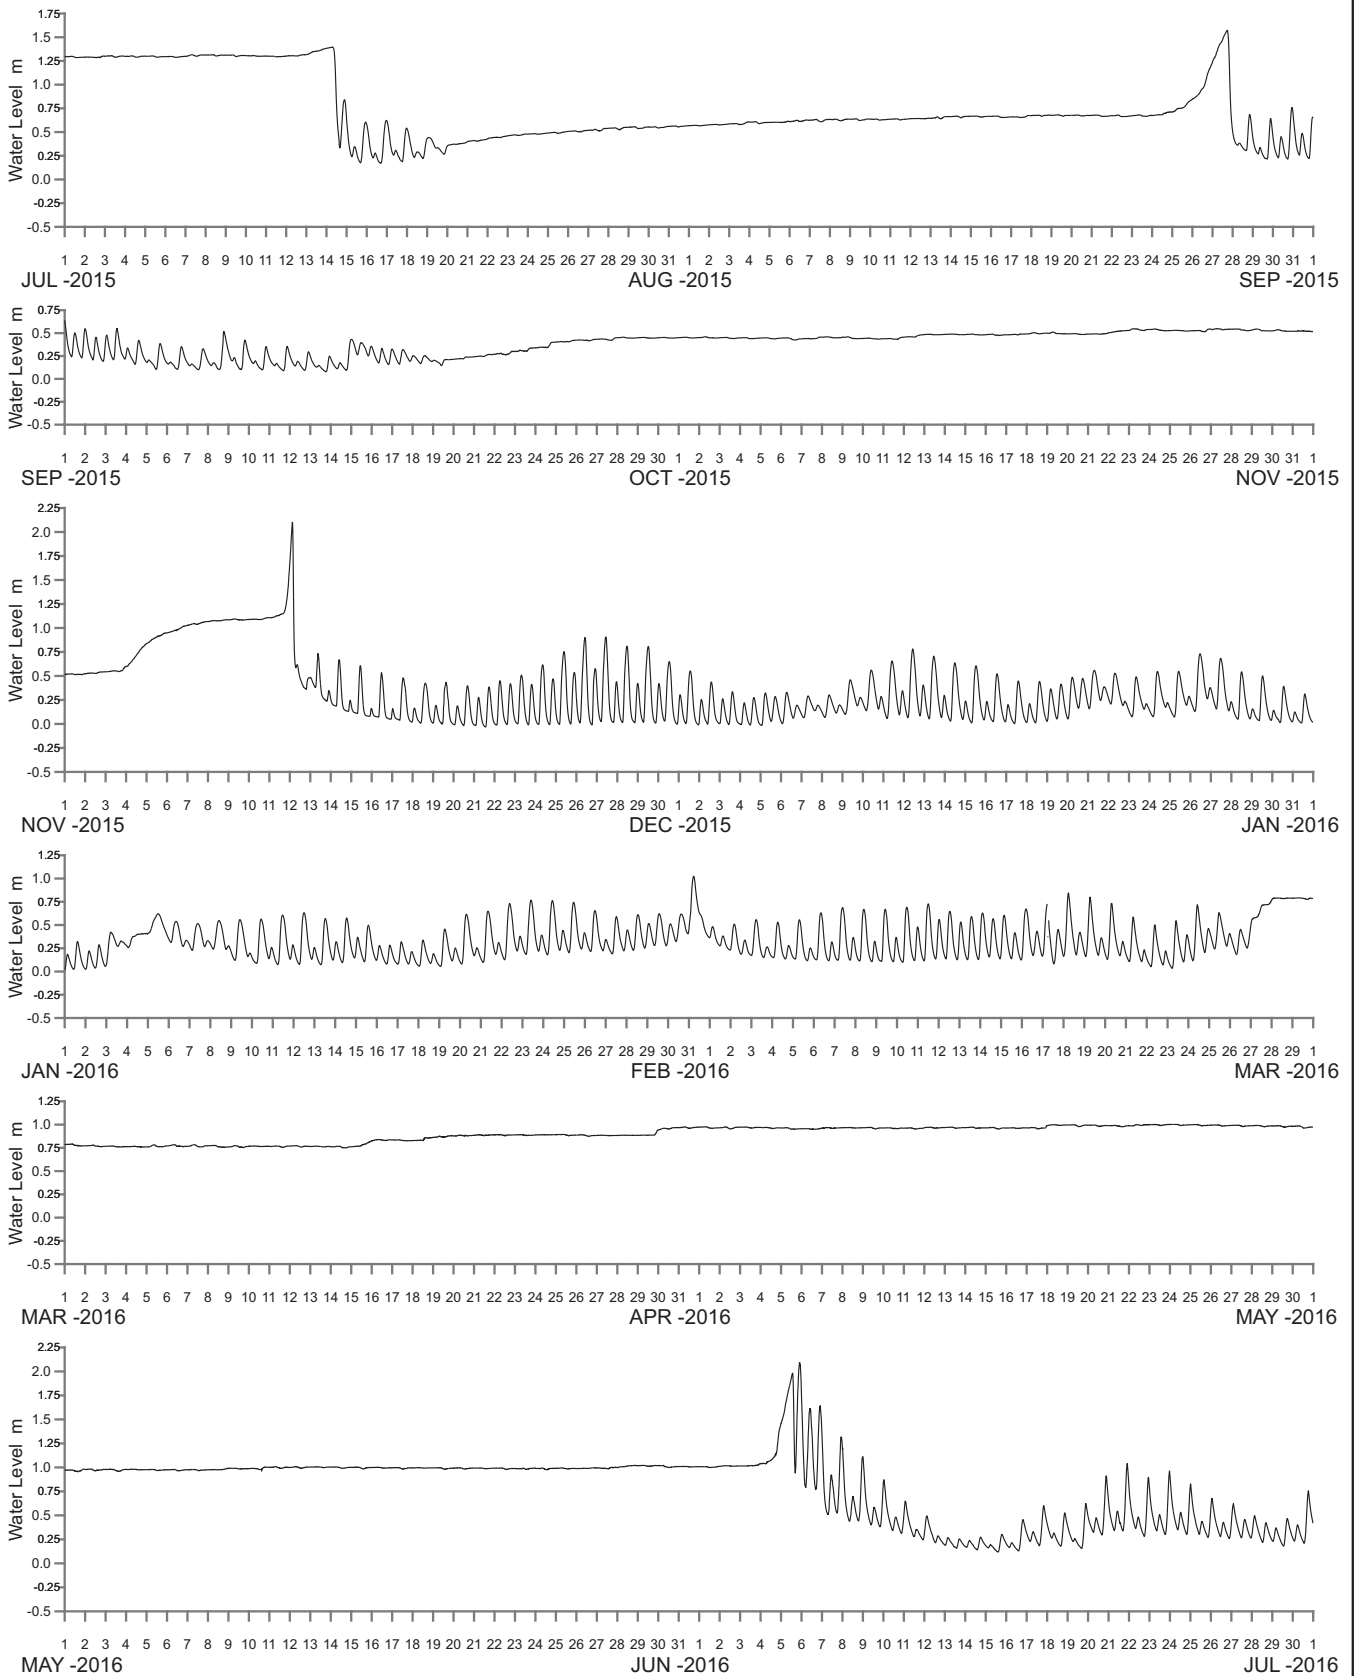
Figure
263

WATER LEVEL REFERENCED TO AUSTRALIAN HEIGHT DATUM

BACK LAGOON AT BACK LAGOON
2015–2016
