River/estuary system	Station name	Figure
Station Locality Map	Wollongong Region	201
Hewitts Creek	Hewitts Creek Upstream	202
Hewitts Creek	Hewitts Creek Downstream	203
Hewitts Creek	Hewitts Creek Entrance	204
Cabbage Tree Creek	Balgownie Road	205
Bellambi	Bellambi	206
Towradgi Creek	Towradgi Creek Upstream	207
Towradgi Creek	Towradgi Creek Downstream	208
Cabbage Tree Creek	Cabbage Tree Creek Upstream	209
Cabbage Tree Creek	Cabbage Tree Creek Downstream	210
Fairy Creek	Fairy Creek Upstream	211
Fairy Creek	Fairy Creek Downstream	212
Byarong Creek	Byarong Creek	213
Byarong Creek	Koloona Avenue Upstream	214
Byarong Creek	Koloona Avenue Downstream	215
American Creek	Blackmans Parade Upstream	216
American Creek	Blackmans Parade Downstream	217
Station Locality Map	Lake Illawarra Region	218
Mullet Creek	Mullet Creek	219
Lake Illawarra	Koonawarra Bay	220
Lake Illawarra	Cudgeree Bay	221
Lake Illawarra	Lake Illawarra Entrance	222

MHL
Report 2474

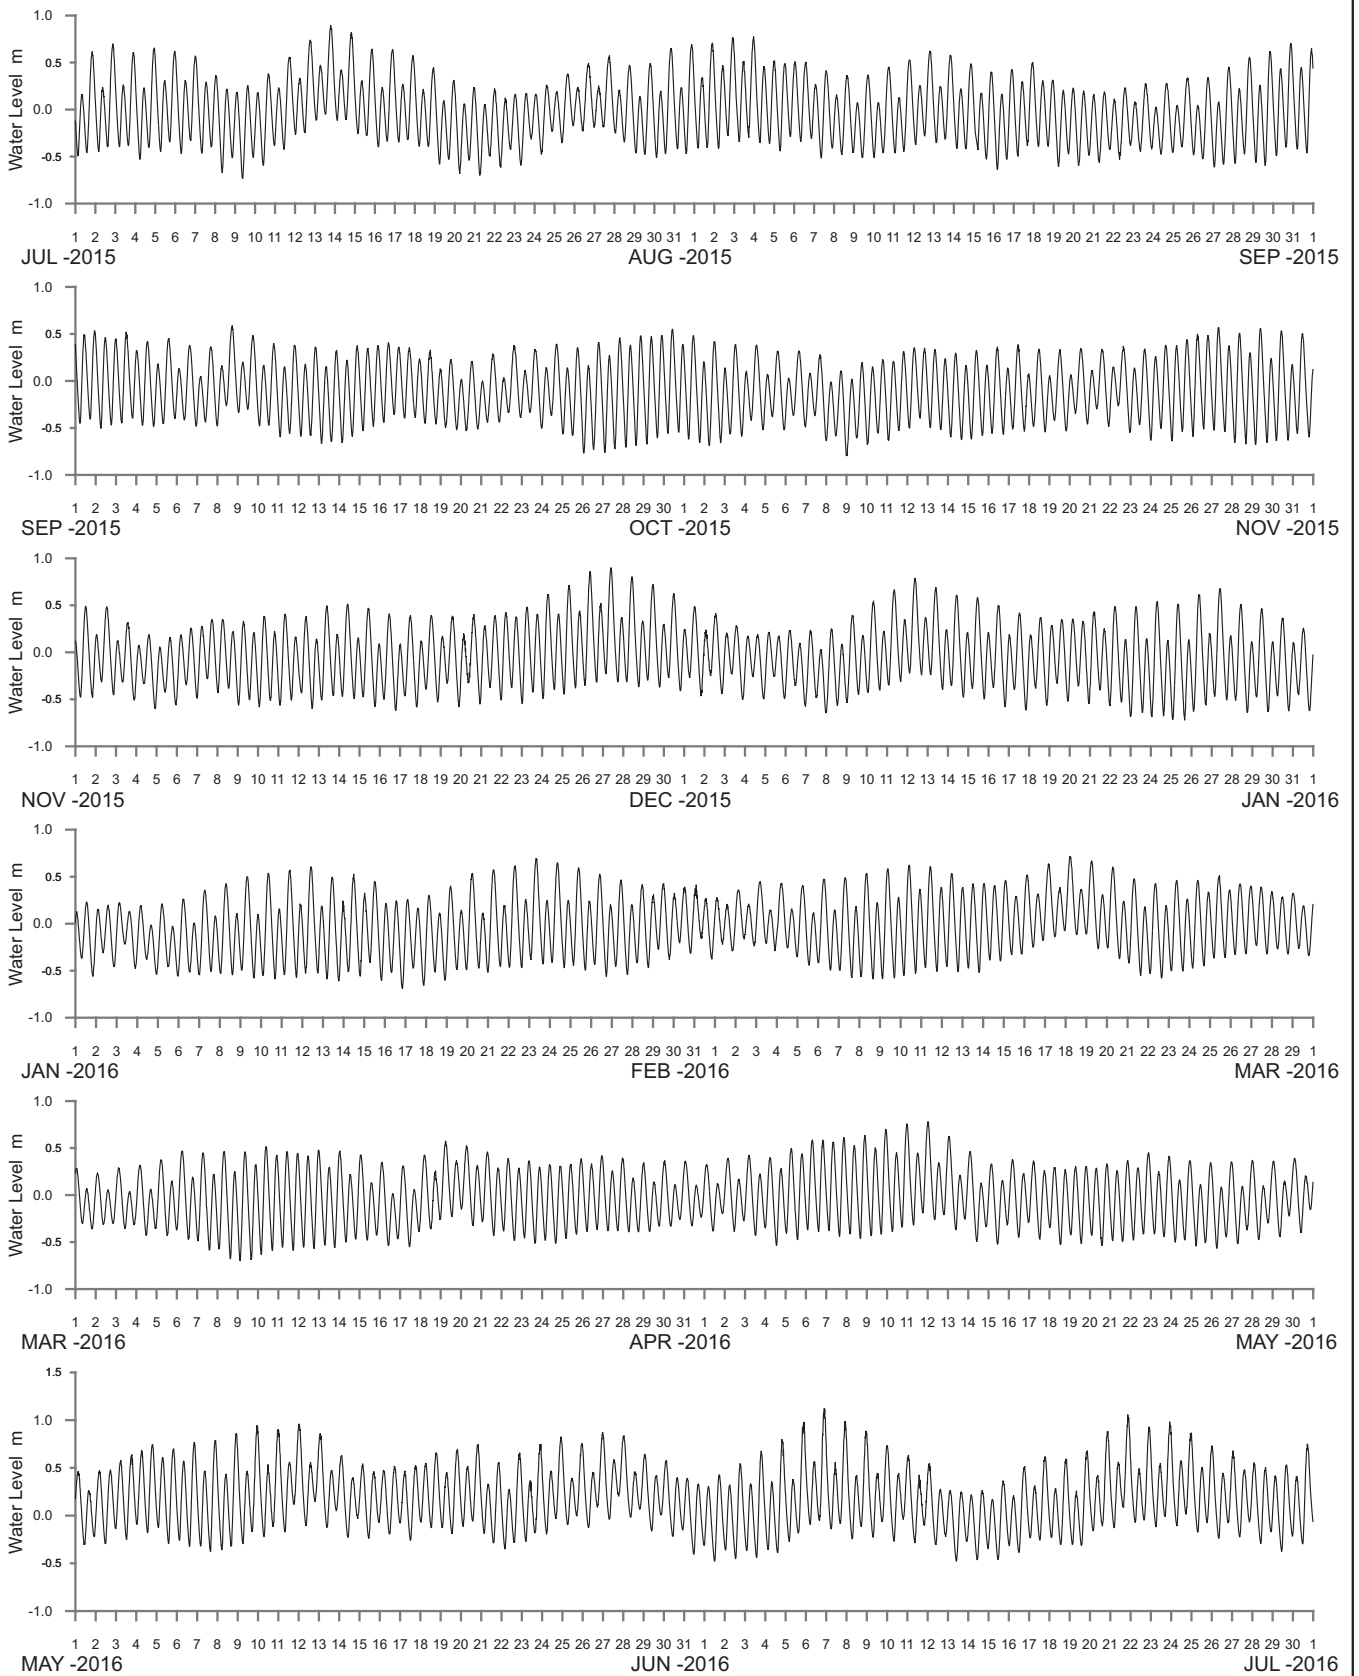
Figure
264

WATER LEVEL REFERENCED TO AUSTRALIAN HEIGHT DATUM

MERIMBULA LAKE AT MERIMBULA WHARF
2015–2016

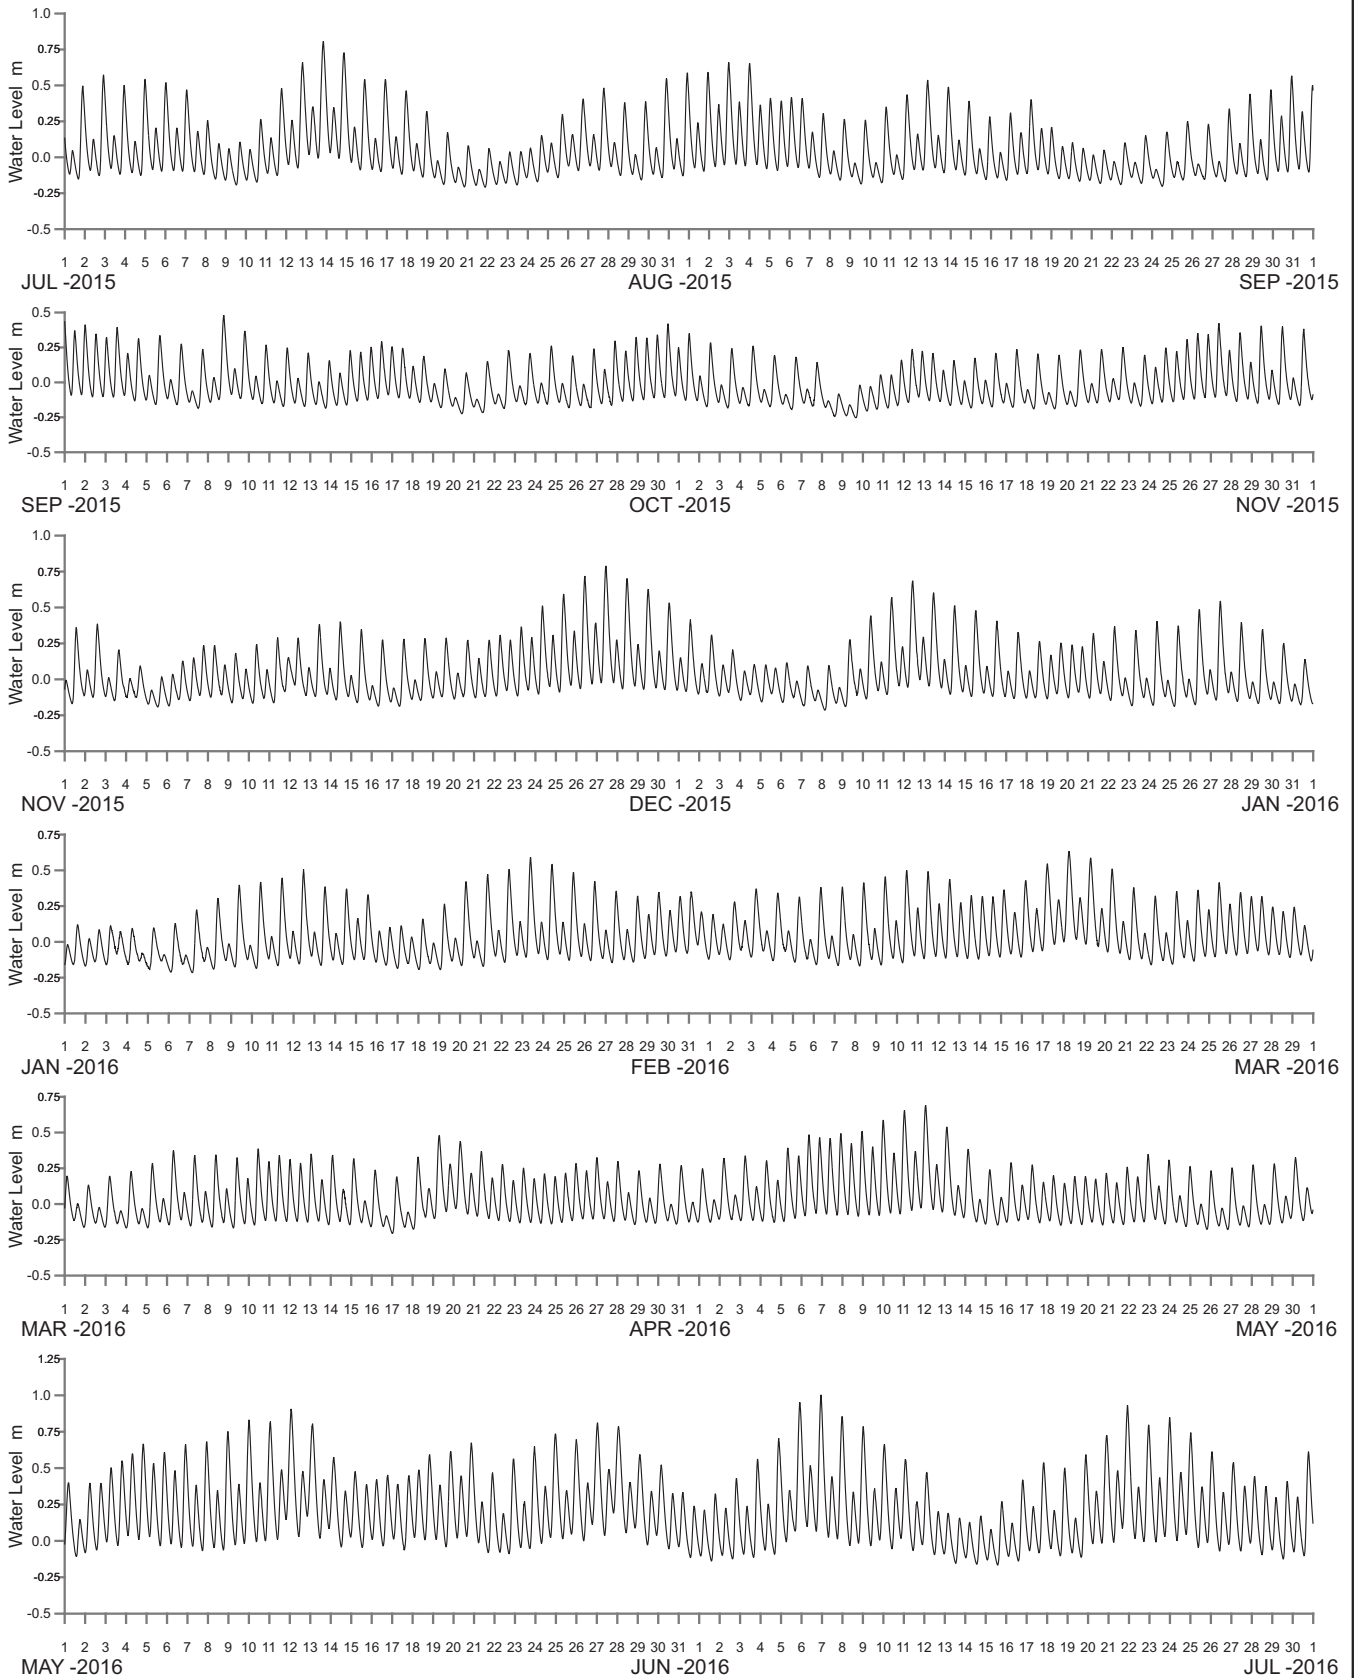
Figure
265

WATER LEVEL REFERENCED TO AUSTRALIAN HEIGHT DATUM

MERIMBULA LAKE AT MERIMBULA LAKE
2015–2016

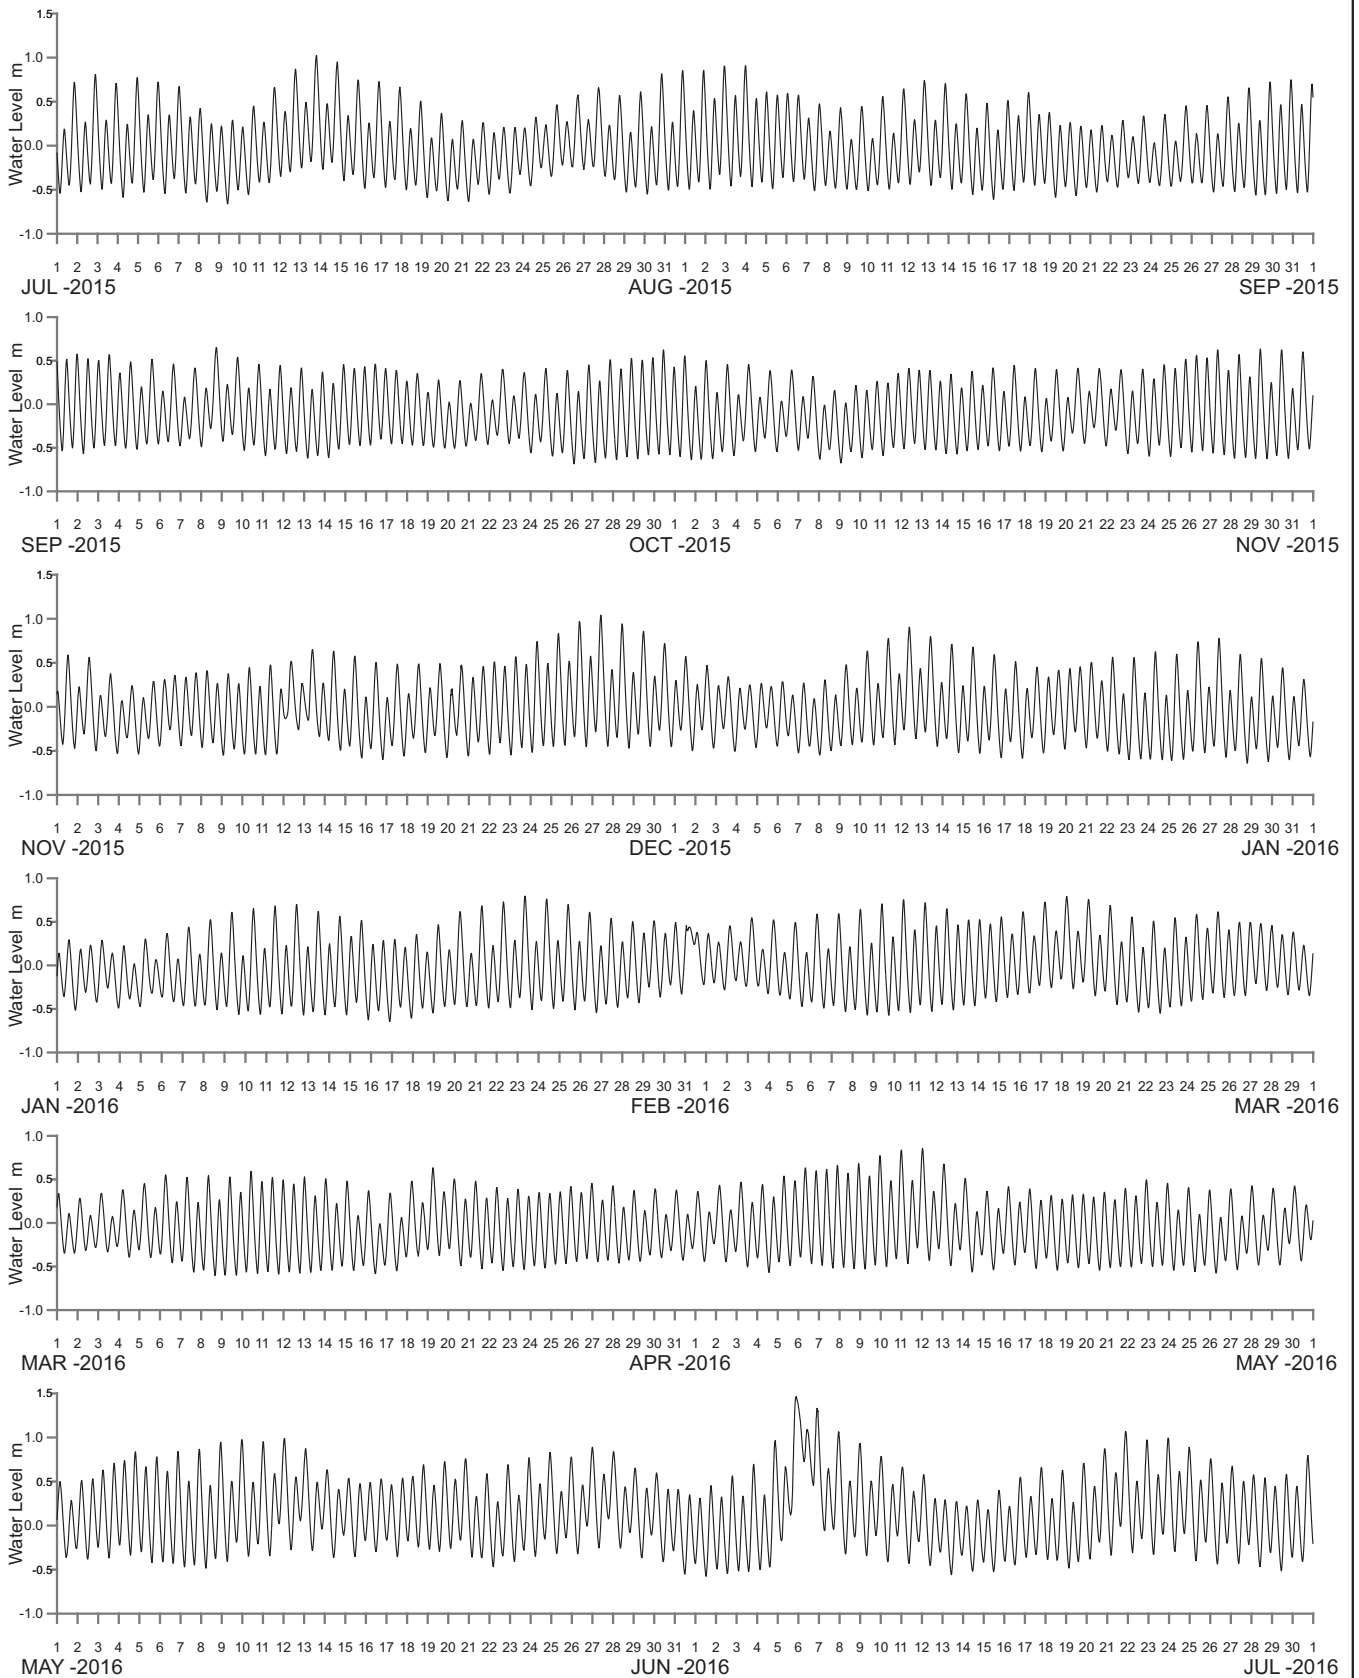
Figure
266

WATER LEVEL REFERENCED TO AUSTRALIAN HEIGHT DATUM

PAMBULA LAKE AT PAMBULA LAKE
2015–2016

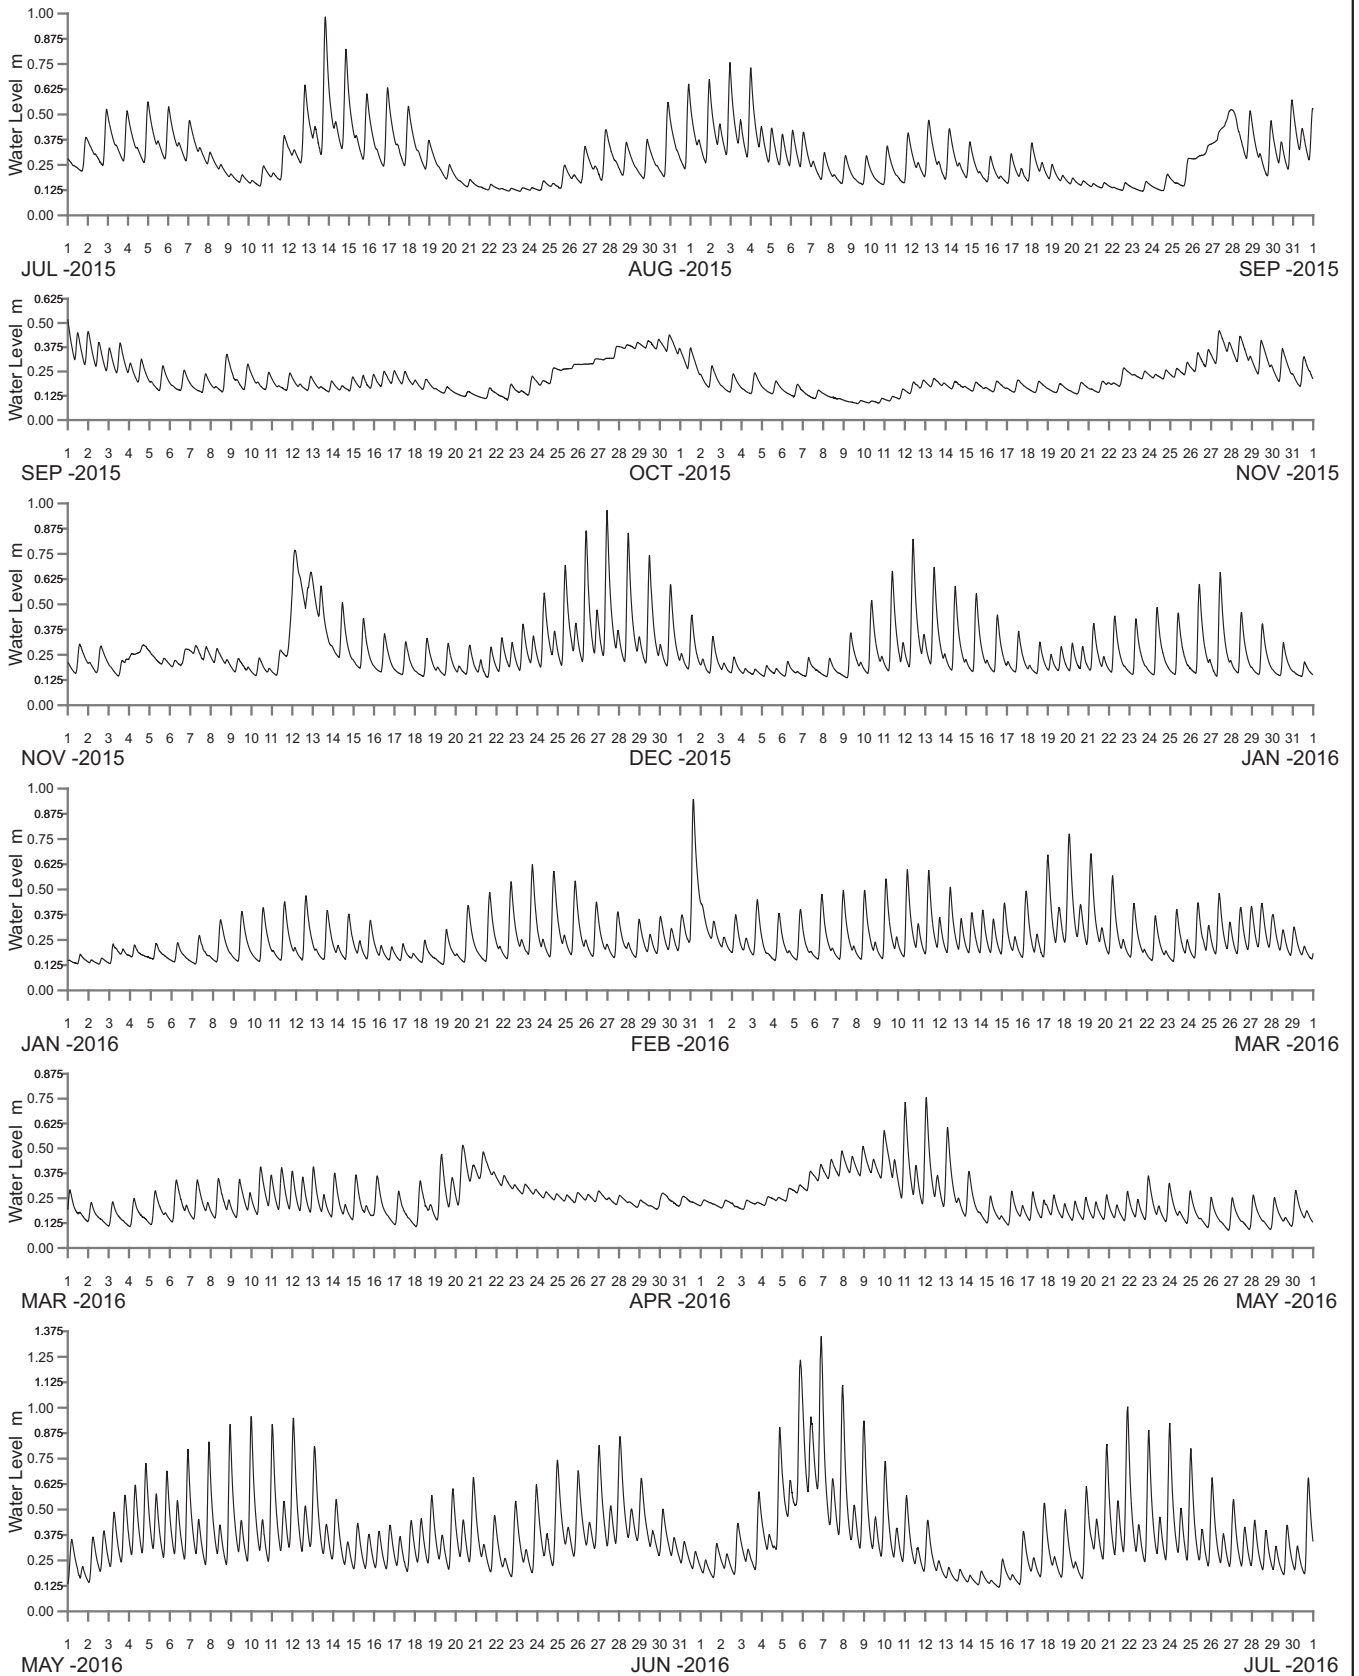
Figure
267

WATER LEVEL REFERENCED TO AUSTRALIAN HEIGHT DATUM

LAKE CURALO AT LAKE CURALO
2015–2016

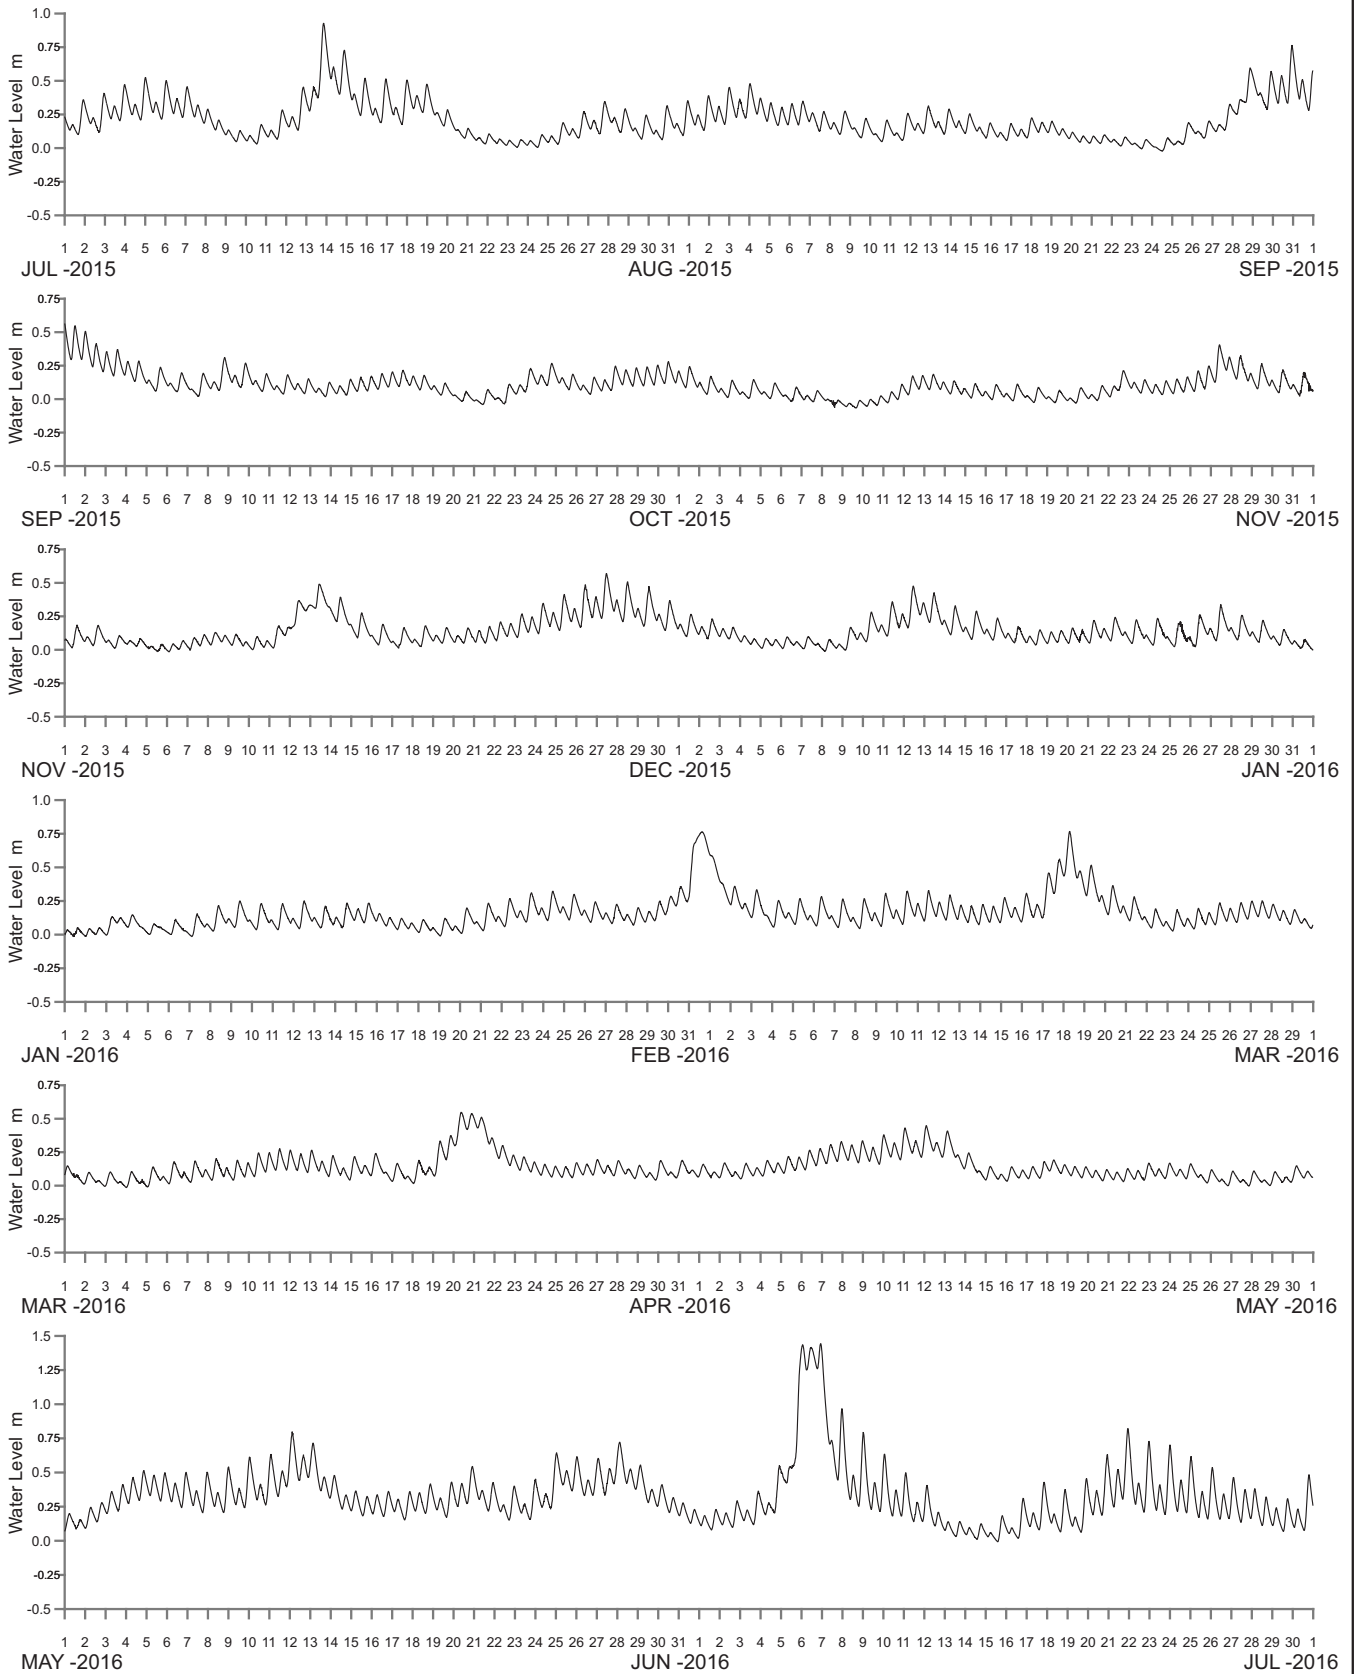
Figure
268

WATER LEVEL REFERENCED TO AUSTRALIAN HEIGHT DATUM

**WONBOYN RIVER AT AGNEW WHARF
2015–2016**
